Alaska Department of Transportation & Public Facilities  
**Research & Technology Transfer**

# High Friction Surface Treatment Experimental Feature Final Report and 3<sup>rd</sup> Year Monitoring Results

Alaska Department of Transportation and Public Facilities,  
Central Region Materials and Statewide Asset Management & Research

**Publication Number:** FHWA-AK-RD-000S(882)

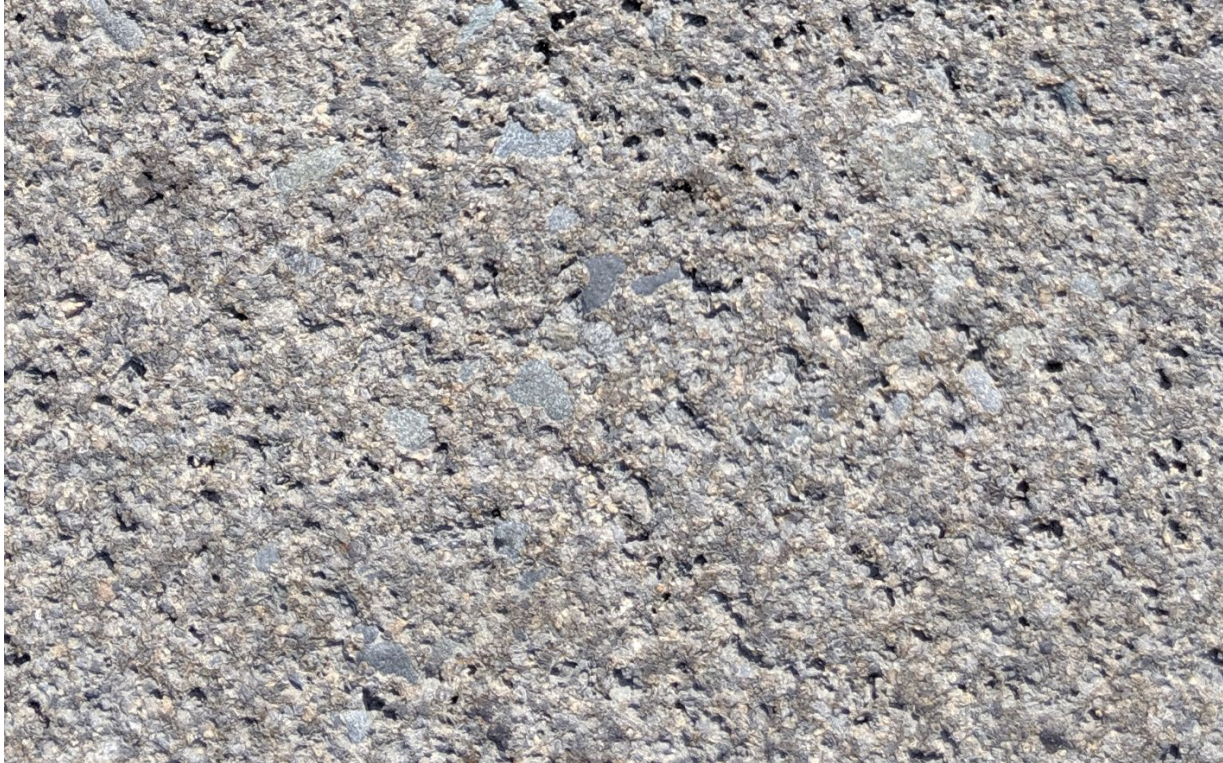
## Site 1 – Sterling Highway MP 104 - Friction Overview

The site has lost significant friction. Four out of the five tests in 2019 were less than typical pavement value of 0.45, with an average value of 0.38. A zoomed in look at the surface texture in 2019 (below) shows visible pavement under the remaining HFST, and the HFST left in the wheelpaths shows signs of polish.

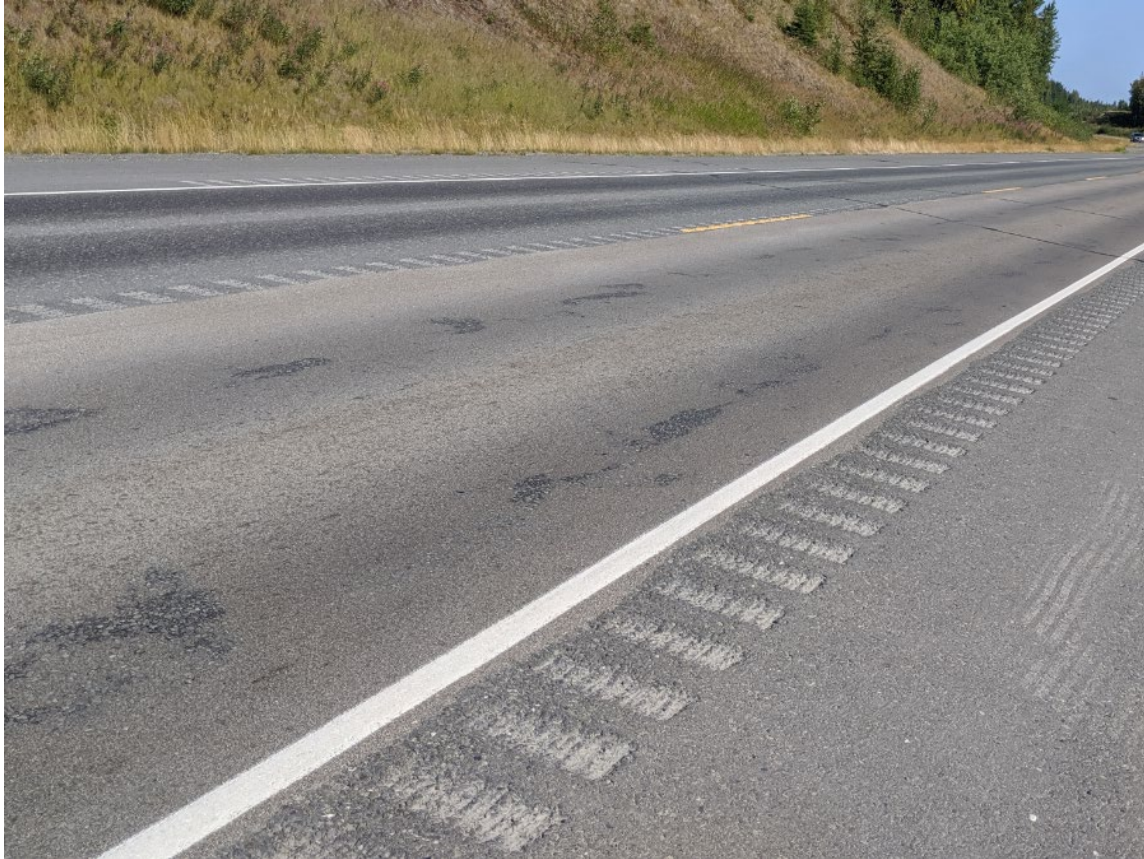
## Site 2 – Sterling Highway MP 86.4 - Friction Overview

The site has lost significant friction. Five out of the six tests in 2019 were less than typical pavement value of 0.49, with an average value of 0.37. The picture below from 2019 shows bare patches of pavement, and the surface texture within the wheelpaths show significant signs of polish.

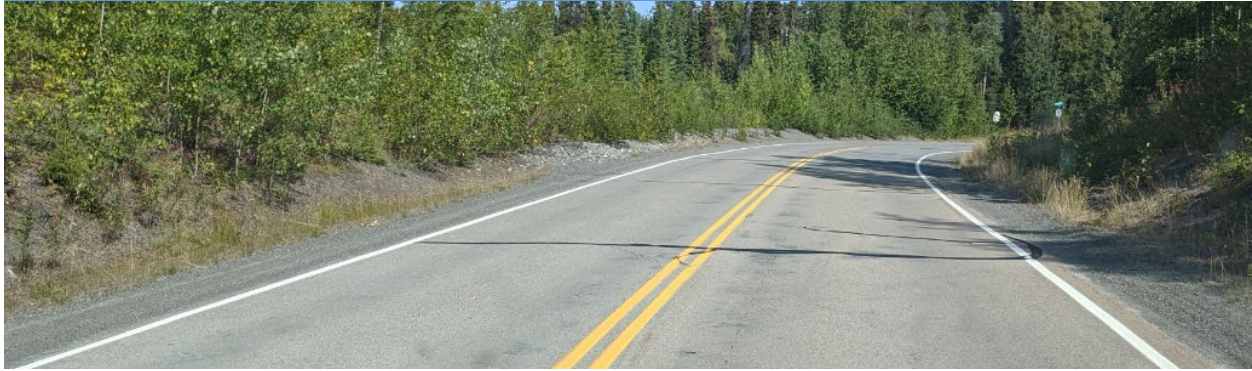
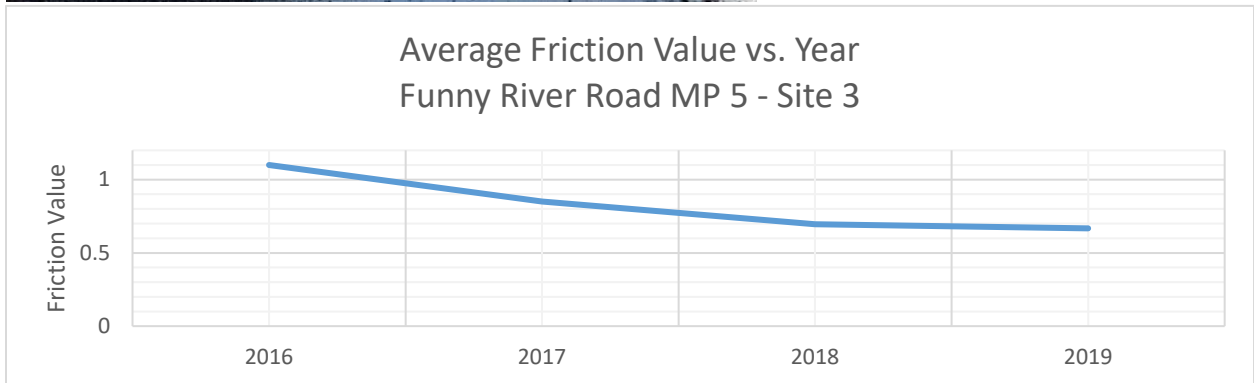
### Site 3 – Funny River Road MP 5 - Friction Overview

Funny River Road has lost moderate friction, but did not lose a large amount between testing in 2018 and 2019. None of the four tests in 2019 were less than typical pavement value of 0.48, with an average value of 0.67. The first picture below from 2019 does show visible wear in the wheelpaths into and out of curves. Areas in straightaways seemed to show less signs of visible wear, as shown in the second picture taken in 2019.

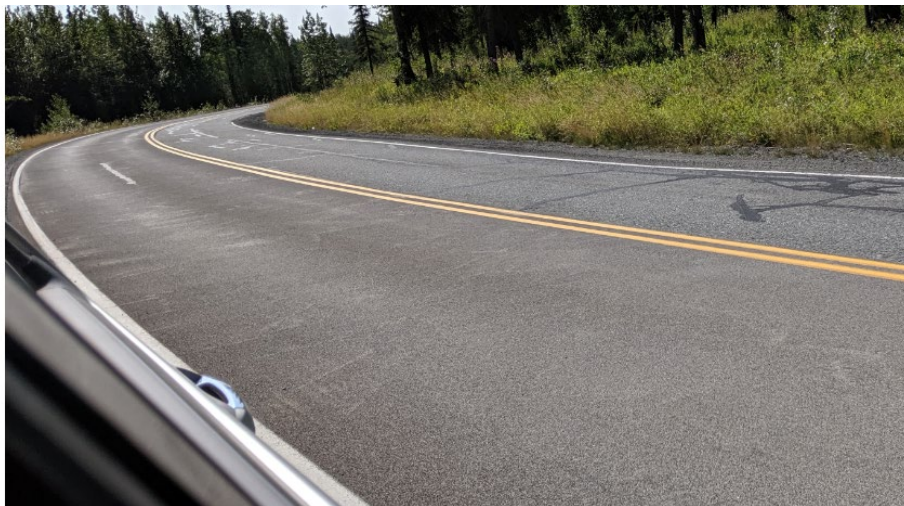
**2019**

Funny River Road has lost moderate friction, but did not lose a large amount between testing in 2016 and 2019. None of the four tests in 2019 were less than typical pavement value of 0.48, with an average value of 0.61. The picture below shows slight wear in the wheelpaths, and as at Site 3 on Funny River more wear was evident into and out of curves.

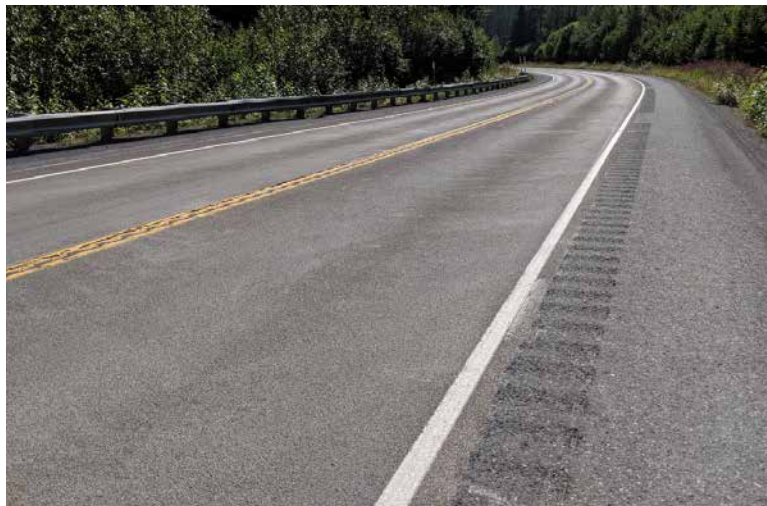
**2019**

Seward Highway at milepost 15 has lost moderate friction overall, but significant friction at specific locations. Three of the six tests in 2019 were less than typical pavement value of 0.48, with an average value of 0.50. The picture from 2019 below shows wear in the wheelpaths going into and out of a curve.

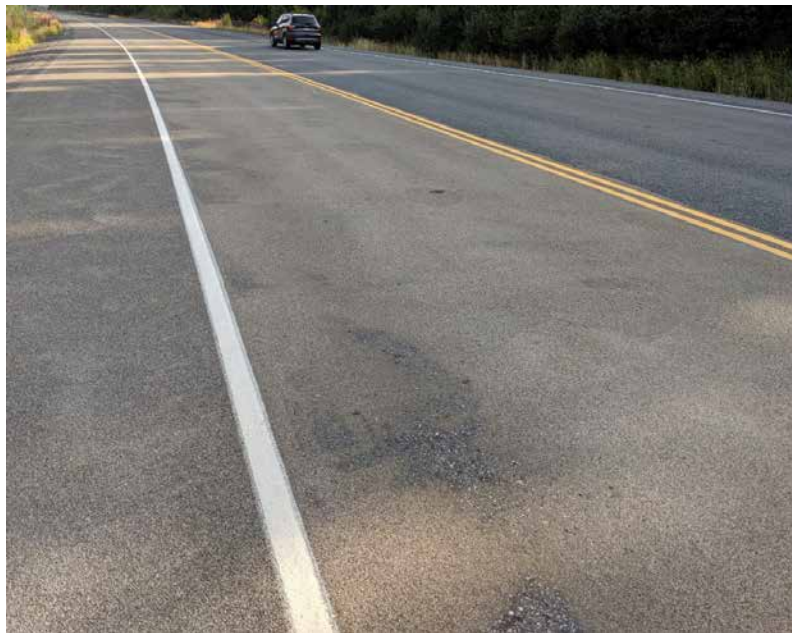
**2019**

Seward Highway at milepost 39.4 has lost moderate friction overall, but significant friction at specific locations. The tests on the shoulder indicate that substantial friction is lost from snowplowing operations. Two of the five tests in 2019 were less than typical pavement value of 0.47, with an average value of 0.48. The picture from 2019 below shows areas of bare pavement in the wheelpaths.

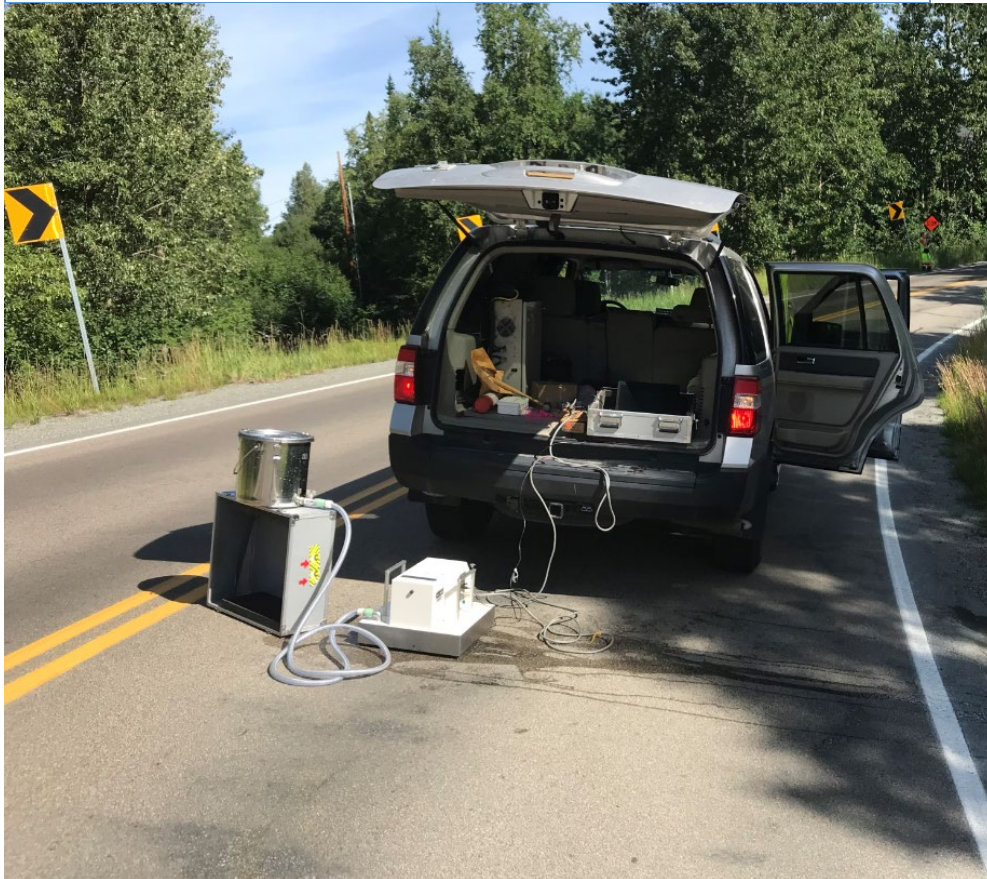
DeArmoun Road lost moderate friction overall. While the friction drop between 2017 and 2018 was not major three of the six tests in 2018 were less than typical pavement value of 0.54, with an average value of 0.55. Bare pavement was visible at locations as can be seen in the 2018 photo, below.

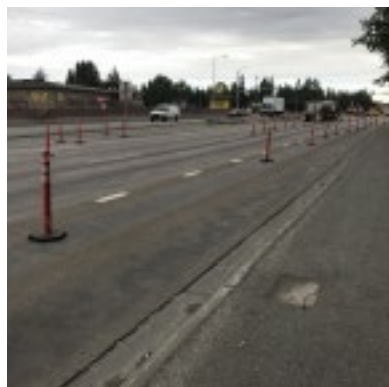
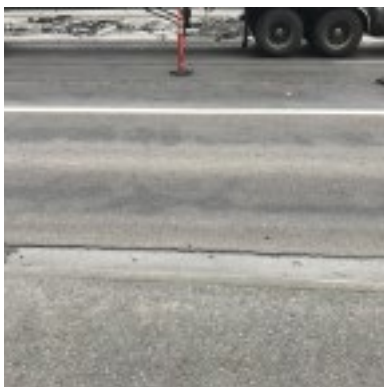
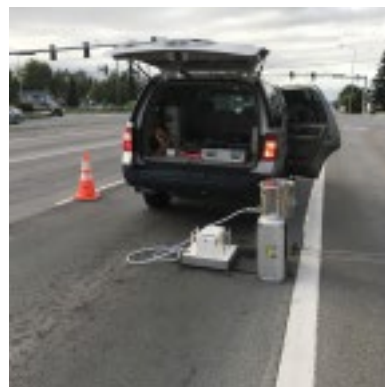
Minnesota Drive at Tudor lost significant friction. The friction drop between 2017 and 2018 was major and all four tests in 2018 were less than typical pavement value of 0.60, with an average value of 0.30. As can be seen in the 2018 photo, below, all wheelpaths show wear and show large amounts of bare pavement.

It is recommended that HFST be removed in Anchorage and not used in the future in urban centers while studded tire use is still allowed.

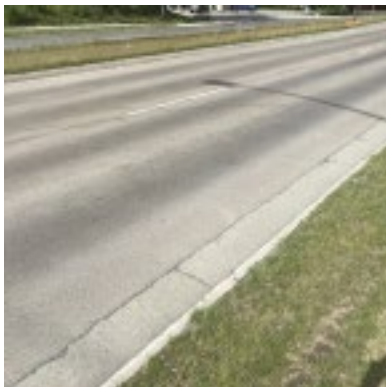
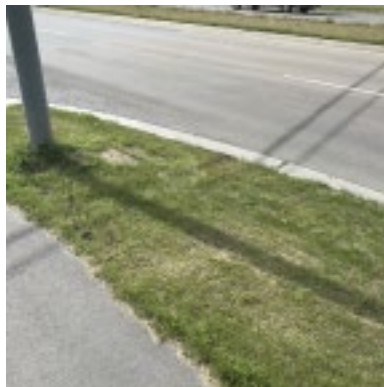
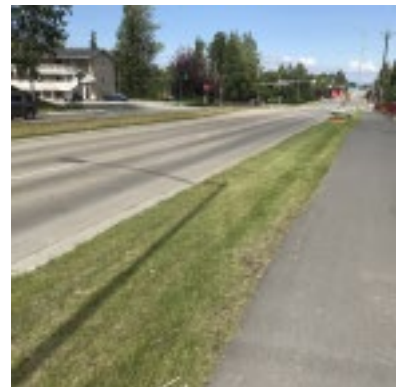
**2018**

Lake Otis at Waldron lost significant friction. The friction drop between 2017 and 2018 was major and the two tests in the through lanes in 2018 were less than typical pavement value of 0.56, with an average value of 0.34. As can be seen in the 2018 photo, below, all wheelpaths show significant wear. The third test performed in 2018 was in the turn pocket, and that data can be seen at the end of the appendix summarized with other turn pocket data.

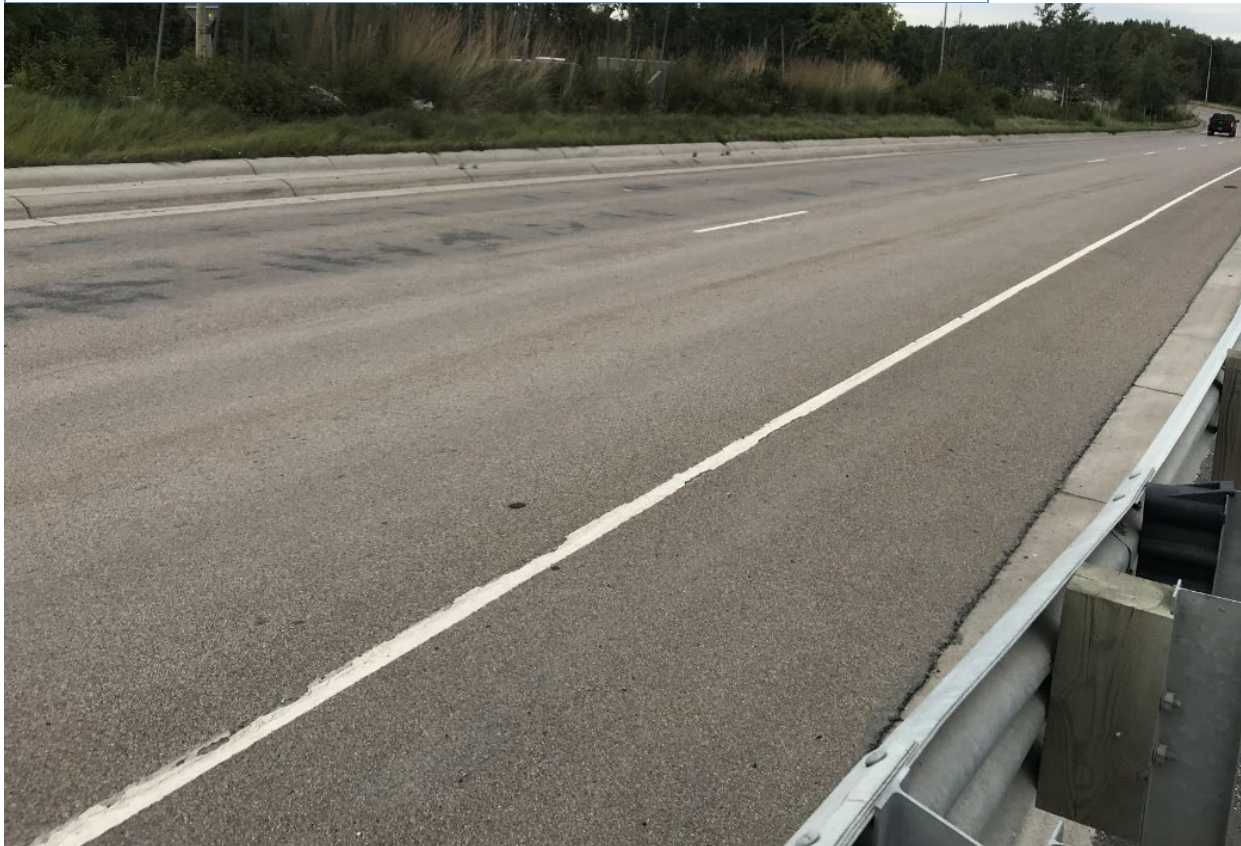
Average Friction Value vs. Year  
MLK- Ballfields to Tudor Center - Site 10

Martin Luther King showed major friction loss in all tests. The friction drop between 2017 and 2018 was significant and all seven tests were less than typical pavement value of 0.58, with an average value of 0.31. As can be seen in the 2018 photo, below, the wheelpaths in the left hand lane show significant wear, while less wear is evident in the right hand lane. The majority of traffic travels in the left lane on this road.

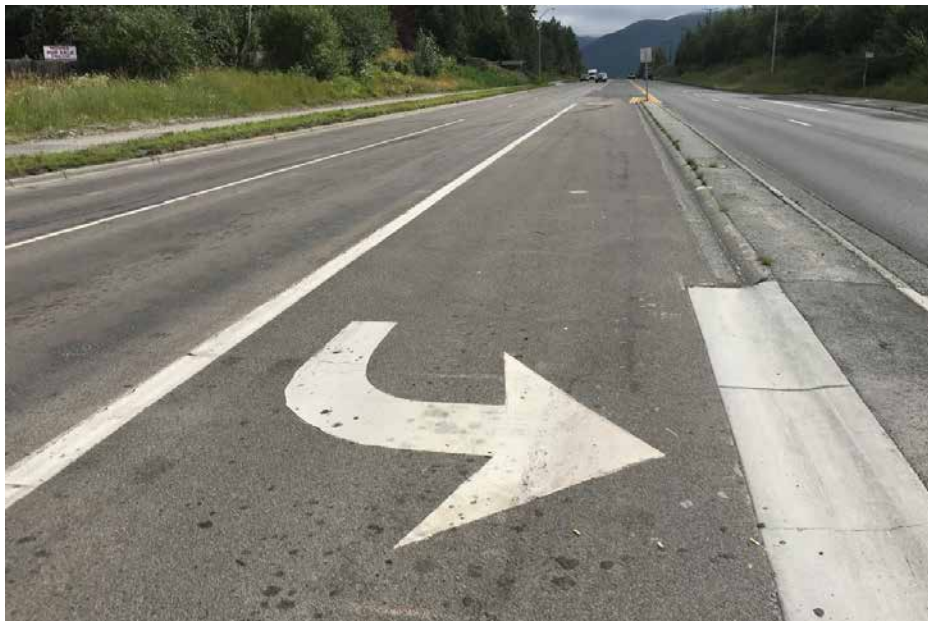
**2018**

Tudor Road showed major friction loss in all tests. The friction drop between 2017 and 2018 was significant and both tests were less than typical pavement value of 0.58, with an average value of 0.31. As can be seen in the 2018 photo, below, the turn pocket shows minimal wear while the wheelpaths in the the through lanes show visible pavement and substantial wear. The third test performed in 2018 was in the turn pocket, and that data can be seen at the end of the appendix summarized with other turn pocket data.

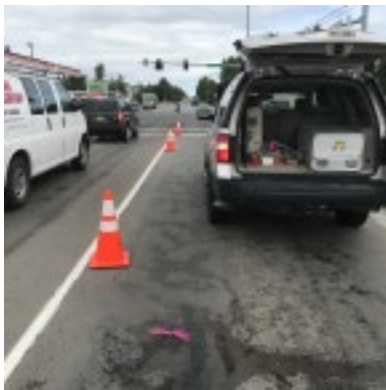
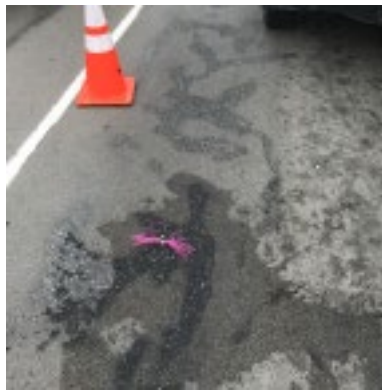
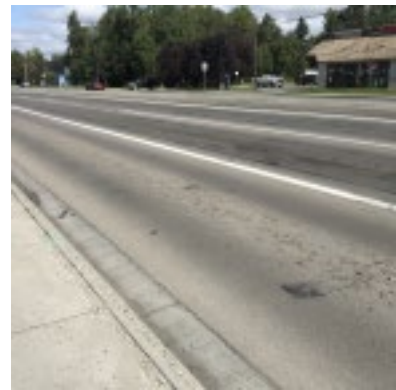
Boniface and Northern Lights showed major friction loss in all tests. The friction drop between 2017 and 2018 was significant and all six tests were less than typical pavement value of 0.60, with an average value of 0.38. Through lanes showed wear with visible pavement in areas. Turn pocket testing can be found at the end of the appendix summarized with other turn pocket data.

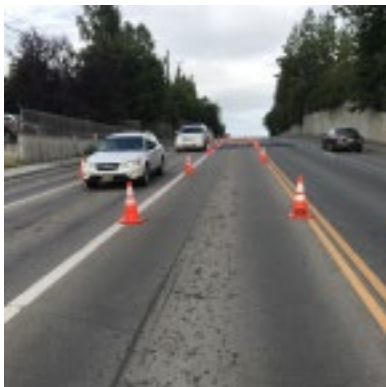
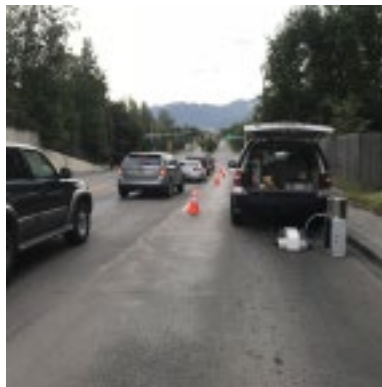
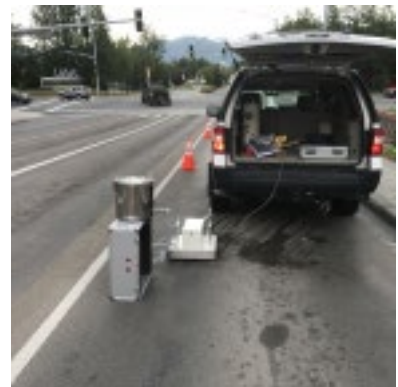
36<sup>th</sup> at Lake Otis showed major friction loss in all tests. The friction drop between 2017 and 2018 was significant and both tests in through lanes were less than the pavement control value of 0.57, with an average value of 0.35. Through lanes showed wear with visible pavement in areas. While the turn pocket showed major wear no pavement was visible. Turn pocket testing can be found at the end of the appendix summarized with other turn pocket data.

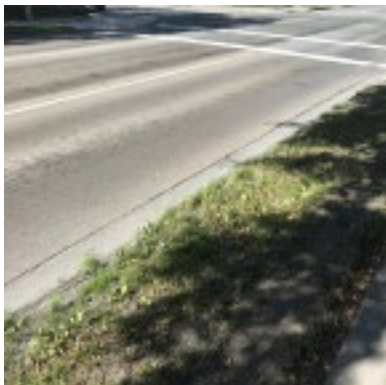
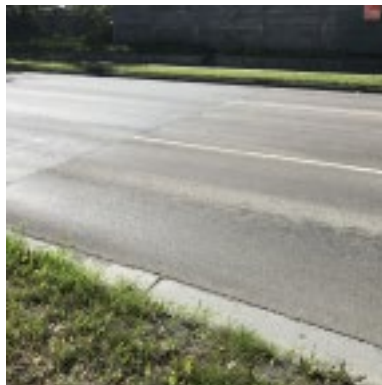
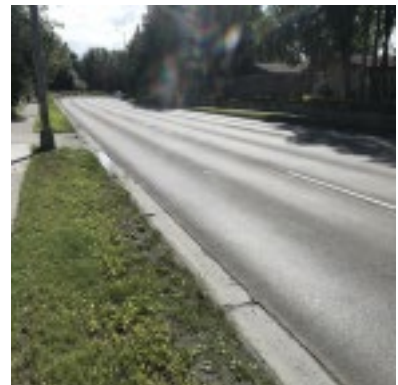
Minnesota Drive showed major friction loss in all tests. All five tests had less friction than the pavement control value of 0.58, with an average value of 0.32. Through lanes showed bare pavement as can be seen in the 2018 photo, below.

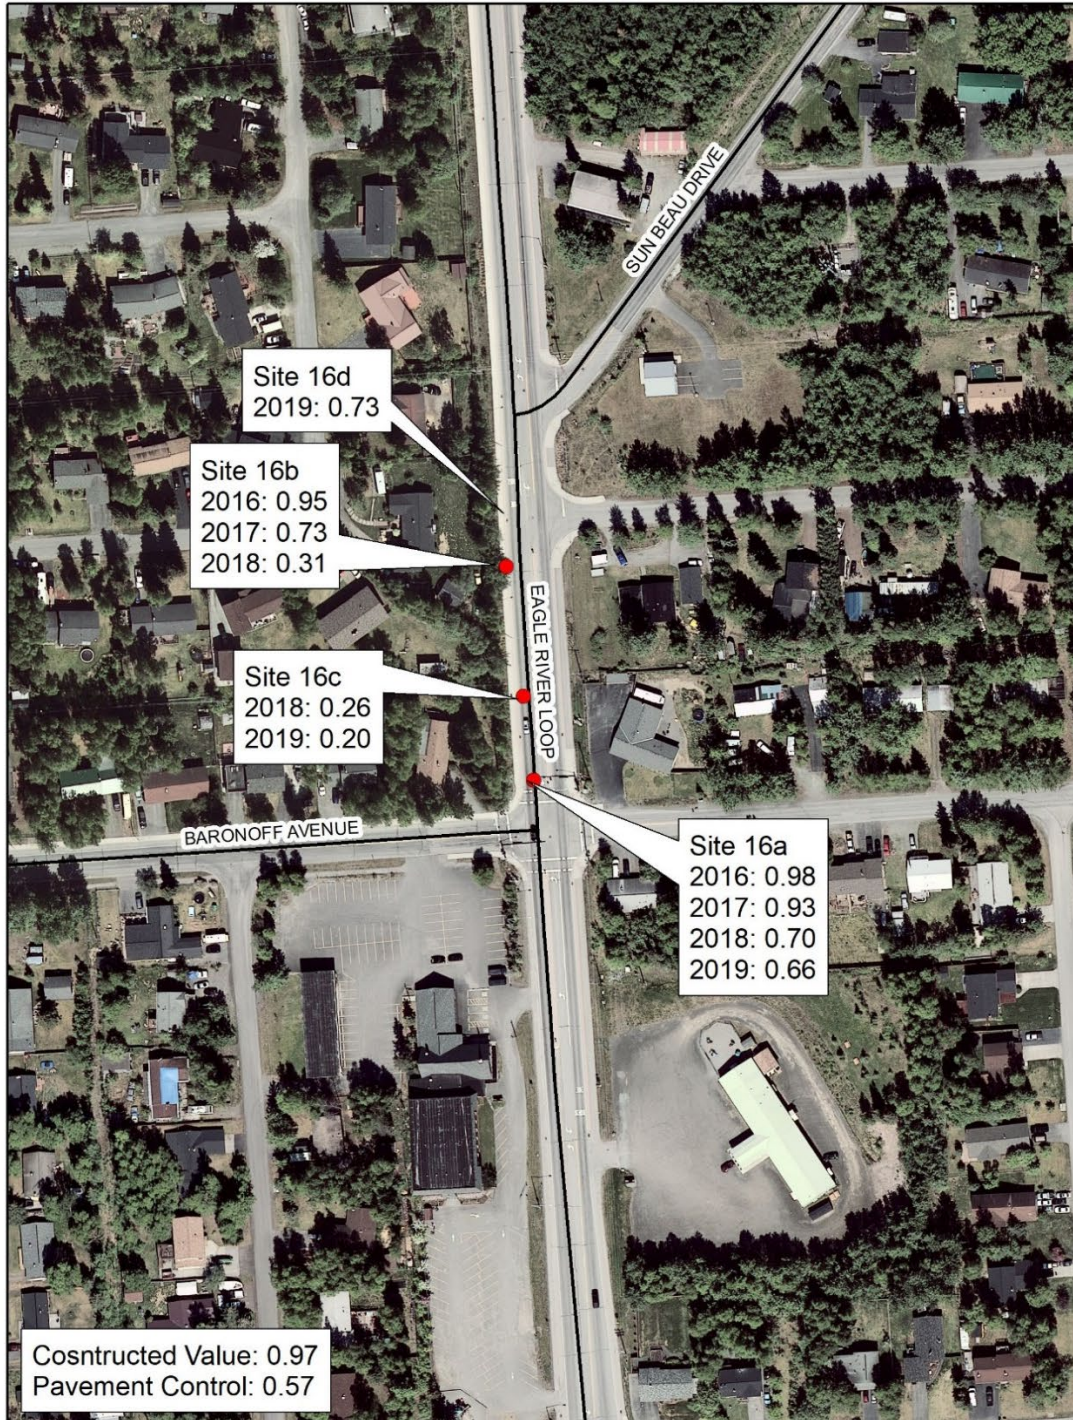
Site 16: Eagle River Lp Rd @ Baranof/Citation

Eagle River Loop Road showed significant friction loss. A third test was performed in through lanes in 2019 with a value of 0.73. This value remained higher than the other two performed in the through lanes closer to the intersection with 2019 values of 0.31 and 0.20. This higher value raised the average value in 2019. Major polishing of the HFST and bare pavement can be seen in the 2019 photo, below. Turn pocket testing can be found at the end of the appendix.

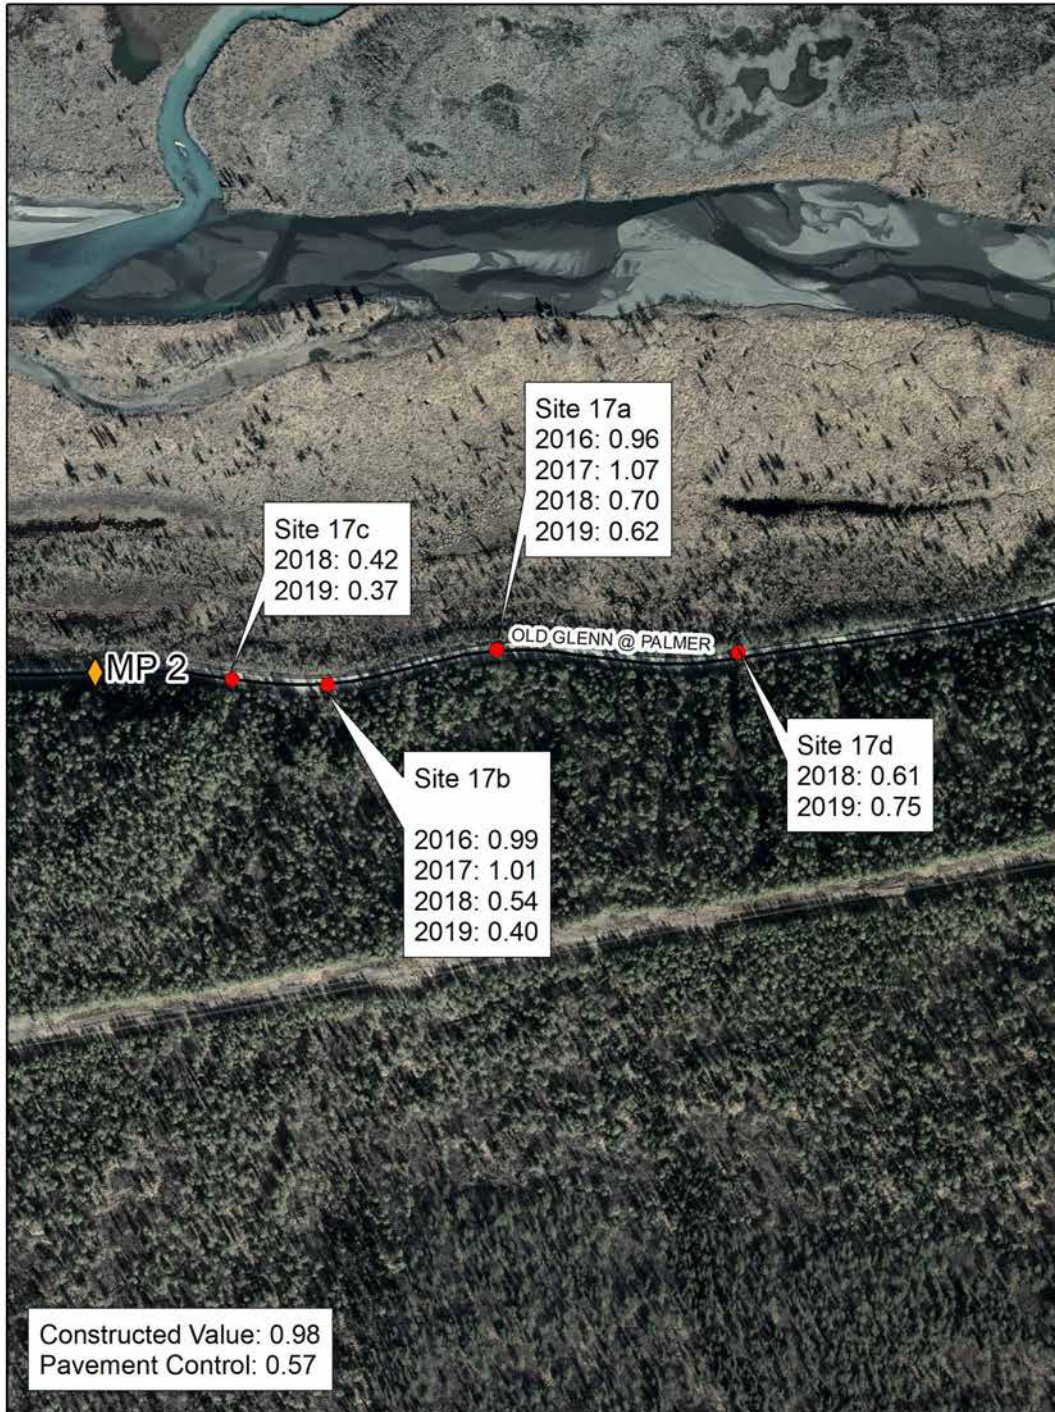
**Site 17: Old Glenn MP 2**

Old Glenn at MP 2 showed moderate friction loss, although not a major loss on average between 2018 and 2019. Two of the four tests had less friction than the original pavement control of 0.57, with an average of 0.54. Areas of bare pavement were visible from both studded tire wear in wheelpaths and areas where the pavement heaved in the winter and the HFST was bladed through, as can be seen in the 2019 photos, below.

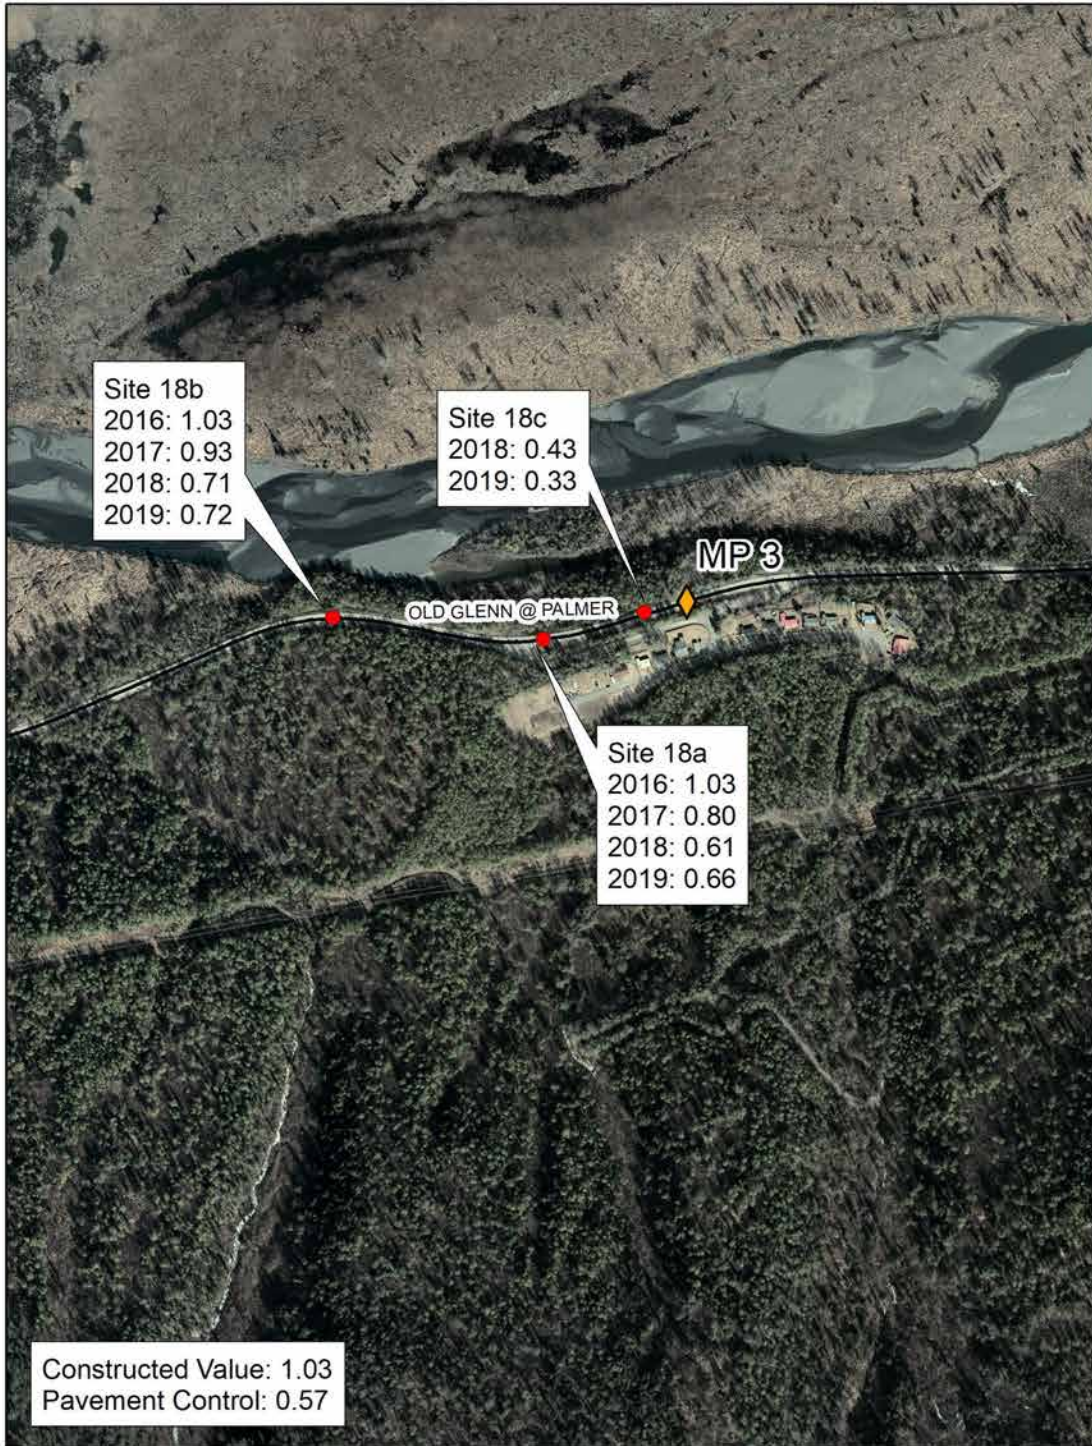
**Site 18: Old Glenn MP 3 (Twin Peaks)**

Old Glenn at MP 3 showed moderate friction loss, although minimal loss on average between 2018 and 2019. One of the three tests had less friction than the original pavement control of 0.57, with an average of 0.57. Areas of bare pavement were visible in wheelpaths as can be seen in the 2019 photo below.

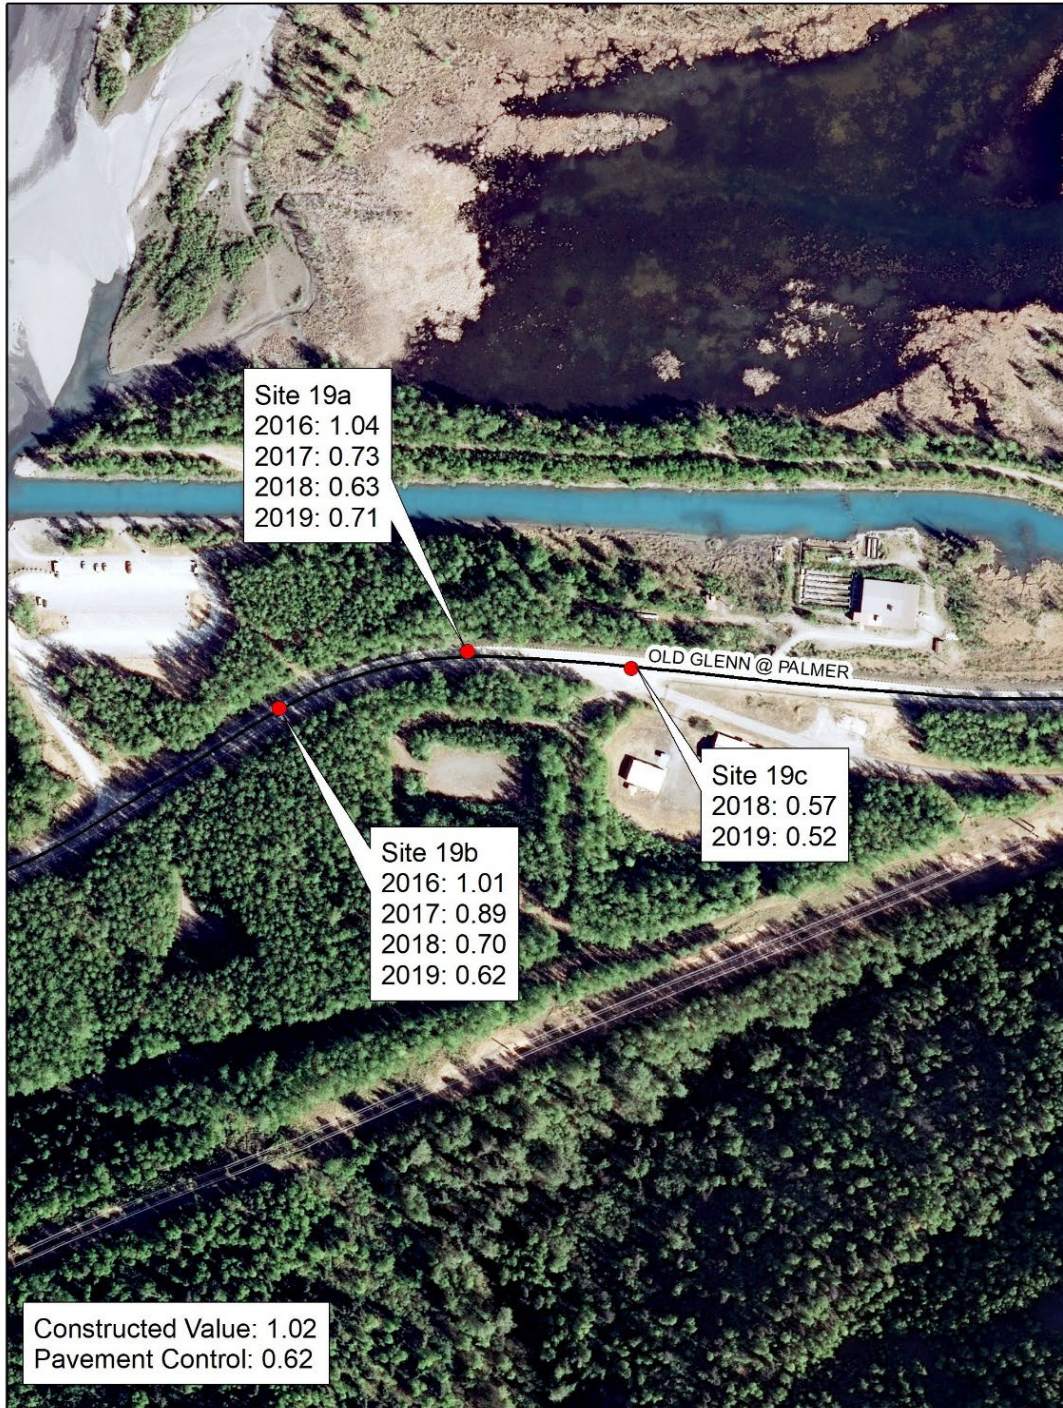
**Site 19: Old Glenn: Power Plant**

Old Glenn at the powerplant showed moderate friction loss, although minimal loss on average between 2018 and 2019. One of the three tests had less friction than the original pavement control of 0.62, with an average of 0.52. The aggregate at this site appeared to have retained more of its angularity than other locations.

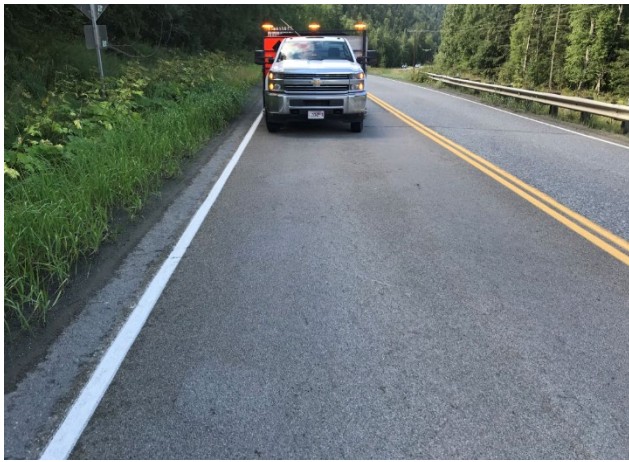
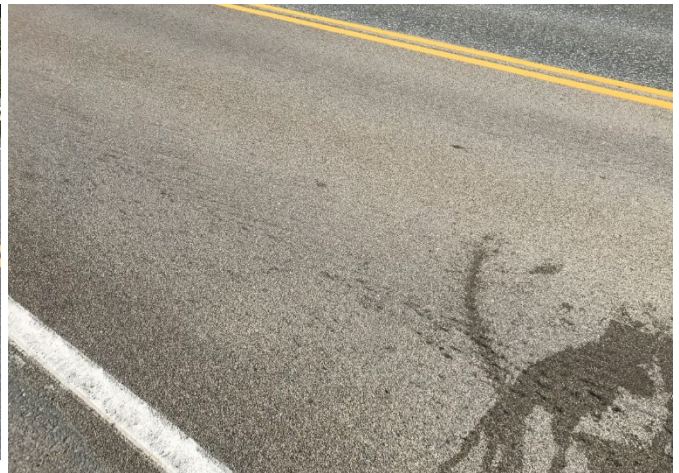
**2017**

Old Glenn at at milepost 5 showed moderate friction loss. None of the three tests had less friction than the original pavement control of 0.54, with an average of 0.68. The PK nails could not be located in 2019 so the testing was performed as close as the crew could manage to the original loations. This is likely the cause of the discrepancy of friction values between 2018 and 2019.

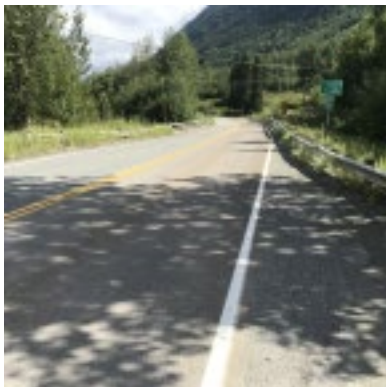
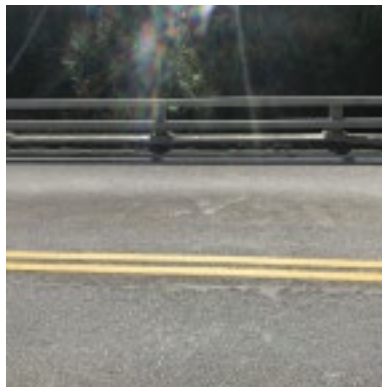
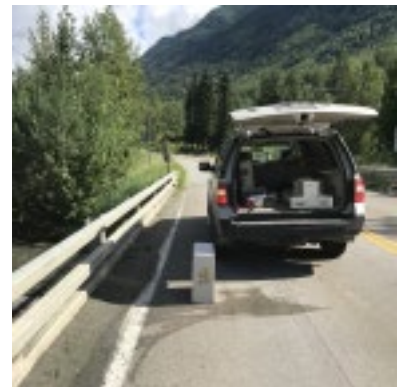
Old Glenn at at milepost 6 showed moderate friction loss, although no loss on average between 2018 and 2019. None of the three tests had less friction than the original pavement control of 0.54, with an average of 0.63. Small amounts of bare pavement was visible under the HFST, although this did not affect testing at this location. Typical wear of the HFST can be seen in the second 2019 picture adjacent to the PK nail, below.

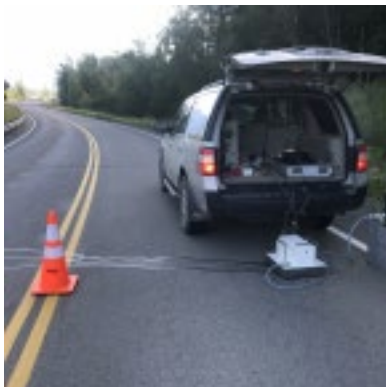
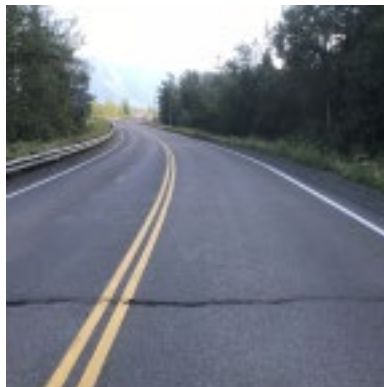
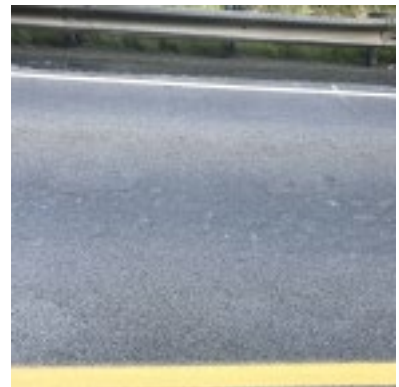
Old Glenn at at milepost 7 showed moderate friction loss. One of the five tests had less friction than the original pavement control of 0.49, while the average was 0.55. Small amounts of bare pavement was visible under the HFST, likely due to snowplowing as there typically wasn't major wear evident in the wheelpaths. See the 2019 picture, below.

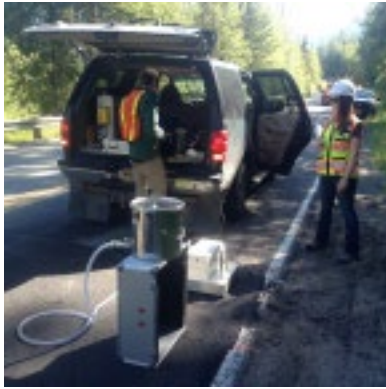
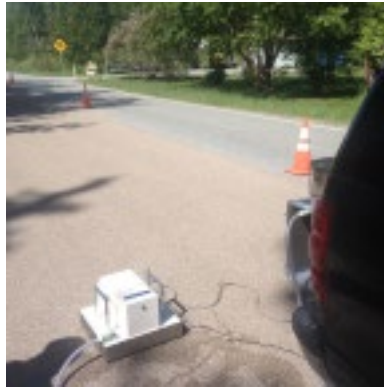
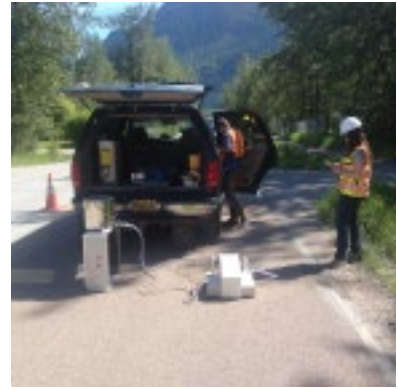
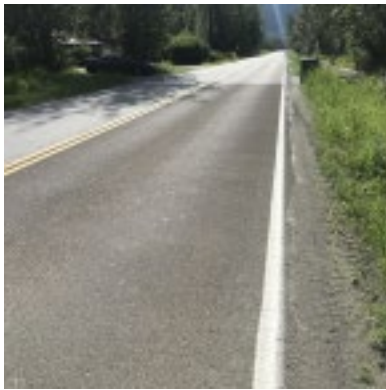
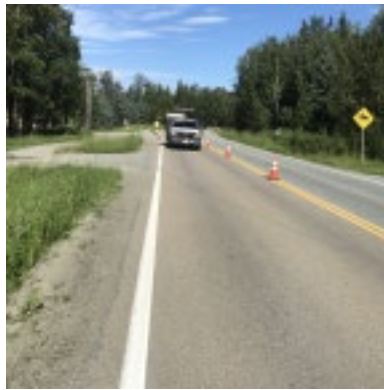
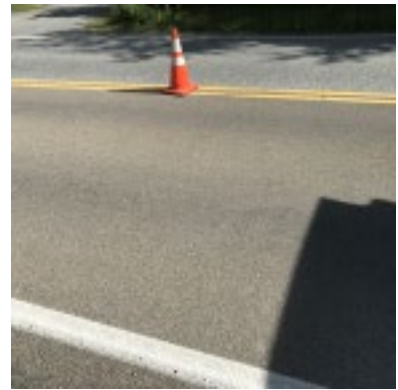
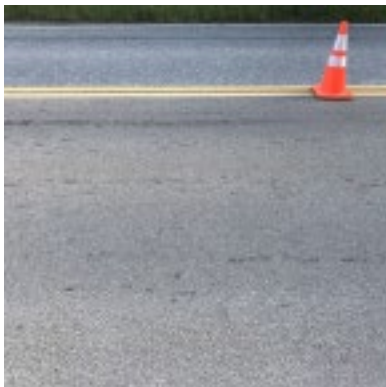
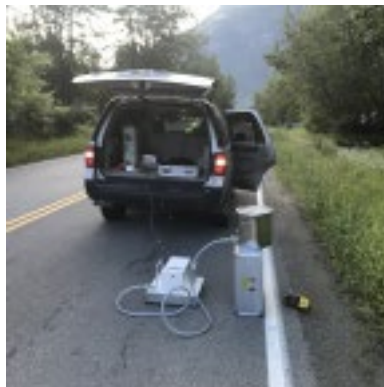
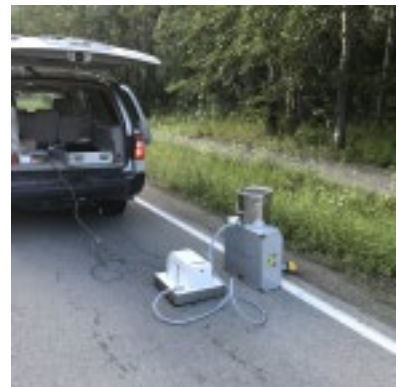
**Site 24 – Photo Log**

Old Glenn at Our Road showed moderate friction loss, although minimal loss on average between 2018 and 2019. One of the three tests had less friction than the original pavement control of 0.55, while the average was 0.59. Small amounts of bare pavement was visible under the HFST, likely due to snowplowing as some of the observed pavement is outside of wheelpaths. The surface texture observed in the 2019 photo, below, is due to the HFST application being located in the floodplain and the surface required milling to maintain elevation.

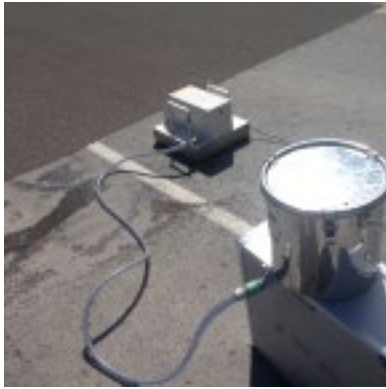
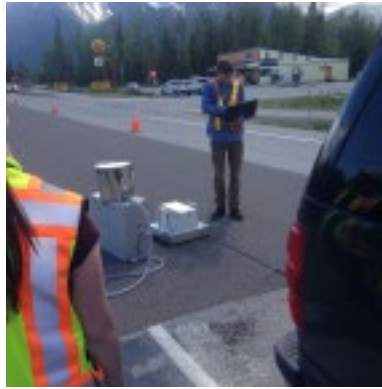
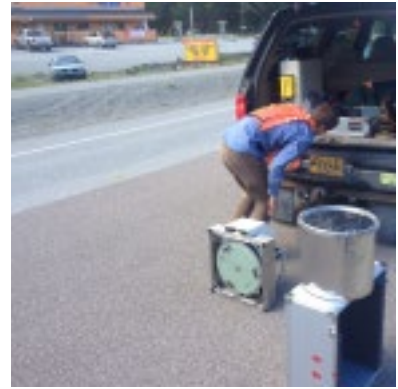
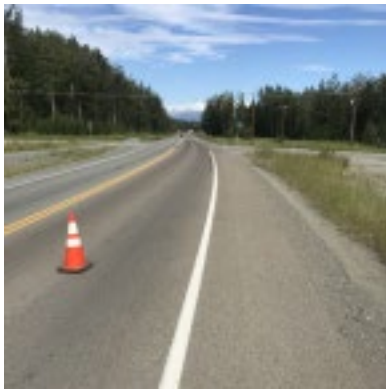
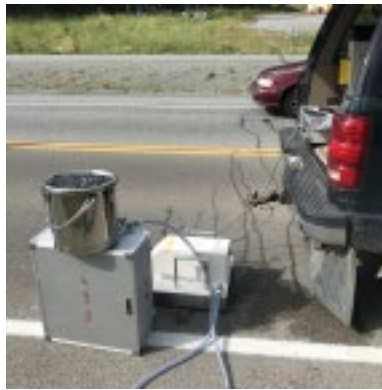
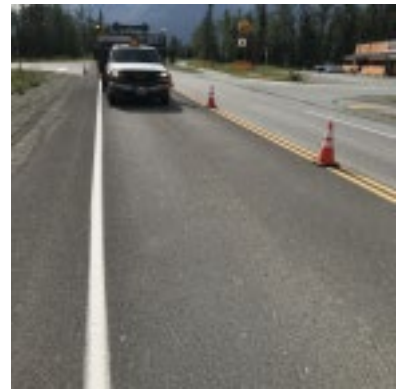
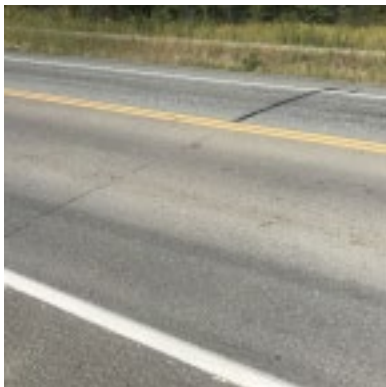
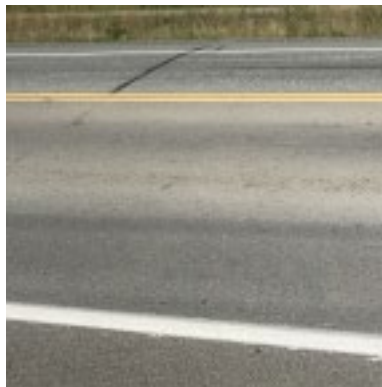
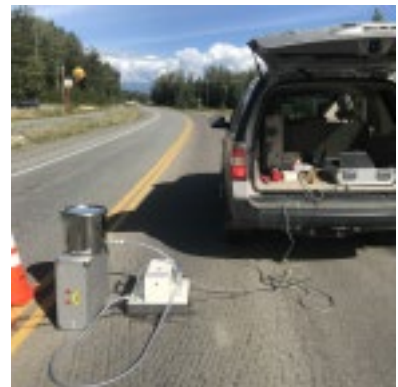
**Site 25 – Photo Log**

Old Glenn at milepost 12 lost significant friction. All three of the tests had less friction than the pavement control of 0.56. The average 2019 friction value was 0.37. Bare pavement was common at this site and in the 2019 photo, below, bare pavement can be observed in the wheelpath where the friction test is being performed. This site is closer to Palmer and contains higher traffic volumes than the rest of the sites on the Old Glenn Highway which is contributing to the wear compared to other Old Glenn Highway sites.
