Alaska Department of Transportation & Public Facilities  
**Research & Technology Transfer**

# High Friction Surface Treatment Experimental Feature Final Report and 3<sup>rd</sup> Year Monitoring Results

Alaska Department of Transportation and Public Facilities,  
Central Region Materials and Statewide Asset Management & Research

**Publication Number:** FHWA-AK-RD-000S(882)

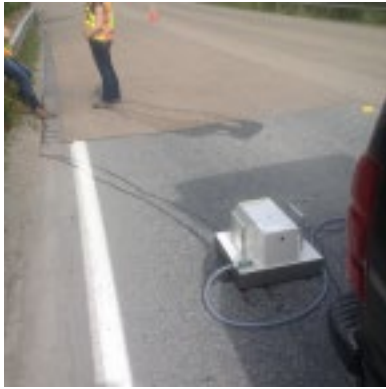
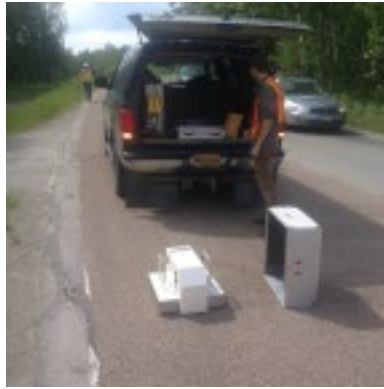
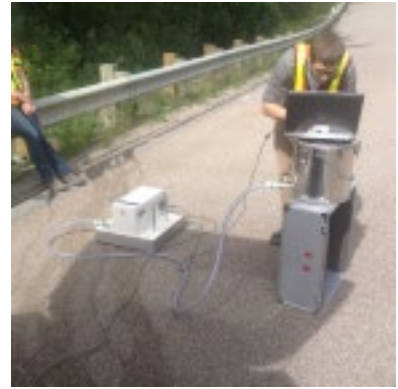
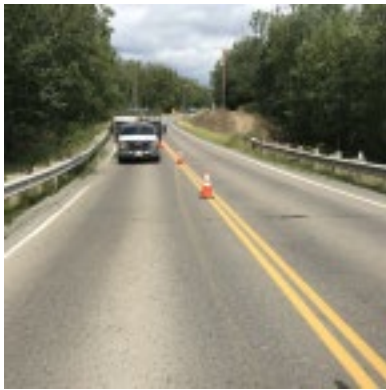
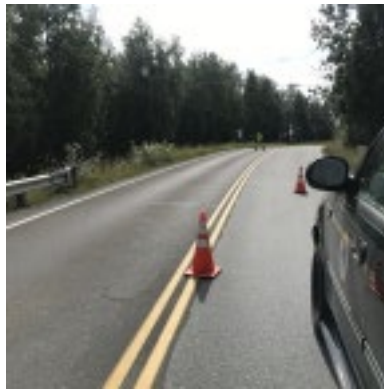
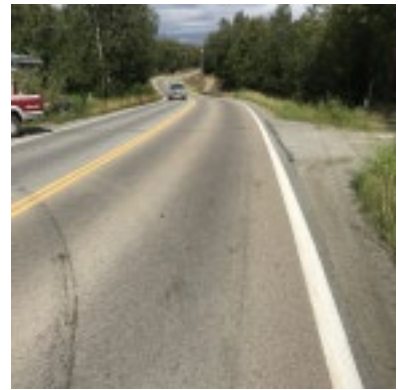
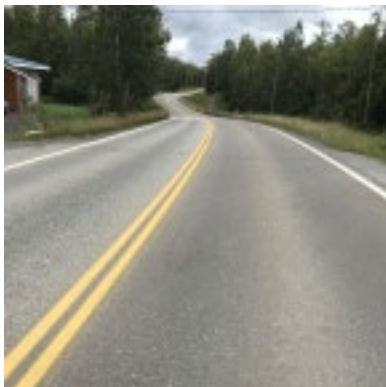
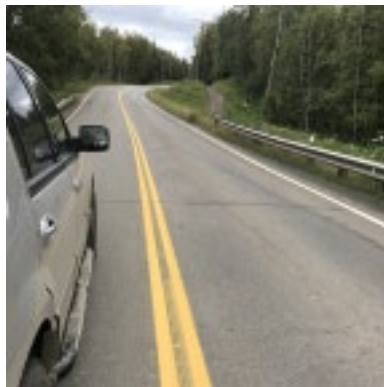
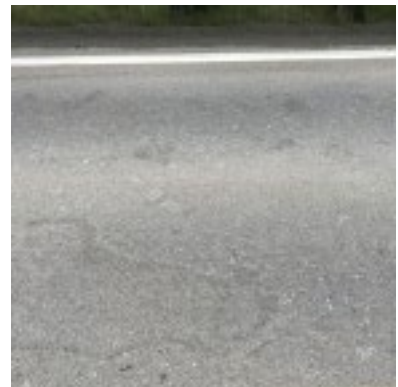
**Site 26 – Photo Log**

Site 26 lost significant friction. All four of the tests performed had less friction than the pavement control of 0.57. The average 2019 friction value was 0.34. Bare pavement was common at this site and in the 2019 photo, below, bare pavement can be observed in both wheelpaths, although primarily in the right. This site is close to East Seldon and Bogard and has the highest traffic volume on Wasilla/Fishhook at almost 5,000 AADT.

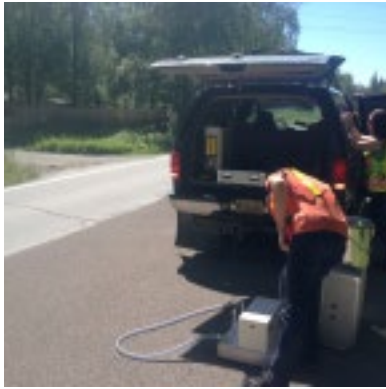
**2016, Test 2**

Site 27 lost significant friction, although the average drop in friction between 2018 and 2019 was minimal. Three of the five tests performed had less friction than the pavement control of 0.57. The average 2019 friction value was 0.47. Bare pavement was visible at this site and in the 2019 photo, below, bare pavement can be observed in the left wheelpath. As with site 26 this location has a relatively high AADT at over 4,000, or twice that of the Old Glenn sites.

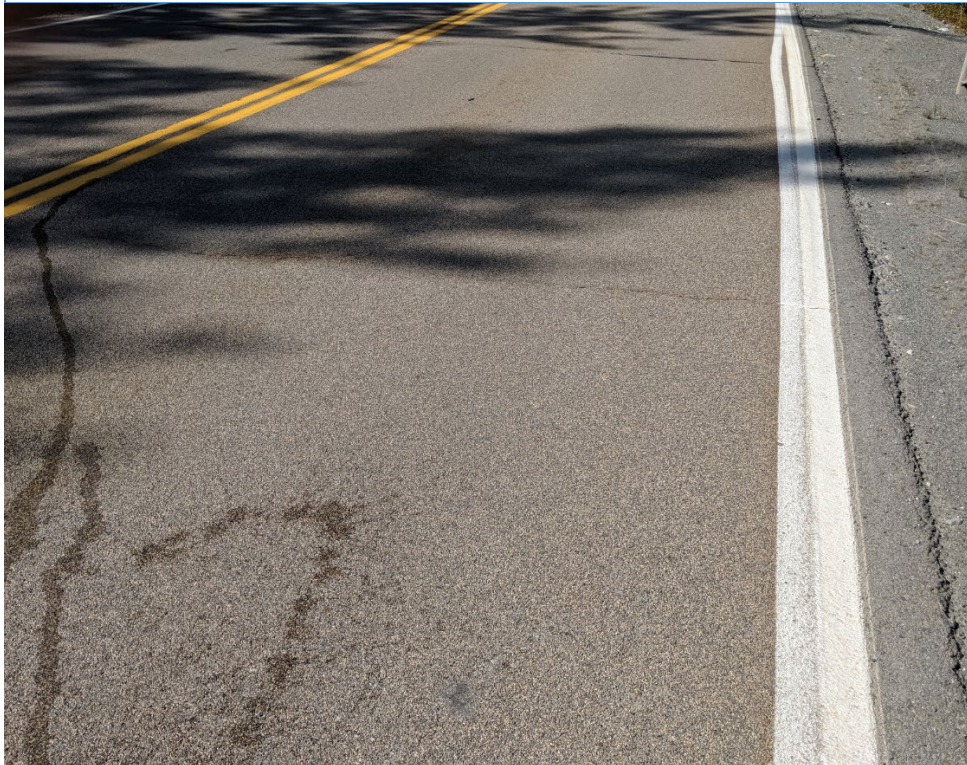
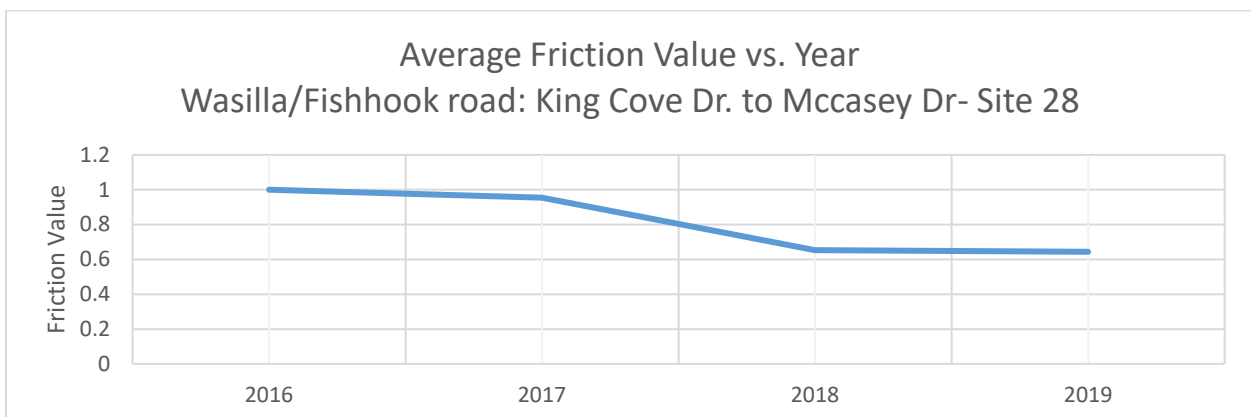
Site 28 lost moderate friction, although the average drop in friction between 2018 and 2019 was minimal. Only one of the eleven tests performed had less friction than the pavement control of 0.57. The average 2019 friction value was 0.64. The slight deviations in friction values between 2018 and 2019 is likely due to the original PK nails not being located during 2019 testing at those locations. While this location had less friction loss it also has less than half the traffic of the other two Wasilla/Fishhook sites.

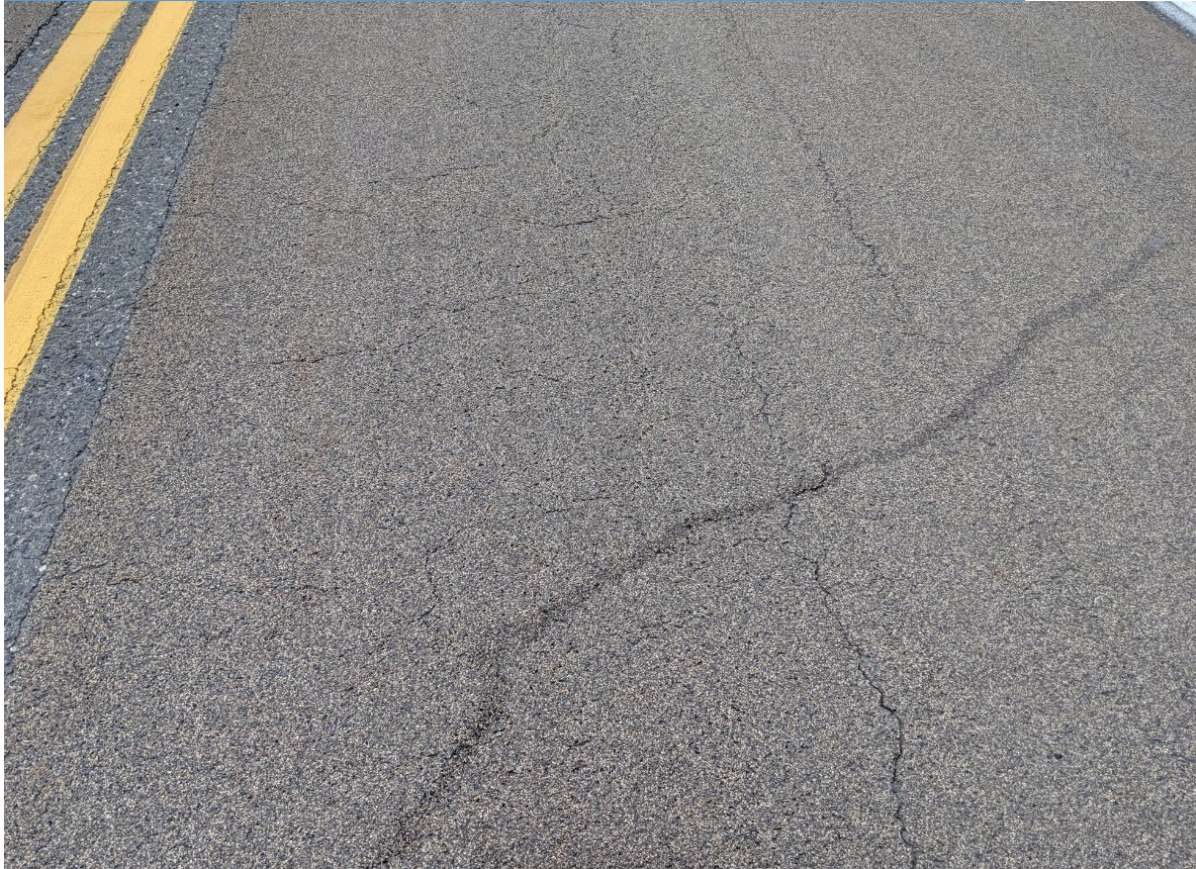
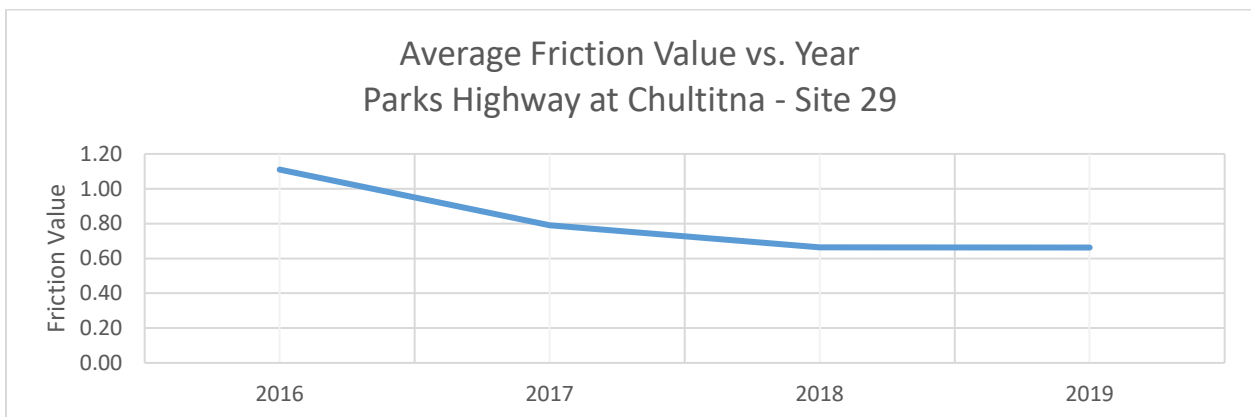
While the Parks Highway at Chutlina lost moderate friction, it still retains higher friction than most other locations. All tests retain the friction of pavement or higher after 4 winters. The average 2019 friction value was 0.66. This was the only location tested that used fully automated application and used epoxy resin. A cracking pattern can be seen in the 2019 photo, below, that may be due to the contraction of the epoxy during the winter seasons.

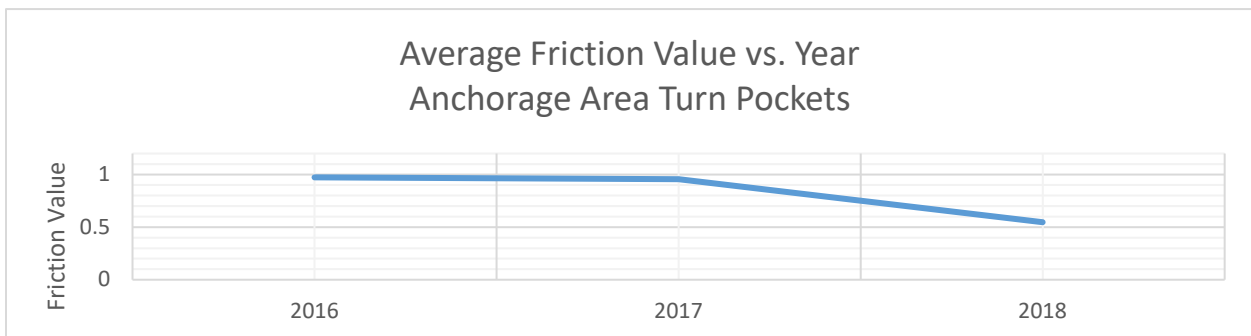
While the turn pockets in Anchorage did lose moderate friction they did retain significantly higher friction than the tests performed in the through lanes. This is likely from traffic running at slower speeds in turn pockets, and also reduced traffic volumes compared to the traffic that runs in the through lanes. These points were removed from the summaries in the through lanes as the data would have increased the friction values being reported in the most heavily trafficked lanes.

In the picture on the previous page, taken in 2018 just south of the intersection of Waldron and Lake Otis, extensive wheelpath wear is apparent in the through lanes while the turn pocket looks to have minimal wear. At this site the turn pocket retained a friction value of 0.70, while the two tests in the through lanes had values of 0.30 and 0.37.
