Test Report No. 608331-01-1A-2-3  
Test Report Date: April 2019

## **MASH TL-4 EVALUATION OF 2019 MASH 2-TUBE BRIDGE RAIL**

Contract No.: 1602767  
Test No.: 608331-01-1A / 2 / 3  
Test Date: 2018-12-10 / 12-12 / 12-14

Sponsored by  
State of Alaska Department of Transportation and Public  
Facilities and North Dakota Department of Transportation

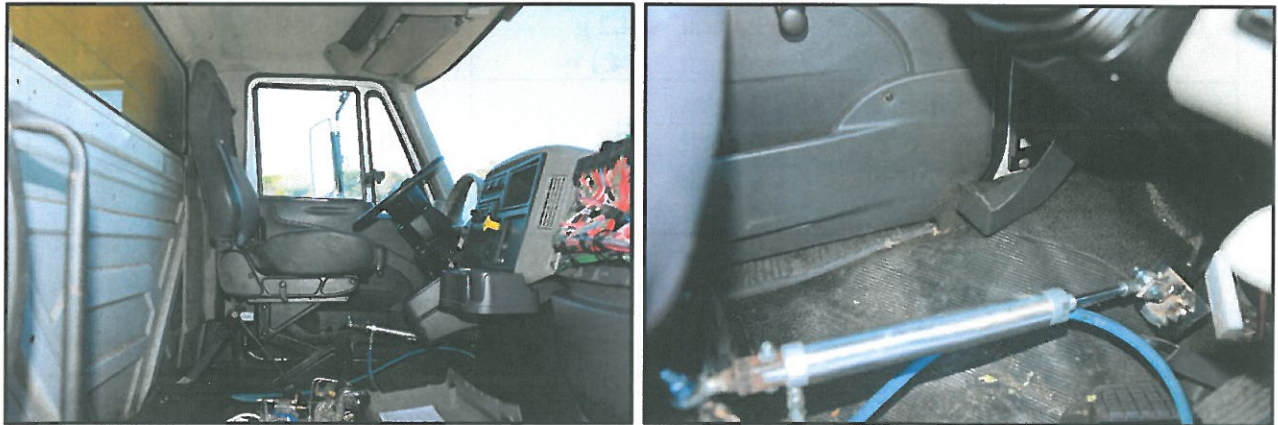
**Figure 5.6. Interior of Test Vehicle after Test No. 608331-01-1A.**

Figure 5.5 shows the damage sustained by the vehicle. The front bumper, hood, left front tire and rim, left front U-bolts, left battery box, left side steps, left door, left rear cab corner, lower edge of box, and left rear outer tire and rim were damaged. Maximum exterior crush to the vehicle was 12.0 inches in the front plane at the left front corner at bumper height. Maximum occupant compartment deformation was 5.5 inches in the left front corner of the floor pan. Figure 5.6 shows the interior of the vehicle.

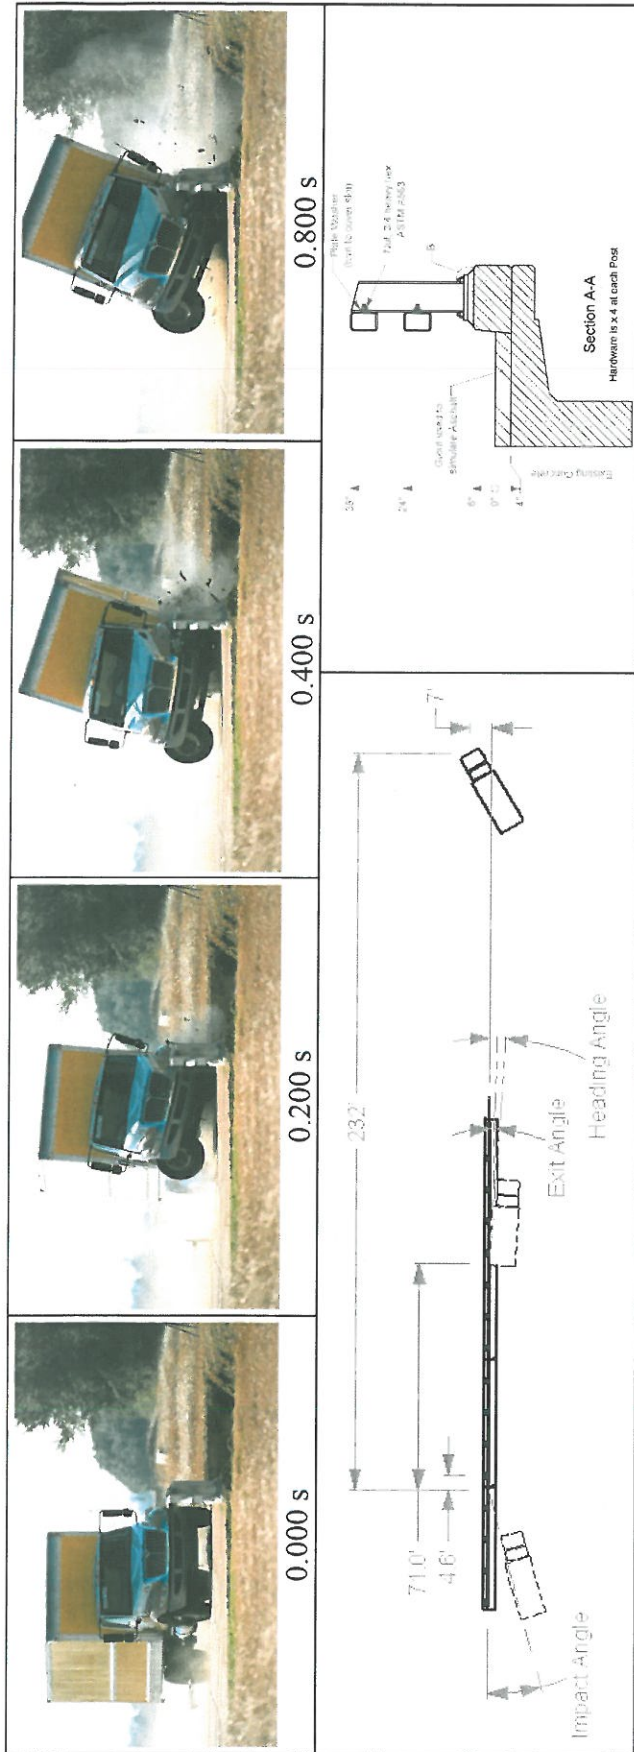
<b>General Information</b>		<b>Impact Conditions</b>		<b>Post-Impact Trajectory</b>	
Test Agency.....	Texas A&M Transportation Institute (TTI)	Speed.....	57.4 mi/h	Stopping Distance.....	232 ft downstream
Test Standard Test No.....	MASH Test 4-12	Angle.....	15.5°		7 ft twd field side
TTI Test No.....	608331-01-1A	Location/Orientation.....	4.6 ft upstream of post 5	<b>Vehicle Stability</b>	
Test Date.....	2018-12-10	<b>Impact Severity</b>	173 kip-ft	Maximum Yaw Angle.....	19°
<b>Test Article</b>		<b>Exit Conditions</b>	Not obtainable	Maximum Pitch Angle.....	9°
Type.....	Bridge Rail	Speed.....	Not obtainable	Maximum Roll Angle.....	19°
Name.....	2019 MASH 2-Tube Bridge Rail	Angle.....	Not obtainable	Vehicle Snagging.....	No
Installation Length.....	154 ft	<b>Occupant Risk Values</b>		Vehicle Pocketing.....	No
Material or Key Elements.....	Two Steel Tubular Rail Elements on Fabricated Steel Posts spaced at 10 ft with 24-inch and 38-inch rail heights and mounted to concrete curb	Longitudinal OIV.....	6.2 ft/s	<b>Test Article Deflections</b>

Installed on Reinforced Concrete Bridge Deck, Damp	Lateral OIV.....	12.1 ft/s	Dynamic.....	3.0 inches
<b>Soil Type and Condition</b> .....		Longitudinal Ridedown.....	3.0 g	Permanent.....	2.0 inches
		Lateral Ridedown.....	6.8 g	Working Width.....	56.7 inches
		THIV.....	15.4 km/h	Height of Working Width.....	136.8 inches
		PHD.....	6.9 g	<b>Vehicle Damage</b>	
		ASI.....	0.43	VDS.....	NA
		Max. 0.050-s Average		CDC.....	11FREW4
<b>Test Vehicle</b>	10000S	Longitudinal.....	-1.6 g	Max. Exterior Deformation.....	12.0 inches
Type/Designation.....	2011 International 4300	Lateral.....	4.2 g	OCDL.....	NA
Make and Model.....	14,000 lb	Vertical.....	-4.1 g	Max. Occupant Compartment Deformation.....	5.5 inches
Curb.....	22,050 lb				
Test Inertial Dummy.....	No dummy				
Dummy.....	22,050 lb				
Gross Static.....

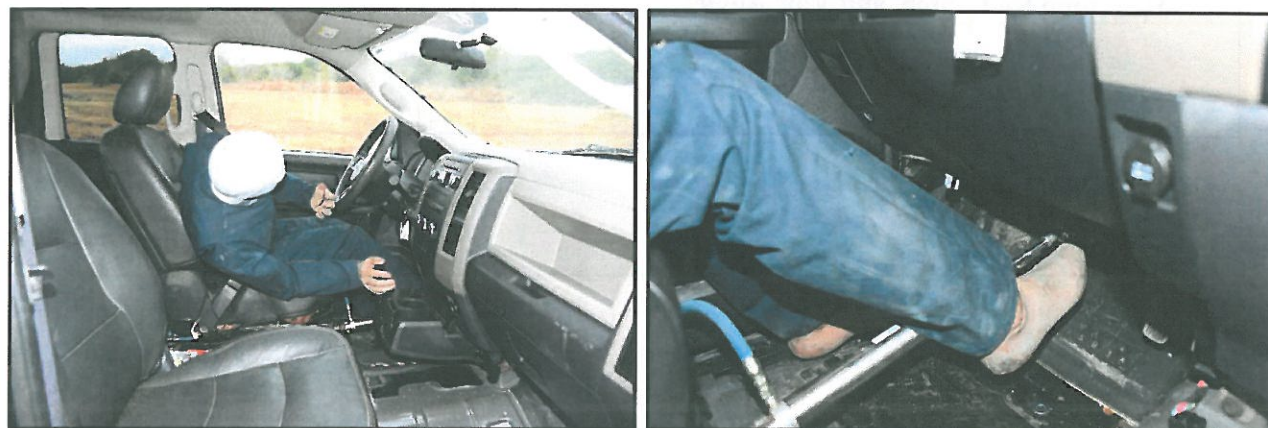
**Figure 6.6. Interior of Test Vehicle for Test No. 608331-01-2.**

Figure 6.5 shows the damage sustained by the vehicle. The front bumper, hood, grill, left tire and rim, left upper and lower A-arms, left upper and lower ball joints, left tie rod end, left front fender, left front and rear doors, left rear cab corner, left rear exterior bed, left rear rim, rear bumper, and tailgate were damaged. The windshield sustained stress cracks radiating up and out from the left lower corner. Maximum exterior crush to the vehicle was 11.0 inches in the side plane at the left front corner at bumper height. Maximum occupant compartment deformation

was 0.5 inch in the left front firewall area. Figure 6.6 shows the interior of the vehicle. Tables D.3 and D.4 in Appendix D1 provide exterior crush and occupant compartment measurements.

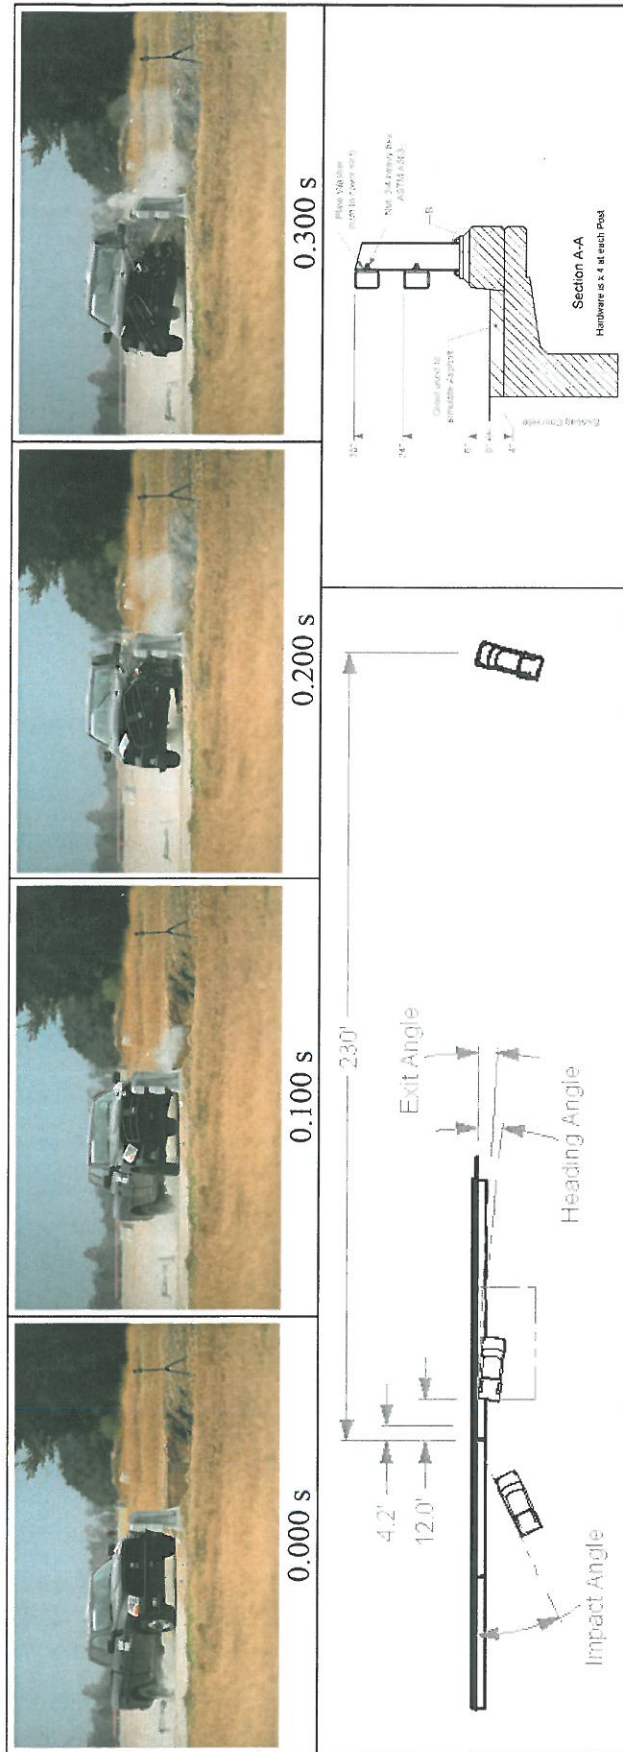
<b>General Information</b>	Texas A&M Transportation Institute (TTI)	<b>Impact Conditions</b>	<b>Post-Impact Trajectory</b>
Test Agency.....	MASH Test 4-11	Speed.....	Stopping Distance.....
Test Standard Test No. ....	608331-01-2	Angle.....	230 ft downstream
TTI Test No. ....	2018-12-12	Location/Orientation.....	<b>Vehicle Stability</b>
Test Date.....		4.2 ft upstream of post 9	Maximum Yaw Angle.....
<b>Test Article</b>	Bridge Rail	Impact Severity.....	33°
Type.....	2019 MASH 2-Tube Bridge Rail	Exit Conditions	Maximum Pitch Angle.....
Name.....	154 ft	Speed.....	3°
Installation Length.....	Two Steel Tubular Rail Elements on	Exit Trajectory/Heading.....	Maximum Roll Angle.....
Material or Key Elements...	Fabricated Steel Posts spaced at 10 ft	118 kip-ft	5°
	with 24-inch and 38-inch rail heights and	Speed.....	Vehicle Snagging.....
	mounted to concrete curb installed on	Exit Trajectory/Heading.....	No
	Reinforced Concrete Bridge Installed on	Longitudinal OIV.....	Vehicle Pocketing.....

Deck, Damp	16.7 ft/s	No
<b>Soil Type and Condition</b> .....		Lateral OIV.....	<b>Test Article Deflections</b>
		29.5 ft/s	Dynamic.....
<b>Test Vehicle</b>	2270P	Longitudinal Ridedown.....	7.1 inches
Type/Designation.....	2012 RAM 1500 Pickup	8.2 g	Permanent.....
Make and Model.....	4902 lb	Lateral Ridedown.....	2.0 inches
Curb.....	5019 lb	13.6 g	Working Width.....
Test Inertial.....	165 lb	THIV.....	20.2 inches
Dummy.....	5184 lb	PHD.....	38 inches, or Top
Gross Static.....		ASI.....	of post
		Max. 0.050-s Average	VDS.....
		Longitudinal.....	11LFQ5
		Lateral.....	CDC.....
		Vertical.....	Max. Exterior Deformation.....
			11FLEW4
			OCDI.....
			Max. Occupant Compartment
			Deformation.....
			LF0010000

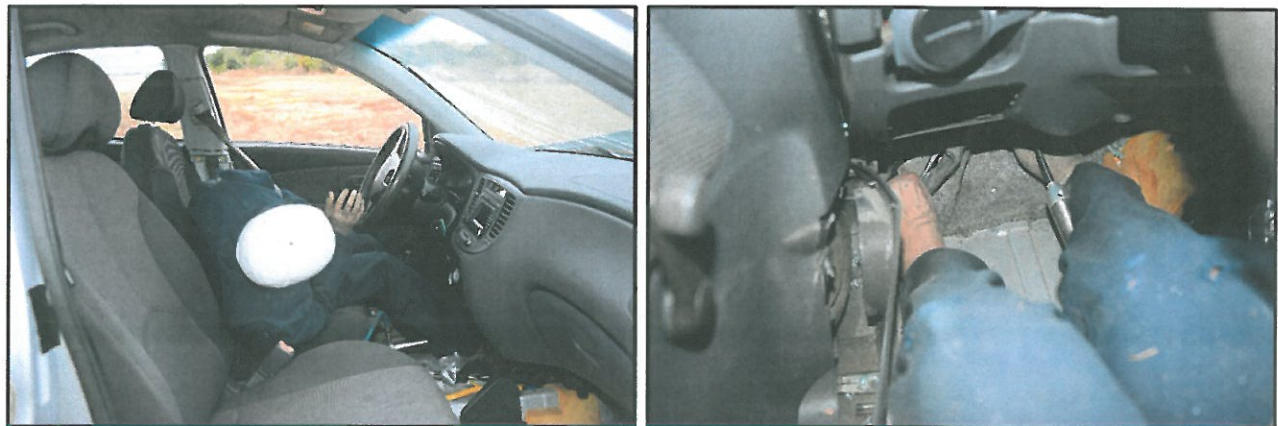
**Figure 7.6. Interior of Test Vehicle for Test No. 608331-01-3.**

Figure 7.5 shows the damage sustained by the vehicle. The front bumper, hood, radiator and support, left front fender, left front tire and rim, left front strut and tower, left A-post, roof, left front door and window glass, left rear door, left rear quarter panel, and rear bumper were damaged. The windshield sustained stress cracks radiating upward and outward from the left lower corner. Maximum exterior crush to the vehicle was 11.0 inches in the side plane at the left front corner at bumper height. Maximum occupant compartment deformation was 4.0 inches in the left front firewall area. Figure 7.6 shows the interior of the vehicle. Tables E.2 and E.3 in Appendix E1 provide exterior crush and occupant compartment measurements.

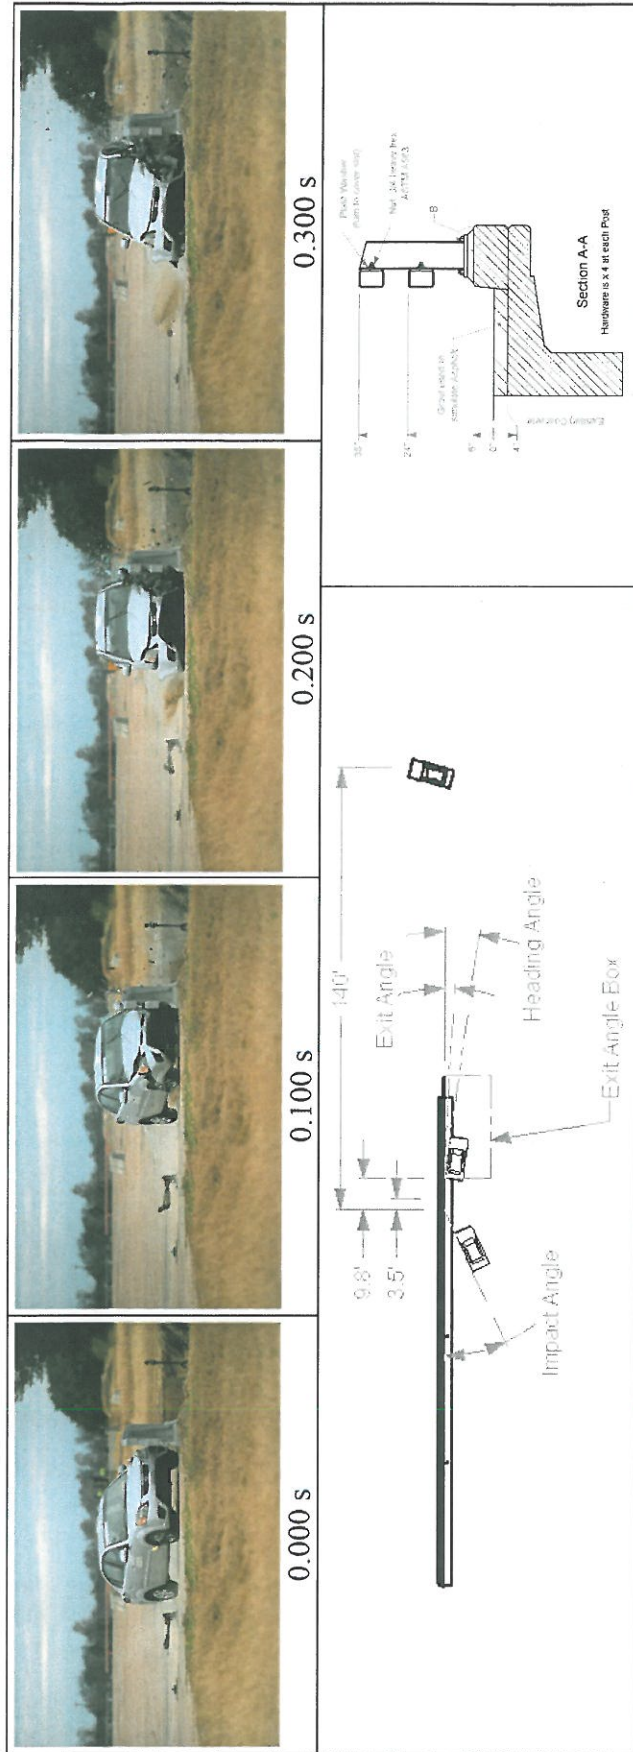
<b>General Information</b>		<b>Impact Conditions</b>		<b>Post-Impact Trajectory</b>	
Test Agency	Texas A&M Transportation Institute (TTI)	Speed	62.5 mi/h	Stopping Distance	140 ft downstream
Test Standard	MASH Test 4-10	Angle	25.3°	Location/Orientation	11 ft fwd field side
TTI Test No.	608331-01-3	Impact Severity	3.5 ft upstream of post 13	Vehicle Stability	
Test Date	2018-12-14	Exit Conditions	58 kip-ft	Maximum Yaw Angle	34°
Test Article		Speed	45.3 mi/h	Maximum Pitch Angle	5°
Type	Bridge Rail	Exit Trajectory/Heading	4.8°/6.0°	Maximum Roll Angle	5°
Name	2019 MASH 2-Tube Bridge Rail	Occupant Risk Values		Vehicle Snagging	No
Installation Length	154 ft	Longitudinal OIV	30.2 ft/s	Vehicle Pocketing	No
Material or Key Elements	Two Steel Tubular Rail Elements on Fabricated Steel Posts spaced at 10 ft with 24-inch and 38-inch rail heights and mounted to concrete curb Installed on Reinforced Concrete Bridge Deck, Damp	Lateral OIV	30.8 ft/s	Dynamic	2.8 inches
