Underwater Inspection of Bridge Substructures Using Imaging Technology

June 14, 2018

Sponsored by
Federal Highway Administration
Office of Infrastructure
FHWA-HIF-18-049

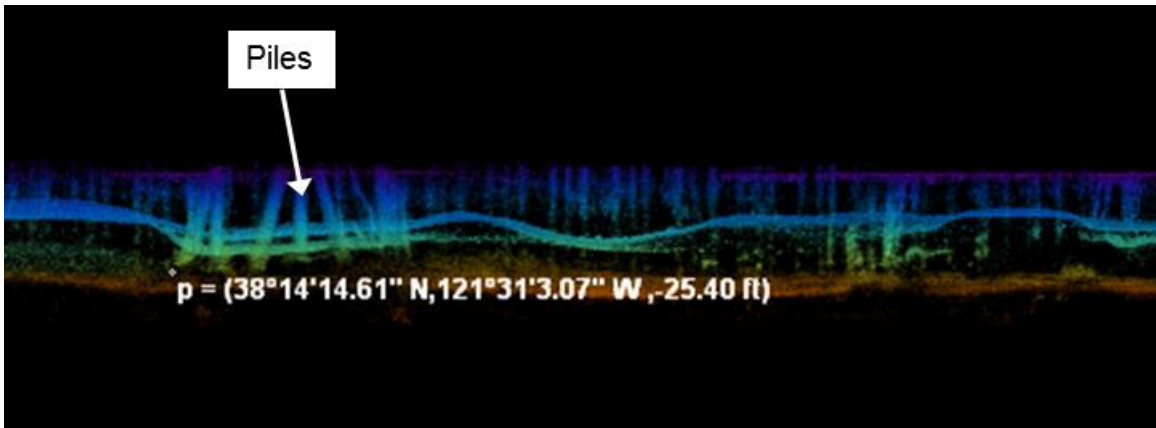
Figure 26. Image. Piles from back side of the fender (Georgiana Slough).

Using a real-time multibeam sonar, inspection team A collected data in the field that produced images that captured general pile features. The images in figure 26 and figure 27 reveal the piles supporting the fender in profile and plan view, respectively. In the profile view, it is evident that several piles are not aligned vertically. In the plan view, the curved alignment of the set of piles is clearly seen.

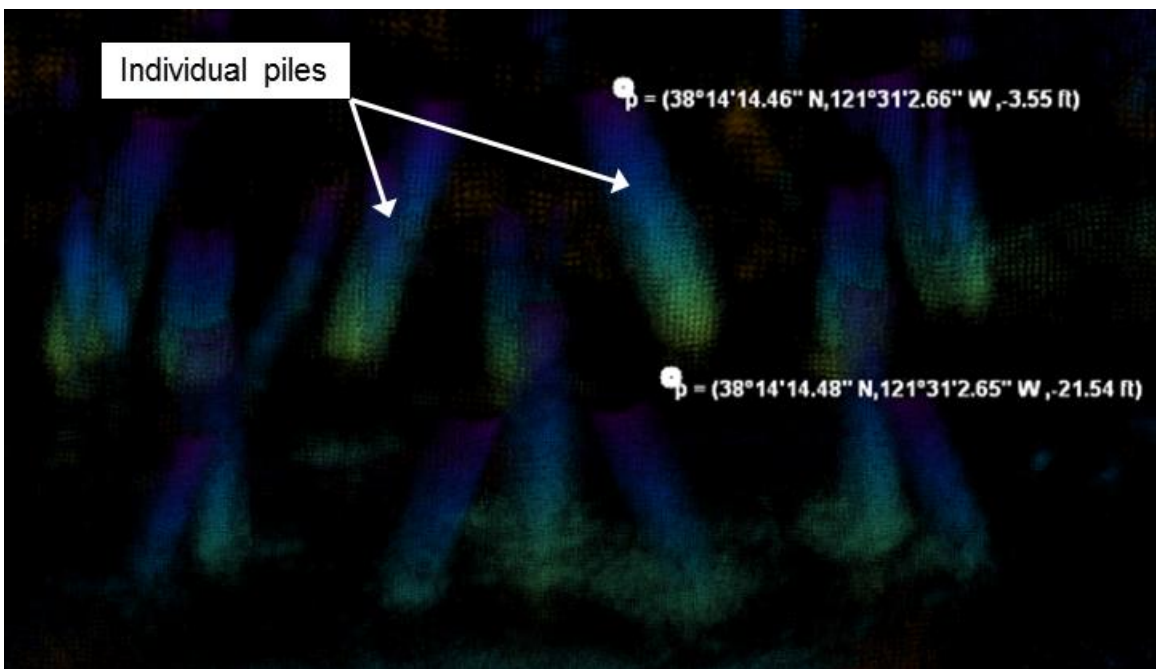
Figure 28. Image. Coordinates from which length of a pile is estimated (Georgiana Slough).

Figure 28 displays a close-up of several piles. With the x,y,z capability, it is possible to estimate feature dimensions such as object length.

Figure 28 shows how the size of debris can be obtained such as for the pile-like objects shown in the figure. This assessment can be conducted by a bridge engineer with a small amount of training on the system and software. The precision of dimensional estimates can be affected by a number of factors, but the approach offers a quick assessment of the bridge structure, as well as a complete image of a potential diving site that can be used to guide a subsequent dive to critical locations quickly and safely.

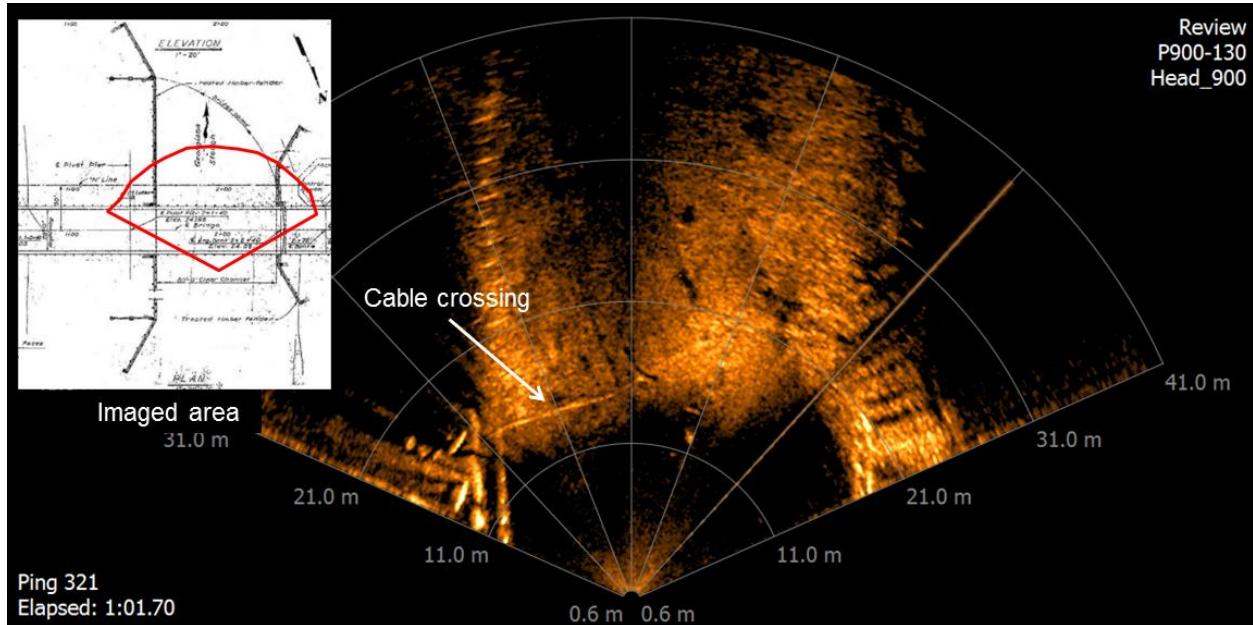
Figure 29. Image. 2D image from a single ping at Georgiana Slough (plan view).

Inspection team B employed two sonar technologies for the inspection of the Georgiana Slough Bridge. Figure 29 shows an example image from a 2D multibeam sonar along with the inset providing the location of the image at the site. The image resulted from a single ping and was captured from boat-mounted equipment. The piles on either side of the channel are evident as is a cable crossing the channel.

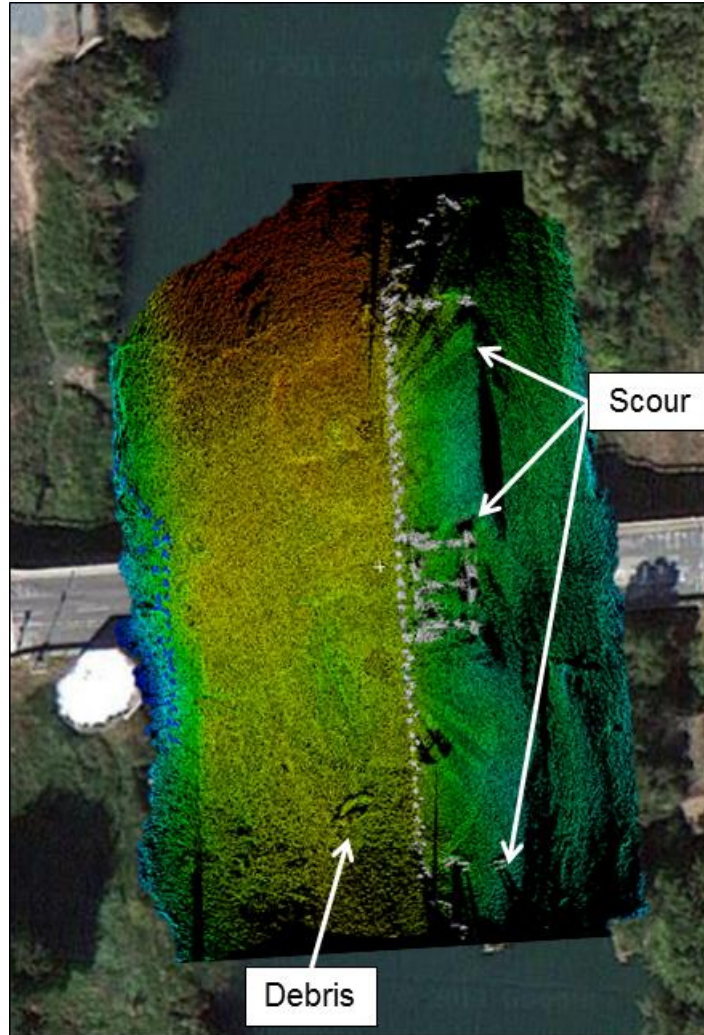
Figure 32. Image. Indications of scouring from 3D image (Georgiana Slough).

Figure 32 provides a sonar image overlain on an aerial photo that highlights darker areas indicative of minor scour around the structures. The image also shows moderate levels of debris, including tree limbs and tires, but no visible damage to the substructure.

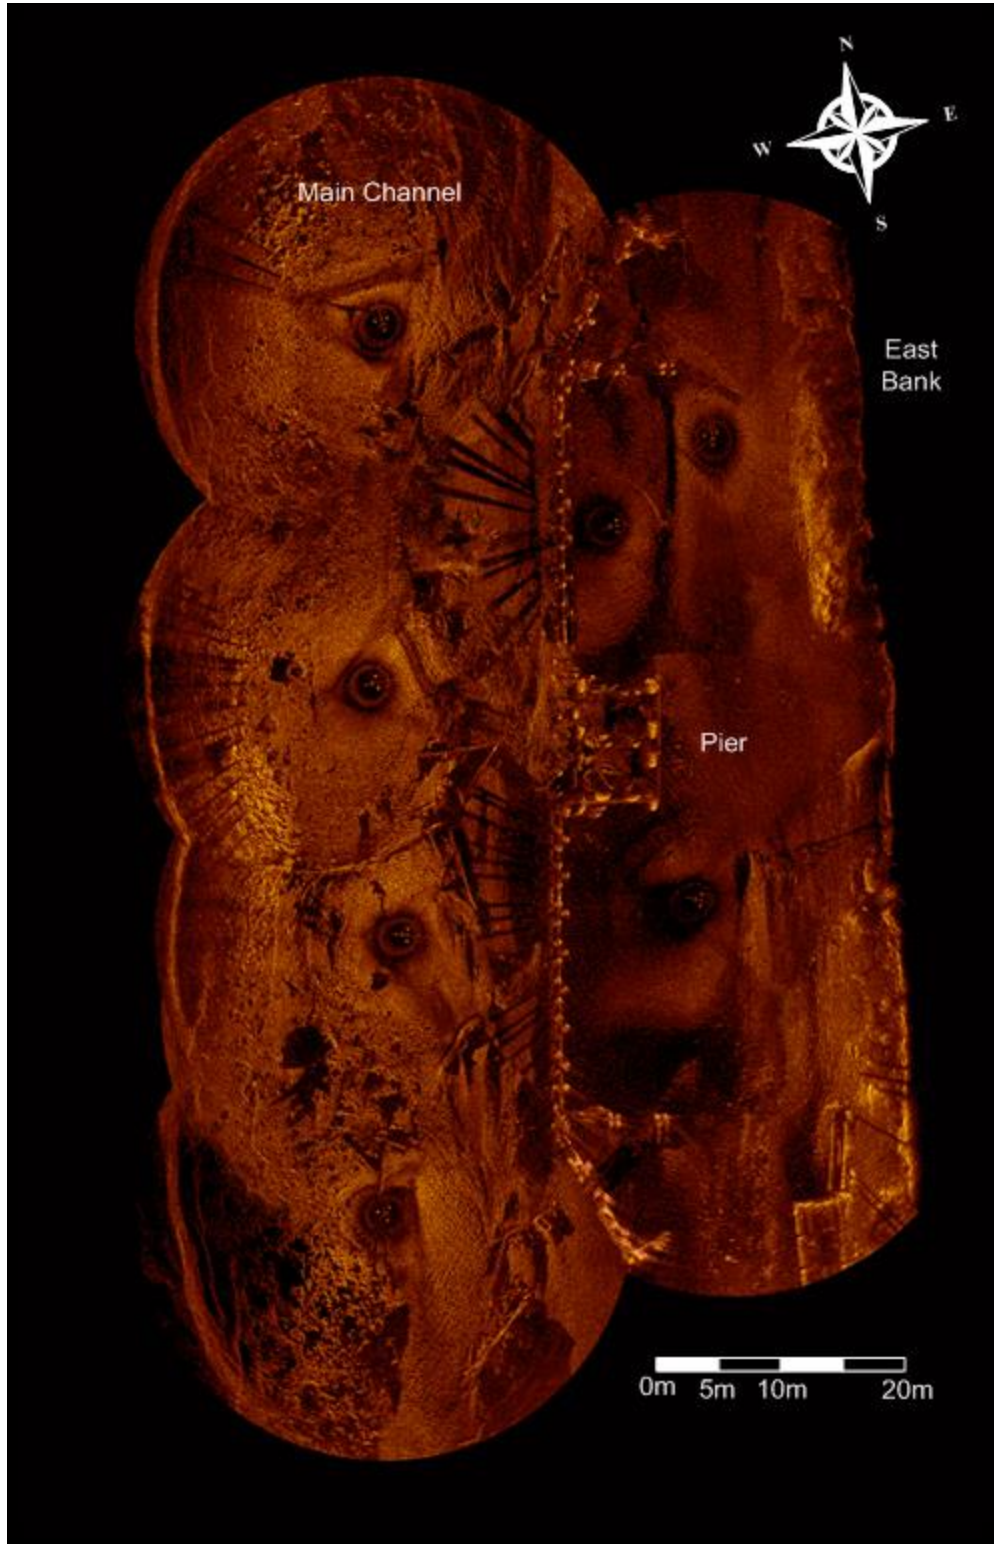
Figure 34. Image. Mosaic of bottom drop images.

Inspection team C used 2D sector-scanning sonar and 3D profiler sonar to collect riverbed and vertical visualization scans of the underwater portion of pier 2 of the Georgiana Slough Bridge. Bottom scans, taken with the sonar head fitted onto a tripod, were collected adjacent to the structure. The bottom scan locations are shown in figure 33 with a resulting mosaic of the drop images shown in figure 34. The bridge pier, piling, bathymetry, and some debris are visible.

The inspection team observed in both the imaging and profiling datasets that although the fender system is there to protect the structure from vessel traffic, it appears to have caused localized scour on the upstream side of the pier. This local scour has induced sediment degradation on the upstream nose and aggregation on the downstream side of the structure. The fender system

appears to be structurally sound with no breaks or splits in the piles. Debris build up was noted on the upstream dogleg. The team reported that the vertical and batter pipe piles appeared to be structurally sound with no visible impact damage or structural deterioration.

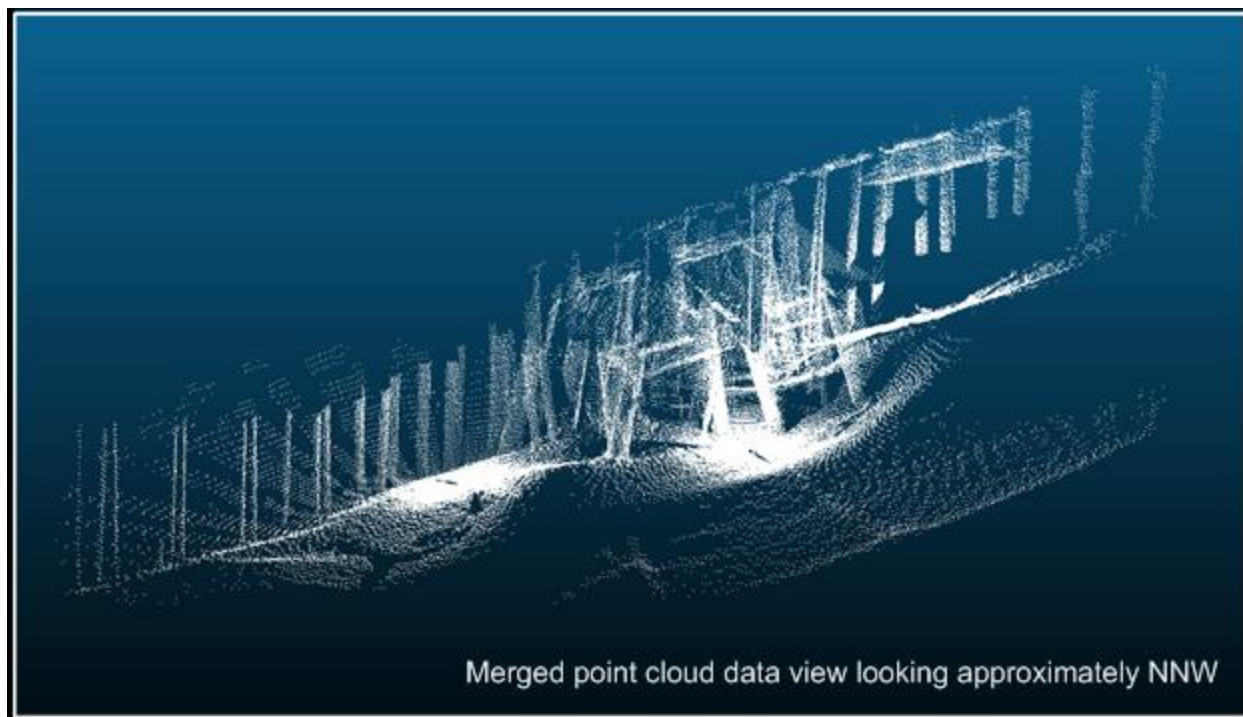
Figure 35. Image. Merged point cloud data at Georgiana Slough Bridge.

After completing the bottom drops, the head was horizontally mounted on a pole and positioned three feet below the surface to vertically scan the fender wall. The data collected from the bottom drops and vertical scans were merged to create 3D representations as shown in figure 35.

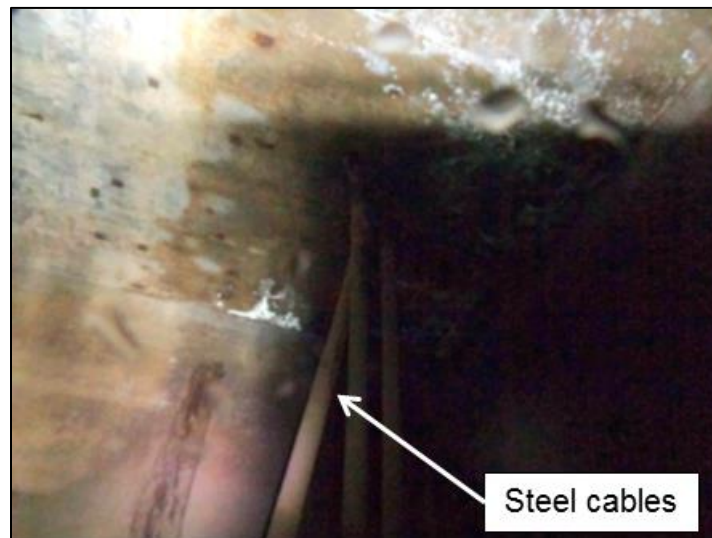
Figure 37. Photo. Above water view of steel cables.

- Three 4-inch (100 mm) diameter steel cables were observed extending vertically from the northwest quadrant of the south bay to the channel bottom as shown in figure 37.

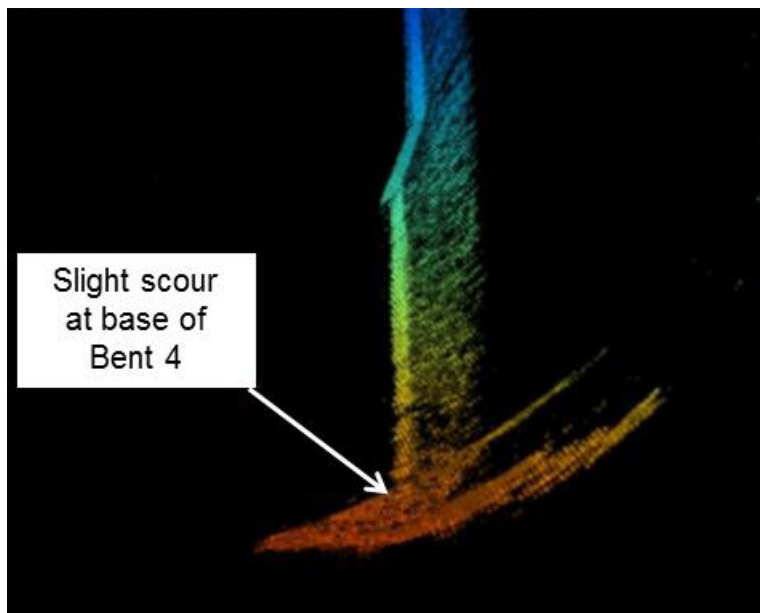
Figure 42. Image. Bent 4 mud line side image.

Figure 40 shows the image of bent 4 captured by the sonar. A symbol representing the data collection boat is also shown to illustrate the range required of the sonar at this site. Figure 41 is a data mosaic showing bents 4 and 5 as viewed from the west side of the bridge. The annotations on the figure demonstrate how structure dimensions can be obtained from the image. Close analysis of the images may reveal reportable observations. For example, a closer view of the base of bent 4 shown in figure 42 provides an indication of scour at the base of the bent.

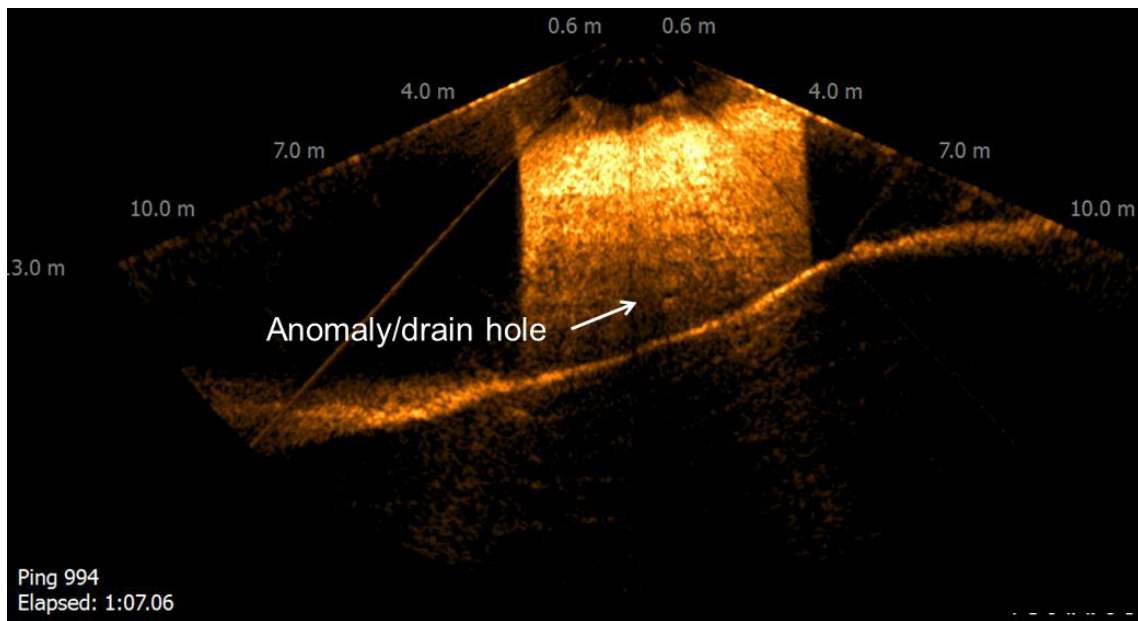
Figure 44. Image. Sonar wing at the bottom of face 3.

Figure 43 displays a plan view of the James E. Roberts Bridge with the naming convention used by inspection team B to label data and images on bent 4. Figure 44 is a sonar wing close-up of the base of face 3 that reveals evidence of an anomaly on the surface.

Overall, the inspection team reported a steep and rocky reservoir bottom at the base of bent 4. Further they observed low scour levels, little debris, and no visible damage to the substructure. They reported that the substructure edges were sharp and the concrete face was smooth.

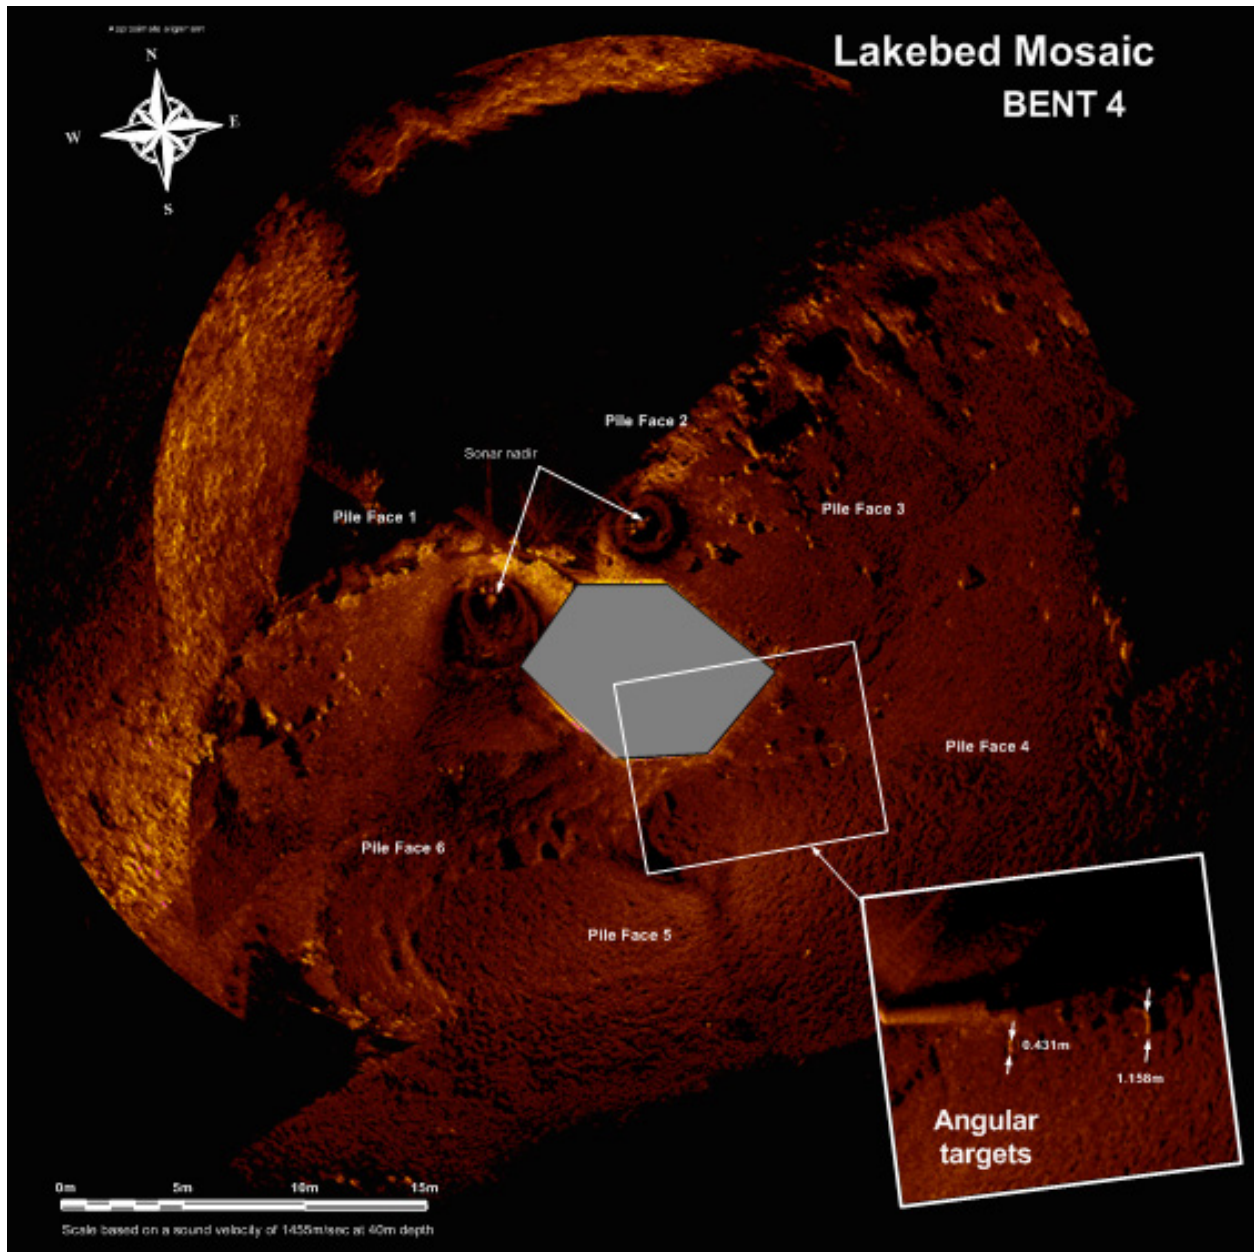
Figure 46. Image. Mosaic bed image of the James E. Roberts Bridge.

A total of six 98 ft (30 m) radius scans were collected. These were combined into a mosaic of the vicinity around bent 4 as shown in figure 46. The bottom shows significant upward elevation change to the northwest of bent 4 (shaded area). This elevation difference has resulted in some acoustic distortion in plotting the shape of the base of bent 4 as the record cannot be slant-range corrected to a single elevation plane without introducing additional range errors. There are a few angular targets situated close to the structure; their shape suggests they are not natural objects. There is no indication of bottom scour adjacent to the structure or of slope instability in this mosaic.

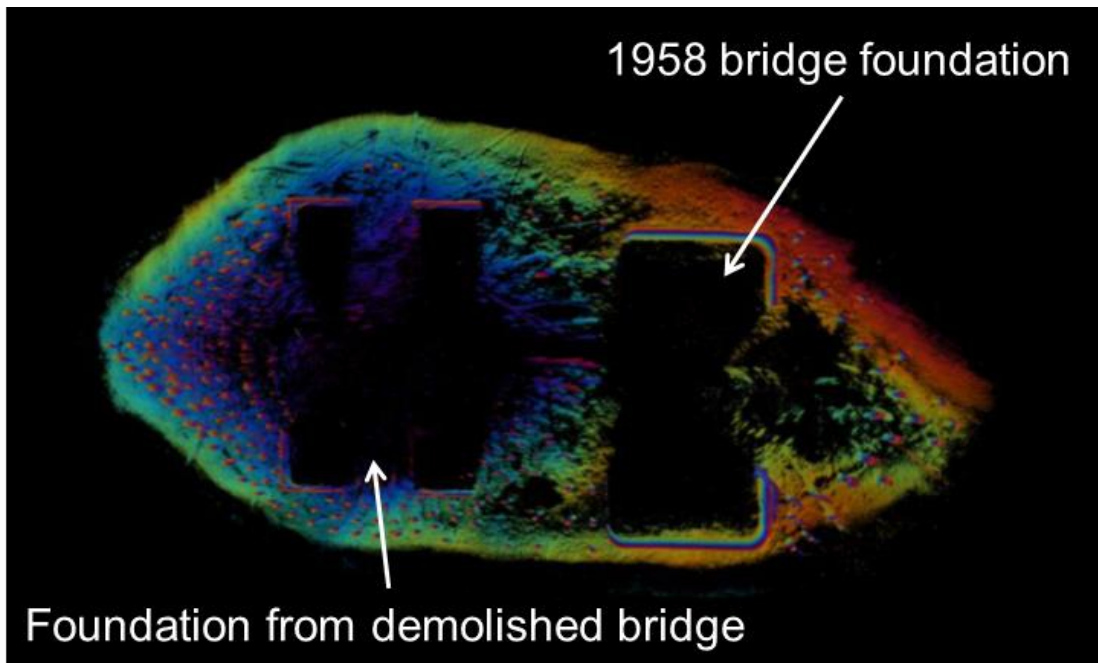
Figure 54. Image. Pier 3 plan view.

Water depth at the pier at the time of the inspection by team A was approximately 75 ft (23 m) on both the north and south sides of the pier. A plan view of the sonar results is shown in figure 54. The foundation for the 1958 bridge is the dark area on the right; the darker area on the left is the remaining foundation from the demolished 1927 bridge. A fender is shown to enclose both foundations. Figure 55 and figure 56 show views from the north and the south, respectively. The partial demolition of the 1927 foundation is clearly visible.

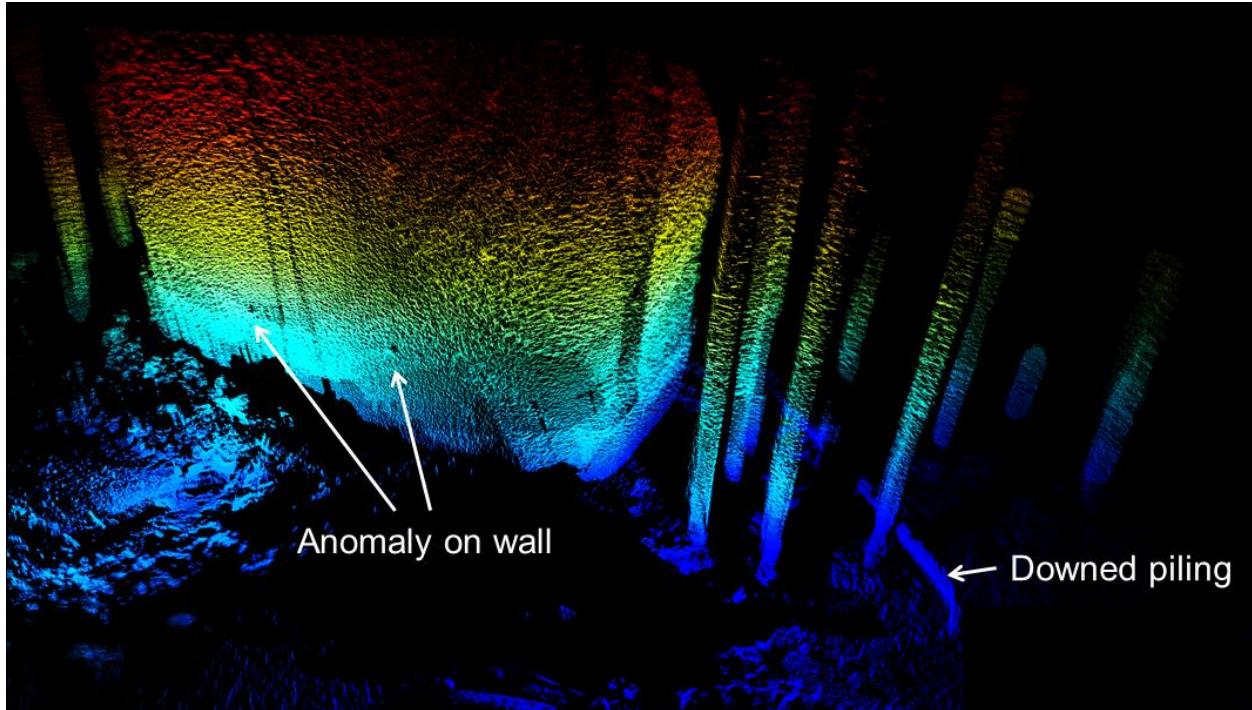
Figure 59. Image. 3D view of base of pier 3.

Inspection team C performed a combination of 2D and 3D scanning of the 1958 Carquinez Bridge. Figure 57 displays the areas on the pier foundation subject to inspection. An example of the 2D imaging is shown in figure 58. The reference location for this image is indicated in figure 57. An example of one of the 3D images, that among other features reveals a downed pile, is shown in figure 59.

Overall, the inspection team reported little evidence of scour and moderate to high levels of debris. Several small anomalies were noted on the concrete footings and many downed piles were identified.

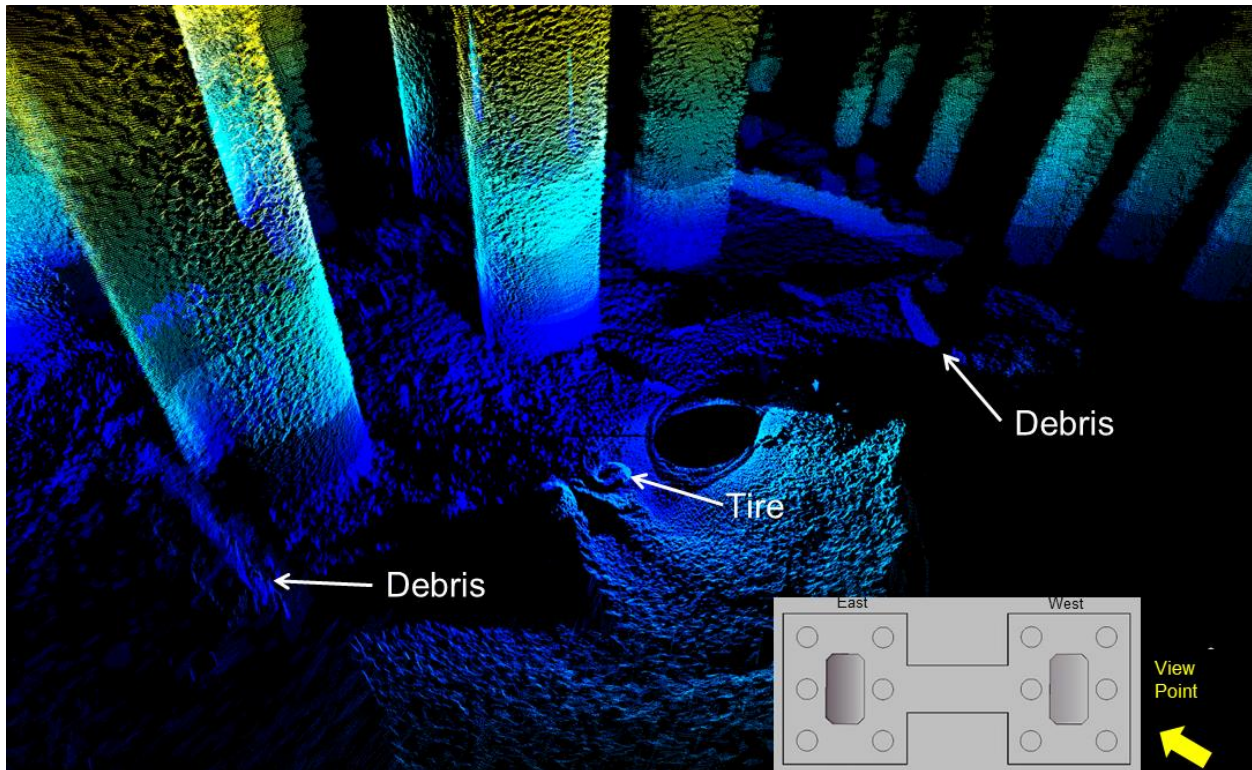
Figure 68. Image. 3D image viewed from the west side of the pier foundation.

Inspection team B performed a combination of 2D and 3D scanning of the 2003 Carquinez Bridge. An example of the 2D imaging is shown in figure 67. The figure is an image of the north pilings imaged as the boat was traveling from west to east using the 2D multibeam sonar in the vertical orientation. An example of 3D imaging is shown in figure 68 where several signs of debris are apparent.

Overall, the inspection team reported little evidence of scour and moderate levels of debris to the west with little debris elsewhere. No indication of structural damage was identified.

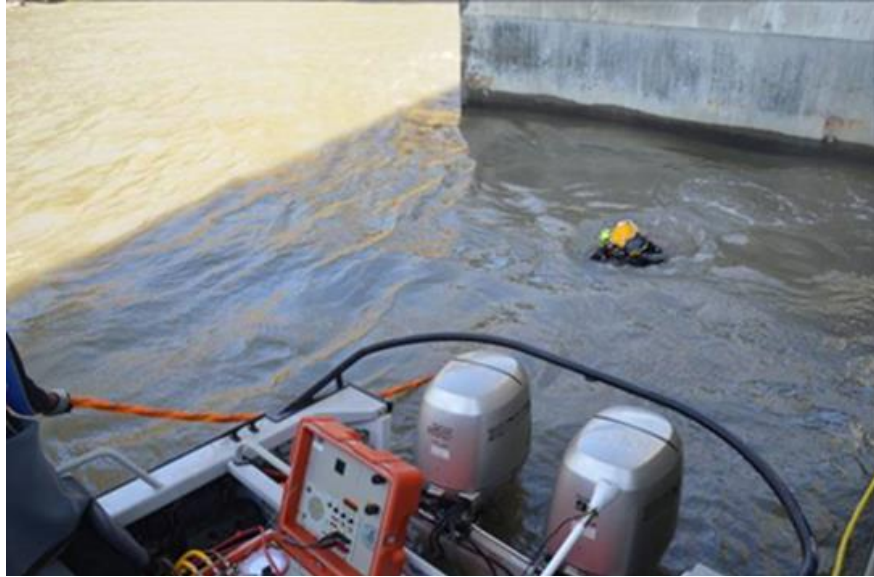
Figure 69. Photos. Wave and current condition during the diving operation.

With respect to the diving team at the Carquinez Bridge, the first dive was timed close to a slack tide. Overall, the current was manageable, but challenging for the divers. Examples of the water surface conditions are shown in figure 69. In addition, the depth was approximately 90 ft (27 m). The diver used the maximum amount of time allowed for the depth (30 min) to inspect one pile including one level II cleaning. The second dive occurred at a time between slack tide and maximum current. Inspection was nearly impossible because of the current. While the estimated current was likely between 2 ft/s (0.6 m/s) and 3 ft/s (0.9 m/s), the diver reported experiencing an approximately 4 ft/s (1.2 m/s) equivalent current. Based on the post-dive description and observation of the flow condition, it was hypothesized that the blockage caused by the massive pile cap might have produced a high velocity area some distance below the bottom face of the pile cap. This condition was hazardous for the diver.

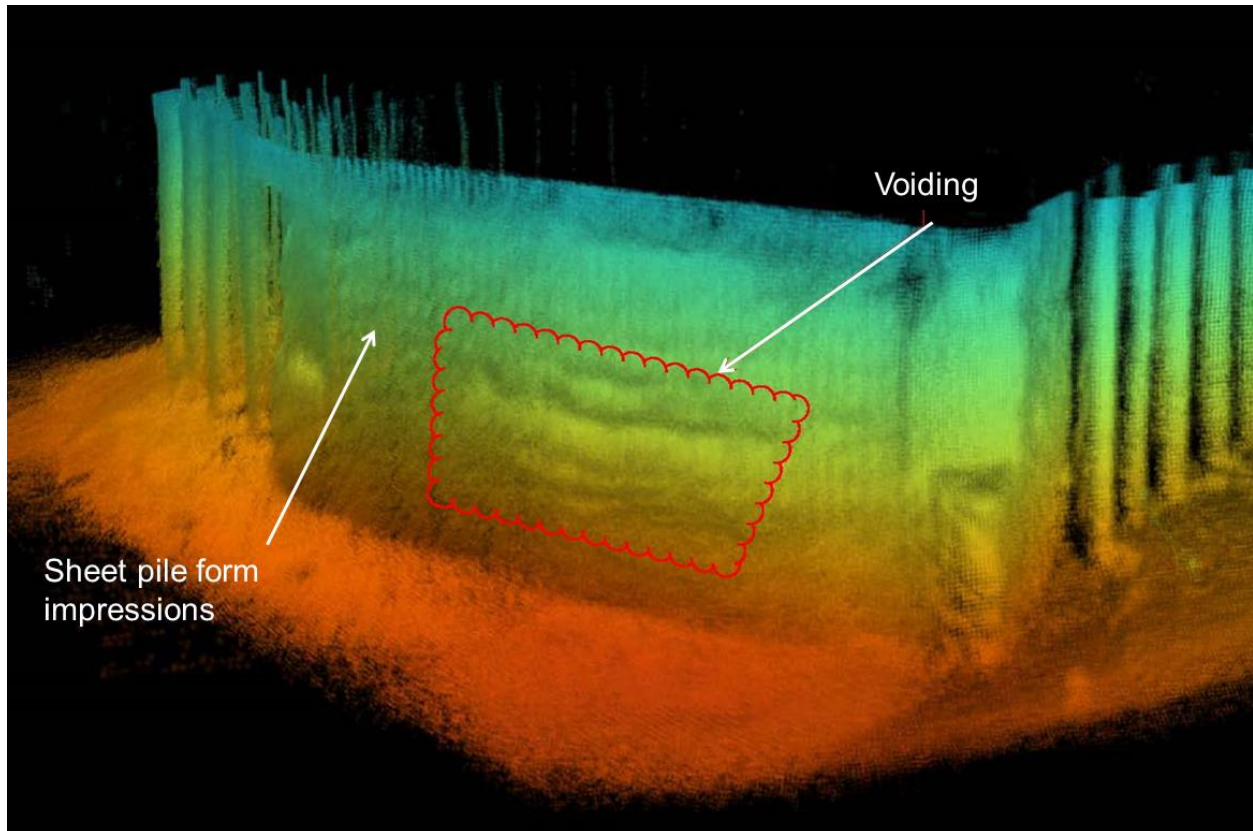
Figure 79. Image. Pier W2 viewed from the east.

The piles from old Wharf Pier 24 prevented access to the south and west faces of the concrete caisson for inspection team A. Team A reported that sheet pile form impressions were visible on all inspected faces (east and north) of pier W2. As shown in figure 79, the underwater acoustic imaging results show areas of voiding along the east face of pier W2. These horizontal bands varied in size, up to a maximum of 50 ft (15 m) long by 4 ft (1.2 m) high by 1.5 ft (0.46 m) deep, and are located near the center of the east face, ranging from approximately 10 ft (3 m) above the channel bottom to approximately 30 ft (9 m) above the channel bottom.

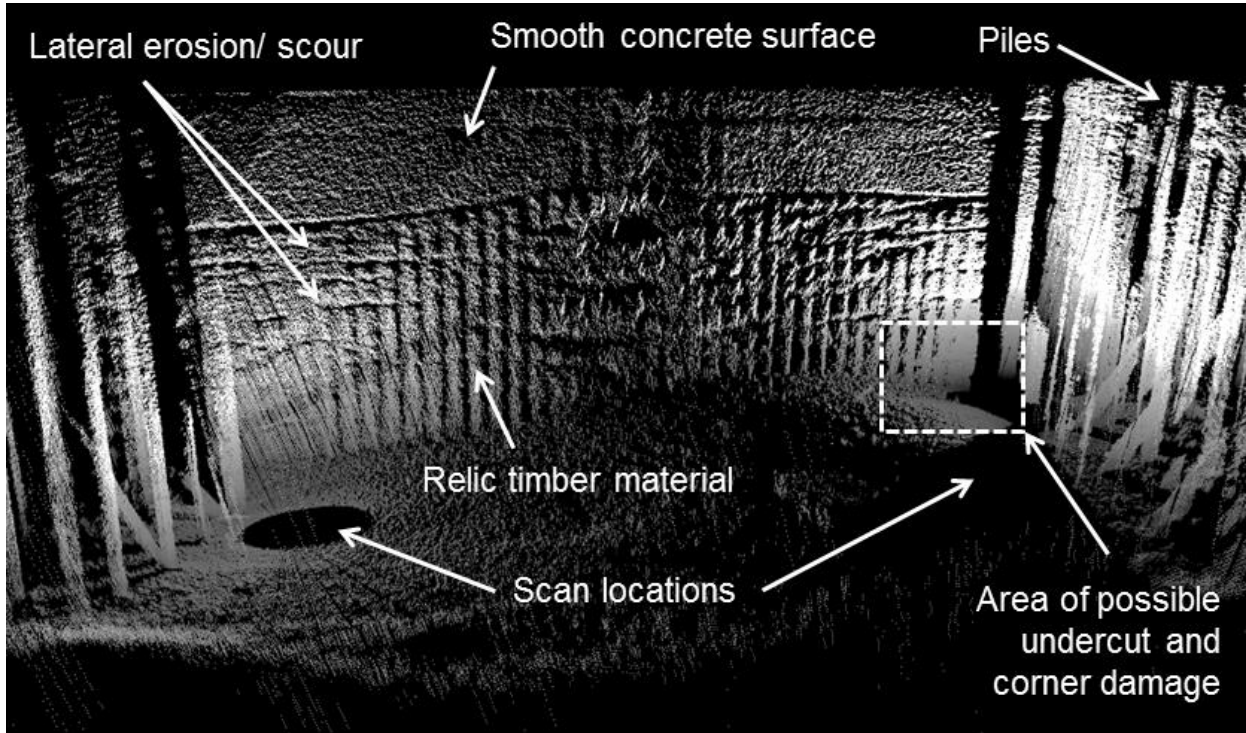
Figure 80. Image. Pier W2 3D data viewed from west.

Inspection team B reported that much of the sheet pile appears to have deteriorated from the submerged portions of the caisson at pier W2. As shown in figure 80, there were intermittent horizontal bands of voiding in the concrete caisson throughout the lengths of the entire east and west faces, with a maximum height of approximately 6 ft (1.8 m) and a maximum depth of approximately 1 to 2 ft (0.3 to 0.6 m). On the east face, the voids were most prominent at approximately 15 ft (4.6 m) and 30 ft (9.1 m) above the channel bottom. On the west face, the voids were evident beginning just below the top of the sheet pile form and extending down to approximately 8 ft (2.4 m) above the channel bottom near the center of the face. These voids were also visible on the northeast and southeast corners of the caisson.

analyst identified the transition from smooth concrete in the upper portion of the image to where the original concrete forms had been removed. They further identified numerous lateral erosion pockets, which were easily discernable in the data.

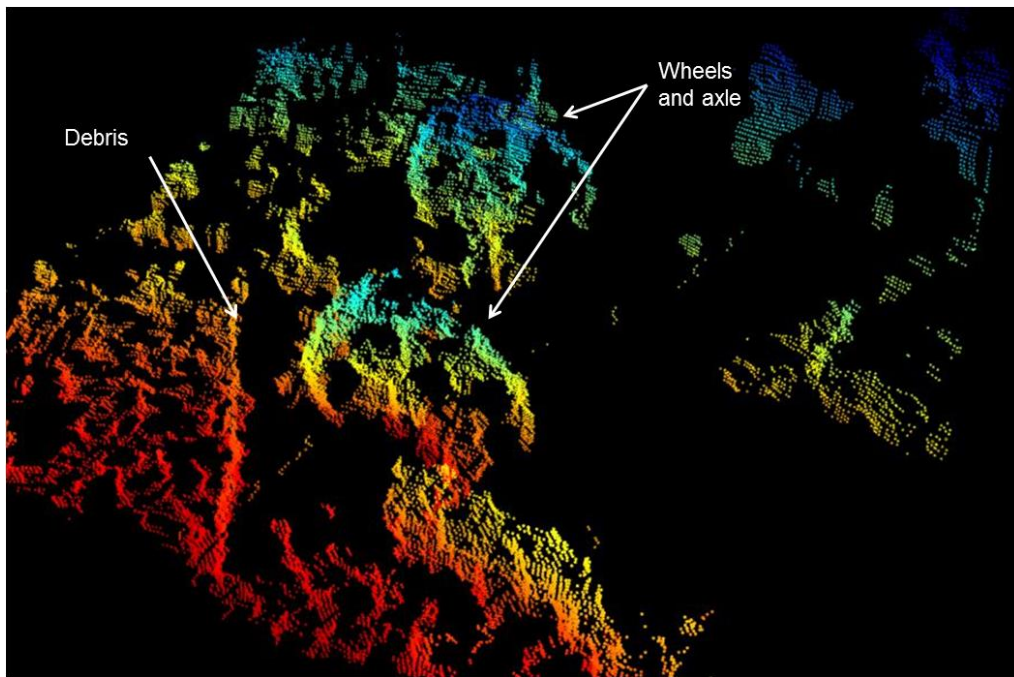
Figure 81. Image. Detail at bed near pier W2.

Inspection team B also identified debris on the bed near pier W2. The image in figure 81 shows evidence of debris including an axle with a pair of wheels.

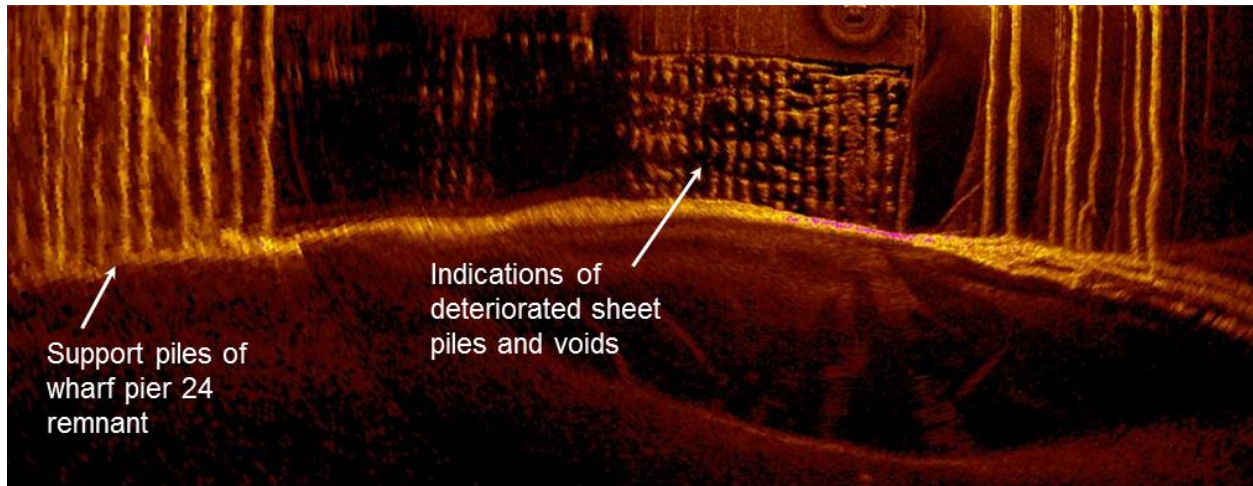
Figure 82. Image. Southeast corner of pier W2.

Inspection team C reported that the imaging results showed sheet pile form impressions at pier W2. They noted that much of the sheet pile appeared to have deteriorated from the submerged portions of the caisson at pier W2 as shown in figure 82. They further observed that there were intermittent horizontal bands of voiding in the concrete caisson and that they varied in size, up to a maximum of approximately 50 ft (15 m) long by 8 ft (2.4 m) high by 2 ft (0.6 m) deep. On the east face, the voiding was visible beginning near the top of the sheet pile form, and extended down approximately 15 ft (4.6 m). On the west face, the voiding was found throughout the entire submerged height of the sheet pile formed caisson. These voids were most prominent on the east

and west faces of the pier, but were visible in varying degrees on all of the scanned faces. The remaining sheet pile appeared to be delaminating from the pier.

The dive team and all three sonar teams drew the same general conclusions regarding the overall stability of the underwater portions of pier W2: voids were common, but nonthreatening, and scour was not evident. The sonar teams also noted aggradation at the southeast corner of the pier (visible in figure 82), but this was not reported by the dive team. Except for sonar team A, all inspection teams were able to access all four pier faces.

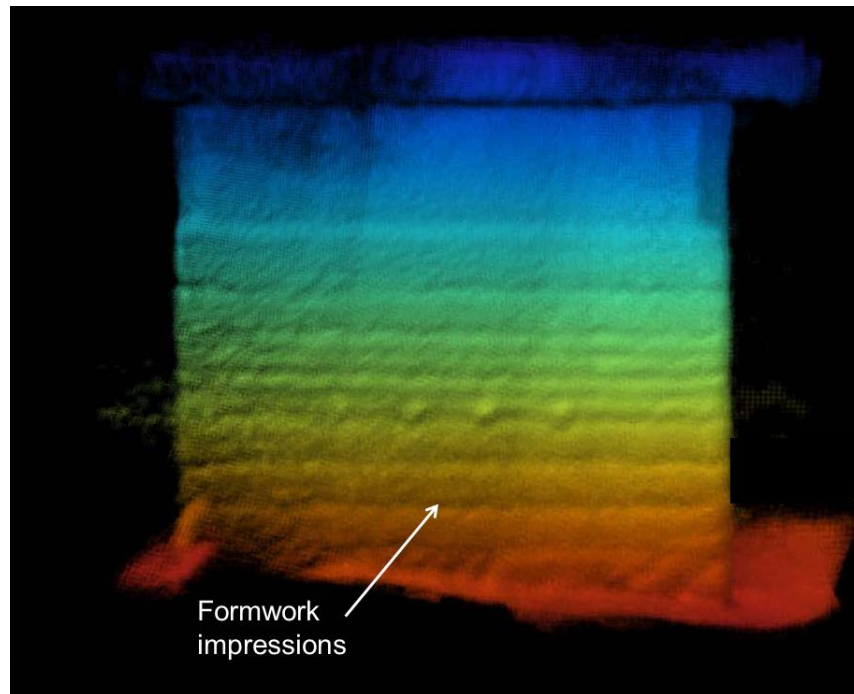
Figure 84. Image. Pier W6 viewed from the west.

Inspection team A reported that there were no significant deficiencies visible at pier W6. The report identified that formwork impressions are visible on all submerged faces of the caisson as shown in figure 84. The change from the smooth concrete to the formwork is visible in the figure.

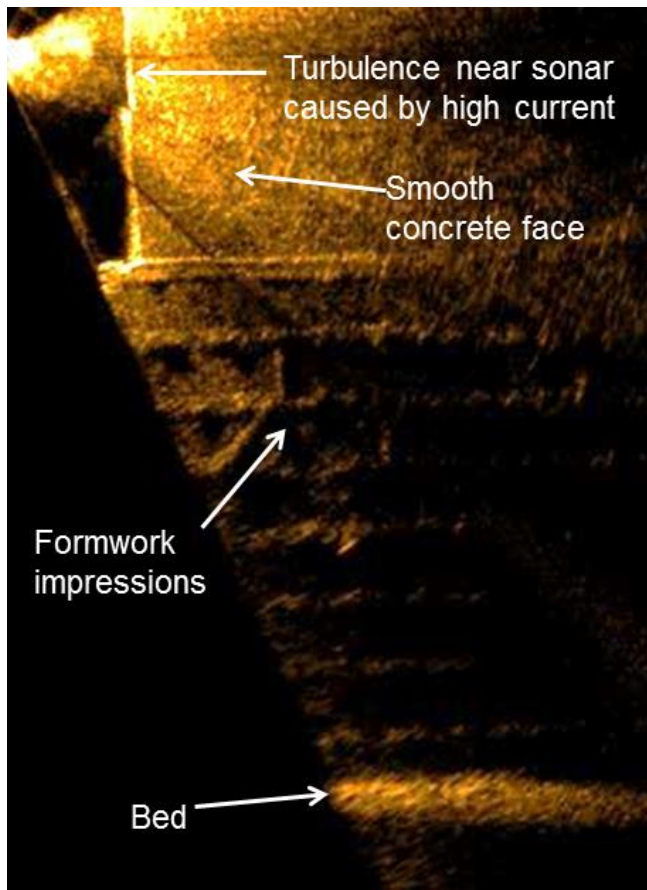
Figure 85. Image. South face of pier W6 in a 2D sonar image.

Inspection team B noted formwork impressions visible on the submerged caisson as shown in figure 85. A possible area of abrasion is distinguishable at the southeast corner, near the top of the caisson, just below the step-out.

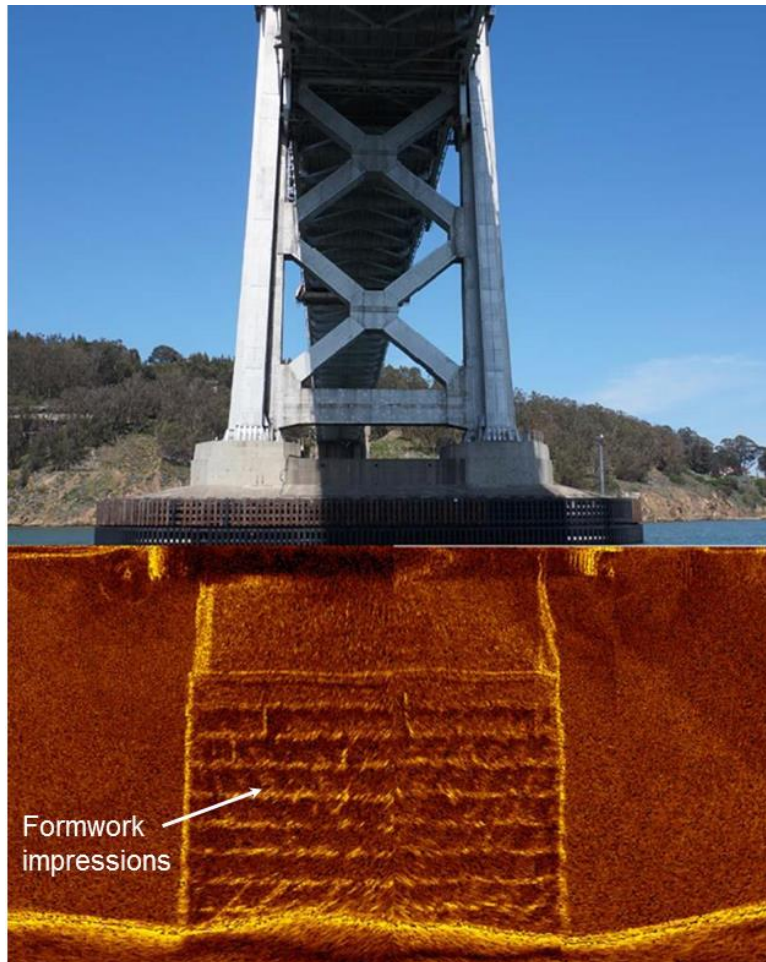
Figure 86. Image. West face of pier W6.

Inspection team C also noted formwork impressions visible on the submerged caisson at pier W6 as shown in figure 86. There are also possible diagonal sheathing remnants or impressions visible on the south and west faces near the southwest corner.

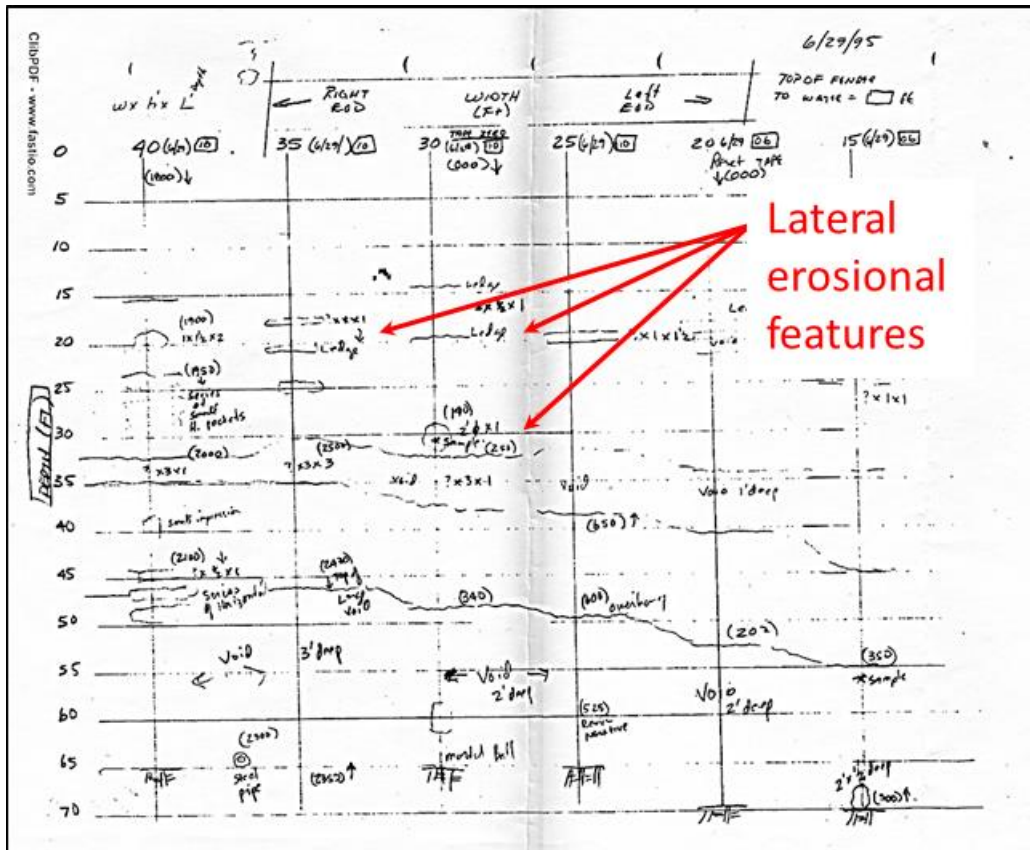
Figure 87. Image. Page from the 1995 diver inspection report on SF-OBB pier W2.

Analysts from sonar team B noted that the 1995 dive inspection report pertaining to pier W2 showed many linear features as shown in figure 87. They stated that similar features are readily noticeable in both the 2D multibeam images and the 3D mechanical multibeam point cloud data. For example, the analyst estimated that the lateral erosion was approximately 2 to 3 ft (0.6 to 0.9 m) deep from the image shown in figure 88. In addition, using the image shown in figure 80, the

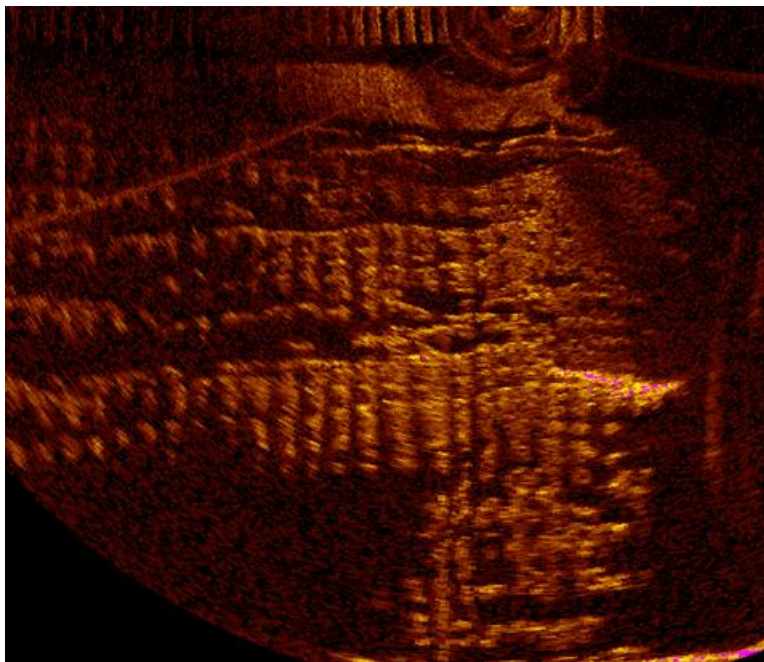
Figure 89. Image. Close-up view of the east face of pier W2.

The reanalysis noted that the close up views, such as the one shown in figure 89, revealed the deteriorated concrete and voids that number far more than the dive reports indicated and are too numerous to detail in light of the lack of structural significance. However, they maintained that it is possible to estimate penetration depths and to document each specific spall and void with the equipment and software used by team C.

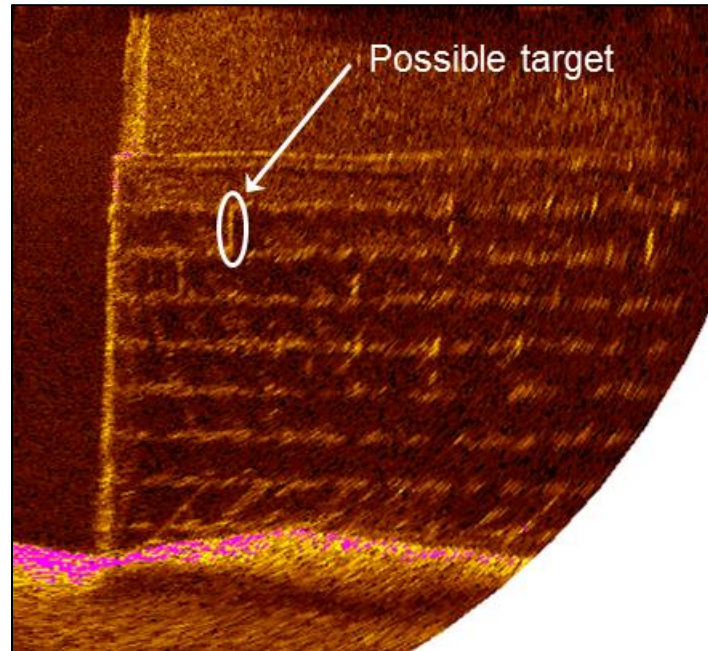
Figure 90. Image. South face of pier W6.

The reanalysis by inspection team C also resulted in several observations regarding the planted targets on pier W6. The analyst observed that while there is a signature shown in figure 90 that is in the correct location and exhibits the appropriate dimensions for planted target 2 (a 7 ft (2.1 m), 3/8-inch (9.5 mm) chain), the nature of the object, if present, could not be identified. Several other linear articles of debris hanging on the pier are observed in the sonar images. The analyst noted that this is typical so it is not practice to call out each article of debris if it is not of consequence to the structural integrity.

In addition, the analyst speculated that the targets were not placed on pier W6, but on a different pier. The targets were planted in 2013 and the analyst notes that there was a pier designation change for the pier W6 inspection that occurred in early March of 2014 the month before the sonar inspection. However, there is no documentation supporting this assertion.

Further, the analyst from team C observed that there is no indication in the sonar imagery of the diagonal wood formwork around the caisson reported by the dive team. To the contrary, there is the observed characteristic typical of remnants of a concrete pour that has squeezed through horizontal formwork. The analyst suggested that the sonar indicated that the formwork is no longer surrounding the pier.
