Underwater Inspection of Bridge Substructures Using Imaging Technology

June 14, 2018

Sponsored by
Federal Highway Administration
Office of Infrastructure
FHWA-HIF-18-049

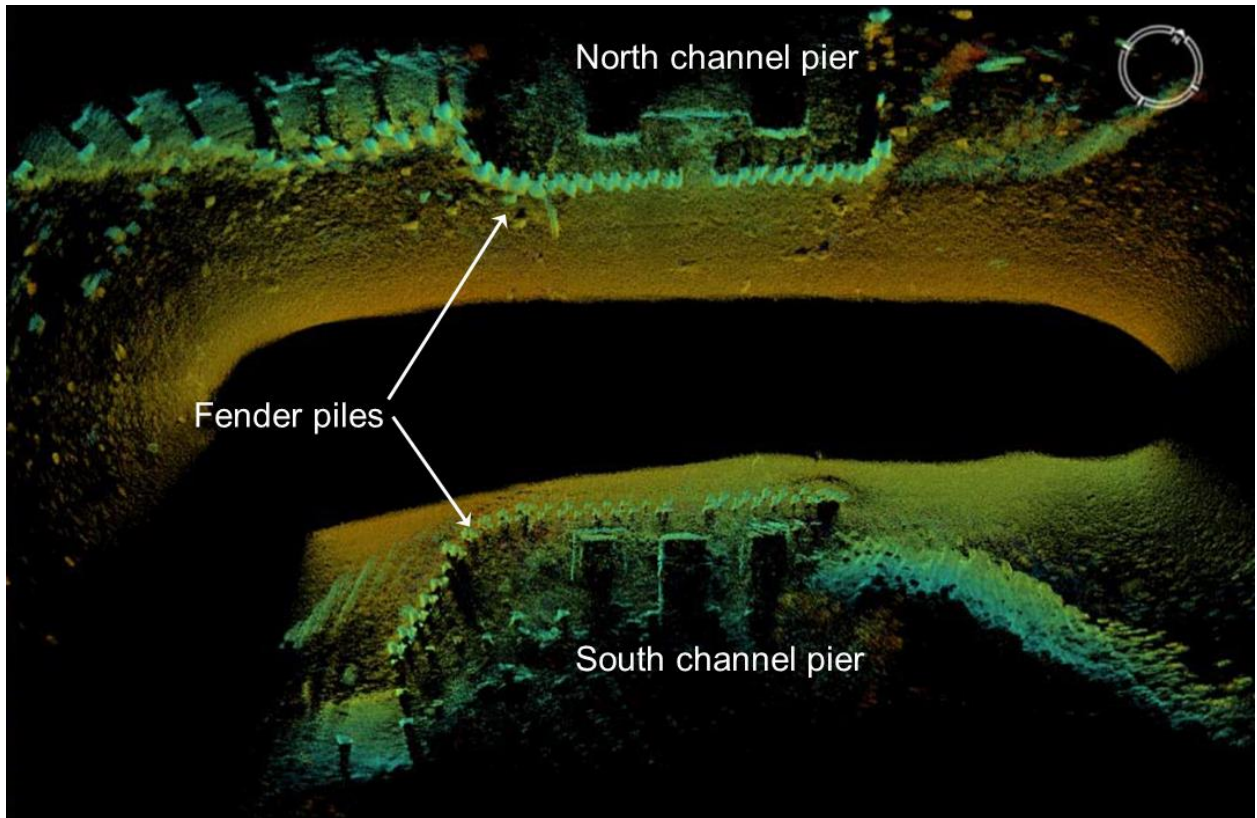
Figure 93. Image. North and south piers of the Third Street Bridge.

An image of both piers from sonar inspection team A is shown in figure 93. The report from sonar team A states that acoustic imaging of both the south channel pier (figure 94) and the north channel pier (figure 95) revealed no major deficiencies. The team reported that because of limited access, in-depth scanning was limited to the east support (column 2) of the north channel pier.

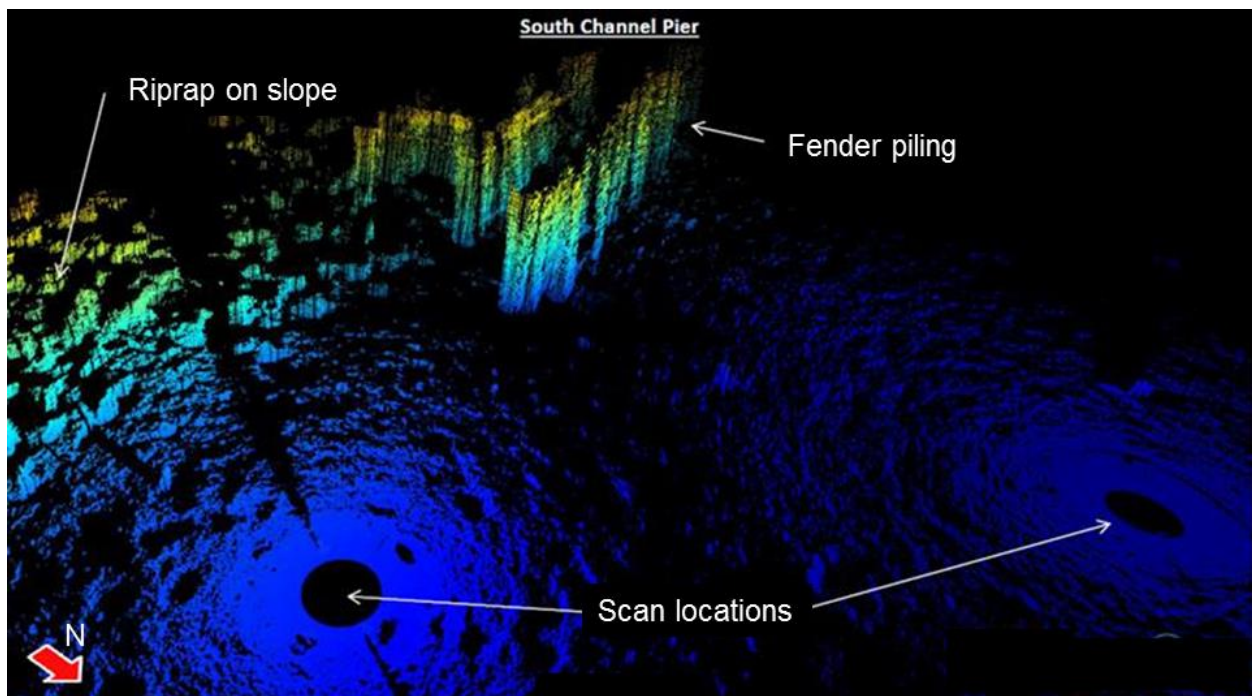
Figure 96. Image. South channel pier viewed from the northeast.

Inspection team B noted that because of limited access and time constraints, scanning of the south channel pier was limited to a few scans of the east support (column 2). These images, such as found in figure 96, revealed no significant deficiencies.

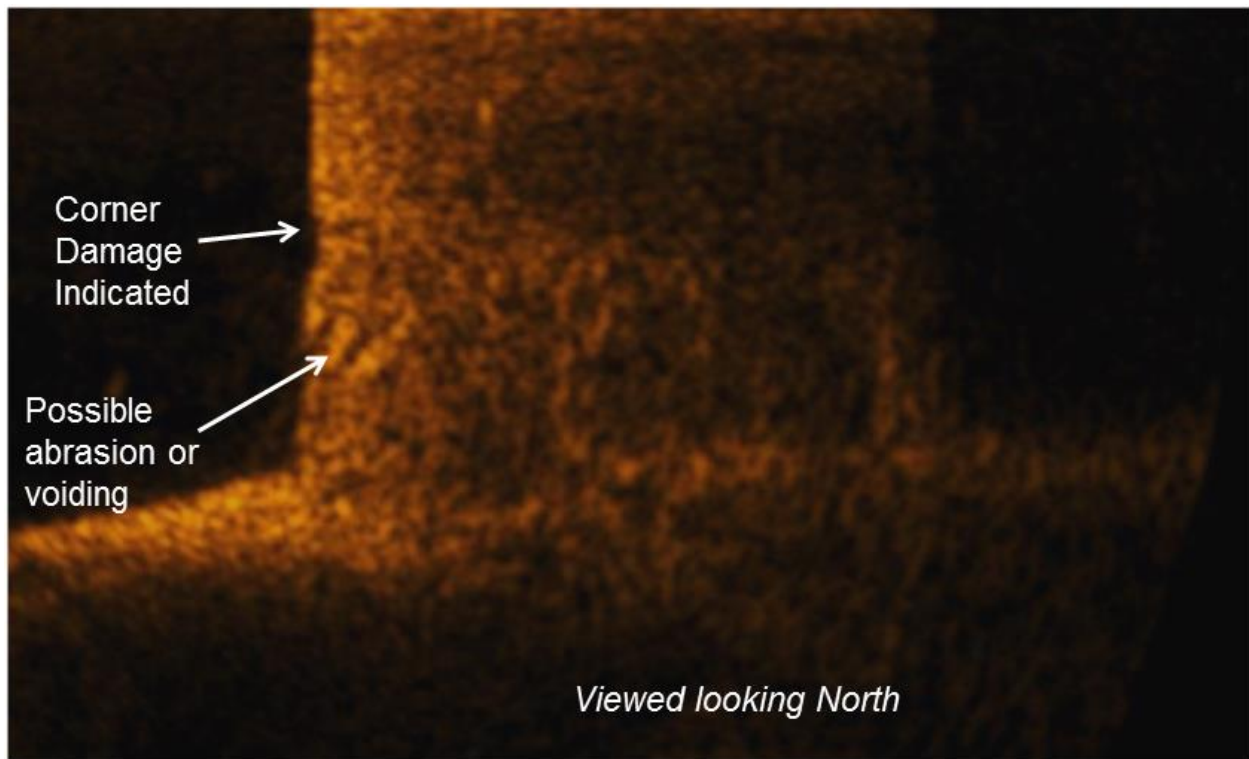
Figure 97. Image. Detail of south face of west support of the north channel pier.

With respect to the west support (column 1) of the north channel pier, team B did identify possible abrasion damage or voiding along the west end of the south face as shown in figure 97. This area was reported as approximately 3 ft (0.9 m) long by 2 ft (0.6 m) high and positioned

approximately 5 ft (1.5 m) above the channel bottom. On the northwest corner of the same support column, the report also noted two possible areas of corner spalling or abrasion. These areas were reported as being approximately 1 to 2 ft (0.3 to 0.6 m) high by up to approximately 3 inches (76 mm) deep and located approximately 5 to 8 ft (1.5 to 2.4 m) above the channel bottom.

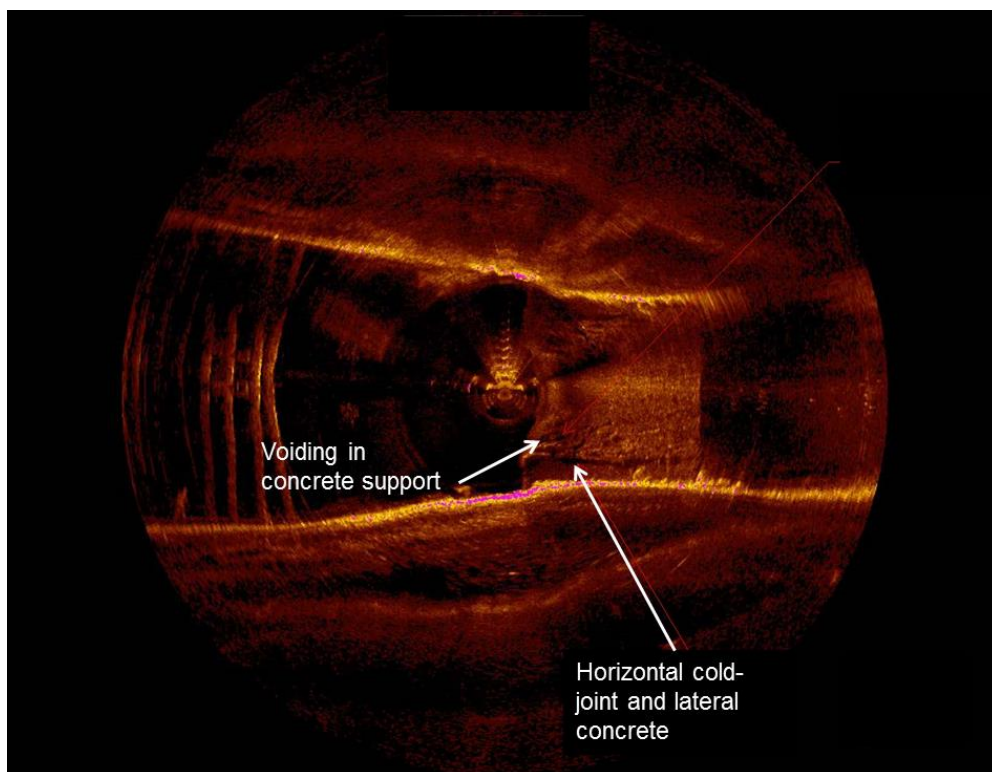
Figure 98. Image. Raw image of north channel pier, east support, south face.

At the north channel pier, the inspection report noted horizontal cold-joints and associated latent concrete visible on the supports as shown in figure 98 as well as vertical and horizontal

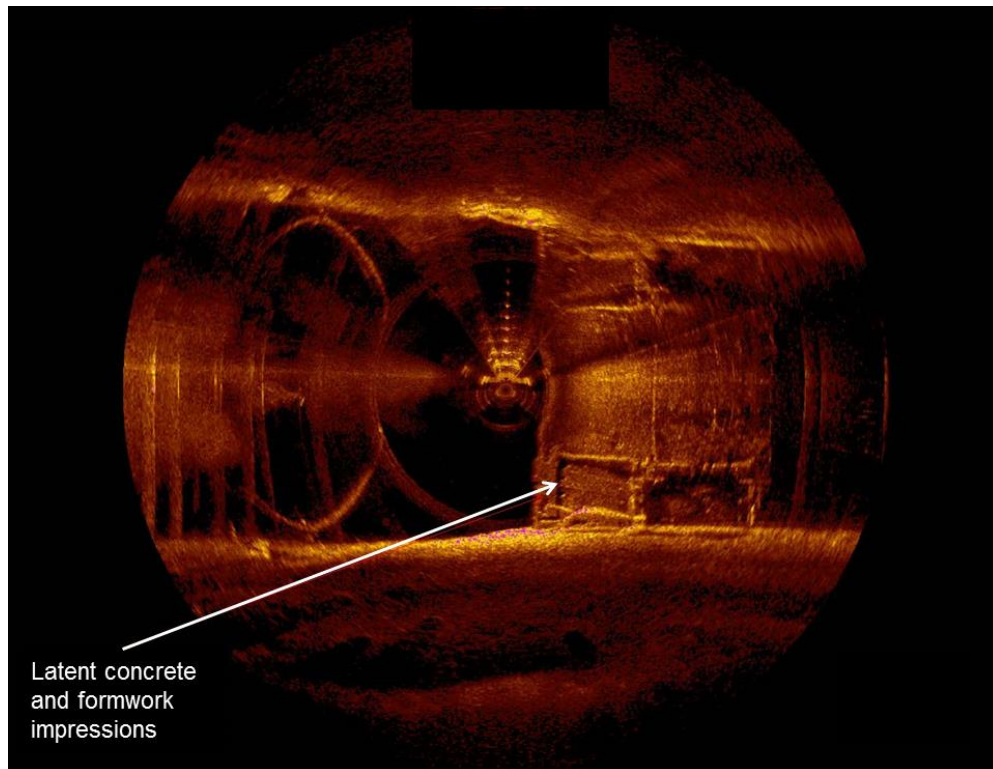
Figure 99. Image. Raw image of north channel pier, west support south face.

formwork impressions as shown in figure 99. In addition, the report noted voiding on the east support of the north channel pier. On the east face a void ranging from approximately 0.5 ft (0.15 m) to 2 ft (0.6 m) high located approximately 12 ft (3.7 m) below the top of the concrete support was identified. The report noted this voiding extended intermittently along the entire length of the east face and continued around the northeast corner to the north face for approximately 5 ft (1.5 m). Additional voiding at the east end of the south face approximately 5 ft (1.5 m) long by 6 inches (150 mm) high positioned approximately 19 ft (5.8 m) below the top of the concrete support was reported.
