SCHLEICHER

61-13-3 Schleicher Amdt. 299 Part 507
Federal Register June 24, 1961. Applies to
Model K-7 Gliders With Serial Numbers Up
To and Including 935 and Serial Number
984.

SIKORSKY

47-32-15 Sikorsky (Was Mandatory Note 1 of AD-2H-1.) Applies to Model S-51 Helicopters.

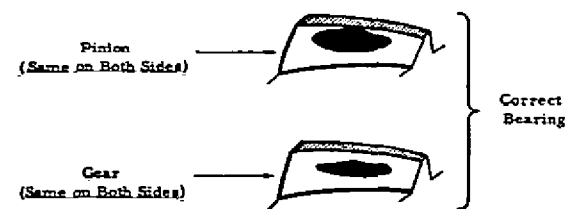
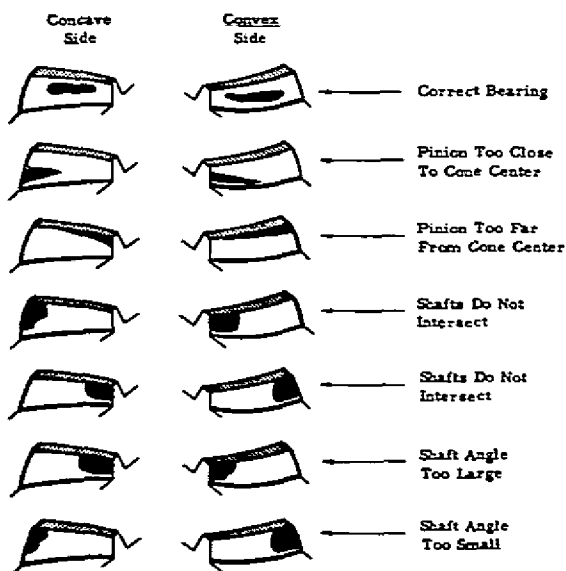
FIGURE 5

(l) After the power takeoff has been fastened securely in place, the gearbox must be operated by hand by turning the end of the pinion shaft protruding from the power takeoff. After a few revolutions, remove the power takeoff and check the tooth pattern. The correct tooth pattern is shown in Figure 5. The necessary adjustment for proper tooth pattern and backlash should be accomplished by shimming with power takeoff housing shims. Shims are to provide adjustments for both mounting distance of ring gear and pinion and also tooth pattern.

BEARING PATTERNS ON DRIVEN GEAR

TOOTH BEARING OF SPIRAL BEVEL GEARS
