GEORGIA DOT RESEARCH PROJECT 17-29

FINAL REPORT

**DEVELOPMENT OF POSSIBLE SOLUTIONS TO
ELIMINATE OR REDUCE DECK CRACKING ON
SKEWED BRIDGES BUILT BY USING THE
ACCELERATED BRIDGE CONSTRUCTION METHOD**

1. Report No.: FHWA-GA-19-1729	2. Government Accession No.:	3. Recipient's Catalog No.:	
4. Title and Subtitle: Development of Possible Solutions to Eliminate or Reduce Deck Cracking on Skewed Bridges Built by Using the Accelerated Bridge Construction Method		5. Report Date: December 2019

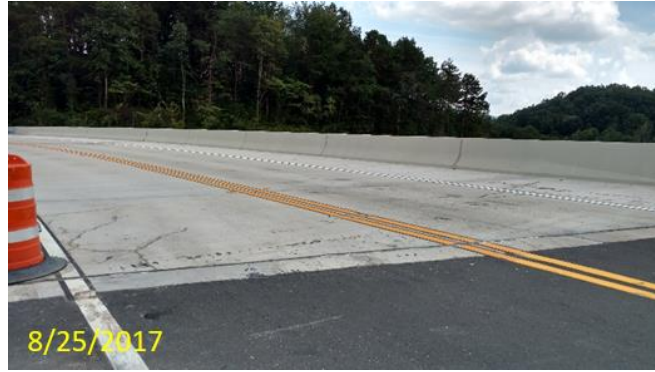
Figure 5 – Typical deck corner cracks in Span 1.

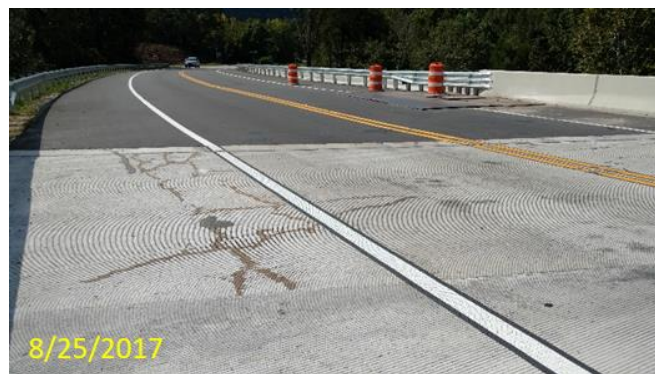
Figure 6 – Typical cracks in the acute corner of Span 1.

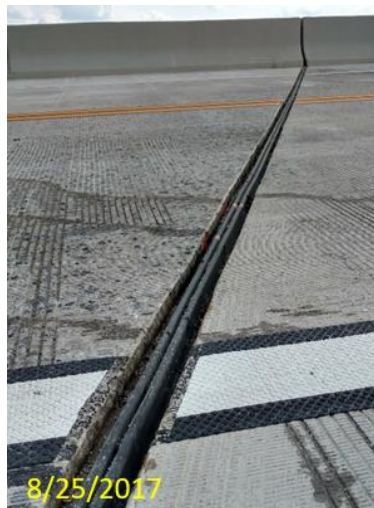
Figure 7 – Typical longitudinal cracks at the expansion joint.

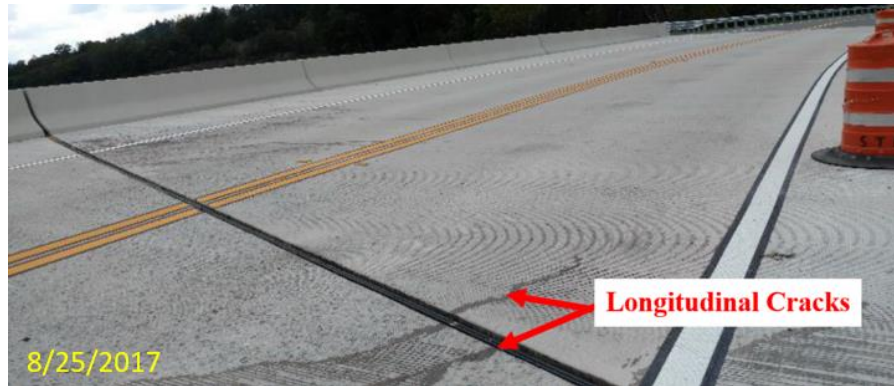
A large number of cracks were seen on the bridge deck. Longitudinal cracks were observed across the expansion joint in the middle of the bridge. Figure 13 shows the longitudinal cracks running parallel to the direction of the precast girders.

Figure 13 – Longitudinal cracks at the expansion joint on SR299 bridge (eastbound lane of Spans 1 and 2).

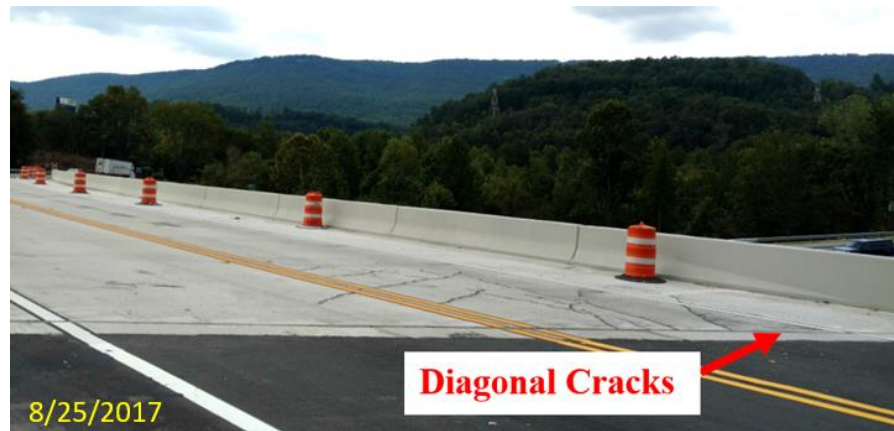
Figure 14 – Typical diagonal corner cracks on SR299 bridge (eastbound lane of Span 2).

Diagonal cracks were also found at two corners of the two-deck slabs on the abutment sides, as shown in Figure 14 and Figure 15, respectively. The diagonal and longitudinal cracks were approximately 1/32 in. (0.80 mm) wide. Moreover, transverse cracks were about 1/64 in. (0.40 mm) wide and propagated on the bridge deck. These cracks were mainly found at the acute corners with a skew angle ranging between 16.15° and 30.26°. Cracks were more visible because they were repaired with epoxy injection. Finally, hairline cracks that appear to be shrinkage cracks were observed, although they were found in limited areas with crack widths significantly smaller than those of the diagonal and longitudinal cracks described above.

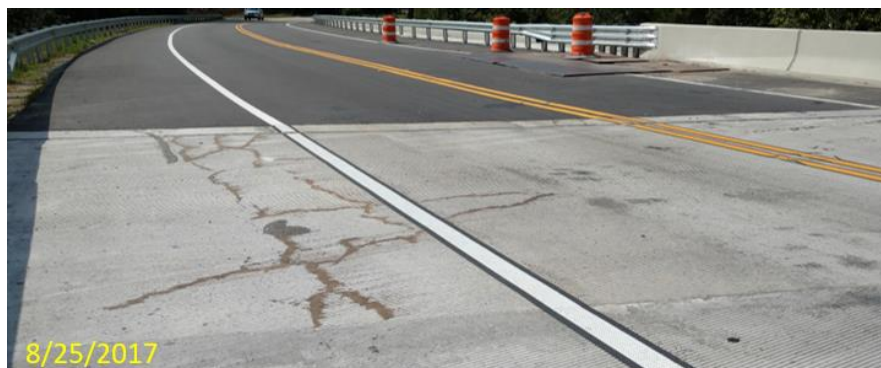
Figure 15 – Additional cracks along SR299 bridge (westbound lane shoulder of Span 1).

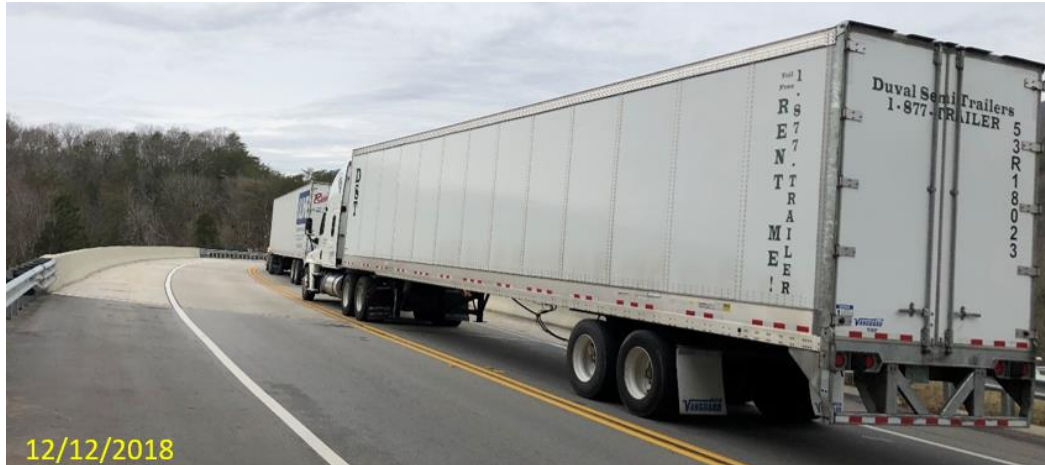
The results from the 2018 traffic count were consistent with the findings from the first site investigation: an unusually high number of Class 9 trucks used the bridge. Figure 26 illustrates a few cases where trucks traveling back-to-back were observed. Trucks traveling in both directions were also observed, along with a few oversized load trucks, shown in Figure 27. In conclusion, such service live (i.e., truck) load patterns might have

caused additional cracks—as the load distribution changes at the skewed deck edges—or contributed to widening the existing cracks.

Figure 26 – Back to back Class 9 trucks crossing SR299 bridge.

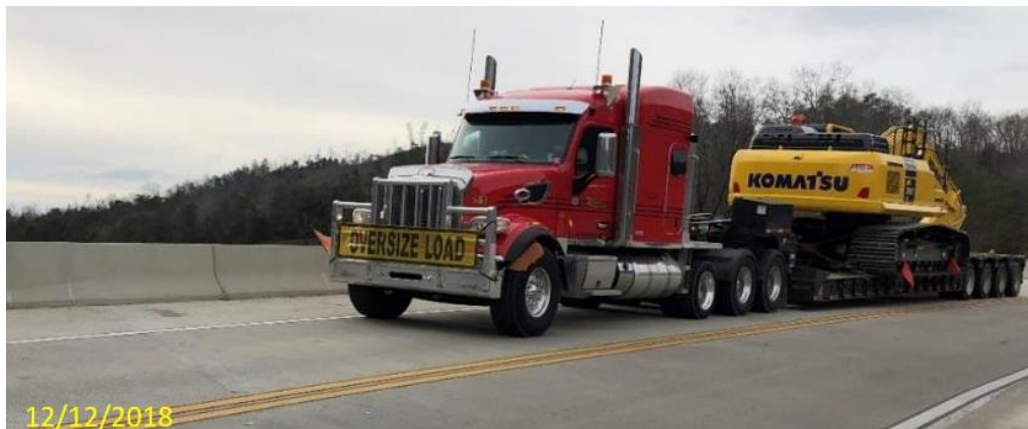
Figure 27 – Oversize load Class 9 truck crossing SR299 bridge.

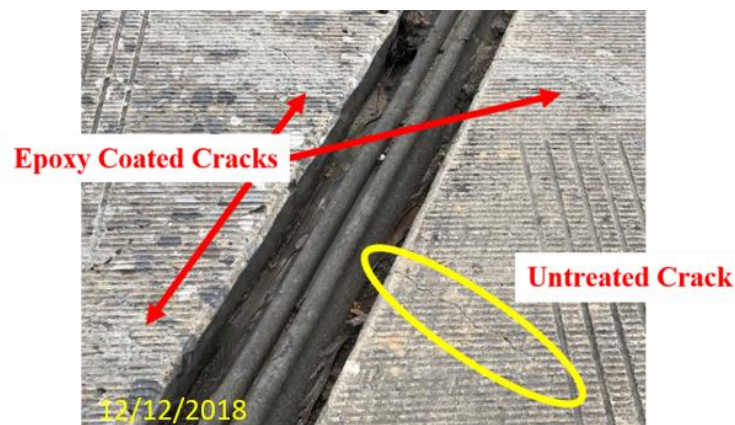
presents crack patterns present on the bridge deck during the second visit. Specifically, Span 2 had a higher number of cracks at the acute corner on both the expansion side and the abutment side, and cracks ran across the expansion joint between Span 1 and Span 2, as shown in Figure 29. Several untreated cracks are shown in Figure 30 and Figure 31.

Figure 29 – Crack through the expansion joint.

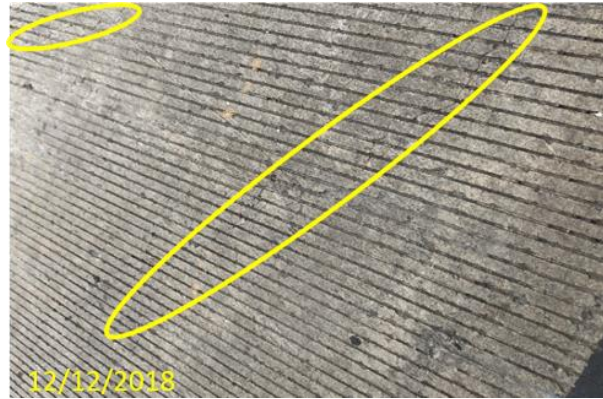
Figure 30 – Untreated diagonal cracks without epoxy coatings.

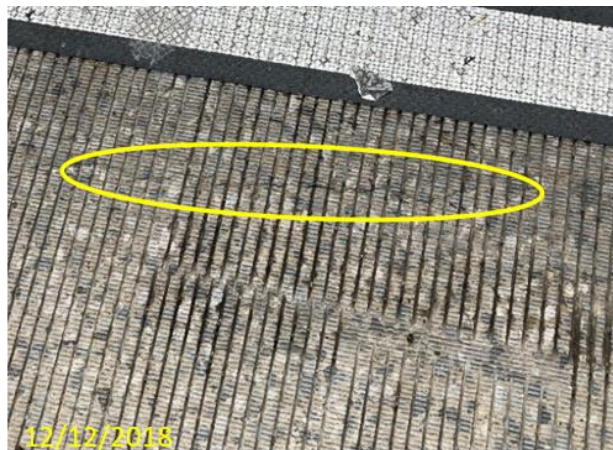
Figure 31 – Untreated longitudinal cracks without epoxy coatings.

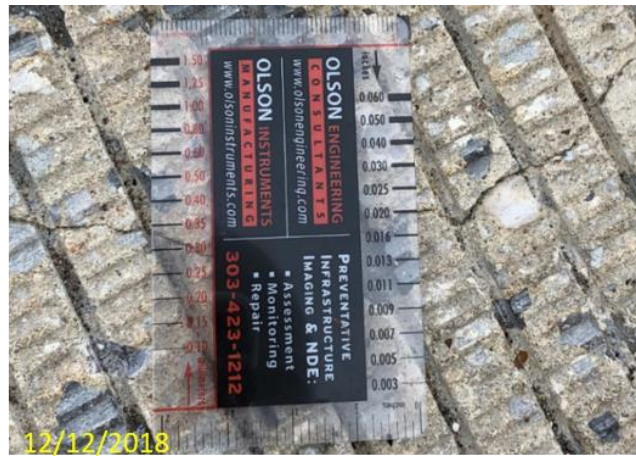
New crack widths ranged between 1/64 in. (0.40 mm) and 1/25 in. (1.02 mm). Cracks in the shoulder areas and at the skewed corners were wider than cracks in other areas. Figure 32 through Figure 36 show crack widths measured with a crack width gauge. In reviewing these photos, it is important to recognize that crack width varies along the length of the crack.

Figure 33 – Crack width measurement (0.020 in. or 0.51 mm).

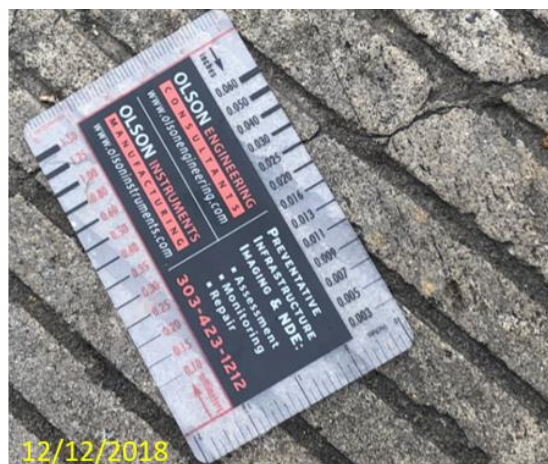
Figure 34 – Crack width measurement (0.025 in. or 0.64 mm).

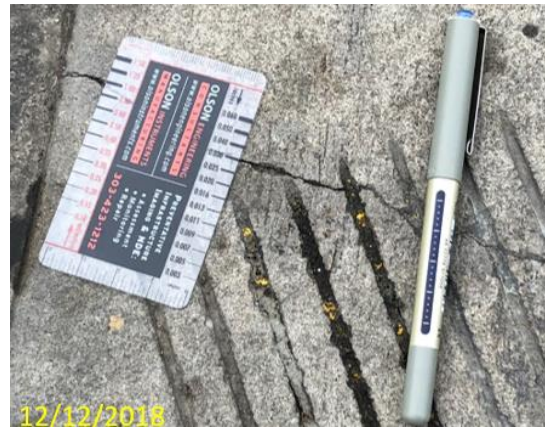
Figure 35 – Crack width measurement (0.030 in. or 0.76 mm).

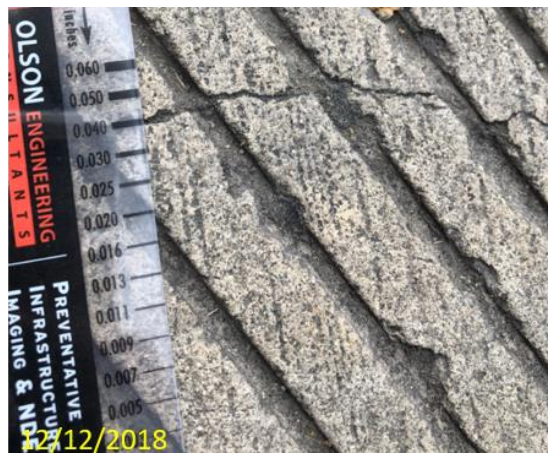
Figure 36 – Crack width measurement (0.040 in. or 1.02 mm).

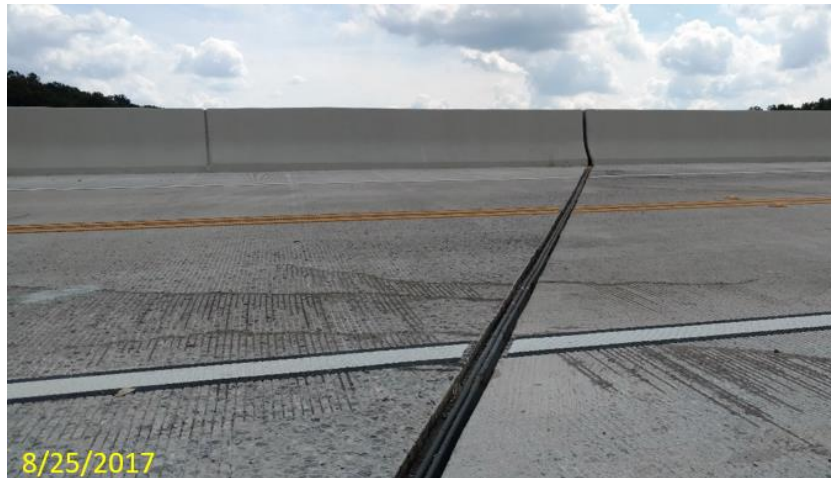
Figure 41 – Old photo showing cracks thru expansion joint between Spans 1 and 2.

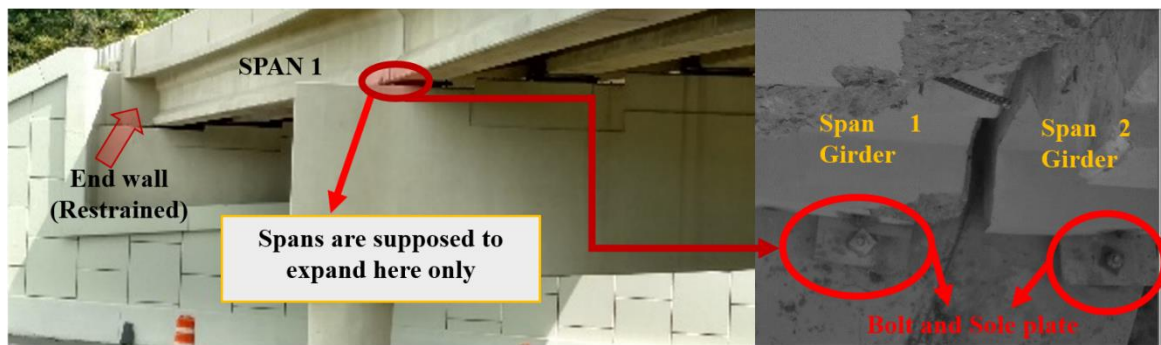
According to bridge inspection photos (GDOT BIR, 2017) taken after the bridge was placed in its final location, however, the sole plates at Intermediate Bent 2 are different from those designed in the bridge drawings. Instead, the same sole plates used for Bents 1 and 3 are used at Intermediate Bent 2. Figure 71 (a) shows an illustration of the boundary condition at Intermediate Bent 2. Figure 71 (b) shows the bearing conditions during the first bridge inspection performed by GDOT (GDOT BIR, 2017). Figure 71 (c) shows bearing conditions during the first site investigation performed by the study team. Figure 71 (d) shows bearing conditions enlarged from the photo shown in Figure 71 (c). In the FEA, a comparison is made between using as-built versus as-designed sole plates to study the effect of the sole plates on restraining the bridge deck from thermal contraction and expansion (see Section 5.3.3). The following subsections describe three boundary conditions considered in this study.

(a) Sole plates at Bent 2 shown in the inspection report (GDOT BIR, 2017).

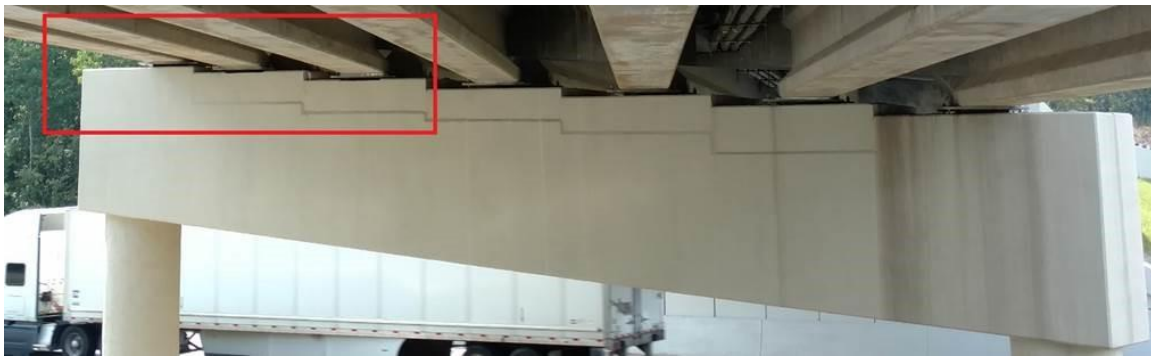
(c) Bearing conditions during the first site investigation (by this study team).

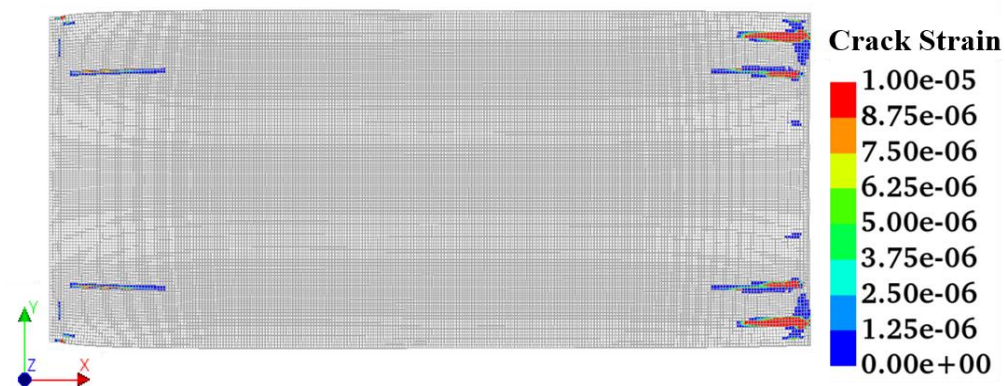
Figure 103 – Top view showing cracked elements in Straight-FR.

Figure 103 and Figure 104 show cracked elements on the top and bottom surfaces, respectively. Crack strain ranges between 0 and 10 microstrain ($\mu\epsilon$). Figure 105 shows the crack width plot corresponding to Figure 103. Figure 106 shows the crack orientations magnified by 100. The maximum crack strain calculated for the cracked elements is 3760 microstrain, in turn resulting in a maximum crack width of 1.12×10^{-2} in. (0.28 mm).

Note: Maximum crack strain = 3760 $\mu\epsilon$.

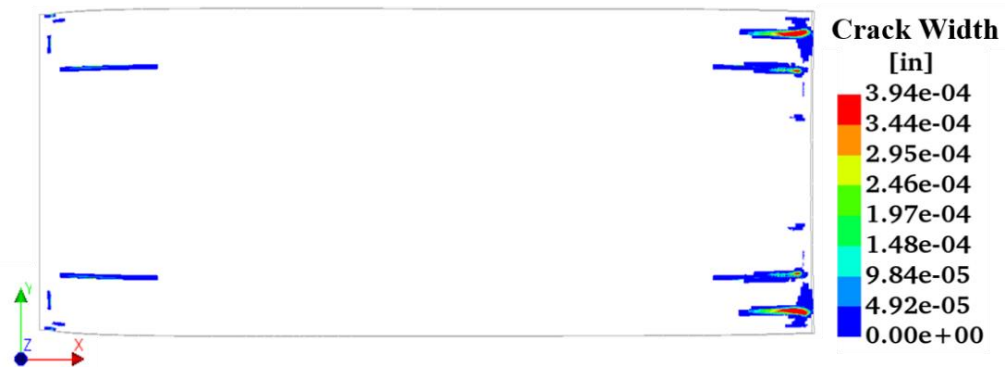
Figure 105 – Top view showing crack widths in Straight-FR.

Note: Maximum crack width = 1.12×10^{-2} in. (0.28 mm).

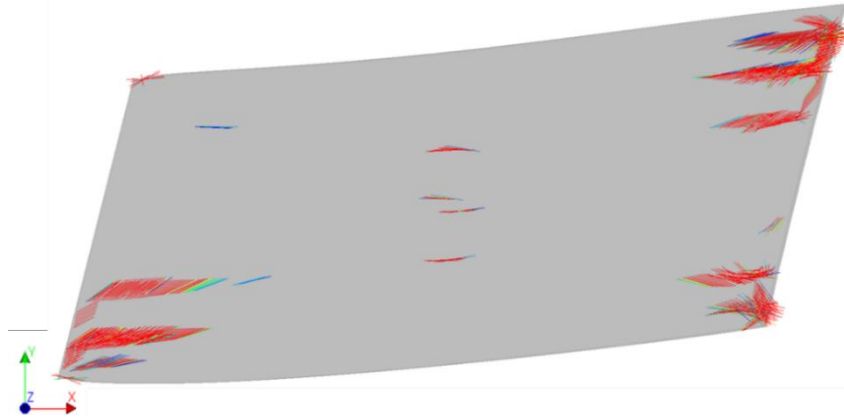
Figure 148 – Top view showing crack orientations in Skewed & Curved-FR.

Note: The crack size is exaggerated for illustration.

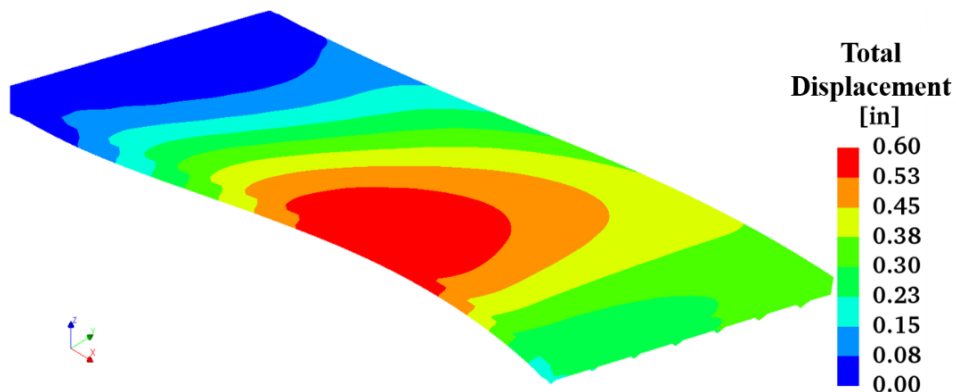
Figure 149 – Total displacement in Skewed & Curved-LVR.

When girder ends are restrained from longitudinal and vertical movements, a maximum displacement of 0.60 in. (15.24 mm) is predicted, as shown in Figure 149. This includes the effect of cracking. The longitudinal and transverse displacements are greatest at the Bent 2 corners, as shown in Figure 150 and Figure 151, respectively.

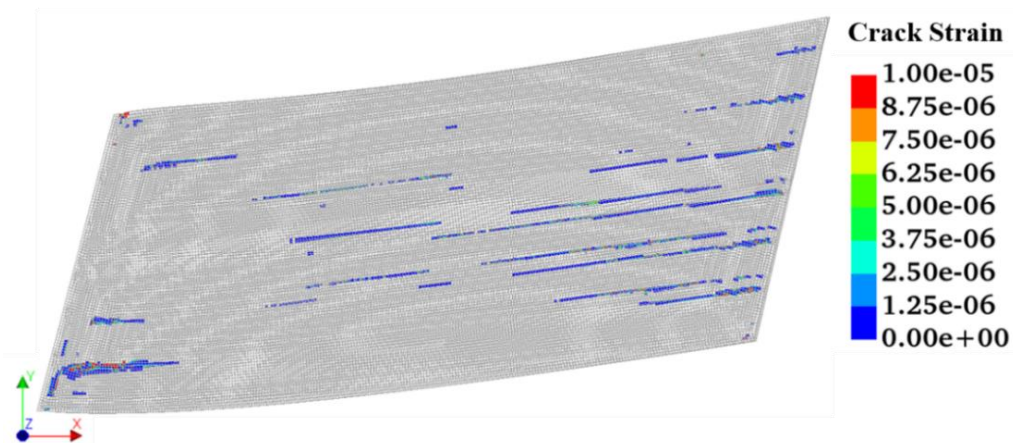
Figure 152 – Top view showing cracked elements in Skewed & Curved-LVR.

The maximum crack strain is 2620 microstrain, and the maximum crack width is 1.30×10^{-2} in. (0.33 mm). Figure 152 and Figure 153 show the cracked elements on the top and bottom surfaces, respectively. Figure 154 shows the crack widths, and Figure 155 illustrates the crack orientations.

Note: Maximum crack strain = 2620 $\mu\epsilon$.

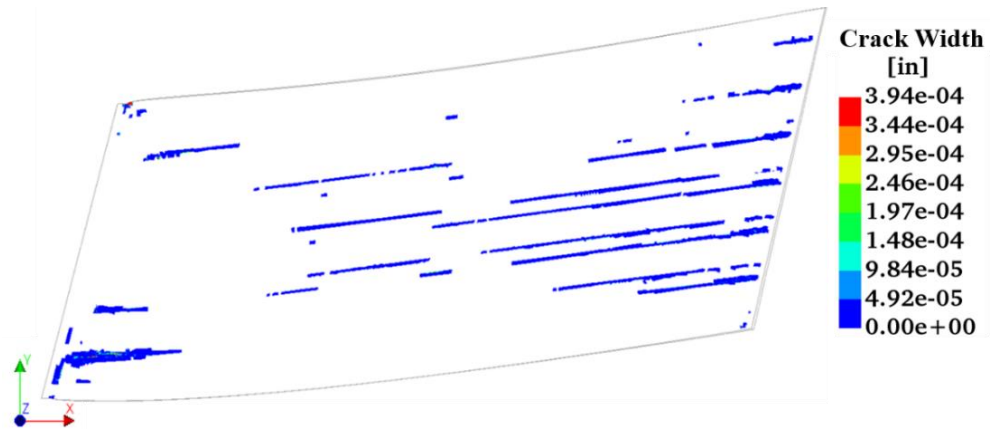
Figure 154 – Top view showing crack widths in Skewed & Curved-LVR.

Note: Maximum crack width = 1.30×10^{-2} in. (0.33 mm).

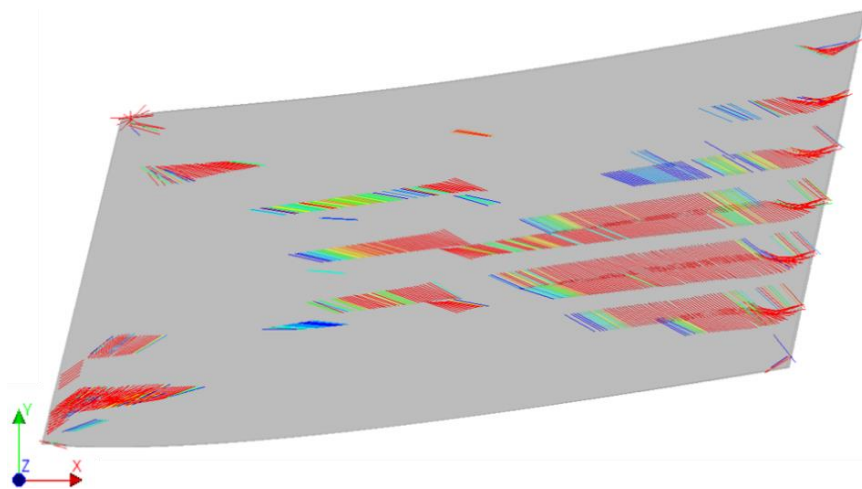
Figure 155 – Top view showing crack orientations in Skewed & Curved-LVR.

Note: The crack size is exaggerated for illustration.

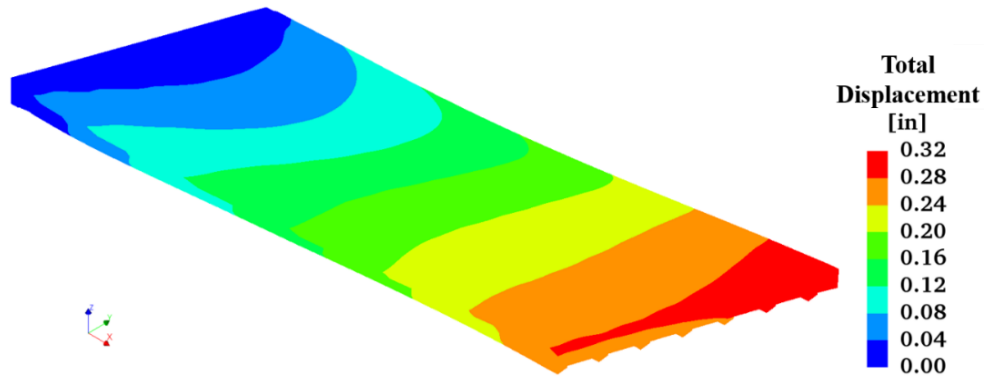
Figure 156 – Total displacement in Skewed & Curved-VR.

When the girder ends are restrained only in the vertical direction at Bent 2, the maximum total displacement is 0.32 in. (8.13 mm), as shown in Figure 156. The maximum longitudinal displacement occurs at Bent 2 (see Figure 157). Figure 158 shows the maximum transverse displacement, which occurs at the top right corner.

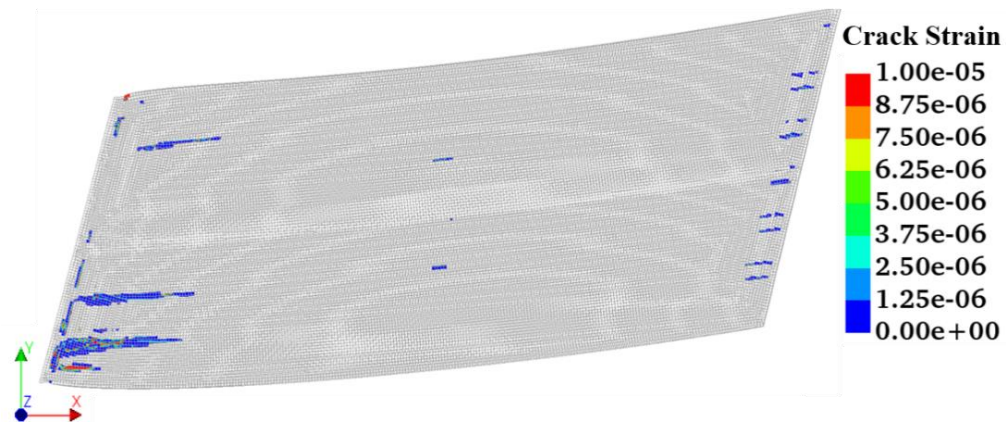
Figure 159 – Top view showing cracked elements in Skewed & Curved-VR.

The maximum crack strain and maximum crack width are 3940 microstrain and 9.66×10^{-3} in. (0.25 mm), respectively. The top and bottom views of the cracked elements are shown in Figure 159 and Figure 160, respectively, for crack strain indices of 0 to 10 microstrain. Crack widths are shown in Figure 161. Figure 162 shows the orientation of the cracks.

Note: Maximum crack strain = 3940 $\mu\epsilon$.

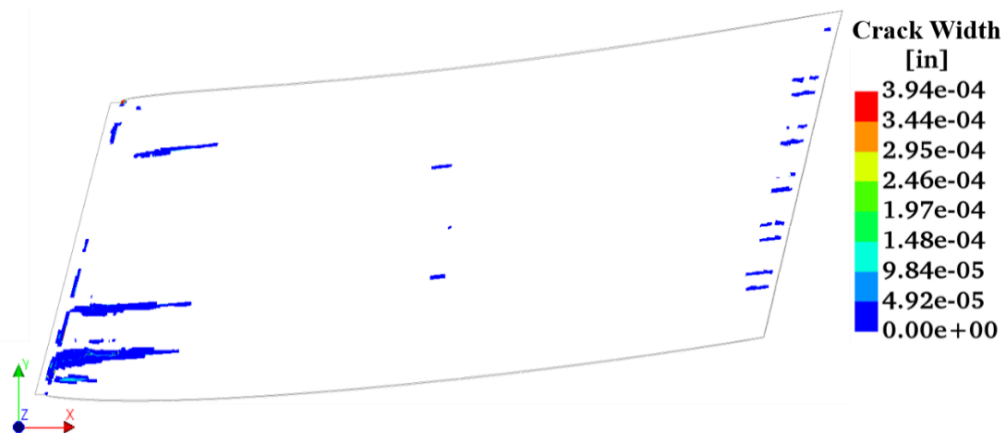
Figure 161 – Top view showing crack widths in Skewed & Curved-VR.

Note: Maximum crack width = 9.66×10^{-3} in. (0.25 mm).

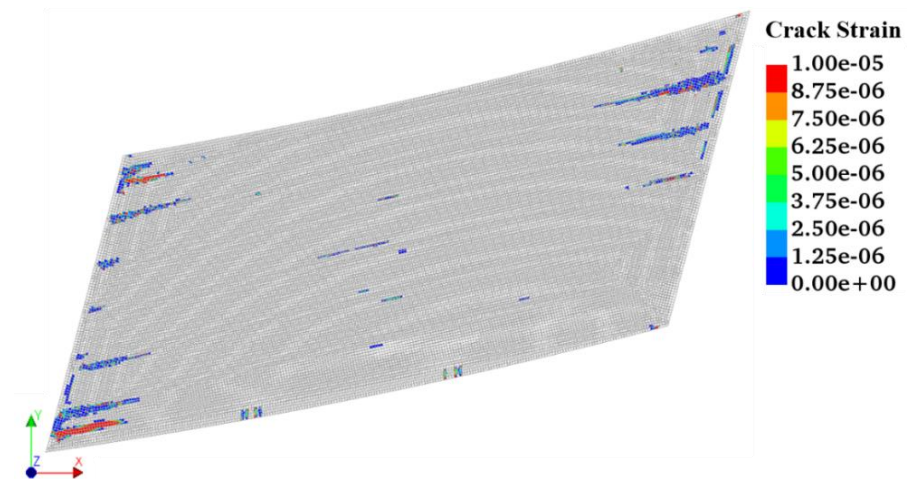
Figure 166 – Top view showing cracked elements in Highly Skewed-FR.

Figure 166 and Figure 167 show cracked elements for crack strain indices of 0 to 10 microstrain on the top and bottom surfaces, respectively. Corresponding crack widths are shown in Figure 168. The maximum crack strain is 7990 microstrain, and the maximum crack width is 1.07×10^{-2} in. (0.27 mm). Figure 169 shows the crack orientations.

Note: Maximum crack strain = 7990 $\mu\epsilon$.

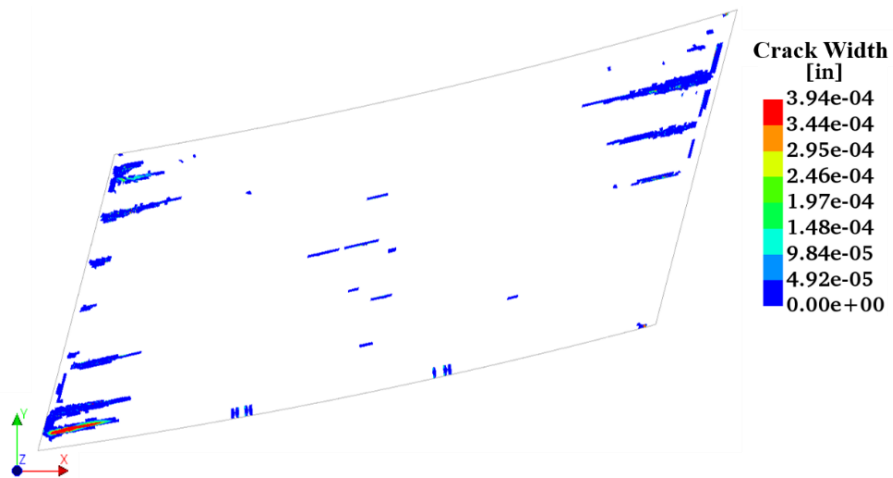
Figure 168 – Top view showing crack widths Highly Skewed-FR.

Note: Maximum crack width = 1.07×10^{-2} in. (0.27 mm).

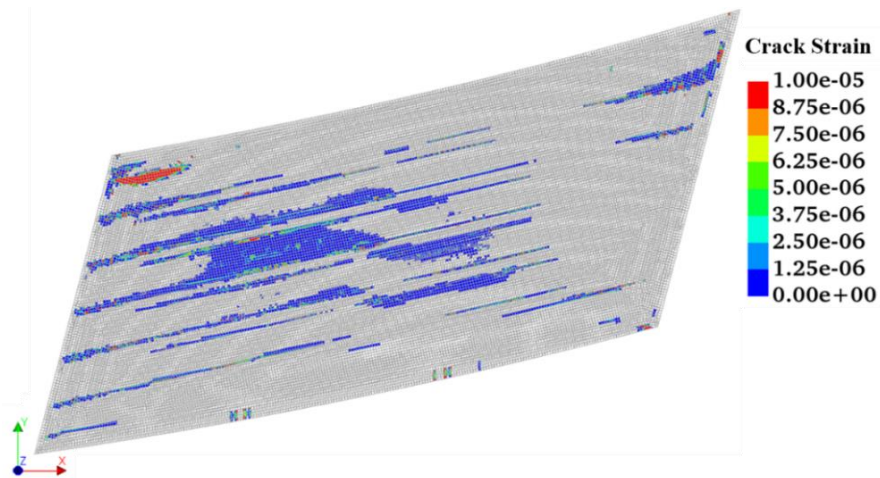
Figure 173 – Top view showing cracked elements in Highly Skewed-LVR.

The maximum crack strain is 3530 microstrain, and the maximum crack width is 1.12×10^{-2} in. (0.28 mm). Figure 173 and Figure 174 show the cracked elements on the top and bottom surfaces, respectively. Figure 175 shows the corresponding crack widths, and Figure 176 illustrates the crack orientations.

Note: Maximum crack strain = 3530 $\mu\epsilon$.

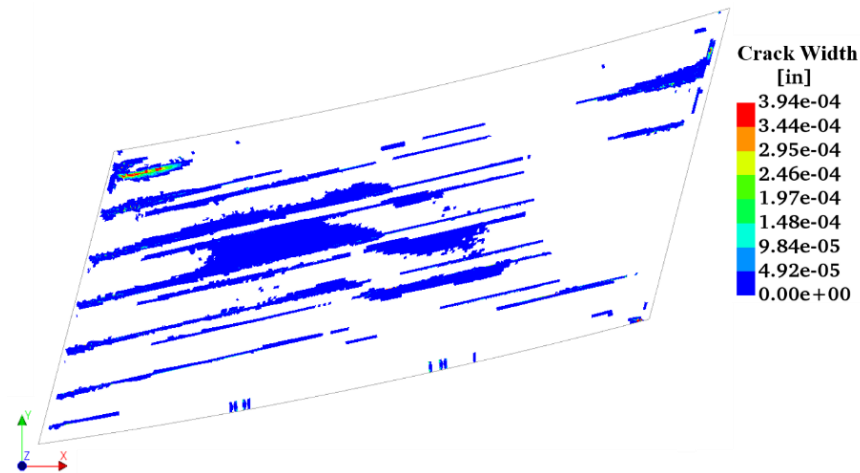
Figure 175 – Top view showing crack widths in Highly Skewed-LVR.

Note: Maximum crack width = 1.12×10^{-2} in. (0.28 mm).

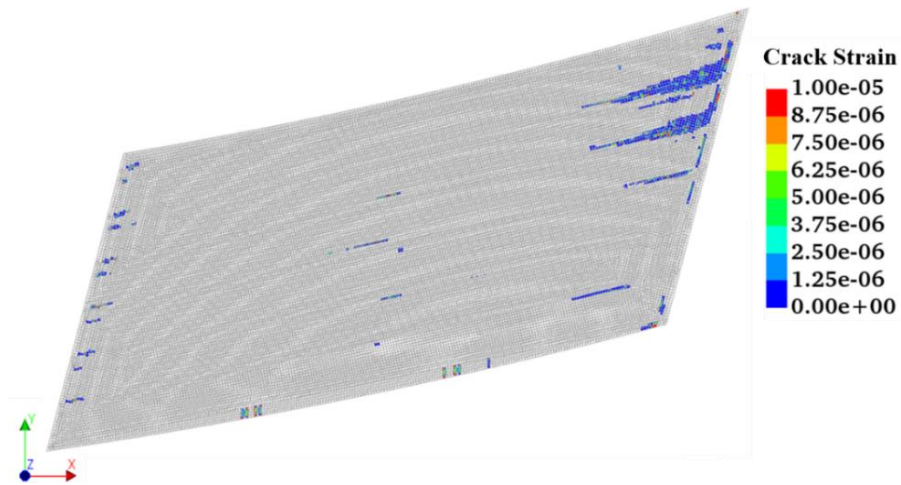
Figure 180 – Top view showing cracked elements in Highly Skewed-VR.

The maximum crack strain and maximum crack width are 4230 microstrain and 1.12×10^{-3} in. (0.28 mm), respectively. The top and bottom views of the cracked elements are shown in Figure 180 and Figure 181, respectively, and Figure 180 shows the crack strain index of 0 to 10 microstrain. Crack widths are shown in Figure 182. Figure 183 shows the orientation of the cracks.

Note: Maximum crack strain = $4230 \mu\epsilon$.

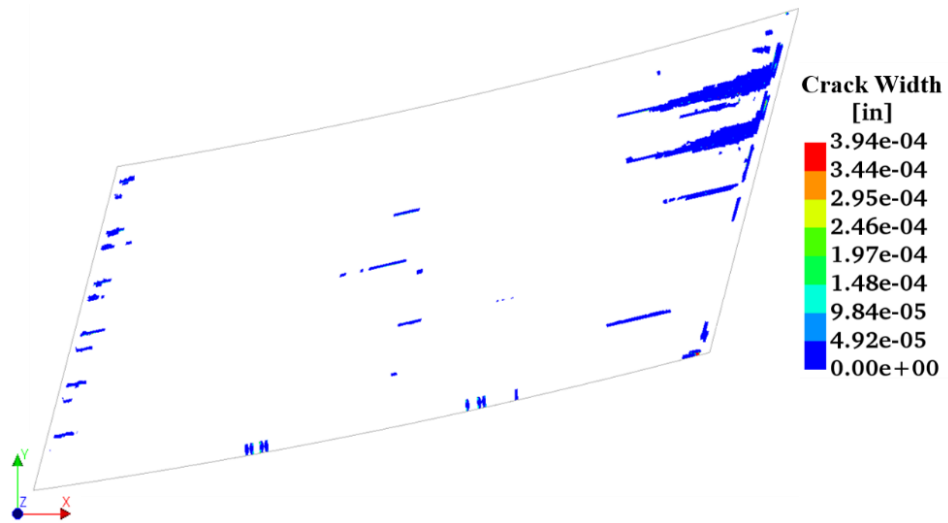
Figure 182 – Top view showing crack widths in Highly Skewed-VR.

Note: Maximum crack width = 1.12×10^{-2} in. (0.28 mm).

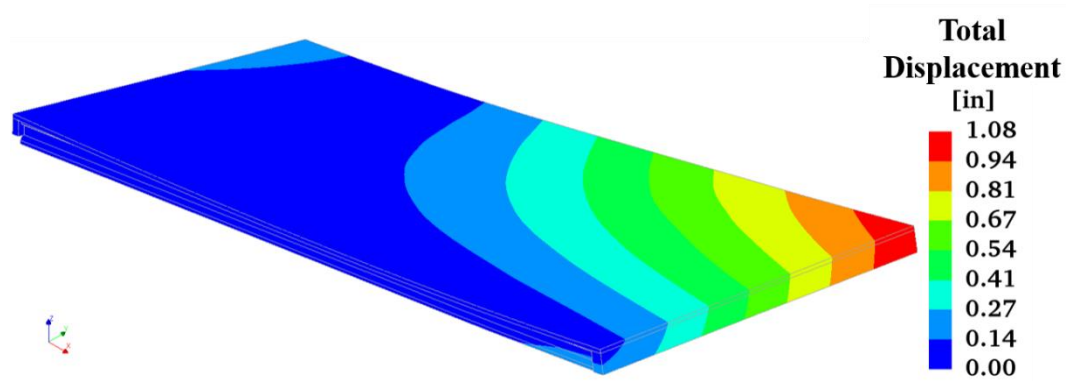
Figure 188 and Figure 189 present a displacement contour and a stress intensity diagram for the worst case, Case V4 (see Section 4.9), respectively. The results from the four displacement cases yield similar outcomes and thus are not presented here. However, when the maximum displacement is induced on the side of the acute corner with the larger skew angle, the largest displacement occurs at the acute corner. Consequently, the tensile stress peaks where the deck adjoins the girders, and its magnitude increases towards the obtuse corner as shown in Figure 189. The peak tensile stress is concentrated at a few localized locations, and thus Case V4 has an overall insignificant effect on deck cracking.

Figure 188 – Total displacement contour for Displacement Case V4.

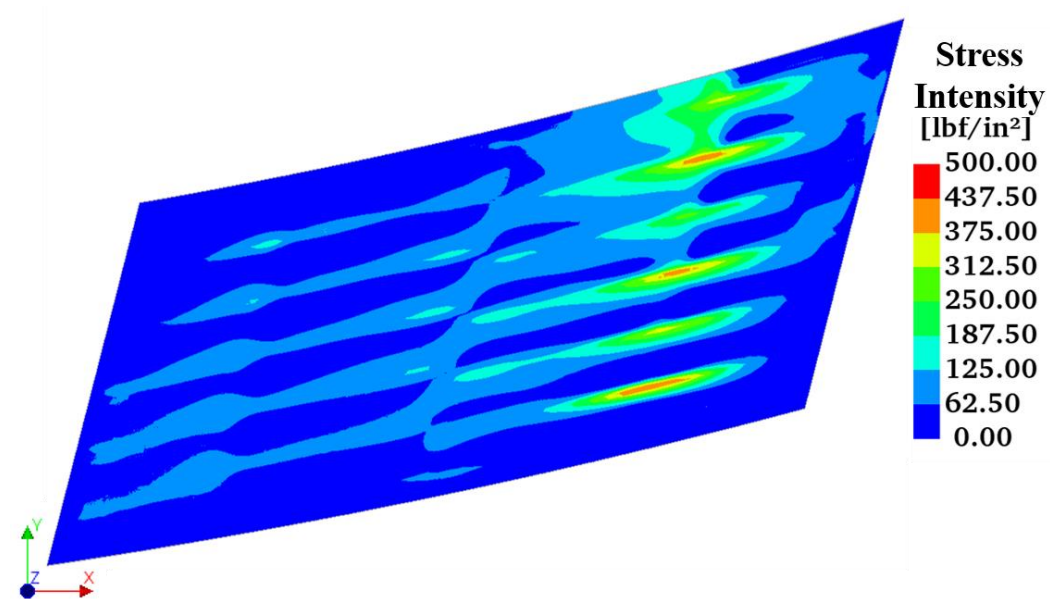
Figure 189 – Tensile stress intensity plot for Displacement Case V4.

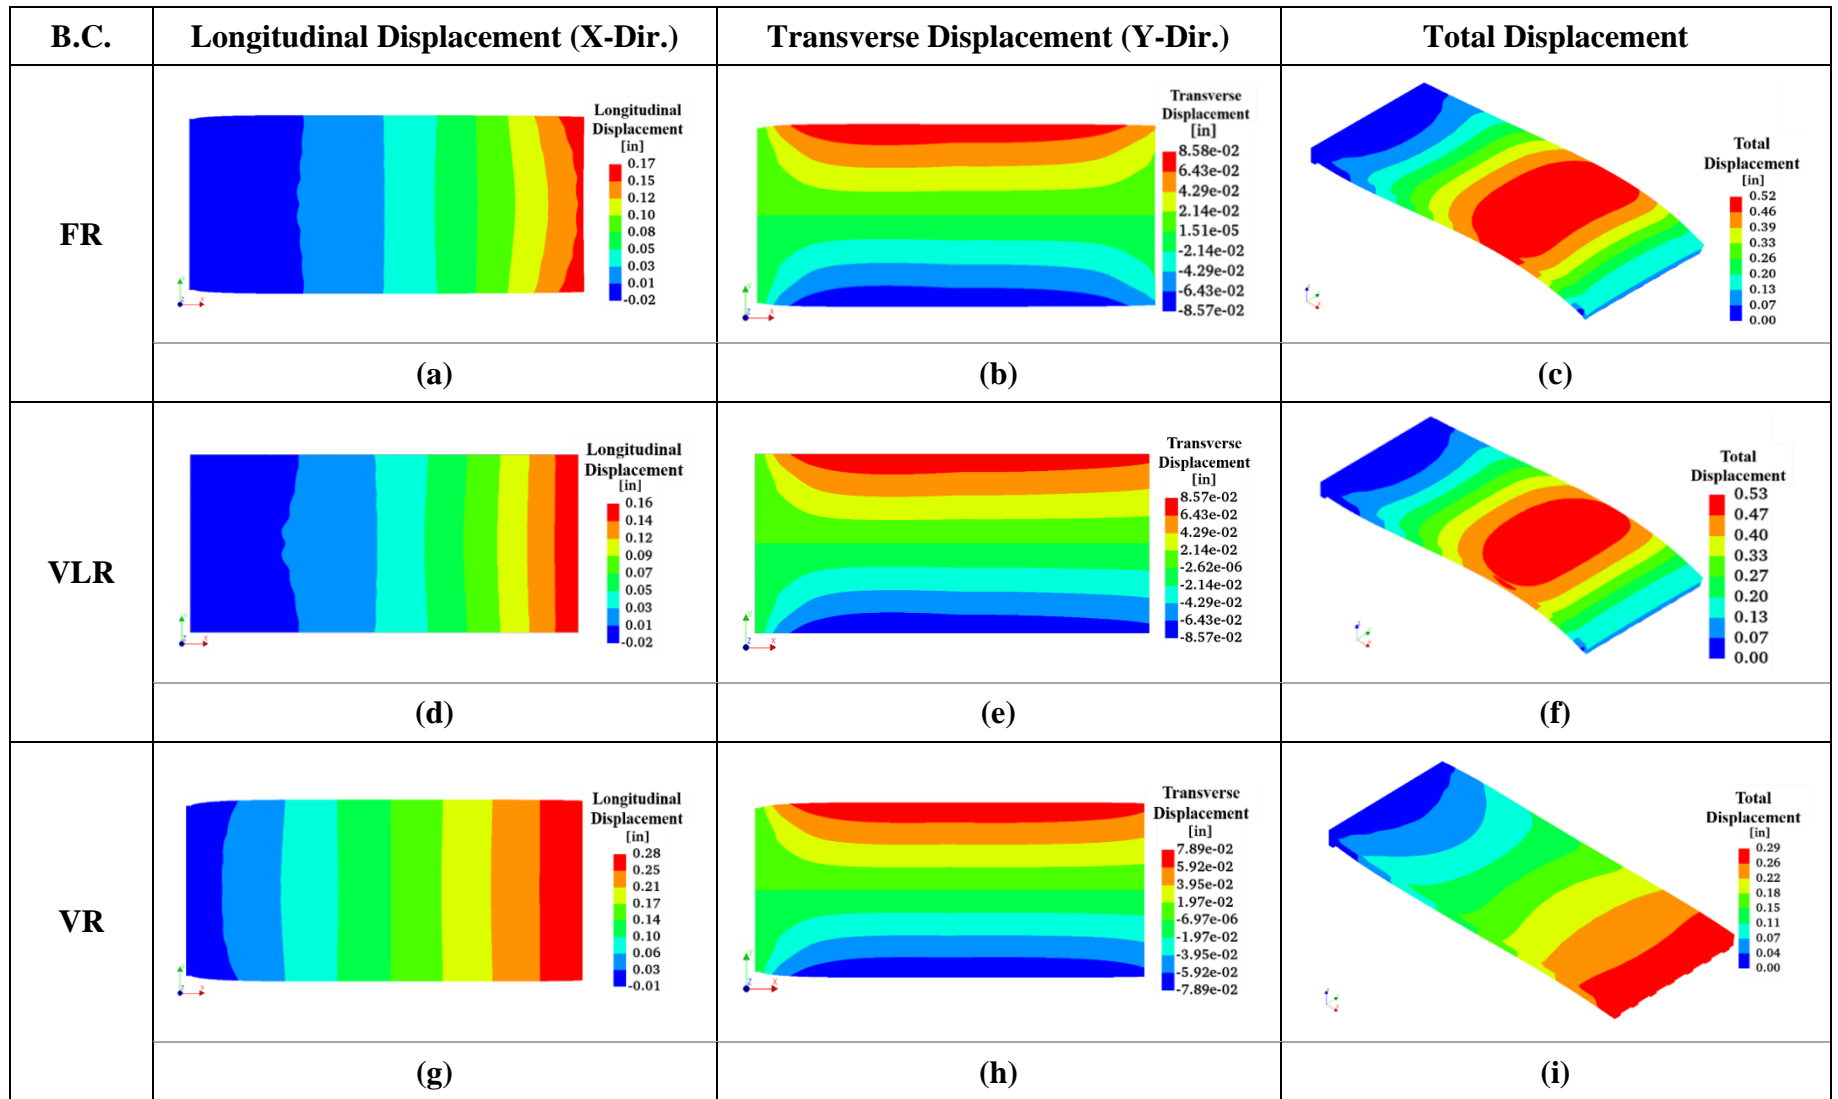
Figure 190 – Effect of restraints on displacements (Straight Deck).

Figure 190 illustrates the effect of restraints on displacements. Figure 193 shows the crack width predictions for changing boundary conditions (B.C.) and deck geometries.

- As anticipated, when the degree of restraints increases, the extent of cracking and the maximum crack width grow (see Figure 193 (a) through (c)).
- When the deck is restrained from both longitudinal and vertical movements, the total displacement, which includes the effect of cracking, is greatest (see Figure 190).
- Cracks occur at the location of restraints when girder ends at Bent 2 are restrained (see Figure 193 (a)).
- When the girder ends are vertically supported (i.e., no longitudinal and transverse restraints), as detailed in the design drawings, minor cracks (e.g., crack width less than 0.0093 in. or 0.24 mm) form at the integrated abutment ends. This is due to the integrated girder ends, which are inherent in a semi-integral abutment bridge design. These cracks are not expected to be visible to human eyes.

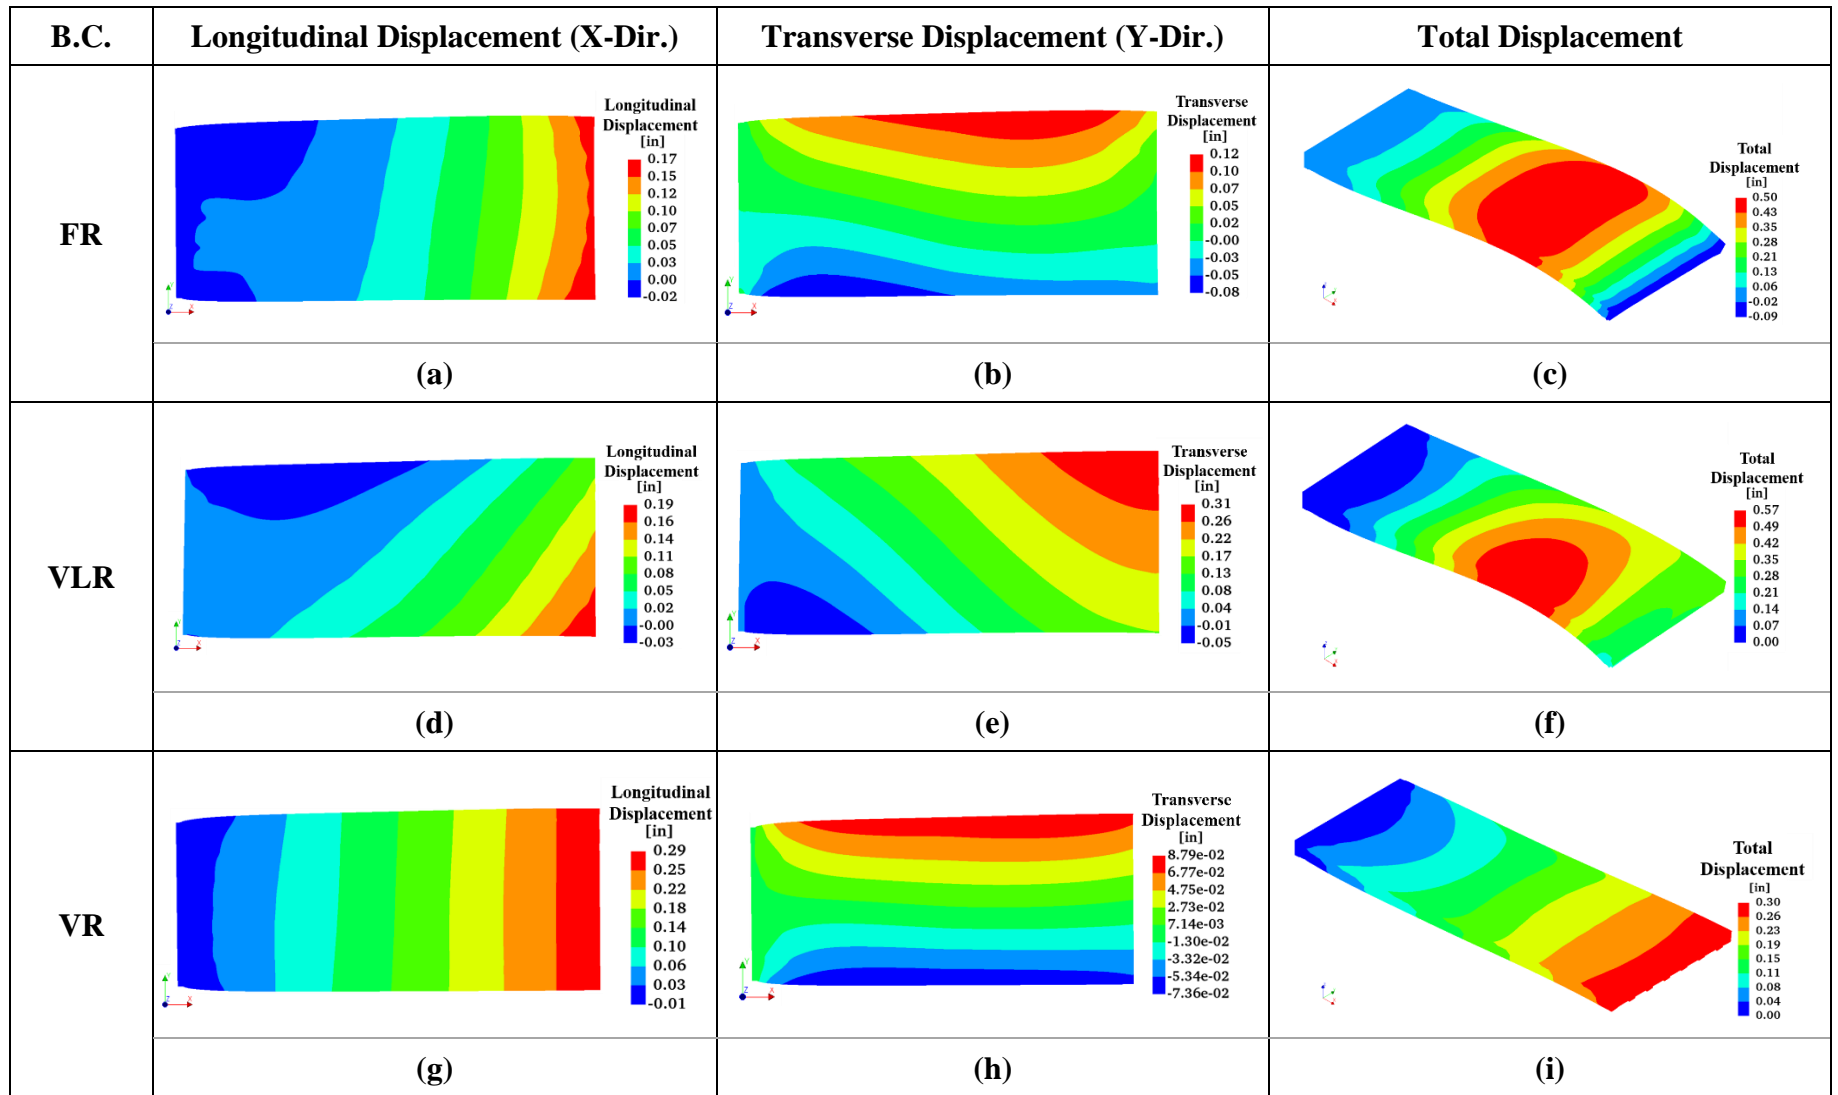
Figure 191 – Effect of restraints on displacements (Inclined Deck).

Figure 191 shows changes in displacements.

- Due to the elevation variation, the deck shows an asymmetric expansion (Figure 191 (d) through (f)) in both transverse and longitudinal directions when asymmetric boundary conditions are provided.
- When the deck is free to longitudinally expand, the largest expansion occurs at the expansion joint location (Figure 191 (g) through (i)).

- When the girder ends are asymmetrically restrained from transverse movements (see Figure 191 (f)), the inflection point, near the highest point in the deck, has the largest total deformation.
- Compared to the straight deck model, decks with an asymmetric elevation profile are more sensitive to asymmetric boundary conditions (see Figure 193 (b) and (e)).
