GEORGIA DOT RESEARCH PROJECT 17-29

FINAL REPORT

**DEVELOPMENT OF POSSIBLE SOLUTIONS TO
ELIMINATE OR REDUCE DECK CRACKING ON
SKEWED BRIDGES BUILT BY USING THE
ACCELERATED BRIDGE CONSTRUCTION METHOD**

1. Report No.: FHWA-GA-19-1729	2. Government Accession No.:	3. Recipient's Catalog No.:	
4. Title and Subtitle: Development of Possible Solutions to Eliminate or Reduce Deck Cracking on Skewed Bridges Built by Using the Accelerated Bridge Construction Method		5. Report Date: December 2019

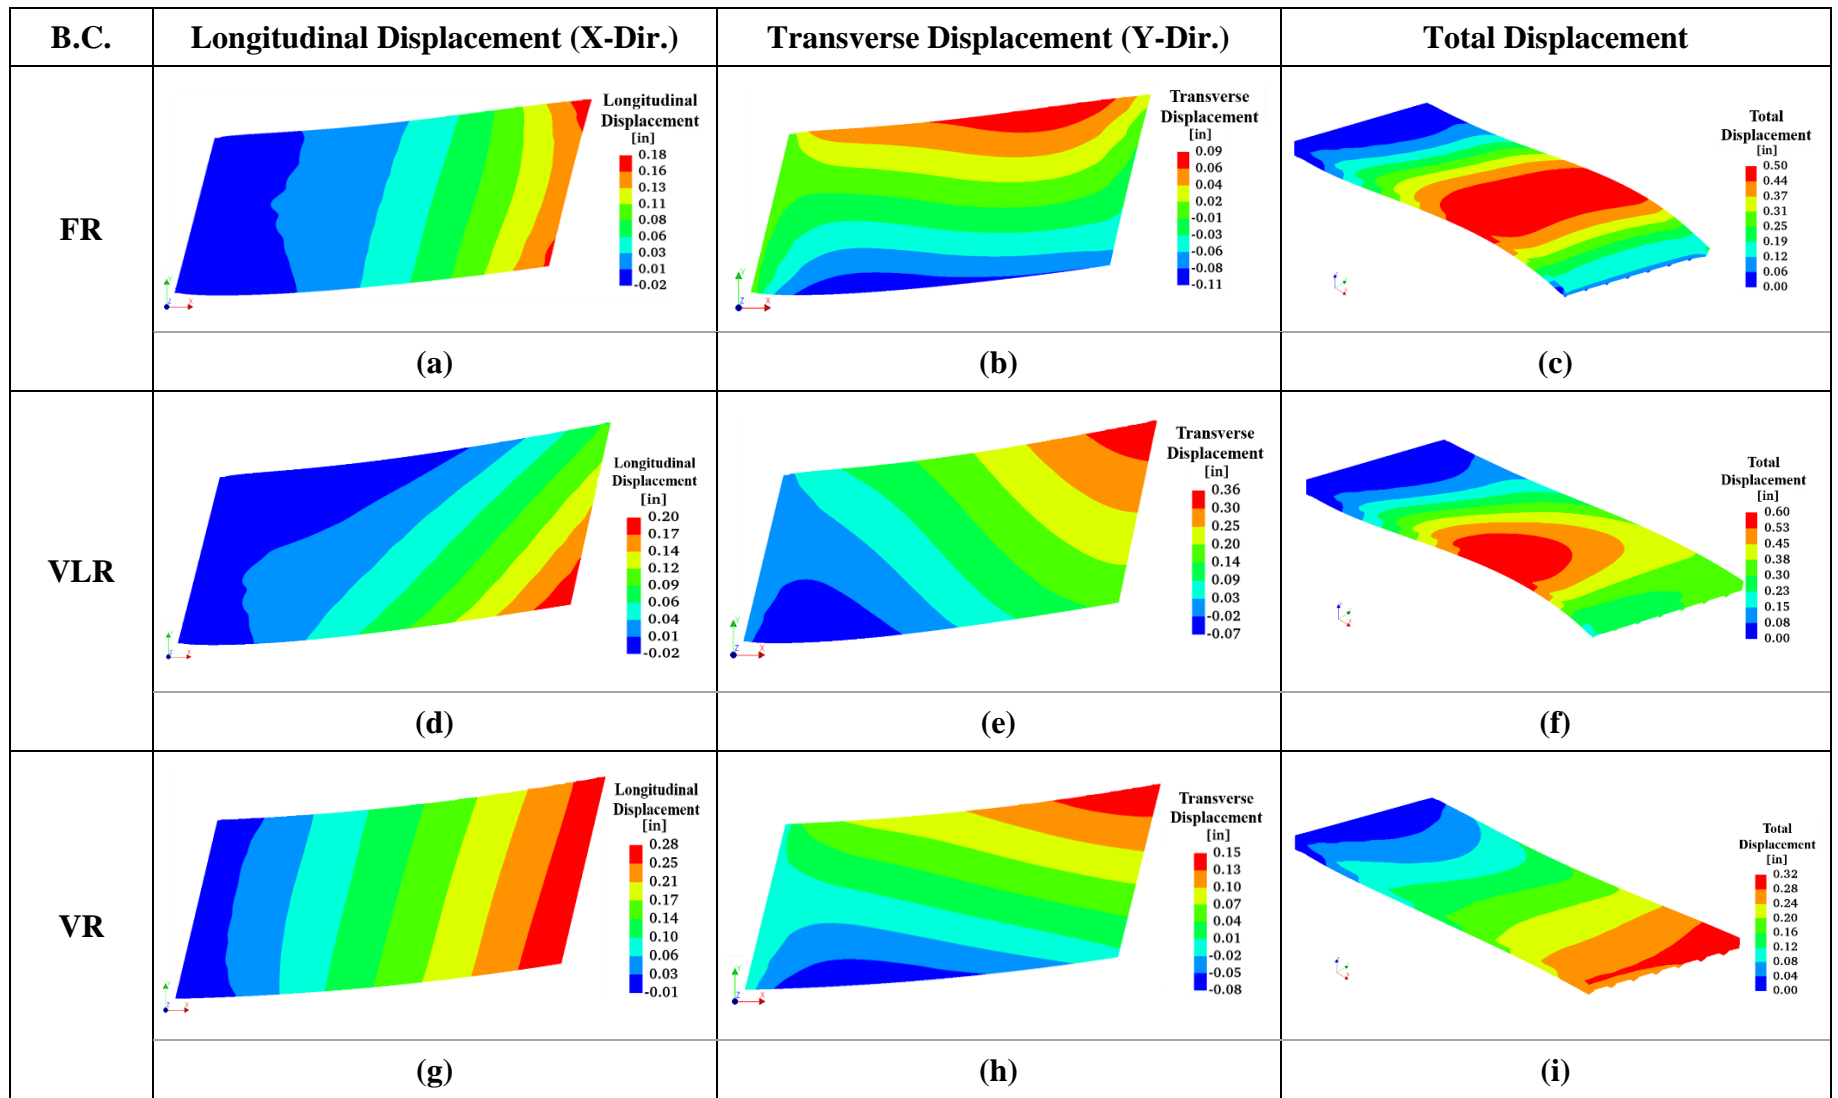
Figure 192 – Effect of restraints on displacements (Skewed & Curved Deck).

Figure 192 illustrates the effects of asymmetric geometries and associated thermal expansions on the total displacement. Figure 193 shows these effects on crack widths.

- Differential thermal expansion occurs in the acute corners at Bent 2 (see Figure 192 (a)). As predicted, the expansion mainly occurs in the longitudinal (longer) direction.

- Similar to the inclined deck, when the girder ends are not allowed to move in the longitudinal direction and are allowed to move in the transverse direction, an asymmetric expansion occurs (see Figure 192 (e)).

- In contrast to the straight deck, an asymmetric displacement contour is primarily observed in the transverse direction (see Figure 192 (b), (e) and (h) versus Figure 190 (b), (e), and (h)) regardless of the symmetry in the boundary conditions at Bent

2. This is also evident from the asymmetric total displacement contours and increased displacements at the acute corners (see Figure 192 (i)).
- With the skewed and curved deck geometry, the displacement in the transverse direction slightly exceeds the allowable 1/8 in. (3.18 mm) hole dimension in the sole plate (see Figure 192 (h)). Therefore, as-built boundary conditions at Bent 2 may approach the FR condition.

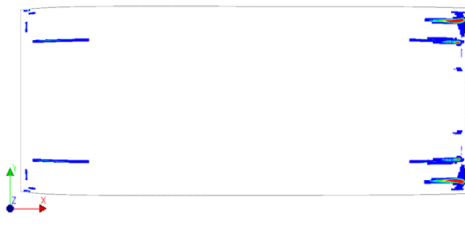
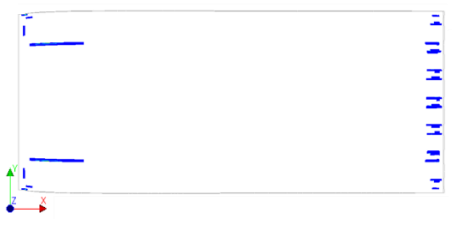
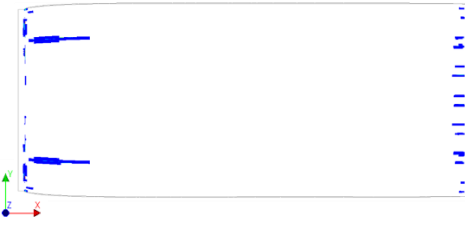
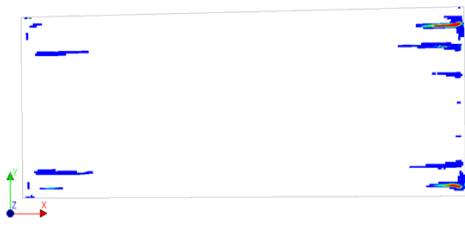
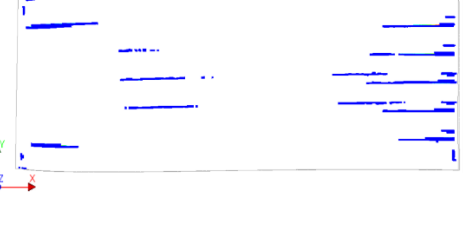
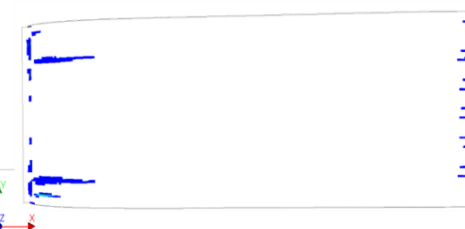
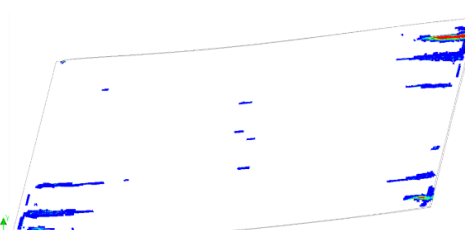
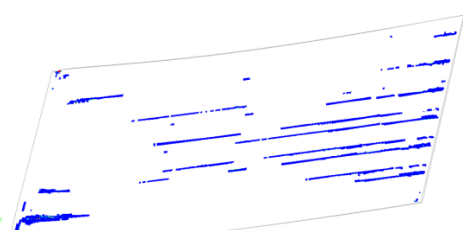
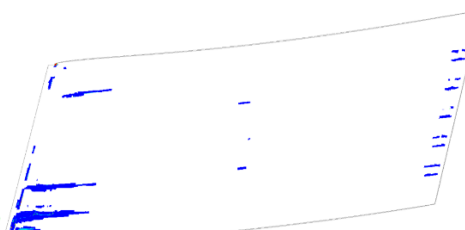
(a) MCW = 1.12×10^{-2} in. (0.28 mm)	(b) MCW = 4.18×10^{-3} in. (0.11 mm)	(c) MCW = 9.29×10^{-3} in. (0.24 mm).
Inclined

(d) MCW = 7.16×10^{-3} in. (0.18 mm)	(e) MCW = 5.38×10^{-3} in. (0.14 mm)	(f) MCW = 3.19×10^{-3} in. (0.08 mm)
Skewed & Curved

(g) MCW = 1.14×10^{-2} in. (0.29 mm)	(h) MCW = 1.30×10^{-2} in. (0.33 mm)	(i) MCW = 9.66×10^{-3} in. (0.25 mm)

Figure 193 – Effect of restraints and deck geometries on crack width.

- As anticipated, when the degree of restraints increases, the extent of cracking and the maximum crack width grow (see Figure 193 (a) through (c)).
- When the deck is restrained from both longitudinal and vertical movements, the total displacement, which includes the effect of cracking, is greatest (see Figure 190).
- Cracks occur at the location of restraints when girder ends at Bent 2 are restrained (see Figure 193 (a)).
- When the girder ends are vertically supported (i.e., no longitudinal and transverse restraints), as detailed in the design drawings, minor cracks (e.g., crack width less than 0.0093 in. or 0.24 mm) form at the integrated abutment ends. This is due to the integrated girder ends, which are inherent in a semi-integral abutment bridge design. These cracks are not expected to be visible to human eyes.

- In curved bridges, longitudinal cracks are observed mid-length of the span.
- Diagonal cracks are predicted at the corners of the skewed and curved deck models regardless of the boundary conditions. These cracks are expected to occur at the abutment end on the side that is restrained from movement (see Figure 193 (g) through (i)). Although they are small in width (< 0.013 in. or 0.33 mm), these cracks could widen over the service life.

- When such asymmetric thermal expansions are fully restrained, thermal cracks form in both corners at the Bent 2 location (see Figure 193 (g)).
 - When girder ends are not allowed to expand in the longitudinal direction, cracks form throughout the deck surface, primarily due to the increased asymmetric expansion in the transverse direction (see Figure 195).

- When girder ends are free to expand (see Figure 196), cracks mainly form (see Figure 193 (i)) at the corner on the abutment side.

Thus, in a semi-integral abutment bridge, acute corners are vulnerable to thermal cracking due to a specific design feature—the integrated girder ends. These cracks may be mitigated by providing additional reinforcement. Meanwhile, the girder ends at the expansion joint location should be detailed to allow for increased thermal expansion from the deliberately restrained conditions at the abutment ends.

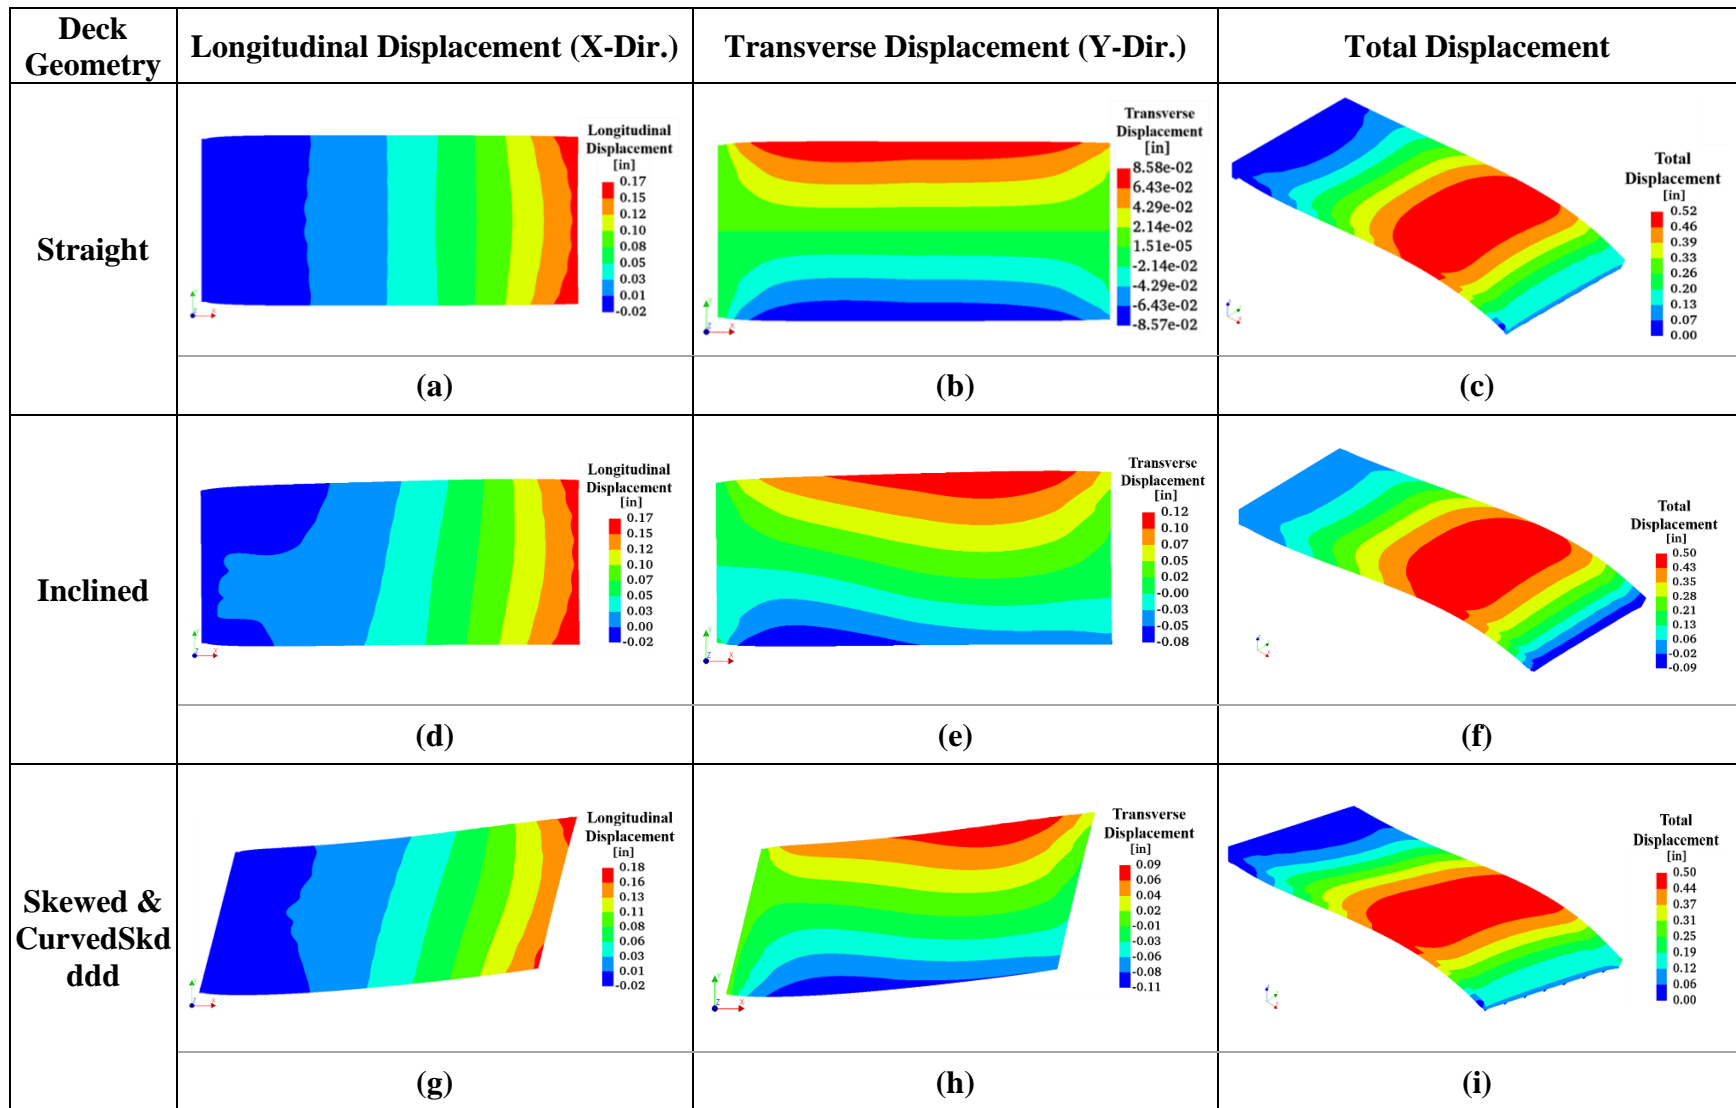
Figure 194 – Effect of deck geometries on displacements (movements fully restrained).

- In reviewing the effect of deck geometry in the FR conditions (see Figure 194) on deck deformation, asymmetric expansions consistent with deck geometry are predicted.

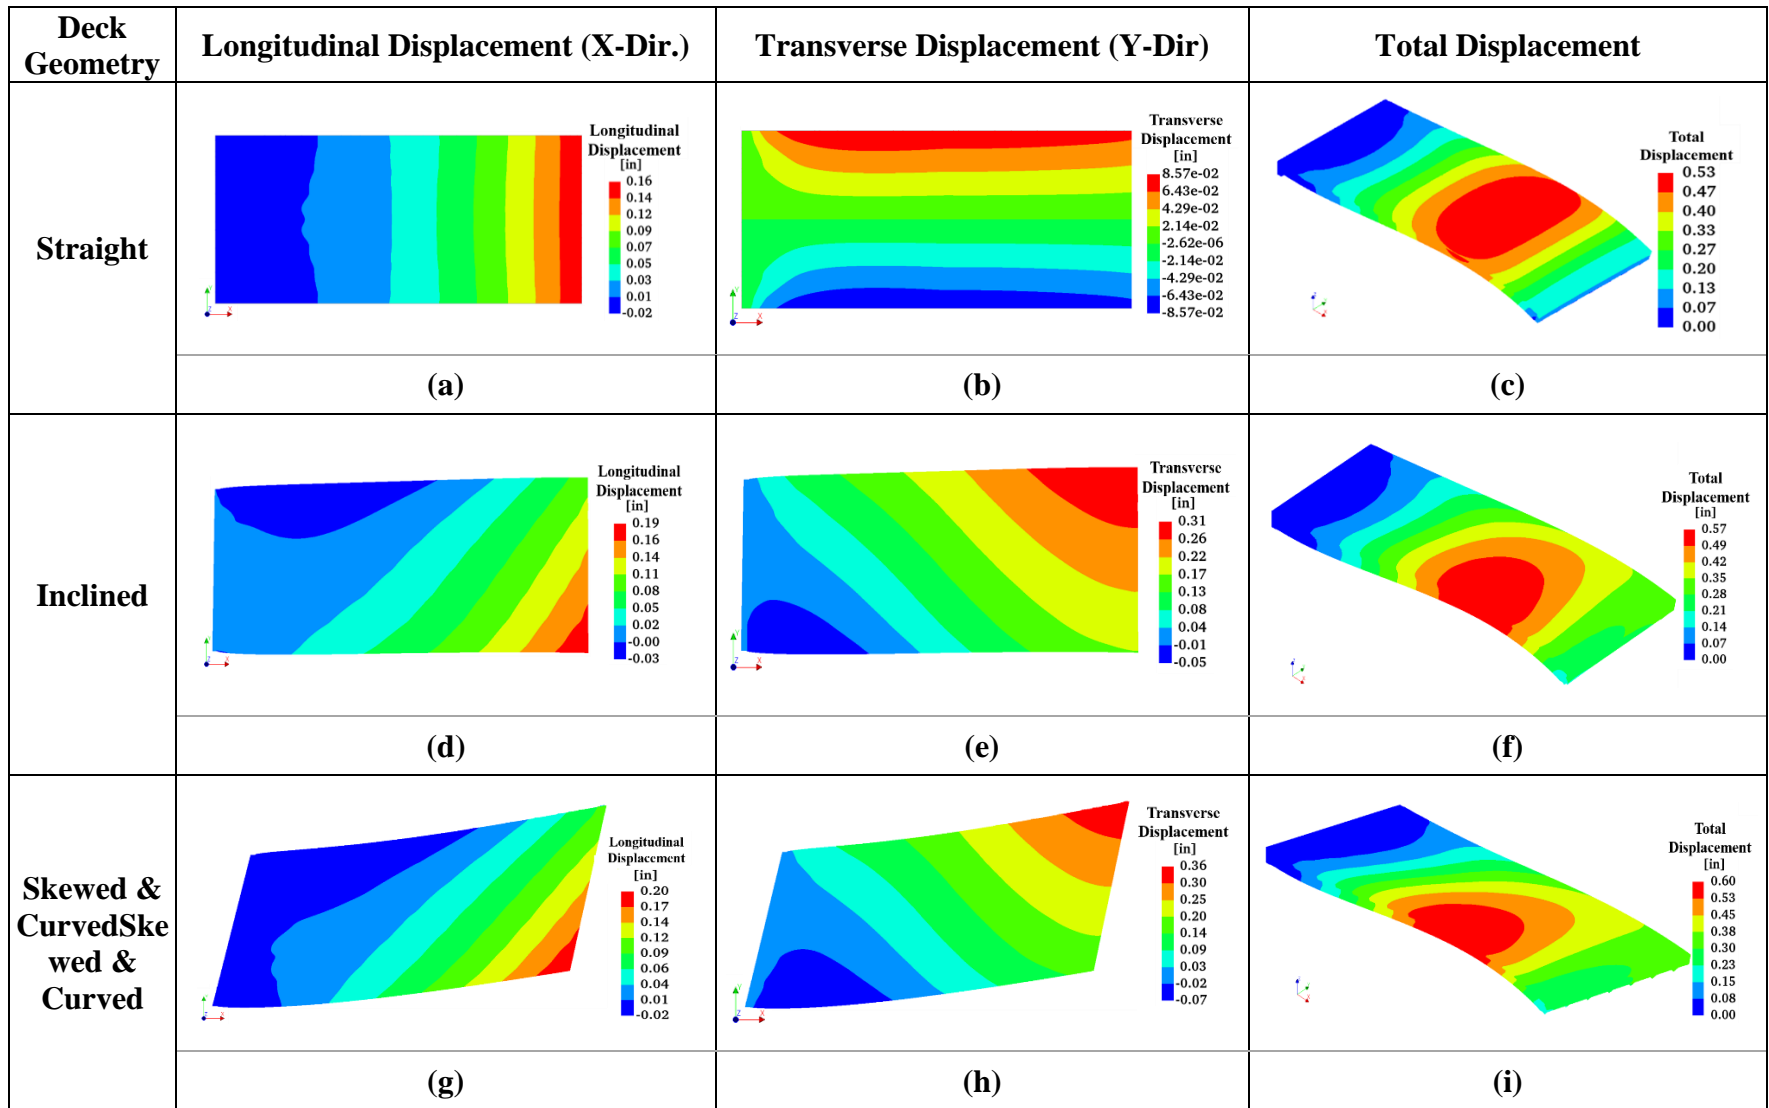
Figure 195 – Effect of deck geometries on displacements (longitudinal and vertical movements restrained).

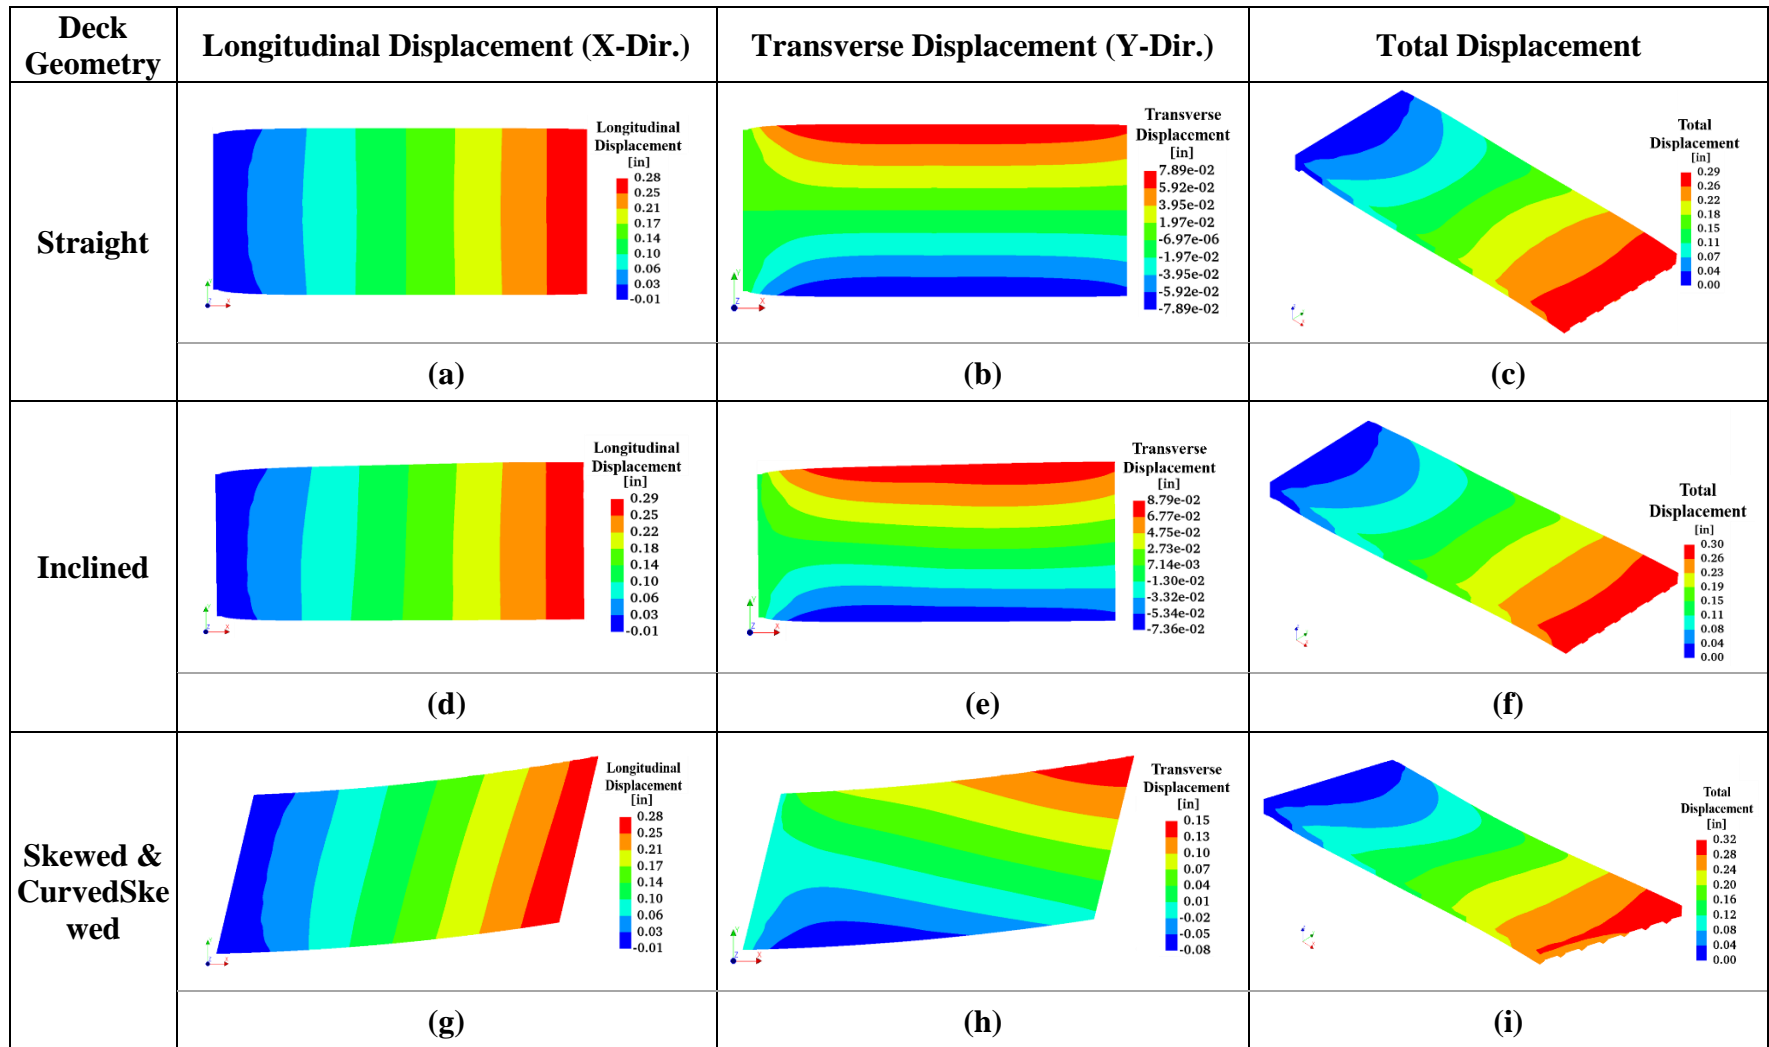
Figure 196 – Effect of deck geometries on displacements (vertical movements restrained).

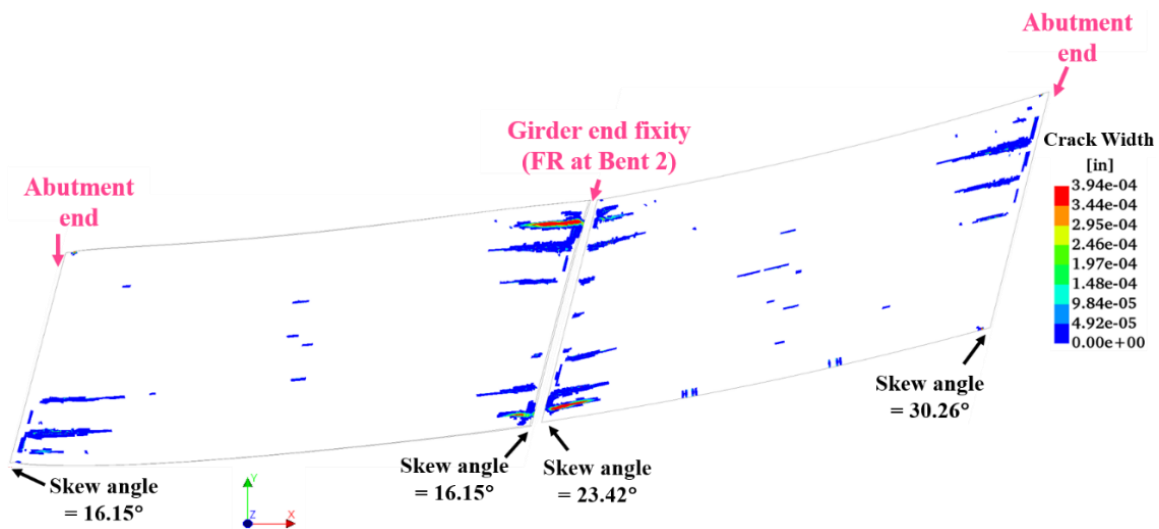
Figure 197 – Predicted cracks in Spans 1 and 2.

- The results from Span 2 are consistent with those from Span 1. The cracks primarily occur at the acute corners (see Figure 197).
- With the LVR case, longitudinal expansion is largest in the obtuse corners at Bent 2 (See Figure 198 (c) and (d)).

- The extent of cracking is greater in Span 2 due to the increased skew angle in the deck geometry.

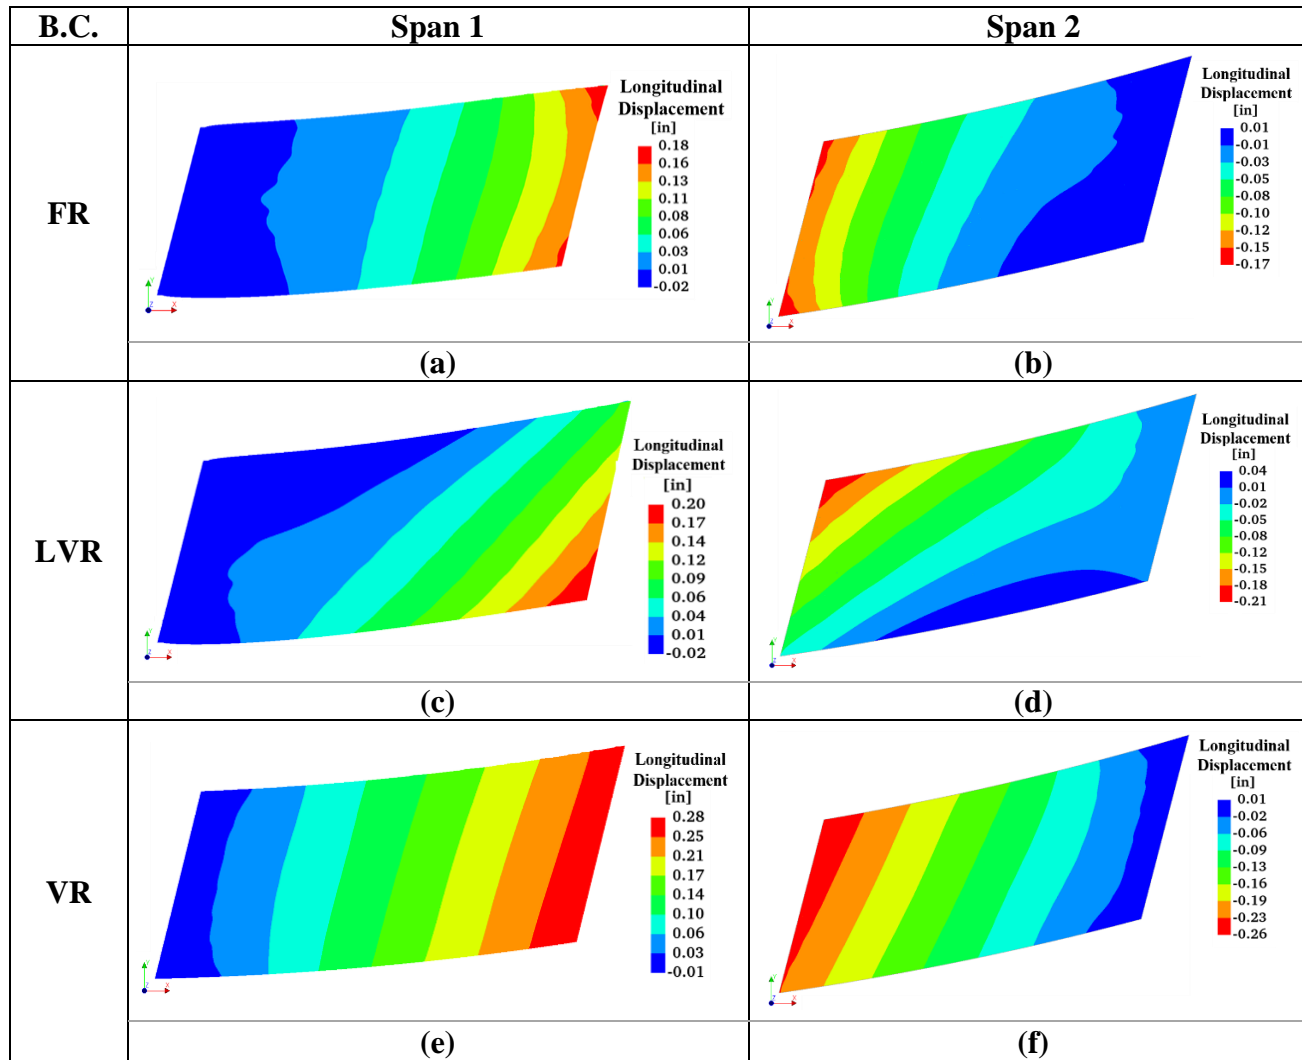
Figure 198 – Comparison of longitudinal displacements between Spans 1 and 2.

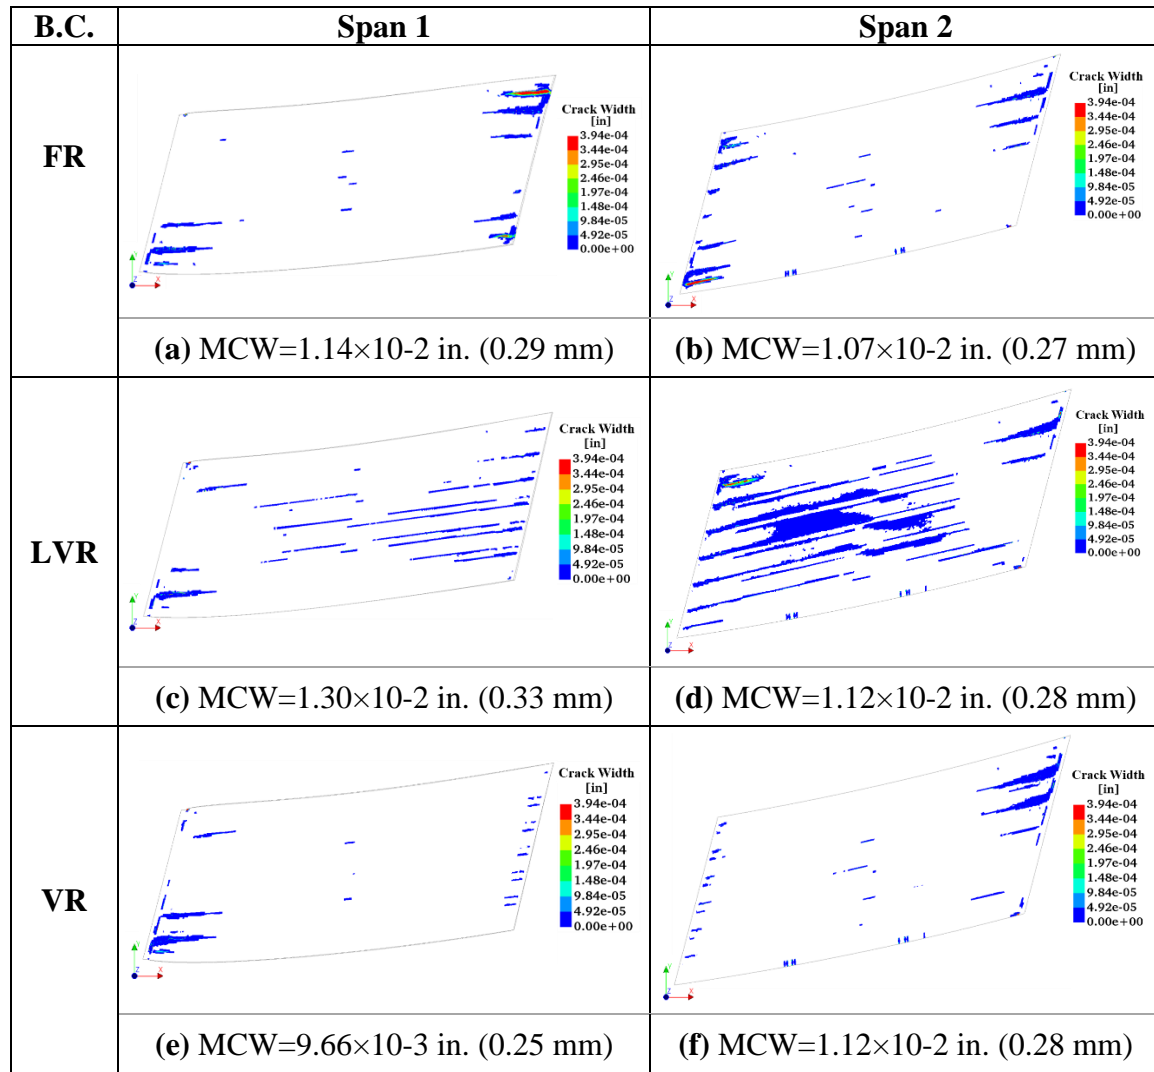
Figure 201 – Comparison of crack widths between Spans 1 and 2.

- Regardless of the boundary conditions at Bent 2, the acute corners on the abutment ends are susceptible to thermal cracking (see Figure 201 (e) and (f)).

- When the girder ends at Bent 2 are free to expand, cracks form on the abutment ends (see Figure 201 (e) and (f)).
- When the girder ends are only allowed to expand in the transverse direction, expansion in the transverse direction increases (Figure 200 (c) and (d)); thus, cracks form throughout the deck area (see Figure 201 (c) and (d)).

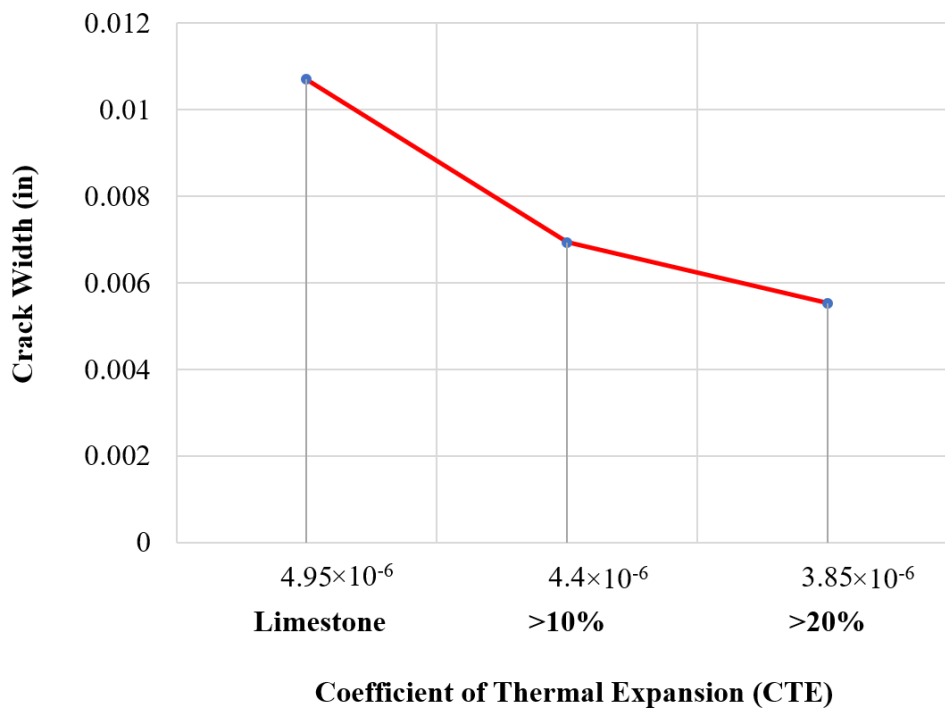
Figure 202 – Sensitivity of Crack width for reduced CTE

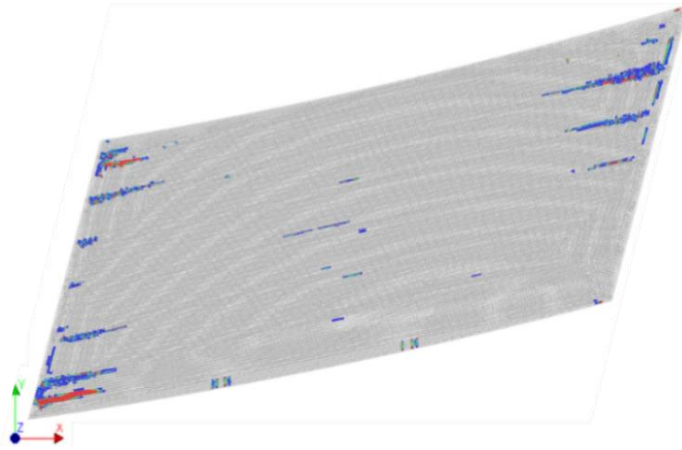
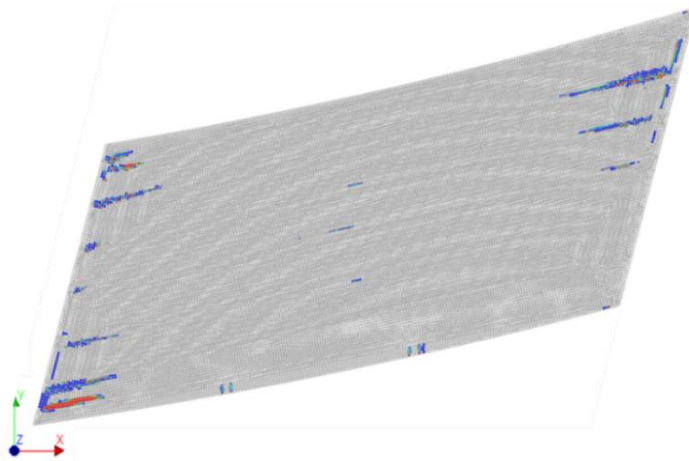
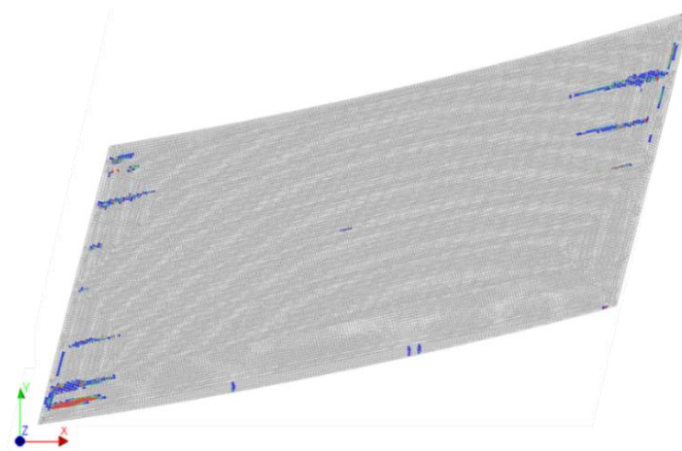
In this study, the coefficient of thermal expansion (CTE) value for normal concrete (5.5×10^{-6} in/in/°F or 1.0×10^{-5} cm/cm/°C) is reduced by about 8-10% to account for the limestone aggregate used in the concrete mixture (see Figure 203 (a) for the analysis results). This section considers additional reductions (10% and 20%) in CTE and presents the resulting crack widths. Figure 202 provides a summary of the findings. Figure 203 shows the crack width plots for varying CTE.

Figure 203 – Crack plots showing the effect of reduced CTE.

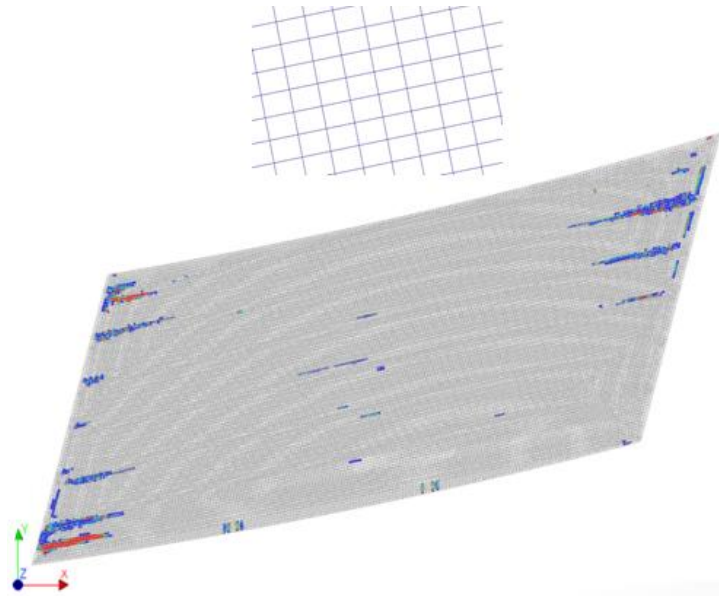
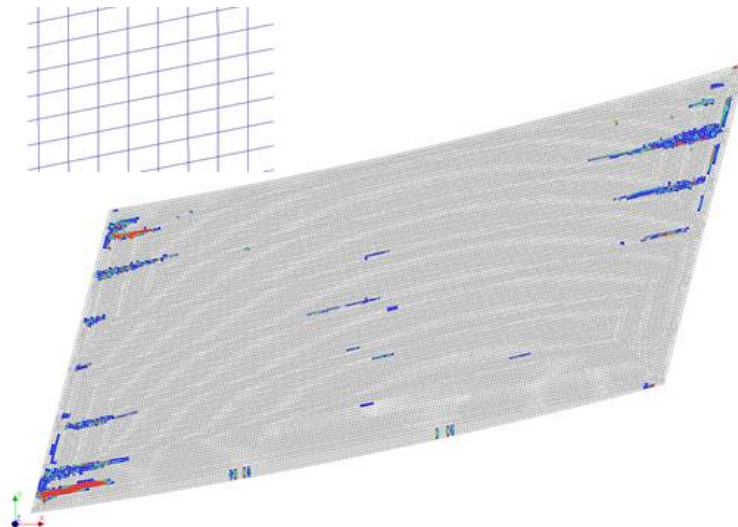
In Figure 205, the analysis results indicate there is a slight reduction in the crack width (0.018 in. or 0.46 mm), which is an insignificant change.

(a) Radial Transverse Reinforcement.
maximum crack strain = 7990 $\mu\epsilon$
maximum crack width = 1.07×10^{-2} in. (0.27 mm)

(b) Radial Transverse Reinforcement.
maximum crack strain = 6620 $\mu\epsilon$ (< 17%)
maximum crack width = 1.05×10^{-2} in. (~ 0.27 mm) (< 2%)

Figure 205 – Crack width plots showing the effect of reinforcement pattern.

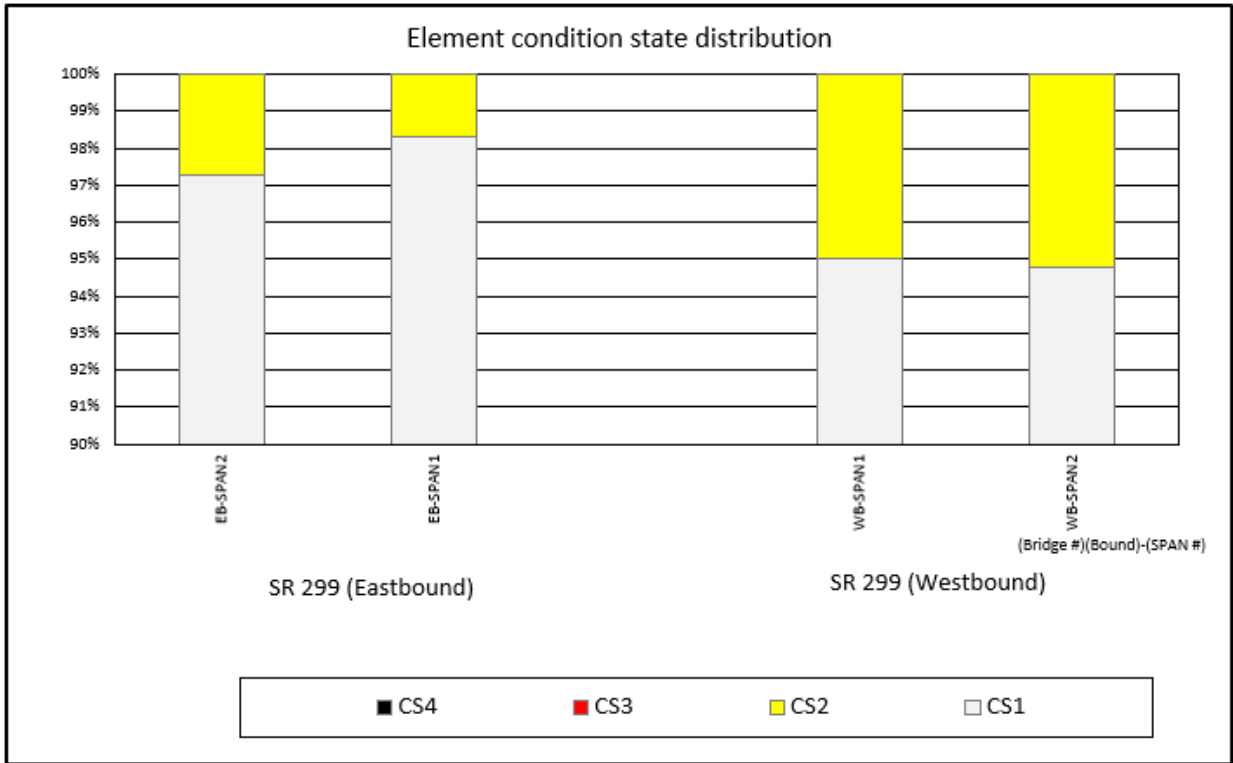
Figure 8c: Condition state distribution for each span

Favorable weather conditions and a smooth scan resulted in a successful analysis of the bridge. All data collected—raw infrared, processed infrared, and visual—were compared closely side-by-side to eliminate false positives. The AASHTO Manual for Bridge Element Inspection, First Edition (AASHTO, 2013) provides a guideline for condition state definition of bridge elements based on the severity of delamination, spalling, exposed rebar, and cracking conditions. The distribution and location of the AASHTO-categorized deficiencies for each bridge was also prepared in the form of a plan-view map, where the deficiencies were highlighted and super-imposed onto an image of the bridge deck. Percentage of deck areas for each condition state was also summarized for each span of the bridge and graphically displayed as shown in Figure 8. This information can be used by bridge owners as a general assessment, and can help to prioritize future repair/rehabilitation programs by identifying deficient areas in their early stages.

Span Number	Element Description	Unit of Measure	Total Quantity	Condition State 1	Condition State 2	Condition State 3	Condition State 4
2	Reinforced Concrete Deck	ft ² (%)	4,338 (100%)	4,242 (97.791%)	95.84 (2.209%)	0 (0.000%)	0 (0%)

Span Number	Element Description	Unit of Measure	Total Quantity	Condition State 1	Condition State 2	Condition State 3	Condition State 4
2	Reinforced Concrete Deck	ft ² (%)	4,255 (100%)	4,037 (94.898%)	217.05 (5.102%)	0 (0.000%)	0 (0%)

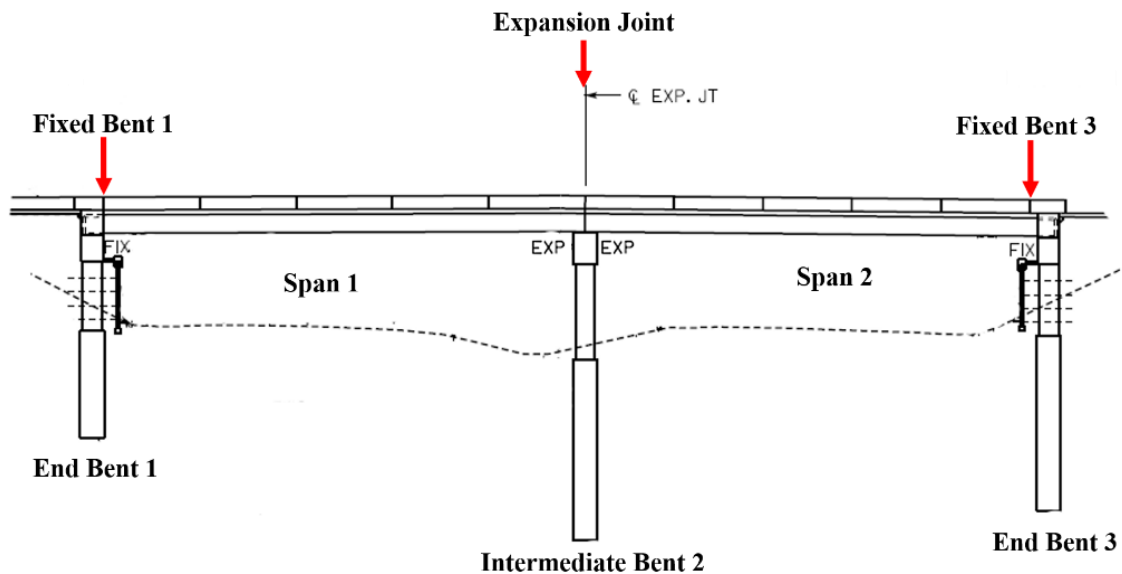
Figure B-1: Elevation view of the SR299 bridge showing the fixity conditions.

- Fixity conditions and associated bearing/sole plate details. In case of the SR299 bridge, the (side) elevation view shows FIX-EXP and EXP-FIX conditions.
