Experimental and Analytical Evaluation of Residual Capacity of Corrosion-Damaged Prestressed Concrete Bridge Girders

Via Department of Civil and Environmental Engineering
Virginia Tech

Final Report VTRC 21-R6

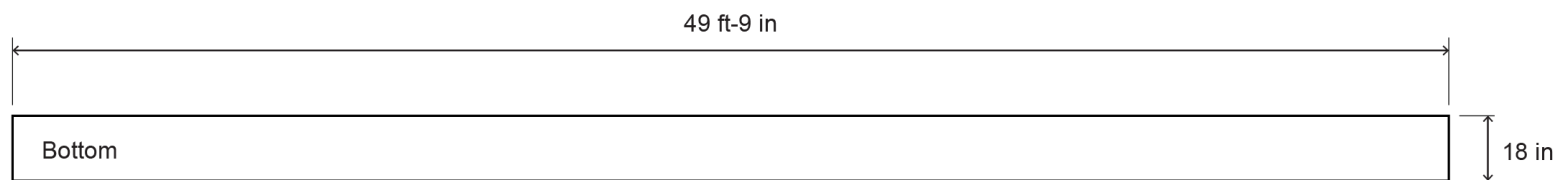
Figure 25. I-Beam 7 – Good Condition

For the rating system devised, a high score indicated good condition, while a low score indicated bad condition. Based on the results presented, I-Beams 3, 6 and 7 were chosen from the Lesner Bridge. I-Beam 7 was chosen since it had the best score and would represent the baseline, undamaged state (good). I-Beam 3 was chosen since it had the worst score and would represent a severely damaged beam (bad). Finally, I-Beam 6 was chosen as an average score, representing a moderately damaged beam (medium). Of the six Aden Road box beams available, three were selected for testing. The Aden Road Bridge beams were not as accessible for inspection as the Lesner I-beams. The three beams that were most easily accessed in the storage yard were retrieved and moved into the lab. The conditions of these beams were examined once they were brought inside the testing facility. Damage maps of the six selected beams selected for study testing in this study are shown in Figures 25 through 30.

In Figures 25 through 30, each figure presents three sides of the beams. The top sketch is one side, oriented right-side-up, the middle sketch is the bottom of the beam, and the bottom sketch is the other side of the beam, oriented up-side-down. This allows the reader to see how side damage and bottom face damage are related to each other spatially.

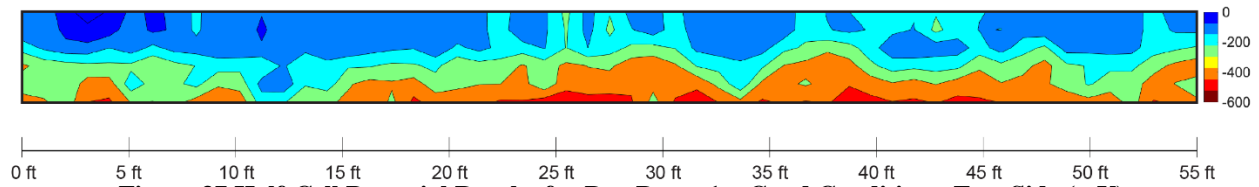
Figure 37 Half-Cell Potential Results for Box Beam 1 – Good Condition - East Side (mV)

All of the Aden Road box beams showed high potential for corrosion along the bottom edge of the beams. These results for the box beams are in agreement with the visual inspection, which indicated considerable spalling, delamination and exposed, corroded strands.

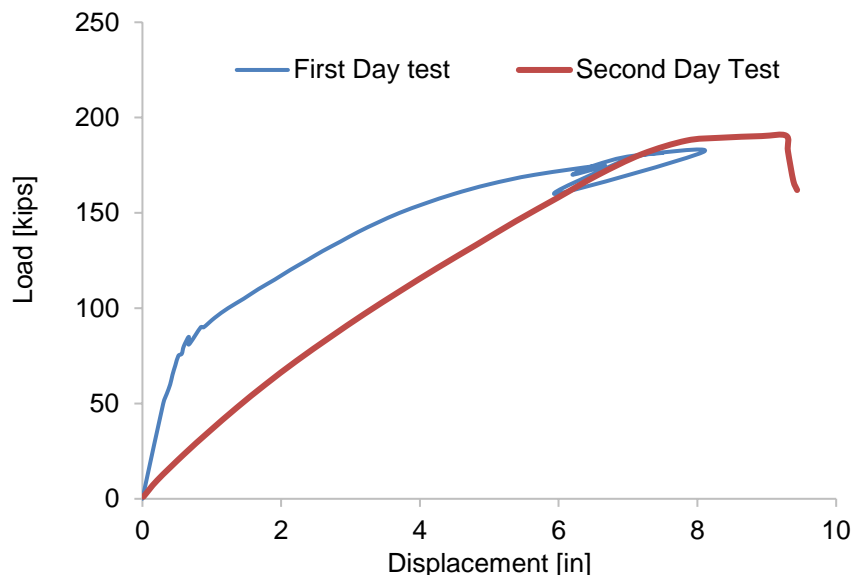
Figure 45. Load Versus Displacement on First and Second Day of Testing I-Beam 7

The load-deflection plot is shown in Figure 45 for first day and second day. For the first day test, a slight change in the slope of the line can be seen at around 80 kips, confirming the

first cracking load determined visually. For the second day test, at around 190 kips the load-deflection curve begins to plateau, indicating the strands were yielding.

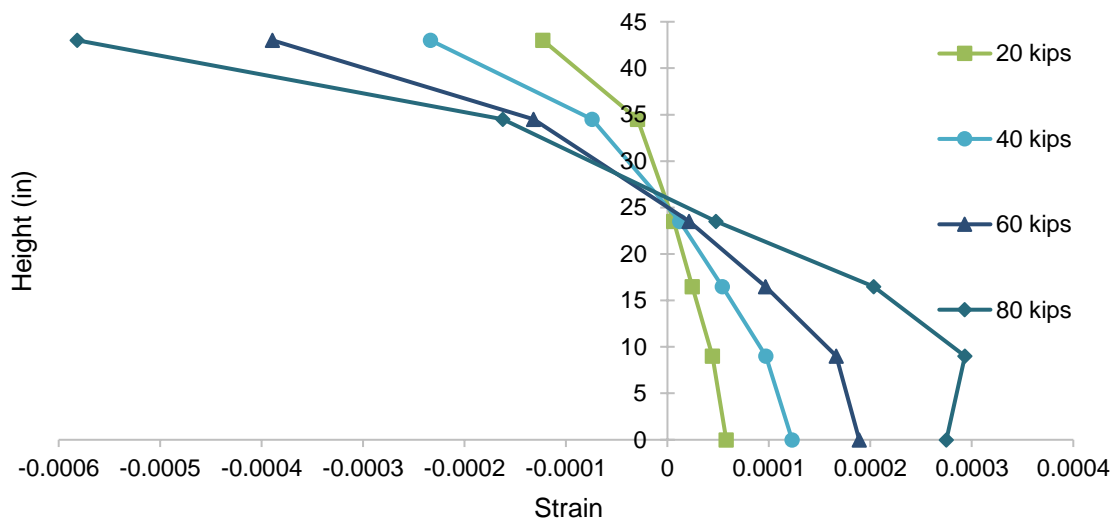
Figure 46. Strain Versus Height for I-Beam 7

Figure 46 shows a plot of longitudinal strain versus distance from the bottom of the beam measured by the gages at mid-span of the beam. Several load steps are presented in the figure. The neutral axis determined from the strains measured just before the cracking load is 26 in from the bottom of the beam. The neutral axis based on calculation, including all the strands and the concrete modulus obtained from the compressive strength test, was 28.8 in, which was 10% higher than the measured neutral axis. The strain distributions were relatively linear, except for the upper most and lower most gages. However, the highest strain reading was on the side of the slab, and for unknown reasons, was larger than expected based on calculations. The strains on the bottom flange were smaller than expected, possibly due to the damage to the concrete on the bottom.

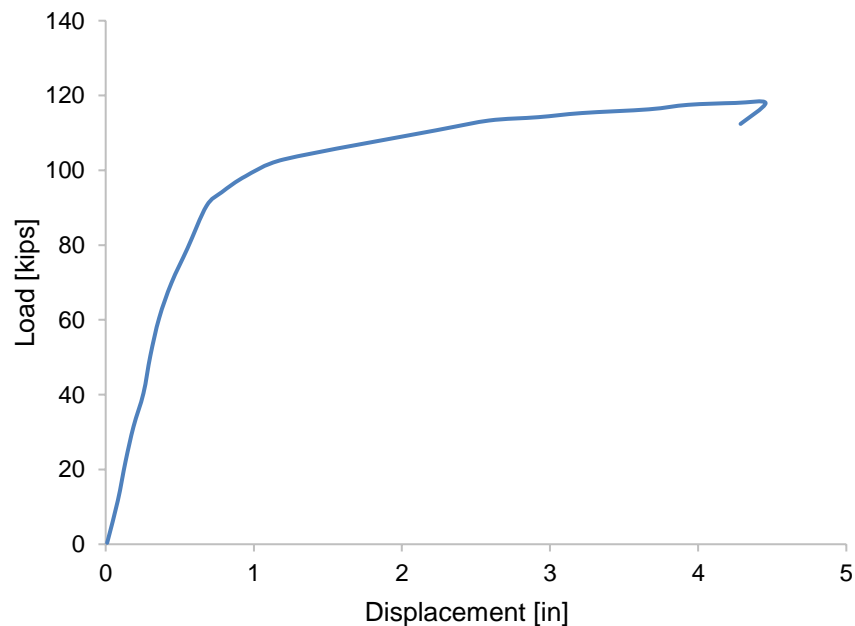
Figure 48. Load Versus Displacement Plot for I-Beam 6

I-Beam 6 failed at an applied load of 118 kips and a deflection of 4.46 in, due to crushing of the top flange. The load versus deflection plot is shown in Figure 48. The first crack was visually observed at 50 kips; however, there was no noticeable change in the slope of the load displacement plot at that load.

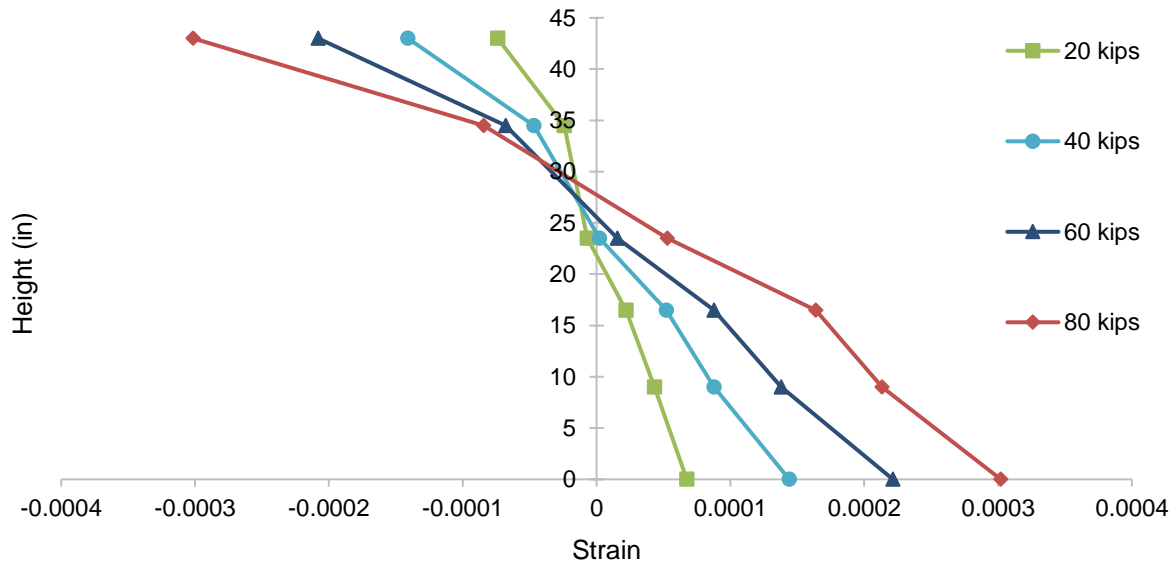
Figure 49. Strain Versus Height for I-Beam 6

Figure 49 is a plot of longitudinal strain at mid-span versus distance from the bottom of the beam for several different load steps. The figure indicates that the measured neutral axis prior to cracking was 24 in, while the calculated neutral axis was 26 in, based on the remaining cross-sectional area of the strands and the tested concrete compressive strength. The difference of the neutral axis location was about 8%. As with the strains measured for I-Beam 7, the gage on the top slab had strain readings that were higher than expected.

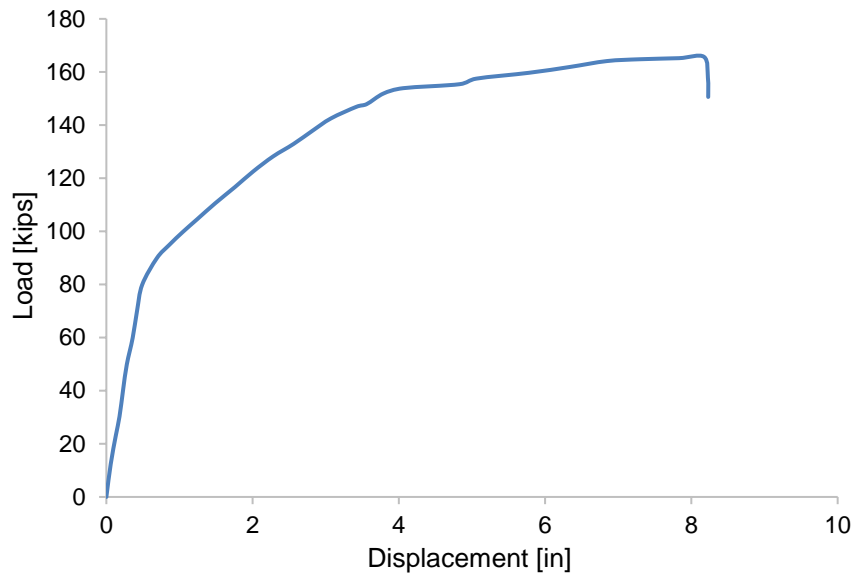
Figure 53. Load Versus Displacement Plot for I-Beam 3

The first flexural crack of the I-beam in “bad condition”, I-Beam 3, was observed at a load of 80 kips. For reasons of safety, the beam was no longer closely inspected between load intervals after an applied load of 125 kips. The load deflection plot is presented in Figure 53. Based on strain measurements through the depth of the beam, the neutral axis, just before the cracking load, was 26 in from the bottom of the beam (see Figure 54), which is comparable to the calculated neutral axis of 26.7 in, which was based on the cross-sectional area of the remaining strands and the concrete compressive strength from testing. The beam ultimately failed due to crushing of the top flange (see Figure 55), with an applied load of 166 kips and a deflection of 8.19 in.

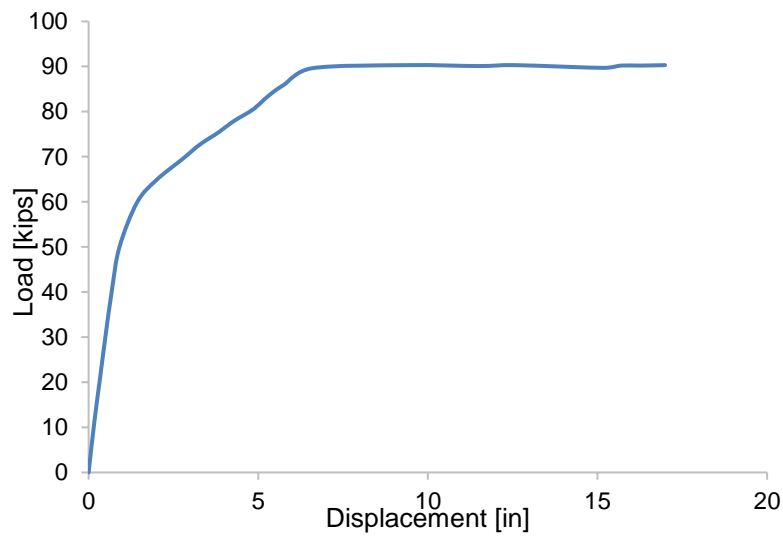
Figure 58. Load Versus Displacement Plot for Box Beam 1

First cracking was observed at a load of 50 kips. After cracking, the researchers applied additional load in 5-kip increments up to 70 kips, after which, the beam was no longer closely inspected, out of concern for safety. Also, after 70 kips, displacement control was used with 0.25-in increments. The test was terminated at 90.3 kips, when the deflection reached 16.99 in without any increase in load. This can be seen in the load versus deflection plot in Figure 58. The large deflection at the ultimate load can be seen in Figure 59.

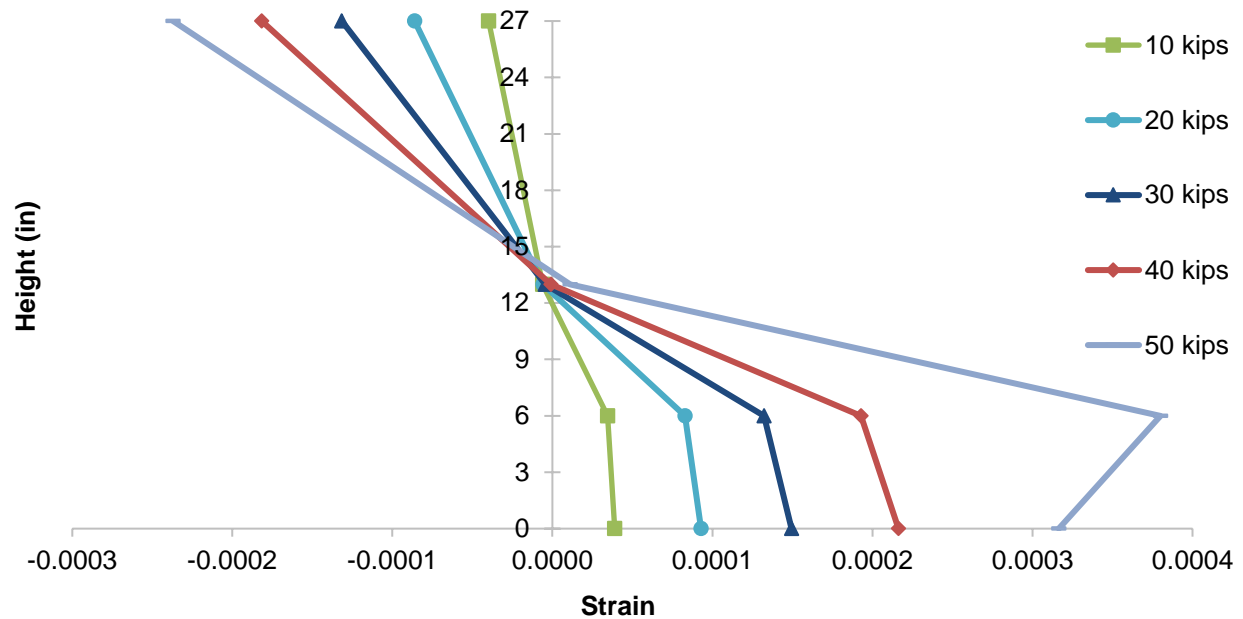
Figure 60. Strain Versus Height for Box Beam 1

Based on the mid-span strain measurements through the depth of the beam and just before the cracking load, the neutral axis was 13.5 in from the bottom of the beam (see Figure 60). The neutral axis based on calculation was also 13.5, identical to the neutral axis determined from measurements. A slight change in the location of the neutral axis can be seen at the 50 kip load increment, which corresponds to the load at which cracking was observed. Again, the measurements from the strain gages became erratic shortly after first cracking. Thus, Figure 60 only contains data up to that point.

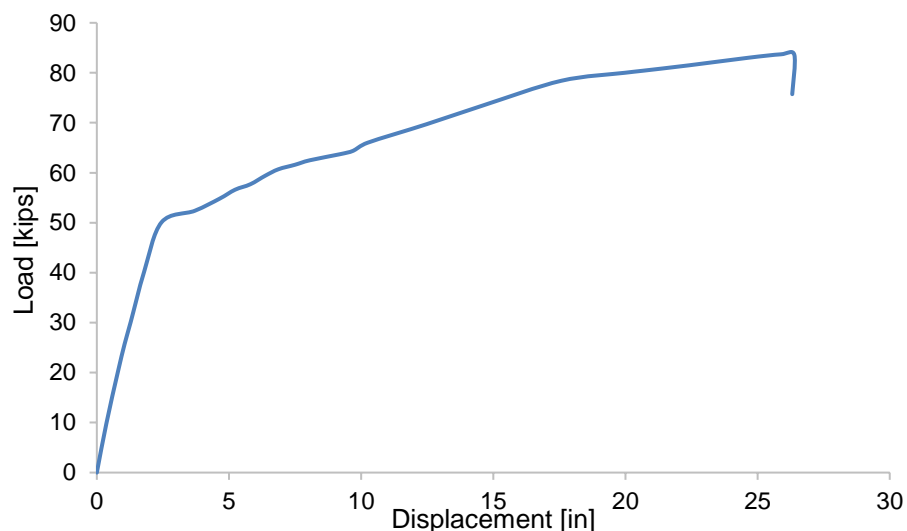
Figure 65. Load Versus Displacement Plot for Box Beam 4

First cracking was visually observed at a load of 45 kips, as confirmed by the change in slope of the load-deflection plot in Figure 65. During the test and at high deflection, considerable water began leaking from the void in the beam. At that point, the load was held constant, and buckets were used to collect the leaking water. After a load of 65 kips, the beam was no longer closely inspected, due to safety concerns. The beam failed when the corroded strands ruptured at an applied load of 83.8 kips. Unfortunately, there was some difficulty with the data collection system before approximately 52 kips of applied load. Thus, strain measurements were not recorded. Additionally, deflection readings were taken manually after 52 kips of applied load, thus the deflection data in the second part of the test was not as accurate as in the previous tests.

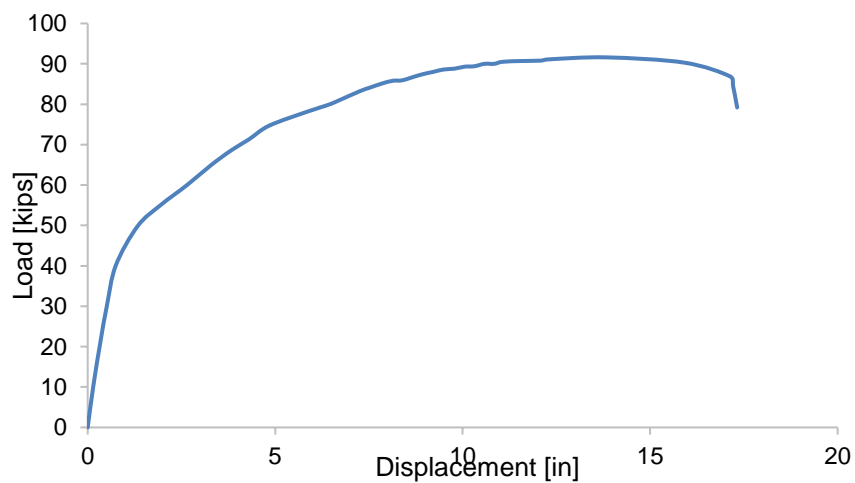
Figure 71. Load versus Displacement Plot for Box Beam 2

safety purposes, the beam was no longer closely inspected after 65 kips of applied load. Figure 71 presents the load-versus-displacement plot, and Figure 72 shows the top flange crushing.

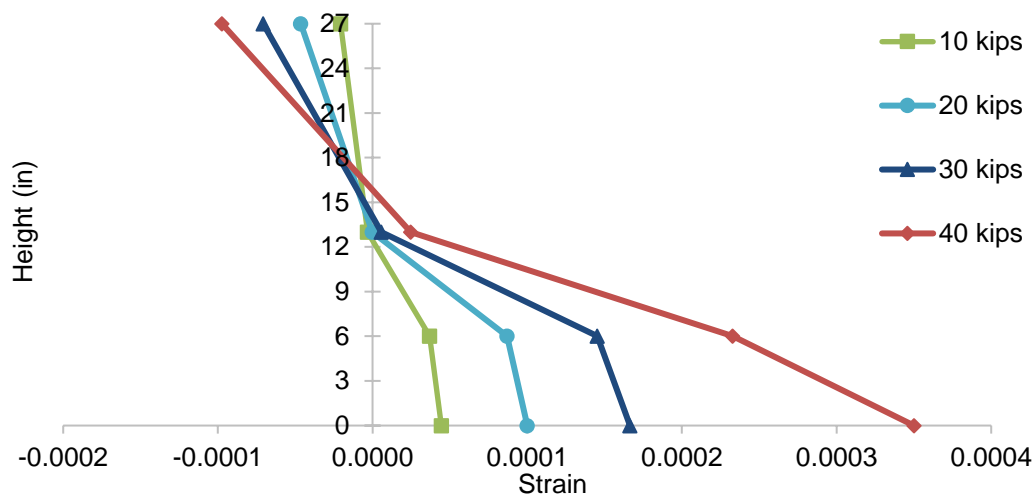
Figure 73. Mid-span Strain Versus Height of Box Beam 2

Based on strain measurements through the depth of the beam at mid-span from loads of 10 kips to 30 kips, the neutral axis was 13.5 in from the bottom of the beam (see Figure 73). The neutral axis based on calculation was also 13.5 in, identical to the neutral axis determined from measurements. Note that the height to the neutral axis increased at 40 kips, indicating that there may have been some microcracking that was not visible to the naked eye. Also note in Figure 71, the change in slope of the load-deflection plot occurred near 40 kips, which also indicated that cracking occurred before it was visually identified at 49 kips. Note that the measurements from the strain gages became erratic shortly after first cracking. Thus, Figure 73 only contains data up to that point.

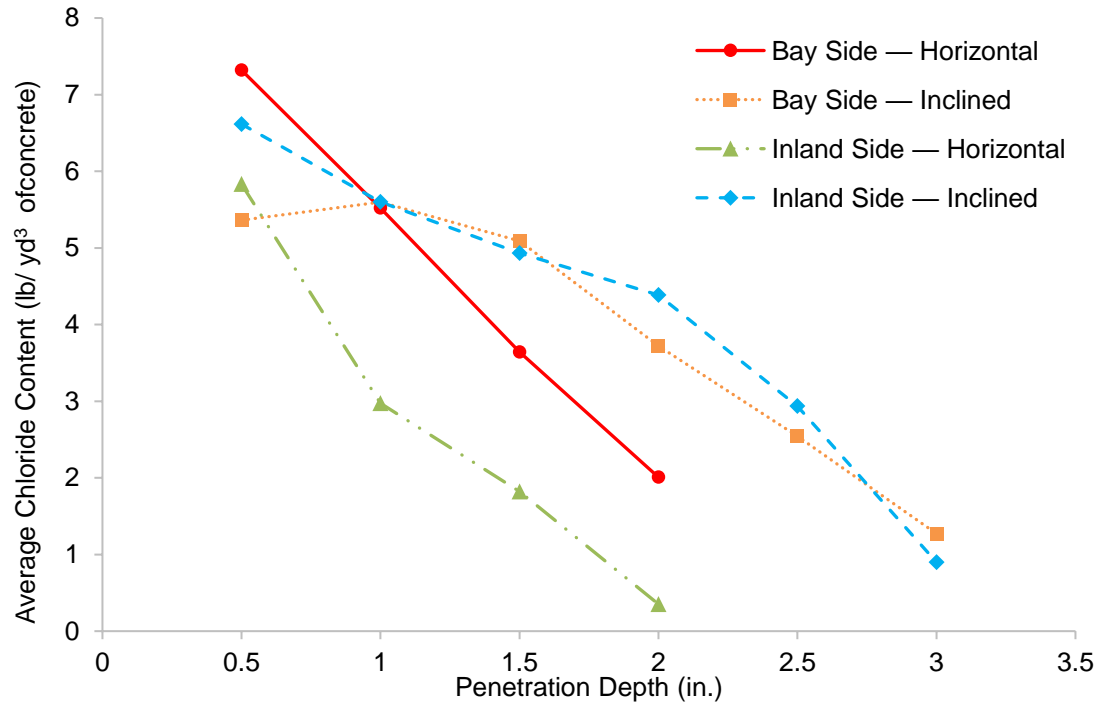
Figure 76. Results of Chloride Testing for I-Beam 7

For I-Beam 7, the chloride concentration of all of the sides decreased significantly as the depth of the sample increased. The only exception was the bay side – inclined which had a slight increase in the chloride content from 0.5 in to 1.0 in. For the samples taken from the vertical faces, the chloride content in the bay side was substantially higher than the inland side at each depth point, likely because the bay side was exposed to a harsher environment compared to the inland side. On the inclined faces, the bay and inland sides had very similar chloride contents at each depth, and were higher than the vertical faces. This could be explained by salts being deposited on the inclined faces, and not washing away as easily as on the vertical faces.

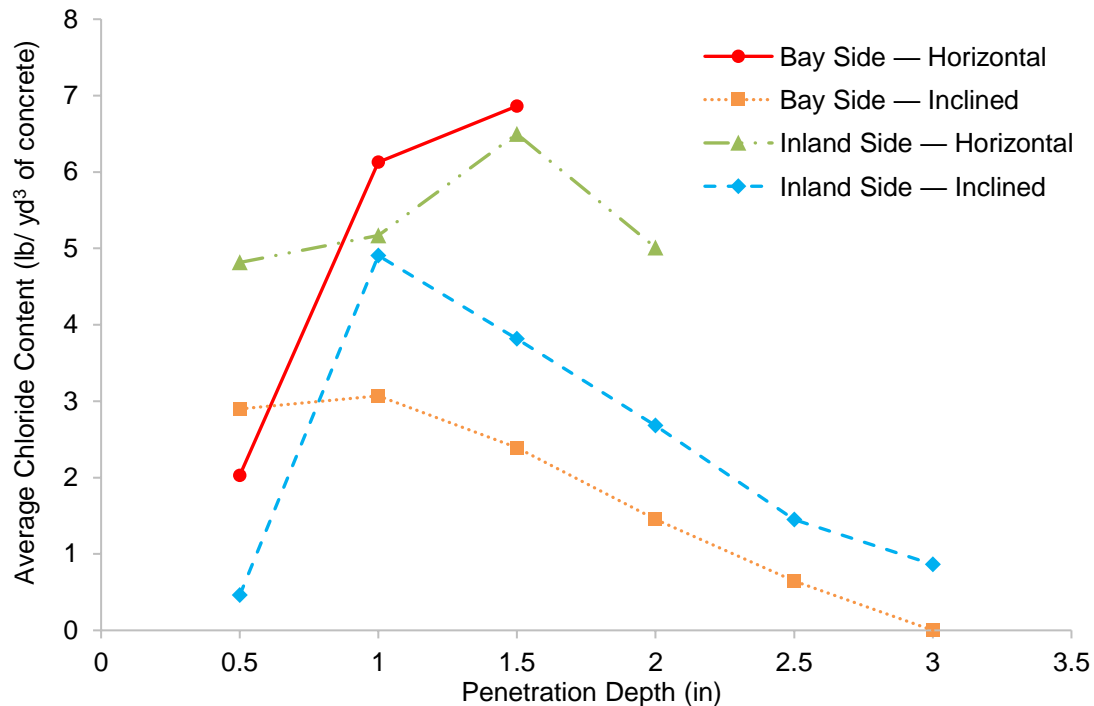
Figure 77. Results of Chloride Testing for I-Beam 6

The results of chloride content testing for I-Beam 6 are shown in Figure 77. Figure 12 shows the locations of the extracted samples on I-Beam 6. The bay side – horizontal sample had a steep increase in the chloride content from 0.5 in to 1.0 in; this result can be explained by the fact that water or rain could probably wash off chloride content at the concrete surface which resulted in a low reading. The inland side – horizontal showed similar results as the bay side – horizontal, but with slightly lower chloride concentrations. This result can be explained by the fact that the bay side was subjected to higher chloride exposure as the wind coming from the bay

side direction pushed salt directly onto the bay side surface of the beams. For both sides, the chloride content in the inclined face of the bottom flange in the girder decreased considerably from 1.0 in to 3.0 in. with the inland side, surprisingly, having a higher chloride content. It is not known why the chloride concentration on the inland side is higher, as it is subjected to a milder environment.

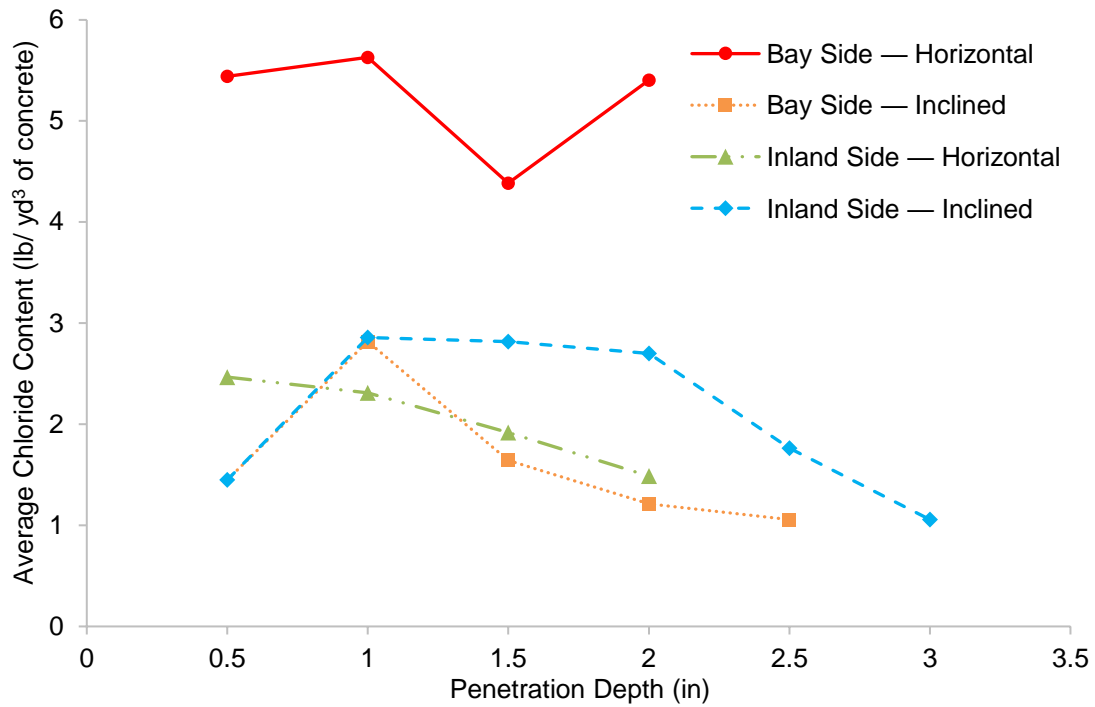
Figure 78. Results of Chloride Testing for I-Beam 3

The results of chloride content testing for I-Beam 3 are shown in Figure 78. Figure 13 shows the locations of the extracted samples on I-Beam 3. As a general trend, the chloride content in both the inclined and horizontal samples were the highest near the concrete surface and decreased gradually with deeper samples. However, for the inland side inclined and bay sides, the penetration depth of 1 in had a higher chloride content than the starting depth 0.5 in. This can be explained by the fact that water or rain could probably wash off chloride content at the concrete surface which resulted in a low reading. The highest chloride content was found in the bay side with (5.6 lb/yd³) which is considered in a high risk of corrosion category.

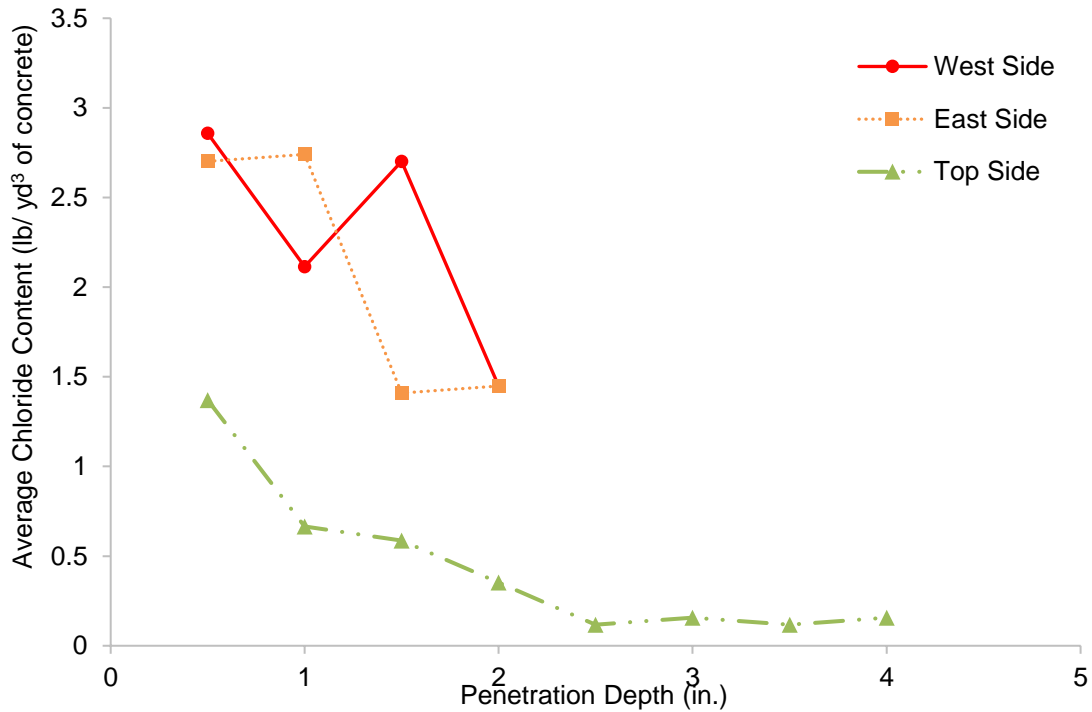
Figure 79. Results of Chloride Testing for Box Beam 1

The results of chloride content testing for Box-Beam 1 are shown in Figure 79. Figure 14 shows the locations of the extracted samples on Box Beam 1. As can be seen from the graph, the chloride content of the top portion of the box beam had the lowest chloride content compared to the east side and the west side. This result can be explained by the fact that the top of the box beam was covered with an asphalt overlay that was a first line of defense against chloride penetration. Additionally, cracks are known to form in the top surface and along the longitudinal

joints between adjacent precast box beams. These longitudinal cracks provide a direct path for chloride-laden water to reach the side and bottom of the beams. Similar to all other beams, the chloride contents gradually decreased as the depth of the sample increased. For the west side, the highest chloride content was at a depth of 0.5 in and lowest at a depth of 2.0 in. While for the east side, the highest and lowest chloride content was at 1.0 in and 1.5 in, respectively.

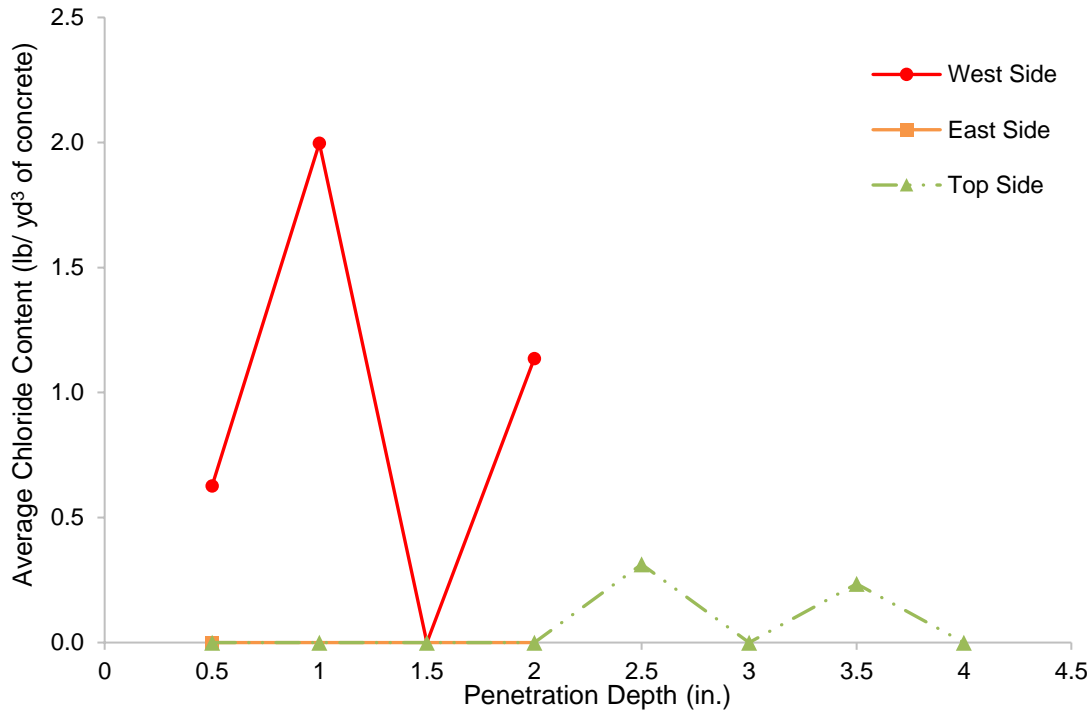
Figure 80. Results of Chloride Testing for Box Beam 4

The results of chloride content testing for Box Beam 4 are shown in Figure 80. Figure 15 shows the locations of the extracted samples on Box Beam 4. The west side had the highest chloride content at 1.0 in depth, and the chloride content fluctuates as the depth increase. There was no detected chloride content for the east side. For the top side, the chloride content was very low with 0.313 lb/yd³ at 2.5 in and 0.235 lb/yd³ at 3.5 in. One possible explanation is that these box beams had been stored outside for more than five years, allowing rain water to wash off much of the chlorides at the shallow depths.

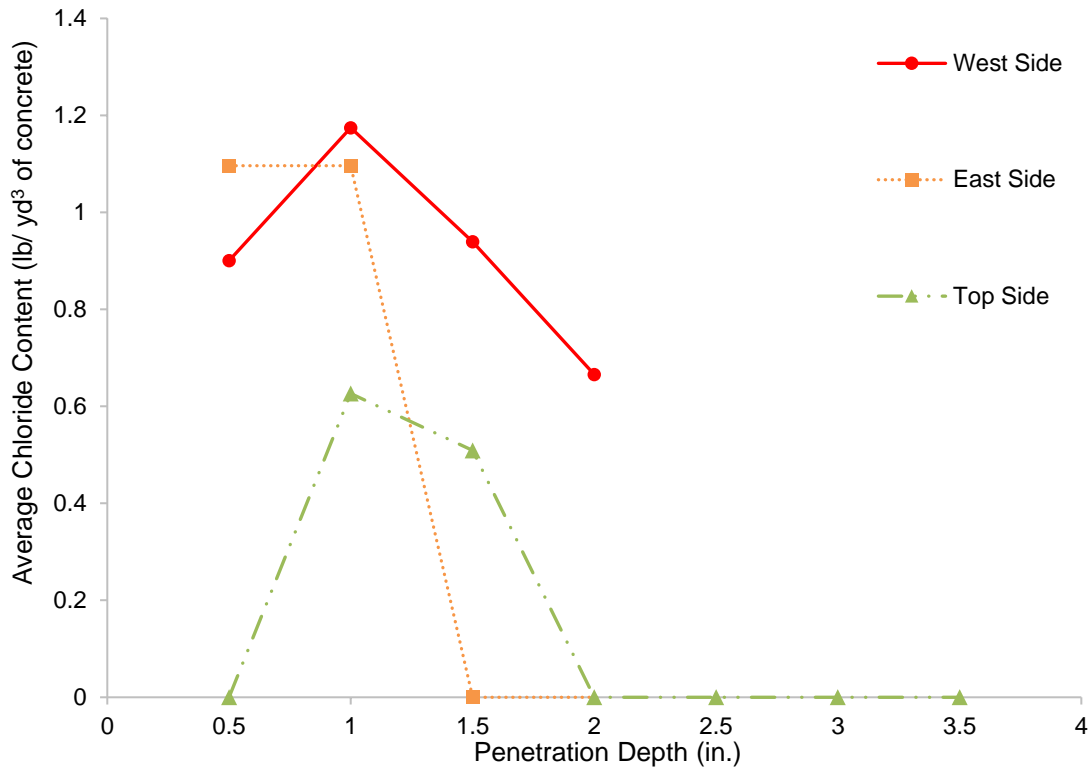
Figure 81. Results of Chloride Testing for Box Beam 2

The results of chloride content testing for Box Beam 2 are shown in Figure 81. Figure 16 shows the locations of the extracted samples on Box Beam 2. As can be seen in the graph, overall, the west side had the highest chloride content at 1.0 in depth. The second highest chloride content was the east side at 0.5 in and 1.0 in. For the top section, the chloride content was the lowest compared to the other parts of the concrete. For all of the sections, as a general trend, the chloride content decreased gradually with depth of the sample.

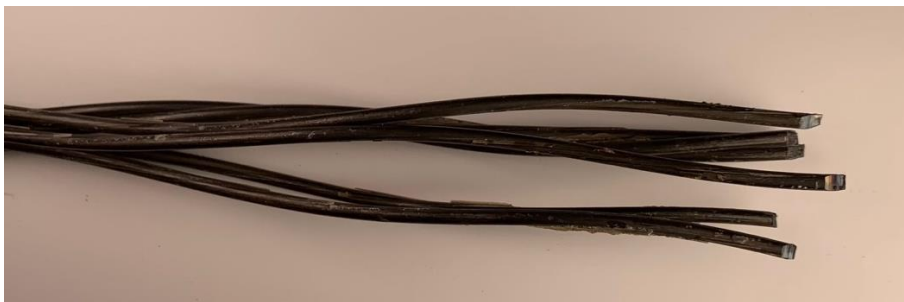
Figure 87. Strand Taken from I-Beam 3 after Testing

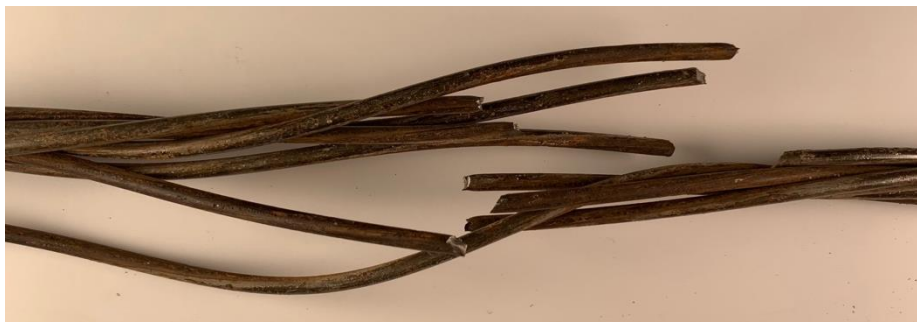
Figure 89. Strand Taken from Box Beam 1 after Testing

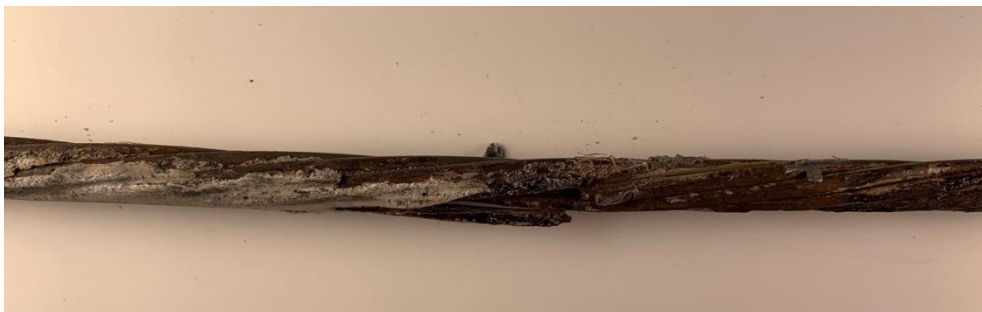
Figure 91. Strand Taken from Box Beam 4 after Testing

All the tensile tests were very similar to the stress strain model, prior to yield, except for the strand from Box Beam 4. The strands extracted from I-beam 6 and all three box beams failed to reach a strain of 0.02, because of their heavy corrosion. The stress-strain behavior of the strand from I-beam 3 was identical to the stress strain model, because it did not show any signs of damage. The strand from I-beam 7 did not achieve the expected ultimate strain, but also had light corrosion on its surface.

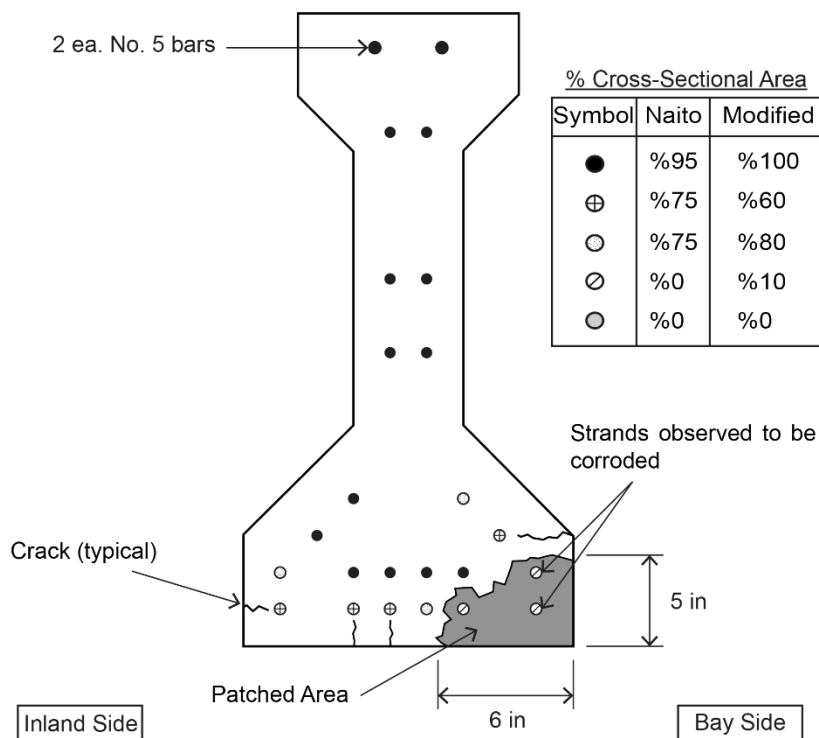
Figure 96. Damage Estimated from Visual Inspection for I-Beam 6

The strength for this beam was calculated using two methods to account for the damage: the recommendations of Naito et al. (2010), and the modified method. The damage inferred from the pre-test visual inspection is presented in Figure 96. The calculations were performed with the tested deck concrete strength of 2900 psi and the beam concrete strength of 6100 psi. The haunch at mid-span was 1.5 in. The tested strength of this beam was 1393 k-ft. The calculations using strain compatibility and the AASHTO method are presented in Table 12. Based on the damage maps, two out of six strands in the first lower level were in a patched area, and the other two had longitudinal cracks. Additionally, one strand out of six in the second lower level was in the patched area.

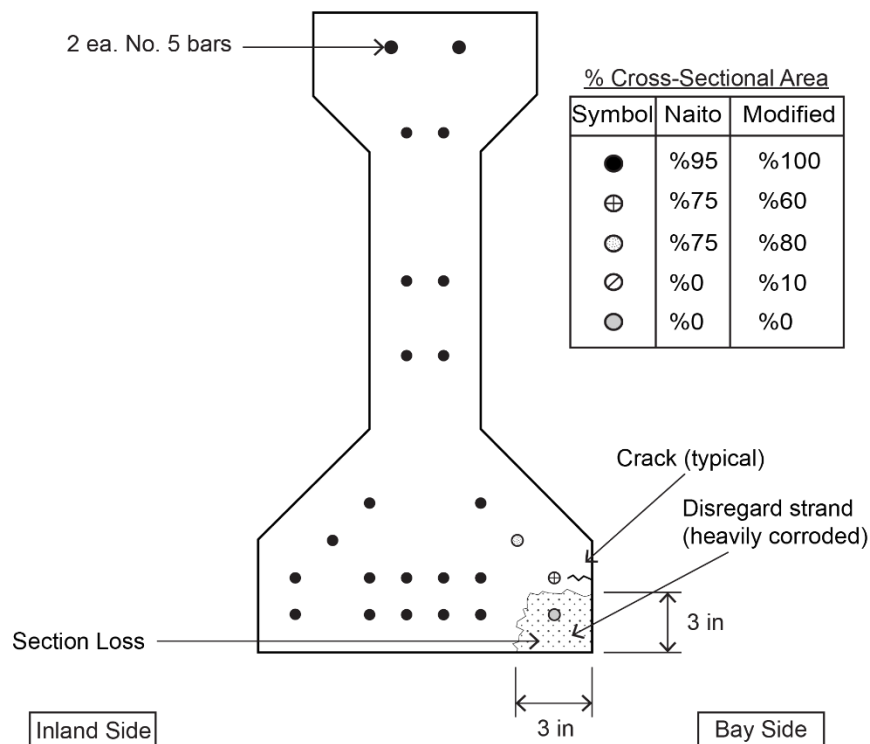
**Figure 98. Damage Estimated from Visual Inspection for I-Beam 3**

Naito et al. (2010) and the modified method were used to account for the damage in I-Beam 3 (see Figure 98). Prior to testing, there was one exposed strand in the first lower level. The deck concrete strength was 3500 psi and the beam concrete strength was 5600 psi. The haunch at mid-span was 1.5 in. The tested strength of this beam was 1873 k-ft. The effective

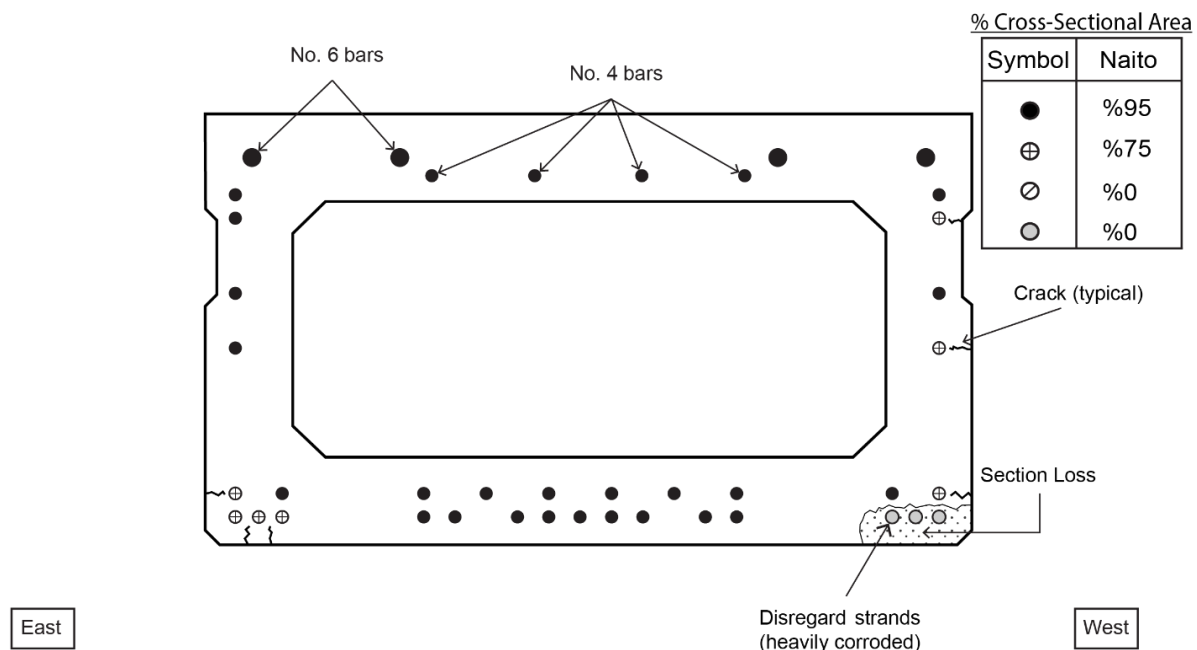
Figure 99. Damage Estimated from Visual Inspection for Box Beam 1

The cross-sectional area of the strands in Box Beam 1 to be used for calculations were assumed using the recommendations of Naito et al. (2010). Based on visual inspection, three exposed strands in the first lower level were heavily corroded (see Figure 99). Those assumptions, along with the tested concrete strength of 7250 psi, resulted in estimated flexural strengths that were within about 1% the actual strength determined from load testing. The total moment on the beam during testing, including self-weight, was 1269 k-ft. Using strain compatibility, the calculated flexural strength was 1253 k-ft, while the capacity at ultimate using the AASHTO method was slightly lower at 1251 k-ft. Note that the effective prestress calculated from the AASHTO method was 156 ksi. On the other hand, the effective prestress calculated from the observed 50-kip cracking load and the Naito et al. (2010) recommendations was 128 ksi, which was about 18% below the AASHTO-based effective prestress.

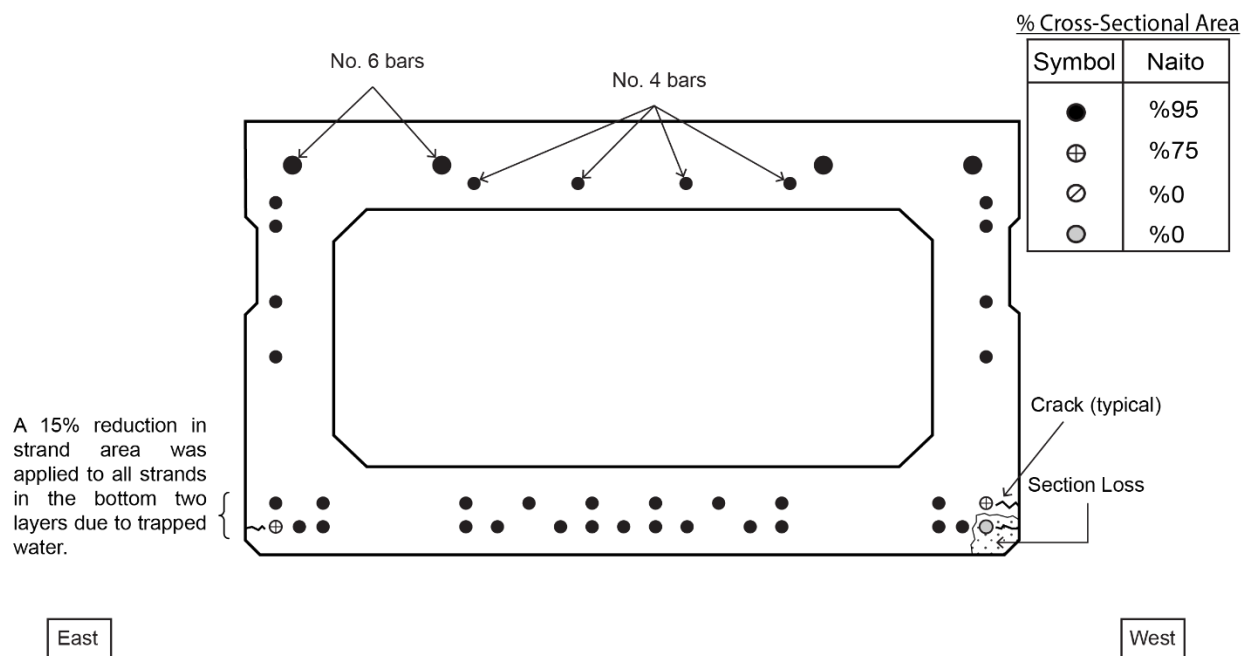
Figure 100. Damage Estimated from Visual Inspection for Box Beam 4

Box Beam 4 had different conditions than the other two box beams, with water trapped in the beam leading to a lower strength. The recommendations of Naito et al. (2010) were used with a small modification to account for the trapped water, where a 15% reduction was applied on top of the Naito reductions to the two lower strands levels (see Figure 100). This percentage reduction gave reasonable calculated results. Based on the compressive test, the concrete strength was 6250 psi. The tested strength of this beam was 1196 k-ft. The calculations using strain compatibility and the AASHTO method are presented in Table 14. Note that the actual cracking load of 50 kips resulted in an effective prestress equal 167 ksi. On the other hand, the effective prestress calculated from the AASHTO method was 156 ksi. This latter value for effective prestress was used in the strain compatibility calculation method for flexural strength.

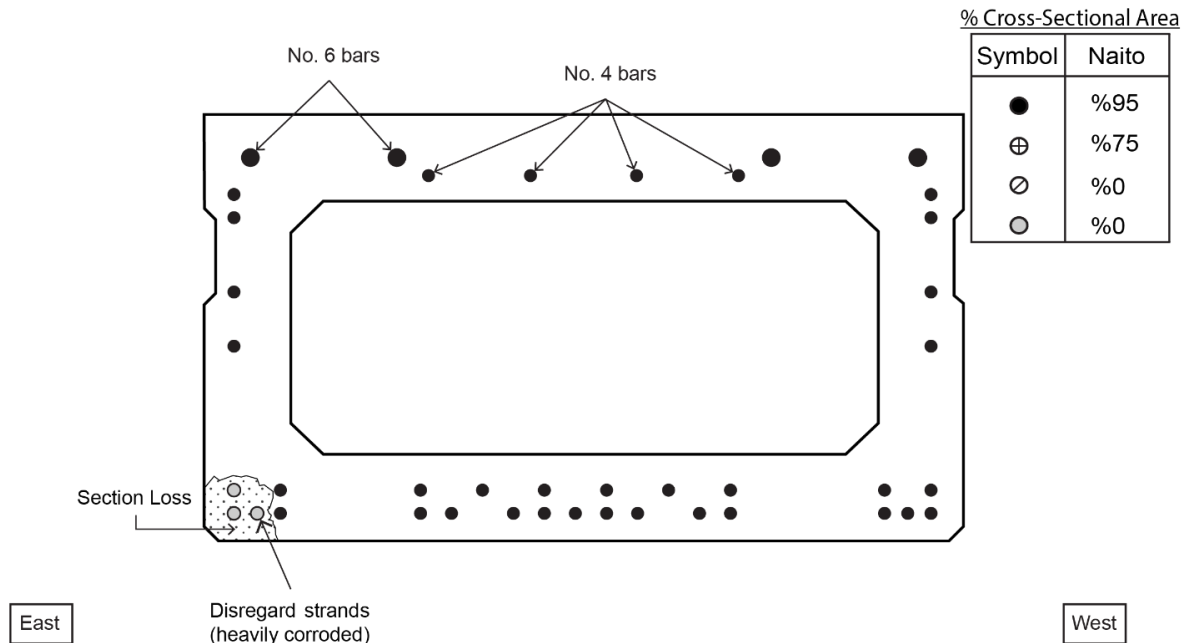
Figure 101. Damage Estimated from Visual Inspection for Box Beam 2

The residual capacity for Box Beam 2 was calculated using the recommendations of Naito et al. (2010) to estimate the remaining cross-sectional area of the strands. Three exposed strands were disregarded in the calculation of the flexural strength (see Figure 101). The concrete
