# Corrugated Metal Pipe Culvert Invert Repair Using Engineered Cementitious Composite

**Final Report VTRC 21-R5**

**CORRUGATED METAL PIPE CULVERT INVERT REPAIR USING ENGINEERED  
CEMENTITIOUS COMPOSITE**

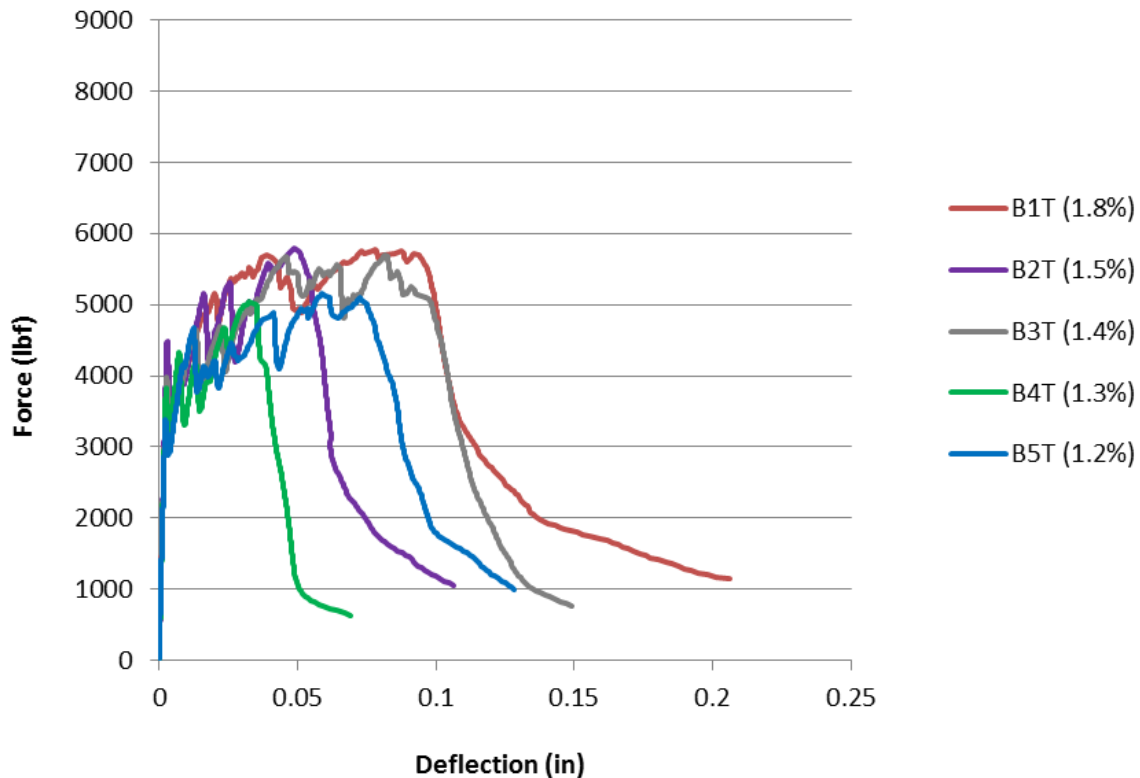
The 7-day flexural strengths for typical ECC mixtures are given in Table 8. Load versus deflection curves for Batches 1T through 5T with fiber contents varying from 1.2% to 1.8% are displayed in Figure 5. The first peak strength and residual strengths at deflections of 0.2 in (span length/600), 0.4 in (span length/300), and 0.8 in (span length/150) are given. The beams exhibited deflection hardening. All the typical mixtures exhibited ductility; in general, with higher fiber content, ductility increased. Deviations from this trend were attributed to the varying mortar consistency that affects the fiber dispersion. The batches for which the mini-slump cone measurements were taken to ensure that high flow was attained had the higher ductility.

**Figure 5. Load Versus Deflection Curves for Typical ECC Mixtures With Varying Amounts of PVA Fibers.** Values in parentheses are the percentage of PVA fibers per volume. ECC = engineered cementitious composite; B = batch; T = typical.

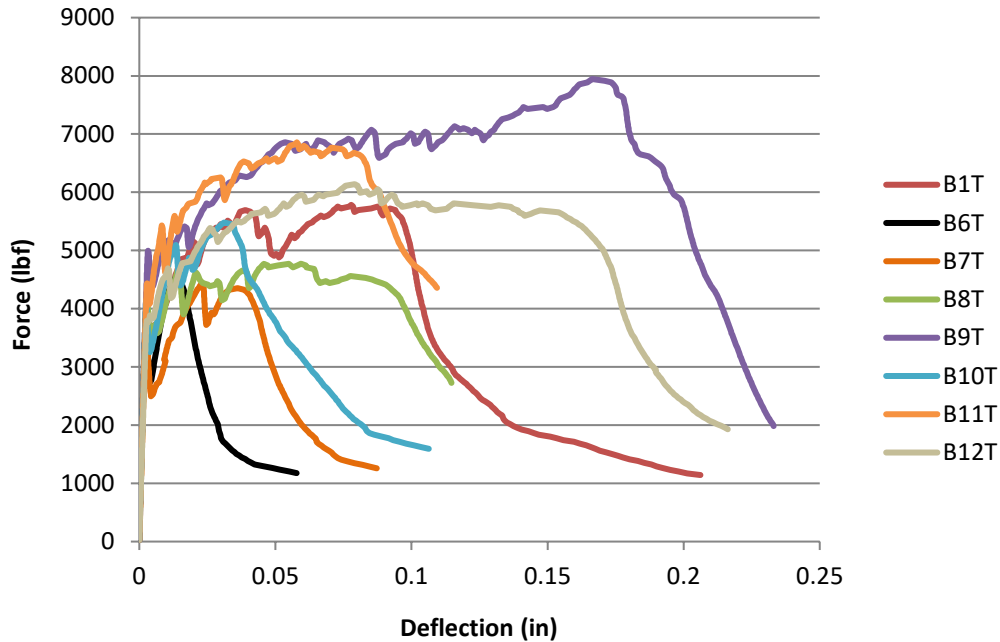
Load versus deflection curves for the mixtures with 1.8% PVA fiber are shown in Figure 6. The beams exhibited deflection hardening except for Batch 6T. Batch 6T had a slump flow at the low limit of self-consolidating concrete, which could have adversely affected the fiber distribution. The change in ductility and the load in the batches was attributed to the consistency of the mortar, which would affect the dispersion of the fibers.

**Figure 6. Load Versus Deflection Curves for Typical ECC Mixtures With 1.8% PVA Fibers.** ECC = engineered cementitious composite; PVA = polyvinyl alcohol; B = batch; T = typical.

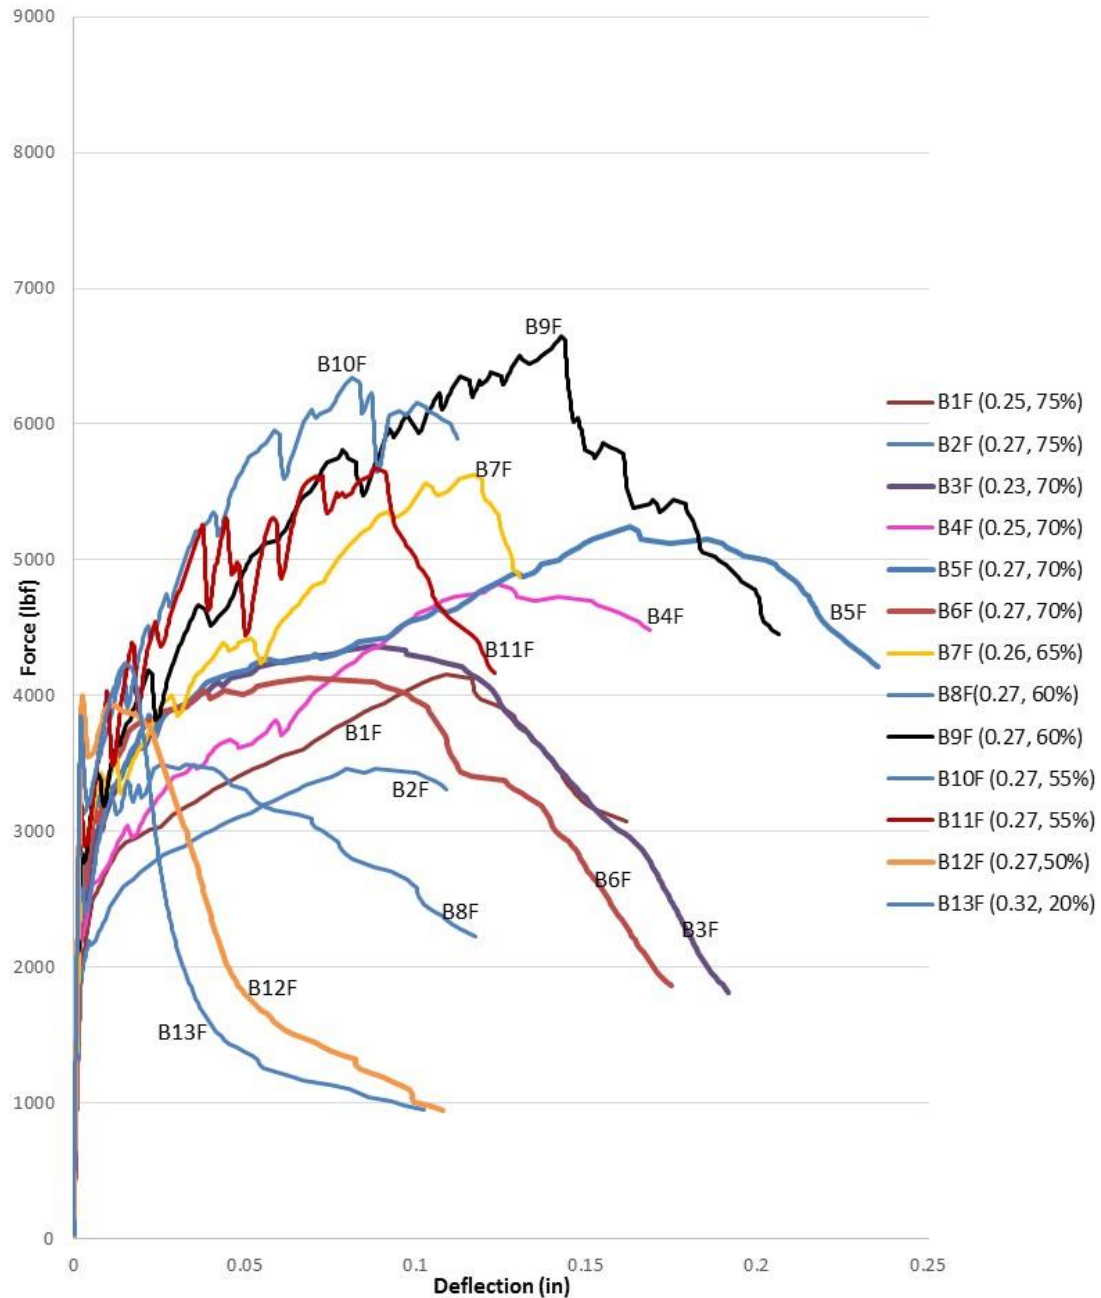
Flexural strengths for ECC mixtures with high amounts of fly ash are given in Table 10. Figure 7 displays the load versus deflection curves for these mixtures. Deflection hardening and high ductility were found even though the flexural strengths were not as high as for the typical ECC mixtures. Mixtures with typical proportions of cementitious material, 55% fly ash replacement, and higher percentages of fly ash have good ductility; at lower percentages of fly ash, ductility was lower. The variation in ductility with high percentages of fly ash is attributed to differences in fiber amount and distribution and the w/cm. Use of high amounts of fly ash is beneficial in this instance, since improved robustness (reduced variability) in ductility has been found (Yang et al., 2007).

Figure 7. Load Versus Deflection Curves for ECC Mixtures With High Amounts of Fly Ash. ECC = engineered cementitious composite; B = batch; F = high fly ash. Values in parenthesis are the water-cementitious material ratios and the percentages of fly ash.

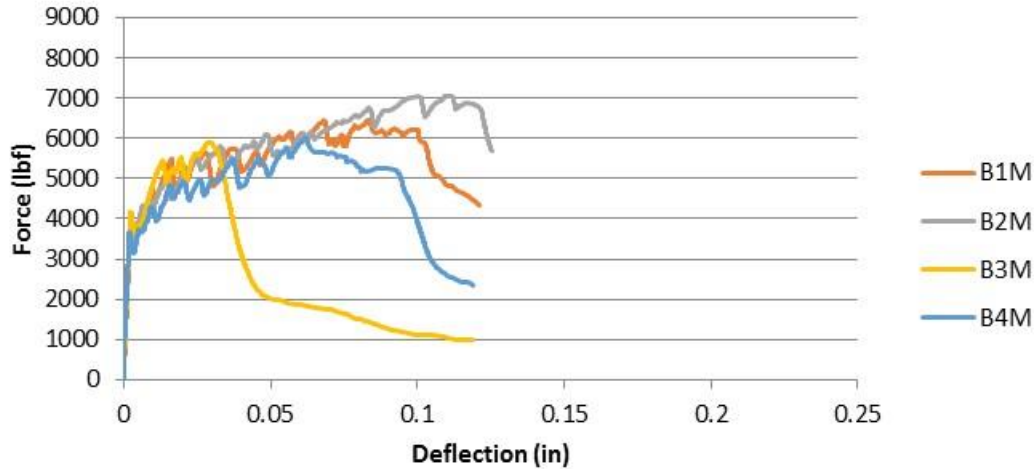
Flexural and splitting tensile strengths for ECC mixtures with mortar sand are given in Table 12; Figure 8 displays the load versus deflection curves for these mixtures. These mixtures exhibited deflection hardening and good ductility with a fiber content of 1.5%. Batch 3M with lower workability and an 8.5-in slump, rather than the slump flow obtained for others, had the lowest ductility (Figure 8).

**Figure 8. Load Versus Deflection Curves for ECC Mixtures With Mortar Sand. ECC = engineered cementitious composite; B = batch; M = mortar sand.**

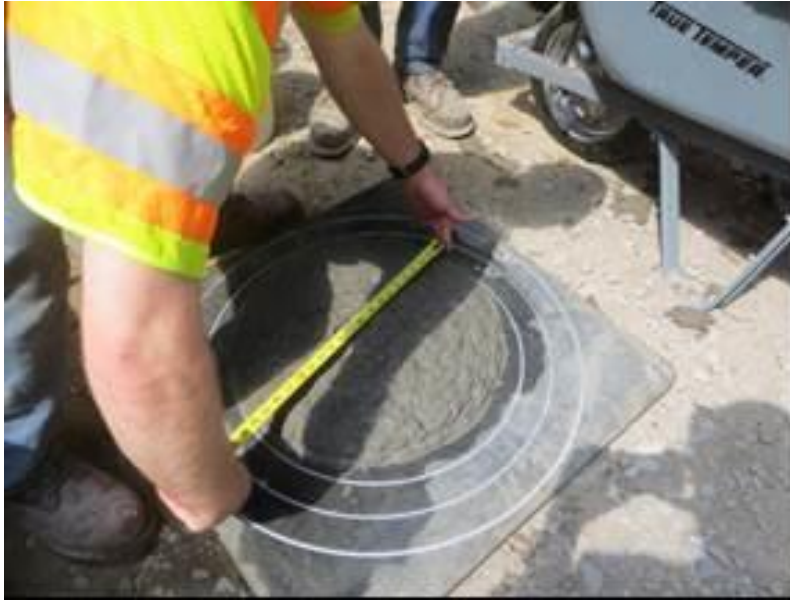
The results for the fresh concrete properties of the mixtures used in the field are summarized in Table 13. In the trial batch, the ECC prepared in the mortar mixer (MM), and Batches 1 and 2, self-consolidating mixtures were obtained with slump flow values of 18 in and above, as shown in Figure 9 and Table 13. Batch 7 was prepared on 4-17-2019, and there were no data for fresh properties but specimens were prepared for hardened properties.

**Figure 9. ECC in the Trial Batch and Mortar Mixer Batch. Batches 1 and 2 were self-consolidating, as shown by the measured slump flow. ECC = engineered cementitious composite.**

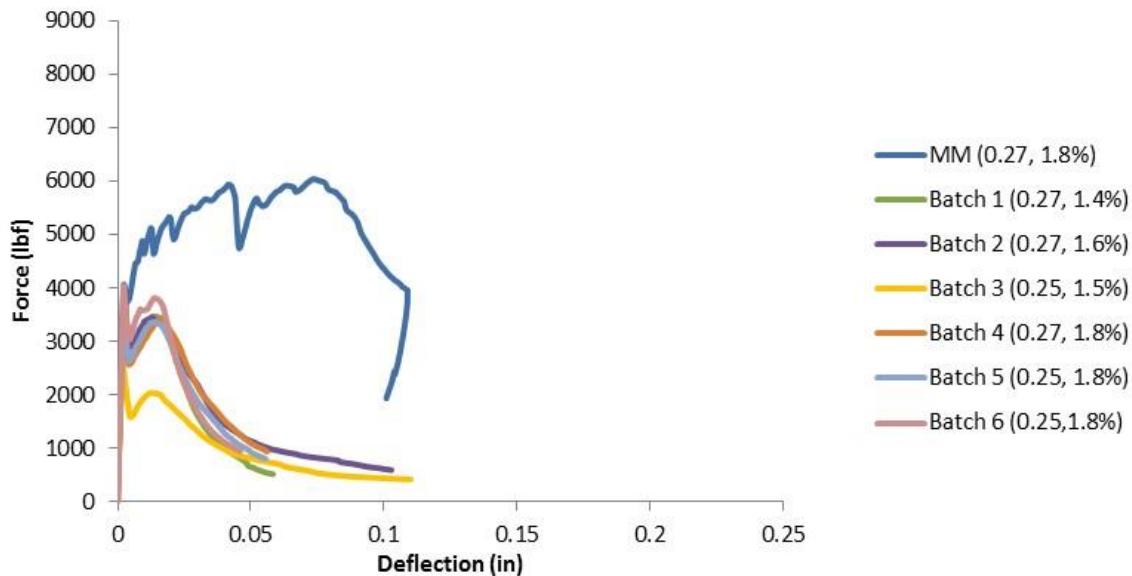
The flexural test data for the field batches are summarized in Table 15 and Figure 13. The first peak strength and residual strengths at deflections of 0.2 in (span length/600), 0.4 in (span length/300), and 0.8 in (span length/150) are given. In the MM batches mixed in a mortar mixer, the residual strengths at 0.2 and 0.4 in were higher than the first peak strengths, indicating deflection hardening, but other batches prepared in the truck mixer with varying fiber contents did not deflection harden.

**Figure 13. Load Versus Deflection Curve for All Batches of ECC at 7 Days. Values in parenthesis are the water–cementitious material ratios and the percentages of polyvinyl alcohol fiber per volume. ECC = engineered cementitious composite; MM = ECC prepared in a mortar mixer.**

Even though deflection hardening did not occur, there was a high residual strength that when accompanied with the geogrid is expected to control the width of the cracks. The lack of deflection hardening in truck-mixed concrete was attributed to lower mixing efficiency that does not enable good fiber distribution. The need for good fiber dispersion to achieve deflection hardening in ECC is a basic component of its design.
