Federal Highway Administration
Every Day Counts
Innovation Initiative

Safety Edge_{SM}
Demonstration Project
State Route 182
Columbus, Mississippi

Field Report
June 27, 2011

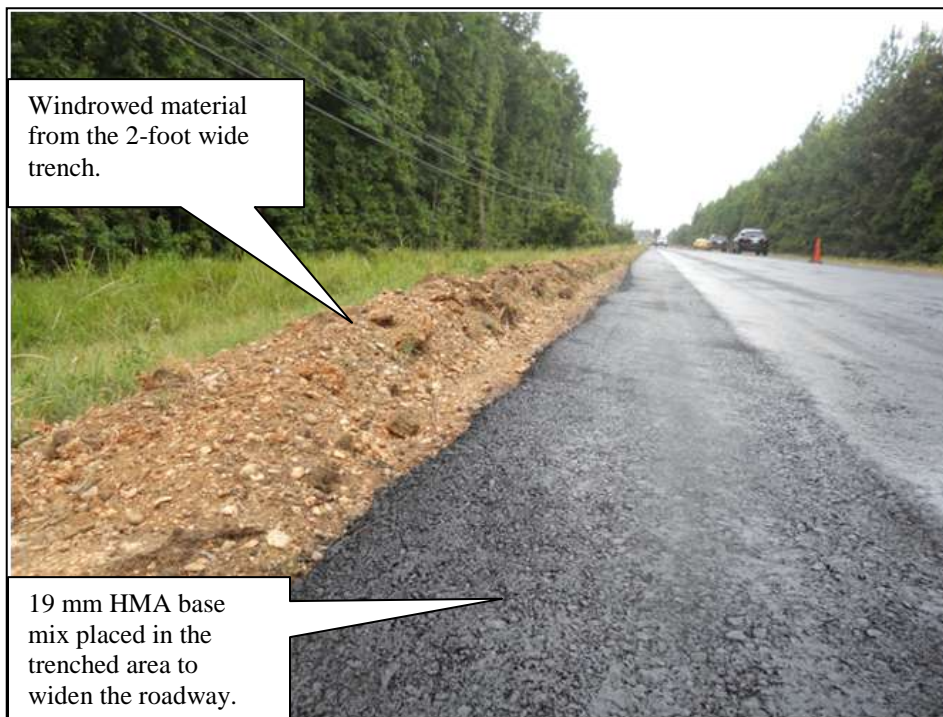
Figure 5. General view of the 19 mm HMA base placed to widen the roadway.

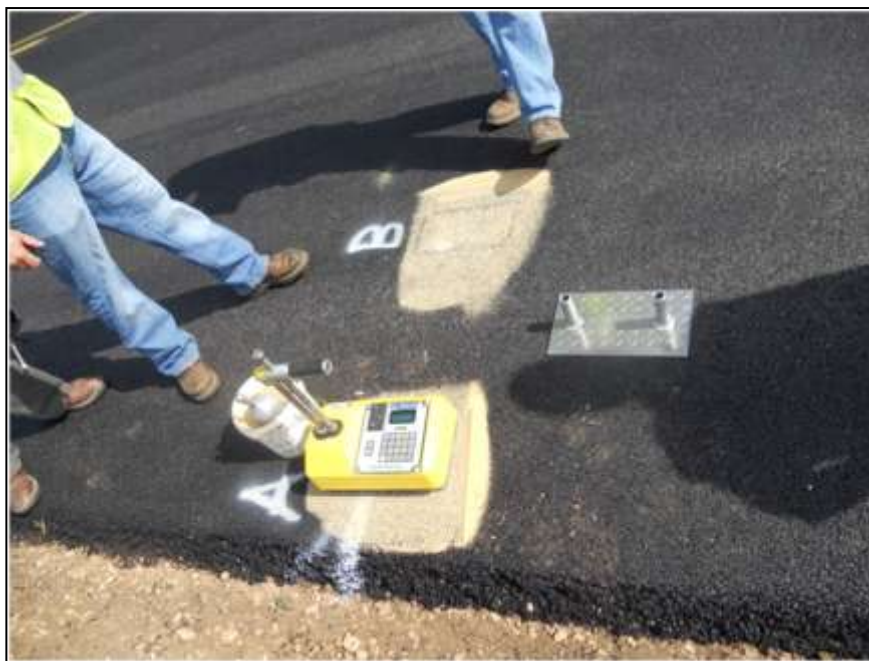
Figure 7. Nuclear gauge used to measure HMA density.

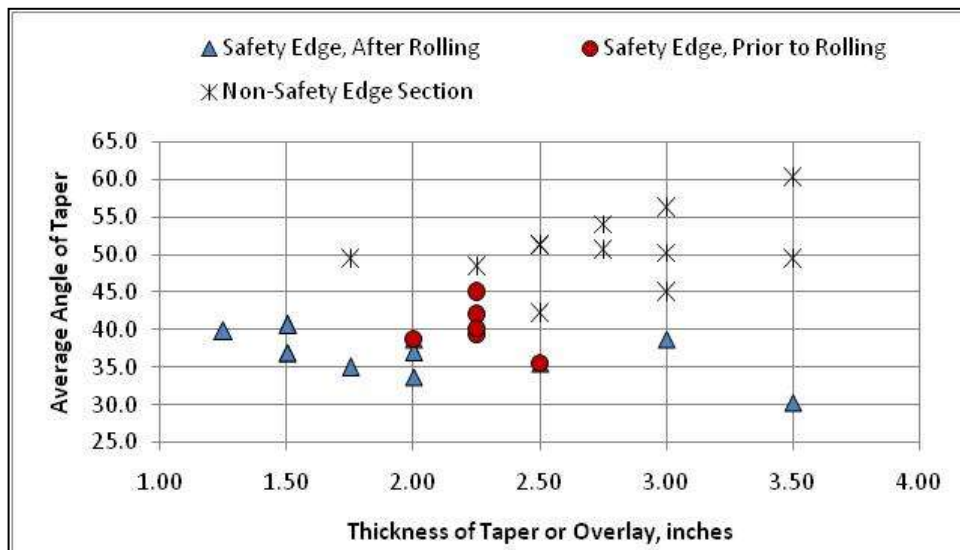
Slope measurements were also made prior to rolling the Safety Edge_{SM}. These measurements are in Table A-2 in Appendix A and were compared to the values after final rolling; refer to Figure 8. As shown, the slopes prior to rolling are slightly steeper than after final rolling. These data sets were measured in different areas, so there is no direct correspondence between the individual point measurements. An observation from this comparison is that rolling did not steepen the slope, and suggests that rolling the Safety Edge_{SM} by overhanging the steel drum about 4 to 6 inches over the edge did not increase the slope. The rolling patterns used along the project are explained in the *Compaction Operations* section.

Slopes were also measured along the non-Safety Edge_{SM} section. These slope measurements are included in Table A-3 in Appendix A and shown in Figure 8. As expected, the slopes without use of the Safety Edge_{SM} are greater than when using the Safety Edge_{SM} device.

Other slope measurements were made at random along the Safety Edge_{SM} in other areas of the project, and the results were the same as for the specific Safety Edge_{SM} sections established for future performance reviews. Thus, the slope of the Safety Edge_{SM} was found to be steeper than what was planned.

Figure 8. Comparison of the Safety Edge_{SM} slope and thickness of the HMA adjacent to the edge of the HMA overlay.

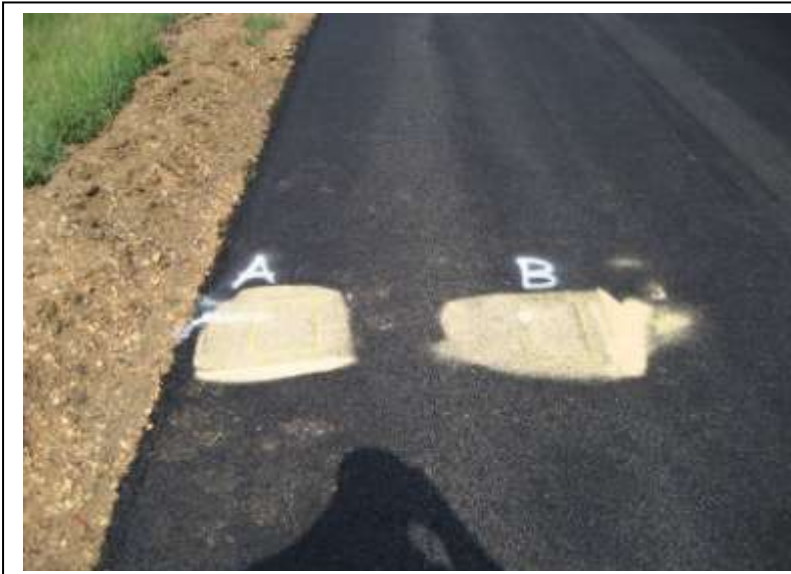
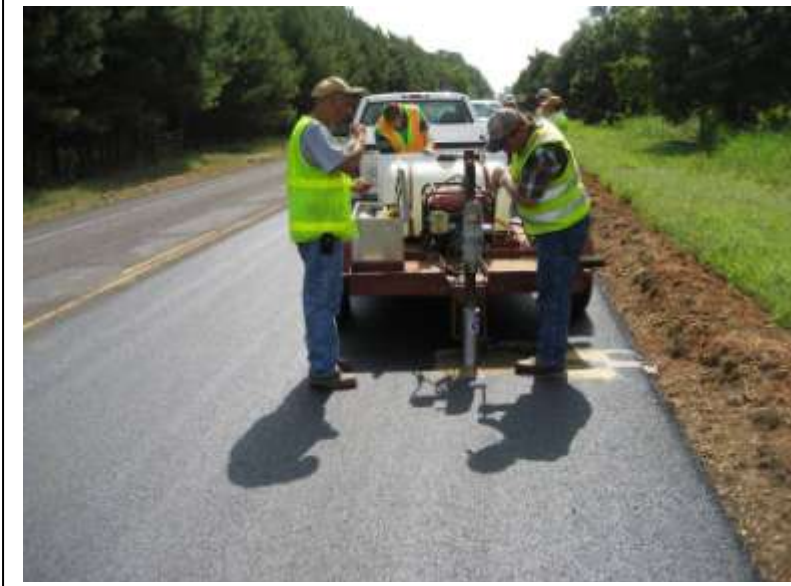
Figure 9. Photos showing location of cores and nuclear density tests made with the Troxler 3440 gauge (nuclear density readings were taken and then the HMA overlay was cored).

Location of nuclear density test; A location is adjacent to the edge; B location is near the center of the steel drum roller (about 3 feet from edge).

Core sets recovered from selected stations; A location is adjacent to the edge; B location is near the center of the steel drum roller (about 3 feet from edge).

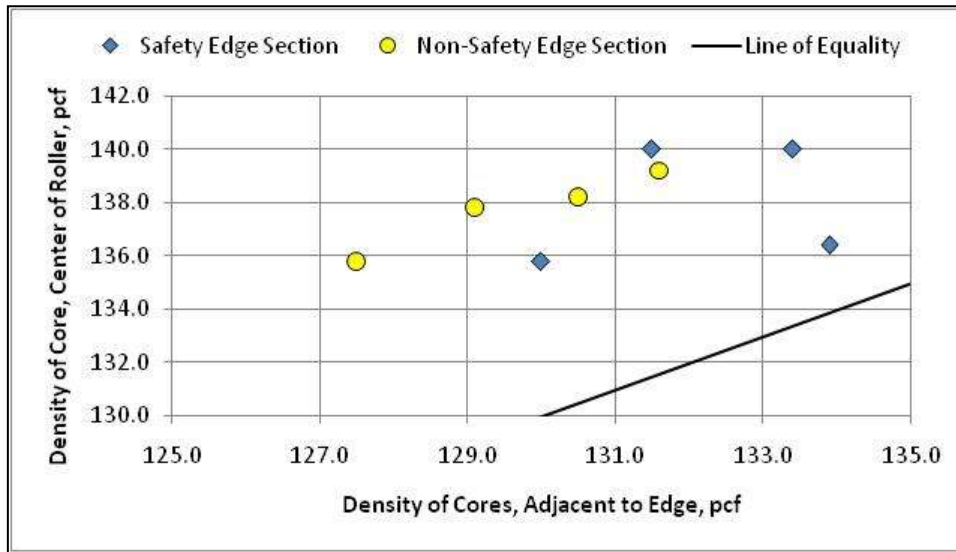
Tables A-4 and A-5 in Appendix A include a summary of these test results; core thickness and bulk specific gravities (saturated surface dry) converted to bulk densities. Figure 10 includes a comparison of the core densities taken along the edge and near the center of the steel drum roller for the Safety Edge_{SM} and non-Safety Edge_{SM} sections. As expected, densities near the center of roller are higher than along the edge of the mat (unconfined edge). More importantly, the core densities taken along the pavement's edge are consistently higher for the Safety Edge_{SM} section than for the non-Safety Edge_{SM}. These results suggest that the Safety Edge_{SM} is providing better confinement for rolling an unconfined edge of the mat.

Figure 10. Comparison of core densities adjacent to the edge of pavement and near center of steel drum rollers.

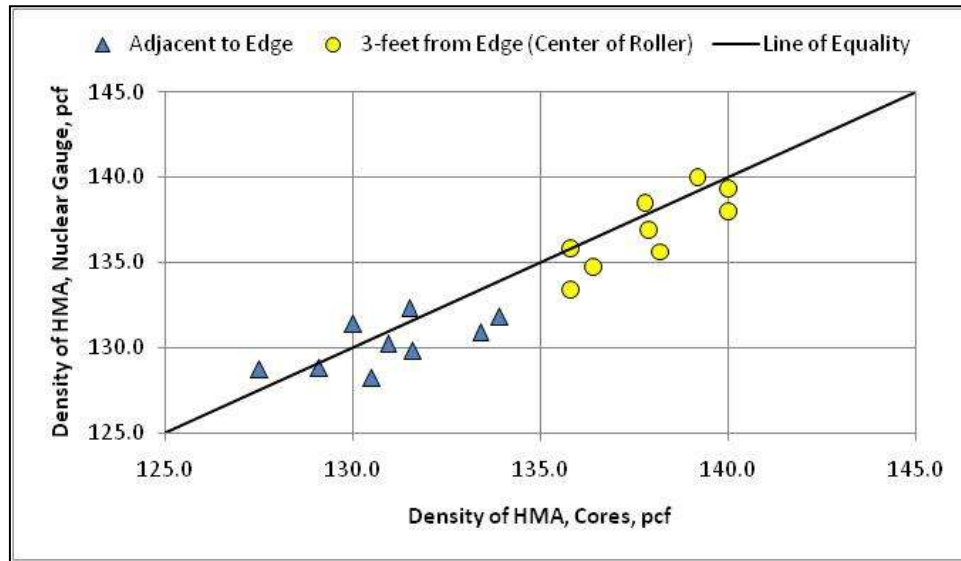
Nuclear density readings were taken before drilling each core. Figure 11 shows a comparison of the nuclear gauge readings and densities measured on the cores. As shown, there is close correspondence between the nuclear gauge readings and core densities. Adjustment factors were determined for the nuclear gauge readings taken at the Safety Edges_{SM} and near the center of the steel drum roller being used to compact the HMA mat. The adjustment factors are included in Table A-4 in Appendix A. The following lists the average factors determined for this project, which are near unity.

Figure 11. Comparison of the nuclear density readings and densities measured on the cores recovered from the mat.

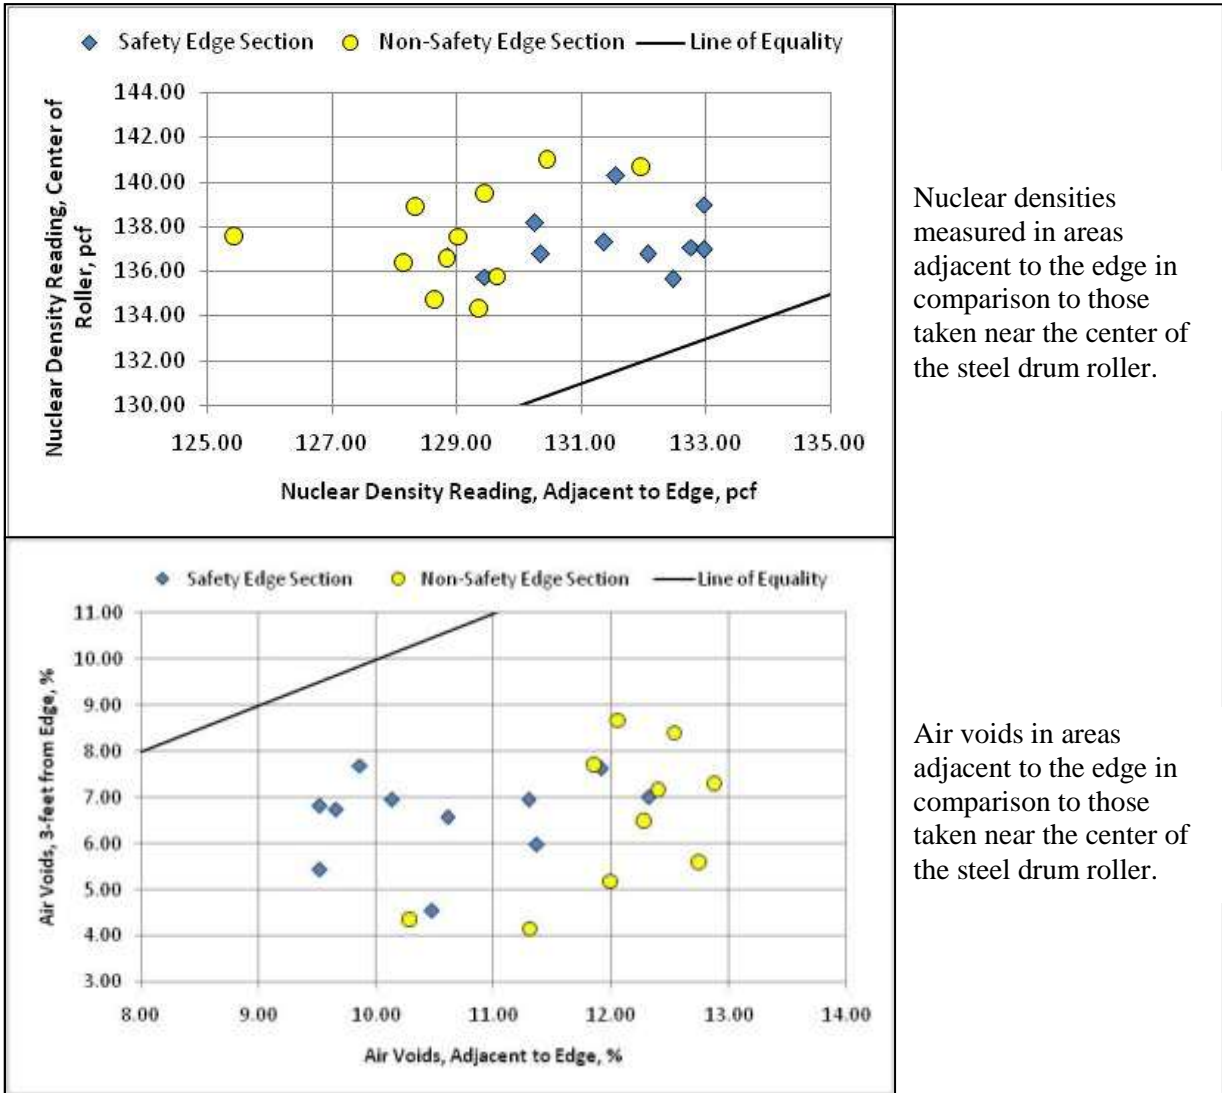
Figure 12 shows a comparison of the adjusted nuclear density gauge readings taken adjacent to the Safety Edge_{SM} and near the center of the vibratory steel wheel roller. Figure 12 also includes a comparison of the HMA air voids between both areas. As shown, the air voids are higher adjacent to the Safety Edge_{SM}, in comparison to 3-feet from the Safety Edge_{SM}. The other important observation from this data is that the densities are higher and air voids consistently lower along the mat’s edge for the Safety Edge_{SM} sections, in comparison to the non-Safety Edge_{SM} section.

Nuclear densities measured in areas adjacent to the edge in comparison to those taken near the center of the steel drum roller.

Air voids in areas adjacent to the edge in comparison to those taken near the center of the steel drum roller.

Figure 12. Comparison of the adjusted nuclear density readings and air voids between the areas adjacent to the edge and center of the steel drum roller.

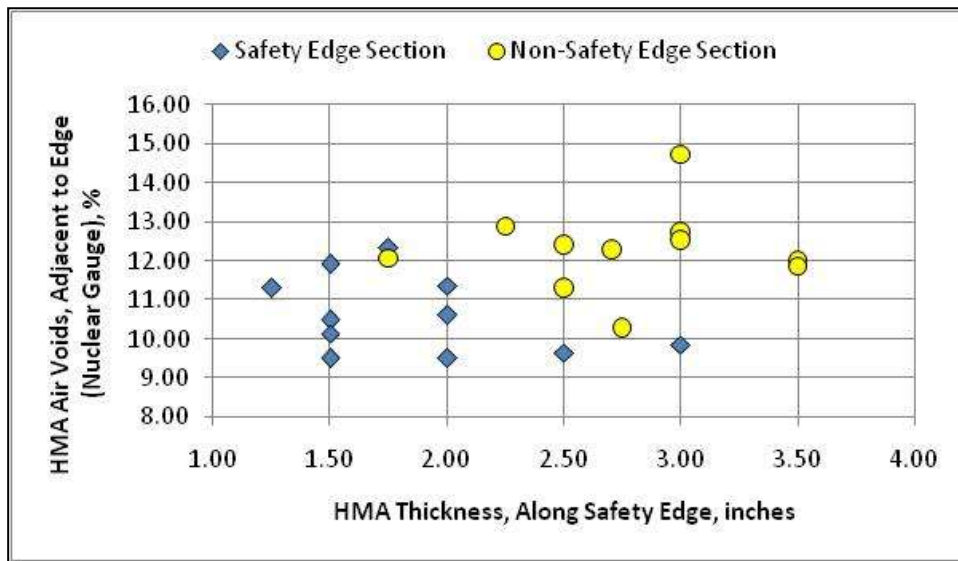
Figure 13. Comparison of HMA thickness at the edge of the mat and HMA air voids.

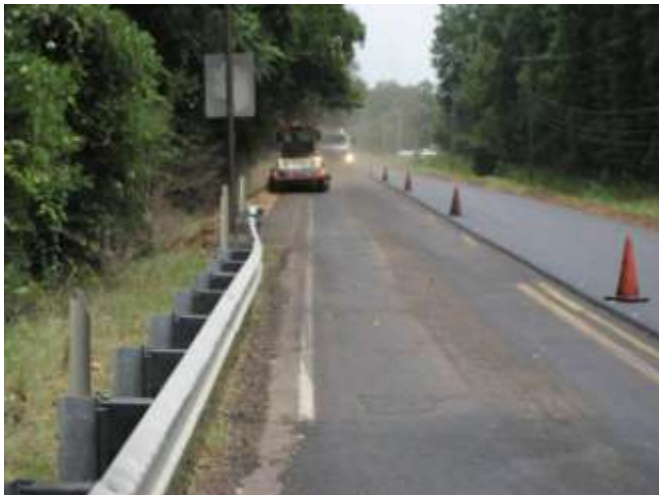
A motorized broom was used to clean the surface of the pavement prior to applying the tack coat to the surface of the existing pavement.

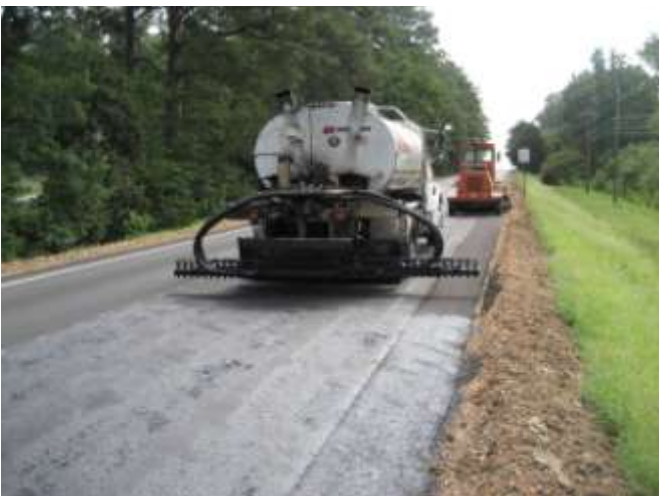
A tack coat (emulsion) was applied to the cleaned pavement surface prior to placing the HMA overlay.

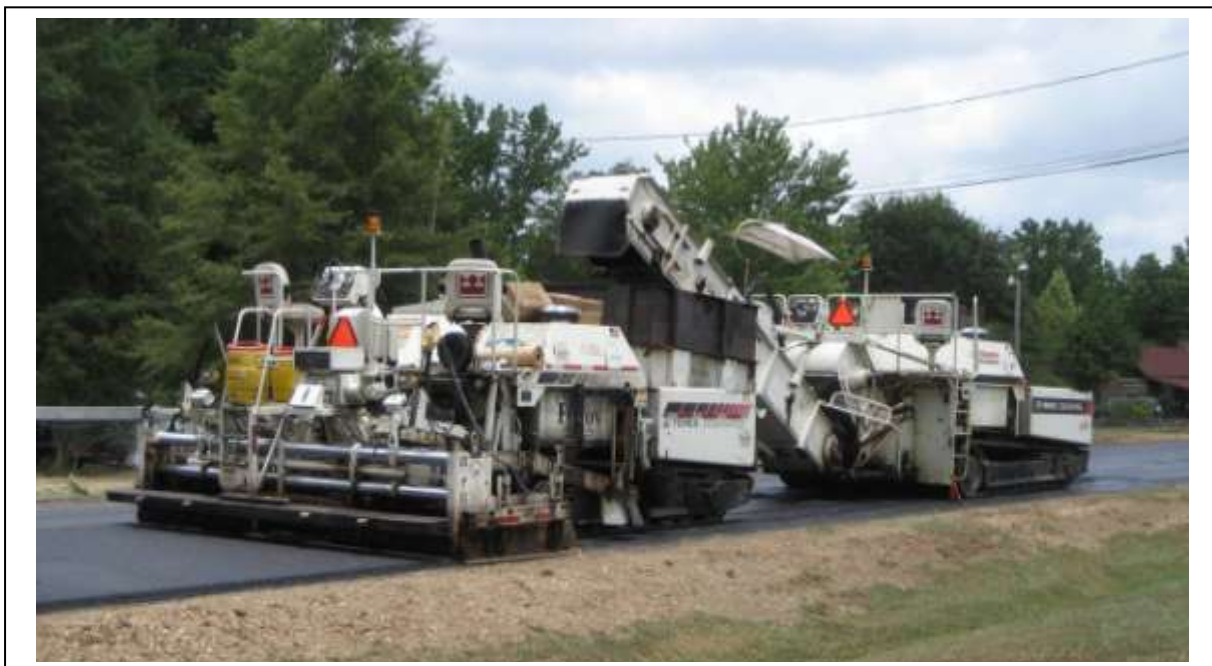
Figure 15. Equipment used to place the HMA overlay.

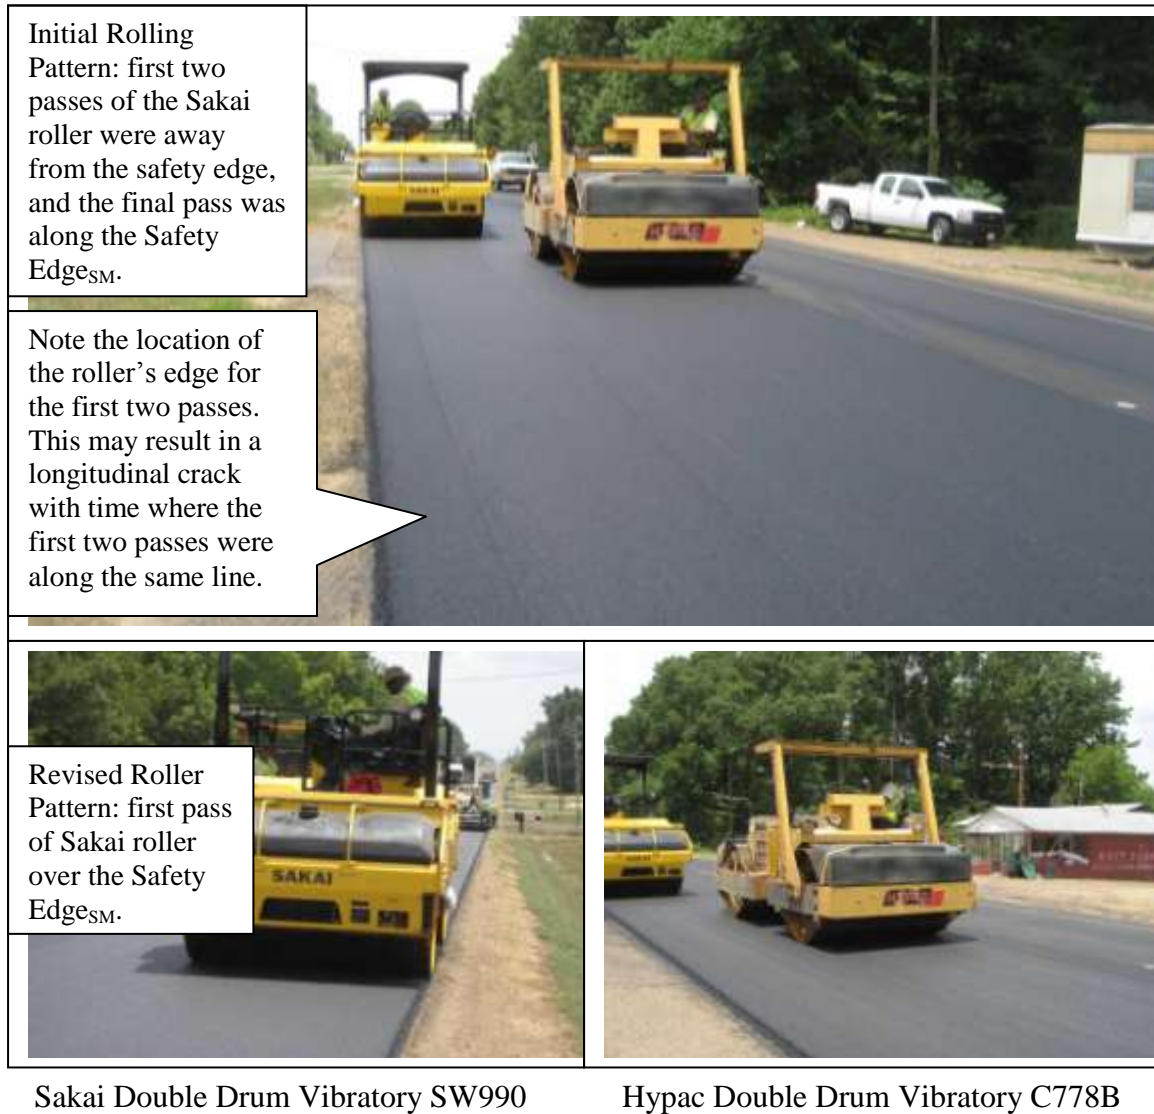
Figure 18. Two double drum vibratory steel wheel rollers were used in parallel in the breakdown position to compact the 9.5 mm HMA mix.

The Safety Edge_{SM} was rolled inconsistently along the project. The rolling pattern used along most of the project, however, was that the first pass of the Sakai breakdown roller was along the Safety Edge_{SM} with the roller extended over the edge of the HMA mat by about 4 to 6 inches (refer to Figures 18 and 20). As noted above, the Sakai roller operator did divert back to initially rolling the mat away from the edge and delayed rolling the edge until the last pass in different locations (refer to Figures 18 and 20). For the initial rolling pattern, the edge of the mat along the Safety Edge_{SM} received only one pass of the breakdown roller. The exact locations of the different rolling patterns were not identified along the project.

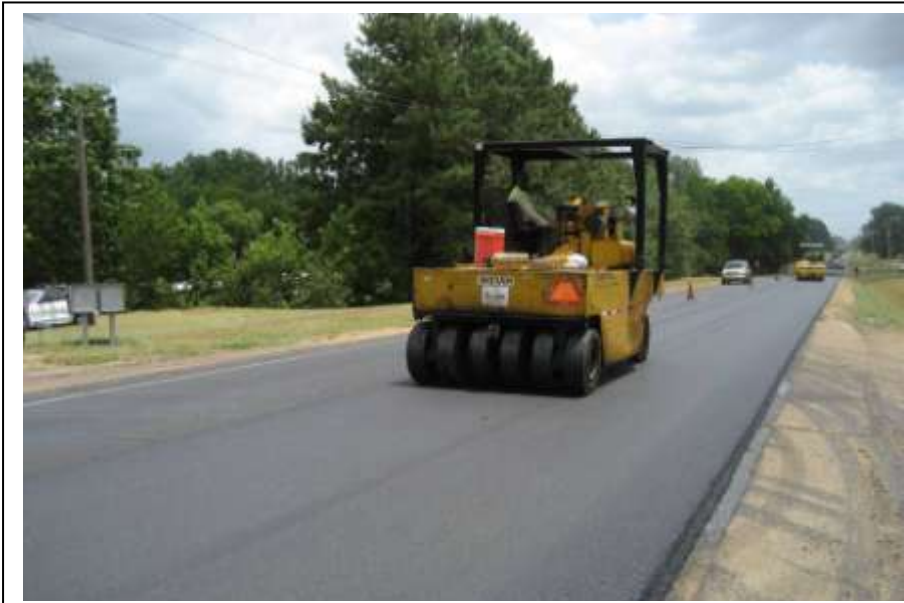
Ingram pneumatic or rubber tired roller (5x6 tires) that was used in the intermediate position.

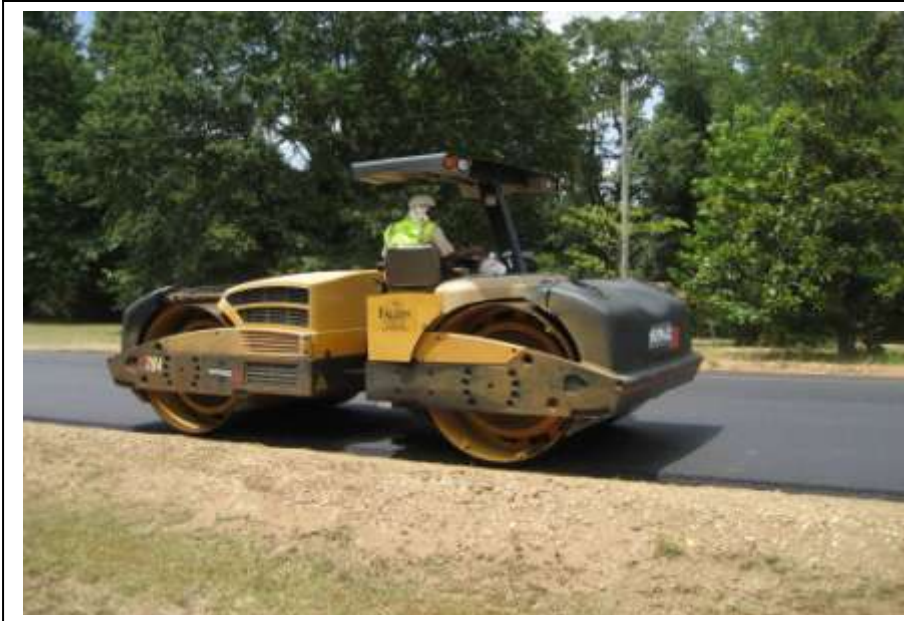
Hypac Double Drum static steel wheel (C784) that was used in the finish position for compacting the HMA overlay.

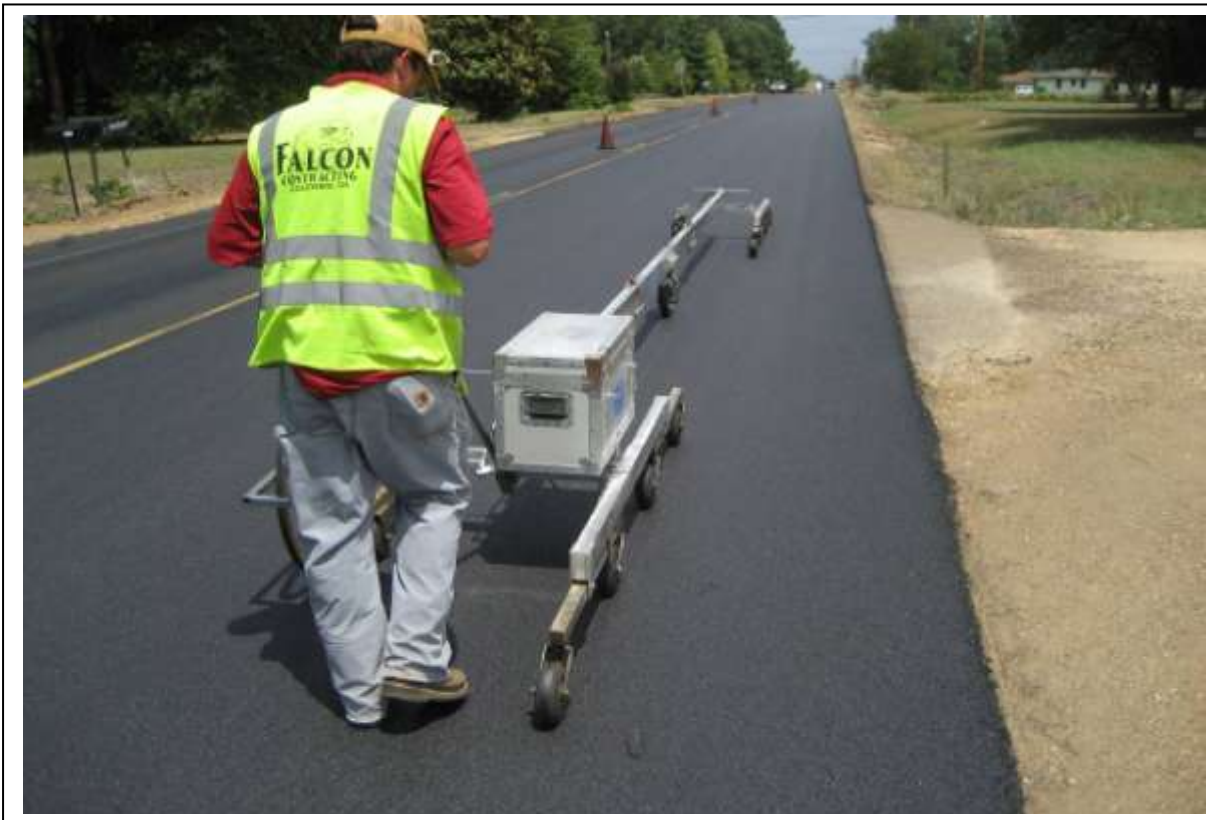
The other concern of the contractor was that the smoothness of the mat would decrease in those areas, and smoothness was a pay item (refer to Figure 24). The contractor requested that the Mississippi DOT permit the Safety Edge_{SM} device to be removed in those areas. It is unknown whether the Mississippi DOT permitted the contractor to remove the Safety Edge_{SM} device in those areas.

Figure 24. Longitudinal Profile Testing of Final Surface of Overlay
