Report No. FHWA/RD-80/158

STABILITY OF RELOCATED STREAM CHANNELS

March 1981
Final Report

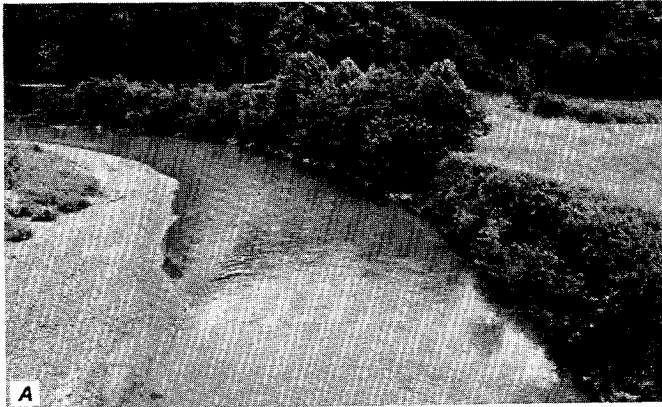
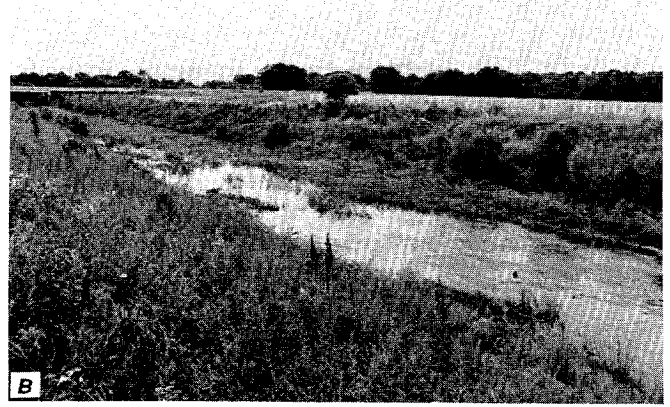
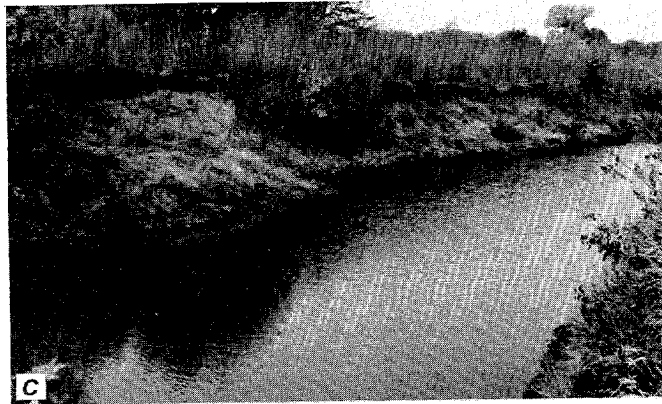
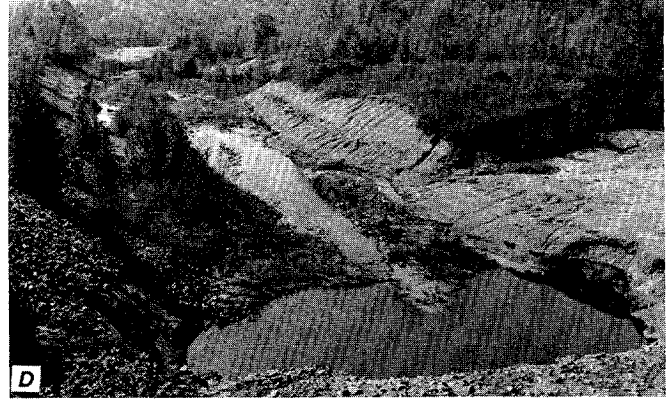
Figure 3. Photographs illustrating bank stability classes. Class A, cut banks rare or absent, Hocking River, Ohio. Class B, cut banks local and not severely cut, Poteau River, Ark. Class C, cut banks local but severely cut or slumped, Big Blue River, Nebr. Class D, banks generally cut or slumped, Crow Creek, Ark.

Typical changes with time in the cross section of a trapezoidal relocated channel, having 2:1 side slopes, are shown in figure 11. In addition, the steepening of side slopes by erosion at the toe is well shown by a photograph of the Poteau River in Arkansas (fig. 3B), where the slopes steepened during a period of 9 yr from an original value of 26.5° to values in the range of 30°-40°. Observed values for the side slopes of relocated channels are within the range of values observed for natural creeks and small rivers, and it is therefore unlikely that the angles will recline as the performance periods are lengthened. Nevertheless, construction of initial side slopes not steeper than 2:1 is a good practice. The steeper the slope, the greater the difficulty in establishing vegetation on it and the more subject it is to failure by slumping. If the growth of vegetation were encouraged by a suitable mulching technique (Normann, 1975), and if no major floods occurred soon after construction, 2:1 slopes could probably be stabilized without much erosion at the toe.

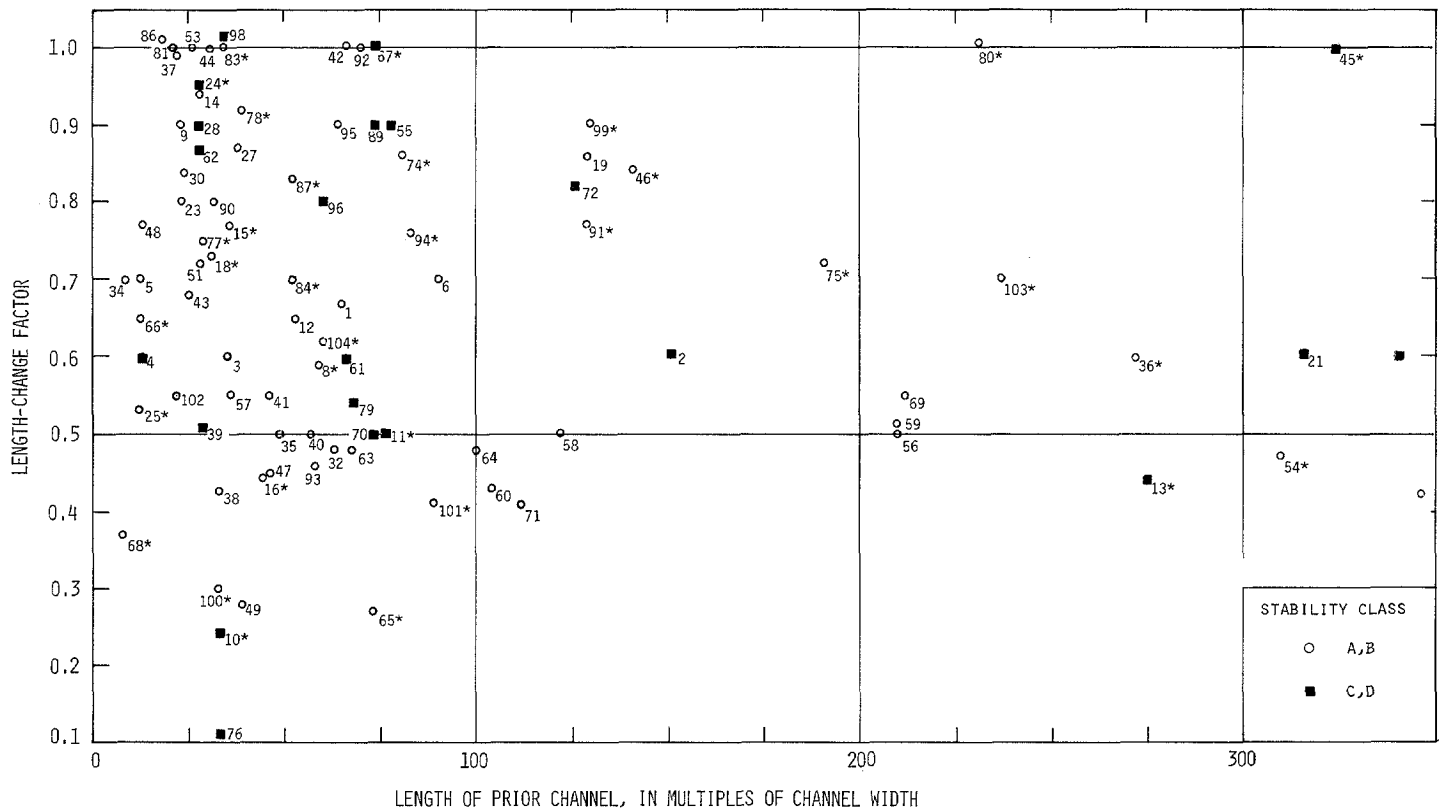
11, 39, 61, 70, and 79 have class C or D stability and the others have A or B stability. At sites 4, 39, and 70 the prior channel had such a high degree of instability that stability of the relocated channel was improbable. Bank erosion at site 61 was due to flow constriction at a bridge, and bank slumping at site 79 was due to high steep side slopes. At site 11, the mouth of a small stream was shifted and its length shortened substantially in relation to its total length. Thus, instability at these sites is due to factors other than length of prior channel.

All the longer relocations (greater than 250 channel widths in length) have class B or C stability, despite the fact that most are protected by erosion-control measures. At site 20 (Bear Creek, Iowa), site 26 (Stevens Creek, Ill.), site 36 (Beargrass Creek, Ky.), and site 54 (Kanaranzi Creek, Minn.), channel degradation has probably been prevented by check dams. At site 45 (Maiden Choice Branch, Md.), the relocated channel is lined with concrete. At the longest relocation in terms of channel width (site 97, Five Mile Run, Pa.; not shown in figure 7), the length of prior channel is 550 channel widths. Degradation has been inhibited by outcrops of bedrock in the channel; banks are stable along some parts of the channel and unstable along others.

Figure 7. Scatter diagram showing stability class of relocated channel in relation to length-change factor and length of prior channel. Numbers refer to sites, and asterisks indicate sites where countermeasures have been effective. Stability class A, cut banks rare or absent; class B, cut banks local and not severely cut; class C, cut banks local and severely cut; class D, banks generally cut or slumped.

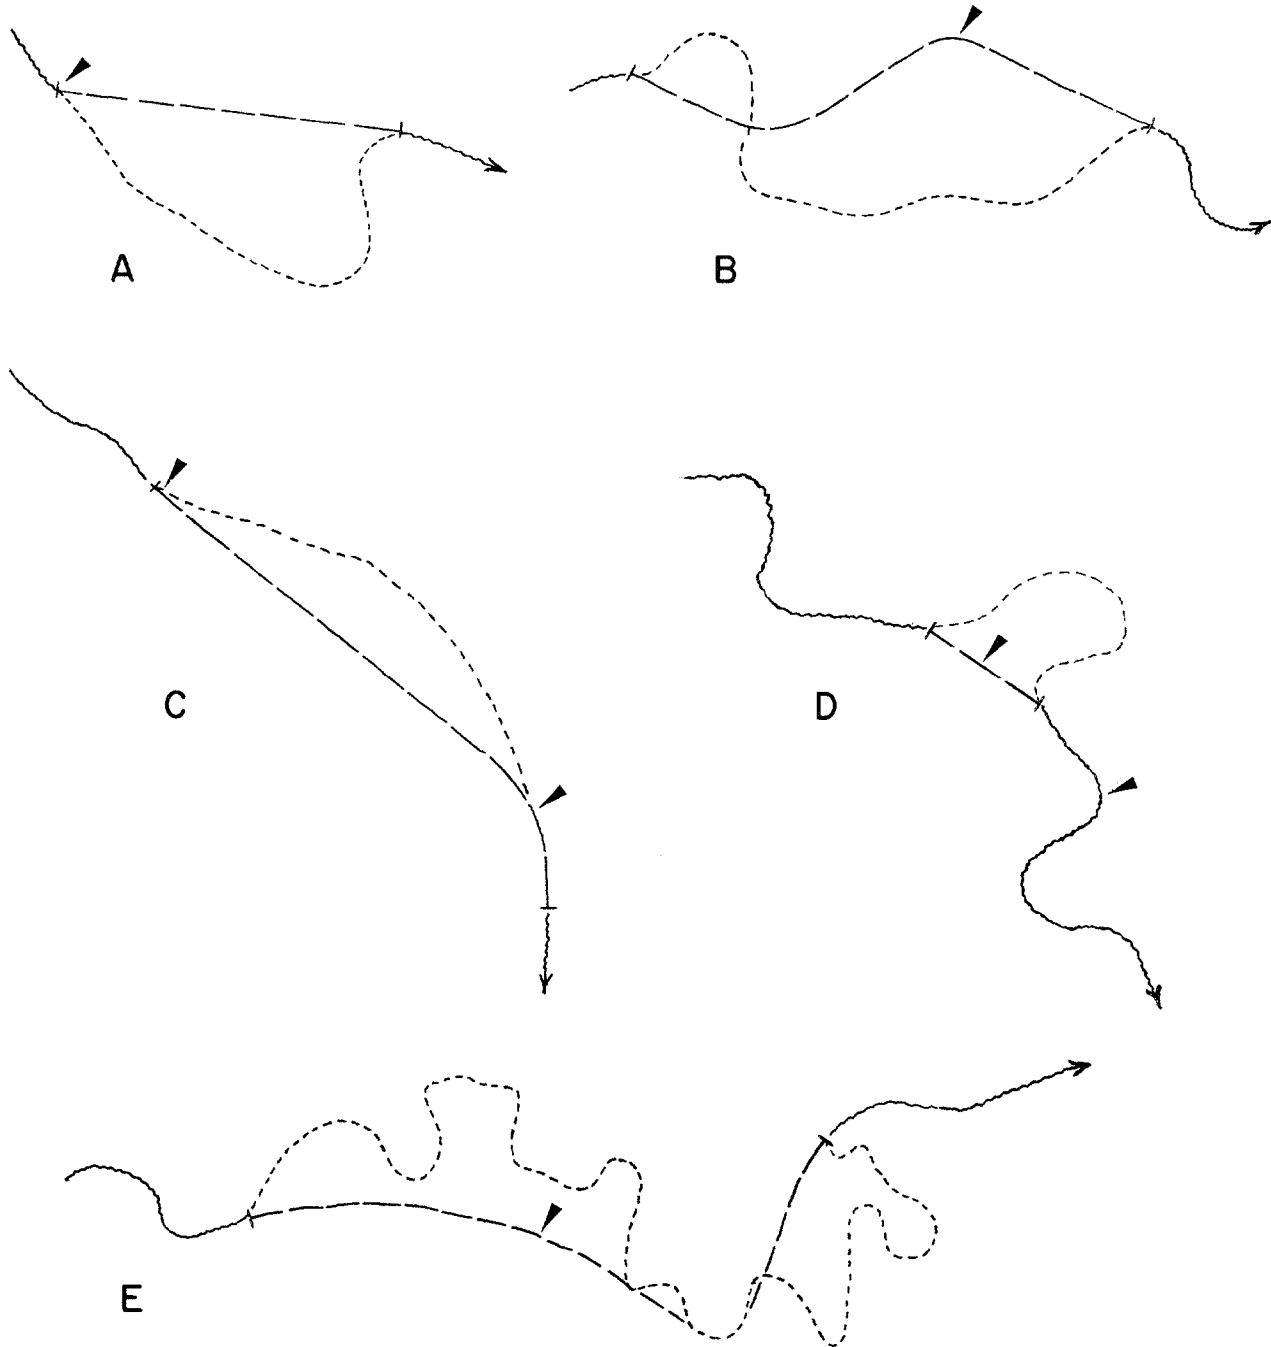
Figure 13. Examples of channel alinement. Prior channel is shown in dotted line, relocated channel in dashed line, and adjacent segments of natural channel in solid line. Arrows indicate points at which bank erosion occurred.

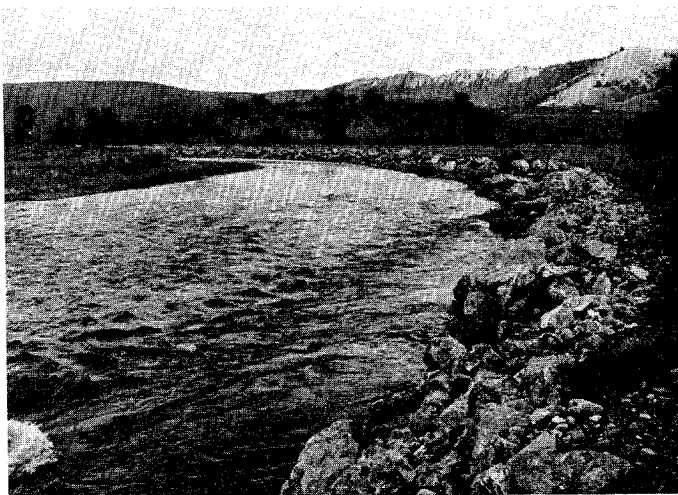
Figure 14. Relocated channel of Clark Fork at artificial meander near Drummond, Mont.

observation in 1979 showed that the meanders were stable, but the appearance was not natural because of the large riprap placed continuously along both banks. The designer of artificial meanders is faced with a dilemma: In order to avoid deterioration of the channel while woody vegetation is becoming established, bank protection measures must be applied and these are likely to look unnatural. In addition, equalling or even exceeding the length of prior channel does not necessarily prevent degradation.

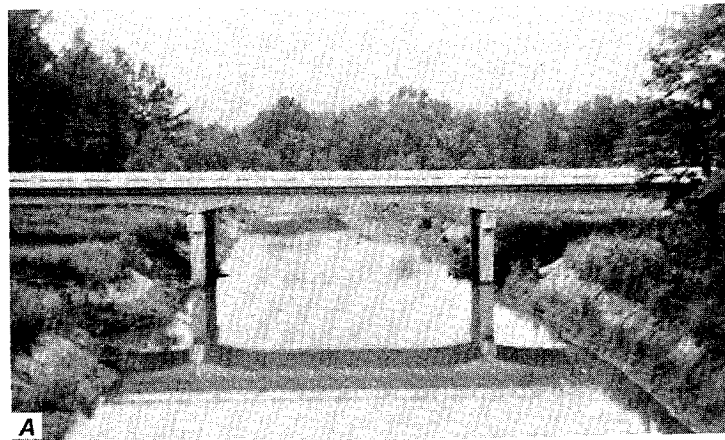
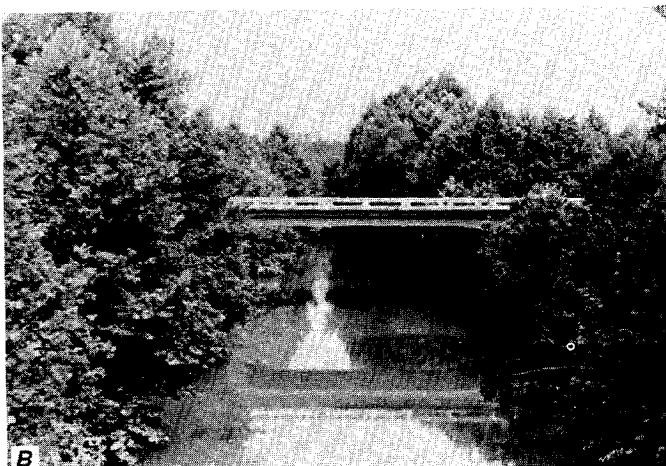
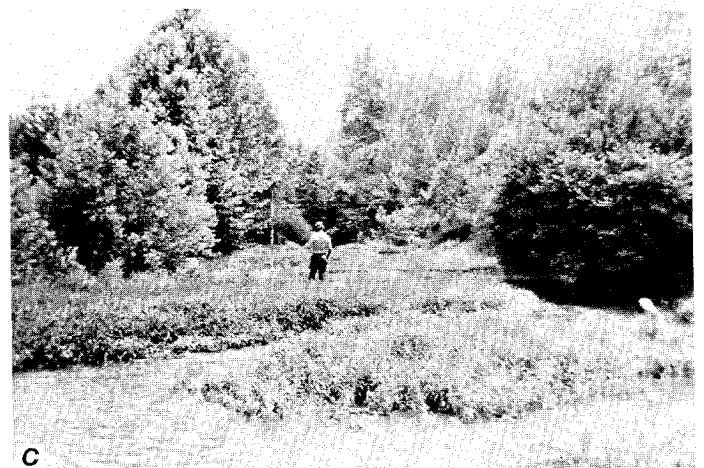
SYNOPSIS--Channel segment was relocated and thereby shortened from a length of 605 m to 400 m, for purpose of improving channel alinement at bridge (fig. 16). Performance period, 17 yr (1961-78) during which the largest flood (in March of 1970) had a recurrence interval of about 10 yr. As built, the relocated channel was trapezoidal in cross section, with a bottom width of 15 m, 1½:1 side slopes, and a longitudinal slope of 3.5 m/km. No bank protection measures were applied. This site was reported on by Jefferson (1965), who observed minor bank erosion near the bend in the relocated channel but saw no evidence of instability elsewhere. Channel cross sections were surveyed by the U.S. Geological Survey in 1965, and these same sections were resurveyed in 1978 (fig. 17). The right bank at section 1 receded about 6 m during the period 1965-78, a lesser amount of bank erosion occurred in section 2, and none at section 4. The surveys also indicate about 0.6 m of degradation at sections 1 and 2, but aggradation at section 4. By 1978, the bankline had become densely vegetated (figs. 18A and 18B) and the cut banks, although present, seemed not to be receding. Grass had become established on alternate gravel bars in the channel (fig. 18C), and these may lead to development of sinuosity.

Figure 18. Big Canoe Creek at site 1. A, View upstream along relocated channel from downstream bridge, in 1965. B, View from same point as in A, in 1978. C, View upstream along relocated channel from section 1, in 1978.

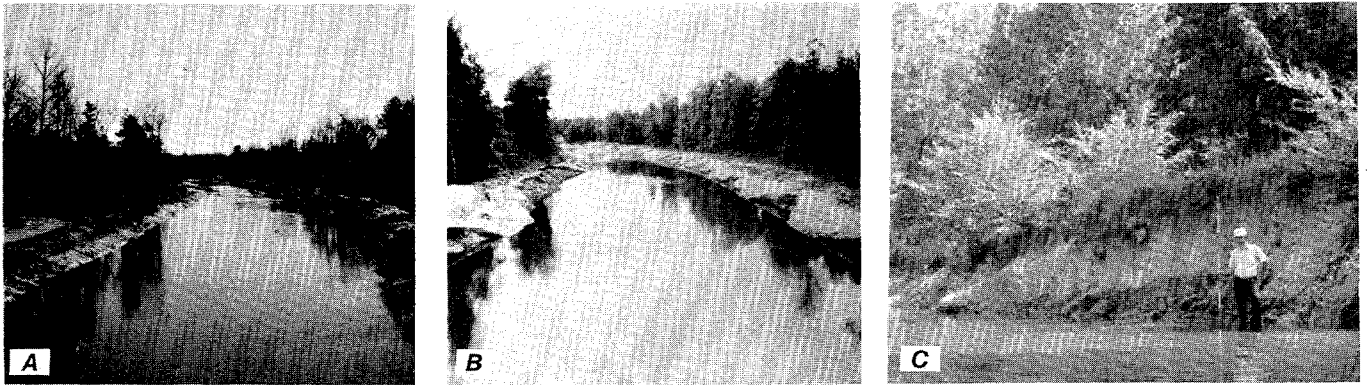
DISCUSSION--The timing of floods in relation to channel relocation is a definite factor in channel stability, and the flood at this site occurred at an unfortunate time. Even if an attempt had been made to plant vegetation along the banks, it could scarcely have become well enough established to inhibit bank slumping. If further bank erosion is to be controlled under such circumstances, it would be necessary to regrade the banks after the flood and apply a vegetal lining or some other bank protection measure.

Figure 20. Calebee Creek at site 2. A, Relocated channel as viewed upstream from interstate bridge, on January 19, 1964. B, View from same point as in A, on April 22, 1964. C, Bank erosion at section 2, on August 28, 1978.

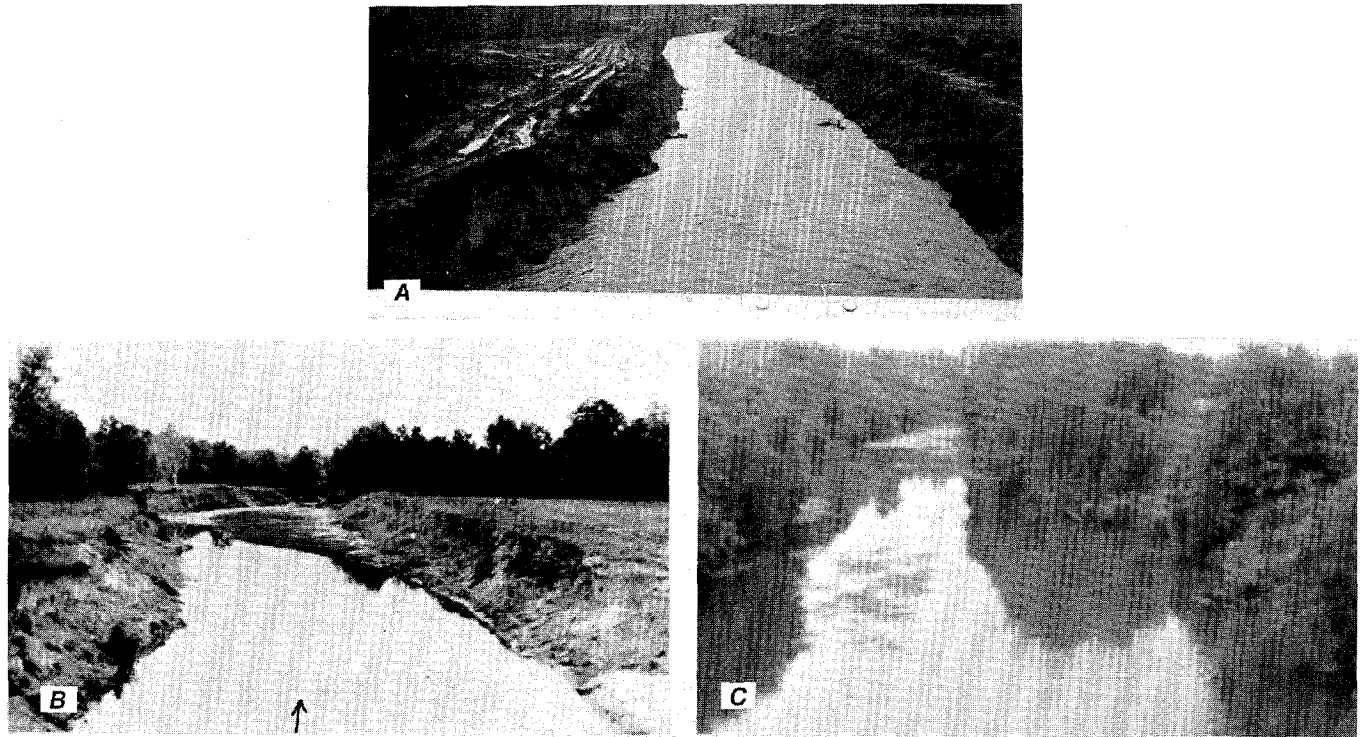
cantly during the period 1965-78, and in 1978 trees were well established along the bankline (fig. 23C). As observed on a 1955 airphoto, meandering reaches of the natural channel were decidedly unstable, as indicated by almost continuous cut banks and wide point bars. On a 1974 airphoto, the pattern of the natural channel is much changed because of many meander cutoffs, but the degree of instability is about the same as in 1955.

Stability class B4 for relocated channel and class C4 for adjacent segments of natural channel. Lateral instability of the relocated channel is attributed to its narrow width, to erodibility of the bank materials, and to the occurrence of a major flood almost immediately after construction.

Figure 23. Cedar Creek at site 3. A, Relocated channel as viewed downstream from bridge, in January 1961. B, Same view as A, in June 1962. C, Same view as A, in August 1978.

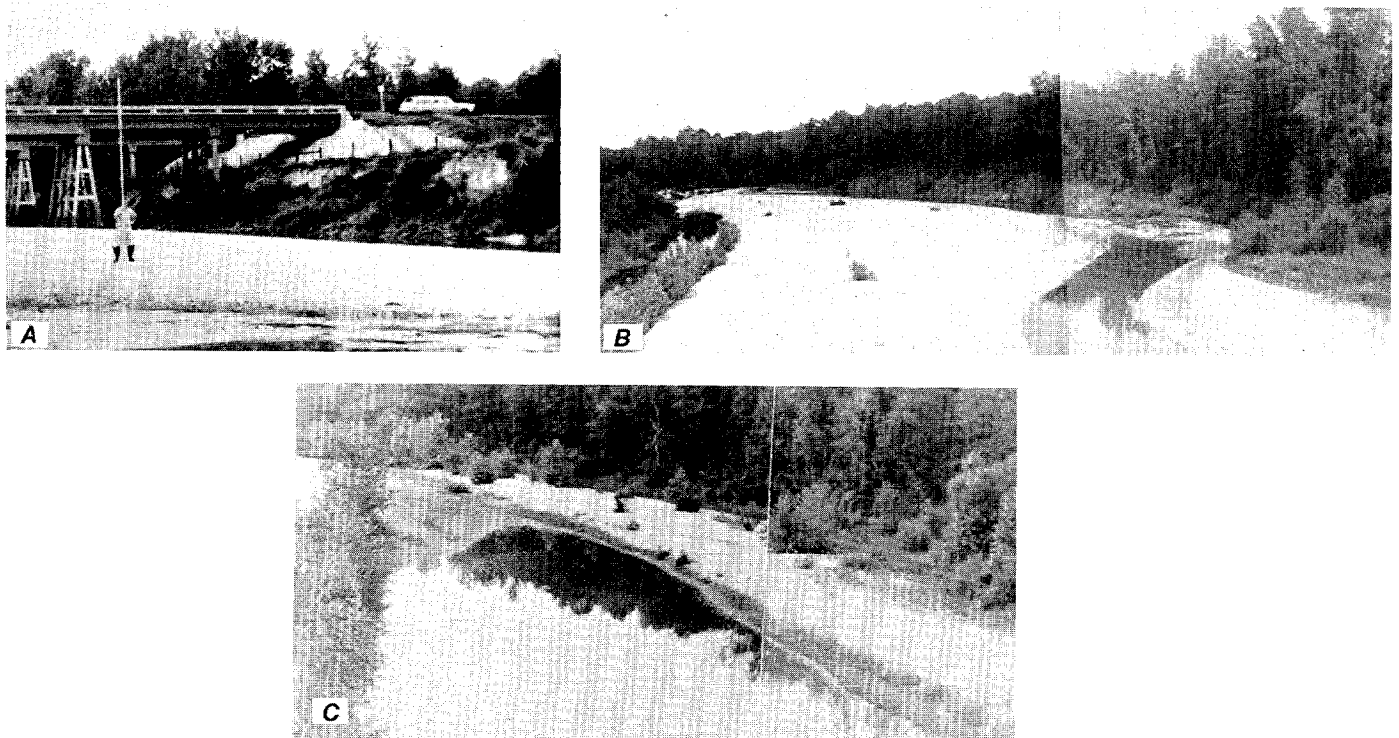
DISCUSSION--Widening of the relocated channel, although severe, was predictable in view of the prior instability of the natural channel and the lack of countermeasures. The channel is not likely to increase much in width, but lateral erosion is probable as the thalweg shifts from side to side within the wide channel.

Figure 26. Line Creek at site 4. A, Lateral erosion at right abutment of interstate bridge, as photographed in 1965. Pile bent behind man was originally at toe of abutment fill slope. B, Relocated channel as seen downstream from interstate bridge, in 1966. C, Same view as B, as photographed in 1978. Channel has shifted to left.

upstream from the bridge in 1964-65, riprap was placed at the abutments and the eroded bank indentation was filled and revetted with riprap. Bank erosion at the surveyed cross sections has progressed little since 1965 (fig. 27), and trees have become well established along the bankline (fig. 26C).

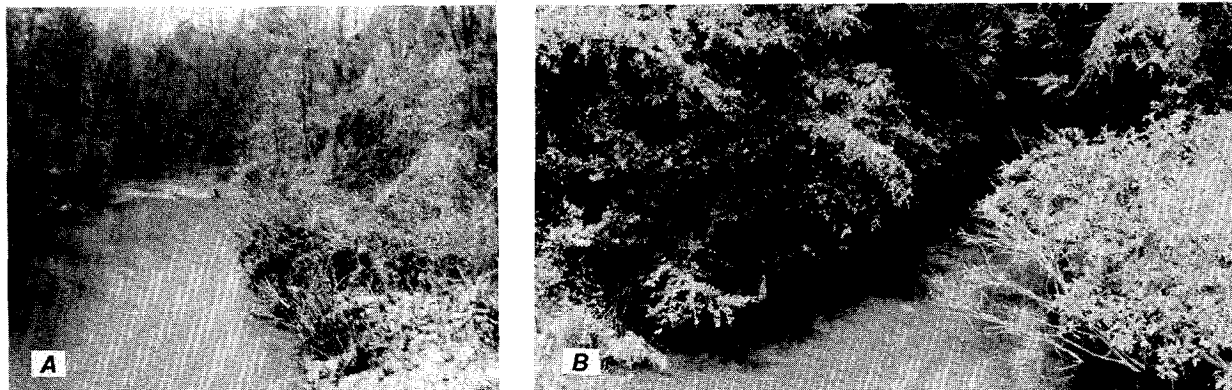
SYNOPSIS--Channel of stream flowing through swampy and densely forested flood plain was relocated to improve channel alignment and flow conveyance through bridge opening; a channel segment 145 m in length was straightened and shortened to 100 m (fig. 28). Performance period, 24 yr (1954-78), during which a 25-yr flood occurred in February 1961. Relocated channel was trapezoidal in cross section, with a bottom width of 6 m, 1.5:1 side slopes, and a channel slope of 1.5 m/km. No countermeasures were applied. In January 1964, the site was observed by Jefferson (1965), who reported no evidence of instability (fig. 29A) and noted that the natural low-water channel was inefficient at high water stages. However, minor bank erosion near the bridge, perhaps caused by drainage along the roadway embankment, was photographed in April 1964 by members of the U.S. Geological Survey. In June 1978, the site was revisited by the Geological Survey. Although cut banks in moderately coherent clayey sand were observed, the banks were vegetated (fig. 29B) and the channel had not enlarged. Water in the relocated channel was ponded by a beaver dam downstream.

Figure 29. Little Lubbub Creek at site 5. A, View upstream from bridge along relocated channel in January 1964. B, Same view as in A, June 1978.

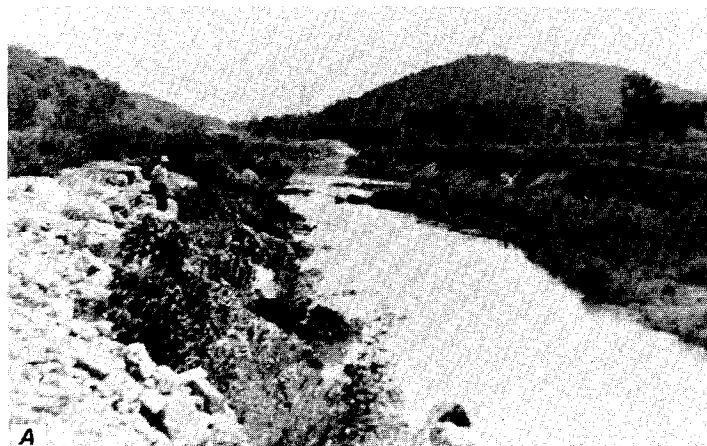
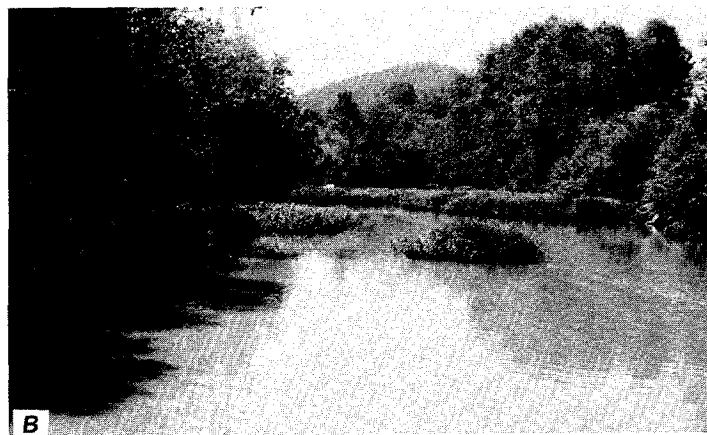
DISCUSSION--The bottom width of the relocated channel was about 1.5 times that of the natural channel; consequently, bars have formed in the relocated channel and these may eventually induce sinuosity. The angular junctions of the relocated channel with the natural channel (fig. 30) might have been expected to induce bank erosion; but this has not occurred, evidently because of the resistance of the bank materials. However, a scour hole about 2.5 m deep has formed in the channel bed at the downstream junction.

Figure 33. Ohatchee Creek at site 6. A, View downstream along relocated channel near station 3, in 1967. B, View downstream along relocated channel near station 3, in 1978.

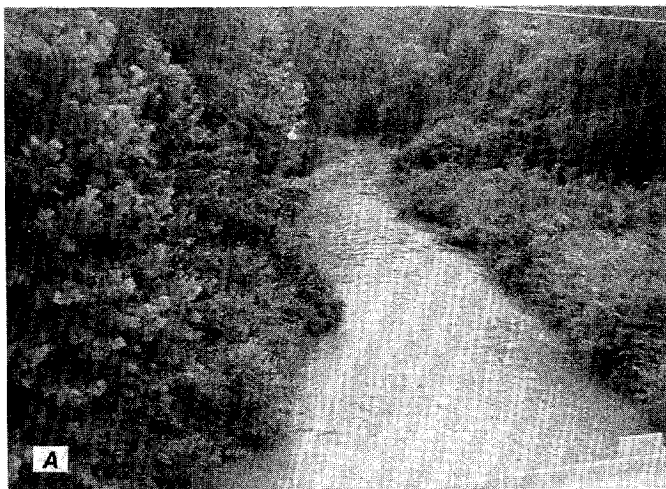
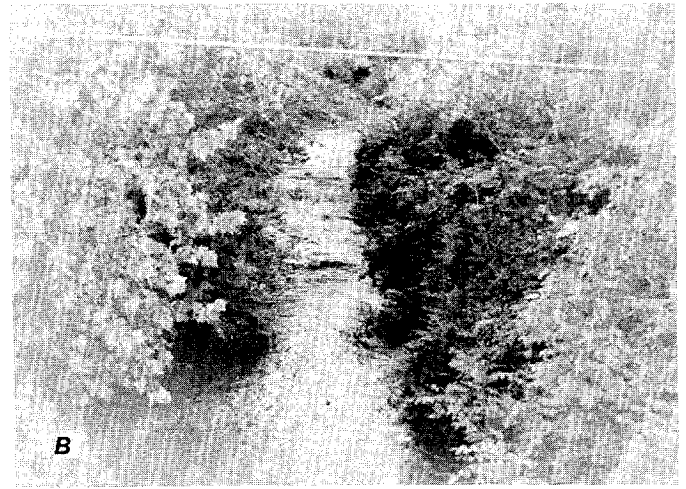
DISCUSSION--The dredged bypass channel has served the intended purpose of diverting flood flow through a relief bridge that would, in the absence of the channel, have been built longer to span both arms of the oxbow depression. The risk that the stream would be entirely diverted through the dredged channel seems not to have been considered in design, but such diversion has not occurred and seems unlikely now. Banks of the dredged channel have been stabilized by vegetation, and the natural channel remains stable.

Figure 36. West Fork Choctawatchee River at site 7. A, View downstream along bypass from bridge, in 1965. B, View downstream along bypass channel from bridge, in 1978.

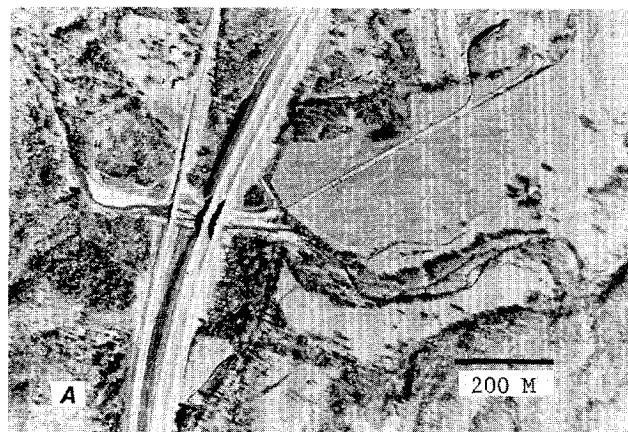
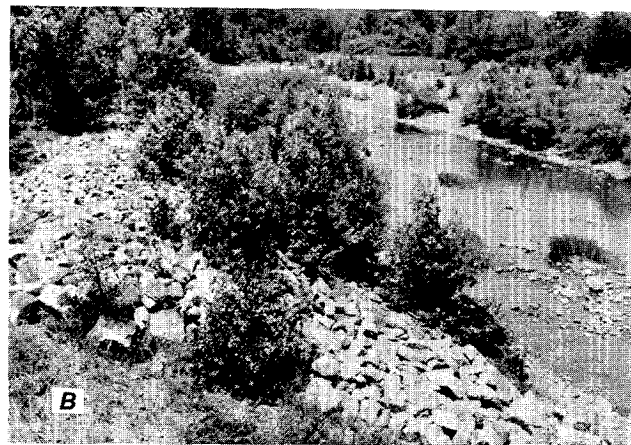
POST-ALTERATION FACTORS--Upstream from the SR-84 bridge, near the junction of natural and relocated channel, the relocated channel has widened from an as-built width of 25 m to a width of 36 m in 1979. Channel degradation has been precluded by an outcrop of resistant bedrock in the channel upstream from the SR-84 bridge. No further floods have occurred since 1968, but the existing bank protection appears to be competent to resist further bank erosion.

DISCUSSION--The upstream junction of natural and relocated channel was sufficiently angular to require the use of bank protection measures, in view of the erodibility of the banks and the magnitude of the flood.

Figure 38. Blakley Creek at site 8. A, Airphoto of channel relocation, in 1976. (From Arkansas Dept. of Transportation) B, Upstream view of relocated channel in 1979, showing rock dike at right bank near SR-84 bridge.

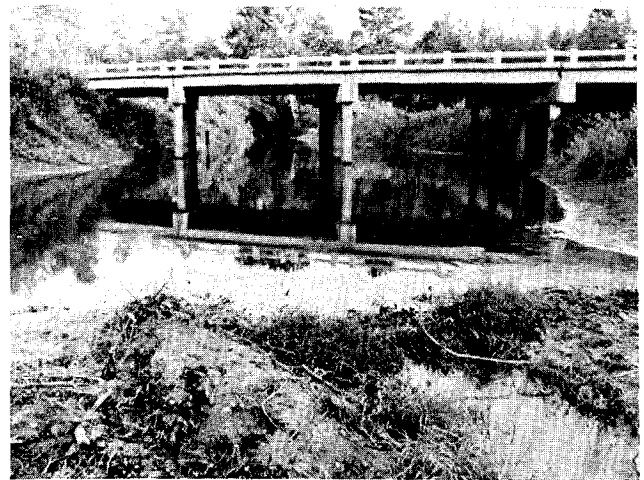
POST-ALTERATION FACTORS--In 1973, shortly after construction was completed, a flood estimated at 50-yr or greater recurrence interval caused erosion of the bridge abutment fill slopes and roadway embankment, and general scour at the bridge opening; similar erosion, to a lesser degree, occurred in 1975. The eroded areas were filled in, but no riprap or other bank protection measures were applied. Establishment of vegetation along the channel was delayed by these floods, but by 1979 young trees were beginning to grow along the banks.

DISCUSSION--The relocated channel was widened and deepened by erosion at the bridge because of constriction of flood plain flow. Elsewhere, the relocated channel has not increased in top width, but its original configuration has been much changed by fill and scour. The erosion that occurred is attributed to the fact that the recently constructed channel was unvegetated and unprotected by countermeasures. No effect of the relocation on the natural channel, which is bordered by dense forest, could be discerned. The relocated channel seems well designed, and its width, greater by a factor of 2 than the natural channel, is probably justified by the severe floods to which this area is subject. The pool at the bridge is analogous to scour pools that commonly form at relief bridges. This pool will probably remain and become stabilized by vegetal growth along the banks and the rest of the relocated channel will probably be stabilized and constricted by vegetation.

Figure 40. Sandy Creek at site 9. Upstream view toward bridge in 1979, showing area scoured during flood in 1975.

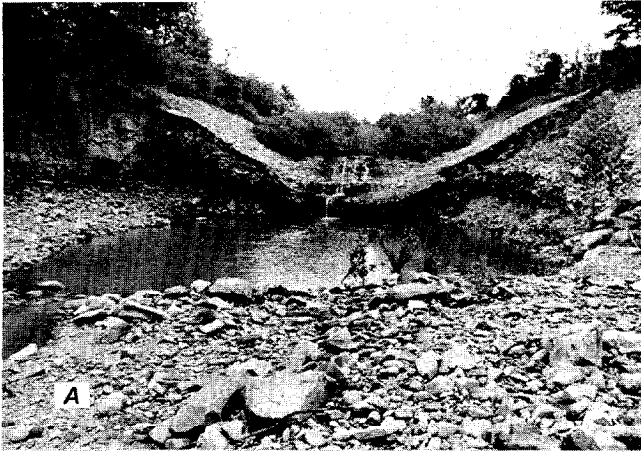
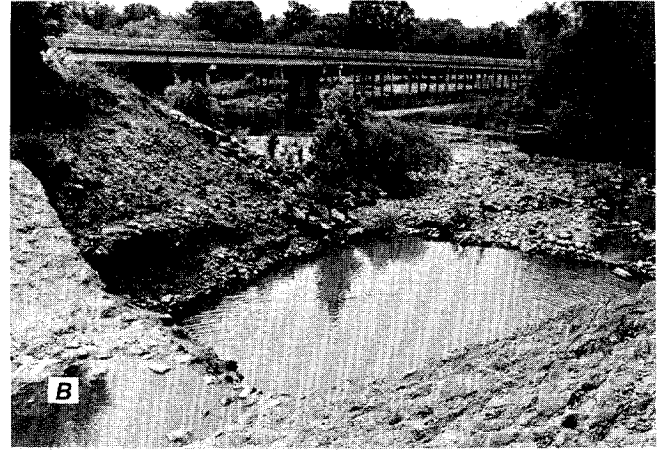
In 1979, a large scour hole having a depth of 1-2 m was observed below the check dam (figs. 43A and 43B), and the downstream end of the check dam was undermined. The top width of the relocated channel had not increased along most of its length but degradation estimated at 1-2 m had occurred prior to construction of the check dam and bank erosion had occurred at the upstream and downstream ends of the relocation (figs. 43A and 43C). About 1 m of degradation was observed on the natural channel upstream from the relocation (fig. 43D).

POST-ALTERATION FACTORS--Channel degradation was apparently a major reason for construction of the check dam, but there is no record of the actual amount of degradation at the time the dam was built. However, the gravel bar at the tributary entrance was mostly derived from bank erosion at the entrance and from bed scour at the check dam overfall. Rock riprap placed along the banks downstream from the check dam has been most removed by erosion (fig. 43B).

DISCUSSION--In 1979, the lip of the check dam stood 2.5 m above the surface of the plunge pool at its base. If the check dam fails, degradation will proceed upstream along the tributary, but it will be detained by the resistant cemented gravel in the streambed. The most serious erosion has been induced by overfall at the check dam. Overfall of this magnitude could probably have been prevented by a series of low, flexible check dams of rock riprap, rather than a single check dam.

Figure 43. Tributary to Caddo River at site 11. A, Check dam at entrance of tributary to Caddo River in 1979. B, Scour hole at base of check dam, Caddo River and I-30 bridge in background, in 1979. C, Downstream view near upstream end of relocated channel, in 1979. D, Natural channel about 50 m upstream from relocated channel, in 1979.

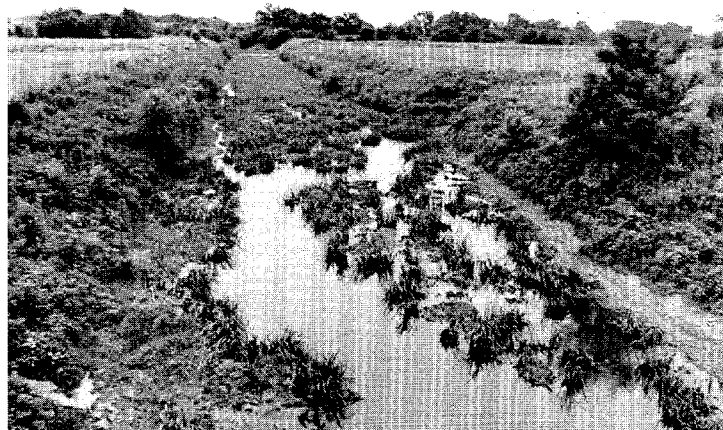
POST-ALTERATION FACTORS--Although the site is ungaged for streamflow, lines of debris indicate that overbank flow has occurred at least once since channel relocation. There is no evidence of post-construction maintenance at the site. Young trees have become established at the toe of banks along the relocated channel (fig. 45).

DISCUSSION--Bank stability has probably been enhanced along the relocated channel by its greater bottom width (18 m as compared with 12 m for the natural channel), but this has led to a growth of vegetation in the channel bottom.

Figure 45. Relocated channel of Poteau River, upstream from US-71 bridge, in 1979.

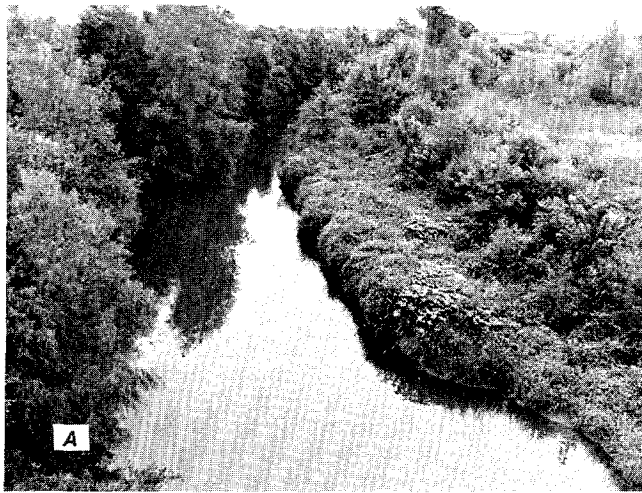
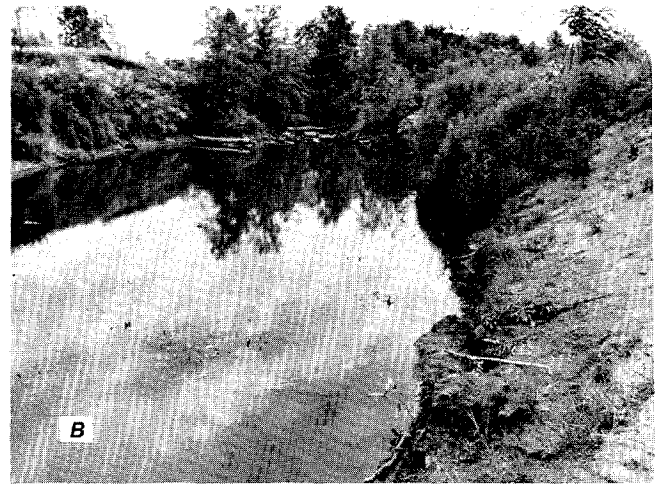
ALTERATION AND POST-ALTERATION FACTORS--Channel length was reduced by a factor of 0.45, with a consequent substantial increase in slope. At the upstream end of the relocation, the natural channel is crossed by a length of iron pipe and a low dam of siltstone riprap (fig. 47B) that evidently represents a check dam, although none is specified on the plans. Bank erosion has occurred downstream from this dam and is attributed to overfall at the dam. Elsewhere, the banks of the relocated channel were stable and well vegetated, and channel width has decreased upstream from the bridge.

Figure 47. Flat Rock Creek at site 13. A, View upstream from I-405 bridge, in 1979. B, Upstream end of relocated channel, in 1979.

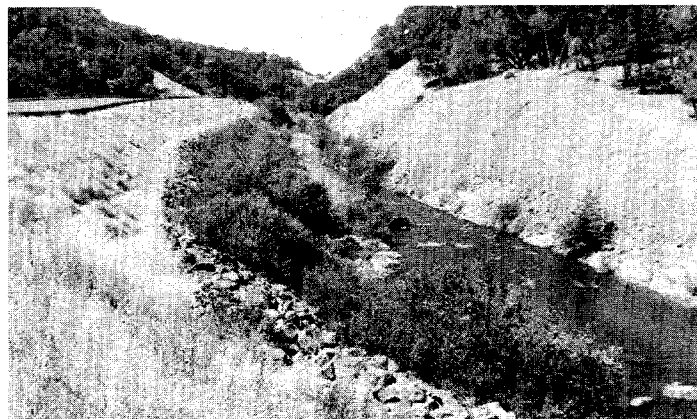
POST-ALTERATION FACTORS--There is no record of maintenance or installation of additional countermeasures at the site, and no slumping or bank erosion was evident when the site was inspected in September, 1978. Shrubs and small trees had become well established in the riprap along the left bank.

DISCUSSION--Slumping of the alluvium (or colluvium) in the upper part of the right bank may occur at some future time, and this could result in blockage of the relocated channel.

Figure 49. View downstream along channel relocation, East Fork Russian River, in 1978.

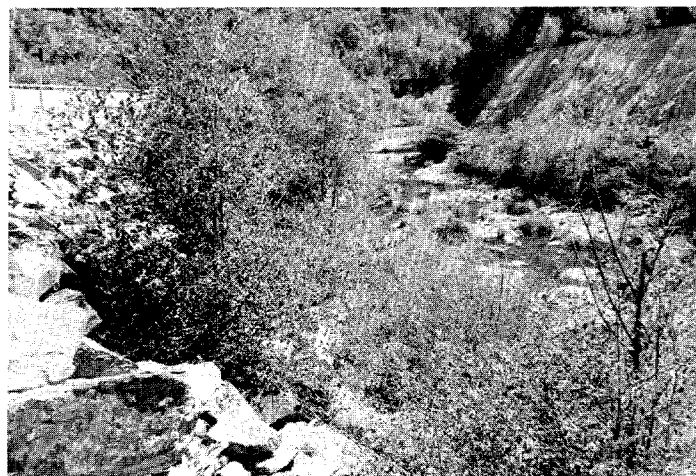
POST-ALTERATION FACTORS--No maintenance work, following the extreme flood of 1964, is apparent. Small trees have become established on the riprapped highway embankment and along the base of the cut slope (fig. 51).

Figure 51. View upstream along relocated channel of Outlet Creek, in 1978.

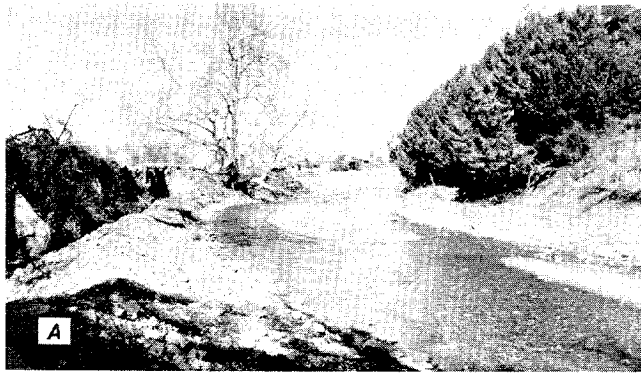
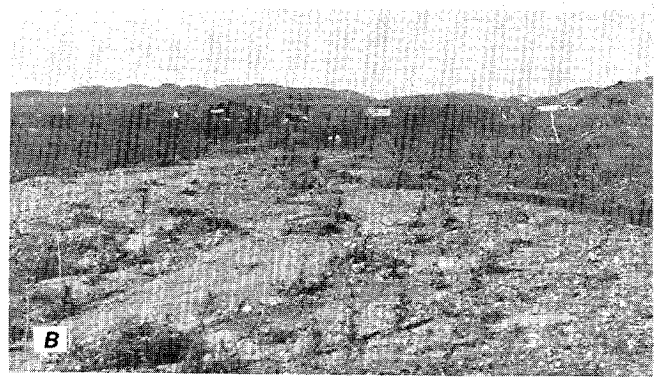
POST-ALTERATION FACTORS--Floods having an estimated recurrence interval of greater than 25 yrs occurred in 1969 and 1978. The banks of the natural channel at a bend upstream from the re-location were severely eroded in 1978 (fig. 53A), and the channel was subsequently realigned by the bulldozing of bed material against the banks. The flood apparently disrupted the riprap facing of dikes along the relocated channel, but there is no evidence that the dikes were broken. Young willows and other vegetation have become established along the dikes and, locally, in the channel bottom.

DISCUSSION--Because the bottom width of the relocated channel is more than twice that of the natural channel, a sinuous low-water channel has developed (fig. 53B), which may eventually erode laterally against the bounding dikes. In addition, the wide bottom may become overgrown with willows, which will impair its transmission of floods. As depicted on 1957 airphotos, the reach of natural channel subsequently to be re-located was nondescript in appearance, already disturbed by road construction, and not much more attractive in appearance than the present relocated channel.

Figure 53. Nojoqui Creek at site 16. A, Bank erosion, extreme left, upstream from relocated channel, in 1979. B, Downstream view along relocated channel, in 1979.

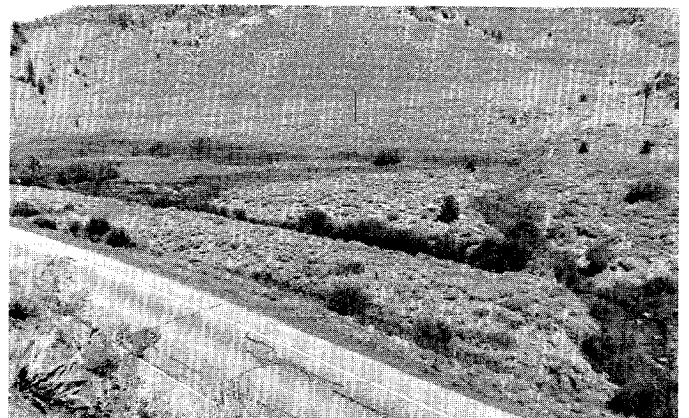
POST-ALTERATION FACTORS--There is no evidence of serious flooding or of maintenance at the site during the performance period, and drainage at the upper end of the relocated channel has been ponded by a beaver dam. Vegetation has become established along part of the channel (fig. 55).

Figure 55. View of relocated channel of Swauger Creek in 1978. Flow is to right.

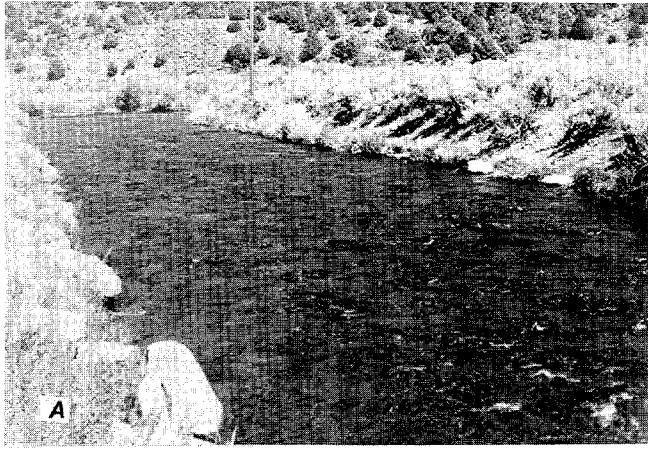
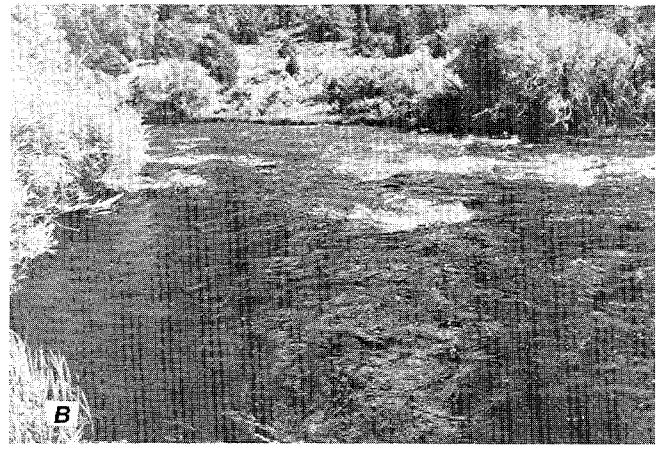
SYNOPSIS--Channel relocation, reach 370 m in length shortened and moved laterally by 70 m to avoid sharp curve in new roadway (fig. 56). Performance period 25 yr, 1954-1978. Streamflow is regulated by upstream reservoir, and no major floods occurred during performance period; although a peak flow of $39 \text{ m}^3/\text{s}$ (ten times average discharge) occurred in 1963. Left bank of relocated channel is riprapped roadway embankment, right bank is in alluvium. Regeneration of vegetation, mainly willows, has occurred for about half the length of the right bank; the rest, although partially bare, is not actively eroding (fig. 57A). No effect of relocation on the natural channel could be discerned (fig. 57B).

Figure 57. East Walker River at site 18. A, View downstream, about midway along re-located channel, in 1978. B, Natural channel about 30 m downstream from relocation.

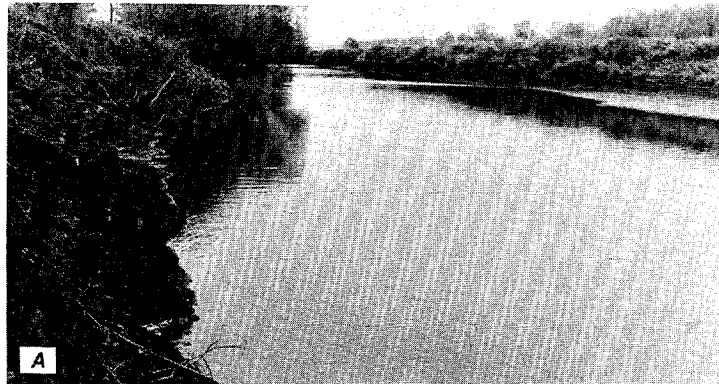
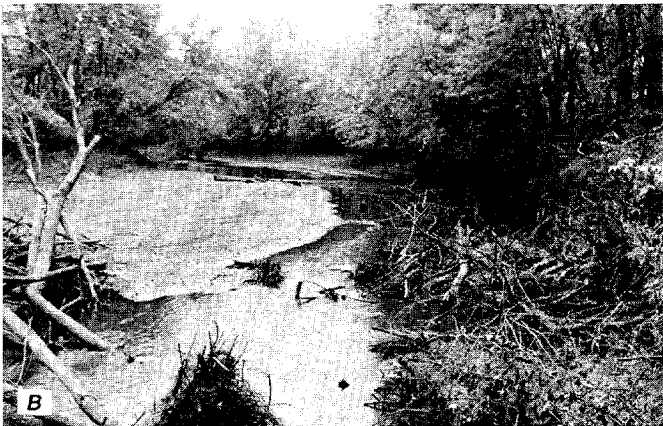
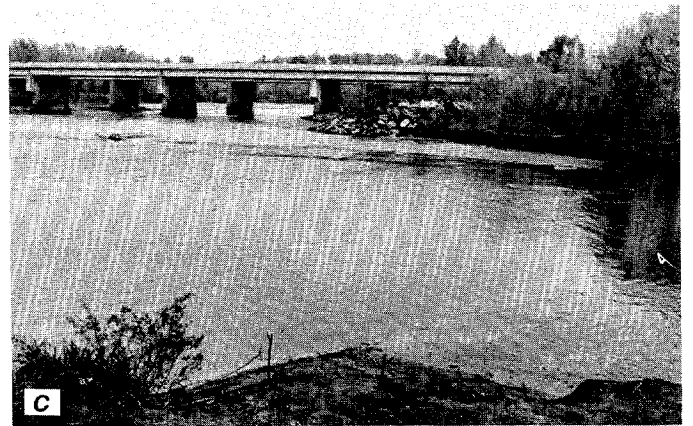
SYNOPSIS--A channel segment of Beaver Creek extending 2,200 m above its junction with Des Moines River was relocated and thereby shortened to 1,950 m; and the junction was moved upstream on the Des Moines River (fig 58). The purpose of the relocation was evidently to avoid a crossing of Beaver Creek. Performance period, 18 yr (1961-79), during which the highest flow in an 18-yr period of record occurred in 1974. Relocation was effected by diverting flow along a pilot channel having a bottom width of 12 m and a slope of 1.17 m/km. In 1979, bottom width of the relocated channel ranged from 30 to 40 m. About half of the bankline was bordered by trees, and the rest was bordered by grass. The streamward face of the banks was mostly unvegetated and small scale slumping was common (fig. 59A), but bank recession was judged to be slow. Upstream from the relocation, the natural channel was eroding rapidly at bends (fig. 59B).

In connection with the relocation of Beaver Creek, a meander of the Des Moines River was cut off, with little change in channel length, to improve channel alinement at the interstate bridge (fig. 58). Subsequently, an island has formed in the channel upstream from the bridge (opposite the relocated mouth of Beaver Creek), and flow has been diverted toward the west bridge abutment (fig. 59C). Riprap has been placed

DISCUSSION--Bottom width of the relocated channel of Beaver Creek has increased from 12 m (pilot channel) in 1961 to 30-40 m in 1979. By comparison, the bottom width of the natural channel was in the range of 15-20 m in 1955. No sinuosity of the thalweg within the wide relocated channel was observed in 1979, but such sinuosity is likely to develop. The relocated channel is unattractive in aspect, although the area has potential for recreation.

Relocation of the Des Moines River has led to a bank erosion problem near the west bridge abutment because of the growth of an island in the channel. Islands are uncommon in the Des Moines River, and this one is probably due to sediment discharged into the Des Moines from Beaver Creek and derived from eroding banks of relocated Beaver Creek.

Figure 59. Beaver Creek at site 19. A, Downstream view of relocated channel, about midway of its length, in 1979. Note small scale slumping of cohesive clay in foreground. B, Natural channel of Beaver Creek, upstream from relocation, in 1979. C, Junction of Beaver Creek, right, and Des Moines River; interstate bridge across Des Moines River in background.
