Report No. FHWA/RD-80/158

STABILITY OF RELOCATED STREAM CHANNELS

March 1981
Final Report

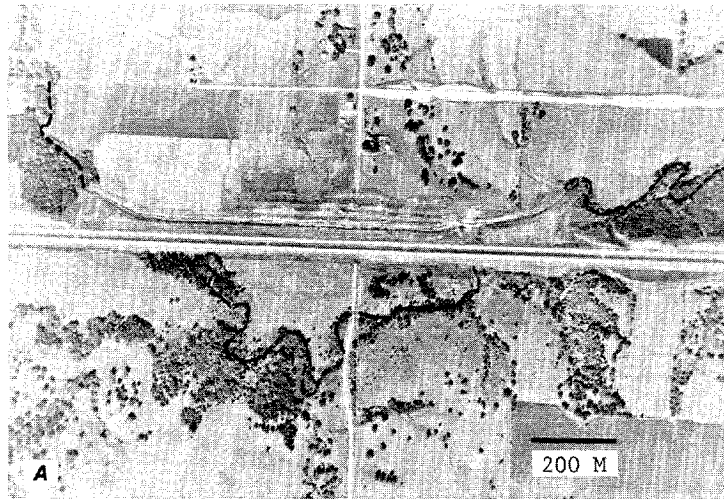
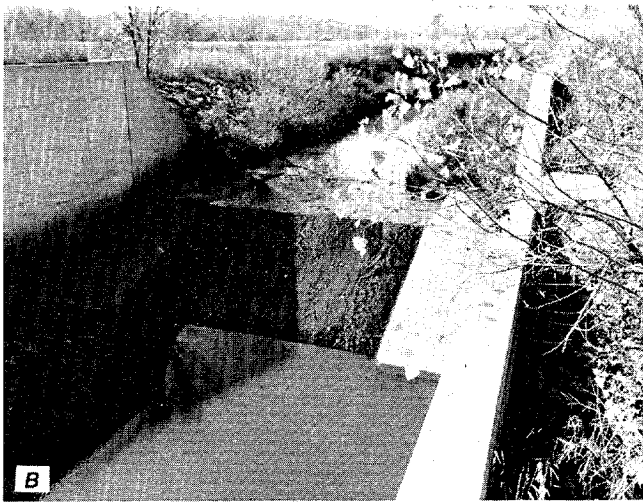
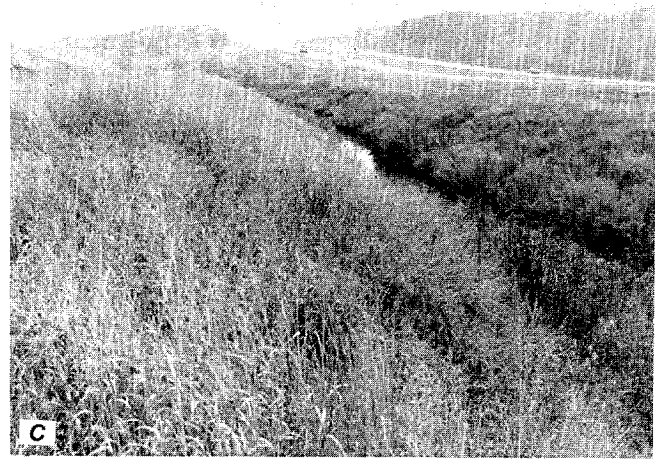
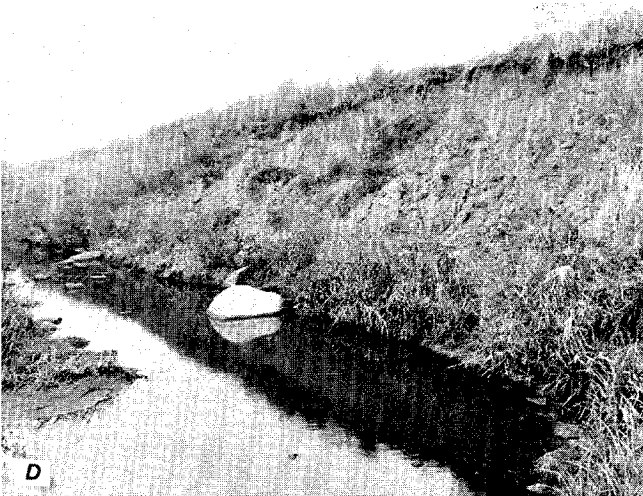
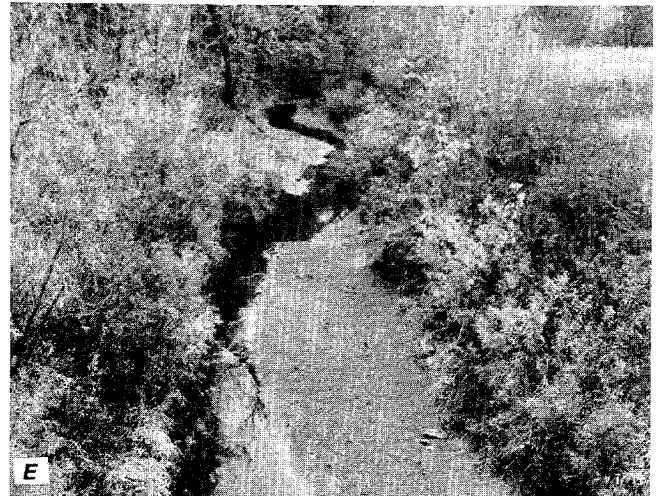
SYNOPSIS--A channel segment 2,050 m in length was relocated and thereby shortened to 1,200 m, in order to avoid two stream crossings (figs. 60 and 61A). Performance period, 13 yr (1966-79). Bear Creek is ungaged, but a general storm occurred in the area in July 1973, which caused a major flood on adjacent gaged streams. As built, the relocated channel was trapezoidal in cross section (fig. 60, inset), with a bottom width of 6 m, 2:1 side slopes, and a longitudinal slope that was reduced to 2 m/km by addition of a concrete drop structure (fig. 61B) having a fall of 2 m. No other counter measures were used, except for local application of jute mesh and sod on the cut (fig. 61C) north of the relocated channel. This cut was terraced (fig. 60, inset), and the terrace treads slope at 2 percent away from the risers. In 1979, the cut was heavily grassed, but the banks along the relocated channel had slumped in a few places (fig. 61D), and several gullies 2-3 m in depth had developed from side drainage. In addition, several large slumps were observed on the opposite (south) bank of the channel downstream from the culvert entrance. The banks of the relocated channel were otherwise generally stable, and the channel bottom width was within 1 or 2 m of the width as built. Two beaver dams were observed in the relocated channel, one about midway of its length and the other near the downstream end. Downstream from the relocation, the natural channel was generally stable (fig. 61E) except for cut banks at bends, and its condition was similar to that observed on a 1955 airphoto.

Stability class C2 for relocated channel and class B1 for adjacent segments of natural channel. Slumping along the relocated channel is attributed to the height and steepness of the channel side slopes and the lack of coherence of the slope materials. Gullying is attributed to the same factors. Degradation has probably been prevented by the concrete drop structure, although there is some evidence for 0.5-1 m of degradation along the relocated channel upstream from the structure.

DISCUSSION--The length of the relocated segment was large in relation to stream size, and original channel length was reduced by a factor of 0.6. Serious channel degradation would probably have occurred without the drop structure. Terracing of the high cut has probably prevented more serious slumping and gullying.

Figure 61. Bear Creek at site 20. A, Airphoto of channel relocation in 1967. B, Concrete drop structure on relocated channel. C, Downstream view along relocated channel, in 1979. D, Bank slumping along relocated channel, about midway of its length. E, Natural channel in 1979, at bridge 700 m downstream from relocation.

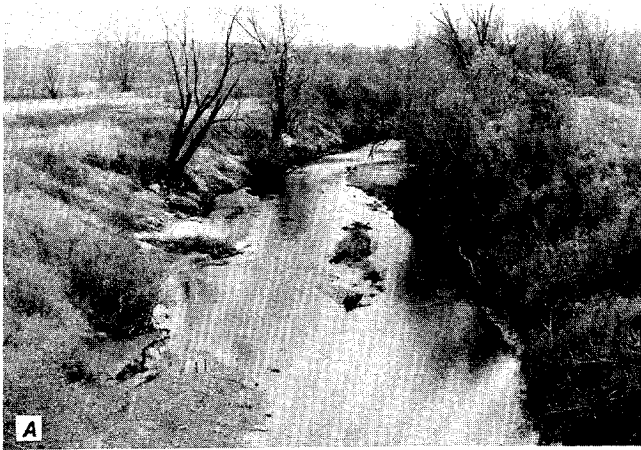
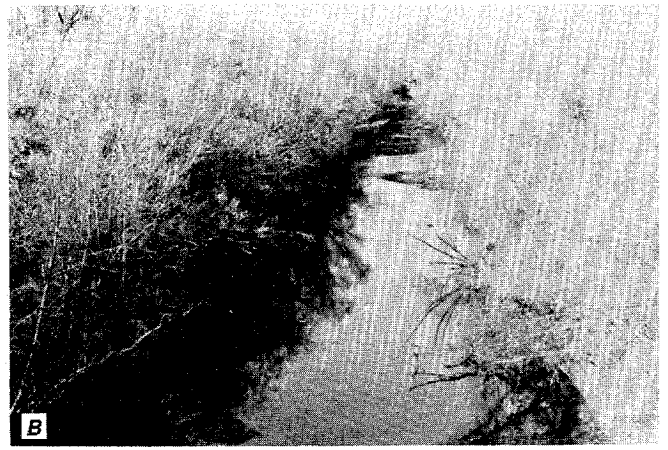
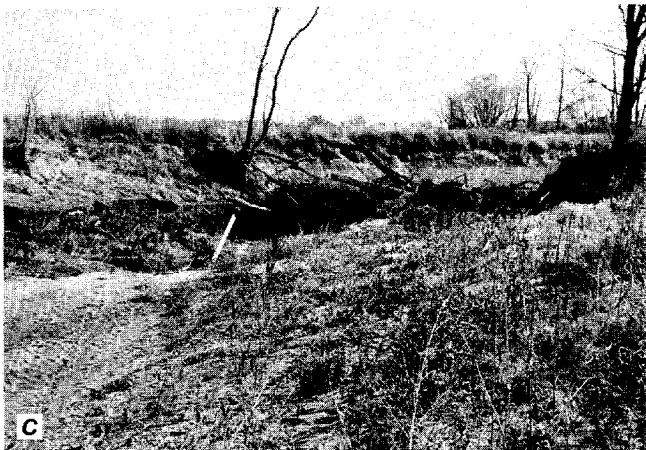
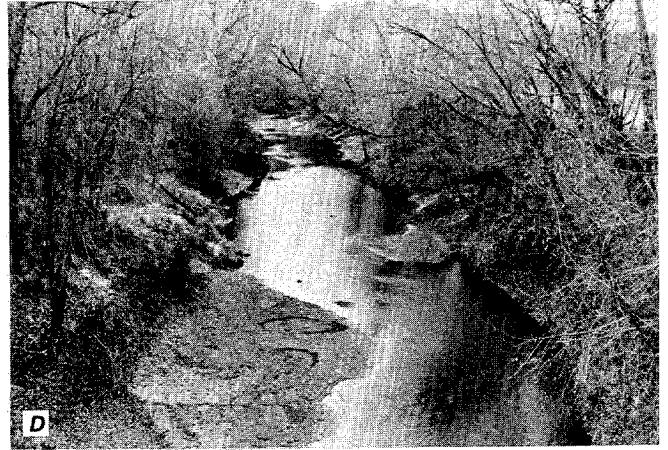
SYNOPSIS--Channel segment was relocated and thereby shortened from a length of 975 m to 580 m, for purpose of improving channel alignment at bridge and to accommodate planned roadway alignment (fig. 63). Performance period, 16 yr ✓ (1963-79). No flow records for Soap Creek or adjacent comparable streams are available; however, at least one flow above bankfull stage is indicated by overbank deposits observed in 1979. Relocated channel, as built, was trapezoidal in cross section, with a bottom width of 18.5 m, 2:1 side slopes, and a channel slope of about 0.5 m/km. No bank protection measures were specified on the plans or observed in the field; and vegetation along the relocated channel was cleared and not replanted. In 1979, the relocated channel was stable, with vegetated banks, both downstream (fig. 64A) and upstream (fig. 64B) from the bridge, and the bottom width was within 1-2 m of as-built bottom width. Upstream from the relocation, the natural channel of Soap Creek had cut banks at some bends, and about the same degree of stability as observed on a 1957 airphoto. At the first bend downstream from the relocation, bank erosion was severe (fig. 64C) and bottom width had reached 40 m; severe bank erosion was also observed at the second bend. However, at the old US-63 bridge, 1.8 km downstream, the natural channel was generally stable (fig. 64D) except for some inactive bank slumping.

DISCUSSION--Consequences of the relocation are similar to those of a natural meander cutoff, which commonly is followed by a period of rapid growth of adjacent meanders. It is noteworthy that the straight relocated channel is more stable than adjacent meandering reaches of the natural channel.

Figure 64. Soap Creek at site 22. A, Junction of natural and relocated channels (middle ground), as viewed downstream from US-63 bridge, in 1979. B, Relocated channel as viewed upstream from US-63 bridge. C, Bank erosion at first bend downstream from channel relocation. D, Natural channel upstream from old US-63 bridge.

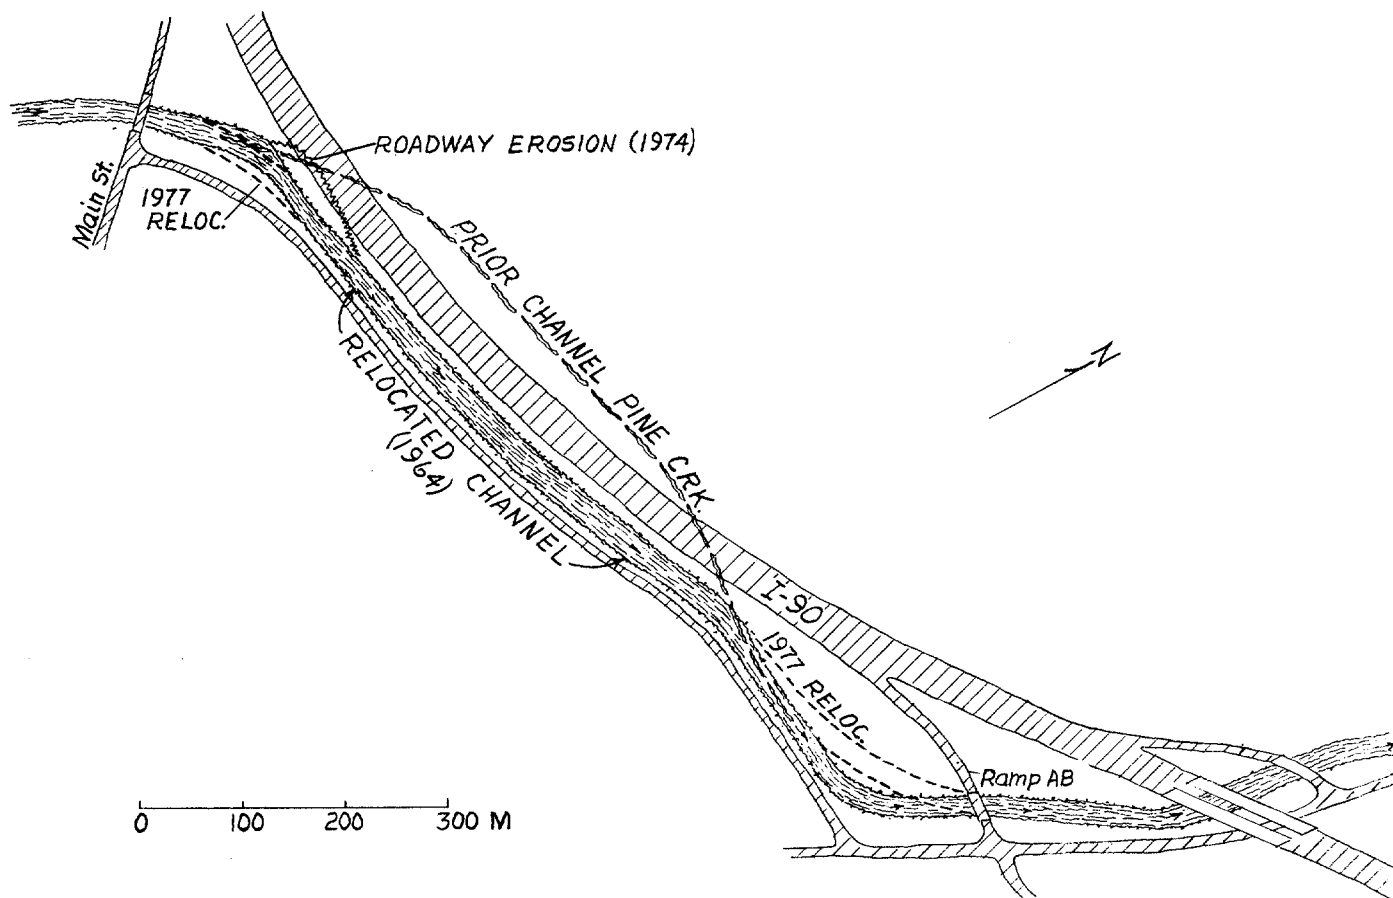
Figure 66. Plan sketch of Pine Creek channel relocation.

SYNOPSIS--Channel relocation, reach 675 m in length shortened to 645 m and moved laterally by about 100 m to make room for roadway. Performance period 10 yr, 1964-74. During an 85-yr flood in 1964, lateral erosion at an upstream bend in the relocated channel encroached on the I-90 roadway (fig. 66) and erosion and overflow also occurred at a downstream bend. The natural channel was already disturbed by mining operations and diking along one bank, and no effect on relocation on it could be discerned.

POST-ALTERATION FACTORS--During peak of the 1974 flood, the relocated channel upstream from the Ramp AB bridge had a cross-sectional flow area of 79 m² and an average velocity of 3 m/s. Lateral erosion is attributed to the sharpness of bends in the relocated channel.

DISCUSSION--Inasmuch as the banks of the re-located channel were riprapped, the curves in the relocated channel would probably have caused no problems during floods of moderate intensity. During the 85-yr flood of 1974, in which the average water velocity in the relocated channel reached about 3 m/s, the curves proved to be too sharp. Substantial expense was involved in modifying the channel and in replacing the Ramp AB bridge, whose waterway opening proved to be inadequate. Some channel degradation, perhaps amounting to 0.6 m, has apparently occurred, as indicated by exposure of piers and a pipeline at the Main Street bridge; but this may not be caused by the channel relocation.

In 1977, the relocated channel was modified to prevent a recurrence of flood erosion damage. The radius of the bend at the Main Street bridge was increased from 84 m to 349 m, and the radius of the bend above the Ramp AB bridge was increased from 81 m to 218 m. Riprap on the banks of the modified channel was placed to a depth of 1 m, and the toe of the riprap blanket was extended to 1.5 m below the channel bottom. Riprap on the outside of the curve above the Ramp AB bridge was concrete grouted. There has been little growth of vegetation along the channel since 1977.

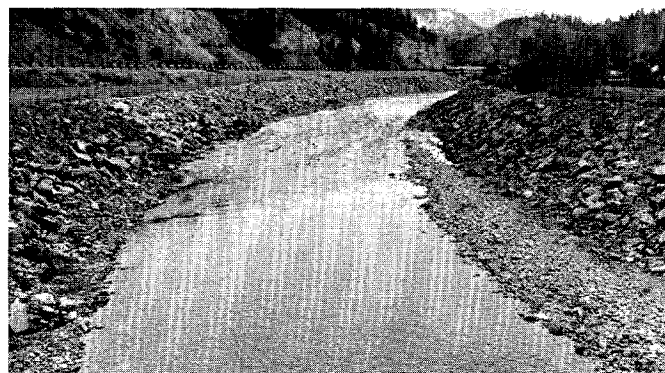
Figure 67. View downstream, from Main Street bridge, along relocated channel of Pine Creek. Erosion during 1974 flood occurred along bank in left background.

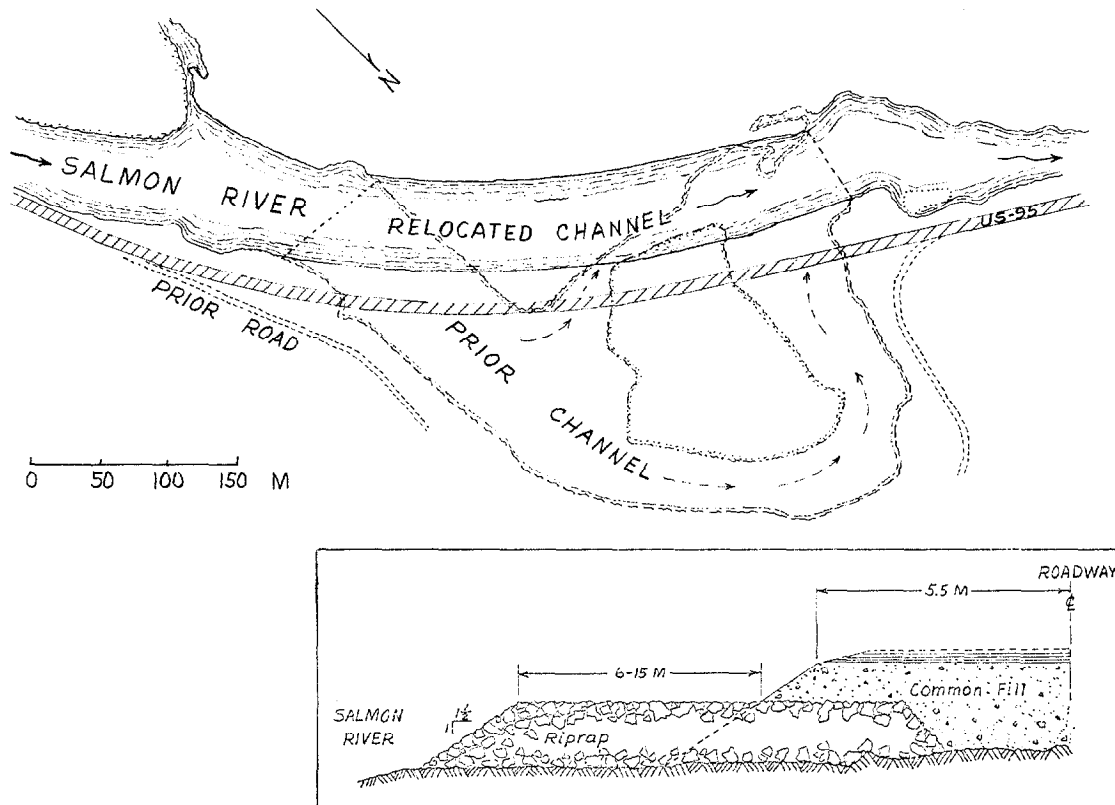
Figure 68. Top, plan sketch of Salmon River channel relocation. Inset, cross section of typical revetment along roadway embankment.

POST-ALTERATION FACTORS--According to the Idaho Department of Transportation, no maintenance or repair to the relocated channel has been required since construction, although bank revetment in the constricted section just downstream was damaged during the 1974 flood.

DISCUSSION--The channel cannot migrate very far laterally because the narrow alluvial valley bottom is bounded by bedrock. The main potential for instability is along the roadway embankment, which is at the outside of a broad curve. Here, the heavy riprap revetment maintained stability even during an extreme flood. No aerial photographs taken prior to relocation are available, so the natural channel cannot be assessed. However, in 1979 no cut banks were observed in the alluvial reach upstream from the relocation, and downstream the channel is in a rocky gorge.

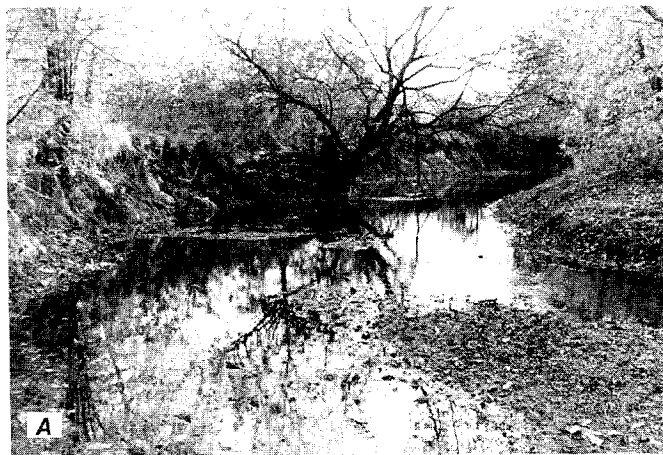
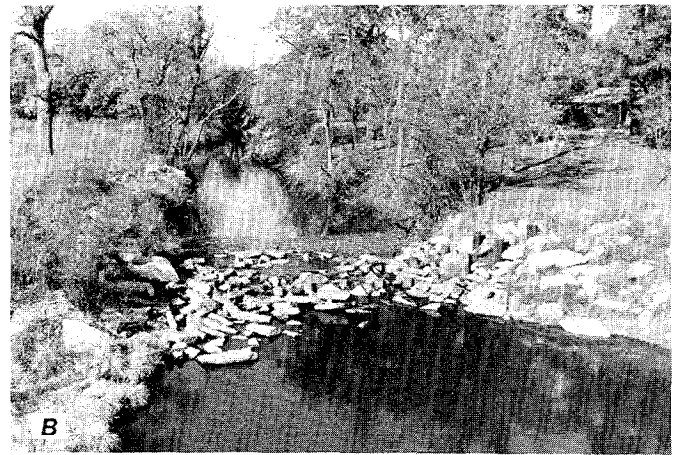
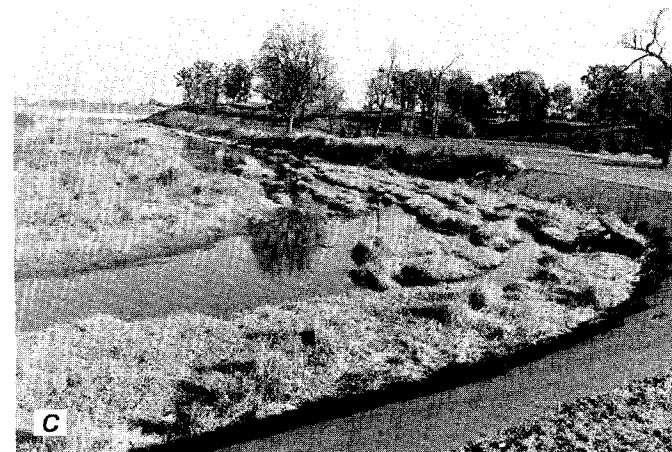
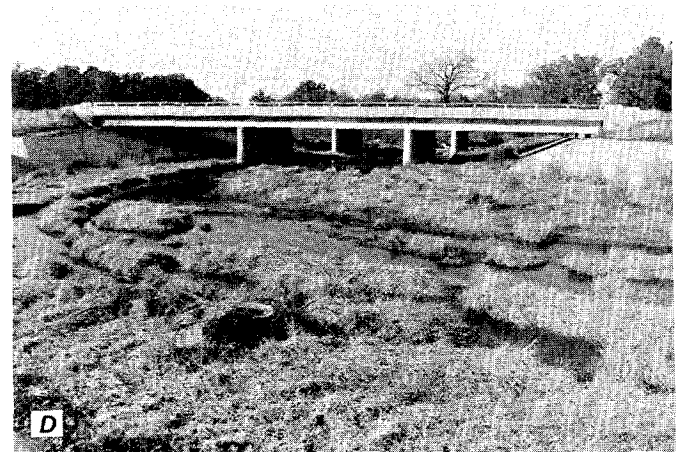
tion, amounting to about 0.6 m, extended upstream along the natural channel and downstream along the relocated channel as far as a concrete check dam. Lateral erosion also occurred at the toe of the concrete slope pavement just downstream from the bridge. Downstream from the relocation, the natural channel was apparently not much affected, as the extent of cut banks as observed in 1978 (fig. 71A) is not significantly different from that shown on a 1965 airphoto.

Figure 71. Stevens Creek at site 26. A, Natural channel in 1978, about 125 m downstream from relocated channel. B, Check dam, built after 1974 flood, upstream from I-72 bridge. Natural channel in background. C, View of relocated channel looking downstream from I-72 bridge, in 1978. D, View of relocated channel looking upstream toward I-72 bridge, in 1978.

DISCUSSION--Although the relocated channel is overly wide, and a braided low-flow channel has developed within it (fig. 71D), the erosion that occurred between stations 30.5 and 32 is attributed to the increase in slope, which resulted from drastic channel shortening. At the transition between the natural and the relocated channel, the increase in slope (and consequent increase in water velocity) caused channel degradation and undercutting of banks, which contributed to the lateral erosion. Action of eddies at the expansion may also have been involved in the lateral erosion. Downstream from the bridge, the bottom of the overly-wide relocated channel is now largely overgrown with coarse grass (fig. 71D), which is likely to trap sediment. Infilling and consequent reduction of channel capacity will probably occur. In addition, a meandering low-flow channel can be expected, which may cut laterally against the banklines. Scour downstream from check dams is a common occurrence, and they must be regarded as risky countermeasures. Placement of riprap on the bed and banks through the eroded reach upstream from the bridge would probably have been a better remedy for degradation.

POST-ALTERATION FACTORS--In 1974, the year after completion of the relocated channel, a flood occurred that exceeded in stage by about 0.3 m the previous flood of record. To remedy the erosion damage between stations 30.5 and 32, and to prevent recurrence, the bank was filled in to its former position and riprapped. The transition section was eliminated and a check dam, consisting of a double row of timber pile faced with chain-link fence fabric and filled in with broken concrete riprap, was built just upstream from the I-72 bridge (fig. 71B). Riprap was also placed at local problem areas on the relocated channel downstream from the bridge (fig. 71C). During a second flood in April of 1979, an undulating hydraulic jump was observed at the check dam, a hole 3.5 m deep was scoured at the east pier of the bridge, and much of the riprap at the check dam was removed by erosion.

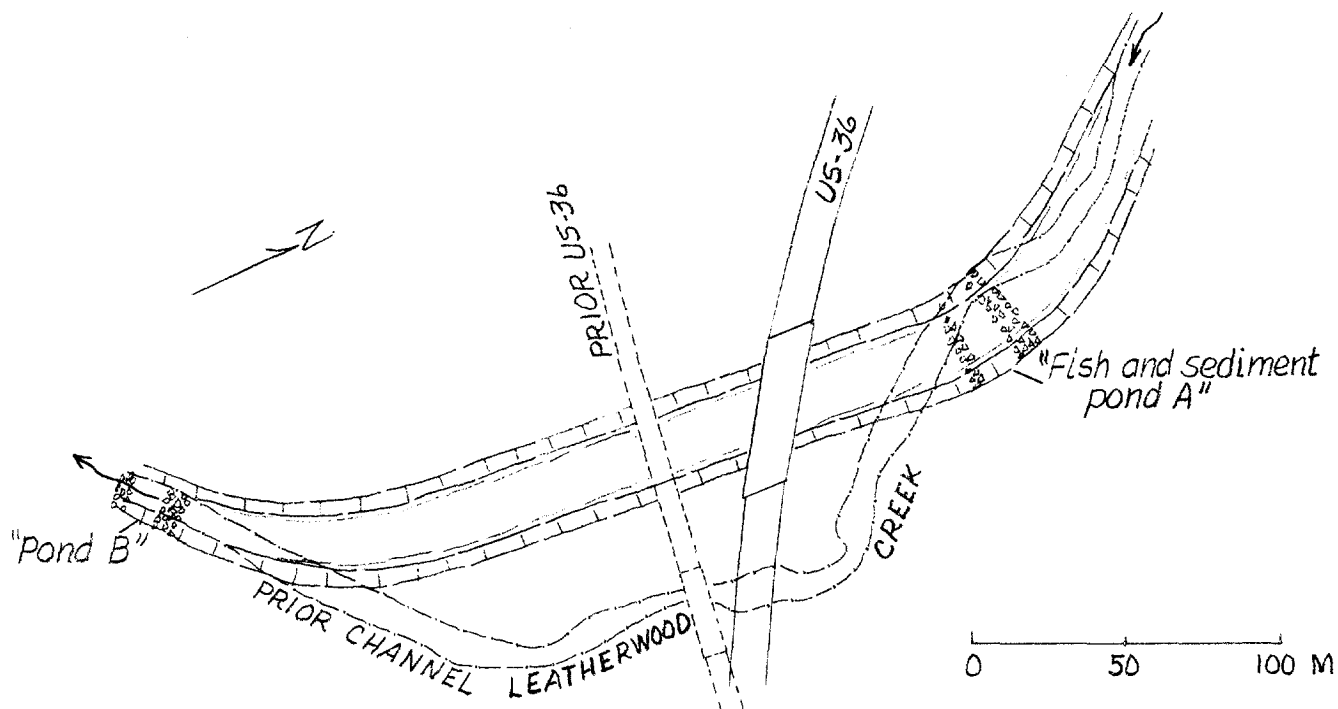
Figure 72. Plan sketch of Leatherwood Creek channel relocation.

SYNOPSIS--Channel was relocated by cutting across a broad bend, thereby reducing the length of the channel segment from 418 m to 366 m, for the apparent purpose of improving channel alinement at the new US-36 bridge (fig. 72). Relocation may also have facilitated construction of the new bridge. Performance period, 2 yr (1976-78), during which no major floods occurred. The site nevertheless provides an example of the performance of fish habitat structures described as "fish and sediment ponds" on the plans, and it also demonstrates an early consequence of an overly wide relocated channel. The relocated channel was trapezoidal in cross section, with a bottom width of 21.5 m, 2:1 side slopes, and a channel slope that ranged from 2 m/km to 6 m/km. Riprap bank protection was placed at the bridge and at the downstream curve in the relocated channel. A "fish and sediment pond" consisted mainly of a riprap check dam extending across the stream, rising about 0.6 m above the streambed, but not keyed into the streambed or streambanks. Such a structure would not be expected to be permanent, and the structures at this site were mostly gone by 1979 (fig. 73A). Upstream from the bridge, alternate bars have formed along the sides of the channel, and these are inducing bank erosion and sinuosity. Downstream from the bridge, flow is divided by grassed bars (fig. 73B) on which willows are likely to become established. The relocation

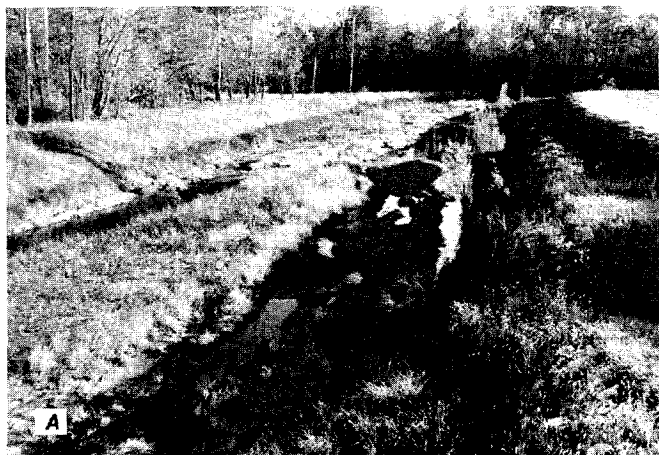
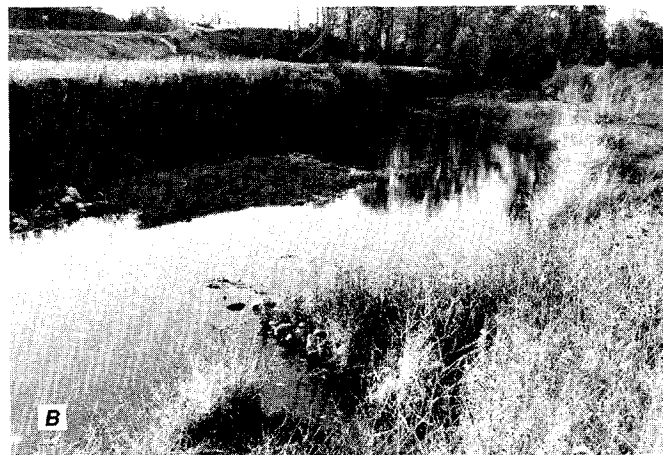
Figure 73. Leatherwood Creek at site 27. A, View upstream along relocated channel from US-36 bridge, in 1978. "Fish and sediment pond A" at left center. B, View downstream along relocated channel in 1978.

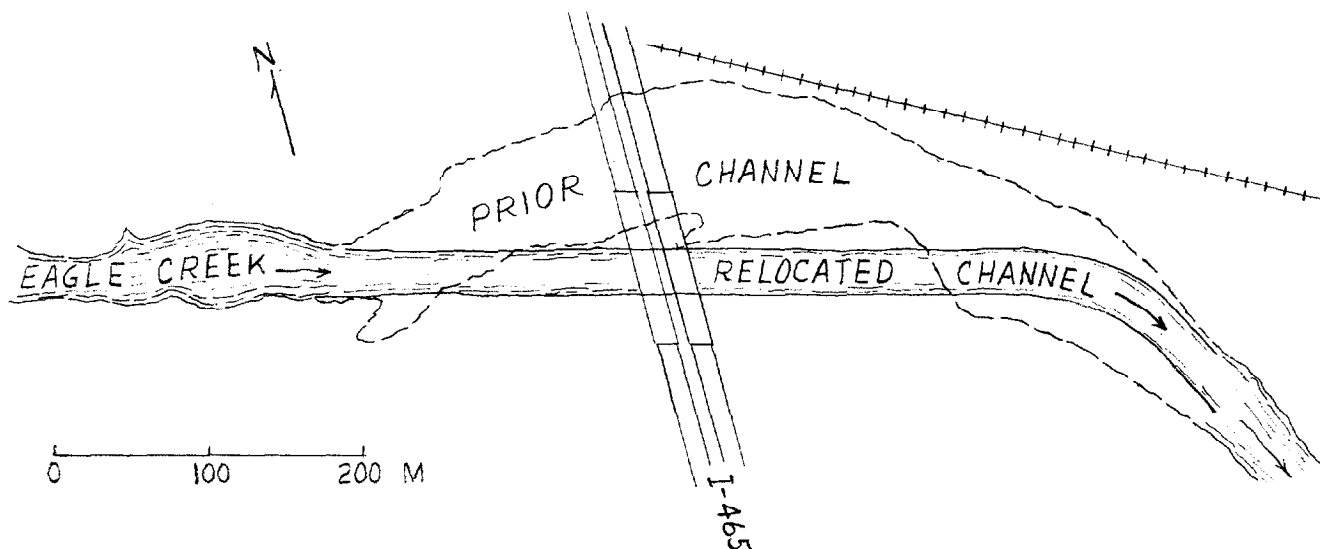
Figure 74. Plan sketch of Eagle Creek channel relocation.

SYNOPSIS--Channel relocation, reach 645 m in length straightened to length of 580 m, to improve alignment of flow approaching bridge (fig. 74). Performance period 19 yr, 1960-1978. The relocated channel was subjected to moderate floods in 1970 (174 m³s) and in 1976 (218 m³s). The left bank of the relocated channel upstream from the bridge has eroded laterally by about 20 m, over a channel length of about 250 m, and a 90-m length of concrete slope pavement has been destroyed (figs. 75A and B). This left-bank erosion has deflected flow toward the right abutment affecting the original intent of the channel relocation. In addition, erosion has occurred at the downstream bend in the relocated channel (fig. 75C). Adjacent segments of the natural channel have raw and unstable banks in many places, but the general extent of these is similar to that observed on airphotos taken in 1953. Stability class C3 for relocated channel, C2 for adjacent segments of natural channel.

POST-ALTERATION FACTORS--Most of the bank erosion in the relocated reach, as observed in 1978, has occurred since 1972, and the concrete slope pavement was almost intact in that year. No countermeasures to replace the damaged left-bank pavement are evident, but riprap and a sheet-pile cutoff wall have been placed at the upstream end of the right-bank pavement. The straight reach of relocated channel downstream from the bridge has not increased in width and appears stable, with a good growth of young willow, sycamore, and cottonwood along the bank-line.

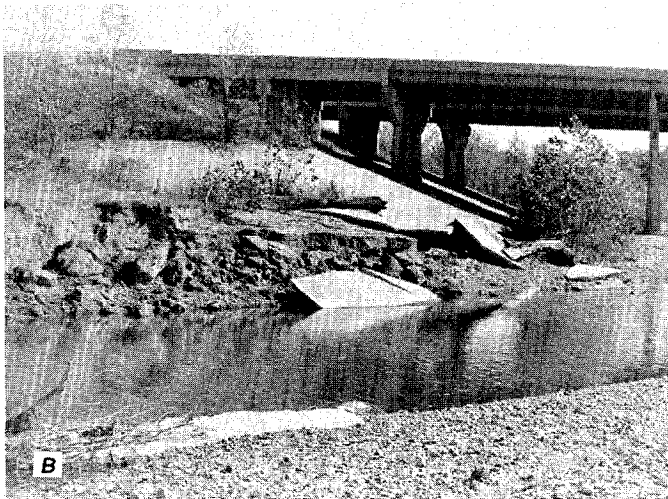
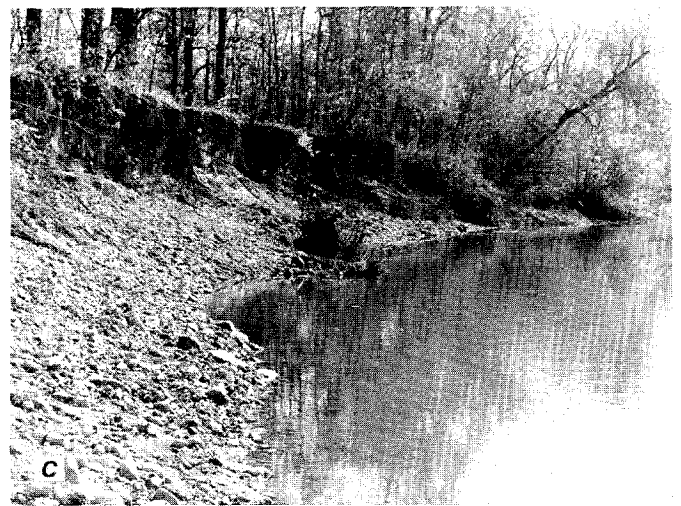
DISCUSSION--The instability of the left bank of the natural channel, prior to relocation, was an indication of potential problems with lateral erosion of the relocated channel. In hindsight, it seems probable that the lateral erosion may

Figure 75. Eagle Creek at site 28. A, Airphoto of channel relocation, in 1972. (From Indiana Dept. of Transportation). B, Eroded concrete slope pavement at left bank upstream from bridge, in 1978. C, Eroded left bank at downstream bend in relocated channel, in 1978.

have been prevented by the placement of flexible revetment, such as riprap, along the left bank at the junction of natural and relocated channel. Rigid revetment, such as concrete slope pavement, is particularly susceptible to destruction by outflanking. Upstream from the relocation, the right bank is composed of resistant glacial till, which apparently deflects flow toward the less resistant left bank. The present situation is difficult, because the meander may continue to grow and migrate to the left, worsening the alinement of flow approaching the bridge. As a countermeasure, the left bank could be straightened and protected with flexible revetment for a distance of about 75 m upstream from the bridge. Special care would have to be taken to prevent outflanking of the upstream end of this revetment.

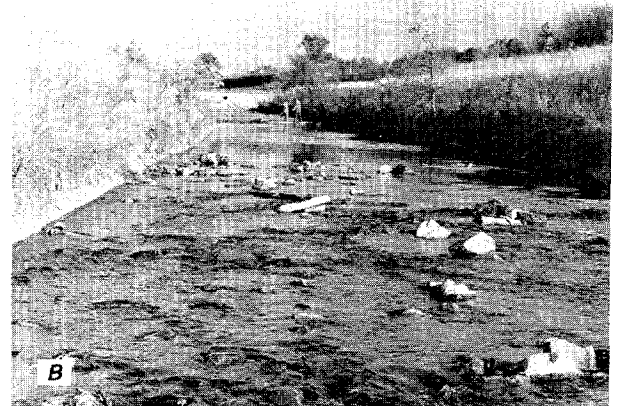
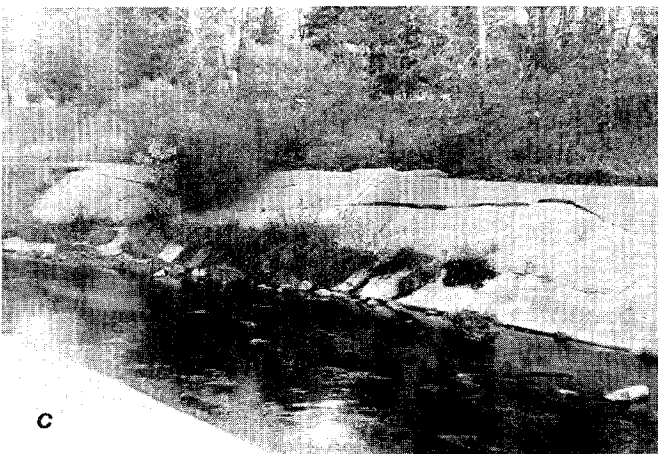
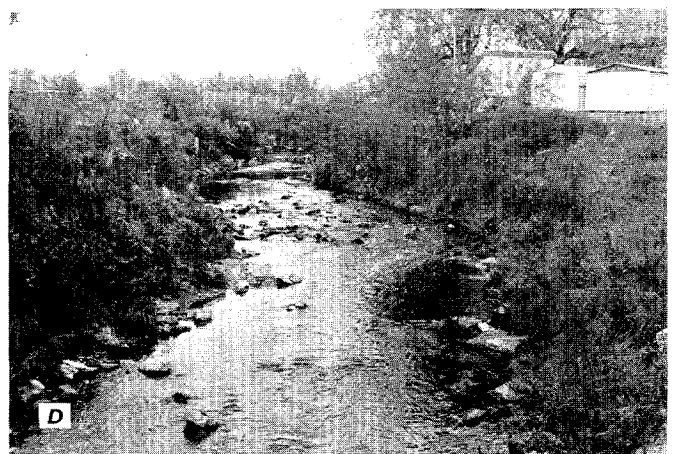
SYNOPSIS--In the construction of I-465, Lick creek was relocated for a channel length of about 1 km, of which only the upstream 600 m were studied for this report (fig. 76A). As with most streams in urban areas, the natural channel has been disturbed over a long period of time by various kinds of construction; therefore, only the performance of the re-located channel will be considered. Performance period 16 yr (1962-78) during which a severe flood occurred in 1974, and the maximum flood for the period of record, in June 1978. As built, the relocated channel was trapezoidal in cross section, with a bottom width of 9 m, 2:1 side slopes, and a channel slope of about 3 m/km. The channel bottom is crossed at intervals by low concrete check dams, for which no design specifications were obtained. Banks were revetted with concrete slope pavement at curves, and elsewhere with articulated concrete blocks set above a concrete toe wall. In 1979, vegetation had become well established in the concrete blocks (fig. 76B) which were intact except at two places, one at a culvert and the other at a side

drain. Partial failure of the concrete slope pavement, over a much greater lateral distance, was also observed at a side drain (fig. 76C). Upstream from the relocation, the natural channel (fig. 76D) is closely bordered by houses, and the steep banks are cut from place to place.

Figure 76. Lick Creek at site 29. A, Airphoto of relocated channel in 1972. Approximate course of prior channel is shown in dotted line. (From Indiana Dept. of Transportation). B, Upstream view, toward bridge, of relocated channel in 1978. C, Partial failure of concrete slope pavement at side drain upstream from bridge, as photographed in 1978. D, "Natural" channel upstream from relocation, in 1978.

DISCUSSION--The failure of bank revetment by undermining at side drains and culverts is noteworthy. The articulated concrete blocks seem superior to the concrete slope pavement, because their failure is more localized and because vegetation, including trees, has become estab-

lished on them. The relocated channel is assigned to stability class A because of the generally good performance of the revetment, whose local failure is tentatively attributed to lack of a suitable filter blanket.

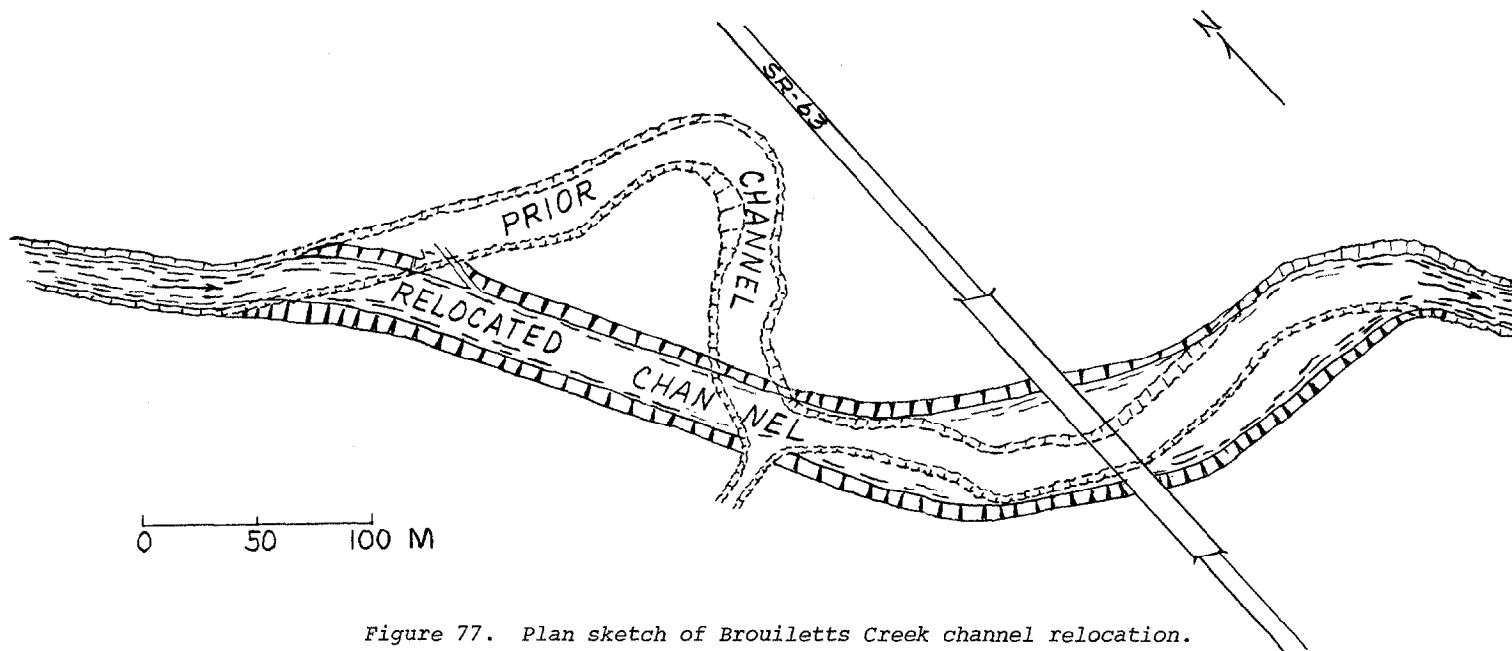
Figure 77. Plan sketch of Brouilletts Creek channel relocation.

SYNOPSIS--Channel relocation, reach 610 m in length straightened to a length of 510 m, to prevent encroachment of meander loop against new roadway (figs. 77 and 78A). Performance period 15 yr, 1963-78. Except for erosion of the toes of side slopes, the relocated channel did not change significantly in general dimensions during the performance period. Local erosion has occurred at sections of the right bank just upstream and downstream from the bridge (fig. 78 B), and a point bar has formed at the left bank upstream from the bridge. A meander may eventually form just upstream from the bridge. As indicated by comparison of airphotos taken in 1949 and in 1962, adjacent segments of the natural channel were eroding at the outside of bends prior to the relocation, and the rate of erosion increased somewhat during the period 1962-72. The relocation may have contributed to this increase in erosion, particularly at bends downstream from the bridge (fig. 78C). Stability class B2 for relocated channel, C3 for adjacent segments of natural channel. In general, the relocated channel has performed well in view of its curvature, the limited use of bank revetment, and the prior instability of the natural channel. The critical factor in this performance is probably the absence of major floods during the time that vegetation was becoming established along the bankline.

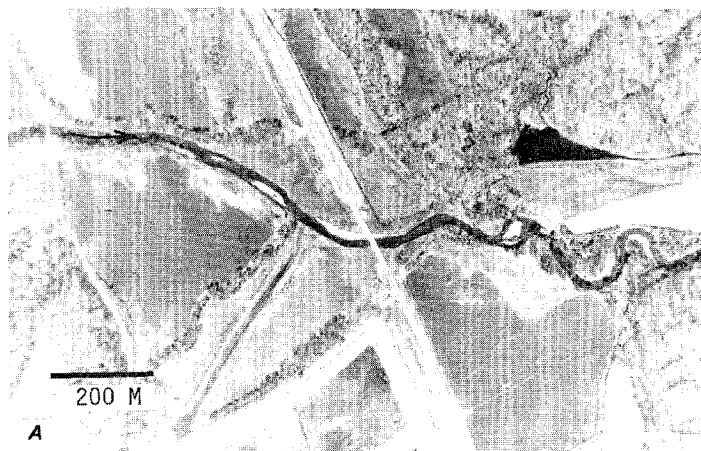
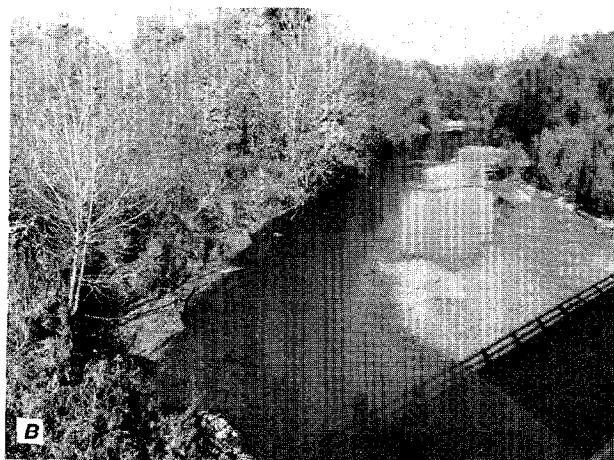
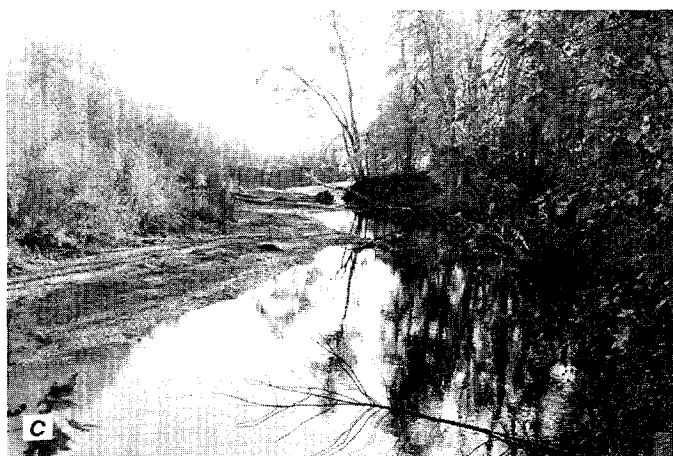
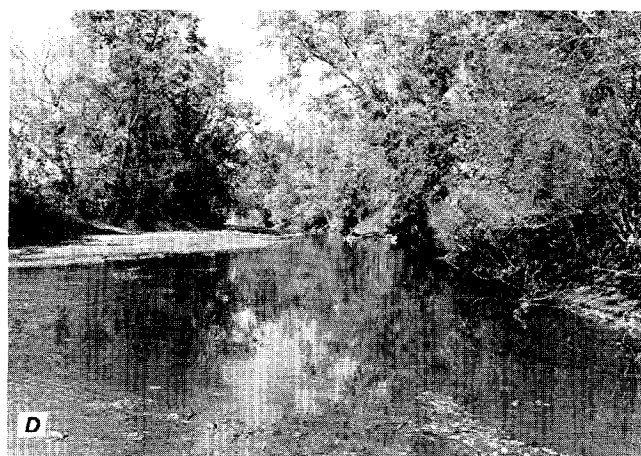
POST-ALTERATION FACTORS--No maintenance or installation of countermeasures since relocation, is evident. Vegetation along the relocated channel was slow in becoming established, as little is evident on 1972 airphotos; but a good vegetal cover was present, except for a few places, in 1978 (fig. 78B).

DISCUSSION--Although the relocated channel has performed satisfactorily during the 16-yr period since relocation, the development of point (or alternate) bars in the channel (fig. 78A) is an indication that meander development has begun. However, this development is progressing slowly, and is not likely to be a problem during the normal life span of the bridge. Now that vegetation has become established, the relocated channel (fig. 78B) looks much like the natural channel (fig. 78C and D).

Figure 78. Brouillets Creek at site 30. A, Airphoto of relocated channel in 1972. B, View of relocated channel looking upstream from bridge, in 1978. C, Natural channel downstream from bridge, in 1978. D, Natural channel upstream from bridge, in 1978.

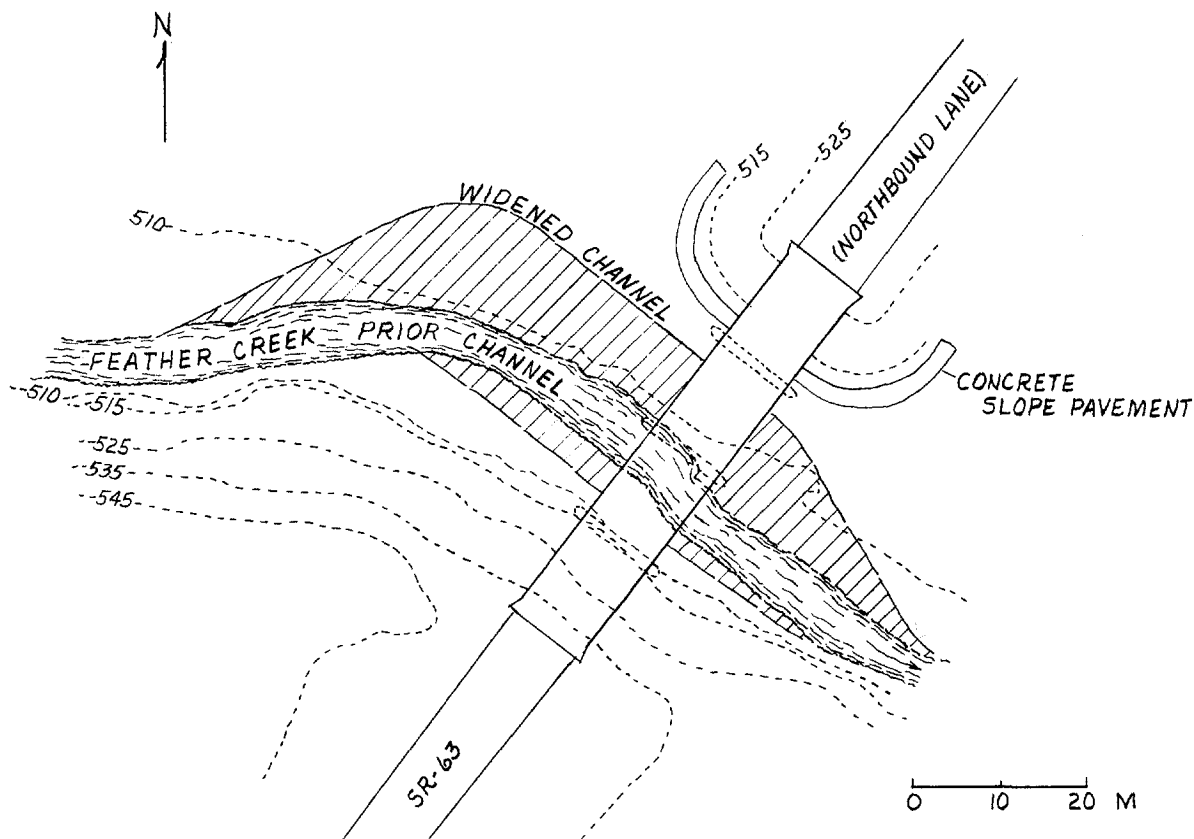
Figure 79. Plan sketch of Feather Creek channel relocation

ALTERATION FACTORS--Over a length of 93 m, the natural channel was widened to a maximum bottom width of 18.5 m and a top width of about 23 m (fig. 79), which represents an increase in channel width by a factor of three or four. Channel curvature was slightly increased by widening, as was channel length.

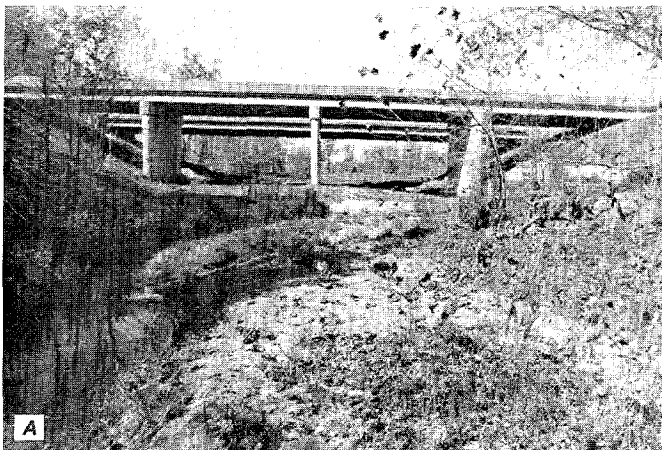
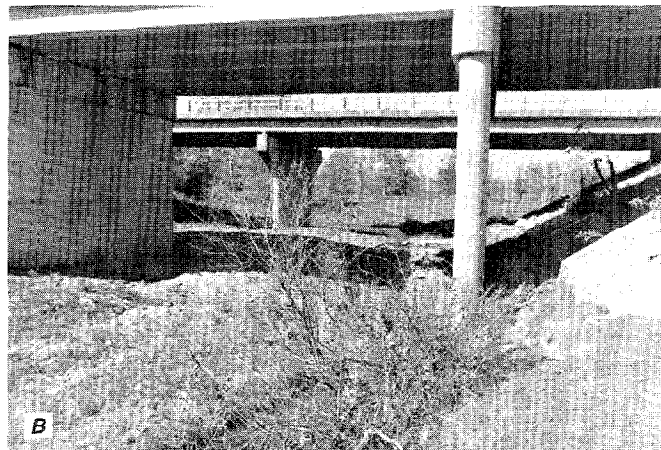
POST-ALTERATION FACTORS--Although the low-water flow line was placed in the center of the widened channel at the time of construction, it has subsequently migrated against the toe of the left-bank abutment fill-slope. Except for scattered shrubs and annuals, little vegetation had become established along the widened channel by 1978.

DISCUSSION--The reasons for widening the natural channel by such a large factor are not apparent, but the designer may have operated on the premise that overwidening could do no harm. The consequent lateral migration of the low-water channel is probably not serious in view of the small size of the stream and the very large area of the bridge waterway, but it may lead to maintenance expense.

Figure 80. Feather Creek at site 31. A, View upstream in 1978, showing width of bridge waterway in relation to that of natural channel, in left foreground. B, View in 1978, showing location of low-water channel against abutment, at right, and, at left, infilling of wide channel.

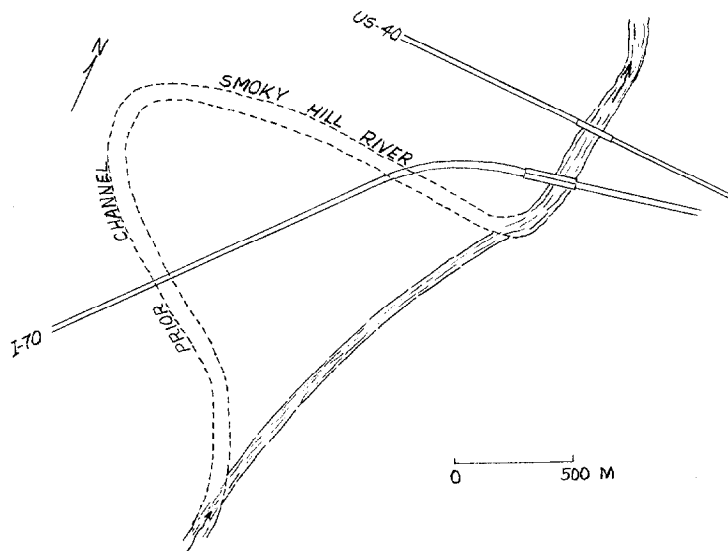
Figure 81. Plan sketch of channel relocation, Smoky Hill River.

SYNOPSIS--Channel was relocated by cutting off a meander loop, thereby reducing the length of the segment from 3,475 m to a value of 1,675 m; for the purpose of avoiding an additional crossing along the planned roadway location and to obtain embankment fill from the excavated channel (figs. 81 and 82A). Performance period, 16 yr (1963-79), during which no major floods occurred. According to the plans, the relocated channel was trapezoidal in cross section, with a bottom width of 134 m, 2:1 side slopes, and a longitudinal slope of 0.3 m/km. No bank protection along the relocated channel was specified in the plans or observed in the field. The ends of the prior channel were closed, but the channel was not filled for most of its length. In 1979, bottom width was 84 m, trees grew densely along the bankline (figs. 82A and 82B), and the streamward faces of banks tended to be steep, rather high (3.3-3.5 m), and unvegetated. Thus, by comparison with the width as planned, the width in 1979 had diminished by about 50 m. No information was obtained as to any departure of as-built width from planned width.

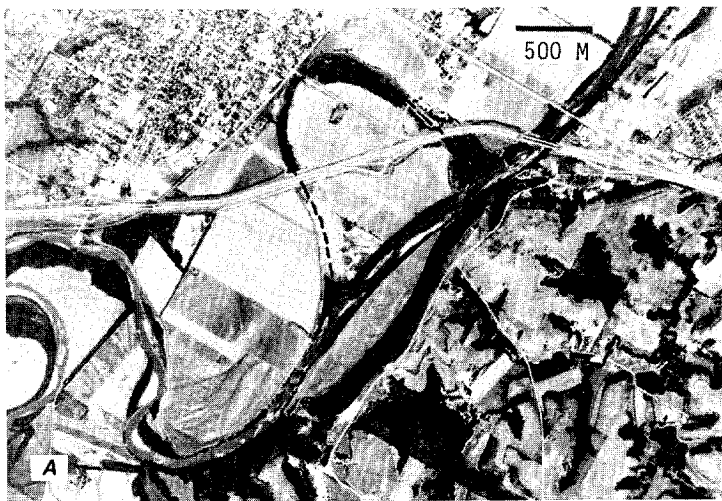
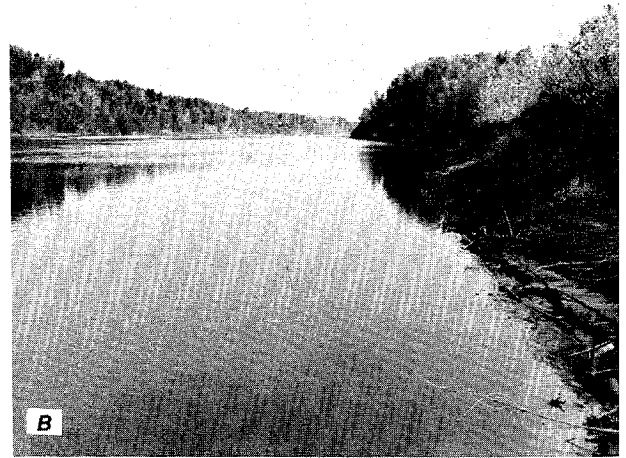
The natural channel upstream from the relocation had a rather rapid rate of lateral migration for the period 1964-78, amounting to a maximum linear distance of about 20 m at several meander loops. However, this rate is not inconsistent with the historical lateral migration since 1863, as plotted by Dort and others (1979). No evidence of channel degradation was observed, and degradation may have been prevented by an outcrop of resistant bedrock in the channel near the downstream end of the relocation. Stability class B1 for relocated channel and class D2 for adjacent segments of natural channel.

Figure 82. Smoky Hill River at site 32. A, Airphoto of channel relocation in 1978. (From U.S. Dept. of Agriculture). B, Downstream view along relocated channel in 1979.
