Report No. FHWA/RD-80/158

STABILITY OF RELOCATED STREAM CHANNELS

March 1981
Final Report

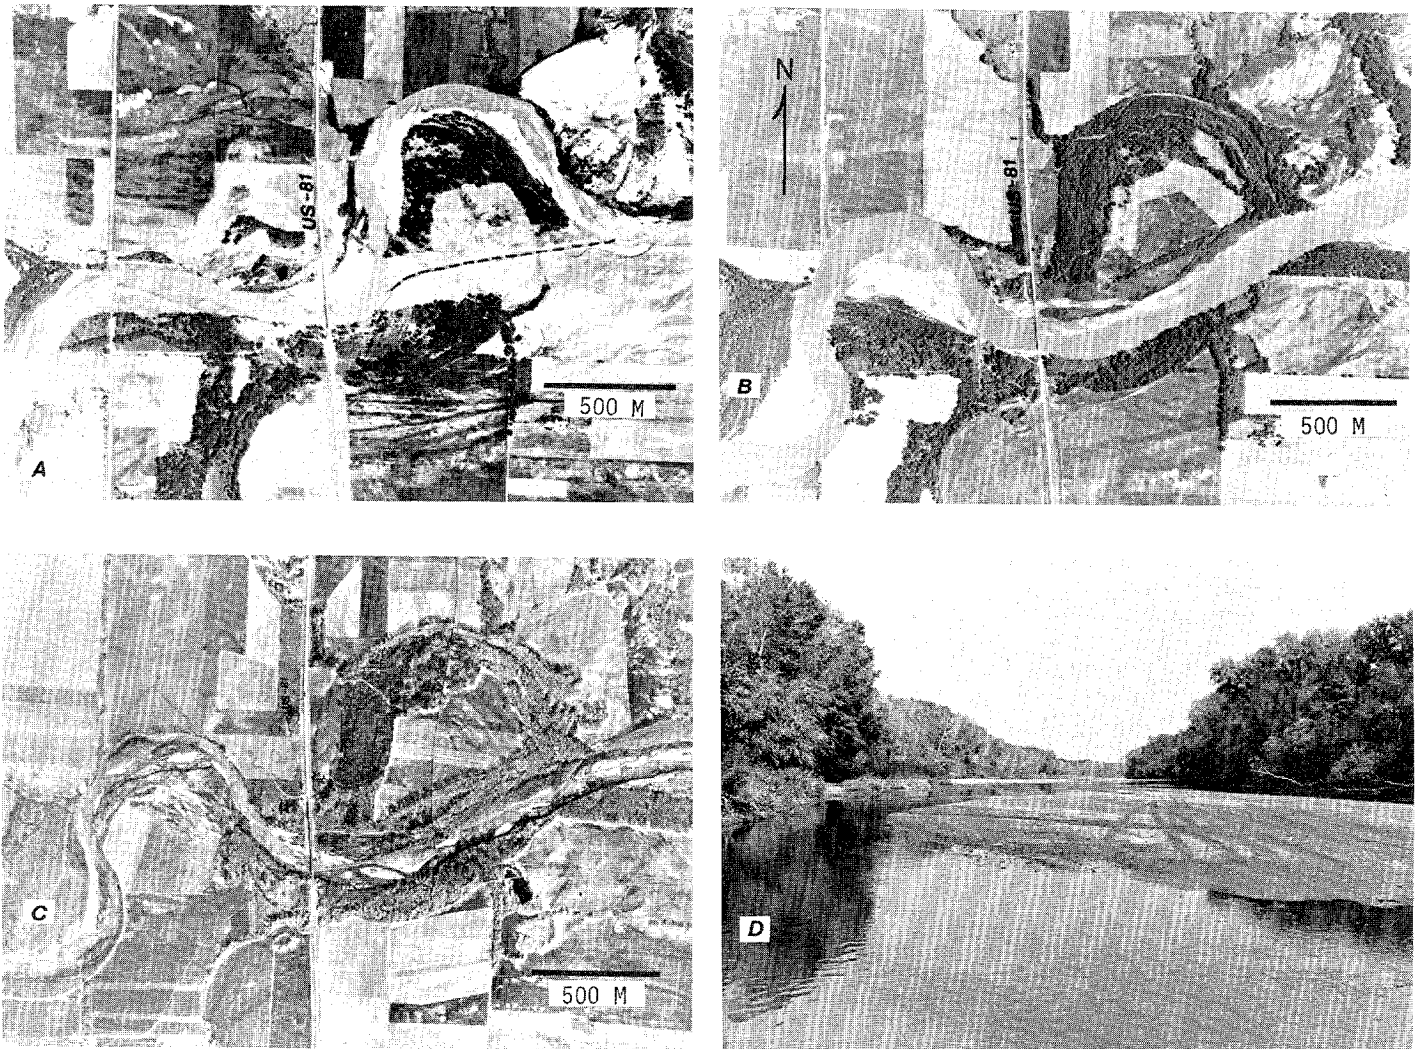
During the period 1937-52, the relocated channel shifted to the right because of the rapid growth of an upstream meander (fig. 83B), and its bottom width increased to 180 m. The width had decreased to 100 m by 1957, and to 80 m by 1975 (fig. 83C). In 1979, the banks were well vegetated and generally stable (fig. 83D). although banks were locally cut because of the sinuous low-flow channel. Adjacent reaches of the natural channel were also much more stable than during the period 1937-52. Stability class B for relocated channel and adjacent reaches of natural channel. The critical factors in channel stability are the lack of major floods since 1951, growth of vegetation along the channel, and a moderate control of flow by upstream reservoirs.

endangering the right-bank bridge abutment. In 1948, a pilot channel was constructed beneath the bridge to divert flow to the left, and a pile retard was constructed at the left bank upstream from the bridge (fig. 83B). Flow was not diverted by the pilot channel. In 1972, a jack field was constructed at the right bank near the bridge. The countermeasures, together with the general increase in stability of the river, have prevented further lateral migration toward the left bridge abutment.

DISCUSSION--Although the relocated channel has become stabilized and has had little or no detrimental effect on the river, the purpose that it has served in protecting the bridge is questionable. Bank protection or flow-control measures at and downstream from the left bridge abutment would probably have been more effective, at less cost.

Figure 83. Republican River at site 33. A, Airphoto of channel relocation in 1937. (From U.S. Dept. of Agriculture). B, Airphoto of relocated site in 1952. (From U.S. Dept. of Agriculture). C, Airphoto of relocation site in 1975. (From Kansas Dept. of Transportation). D, View downstream about midway along relocated channel, in 1979.

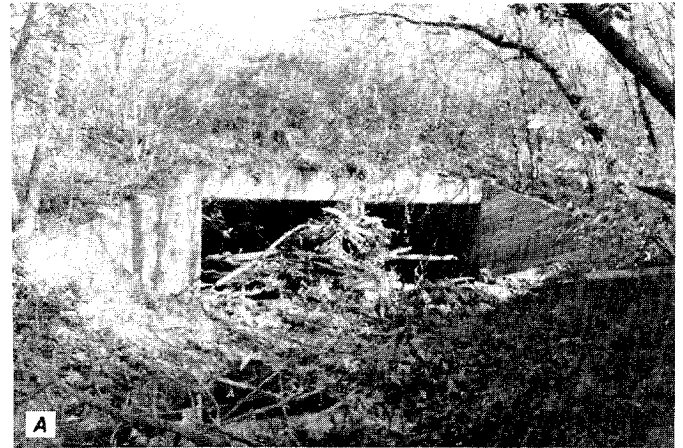
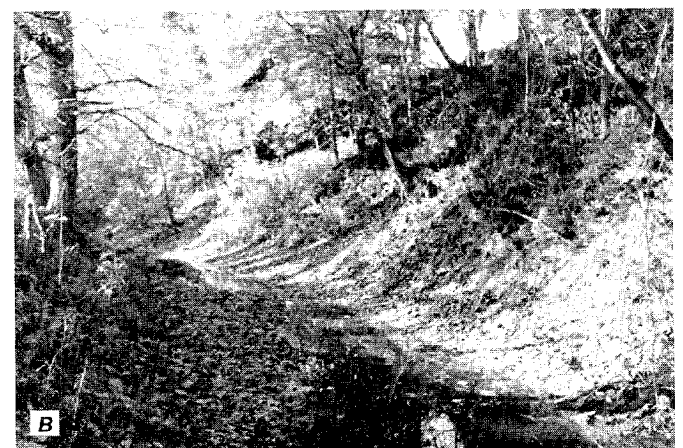
ALTERATION FACTORS--In relocation, the channel was shortened by a factor of 0.7, and the relocated channel was constructed to about the same width as the prior channel. Most of the relocated channel is within a double, 12 by 10 ft (3.66 by 3.05 m) reinforced concrete box culvert (fig. 85A). The wide concrete wing-walls of the culvert have apparently been effective in preventing lateral erosion.

Figure 85. Yellow Creek at site 34. A, Culvert entrance at upstream end of relocated channel, in 1978. B, Natural channel upstream from relocation, in 1978.

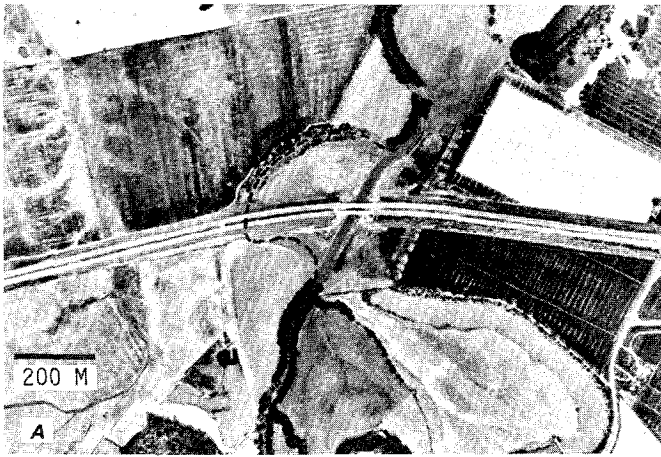
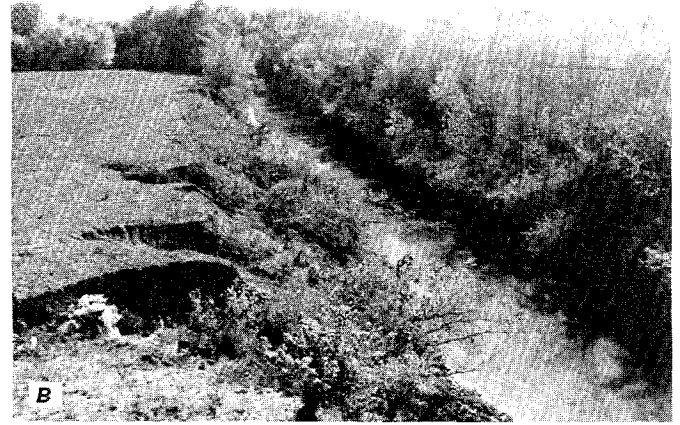
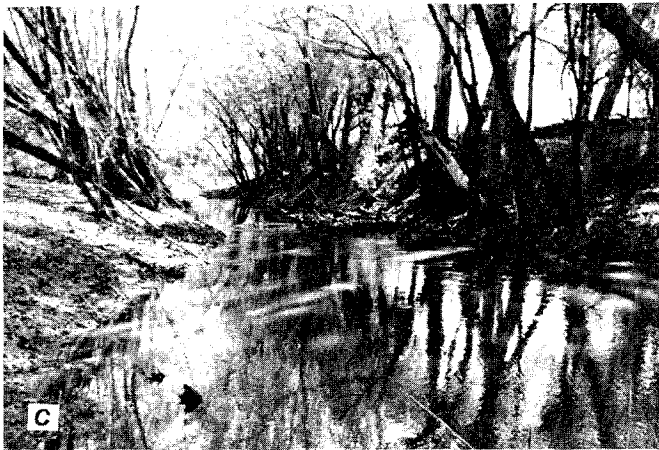
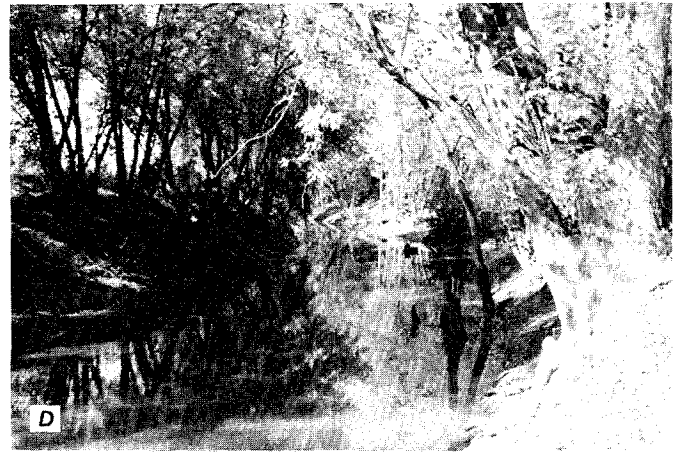
POST ALTERATION FACTORS--A major flood occurred at the site in 1970, four years after the alteration and before natural vegetation could have been well established. Field study of the site in 1978 indicated that no severe erosion occurred, and that the channel bottom was in fact less wide than in 1969. Gully erosion and recession of the upper right bank upstream from the bridge (fig. 87B) is attributed to the planting of row crops close to the channel, and the failure of natural vegetation to become established on the bank slope. In 1978, trees were well established along the left bank. No maintenance work on the relocated channel is apparent.

DISCUSSION--In view of the site of the stream, the degree of channel shortening, the occurrence of a major flood, and the lack of bank protection, the stability of the relocated channel is surprising. The factors that account for the prior stability of the natural channel--coherence of bank materials and degree of incision--have apparently contributed to the stability of the relocated channel. Recession and gulying of the upper bank upstream from the bridge is troublesome, but it does not constitute a real threat to channel stability.

Figure 87. Rolling Fork at site 35. A, Aerial photograph of channel relocation in 1969. (From U.S. Dept. of Agriculture). B, View of relocated channel, looking upstream from bridge, in 1978. C, Natural channel downstream from relocated channel, in 1978. D, Natural channel upstream from relocated channel, in 1978.

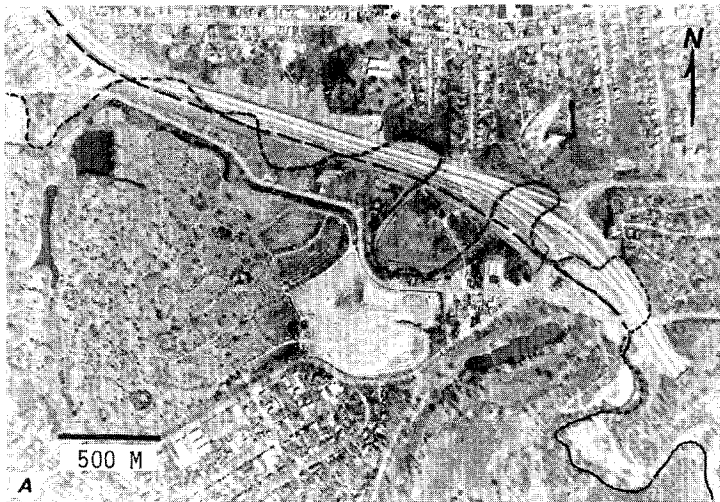
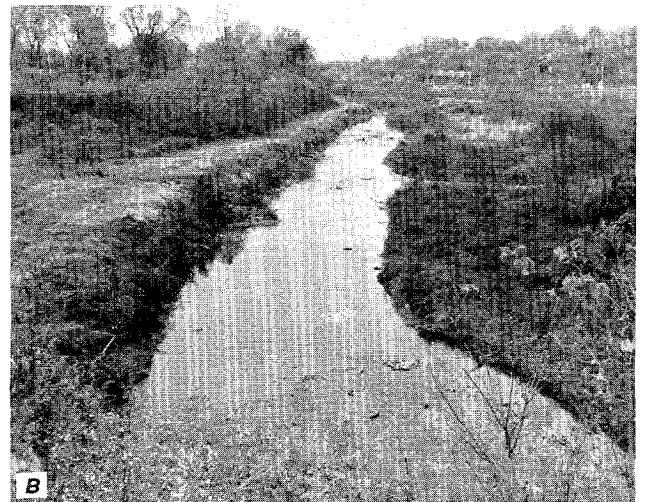
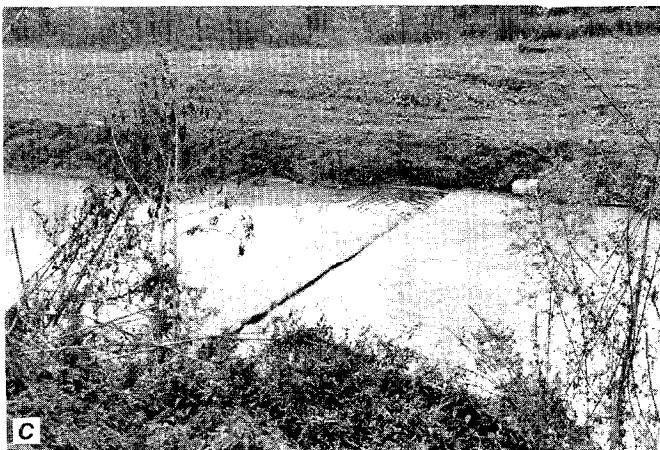
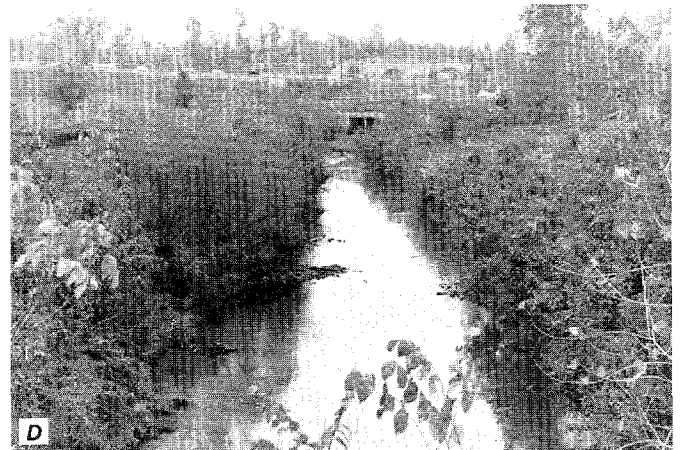
POST-ALTERATION FACTORS--As indicated on an airphoto taken in 1971, bank erosion occurred during the 1970 flood along the relocated channel downstream from Grinstead Drive. However, this erosion was not severe, and by 1978 the banks were vegetated and only minor local erosion was evident (figs. 88B and C).

DISCUSSION--In view of the degree of shortening, the stability of the relocated channel is better than would be expected, and it has been adequately tested by flood. The relocated channel is much less attractive in appearance than is the natural channel upstream in Cherokee Park. However, the appearance of the channel would have been much impaired by several crossings of the interstate highway, even if no relocation had been done.

Figure 88. Beargrass Creek at site 36. A, Aerial photograph, taken in 1971, showing channel relocation. Prior channel is shown in dotted line, relocated channel in dashed line. (From U.S. Geological Survey) B, Relocated channel looking downstream from bridge at Grinstead Drive. C, Relocated channel at concrete check dam. D, Relocated channel, looking upstream from bridge at Grinstead Drive.

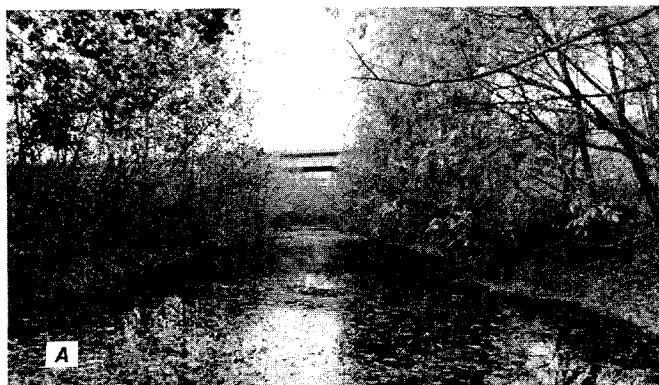
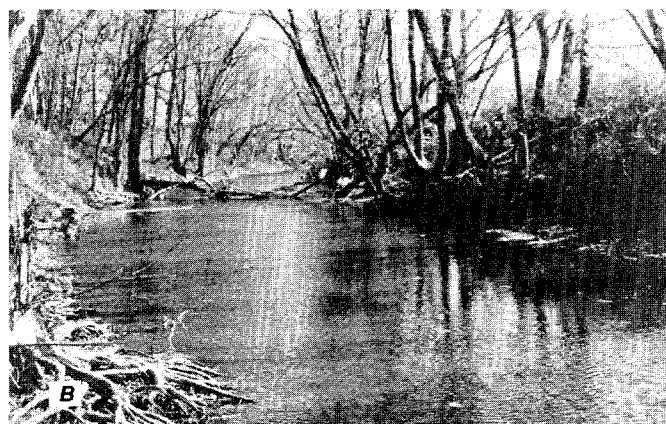
ALTERATION AND POST-ALTERATION FACTORS--Straightening of the channel led to only a slight decrease in length, from 245 m to 240 m, and consequently only a slight change in slope. No information was obtained on the as-built width of the relocated channel, but both the bottom and top width as measured on a 1969 airphoto are very nearly the same as for the natural channel. The banks of the relocated channel were evidently revetted to some degree with limestone riprap, of which only discontinuous remnants were visible in 1978. Sycamore, willow, and box elder have become well established along both banks of the relocated channel (fig. 90A).

DISCUSSION--The factors that account for the stability of the natural channel--low slope, coherent bank materials, and a slight degree of incision--have also contributed to the stability of the relocated channel. In addition, the riprap placed along the relocated channel contributed to stability and probably to the early establishment of vegetation.

Figure 90. Benson Creek at site 37. A, View upstream toward bridges in 1978, from end of relocation. B, Natural channel upstream from relocation, in 1978.

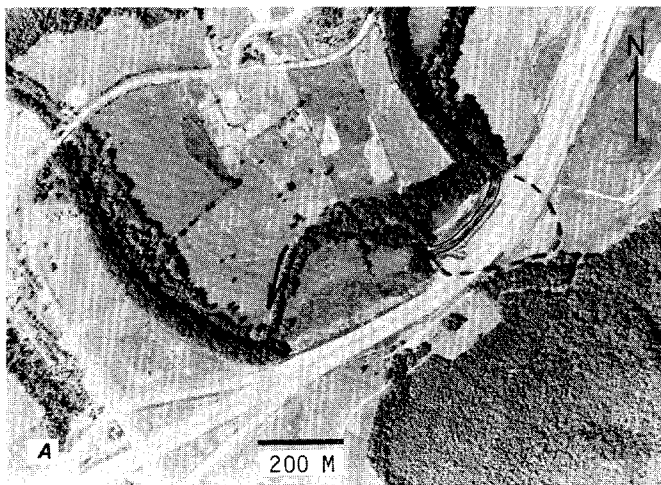
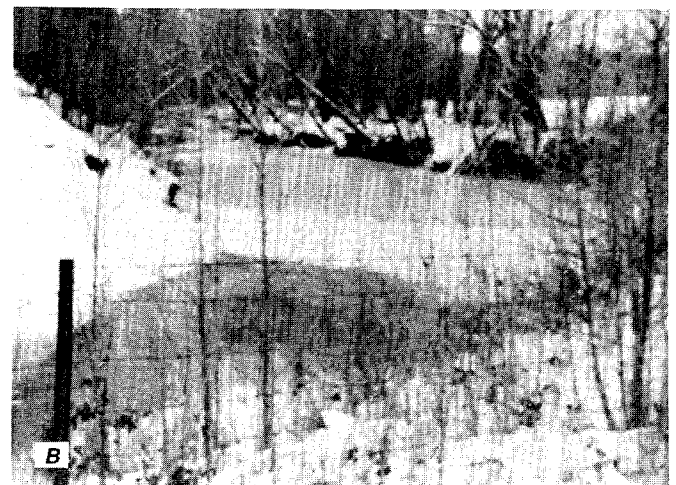
DISCUSSION--The junctions of relocated and natural channel are nearly at 90°, a factor that commonly leads to bank erosion. The lack of bank erosion is tentatively attributed to natural bank coherence, enhanced by vegetation.

Figure 91. North Fork Triplett Creek at site 38. A, Airphoto of channel relocation in 1972. Prior channel shown in dashed line. (From U.S. Dept. of Agriculture). B, Upstream junction, at bend, of relocated and natural channel in 1980.

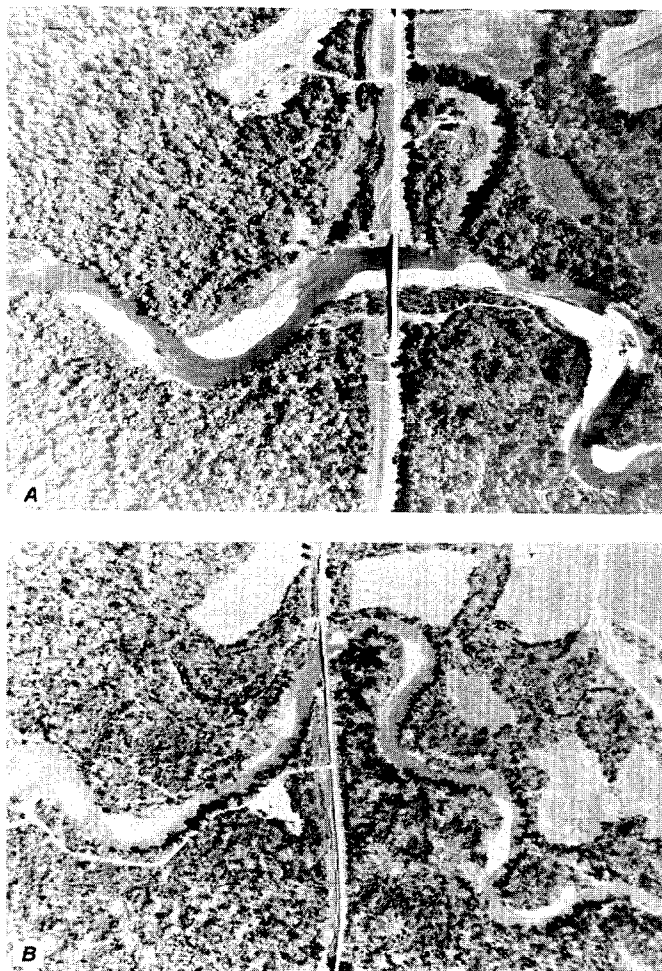
broad meander loop upstream and a more narrow loop downstream (fig. 93A), such that bank erosion was probable at the downstream loop.

DISCUSSION--Inasmuch as the river has rather high sinuosity and an apparently rapid rate of lateral migration at bends, good crossing sites are uncommon. The former crossing site was decidedly unsatisfactory (fig. 93B), and cutting off the meander loop seems the most logical way of improving it. Protection of the bridge at the present site will require counter-measures both at the left abutment and at the outside of the first meander loop upstream.

Figure 93. Amite River at site 39. A, Airphoto of site in 1975. (From Louisiana Dept. of Transportation) B, Airphoto of site in 1937. (From U.S. Dept. of Agriculture).

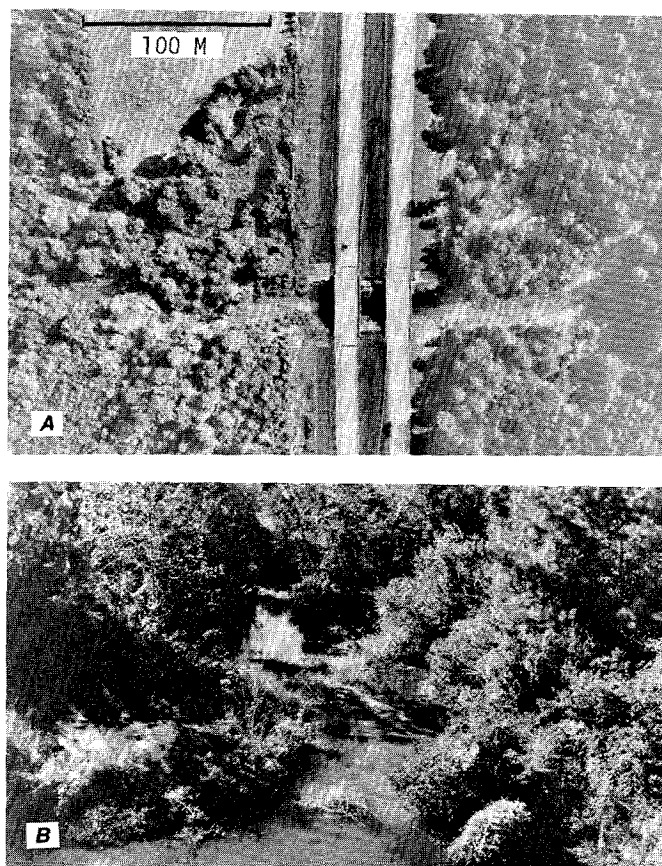
POST-ALTERATION FACTORS--In connection with general scour at the bridges, the bank revetment on the abutment fill-slopes was undermined. The concrete slope pavement subsided and the slabs were displaced downslope. The sacked concrete also failed on the lower slope but remained more intact than did the pavement. In the area of general scour, bottom width of the relocated channel was increased from its original value of 7.5 m to 11 m. The revetment had not been repaired by 1979, and no further erosion was apparent. Vegetation had become re-established along the relocated channel (fig. 95B).

DISCUSSION--In view of the small size and prior stability of the natural channel, and its border of dense forest, it would probably have remained stable if general scour had not been induced at the bridges by contraction of flood flow.

Figure 95. Cool Creek at site 40. A, Airphoto of site in 1975. B, Relocated channel in 1979, as viewed upstream from I-55 bridge.

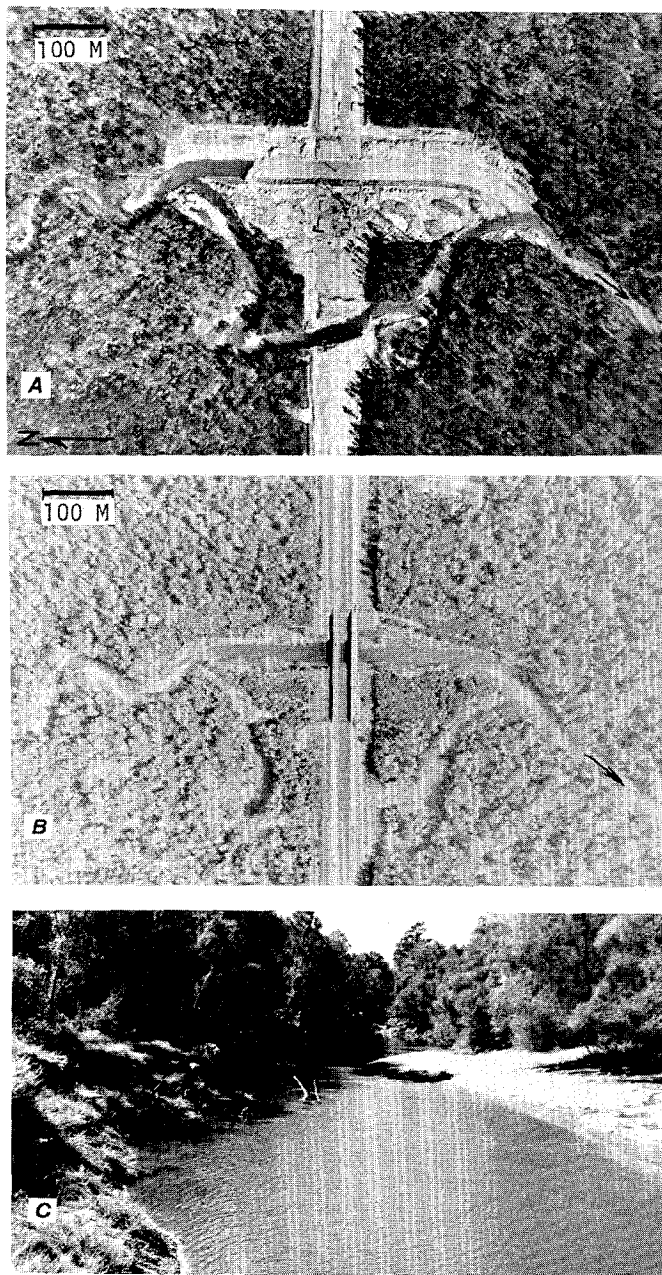
Stability class B3 for relocated channel, class B2 for adjacent reaches of natural channel. Critical factors in widening of the relocated channel are the removal of bank vegetation, which was not replaced, and contraction of flood flows at the bridge.

18 m and a top width of about 24 m, the relocated channel was built with a bottom width of 24.5 m and a top width of 41 m. This increase in width was enough to offset the increase in slope, yet not so much as to induce infilling and the formation of a meandering low-water channel. Widening of the relocated channel in the vicinity of the bridge is attributed to contraction of flood flow, and could probably have been prevented with a suitable revetment.

Figure 96. Tickfaw River at site 41. A, Airphoto of site during relocation in 1967. B, Airphoto of site in 1978. (From Louisiana Dept. of Transportation) C, Downstream end of relocated channel. Left bank is at outside of curve in channel.

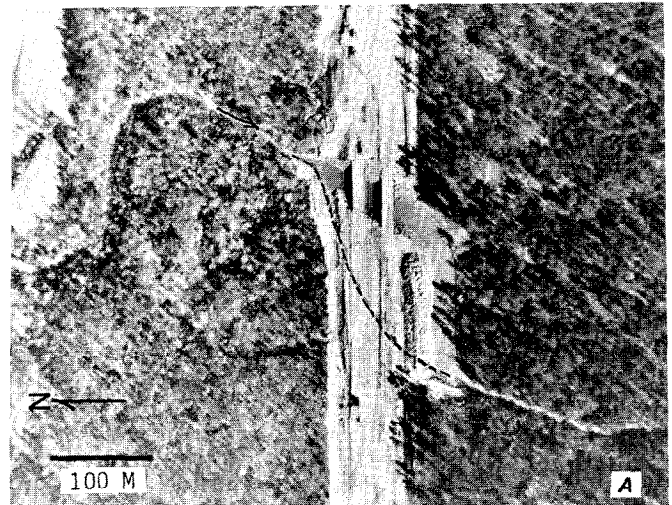
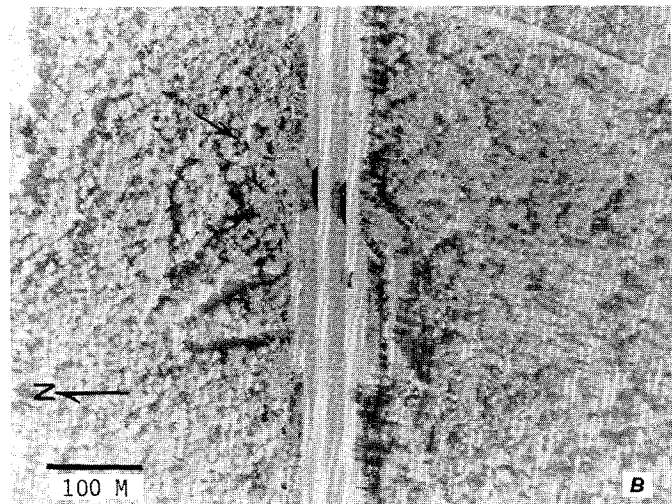
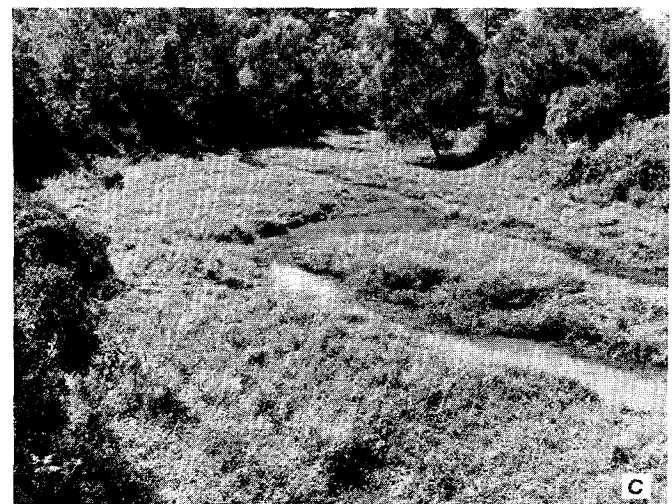
DISCUSSION--Bottom width of the relocated channel is 17 m, as compared with a bottom width of about 4.5 m for the prior channel. Probably, this increase in width was intended to convey flood flows without the use of spur dikes. Downstream from the bridges, a meandering low-flow channel has formed and most of the channel bottom is grassed (fig. 97C). Conveyance of the channel may eventually be reduced by the growth of trees on the channel bottom.

Figure 97. Big Branch at site 42. A, Airphoto of channel relocation, in 1967. Prior channel is indicated by dashed line. B, Airphoto of relocated channel, in 1978. (From Louisiana Dept. of Transportation) C, Relocated channel as viewed downstream from I-12 bridge, in 1979.

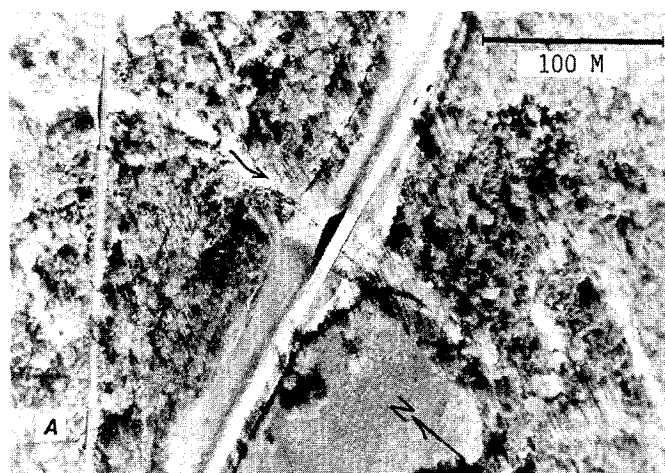
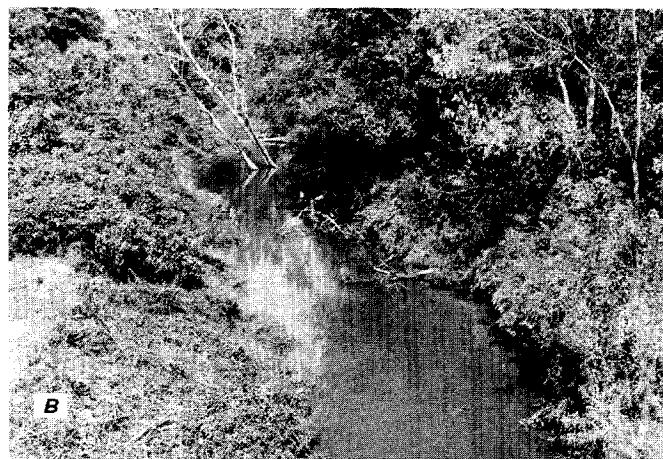
POST-ALTERATION FACTORS--Although Redwood Creek is not gaged at this site, a flood was recorded at the U.S. Geological Survey gage at Slaughter (16 km downstream) in 1977. In 1979, the banks of the relocated channel were grassed within the highway right-of-way, and elsewhere bordered by trees (fig. 99B).

DISCUSSION--In 1979, the relocated channel was somewhat more stable in aspect than sinuous reaches of the natural channel. It is doubtful if relocation had any effect on the natural channel, which tends to be somewhat unstable because of erodible banks.

Figure 99. Redwood Creek at site 43. A, Air-photo of site in 1974. (From Louisiana Dept. of Transportation). B, Creek as viewed upstream from SR-19 bridge, in 1979. Natural channel begins at trees.

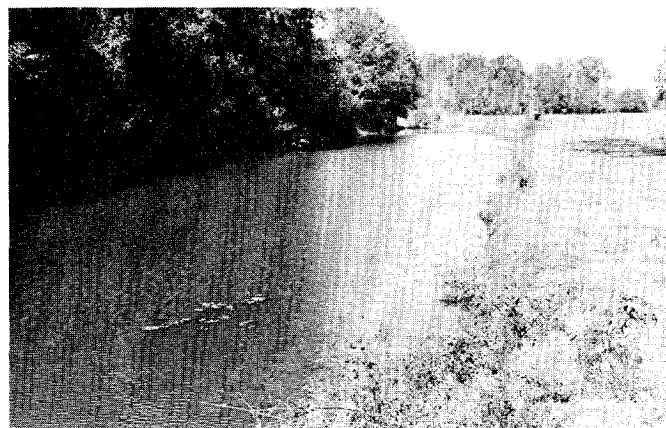
SYNOPSIS--Reach 220 m in length relocated, widened, and decreased slightly in length for purpose of alinement at bridge (fig. 100). Performance period, 31 yr (1949-79). By 1979, the relocated channel had increased in width from an as-built value of 11 m to about 13 m. The low banks were vegetated, with grass on the left bank and trees on the right (fig. 101), and were generally stable except for minor erosion at the bend just downstream from the SR-19 bridge.

Figure 101. Relocated channel of Doyle Bayou in 1979, as viewed upstream toward bridge.

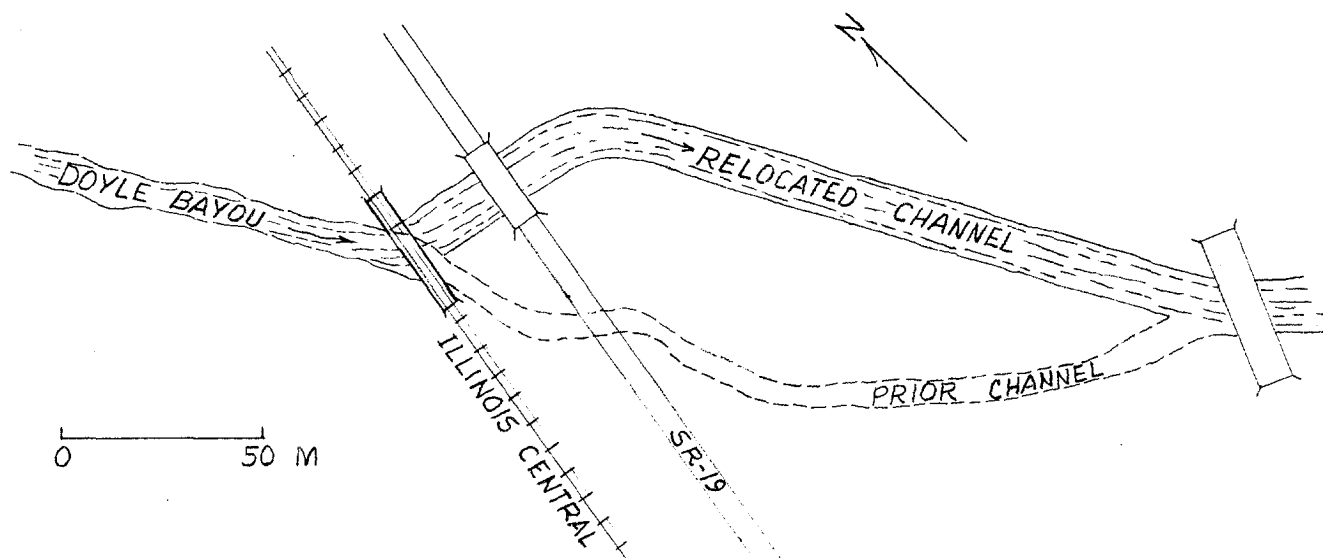
DISCUSSION--A bend such as that in the relocated channel downstream from SR-19 bridge (fig. 100) would have induced more severe bank erosion on many streams, as would the bend at the railroad bridge. Here, water velocity at normal discharge is too low to have any erosive effect, and, because of the wide shallow cross section, velocity would not be high at bankfull stage.

Figure 100. Plan sketch of channel relocation, Doyle Bayou.

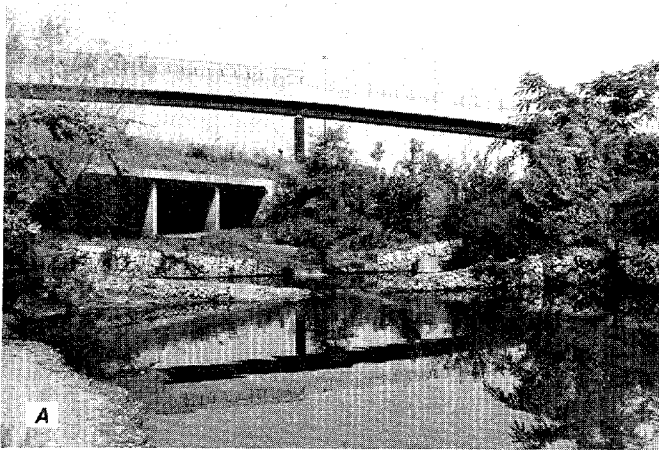
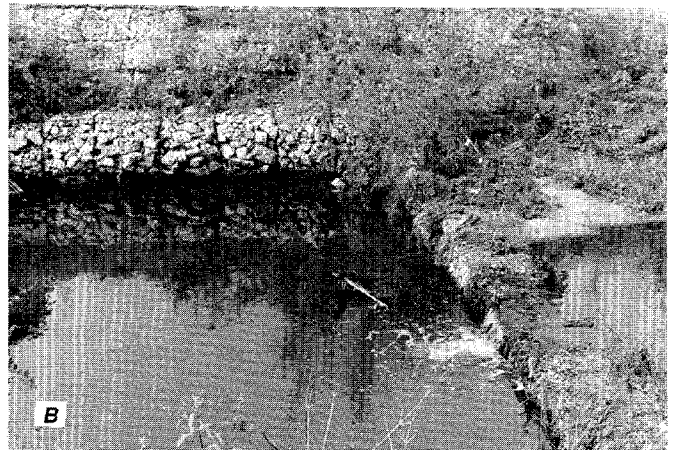
POST-ALTERATION FACTORS--In addition to the minor undercutting of countermeasures, previously described, sediment has accumulated in the north cell and the center cell of the three-cell box culvert, such that low flow is conveyed by the south cell. However, the flood capacity of the culvert has not been significantly reduced. In 1978, young trees had become well established in and around the mattress on the relocated channel, providing additional bank protection (figs. 105A and B). Trees are likely to encroach on the overly-wide channel and reduce its flood capacity.

Figure 105. Moores Run at site 46. A, View upstream of stilling basin downstream from culvert. B, Apparent undercutting of gabion at toe of side slope, on stilling pool downstream from twin bridges. Note rock-and-wire mattress in background.

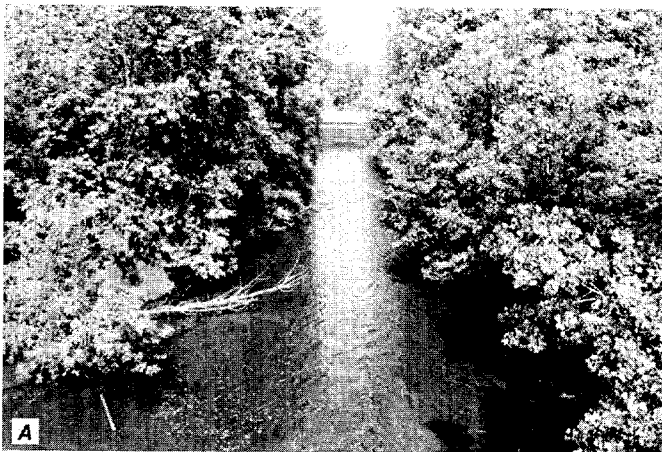
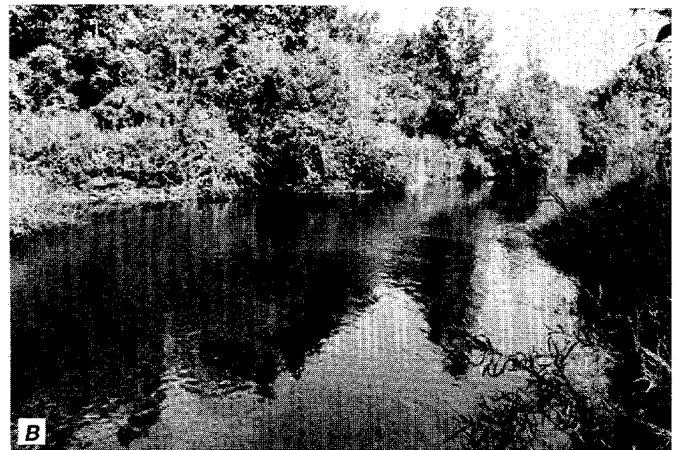
POST-ALTERATION FACTORS--In 1978, the relocated channel was bordered by well-established vegetation and there was no indication of present or past instability. Bank stability of adjacent segments of the natural channel was generally good, and similar to that observed on a 1958 airphoto.

Figure 107. South Branch Tobacco River at site 47. A, Relocated channel in 1978, as viewed downstream from bridge on southbound lane. B, Downstream junction of relocated and natural channel, in 1978.

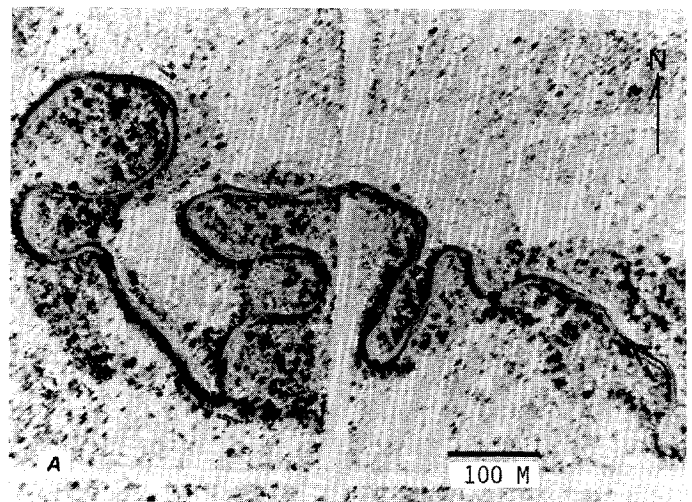
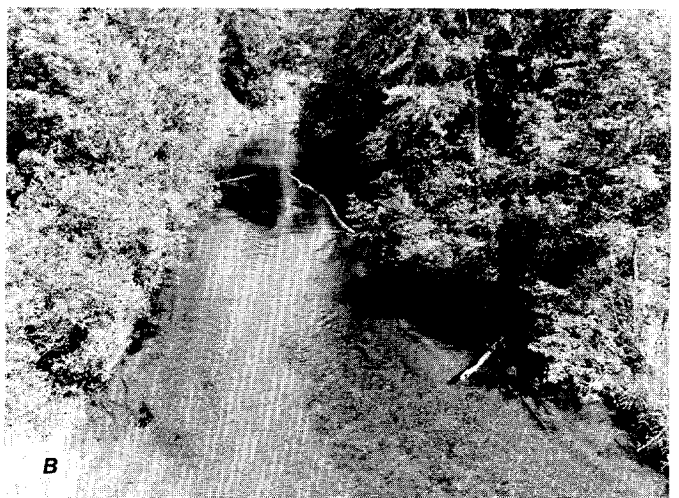
DISCUSSION--The stability of this stream is attributed to natural regulation of flow by ground- and surface-water storage, to incision, and to the dense growth of vegetation along the banks and surrounding areas. Steep unvegetated banks of non-coherent sand and gravel occur at the outside of some bends (fig. 111B), but these evidently erode very slowly.

Figure 111. Pere Marquette River at site 50. A, Airphoto of site in 1958. (From U.S. Dept. of Agriculture) B, Channel upstream from railroad bridge, in 1979.

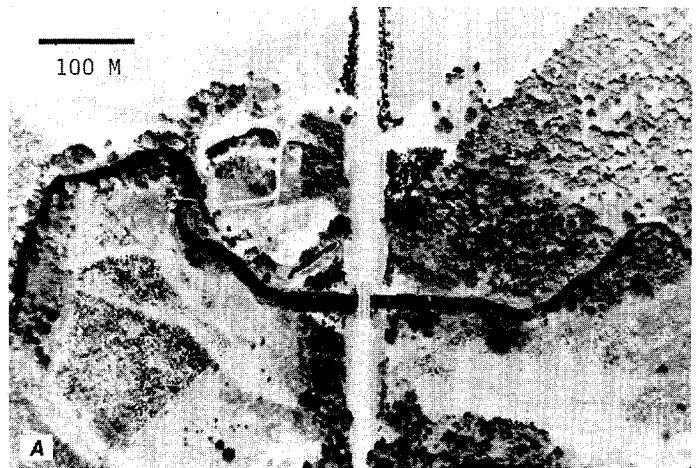
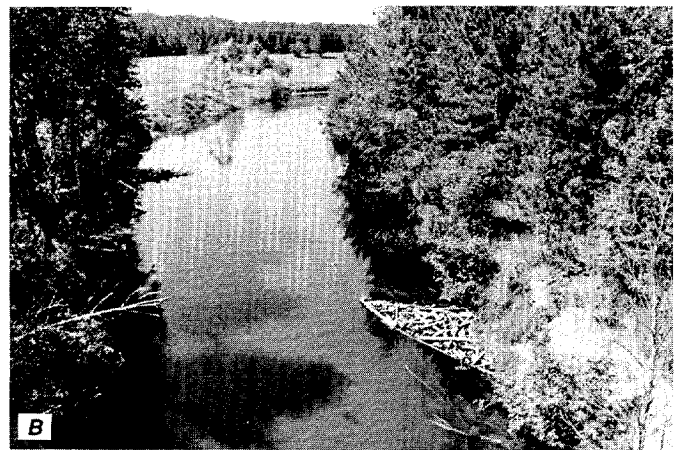
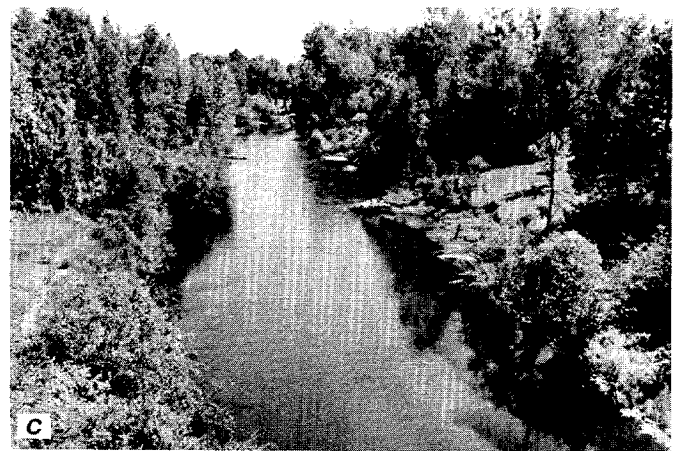
Figure 113. Betsie River at site 51. A, Air-photo of site in 1965. (From U.S. Dept. of Agriculture) B, Relocated channel downstream from bridge, in 1979. Grouted-riprap bank revetment and fish habitat structure at right. C, View upstream from bridge in 1979; relocated channel in foreground.

POST-ALTERATION FACTORS--Log spurs, probably installed by the Michigan Department of Natural Resources as fish habitat structures (fig. 113B)

were in place along the channel in 1979, but are not on a 1965 airphoto. These consist of small logs randomly placed, held together with spikes and secured to the stream bottom with log stakes. That such a structure would remain intact for several years is evidence of the low erosive power of the stream. The grouted riprap revetment, although not keyed into the sandy bank at the upstream end, has not been undercut.

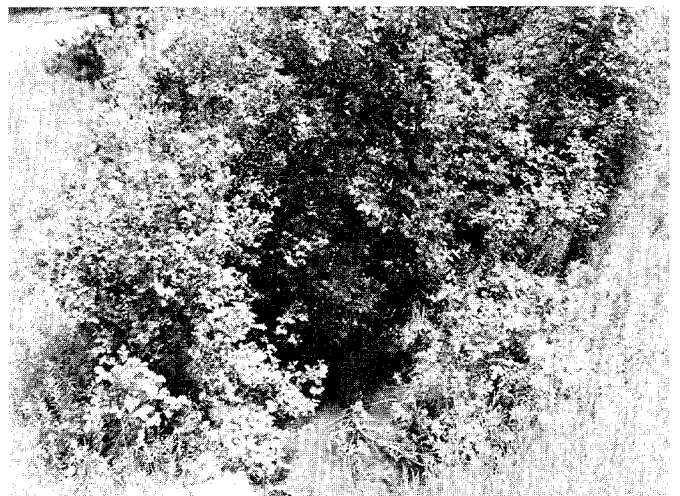
SYNOPSIS--Segment of small stream (2.5 m in width and 430 m in length) relocated and thereby shortened to 320 m, to avoid multiple crossings and to improve alinement at culvert (fig. 114). Performance period, 28 yr (1952-79). There is no record of flow, but some moderately high flows during a period of this length are probable. Banks of both relocated and natural channel were densely vegetated in 1979 (fig. 115), and there was no indication of present or past instability.

Figure 115. Relocated channel of Peterson Creek upstream from culvert, in 1979.

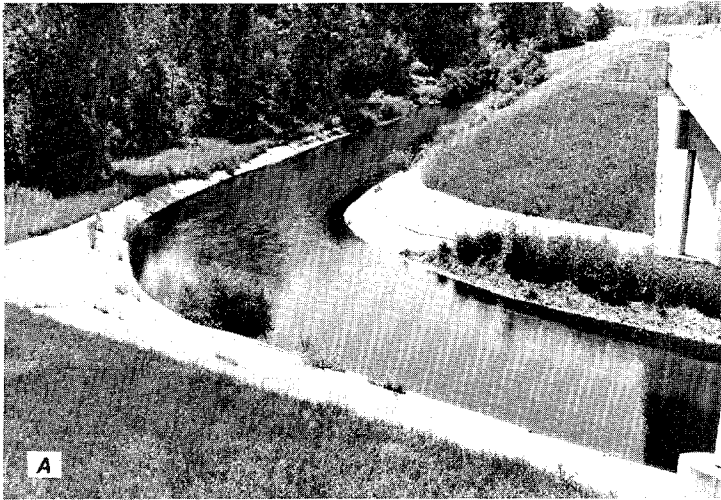
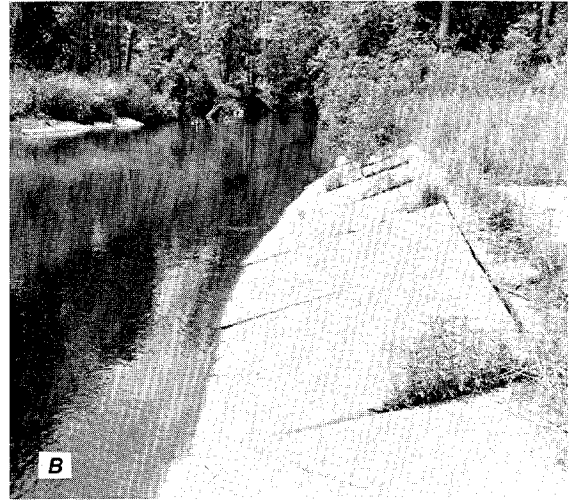
DISCUSSION--Minor subsidence of the concrete slope pavement is attributed to instability of the foundation rather than to stream erosion. The natural channel was undisturbed in the median area, and the relocated reaches were kept to a minimum length.

Figure 117. Tamarack Creek at site 53. A, View upstream from east bridge in 1979. B, View downstream from west bridge in 1979.

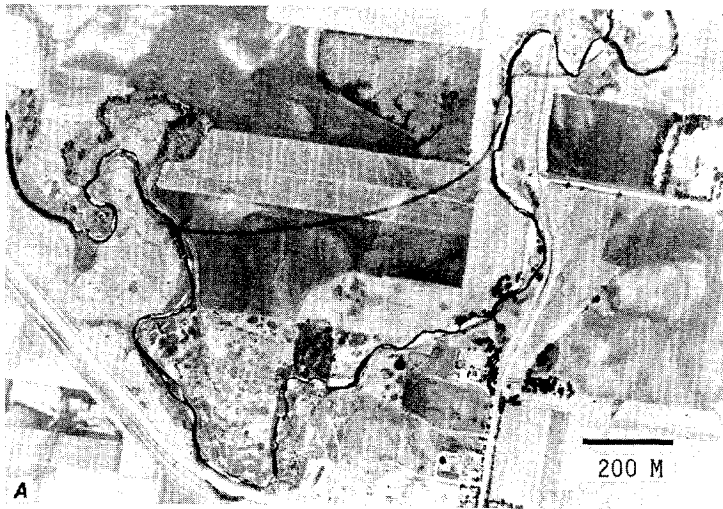
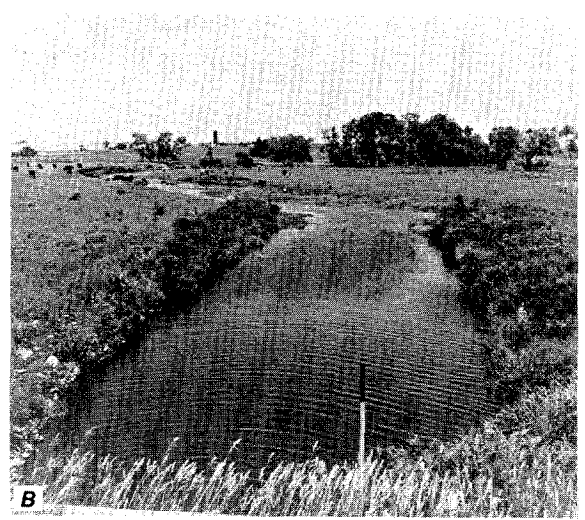
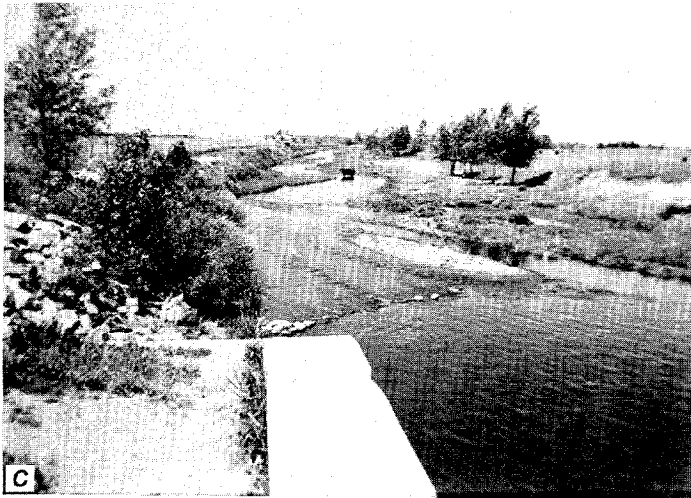
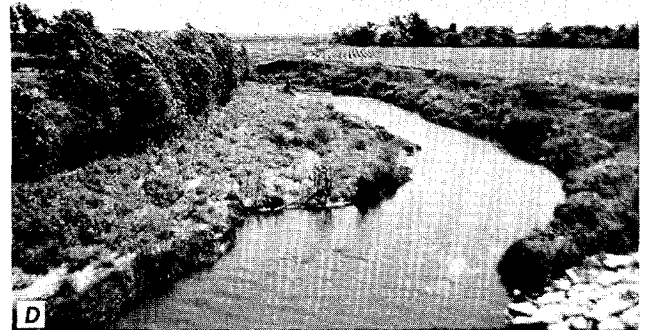
Stability class B1 for relocated channel, class D for natural channel. Critical factors in stability of the relocated channel are: (1) Use of a check dam, with an overfall of 1.35 m, to offset the increase in slope resulting from severe channel shortening. (2) The greater width of the relocated channel, relative to the natural channel has probably served to reduce bank erosion by reducing depth and velocity. However, the stream will eventually meander within this wide channel (fig. 119D), eroding banks at bends. (3) Where installed, riprap has effectively prevented bank erosion.

the culvert intended to carry base flow to the prior channel was filled with sediment, and has not functioned since. There is no record of maintenance or installation of countermeasures since 1967. The low-flow channel has shifted from the center of the relocated channel to a position along the left bank (fig. 119C).

Figure 119. Kanaranzi Creek at site 54. A, Airphoto of site in 1954, before relocation. Solid line indicates position of relocated channel. (From U.S. Dept. of Agriculture) B, Relocated channel upstream from SR-91 bridge, in 1979. C, Relocated channel downstream from check dam, in 1979. D, Downstream intersection of prior channel, foreground, with relocated channel, right background.

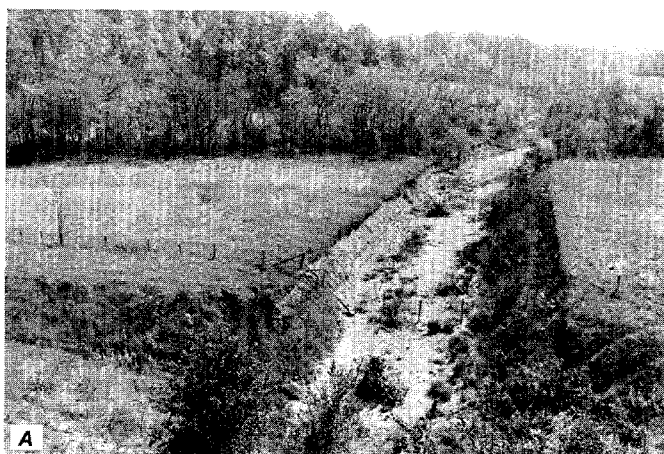
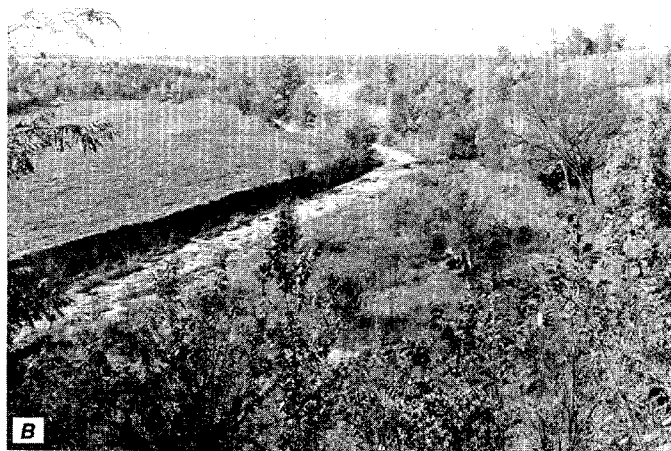
SYNOPSIS--Channel was relocated and a segment was thereby shortened from a length 550 m to 490 m, for purpose of improving channel alignment at culvert (fig. 120). Performance period, 18 yr (1960-78), during which two or three rainstorms of fairly high intensity occurred, and a flood of about 5 yr recurrence interval is estimated. The relocated channel was trapezoidal in cross section, with a bottom width of 9 m, side slopes of 2:1, and a channel slope of about 8 m/km. No countermeasures were used. In 1978, the channel bottom width upstream from the culvert was in the range of 9-10.5 m; the right bank was raw and nearly vertical, and the left bank was more gently sloping and stabilized by vegetation (fig. 121A). Downstream from the culvert, the

bottom width was about 12 m and the right bank was more stable than the left (fig. 121B). Channel degradation is indicated by the incised nature of the channel, but degradation has been halted by an outcrop of cherty limestone in the channel upstream from the site. Moreover, the degradation, and associated bank erosion, which is common to streams in the area, is attributed to land use practices rather than to relocation.

DISCUSSION--Although the bank on one side of the relocated channel is cut, channel top width has not increased significantly since relocation. Bottom width of the relocated channel (9 m) was only slightly greater than that of the natural channel (6-7.5 m), but the thalweg has shifted against one bank. Bank erosion could probably have been prevented by a vegetal lining or some other bank protection measure.

Figure 121. Collie Hollow at site 55. A, View upstream from I-44 embankment along relocated channel in October 1978. Line of trees in left background marks location of prior channel. B, View downstream from I-44 embankment along relocated channel in October 1978.

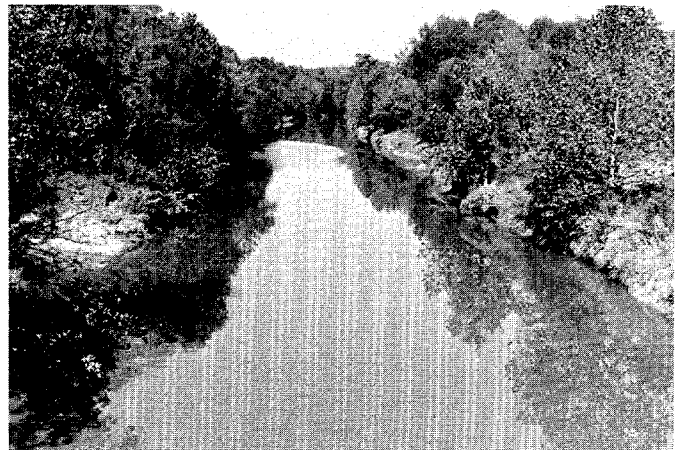
Figure 127. View along relocated channel of Bear Creek downstream from bridge, in 1979.

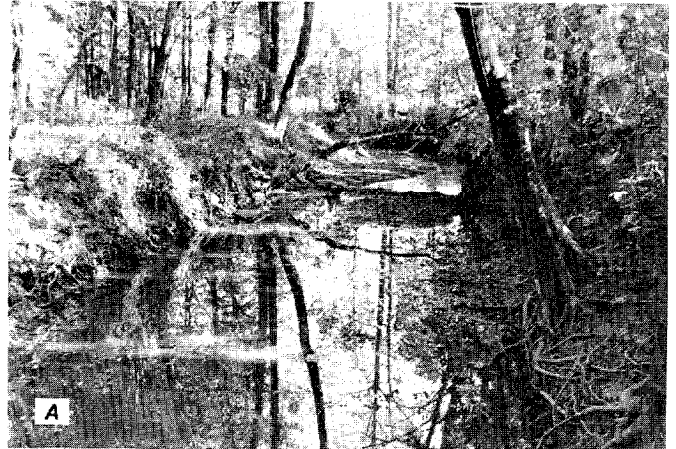
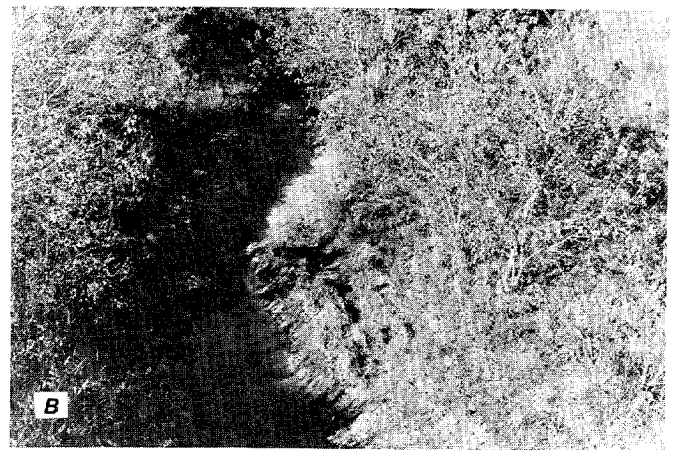
Figure 129. Strong River at site 59. A, Natural channel upstream from relocation, in 1979. B, Relocated channel upstream from I-20 bridge, in 1979.
