Report No. FHWA/RD-80/158

STABILITY OF RELOCATED STREAM CHANNELS

March 1981
Final Report

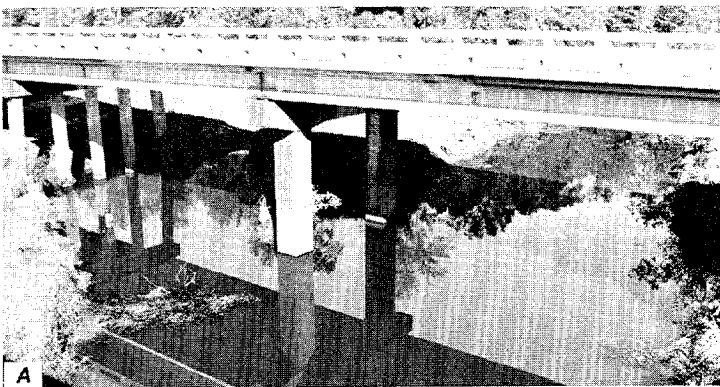
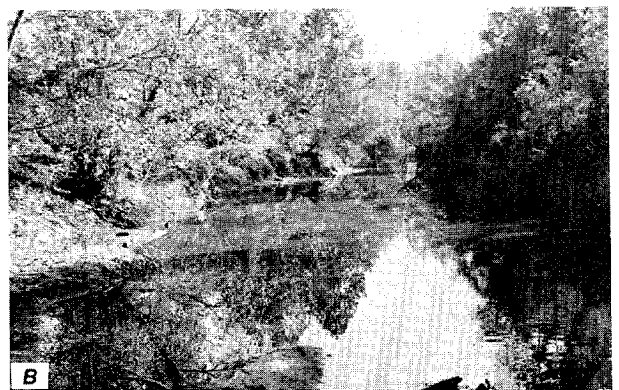
Figure 133. Oakahatta Creek at site 61. A, Channel widening at west-bound interstate bridge, as photographed in 1979. B, Relocated channel downstream from interstate bridges, in 1979.

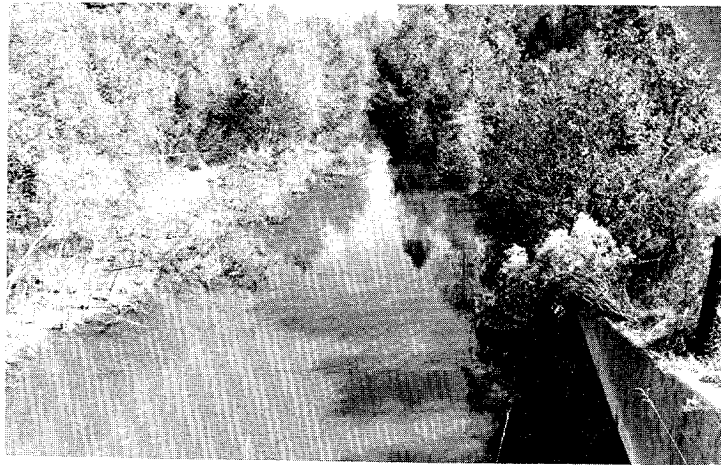
Figure 137. Relocated channel of Bogue Homo downstream from culvert, in 1979.

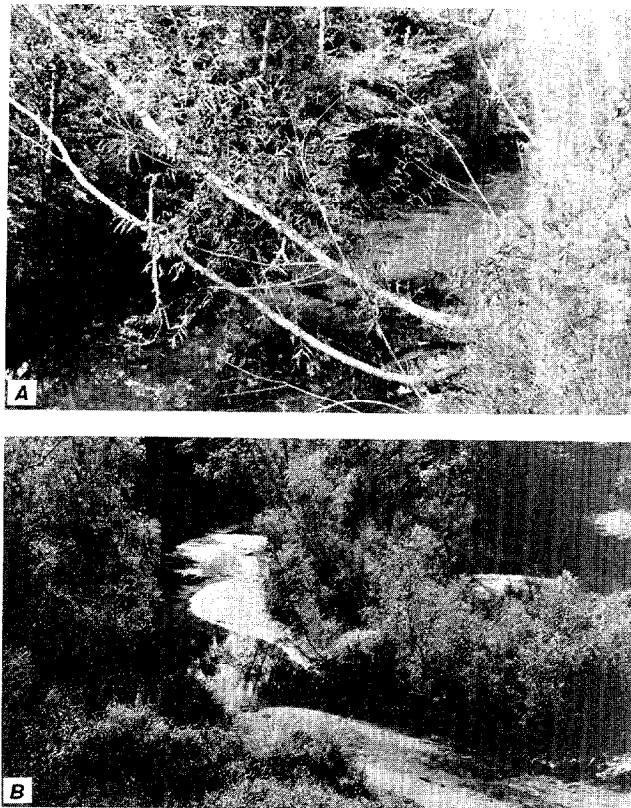
The relocated channel was trapezoidal in cross section, with a bottom width of 12 m, 2:1 side slopes, and a channel slope of about 1.3 m/km. No bank protection measures were applied. In 1979, banks of the relocated channel upstream from the bridge were stable and well vegetated (fig. 139A) and the channel downstream was also stable (fig. 139B). At the upstream transition to the natural channel, local bank erosion had increased the channel width to 20 m; but in general the natural channel was stable.

Figure 139. East Hobolochitto Creek at site 64. A, Relocated channel upstream from bridge, in 1979. B, Relocated channel downstream from bridge, in 1979.

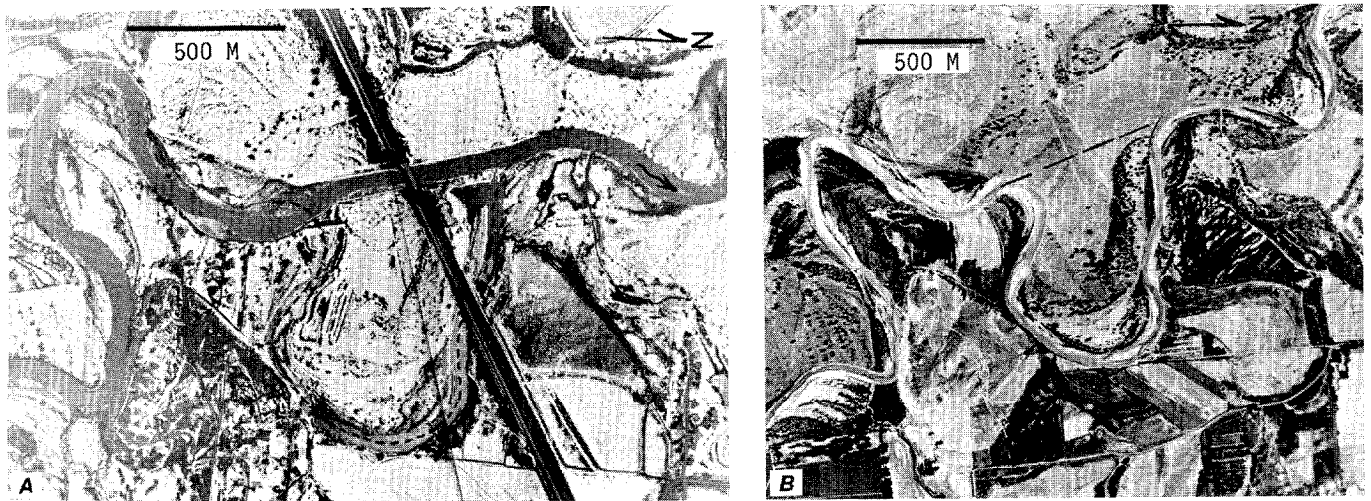
SYNOPSIS--Channel was relocated by cutting of a meander bend, reducing the length of a channel segment from 2,200 m to 600 m, for purpose of improving alinement at bridge and preventing encroachment of meander on planned roadway location (fig. 140A). Performance period, 17 yr (1962-79). At the U.S. Geological Survey gage about 5 km upstream, the maximum peak flow ($377 \text{ m}^3/\text{s}$) for a 32-yr period of record occurred in 1962; a second major flood ($289 \text{ m}^3/\text{s}$), in May 1975; and another, in March of 1979. As built, the relocated channel was trapezoidal in cross section, with a bottom width of 52 m, 2:1 side slopes, and a channel slope of about 1.1 m/km. In the plans, riprap bank protection is specified only at the bridge; but large riprap, at the toe of both banks for the full length of the relocated section, is visible on a 1969 airphoto. This site was not visited in the field, but airphotos taken in 1950, 1958 (fig. 140B), 1966, 1969, and 1979 were obtained mainly from the Montana Department of Transportation. As observed and measured on the airphotos, bottom width of the relocated channel was 56 m in 1966 and 57 m in 1979, and the banks were stable in 1979. Alternate lateral bars, which may be the precursors of meandering, had formed in the straight relocated channel by 1969. Maximum lateral erosion measured at bends on the natural channel was 8 m for the period 1950-58 and 33 m for the period 1969-79. The

Figure 140. Tongue River at site 65. A, Airphoto of channel relocation in 1979. Prior channel is shown in dotted line. (From Montana Dept. of Transportation) B, Airphoto of site in 1958. Position of relocation is shown in dashed line. (From U.S. Dept. of Agriculture)

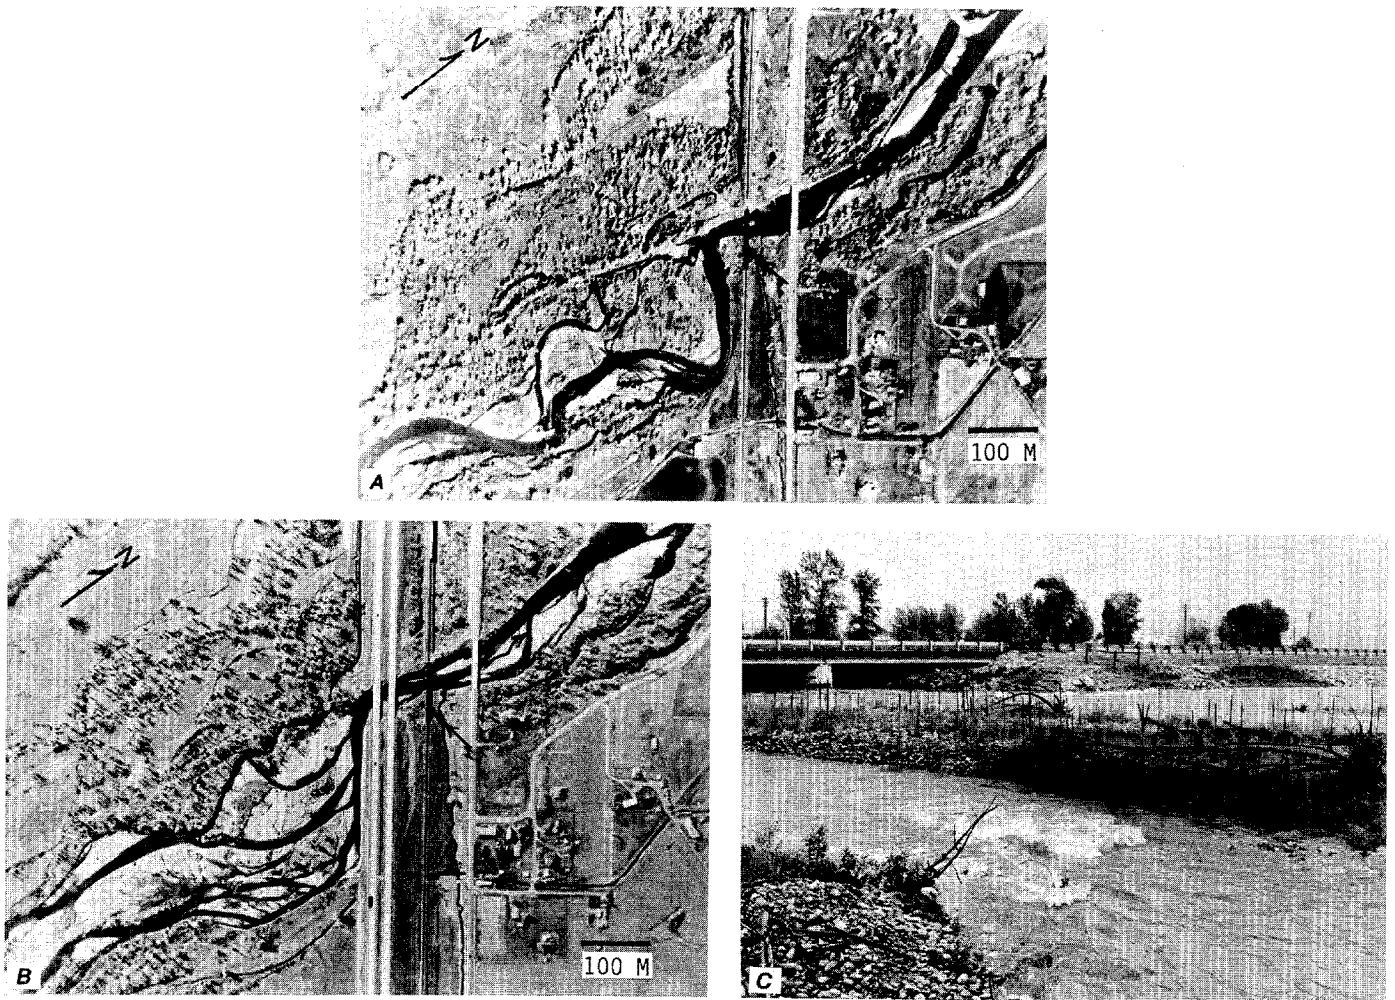
SYNOPSIS--Channel relocation, involving a main channel segment of anabranching river about 365 m in length, which was shifted to the left and shortened to 240 m; for purpose of accommodating planned roadway location, improving channel alignment at bridge and confining the stream width (fig. 141A). Performance period, 13 yr (1966-79), during which three floods occurred. The relocated channel had a bottom width of 36.5 m and a channel slope of 6.6 m/km. Riprap was placed along the roadway embankment (fig. 141B) and along the left bank upstream from the bridge. By 1979, the anabranch at the right bank in figure 141B had been abandoned and impingement of flow directly against the riprapped roadway embankment had caused local erosion and slumping (fig. 141C). Otherwise, the streambanks were stable and the relocation appeared to be functioning as planned. Because of the minor nature of the relocation and the shifting anabranches and braids of the stream, no effect on adjacent segments would be anticipated and none was observed.

Figure 141. Gallatin River at site 66. A, Airphoto of site in 1963, position of re-located channel indicated by dashed line. Railroad bridge, indicated by arrow, is 90 m in length. (From Montana Dept. of Transportation) B, Airphoto of site in 1972. (From Montana Dept. of Transportation) C, View downstream toward interstate bridge in 1979.

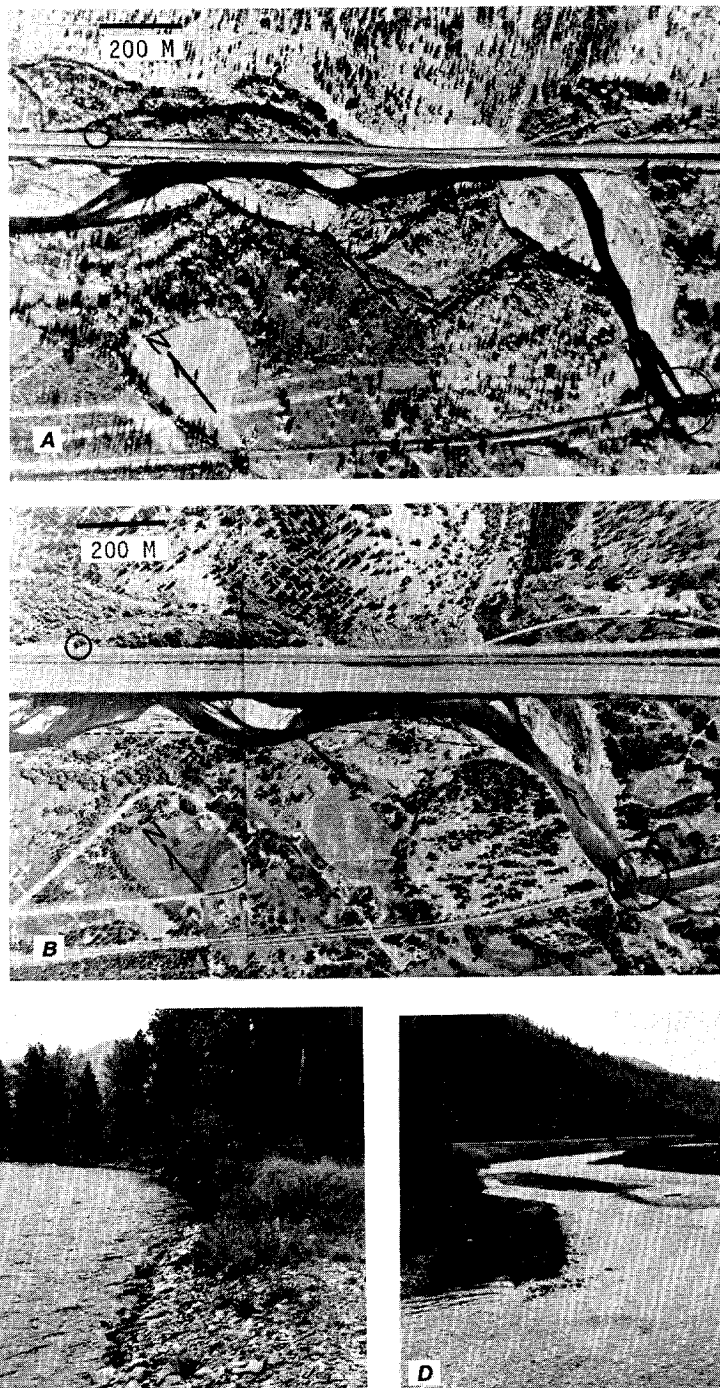
Figure 142. Clark Fork at site 67. A, Airphoto of site in 1956. Milwaukee, St. Paul, and Pacific Railroad bridge, circled at right, is 120 m in length. (From Montana Dept. of Transportation) B, Airphoto showing upstream end of relocated channel in July 1975, after major flood in June 1975. Original left bank of relocated channel is shown in dashed line. Railroad bridge is circled at right. (From Montana Dept. of Transportation) C, Eroded left bank of relocated channel in 1979. D, Upstream end of relocated channel in 1979.

1.2-m thickness of rock riprap. A rock riprap dike was constructed on the right bank at the downstream end of the relocation. During the 1975 flood, two large scallops developed in the left bank near the downstream end of the relocation, increasing the total channel width locally to 140 m (fig. 142B). The channel has shifted away from one of these scallops; but in 1979, active bank erosion was continuing at the other (fig. 142C). The banks were generally stable at the downstream end of the relocated channel (fig. 142D). The natural channel underwent significant changes during the period 1965-78, such that the entire channel length on the Bonner 7.5' map was redrawn on the 1978 photorevision of the 1965 map. However, it is doubtful that the relocation, which involved no change in channel length, had any effect on adjacent segments of the natural channel.

Stability class C3 for relocated channel for which local bank erosion had a maximum value of about 40 m for the period 1964-75. Stability class D4 for natural channel, whose instability is expressed mainly in shifts of anabranches. The immediate cause of bank erosion is the development of bars in the channel, which deflected flood flow toward the erodible and unprotected left bank.

DISCUSSION--The channel at this site had previously been relocated (by moving it laterally to the left) during construction of the Burlington Northern Railroad in the early 1900's. By 1956 (fig. 142A), the relocated channel had reached a maximum width of about 170 m, which is within the range of widths for the natural channel. The river has a natural tendency toward lateral instability, and bank erosion can be expected unless the bank is riprapped. The ability of riprap to resist lateral erosion by the river has been established by the many railroad embankments that have been protected by riprap for decades.

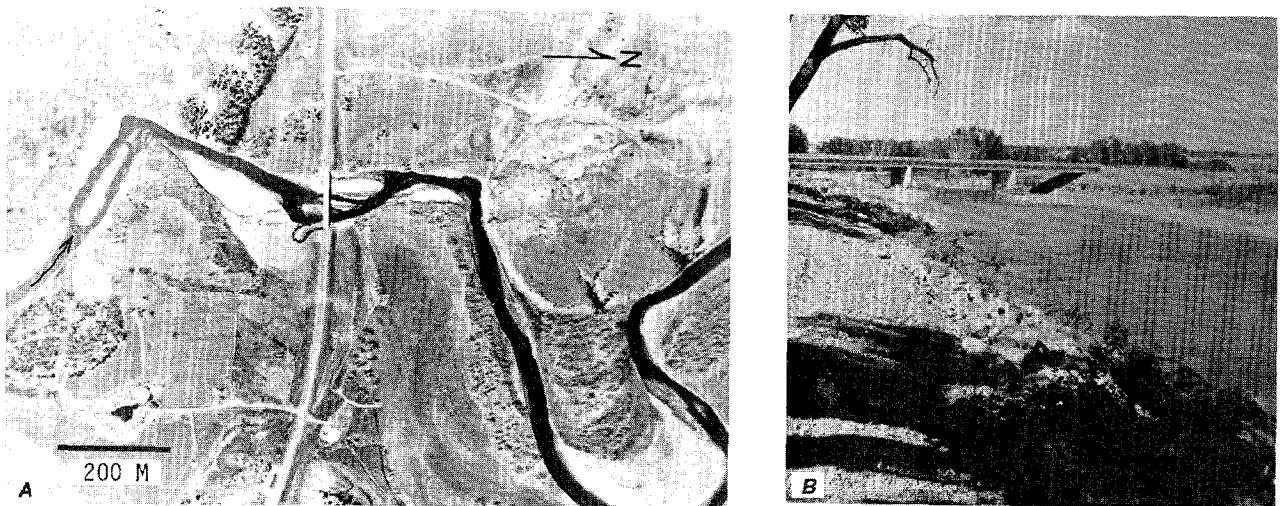
Figure 144. Musselshell River at site 68. A, Airphoto of site in 1976. Spur dike is indicated by heavy line. (From Montana Dept. of Transportation) B, Downstream view along relocated channel in 1979. Riprapped left bank is in foreground.

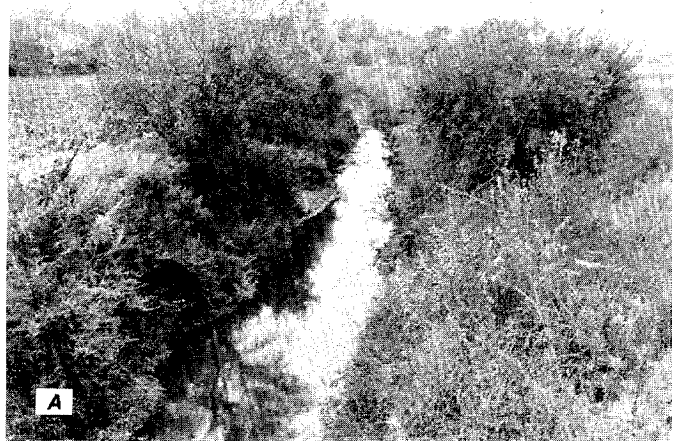
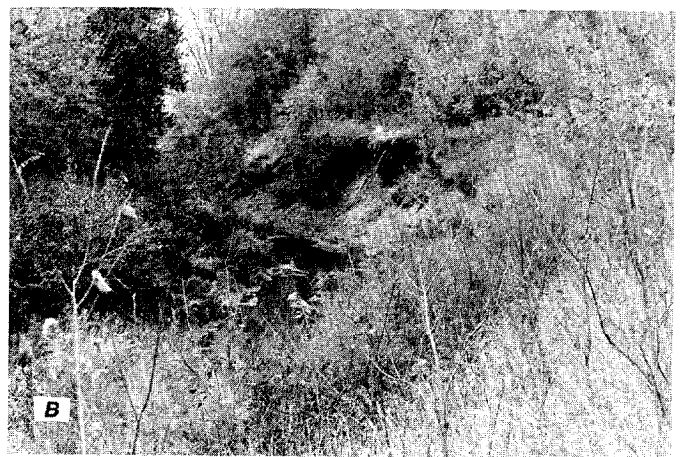
SYNOPSIS--A reach 865 m in length was relocated and thereby shortened to 475 m, for purpose of improving channel alinement at bridge and to accommodate planned interstate location (fig. 145). Performance period, 18 yrs. (1961-79), during which a flood of approximately 10-yr recurrence interval was recorded at gaging stations on nearby creeks. The relocated channel was trapezoidal in cross section, with a bottom width of 6 m, 2:1 side slopes, and a channel slope of about 2.7 m/km. Although no countermeasures are specified on the plans, a small riprap check dam was observed upstream from the bridge on a field visit in 1979, and scattered broken concrete riprap was present along the banks of the relocated channel in the vicinity of the bridge. The banks were moderately stable (fig. 146A) by comparison with banks on other streams of this type in Nebraska, but bank slumping was observed downstream from the bridge and bank erosion, at the downstream junction of natural and artificial channel (fig. 146B). On a 1955 airphoto, cut banks are visible at bends along Camp Creek and at reaches where the stream had been channelized for agricultural purposes. Channel stability had not deteriorated significantly by 1979, except at the channelized reaches, where bank erosion was severe.

Figure 146. Camp Creek at site 69. A, View of relocated channel downstream from I-80 bridge, in 1979. B, Bank erosion at downstream junction of natural and relocated channels, in 1979.

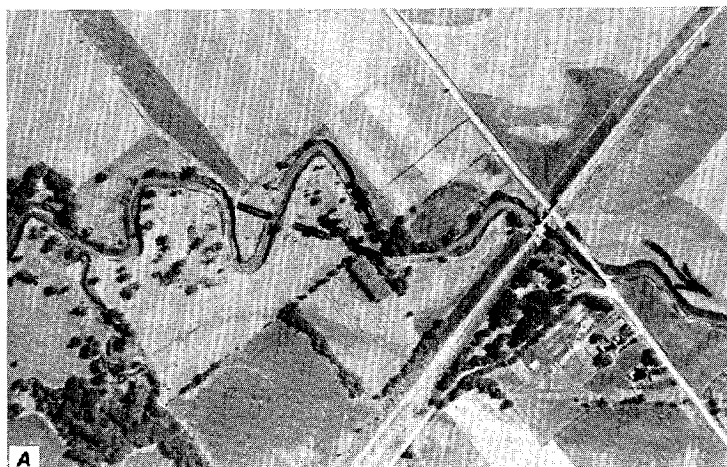
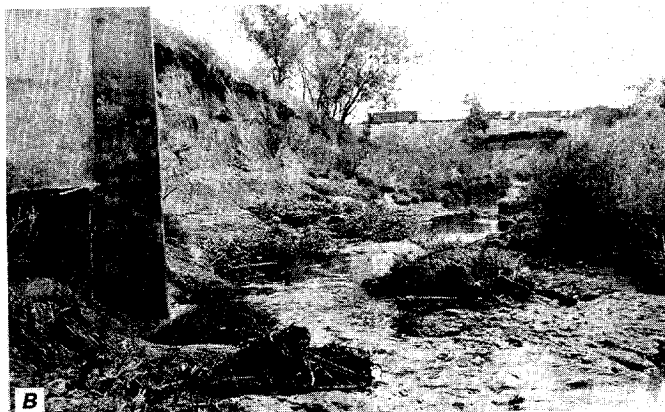
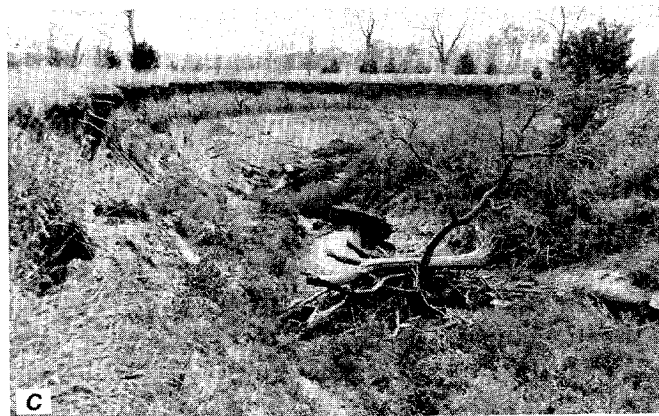
SYNOPSIS--Channel of deeply incised creek was relocated, thereby reducing the length of a channel segment from 510 m to 255 m; for purpose of improving channel alinement at bridge and accommodating planned interstate location (figs. 147A and B). Performance period, 18 yr (1961-79), during which two floods of recurrence interval in the range of 5-10 yr occurred. No countermeasures were apparent from field inspection in 1979. Channel degradation at the bridge had exposed the top of a pier footing (fig. 147B), the bankline at the pier had receded about 6 m, and bank erosion had occurred along the relocated channel downstream from the bridge. At the first bend upstream from the relocation, severe bank recession was in progress at the outside of a bend (fig. 147C). As observed on a 1955 airphoto, the banks along the natural channel were generally steep and unstable, but the relocation has probably contributed to bank erosion in adjacent segments of the channel. Channel degradation had probably already occurred along the channel prior to relocation, as indicated by countermeasures at the railroad bridge downstream.

Figure 147. Middle Creek at site 70. A, Airphoto of site in 1955, position of relocated channel shown in dashed line. (From U.S. Dept. of Agriculture) B, View upstream along relocated channel from beneath bridge, in 1979. Top of exposed pier footing is at left. C, Bank erosion at bend upstream from relocated channel, in 1979. Bank height is 7.5 m.

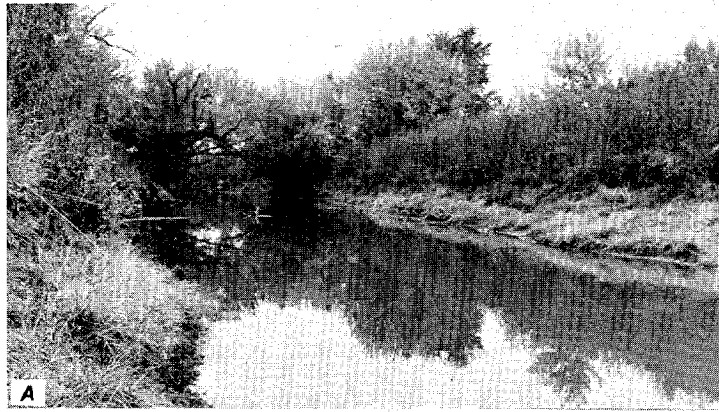
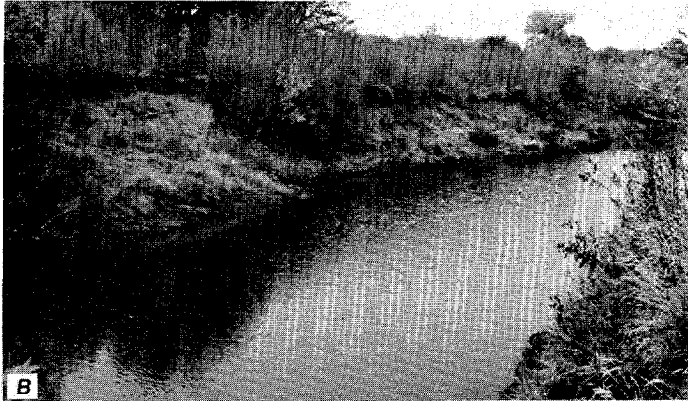
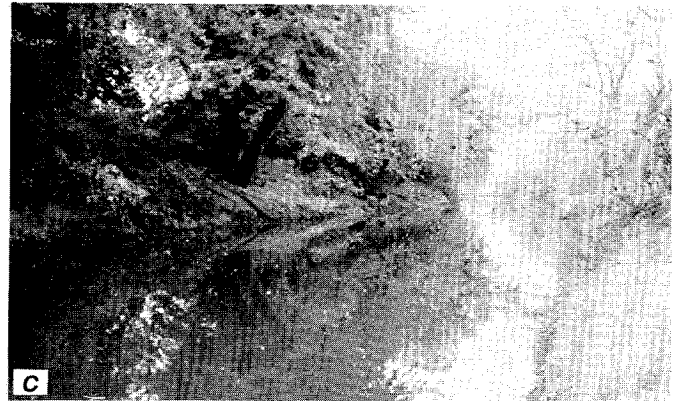
SYNOPSIS--Channel was relocated by cutting off two bends such that the relocated segments were separated by a short segment of natural channel (fig. 148). At the upstream bend, where the relocation was done to improve channel alignment at the interstate bridge, the channel was shortened from a prior length of 820 m to 400 m. At the downstream bend, where the apparent purpose of the relocation was to reduce flooding of a rest area, the channel was shortened from a prior length of 700 m to 250 m. No bank protection measures were applied. Performance period, 16 yr (1963-79) during which floods approaching a 25-yr recurrence interval occurred in 1963 and 1967. Floods of recurrence interval in the range of 5-10 yr have occurred since 1967. No plans showing the dimensions of the relocated channel were obtained, but the bottom width as measured on a 1965 airphoto was 14.5 m, narrowing to 12 m at the upstream end. In 1979, the banks of the relocated channel were generally stable (fig. 149A, except for bank slumping upstream from the interstate bridge (fig. 149B). Prior stability of the natural channel was good, as observed on a 1955 airphoto, except for cut banks at some bends. However, meander cutoffs that appear to be natural are common along the course of the river. No effect of relocation on the natural channel was discerned (fig. 149C).

Stability class B2 for relocated channel and B1 for adjacent segments of natural channel. Channel stability is tentatively attributed to the establishment of vegetation on the graded banks, which are kept moist by the permanent flow of the stream. In addition, the banks are not high by comparison with those along many smaller streams in the area.

Figure 149. Big Blue River at site 71. A, Downstream junction of relocated channel (foreground) with natural channel, in 1979. B, Bank slumping along relocated channel upstream from bridge, in 1979. C, Natural channel along short segment between relocations, in 1979.

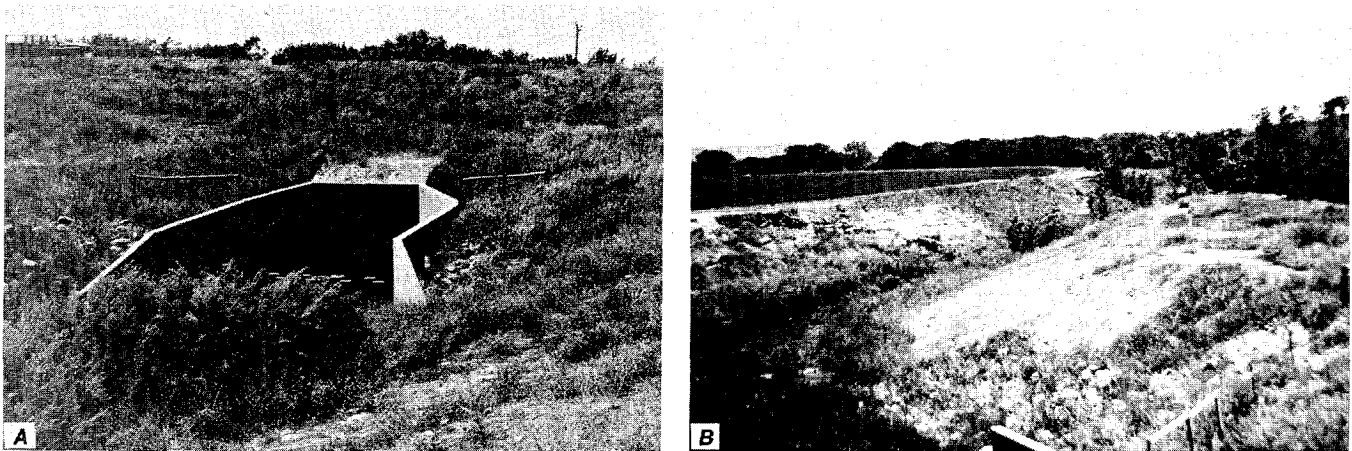
SYNOPSIS--Channel segment of intermittent stream was relocated in 1962 and thereby shortened from a length of 440 m to 370 m, for purpose of improving channel alignment at culvert entrance (fig. 150). During rainstorms between 1967 and 1975, bank erosion and channel degradation occurred downstream from the culvert. Riprap revetment was replaced three times. In 1975, the relocated channel was rebuilt to a lower gradient for a distance of 91 m downstream from the bridge, the box culvert was extended, and a drop structure (having a fall of 2.1 m) and a stilling basin were constructed (fig. 151-A). No significant storms have occurred since 1975. In 1979, field observations indicated that the relocated channel upstream from the culvert was stable and well vegetated. Downstream from the culvert, the channel bottom was grassed but the side slopes were mostly bare and the left bank has slumped at one place (fig. 151B). No effect of relocation on the natural channel was discerned.

Figure 151. One Mile Creek at site 72. A, Culvert and stilling basin at downstream side of roadway embankment. B, View downstream from bridge along relocated channel of One Mile Creek, in 1979.

ALTERATION AND POST-ALTERATION FACTORS--The channel as relocated in 1962 was trapezoidal in cross section with 3:1 side slopes and a bottom width of 6.1 m. For a distance of about 12 m downstream from the culvert outlet, the channel was lined with "fieldstone" riprap to a depth of 0.45 m and extending a vertical distance of 1.5 m onto the side slopes. The ends of the riprap blanket were keyed into the channel sides and bottom by a trench filled with riprap. In the 1975 reconstruction, the channel downstream from the added drop structure and stilling basin was protected with loose rock riprap installed over a filter blanket. The drop structure and stilling basin were designed to achieve a 70 percent reduction in outlet energy.

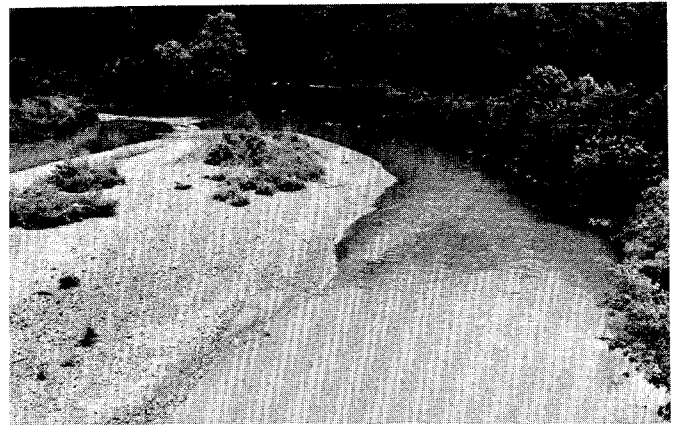
DISCUSSION--The explanation for the much greater sinuosity of the natural channel downstream from this site is not apparent, but the greater sinuosity is associated with a decided deterioration in lateral stability. With regard to the relocated channel, the large blocks of riprap along the left bank at the downstream end have apparently aided in the establishment of young trees along the bankline.

Figure 153. View of relocated channel of Hocking River downstream from US-33 bridge, in 1979.

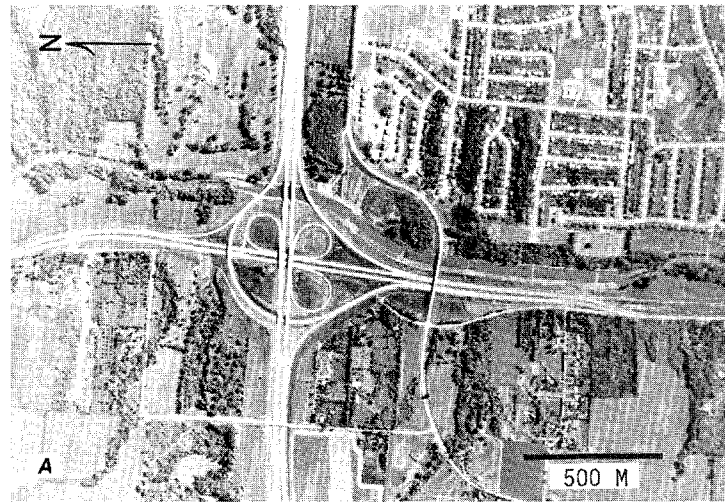
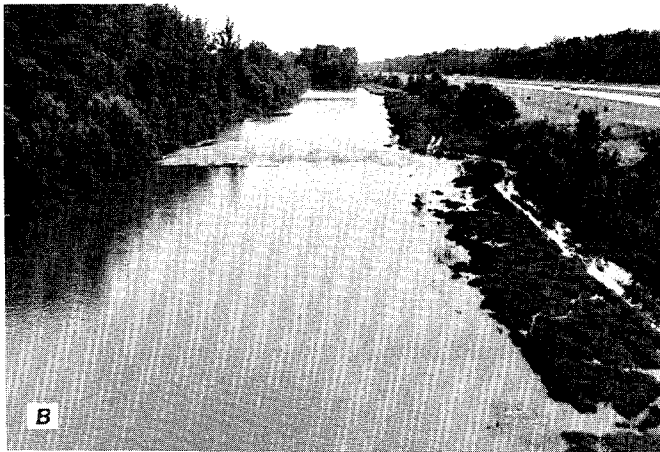
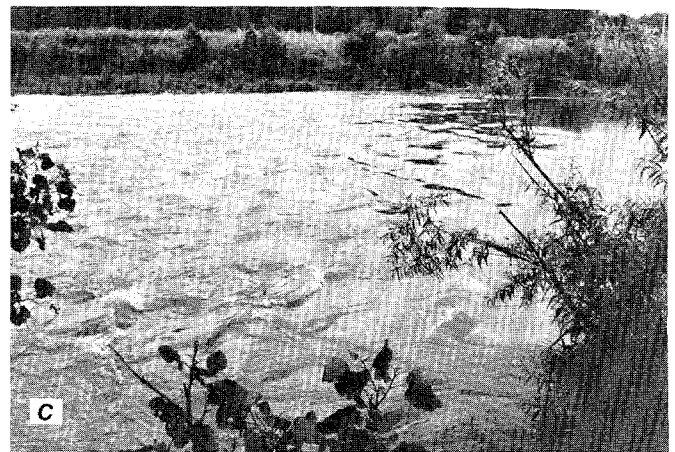
Figure 155. Olentangy River at site 74. A, Airphoto of site in 1971. (From U.S. Dept. of Agriculture) B, View downstream along relocated channel in 1979. Riffle in background is at check dam. C, View of riffle at check dam, in 1979.

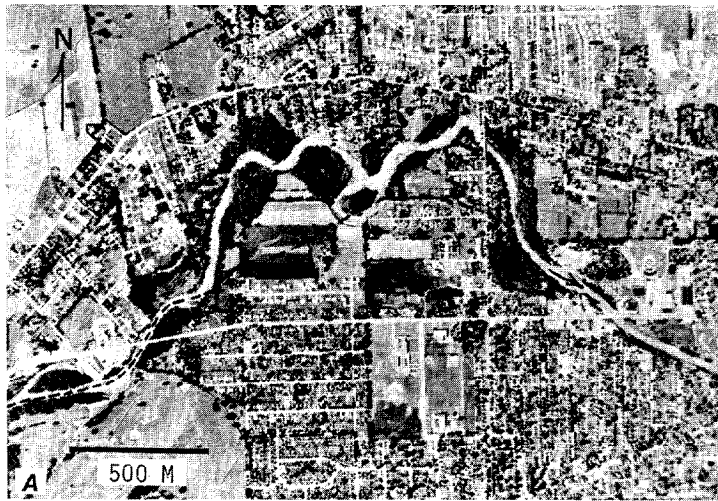
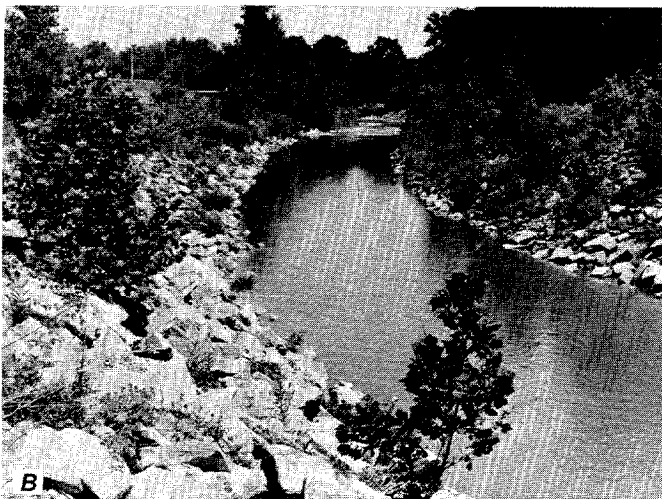
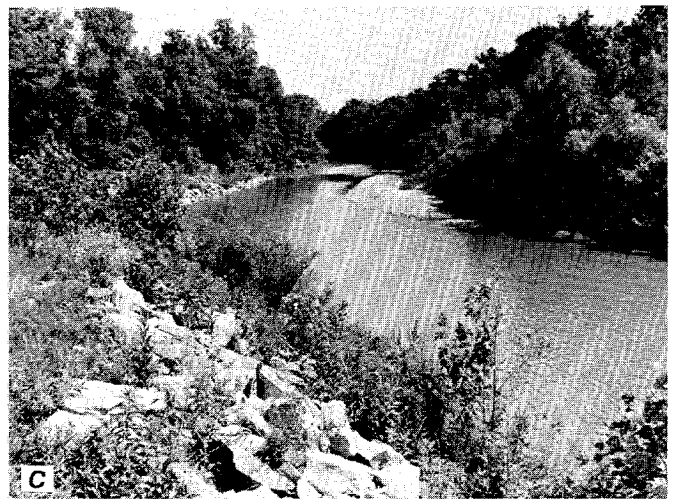
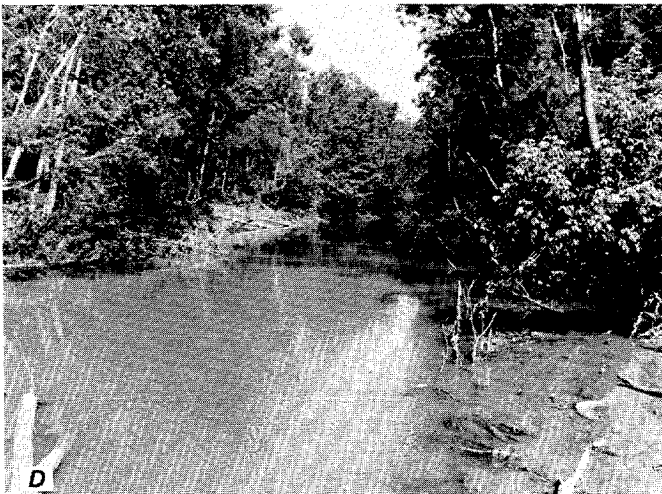
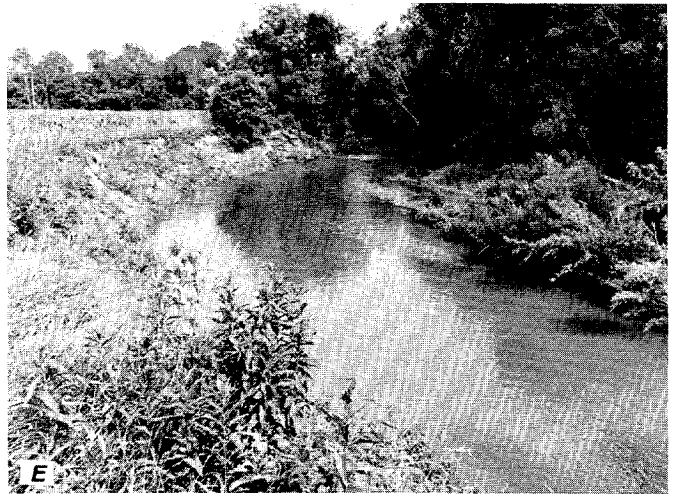
rock outcrop in the channel near the upstream end of the relocation. As observed on a 1957 airphoto, cut banks were at bends in the natural channel and a substantial lateral migration rate is apparent from comparison with a 1964 airphoto. No apparent effect of relocation on the natural channel (fig. 157 C) was observed.

As observed in the field in 1979, the relocated channel was in many places bordered by a dense growth of trees (fig. 157D) and the banks were generally stable except for local erosion where the flow was deflected by mid-channel bars. However, a tendency for re-establishment of the meandering pattern was noted, particularly where the channel was bordered by cultivated fields (fig. 157E).

Figure 157. Raccoon Creek at site 75 and near Granville, Ohio. A, Aerial photograph of site in 1964. Approximate position of relocated channel shown in dashed line. B, Riprapped section of relocated channel, in 1979. C, Downstream junction of relocated channel with natural channel, in 1979. D, Relocated channel of Raccoon Creek near Granville, in 1979. E, Bank erosion at bend in relocated channel of Raccoon Creek near Granville, in 1979.

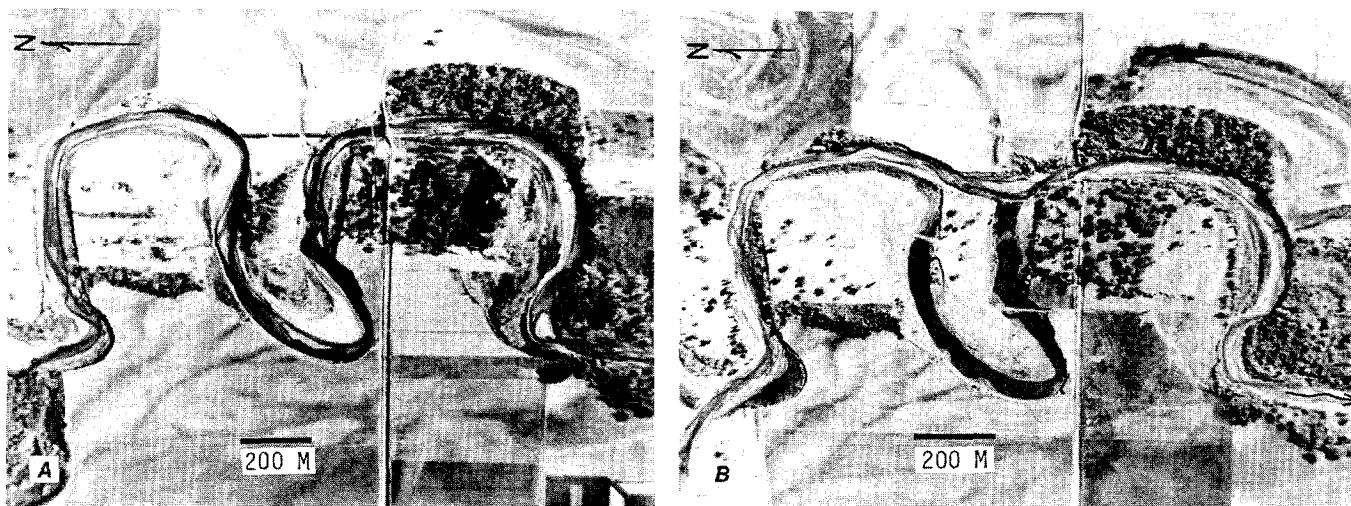
DISCUSSION--Although the relocated channel is given a low stability rating by comparison with very stable channels, its stability is good by comparison with other reaches of the Washita River. If the channel had been aligned with the nearly straight adjacent segments of natural channel (fig. 158A), its stability would probably have been improved.

Figure 158. Washita River at site 76. A, Airphoto of site in 1969. Position of relocated channel is shown in dashed line. (From U.S. Dept. of Agriculture) B, Airphoto of site in 1978. (From U.S. Dept. of Agriculture)

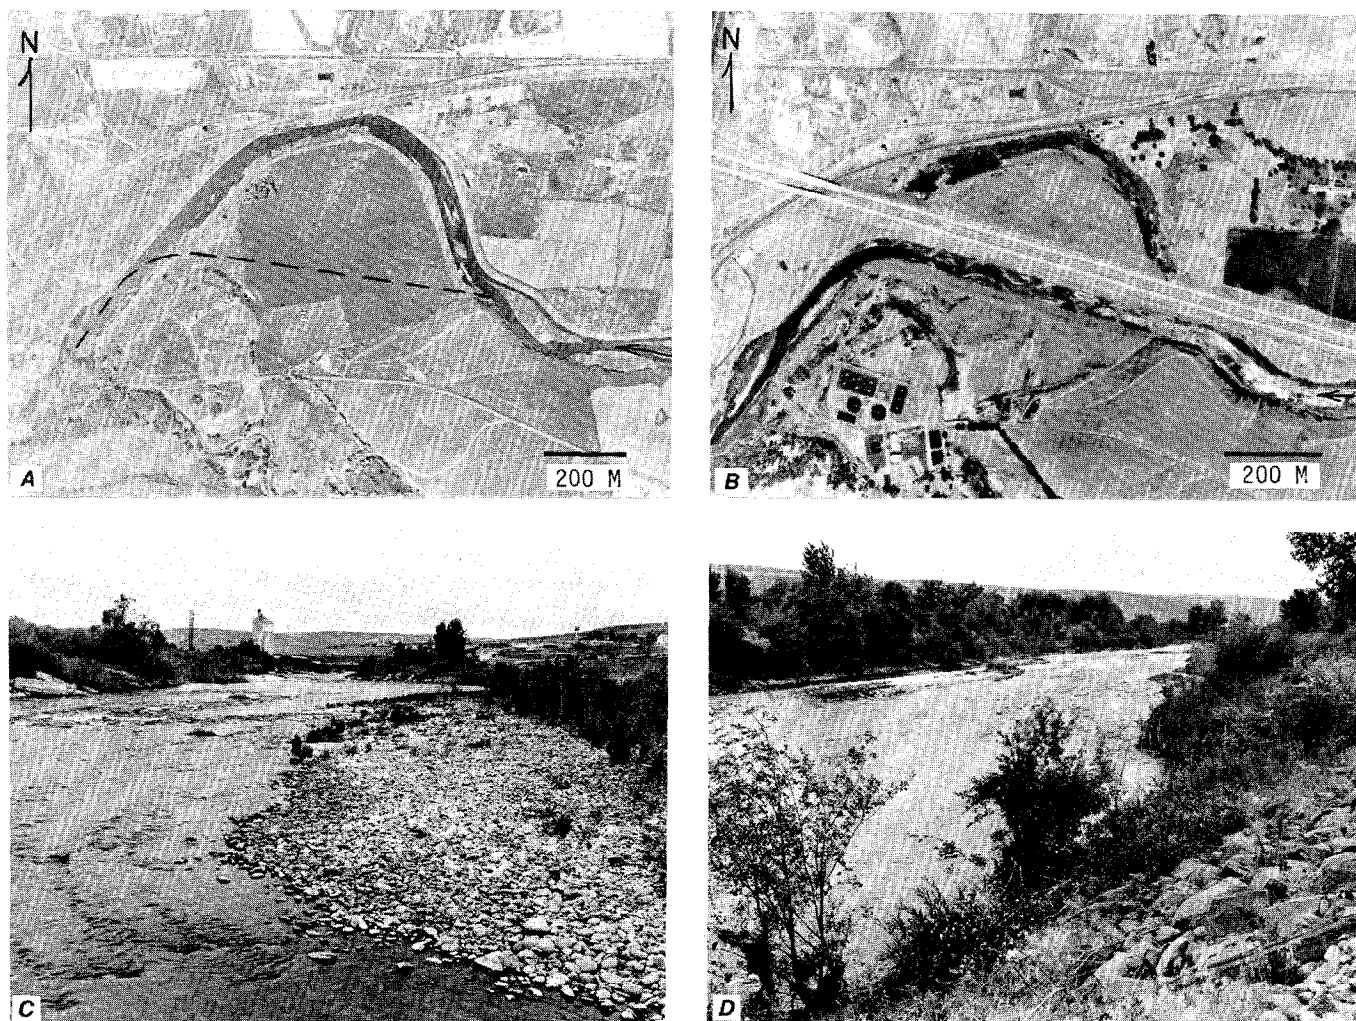
SYNOPSIS--Channel relocation, reach 1,300 m in length straightened to avoid two crossings by I-80N and thereby shortened to 975 m (fig. 159A and B). Performance period 11 yr, 1969-79. The relocated channel has been tested by a 9-yr flood in 1970, a 6-yr flood in 1972, and a 15-yr flood in 1975. The banks of the relocated channel were graded to a 4:1 slope and revetted with rock riprap. In addition, 11 spurs of heavy rock riprap were placed alternately on the left and right banks, apparently for bank protection and to induce sinuosity, thereby avoiding a canal-like aspect. By 1973, gravel bars had been deposited downstream from spurs, small-scale sinuosity (as well as a sequence of pools and riffles) had formed, and vegetation had begun to grow in the riprapped banks (fig. 159B). By 1979, vegetation was well established (fig. 159C), as were the pools and riffles. Sinuosity appeared to be somewhat diminished because the tips of

spurs had been eroded. No bank erosion was noted. Minor bank erosion along the natural channel downstream was noted (fig. 159D); this may, or may not, be related to the relocation.

Figure 159. Umatilla River at site 77. A, Airphoto in 1962, prior to relocation. Position of relocated channel shown by dashed lines. B, Airphoto of site in 1973. (From Oregon Dept. of Transportation) C, Downstream view along relocated channel in 1979, showing deposition of gravel bars, and sinuosity induced by spurs. D, Natural channel just downstream from relocated reach.

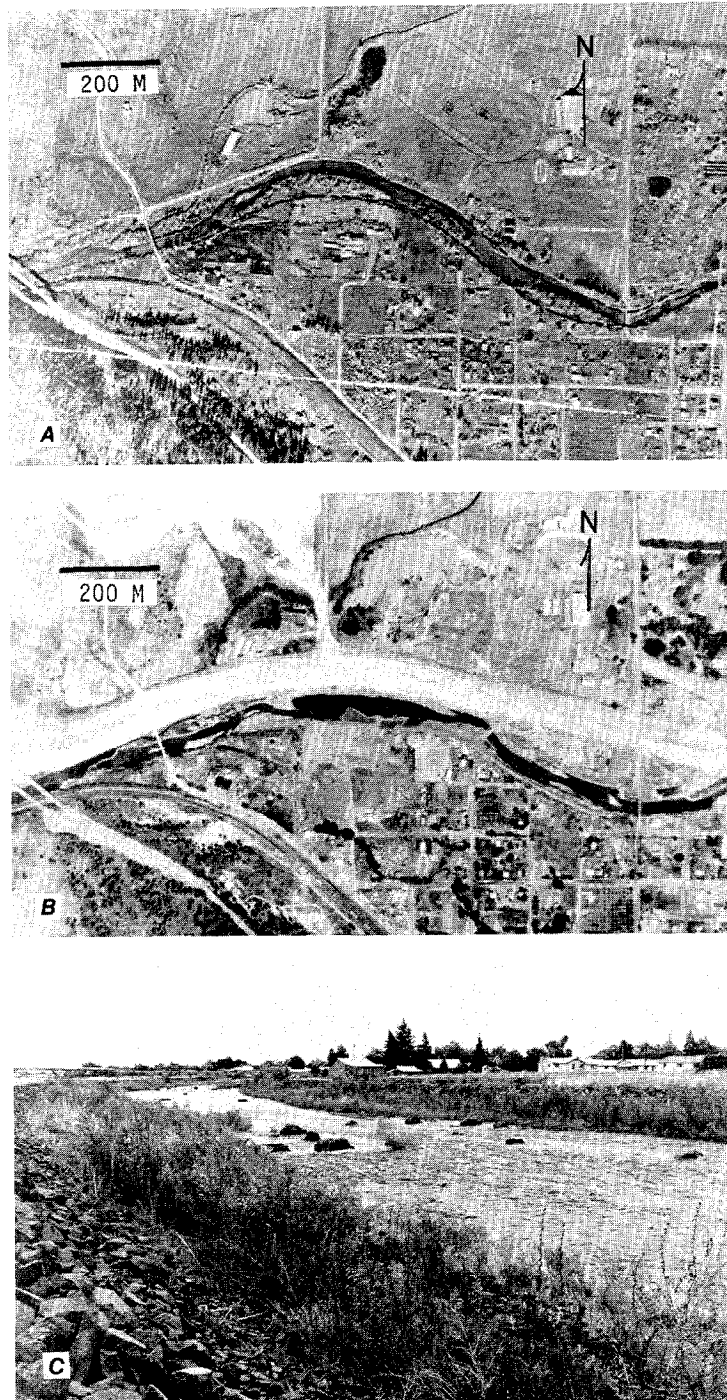
ALTERATION FACTORS--The relocated channel was designed to have a top width of 55 m, a bottom width of 46 m, 2:1 side slopes, and a depth of 2.5 m. The cross section was trapezoidal, except that the bottom sloped gently at 20:1 toward the channel centerline. Boulders were placed in the channel bottom to enhance the fish habitat. Longitudinal slope of the channel bottom was so constructed that sections of 1 m/km slope alternated with flat sections, at 90 m intervals; this feature was evidently intended to provide alternating rapids and pools, which were apparent at normal stage in 1979 (fig. 160C).

Figure 160. Grande Ronde River at site 78. A, Airphoto in 1963, prior to relocation. Position of relocated channel shown in dotted line. (From Oregon Dept. of Transportation) B, Airphoto of channel relocation under construction, in 1971. (From U.S. Dept. of Agriculture) C, View downstream near center of relocated reach, in 1979. Boulders have been placed in channel for fish habitat.

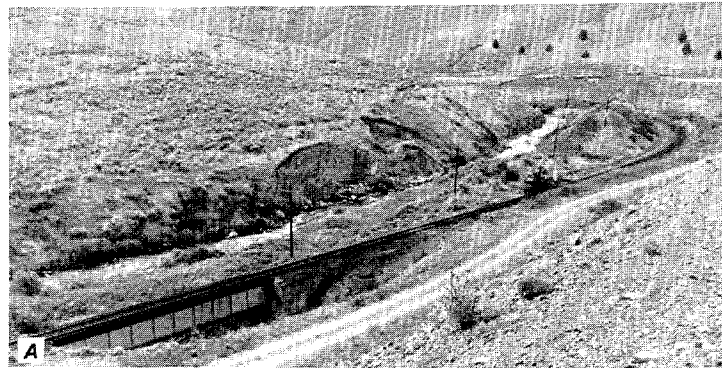
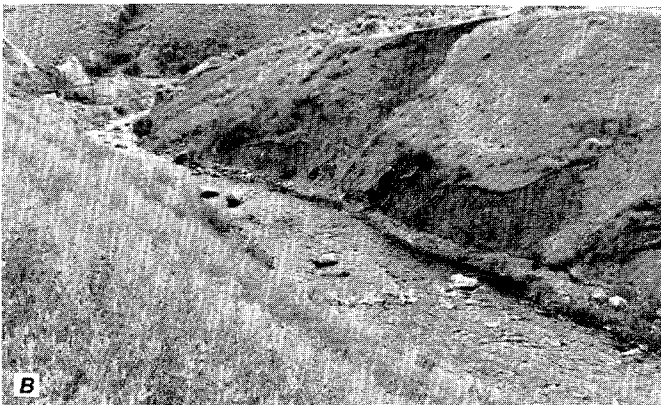
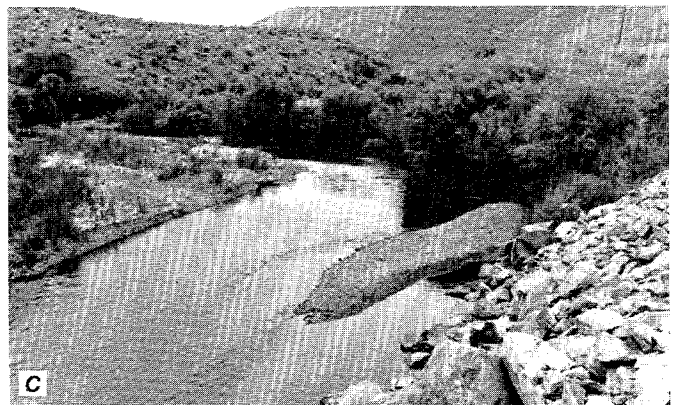
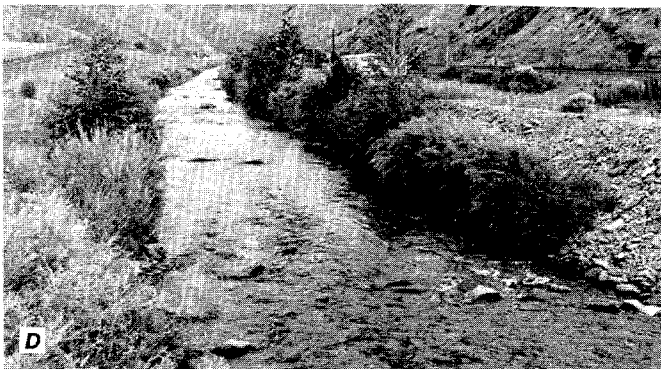
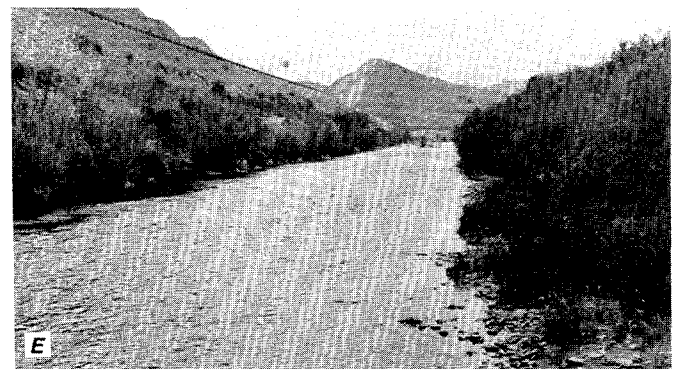
POST-ALTERATION FACTORS--In addition to the mass movement along the cut, the banks of the relocated channel have been eroded laterally (fig. 162B); but the channel has not widened significantly. Only annual vegetation (sweet clover) has been established along the bank-line.

DISCUSSION--Further movement of the slump blocks along the right side of the relocated channel is highly probable, and the largest block (fig. 162B) presents a particular hazard. This block may move gradually into the channel at a rate no faster than the toe can be removed by stream erosion, or it may move quickly and fill the entire channel.

Figure 162. Burnt River at site 79 and vicinity. A, Upstream view showing full length of relocated channel at site. Note large scale slumping along cut. B, View downstream along relocated channel at site, in 1979. At right is a large slump block which extends the full height of the cut. C, View upstream along natural channel at end of relocation. Riprap retard is in right foreground. D, Relocated channel, Burnt River at Weatherby interchange. E, Relocated channel, Burnt River just downstream from Lime.

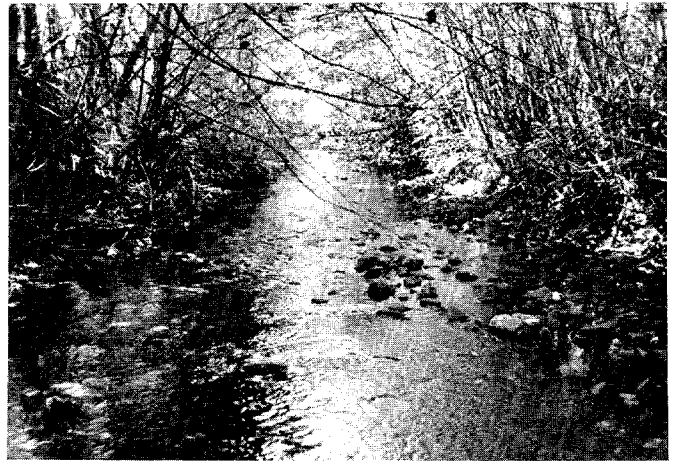
Figure 164. Typical aspect of relocated channel, Wolf Creek, in 1979.

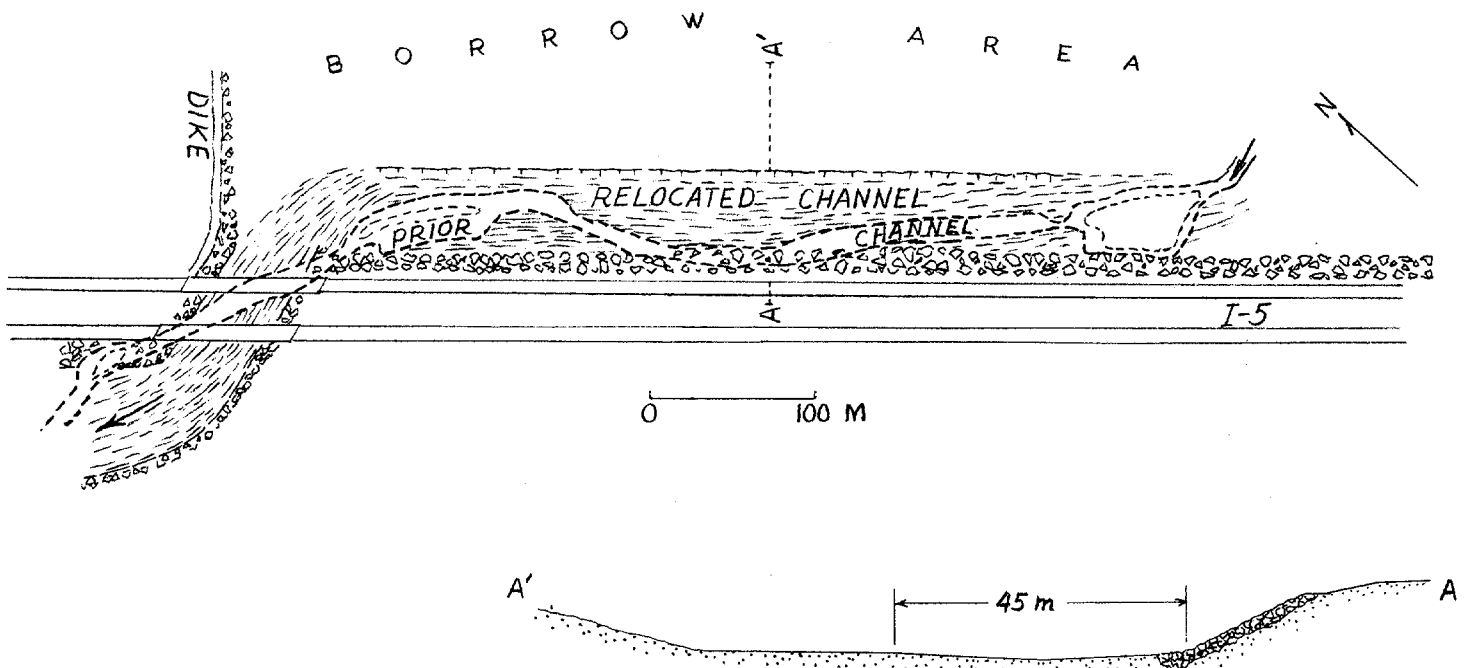
ALTERATION FACTORS--Channel length was not significantly changed by encroachment and relocation, but in effect the width of the stream was constrained only by the riprapped highway embankment, and its course was directed beneath the bridge by a riprapped dike (fig. 165).

DISCUSSION--To allow a stream to form its own channel within a very wide cross section would not be feasible under most circumstances, but it was a good alternative at this site, where the bedload was coarse, the stream was braided, and the general area had been excavated by prior gravel mining operations. However, lateral erosion at the right bridge abutment could prove to be a problem during a flood.

Figure 165. Plan sketch and cross section of Bear Creek channel alteration.

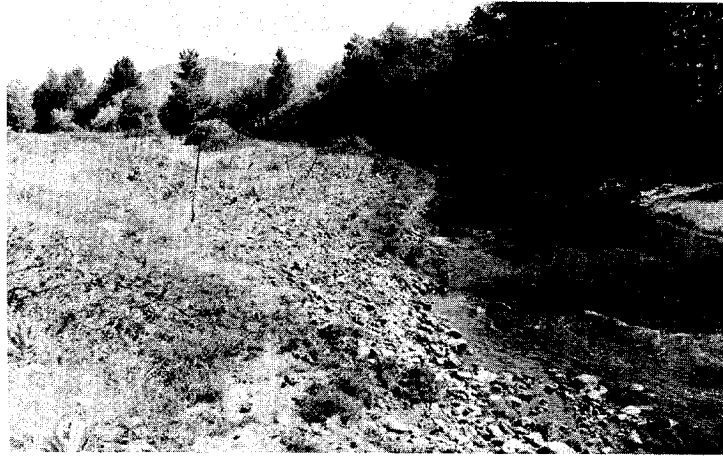
Figure 166. Low-water channel established by Bear Creek, as viewed upstream in 1979.
