Report No. FHWA/RD-80/158

STABILITY OF RELOCATED STREAM CHANNELS

March 1981
Final Report

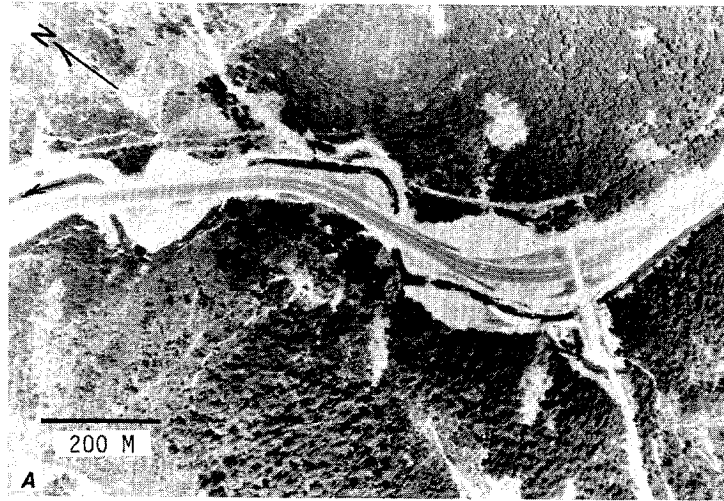
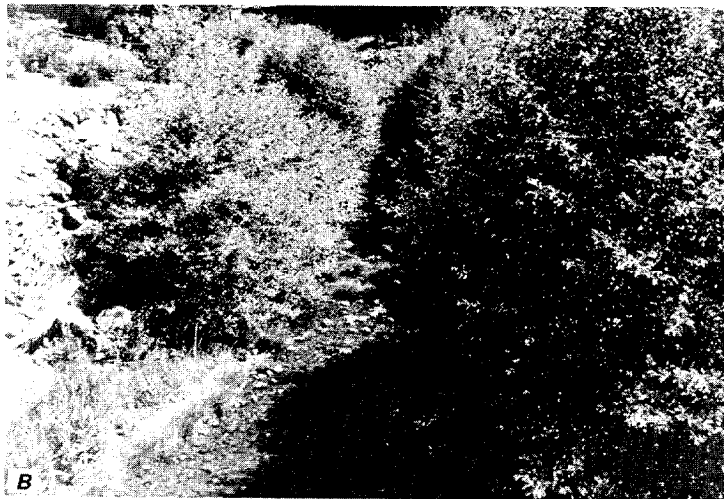
Figure 167. Canyon Creek at site 82. A, Airphoto of site in 1976. The highway overpass is at West Fork Canyon Creek, 4 km south of Canyonville. (From Oregon Dept. of Transportation) B, View downstream from culvert at I-5.

SYNOPSIS--This small stream in a narrow mountain valley was relocated, or encroached upon, for a distance of about 16 km (most of its length) for construction of I-5. The site examined in the field, which has a length of about 1 km, is considered to be representative. Because the channel had already been altered during construction of the prior road (US-99), no comparisons can be made with the natural channel. It is evident, from the narrowness of the valley and the preservation of many bends, that relocation has not involved a significant amount of shortening (fig. 167A). Performance period is 13 yr (1967-79). Canyon Creek is ungaged, but the nearby gage on Cow Creek recorded in 1974 the maximum flood in a 45 yr period of record. The relocated channel was lined with riprap, and the interstate crossings were by concrete culvert. By 1979, the bottom of the relocated channel was continuously bordered by alder trees (fig. 167B), and no erosion was evident.

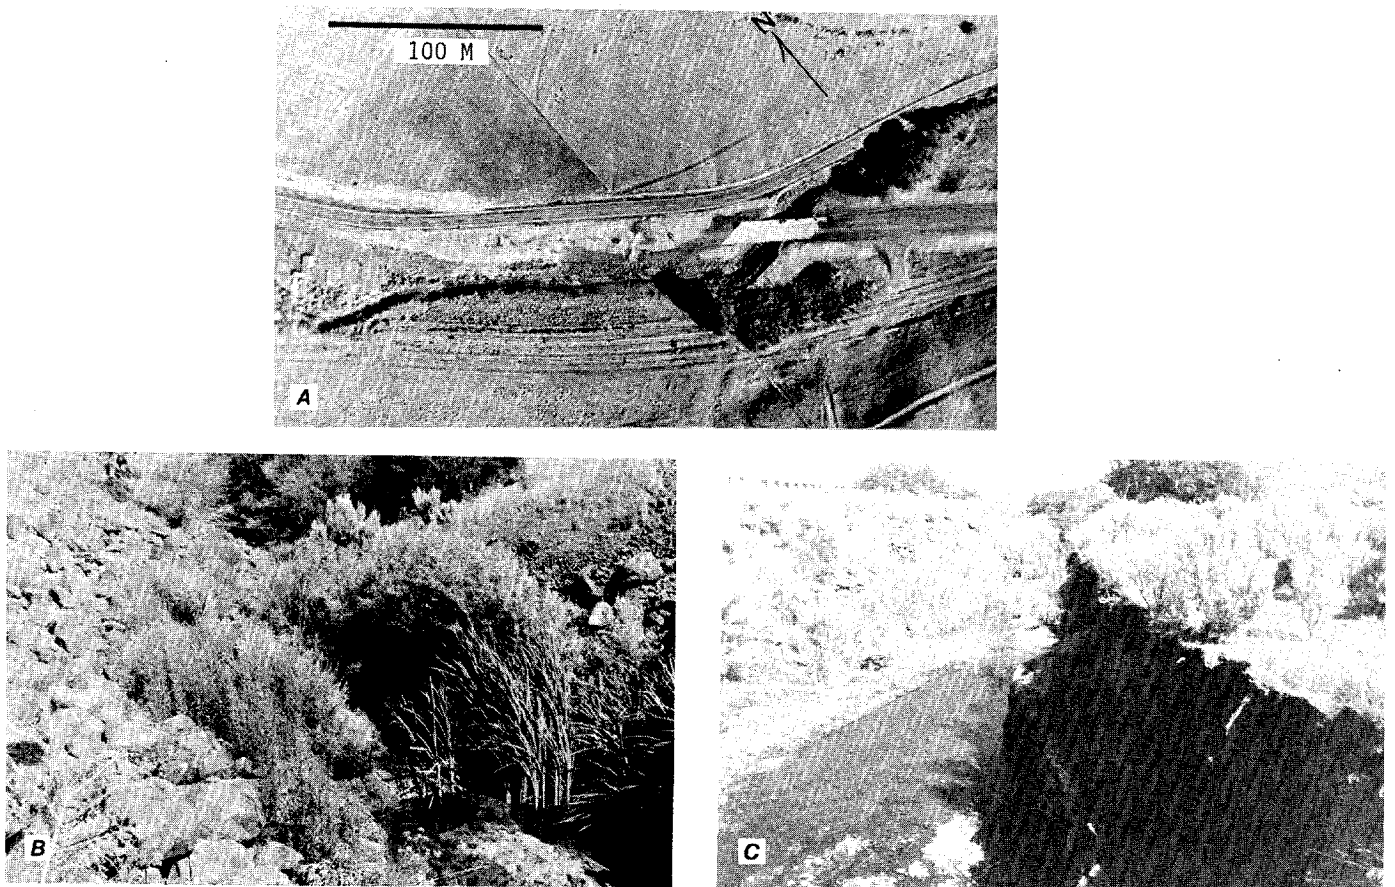
POST-ALTERATION FACTORS--Although flow has not reached bankfull stage since alteration, the flow depth (about 2 m) was sufficient to cause bank erosion. Sediment, held in place by growth of

DISCUSSION--Inasmuch as the slope of the channel was not increased by relocation, and the width was increased, this relocation would probably have not contributed to bank erosion if gabion check dams had not been set against erodible materials in the right bank. The function of the gabions as fish habitat structures is unclear, in view of the shallow and intermittent nature of the stream.

Figure 169. Spanish Hollow Creek at site 83. A, Airphoto of channel relocation under construction, in 1973. (From Oregon Dept. of Transportation) B, Relocated channel upstream from US-97 bridge, in 1979. C, Bank erosion downstream from relocated channel, in 1979.

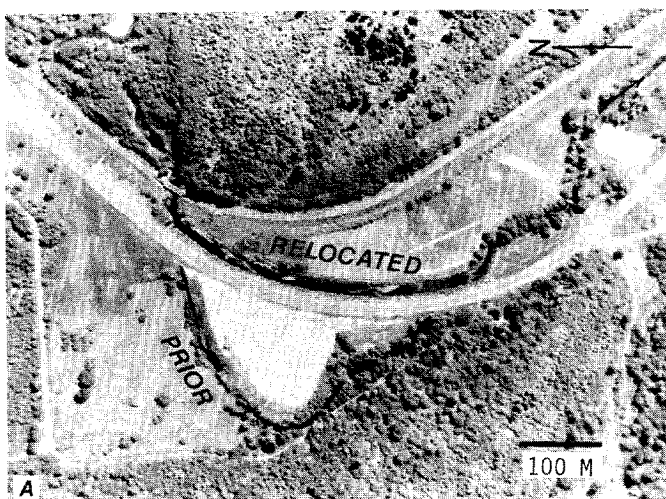
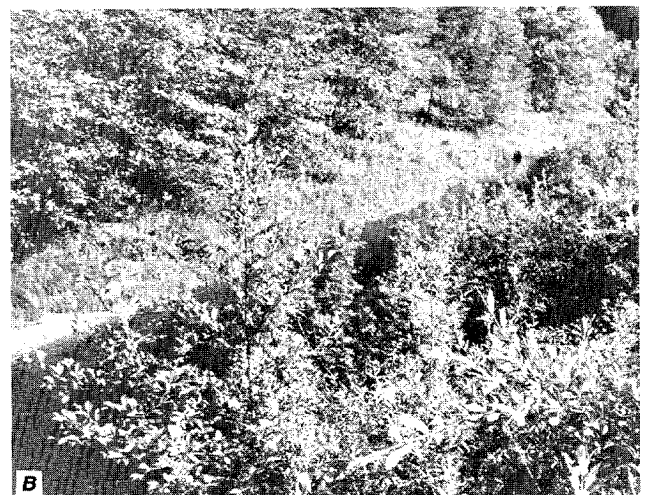
POST-ALTERATION FACTORS--As observed on a 1968 airphoto, an almost continuous strip of vegetation had become established along both banks of the relocated channel, about five years after relocation. By 1979, vegetation was becoming established on a bar along the right bank, and this bar will probably eventually induce sinuosity.

Figure 170. Wildcat Creek at site 84. A, Airphoto of site in 1968. (From U.S. Dept. of Agriculture) B, relocated channel as viewed from right bank in 1979.

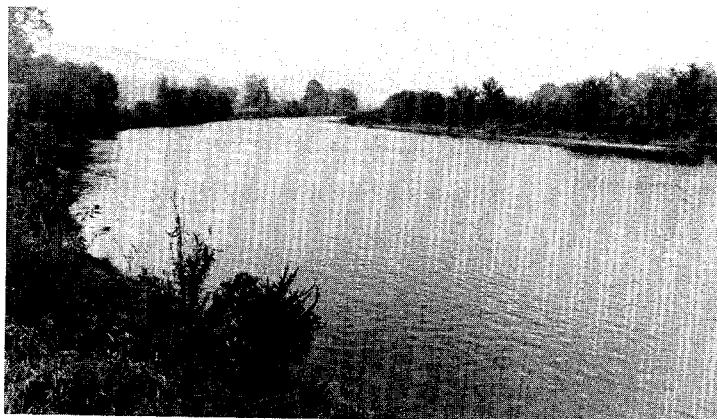
located channel. Minor bank slumping was observed along the concave bank of the relocation in 1979, and tree growth, though locally dense, was not continuous (fig. 174). Adjacent reaches of the natural channel were generally stable prior to relocation, and no effects of relocation on bank stability were observed.

Figure 174. Upstream view at bend in relocated channel, Bald Eagle Creek.

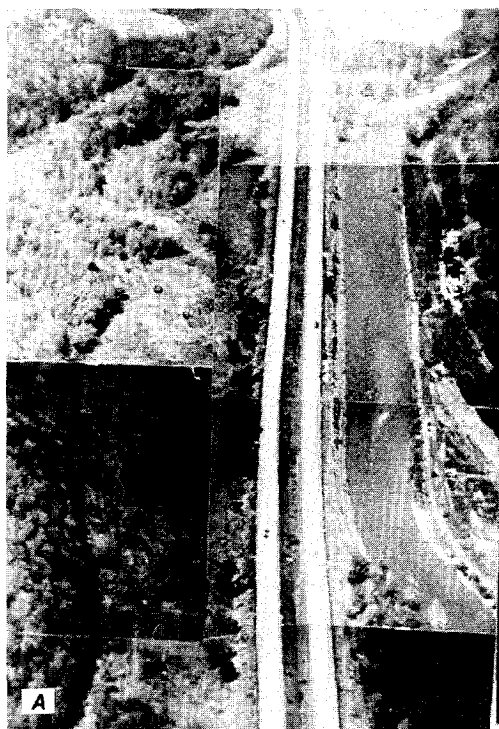
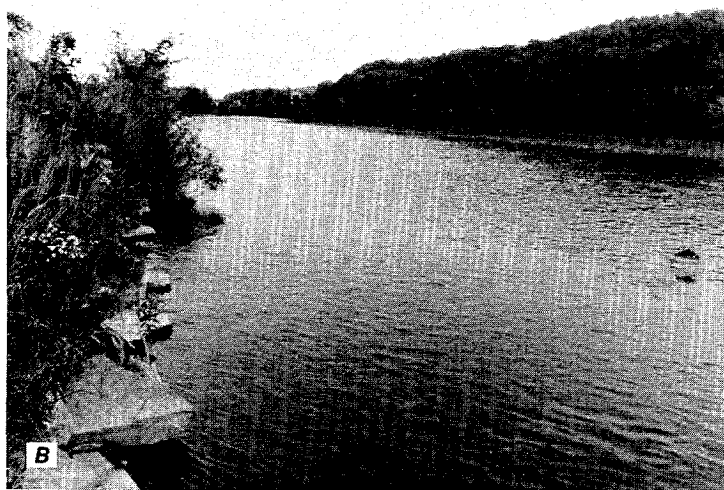
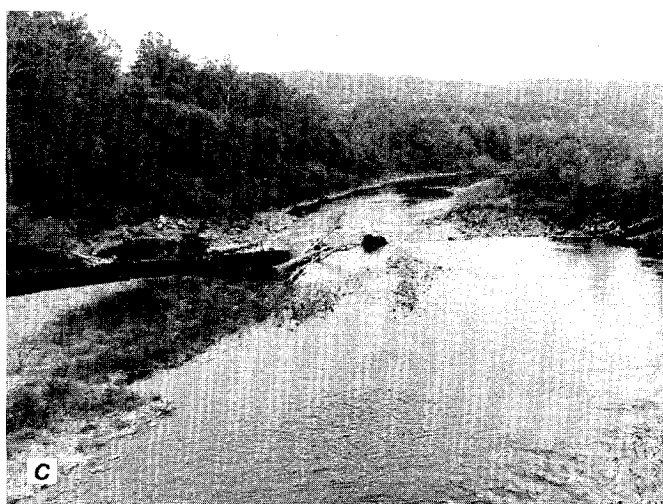
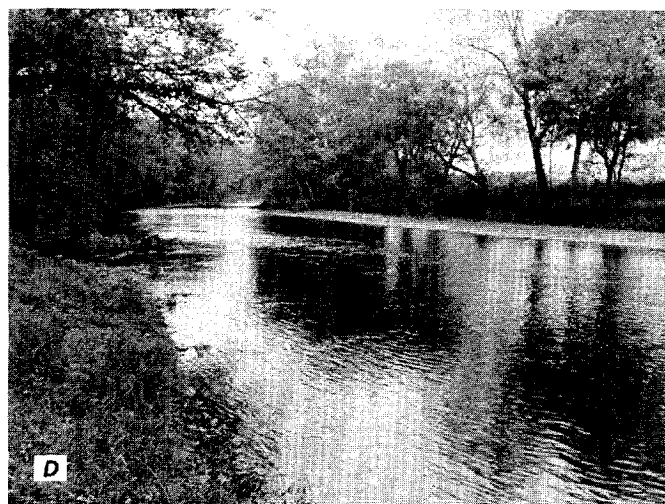
POST-ALTERATION FACTORS--The effect of two very large floods was to obliterate the low-water channel, but the flood channel was not widened significantly. By 1979, young trees were growing along the riprapped bankline (fig. 176B), but the tree cover was not continuous.

DISCUSSION--Although the flood channel is significantly wider than the natural stream channel, by a factor of 1.4, it has so far been mostly occupied by the stream at normal stage. On the 1974 airphoto, there is some indication that the thalweg had shifted toward the right bank downstream from the bend (foreground of fig. 176A). The thalweg is likely to meander broadly within the flood channel, but a bank erosion problem is unlikely because of the revetment.

Figure 176. Fishing Creek at site 87. A, Oblique airphoto, looking downstream, of relocated channel in 1974. (From Pennsylvania Dept. of Transportation) B, View upstream along relocated channel, in 1978; riprapped south bank in foreground. C, View toward upstream end of relocated channel, in 1978. Sheet-pile check dam, in foreground, is upstream from relocation. D, Natural channel downstream from relocation, in 1978.

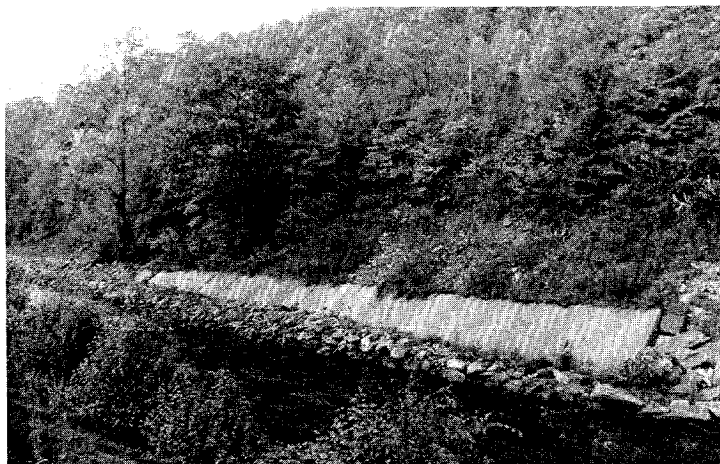
DISCUSSION--The bank erosion was not particularly severe in view of the magnitude of the flood, and probably would not have been considered a problem if the railroad embankment had not been jeopardized.

Figure 178. View upstream along Shamokin Creek, showing bank slumping above remaining concrete slope pavement, and rock riprap installed in 1972.

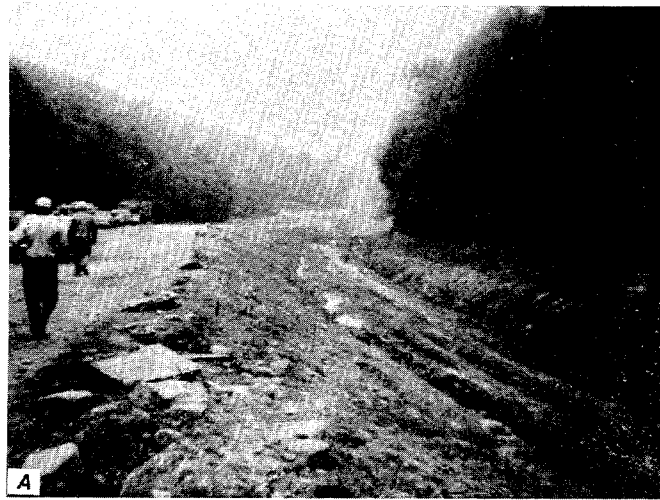
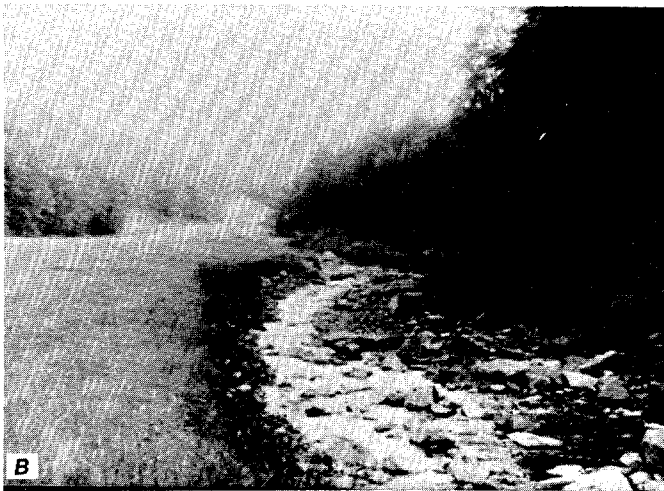
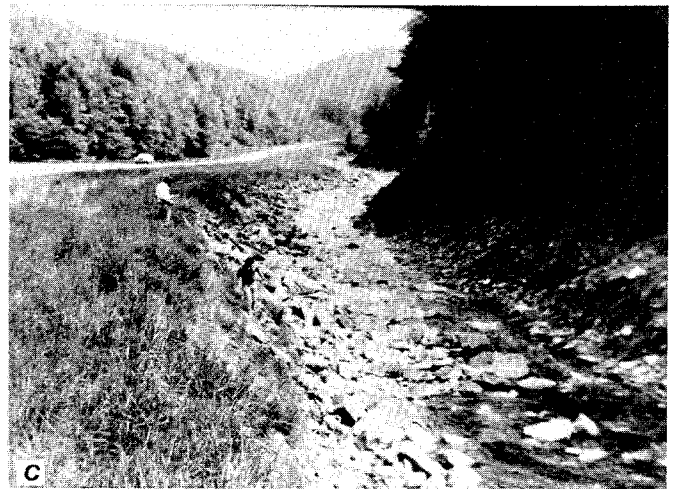
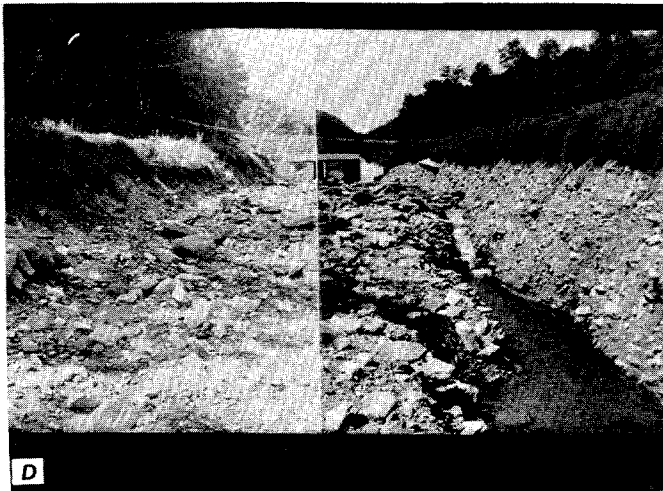
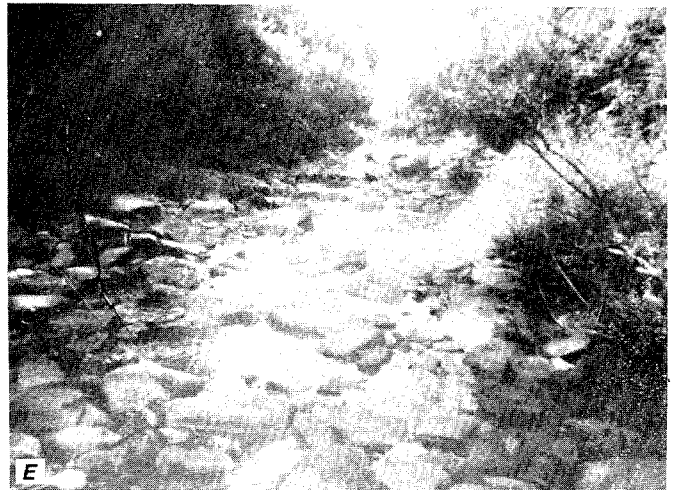
Although no measurements of degradation are available, a waterfall about 1.5 m in height had developed in the channel by 1976 (fig. 180D), and the maximum amount of degradation is probably not less than 2 m. By 1976, four riprap spurs, which had been installed as countermeasures for bank erosion, had been removed by erosion. In 1979, the bridge at Road 345 had been closed because of undermining of the center pier and both abutments, which had been founded on erodible bedrock.

DISCUSSION--The slope of the natural channel was in the range of 17-20 m/km but was not uniform, probably because of bedrock outcrops from place to place. The bedrock consists of almost horizontal beds of sandstone, shale, and conglomerate, susceptible to erosion because of well-defined joints and thin bedding. Instability of the relocated channel is not attributed to the increase in slope relative to that of the natural channel, which was slight. The major floods that occurred during and soon after construction steepened the weakly coherent banks and probably formed scarps in the channel bottom, thus initiating progressive bank erosion and degradation. The bed of the natural channel was well armored with boulders and the low banks were well vegetated, as shown in ground photographs taken prior to relocation (fig. 180E).

Figure 180. Wilson Creek at site 89. A, View of relocated channel during construction in 1973, looking downstream from a location below the bridge at Road 345. B, View from nearly the same location as for A, in 1974. C, View from nearly the same location as for B, in 1979. Dumped rock riprap has been placed at left bank. D, View upstream toward bridge at Road 345, in 1976. Degradation indicated by scarp in channel, at right. E, Natural channel prior to relocation. (From Pennsylvania Dept. of Transportation).

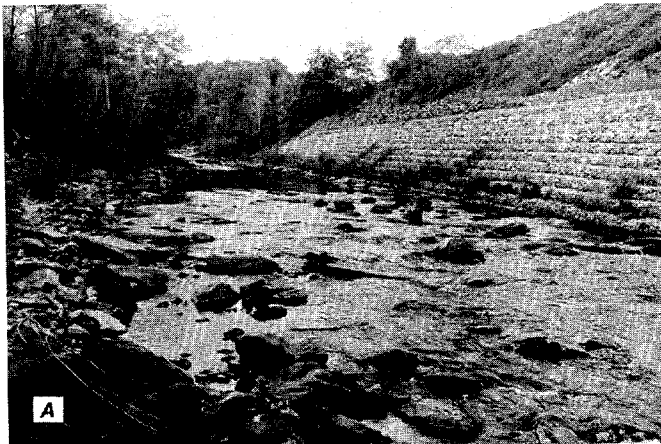
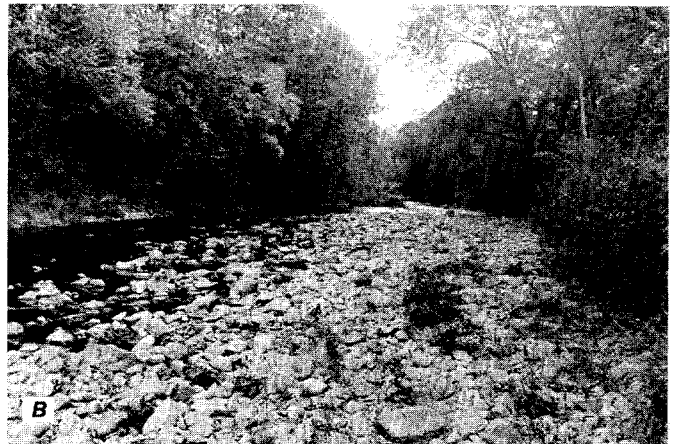
Stability class A2 for relocated channel, A1 for downstream segment of natural channel. The critical factor in the localized bank erosion and failure of the riprap was apparently the height and steepness of the embankment, which probably slumped when undercut at the toe.

DISCUSSION--Although the relocated channel is 670 m in length, bank erosion occurred only at one bank, for a length of about 50 m, where there is no bend in the channel. This suggests that the toe of the riprapped bank was undercut, and that failure occurred by mass movement. The size of the failed riprap is not specified in the plans, but remnants of half-ton (500 kg) size are in the channel.

Figure 182. Pocono Creek at site 90. A, View upstream toward gabions on left bank, in 1978. B, View of natural channel downstream from relocation, in 1978.

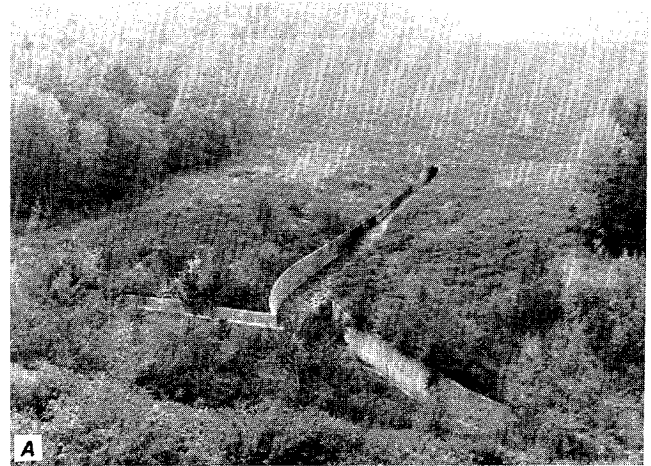
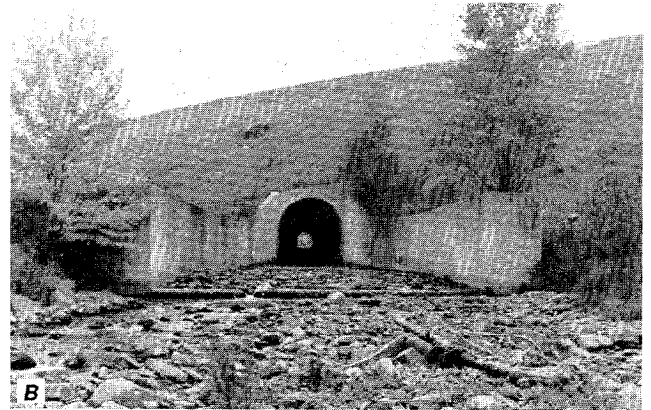
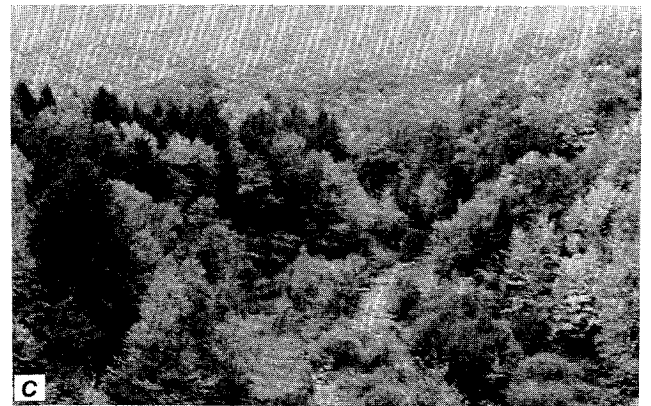
DISCUSSION--Except for minor accumulation upstream from the tributary entrance in the median (figs. 183 and 184A), the concrete-lined channel contains little bed material. Its width, about 4 m, is somewhat narrower than the bottom width of the natural channel, and water velocities consequent upon its width and slope (about 50 m/km) have proved sufficient to transport coarse bed material without aggradation.

Figure 184. Sawmill Run at site 91. A, Upstream view of concrete-lined channel in highway median area, in 1978. B, Upstream view of culvert, near end of relocation. C, Natural channel downstream from relocation.

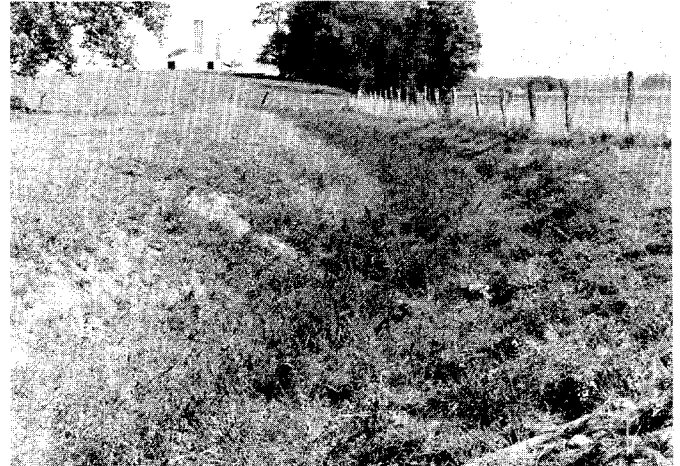
Figure 186. View upstream along relocated channel of Mountain Run.

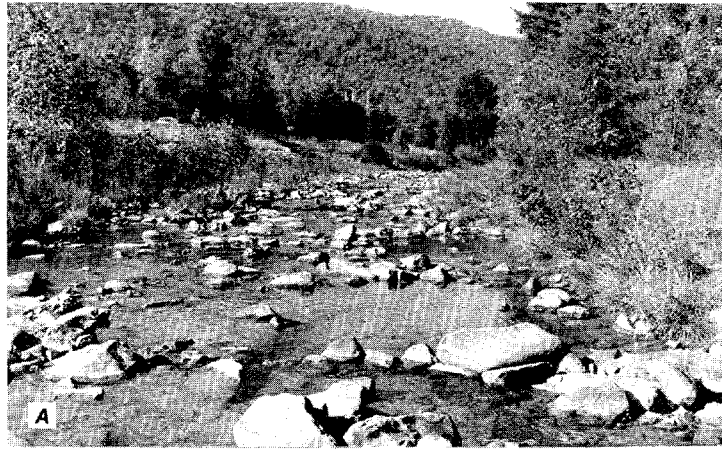
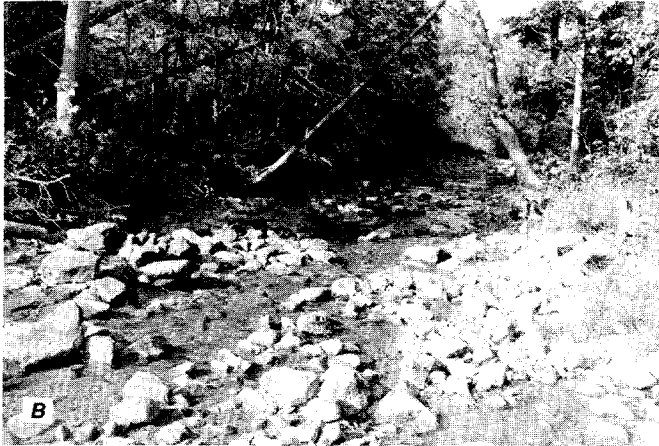
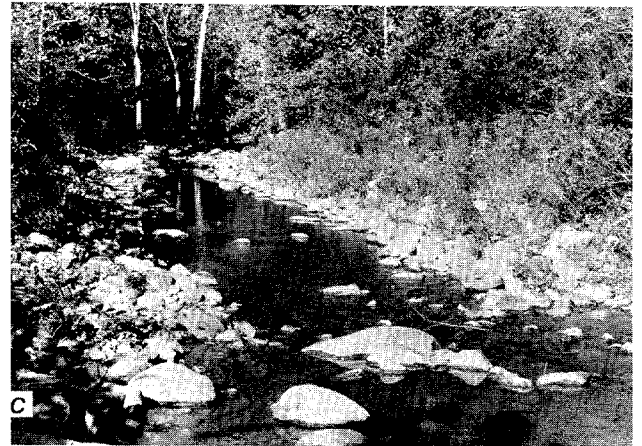
DISCUSSION--Shade Creek is generally similar in form and setting to Wilson Creek (site 89), and the length and degree of shortening by relocation is also similar; yet it has remained stable and Wilson Creek has not. The bottom of Shade Creek has a rather continuous armor of boulders; but the bottom of Wilson Creek is less well armored and its banks are less bouldery and more erodible. No other factors are apparent to account for the differences in stability.

Figure 190. Shade Creek at site 94. A, Downstream view of relocated channel, in 1978. B, Downstream junction of relocated channel with natural channel, in 1978. C, Natural channel downstream from relocation, in 1978.

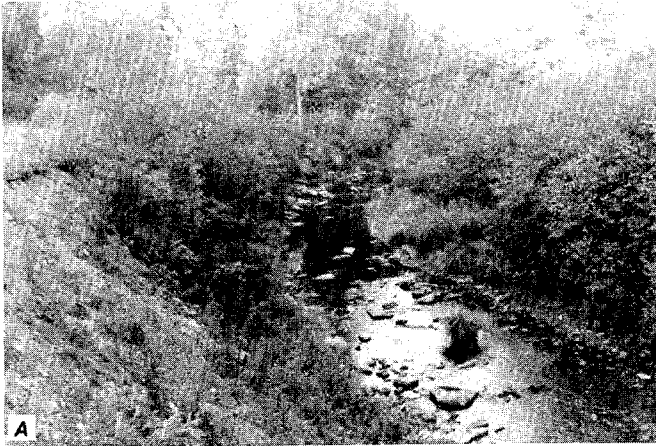
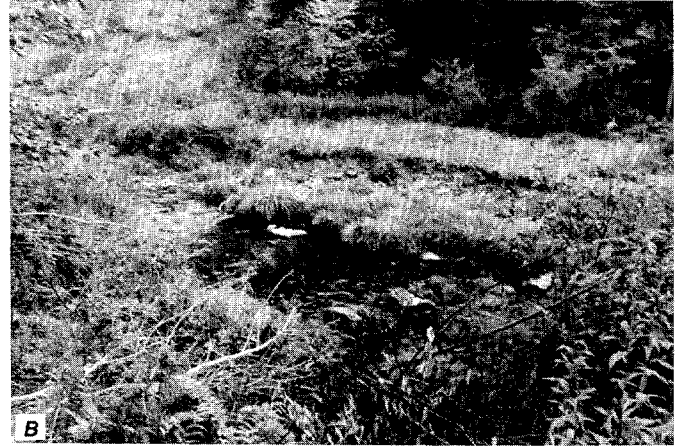
Figure 192. Little Mill Creek at site 95. A, Unvegetated bank at curve in relocated channel, upstream from I-80 crossing of Little Mill Creek, in 1978. B, Natural channel about 100 m downstream from crossing, in 1978.

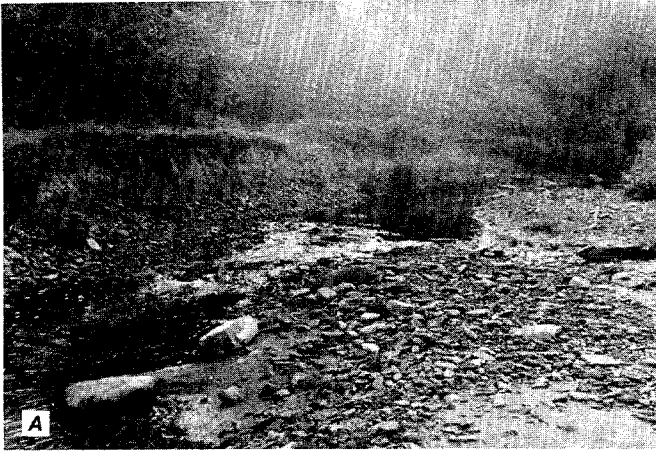
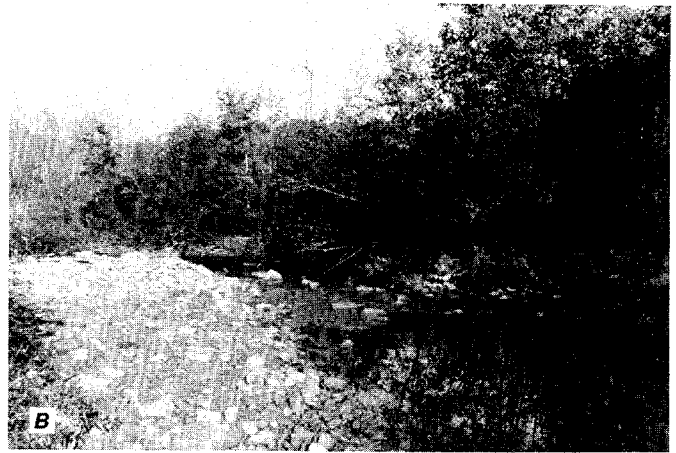
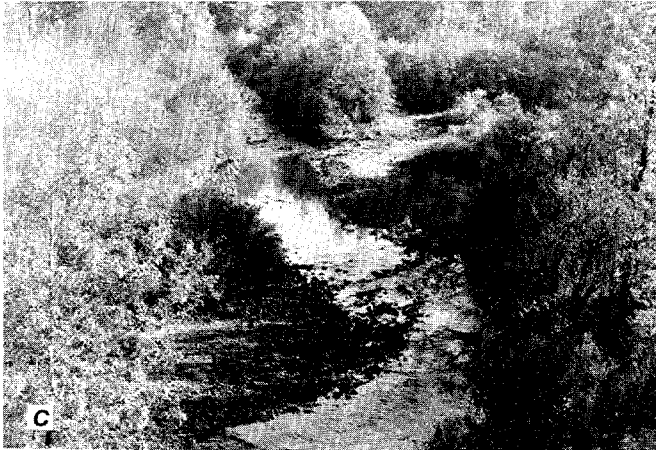
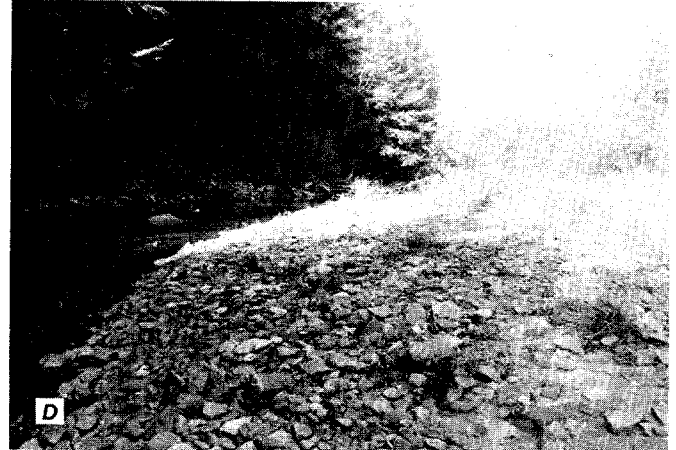
DISCUSSION--In view of the magnitude of the 1972 flood (recurrence interval of about 100 yr), bank erosion at bends on the relocated channels is not regarded as an indication of poor performance, although the banks have remained steep and unvegetated. The drop in bed elevation of Five Mile Creek at the confluence is attributed to aggradation, which has resulted from bank erosion and minor degradation along the lengthy relocation 4-6 km upstream (site 97).

Figure 194. Mill Creek and Five Mile Run at site 96. A, Bank erosion at bend in re-located channel of Five Mile Creek, in 1978. B, Rapids in Five Mile Creek at confluence with Mill Creek, in 1978. C, View along Mill Creek upstream from I-80 bridge, in 1978. Mouth of Five Mile Creek is in background, at right. D, View of bend in relocated channel of Mill Creek, downstream from I-80 bridge, in 1978.

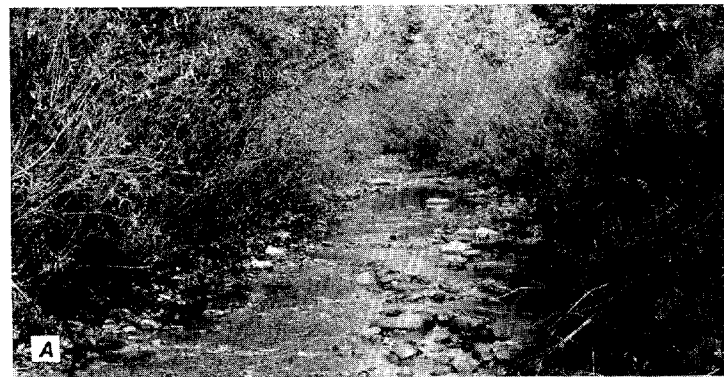
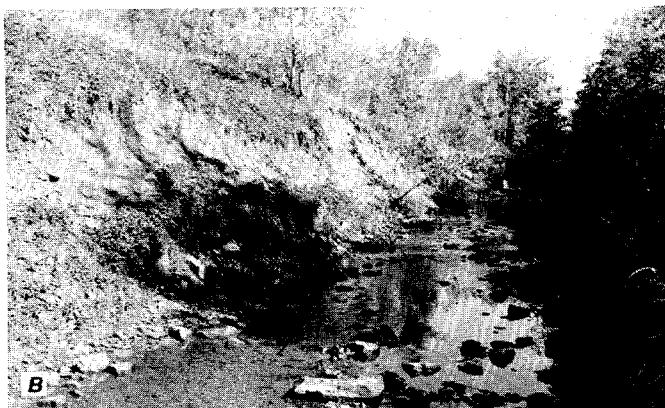
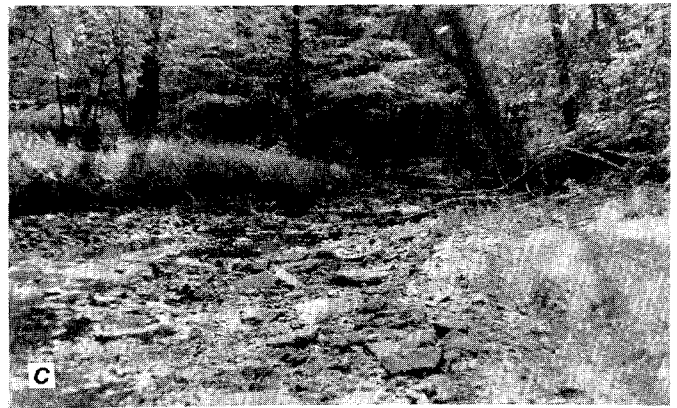
small amount of degradation is probable, upstream from a bedrock outcrop in the channel near sta. 770. Downstream from the relocation, the natural channel is generally stable, and the cut banks that occur at bends may have been present prior to relocation (fig. 196C).

Stability class C2 for upstream part of relocation, B1 for downstream part and for adjacent segments of the natural channel. Channel degradation has probably been inhibited by boulders on the streambed. Bank erosion, mainly by slumping, is restricted to places where the banks are higher than about 2 m, and elsewhere has been controlled by vegetation and by boulders along the bankline.

banks, the lack of countermeasures, and the large magnitude of the flood to which it has been subjected, a substantial amount of instability might have been expected along the relocation. Instead, bank instability is restricted to places where the banks are high, and the amount of degradation is estimated to be less than 0.5 m. Vegetation is particularly important in controlling bank erosion along a small stream, and the major flood did not occur until 10 years after relocation and after the time that small trees had become established along the bankline. Where banks were high, the vegetation was not effective and slumping occurred.

Figure 196. Five Mile Run at site 97. A, View upstream along relocated channel in vicinity of sta. 770. B, Unstable bank along relocated channel in vicinity of sta. 795. C, Natural channel just downstream from sta. 770.

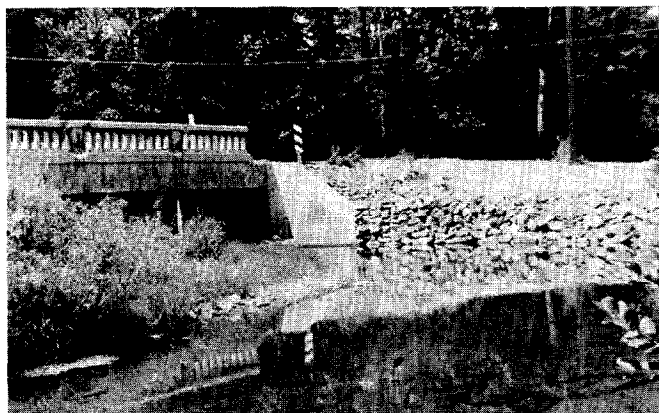
no record or evidence of installation. On an airphoto taken in 1968, the banks of the relocated channel, particularly at the bend, appear to be cut and tree cover along the channel is scant. During the flood of 1972, a large area was eroded at the bend, and the right approach roadway was nearly breached.

DISCUSSION--The nearly parallel trends of stream and roadway, in a narrow valley, presented a difficult problem in crossing location and it was difficult to avoid the bend in the relocated channel. In spite of the sharpness of the bend, it did not erode seriously until the major floods in 1970 and 1972. The damage that resulted could probably have been prevented, or greatly diminished, by bank protection and the establishment of vegetation.

Figure 198. Bankline of Hunters Run as protected with hand-placed riprap and as established after the flood of 1972 (Photograph of July 1976).

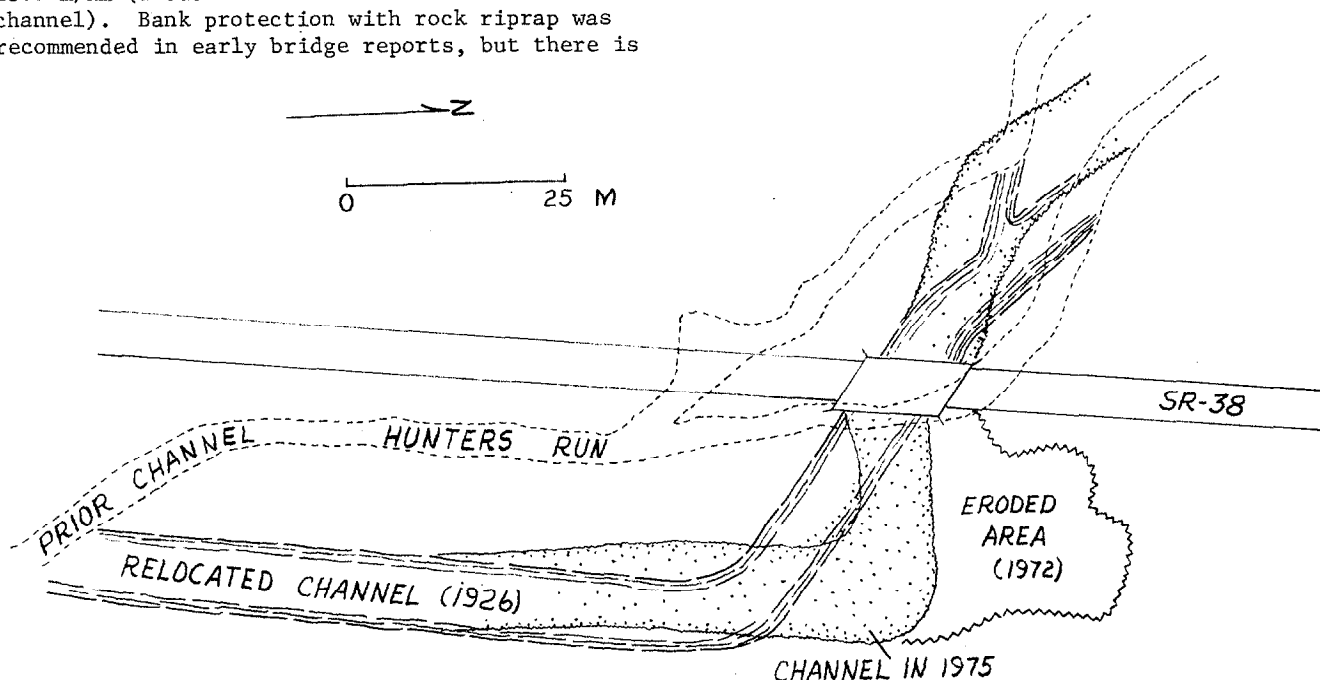
Figure 197. Plan sketch of Hunters Run channel relocation, and of bank erosion that occurred during the flood of 1972.

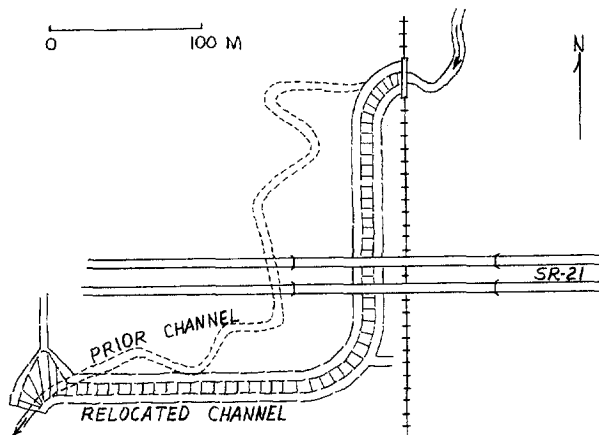
Figure 199. Plan sketch of Gills Branch channel relocation.

SYNOPSIS--Channel segment 457 m in length was relocated and shortened to 417 m, evidently for purpose of combining stream crossing with railroad overpass (fig. 199). Performance period, 21 yr (1956-77). Relocated channel was subjected to a flood of substantial magnitude during the period 1973-74. As built, the relocated channel was trapezoidal in cross section, with a bottom width of 7.5 m, 2:1 side slopes, and a longitudinal slope of 5.5 m/km. Both bed and banks were lined with concrete pavement (fig. 200A). In connection with the flood, a section of the bottom lining was raised, evidently by hydrostatic pressures, and a scour hole was formed at downstream junction with the natural channel (fig. 200B). Subsequently, the raised section of bottom lining was broken up and left in place as riprap. A comparison of airphotos taken in 1966 and 1977 indicates that some deterioration of adjacent segments of the natural channel has occurred by bank erosion (fig. 200C).

DISCUSSION--Local failure of the concrete channel lining is tentatively attributed to the lack of weep holes for relief of hydrostatic pressures. Upstream and downstream transitions between a natural channel and a concrete-lined channel are potential problem areas because

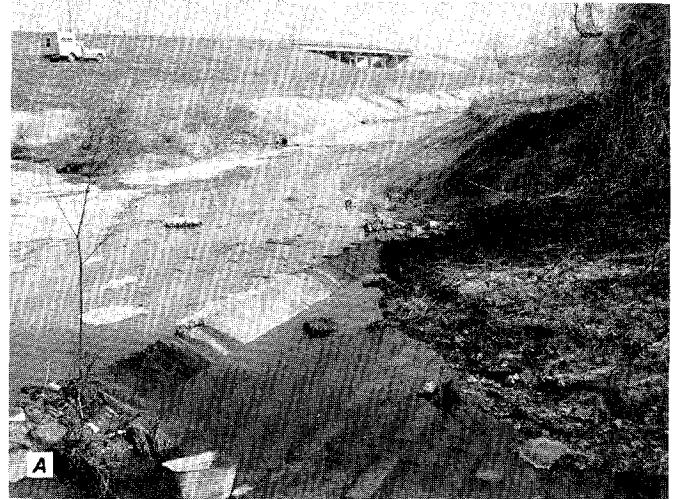
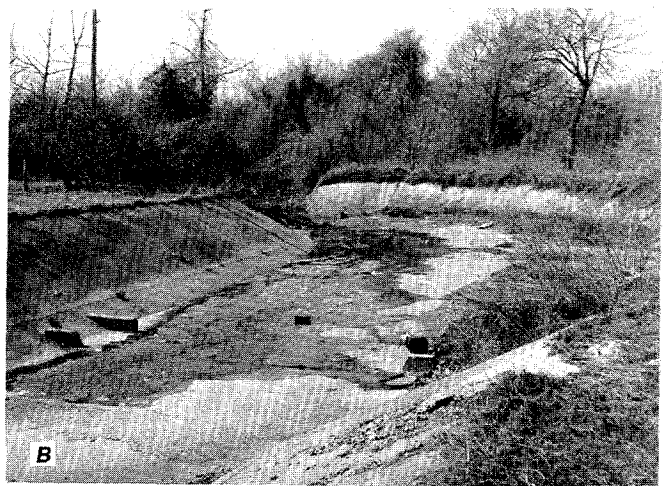
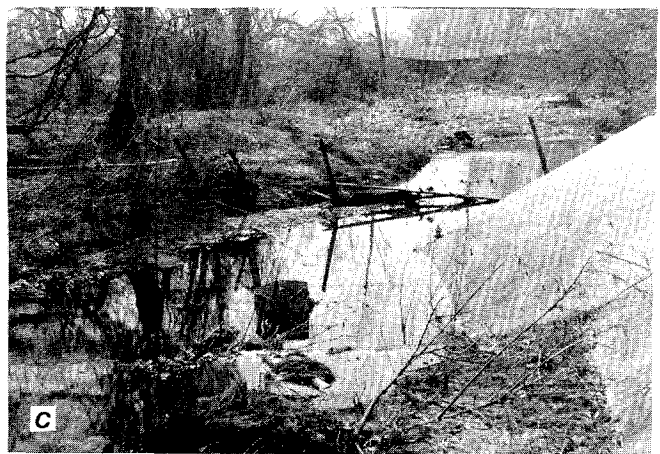
Figure 200. Gills Branch at site 99. A, View along relocated channel, upstream toward bridge, in 1977. B, View downstream toward end of relocated channel, in 1977. Scour hole is at terminus of concrete pavement. C, Natural channel downstream from relocation, in 1977.

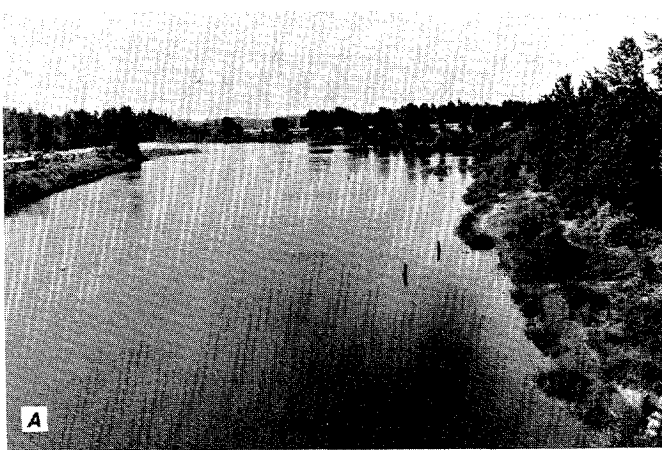
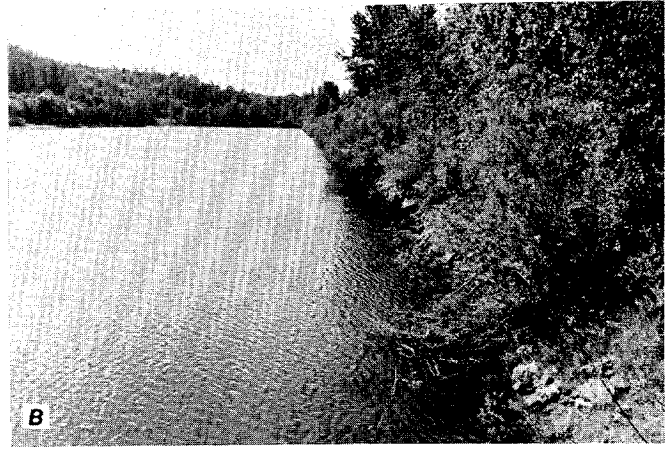
Figure 202. Lewis River at site 100. A, Relocated channel as viewed downstream from bridge at Woodland, in 1979. B, Growth of vegetation on riprapped right bank of relocated channel, in 1979.

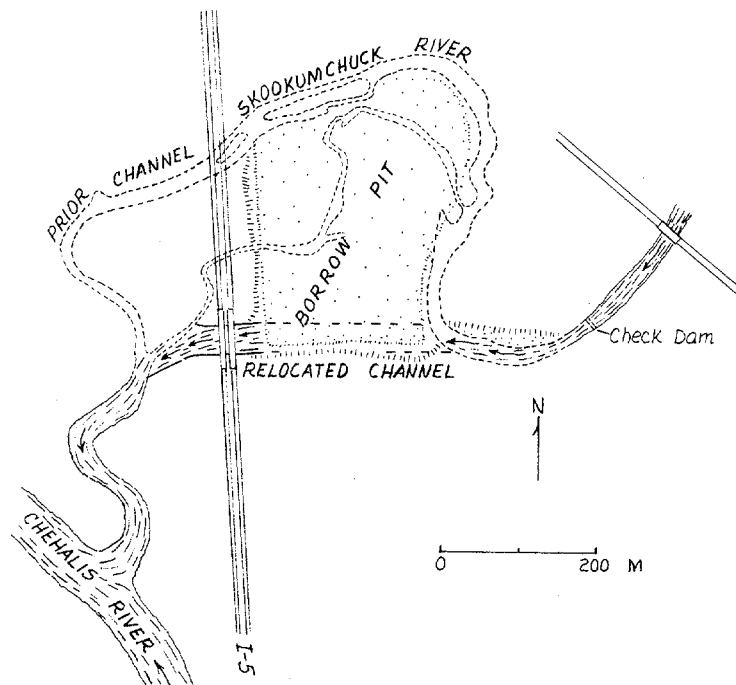
Figure 203. Plan sketch of channel relocation, Skookumchuck River.

SYNOPSIS--Anabranch channel segment 1,340 m in length was relocated and shortened to 565 m, apparently to avoid crossing of an anabranch and to accommodate excavation of a borrow pit (fig. 203). Performance period, 23 yrs(1952-79). At the nearest U.S.G.S. gage, 19 km upstream, the maximum flood in a 42-yr period of record occurred in 1953. The relocation was connected with a borrow pit operation, and a berm was maintained between the borrow pit and the river channel until diversion of the stream through the south end of the borrow pit and under the I-5 bridge. Thus the south bank of the relocated channel was the south embankment of the borrow pit; and the north bank was indefinite except in the vicinity of the bridge, where the channel was trapezoidal in cross section, with a bottom width of 40 m. As shown on an airphoto taken in 1960 (fig. 204A), the relocated channel was largely blocked with gravel bars and much of the flow was apparently diverted into the water-filled borrow pit. In 1979, boundaries of the relocated channel were more definite and tree-lined, and the channel was somewhat natural in aspect (fig. 204B). Channel degradation has apparently been inhibited by a massive riprap check dam, which extends to a depth of 10 ft below the channel bottom (fig. 204-C). Rapid bank erosion occurred along the natural channel at the first bend upstream from the relocation (fig. 204A) during the period 1948-1960, but in 1979 the banks had been stabilized with riprap.

DISCUSSION--Relocation by diversion through a borrow pit is an uncommon procedure, which created an artificial lake and a rather indefinite stream channel. Backwater flooding was precluded by the large bridge opening, which had a bottom width about 2.5 times greater than the natural channel. Despite the sharp reduction in channel length, with consequent increase in slope, major degradation was prevented by a massive riprap check dam. Flexible check dams of this sort are probably preferable to rigid structures, in that they are less likely to induce scour and bank erosion at the overfall. As built, this dam in cross section had a surface width of 8 m, which tapered to a width of 1.8 m at a depth of 3 meters below the streambed. Nevertheless, some degradation (estimated at 1 m or less) occurred, which evidently induced bank erosion at upstream bends.

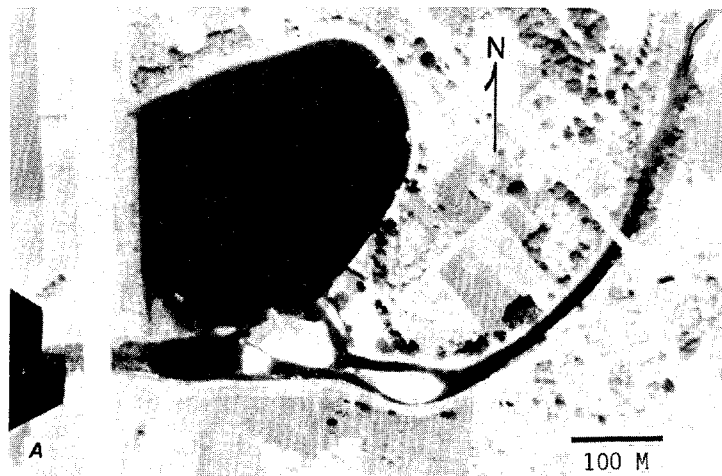
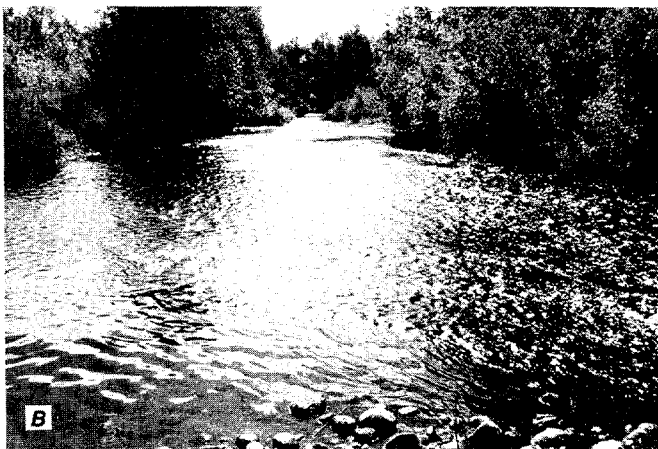
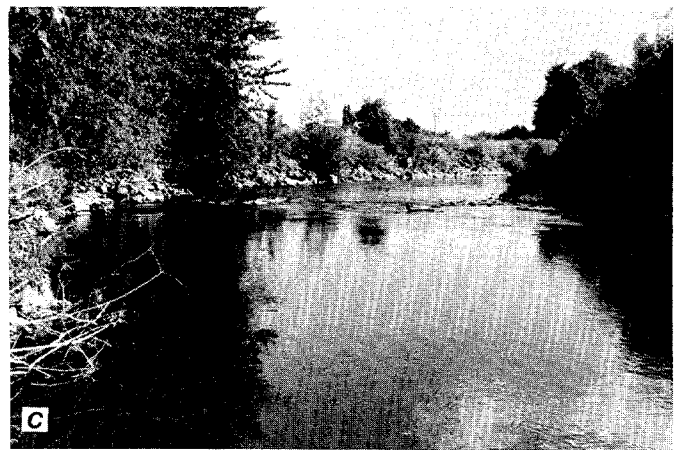
Stability class A2 for relocated channel, which has narrowed in width since relocation; and class B3 for adjacent segments of natural channel. Critical factors in channel performance are the check dam, which has reduced channel degradation; and the flow regimen of the stream, whose annual peak flow does not vary greatly from one year to the next and does not include any extremes during a 42-yr period of record.

Figure 204. Skookumchuck River at site 101. A, Airphoto of relocation in 1960. Dark area is water-filled borrow pit. (From U.S. Dept. of Agriculture) B, View downstream in 1979 along relocated channel, which follows south end of borrow pit. C, Natural channel just upstream from relocation. Check dam forms riffle in background.

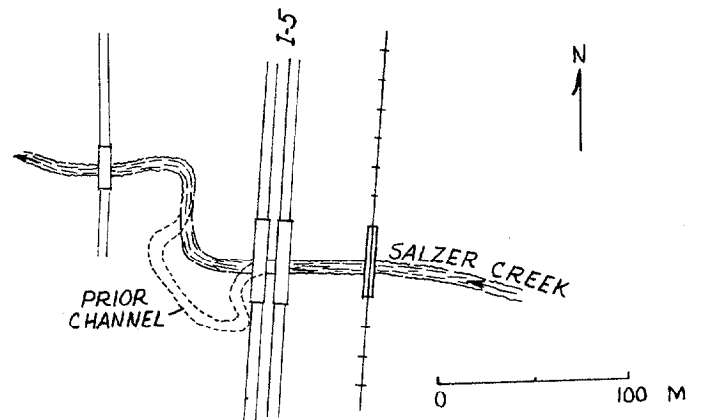
Figure 205. Plan sketch of Salzer Creek channel relocation.

SYNOPSIS--Channel was relocated by shortening a bend, thereby reducing its length from 110 m to 60 m, for purpose of improving alinement of channel at bridge and to accommodate roadway location (fig. 205). Performance period, 23 yr (1952-79). Salzer Creek is ungaged, but a high peak flow was recorded in 1972 at a nearby gage on the Newaukum River. No data were obtained on the as-built cross section of the relocated channel, but the bottom width as observed in 1979 was about 5 m, which is the width of the natural channel. The banks were stable and grassed (fig. 206) and it is unlikely that any significant widening has occurred. No bank protection measures were observed.

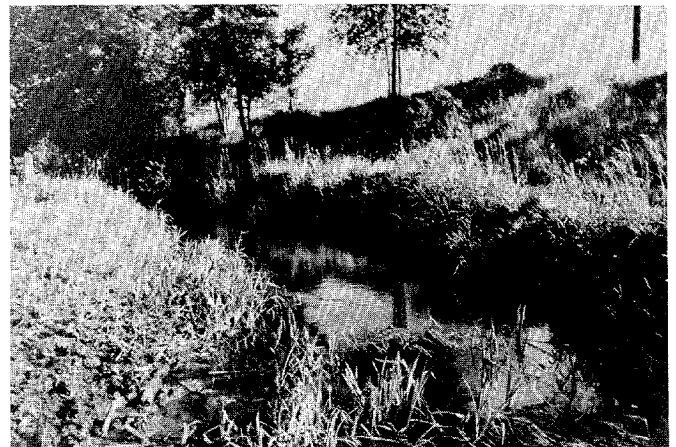
Figure 206. Upstream view of bend in relocated channel, Salzer Creek.
