Report No. FHWA/RD-80/158

STABILITY OF RELOCATED STREAM CHANNELS

March 1981
Final Report

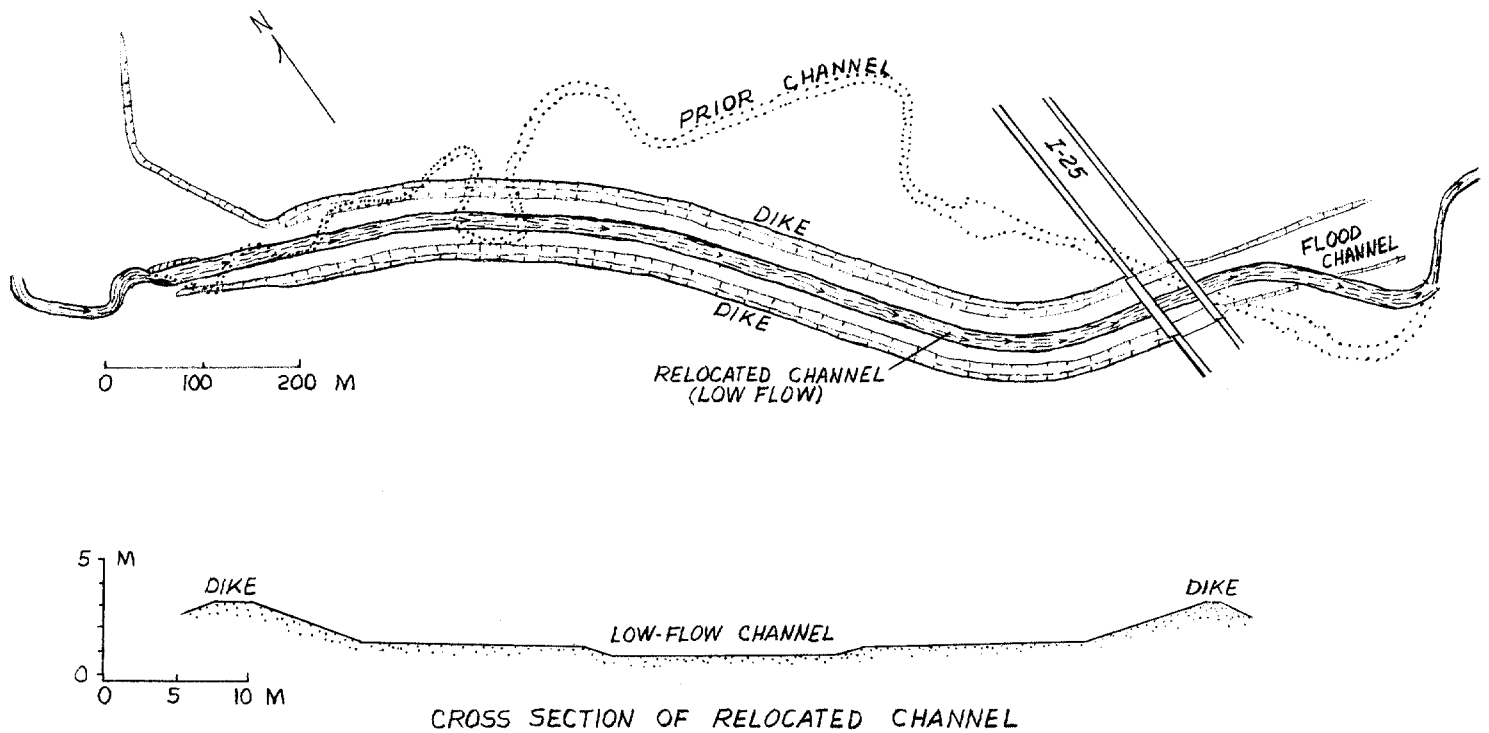
Figure 207. Plan sketch of channel relocation, North Laramie River.

SYNOPSIS--A channel segment about 1,900 m in length was relocated and shortened by a factor of 0.7, for purpose of improving channel alinement at bridge and apparently to facilitate relocation of irrigation ditches (fig. 207). Performance period, 15 yr (1964-79), during which one 10-yr flood occurred. The relocated channel has a bottom width of 15 m and is bordered by dikes (fig. 208-A). Riprap was placed along the banks at the upstream end, and at the curve downstream from the bridge. In 1979, no bank erosion was seen along the relocated channel (figs. 208A and B), and bank stability of adjacent reaches of the natural channel was similar to that observed on an air-photo taken in 1949.

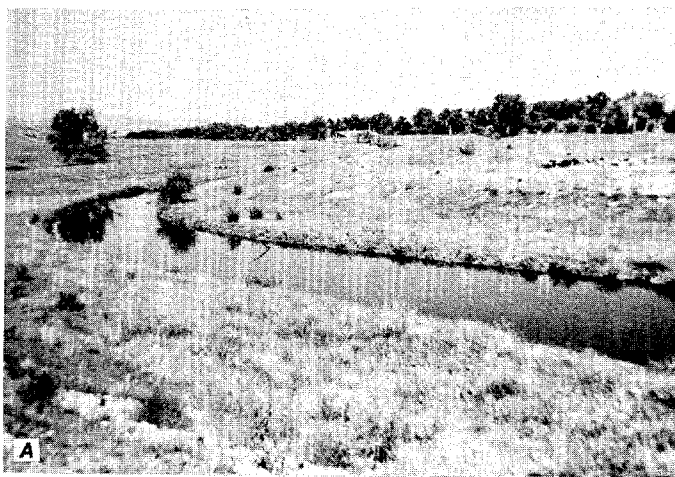
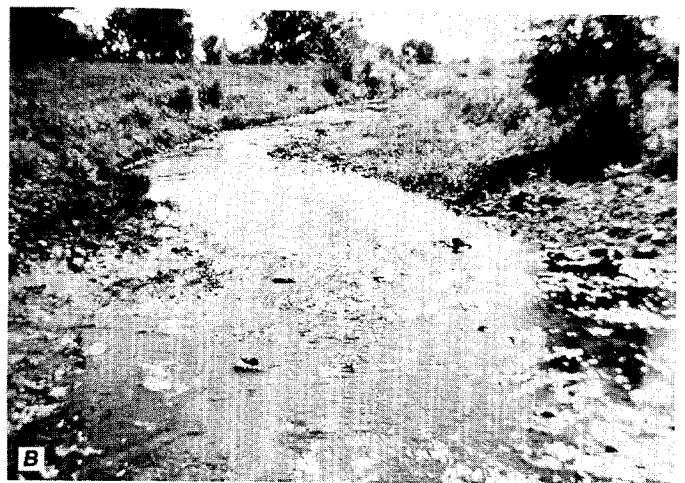
Figure 208. North Laramie River at site 103. A, Relocated channel, as viewed upstream from I-25 bridge, in 1979. B, Relocated channel as viewed from upstream end, in 1979.

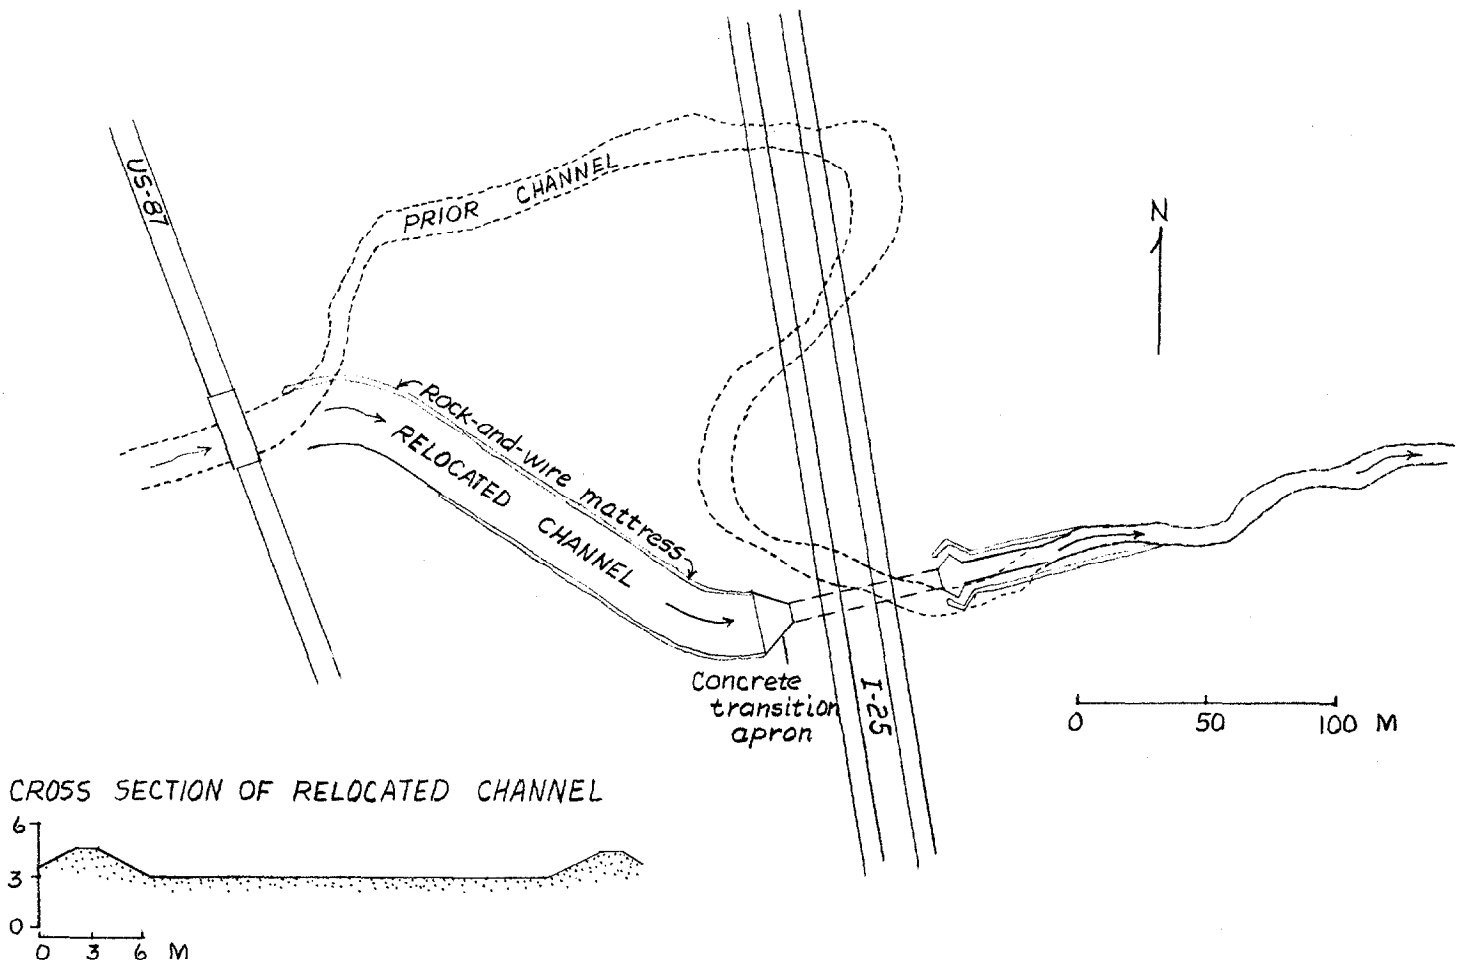
Figure 209. Plan sketch of Clear Creek channel relocation.

SYNOPSIS--Channel relocation, reach 663 m in length shortened to 417 m, to avoid two stream crossings and to improve alinement of channel with culvert (fig. 209). Performance period, 18 yr (1962-79). At the gaging station on Clear Creek 6.5 km west of Buffalo, a flood having a recurrence interval greater than 100 yr was recorded in 1963, and a 25-yr flood was recorded in 1968. Minor bank erosion has occurred at upstream bend in relocated channel (fig. 210A), but no significant change in channel dimensions. No effect of relocation on adjacent segments of the natural channel could be discerned (fig. 210B).

POST-ALTERATION FACTORS--A flood having an estimated recurrence interval of 100 yr occurred shortly after construction. At the culvert transition, bank material was washed out behind the rock-and-wire mattress. To remedy this problem, the mattress was pressure grouted and the wingwalls were extended into the dikes along the sides of the relocated channel. A line of trees, which appear to have been planted, extends along the relocated channel except at the outside of the upstream

curve. Here, bank erosion has progressed about a meter beyond the mattress. In addition, a well-defined point bar has developed at the inside of the bend.

DISCUSSION--The relocated channel has performed well, but bank erosion and meander development may progress at its upstream curve unless the rock-and-wire mattress is maintained.

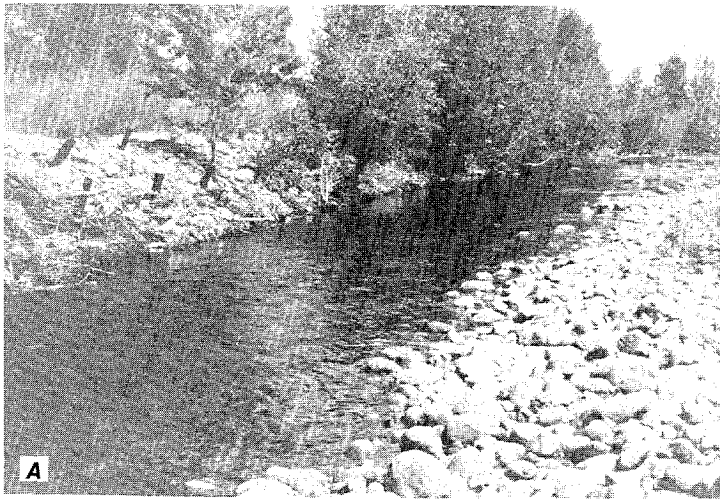
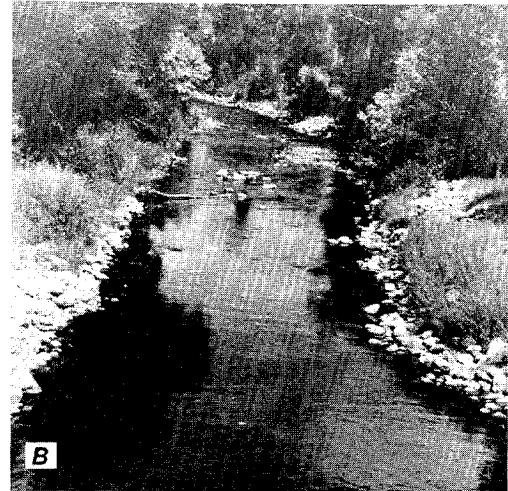
Figure 210. Clear Creek at site 104. A, View of relocated channel downstream from US-87 bridge, in 1979. B, View of channel downstream from culvert beneath I-5.
