Federal Highway Administration
Every Day Counts
Innovation Initiative

Safety Edge_{SM}
HMA Demonstration Project
Jasper County, Iowa

Field Report
June 6, 2011

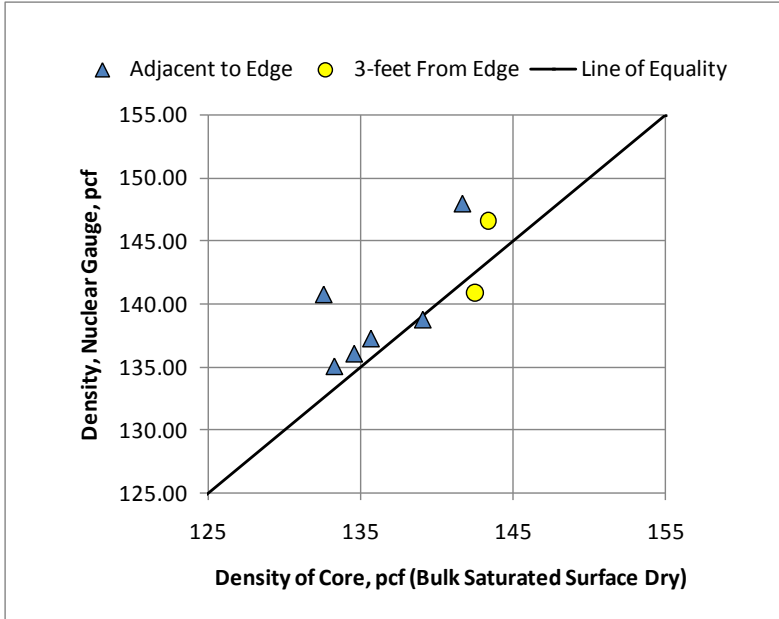
Figure 7. Comparison of the nuclear density readings and core densities.

Figure 7 shows a comparison of the nuclear densities and densities measured from the cores. As shown, the value at 3 ft. from the edge was close to unity and the value adjacent to the edge is not as close to unity. The adjusted densities using the adjustment factors are also listed in Table A-4 in Appendix A. The factors were used to adjust the nuclear density gauge readings to be consistent with the densities that were measured in the laboratory. The nuclear density test results are listed in Table A-5 and A-6 in Appendix A.

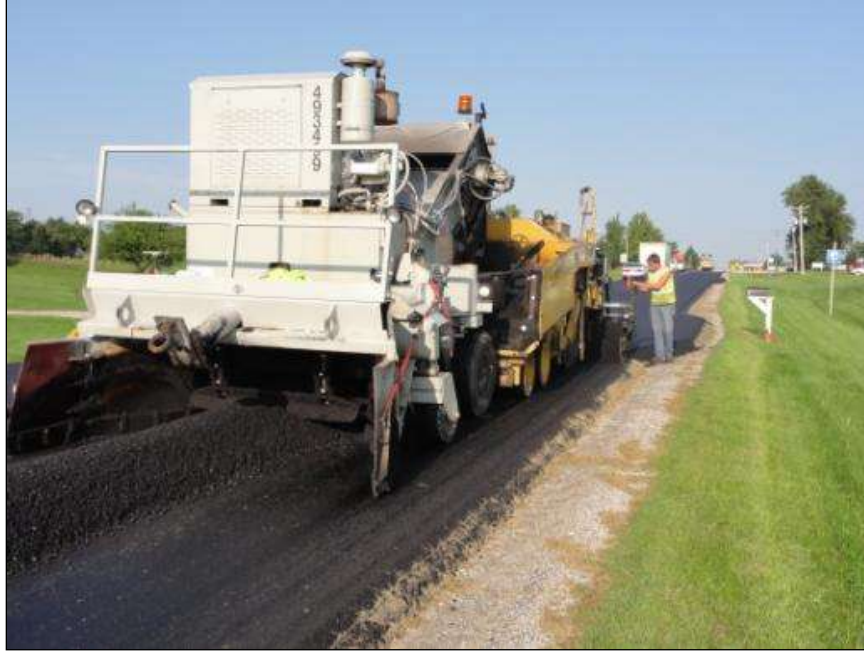
Figure 10. Material transfer vehicle ahead of the paver.

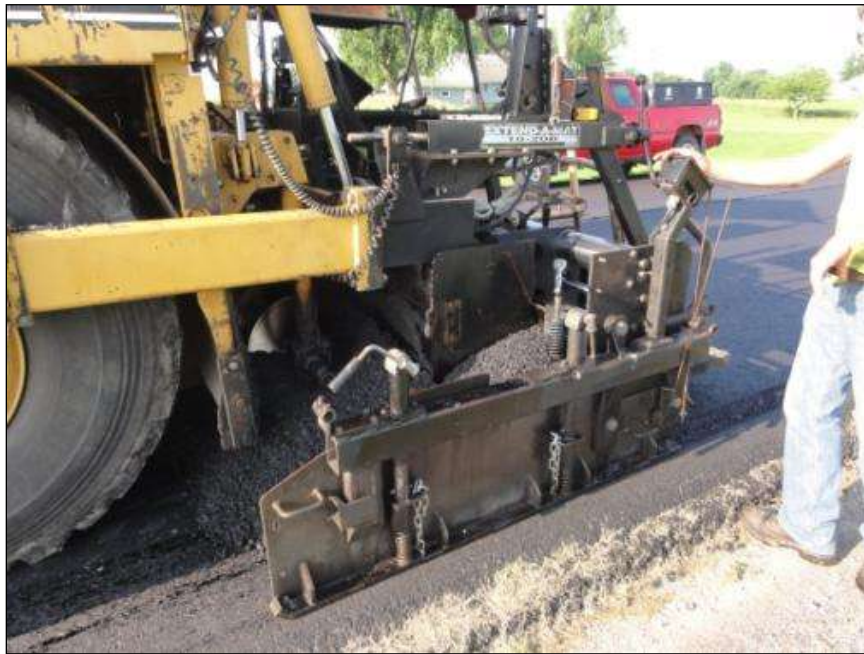
Figure 11. Blaw-Knox paver with the Caterpillar screed.

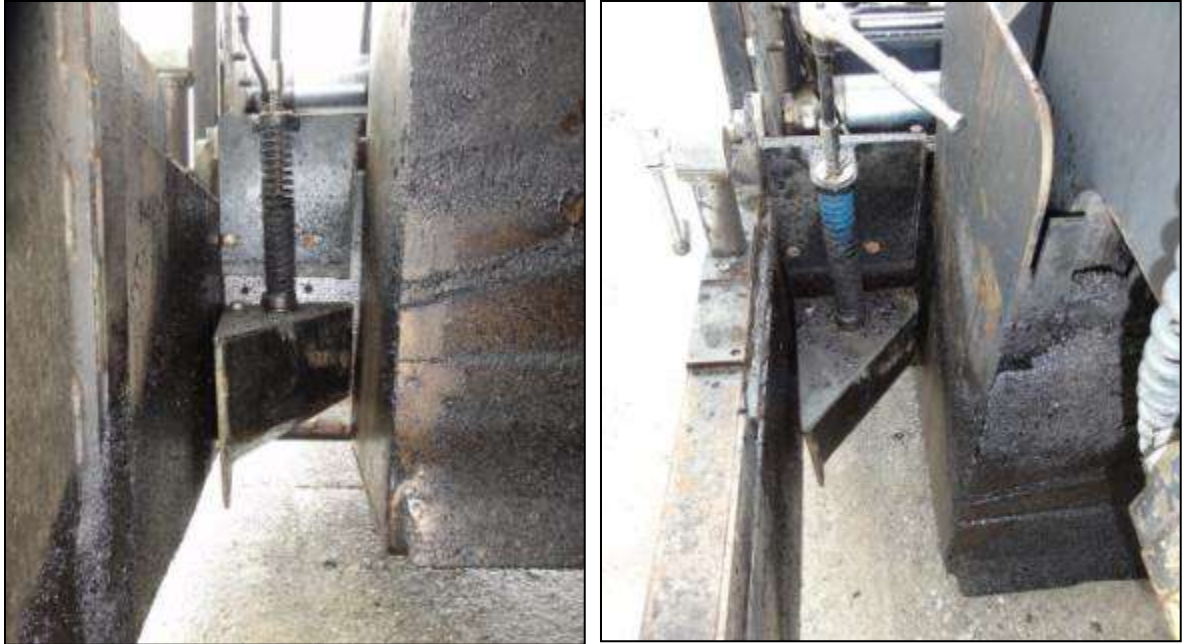
The contractor utilized a windrow material transfer vehicle (MTV) together with a Blaw-Knox rubber tire paver equipped a Caterpillar Extend-A-Mat 10-20B screed (Figure 10). Figure 11 and Figure 12 are images of the paving screed and the Safety Edge_{SM} device bolted to the screed. Vertical control of the Safety Edge_{SM} device was accomplished by hand cracking the device by the screed operator walking beside the paver.

Figure 12. TransTech Shoulder Wedge Maker bolted to the paver screed.
