Federal Highway Administration  
**Every Day Counts**  
Innovation Initiative

**Safety Edge<sub>SM</sub>**  
**Demonstration Project**  
**Kearney, Nebraska**

**Field Report**  
**May 24, 2011**

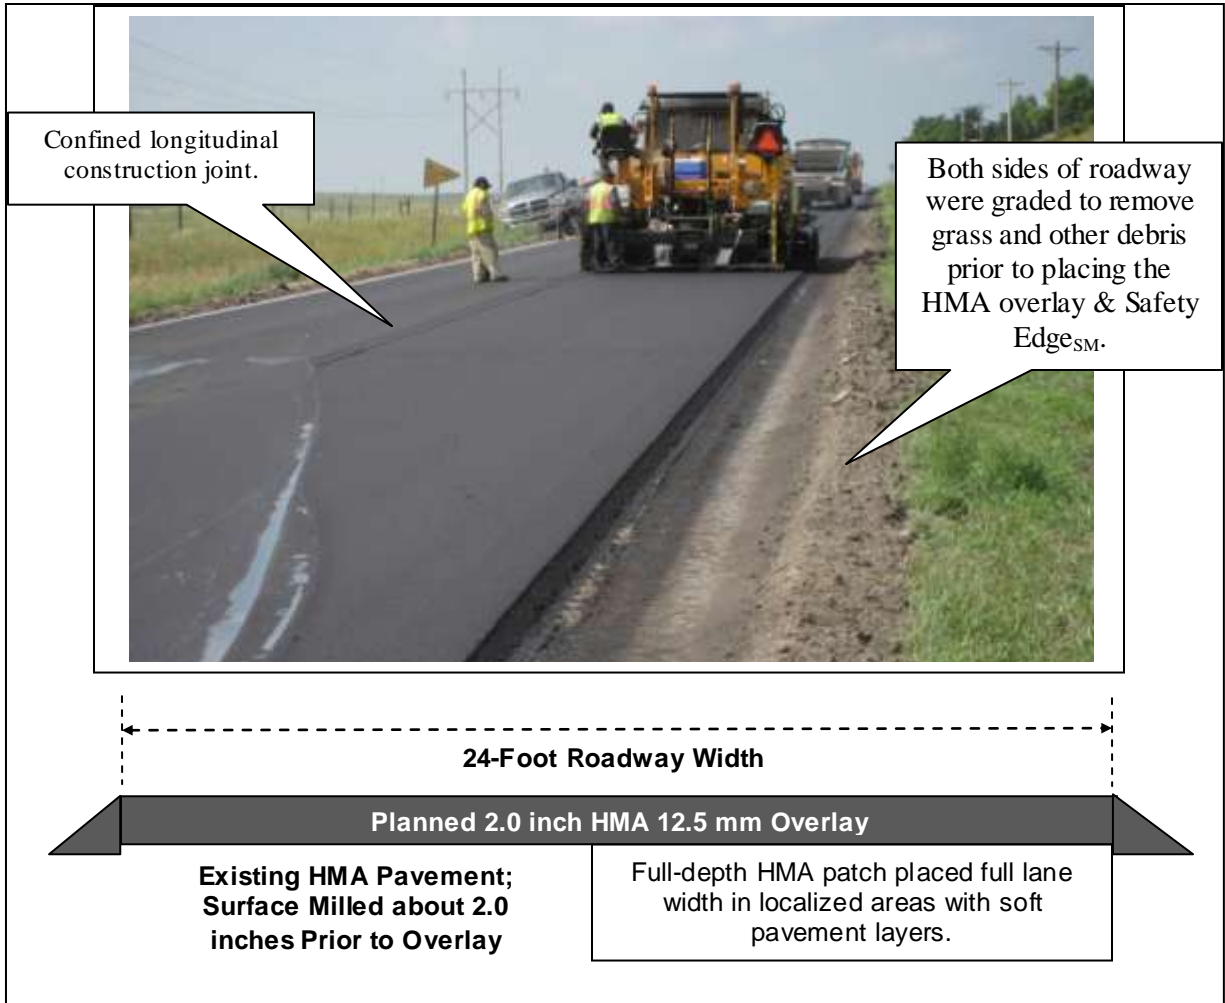
The project consisted of milling the existing surface to a depth of about 2 inches (basically removing the existing wearing surface and some of the underlying layer) and placing a 2 inch lift of a 12.5 mm HMA mix over the existing HMA pavement. Figure 2 provides a general view of the 2 inch HMA overlay and typical cross section of the pavement. Figure 3 provides a general view of the roadway for this project. In preparation for the HMA overlay, the following activities and repairs were made.

Figure 2. 12.5 mm HMA overlay being placed in one direction where the overlay in the opposite lane has already been placed.

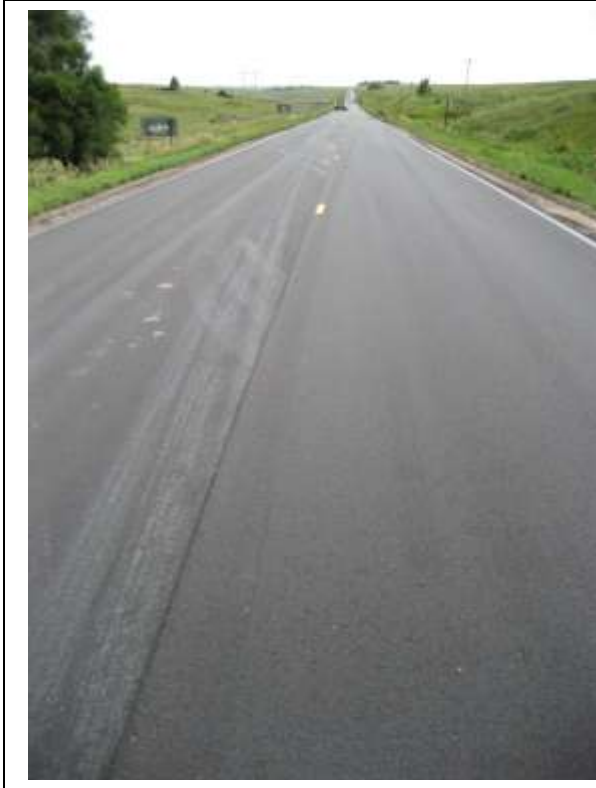
Figure 3. General overview of project location; view is towards the north.

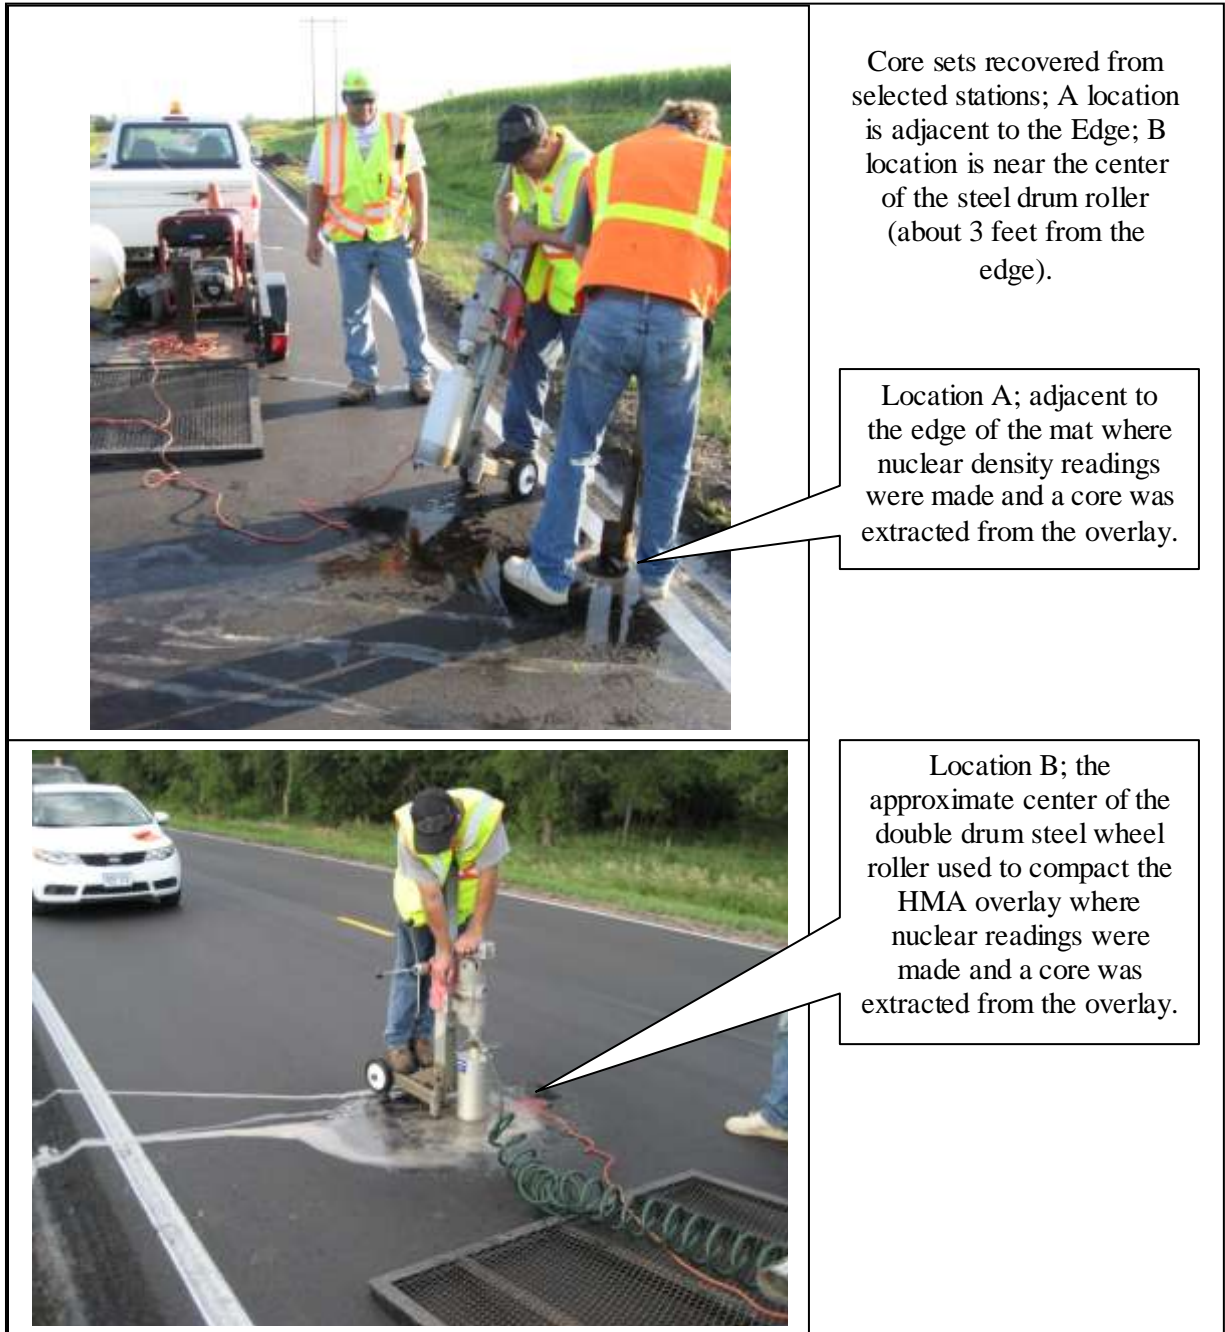
Figure 9. Photos show location of cores and nuclear density tests made with the Troxler gauge (nuclear density readings were taken and then the overlay was cored).

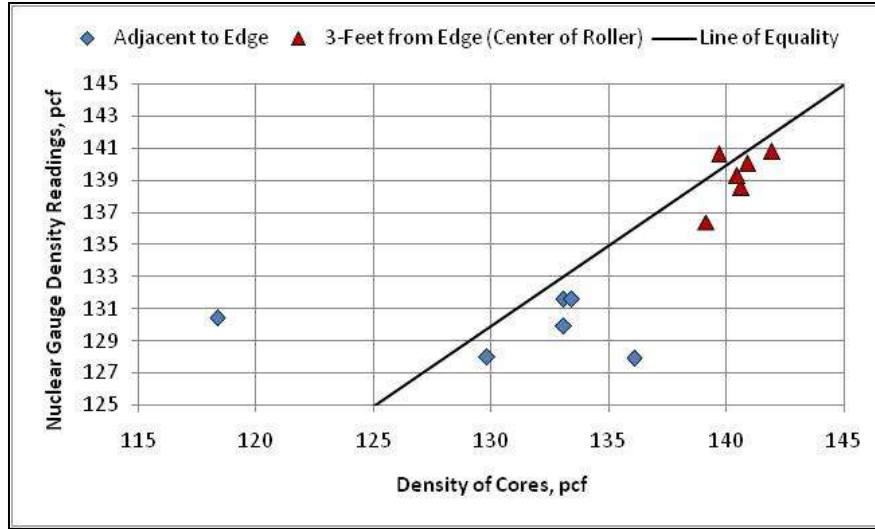
Nuclear gauge readings were taken before drilling each core. Figure 11 shows a comparison of the nuclear gauge readings and densities measured on the cores. As shown, there is a positive bias for the readings taken adjacent to the edge of the mat. Adjustment factors were determined for the nuclear gauge readings taken at the edge of the HMA mat and near the center of the steel drum roller being used to compact the HMA mat. The following lists the average adjustment factors determined for this project:

Figure 11. Comparison of the nuclear gauge readings and densities measured from cores.

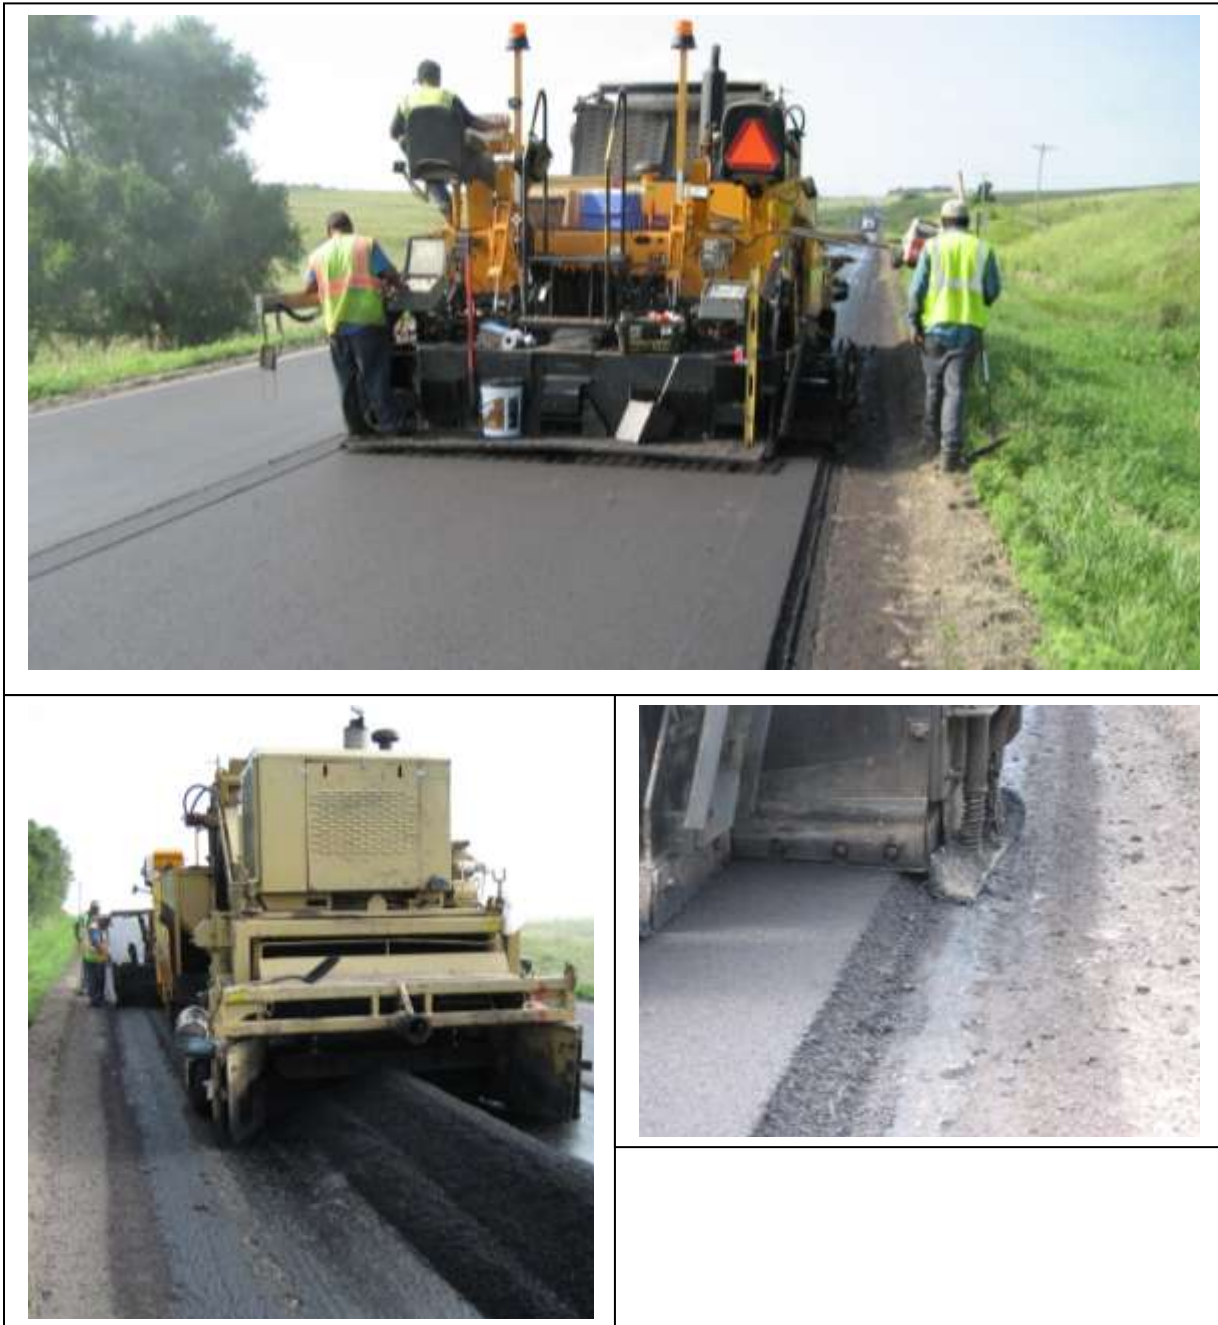
Figure 14 shows the equipment used to place the HMA overlay. The paving contractor operated the paver in the automatic longitudinal grade control mode and used non-contact sonic sensors for controlling the grade. Figure 15 shows the TransTech Shoulder Wedge

Figure 14. Equipment used to place the HMA overlay.

Figure 14 showed the HMA behind the screed and the Safety Edge<sub>SM</sub> slope prior to rolling. The slope of the Safety Edge<sub>SM</sub> prior to rolling was equal to or slightly steeper than the planned 30°. The distance between the end of the auger and screed end plate was about 18 inches (refer to Figure 15). This distance should be less than 18 inches. The temperature of the HMA being delivered to the project site was reported to be 310 to 318 °F. Mix temperature and the distance between the end of the auger and screed end plate are not believed to be contributing factors to the steeper slopes.

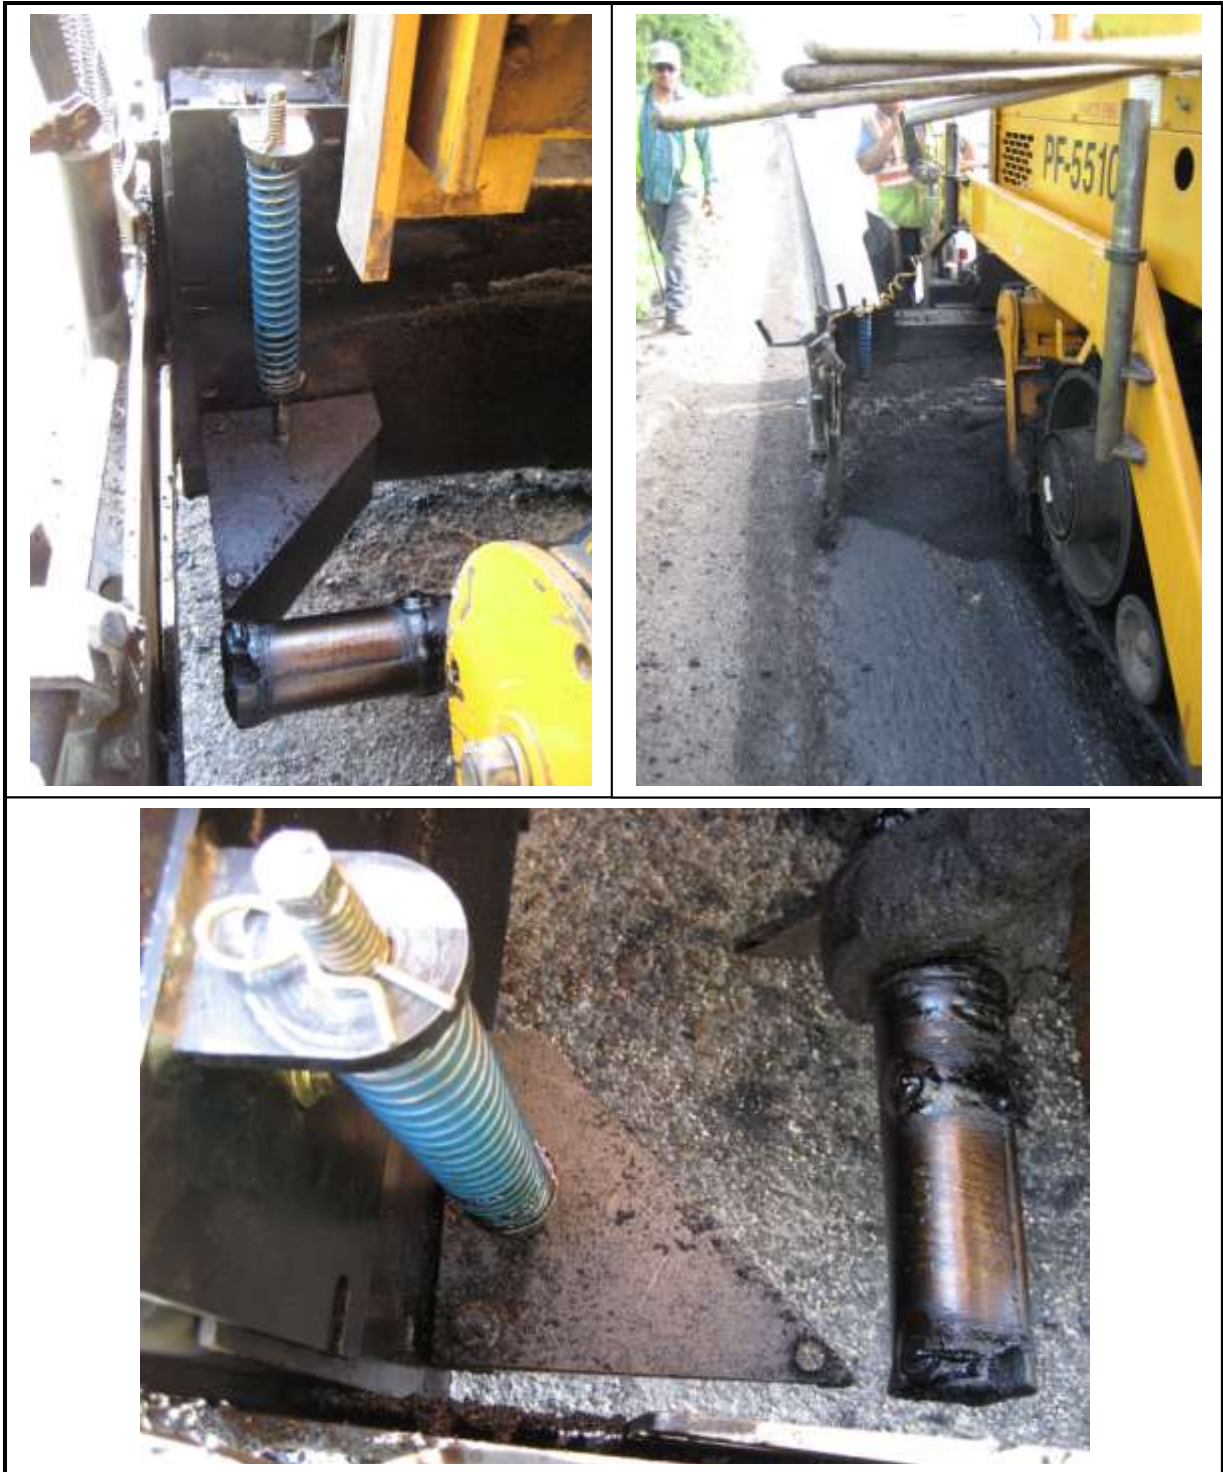
Figure 15. TransTech Shoulder Wedge Maker device attached to the screed.

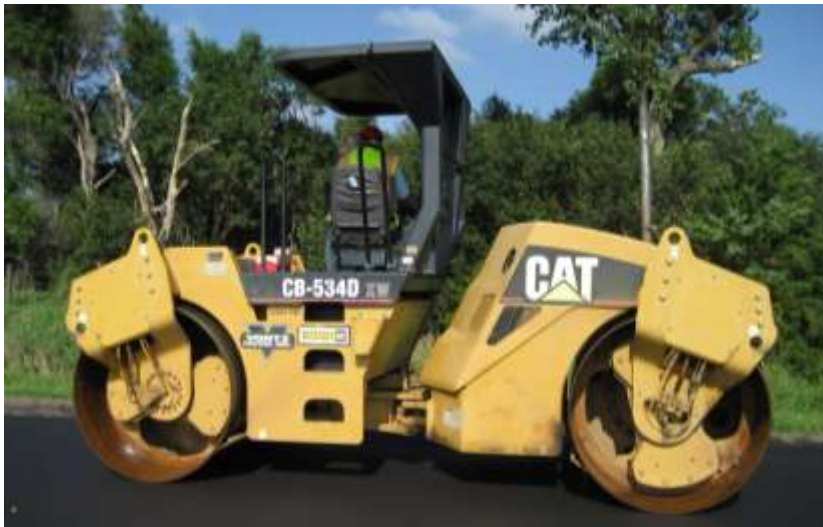
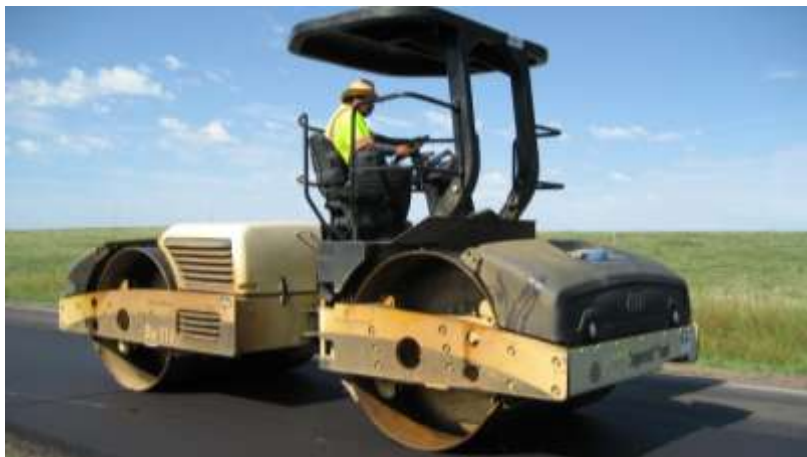
Figure 17 shows the two rollers that were used to compact the 12.5 mm HMA mixture. The primary or breakdown roller was a Caterpillar double drum vibratory (CB 534D), while the finish roller was an Ingersoll-Rand double drum vibratory (DD118 420HFA). The field evaluation forms identify the number of passes and coverage used by all rollers (a pass is defined as one movement of the roller in one direction, while coverage is defined as each point on the mat receiving a pass of the roller). In summary, each roller had 5 passes with 2 coverages, except for the area adjacent to (within 6 inches) and along the Safety Edge<sub>SM</sub>, which only received one pass of the breakdown roller.

A control strip was not used to confirm that the roller pattern being used was achieving an adequate density of the mix. The nuclear density gauge readings and the densities of the cores suggest that adequate density was obtained for this mixture away from the edge, but the density was low near the edge.

Caterpillar double drum vibratory steel wheel roller used in breakdown or primary position for compacting the HMA overlay.

Ingersoll-Rand double drum vibratory steel wheel roller used in the vibratory and static mode that was used in the finish position for compacting the HMA overlay.

Figure 17. Rollers used for compacting the 12.5 mm HMA overlay mixture.
