Safety Edge_{SM}
Demonstration Project
Elizabethtown,
Pennsylvania

Field Report
May 24, 2011

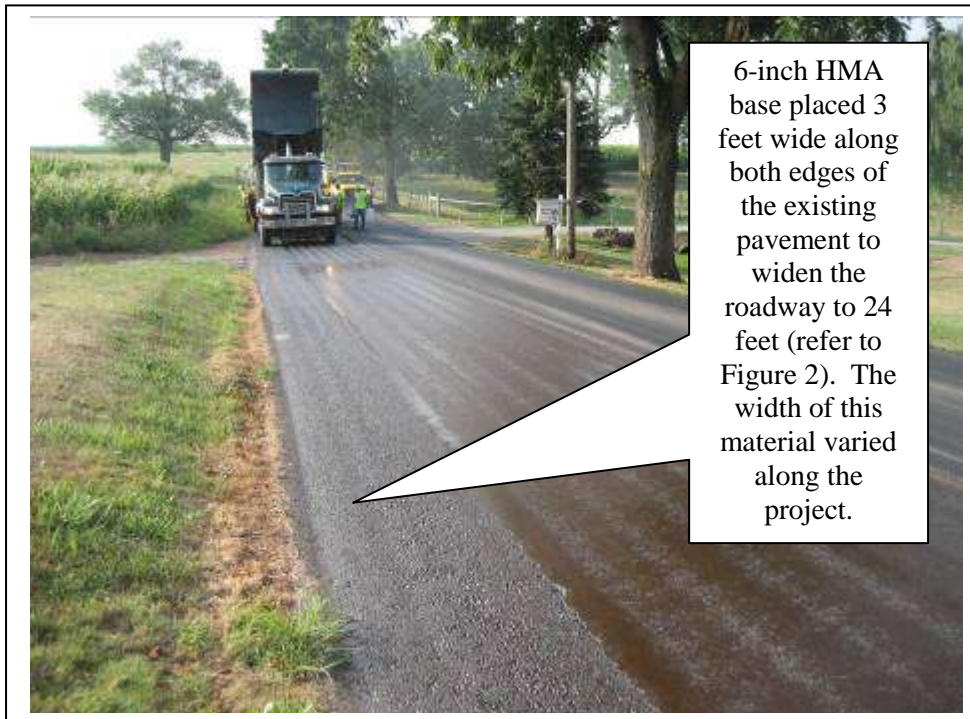
As noted above, the existing pavement was widened on both sides by about 1 foot, by placing an HMA base mix (refer to Figure 4). The HMA base mix had already been placed along the pavement's edge. The surface of this material was rough, as shown in Figures 4 and 5. The width of the pavement varied significantly along the project because of site features and driveways that exist along the project (refer to Figures 3 and 6).

Figure 4. Additional HMA base material placed along each edge of the roadway.

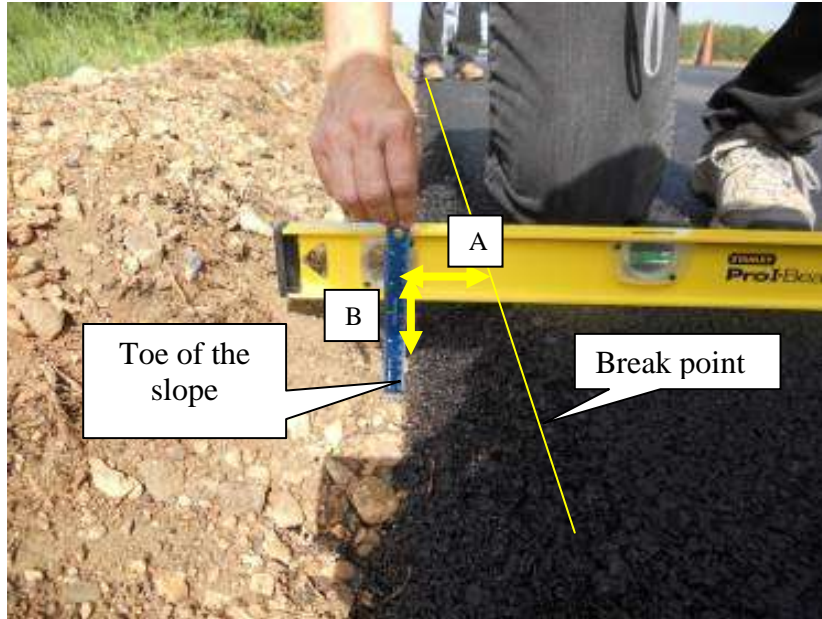
Slope measurements were taken using a straight-edge to measure the width and thickness of the taper of the Safety Edge_{SM} (refer to Figure 8). The average slope of the Safety Edge_{SM} was 48°. Table A-1 in Appendix A contains slope measurements recorded at each individual measurement location. Only one of the measurements was less than 40°. Figure 9 includes a comparison between the slope of the Safety Edge_{SM} and mat thickness at the Safety Edge_{SM} for the two test sections. As shown, there appears to be no correspondence between mat thickness and the slope of the Safety Edge_{SM}.

Figure 8. Measurement of the Safety Edges_{SM} angle.

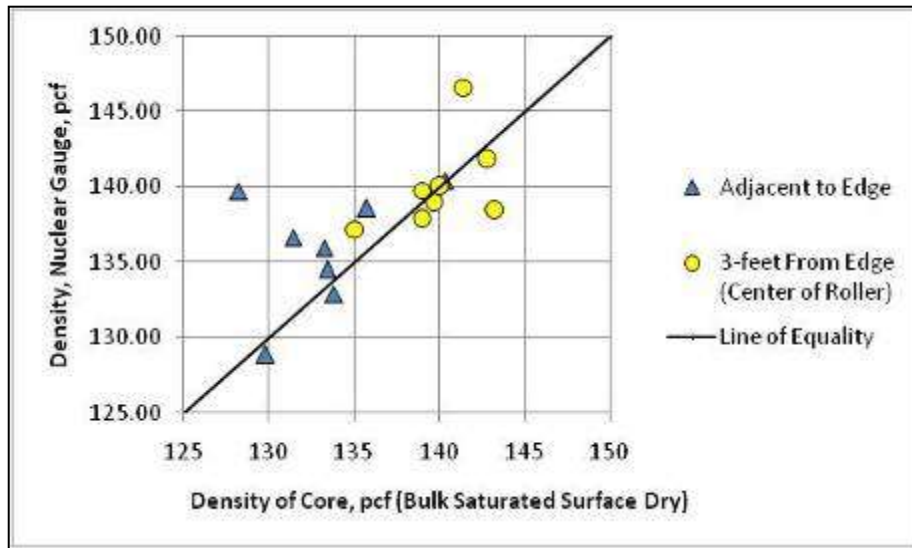
Nuclear density readings were taken at each core. Figure 12 shows a comparison of the nuclear densities and densities measured on the cores. As shown, there is close correspondence between the nuclear and core densities. Adjustment factors were determined for the nuclear density readings taken at the Safety Edge_{SM} and near the center of the steel drum roller being used to compact the HMA mat. The adjustment factors are included in Table A-3 in Appendix A and are summarized as follows:

Figure 12. Comparison of the nuclear density readings and densities measured on cores recovered from the HMA overlay.

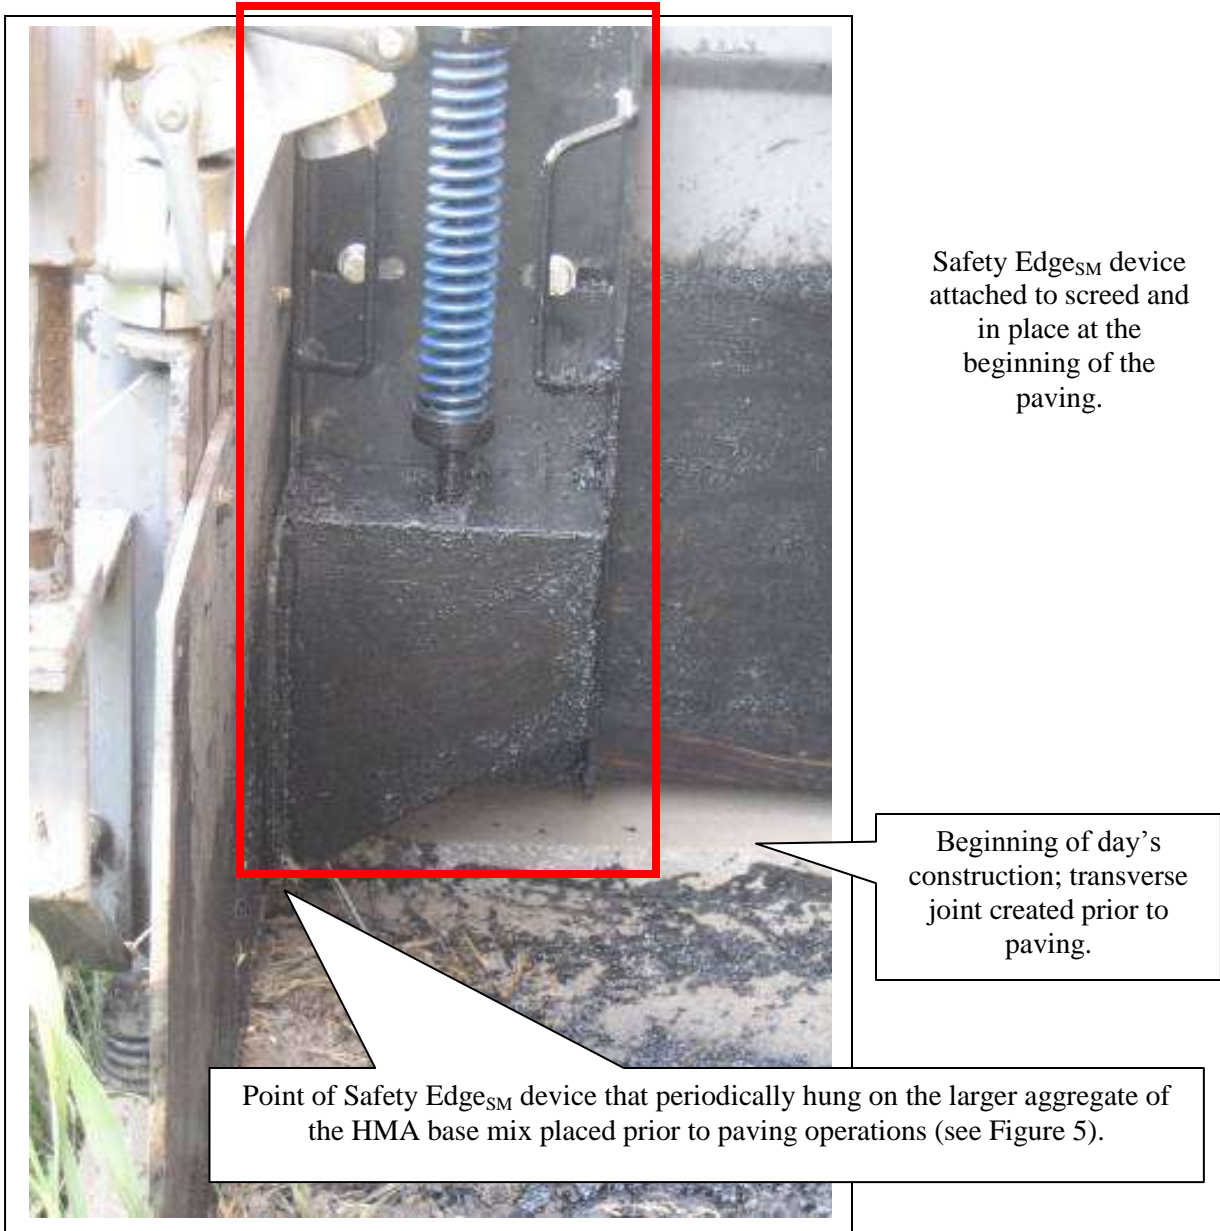
Figure 17. Safety Edge_{SM} device attached to the screed.

- The screed operator's opinion was that it was difficult to control the height of the screed, screed end plate, screed extension, and Safety Edge_{SM}. It was recommended that the Safety Edge_{SM} device be automated rather than operated by manually turning the screw.
- One major issue that was observed during the paving operation was that the bottom part of the Safety Edge_{SM} device or shoe would periodically get caught on the coarse aggregate of the HMA base mix used to widen the roadway. This caused a sudden jerk in the screed when the coarse aggregate-broke loose or the Safety Edge_{SM} device/screed rose above the aggregate. The screed operator forced the Safety

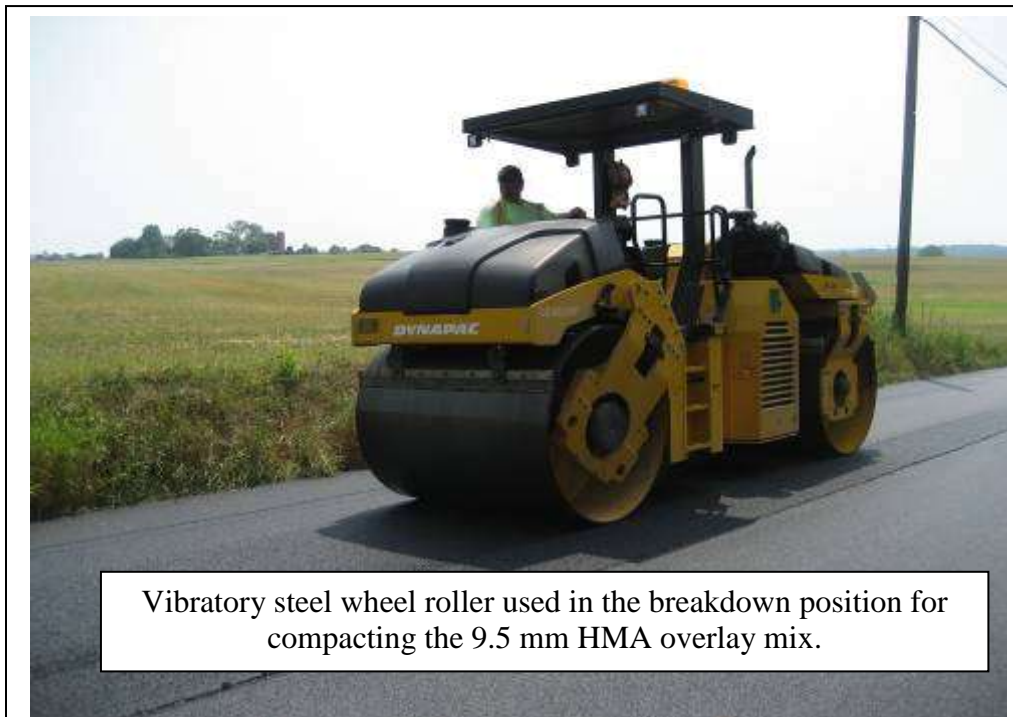
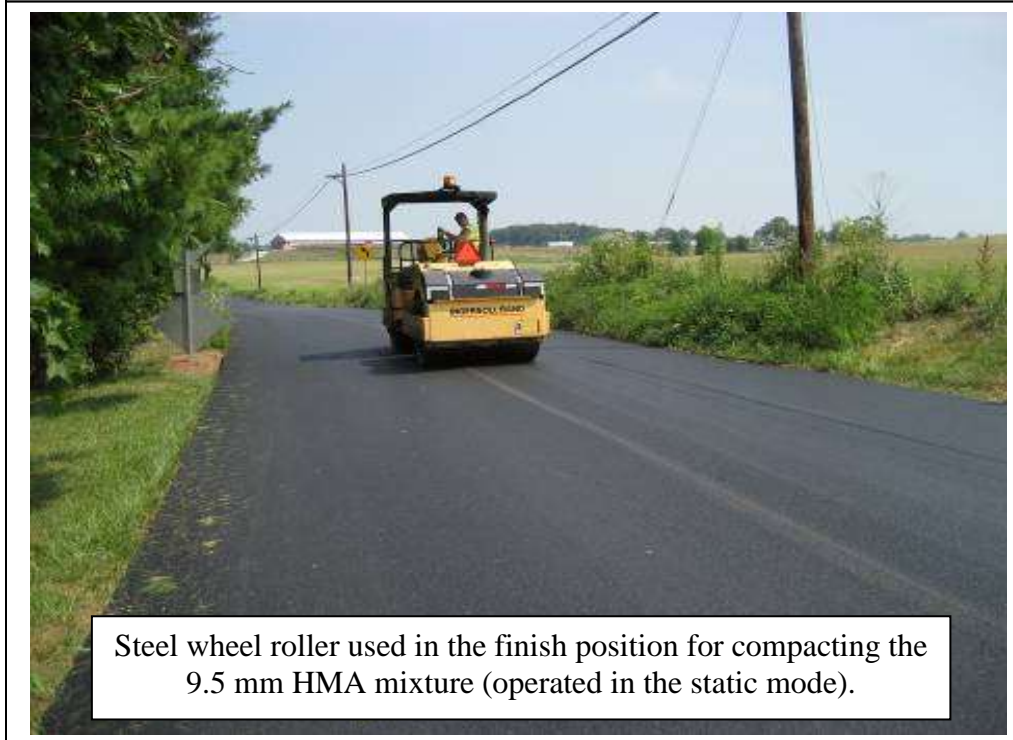
Figure 21 shows the two rollers that were used to compact the HMA 9.5 mm mixture. The breakdown roller was a Dynapac CC422VHF and the finish roller was an Ingersoll-Rand DD90.

Figure 21. Two steel wheel rollers used to compact the 9.5 mm HMA mix.
