Federal Highway Administration
Every Day Counts
Innovation Initiative

Safety Edge_{SM}
Demonstration Project
Seaford, Delaware

Field Report
January 30, 2011

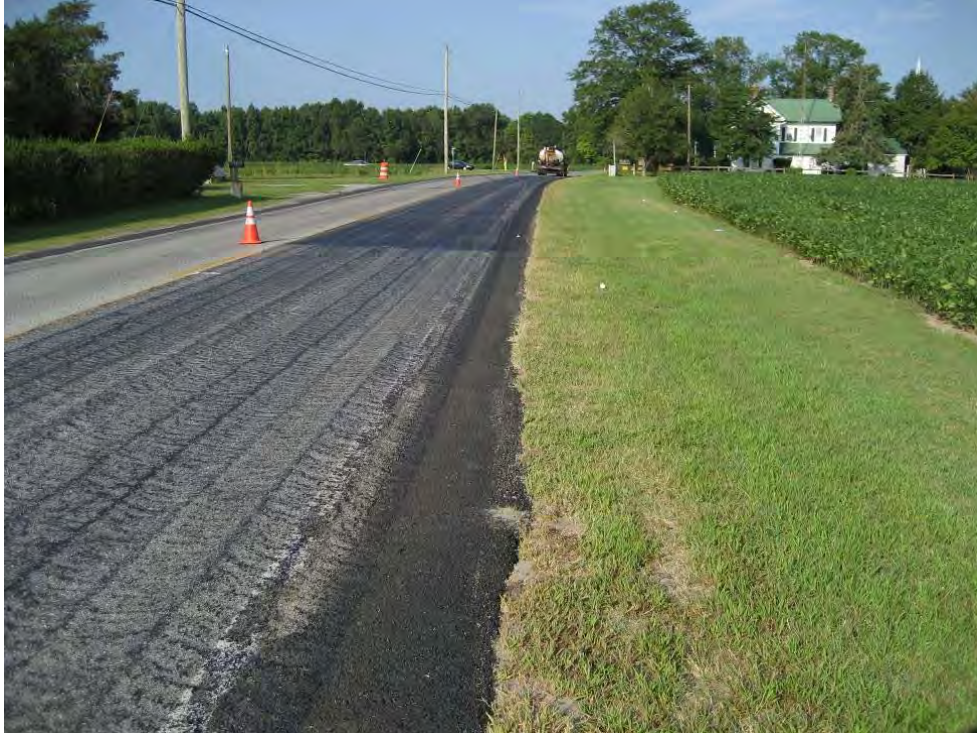
The ditches along the edge of the pavement were generally shallow (1 to 3 ft) with shallow slopes (10 to 30°). No lane-shoulder drop-offs were observed; however, the shoulder had been graded and the roadway widened on each side of the roadway prior to visiting the project. Figure 3 through Figure 6 include general views of the roadway during construction. The Safety Edge_{SM} backing material was planned to be an on-site fine to coarse-grained soil. The backing material was scheduled to be graded back to the Safety Edge_{SM} near the end of this rehabilitation project, after paving.

Figure 6. General view of the roadway and right-of-way.

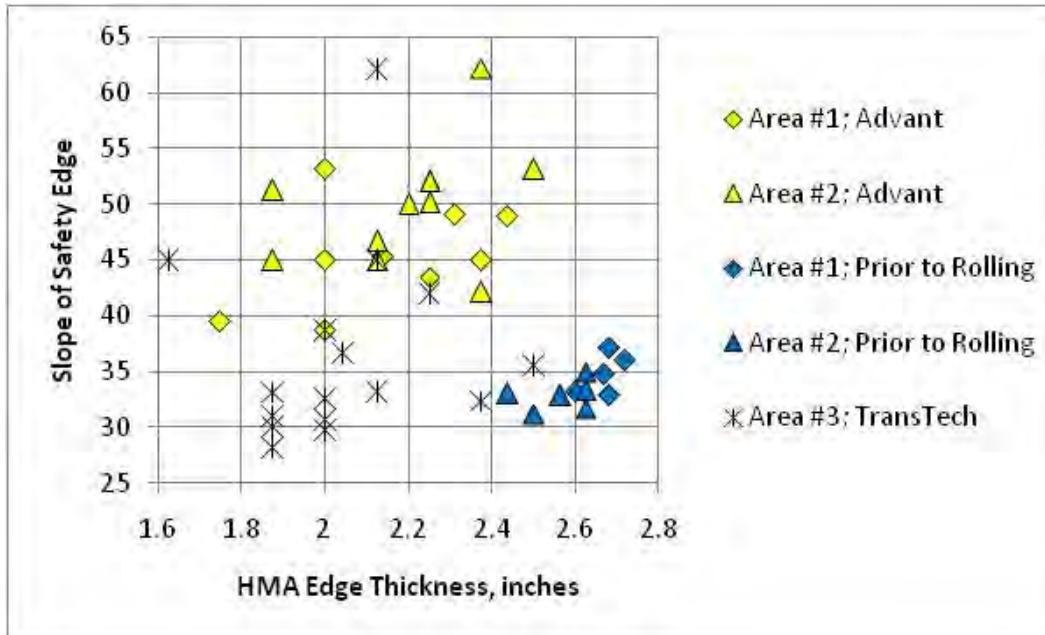
All slope measurements are listed in Tables A-1 through A-3 of Appendix A. Figure 9 includes a comparison between the slope of the Safety Edge_{SM} after final rolling and thickness of the

Safety Edge_{SM} for the three sections. As shown, no correspondence between thickness and the slope of the Safety Edge_{SM} exists.

Figure 9. Comparison of the Safety Edge_{SM} slope and thickness of the WMA adjacent to the edge of the HMA overlay.

Figure 9 included a comparison between the WMA thickness (near the Safety Edge_{SM}) and slope of the Safety Edge_{SM}. The thickness of the WMA has little to no effect on the slope of the Safety Edge_{SM}. Figure 14 shows a comparison of the density and WMA overlay thickness. As shown, there is also little correspondence between the overlay thickness and air voids or densities.

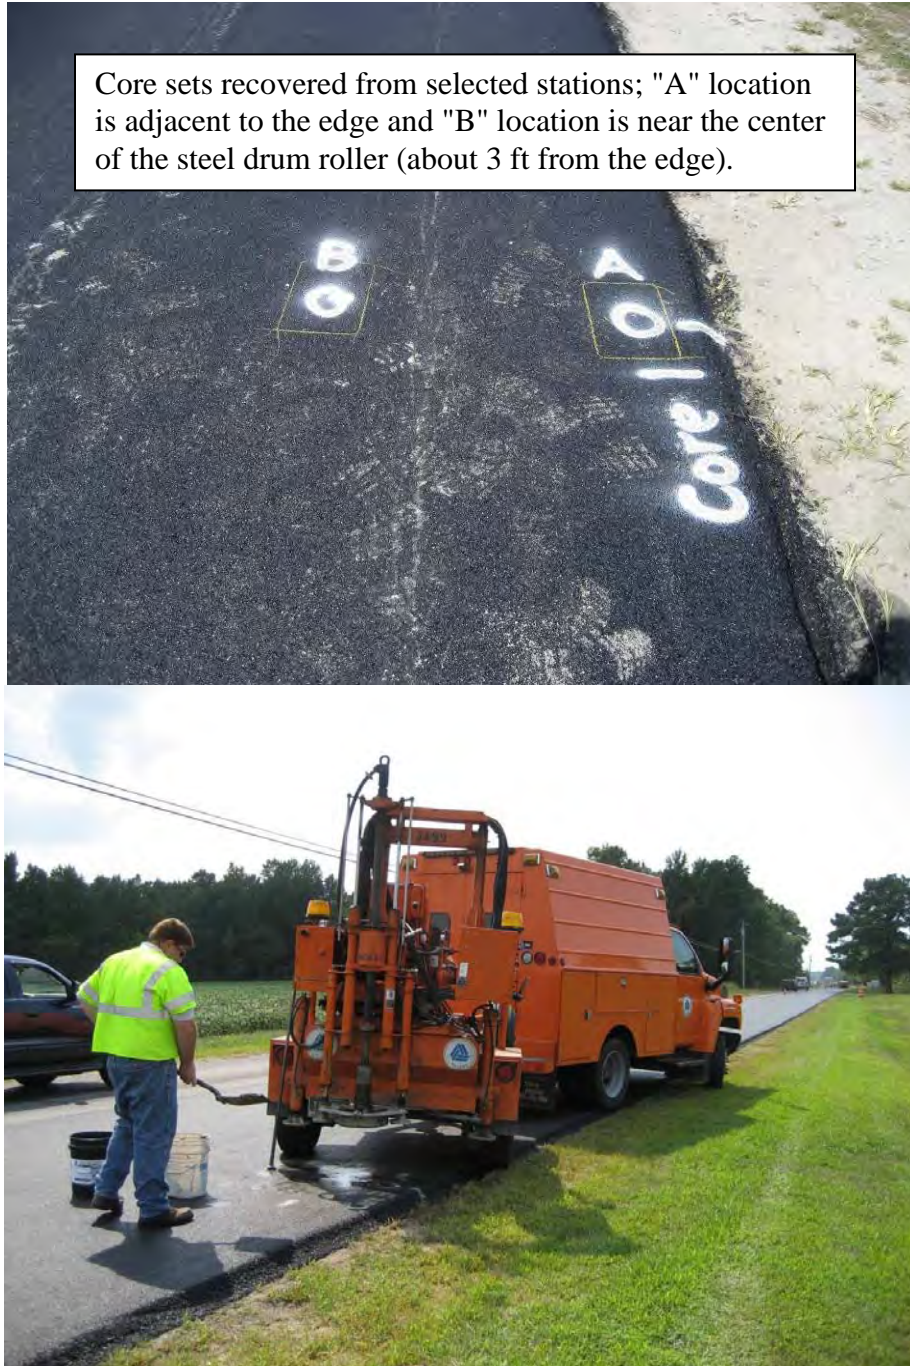
Figure 10. Photos showing location of cores and nuclear density tests made with the Troxler 3430 gauge (nuclear density readings were taken and then the WMA mix was cored).

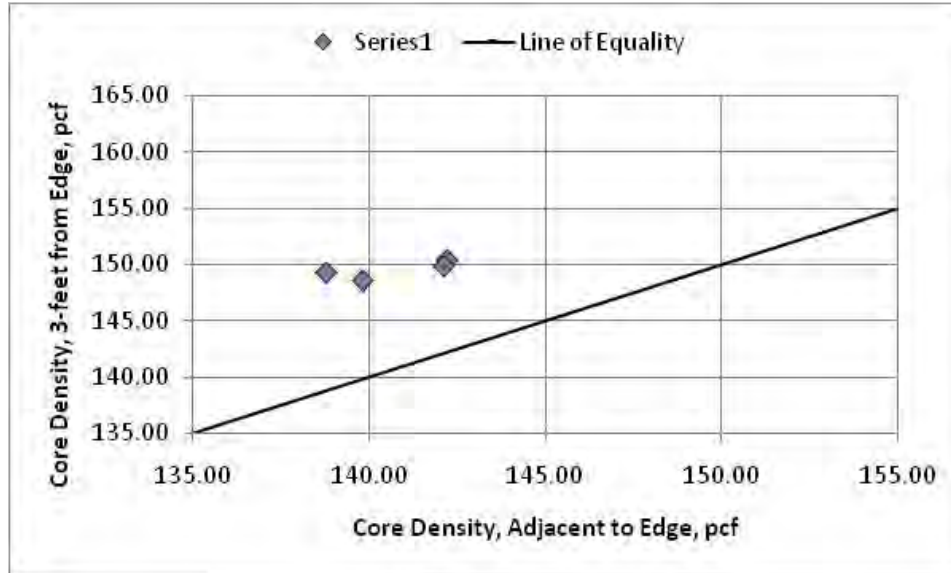
A total of eight cores were drilled along the project. Two cores were taken at each station or location; in the same areas where the densities were measured with the Troxler nuclear density gauge. These cores were taken to measure the bulk specific gravity of the WMA for developing a correction factor for the nuclear density gauge readings taken adjacent to the edge and within the center of the mat. Figure 10 shows the location of the cores and nuclear density gauge readings relative to the edge of the WMA mat. Photographs of all eight cores recovered from the roadway are included in the appendix. A summary of these test results; core thickness and bulk specific gravities (saturated surface dry) converted to bulk densities is included in Table A-4 in Appendix A. Figure 11 is a comparison of the core densities taken along the edge and 3 ft from the edge (center of the steel drum breakdown roller) for the Safety Edge_{SM} sections. As expected, densities 3 ft from the edge are higher than along the edge of the mat (unconfined edge).

Figure 11. Comparison of core densities adjacent to the edge of pavement and 3 ft from the edge.

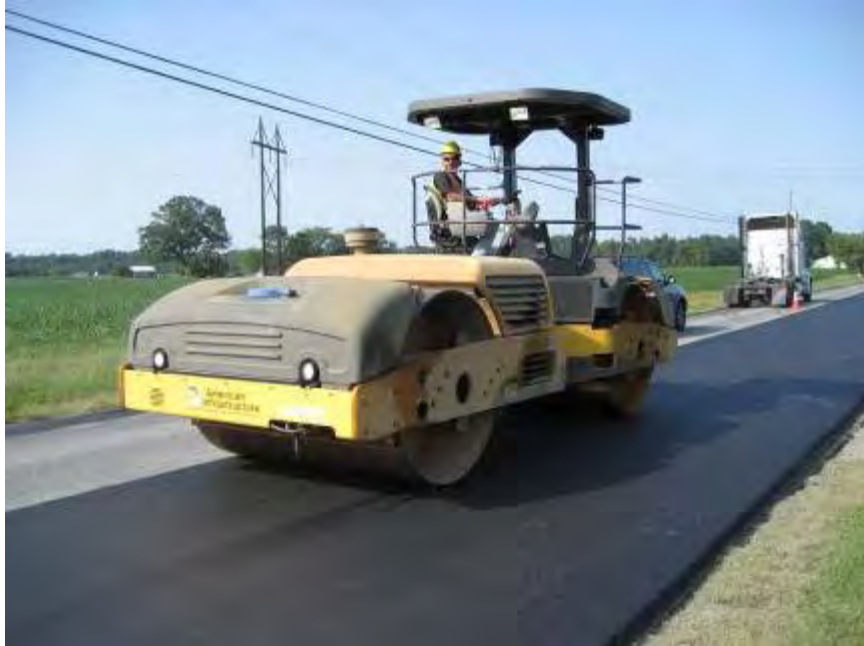
Figure 19 shows the two rollers that were used to compact the 9.5 mm WMA mixture. The primary or breakdown roller was a Volvo DD118 double drum steel wheel vibratory roller, while the finish roller was a Volvo DD112 double drum steel wheel vibratory roller. The field evaluation forms identify the number of passes and coverage used by all rollers (a pass is defined as one movement of the roller in one direction, while coverage is defined as each point on the mat receiving a pass of the roller).

nuclear density gauge readings and the densities of the cores suggest that adequate density was obtained for this mixture 3 ft from the edge, but the density was low near the edge.

Volvo double drum vibratory steel wheel roller used in breakdown or primary position for compacting the WMA overlay.

Volvo double drum vibratory steel wheel roller used in the vibratory and static mode that was used in the finish position for compacting the WMA overlay.

Figure 19. Rollers used for compacting the 9.5 mm WMA overlay mixture.
