FULL-SCALE UNINSTRUMENTED TEST OF BRICK MAILBOX STRUCTURES

Southwest Research Project No. 06-1917-205
Federal Highway Administration Order Number 06-00-113(88)

Frank D. Masch, Ph.D., P.E.

June 1988

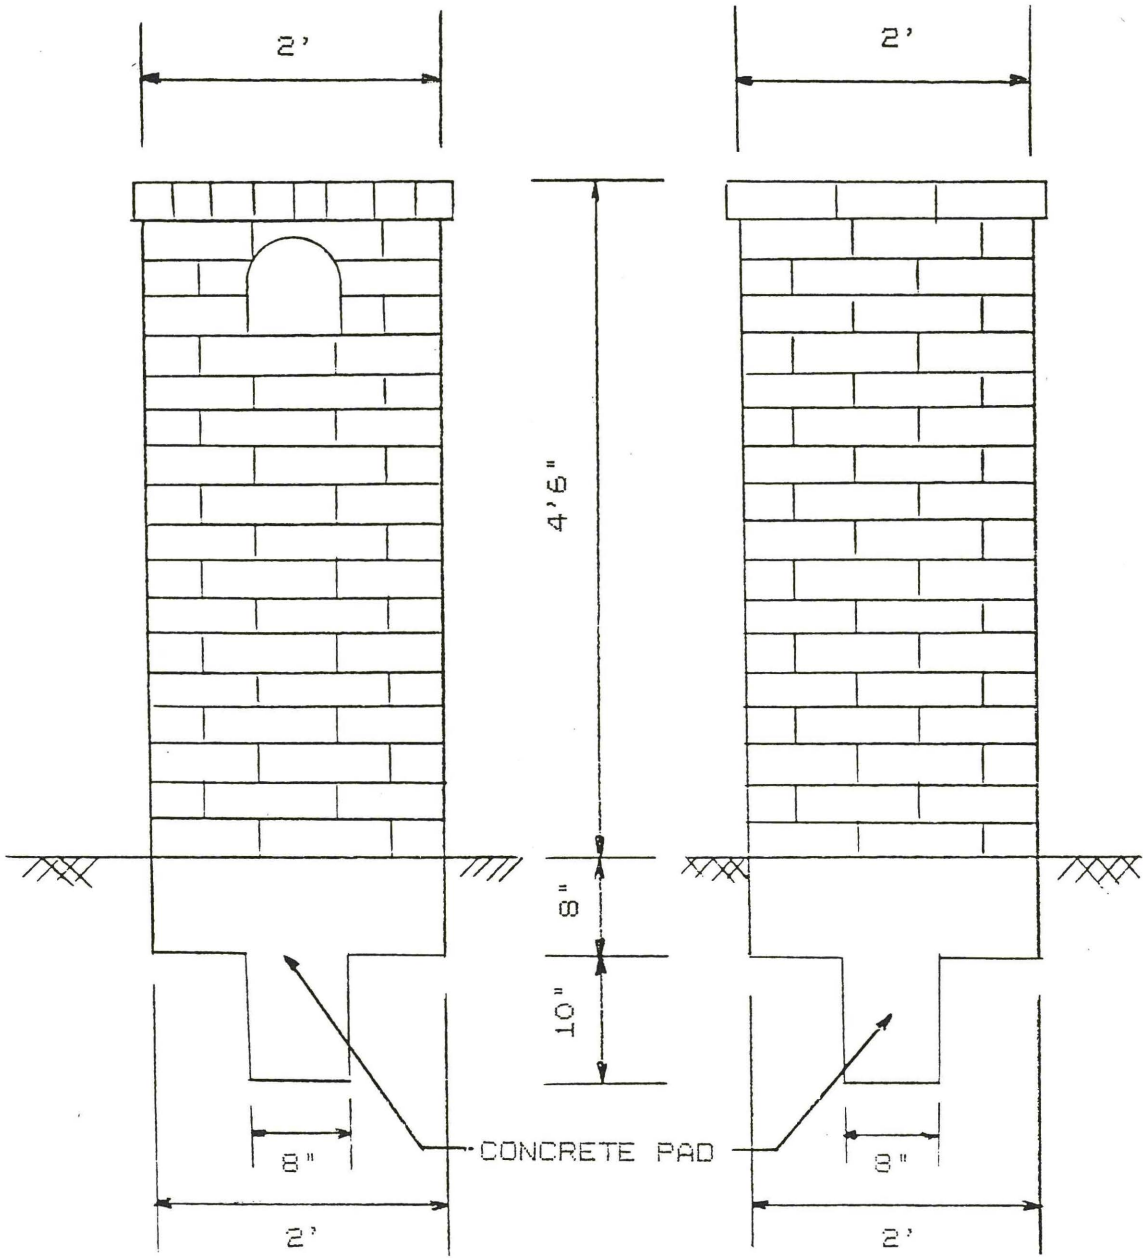
Figure 1. Mailbox Stand Construction Details

BARRIER INSTALLATION: The barrier evaluated in this test was a 2' x 2' x 4-1/2' brick mailbox stand with a hollow interior. Figure 1 presents mailbox stand construction details.

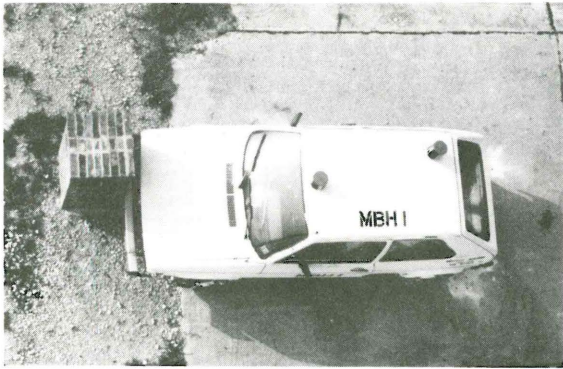
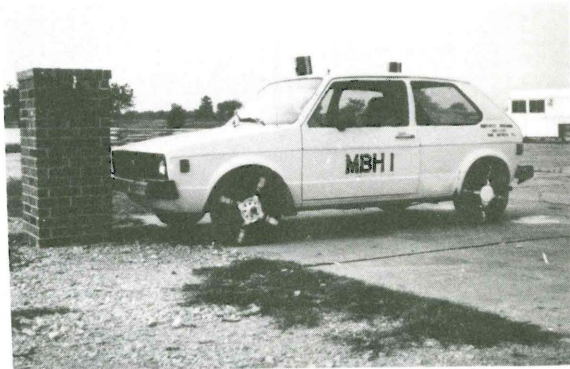
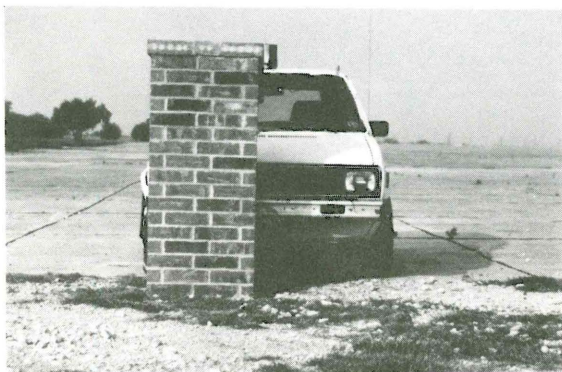
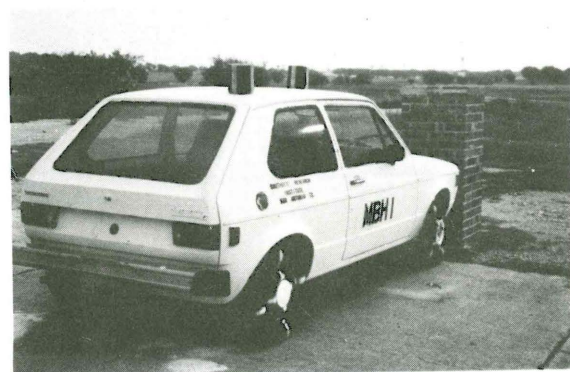
Figure 2. Mailbox Stand and Vehicle Details
Test MBH-1

TEST VEHICLE: The vehicle used in the test was a 1978 Volkswagen rabbit. Gross test weight, including the driver dummy was 1845 lbs. Figure 2 contains photographs of the mailbox stand and the test vehicle.

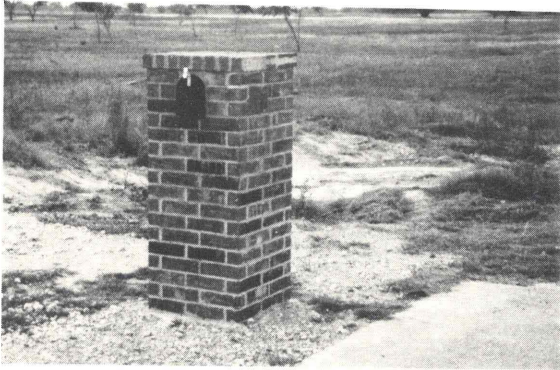
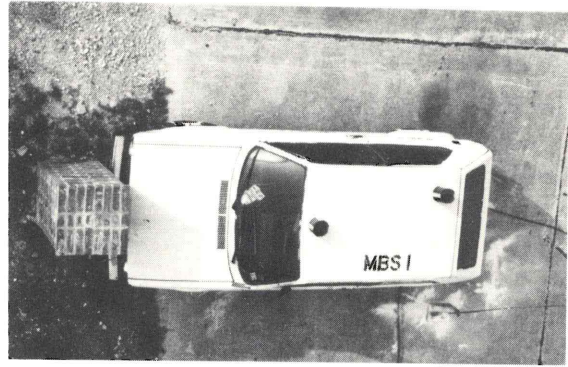
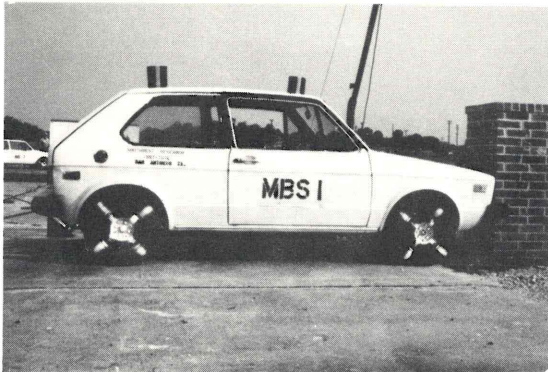
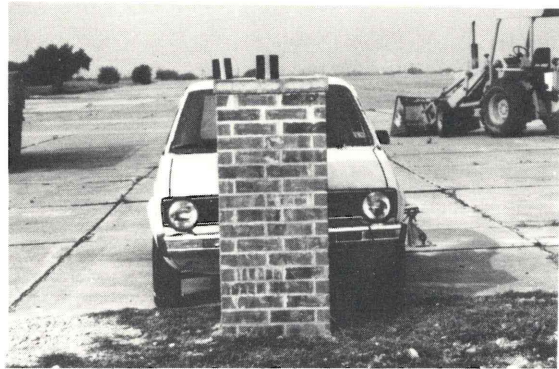
Figure 5. Mailbox Stand and Vehicle Details

TEST VEHICLE: The vehicle used in the test was a 1978 Volkswagon rabbit. Gross test weight, including the driver dummy was 1845 lbs. Figure 5 contains photographs of the mailbox stand and the test vehicle.
