# **Guardrail Testing Program**

## **Final Report**

**Publication No. FHWA-RD/FLP-90-087**  
**May 1990**

14. Sponsoring Agency Code	
15. Supplementary Notes FHWA Contract Manager: C. McDevitt (HSR-20)					
16. Abstract A series of crash tests were conducted to evaluate aesthetic guardrails, guardwalls, median barriers and bridge rails that have been designed for use on park roads, parkways and other Federal Lands roads.  Following two iterations of redesign, a steel-backed wooden guardrail showed acceptable performance when tested and evaluated in accordance with NCHRP Report 230. The successful system feature 10-in by 12-in by 7-ft (0.25-m by 0.30-m by 2.1-m) posts.  A rough stone masonry guardwall showed acceptable performance when tested and evaluated in accordance with NCHRP Report 230, following a modification consisting of raising the concrete core.  An artificial stone median barrier made of precast concrete showed acceptable performance when tested and evaluated in accordance with NCHRP Report 230. The excellent appearance of this artificial stone barrier makes it a very acceptable replacement for natural stone barriers. The use of this barrier could result in a great s

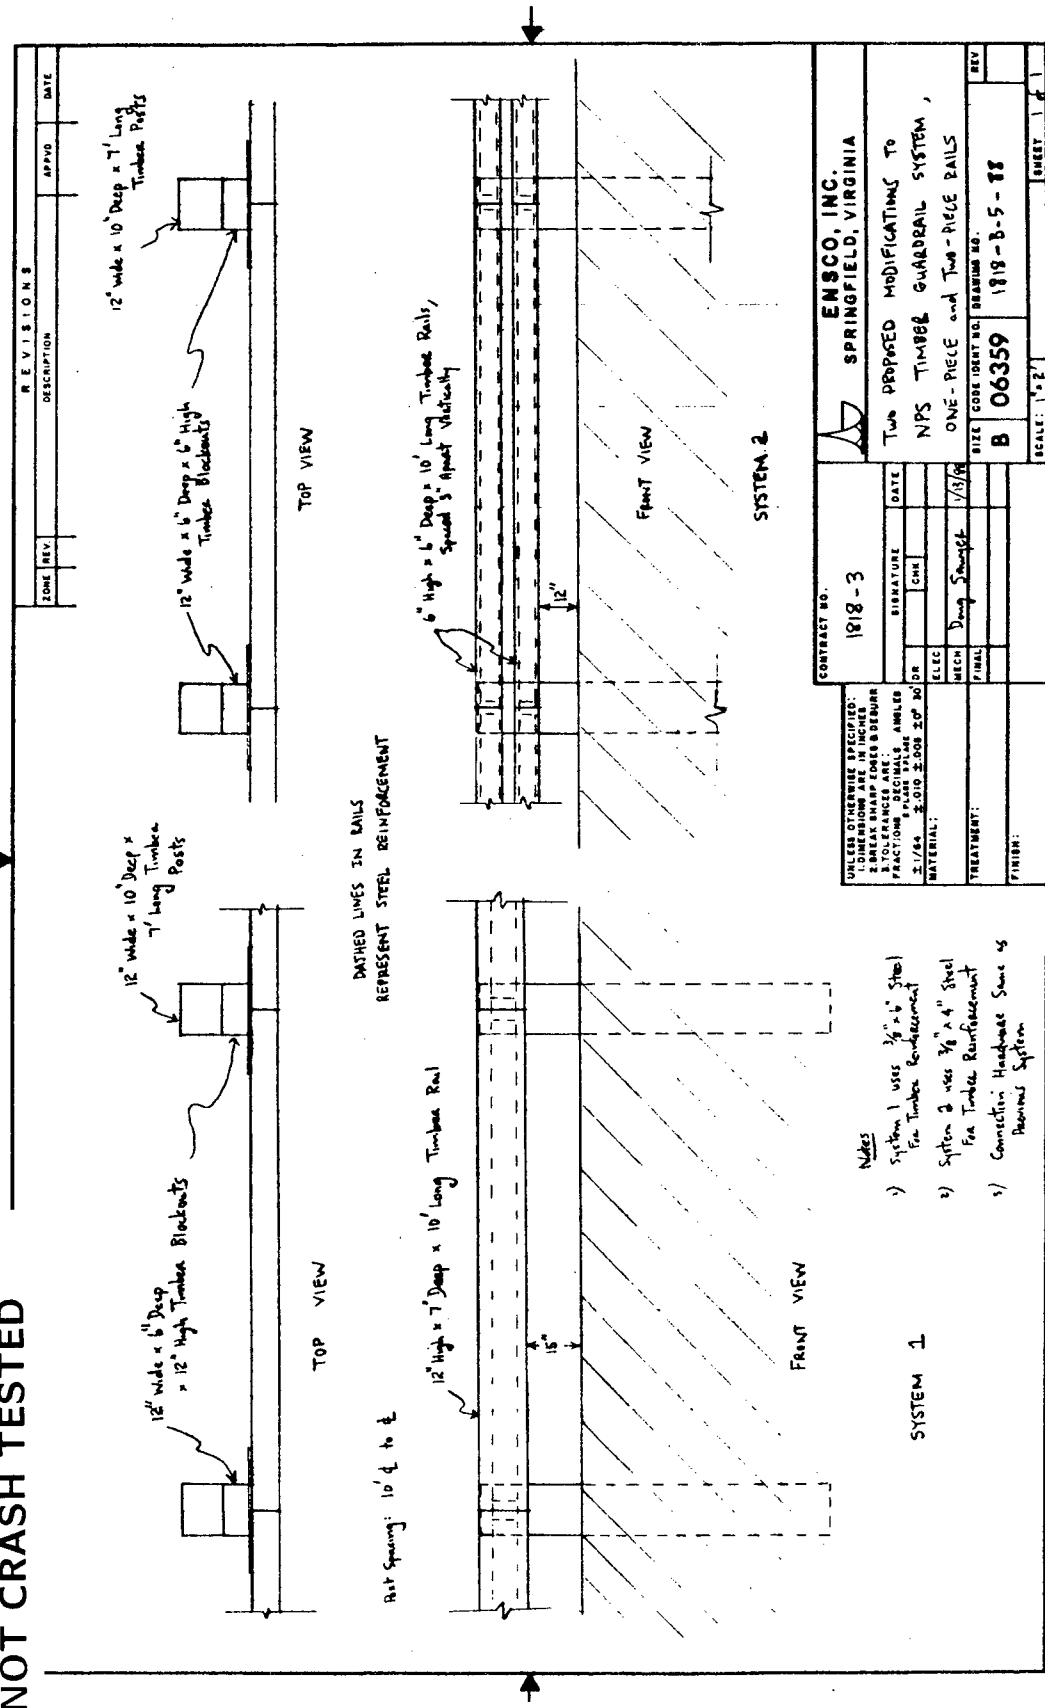
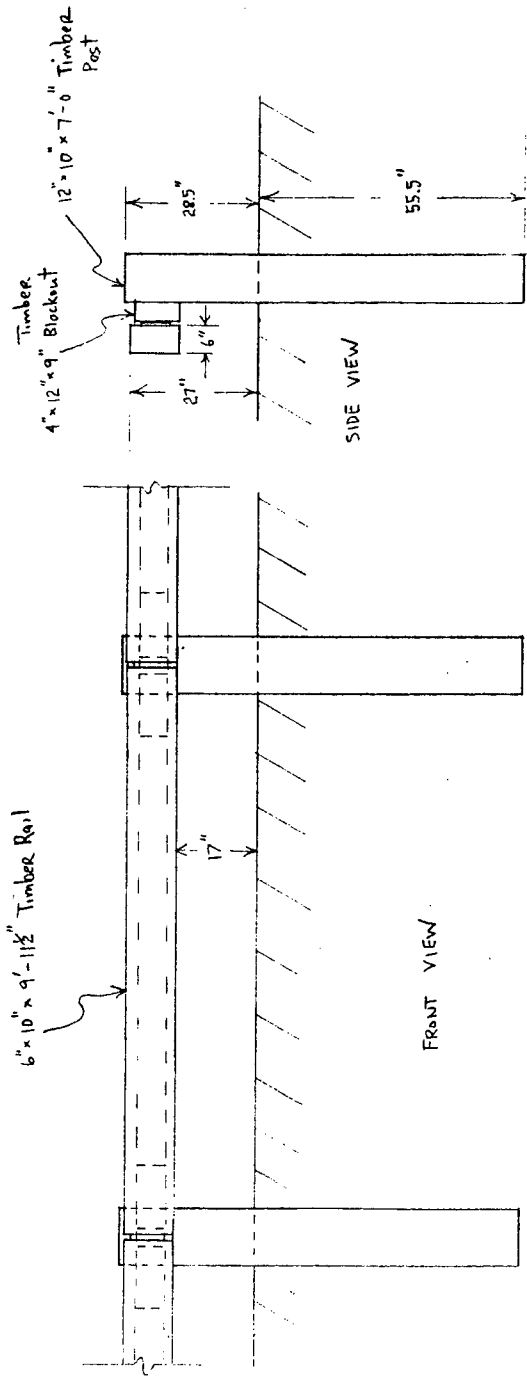
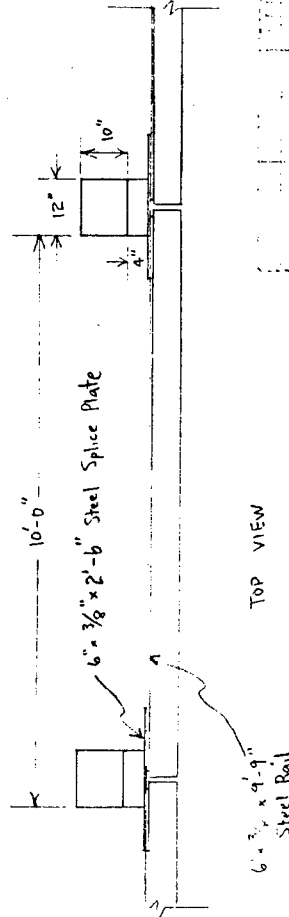
Figure 4. Improved wooden guardrail designs.

Two recommendations are made to alleviate these flaws. First, the rail should be thickened from 6 in (0.15 m) to 7 in (0.18 m). Using  $M_c/I$  calculations where  $I = 1/12 (b)(h)^3$ , the 17 percent increase in rail thickness provides a 36 percent increase in bending resistance for the wood alone. This is a much easier and cheaper approach to stiffening the rail than to decrease the post spacing. A decrease in post spacing increases the installation time and labor cost significantly while thickening the rail by 1 in (0.03 m) has a negligible effect on installation time. This 1 in (0.03 m) generates an additional inch of blocked out space between the rail face and the post, lowering the potential for snag. Furthermore, a 1-in (0.03-m) increase in the rail thickness uses less wood material when compared to decreasing the post spacing from 10 ft (3.0 m) to 8 ft (2.4 m) for a 12-in by 10-in by 7-ft (0.30-m by 0.25-m by 2.1-m) post. From an economical standpoint, money is better spent in enlarging the rails than increasing the number of posts.

The second recommendation is to increase the blackout distance from 4 in (0.10 m) to 6 in (0.15 m). Thus, the total post/blockout distance (including rail thickness) will be increased from 10.75 in (0.27 m) to 13.75 in (0.35 m). This additional 3 in (0.08 m) should help to eliminate snagging and result in cleaner redirection and higher redirection speeds.

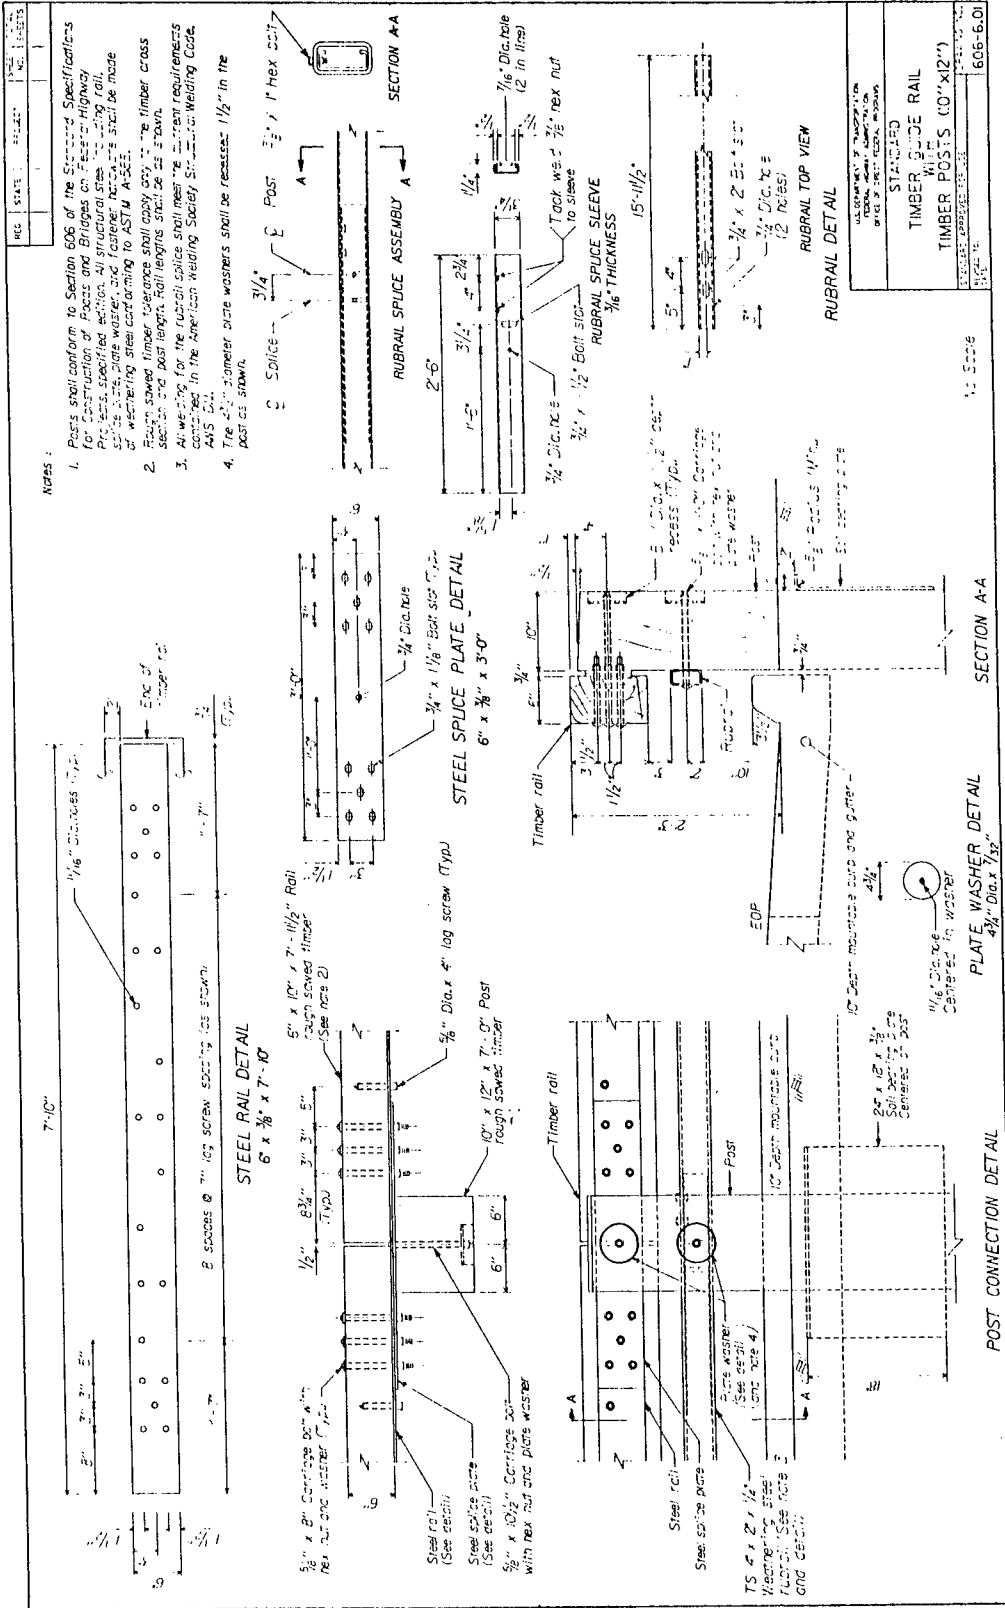
Figure 5. High speed wooden guardrail design.

Another conceptual redesign of the wooden guardrail system, which was proposed by the FHWA, is shown in figure 5. This system was meant to be used for high-speed (60 mi/h (26.8 m/s)) installations. When this system was designed, a modified version of the later successfully tested wooden guardrail system was modified for lower speed installations. The high-speed design included many improvements to the strength of the standard system.

An 18-in high by 24-in wide by 0.375-in (0.46-m by 0.61-m by 0.010-m) thick soil plate with an additional 2-in (0.05-m) long by 90 degree bend at the top is located behind the post, 2 in (0.05 m) below grade. In these discussions of the development of traffic barriers for park roads and parkways, it should be kept

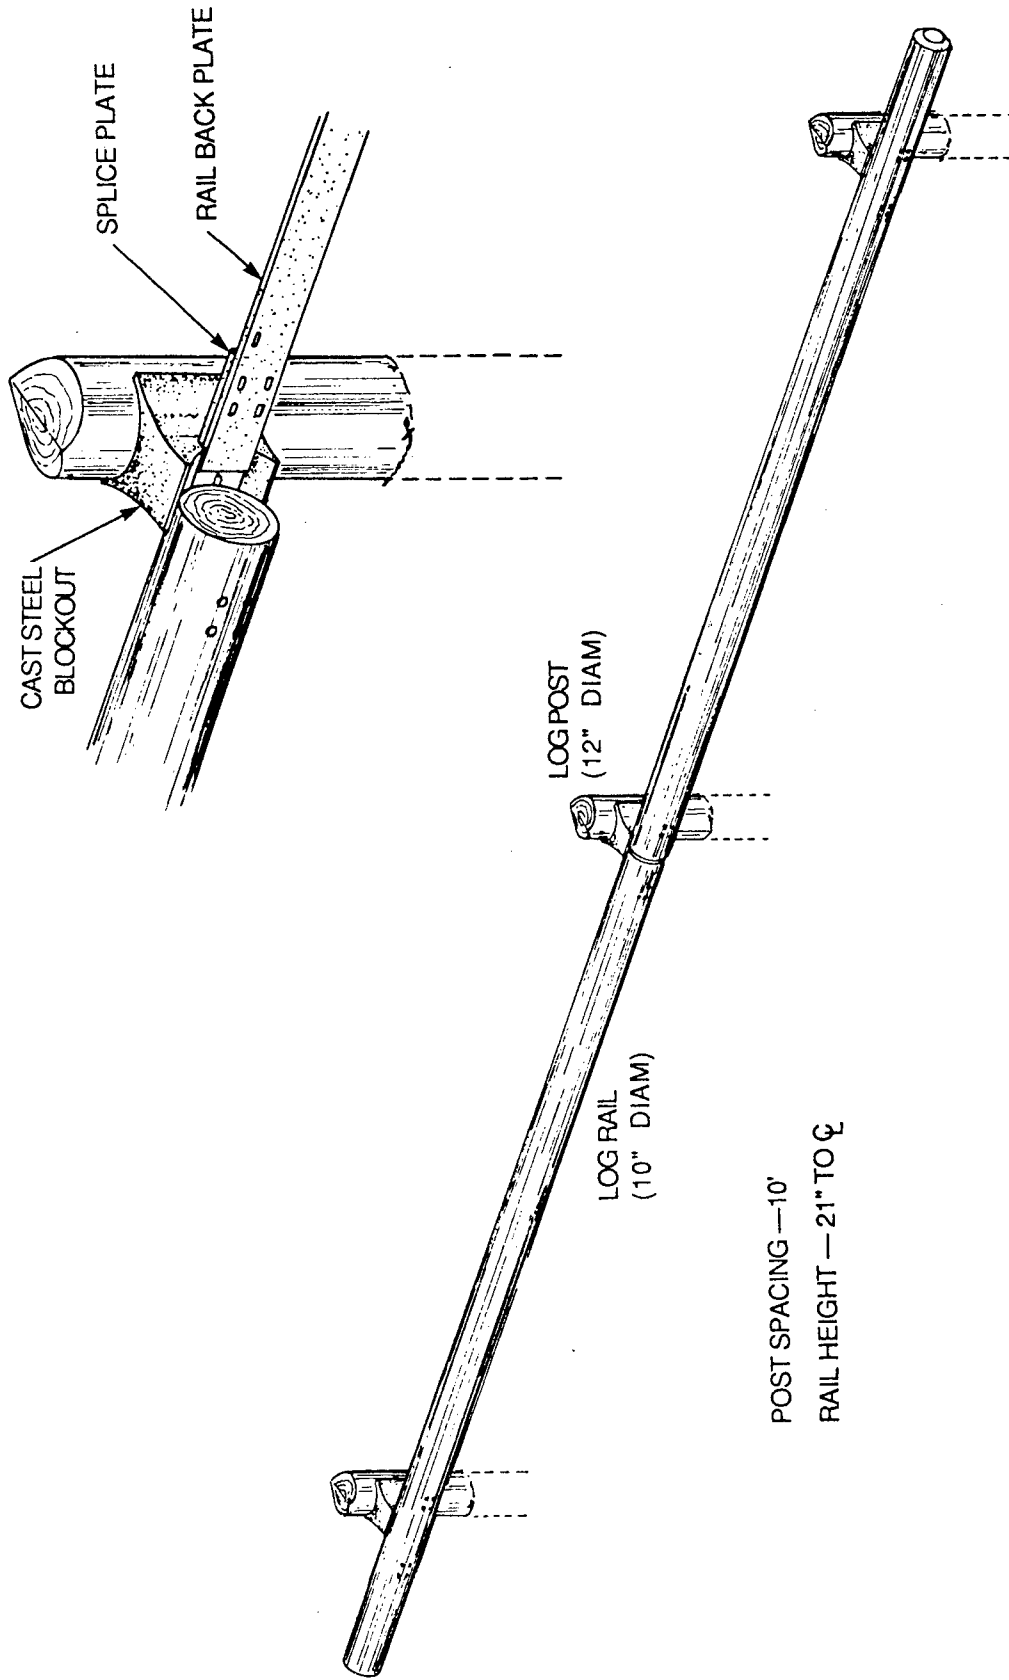
Figure 8. Curved edge blockout design.

The log guardrail system shown in figure 8 is considered structurally adequate. However, this system has the same limitations as the timber system discussed previously. The splice plate/rail connections should be improved to reduce the inherent slack in the system. Furthermore, the contact surface of the log rail presents problems unless it is adequately blocked-out. The round log shape will promote either vaulting or nosing of impacting vehicles. In the case of nosing vehicles, which is more likely, snagging becomes a problem. Therefore, an adequate blockout is required. Two tapered cast steel blockouts were designed and submitted for review to the FHWA. One blockout had straight tapered edges while the second blockout had curved tapered edges. Figure 8 is a drawing of the curved edge blockout. The FHWA plans to crash test this log guardrail under a future contract.

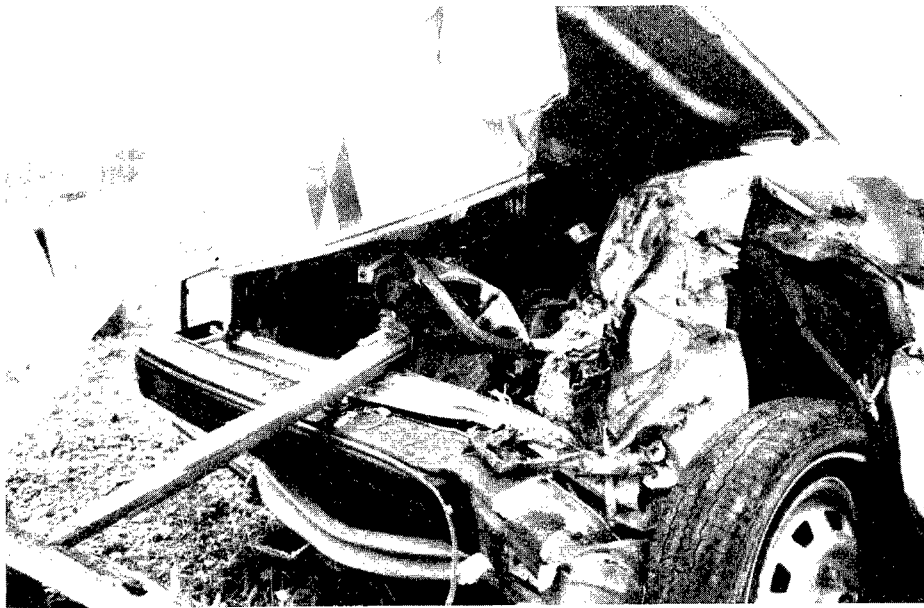
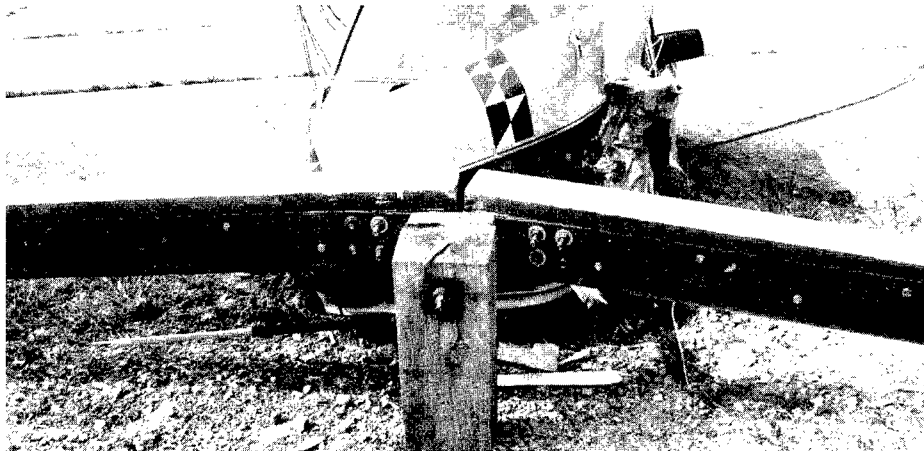
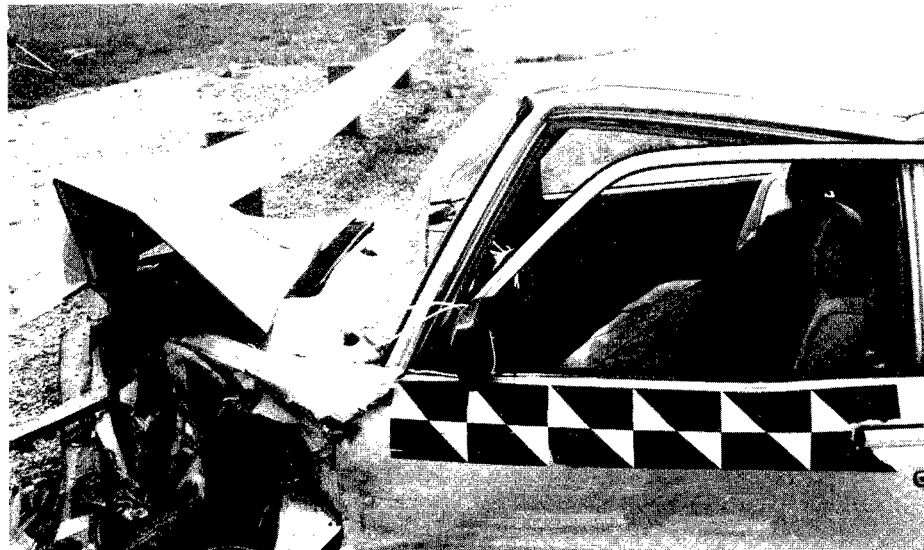
Figure 17. Posttest photographs of test vehicle, test 1818-5-1-87.

Damage occurred mainly to the left front fender, grill and bumper. The driver side door was wedged outward and the windshield and driver side window glass were shattered. Posttest photographs of the vehicle are shown in figure 17.

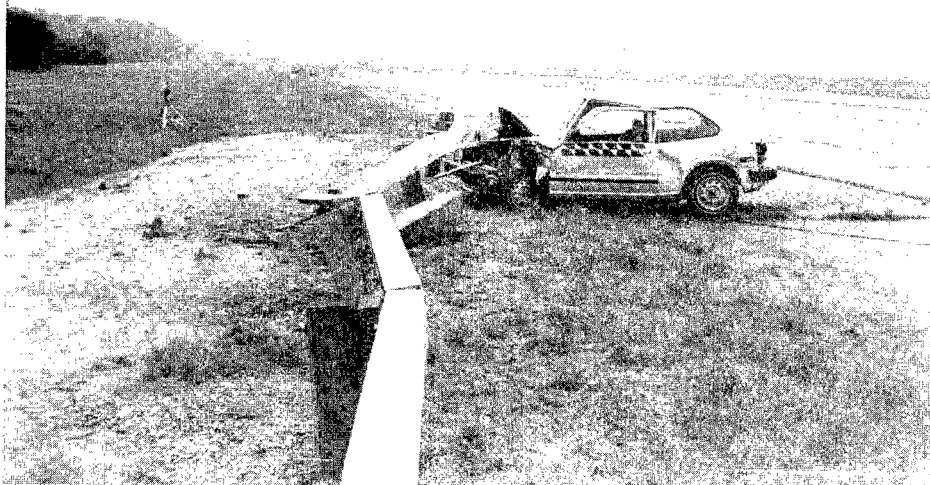
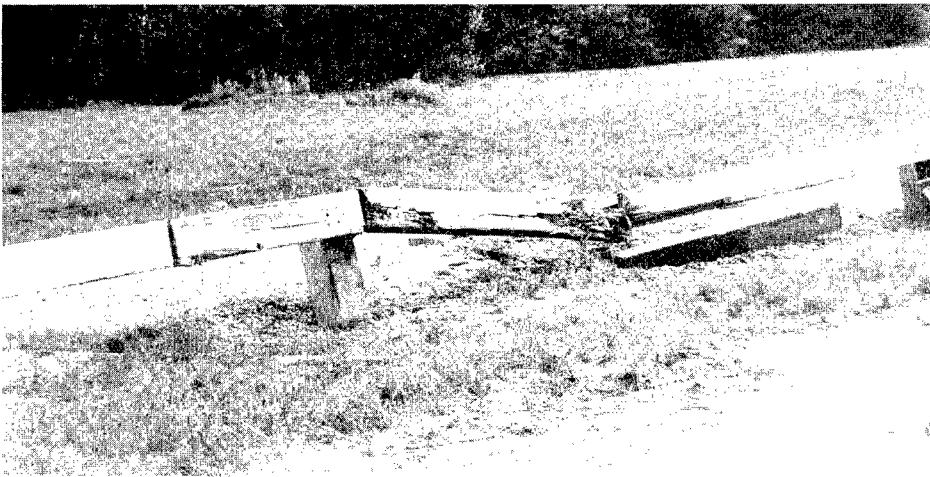
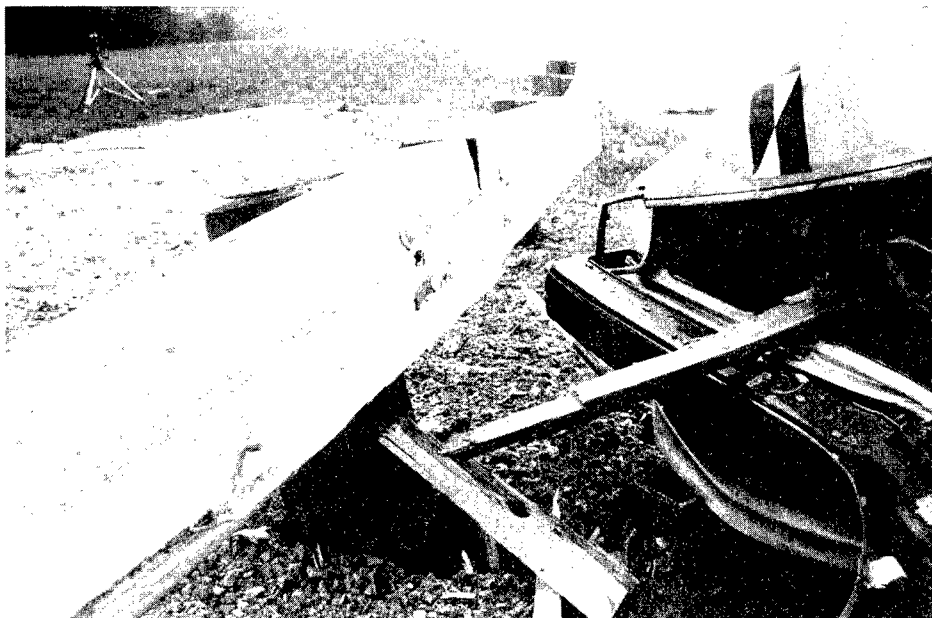
Figure 18. Posttest photographs of guardrail system, test 1818-5-1-87.

Due to the severe impact that occurred at post 6, the splice plate and all connection hardware were bent or sheared. The fifth rail and the sixth post and blockout were severely damaged. Posttest photographs of the guardrail are shown in figure 18.

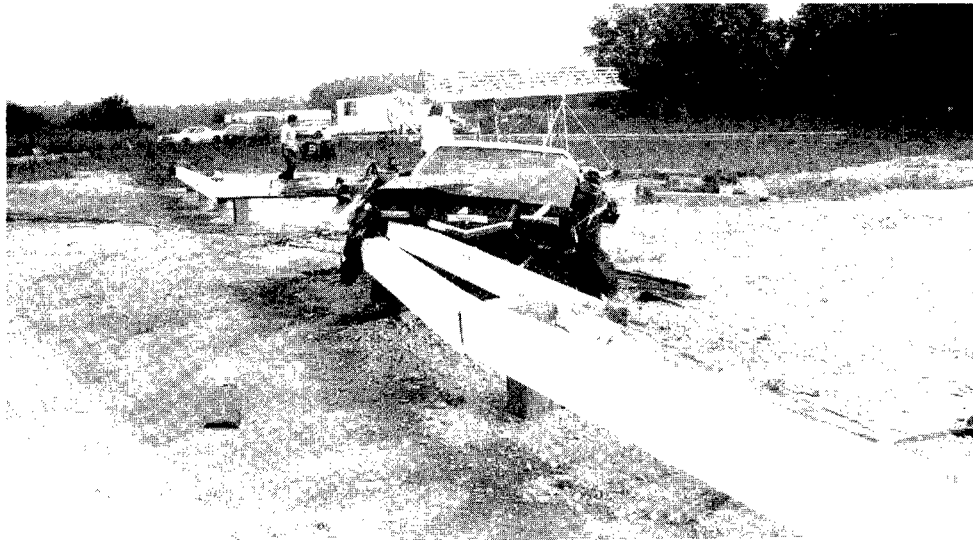
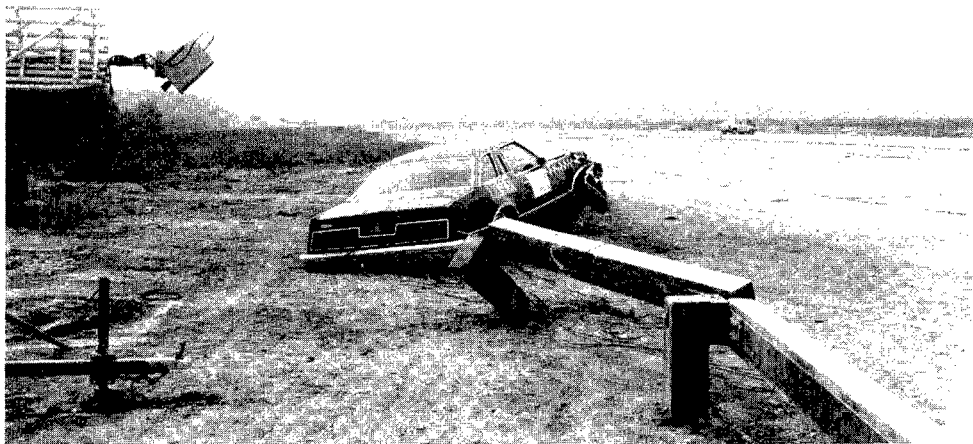
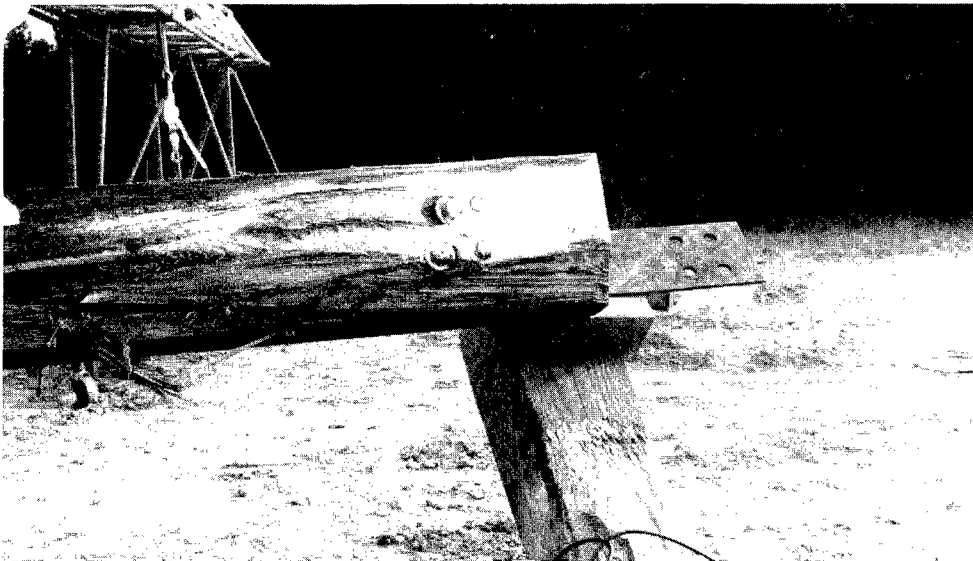
Figure 26. Posttest photographs of guardrail system, test 1818-5-2-87.

Due to the failure of the posts and the connection hardware at post 5, a significant amount of damage occurred. Posts 5, 6 and

7 were broken at or below ground level. Post 6 was cracked open at the top where the rail attachment bolt pulled out. The four 8.5-in (0.22-m) long carriage bolts were sheared off at the upstream end of rail 4. Three splice plates were bent significantly. Posttest photographs of the guardrail are shown in figure 26.

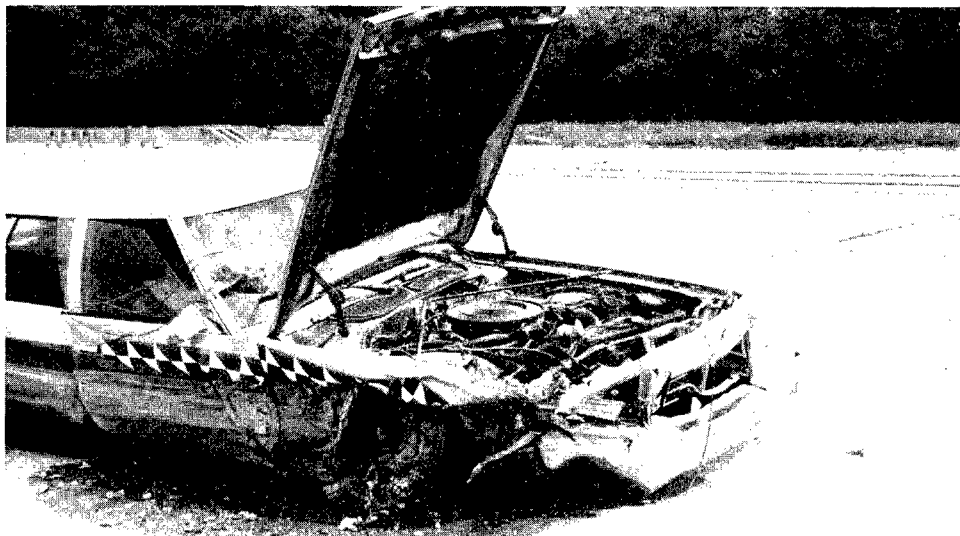
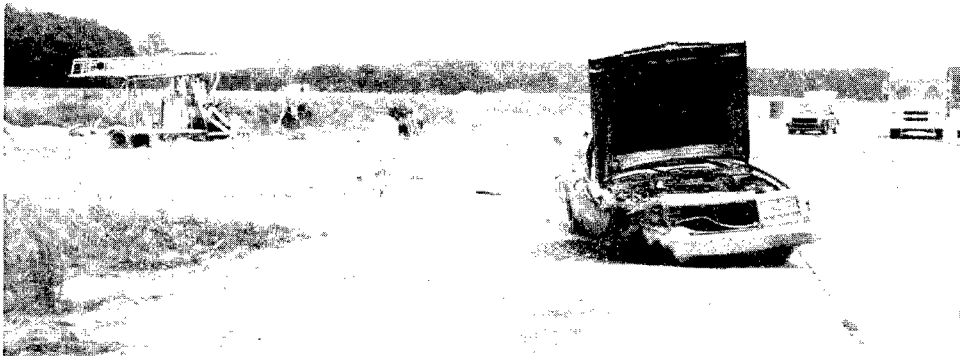
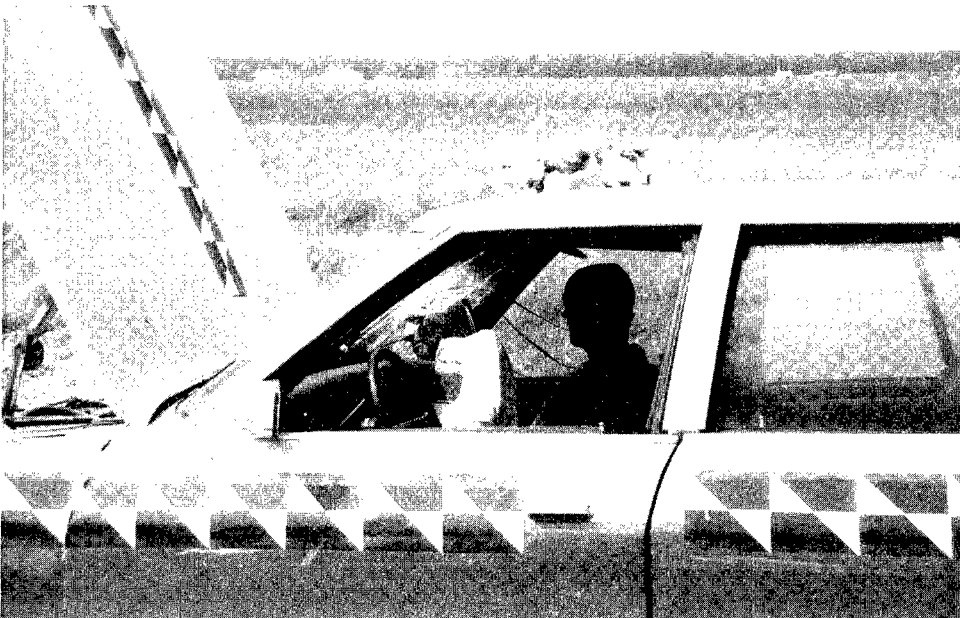
Figure 48. Posttest photographs of test vehicle, test 1818-5-88.

Vehicle damage occurred mainly to the right side of the car. The right front fender, grill, bumper, rear quarterpanel, and vehicle steering suspension were damaged significantly. The passenger side door was wedged outward and the windshield was shattered on the passenger side due to the impact from the dummy. Posttest photographs of the vehicle are shown in figure 48.

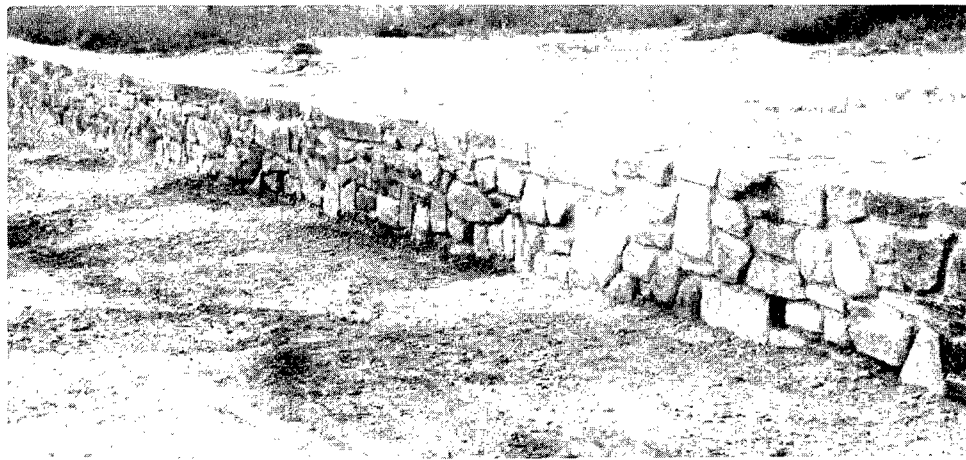
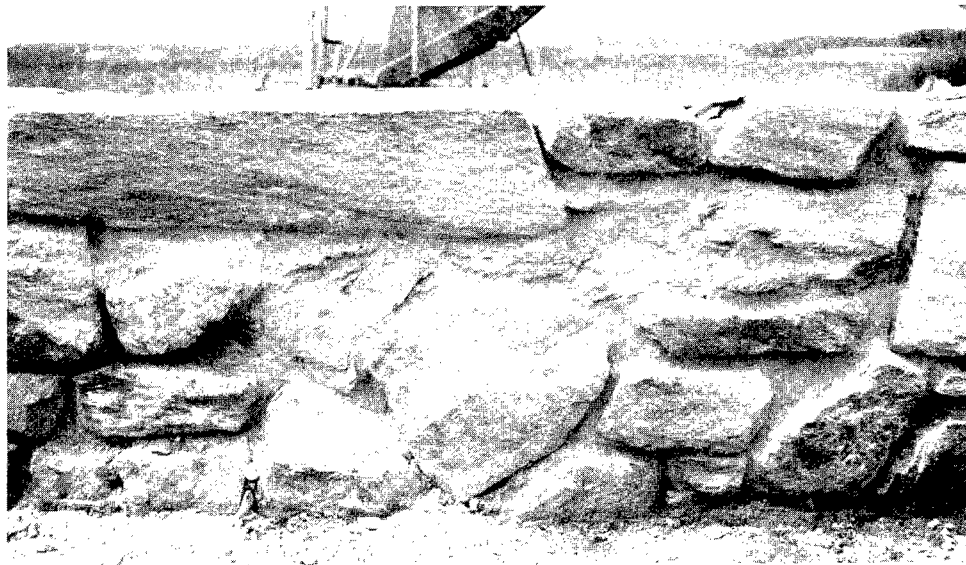
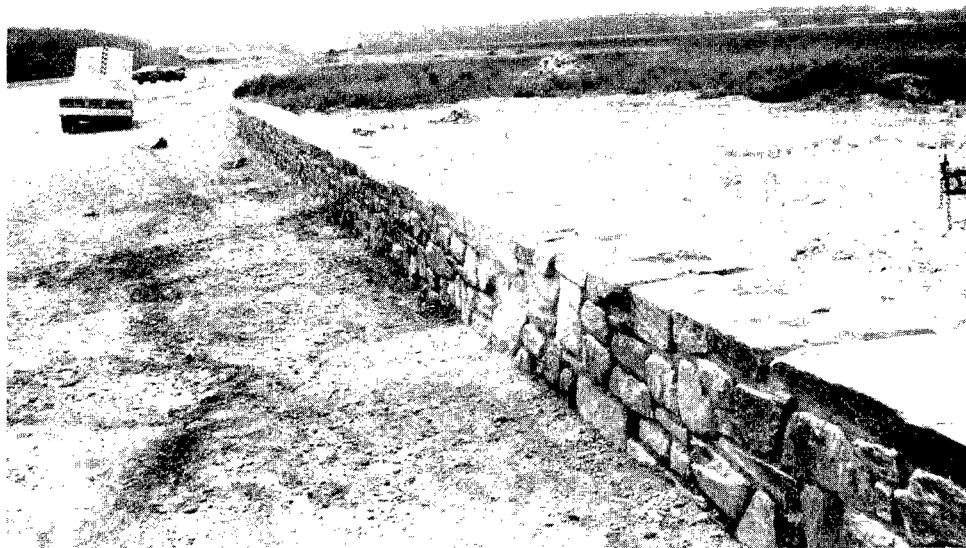
Figure 49. Posttest photographs of guardwall system, test 1818-5-88.

This rough stone guardwall performed as designed. No structural damage was evident. One 1-ft (0.30-m) long hairline crack was detected on the front face, downstream of impact. Two stones had front faces cleaved off, probably by the rear bumper as the vehicle was redirected. Posttest photographs of the guardwall are shown in figure 49.

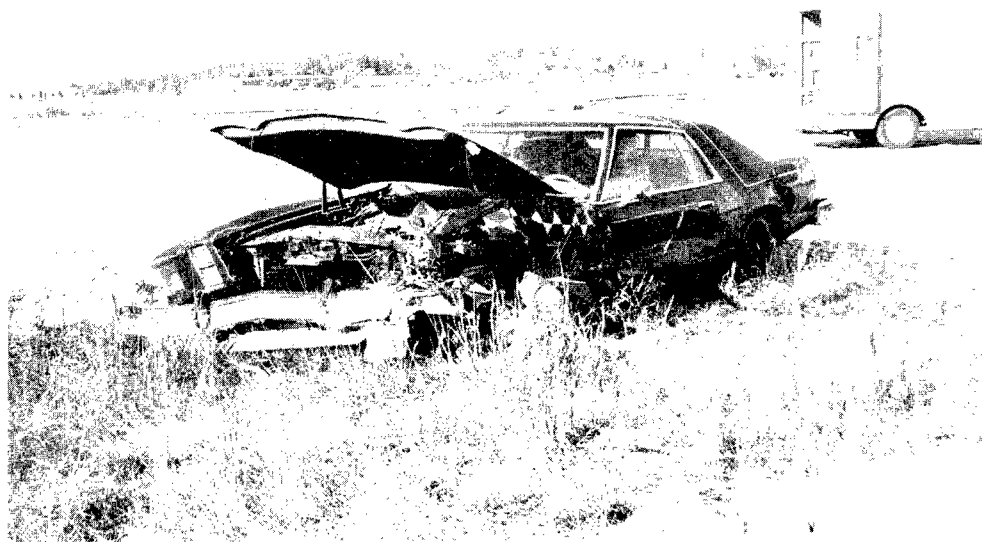
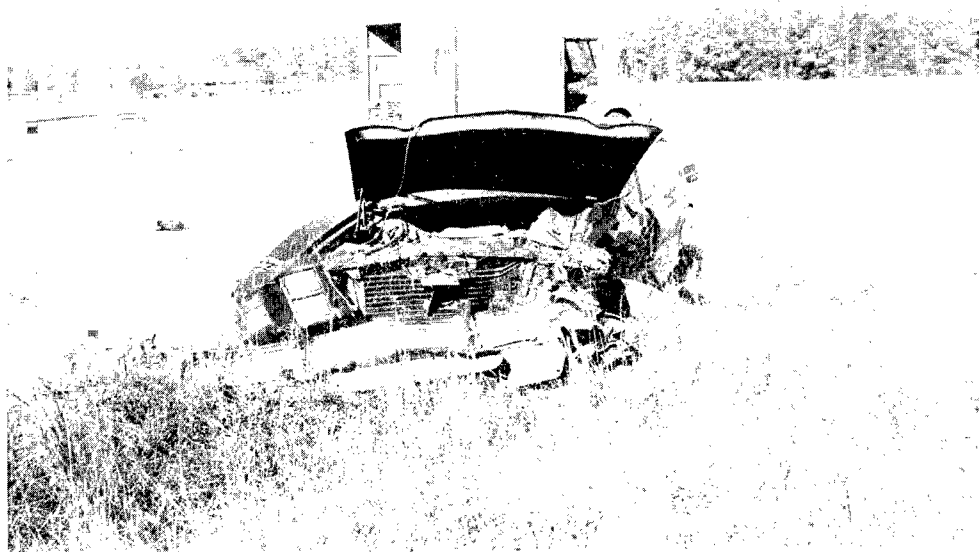
Figure 56. Posttest photographs of test vehicle,  
test 1818-5-6-87.

Vehicle damage occurred mainly to the left front fender, grill bumper, and suspension/steering. The front left wheel was damaged from post snagging causing the tire to deflate. The driver side door was wedged outward. The windshield and the drivers side window glass were shattered. Posttest photographs of the vehicle are shown in figure 56.

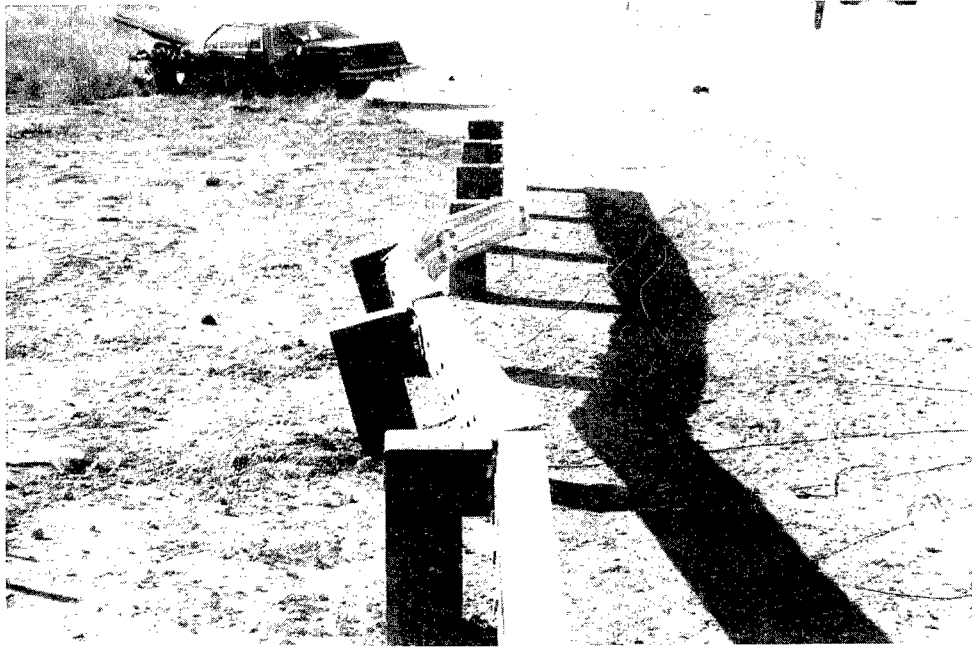
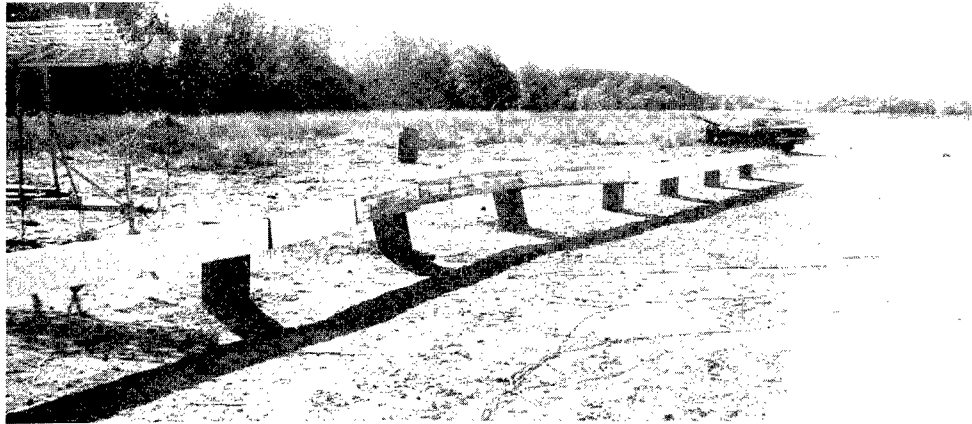
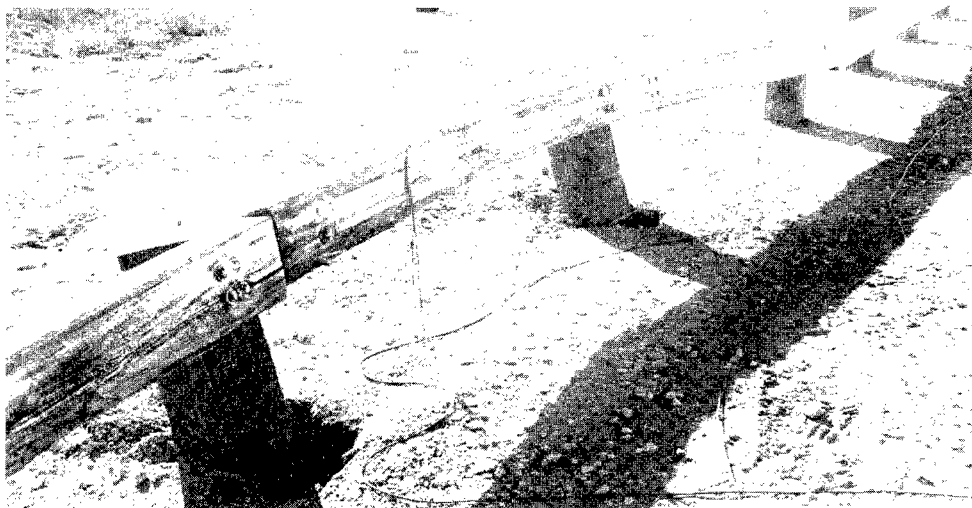
Figure 57. Posttest photographs of guardrail system, test 1818-5-6-87.

Damage to the guardrail system was minimal. The 6 in by 10 in (0.15 m by 0.25 m) timber part of the fifth rail snapped due to pocketing of the vehicle. There was a 16 in (0.41 m) long crack at the trailing end of rail 4. This crack was mostly cosmetic. A 0.5-in (0.013-m) strip of wood was torn off the front corner of post 6. The blockout of post 6 was cracked throughout its entire length. Posttest photographs of the guardrail are shown in figure 57.

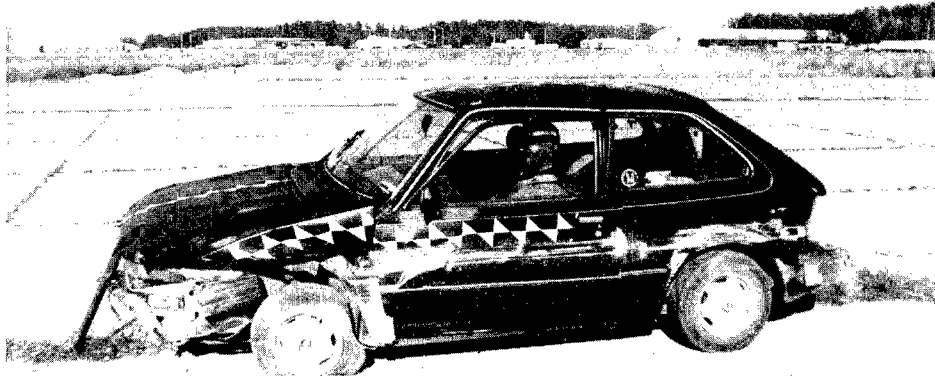
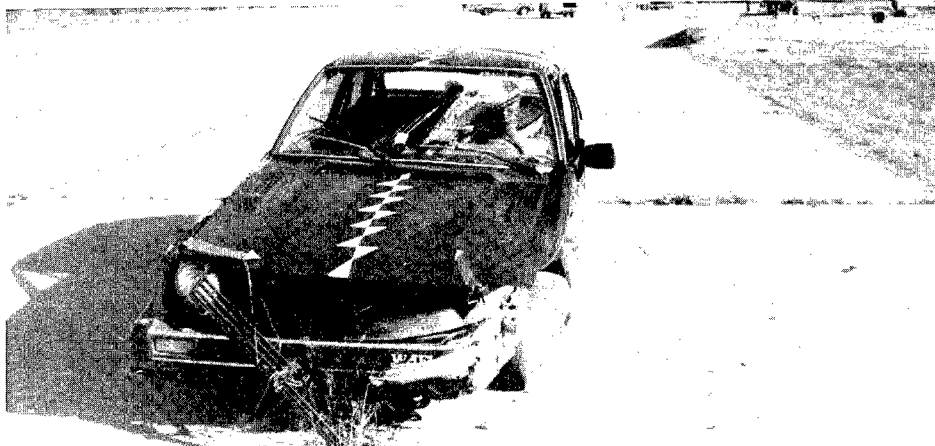
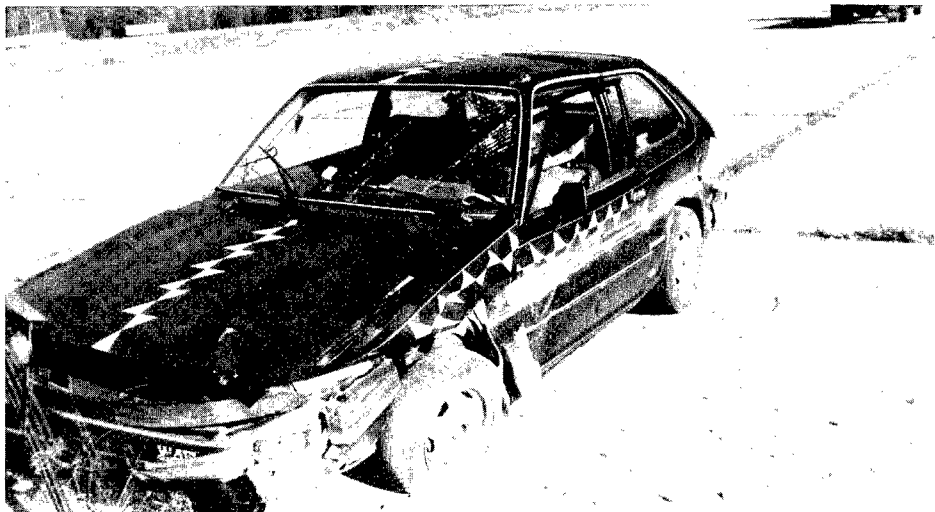
Figure 64. Posttest photographs of test vehicle, test 1818-7-88.

Vehicle damage occurred mainly to the left side and front of the car. The left front fender, grill, bumper, drivers door, vehicle steering suspension were damaged significantly. Posttest photographs of the vehicle are shown in figure 64.

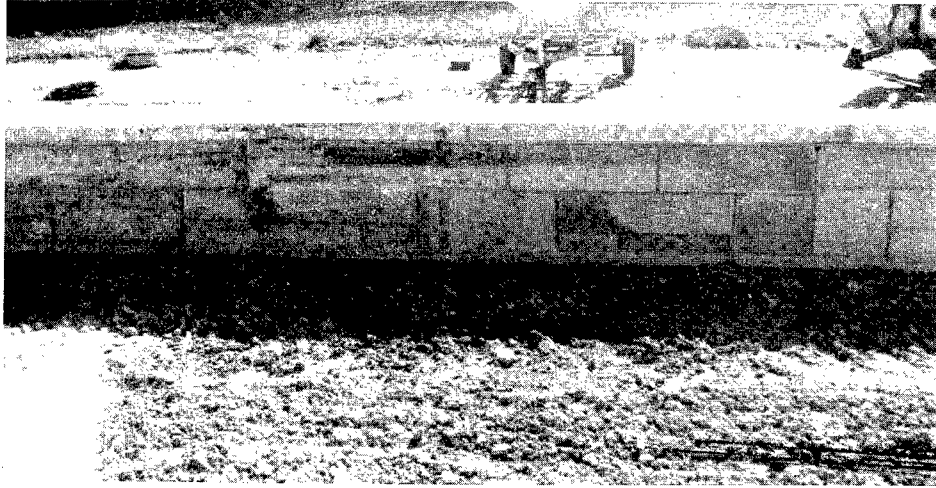
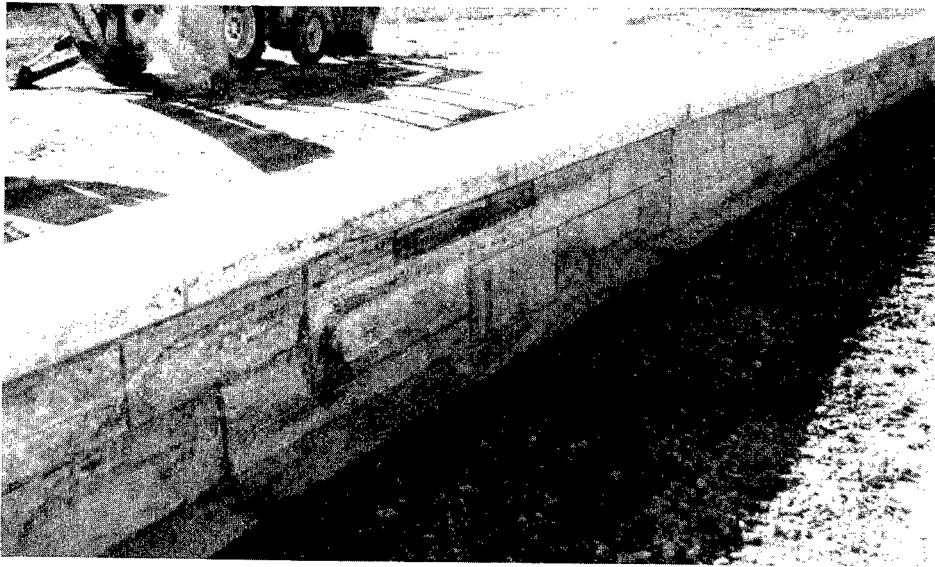
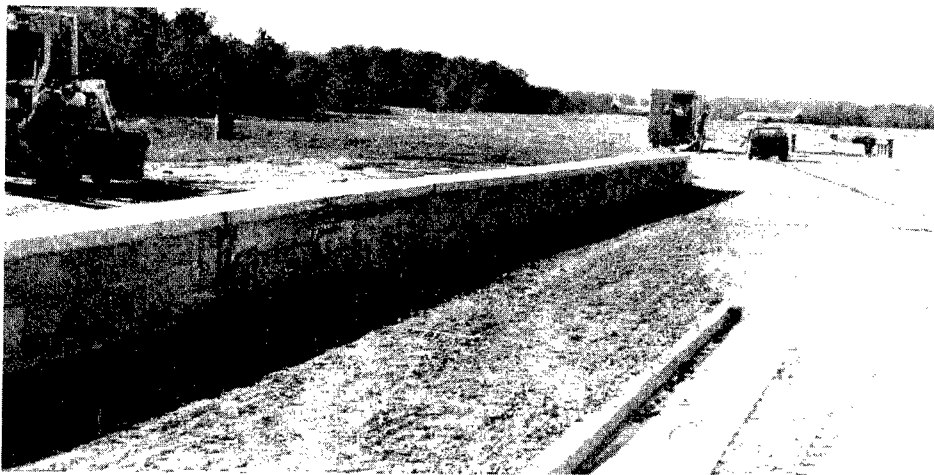
Figure 65. Posttest photographs of median barrier system, test 1818-7-88.

This barrier performed well. The vehicle was redirected. Some light marring of the concrete occurred at the impact point. The barrier showed no permanent deformation. Posttest photographs of the median barrier are shown in figure 65.

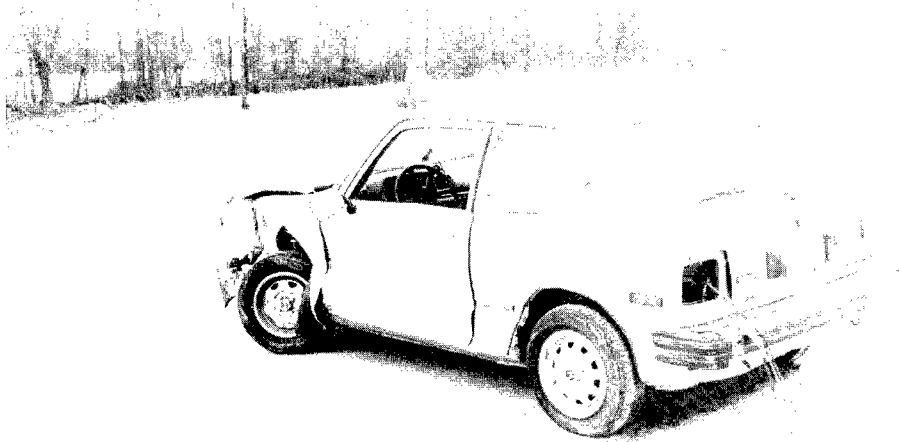
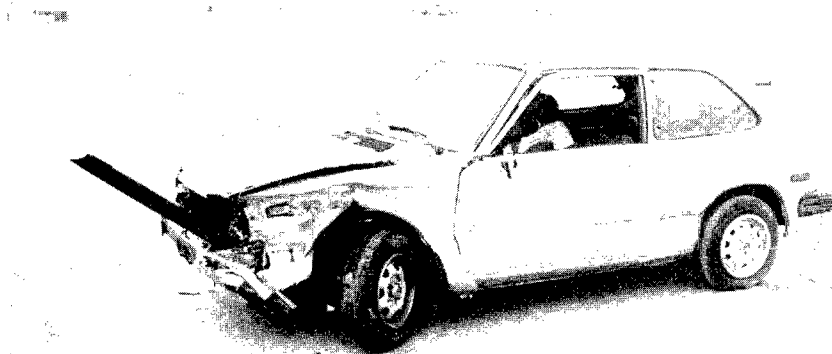
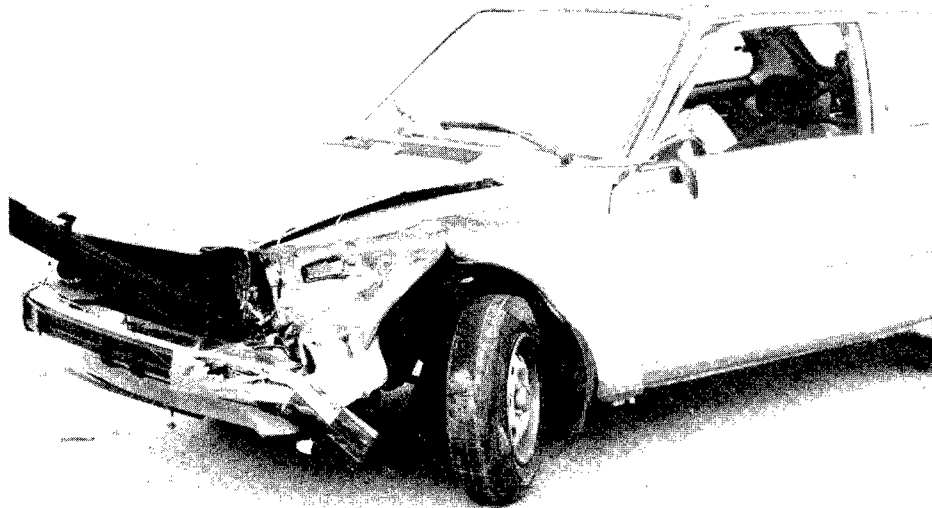
Figure 72. Posttest photographs of test vehicle,  
test 1818-8-88.

Vehicle damage occurred mainly to the left side of the car. The left front fender, grill, bumper, and drivers door were damaged significantly. Posttest photographs of the vehicle are shown in figure 72.

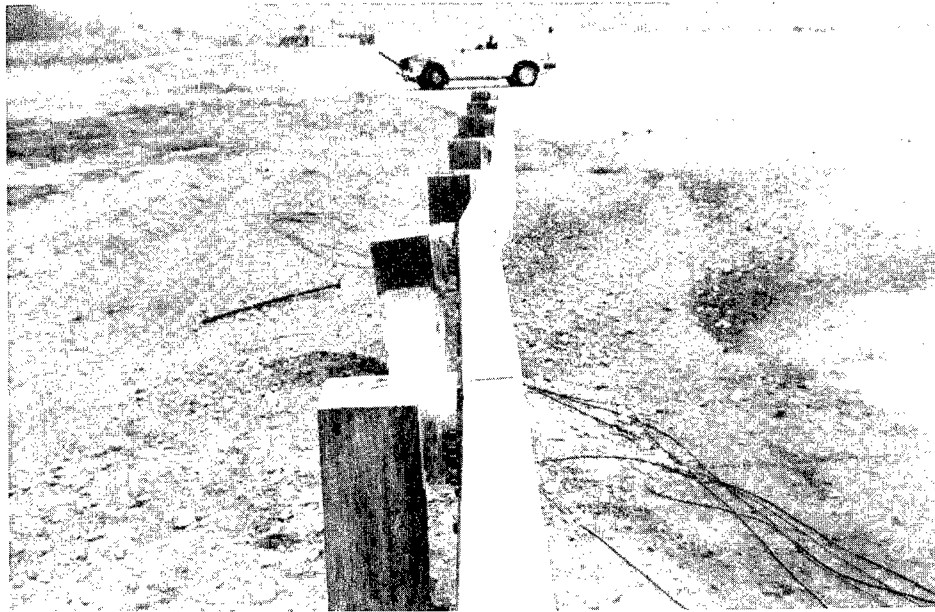
Figure 73. Posttest photographs of guardrail system, test 1818-8-88.

This guardrail performed well. The vehicle was redirected. There was tire scrub on the front of post 5 and the front and side of post 6. Post 6 was impacted by the vehicle front wheel. The bottom of the rail showed tire scrub for 18 ft (5.5 m) (from 2 ft (0.61 m) past impact to midspan of rail 6). The rail at post 5 was pushed back approximately 8 in (0.20 m) dynamically and 5 in (0.13 m) statically and was pushed up approximately 5 in (0.13 m) dynamically and 2.5 in (0.06 m) statically. A portion of the push back and lift were actually rail and splice twist. Posttest photographs of the guardrail are shown in figure 73.
