# **Guardrail Testing Program**

## **Final Report**

**Publication No. FHWA-RD/FLP-90-087**  
**May 1990**

14. Sponsoring Agency Code	
15. Supplementary Notes FHWA Contract Manager: C. McDevitt (HSR-20)					
16. Abstract A series of crash tests were conducted to evaluate aesthetic guardrails, guardwalls, median barriers and bridge rails that have been designed for use on park roads, parkways and other Federal Lands roads.  Following two iterations of redesign, a steel-backed wooden guardrail showed acceptable performance when tested and evaluated in accordance with NCHRP Report 230. The successful system feature 10-in by 12-in by 7-ft (0.25-m by 0.30-m by 2.1-m) posts.  A rough stone masonry guardwall showed acceptable performance when tested and evaluated in accordance with NCHRP Report 230, following a modification consisting of raising the concrete core.  An artificial stone median barrier made of precast concrete showed acceptable performance when tested and evaluated in accordance with NCHRP Report 230. The excellent appearance of this artificial stone barrier makes it a very acceptable replacement for natural stone barriers. The use of this barrier could result in a great s

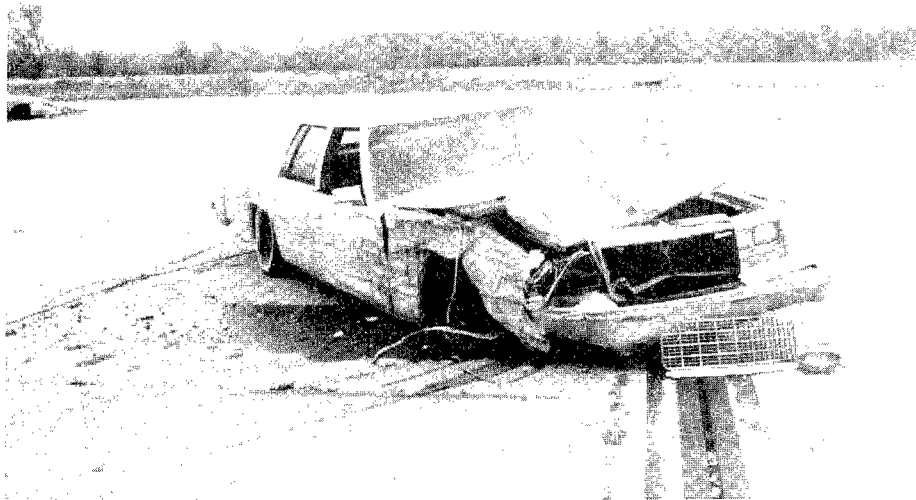
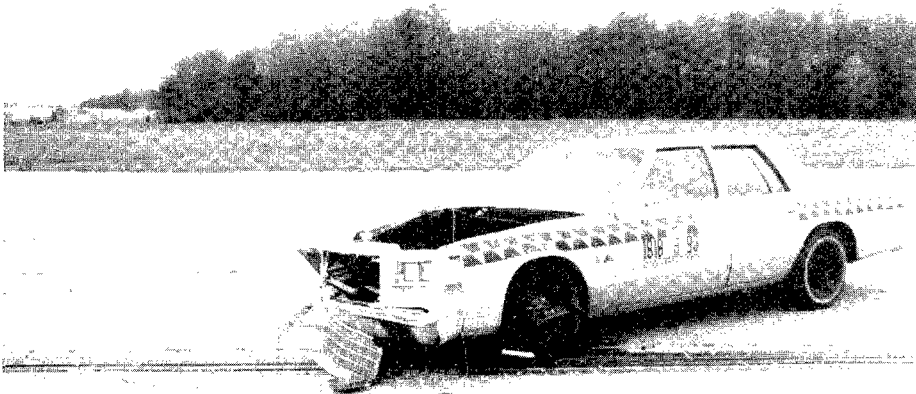
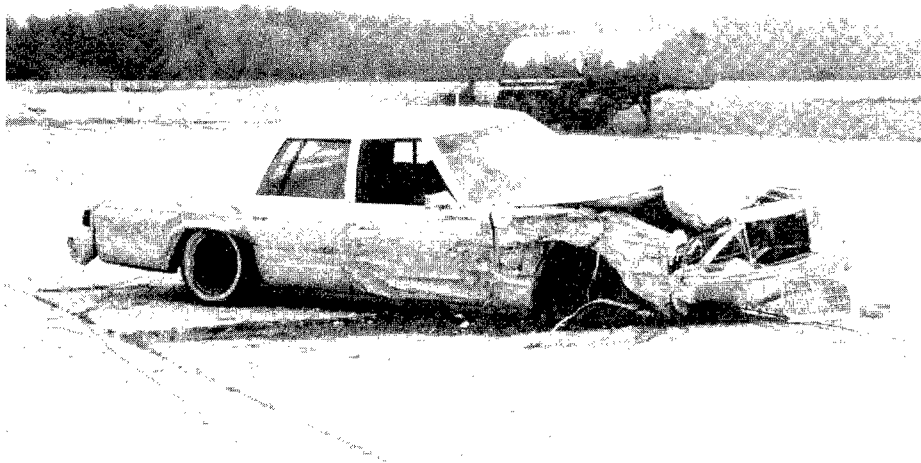
Figure 80. Posttest photographs of test vehicle,  
test 1818-9-90.

Damage occurred to the grill, front bumper, hood and entire right side of the vehicle. The passenger side door was pushed out due to the impact of the passenger dummy. Posttest photographs of the vehicle are shown in figure 80.

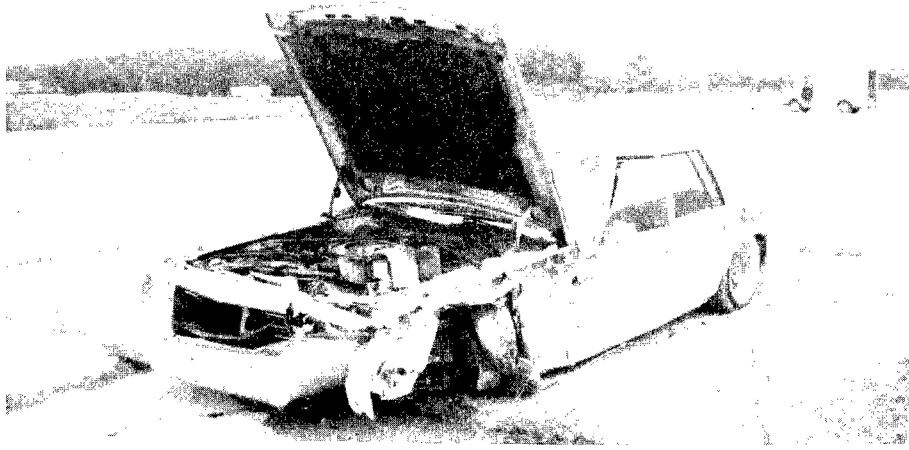
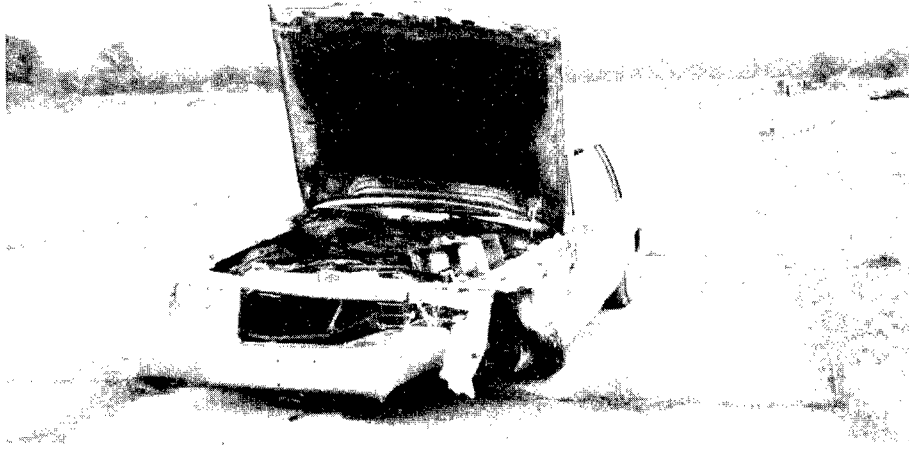
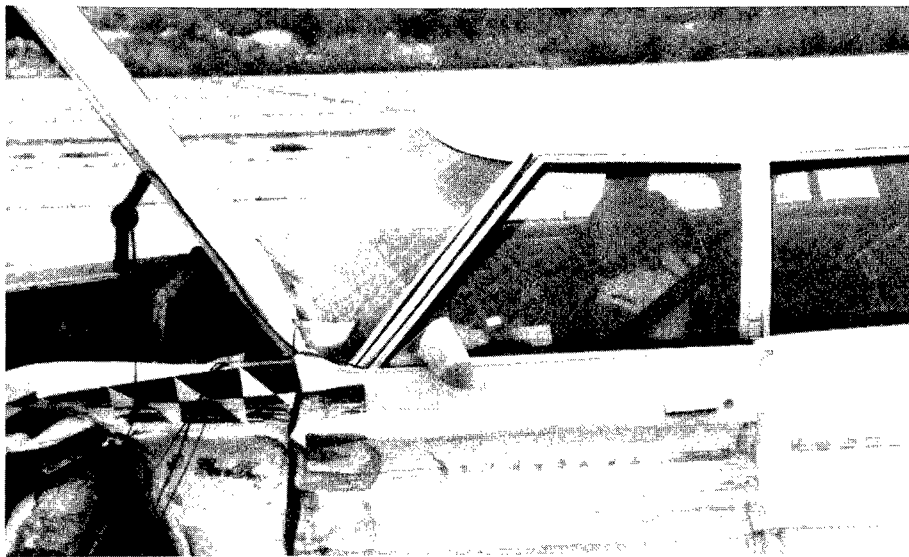
Figure 88. Posttest photographs of test vehicle,  
test 1818-12-88.

Vehicle damage occurred mainly to the left side and front of the car. The left front fender, grill, bumper, drivers door, vehicle steering suspension were damaged significantly. Posttest photographs of the vehicle are shown in figure 88.

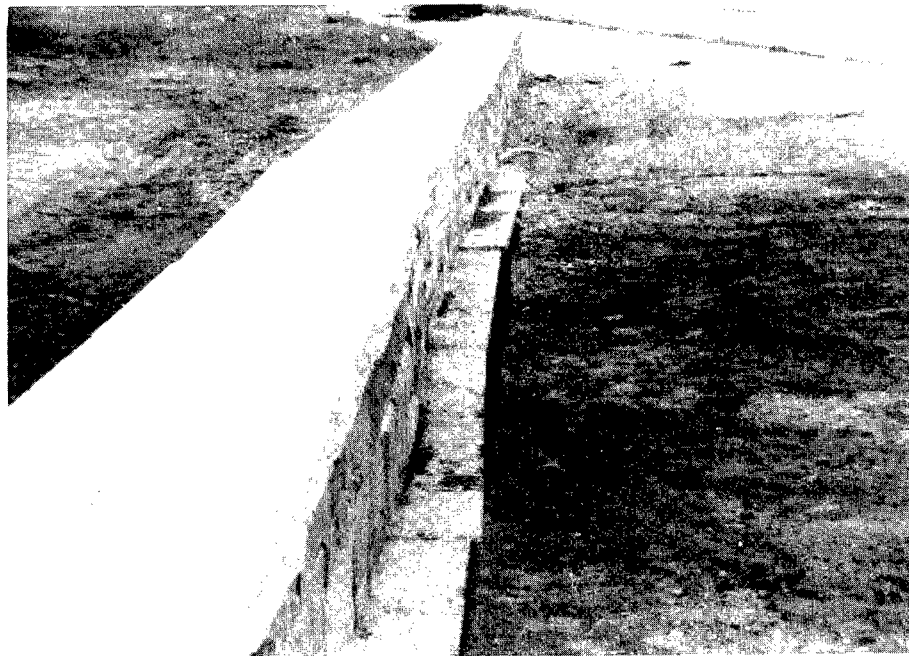
Figure 89. Posttest photographs of median barrier system, test 1818-12-88.

This barrier performed well. The vehicle was redirected. During the impact, the impact section and the next section downstream

rotated back out of the line of the barrier approximately 3 in (0.08 m). Statically, the sections were also pushed back slightly. The maximum push back occurred at the section joint downstream of impact and was measured to be 3 in (0.08 m). Posttest photographs of the median barrier are shown in figure 89.

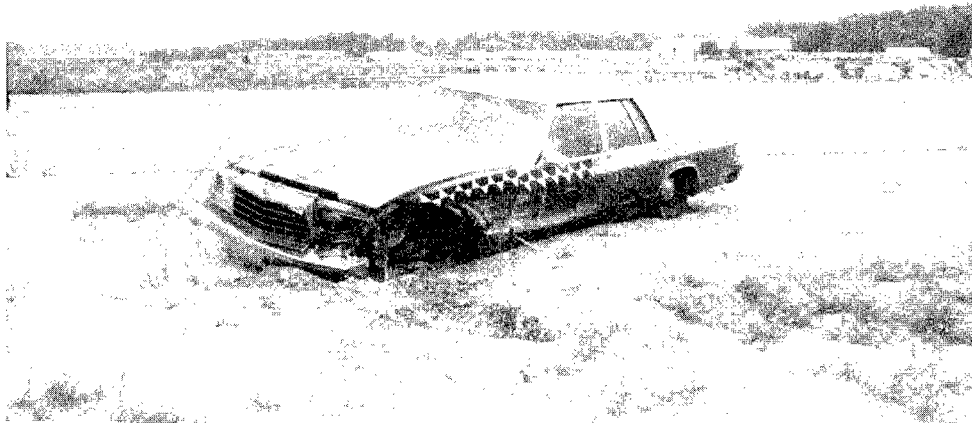
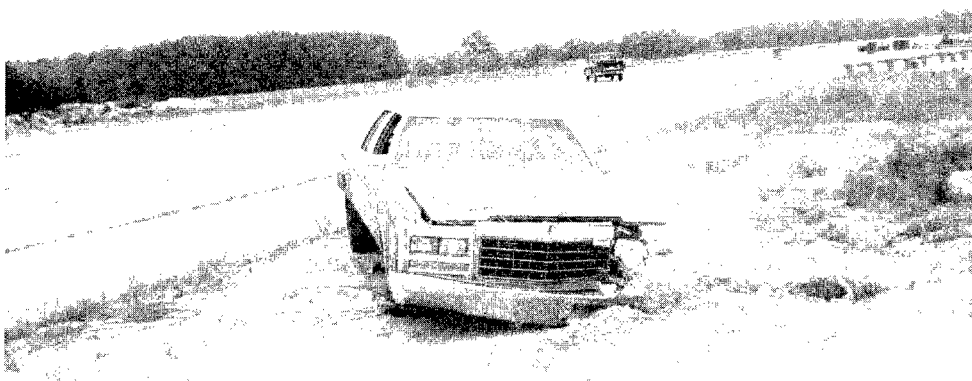
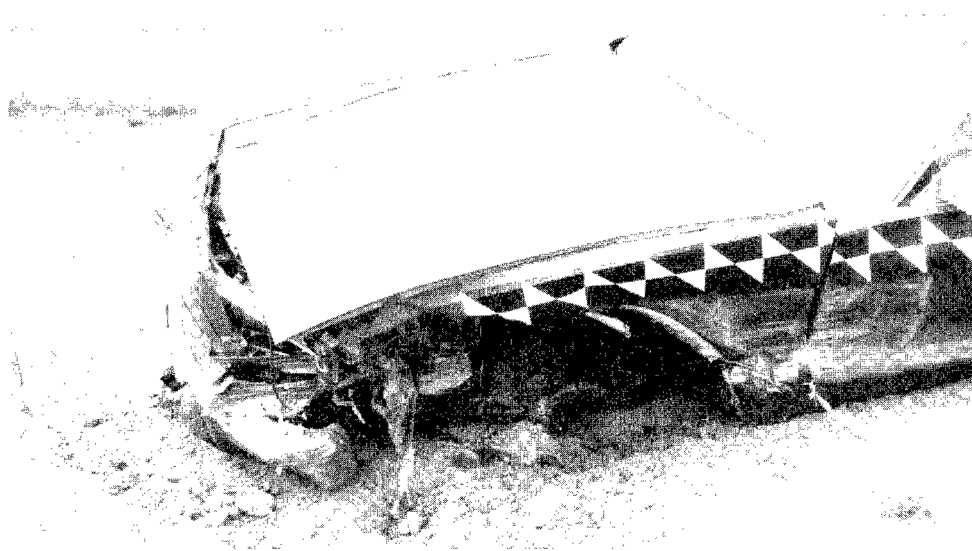
Figure 96. Posttest photographs of test vehicle, test 1818-14-88.

Vehicle damage occurred mainly to the left side and front of the car. The left front fender, grill, bumper, drivers door, and vehicle steering suspension were damaged significantly. The left front wheel was turn off in the impact with post number 5. No vehicle glass was broken during the impact. Posttest photographs of the vehicle are shown in figure 96.

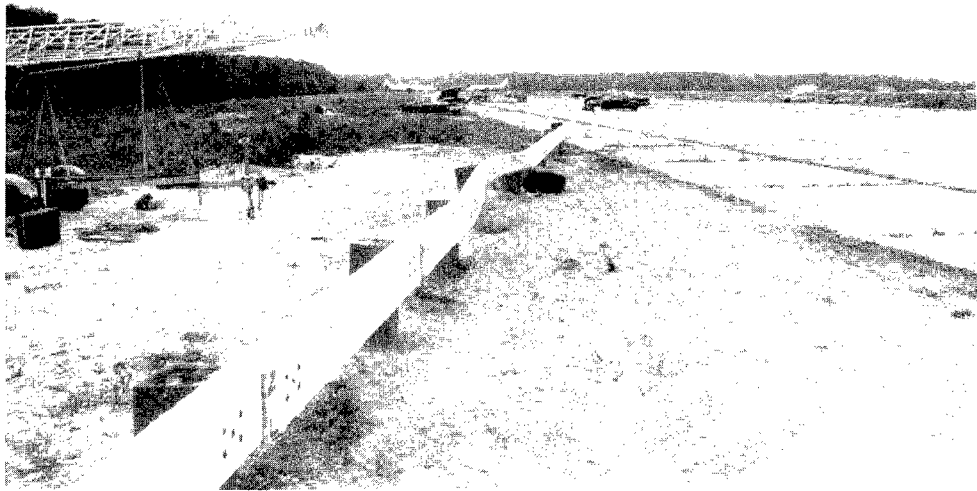
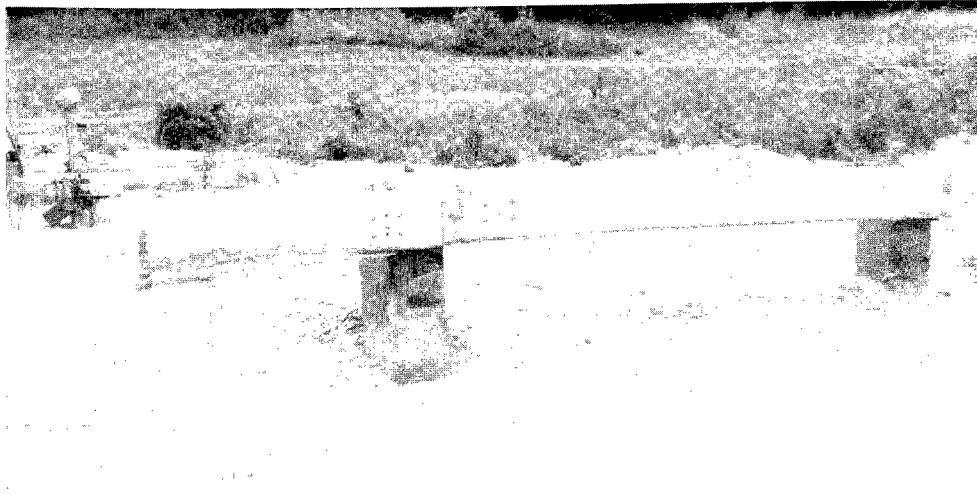
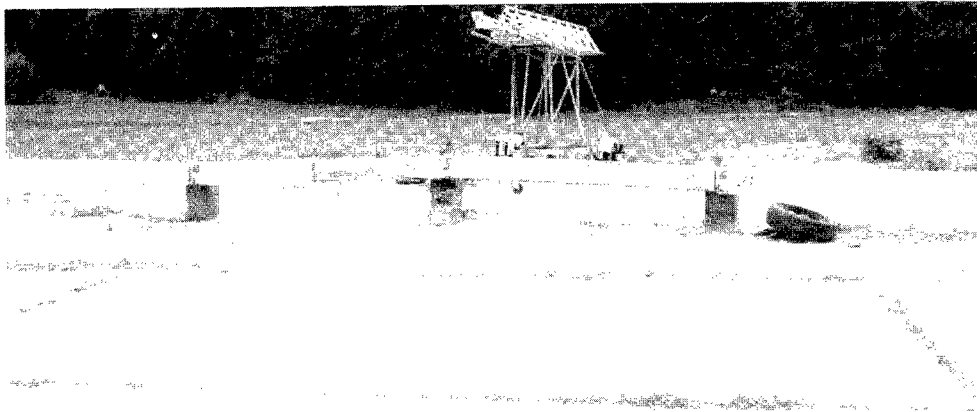
Figure 97. Posttest photographs of guardrail system, test 1818-14-88.

This guardrail performed adequately. The vehicle getting under the rail caused the rail to rise. The left front wheel of the vehicle was torn from the car in the impact with post 5. Posts 4 and 6 were pushed back 1 in (0.03 m) and post 5 was pushed back 5 in (0.13 m). Posttest photographs of the guardrail are shown in figure 97.
