Montana Demonstration Project: Innovative Culvert Rehabilitation Using Trenchless Technologies

**Final Report
June 2009**

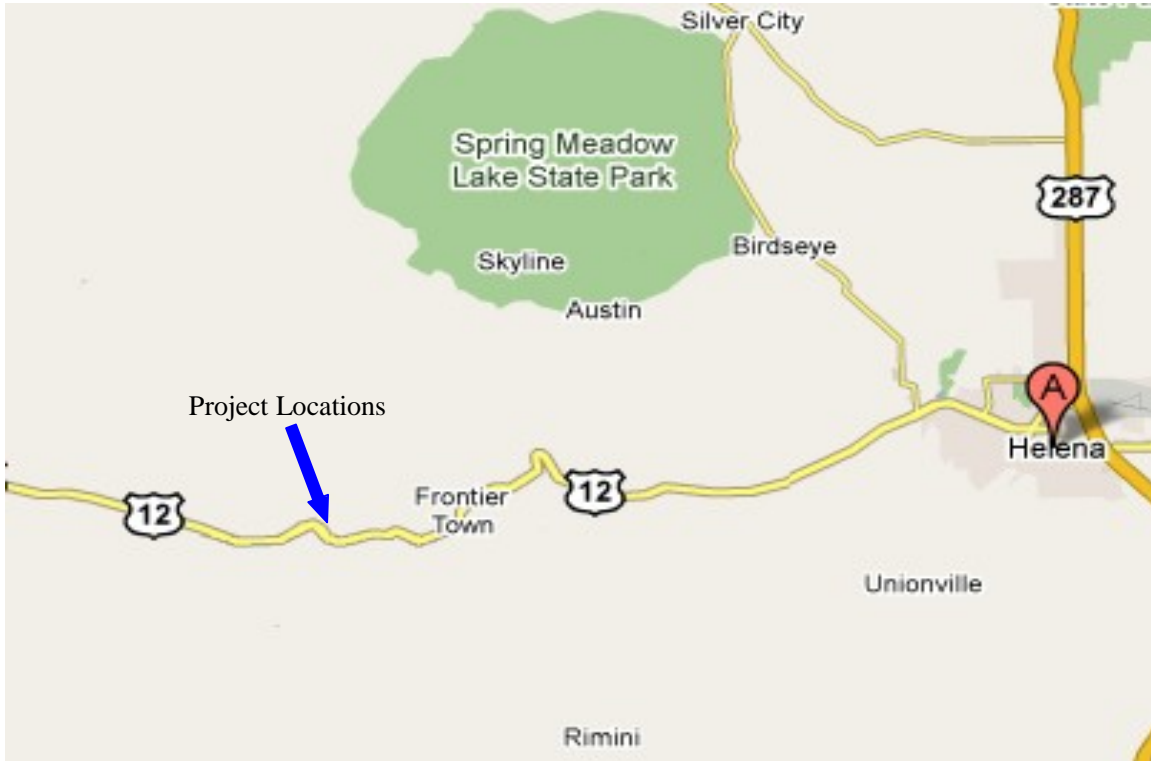
Figure 1. View of the project site.

The project involved rehabilitating 10 24-in (609.6-mm) CSP culverts along a 10-m (16-km) stretch of U.S. 12 in Powell and Lewis and Clark Counties over MacDonal Pass near Helena (see figure 1). U.S. 12 at this location is a mountainous, undivided four-lane National Highway System (NHS) roadway with an ADT of 2,670 and 12.1 percent trucks.

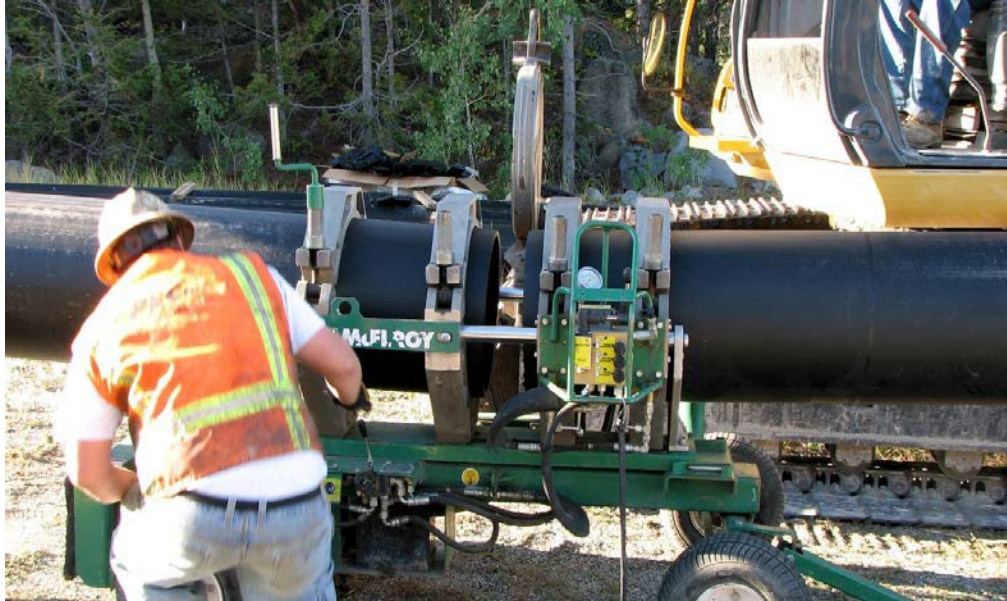
Figure 4. View of the pipe fuser apparatus.

The HDPEP sections were delivered to the job site in 25-foot (ft) (7.6-meter (m)) segments. The pipe sections were welded together to a proper length using a device called a plastic pipe fuser (figure 4). Before the fusing phase, the ends of the pipes were trimmed with a special rotary cutting tool equipped with three razors to remove any imperfections, dirt, or grease and ensure a good-quality weld.

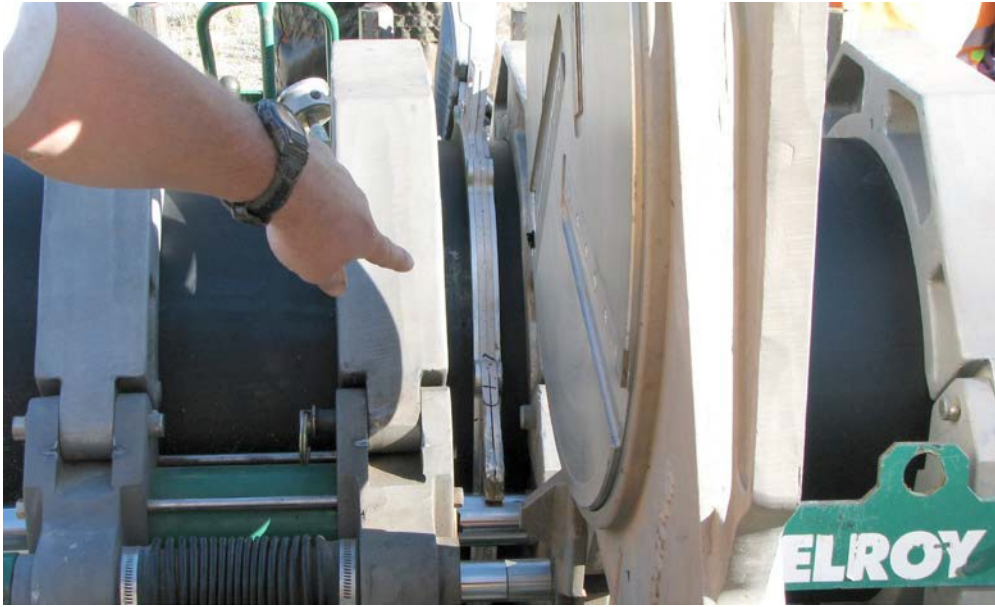
Figure 5. View of the preheated iron during the fusion process.

Next, a preheated round electric iron with an average temperature of 425 degrees Fahrenheit ($^{\circ}\text{F}$) (218 degrees Celsius ($^{\circ}\text{C}$)) was placed between the two pipe sections (figure 5). The pipes were compressed against the heated iron for about 2 to 3 minutes until the pipes started to melt and form a circular bead (figure 6).

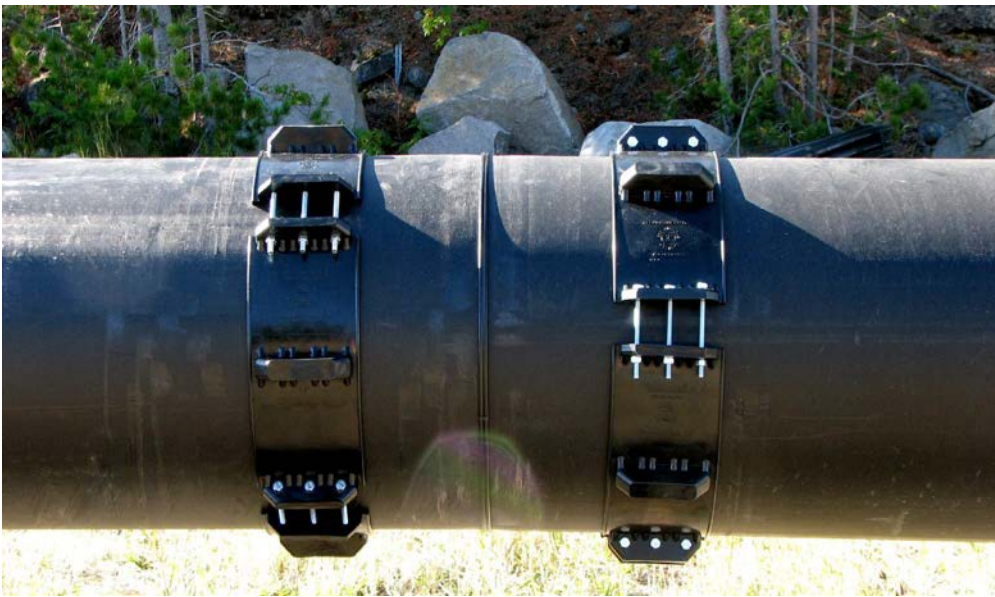
Figure 6. View of the welded pipes and spacers.

After all the sections were fused together to a proper length, spacers were attached along the pipe at intervals of 8 to 10 ft (2.4 to 3 m). The primary purpose of the spacers is to facilitate efficient insertion of the new pipe and placement of the cementitious grout, which was pumped between the existing CSP and the new liner. Figure 6 shows the formed bead after fusion and the spacers. Figure 7 shows the welded pipe liner ready for installation.

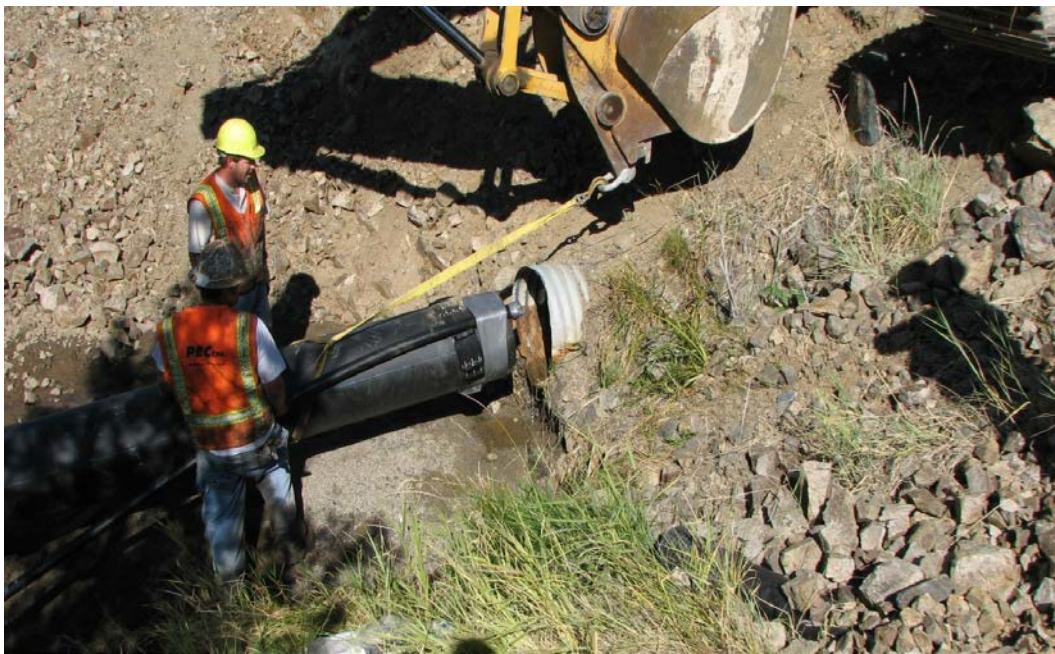
Figure 8. Pulling the liner and PVC tube into the existing pipe.

Before the liner was inserted, a PVC tube was attached along the entire length of the pipe to allow pumping of the cementitious grout material from the pumping station. As the grout was pumped, completely filling the space between the liner and the existing pipe, the PVC tube was pulled back slowly until the grouting was complete. Figure 8, 9, and 10 illustrate the operation.

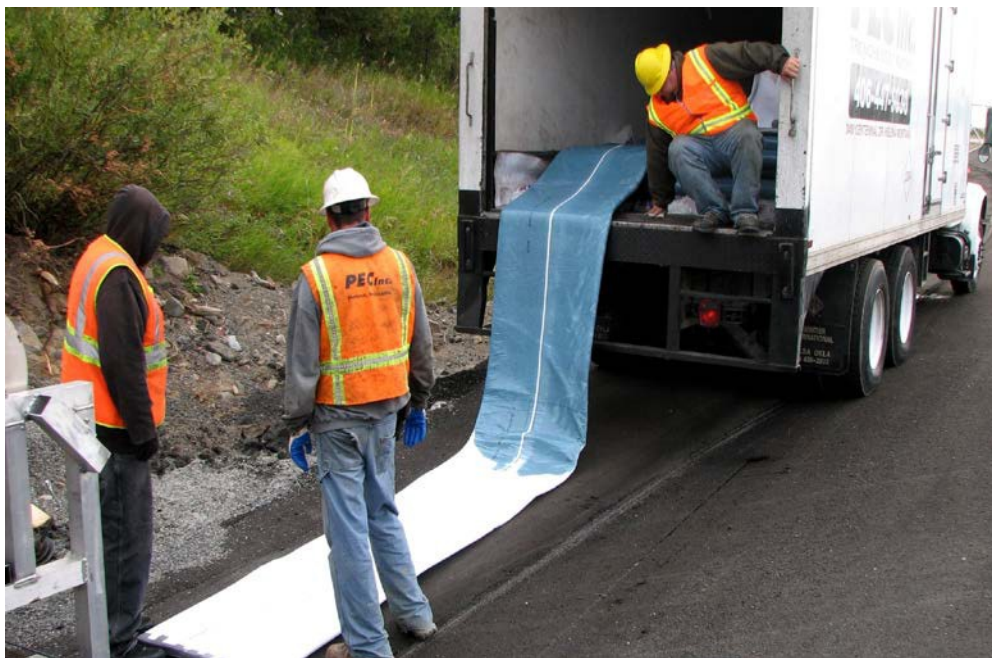
Figure 11. View of the refrigerated truck and the liner.

The CIPP liner installation at MacDonald Pass involved inserting resin-impregnated polyester felt into the existing pipes through an inversion process. The resin impregnation was done offsite at the installer’s facility, and the liner was placed in a refrigerated truck for delivery to the job site (figure 11).

Since curing begins as soon as the resin is applied, it is imperative to keep the resin-impregnated polyester at temperatures below 20 °F (6.6 °C). This retards the setting process until the liner is ready for insertion and final curing. Inversion is achieved using either compressed air or pressurized water. For this project, compressed air was used in installing all CIPP liners.

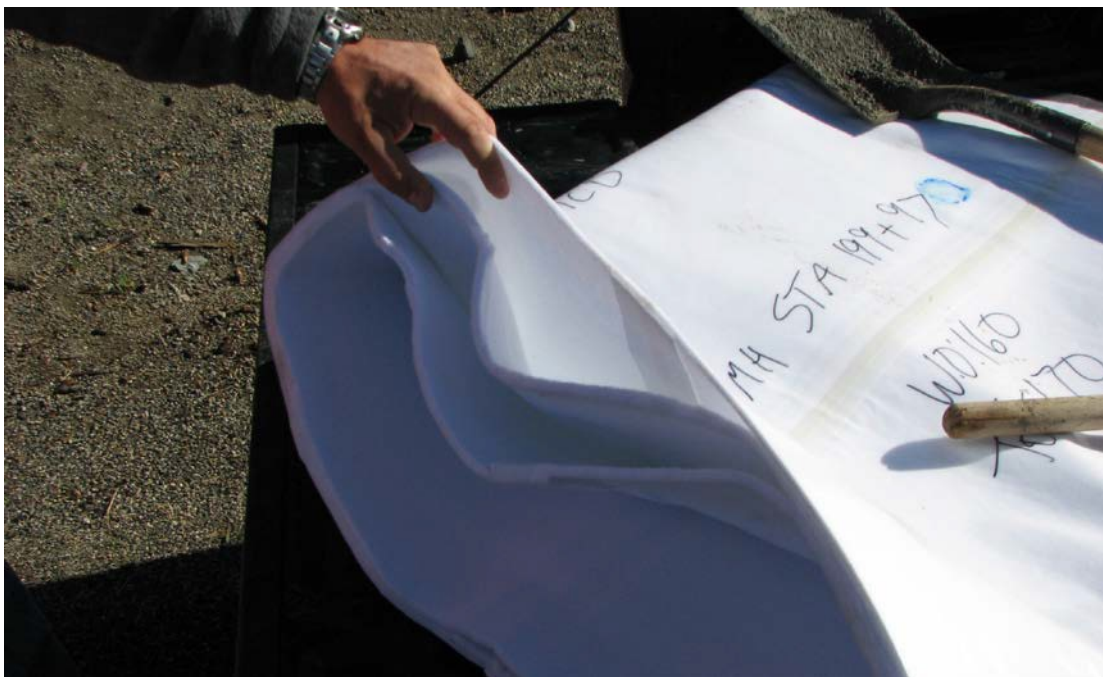
Figure 12. Closeup of the nonimpregnated polyester liner.

- The CIPP liners, specified to proper length and diameter by MDT, were delivered to the jobsite in a refrigerated truck. Several layers of ice bags were placed on the truck bed to ensure the temperature of the liner was kept low enough to impede setting until the steam curing phase.
- The nonresin-impregnated liner system has three separate layers, with the outer layer having a denser weave than the two inner layers. Once cured, all layers are bonded together, forming a monolithic layer that becomes the new interior surface of the existing culvert. Figure 12 shows a closeup of the three layers of the nonresin-impregnated polyester.

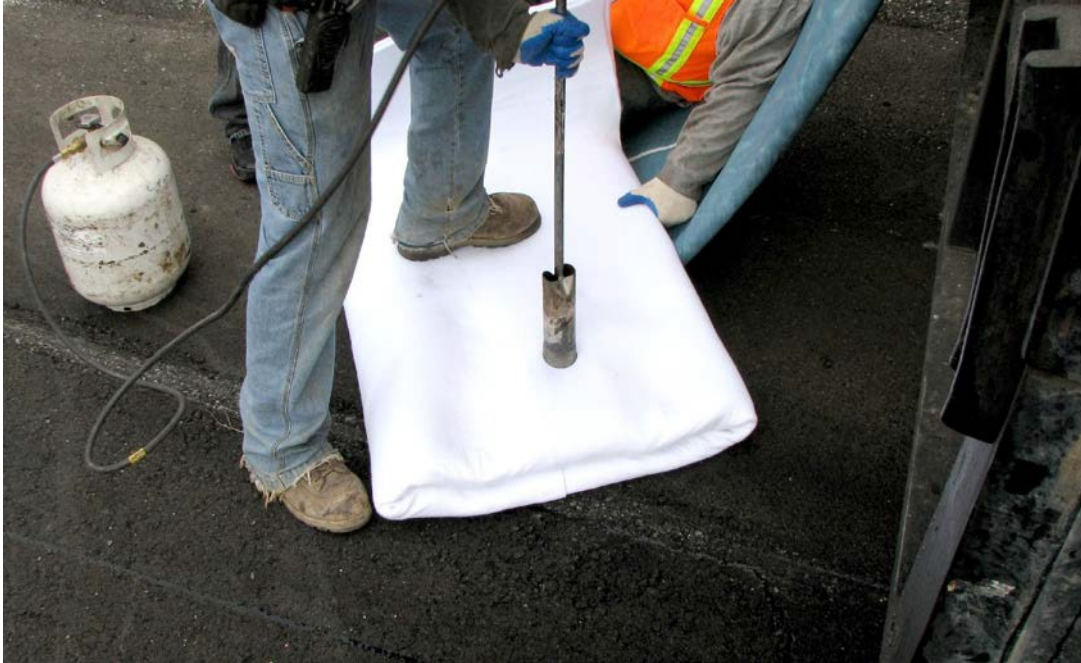
Figure 13. Inserting a circular hole into the liner using a heated core.

- A propane heated core was used to place a 3-in (76.2-mm) diameter hole in the liner, for attaching a bracket and an air hose to the liner (figure 13). In preparation for installation, the contractor cut slots in the liner layers to be hooked onto the inversion apparatus, facilitating the inversion of the liner. All five CIPP liners were inserted at the intake or upstream ends of the culverts.

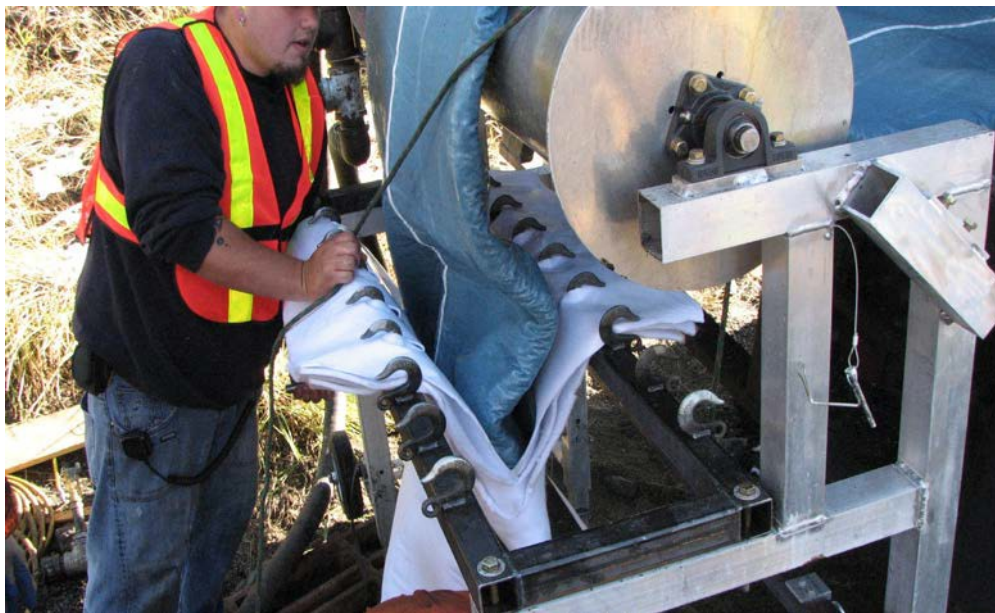
Figure 14. View of the inversion apparatus.

- The inversion apparatus is equipped with two rows of hooks to hold the liner in place while the liner is pressurized for its travel through the existing CSP culvert. Figure 14 shows the process of attaching the liner to the hooks of the inversion apparatus.

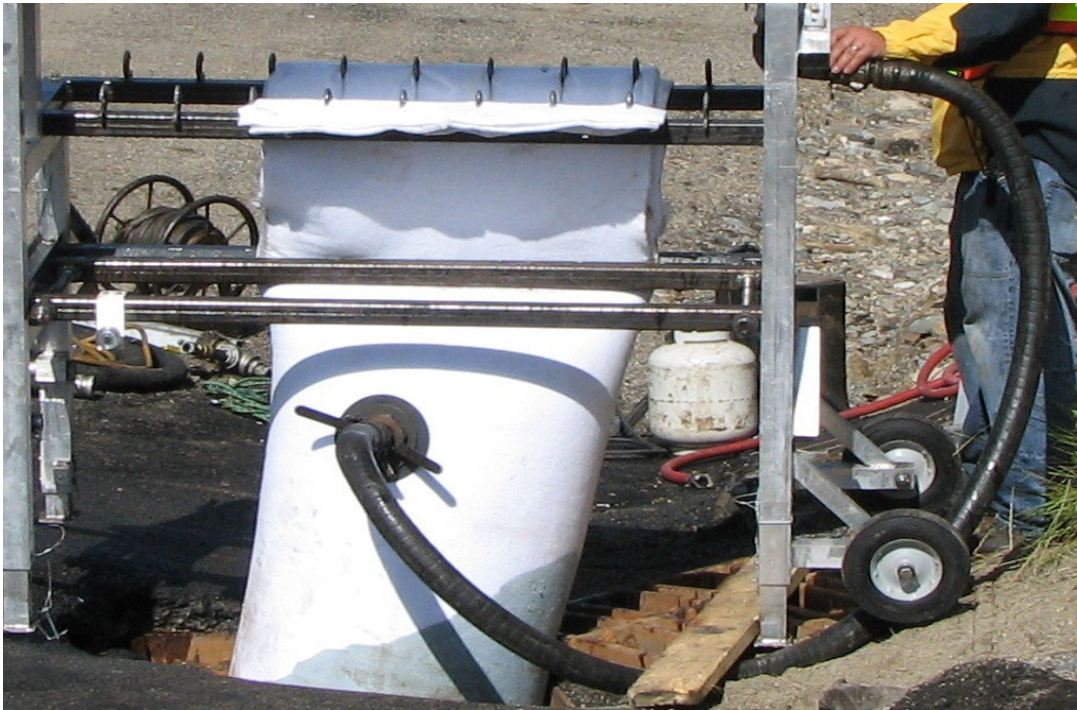
Figure 15. Closeup view of compressed air application and fully inverted liner.

- To invert and force the liner through the CSP culvert, compressed air at an average pressure of 12 pounds per square inch (psi) (82.7 kilopascals (kPa)) was applied through

the bracket into the liner. Figure 15 shows application of the compressed air and a completely inverted liner at the culvert's intake.

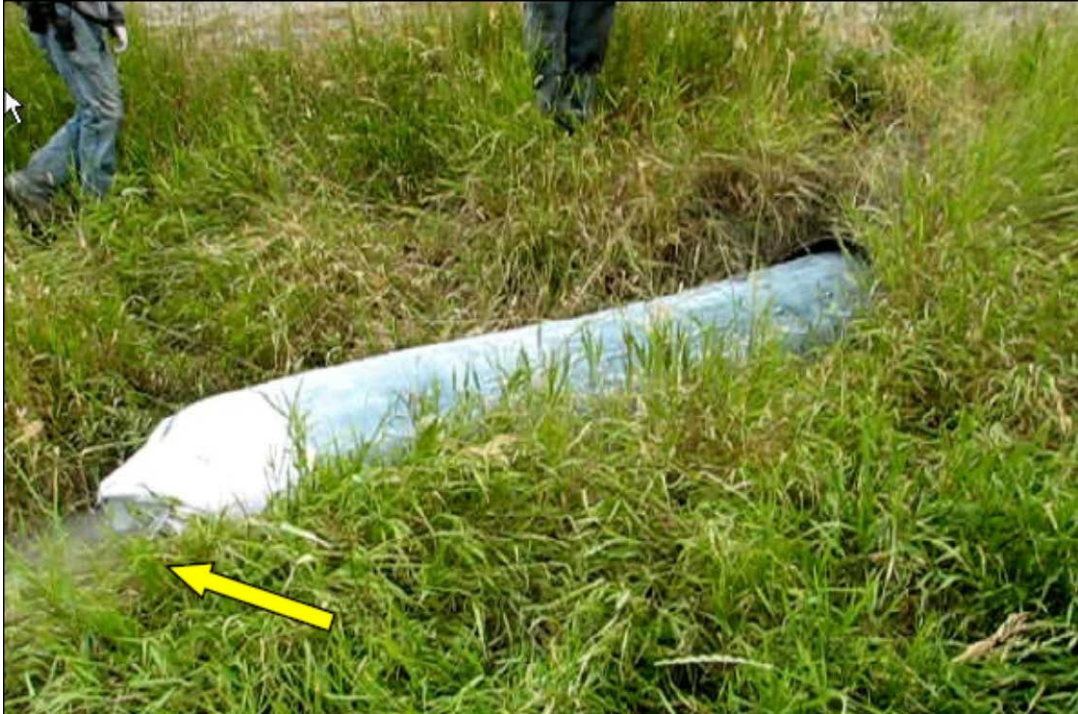
Figure 16. Fully exited liner at the outlet end.

- Figure 16 shows a fully exited liner at the culvert's outlet releasing the air pressure, which had forced it through the culvert (see the yellow arrow). Since the liner was inverted at the culvert's intake, it provided a natural plug through the entire inversion process.
- Once fully deflated, as shown in figure 17, the liner was ready for the curing phase. On average, for a 130-ft (39.6-m) CSP culvert like the ones at MacDonald Pass, it takes about 30 minutes to invert the liner from the intake to the outlet of the culvert.

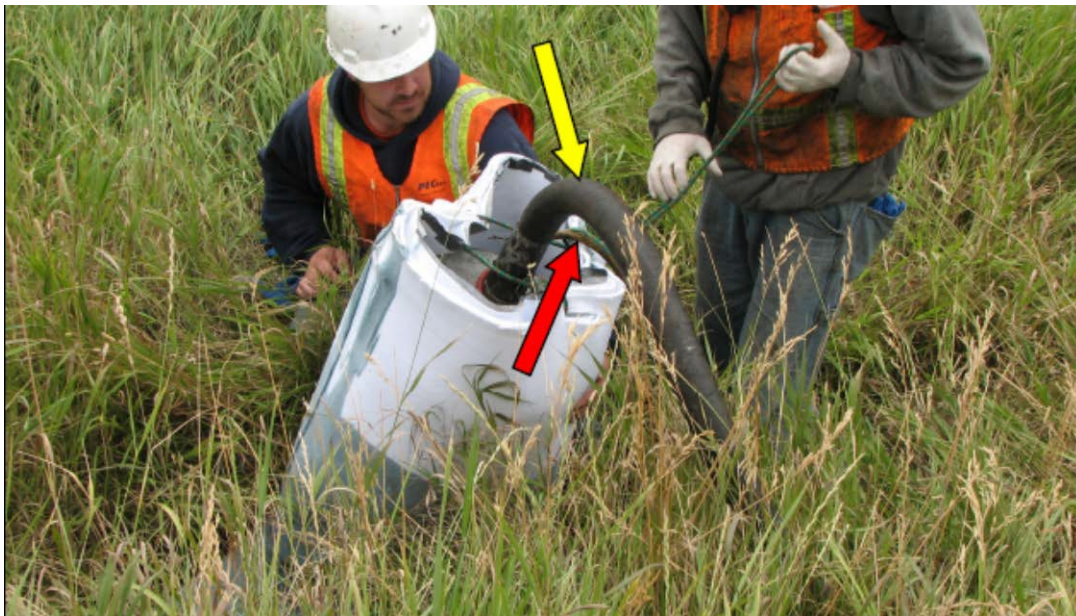
Figure 18. View of the rubber plug with air and steam line connections.

- The next step in the operation, the curing phase, entails the application of air and steam. A large-diameter rubber plug was placed inside the liner at the outlet. The plug was equipped with two connections, which allowed attachment of an air line (red arrow) and steam line (yellow line). Figure 18 shows the rubber plug attached to the air and steam lines.

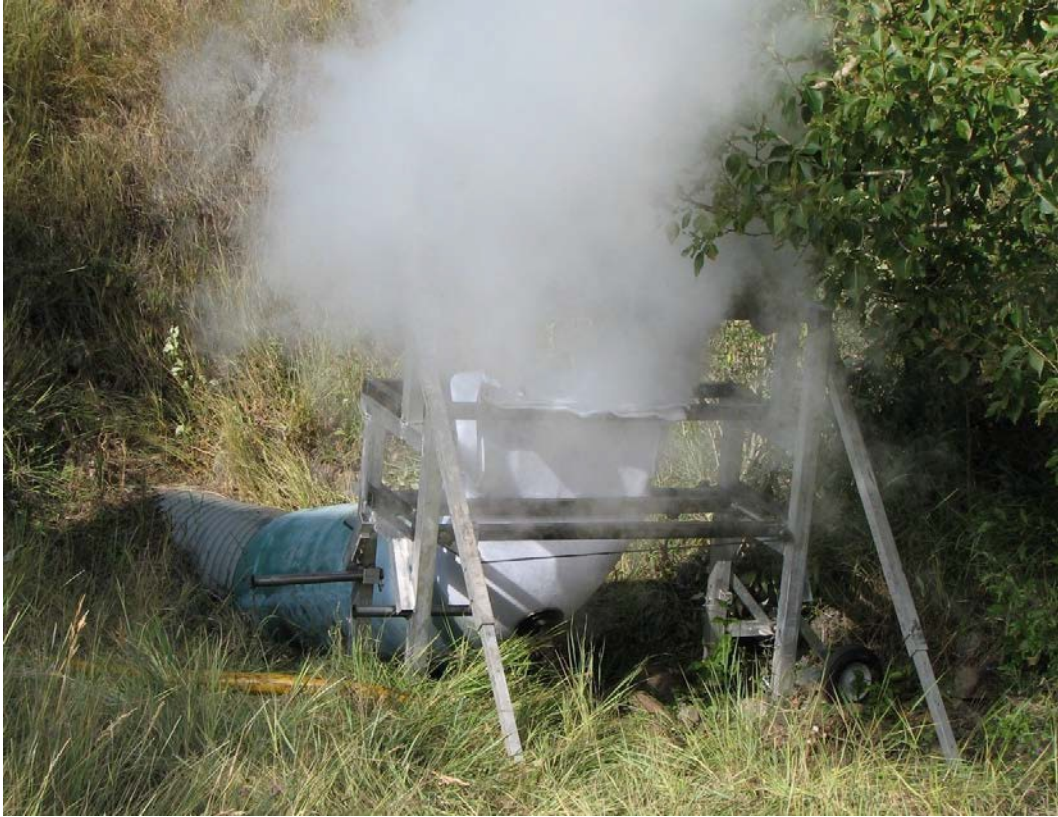
Figure 19. View of steam exiting at the intake end of the culvert.

- Figure 19 shows steam exiting at the intake end of the culvert. Curing can take place at ambient temperature, but using steam can accelerate the curing time. Applying steam reduces the curing time from several weeks to 1.5 hours.

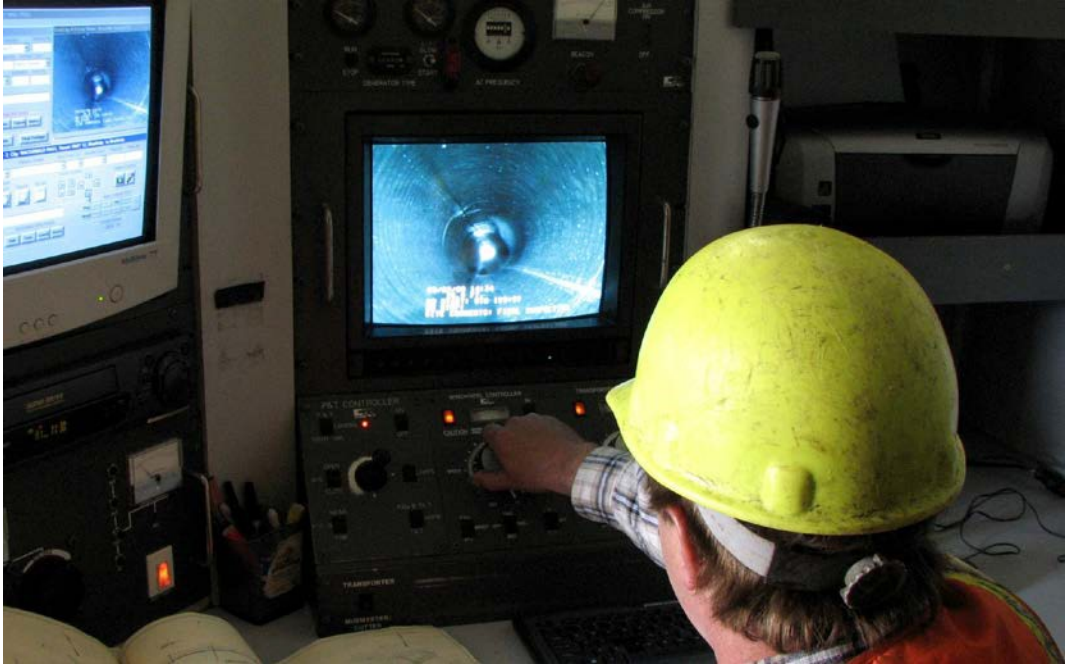
Figure 22. Remote monitoring and inspection.

- After the application of the steam, the CIPP was allowed to cool. The rubber plug was removed, and the excess CIPP at the intake and outlet was trimmed to a proper length.
- Fiber meshed grout was used to seal the interface of the CIPP liner and the existing culvert at its intake and the outlet ends (figure 21).
- As shown in figure 22, the installation of the CIPP liner was monitored and inspected remotely by a tractor-mounted closed-circuit television camera to ensure proper placement.

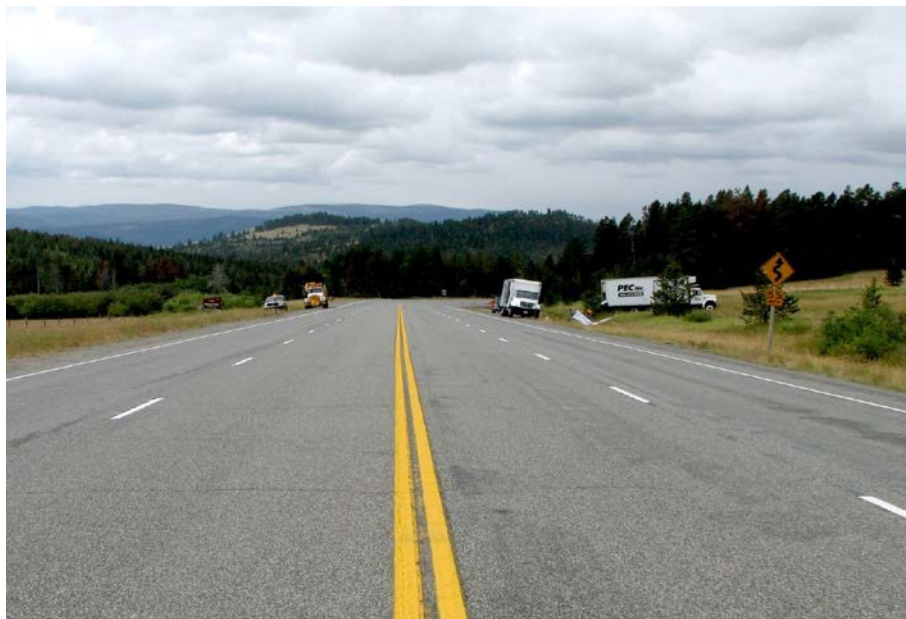
Figure 23. Typical CIPP liner installation.

Figure 23 shows a roadway during culvert rehabilitation using CIPP. No worker injuries or highway user incidents were reported during the rehabilitation of the culverts on MacDonald Pass. Overall, MDT exceeded all the safety performance goals set by HfL.
