# JOINT TRANSPORTATION RESEARCH PROGRAM

# Concrete Box Beam Risk Assessment and Mitigation: Volume 1 – Evolution and Performance

SPR-4009 • Report Number: FHWA/IN/JTRP-2020/06 • DOI: 10.5703/1288284317117

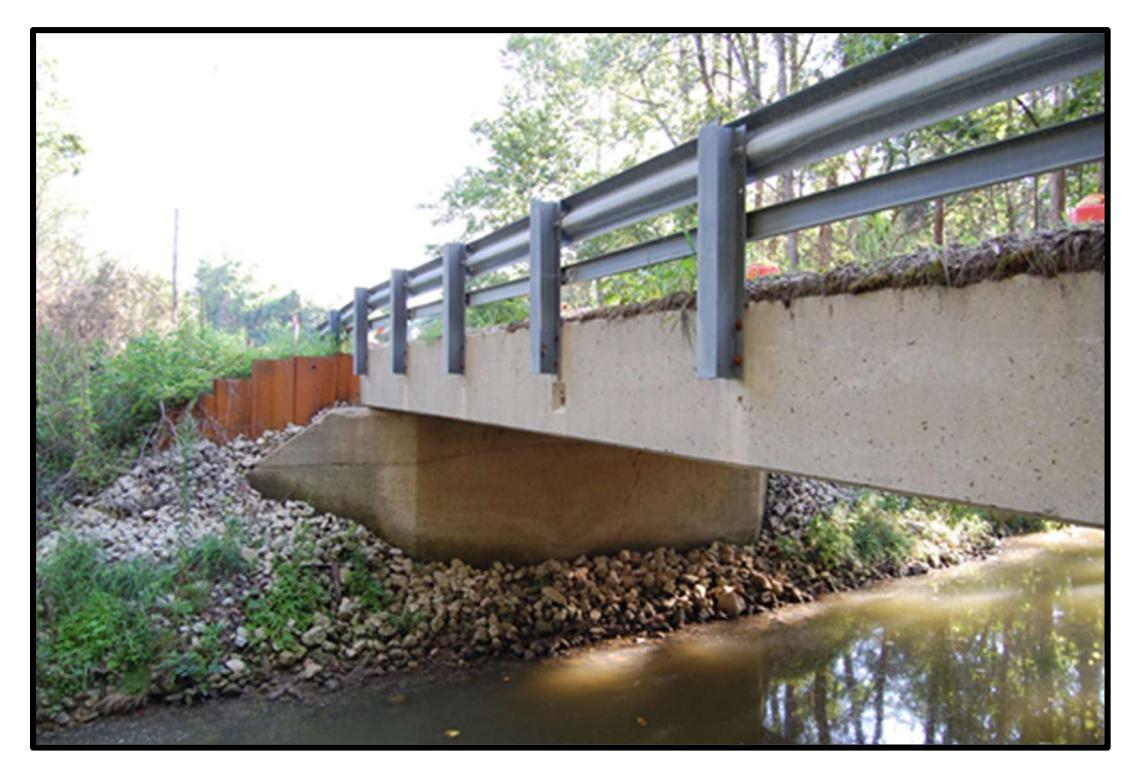
Figure 4.3 Pond creek bridge.

From visual observations made on July 27, 2016, the exterior beam on the east side of the bridge has cracking, spalling, and exposed strands toward midspan (Figure 4.3). Longitudinal cracking in the bottom flange was also noted in one of the middle beams and the first interior beam on the west side (Figure 4.4). Efflorescence covered a majority of the first interior beam on the
west side, which was due to a leaky, exterior shear key (Figure 4.5). The complete deterioration map for this bridge is provided in Figure 4.6.

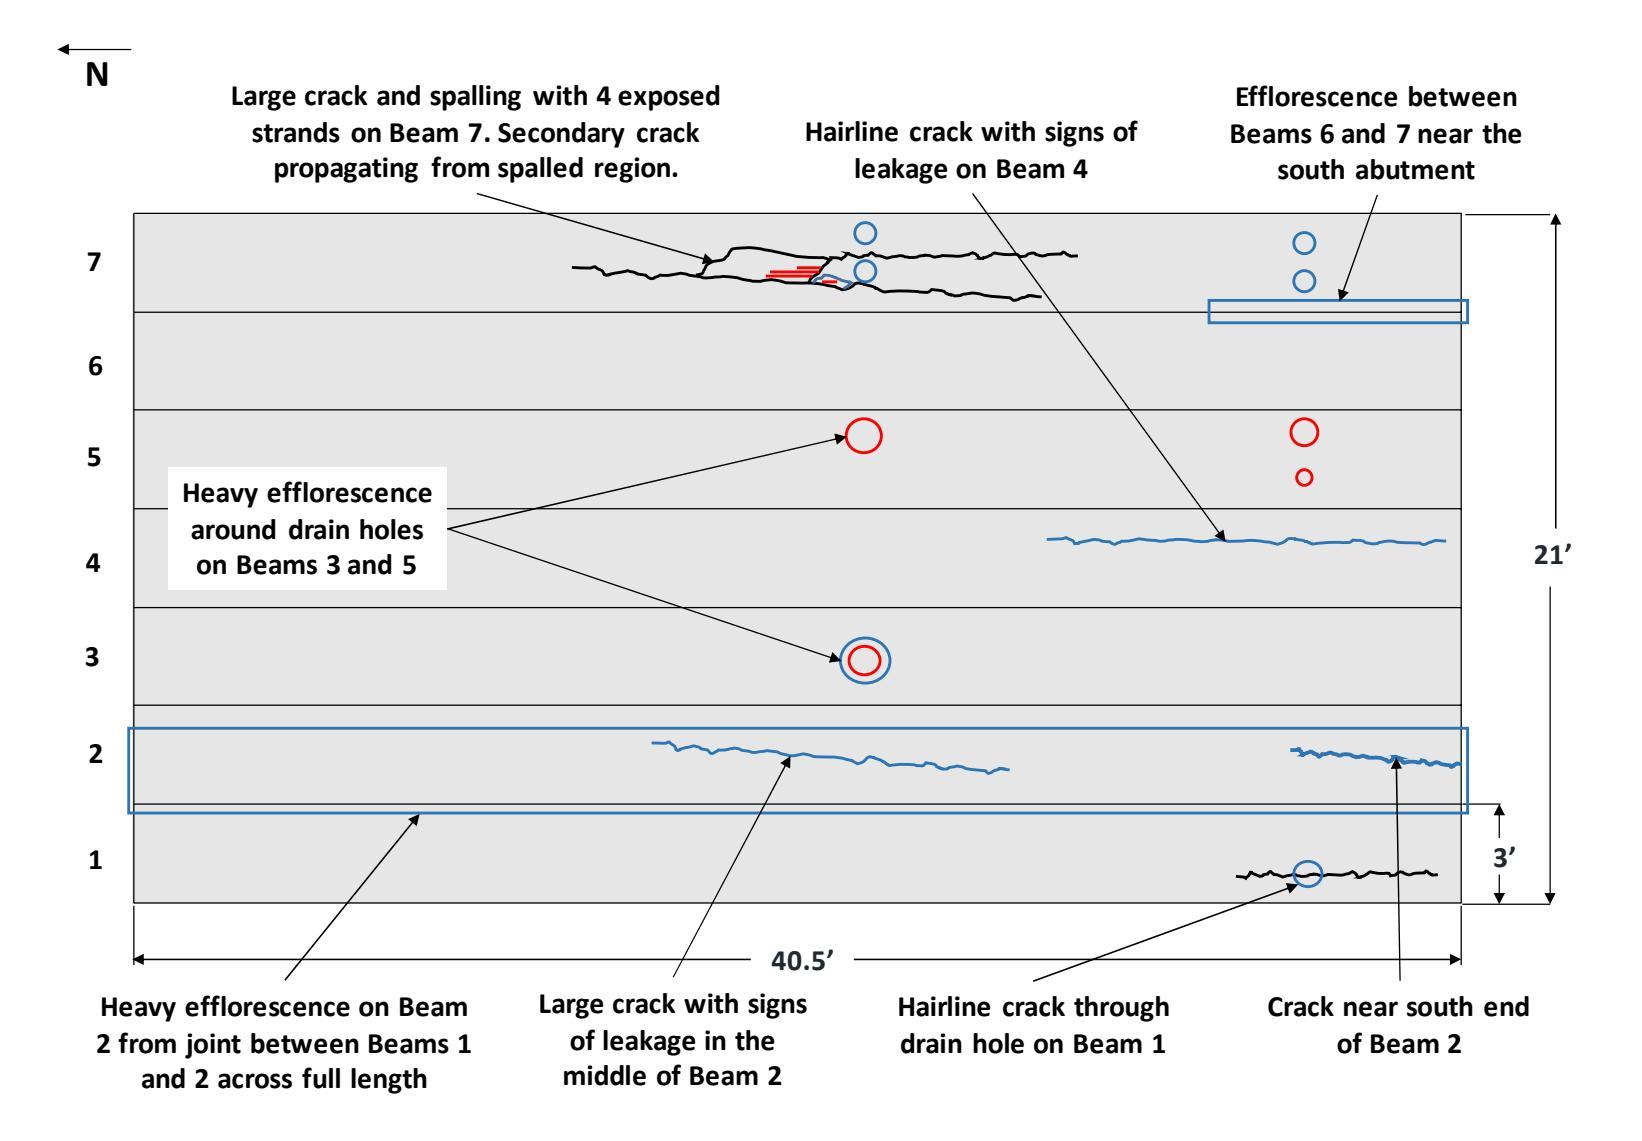
Figure 4.7 Deterioration map of pond creek bridge (35-00013).

In reviewing all of the deterioration maps, it can be observed that the exterior beam and the exterior longitudinal joint are the locations most susceptible to deterioration. For the Pond Creek Bridge (Figure 4.6), the exterior longitudinal joint between Beams 1 and 2 showed signs of leakage, and efflorescence covered most of the bottom of Beam 2. Beam 7, the other exterior beam, had two large cracks connected by a region of spalled concrete and four exposed strands. On the Rock Creek Bridge (Figure 4.11), Beam 7 within Span C had spalling with two exposed stirrups and a longitudinal crack spanning the length of the beam. On the Clear Creek Bridge (Figures 4.16), the bottom of Beam 1 was covered with efflorescence that originated from the exterior longitudinal joint. Beam 12 on the other side of the span appeared to have differential rotation. For the Yellow Creek and Beal-Taylor Ditch bridges, efflorescence, spalling, and exposed reinforcement are close to the exterior joints.

The beams and longitudinal joints under the wheel loads also tend to have more deterioration compared to other beams and joints. Assuming the Pond Creek Bridge has two design lanes with HL-93 wheels spaced apart 6 ft (AASHTO LRFD, 2014), Beam 2, Beam 4, and Beam 6 are located within a wheel load path (Figure 4.6). Beam 2 and Beam 4 have large cracks in the middle of the flange. Making the same assumptions for the Rock Creek Bridge (Figure 4.11), Beam 6B, which has two large cracks and spalled concrete along the first interior joint, would be located within a wheel load path. Similar findings were noted from the beam damage on the other four bridges. Localized wheel loading appears to provide an influence in joint deterioration and leaking.

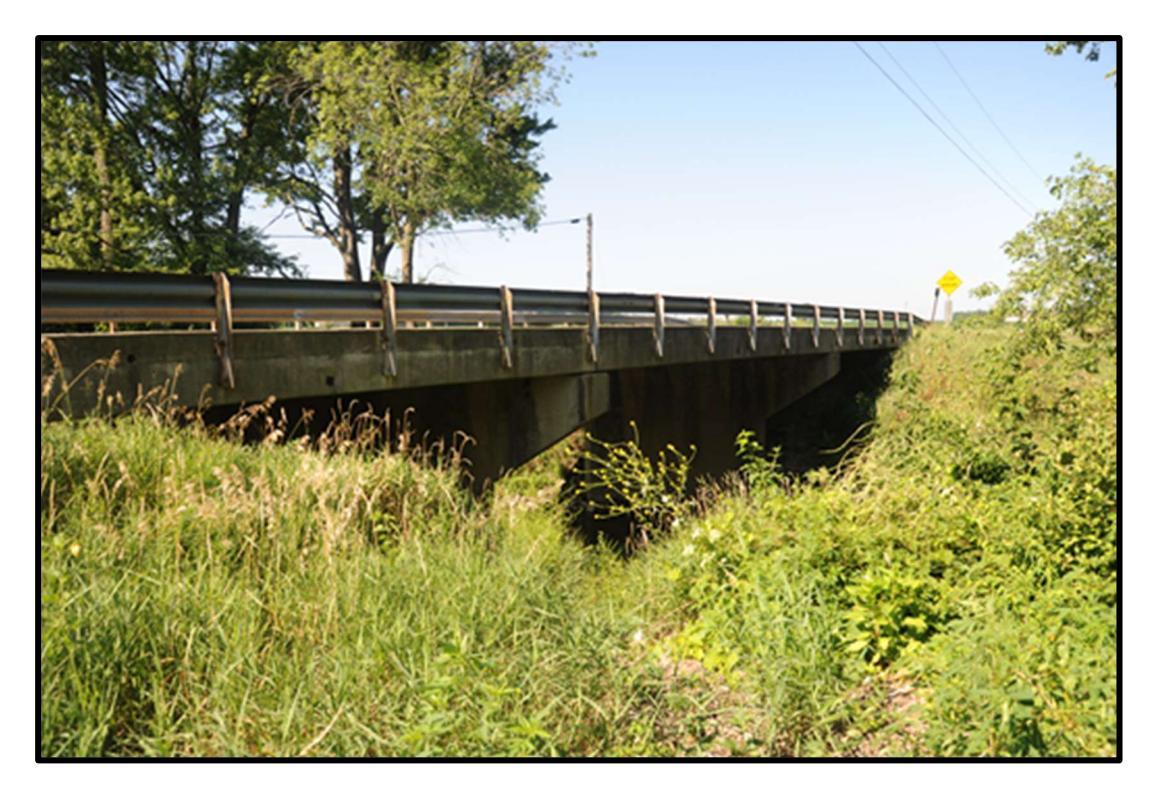
Figure 4.8 Rock creek bridge.

The most deteriorated span was on the east end of the bridge. One of the exterior beams has a large region of spalling with two exposed stirrups and signs of water leakage around the shear key (Figure 4.8). The other exterior beam has a longitudinal crack in the bottom flange and a hole in the top flange (Figure 4.9). The hole revealed standing water in the void of the box beam. The middle span has one beam with a longitudinal crack in the bottom flange and signs of water leakage at the shear key (Figure 4.10). The complete map is provided in Figure 4.11.

For the Rock Creek (90-00079) Bridge, damage in the form of a hole in the top flange of the exterior beam in the east span was discovered. This damage was not found in the box shown in Figure 4.8, but rather observed in the top flange in the other exterior beam on the south side of the same span. The damage was so significant that the void of the box beam could be observed. Standing water, spalled concrete, and small wildlife were found in the void. A longitudinal bar and stirrups were also exposed (Figure 4.46).

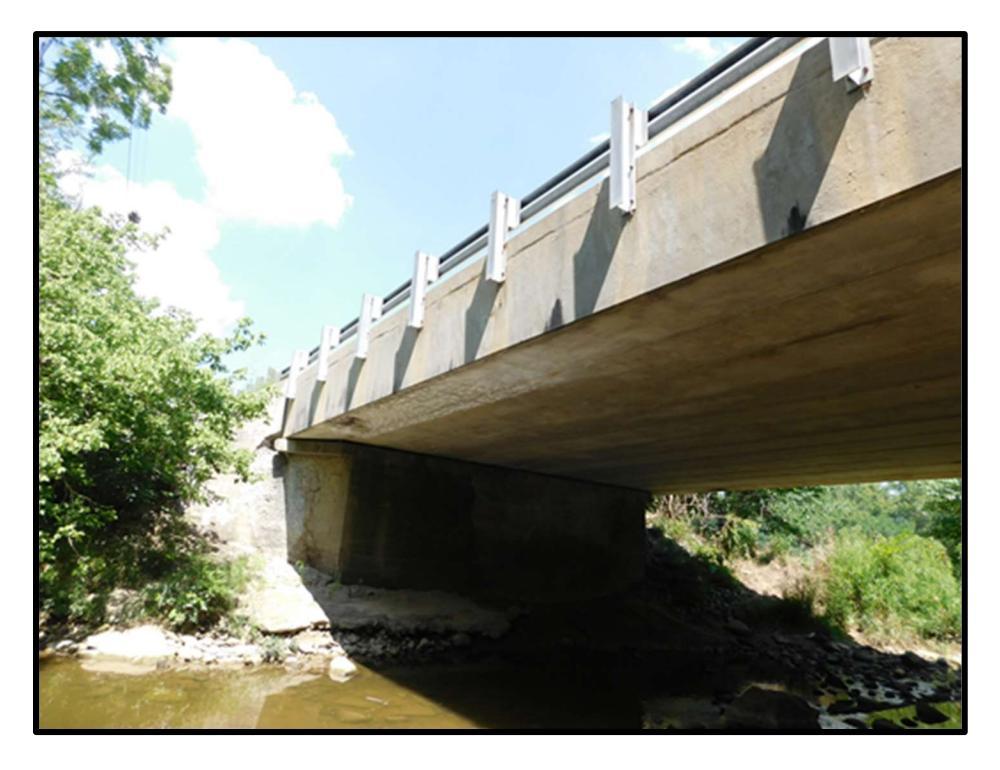
Figure 4.13 Clear creek bridge.

The bottom of the superstructure is in good condition compared to the Pond Creek and Rock Creek bridges. Spalling at the bottom corners of two adjacent beams with two exposed strands in the middle of the span was noted (Figure 4.13). Between Beam 3 and Beam 4, rust staining was observed towards midspan (Figure 4.14). Corrosion and two exposed stirrups were also observed at the southeast corner of the bridge (Figure 4.15). The complete deterioration map is provided in Figure 4.16.

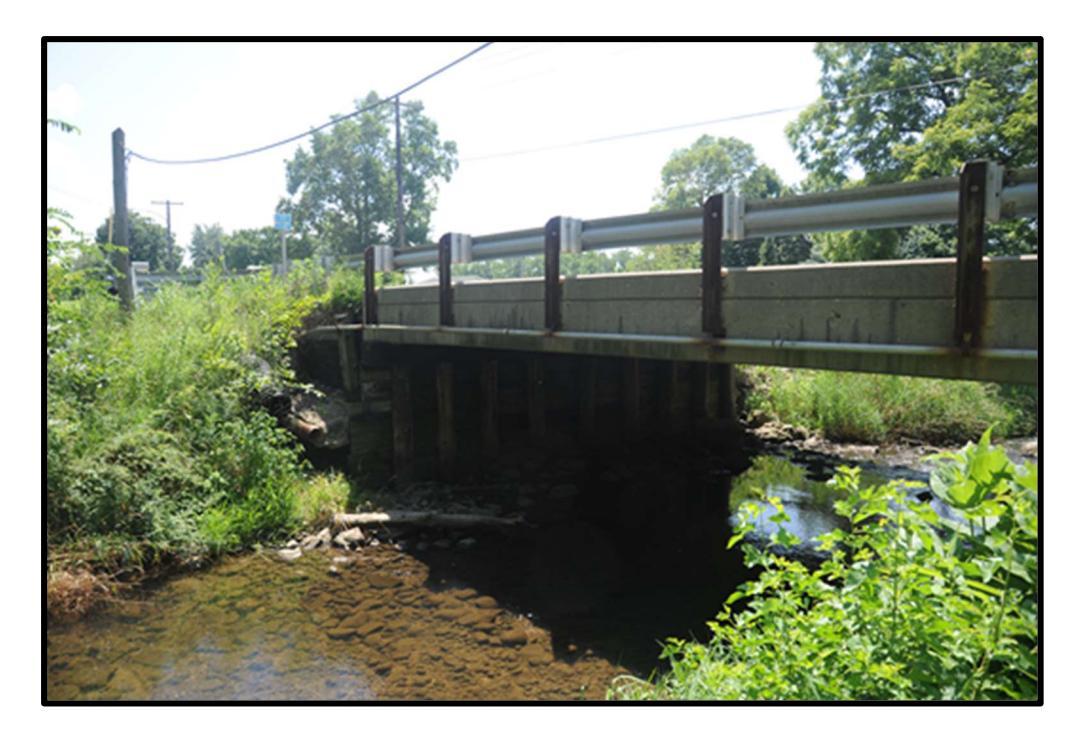
Figure 4.18 Yellow Creek Bridge.

The underside of the Yellow Creek Bridge has small regions of spalling at the edges of the first interior beams along with an exposed strand (Figures 4.18 and 4.19). An exposed stirrup was observed on the exterior face of the exterior beam on the east side (Figure 4.20). Patched potholes were scattered across the concrete wearing surface and were filled with asphalt (Figure 4.21). A correlation was made between the location of the patches and the location of the longitudinal joints of the box beams. A complete map of the deterioration is provided in Figure 4.22.

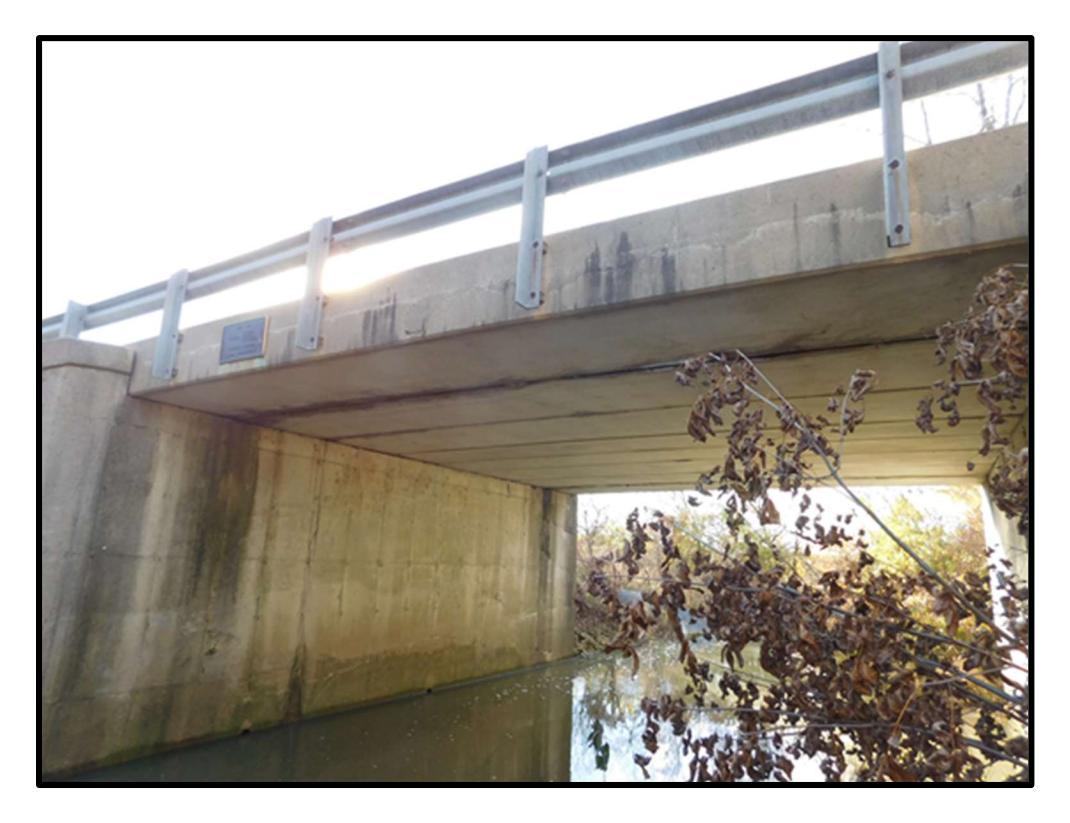
Figure 4.24 Beal-Taylor Ditch Bridge.

Beal-Taylor Ditch (02-00221) is a single-span bridge located in Allen County and carries West Hamilton Road over Beal-Taylor Drain (Figure 4.23). The bridge was built in 1967 and consists of eight adjacent box beams that span 23.9 ft. and have depths of 12 in. The two box beams in the middle of the bridge are 3 ft. wide, while the remainder of the beams are 4 ft. wide. The bridge has a bituminous wearing surface with no membrane and a single tie rod at midspan. The bituminous wearing surface, however, does not extend to the curbs. Instead, the bituminous wearing surface only covers the roadway while the shoulders of the bridge appear to be covered with gravel (Figure 4.24).

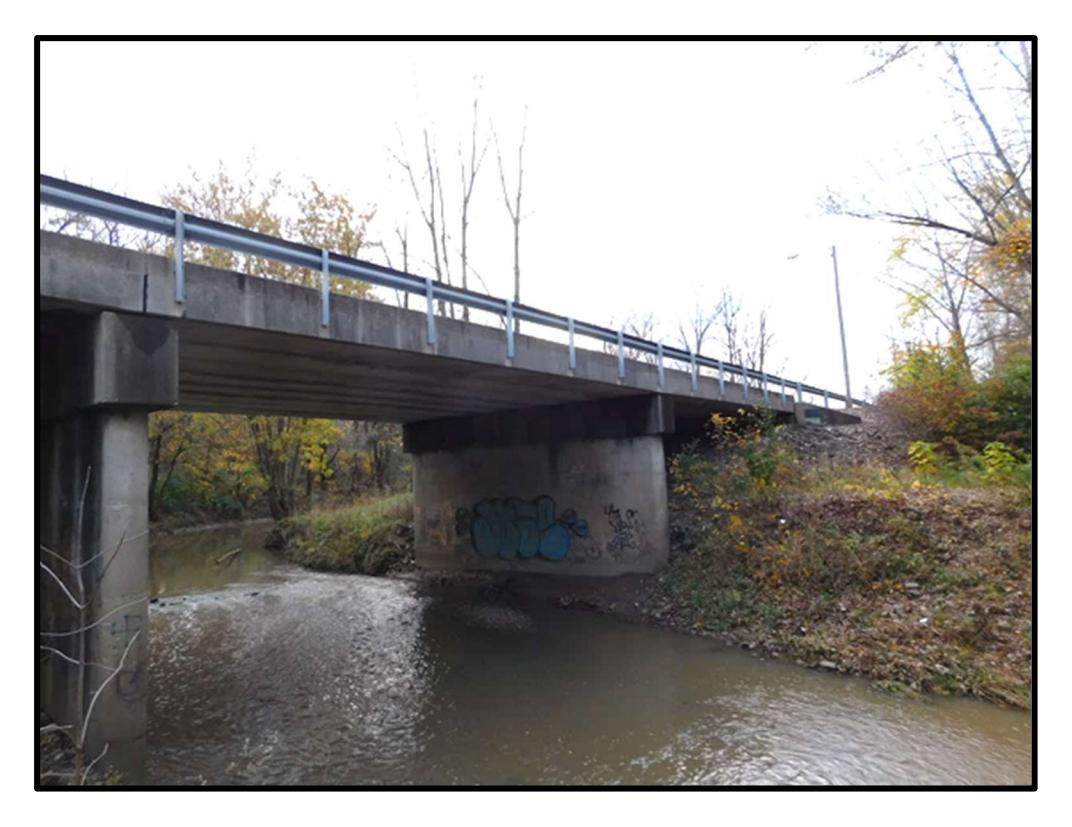
Figure 4.29 Main Street Bridge.

This bridge was noted to be in the worst condition compared to the other five bridges inspected. The end spans have multiple regions of spalling with exposed stirrups and strands (Figure 4.29). Corrosion on the west span was so severe that prestressing strands had fractured and debonded from the concrete (Figure 4.30). Strands were observed hanging from the underside of the superstructure. Spalling initiated near the longitudinal joints and, over time, moved closer to the center of the beams. For one particular beam, 24 exposed stirrups and four exposed prestressing strands were noted. The middle span appeared in better condition with only three locations of spalling, each region having three exposed stirrups (Figure 4.31). A complete deterioration map is provided in Figure 4.32.

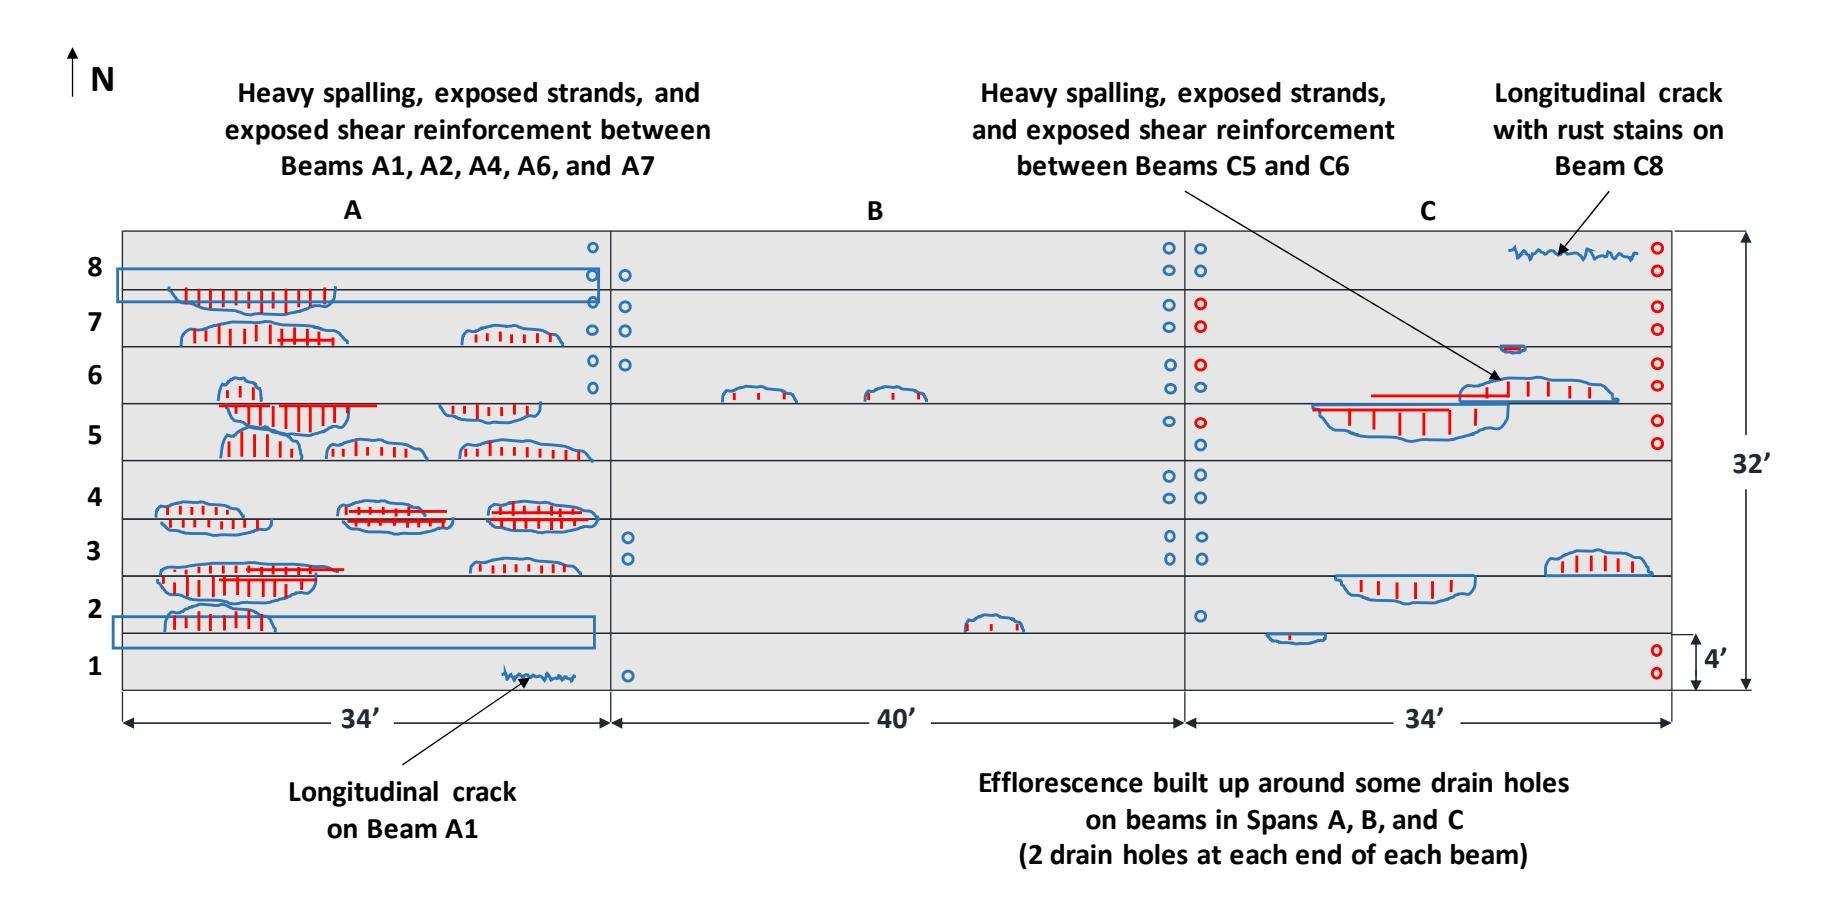
Figure 4.32 Deterioration map of Main Street Bridge (02-00601).

Bridge (Figure 4.33), Beams 2A and 7A are next to exterior joints that showed signs of leakage. Both beams have spalling and exposed stirrups on the side closest to the leaking joint. For this bridge, however, numerous beams have spalling and exposed reinforcement in the bottom edges adjacent to the joint.
