# Identification of Bridges with Fracture-Prone Details

Report Number: KTC-19-35/SPR18-553-1F

Kentucky Transportation Center  
College of Engineering, University of Kentucky, Lexington, Kentucky

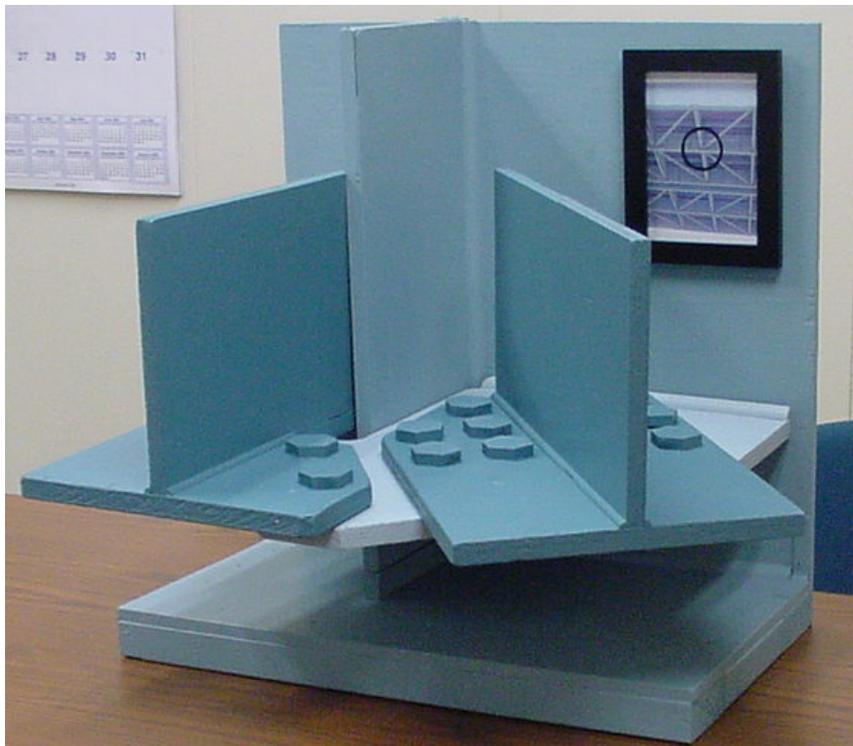
A follow-up investigation concluded that those fractures originated at the gusset plate area connecting lateral bracing to the girder webs (1). Two of these attachment details were involved in the fractures (Figure 3). Previously, the Wisconsin Department of Transportation (DOT) had detected arrested cracks at other approach span locations ranging in length from 6 to 36 inches. Those previously detected cracks were initially attributed to fatigue. A typical mock-up of similar lateral bracing connections is shown in Figure 4. With the lateral bracing removed, the mock-up shown in

**Figure 4** Mock-up of Hoan Bridge-type fracture detail (light green) showing lateral bracing attachments (green).

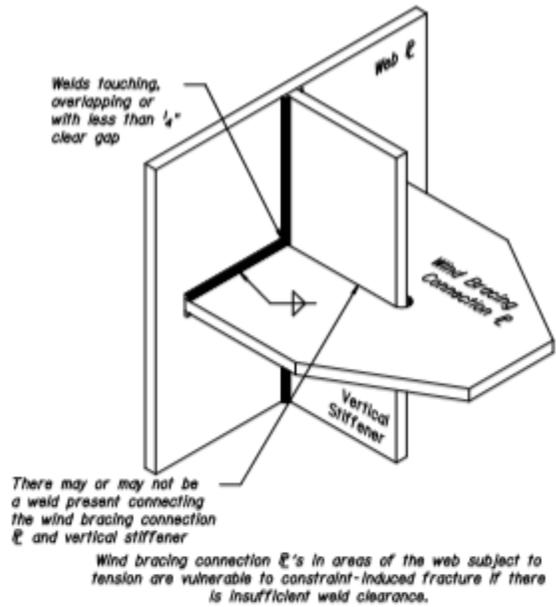
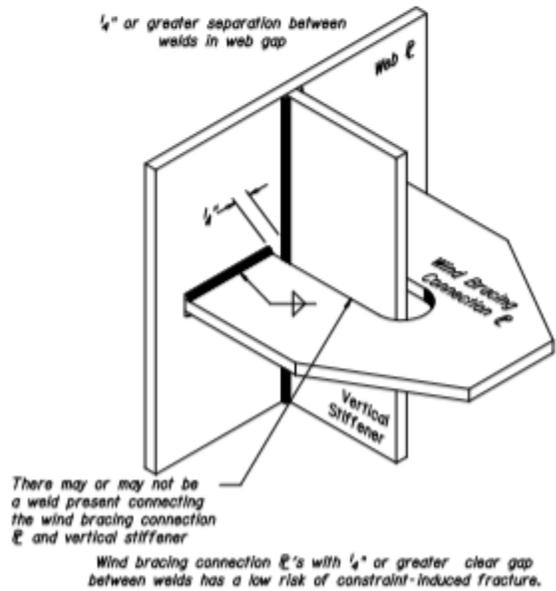
Over time, several DOTs issued internal documents addressing CIF-prone details for agency personnel or consultants and local governments, sometimes along with agency policies for handling them (4, 5). The Illinois DOT circular letter 2010-09 provides illustrations of some CIF-prone details (Figures 6 and 7). Since 2000, several CIF-related fractures have affected several US bridges (Ref 2, 6).

Figure 7 Constraint-induced fracture details from Illinois DOT Circular Letter 2010-09 (Attachment 5).

To identify CIF details (Stage 1), the Illinois DOT pictures are an excellent reference (Figures 6 and 7). Those images should be provided to KYTC inspectors to assist them in identifying CIF details. To determine if a CIF detail is problematic (Stage 2), the gaps between web attachment fillet welds/weld terminations need to be measured for gussets and stiffeners. If the distance between those welds are 1/4" or less *or* the welds are touching, KYTC should consider retrofitting the details to prevent brittle fracture.
