**TECHNICAL REPORT 0-6804-3**  
TxDOT PROJECT NUMBER 0-6804

# Traffic Noise Barrier Analysis for SH 190 in Rowlett, Texas

August 2019; Published September 2020

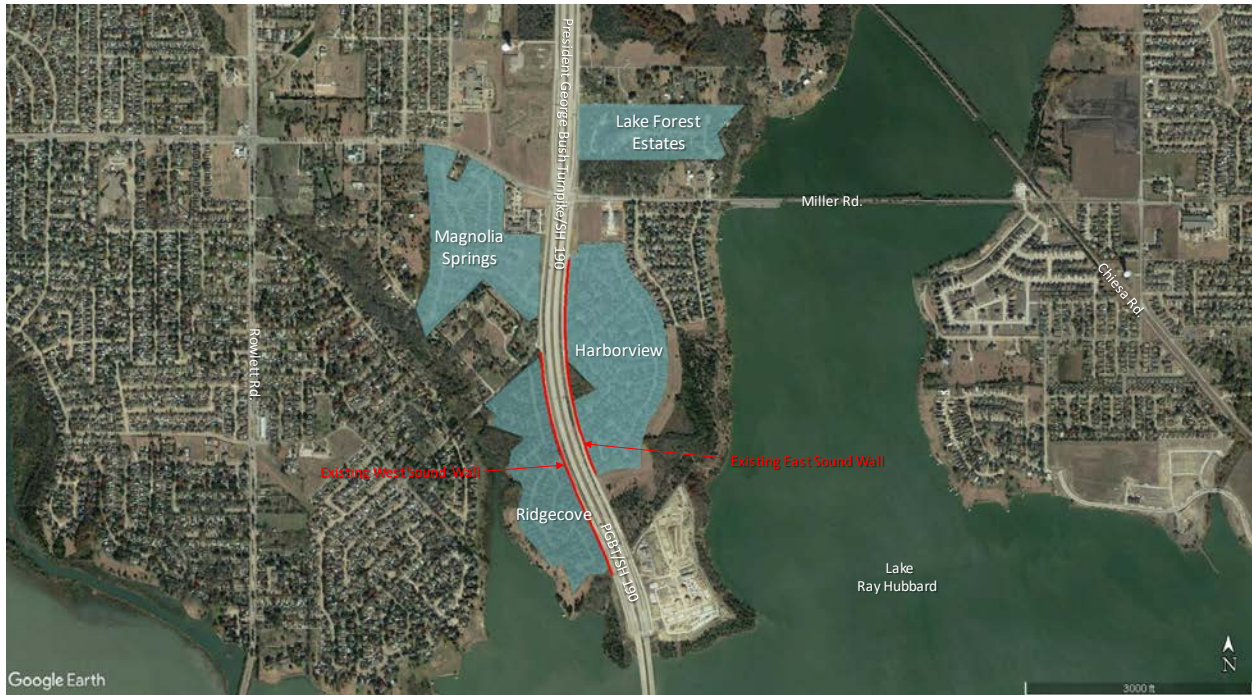
*Figure 1.12: Residential communities and existing noise walls in the area of interest*

As Figure 1.12 shows, the walls do not protect all the homes in the residential communities in question. On the east side, Lake Forest Estates is completely unprotected from the noise, and Magnolia Springs, on the west side, is in the same situation. Ridgecove and the majority of Harborview are protected by the existing walls. There are also some homes on Kirby Rd., on the west side, that are not part of any residential community that are also unprotected by the walls and exposed to the noise in close proximity to the frontage road.

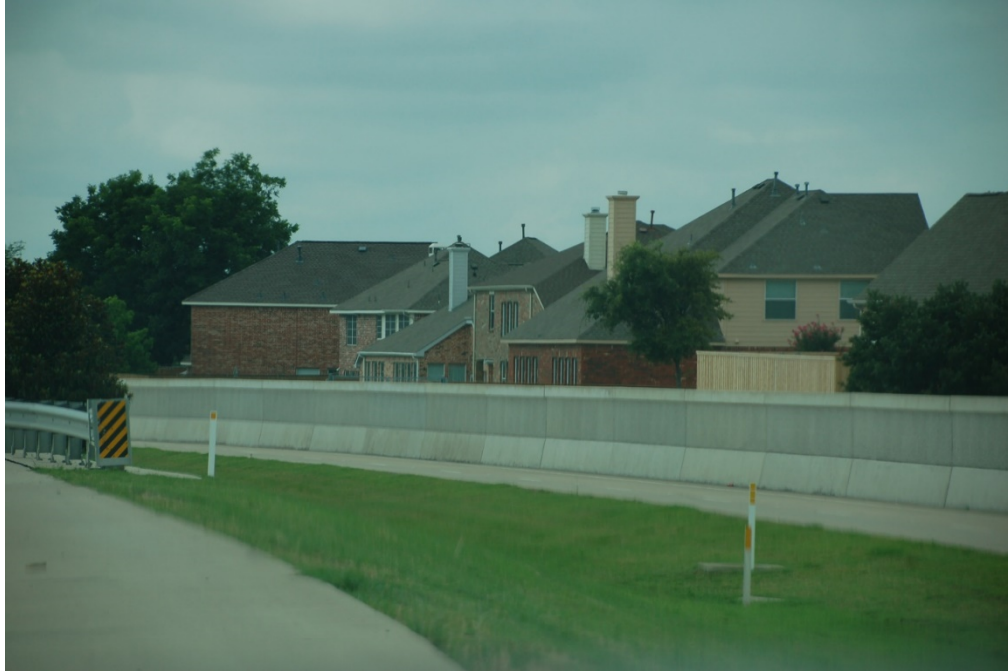
*Figure 1.15: View of the west noise wall from the westbound main lanes*

As can be seen in Figure 1.15, most of the homes are two-story residences; thus, the 8-ft. walls only partially block the line of sight between the highway and the receivers. Therefore, some of the noise travels unobstructed from the source to the receivers. The problem is more complex when the differences in elevation between the main lanes and the frontage roads are considered, as the vertical profiles of frontage road, main lanes and the neighborhood first row residences do not match throughout the length of the section of interest. For instance, Figure 1.16 shows a view from the main lanes of PGBT towards the homes of the Ridgecove community on the west side of the highway, indicating a clear line of sight to the backyards, which signifies that the noise has a direct unobstructed path towards the receivers. In this photograph, the noise wall is not visible from the main lanes. The concrete wall in this image is the CTB. This is an example where the noise wall has no benefit in regard to the noise generated from the main lanes for this particular residence.

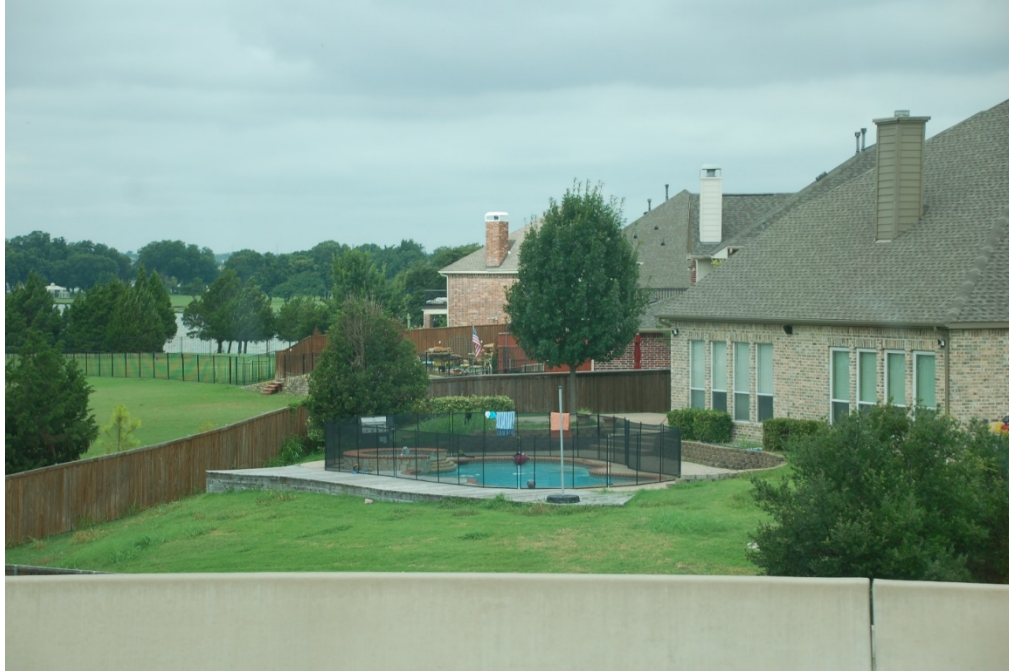
*Figure 1.16: View from the main lanes towards the back of the residences on the west side of PGBT*

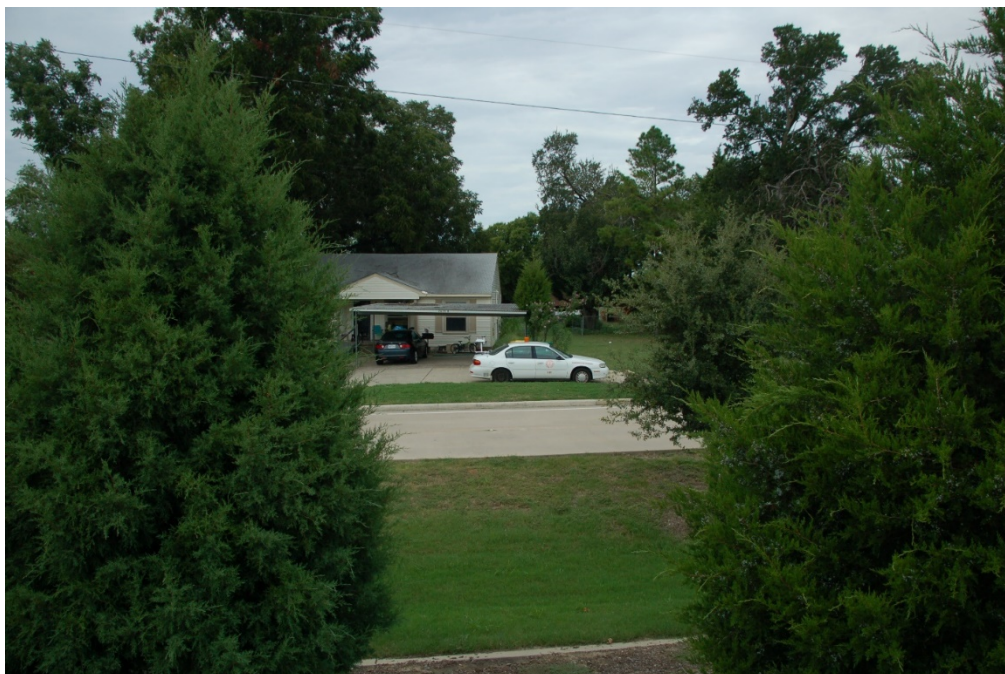
*Figure 2.27: Front view of Site #7: 2629 Kirby Rd., as seen from the main lanes of SH 190*

On the other hand, receiver R7, on Kirby Rd., had the highest noise readings among the receivers studied. The reason is that this house is next to the frontage road, and also is in close proximity to the main lanes, and there is no noise wall to shield it from the noise. Moreover, the receiver is at the same level with the highway main lanes and frontage roads, so the noise has a direct path to the receiver. More information on this residence as well as photographs can be found in Section 2.2.6.

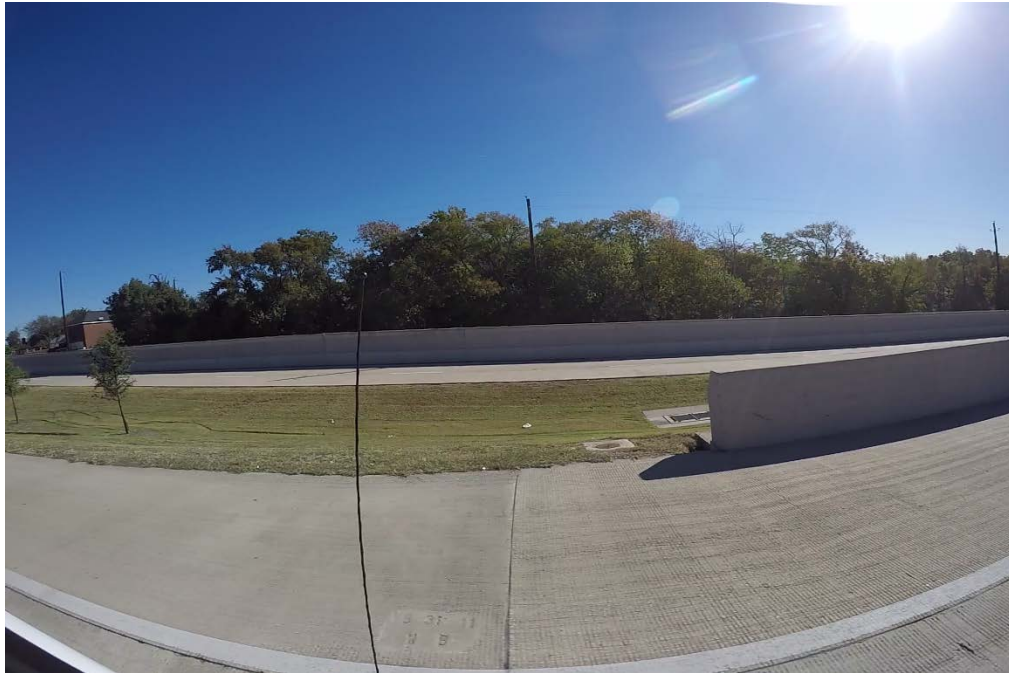
The CRCP on SH 190 was constructed in August and September of 2011. This information was found on the pavement itself: during the condition survey, two inscriptions were found on the main lanes pavement surface indicating the date the concrete was cast, one on the northbound direction, from August 31, 2011 (Figure 3.3) and one in the southbound direction, from September 10, 2011 (Figure 3.4). A CRCP that is 8 years old is still considered fairly new.

*Figure 3.3: SH 190 Northbound main lane. Pavement cast on 8/31/2011 as indicated by inscription on the shoulder as recorded by video*

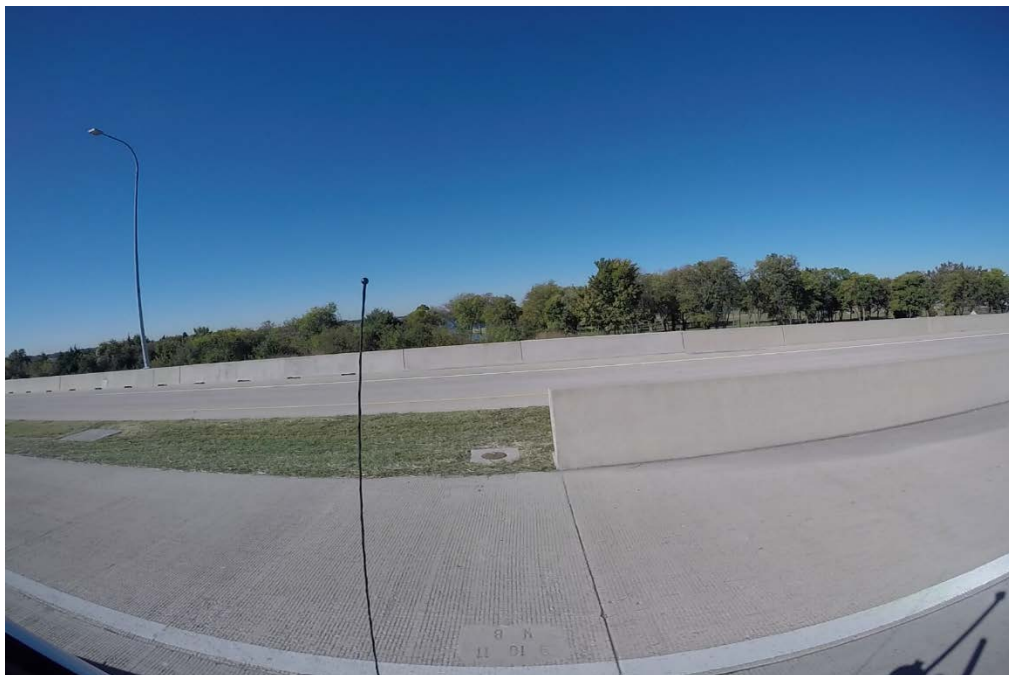
*Figure 3.4: SH 190 Southbound main lane. Pavement cast on 9/10/2011 as indicated by inscription on the shoulder as recorded by video*
