# **MASH 2016 TEST LEVEL 3 EVALUATION OF MNDOT BICYCLE AND PEDESTRIAN RAIL**

## **MINNESOTA DEPARTMENT OF TRANSPORTATION**

MwRSF Research Report No. TRP-03-443-20

December 11, 2020

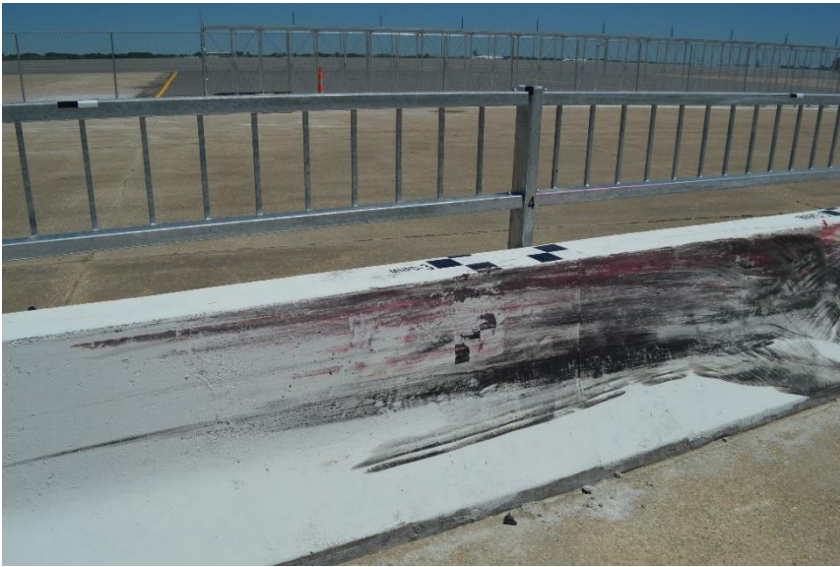
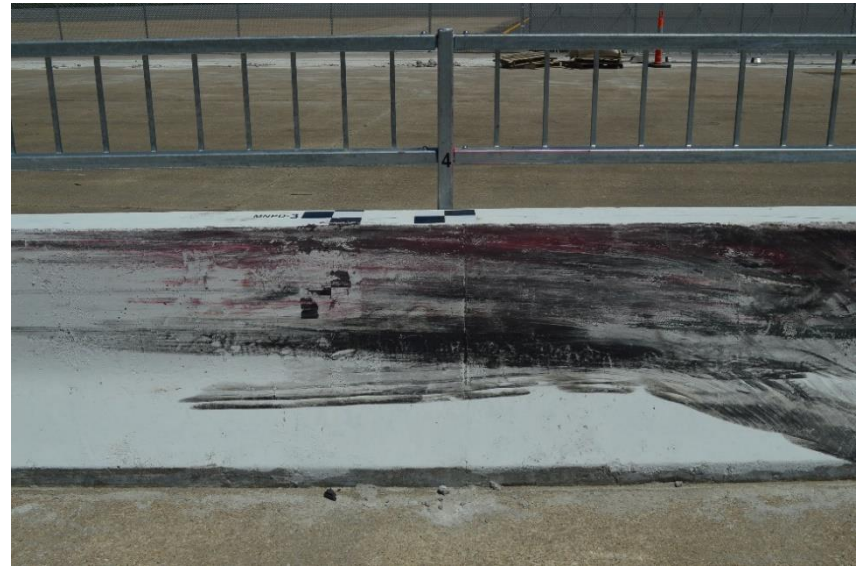
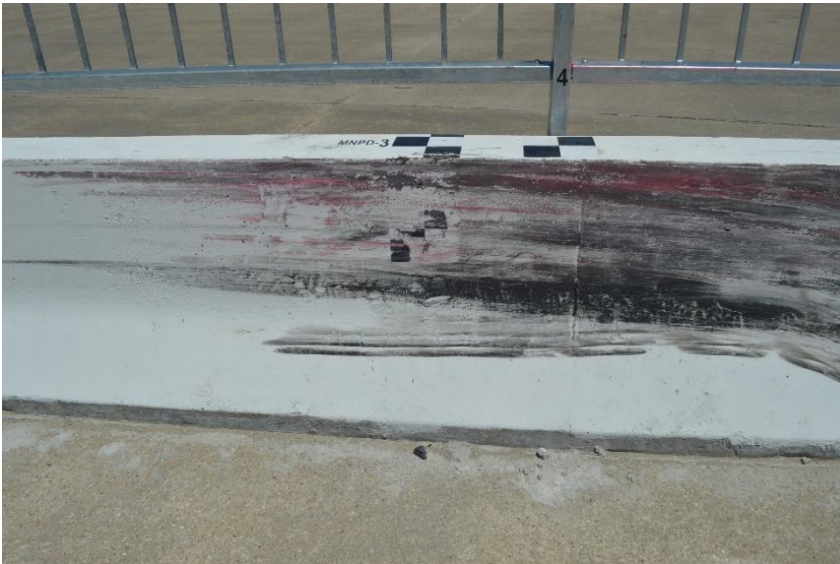
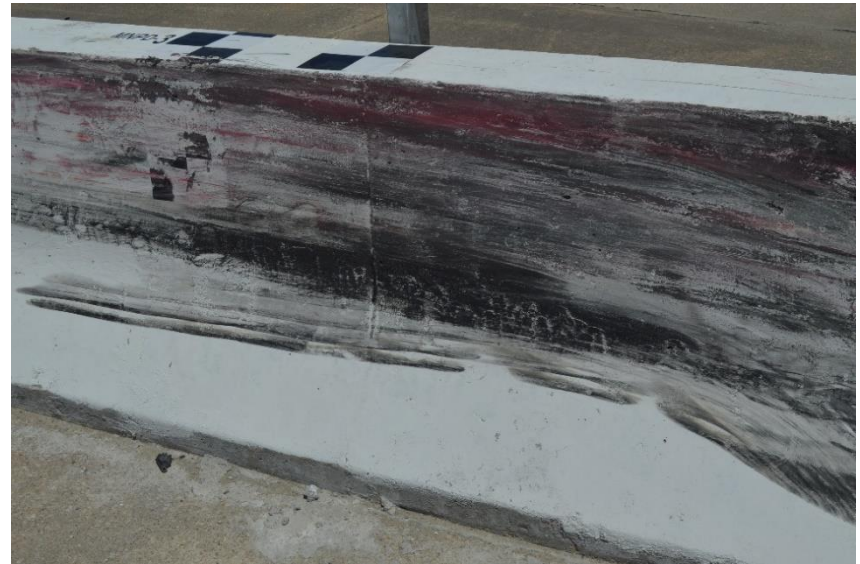
Figure 52. Tire Marks and Concrete Scraping, Test No. MNPD-3

Tire marks were visible on the front face of the J-shape concrete barrier, starting 14½ in. upstream from impact and extending 167 in. downstream across the traffic side of the barrier. Scuff marks were also found along the length of vehicle contact. Gouging was found on the front face of the barrier measuring 4½ in. long and located 15 in. from the top edge and extending 5½ in. downstream from the impact point with a height of 4 in. and a width of ¼ in. Scraping measuring 10 in. long was located 31 in. downstream from the impact point and 7 in. from the top front corner of the concrete barrier with a width of ½ in. Chipping, measuring 2½ in. long, was located 17 in. downstream from the impact point and 13¼ in. below the top front corner of the concrete barrier with a width of ¾ in. Additional chipping, measuring 11¼ in. long, was located on the top traffic-side corner of the concrete barrier 24½ in. downstream from post no. 4 with a height of ¾ in.

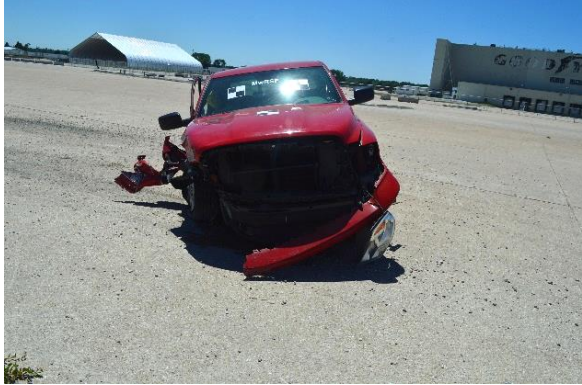
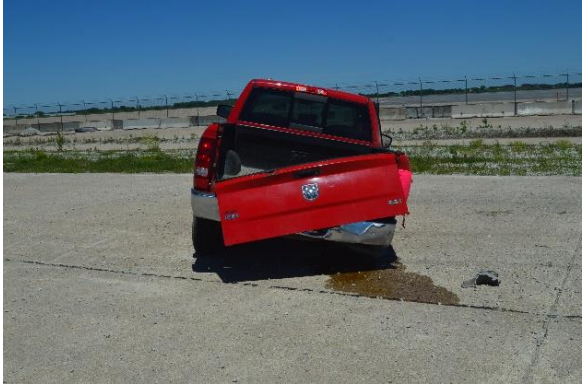
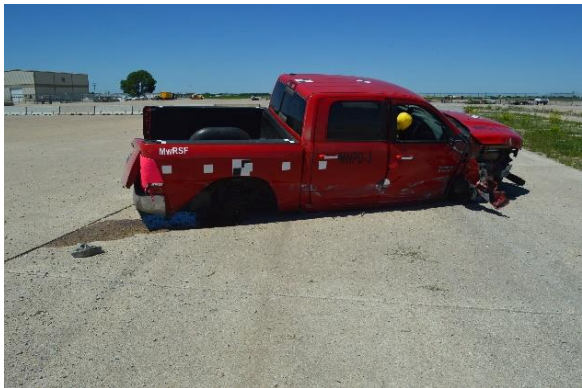
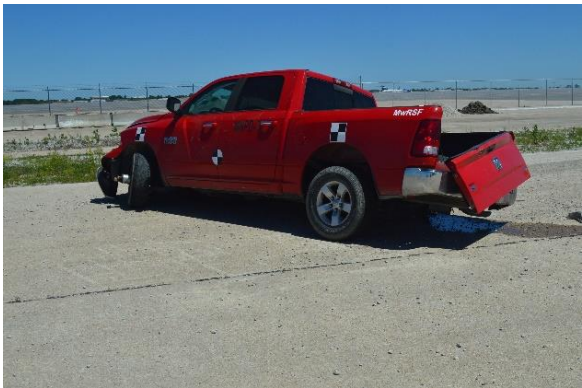
Figure 60. Vehicle Damage, Test No. MNPD-3

The majority of the damage was concentrated on the right-front corner and right side of the vehicle, where impact had occurred, as shown in Figure 60. The vehicle's steel engine hood was deformed across its entirety, and the right edge was deformed inward, as shown in Figures 60, 61, and 62. The left side of the front bumper was pushed downward. The right side of the bumper was crushed inward. The right-front fender was dented, torn front to back, and pushed upward near the

right-front door, as shown in Figures 61 and 62. The right-front cast aluminum rim was severely deformed, fractured, and crushed, as shown in Figure 62. The grille was pushed backward and fractured around the right-side headlight assembly. The right-side headlight was disengaged from the vehicle, as shown in Figure 62. The right-side, upper control arm was fractured. The right side of the radiator was pushed backward. Denting and scraping were observed across the entire right side. The right-front door was slightly ajar, and creases were found in the door's sheet metal. The right-side window glass shattered, as shown in Figures 61, 62, and 63. The right-rear door was dented and ajar. The right side of the truck bed was dented, and the fuel hatch was ajar. The right-rear wheel detached, as shown in Figure 63. The right side of the rear bumper was torn and pushed downward. The right side of the windshield had a hairline crack, as shown in Figure 67. The roof and remaining window glass remained undamaged.

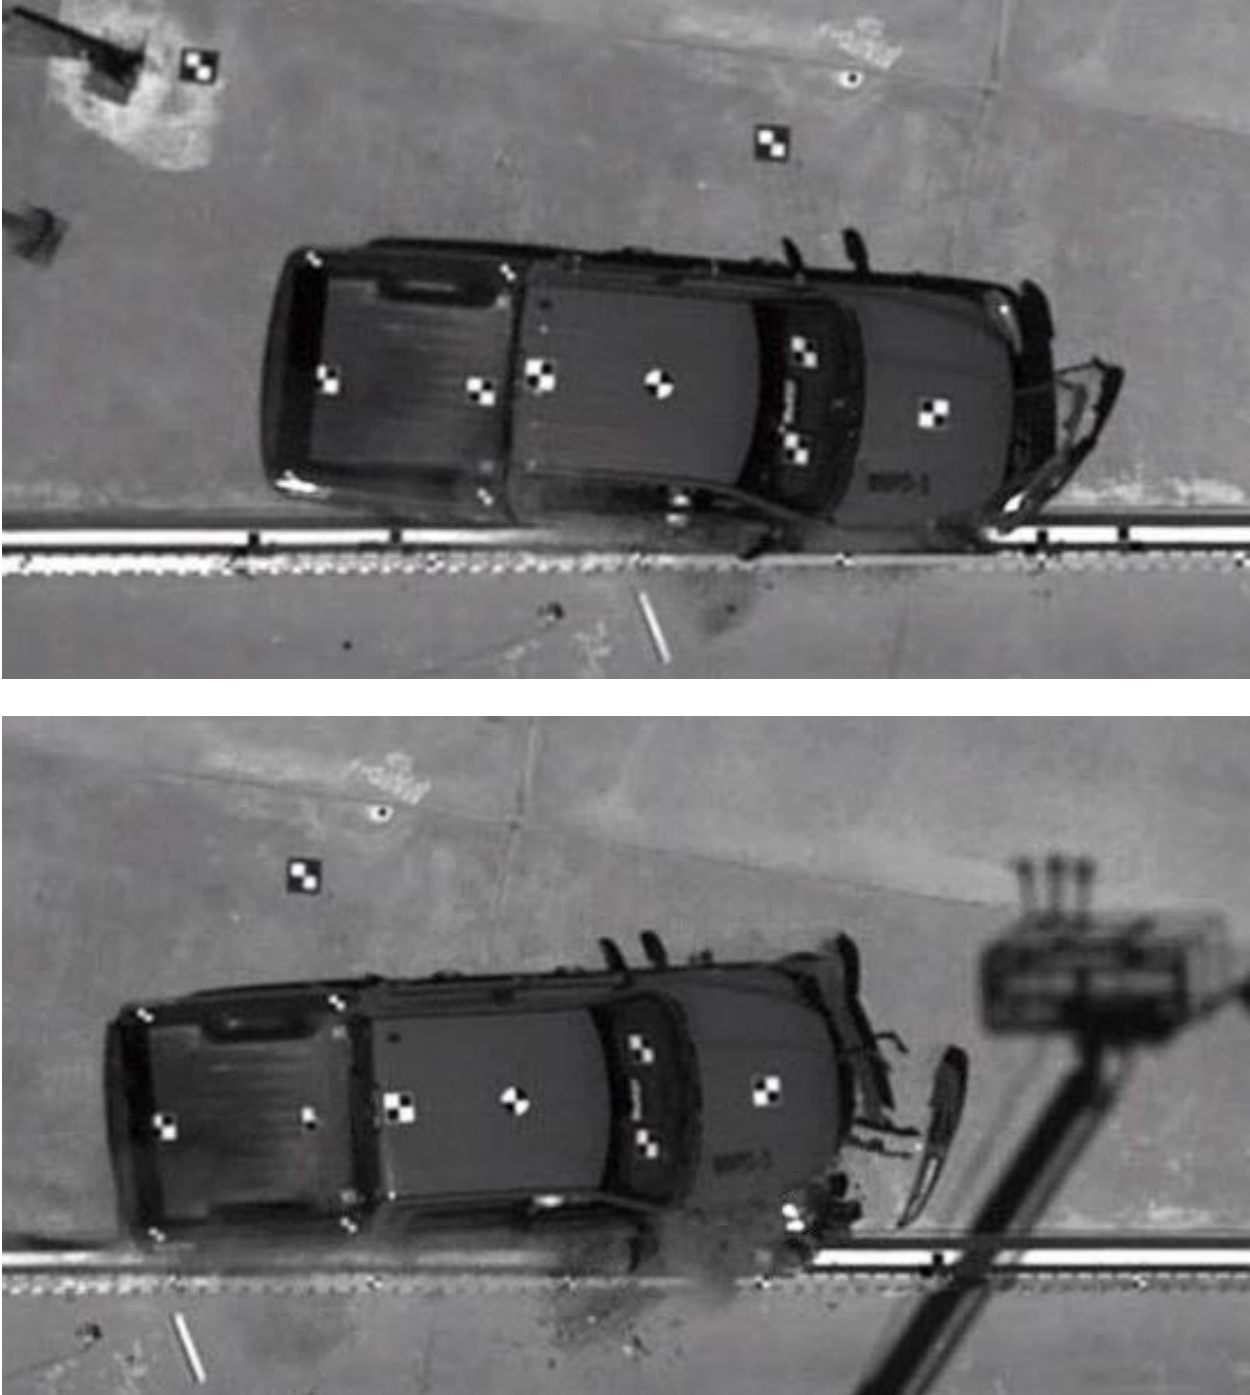
Figure 70. Overhead View of Head Ejection, Test No. MNPD-3

Onboard high-speed footage with camera views of the occupant's head movement for test no. MNP-3 are shown in Figures 68 and 69. Video analysis of the positioning of the dummy's head during test no. MNP-3 showed that head contact with the bridge railing system did not occur, as shown in Figures 70 through 73. Therefore, test no. MNP-3 was deemed to have successfully passed the MASH 2016 evaluation criteria using a stringent interpretation of the occupant risk criteria.
