*Midwest Pooled Fund Research Program  
Fiscal Years 2017-2019 (Years 27 through 29)  
Research Project Number TPF-5 (193) Supplement #106  
NDOT Sponsoring Agency Code RFPF-17-MGS-2*

## **EVALUATION OF THE MGS PLACED 6 IN. BEHIND A 6-IN. TALL AASHTO TYPE-B CURB TO MASH TL-3**

MWRSF Research Report No. TRP-03-390-20

August 27, 2020

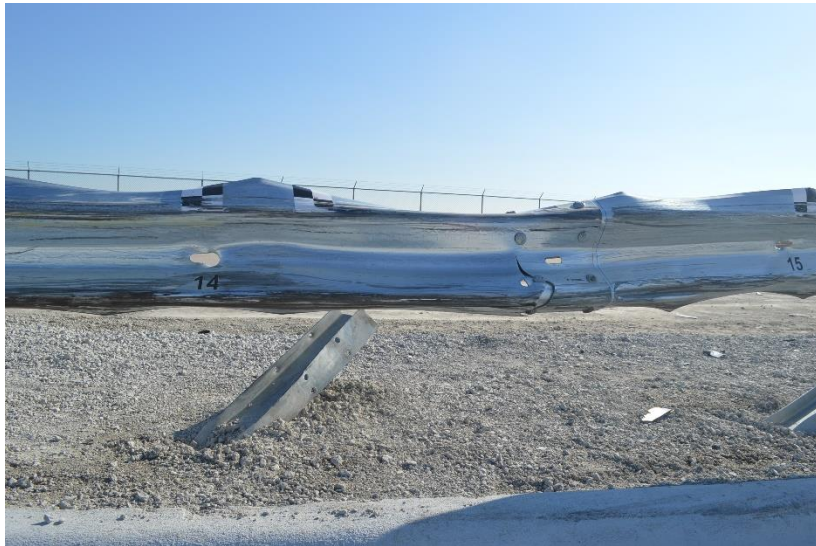
Figure 50. Guardrail Damage, Post Nos. 13 through 15, Test No. MGSC-7

The W-beam guardrail was laterally displaced between post nos. 13 and 17 and was disengaged from post nos. 14 through 17. Rail kinking and flattening was observed at multiple locations along the rail between post nos. 13 and 17. The bottom of the rail was bent upward from post no. 14 to post no. 17. The rail was partially torn at the splice location between post nos. 14 and 15. The tear extended from the bottom edge of the rail, through the lower-upstream bolt holes, and stopped near the middle of the W-beam valley.

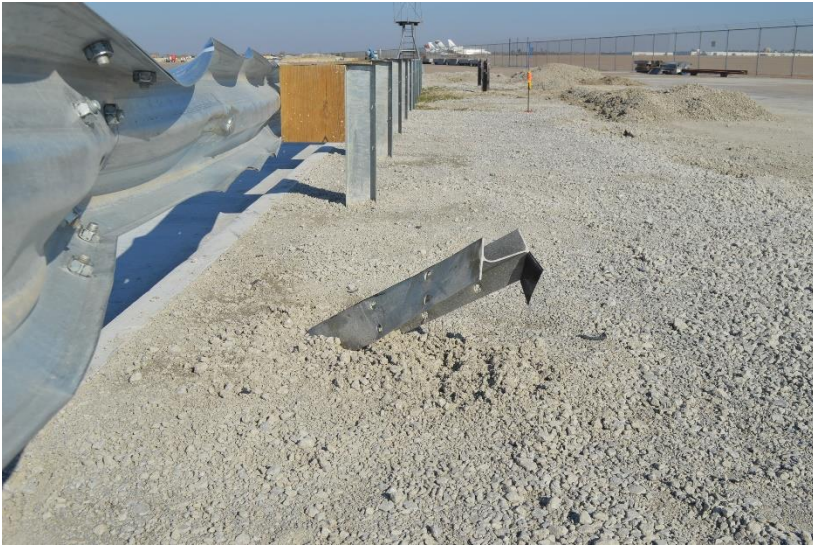
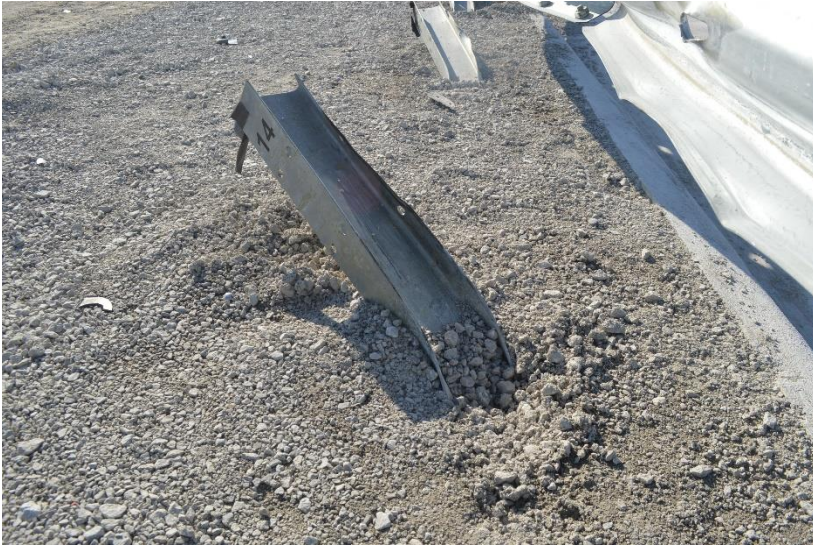
Figure 54. Post Nos. 14 and 15 Damage, Test No. MGSC-7

Post nos. 14 through 16 were bent back and downstream at ground line. Post no. 17 was bent slightly downstream and twisted to face downstream. Soil heaves and craters formed at the bases of post nos. 14 through 17. Contact marks were found on the upstream edge of post nos. 14 through 17. Post nos. 3 through 14, 16, and 17 were twisted to face downstream. Post nos. 1, 2, and 19 through 29 did not deflect and were not damaged.

Blockouts disengaged from post nos. 14 through 17. The attachment bolt of post no. 15 tore out of the upstream flange web. The blockout of post no. 18 was slightly rotated such that the top of blockout angled upstream. Minor blockout splitting was observed on post nos. 3 through 5, 7, 8, and 12. Curb damage consisted of contact marks which spanned from post nos. 13 to 15.

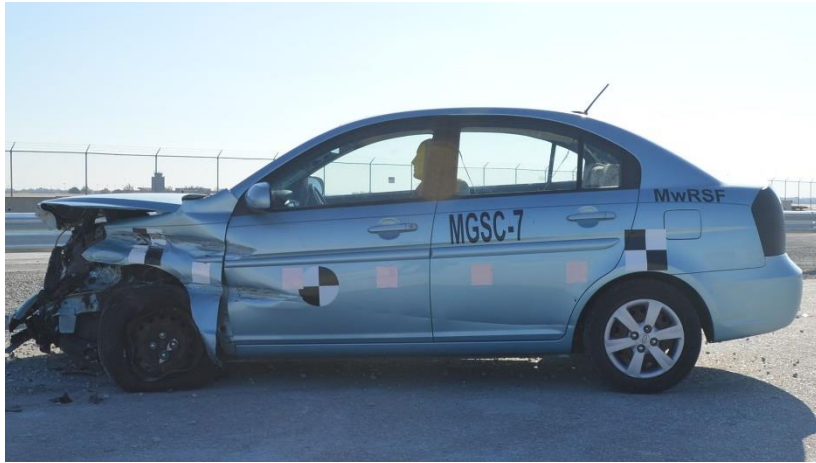
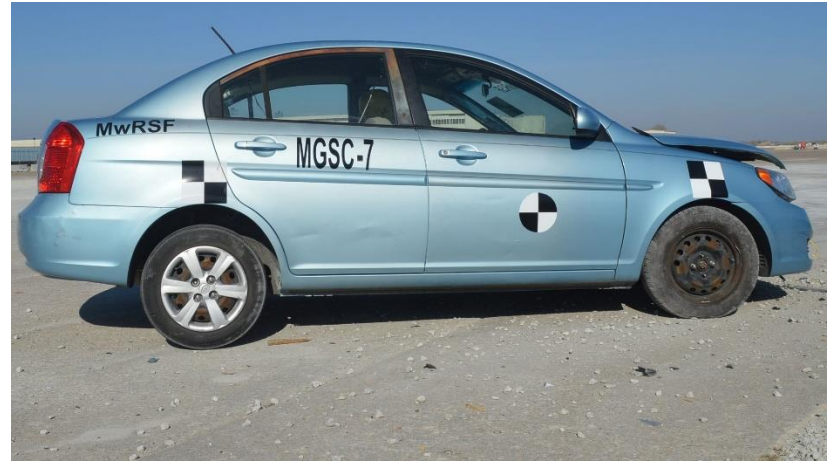
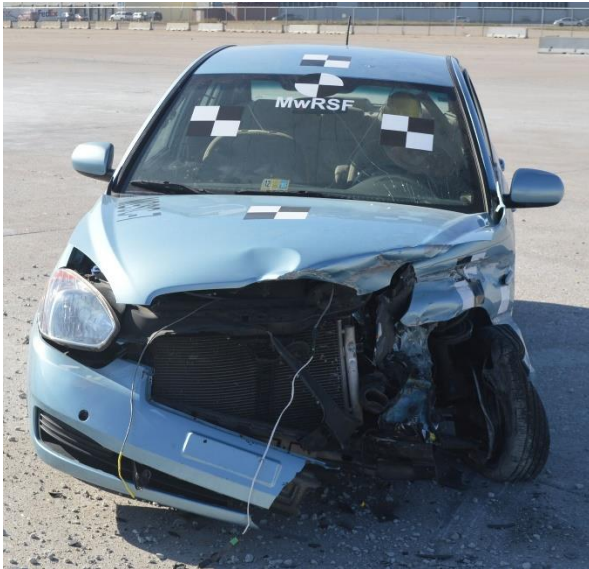
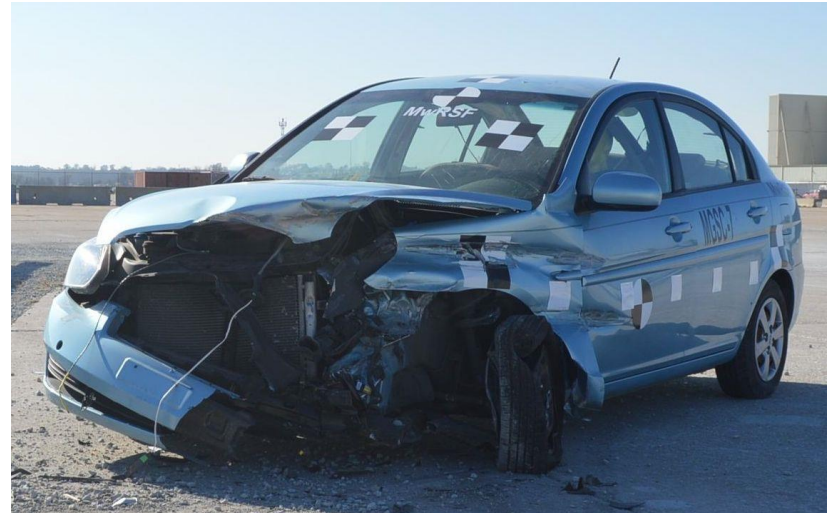
Figure 59. Vehicle Damage, Test No. MGSC-7

The majority of the damage was concentrated at the left-front corner and front end of the vehicle where the impact had occurred. The left-side of the bumper cover was ripped and detached starting 8 in. left of bumper center. The left-front bumper corner was crushed inward and down. The left-side of the radiator core support was displaced. The left-front hood was folded under and pushed in. The left-front fender was bent inward 10 in., and the bottom of the fender protruded outward 5 in. The left-front frame rail was split and crushed backward. The left-front tire was torn, and the wheel rim was bent at three locations. The left-front door was dented near the front and the latch was damaged. The windshield was cracked at the bottom left-front corner, but the roof and remaining window glass were undamaged.

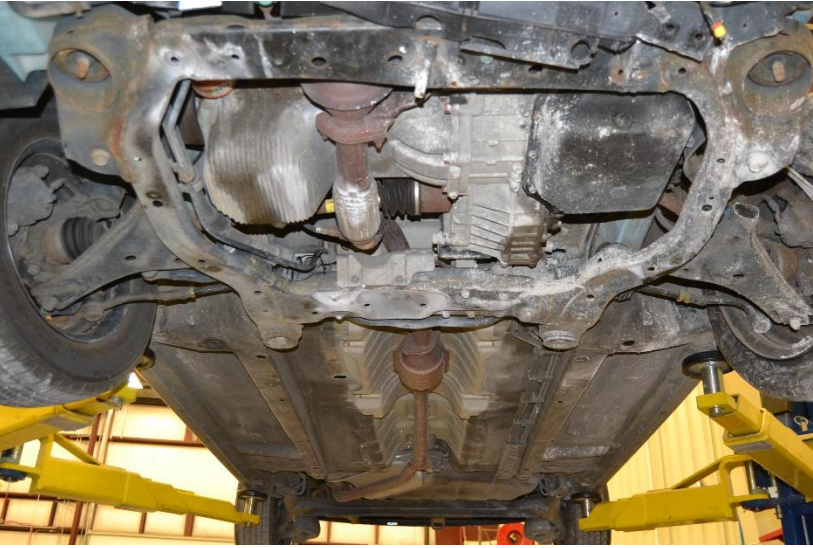
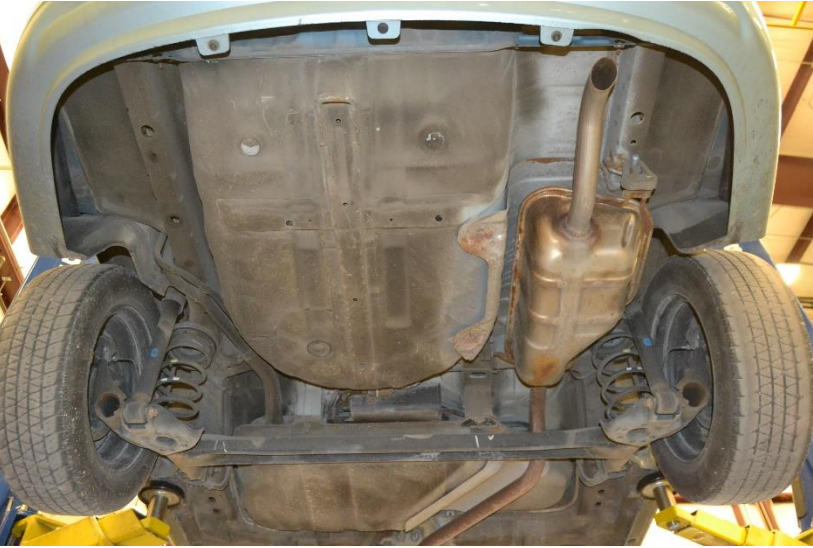
Figure 62. Vehicle Undercarriage Damage, Test No. MGSC-7

The left-front sway bar was bent upward approximately 2 in. and was in contact with the lower control arm. The left lower control arm was torn 6 in. from the center of the king pin and pulled outward 3 in. The left tie-rod was in contact with the left-front tire rim. A 2¾-in. by 6-in. scrape was found on the oil pan. Scrapes were found at multiple locations on the engine and transmission cross members. The left frame horn was crushed inward 6 in. and pushed down.

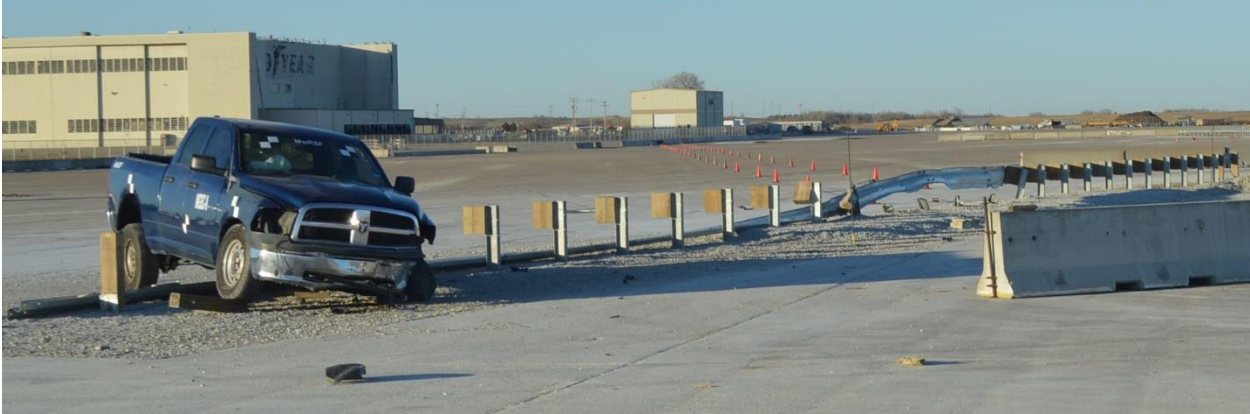
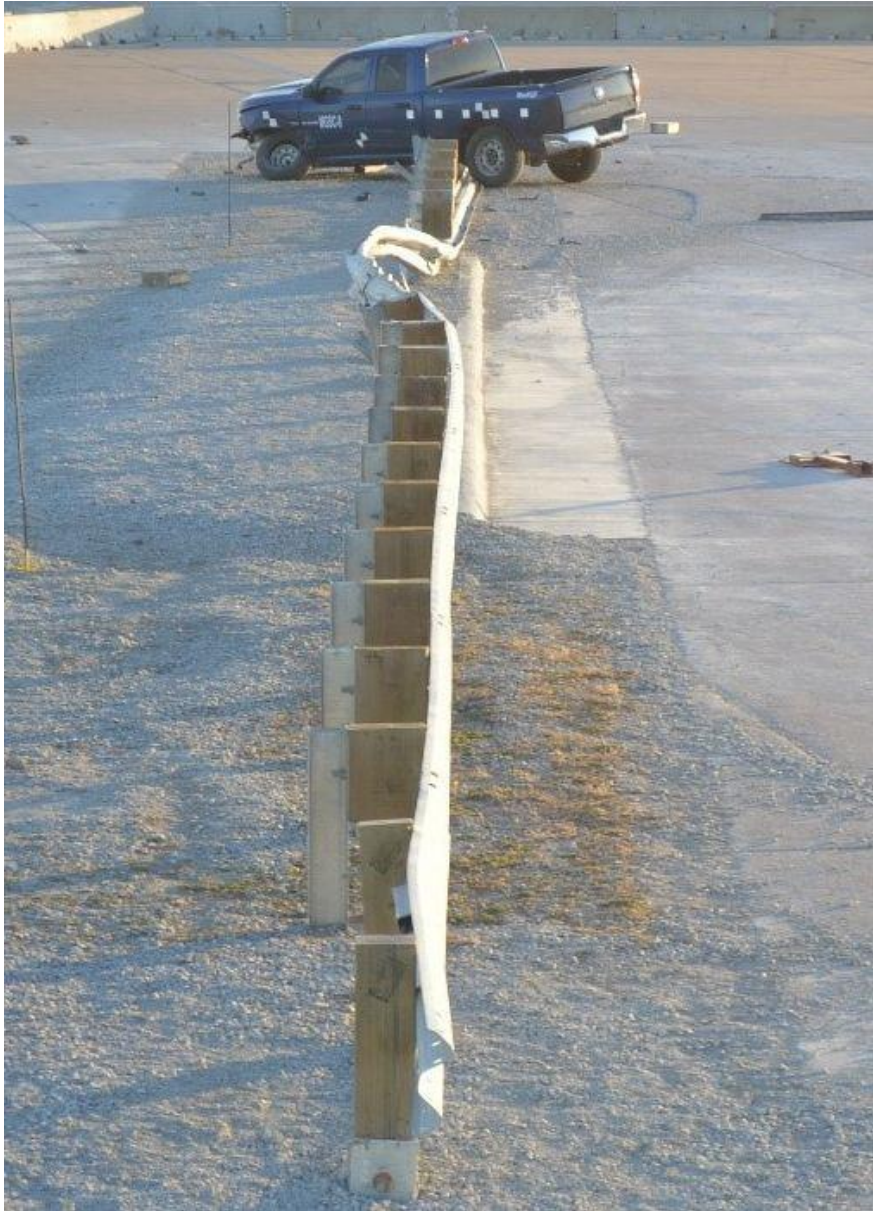
Figure 70. Vehicle Final Position and Trajectory Marks, Test No. MGSC-8

A detailed description of the sequential impact events is contained in Table 9. Sequential photographs are shown in Figures 65 through 67. Documentary photographs of the crash test are shown in Figures 68 and 69. The vehicle trajectory and final position are shown in Figure 70.

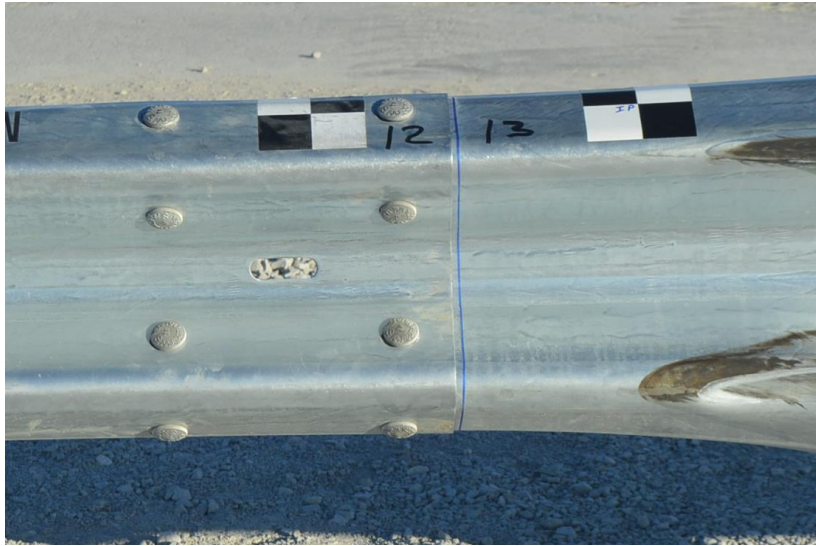
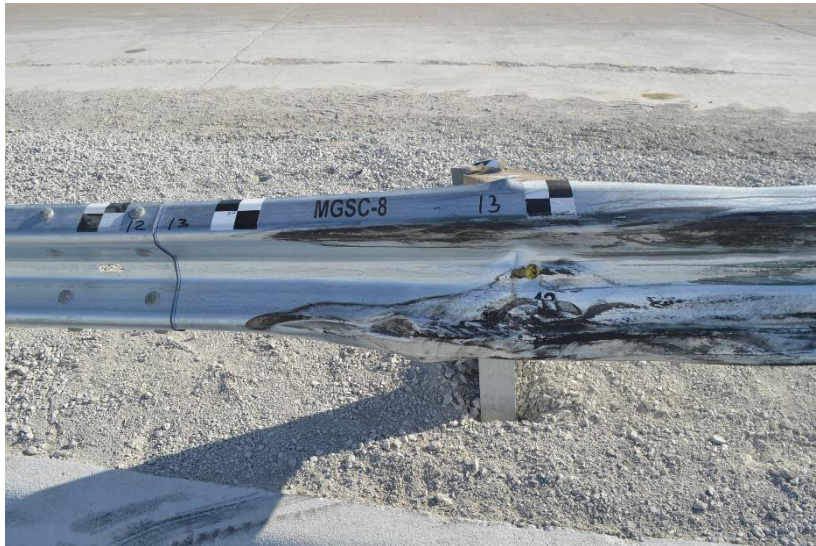
Figure 72. System Damage, Guardrail at Post Nos. 12 through 14, Test No. MGSC-8

Damage to the barrier was moderate, as shown in Figures 71 through 79. Damage to the barrier spanned from post no. 12 through the downstream anchorage of the test installation. The initial contact region spanned from 50 in. downstream from post no. 12 to 5 in. downstream from post no. 18, and the secondary impact was between post nos. 26 and 29.

Curb damage consisted of intermittent tire marks between post nos. 12 and 14. A 68-in. long tire mark was found on the top face of the curb 33 in. downstream from post no. 18. Gouges measuring 7 in., 8 in., and 23 in. were observed near post nos. 13 and 14.

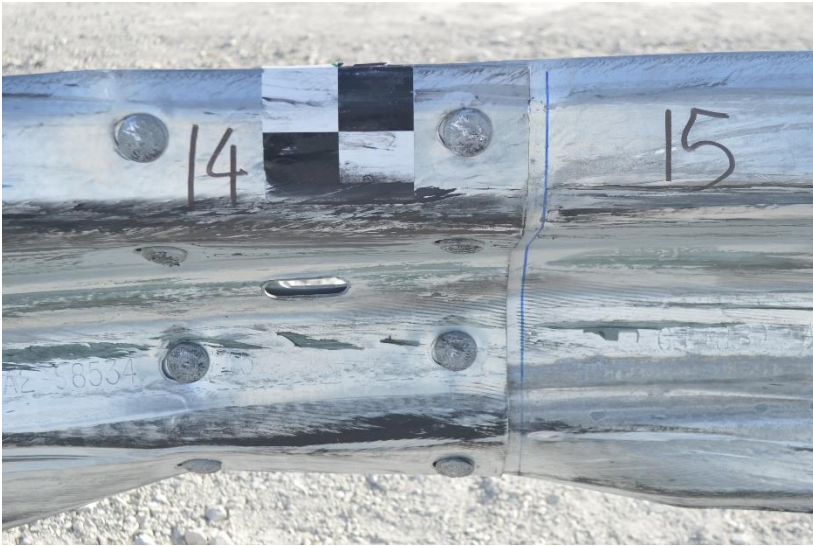
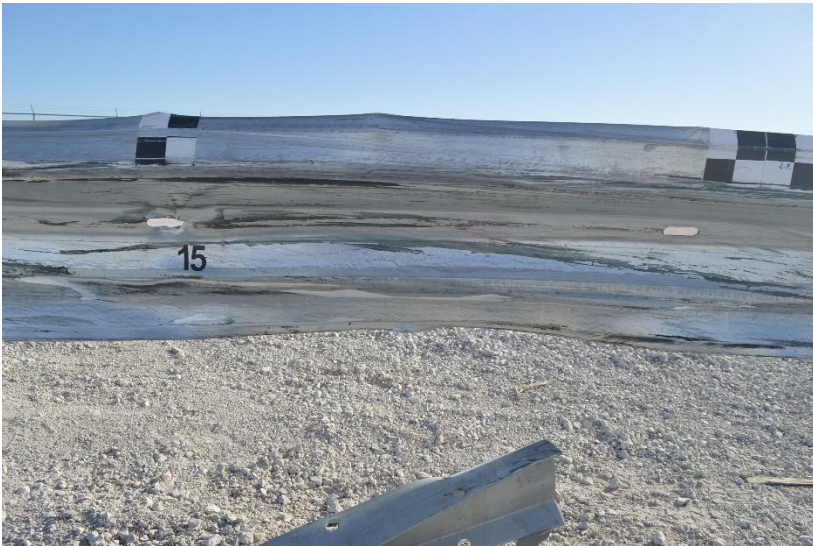
Figure 73. System Damage, Guardrail at Post Nos. 14 through 17, Test No. MGSC-8

Guardrail damage and deformations were observed along the entire length of the test installation. The rail between post nos. 1 and 2 was slightly bent toward the back side of the system due to tension at the anchorage cable connection. Bolt-slot deformation occurred at post nos. 1, 3, 5 through 7, 12, and 13, and bolt pullout occurred at post nos. 2, 4, 8 through 11, and 14 through 29. A small kink in the W-beam guardrail was observed at post no. 12. Various kinking, flattening, and bending of the guardrail was found continuously between post nos. 13 and 18. The rail was folded under along its bottom edge at the center of post no. 13 and 74½ in. downstream from post no. 13. The rail was flattened beginning 3¾ in. downstream from post no. 13 spanning to the center of post no. 16. Kinking occurred at many locations at the top and bottom edges of the rail between post nos. 13 and 19. The rail buckled 6¼ in., ¾ in. downstream from post no. 17. Additional flattening occurred along the base of the rail 1½ in. downstream from post no. 17 for a length of 41 in. The rail was bent 5¼ in. upstream and 5¼ in. downstream from post no. 18. The rail buckled 4¼ in and 5⅛ in. downstream from post no. 18. Several additional kinks were found along the rail from post no. 22 to the end of the system.

The maximum lateral permanent set of the barrier system was 26¾ in., which occurred on the guardrail located at post no. 15, as measured in the field. The maximum lateral dynamic barrier deflection was 39.4 in. measured on the guardrail at post no. 16, as determined from high-speed digital video analysis. The working width of the system was found to be 48.5 in., also determined from high-speed digital video analysis. A schematic of the permanent set deflection, dynamic deflection, and working width is shown in Figure 80.

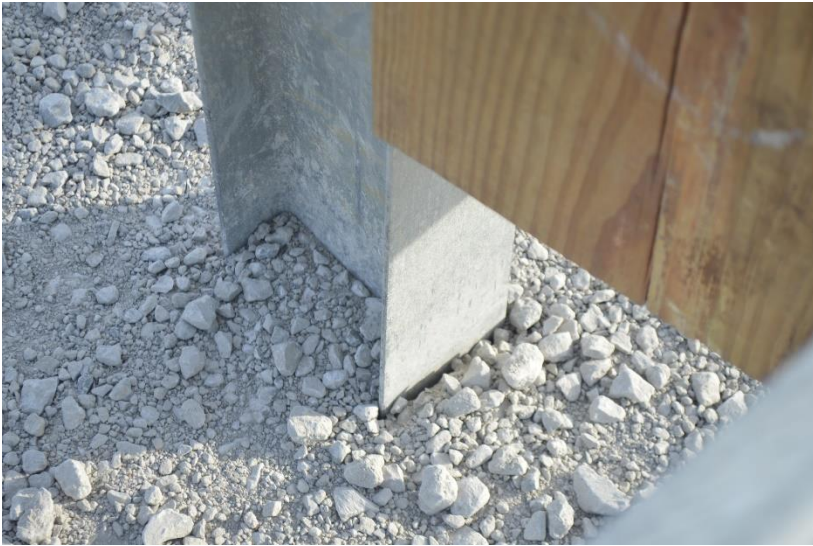
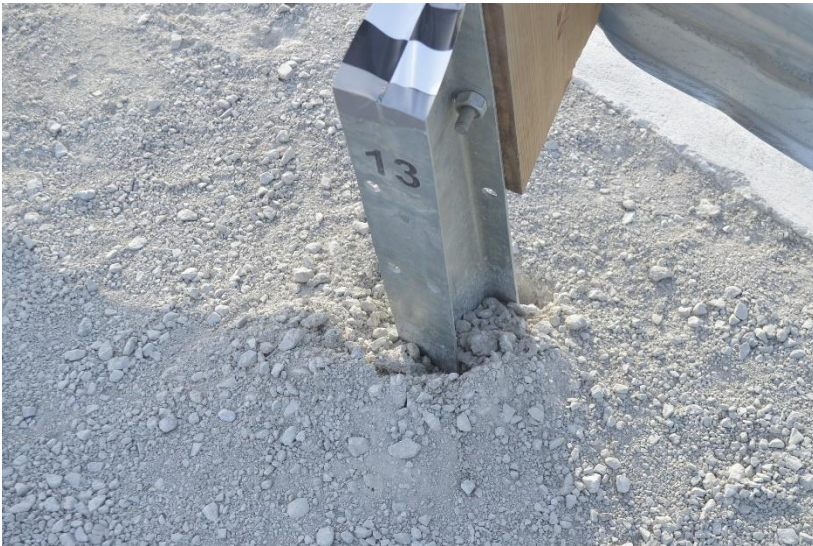
Figure 77. System Damage, Post Nos. 12 through 15, Test No. MGSC-8

The most significant post displacements and deformations spanned from post no. 13 to post no. 18. Soil gaps formed at the bases of post nos. 6 through 8, 10, 12, and 22. Soil heaves and craters formed at the bases of post nos. 14 through 19, and additional soil heaves were found at post nos. 26 and 27. Post no. 13 was bent backward and twisted downstream. Blockouts disengaged from post nos. 14 through 17. Each post in this range was bent backward and downstream in addition to being twisted to face upstream. Post no. 18 was bent backward and downstream while being twisted to face downstream. The blockouts of post nos. 18 through 23 had rotated about the attachment bolt. Post nos. 26 and 17 were bent backward and downstream, and post no. 28, which was a BCT post within the downstream anchorage, fractured off at ground level.

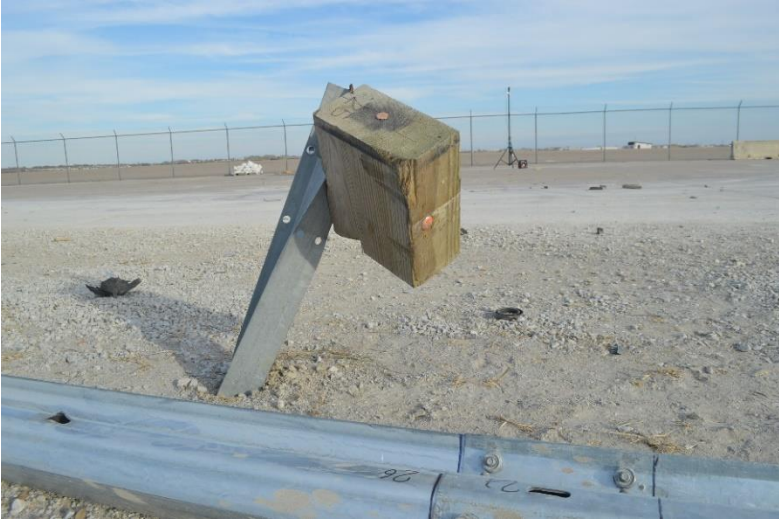
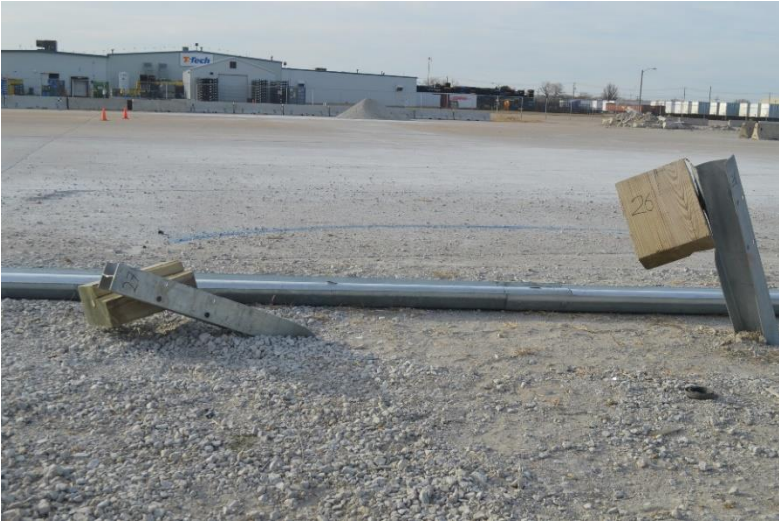
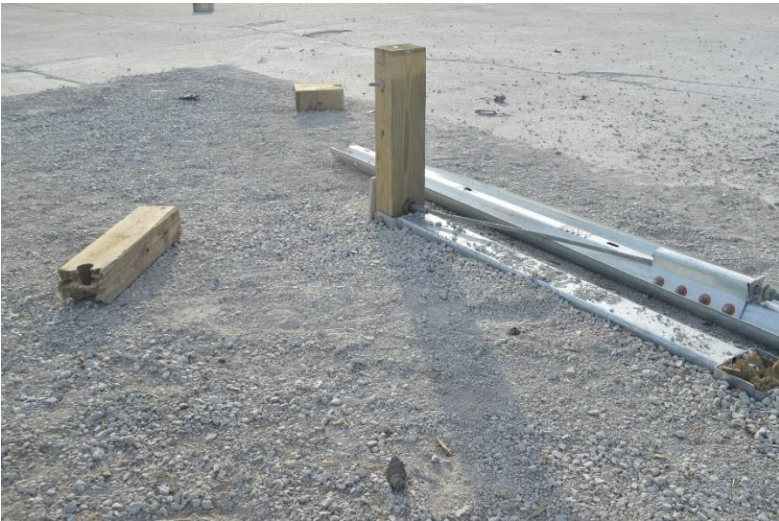
Figure 79. System Damage, Post Nos. 25 through 29, Test No. MGSC-8

- The override occurred as a result of a secondary impact into the system. The vehicle had already been contained, redirected, and exited the system during the initial MASH-specified impact. The evaluation criteria in MASH are not intended for use on secondary impacts that occur after the vehicle exits the system.
- The secondary impact was into a system that had already been damaged by the initial impact. Specifically, the guardrail had been pulled from the downstream posts during

- Although the rail had detached from the posts, the cable anchorage was still intact, so the guardrail anchorage had not failed.
- The secondary impact occurred four posts from the end of the system. Previous research on the downstream anchorage used in the test installation showed that the end of length-of-need (i.e., the farthest downstream point in which a vehicle would be redirected) was six posts from the end [11-14]. Thus, impacts downstream from the sixth post from the end, such as the secondary impact witnessed during test no. MGSC-8, would be expected to result in the guardrail gating and the vehicle traveling behind the system.

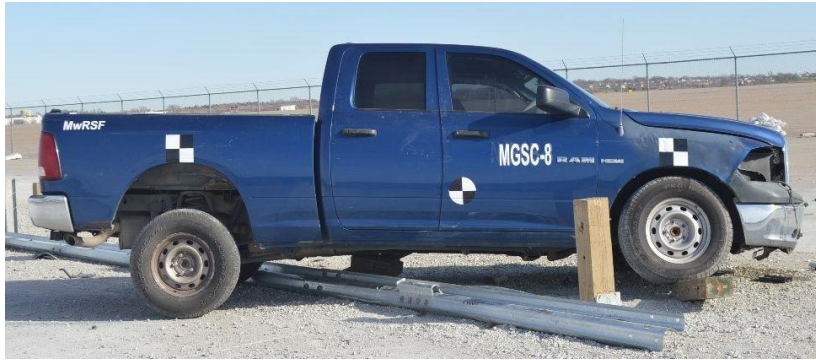
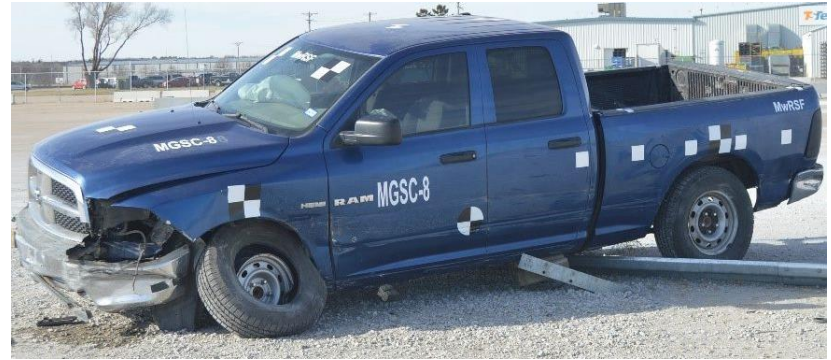
Figure 81. Vehicle Damage, Test No. MGSC-8

The majority of the damage was concentrated at the left-front corner of the vehicle where impact occurred. The left-front bumper was deformed inward toward the engine, and the grille was partially fractured and disengaged from the vehicle. Both front headlights were disengaged. The left-front fender was bent and torn, and the left-front tire sidewall was torn. The wheel rim was bent at several locations. Several minor dents were found on both the left-front and left-rear vehicle doors. Scrapes extended from the left-front fender to the rear bumper along the left side of the vehicle. The left-rear bumper was dented inward. The windshield was cracked at mid-height on the right side due to contact from the vehicle airbag. Additional cracks in the windshield extended outward from the bottom left corner of the windshield. The roof and remaining windows were undamaged.

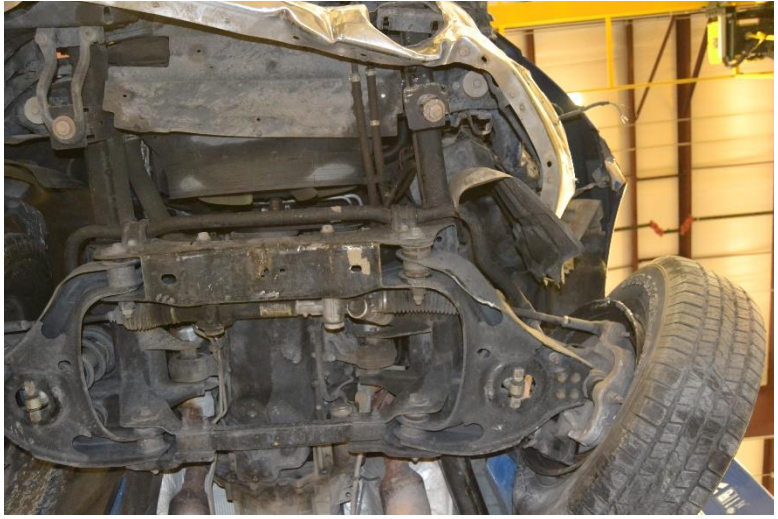
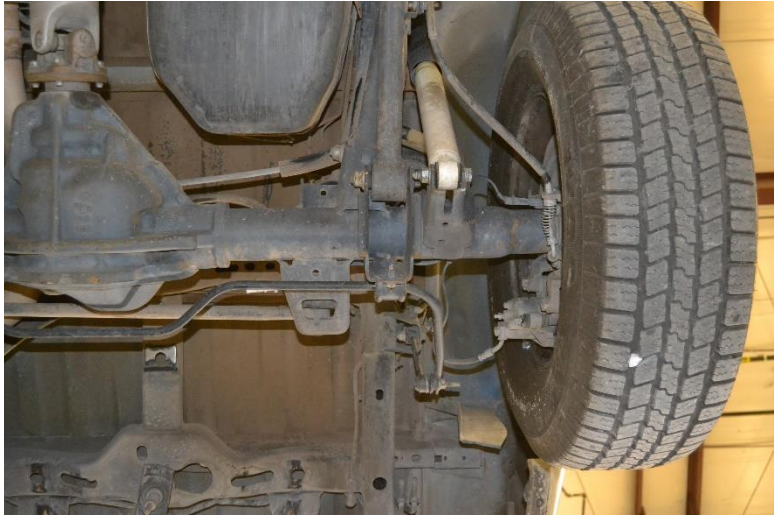
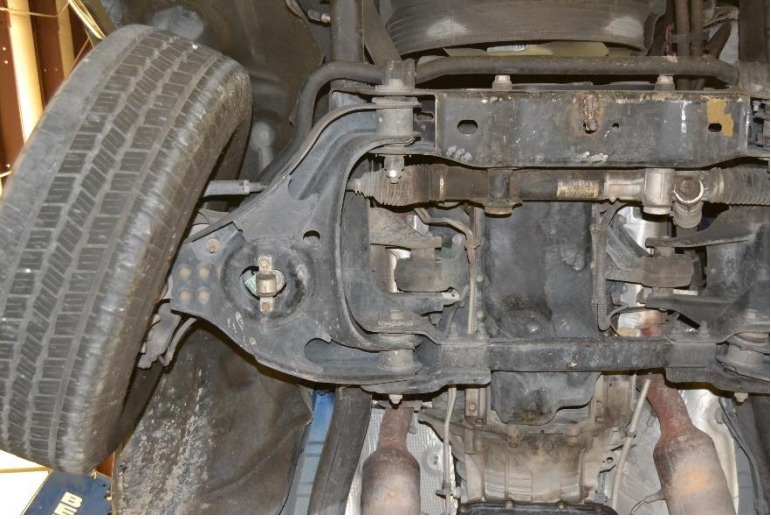
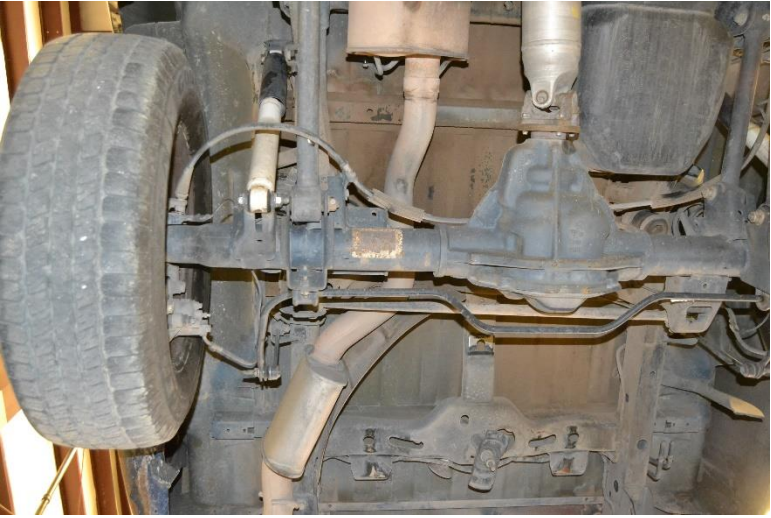
Figure 85. Vehicle Undercarriage Damage, Test No. MGSC-8

Damage to the vehicle's undercarriage was minimal. The right-side lower control arm was bent in approximately ½ in. and disengaged from the front mounting point, and the right-front bumper mounting plate was bent.
