**MARYLAND DEPARTMENT OF TRANSPORTATION
STATE HIGHWAY ADMINISTRATION**

**Highway Rock Cut Inventory and Failure Potential,
Allegany County, Maryland**

FINAL REPORT

May 2020

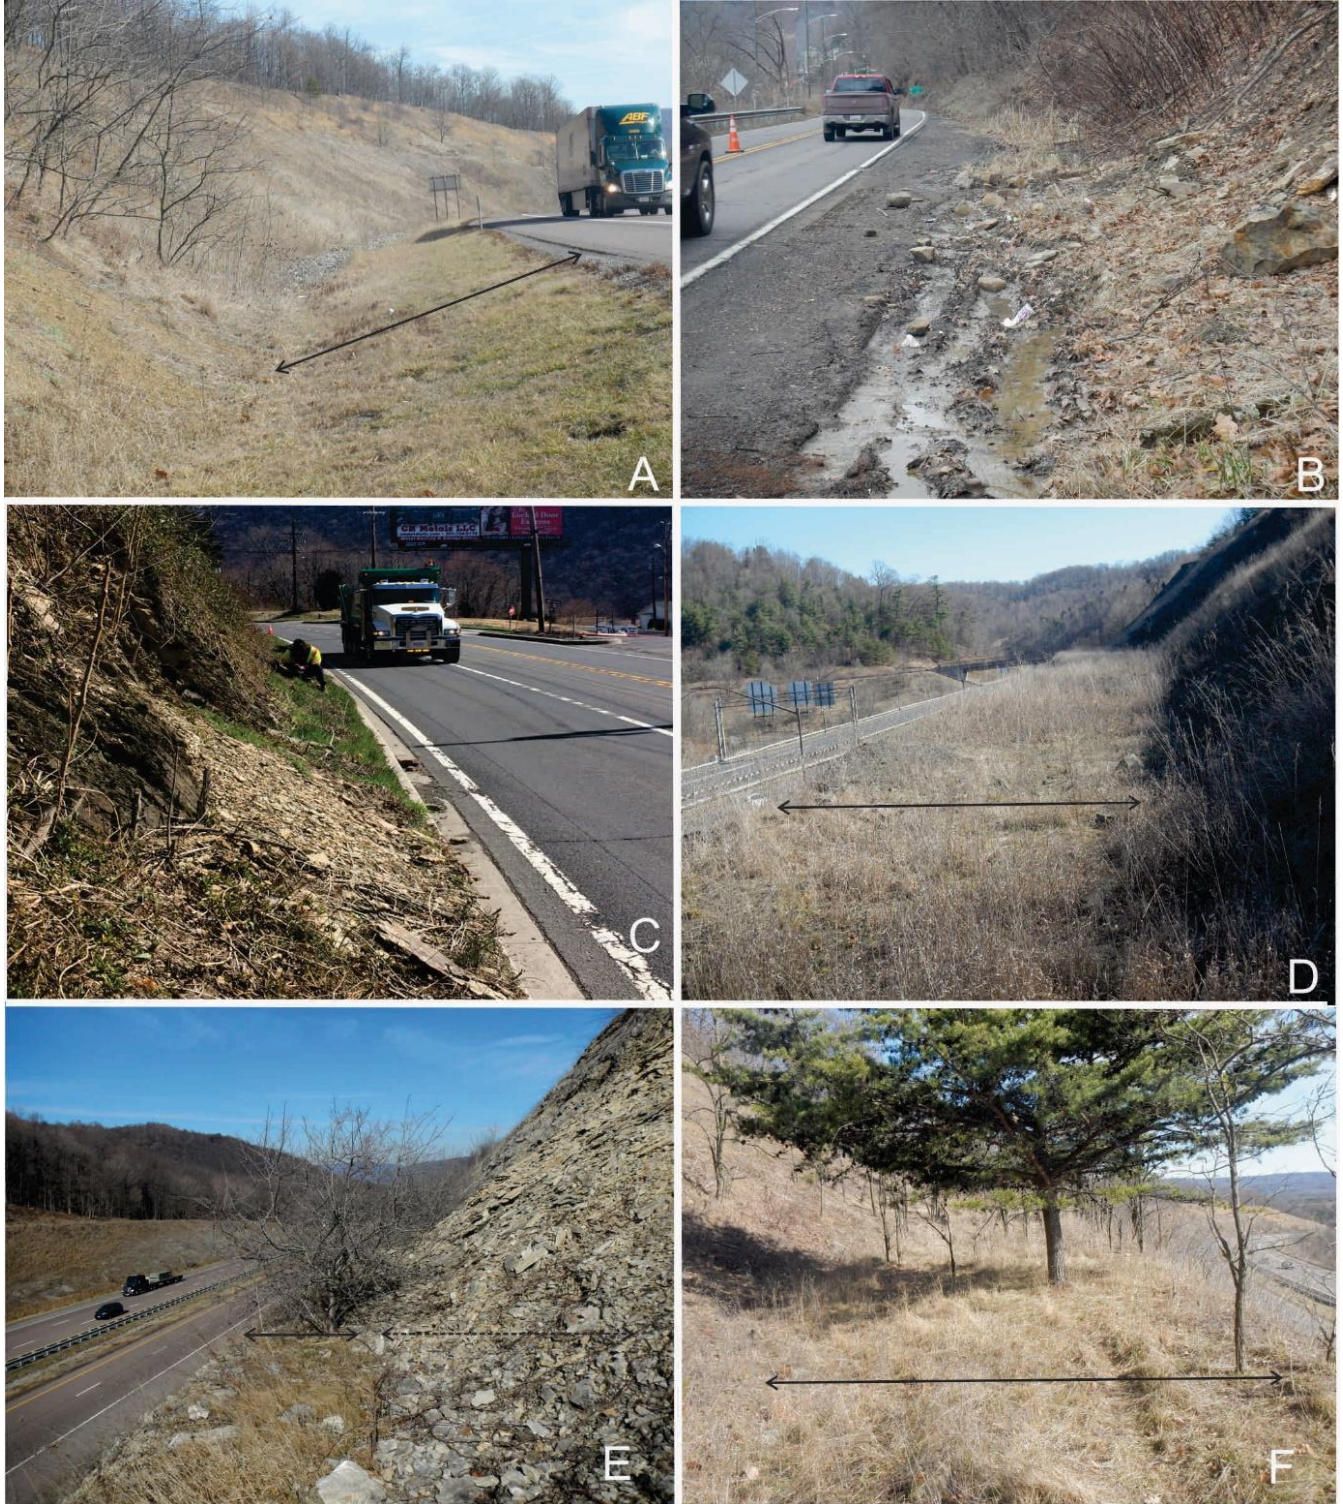
The presence or absence of benches is generally dictated by the height of the exposure. Those exposures less than twenty feet in height rarely have benches. Those greater than forty feet in height typically possessed at least one level of elevated bench (Figure 5D). Although benches

represent elevated catchment areas, when they become filled with debris they can themselves become a launching factor, propelling rolling debris on to the roadway, and beyond roadside catchment (Figure 5E). Thus, filled benches switch from a safety factor to a hazard. When benches become filled, they also tend to spawn vegetation growth (Figure 5F).

Figure 5. Benches and catchments styles and character. A, Catchment shoulder sloping away from roadway. B, Flat catchment shoulder. C, Shoulder inclined towards roadway. D, Elevated catchment bench clear of debris. E, Elevated bench nearly filled with debris. F, Elevated bench with woody vegetation.

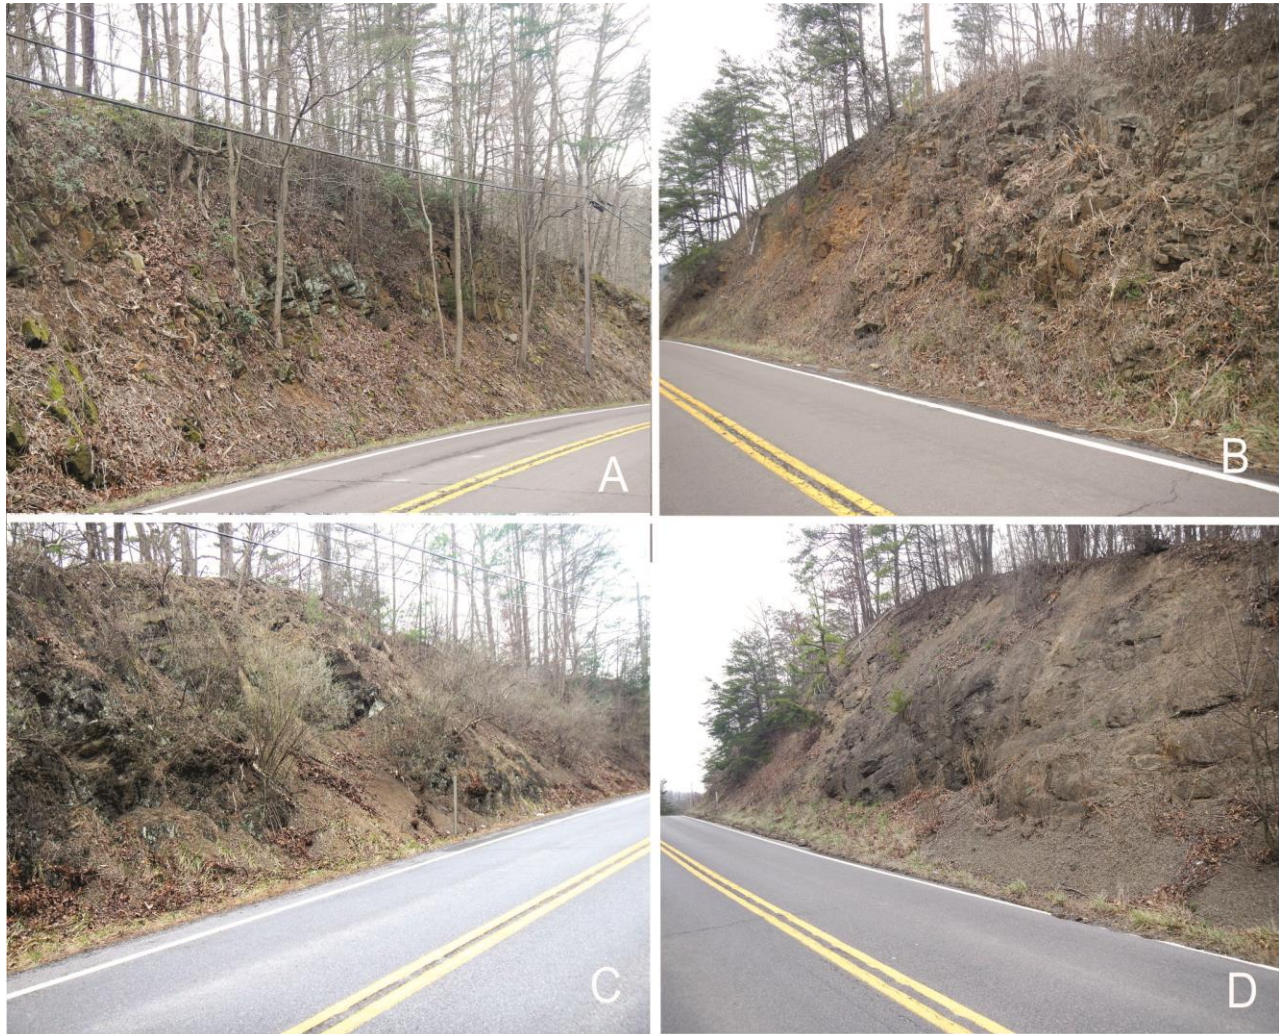
Figure 8. Differences in vegetation between north-facing and south-facing slopes. A, Rooted tree saplings and grasses developed on a north-facing slope of sandstones of the Oriskany Formation. B, South-facing slope from the same road cut as A. This face contains grasses and few shrubs. C, Highly vegetated north-facing slope on shales of the Brallier Formation. Vegetation includes rooted trees, saplings, shrubs, and grasses. D, South-facing slope corresponding to the location shown in C. This slope exhibits only sparse grasses.

As a general observation, vegetation of all types tends to be better developed both where water is present on the outcrop. North-facing slopes maintain moisture that allows increased vegetation development. Branson and Shown (1989) proposed that north-facing highway slopes tended to contain shrubby vegetation, while south-facing slopes more often displayed grassy and herbaceous flora (Figure 8). These authors opined that the cause for these vegetation differences was related to the differing levels of solar radiation. They maintained that south-facing slopes were associated with increased levels of sunlight that resulted in elevated temperatures, reduced moisture, and a reduced potential for plant colonization and growth. Furthermore, these authors suggested that increased duration of freeze-thaw potential on north-facing slopes led to greater moisture availability in those locations. It is in this position that most lichens and mosses were observed during the current study (Figure 9A). In contrast, the presence of grassy vegetation on south-facing slopes tended to be present where water was preserved in fractures and partings of the bedrock units (Figure 9B). Saplings and rooted trees were generally found to verify Branson and Shown's (1989) findings in that they tended to be better established on the north-facing exposures at road cuts (Figures 8 C, D).

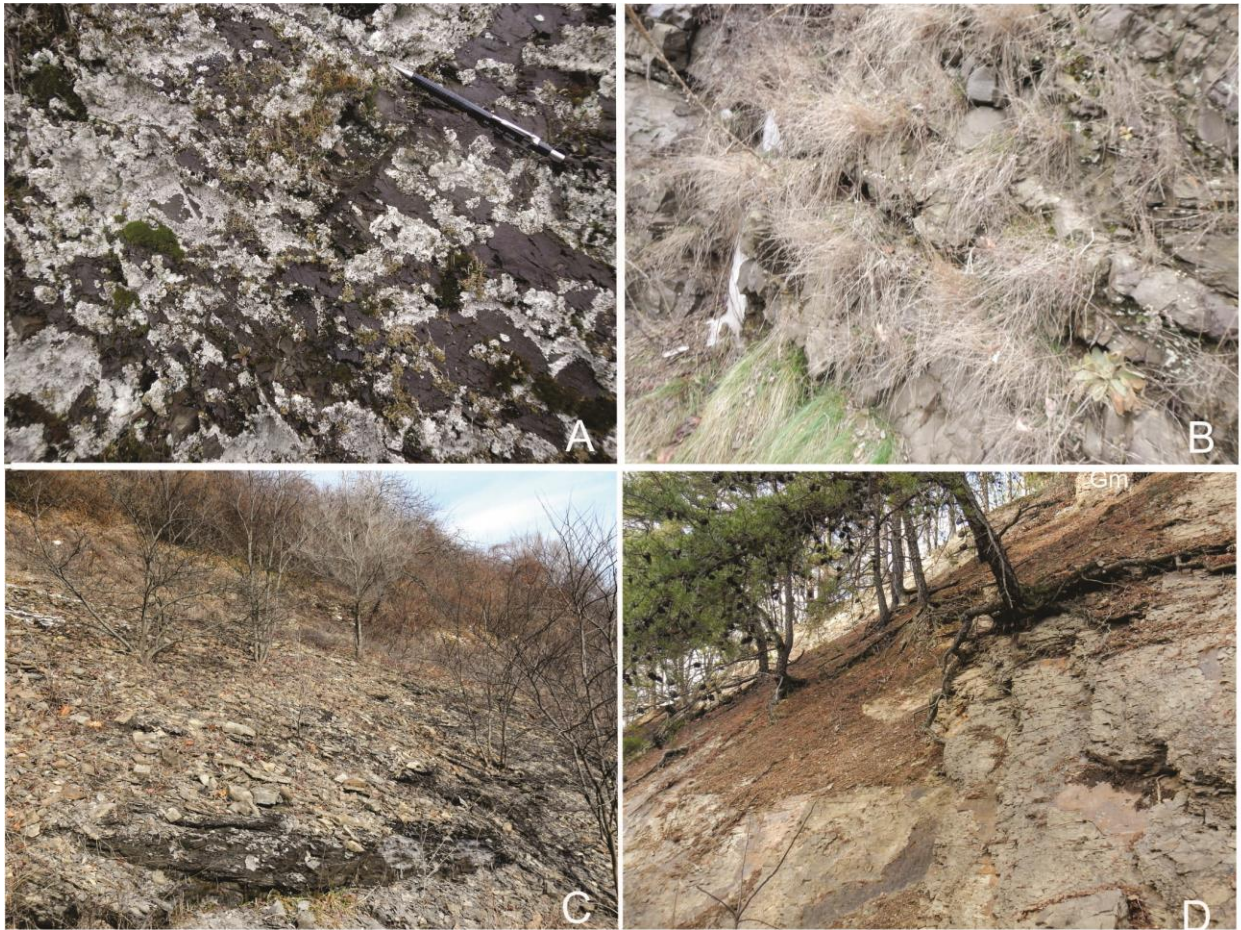
Figure 9. Types of vegetation on roadside slopes. A, Lichens and mosses. B, Grasses in clumps or coatings. C, Rooted saplings. D, Embedded and rooted tree trunks.

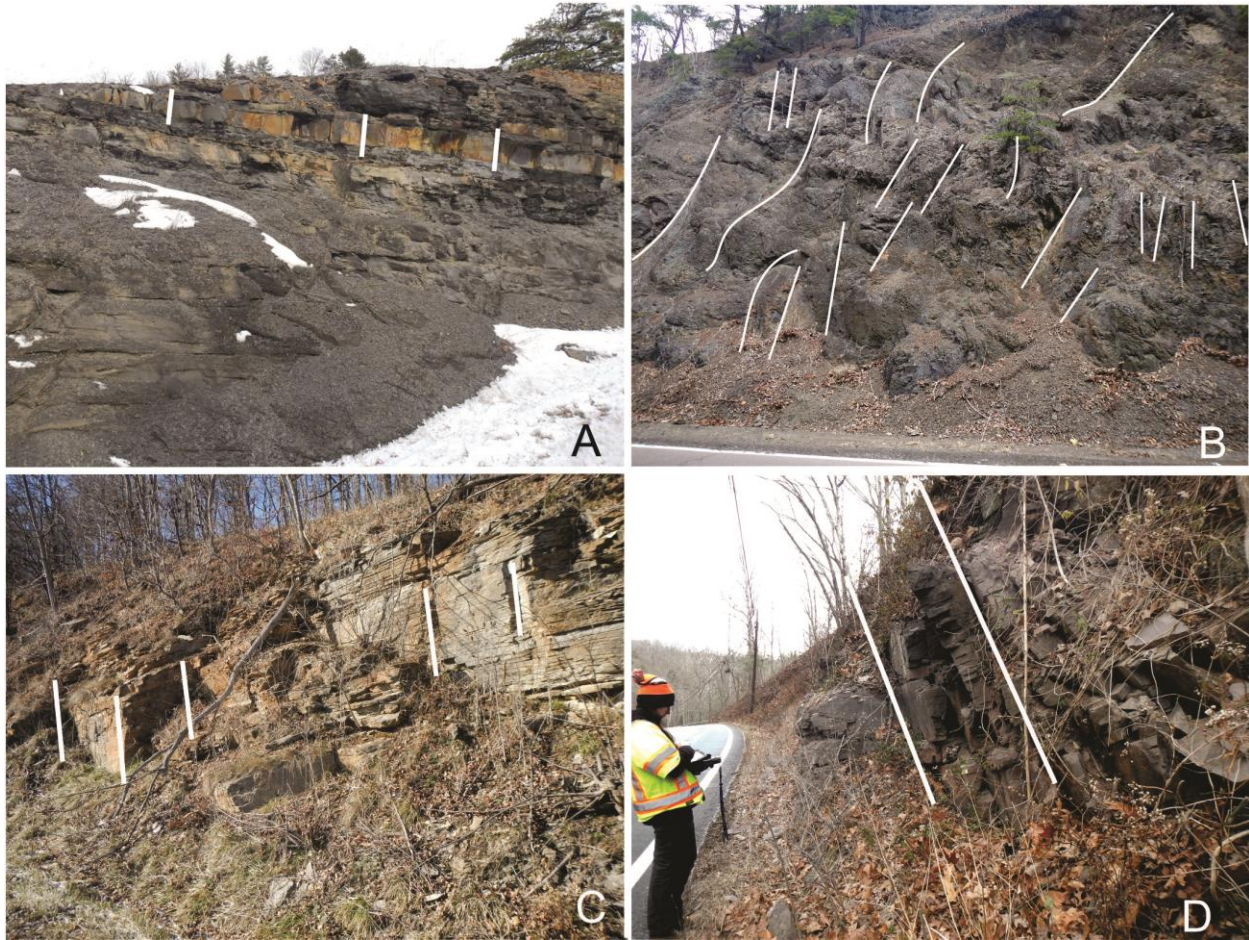
The orientation of joints or other fracture systems with respect to the roadway is important to note because such failure planes dictate a propensity and direction of slope failure. For the current study, joints and fractures that dipped away from the roadway were considered adverse while those dipping towards the highway were recognized as favorable (Figure 11). Although this may seem contrary to general reasoning, it was theorized that the adverse orientations were more likely to produce rockfalls and favorable more likely to yield rock slides and rock rolls. Vanderwater et al. (2005) noted that using the terms *favorable* and *adverse* for rockfall hazard was “ambiguous.” This is because the term *favorable* when used for fracture plane characterization implies favorable as stable, and did not necessarily represent favorability for failure.

Figure 11. Failure plane character. A, Discontinuous and favorable orientation. B, Discontinuous and random orientation. C, Discontinuous and adverse orientation. D, Continuous and adverse orientation.

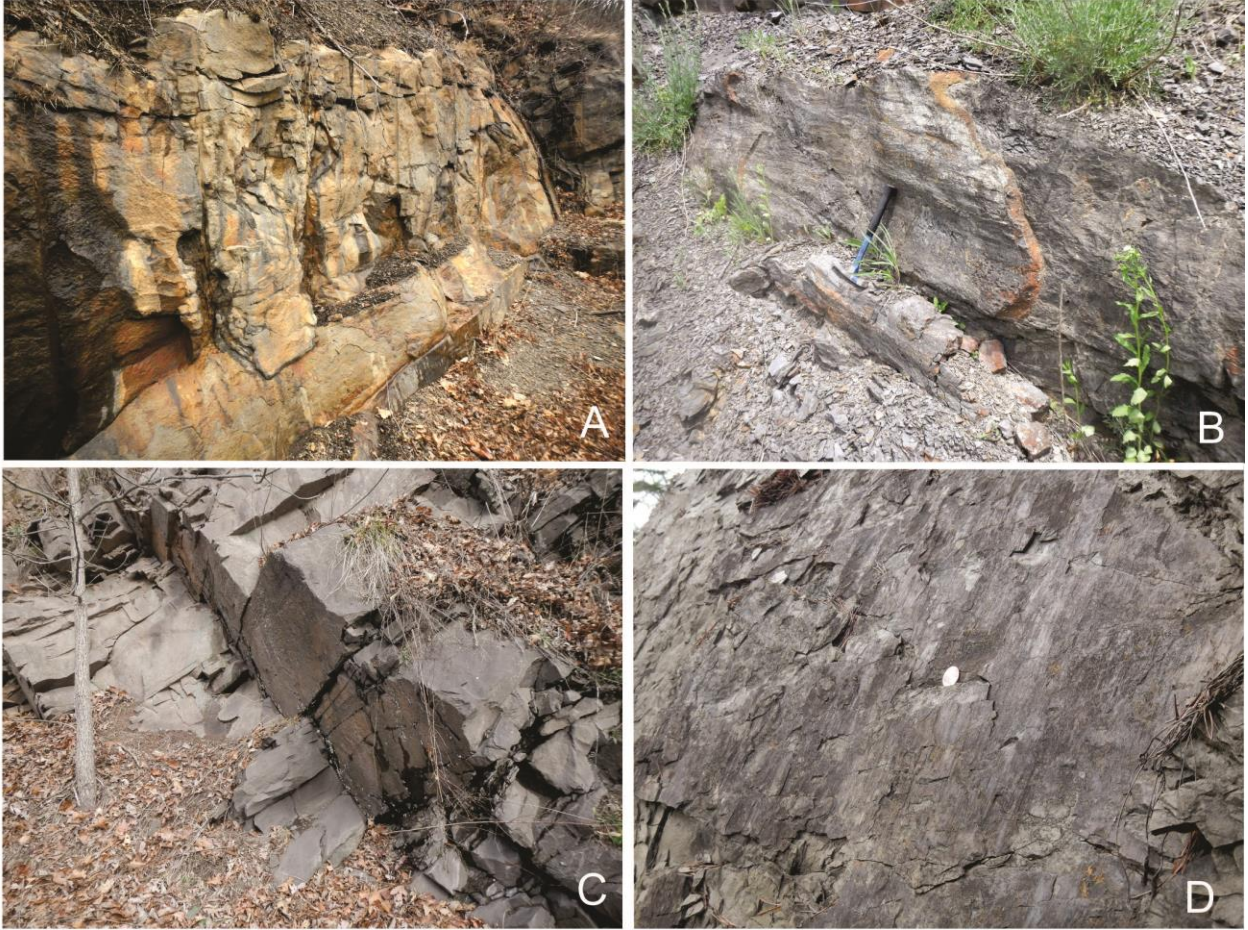
character is considered important because it provides insight as to the potential for further movement along the observed discontinuity. Rough surfaces have a rough and irregular texture to the touch (Figure 12A). Undulating surfaces suggest a level of shearing and movement along the surface (Figure 12B). These surfaces tend to be rounded rather than smooth and planar. Planar surfaces typically display smooth surfaces that may be parallel to one another (Figure 12C). Lastly, slickenside surfaces are tectonically smoothed fractures and suggest that movement parallel to the fracture surface has taken place (Figure 12D).

Figure 12. Rock friction. A, Rough and irregular. B, Undulating. C, Planar. D, Slickensides.

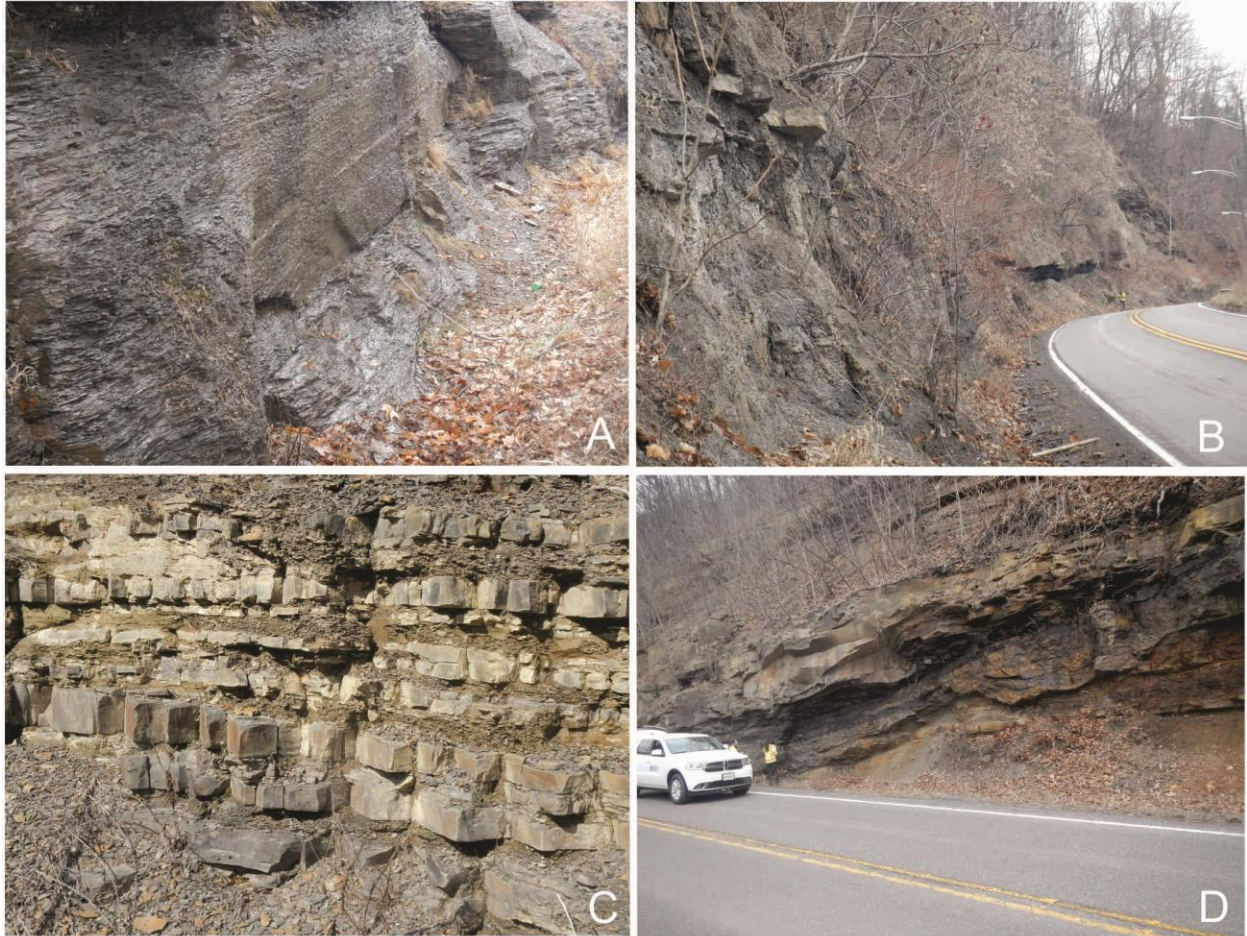
subvertical wall with little overhang. In contrast, interbedded lithologies provide varying levels of both weathering and erosion. This variation is known as differential erosion (differential weathering of Vanderwater et al., 2005). The pervasiveness of interbedding is also a key component in the potential for the number and prominence of differential erosion features (Figures 13B, C). With greater differential erosion there is an increased likelihood for the formation of overhanging ledges (Figure 13D), which therefore present greater potential for both rockfall and rock roll events.

Figure 13. Differential erosion. A, Minor differential erosion within massive siltstone. B, Occasional differential erosion along sandstone interbeds. C, Many differential erosion surfaces within interbedded sandstone and shale. D, Major differential erosion at the contact between the Pottsville and Mauch Chunk formations.

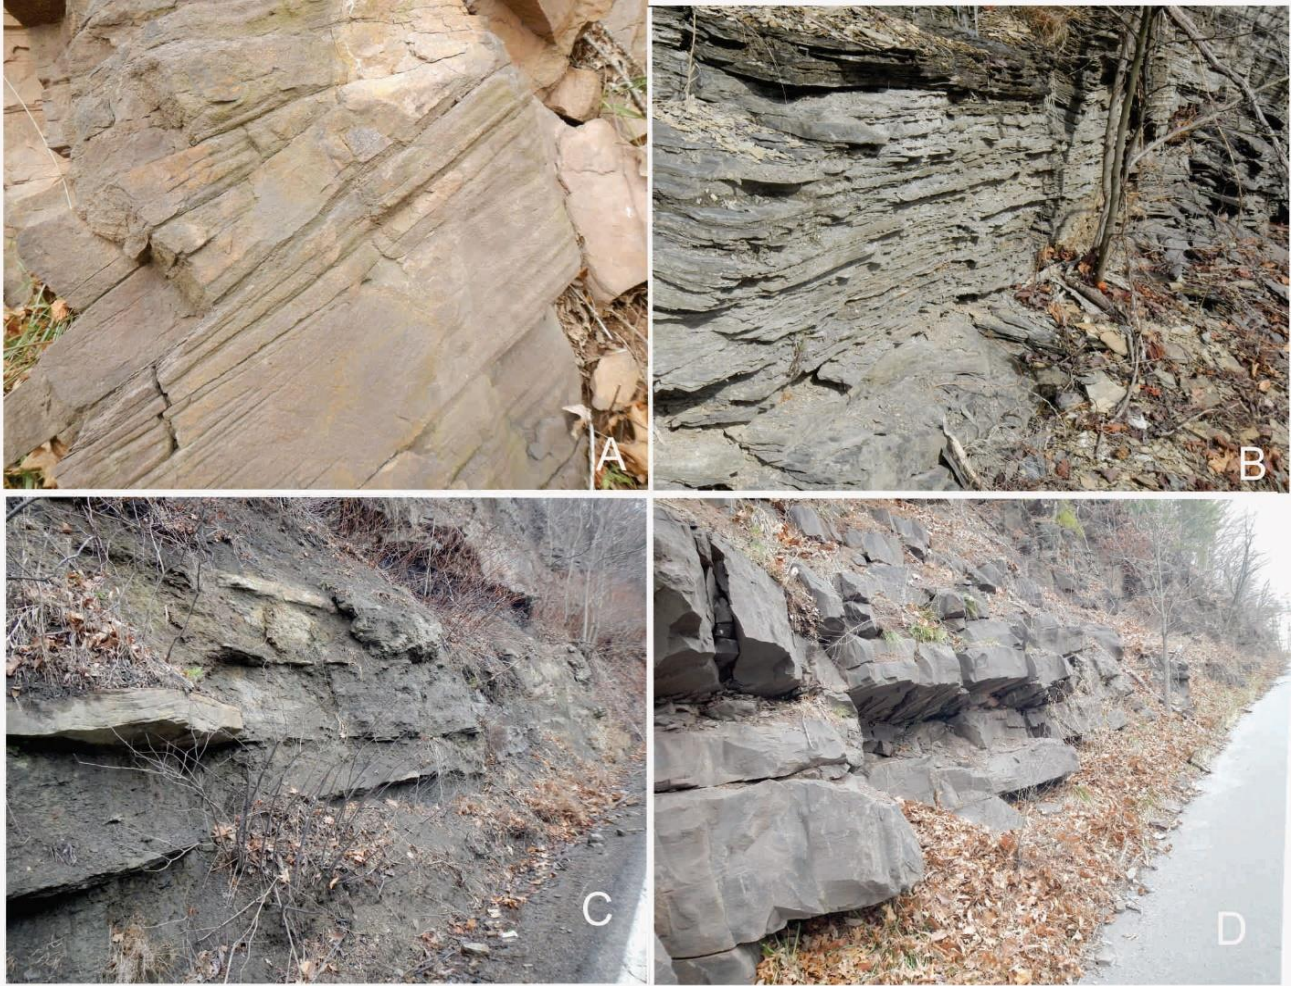
Weathering character is closely related to differential erosion (Figure 14). While Vanderwater et al. (2005) considered these to be the same factor, they will be treated separately herein. Newly created exposures generally present no substantial weathering characteristics. However, with age, rock exposures develop features as a result of weathering. No study outcrop in Allegany County was considered freshly exposed. Massive rock exposures that are susceptible to chemical and physical weathering, have been exposed for a considerable time, or are oriented so that weathering is more effective, tend to display irregular surfaces (Figure 14B). Many more outcrops were categorized as being weathered in relief. These are especially common within limestone strata where solution has removed shaly or more soluble layers along stratification (Figure 14C). The final category, weathered with overhanging ledges, is considered typical of thick

interbedded lithologies, where more massive intervals of rock are interbedded or underlain by more easily removed lithologies (Figure 14D). In this case, weathering produces overhanging ledges created by major differential weathering and erosion. Overhanging ledges appear to be more prevalent where higher levels of freeze-thaw cycles and precipitation are present. Thus, rock exposures of the Appalachian Plateaus Province show greater levels of differential weathering.

Figure 14. Weathering of outcrop. A, B, Weathered on surface. C, Weathered in relief. D, Weathered with overhanging ledges.

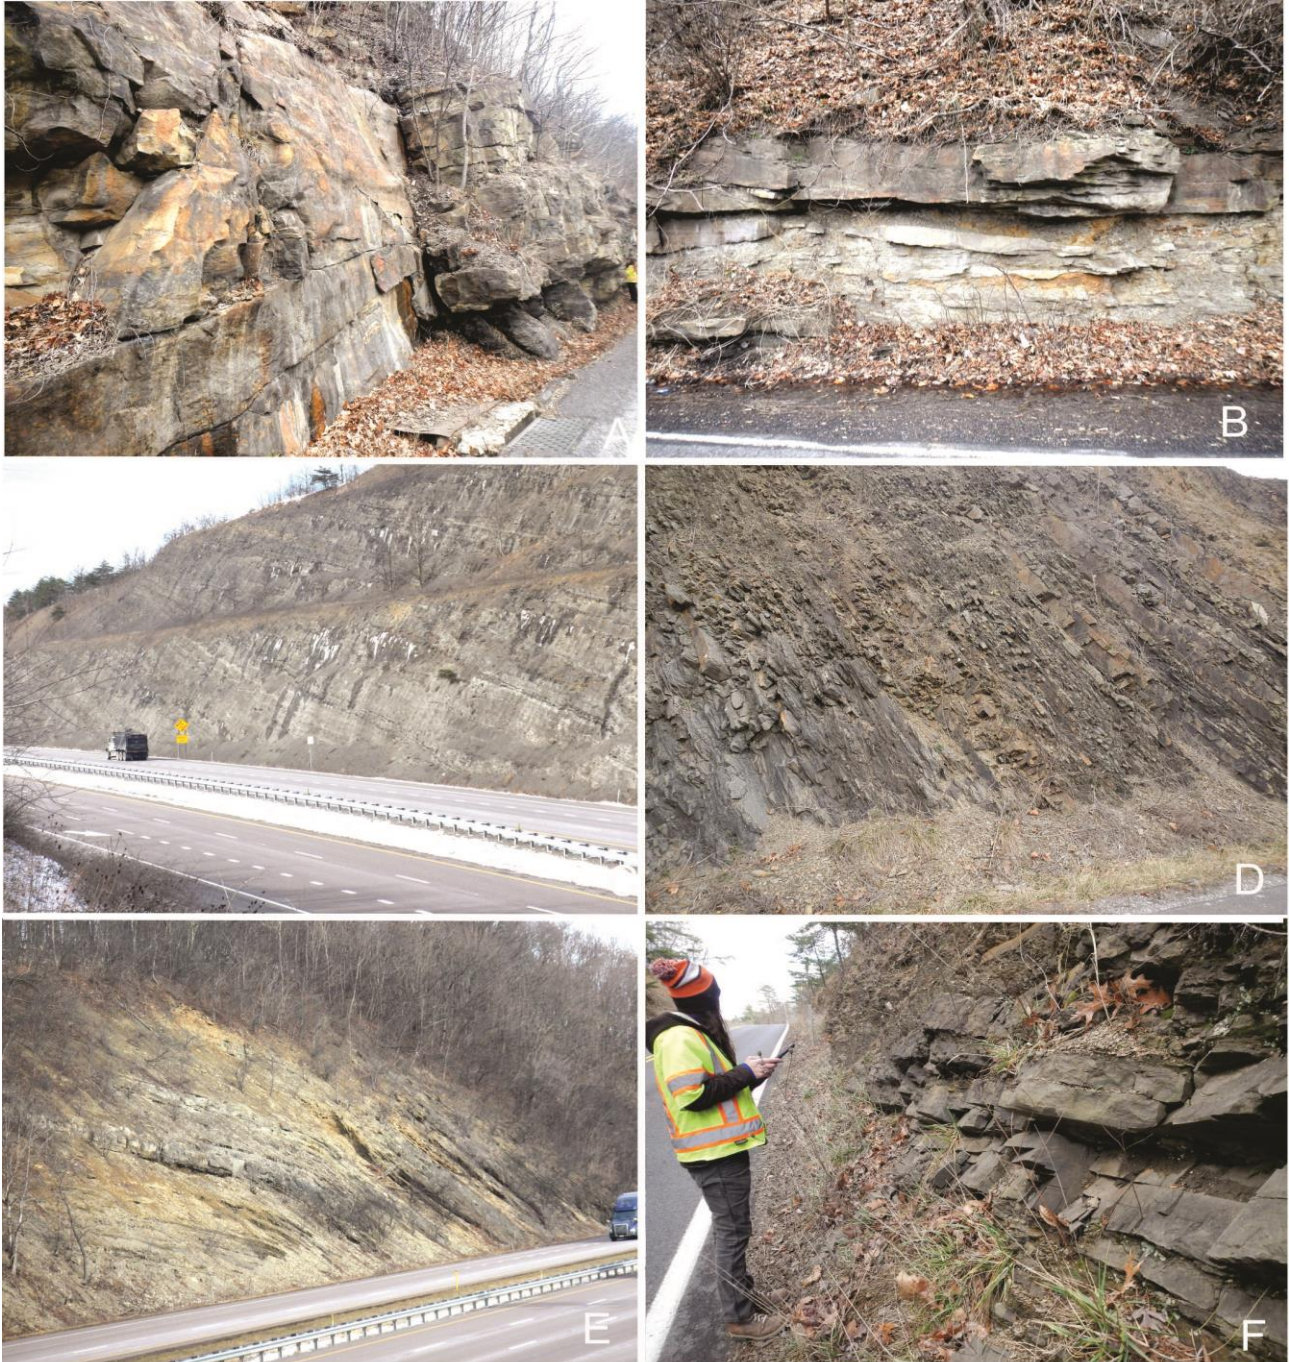
strata decoupling and sliding into the roadway (Figure 15C-D). Strata dipping into the roadway tend to present greater potential for slides, glides, or detached rock masses where rock can be displaced into the highway right-of-way (Figure 15E). Likewise, this orientation of stratification provides abundant potential for rock roll events where weathered and decoupled blocks can roll down the inclined slope and into the roadway. By contrast, strata dipping away from the roadway can present steep slopes, but a reduced potential for either slides, falls, and rolls (Figure 15F).

Figure 15. Stratification. A, Massive with stratification poorly discernible. B, Stratification horizontal. C, Stratification inclined parallel to road at $< 45^\circ$. D, Stratification inclined parallel to road, $> 45^\circ$ angle. E, Stratification inclined into roadway. F, Stratification inclined away from roadway.

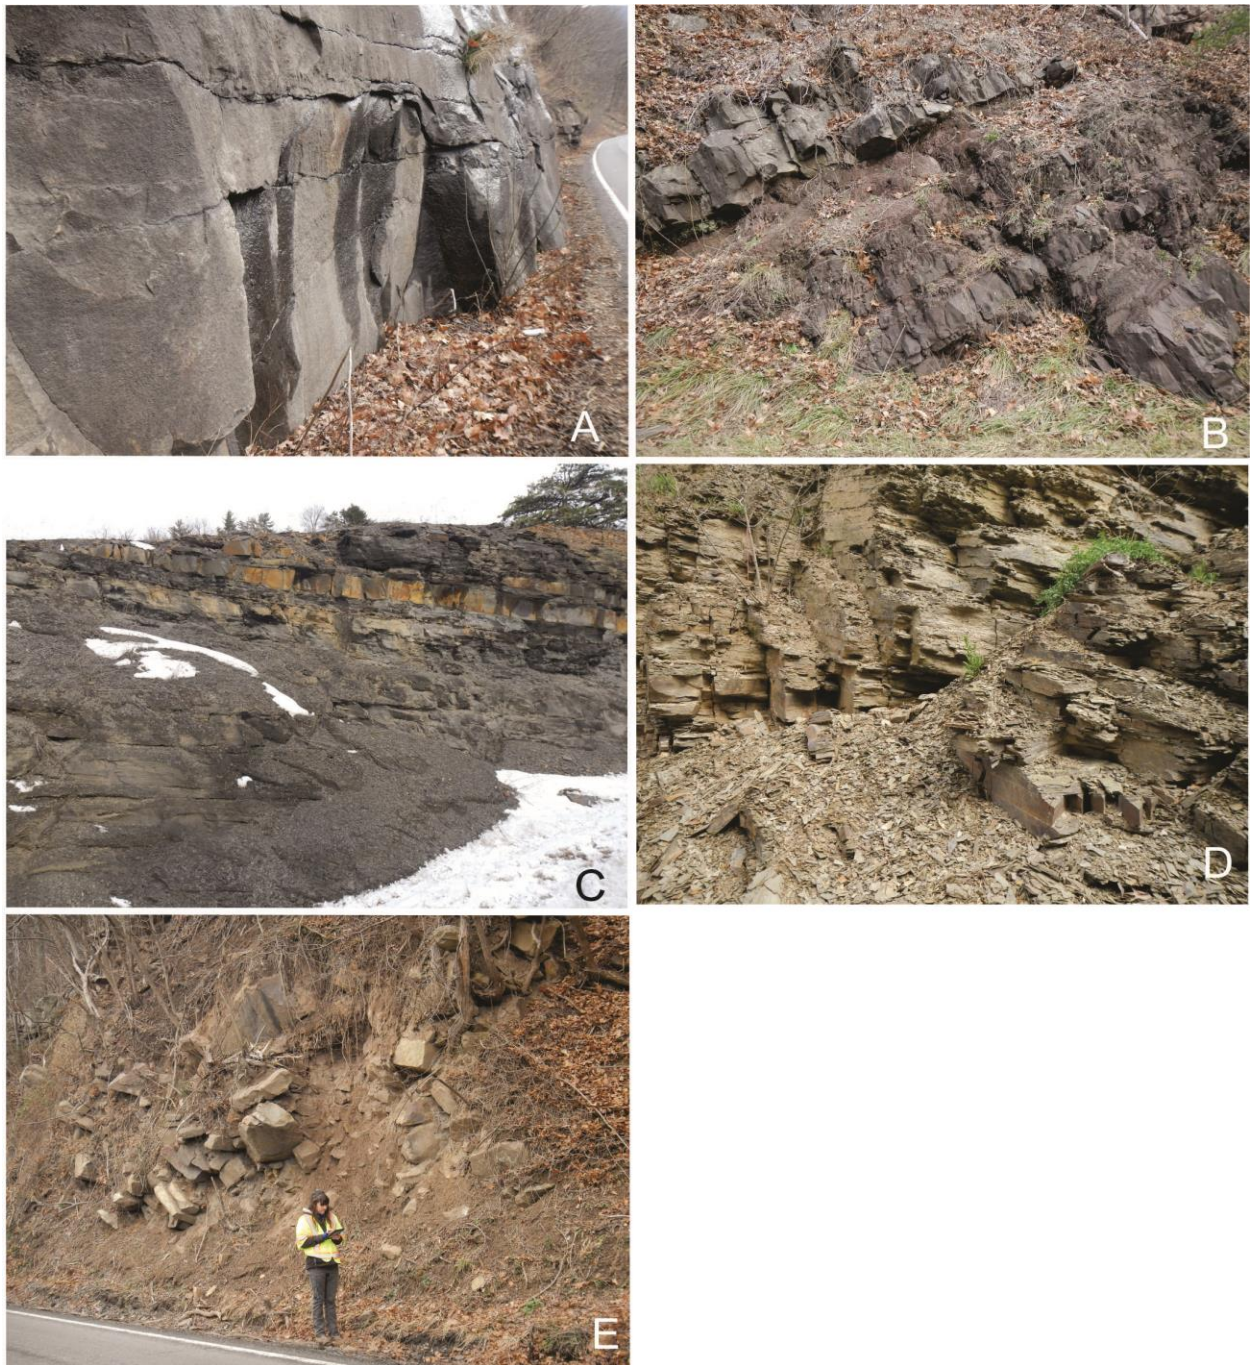
The composition, or lithology, of the rocks through which a road cut passes is a fundamental geologic aspect that affects potential for slope failures (Figure 16). Massive sandstone and limestone tend to create steep slopes adjacent to the roadway, and based upon the type and prominence of failure plane within these rock types, may create the potential for rockfalls and rock rolls (Figure 16A). Lithologies that are pervasively interbedded present the greatest potential for differential weathering (Figure 16B, C). Within these lithologies, failure planes may create an increased potential for rockfall and rock roll. If such interbedded lithologies are oriented with dips into the roadway, especially when water is concentrated along bedding planes, they present the

Figure 16. Lithology. A, Massive sandstone/limestone. B, Sandstone/limestone with shaly interbeds. C, Shale with sandstone/limestone interbeds. D, Massive shale. E, Block in matrix.

greatest potential for massive rock slides. Subhorizontal intervals of massive shale rarely are capable of creating steep slopes. These units tend to weather to slopes of small chips and thick soil. These slopes are readily vegetated, and where abundant water is available, can produce slumps and rotations into the roadway. Lastly, irregular sandstone blocks in existing or preexisting landslides can form incoherent masses of loose blocks (Figure 16E). These blocks can roll or slide into the roadway under the influence of frost action or gravity.

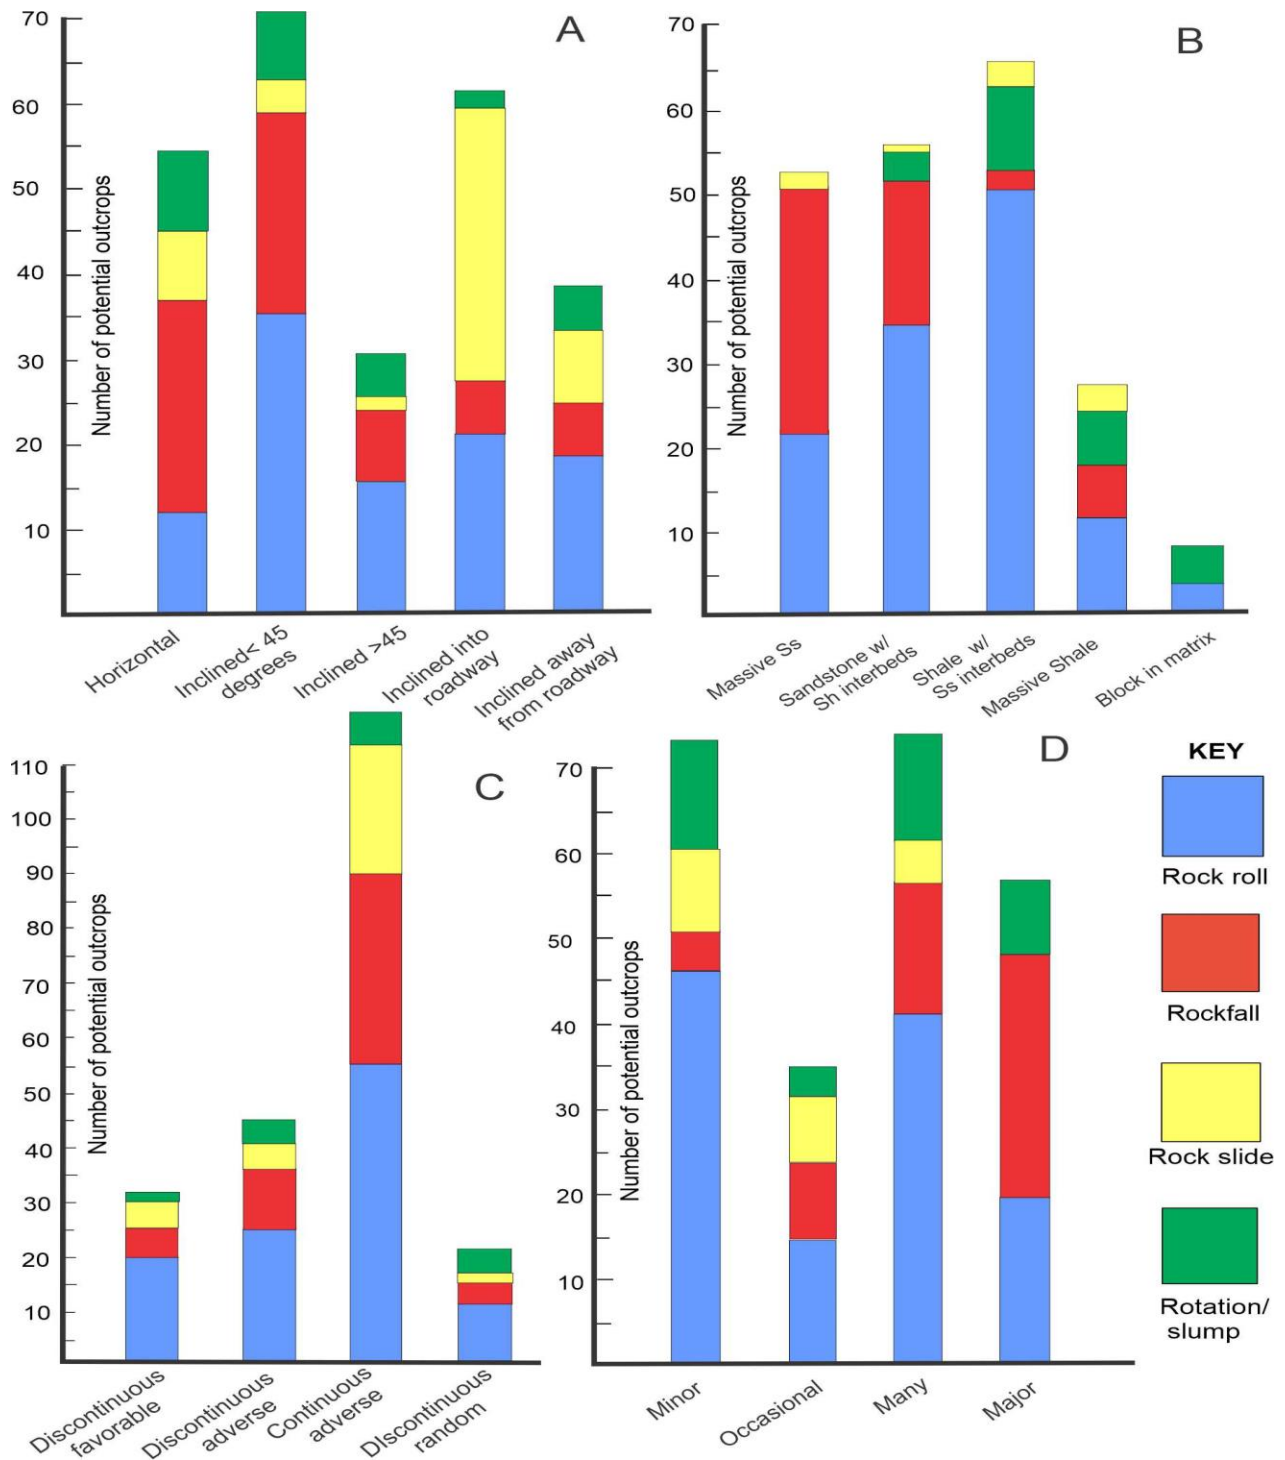
The orientation of stratification was judged to be a significant contributing factor in roadway slope failures (Figure 22A). Based upon inferences derived from these data, rockfall potential appears to be highest within strata that are either horizontal or are inclined parallel to the

Based on outcrop numbers, lithology was considered a significant geologic factor contributing to potential slope failure (Figure 22B). Allegany County data demonstrate that rockfall potential is substantially higher within massive lithologies than within other rock types. This relationship is somewhat reduced within thick-bedded sandstone and/or limestone units that have interbedded shaly layers. Rockfalls are lower in potential where shale with interbeds of sandstone, massive shale, and block in matrix form the slope. The reason for this relationship may not be directly related to lithology, but it maybe tied to road construction techniques. Outcroppings of massive sandstone, or thick intervals of sandstone with shaly interbeds are capable of forming steep-sided rock exposures. As such, excavations passing through these lithologies tend to be steeper than those that pass through rock types that are less resistant to weathering and erosion, like shale. The resulting steep road cuts, therefore, is more prone to rockfall incidence.

Figure 22. Geologic factors related to slope failure. A, Stratification and its frequency in potential failure. B, Lithology and its potential frequency in failures. C, Character of fracture planes and relations to slope failure type. D, Amount of differential weathering and its potential relationship to type of slope failure.

One geologic factor that appears to play a substantial role in the potential for roadway slope failure is the character of the fracture planes within the rock unit (Figure 22C). Fracture planes that are continuous and adverse to the roadway appear to be correlative to most types of failures. This type of fracture system was interpreted to be responsible for 57% of potential failures in the outcrops studied. No other joint or fracture characteristic was responsible for more than 20% of potential failures.

Another factor that impacts the likelihood, degree, and type of slope failure is the extent of differential erosion (Figure 22D). This figure illustrates the increased potential for rockfalls where major amounts of differential erosion are present. This is because significant amounts of differential erosion create over-steepening of slopes and lead to a greater likelihood of rockfalls. Also, rock roll can be shown to have an increased potential where many differential erosion surfaces exist. Differential erosion does not appear to play a significant role in the creation of rock slides or slumps and rotations.

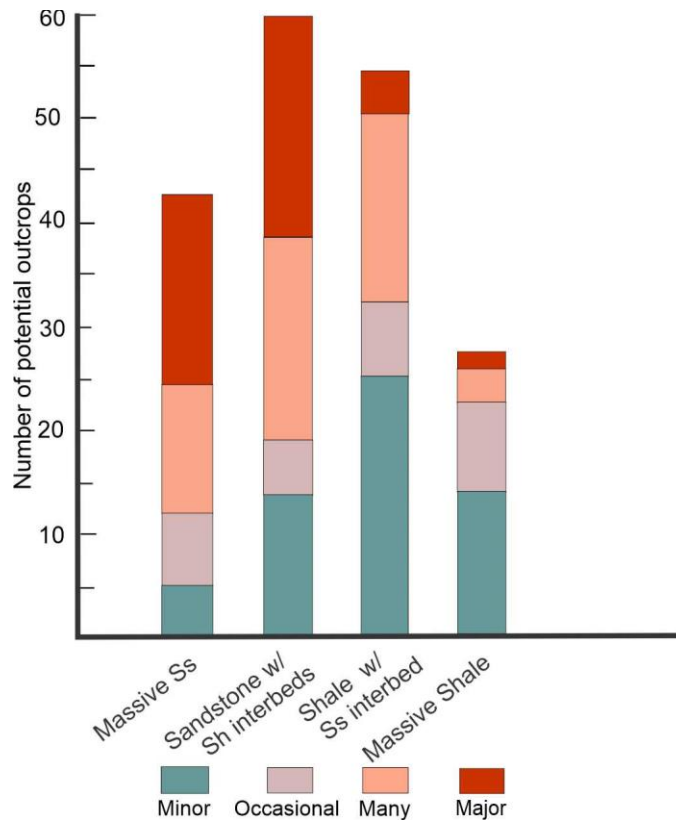
Figure 23. Lithology and its potential relationship to differential erosion.

As discussed in the earlier section on differential erosion, this feature is related to both the weathering rate and lithology. Because differential erosion or differential weathering is more pronounced in interbedded lithologies, it would appear to have a greater tendency to produce loosened rock fragments within those lithologies. Figure 23 illustrates this relationship between differential erosion and lithology. Contrary to *a priori* notions, massive lithologies that are resistant to erosion, such as sandstone and limestone, as well as those resistant lithologies with thin interbeds of shale display a definite differential erosion potential. Meanwhile, shales with
