Proper Overlay Type and Designs for PCC Pavement

Pangil Choi, Hoonill Won, Fei Yu, and Moon C. Won

Research Project 0-6910
Research Report 0-6910-R1
<http://www.techmrt.ttu.edu/reports.php>

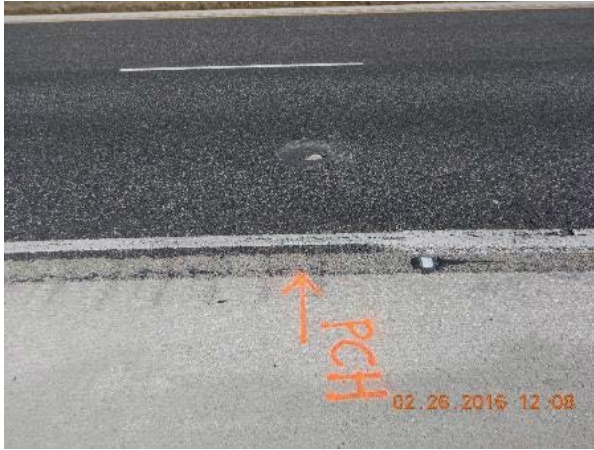
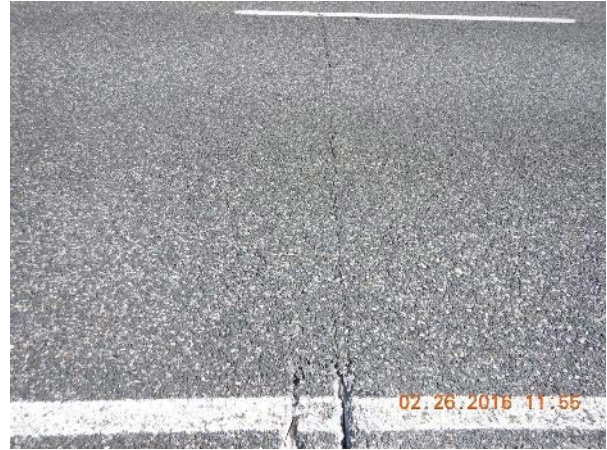
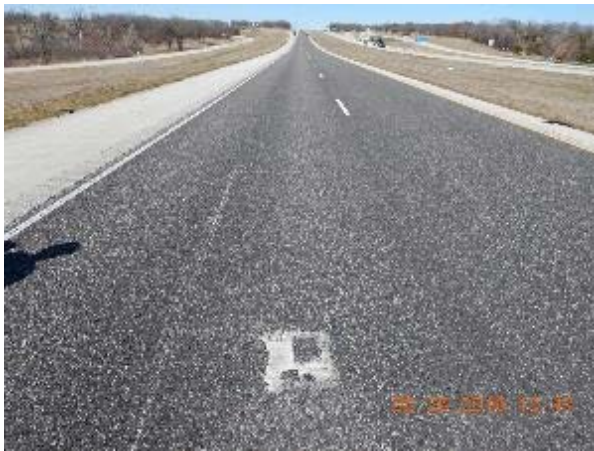
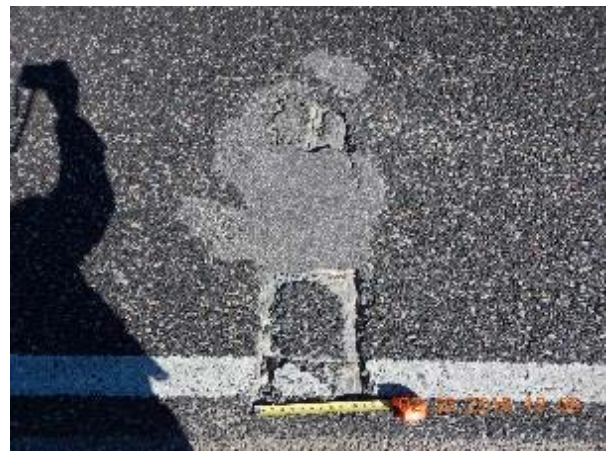
Figure 3.2 Observed AC distresses

After the completion of the 4-in. CRCP BCO in November 2012, distresses in the form of segmentation of concrete slabs in 4-in. BCO started showing up, and to prevent further deteriorations, a 1-in. permeable friction course (PFC) layer was placed in April 2014. Prior to field testing, a visual condition survey was conducted to identify major distress types and to select locations for in-depth evaluations. The major distress types observed at this location were those in the PFC layer that reflected from the distresses in the 4-in. BCO. [Figure 3.2](#) shows the surface conditions of the PFC layer that reflected from the distresses in the 4-in. BCO. Most PFC distresses were observed at the repair joint areas in the existing 8-in. CRCP, which reflected to the 4-in. BCO, where large deflections were measured. As will be discussed later, full debonding between the BCO and CRCP was identified where PFC distresses were observed. Based on the visual survey results, two sections were selected for further evaluations: one with distresses (poor) and the other without distresses (good), as shown in [Figure 3.3](#).

(a) Reflected distress from the existing punchout on 8-in. CRCP

(b) Reflected distress at repair joint in BCO

(c) Surface condition due to BCO distress #1

(d) Surface condition due to BCO distress #2

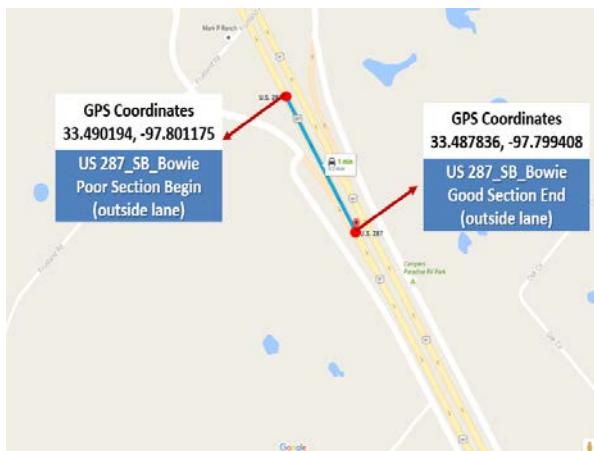
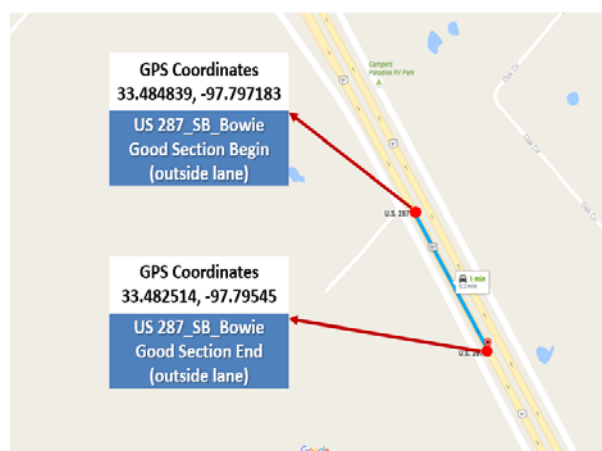
Figure 3.3 Test locations on US 287

(a) With distresses (poor section)

(b) Without distresses (good section)

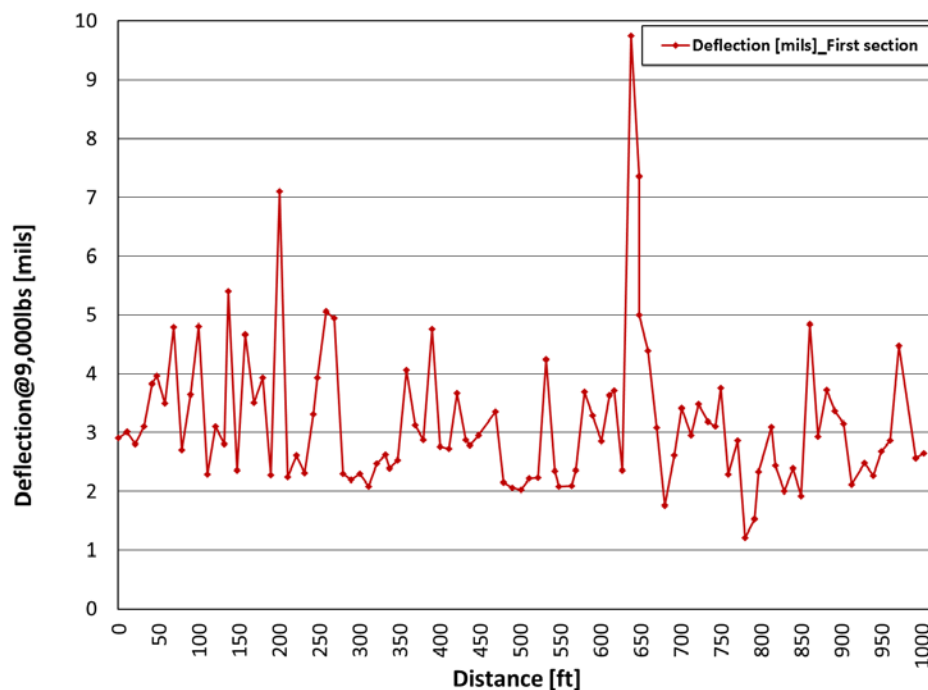
FWD testing was conducted at 10-ft intervals over approximately 1,000-ft for each section. **Figures 3.4 and 3.5** show deflections measured in poor and good sections, respectively. It is observed that overall deflections and their variability were larger in the poor section than in the good section. In the poor section, deflections greater than 7 mils were recorded at two locations, which coincided with PFC distress locations, whereas the deflections in the good section were smaller and more uniform. It appears that delamination or debonding at the poor section was also responsible for larger deflections. Field testing was conducted in 2010 on the existing 8-in. CRCP prior to the overlay, which included Total Pavement Acceptance Device (TPAD) testing, DCP testing, and deflection testing with FWD. Also, bond strength testing was conducted in November 2012, prior to the opening of the 4-in. BCO to traffic. Those field-testing results are discussed in Chapter 4.

Figure 3.4 FWD testing result at poor section (with distresses)

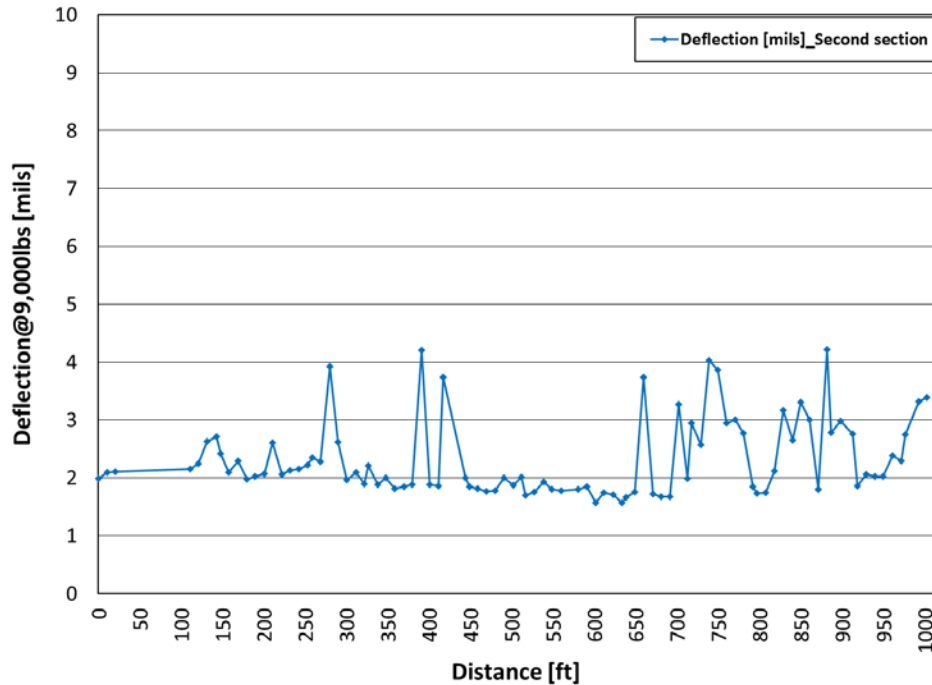
Figure 3.5 FWD testing result at good section (without distresses)

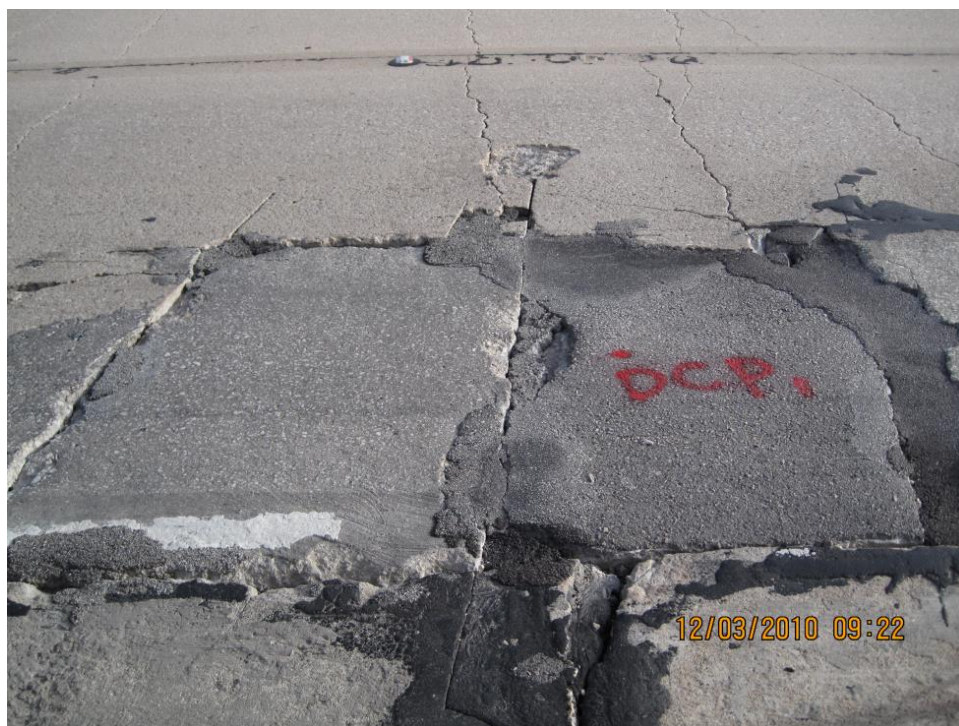
Figure 3.6 shows coring locations for P1 and P2. Two cores were taken upstream and downstream of a distress area. There was a punchout distress on 8-in. CRCP at this location as shown in Figure 3.7, and the personnel of TxDOT's Wichita Falls District repaired this section by full-depth repair (FDR) method before the BCO construction. However, repaired punchout still reflected through the BCO and PFC overlay, which indicates that FDR in the existing CRCP was not able to completely restore the structural condition of the pavement. Quite often FDR just replaces distressed concrete with new concrete, without restoring slab support. The poor slab support must have caused the punchout distress in the first place. Table 3.3 illustrates the measured deflections on PFC overlay at each coring location. The average deflection at the poor section was 3.62 mils compared with 2.21 mils at the good section. Even without detailed statistical analysis, this difference clearly indicates the effects of overlaid slab deflections on the performance of BCO. Figure 3.8 shows the coring operation. As Figures 3.9 and 3.10 show, debonding failures occurred at all coring locations in the poor section. On the other hand, good bonding was observed at all coring locations in the good section, as shown in Figure 3.11. This strong correlation between bonding condition and the overlay pavement deflections and performance is interesting and

Figure 3.7 Punchout distress in the existing 8-in. CRCP (picture taken on December 3, 2010)

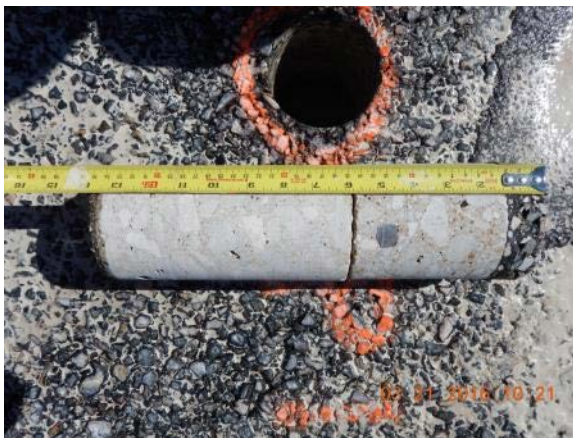
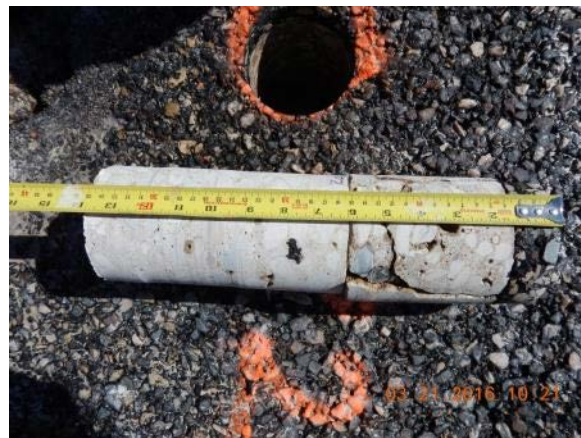
Figure 3.9 Concrete cores at P1 and P2

valuable information. First, it appears that debonding was caused by poor slab support or discontinuities along FDR boundaries and resulting large slab deflections, even after FDR. Small deflections in the good section appear to be due to adequate slab support, which is also responsible for good bonding. Figure 3.11-(e) shows a core taken at the good section. It shows a good bonding, even though the core was taken at a transverse crack in the existing 8-in. CRCP, which indicates that transverse cracks in CRCP do not necessarily cause debonding.

a. P1 core (debonding)

b. P2 core (debonding)

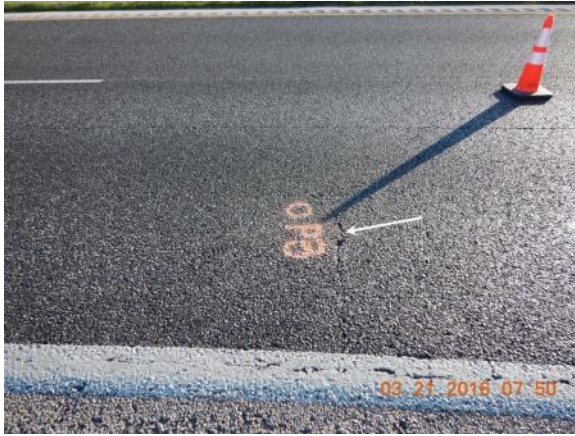
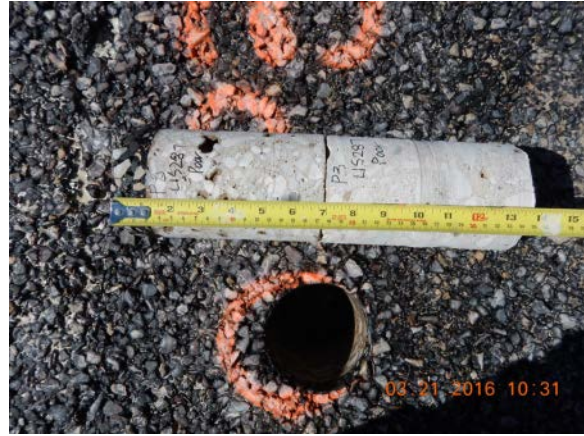
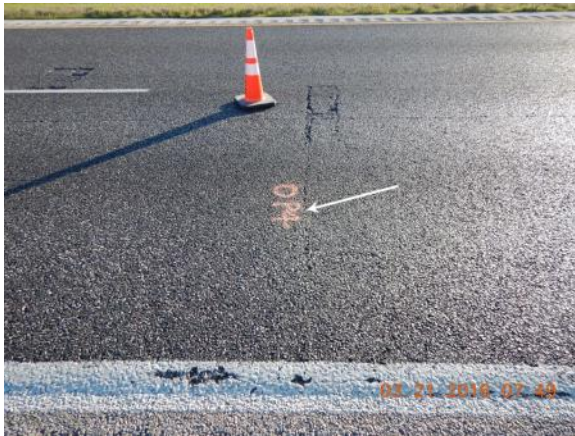
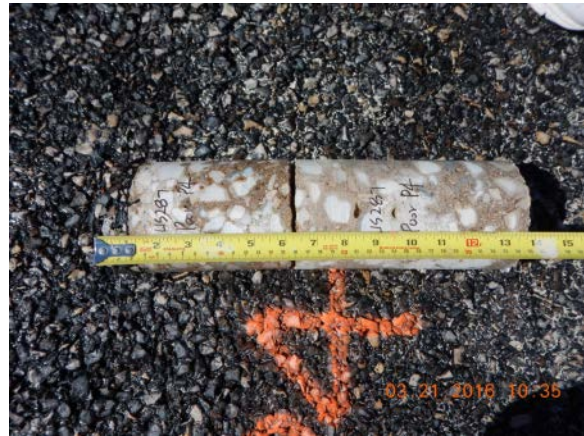
Figure 3.10 Concrete cores at P3 and P4

a. Coring location for P3

b. P3 core (debonding)

c. Coring location for P4

d. P4 core (debonding)

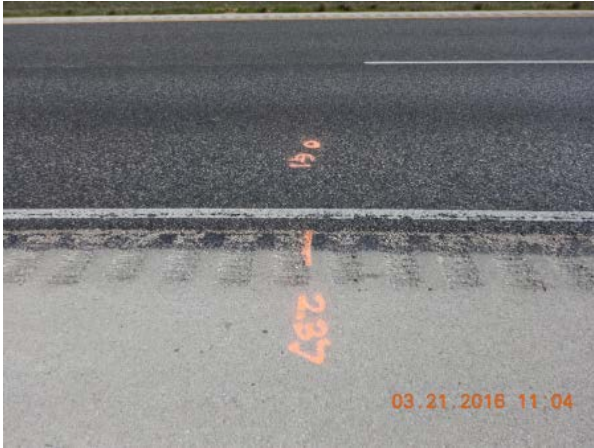
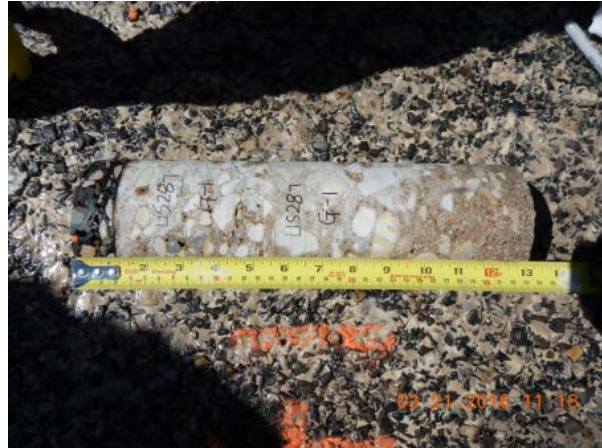
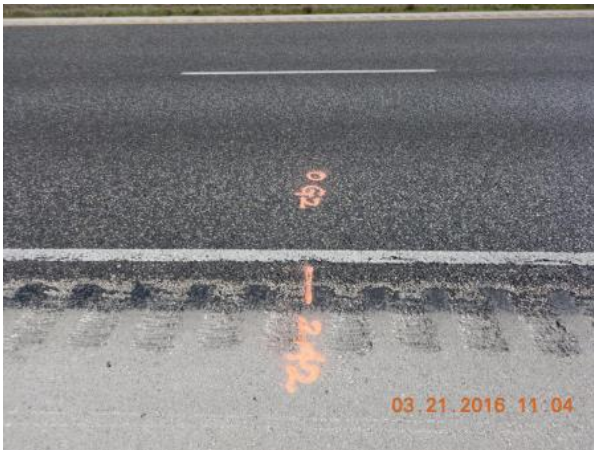
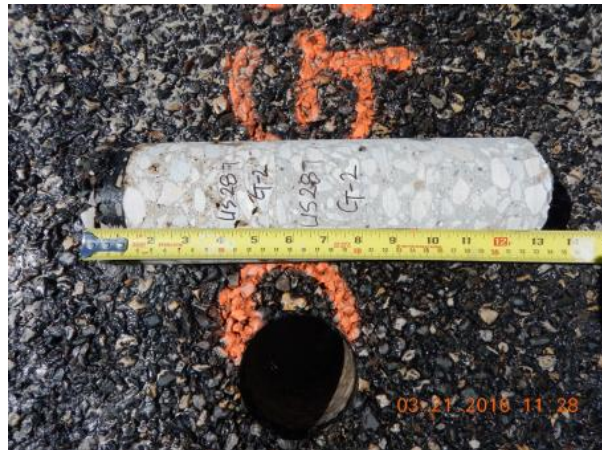
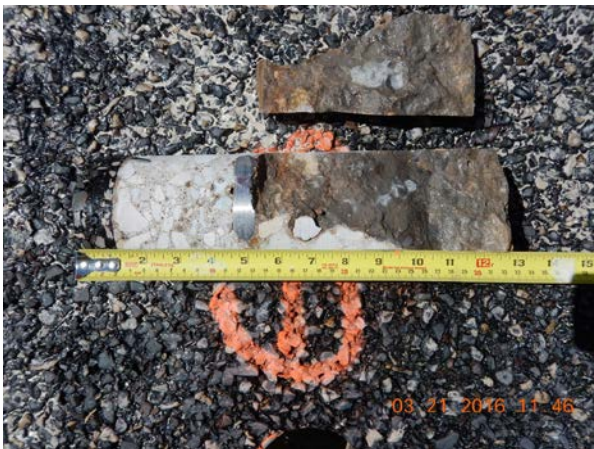
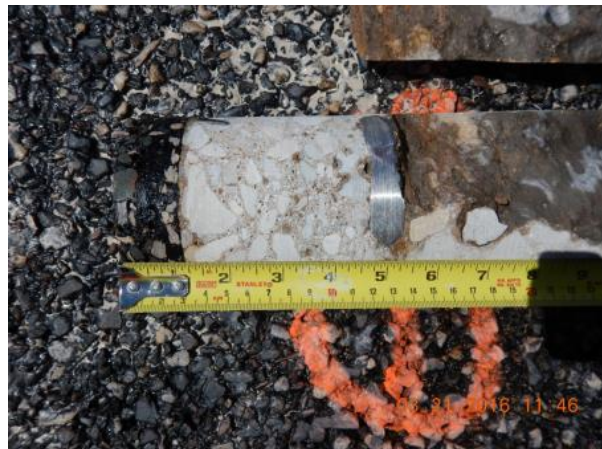
Figure 3.11 Concrete cores at good section (G1, G2, and G3)

b. G1 core (good bonding)

d. G2 core (good bonding)

e. G3 core (good bonding)

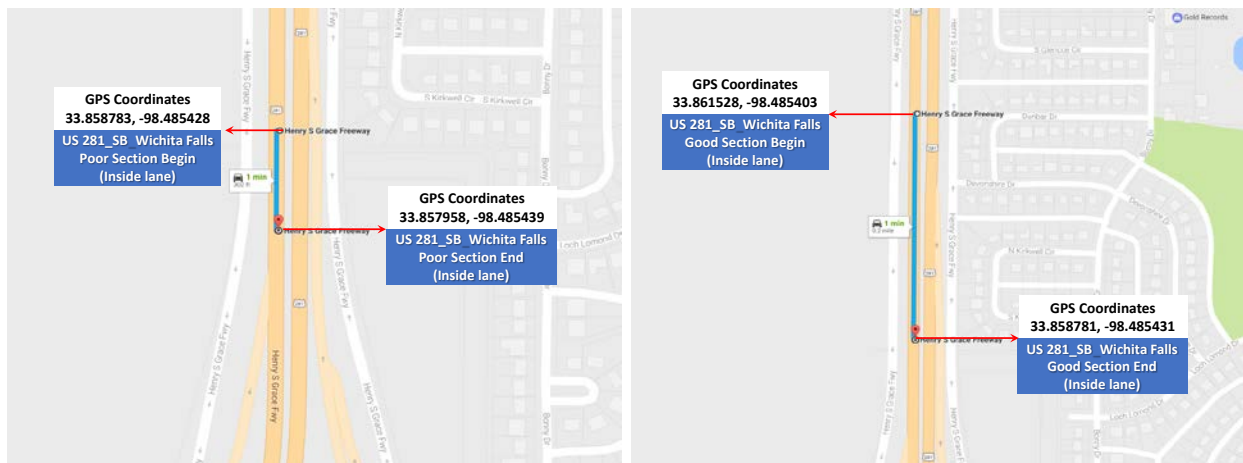
Figure 3.12 Overall pavement condition at poor and good sections

The overall BCO condition on US 281 was good, without any distresses except at a transverse construction joint (TCJ) area. Based on the visual survey results, two sections were selected as good and poor sections, as with the US-287 test section in Bowie. **Figure 3.12-(a)** shows a distress near a TCJ at the poor section and **Figure 3.12-(b)** provides an overall view of the good section selected. **Figure 3.13** shows the testing location on US 281 in Wichita Falls.

(a) With distress (poor section)

(b) Without distress (good section)

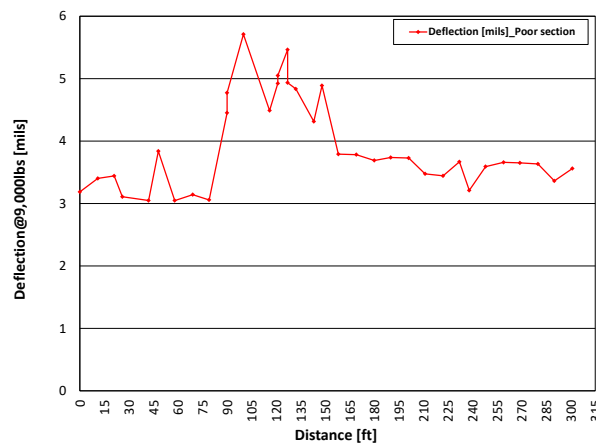
Figure 3.14 FWD deflection on US 281 (poor section)

FWD testing was conducted at 10-ft intervals at both good and poor sections and at 1-ft intervals near the TCJ in the poor section. **Figures 3.14 and 3.15** show FWD testing results at the poor and

good sections, respectively. Average deflections were measured at 3.2 mils at the good section and 3.9 mils at the poor section. Deflections near the TCJ (at about 105-ft) were larger than those further away from the TCJ. To identify the cause(s) for the large deflection at the TCJ, in-depth evaluations—including coring, DCP testing, and the MIRA testing—were conducted, which will be discussed later. It should be noted that the TCJ here is in the 4-in. BCO, and does not necessarily affect the TCJ in the existing 8-in. CRCP. It was quite difficult to determine whether the TCJ in BCO matched the TCJ in the existing CRCP. However, it is most likely that the TCJ in BCO was placed to facilitate the construction of BCO, not to match the existing TCJ in the existing CRCP. The distress observed near the TCJ was due to materials/construction-related issues during BCO construction.

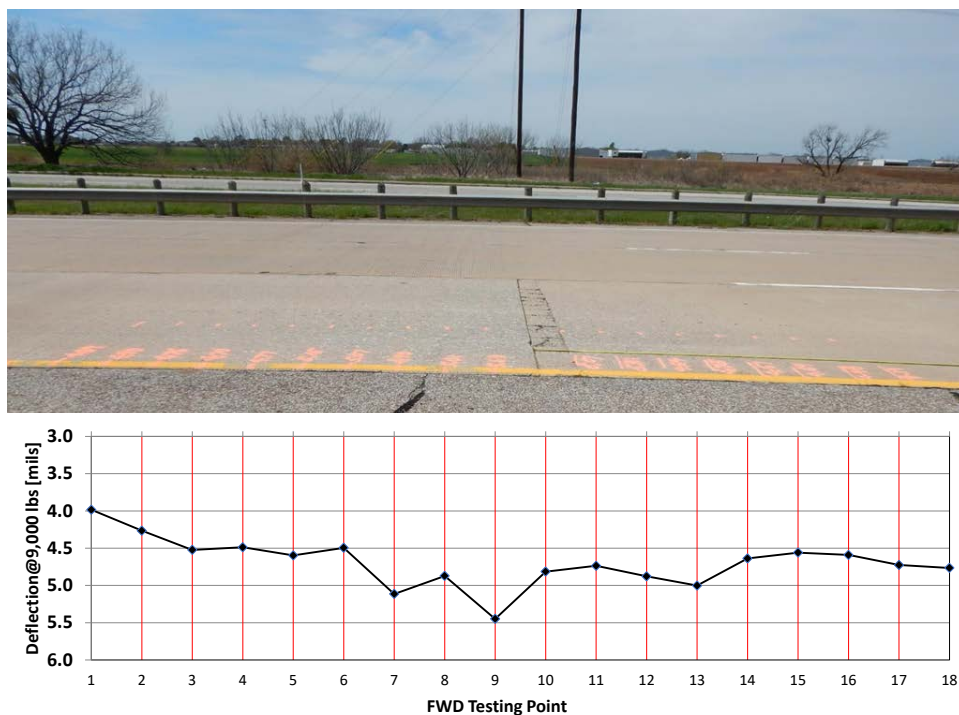
Figure 3.16 FWD deflection near the TCJ

FWD testing was conducted at 1-ft intervals from 8-ft away on one side of the TCJ and 10-ft away from the other side of the TCJ, and testing results are illustrated in [Figure 3.16](#). Deflection increases toward the TCJ (Testing Points 10 and 11) as clearly demonstrated in [Figure 3.16](#).

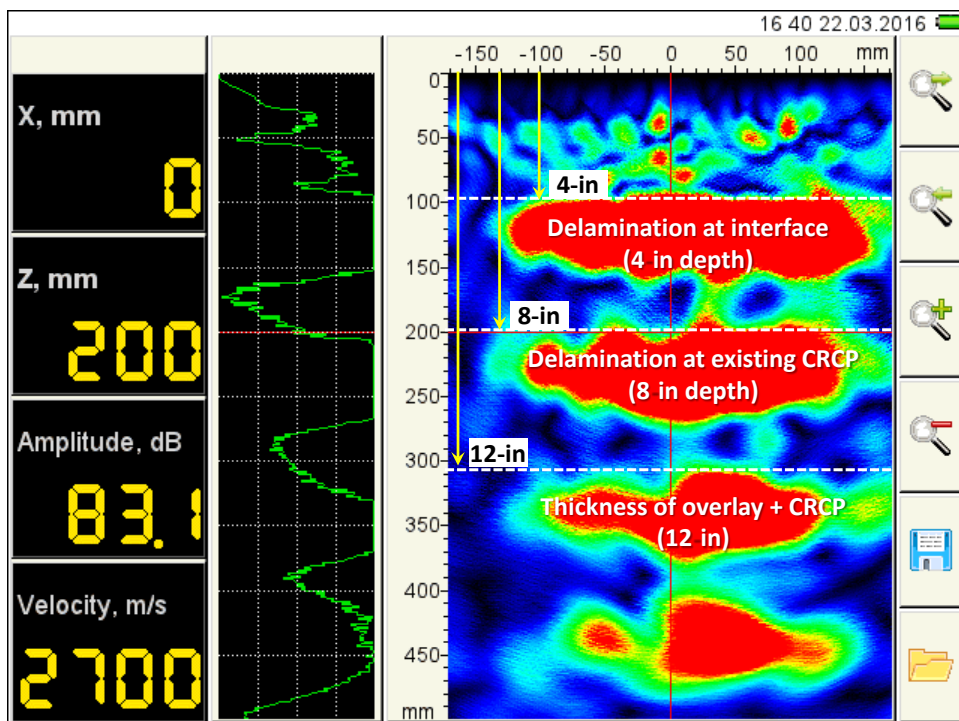
Figure 3.17 MIRA image near the TCJ

MIRA testing was also conducted at every FWD testing location, and delamination was detected near the TCJ at the overlay interface (4-in. depth from the top) and within the existing CRCP (8-in depth from the top) as shown in [Figure 3.17](#). This delamination indicates that there was an existing horizontal crack within the existing 8-in. CRCP. On the other hand, delamination and horizontal crack disappeared away from the TCJ, as shown in [Figure 3.18](#). [Figure 3.19](#) shows slabs removed at this location during FDRs, and horizontal cracks were observed. In Texas, horizontal cracks at the depth of longitudinal steel and resulting distresses such as slab segmentation are the primary distress type in CRCP. Punchout due to closely spaced transverse cracks and cantilever action is rarely observed.

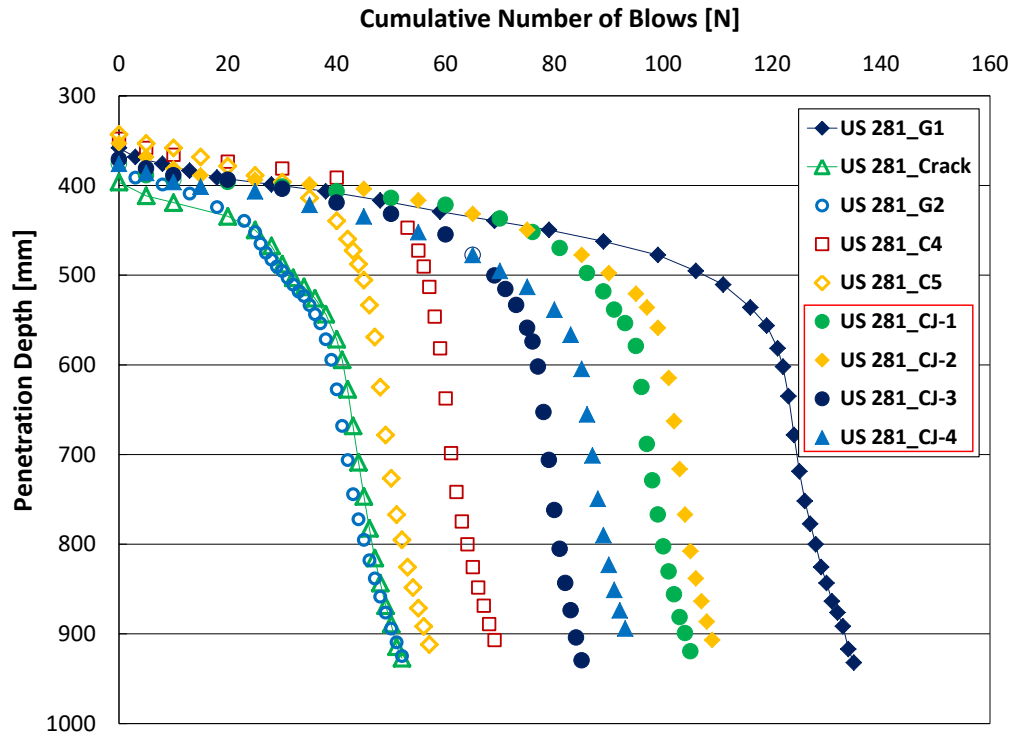
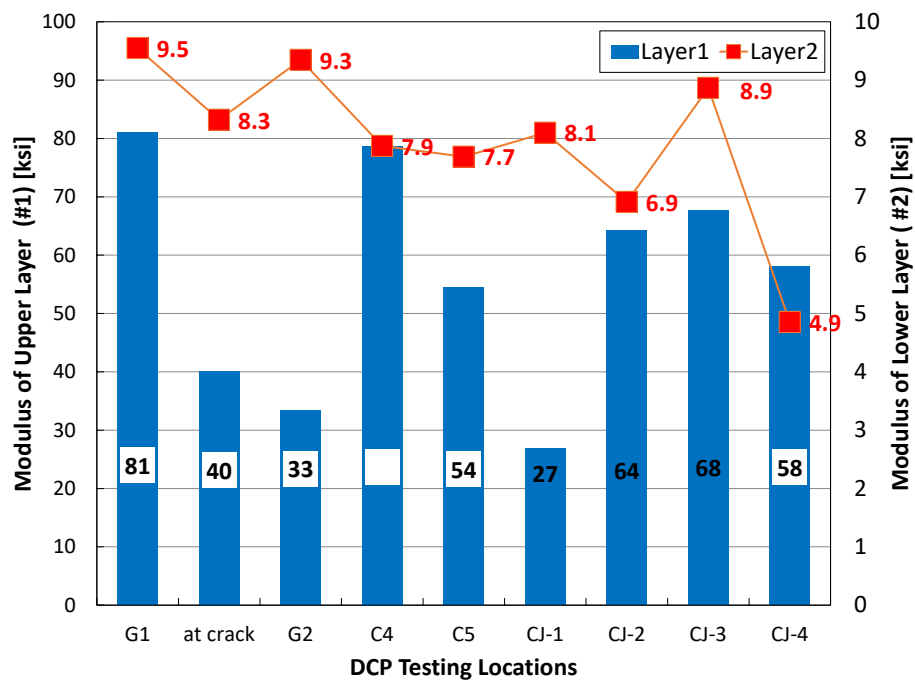
Testing results are illustrated in **Figures 3.21 and 3.22**. The variability in the modulus values of 6-in. base layer estimated from DCP data is rather large, ranging from 27 ksi to 81 ksi, while subgrade modulus is relatively uniform, at about 8,000 psi. These modulus values are somewhat lower than the average values obtained in Texas. On the other hand, the performance of this BCO project has been quite satisfactory for the last 14 years. Although accurate truck traffic information was not available at this location, little truck traffic was observed during field testing. It appears that the level of slab support provided by subgrade and base at this location has been adequate for the traffic load experienced. In contrast, it appears that the truck traffic level at the US-287 section in Bowie was much higher, which might explain the multiple pavement distresses at that location.

Figure 3.21 DCP testing results

Figure 3.22 Modulus values at each layer

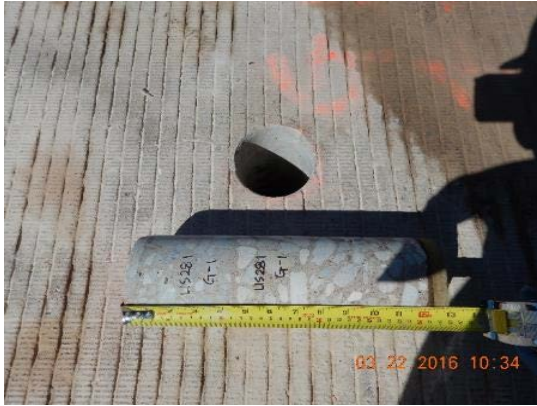
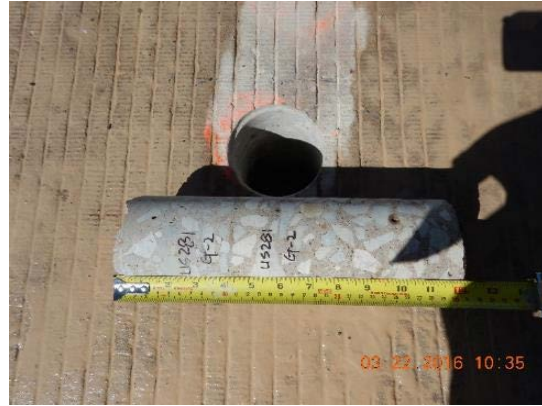
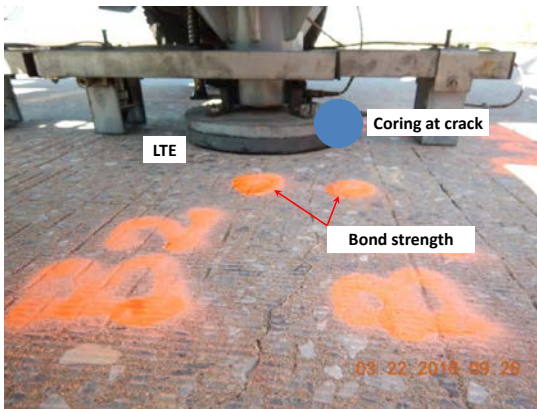
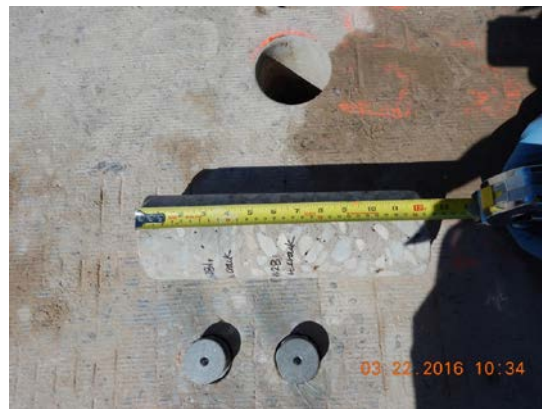
Figure 3.24 Concrete cores away from transverse crack and at transverse crack

Figure 3.24 illustrates the condition of concrete cores at each location, along with deflection at 9,000 pounds measured from FWD testing. As shown in this figure, good bonding was observed at the interface both at the crack and away from the crack. **Figure 3.25** shows a close-up view of the core taken at the transverse crack. This figure illustrates that the transverse crack did not progress toward the pavement bottom, but rather stopped at the mid-depth in the BCO. It shows that the placement of longitudinal steel near the bottom of 4-in. BCO, along with the use of crushed limestone as coarse aggregate (which provides a low CoTE), adequately restrained concrete volume changes due to temperature and moisture variations.

a. G-1: away from transverse crack
(deflection @ 9,000 lbs: 3.5 mils)

b. G-2: away from transverse crack
(deflection @ 9,000 lbs: 3.2 mils)

c. G-3: at transverse crack
(deflection @ 9,000 lbs: 4.0 mils)

d. G-3 core at transverse crack

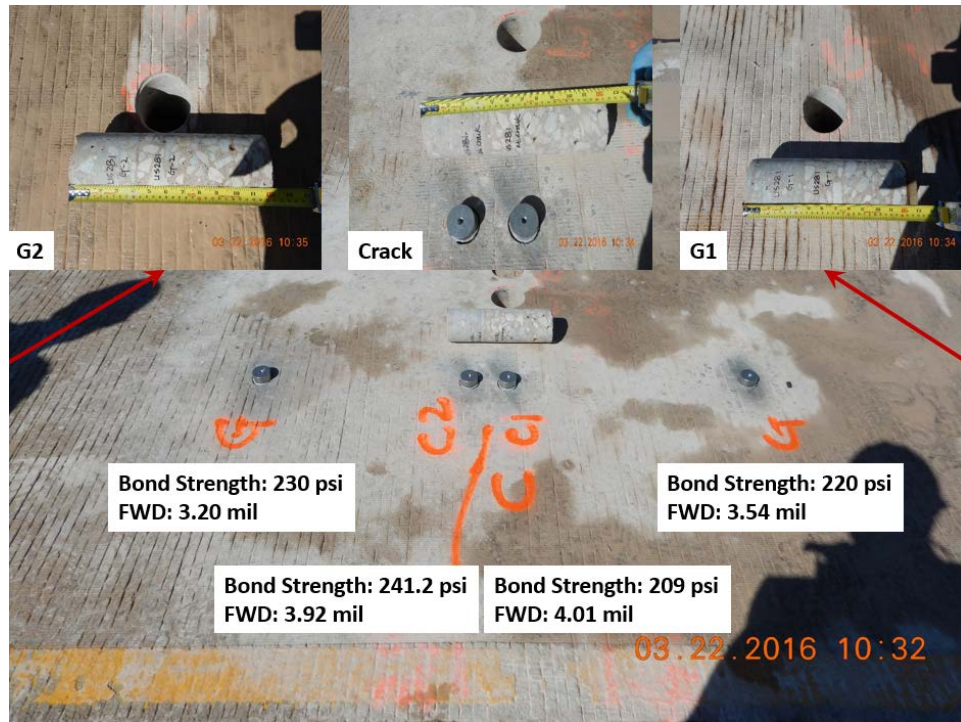
Figure 3.27 Core sampling

Locations for bond strength testing were selected on the basis of deflection, as well as whether transverse cracks existed. **Figure 3.27** shows bond strength testing results with a deflection value at each location. MIRA testing was also conducted before bond strength testing. C1 and C2 in **Figure 3.27** are located near a transverse crack in the overlay pavement. **Figures 3.28-(a) and (b)** show MIRA images at the locations C1 and C2. The reinforcements in the BCO and existing 8-in. CRCP are shown and no delamination observed at the interface between 4-in. BCO and 8-in. existing CRCP.

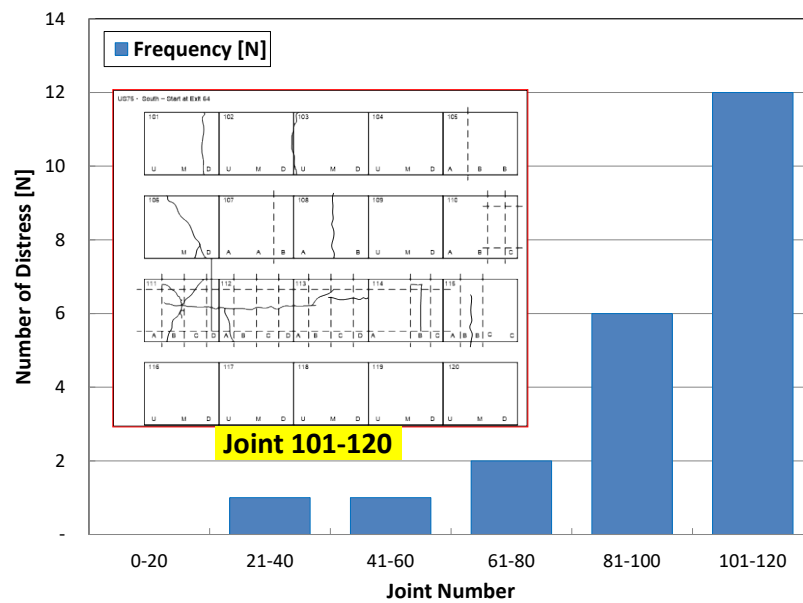
Figure 3.30 Number of distresses

Interestingly, only one distress was observed in the section placed on the first day of outside lane

construction, and the remainder of the distresses were observed in the section placed on the second day of the outside lane construction. At this location, 7-in. CRCP was placed in the inside lane and inside shoulder first. Then the inside lane was opened to traffic, and 7-in. CRCP overlay was placed in the outside lane and outside shoulder. The direction of the construction for both lanes was from north to south. The construction of the inside lane and shoulder went quite smoothly, with no issues. However, during the construction of the outside lane and shoulder, concrete delivered to the jobsite was quite dry and the finishing operation was quite difficult. Some of the concrete had to be removed, and replaced with new concrete, which will be further discussed in Chapter 4. **Figure 3.30** illustrates the number of distresses observed during the visual survey. The embedded figure in **Figure 3.30** also shows a CPCD distress map from slab number-101 (J-101) to slab number-120 (J-120), which was developed during the CPCD condition survey prior to BCO construction. Because the majority of the distresses in BCO were in the section placed on the second day of the outside lane construction and the quite poor condition of CPCD in that area, it appears that either construction quality issues and/or the poor condition of CPCD contributed to the distress development. **Figure 3.31** illustrates a typical distress observed; it appears to have reflected from the existing CPCD joints. It should also be noted that 2-ft wide non-woven fabric was placed along the transverse joints throughout the lane width. The objective was to minimize the detrimental effect of large deflections in existing CPCD on 7-in. BCO performance, since deflections measured on CPCD prior to the BCO construction were more than 20 mils at a number of locations. At that time, it was construed that placing 7-in. CRCP BCO directly on CPCD with such large deflections might result in severe distresses and placing non-woven fabric was expected to alleviate the detrimental effect of large deflections in CPCD on 7-in. CRCP BCO performance. It turned out that this was not the case, because some of the distresses with similar condition shown in **Figure 3.31** were repaired as early as 2012 by removing both the concrete in the 7-in. BCO and non-woven fabric, followed by placing new concrete. These repairs performed very well, indicating that the use of non-woven fabric was not needed, and also the poor quality of the construction of the outside lane might have contributed to the distresses in the 7-in. BCO.

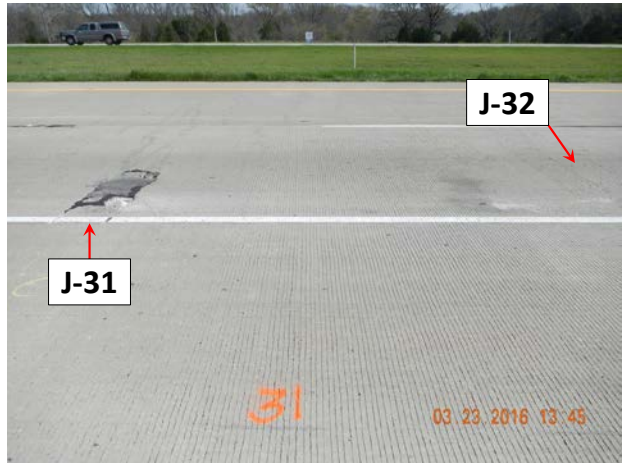
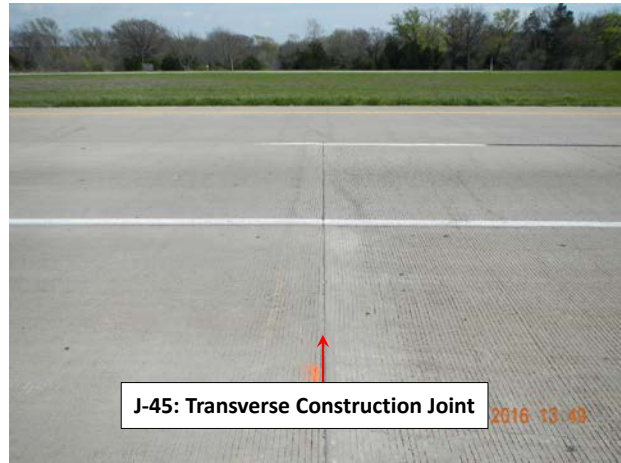
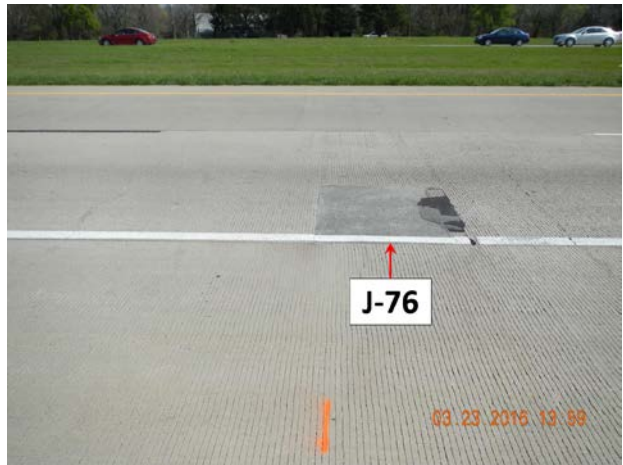
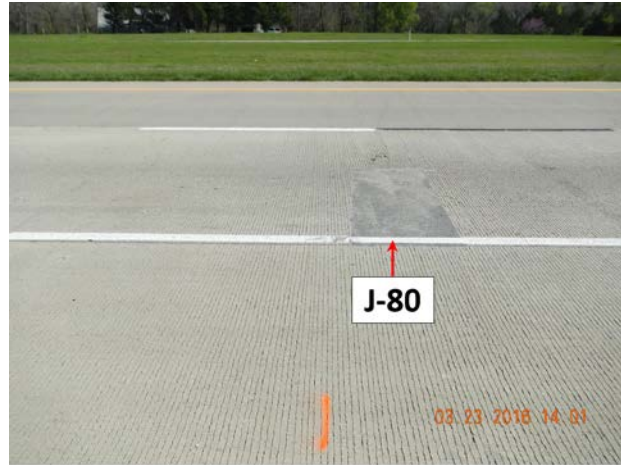
Figure 3.31 Typical BCO distress on US 75

a. Distress at Joint #31 (J-31)

b. TCJ (J-45)

c. Distress at J-71

d. Distress at J-80

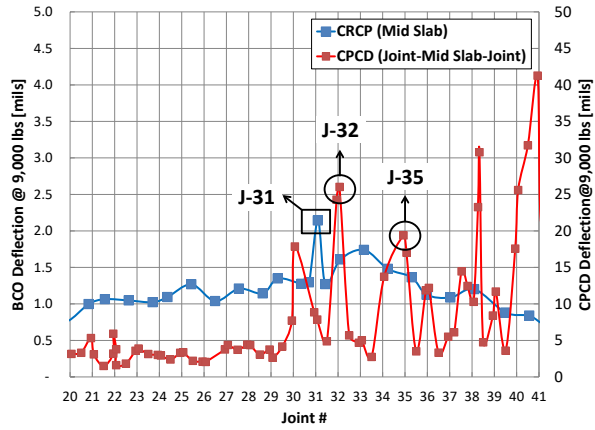
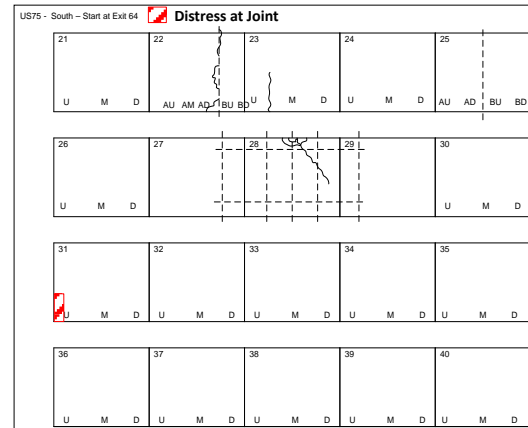
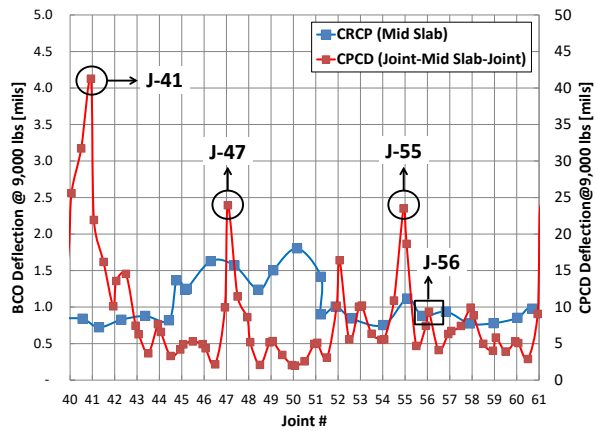
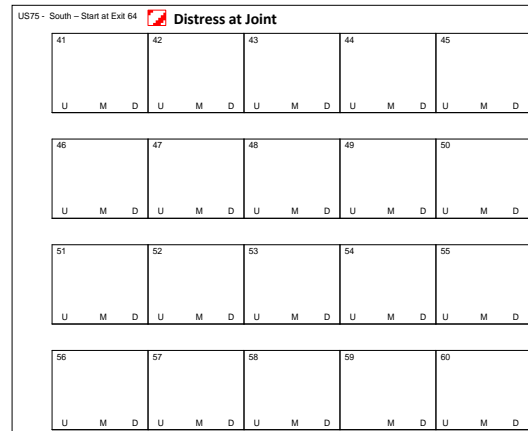
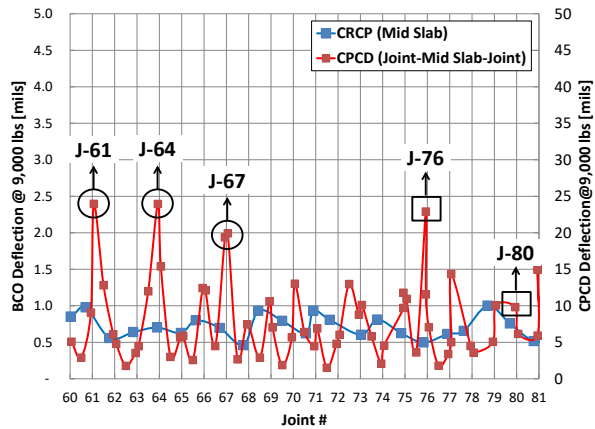
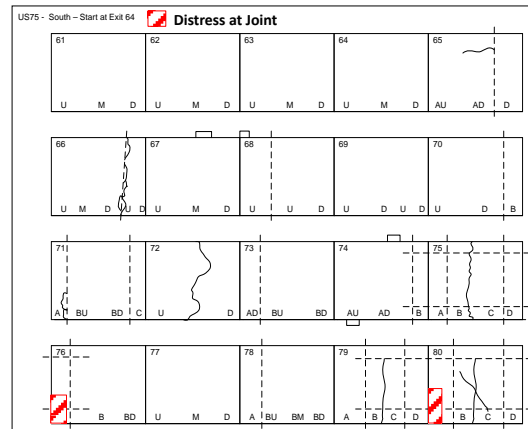
Figure 3.33 Distresses analysis in terms of deflection and existing CPCD condition (J-20 to J-80)

FWD testing was conducted on BCO every 15-ft for the length of the site. The 7-in. CRCP BCO started at the mid-slab between the 15-ft joint spacing of the existing CPCD. **Figure 3.32** shows a comparison between deflections on CPCD and on CRCP. The overall deflection after the BCO was placed decreased substantially; however, BCO distresses were observed at the locations of relatively large deflections on CPCD. FWD testing on CRCP BCO stopped at Joint #97 since traffic control had to be lifted. In **Figure 3.32**, black squares indicate the locations of distress and green squares the locations of PCCPs. On the other hand, although deflections on CPCD were relatively small from J-90 to J-110, distresses and PCCPs were observed. Detailed information on distresses in terms of deflection and existing CPCD distress are illustrated in **Figures 3.33 and 3.34**. In these figures, black squares denote BCO distress and black circles indicate areas with large deflections in BCO. Also, green squares indicate PCCPs, and cross-hatched areas with red and green denote distress and repairs in BCO, respectively. Figure 3.33 indicates that areas with large

deflections in CPCD did not necessarily experienced distresses in BCO; however, deflections in CPCD where distresses developed in BCO were above a certain value. It appears that large deflections in CPCD are not a sufficient condition, but rather a necessary condition for distresses in BCO. This finding is a little different from the findings at US 287 in Bowie, where large deflections in 8-in. existing CRCP were close to sufficient condition for 4-in. BCO. The difference appears to be the thickness of CRCP BCO—7-in. at this location versus 4-in. at the US-287 site in Bowie. Figure 3.34 illustrates the same information from Joint 81 to Joint 120, where deflections in CPCD were quite small, while a number of distresses and PCCPs were observed in BCO. It is not clear whether BCO construction practice or other conditions, such as poor-quality repairs of CPCD, were responsible for the large frequency of distresses and PCCPs in this area.

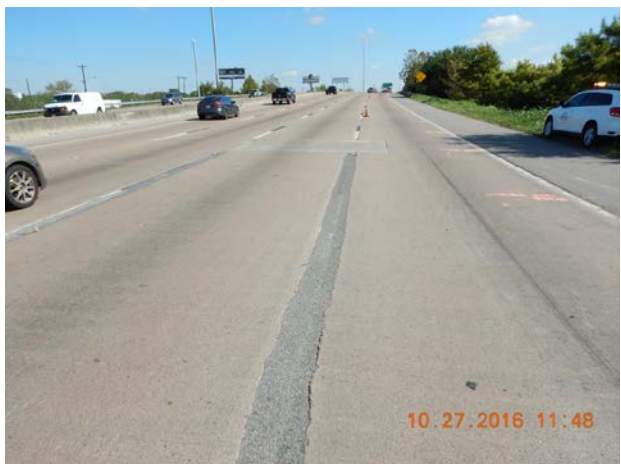
Figure 3.37-(a) provides an overall view of the section. Several PCCPs were placed at the longitudinal joints (Figure 3.37-(b)), and a Fibrecrete patch was also observed, as shown in Figure 3.37-(c). PCCPs at the outside lane were also observed (Figure 3.37-(d)). Bond strength testing was conducted near the PCCP after FWD testing. A detailed distress map was developed, as shown in Figure 3.38.

c. Fibrecrete patch

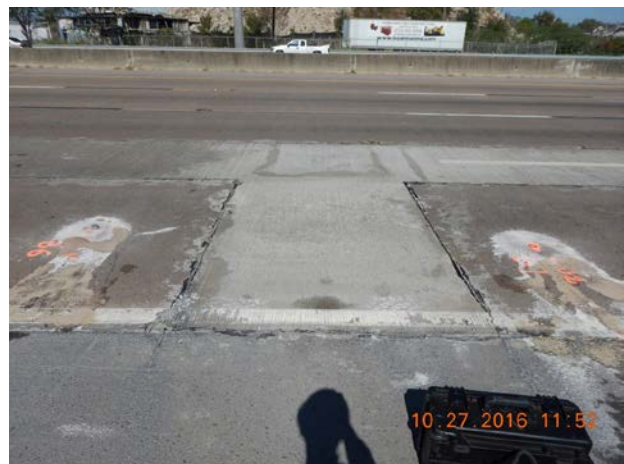
d. PCCP at outside lane

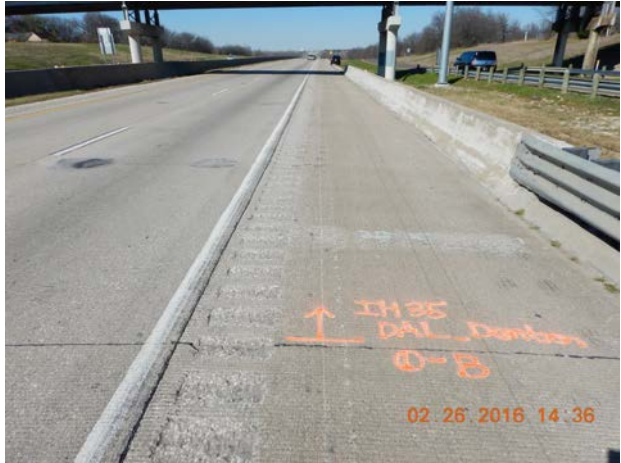
A visual survey was conducted on February 26, 2016, to select locations for field testing and evaluation. Based on the pavement condition, two sections were selected: one section with distresses (poor section) and the other without distresses (good section), as shown in **Figure 3.47**. The only distress type observed in this UBCO project was an asphalt patch under the wheel path at transverse contraction joints, as shown in **Figure 3.47-(a)**.

a. Poor section

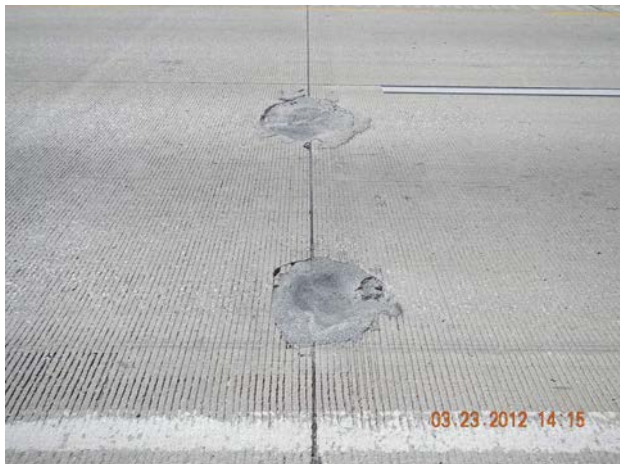
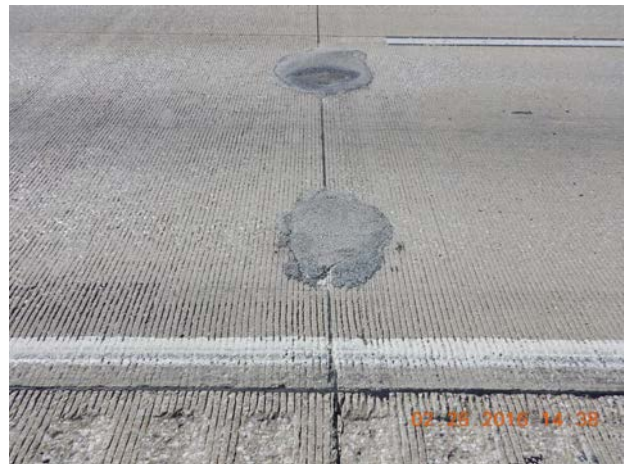
Figure 3.48 Distress comparisons between March 2012 and February 2016

The performance of this UBCO section was monitored under the TxDOT research project 0-6274 (rigid pavement database), and the condition of this distress was evaluated on March 23, 2012. **Figures 3.48-(a) and (b)** illustrate the comparisons of the distresses at the same joint. They show a minute progress in the distress over a 4-year timeframe, and additional asphalt patching material was placed.

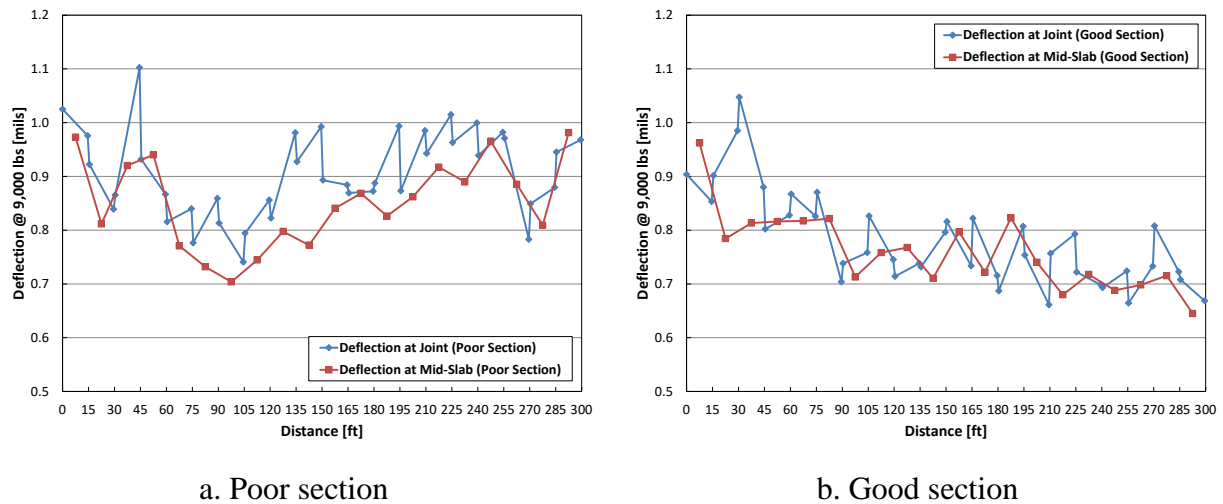
Figure 3.51 Deflection comparison between joint and mid-slab on IH 35 in Denton County

Figures 3.51-(a) and (b) illustrate deflection comparisons at transverse contraction joints and at mid-slab for the poor and the good sections. It is observed that the overall deflections are quite small, indicating that the structural capacity of this UBCO system is quite adequate. It is also observed that the mid-slab deflections were a little lower than those at the joints in the poor section, as shown in Figure 3.51-(a). The average deflections at the joint and mid-slab were 0.91 and 0.85, respectively. On the other hand, in the good section, there was no significant difference in deflections at joint and mid-slab. The average deflections at joint and mid-slab were 0.78 and 0.76, respectively. Also, the average deflection at the good section was slightly lower than that at the poor section. These results illustrate that joint behavior at the poor section was a little more active compared that in the good section. However, it should be recognized that the criterion used for the

selection of “good” and “poor” sections was asphalt patching, as shown in [Figure 3.48](#). It is not clear whether the increased deflections at joints in the poor section caused those distresses. It might have. However, there are CPCD sections in Texas with deflections at transverse contraction joints greater than the values obtained in the poor section, but with no distresses observed. Accordingly, it can be postulated that these distresses could have been due to materials/construction quality issues. [Figure 3.52](#) compares the LTE between the poor section and good sections; no significant difference was identified between the two sections. It is also observed that LTE values remained quite high after almost 30 years under heavy traffic.
