Proper Overlay Type and Designs for PCC Pavement

Pangil Choi, Hoonill Won, Fei Yu, and Moon C. Won

Research Project 0-6910
Research Report 0-6910-R1
<http://www.techmrt.ttu.edu/reports.php>

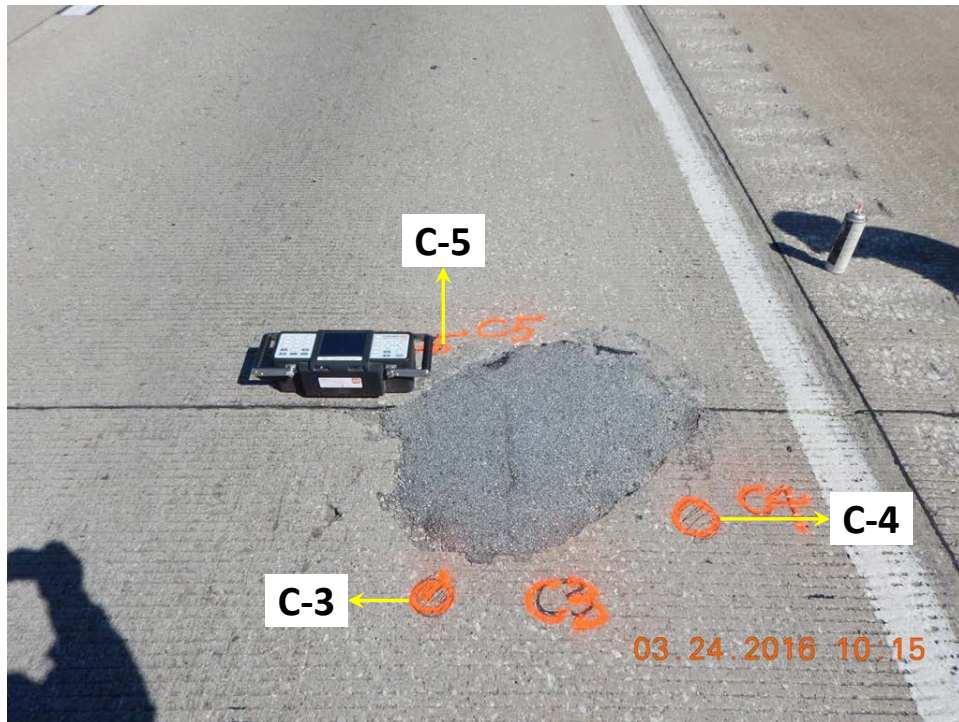
Figure 3.55 Coring locations for C-3, C-4, and C-5 around joint distress

and existing CPCD were in compliance with the design thicknesses. **Figure 3.55** illustrates coring locations for C-3, C-4, and C-5 for in-depth evaluation of distress at the transverse contraction joint. While coring operation was underway, it was observed that for all five cores, the AC interlayers came out in a fully-bonded condition to the overlaid CPCD; this is illustrated in **Figures 3.56 and 3.57**. The quality of asphalt material was quite solid without deterioration. This finding implies that the UBCO system behaves as a partially-bonded condition rather than a fully-unbonded condition, and should be considered for the UBCO thickness design.

Figure 3.57-(a) illustrates the MIRA testing result at Location C-4 (see **Figure 3.55**), showing a delamination at 3.5-in. depth from the pavement surface. The core taken at this location clearly shows that there is delamination at 3.5-in. depth as shown in **Figure 3.57-(b)**. It appears that delamination occurred first at transverse contraction joints and repeated wheel loading applications resulted in the distress observed. At this point, the exact mechanism of initial delamination at the joints is not known. On the other hand, at the same joint with distresses under wheel path, delamination was not detected by MIRA between wheel paths, which contravenes the assumption of delamination first, followed by the distress. Further investigations will be needed to accurately identify the mechanisms of the distress observed at this location.

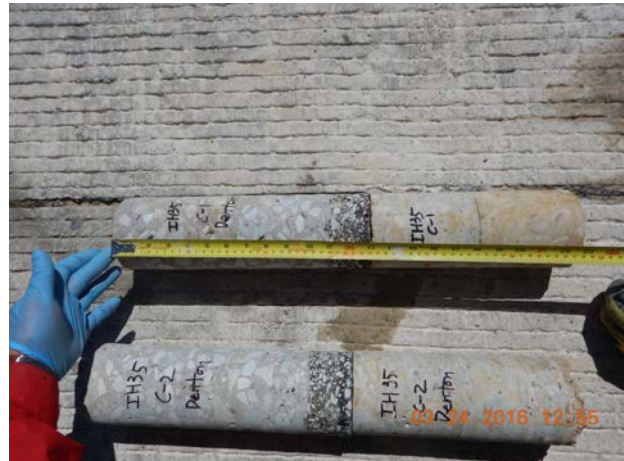
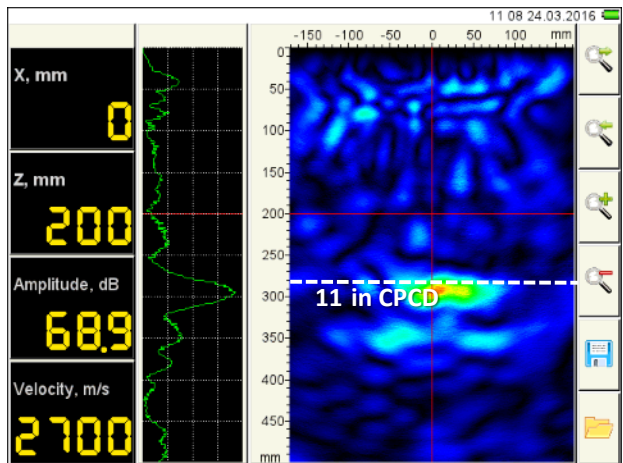
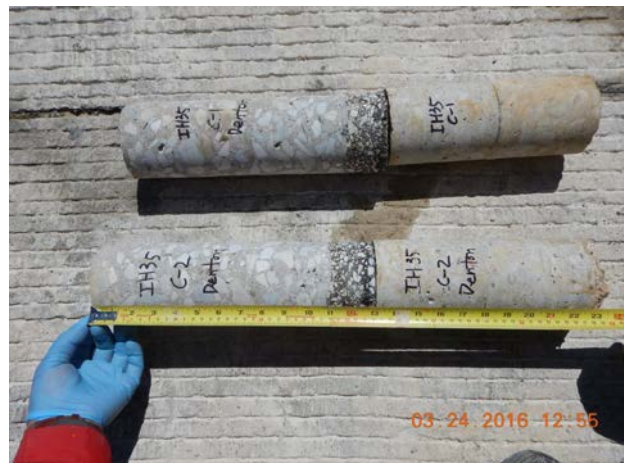
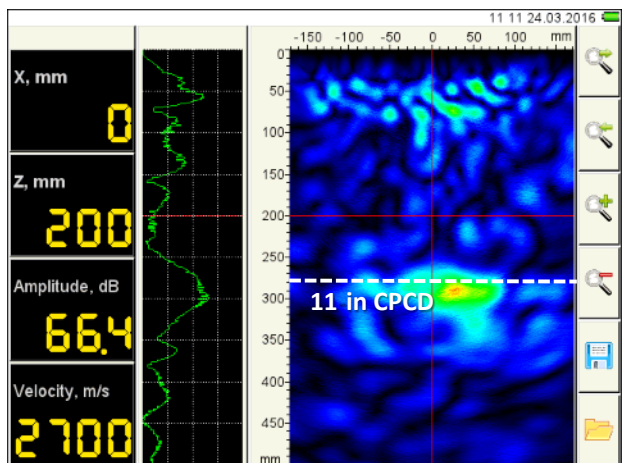
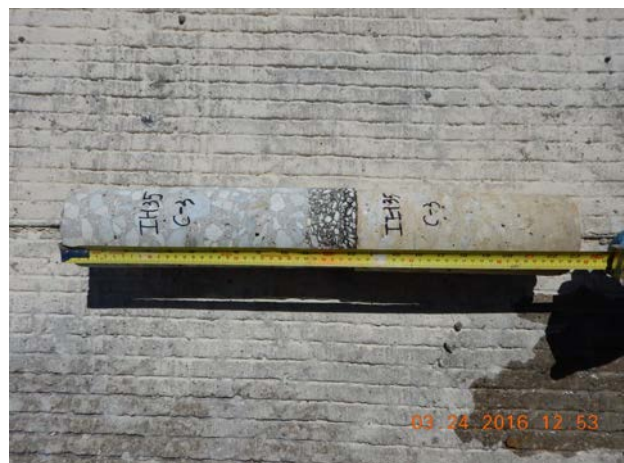
Figure 3.56 MIRA testing result and core condition of C-1, C-2, and C-3

a. MIRA image at C-1

b. C-1 core (1.0 mil@9,000 lbs)

c. MIRA image at C-2

d. C-2 core (0.9 mils@9,000 lbs)

f. C-3 core (1.1 mils@9,000 lbs)

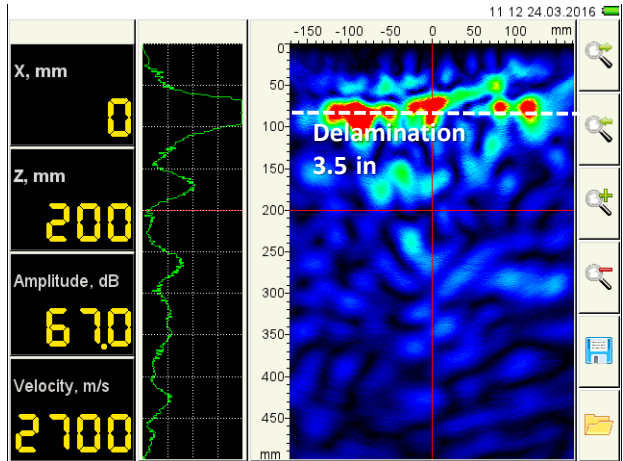
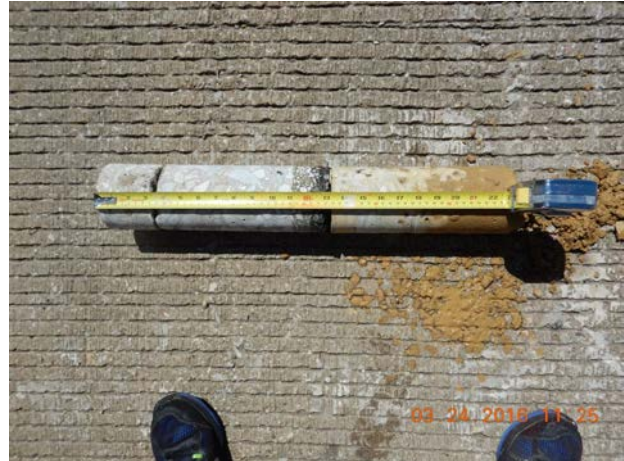
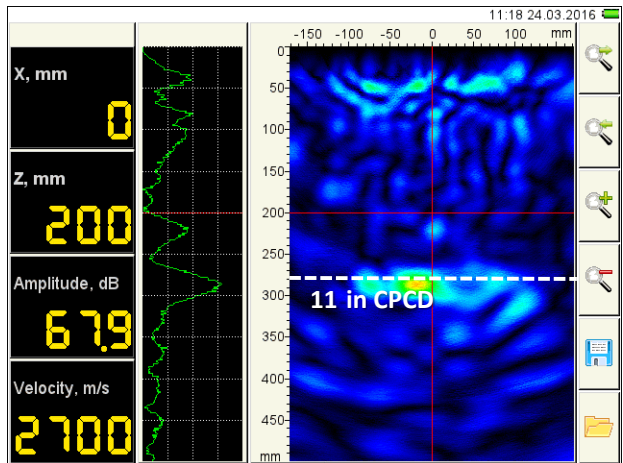
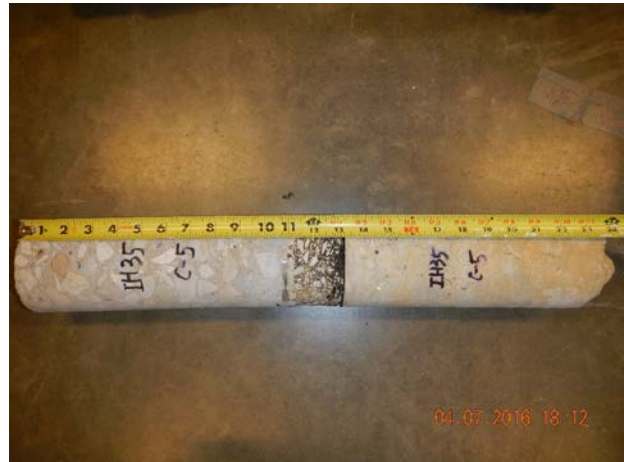
Figure 3.57 MIRA testing result and core condition of C-4 and C-5

a. MIRA image at C-4

b. C-4 core (0.9 mils@9,000 lbs)

c. MIRA image at C-5

d. C-5 core (0.9 mils@9,000 lbs)

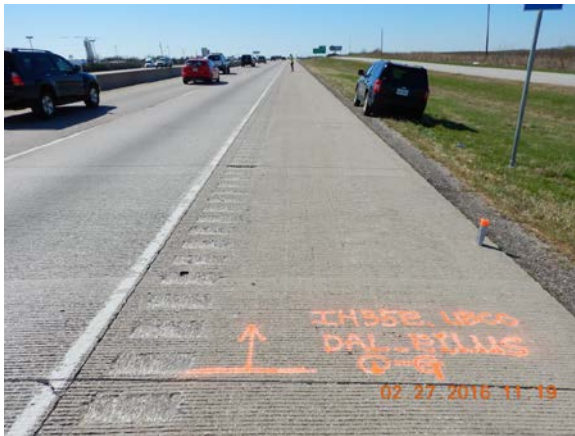
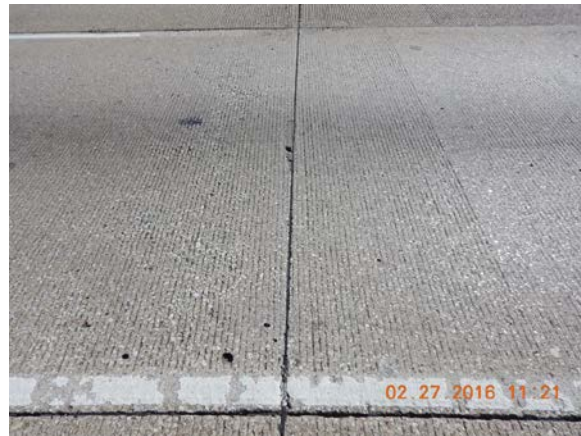
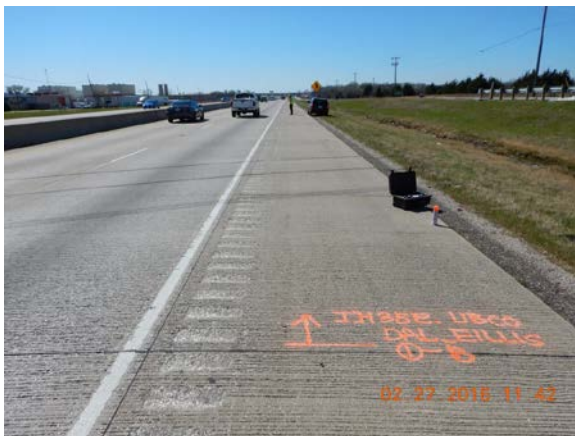
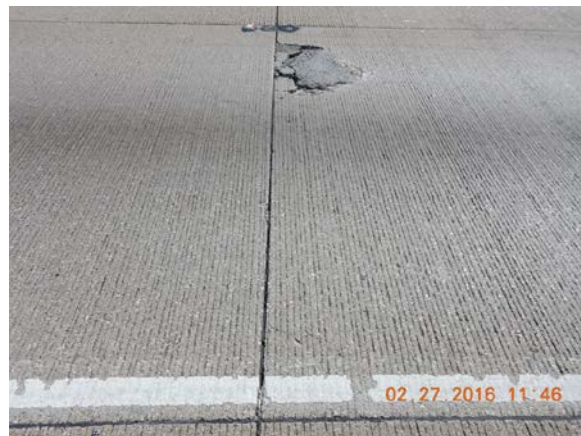
Figure 3.60 Condition of the pavement

Visual survey was conducted on February 27, 2016. Two sections (good and poor) were selected based on visual pavement condition evaluations. Even though the sections were divided into good and poor sections, distress level in the poor section was quite low. Field evaluations including FWD testing, MIRA testing, and DCP testing were conducted on March 29, 2016. Under a heavy traffic volume at this location, the overall pavement condition was quite satisfactory, with the exception of intermittently observed minor distresses at transverse contraction joints. **Figure 3.60** shows the pavement condition at good and poor sections. In the poor section, a distress resembling distresses in CRCP at TCJs is observed.

b. Distress at the good section

d. Distress in poor section

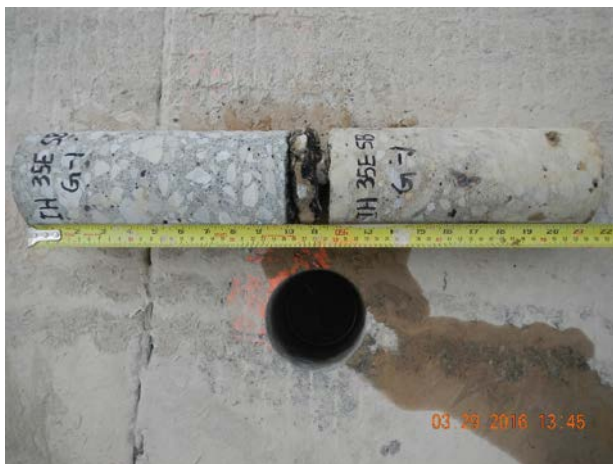
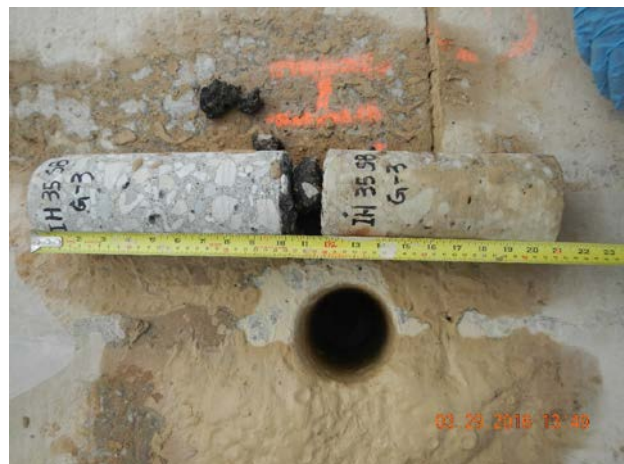
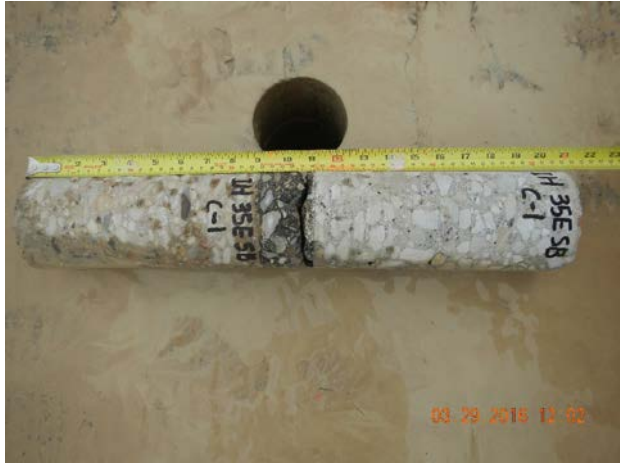
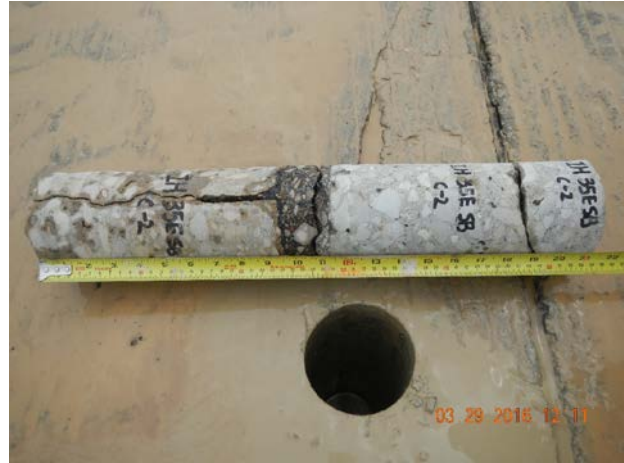
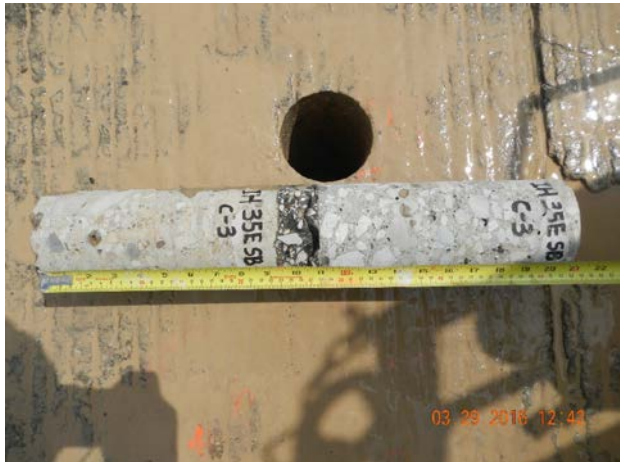
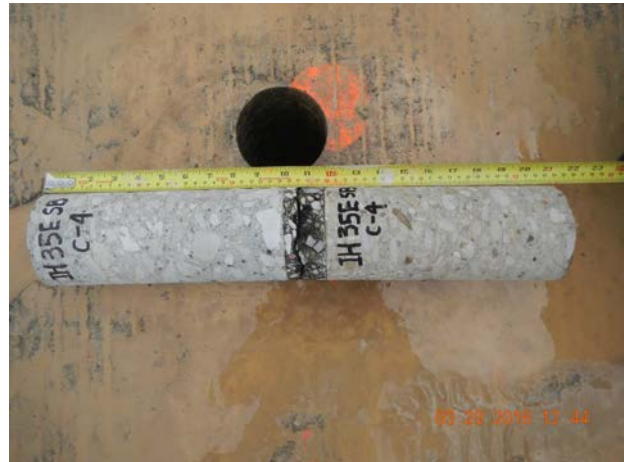
Figure 3.65 Cores taken on IH 35E in Ellis County

As shown in **Figures 3.65-(a) and (b)**, the asphalt interlayer was severely deteriorated, resulting in large deflections. In contrast, a small deflection was measured at the poor section because the asphalt interlayer was in good condition, as shown in **Figures 3.65-(c), (d), (e), and (f)**. Accordingly, it is determined that the main reason for the discrepancy between deflections and base modulus was the quality of the asphalt interlayer. In other words, larger deflections in the good section were due to deteriorated AC interlayer.

Figure 3.65-(d) shows the core taken directly on top of a crack at the outside wheel path of the outside lane, and illustrates that the transverse contraction joint in the overlaid CPCD was mismatched with the old CPCD joint along the crack. As shown in the picture, this distress also included delamination at 3.0-in. or 3.5-in. depth from the pavement surface. The distress here suggests that during UBCO construction of CPCD, matching new joint locations with those in old joints is important, unless joints are mismatched intentionally, which will be further discussed in the next chapter.

a. G-1 core condition at the good section

b. G-3 core condition at the good section

c. C-1 core condition at the poor section

d. C-2 core condition at the poor section

e. C-3 core condition at the poor section

f. C-4 core condition at the poor section

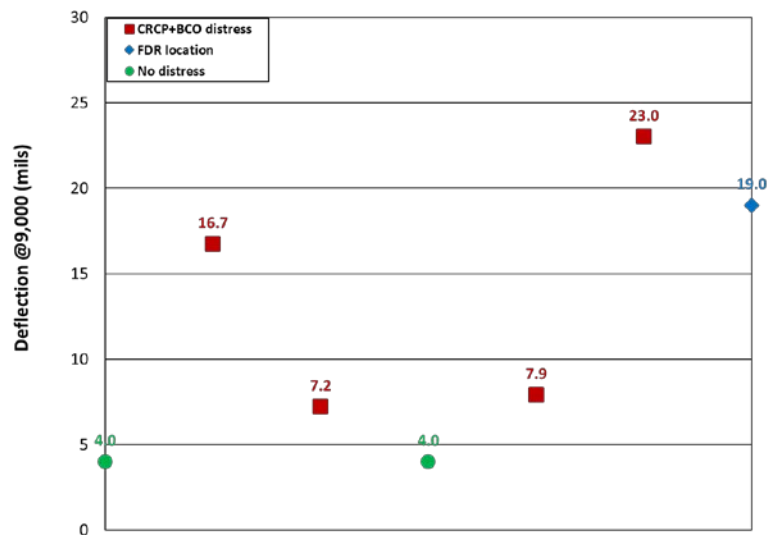
Figure 4.4 FWD deflection with distresses in old CRCP

Since the locations of distresses in the existing CRCP prior to BCO construction were accurately recorded with GPS, it was feasible to determine whether those distresses reflected through BCO and caused distresses in BCO. **Figure 4.4** shows the relationship between distresses in BCO and deflections in the existing CRCP. Red squares indicate distresses in BCO in the form of slab segmentation caused by delamination, while green dots indicate a lack of distresses in BCO. It shows a rather good correlation between deflections in the existing CRCP and distresses in BCO. This implies that FDRs done prior to BCO failed to restore the structural capacity of the existing CRCP, primarily because the distresses in the existing CRCP were due to deficient slab support—and the FDRs did not restore slab support. Instead, FDRs just replaced fragmented concrete with new concrete.

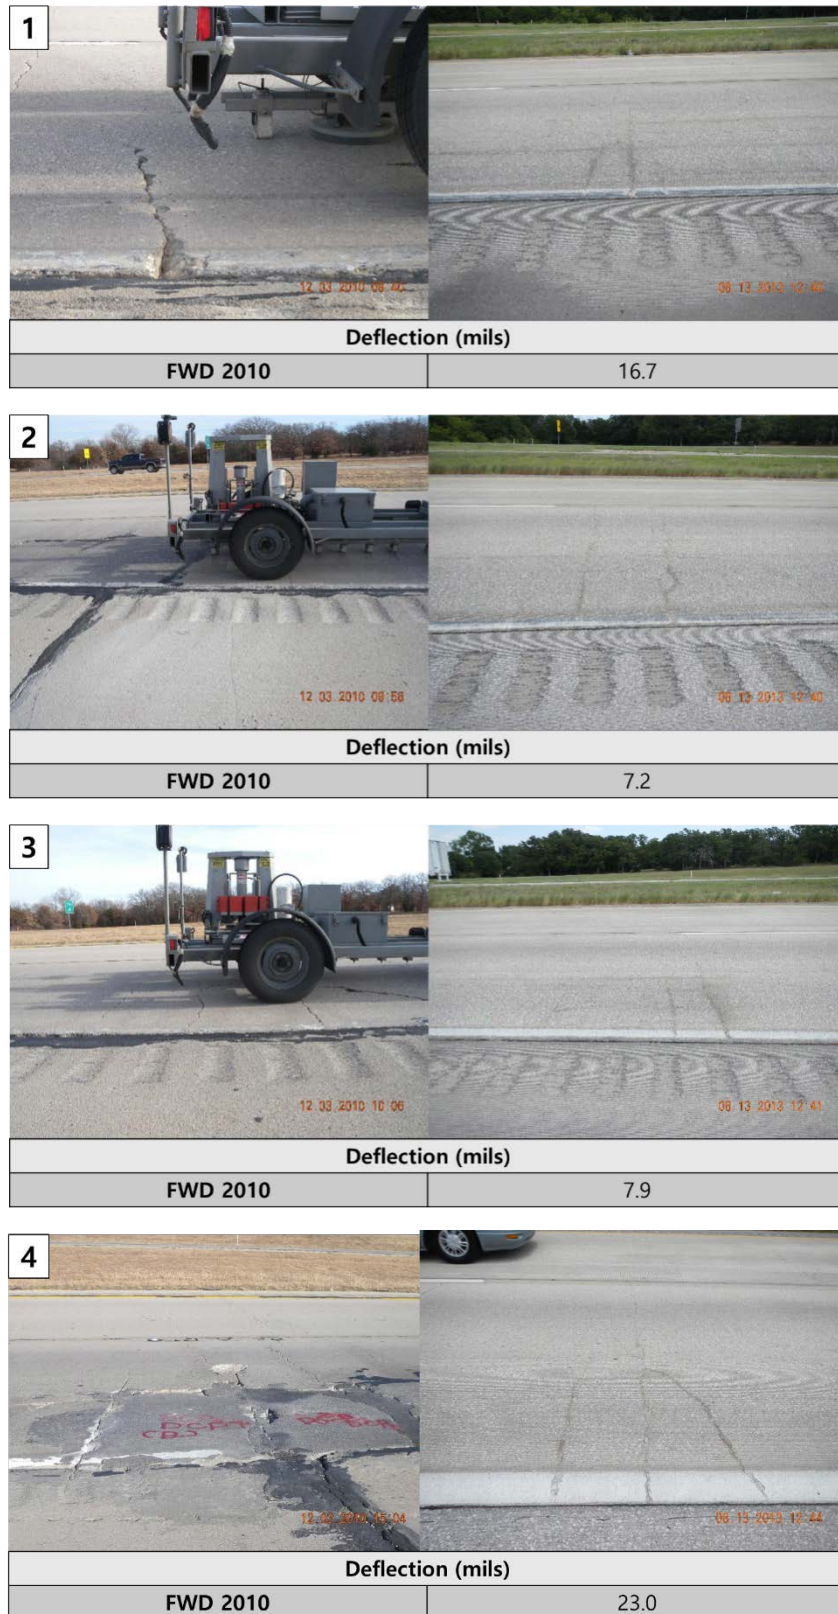
Figure 4.5 Distress comparison between old CRCP and BCO

Figure 4.5 shows comparisons between FWD deflections on existing CRCP measured in 2010 and distresses in BCO. It is interesting to note that the distresses in BCO are of similar shapes to those in the existing CRCP, even though some of these distresses were repaired prior to BCO placement.

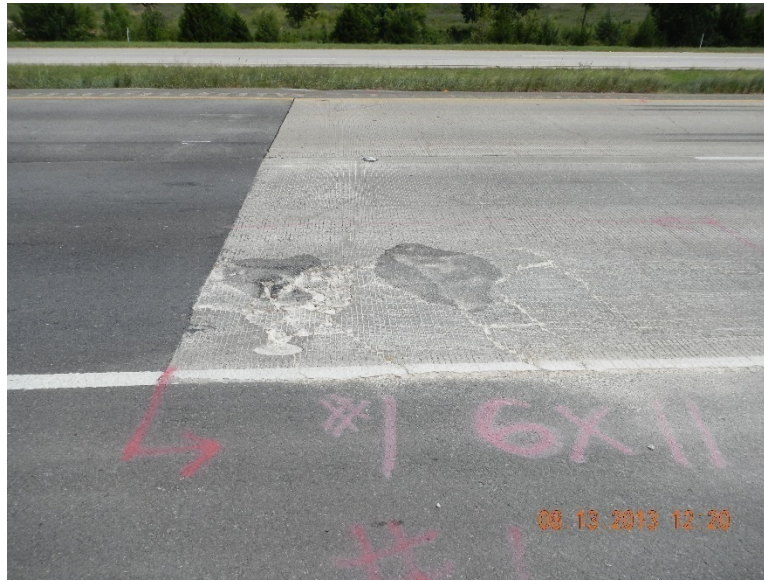
During the field evaluations of BCO performance, it was observed that distresses were more prevalent in areas with discontinuities, such as transition areas between asphalt pavement and BCO, near the bridge expansion joints, or at longitudinal/transverse construction joints. **Figure 4.15** shows transition area conditions in the western end of the US-287 section in Bowie. This distress is confined to the outside lane, which implies that heavy truck wheel loading might have increased stress levels at the interface beyond the bond strength in this area. **Figure 4.16** shows distresses in a TCJ area on US 281 in Wichita Falls. As discussed in Chapter 3, severe delaminations were observed in this area. It appears that warping and curling of concrete caused initial delamination, which developed into fragmentation of overlay concrete. This indicates more stringent quality control or modifications in design may be needed at transverse or longitudinal construction joints, such as better curing.

Figure 4.15 Transition area on BCO on US 287 in Bowie

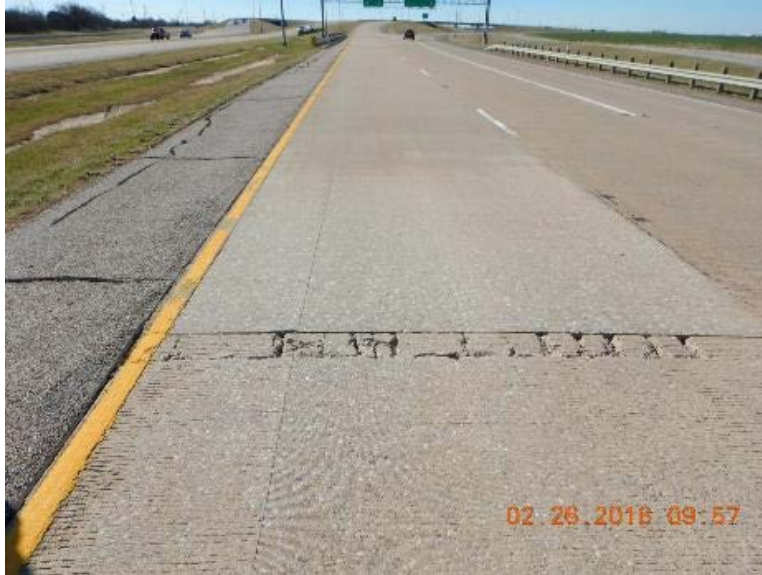
Figure 4.16 Distresses in TCJ on US 281 in Wichita Falls

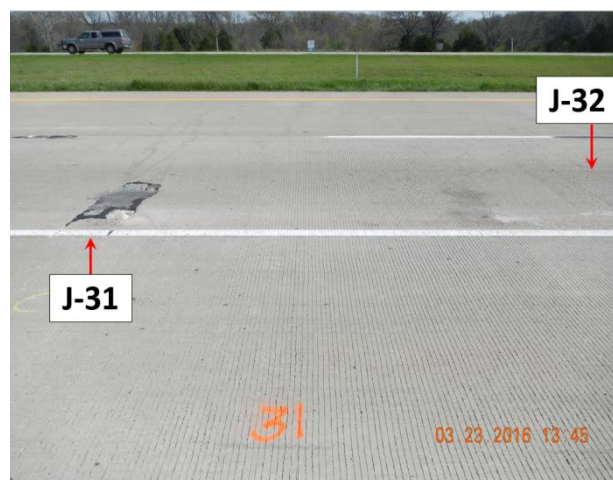
Figure 4.21 Distress on J-31

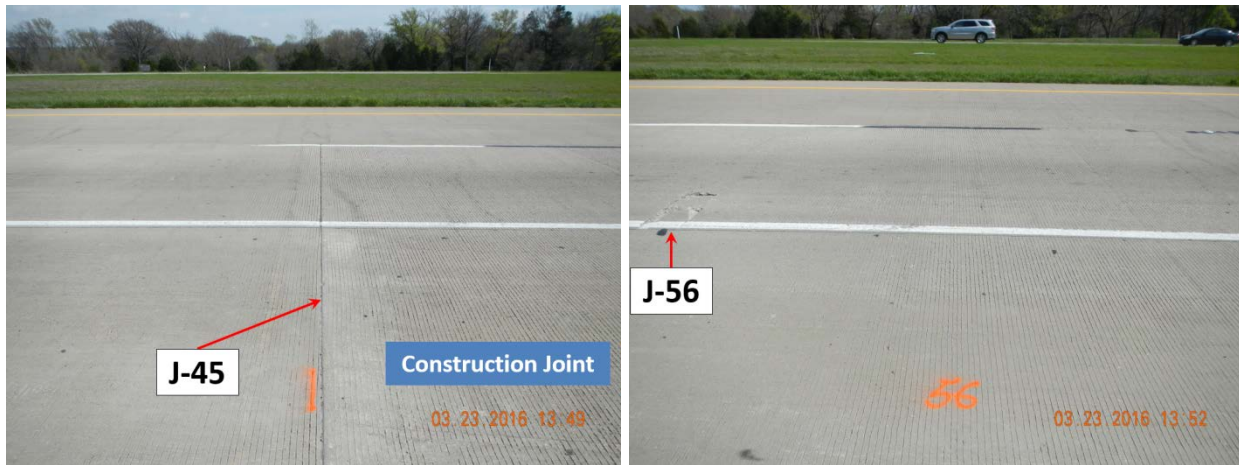
Figure 4.23 Construction joint at J-45 and distress on J-56

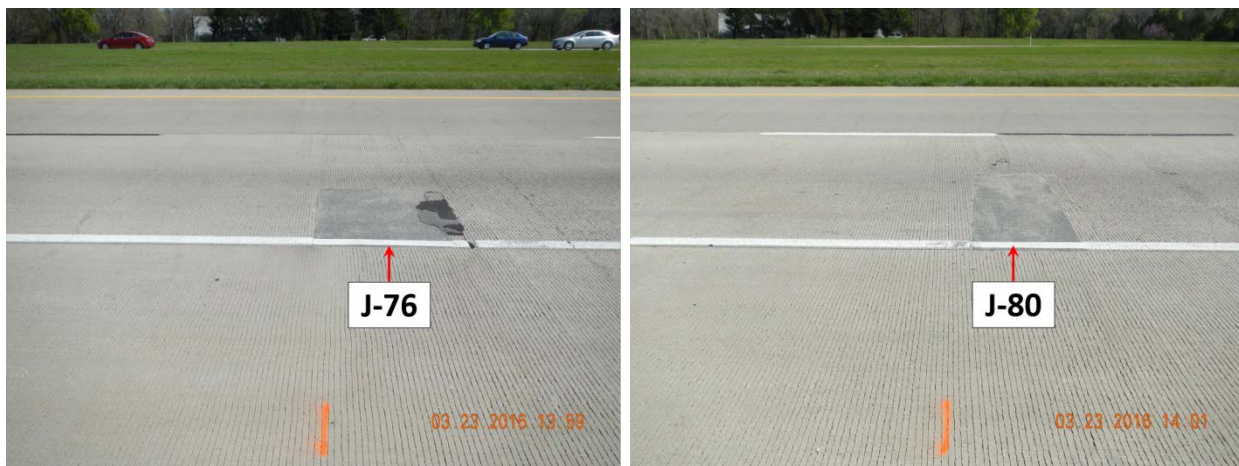
Figure 4.25 Distress on J-76 and J-80

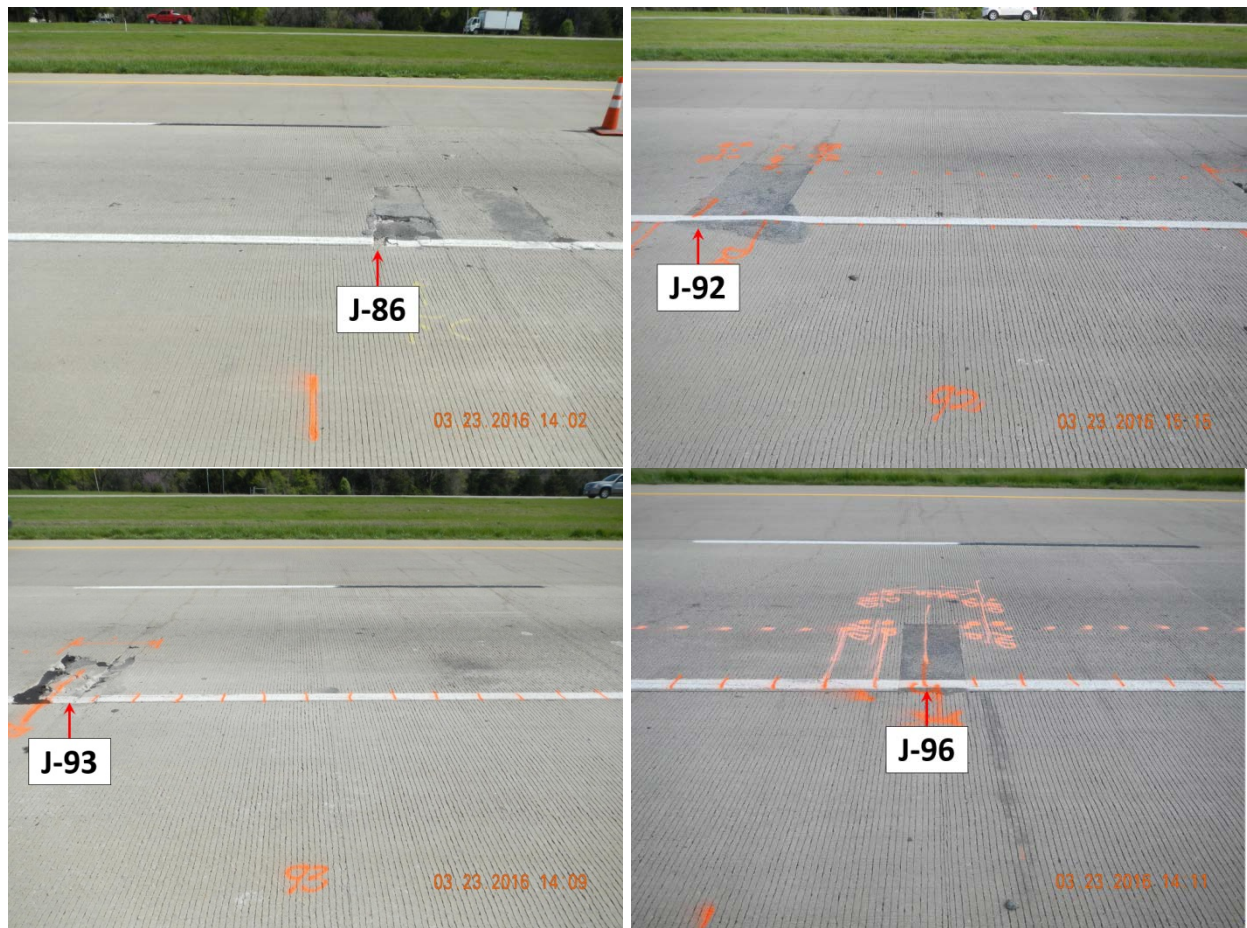
Figure 4.27 Distress on J-86, J-92, J-93, and J-96

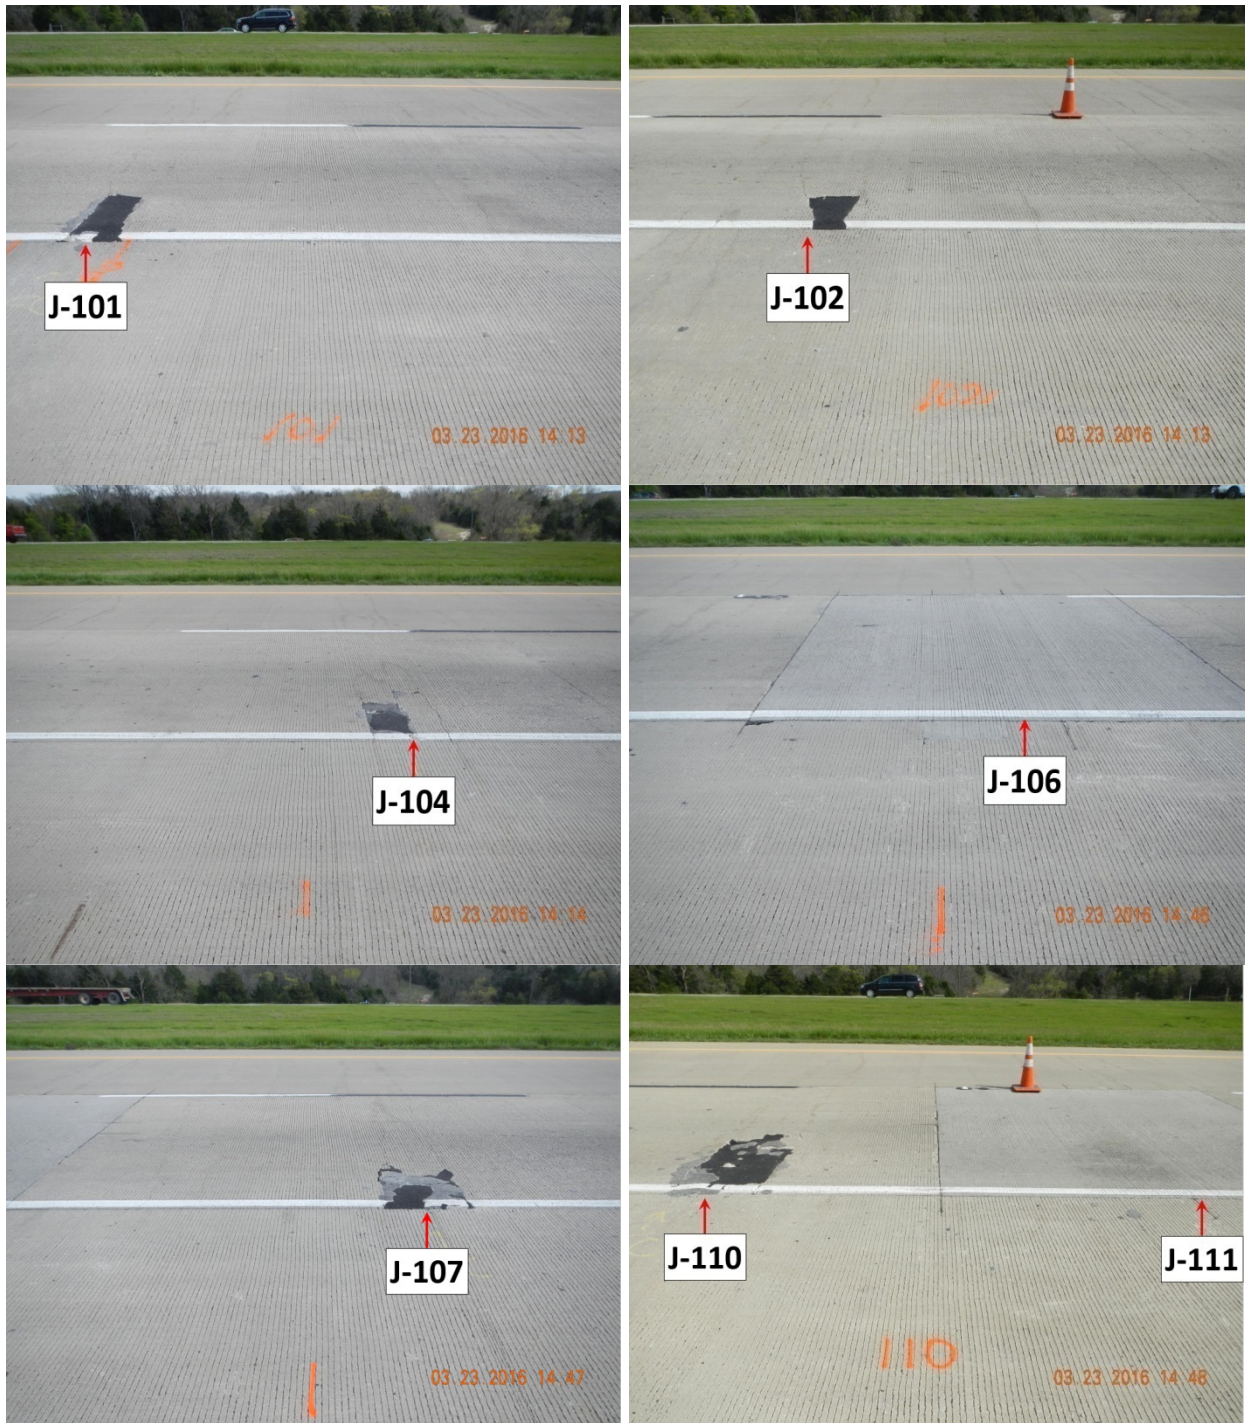
Figure 4.30 Distress on J-101, J-102, J-104, J-106, J-107, J-110, and J-111

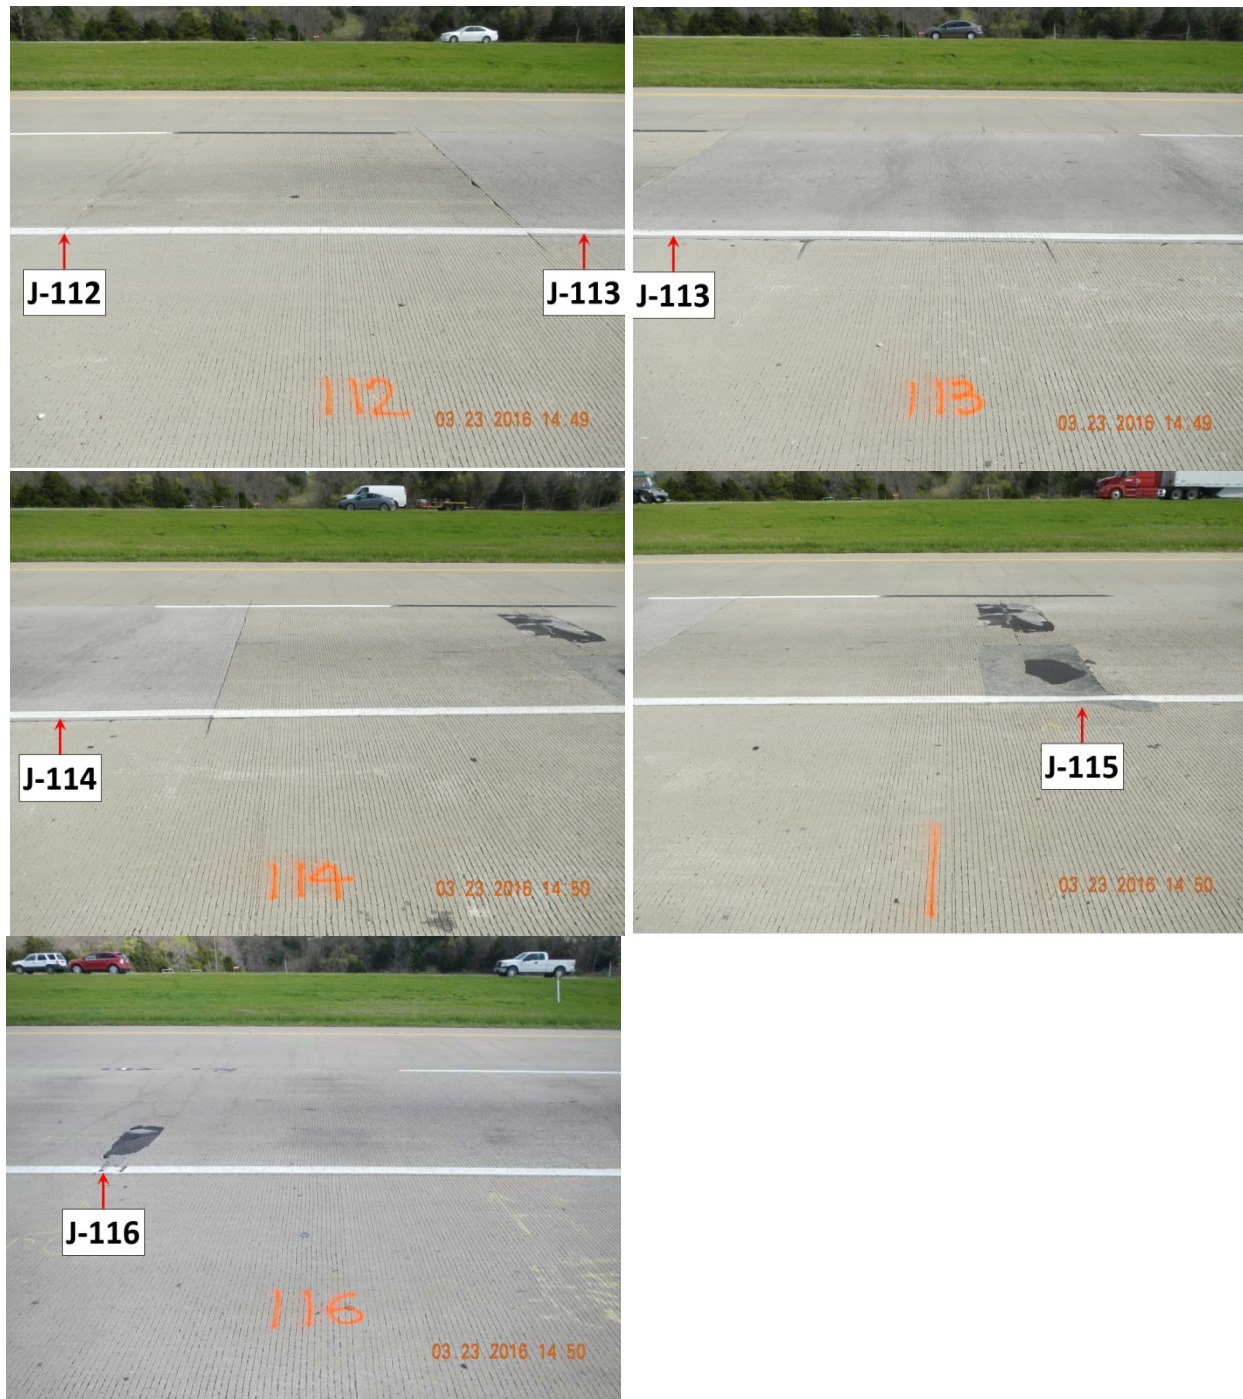
Figure 4.31 Distress on J-112, J-113, J-114, J-115, and J-115

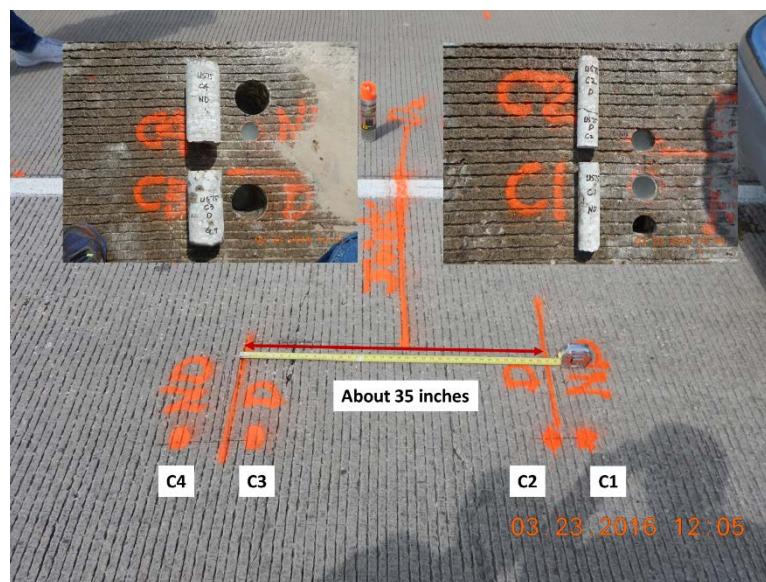
substantially beyond the fabric placement area. To evaluate the extent of debonding from the end of the non-woven fabric, MIRA testing was conducted. MIRA testing at one joint location showed that debonding extended by 6-in. beyond the end of non-woven fabric. To validate the MIRA evaluations, cores were taken at delaminated and non-delaminated areas evaluated by MIRA, as shown in Figure 4.32. MIRA evaluations were quite accurate. It is not known when the delamination actually occurred. Considering this section has been under heavy truck traffic for the last 6 years, this rate of delamination propagation is encouraging and could provide good technical evidence of the feasibility of CRCP BCO on CPCD. As discussed in Chapter 3, some early distresses were repaired as early as 2012 by removing both the concrete in the 7-in. BCO and non-woven fabric, followed by placing new concrete. These repairs performed very well, indicating that the use of non-woven fabric was not needed. Encouraged by this finding and the performance of this CRCP overlay on CPCD, TxDOT scheduled another CRCP BCO on CPCD on US 82 in Paris. Deflections on the existing CPCD were measured and almost all the deflections were less than 20 mils, with an average deflection of 6.4 mils. For this scheduled repair, non-woven fabric will not be used, and CRCP overlay will be placed directly on CPCD.

Figure 4.32 Delamination propagation

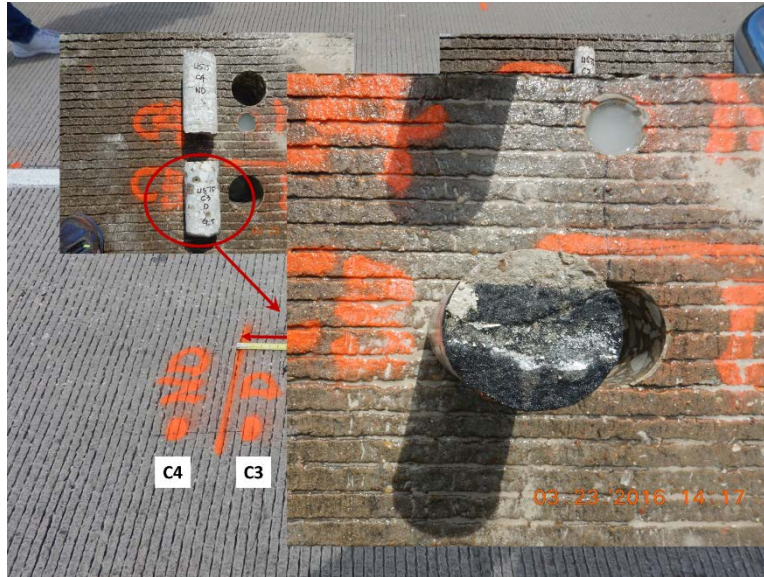
Figure 4.33 shows that fabric was attached to BCO concrete, which is expected since cement mortar from BCO concrete is absorbed into the fabric, creating mechanical bond. Accordingly, the debonding occurred between the fabric and the top of CPCD.

Figure 4.33 Core with an attached non-woven fabric

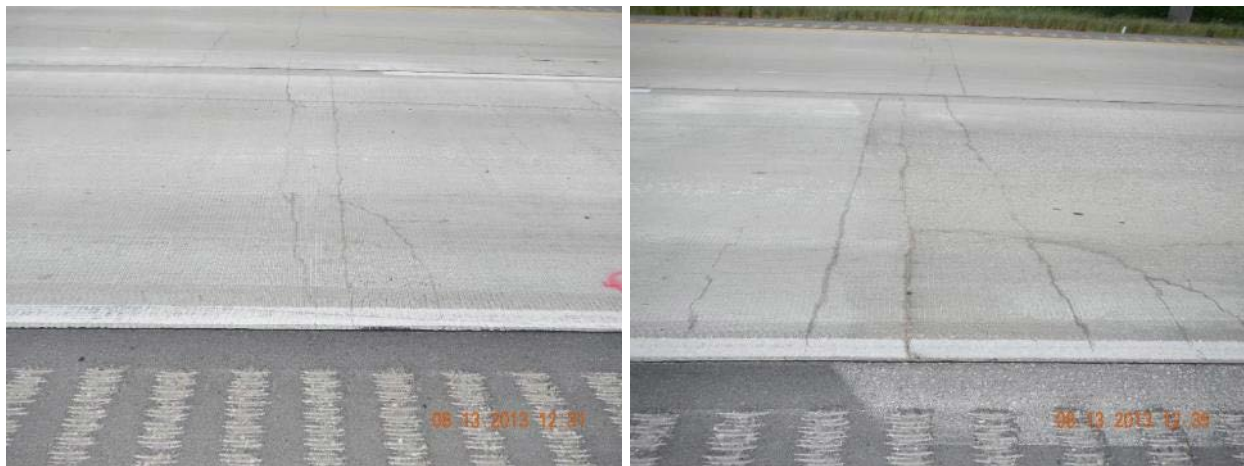
Figure 5.1 Distress due to large deflection in existing CRCP (US 287 in Bowie)

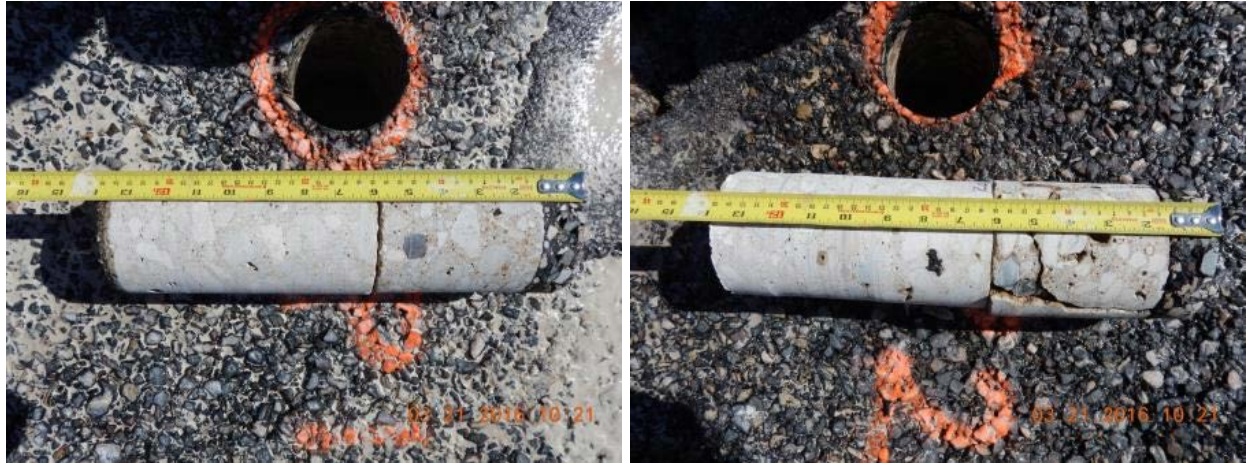
Figure 5.2 Delamination and BCO distress (US 287 in Bowie)

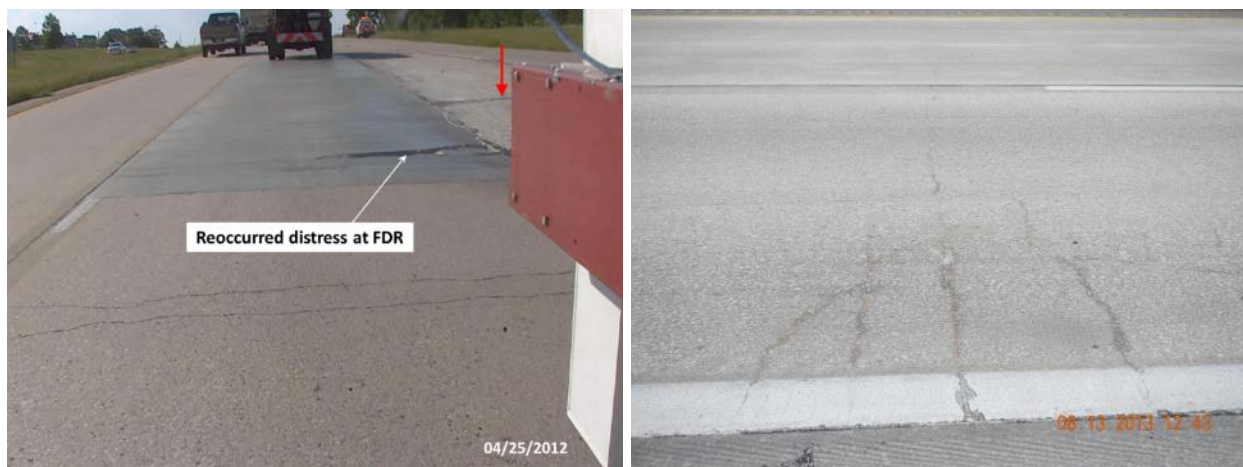
In the US-287 BCO project in Bowie, distresses were observed on BCO slabs along the repair boundaries in the existing CRCP. As shown in Figure 5.3-(a), large deflections were measured at the FDR repair joints. In April 2012, deflection testing was conducted on existing CRCP with TPAD. Deflection profiles in Figure 5.3-(a) are from the TPAD testing. As a result, the secondary distress occurred again within the FDR slab before the BCO was placed, as illustrated in Figure 5.3-(b). Eventually, the distresses in the FDR areas in the existing CRCP were reflected to the BCO as shown in Figure 5.3-(c). This distress mechanism could be considered as a subset of the distress mechanism discussed earlier (larger deflections of BCO system potentially causing delamination and distress). In other words, large deflections in the existing PCC pavement slabs could be one of the primary distress development mechanisms in BCO.

(b) Distress within FDR slab

Figure 5.3 Distress at FDR joint (US 287 in Bowie)

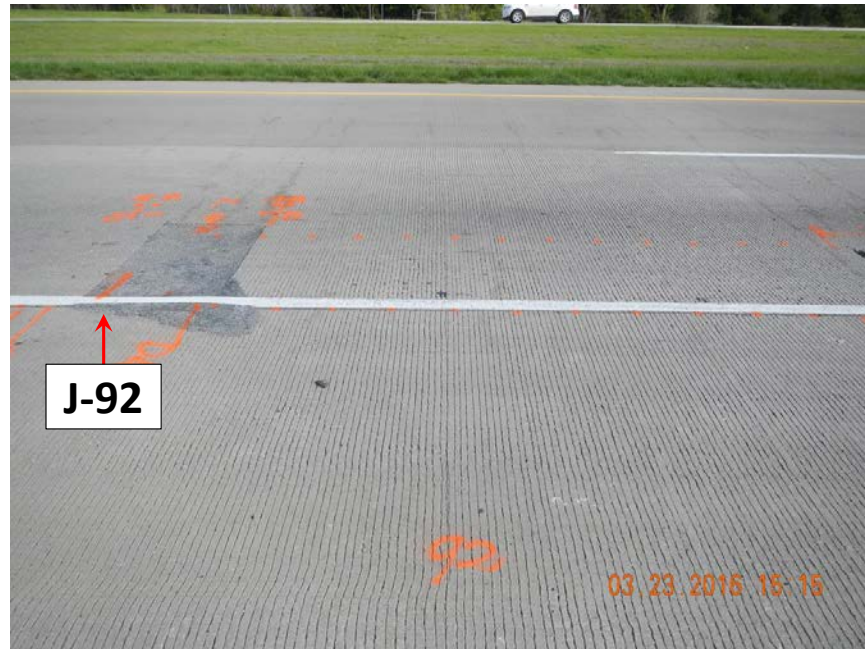
Figures 5.4 and 5.5 show typical distresses in CRCP BCO on CPCD on US 75. The distresses appear to be confined to the extent of the geotextile. It is not known what type of distresses could have occurred without the geotextile. However, if the deflections at transverse contraction joints in existing CPCD are less than a to-be-developed threshold value, a CRCP overlay without a geotextile could work.

Figure 5.5 Distress in CRCP BCO on CPCD (US 75 in Sherman #2)
