# JOINT TRANSPORTATION RESEARCH PROGRAM

## Post-Fire Assessment of Prestressed Concrete Bridges in Indiana

**Amit H. Varma, Jan Olek, Christopher S. Williams,  
Tzu-Chun Tseng, Sijia Wang, Dan Huang, Tom Bradt**

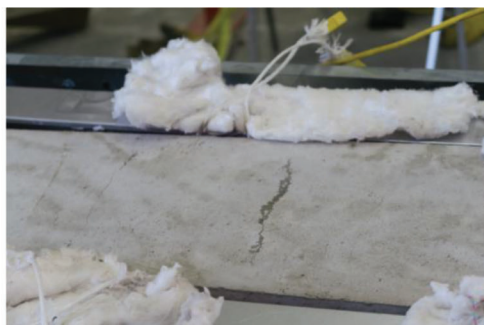
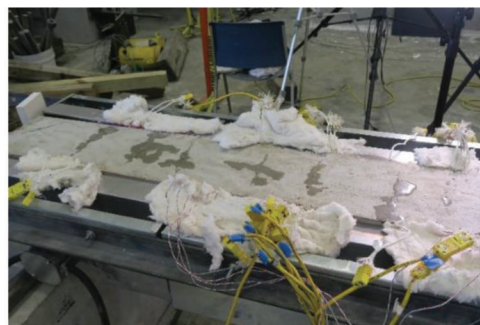
**6.1.1.1 40-minute two-sided heating test for specimen with two strands (PS1).** During the experiment, moisture was observed along with a crack on the top at 23 minutes, when the average exposed surface temperature reached 875°F (468°C). The moisture kept seeping out and spreading during the heating test until heaters were turned off. Figure 6.1 shows the moisture observed on top of the specimen during the test at different stages.

**Figure 6.1** Observation of moisture from specimen PS1 during test.

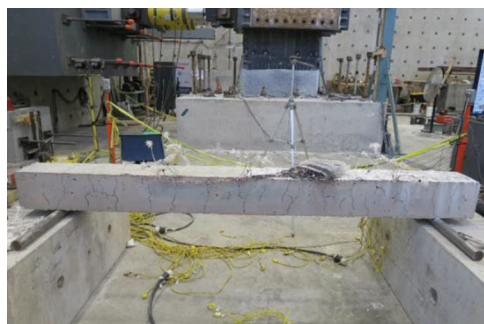
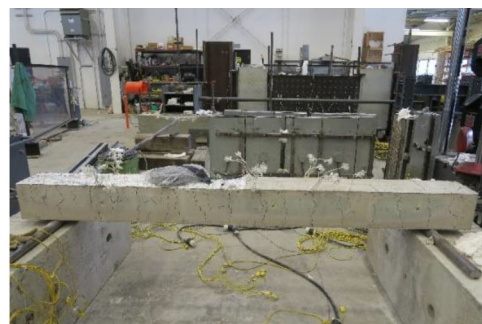
After the test finished and the specimen cooled down to the room temperature, cracks on the exposed surface were observed and marked. As presented in Figure 6.2, relatively narrow cracks (widths < 0.005 in.) were

observed. Most cracks were found along the locations of stirrups on both sides of the specimen, and some cracks extended into top of the specimen. No spalling was found at the surface of concrete. Concrete color at some areas at exposed surface changed to darker grey after the heating test.

**Figure 6.2** Map of cracks for PS1.

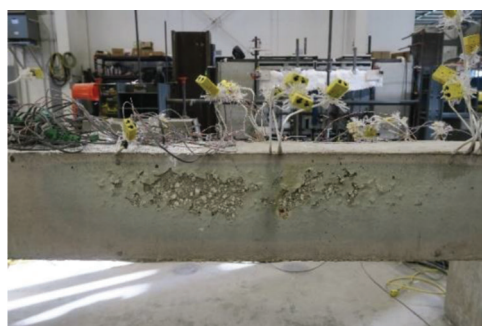
be found at some areas under heaters and the aggregates were exposed, as shown Figure 6.8. The temperature profile of PS2 is shown in Figure 6.4. It can be noticed that concrete temperature at all depth increased constantly till the end of test. Maximum temperatures at different is shown in Table 6.1. According to the results from the deck tests, the CH decomposition

**Figure 6.8** Spalling at exposed surface for PS2.

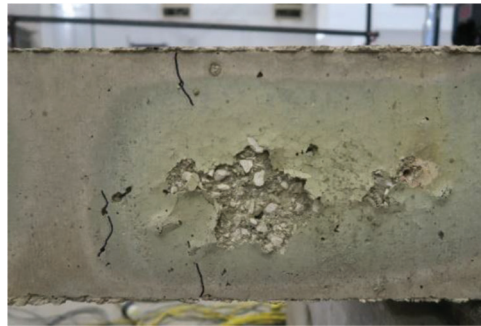
Similar to the PS2 specimen, spalling at the heated surfaces can be observed after the 80-minute heating test, as presented in Figure 6.10. The temperature measurement shows that, the maximum surface temperature of concrete reached to 1,485°F (807°C) after 80 minutes heating, and the internal temperature profile of PS3 during the heating test is demonstrated in Figure 6.11. Maximum temperatures measured at various locations is tabulated in Table 6.2. Based on the experience obtained from deck tests, the CH decomposition could probably be observed at the region between the exposed surface to 0.5 in. depth.

**Figure 6.10** Spalling at exposed surface for PS3.

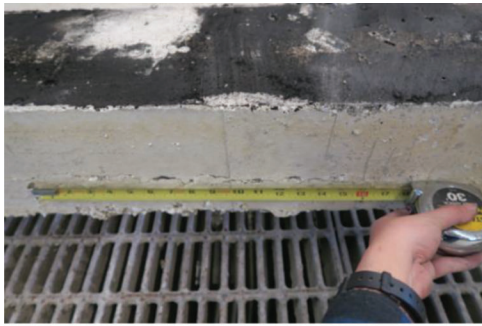
The specimens were placed on the site and cooled for 1 day, after that they were transported back to the laboratory for coring the material samples and measuring the deflections. It could be observed that there were two major longitudinal cracks existing for both beams. The first crack was on the inner surface in midspan with

the length of 18 in., and the other crack was observed on the bottom surface in midspan with the same length, as presented in Figure 6.18(a) and Figure 6.18(b). After the specimen was turned upside down for coring material samples, severe appalling could be seen on the bottom surface of the prismatic specimen. Moreover, a transverse crack could be noticed in the midspan, which connected two longitudinal cracks mentioned together, as shown in Figure 6.18(c). By the inspection at the cored locations, the longitudinal cracks existing on the inner and the bottom surfaces did not extend through the depth, instead of that, they were prone to developed inclinedly toward each other, as shown in Figure 6.18(d).

(a) Longitudinal Crack on Inner Surface

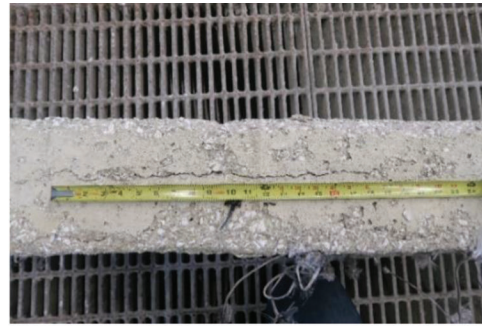
(b) Longitudinal Crack on Bottom Surface

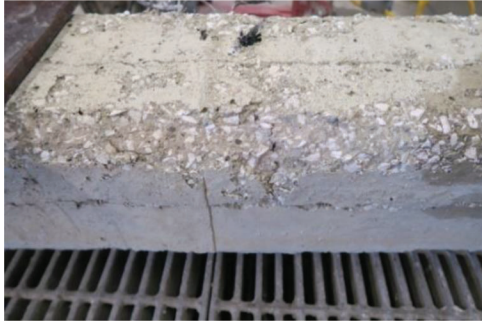
(c) Transverse Crack in Midspan

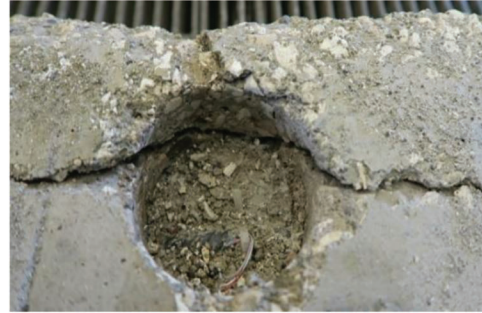
(d) Development of the Crack on Inner Surface

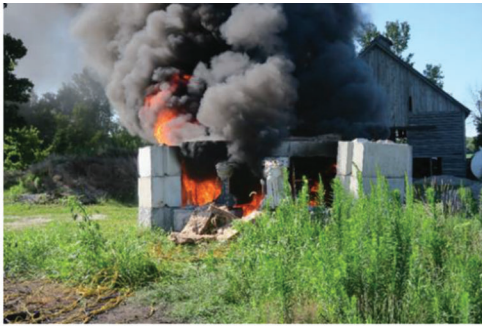
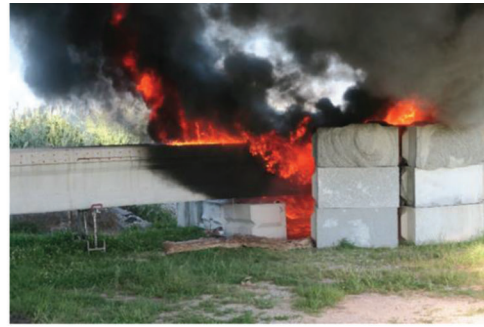
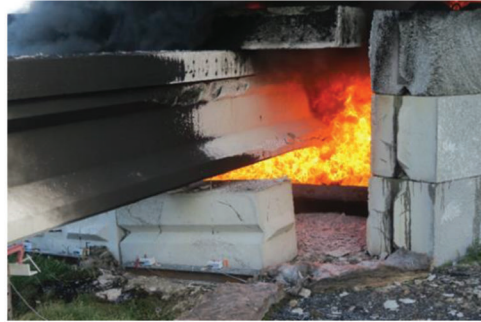
After 10 minutes from the start of the test, the fire propagated along the top of the test girders, as shown in Figure 8.1(b) due to the combustible thin epoxy overlay on the composite deck. Consequently, the fire advanced toward the south and even reached the midspan of the girders, interrupting measurements from the string potentiometers installed at that location.

After 28 minutes of heating, severe concrete spalling could be observed at the corners of the top and bottom flanges, as presented in Figure 8.1(c). Moreover, the two deck segments placed on top of the girders as well as the surrounding concrete blocks also experienced spalling during the test.

**Figure 8.1** Observations during the pool fire test.

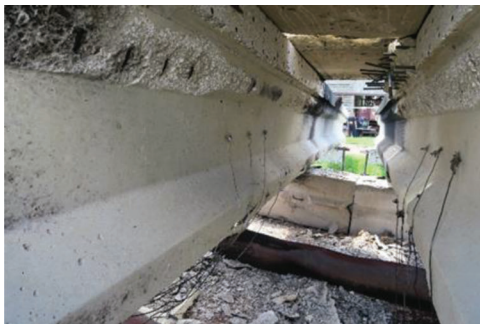
(a) Inside of Girder C5 (West Side)

The damage experienced by the test girders was inspected after the setup cooled down. For Beam C5, it was observed that the inside and outside (west and east) corners of the top and bottom flanges were damaged severely and that notable spalling and cracking occurred within most of the burned region, as shown in Figure 8.2(a) and (b). Furthermore, the concrete surfaces above the pool became yellowish gray and extensive microcracking was observed.

**Figure 8.2** Cracking and spalling of burned girders.

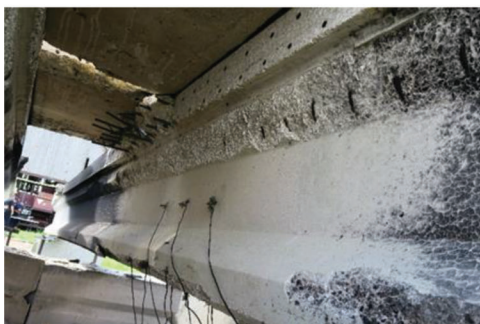
(c) Inside of Girder C7 (East Side)

The condition of the inside (east) surfaces of Beam C7 is shown in Figure 8.2(c). The prestressed girder sustained serious damage to the flanges above the pool. Like Beam C5, the flanges engulfed by the flame spalled and cracked, and the concrete surface within the corresponding region turned to yellowish gray. The damage to the outside (west) surfaces of the specimen, however, was less significant, as shown in Figure 8.2(d). Although some spalling and cracking could still be observed at the corner of the top flange, most of the concrete above the pool was relatively intact. The influence of the light wind on the flames caused the development of different damaged conditions on the two sides of Beam C7.

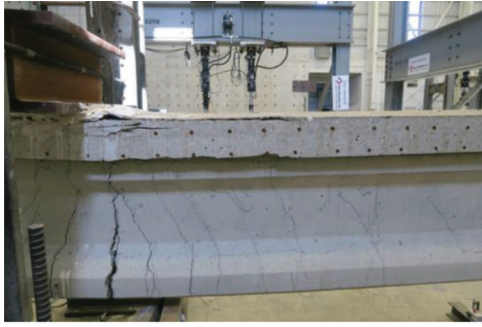
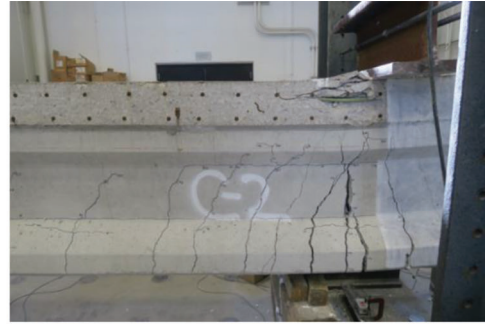
failure, resulting in a sudden loss in load carrying capacity at a deflection of 2.12 in. measured at the location of the loading point. Figure 8.8 shows the failure region of the specimen. Failure was characterized by concrete crushing in compression within the composite deck and the opening of a flexural crack located approximately 1 ft from the loading point, as shown in Figure 8.8. The occurrence of concrete crushing and opening of the crack took place simultaneously. Moreover, rupture of strands (both bottom strands and harped strands) could be observed after removing the concrete at the damaged region. The load-deflection plot in Figure 8.7 includes a load plateau, indicating ductile behavior prior to the occurrence of the flexural failure.

**Figure 8.8** Failure condition for C2-Flexure.

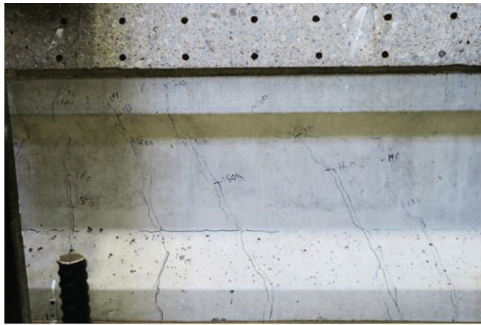
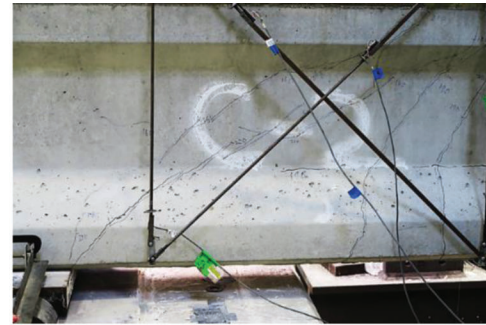
The shear-controlled ambient load test (C2-Shear) used the test setup presented in Figure 7.5. Similar to the flexure-controlled test, flexural cracking during the test was initially observed at an applied load of 140 kips. When the applied force reached 160 kips, the first diagonal crack, a web-shear crack, was observed. Cracks continued to develop and propagate upon further loading. The cracking at an applied load of 240 kips is shown in Figure 8.9. Significant shear

**Figure 8.9** Cracking for C2-Shear at an applied load of 240 kips.

cracking is noted within the 54-in. shear span of the girder (Figure 8.9(b)).

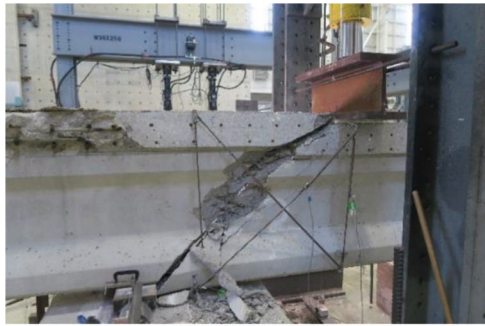
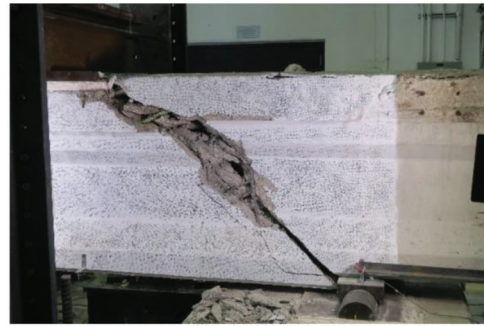
dominated by D-region shear. The specimen after failure is shown in Figure 8.11. Because of the shear-dominated behavior of the girder during the test, a clear load plateau is not observed in the load-deflection curve in Figure 8.10.

**Figure 8.11** Failure condition for C2-Shear.

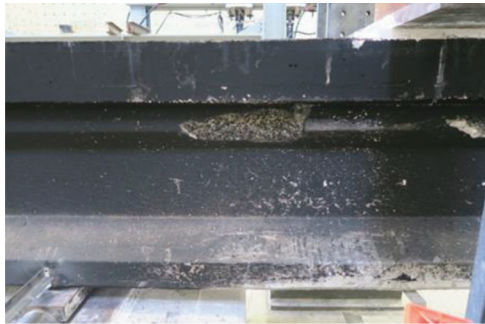
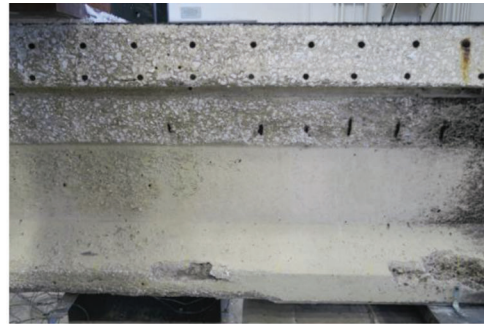
**Figure 8.12** Damaged condition of Beam C7 near loading point prior to load test.

The setup for flexure-controlled load tests was used for the test on Beam C7. The damaged state of Beam C7 prior to the load test is shown in Figure 8.12. Due to the distribution of the flames during the pool fire test, the intensity of the temperatures experienced by the specimen was different for the two sides of the member, as described in Section 8.1. On the west side of the specimen (Figure 8.12(b)), severe spalling of both the top and bottom flanges is noted. A large portion of the top flange of the precast girder was lost. Additionally, the flaking of the concrete surface of the web of the specimen can be seen in the figure. On the east side of the specimen (Figure 8.12(a)), however, the damage was less severe due to the lower temperatures that were experienced. Although some spalling is noted, the flanges were mostly intact for this side of the specimen.

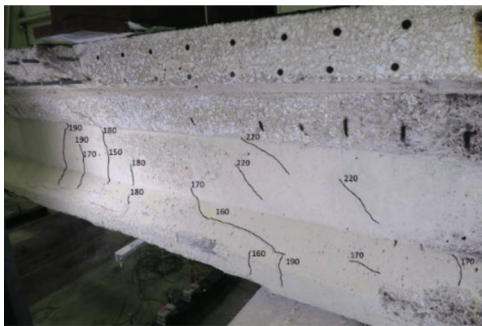
**Figure 8.13** Cracking of Beam C7 at an applied load of 220 kips.

The cracking for Beam C7 under an applied load of 220 kips is shown in Figure 8.13. New crack development observed during the load test is indicated with black lines. As with the previous tests on Beam C2 at a similar loading stage, both flexure and shear cracks were observed within the test region.

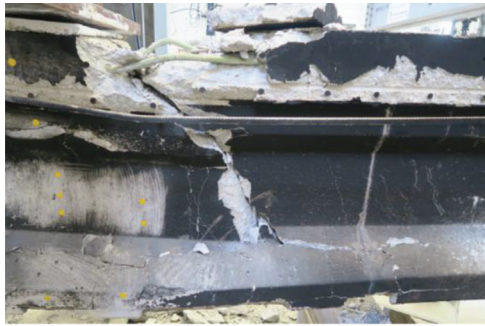
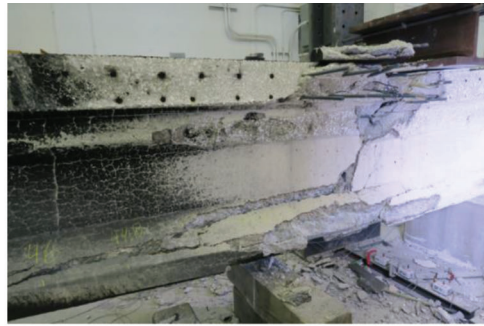
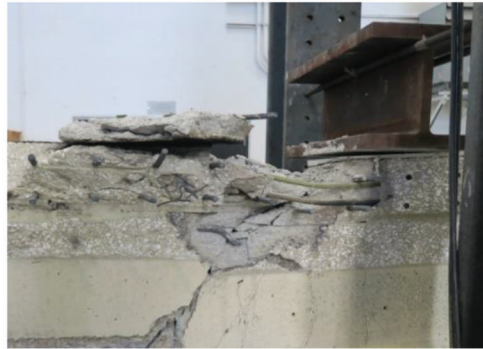
The load-deflection curve for Beam C7 is presented in Figure 8.14. The specimen resisted a maximum applied load,  $P_{test}$ , of 265 kips, corresponding to a bending moment,  $M_{test}$ , of 1,001-kip-ft and a shear force,  $V_{test}$ , of 222 kips. The ultimate failure of the specimen and a sudden loss in load-carrying capacity occurred at a deflection of 2.22 in. measured at the location of the loading point. The specimen experienced failure within the region north of the loading point (that is, the longer shear span), as shown in Figure 8.15. The failure behavior seemed to be influenced by a combination of flexure and shear. Sudden slip along the primary failure crack in the web of the girder was accompanied by crushing of concrete in the composite deck (Figure 8.15(c)) and buckling of the compression bars. It can be observed that the primary failure crack propagated horizontally into the bottom flange north side of the loading point for a distance of approximately 12 ft, splitting the bottom flange. It should be noted that the load-deflection curve in Figure 8.14 includes a load plateau similar to the response curve for the C2-Flexure test that resulted in a flexural failure of Beam C2.

**Figure 8.15** Failure condition of Beam C7.

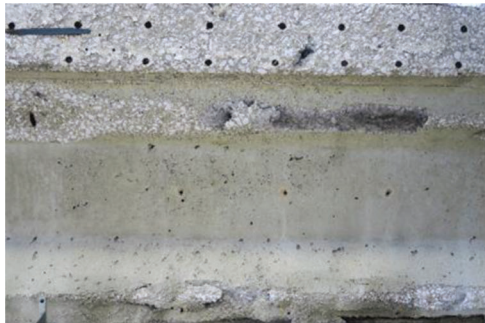
(a) East Side of the Specimen

The setup for shear-controlled load tests was used for the test on Beam C5. The damaged condition of the member prior to the load test is shown in Figure 8.16. The damage caused by the hydrocarbon fire was significant for both sides of the specimen. In the test region, the top flange had experienced severe spalling. Furthermore, cracking and spalling impacted the bottom flange on both its side surfaces and bottom surface. The spalling caused a reduction in the cross section of the member.

**Figure 8.16** Damaged condition of Beam C5 near loading point prior to load test.

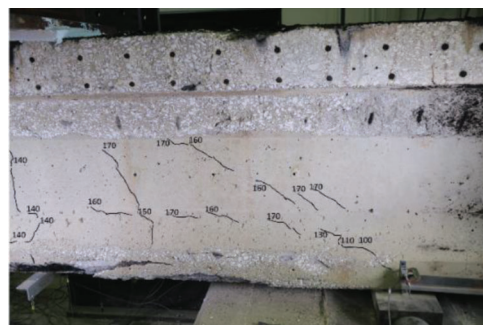
The first notable crack that developed during the load test was observed at an applied load of 100 kips near the support reaction. The cracking of Beam C5 at an applied load of 170 kips is shown in Figure 8.17. It should be noted that the cracking of the girder was not closely inspected when the applied load exceeded 180 kips due to safety concerns.

**Figure 8.17** Cracking of Beam C5 at an applied load of 170 kips.

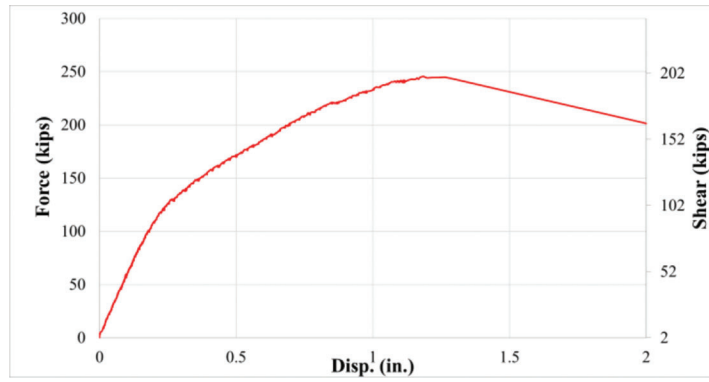
The load-deflection curve for Beam C5 is provided in Figure 8.18. The maximum load applied to the

specimen,  $P_{test}$ , was 246 kips, corresponding to a bending moment,  $M_{test}$ , of 900-kip-ft and a shear force,  $V_{test}$ , of 200 kips. The ultimate failure of the specimen occurred at a deflection of 1.19 in. measured at the location of the loading point. Failure occurred within the 54-in. shear, as shown in Figure 8.19. The primary failure crack extended from the loading point to the support reaction, indicating failure along the strut extending between the load and the support. As shown in Figure 8.19, a horizontal crack propagated along the bottom flange and extended beyond the loading point (Figure 8.19(c)). The lack of a load plateau along the load-deflection curve in Figure 8.18 resembles the response curve for the C2-Shear test on Beam C2.

**Figure 8.18** Load-deflection curve for Beam C5.

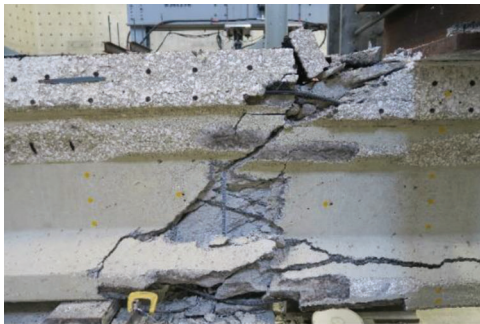
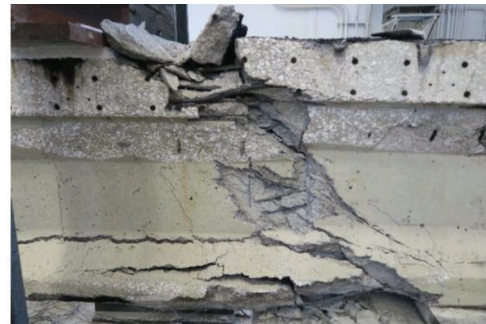
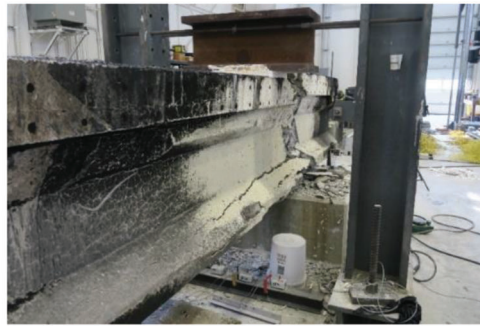
(a) East Side of the Specimen

(b) West Side of the Specimen

(c) Cracking Extending Along Beam C5

**Figure 8.19** Failure condition of Beam C5.

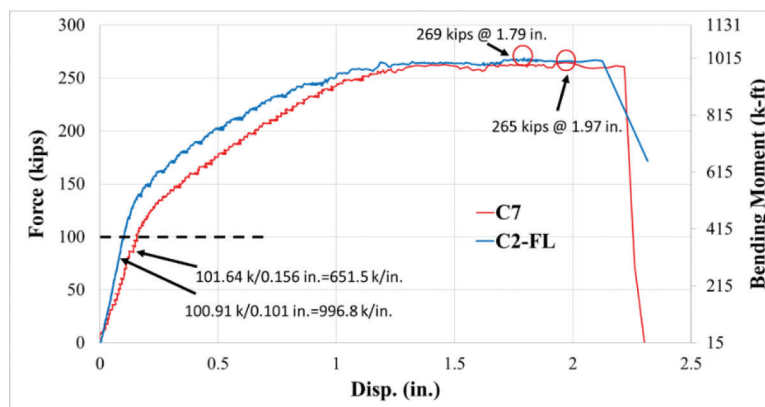
The load-deflection curves for the flexure-controlled (C2-Flexure and C7) and shear-controlled (C2-Shear and C5) load tests are compared in Figures 8.20 and 8.21, respectively. The maximum applied force, initial stiffness, and the corresponding shear force and bending moment are summarized in Table 8.2 for the four tests. Furthermore, the ratios for the values for the fire-damaged girders to those for the ambient tests are shown in parentheses.

For the flexure-controlled load tests, the maximum applied load for Beam C7 was 265 kips, which is equal to 98.5% of the maximum load resisted by Beam C2 not damaged by fire. However, the initial stiffness of the fire-damaged specimen was significantly less than that observed for the ambient test. In this case, a 34.6% reduction in initial stiffness occurred. The load-deflection plots in Figure 8.20, however, reveal that there is essentially no difference in the load plateau demonstrated by the behaviors of both specimens, and the maximum displacements achieved are very similar.

**Figure 8.20** Comparison of load-deflection curves for flexure-controlled load tests.

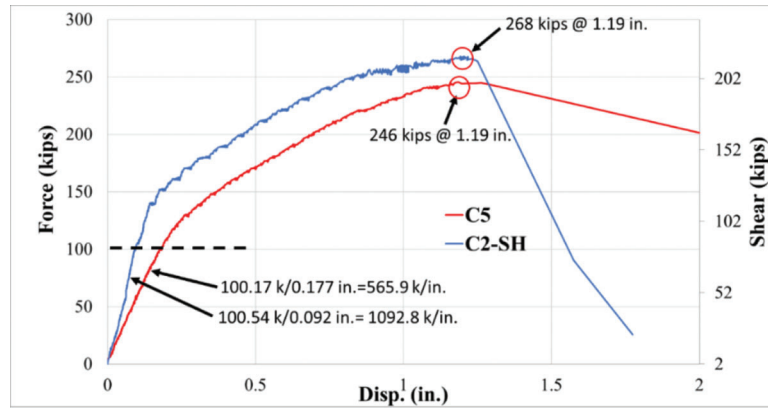
**Figure 8.21** Comparison of load-deflection curves for shear-controlled load tests.

initial stiffness for the damaged girder was 48.2% compared to the specimen not exposed to fire. Despite this difference in behavior between the specimens, the overall behaviors demonstrated by the load-deflection plots in Figure 8.21 are similar.

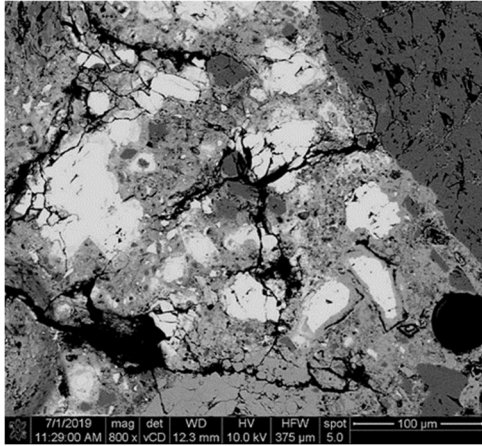
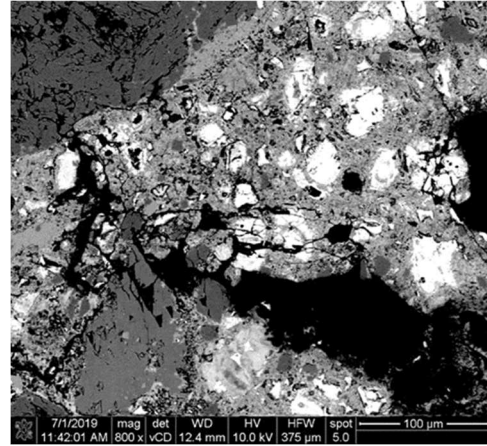
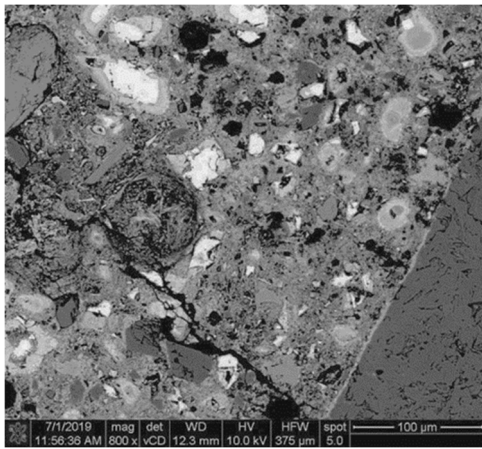
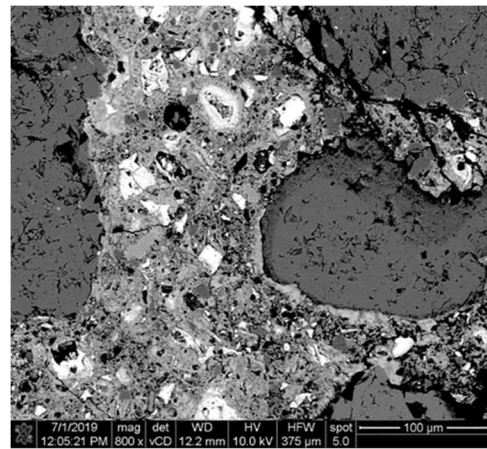
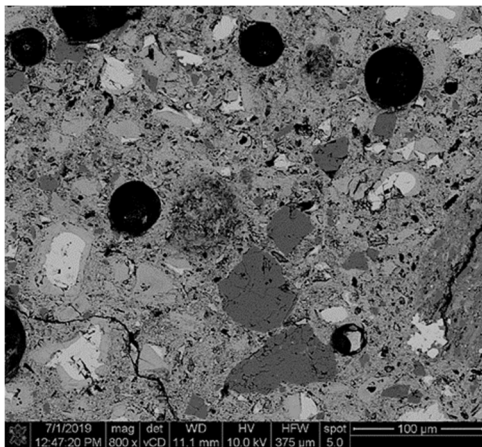
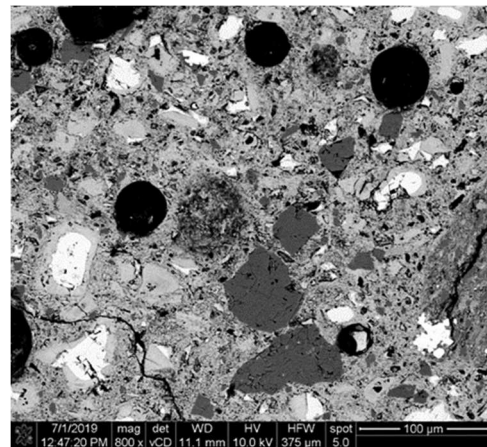
Figure B.1 SEM images of microstructure of heated–40 Specimen.

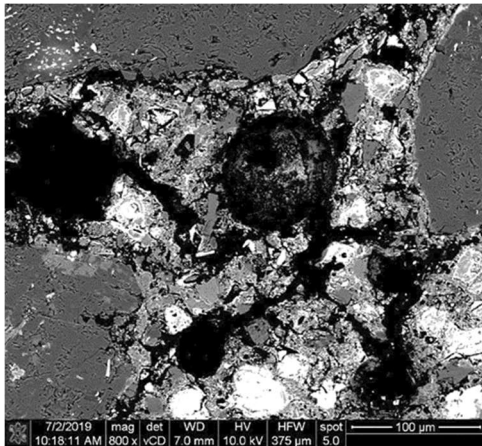
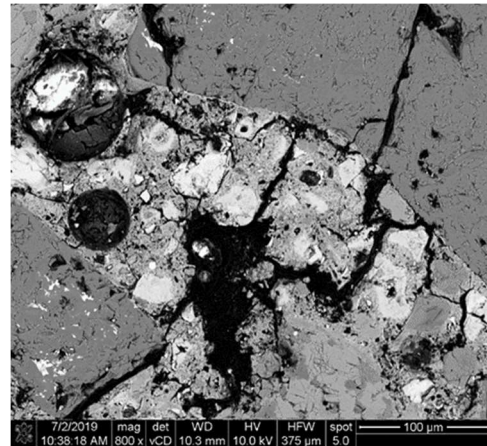
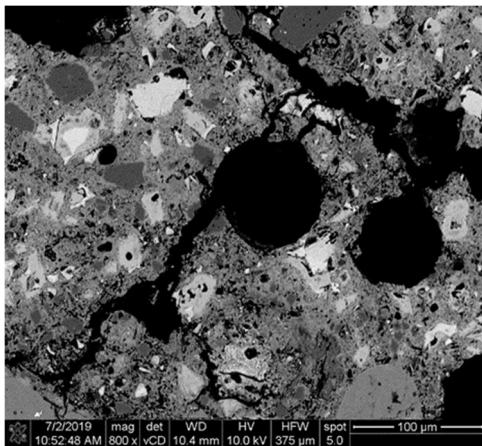
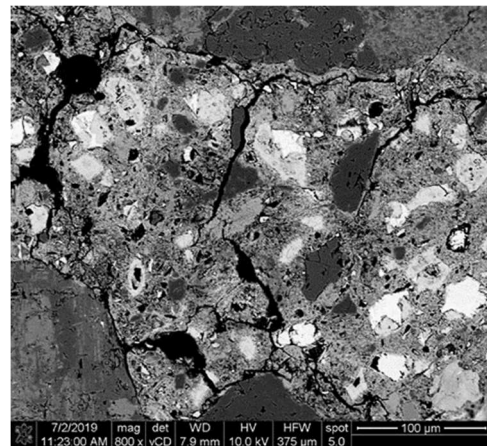
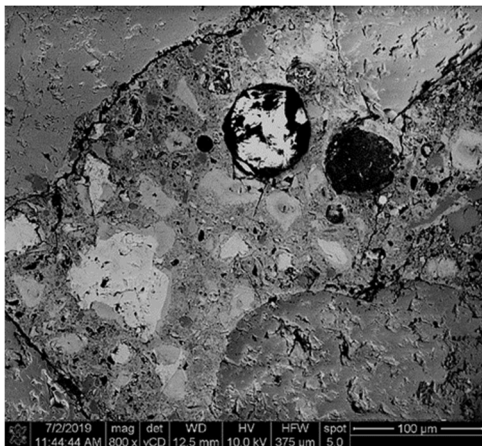
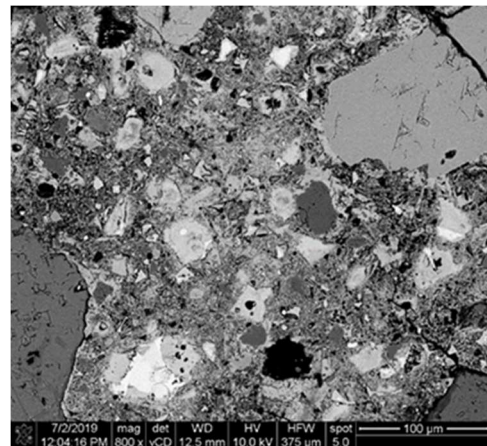
Figure B.2 SEM images of microstructure of heated–80 Specimen.

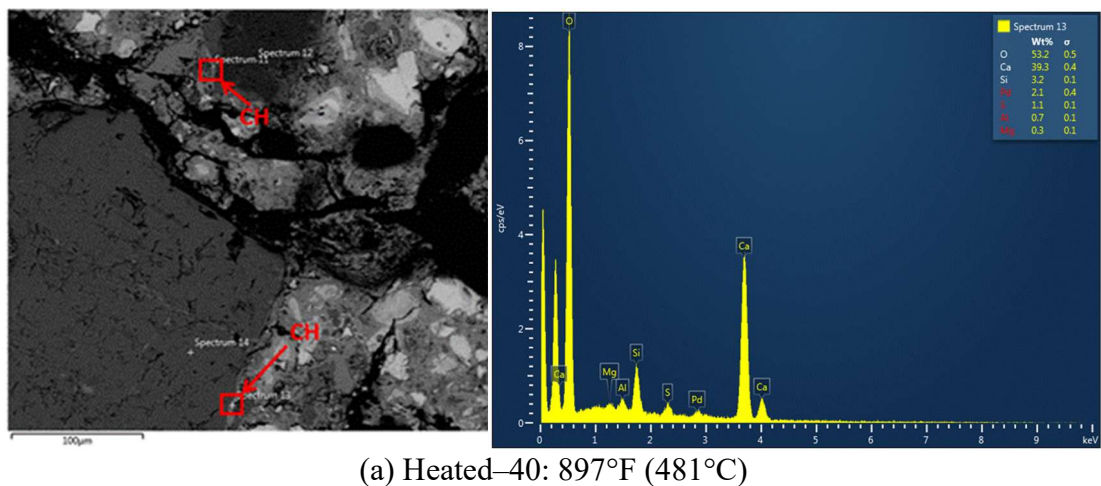
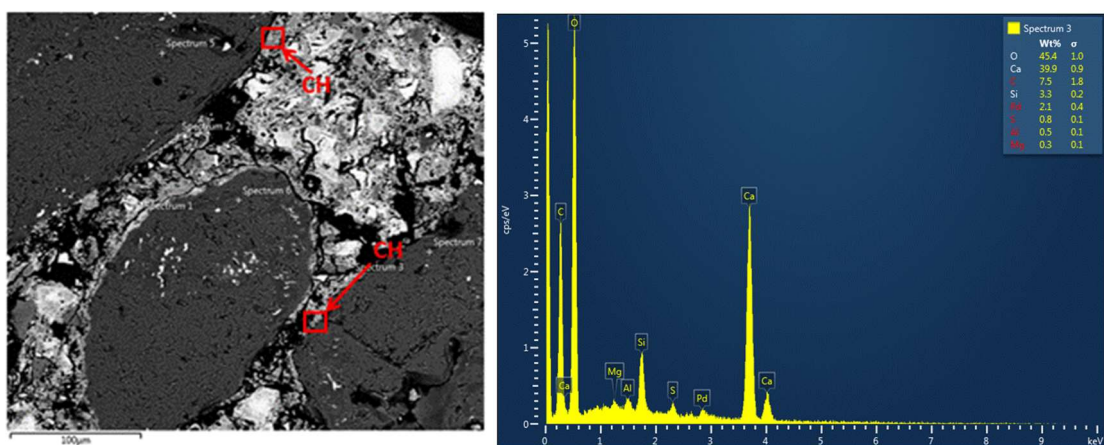
Figure B.3 Location of CH deposits as identified by the EDS signals collected at the depth of 0.25 in. from the heat-exposed surface.

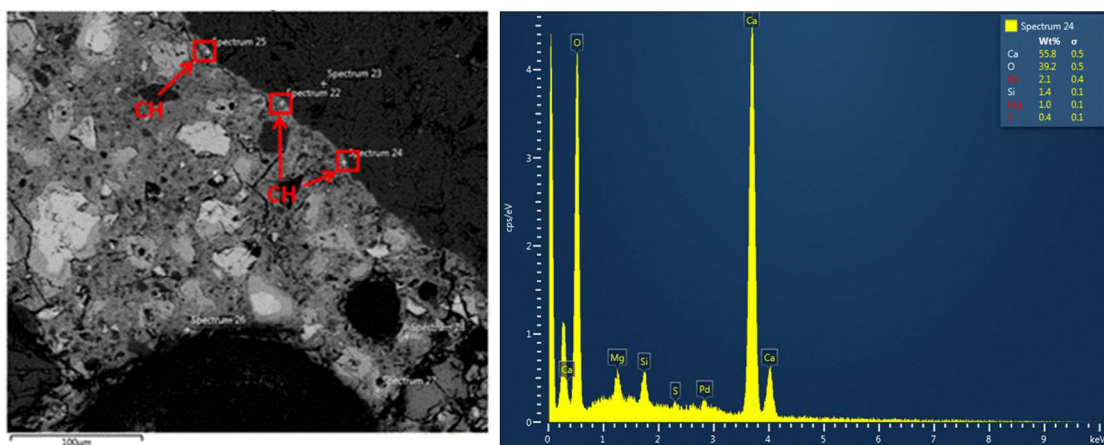
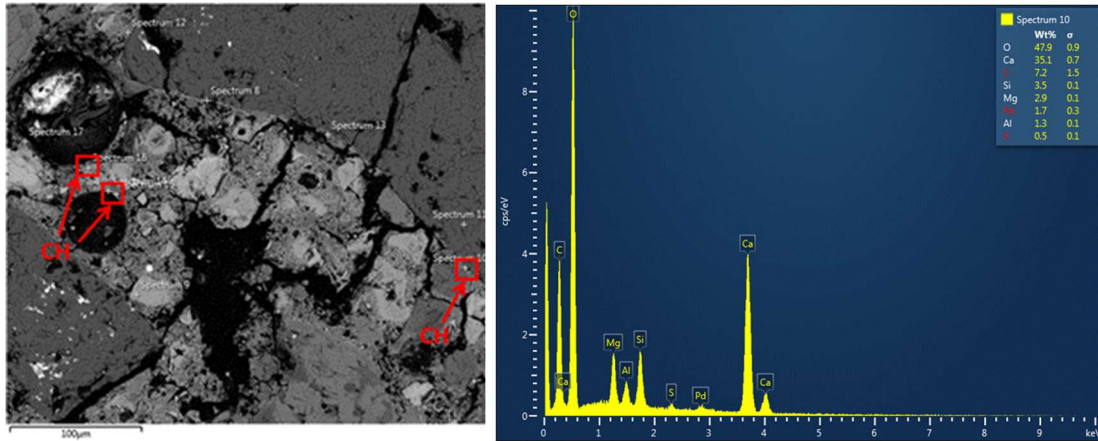
Figure B.4 Location of CH deposits as identified by the EDS signals collected at the depth of 0.5 in. from the heat-exposed surface.

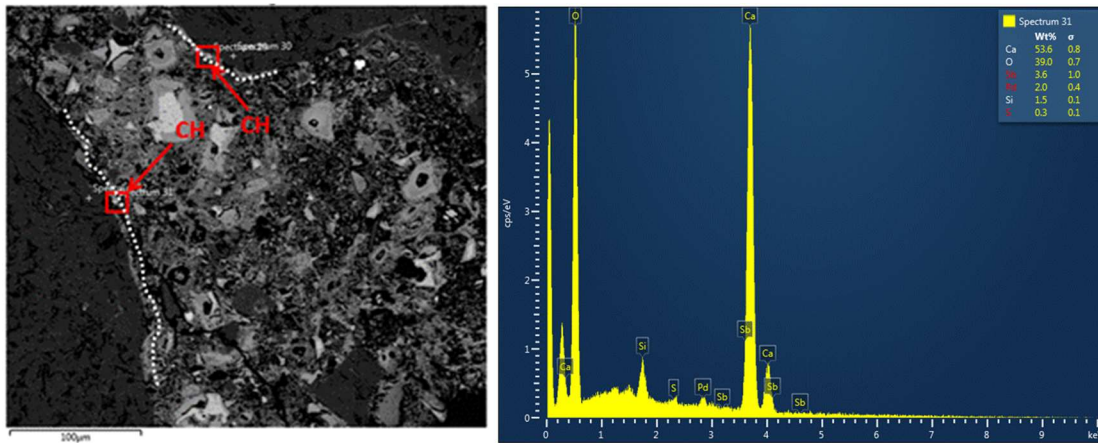
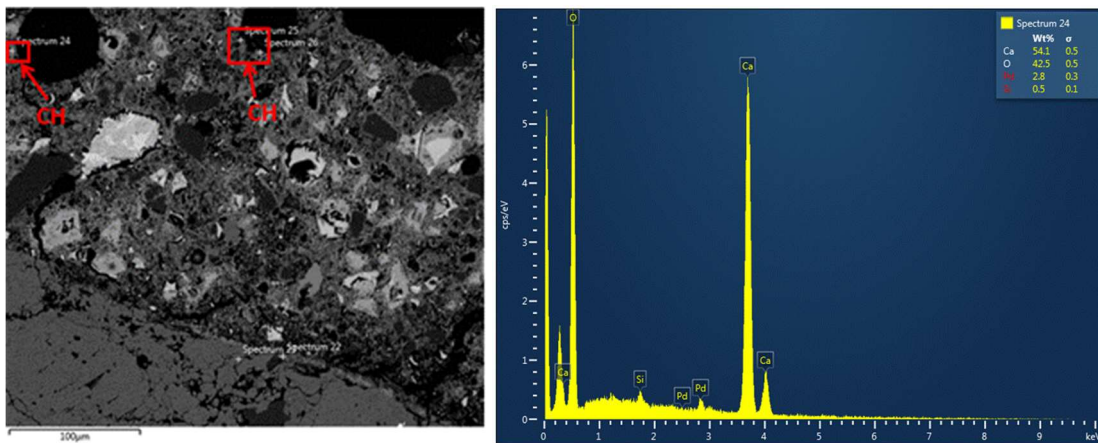
Figure B.5 Location of CH deposits as identified by the EDS signals collected at the depth of 0.75 in. from the heat-exposed surface.

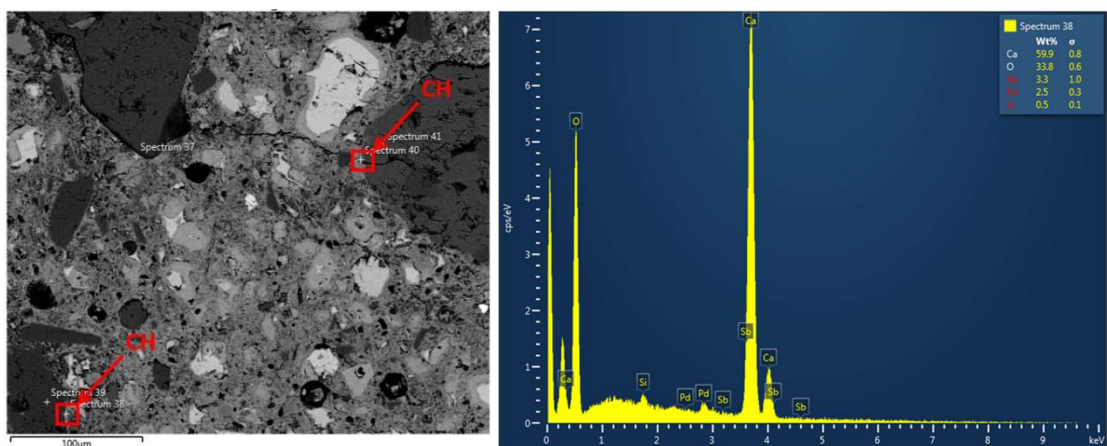
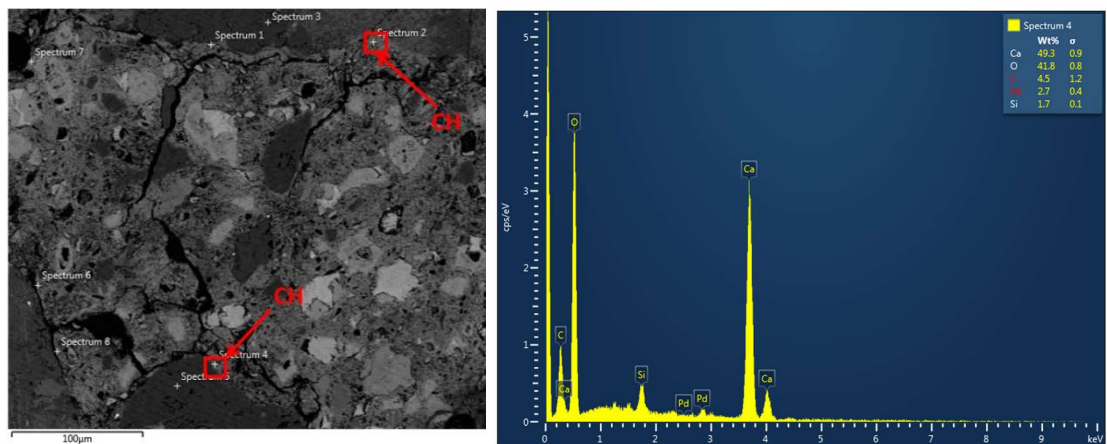
Figure B.6 Location of CH deposits as identified by the EDS signals collected at the depth of 1.0 in. from the heat-exposed surface.

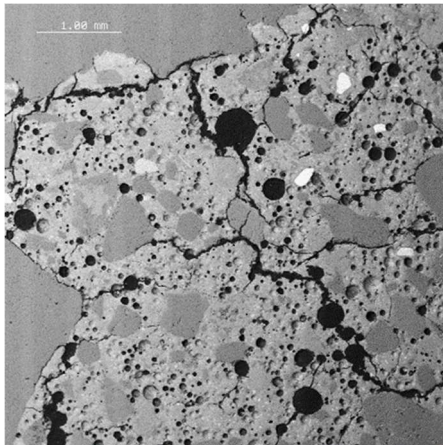
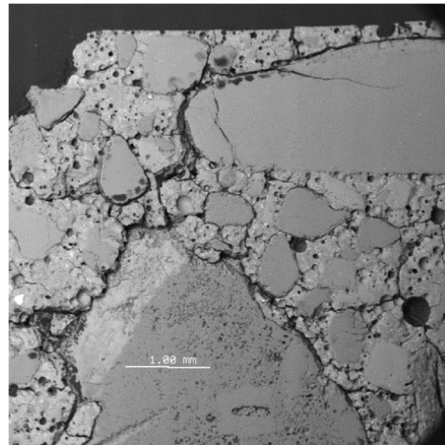
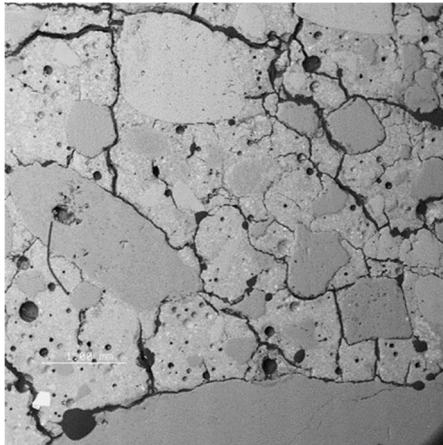
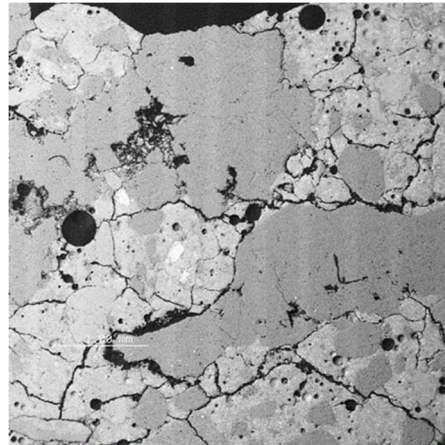
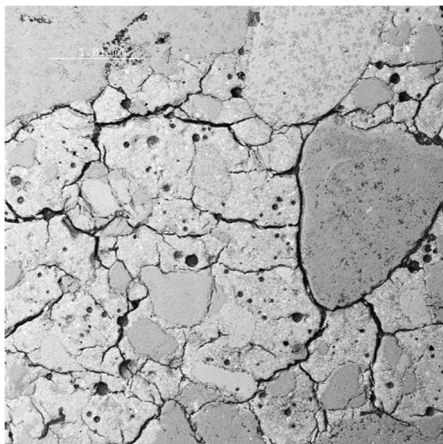
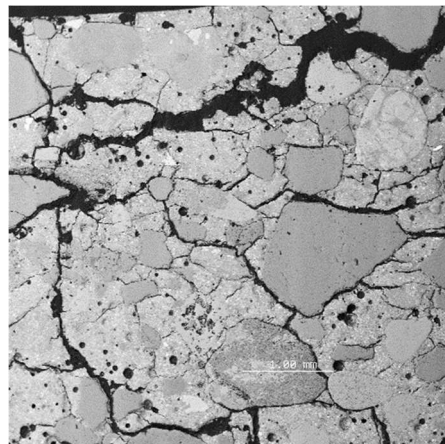
Figure C.1 SEM images of the microstructure of concrete located within 0.0 in. to 0.25 in. from the heated surface.
