# Minnesota Drive Ramps Microsurfacing Experimental Feature

## Post-Construction Report

**October 2020**

**FHWA-AK-RD-4000(181)**

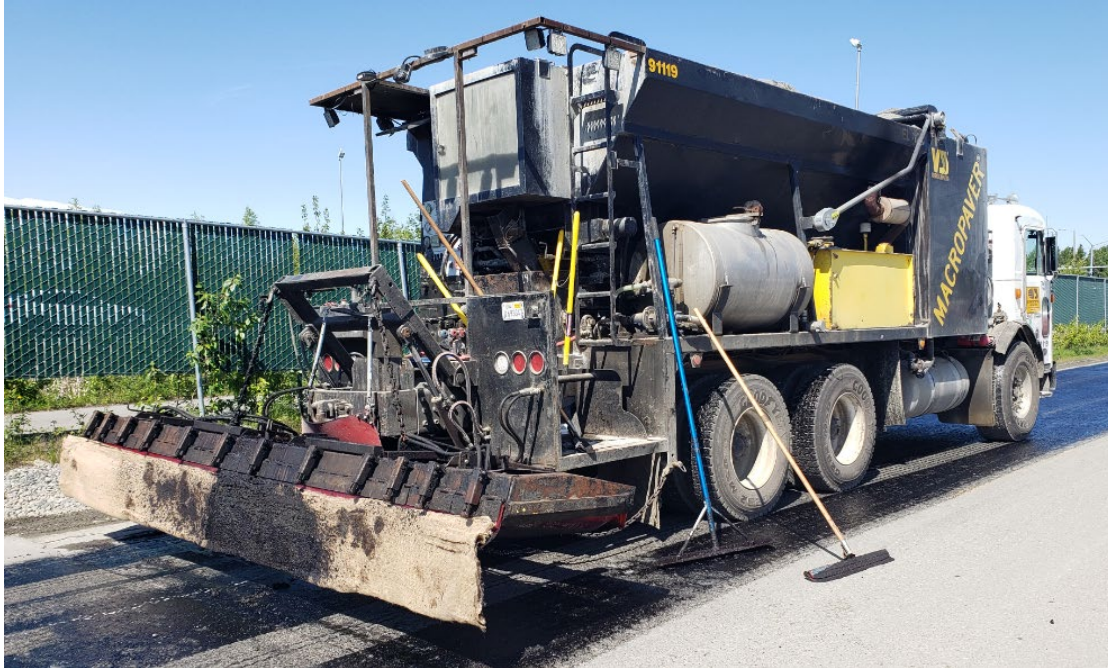
Photo 9 - VSS Macropaver 12B Unit

Microsurfacing is a mix of fine aggregate, additives, and emulsion that are combined and applied at specific rates within the vehicle before the slurry reaches the spreader box and is applied onto the road surface. The equipment used for this application were two Valley Slurry Seal (VSS) Macropaver 12B units.

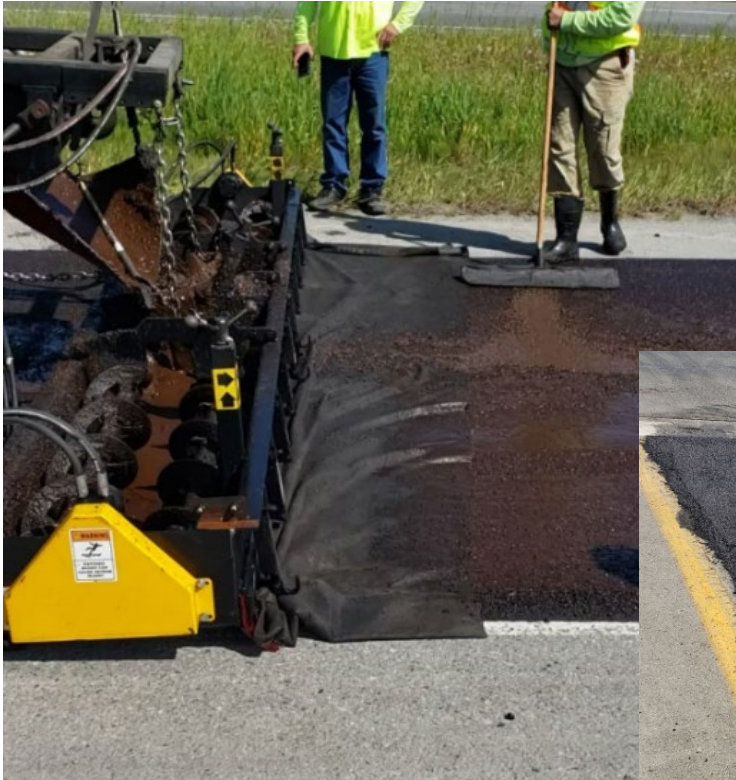
*Photo 10 - Secondary Strike Off and Hand Working*

The sack on the end of the spreader box (see photo below) is used for secondary strike-off to provide surface texture on the final microsurfacing overlay and remove surface defects.

It takes approximately 90 seconds for the materials to be mixed, travel through the Macropaver unit and enter the spreader box through the diverter. The crew will hand work the microsurfacing using a squeegee at locations it is hard for the equipment to access, as well as remove drag marks and other surface imperfections (shown in the picture to the left.) The photo on the right is an example of an area that was hand worked at the intersection of Ramp 6 and International Airport Road.

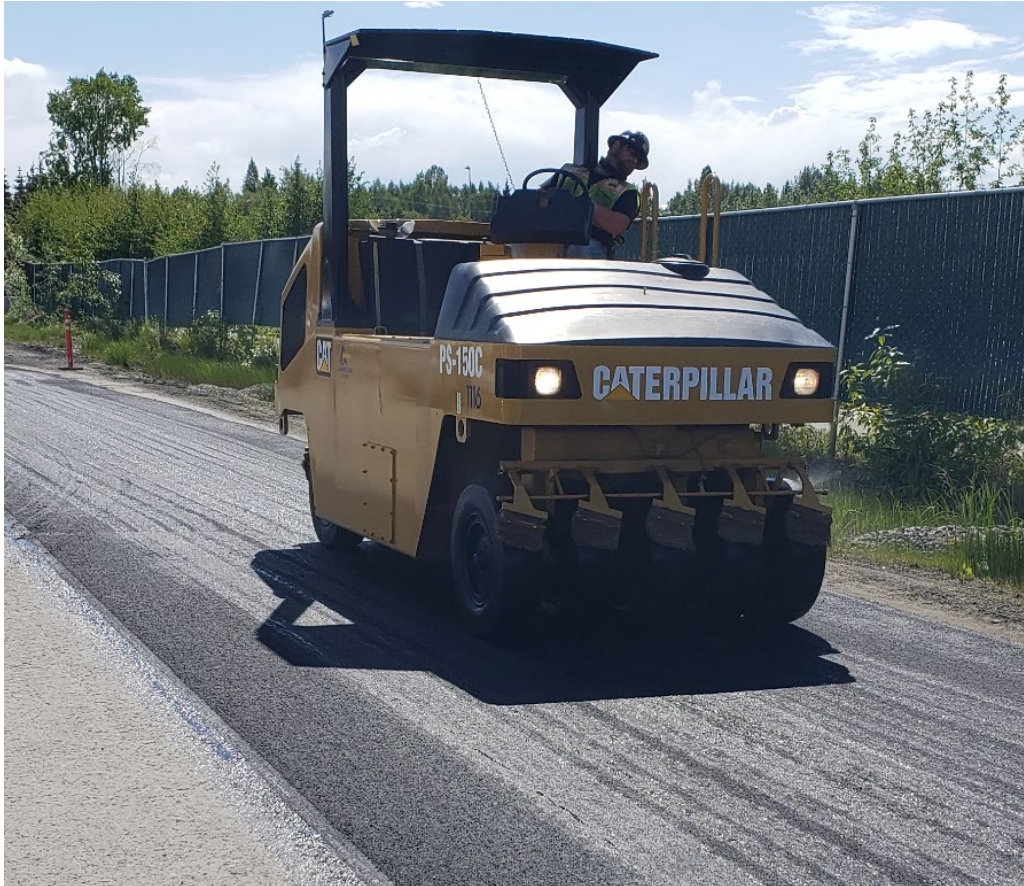
Photo 12 - Pneumatic Roller on Test Strip

This formulation using highly modified PG64-34 base binder is considered a slow-set system, meaning without mechanical assistance the set time would take a few hours. To improve the set time, pneumatic rollers are used to mechanically force the water out of the microsurfacing. The water brought to the surface by the pneumatic rolling on the test strip can be observed in the photo on the next page.

It was intended for the pneumatic roller to finish rolling the mat within an hour of application so traffic would be able to return to the ramp shortly after. However, it took slightly over two hours for the pneumatic roller to begin rolling the test strip without damaging the fresh microsurfacing. The Department was informed this was due to the high emulsion temperature and the reduced lime content and that, with the full lime dosage and cooler emulsion, the pneumatic would be able to begin rolling the mat sooner.
