Appendix A
Preconstruction Documentation

Minnesota Drive Seward Highway to Tudor Road Microsurfacing Locations

Appendix B
Construction Photolog

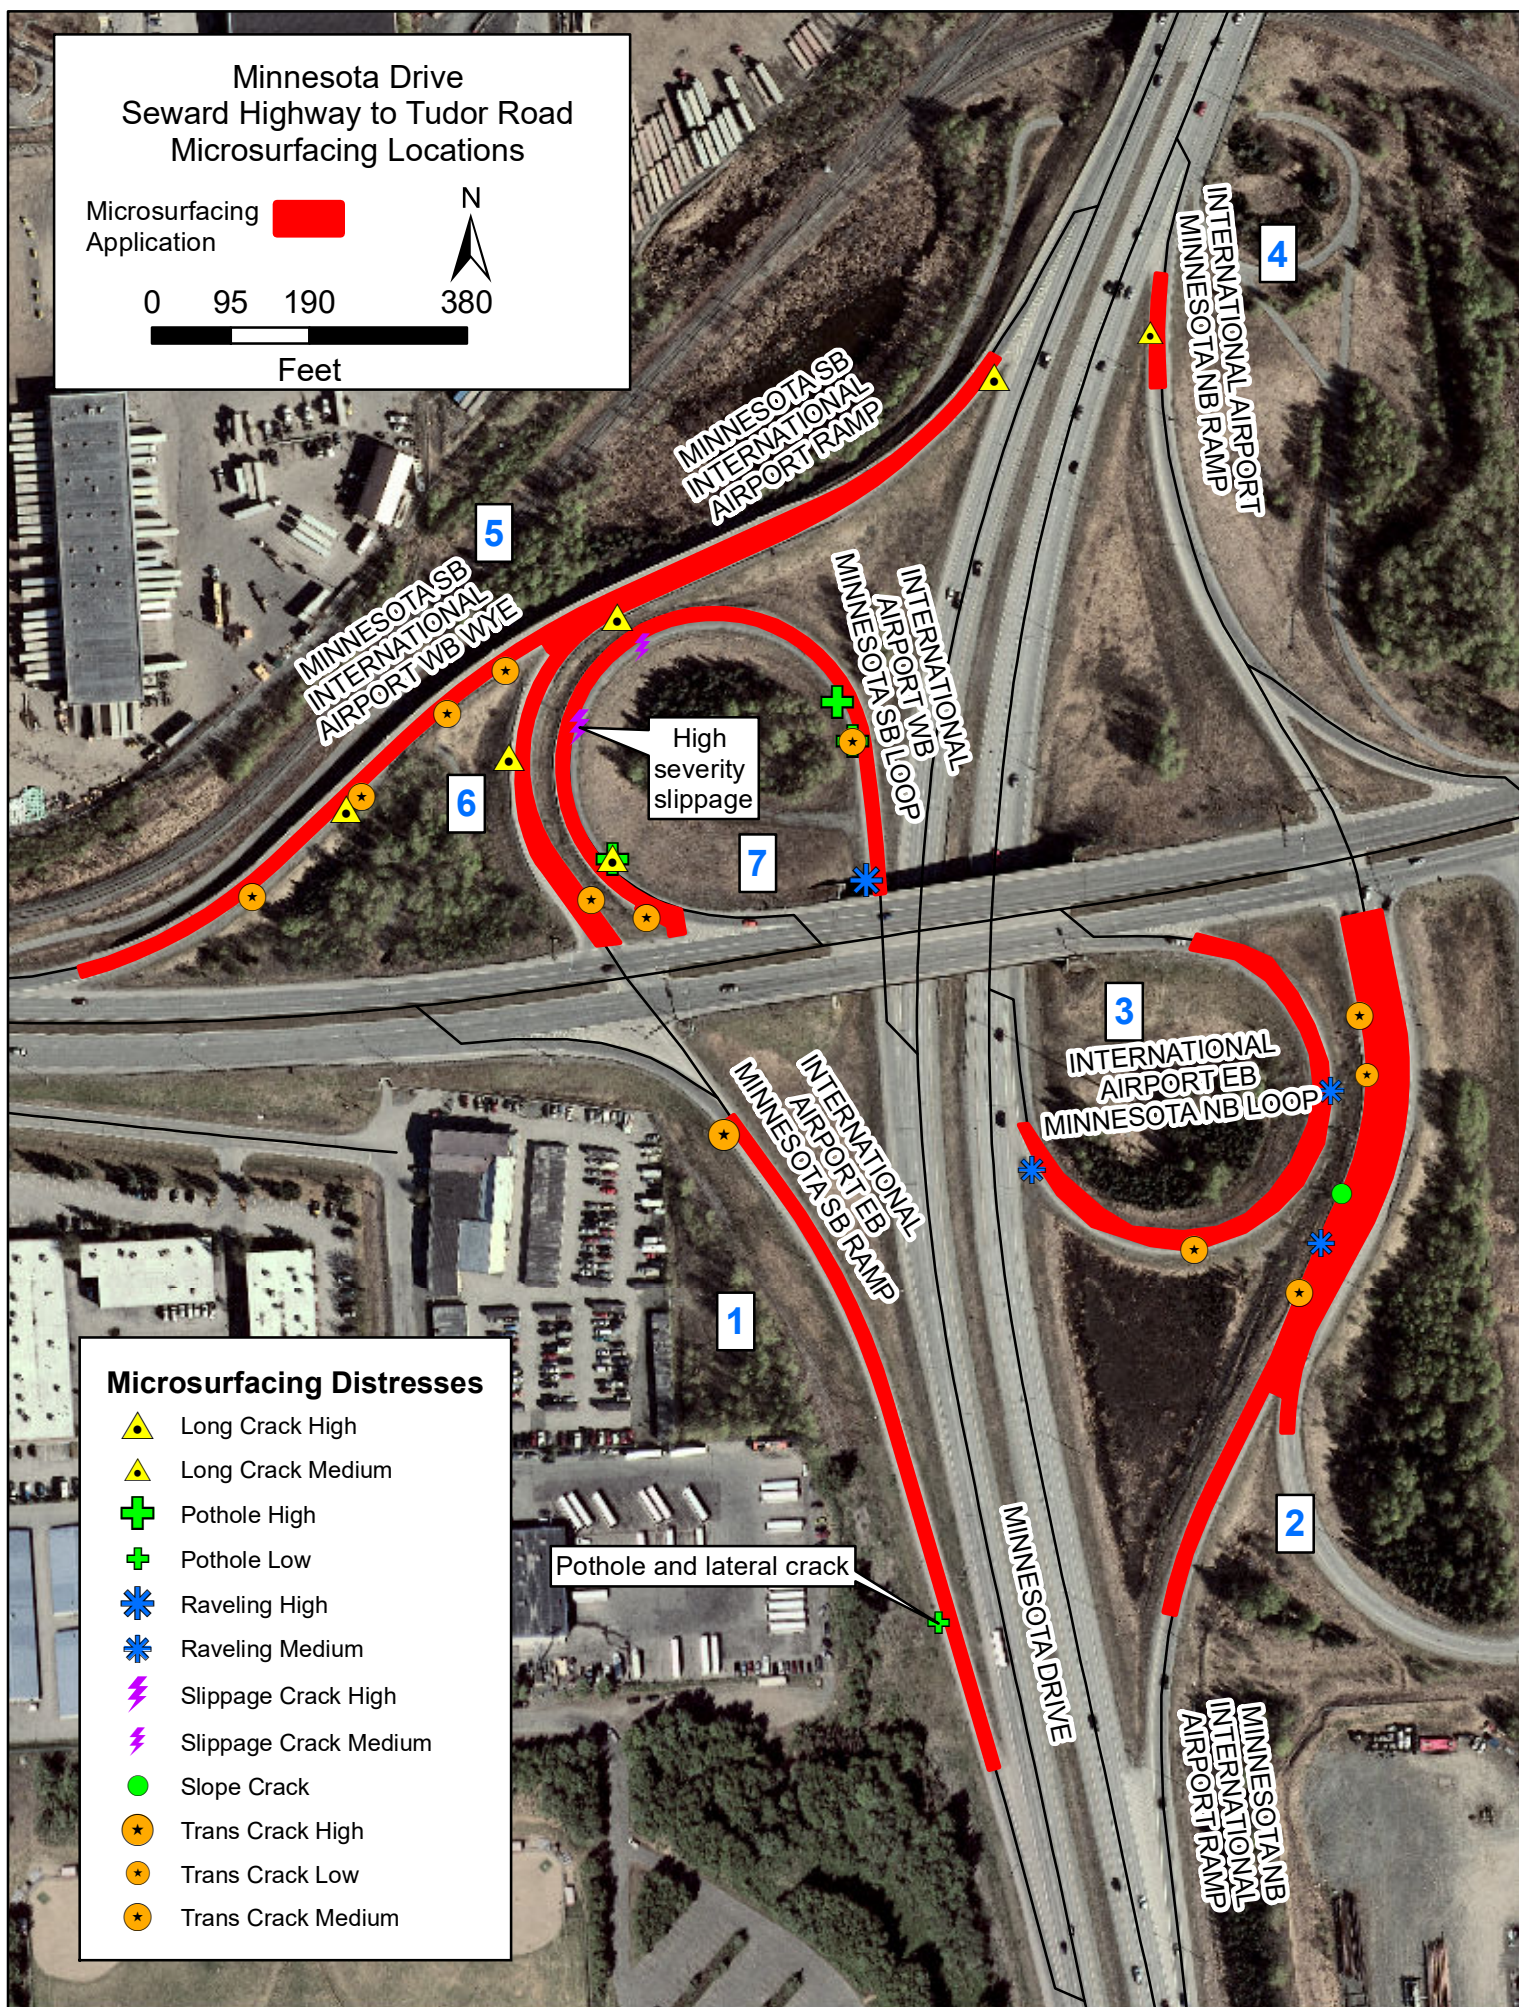
Microsurfacing Distresses

- ▲ Long Crack High
- ▲ Long Crack Medium
- + Pothole High
- + Pothole Low
- ✱ Raveling High
- ✱ Raveling Medium
- ⚡ Slippage Crack High
- ⚡ Slippage Crack Medium
- Slope Crack
- ★ Trans Crack High
- ★ Trans Crack Low
- ★ Trans Crack Medium

Pothole and lateral crack

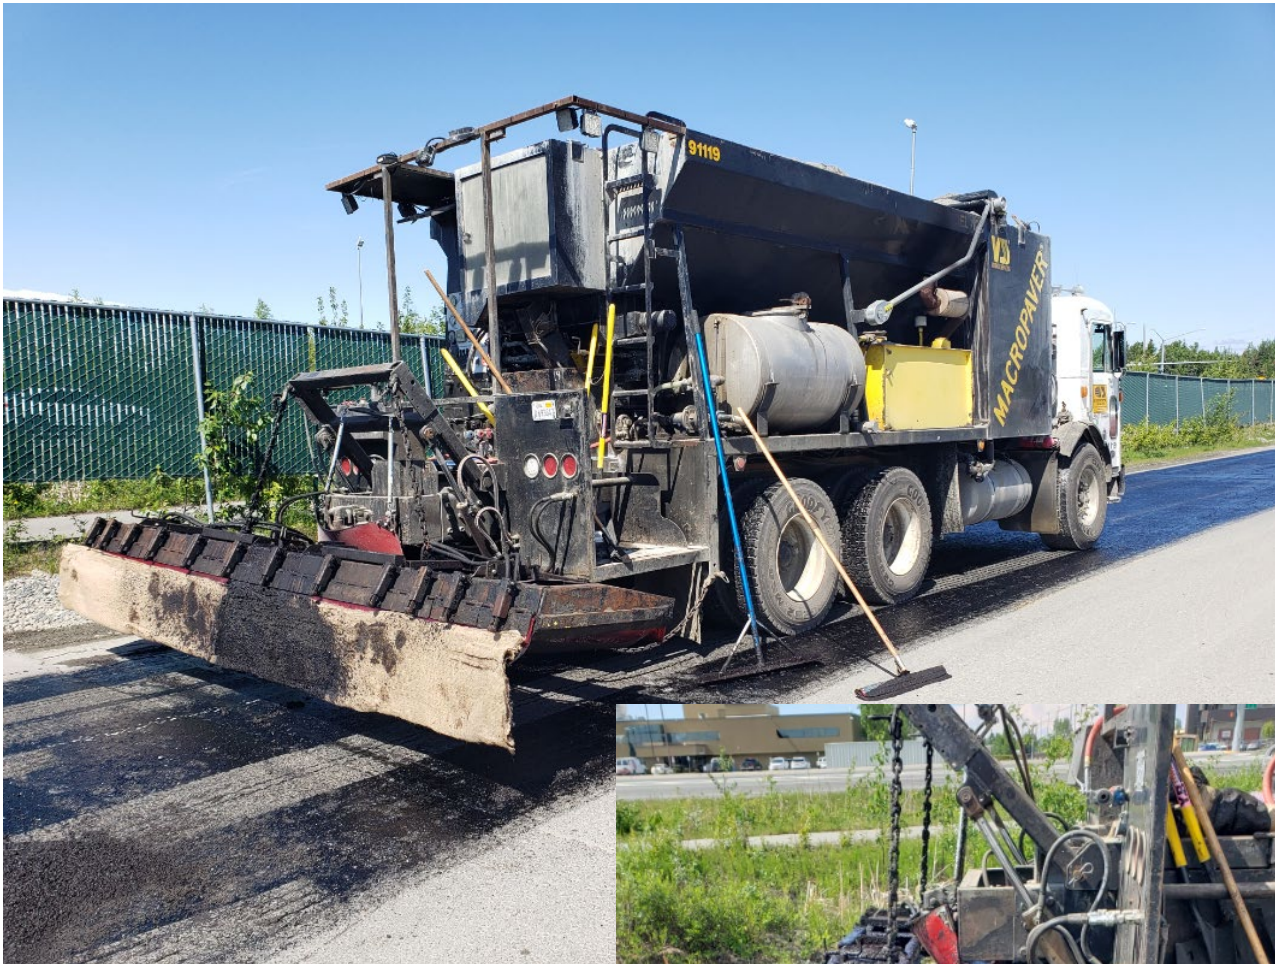
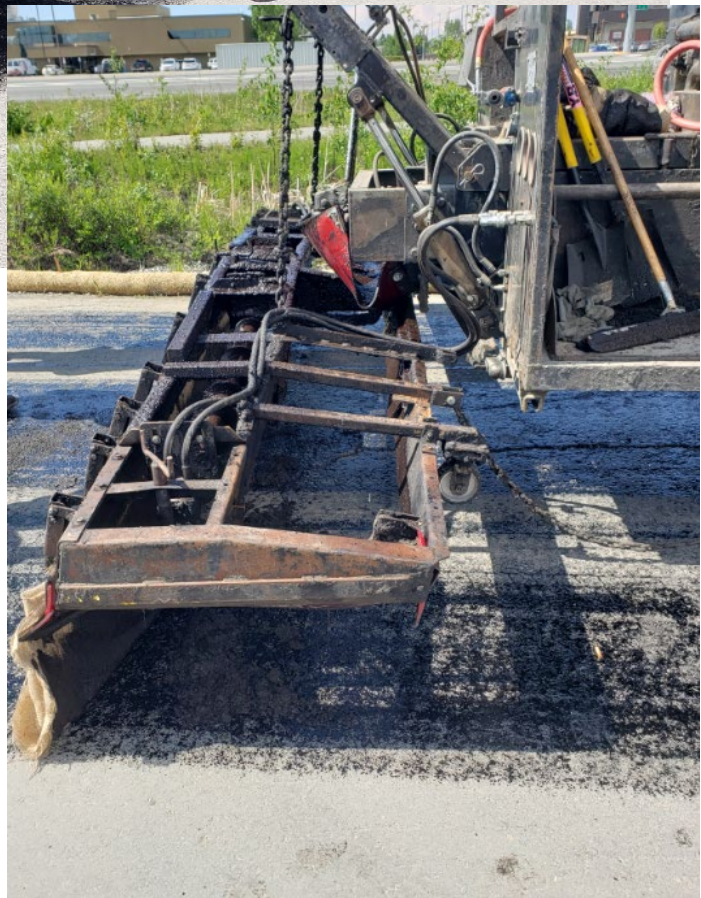
Macropaver equipment with burlap sack for secondary strike off for surface texture

A view of the spreader box with burlap sack. In later photos it can be observed that the spreader box was switched and instead of burlap it appears that canvas was used for secondary strike off.

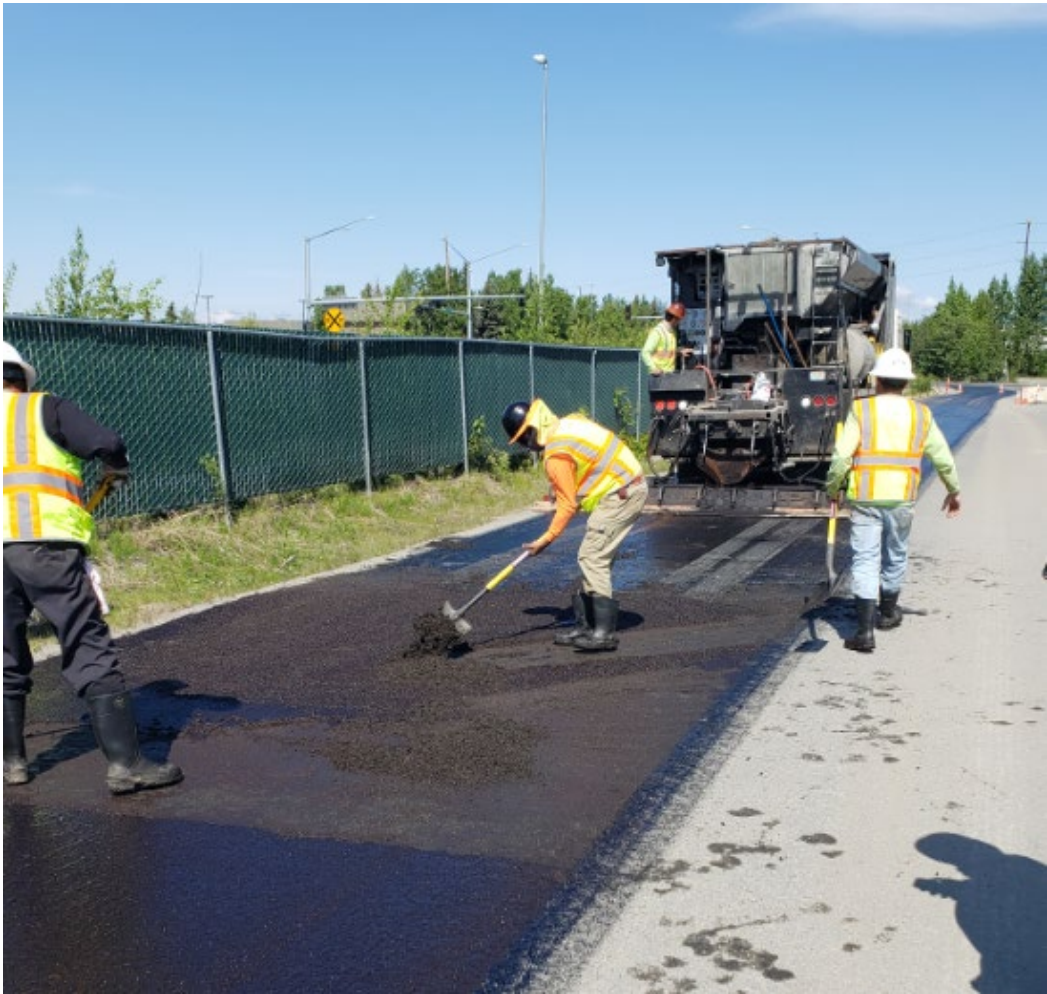
Hand working a portion of the application.

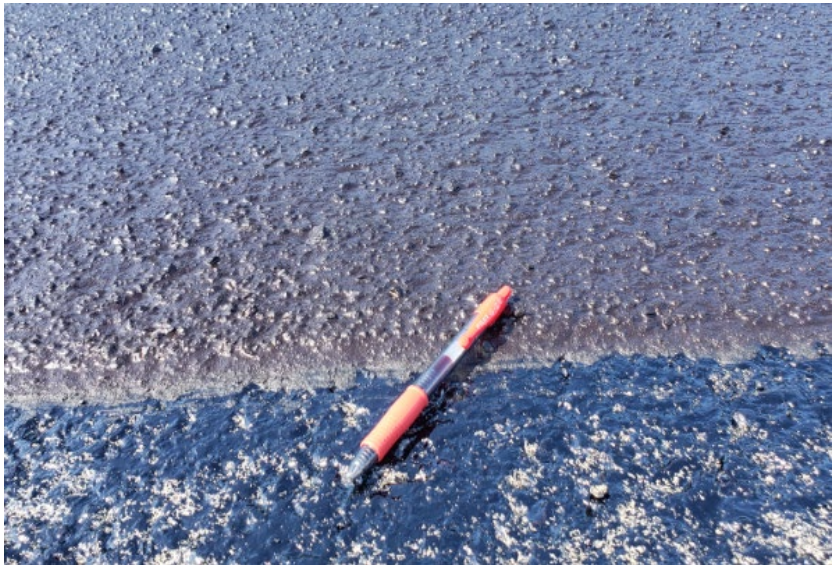
Microsurfacing slurry as it is setting on tack coated pavement

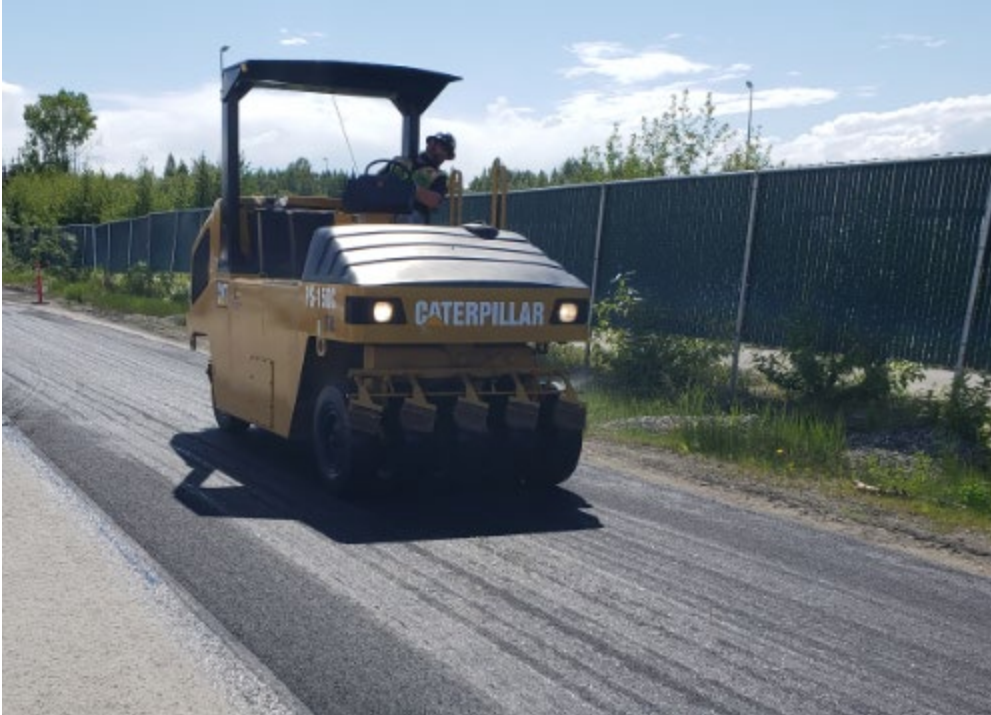
The pneumatic roller mechanically forcing the water out of the system to improve the set time. The water is visible/shiny on the surface after the roller passes over.

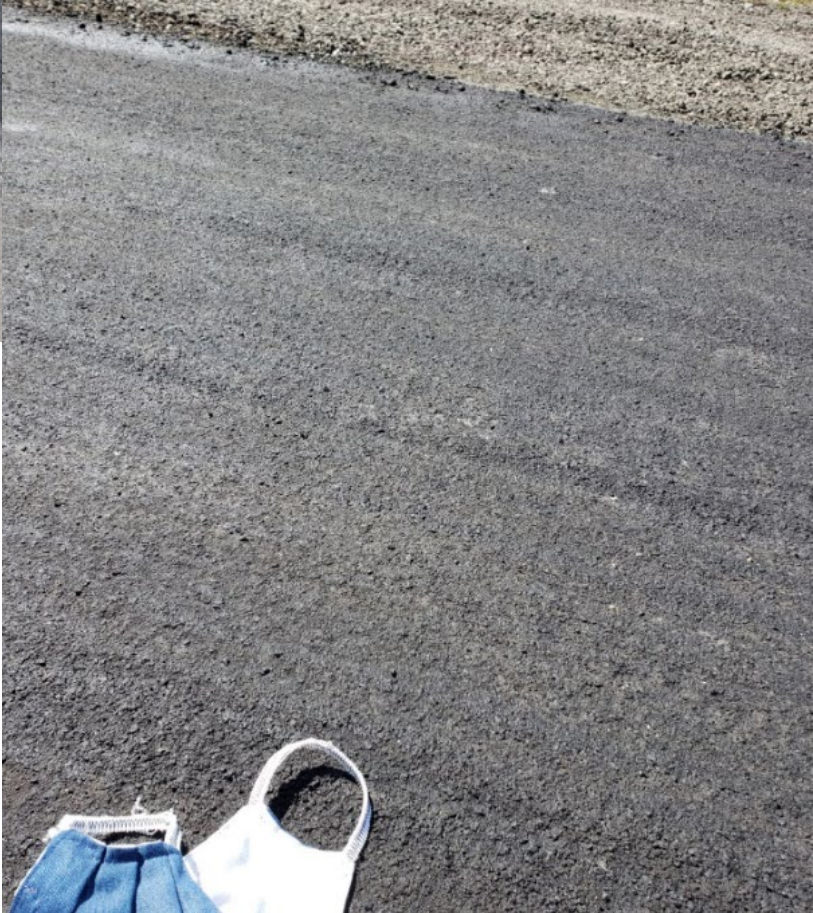
A mask on the microsurfacing test strip after the roller has made its passes and it has set.

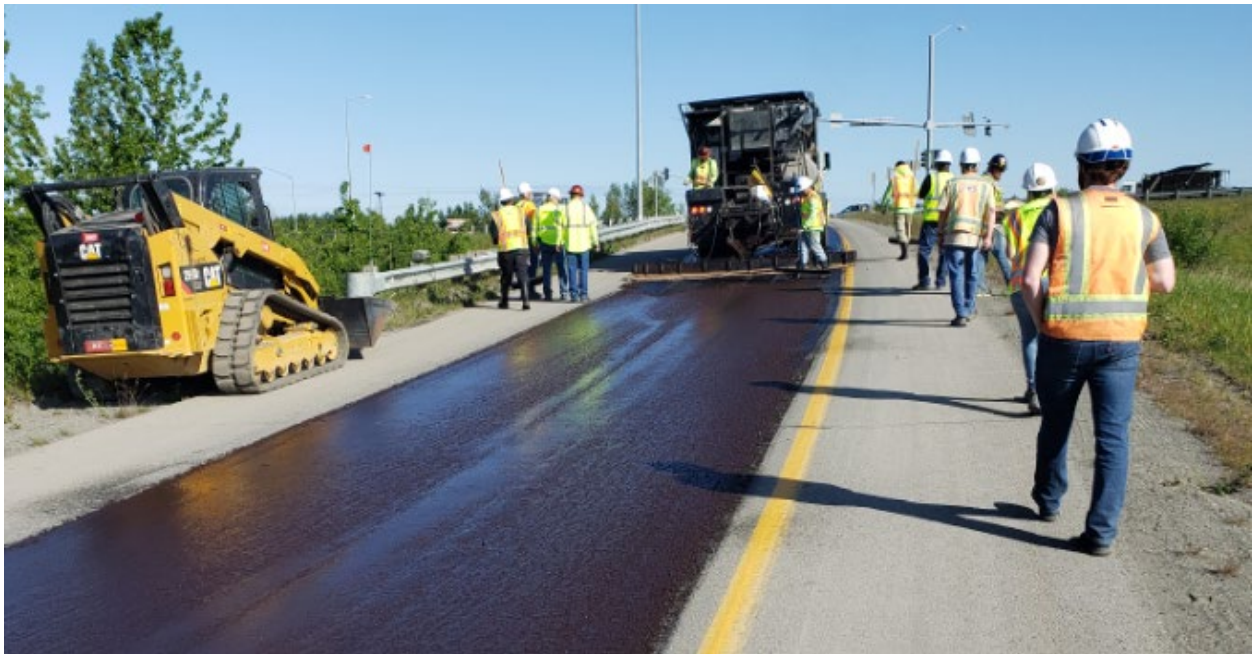
Scratch course being placed on Ramp 1

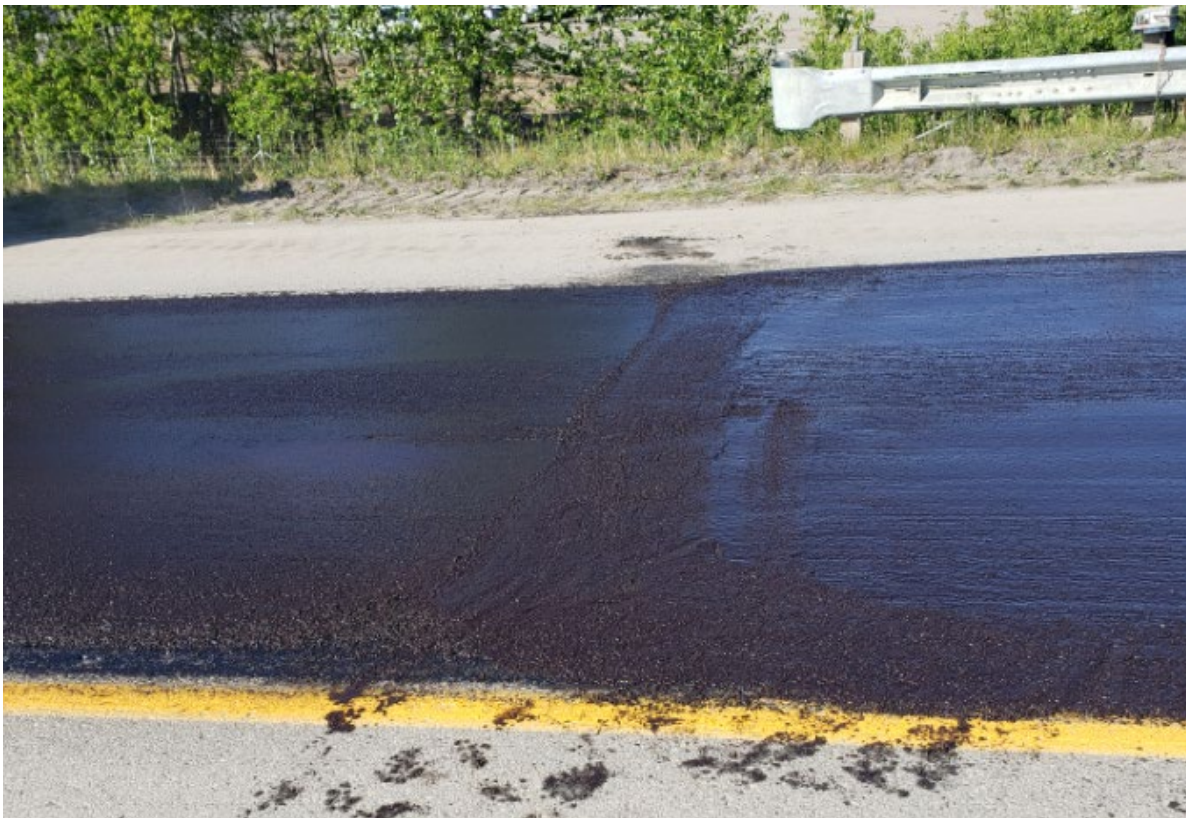
Ramp 1 – Hand worked portion at the joint where the aggregate bin ran out on the first Macropaver and the second Macropaver took over application while it was refilling.

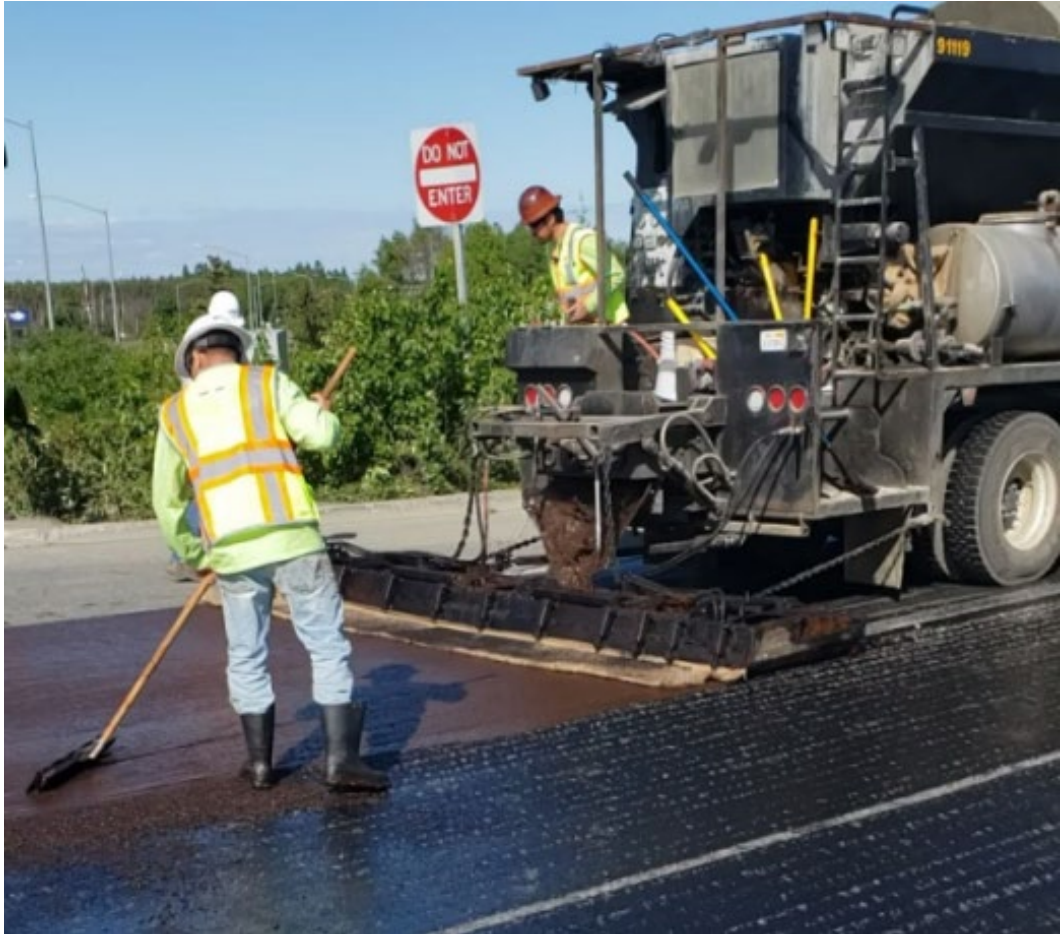
Scratch course being placed over tack coat on Ramp 6

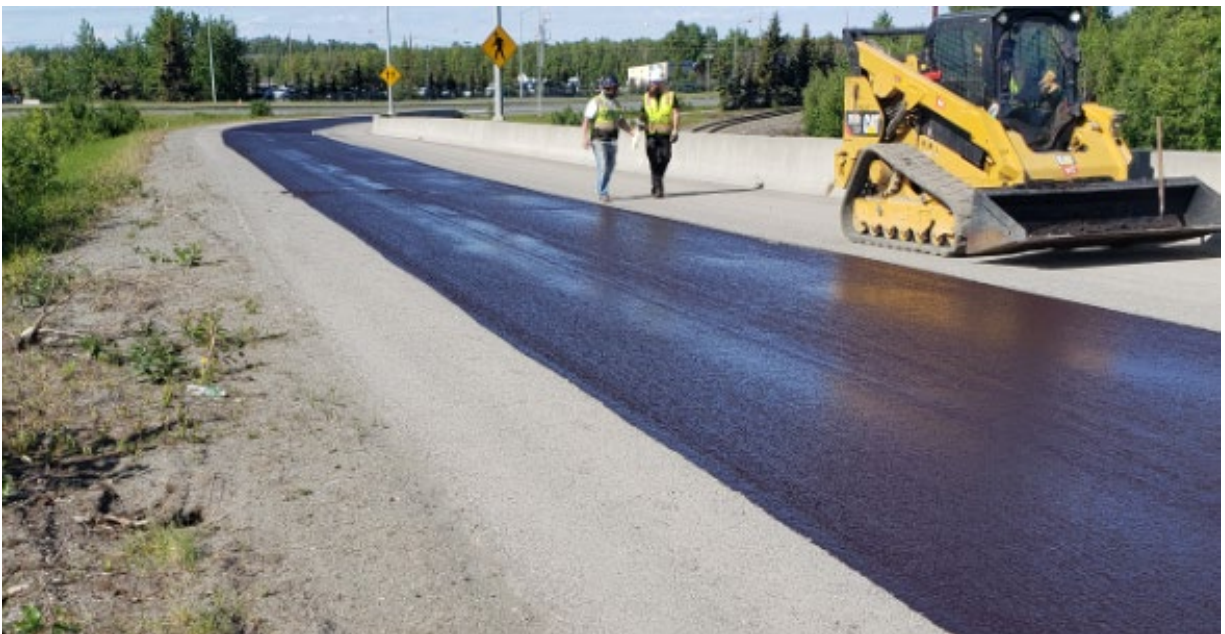
Scratch course placed on Ramp 5 prior to stopping production.

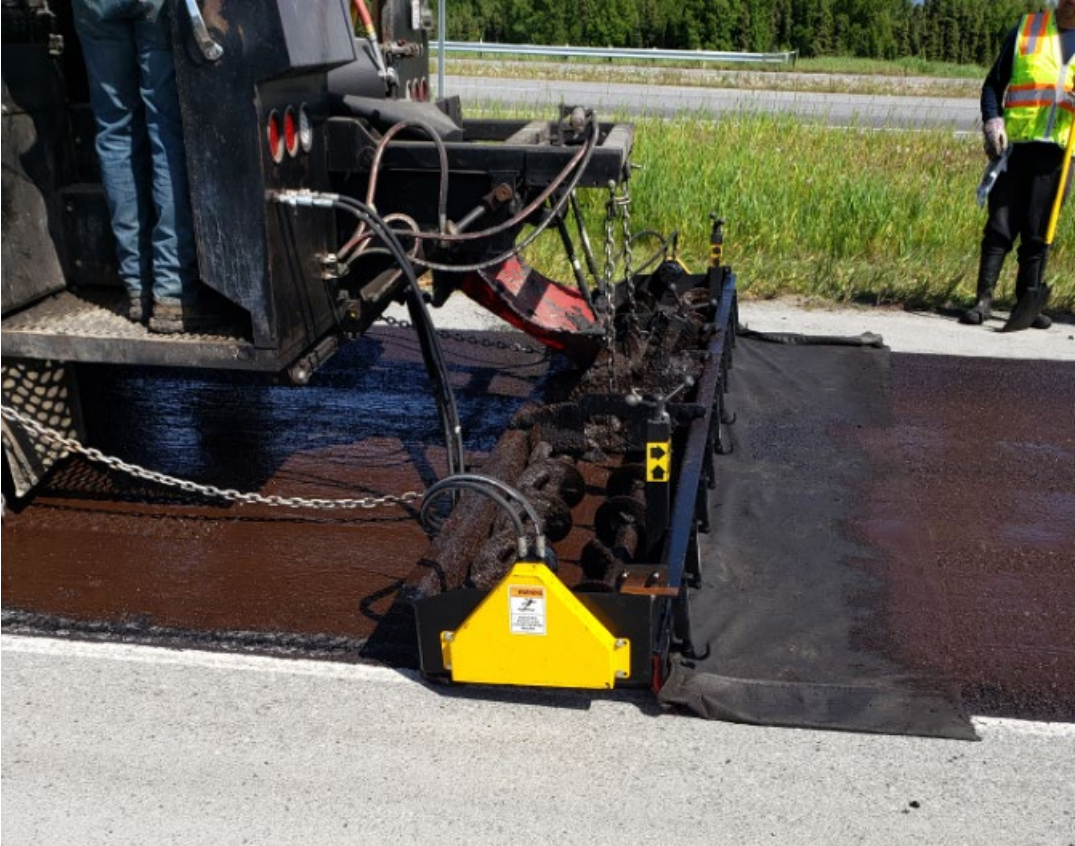
Second day of production on Ramp 11, the Minnesota SB On Ramp off of Raspberry. The spreader box was changed out from the first day of production along with the canvas in place of the burlap sack.

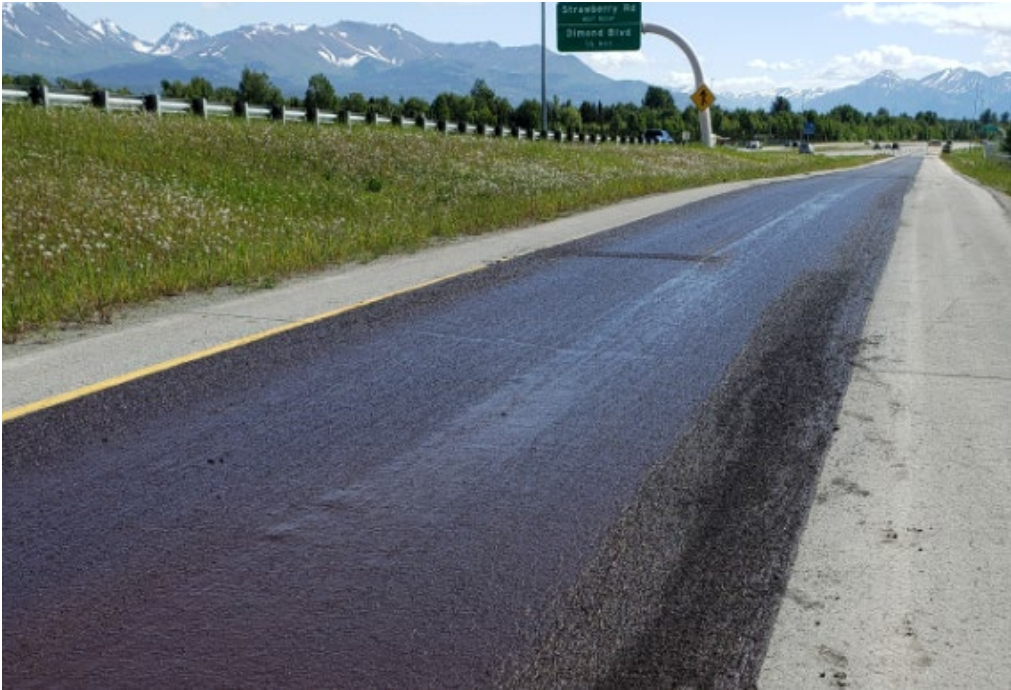
A hand worked area on the right side of the ramp on the scratch course on Ramp 11.

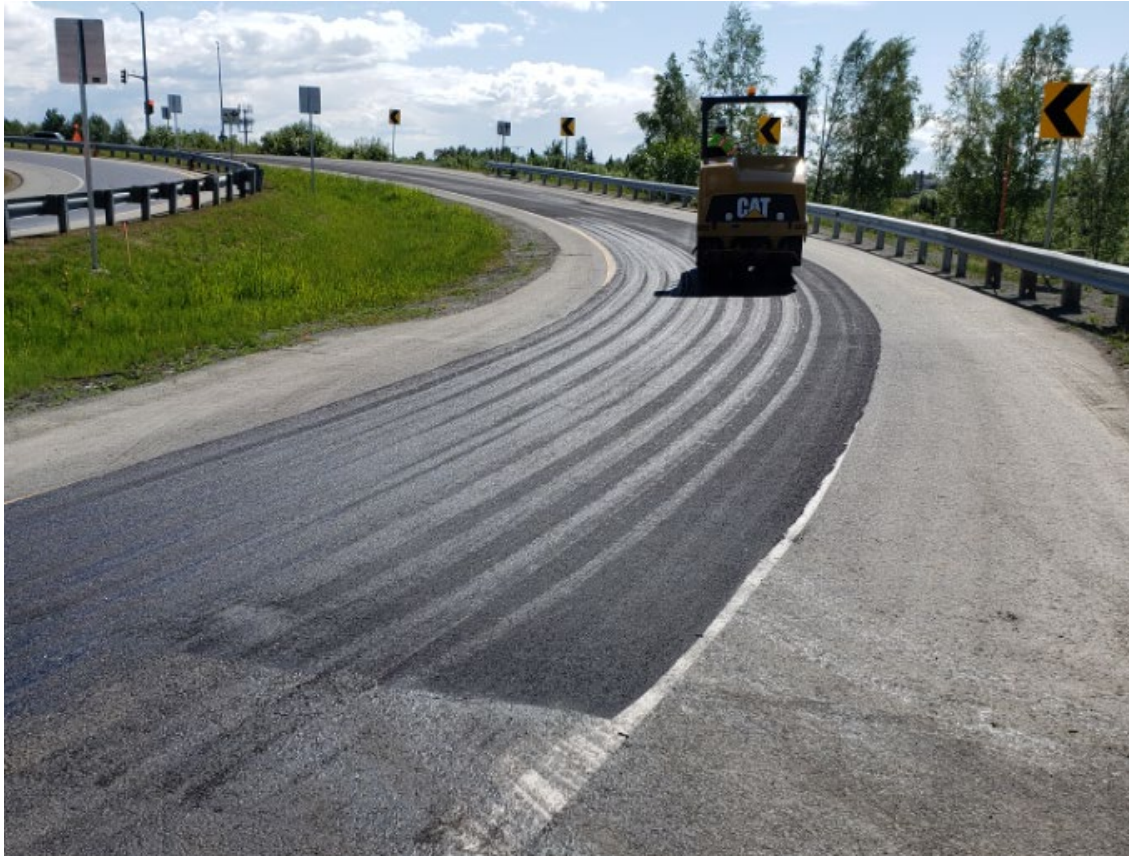
A pneumatic roller finishing a portion of Ramp 6 that was unable to be completed on the first day of production due to the crude source changing for the emulsion. The ramps were able to be rolled and opened to traffic in between 1.5 -2 hours instead of the 4 hours it was taking the first day of production.

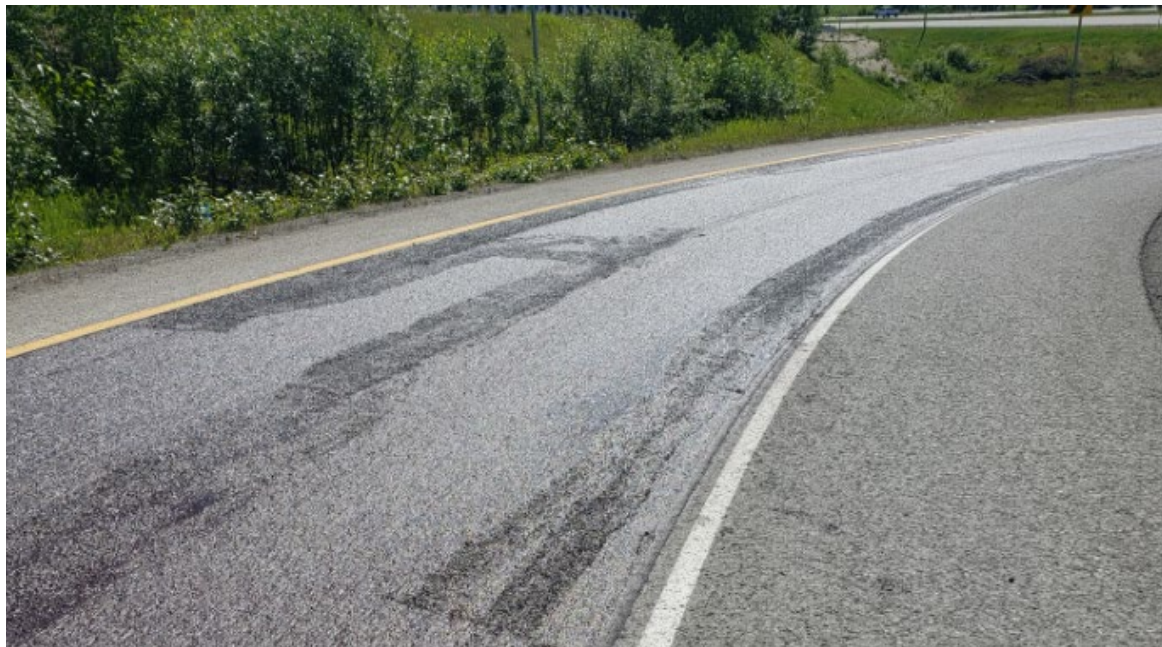
Hand worked areas on the scratch course on Ramp 3 on the fourth day of production.

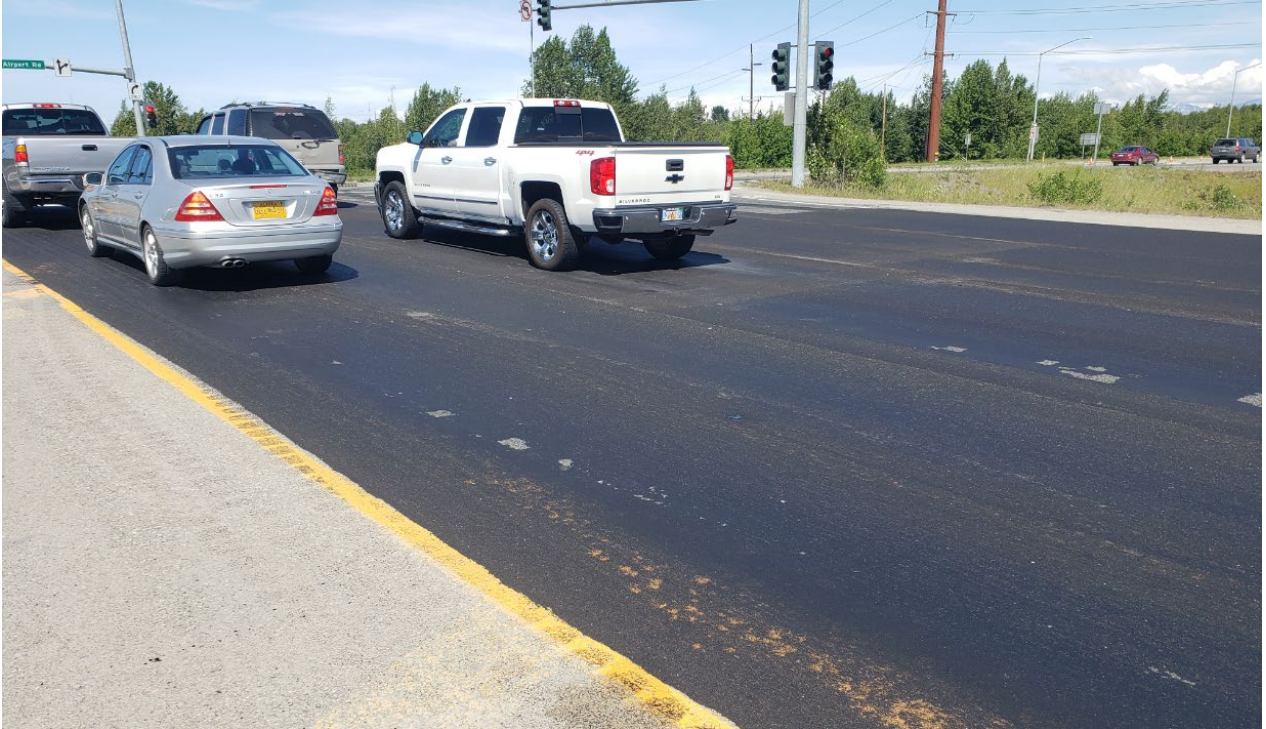
There was some pickup by traffic on the scratch course on Ramp 2 on the fourth day of production. This is at the signalized intersection that the major pickup and deformation occurred on the surface course.

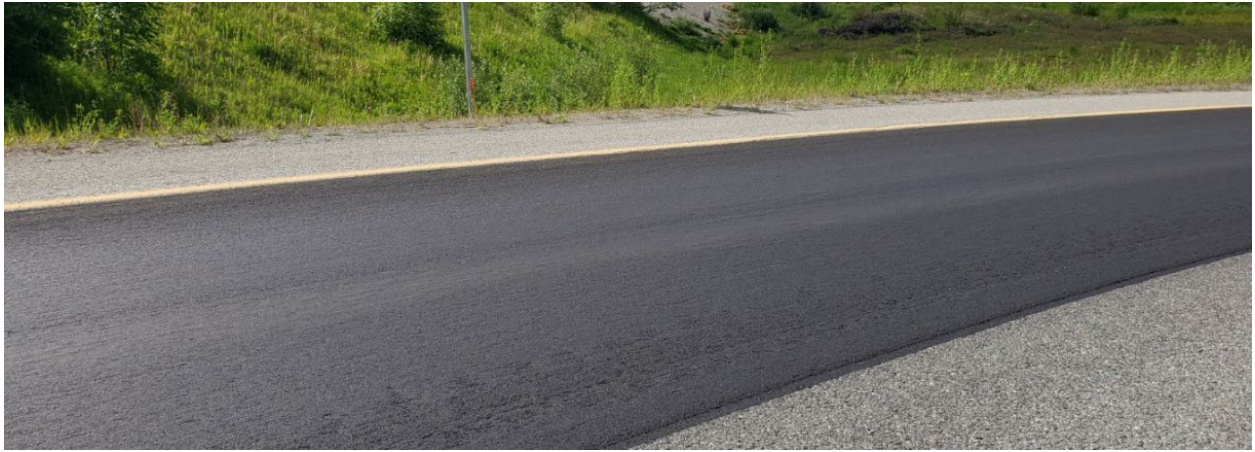
Ramp 3 was reviewed while out looking at Ramps 1 and 2 and no flushing, bleeding or other distresses were present on the ramp. This is the same location that was hand worked in the previous photos.

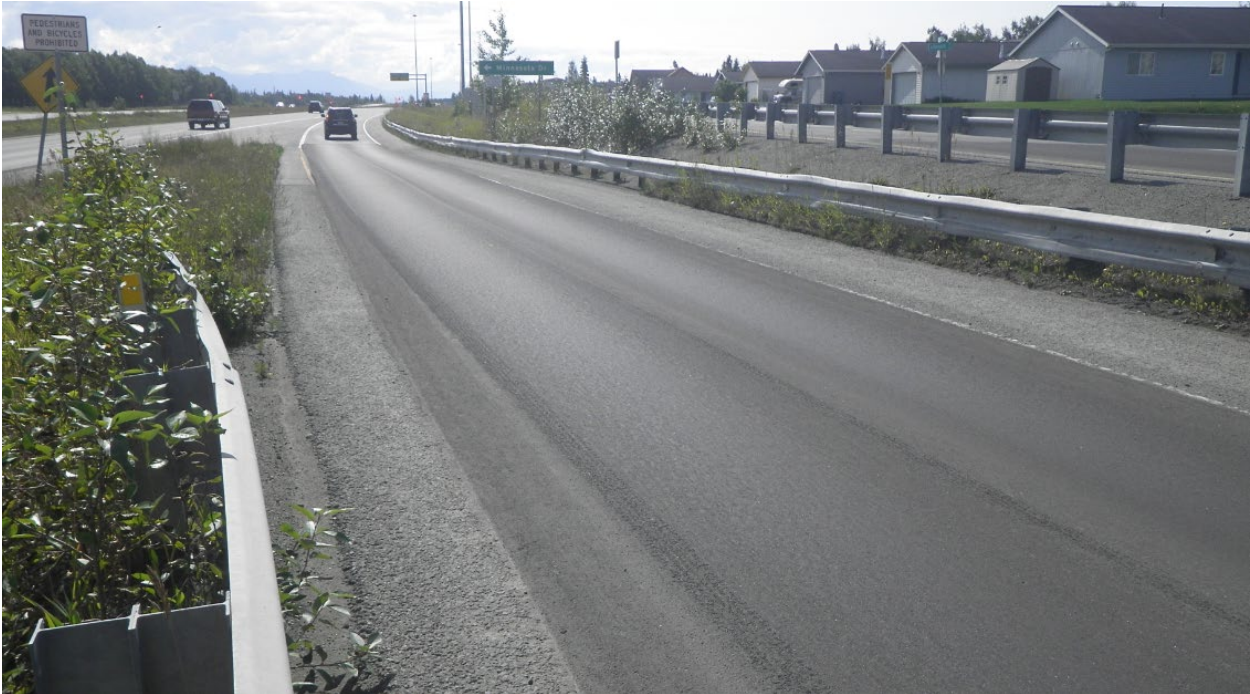
Ramp 13 had the least visible flushing and was placed over a rut filled area, but given the distresses on the other ramps and the shininess visible on the surface it was determined to pursue removal while out performing other milling operations.
