# Case Studies of Two Non-Overlay Cathodic Protection Systems For Bridge Decks

RESEARCH REPORT 149

Research Report 149  
March 1990

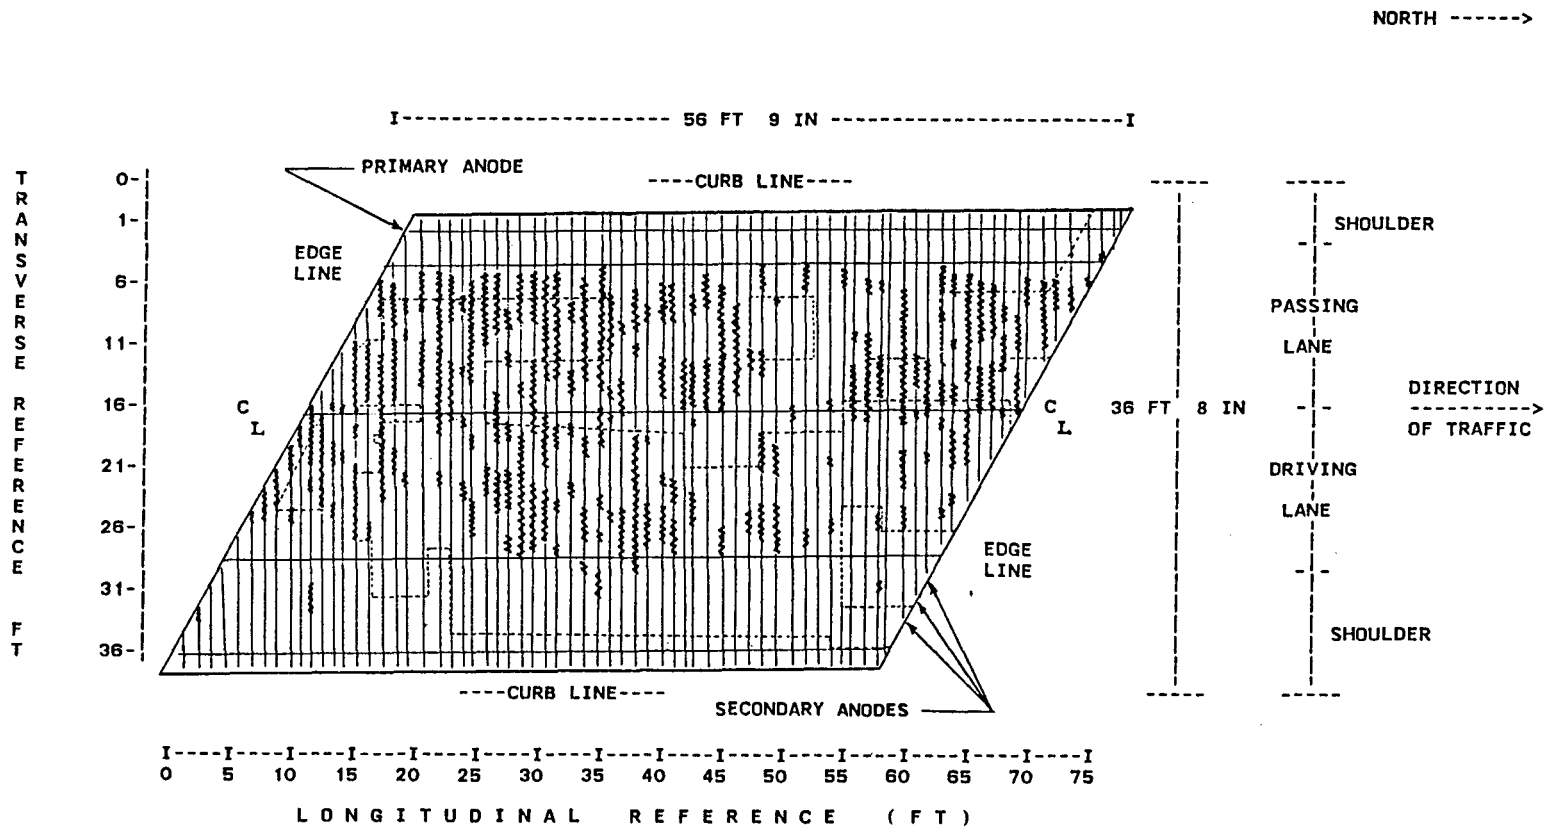
WHITNEY POINT ANODE GROUT REPAIRS

Anode-grout debonding was first observed immediately after exposing the anodes to traffic. Small isolated areas of grout were repaired by the contractor in October 1983. After acceptance of the contract and one winter in service, larger areas of anode-grout distress appeared. By October 1984, about 200 lin ft had debonded or cracked (Fig. 1). Grout distress increased to 600 lin ft by the spring of 1985.

During the winter of 1984-85, the Materials Bureau evaluated several proprietary anode-grout repair materials. Properties of shrinkage, compressive strength, shear-bond strength, freeze-thaw resistance, water absorption, and resistivity were examined. It was determined that the anode-grout mixture is not conductive in the liquid state. As polymerization progresses, the grout mass shrinks. The authors believe that this shrinkage forces carbon particles of the grout mixture into close proximity, making the hardened material conductive.

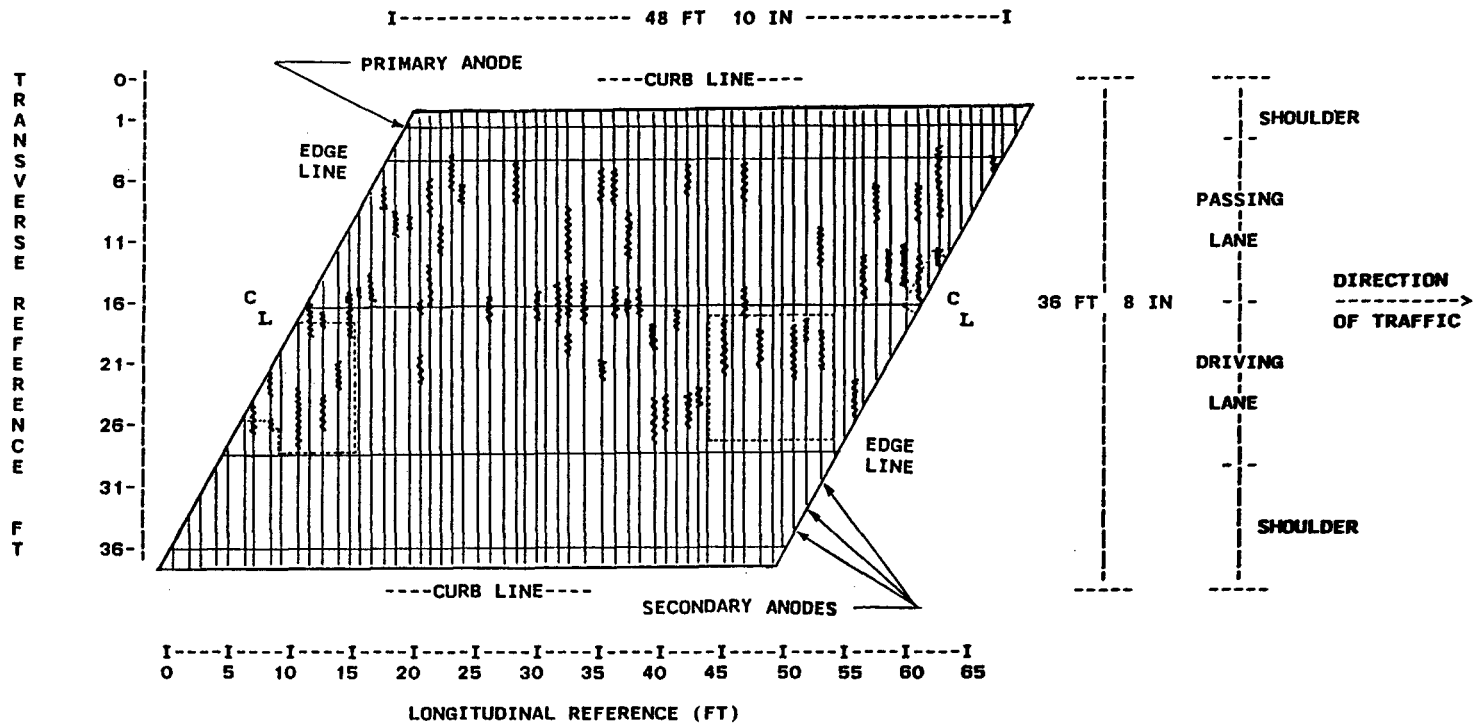
ANODE GROUT DISTRESS SURVEY  
MAY, 1986  
SPAN NO. 2 (ER&DB)

- ~~~~~ GROUT DISTRESS
- CONCRETE PATCH
