DOT/FAA/TC-18/31

High-Energy Wide-Area Blunt Impact Damage Formation to Stiffened-Skin Composite Structure

February 2019

Final Report

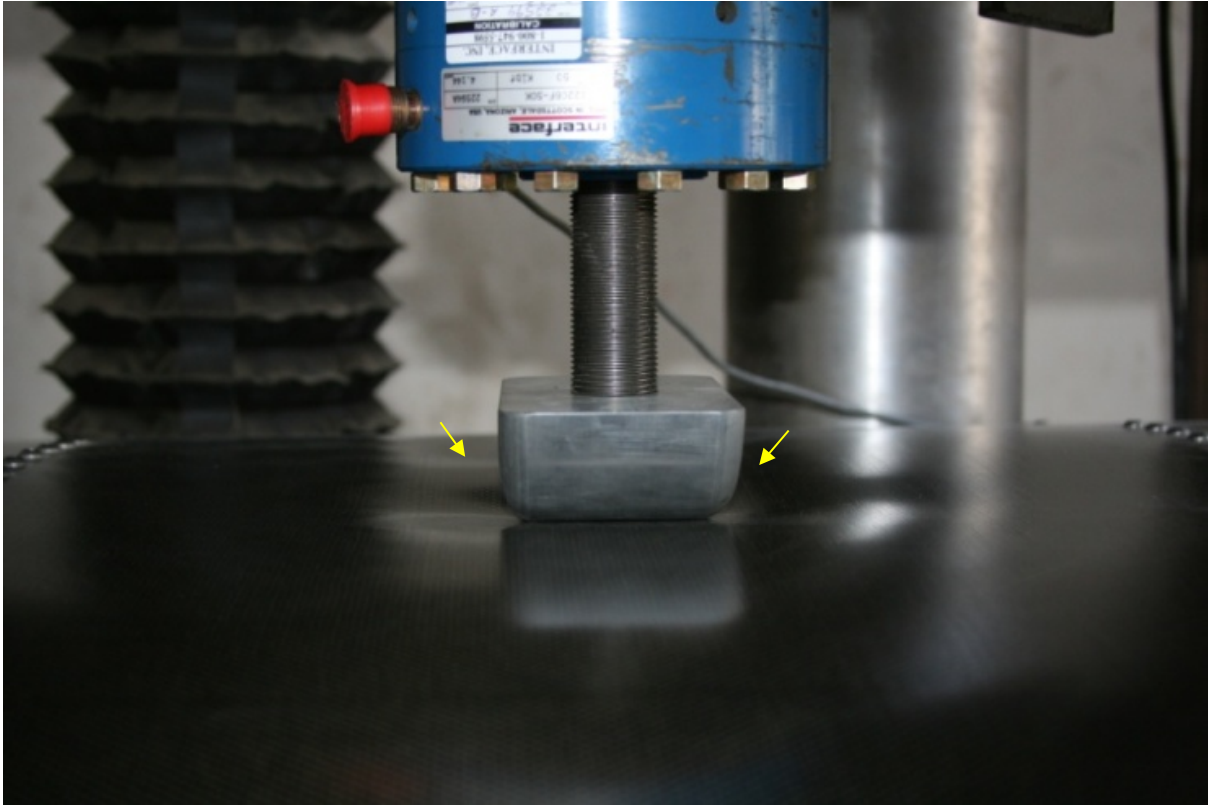
Stringer01 was quasi-statically indented with the 76.2 mm radius aluminum indenter (see figure 13) on the skin bay between the stringers (i.e., not directly onto stringer). Figure 20 shows the panel surface during contact with the indenter. Because the aluminum indenter was essentially rigid compared with the carbon fiber skin, the skin deformed locally around the indenter. The contact stresses were the highest at the small-radius edges of the indenter (see figure 20) leading to damage initiation at these locations. The Stringer01 panel was indented over four progressively increasing loading cycles. Figure 21 shows the contact force versus indentation plots for the load cycles. During the first loading, popping sounds were heard, but no detectable damage was found. During the second loading, local skin delamination damage was detected underneath the indenter at a load of 13.34 kN and an indentation displacement of 14.73 mm. The delaminations were oval-shaped. Their locations coincided with indenter's small-radius edges (see arrows in figure 20). During the third loading, small clicking sounds were heard after 13.79 kN. The test continued until the next significant failure event occurred at 22.83 kN and an indentation of 20.57 mm. The damage mode was local skin delamination growth under the indenter. The specimen was then reloaded for a fourth loading, during which a loud crack noise was heard at 26.71 kN and 21.84 mm indentation displacement. Local skin penetration damage was generated (see figures 22 and 23). The hatched zones also shown in figure 23 were the delamination zones mapped out with ultrasonic A-scan after loading cycles 2 and 3.

Figure 20. Contact between the aluminum indenter and Stringer01 external skin; arrows indicate highest stress locations

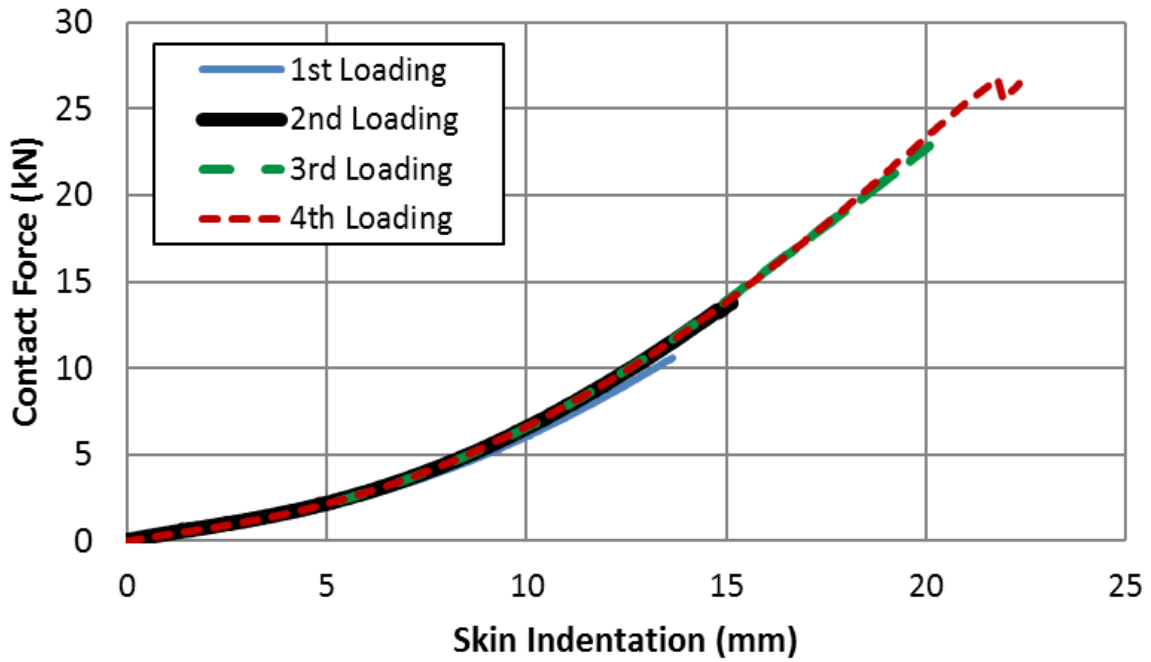
Figure 21. Stringer01 contact force vs. skin indentation plots

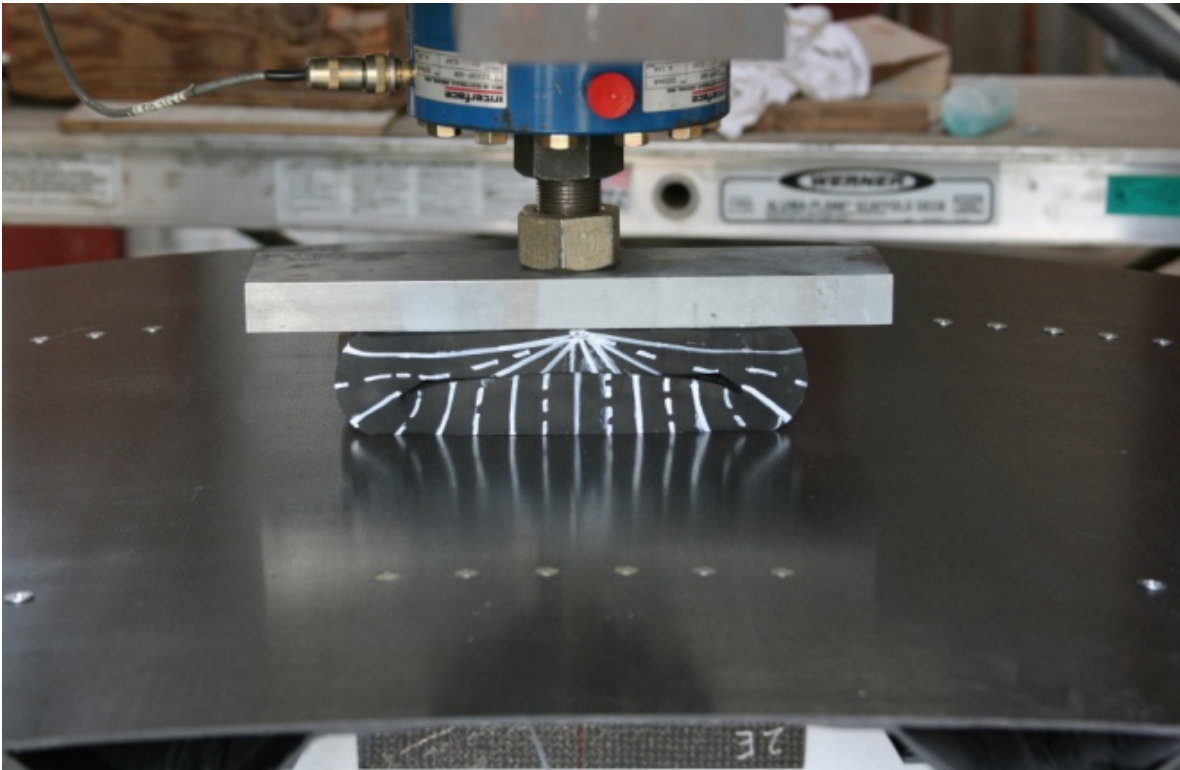
Stringer02 was quasi-statically indented with the TUG D-shaped rubber bumper on the panel's skin between the stringers. Figure 24 shows the highly deformed bumper contacting with the skin of panel Stringer02 (see undeformed bumper shown in figure 14). In this case, the contact stresses were reduced because of flattening of the hyperelastic behavior of the rubber; therefore, local skin delamination was not found. The Stringer02 panel was quasi-statically loaded five times at increasing load levels under displacement control.

Figure 24. Contact between the rubber bumper and Stringer02 external skin

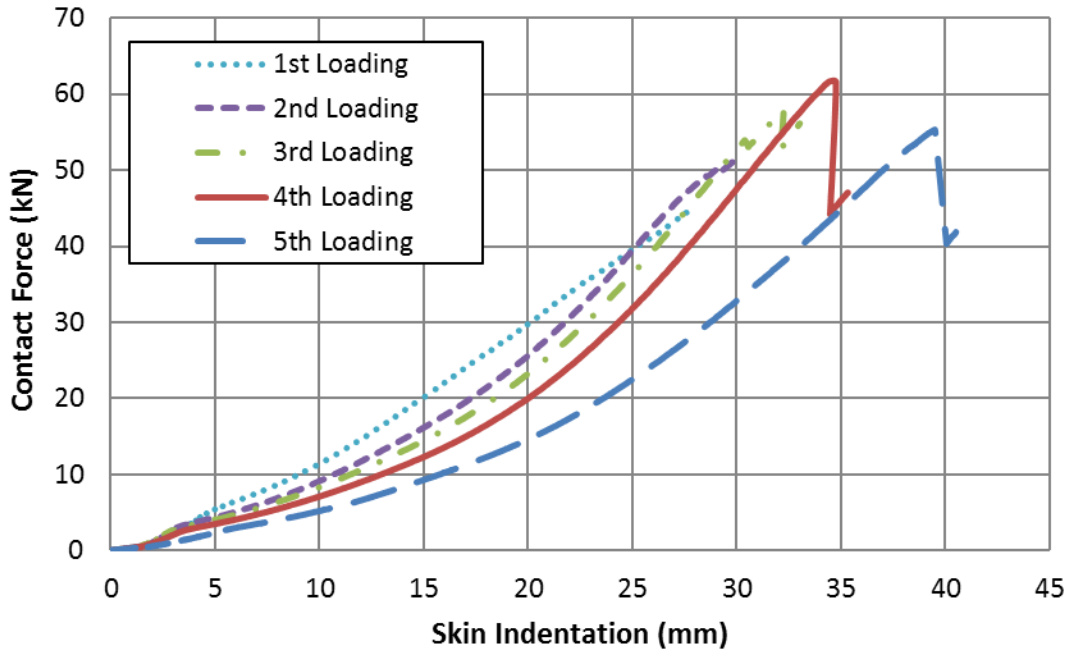
Figure 25 shows the force versus indentation curves for Stringer02. Inflections in the plots were observed at low-level loads due to the stiffening behavior of the rubber bumper as its open D-shaped cavity collapsed under compression. When the load reached approximately 2.89 kN (2–3 mm indentation), the cavity closed, and the bumper stiffened significantly.

Figure 25. Stringer02 contact force vs. skin indentation plots

Stiffness loss was observed for each of the load cycles (see figure 25). This was due to the cumulative damage sustained at the shear-ties corners, and the delamination growth of the stringer flanges during the fourth and fifth load cycles. Sudden damaging events, such as delamination growth, resulted in load drops. Slow damage growths resulted in gradual change in the slope of the loading curves toward the end of each load cycle. The load level at which gradual damage growth occurred was inferred by the softening seen at approximately 56 kN in the fourth loading cycle and at 51 kN in the fifth loading cycle (see figure 25). These damaging events were accompanied by audible cues of composite failure.

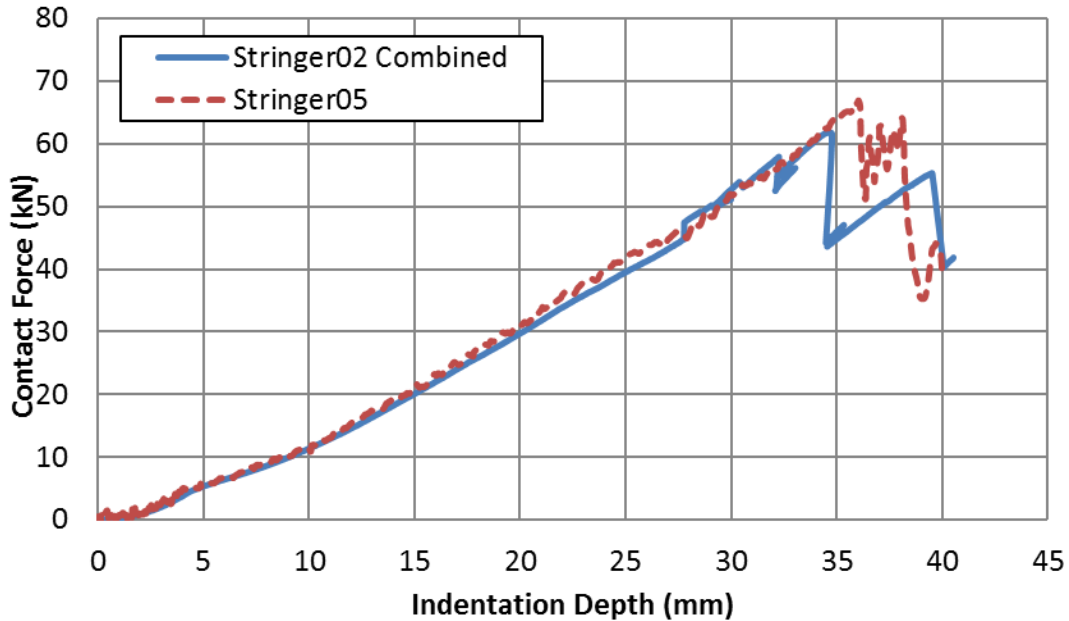
Stringer05 was dynamically impacted at 0.5 m/sec with the TUG D-shaped rubber bumper on the panel's skin between the stringers. Only one load cycle was conducted on Stringer05. The dynamically loaded Stringer05 load versus indentation plot is shown in figure 30 along with a combined loading plot for the quasi-statically tested Stringer02. The two panels show similar stiffness response and peak loads. However, their initial failure modes and path of failure propagation were different.

Figure 30. Stringer02 and Stringer05 contact force vs. skin indentation plots

Two significant load-drops were observed at 36.1 and 38.1 mm of skin indentation, each corresponding to failures occurring at the stringer local to the impact zone. The first load drop at 36.1 mm of indentation was caused by skin-to-stringer delamination and stringer fracture failures on first stringer. Although its failures were not captured within the view of the high-speed camera, carbon fiber debris was seen ejected from that stringer location. Figure 31(b) shows the white carbon fiber debris falling from the out-of-view stringer at 199.0 msec after impact. The timing of this event coincided with the first load drop. This first skin-to-stringer delamination and stringer fracture failures were confirmed after the experiment. The second load drop, at 38.1 mm of indentation, was caused by similar failures at the second stringer in the impact zone. This time, the sequence of damaging events was captured by the high-speed camera. Figure 31(c) shows that the skin-to-stringer delamination initiated underneath the impactor 199.6 msec after the impact and grew toward the boundary shear ties that were outside of the impact zone toward the boundary conditions. Figure 31(d) shows stringer wall fracture failure occurred at 202.4 msec after impact, immediately following the delamination damage.

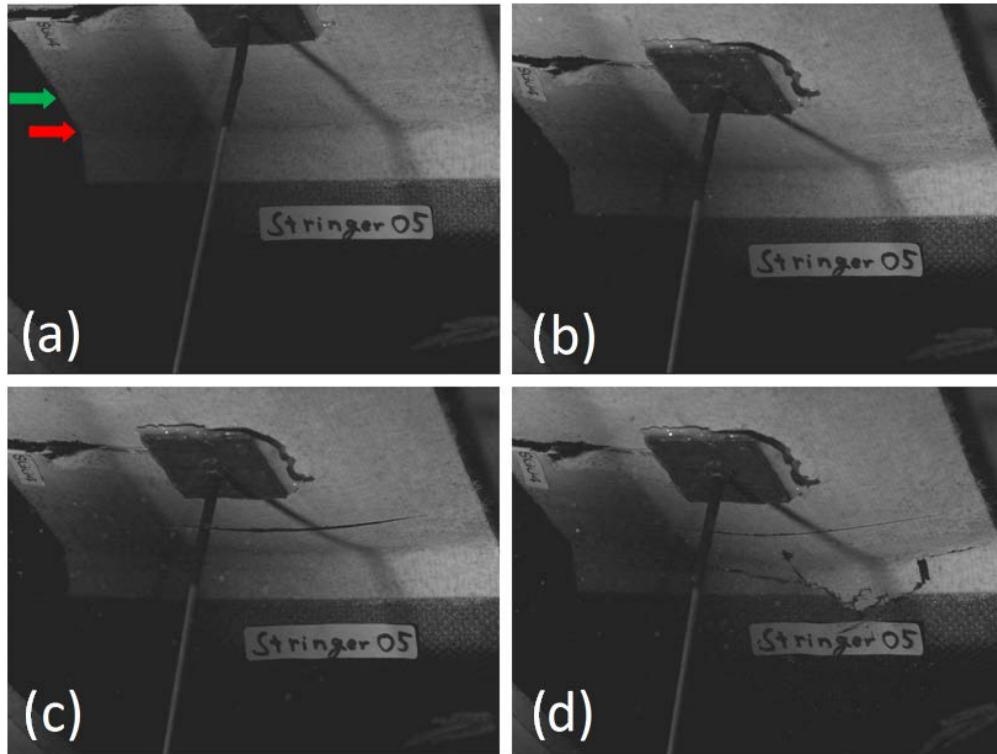
Figure 31. High-speed video still frames of Stringer05 test as viewed from the panel's interior: (a) $t = 17.2$ msec, (b) $t = 199.0$ msec, (c) $t = 199.6$ msec, and (d) $t = 202.4$ msec after impact

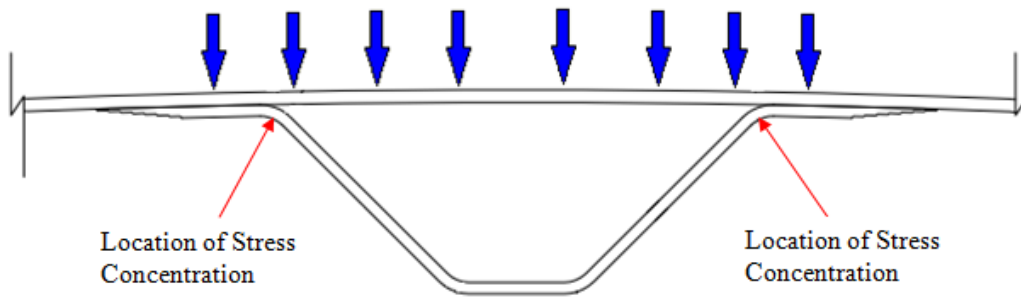
Figure 38. Cross-section view of the stringer-reinforced skin loaded over the stringer; concentrated stress is expected to develop at the skin-stringer joint

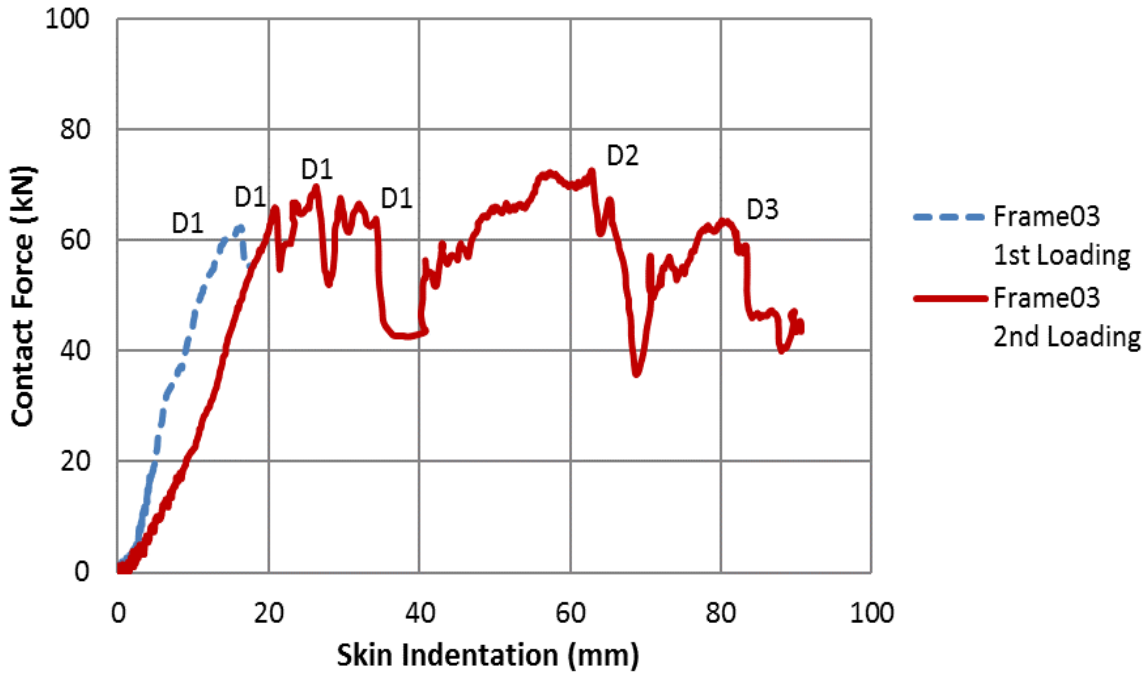
Figure 45. Frame03 contact force vs. skin indentation plots; D1 = initial three shear ties failing; D2 = additional six shear ties failing; and D3 = frame failure

In summary, the final internal damage state is shown in figures 48 and 49. Nine shear ties fractured—three in the impact zone (event D1 in figure 45) and six adjacent to the impact zone (event D2 in figure 45). All three impacted C-frames fractured, indicated as event D3 in figure 45. A view of the outside surface of the specimen after impact is shown in figure 50. The thin skin design was very flexible when impacted against a non-stringer reinforced location. Therefore, the skin rebounded after the experiment. No external skin-cracking damage was visible, and the permanent residual skin deformation was measured to be 4.5 mm 24 hours after the test. Skin deformation was measured by a photogrammetric technique in which the panel surface was digitally constructed based on photographs of the panel (targets seen in figure 50). The visual detectability of a 4.5 mm dent existing over a dent span of more than 1 m was difficult to perceive by visual observation.

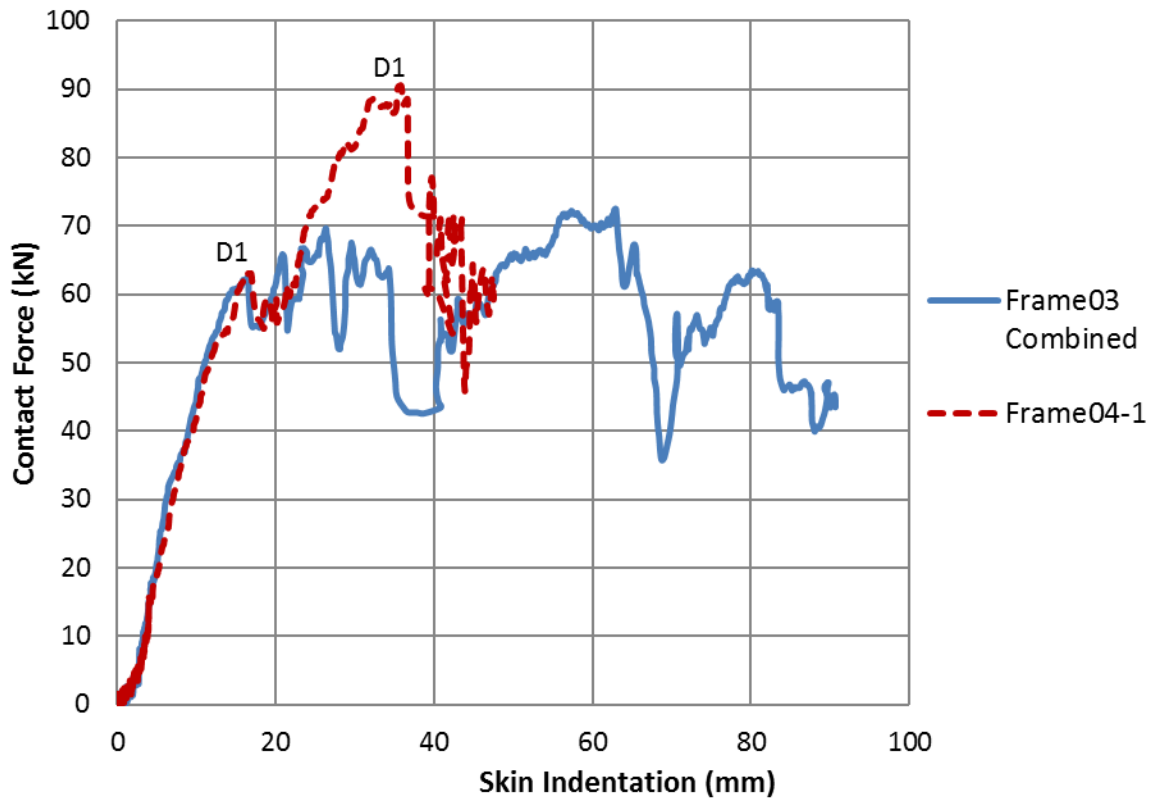
Two additional loading scenarios were explored using the Frame04 specimen. Under the assumption that Frame03's second loading data were compromised by the pre-existing shear-tie damage from the first loading, another dynamic experiment was conducted in an attempt to fill in the data gap. The load at which complete shear-tie fracture occurred was specifically questionable because of the pre-existing delamination induced during the first loading (see figure 46), likely resulting in lower peak load during the second loading. Therefore, the Frame04-1 panel specimen was designed to be identical to Frame03, but was impacted for a maximum actuator displacement of 180.3 mm to determine a pristine panel response through the point of the initial three shear ties fully failing. The Frame04-1 contact force versus skin indentation result is plotted along with the Frame03 results in figure 51 for comparison. The initial loading up until first delaminations (event D1) at 60 kN (20 mm skin indentation) was identical to specimen Frame03. Without unloading, the increasing stroke resulted in much higher load, 90.56 kN due to the continuous actuator stroke leading to complete fracture of the directly loaded three

Figure 51. Frame04-1 and Frame03 contact force vs. skin indentation plots

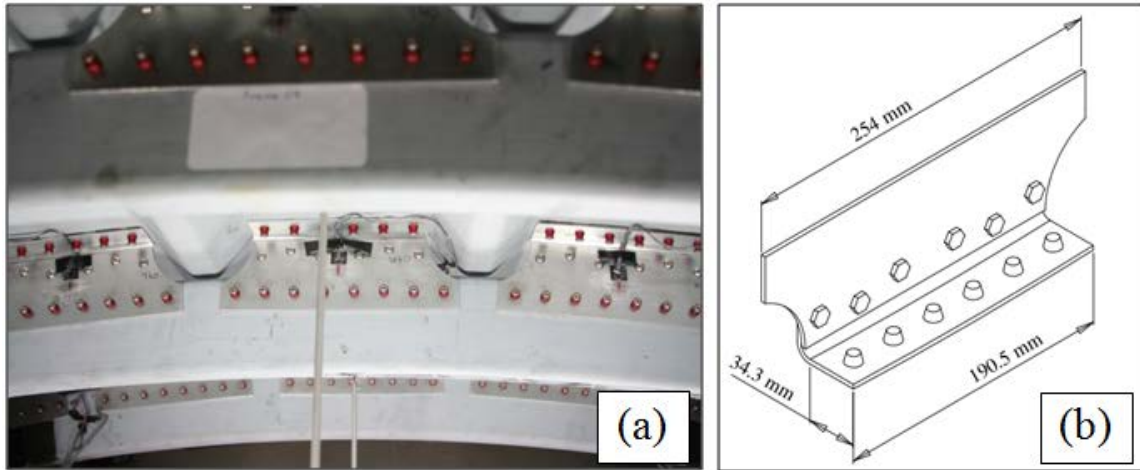
The new configuration enabled the assessment of the impact behavior of a fuselage panel with shear ties that could resist early delamination and fracture failures. Frame04-2 was otherwise identical to Frame03 in layout and loading: The new shear ties made from aluminum alloy 7075 are thicker at 3.18 mm (compared with 2.4 mm composite) and wider at 254 mm, where it mounted to the C-frame, allowing an additional two fasteners. Figure 52(a) shows the shear ties as they

Figure 52. The aluminum 7075 shear ties (a) mounted to the Frame04 panel, and (b) overall dimensions

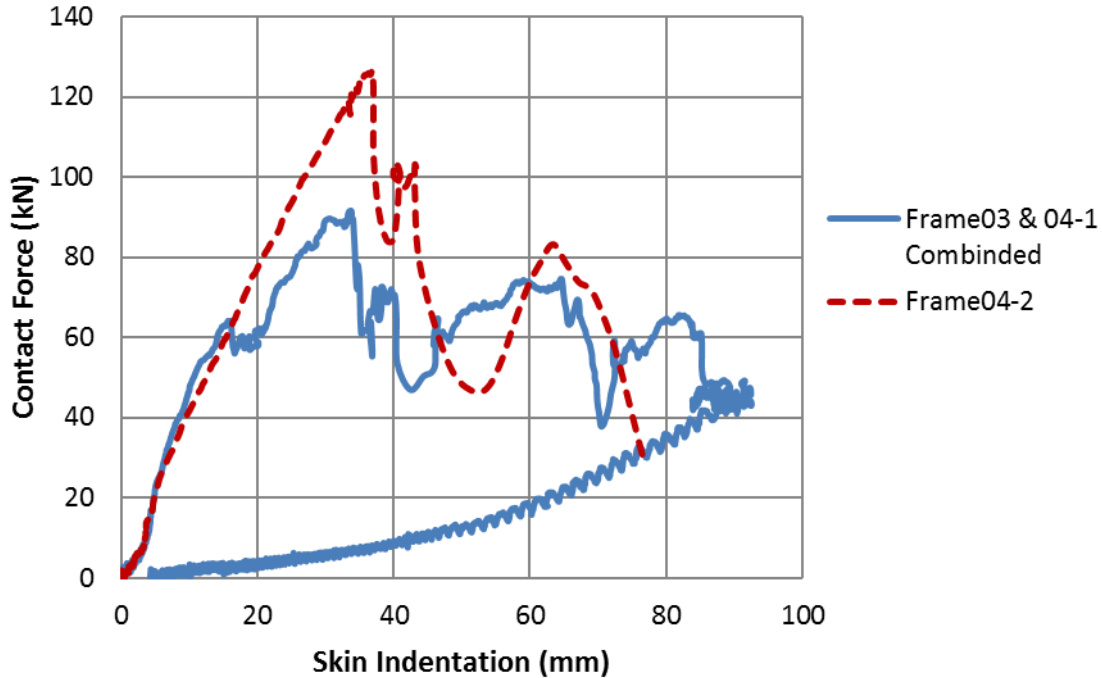
Figure 53. Contact force vs. skin-indentation plot of Frame04-2

In figure 53, three load drops were observed that corresponded to the sequential fracture of each C-frame. Localized shear fracture failures were observed in all three C-frames, as shown in figure 54 (high-speed video still taken during failure event). Minor exterior cracking of the skin developed from the panel's curved free edges where the stringers terminated with the panel edge. These cracks likely would not have developed in the absence of the free edge; furthermore, the Frame04-2 test significantly overdrove the actuator, with skin indentation of 40–50 mm producing major frame failures, thereby reducing the minor skin cracks formed. Although the frame shear-out failure mode was localized near the location of impact, and the specimen carried significantly higher peak loads, this configuration with stronger shear ties led to major C-frame failure as both the initial and final failure mode, without any intermediate failure modes that would perhaps be less detrimental to residual structural capability (i.e., crushed shear ties less detrimental than cracked frames).

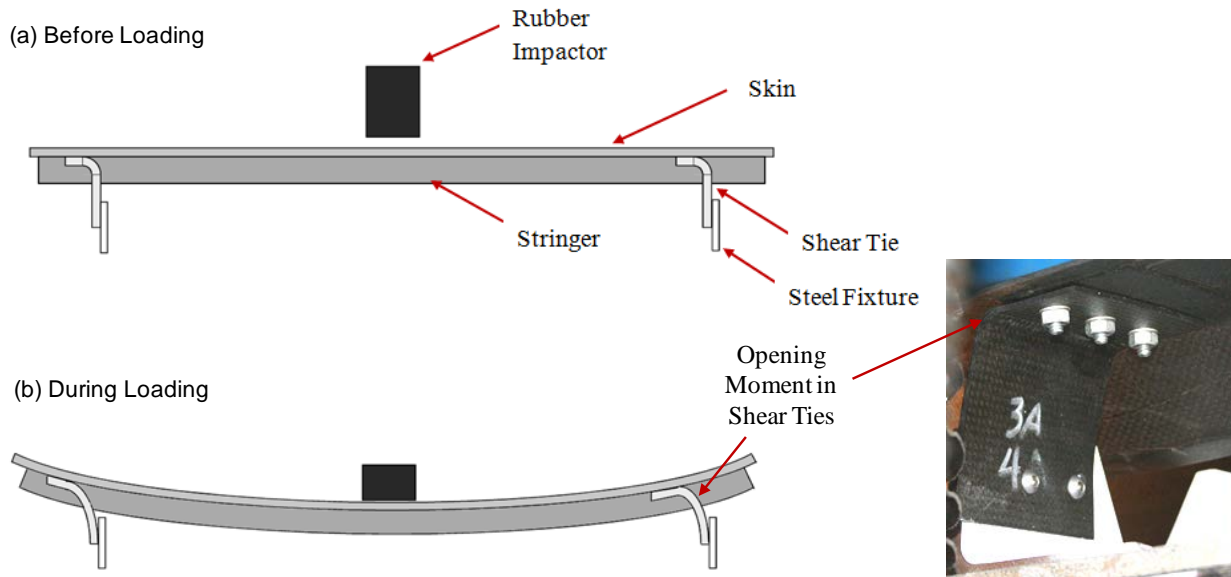
Regardless of the test configuration, damage in the StringerXX specimens always initiated at the shear ties due to the downward compression and moment loading on the shear ties (see figure 55). Opening moment was induced by both skin rotations at the shear-tie supports and lateral movement of the panel, resulting in interlaminar tension stress at the shear-tie corners (i.e., radial-direction tension stress acting through the laminate thickness). The composite material's interlaminar tension strength is low, typically in the range of 40–50 MPa (mode I interlaminar fracture toughness of approximately 700 J/m^2). Therefore, shear-tie delamination was the first failure mode developed. As the compression load was increased, fiber breakage at the shear ties was also found because of crushing from the impact load.

Figure 55. Side view of StringerXX panel: (a) before impact loading, and (b) during impact loading; compression and opening moment loading are exerted on the shear ties

The shear-tie failures were minor failure modes because of their progressive nature and, although having minimal effect on the structural integrity of the stringer-stiffened panel, would affect load transfer from the skin to the frames. Furthermore, the existence of damaged shear ties could serve as an indicator that a HEWABI event has occurred (reported or not) and that other internal damage could be present in the area. Increasing the visibility of damage in the shear ties (e.g., painting them white) could serve to aid in visual inspection for damage in the shear ties.

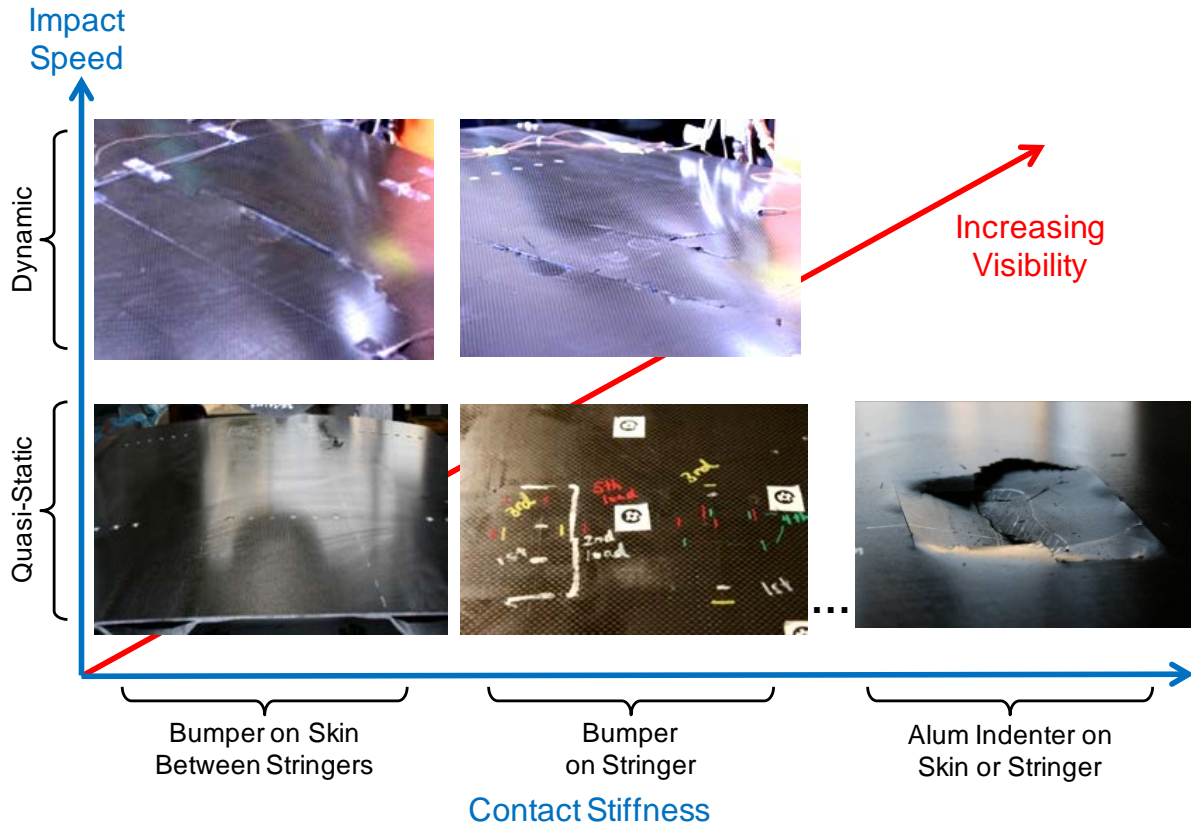
Blunt-impact-induced damage to stringer-reinforced composite panels could be externally visible (skin penetration and cracking) or masked (skin-stringer delamination). Damage could also be localized or widespread. These damage characteristics were strongly dependent on impactor sharpness, impact location, and impact velocity. Figure 56 summarizes the effects of these three factors on damage visibility. First, the impactor stiffness and impact locations affect the panel deformation by changing the local contact stiffness between the impactor and the panel surface. Higher contact stiffness generated higher contact stresses, which created localized skin cracking with increased external visibility at the point of impact. Conversely, lower local stiffness reduced the contact stresses (allowing higher loads) and generated widespread internal damage along the load path, particularly at points of stiffness change and joints. This internal damage was obscured

Figure 56. General trend of damage based on the StringerXX series experiments

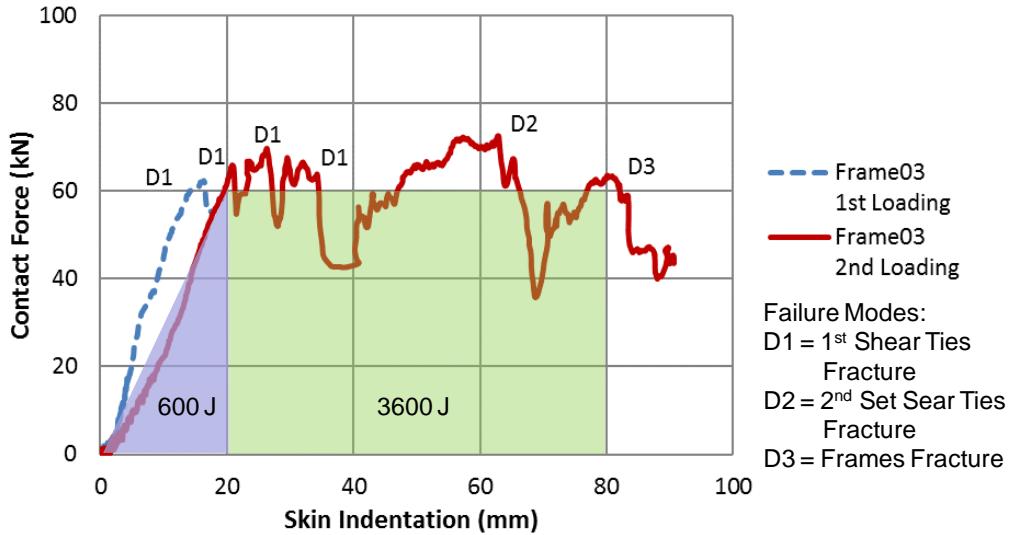
Force versus displacement data measured during the blunt impact tests reported herein can be related to ground threats via energy balance. Specifically, the energy dissipated by the deforming and fracturing composite structure is equal to the area under the force versus displacement curve, leading up to that level of displacement. This is shown in figure 57, which plots the force versus displacement data of specimen Frame03 (dynamically loaded at 0.5 m/s across three frames). The initial major failure mode for which the first set of directly loaded shear ties fractured (indicated as D1 in figure 57) is associated with 600 J of energy at a skin indentation level of 20 mm. Further driving in of the skin produces additional levels of internal damage severity, accompanied by increasing energy levels. For fracture of the frames, an additional 3600 J energy is needed at a skin indentation level of 80 mm.

Figure 57. Frame03 force versus displacement data with energy associated with 1st shear ties fracturing (600 J) and with frames fracturing (600 + 3600 J)

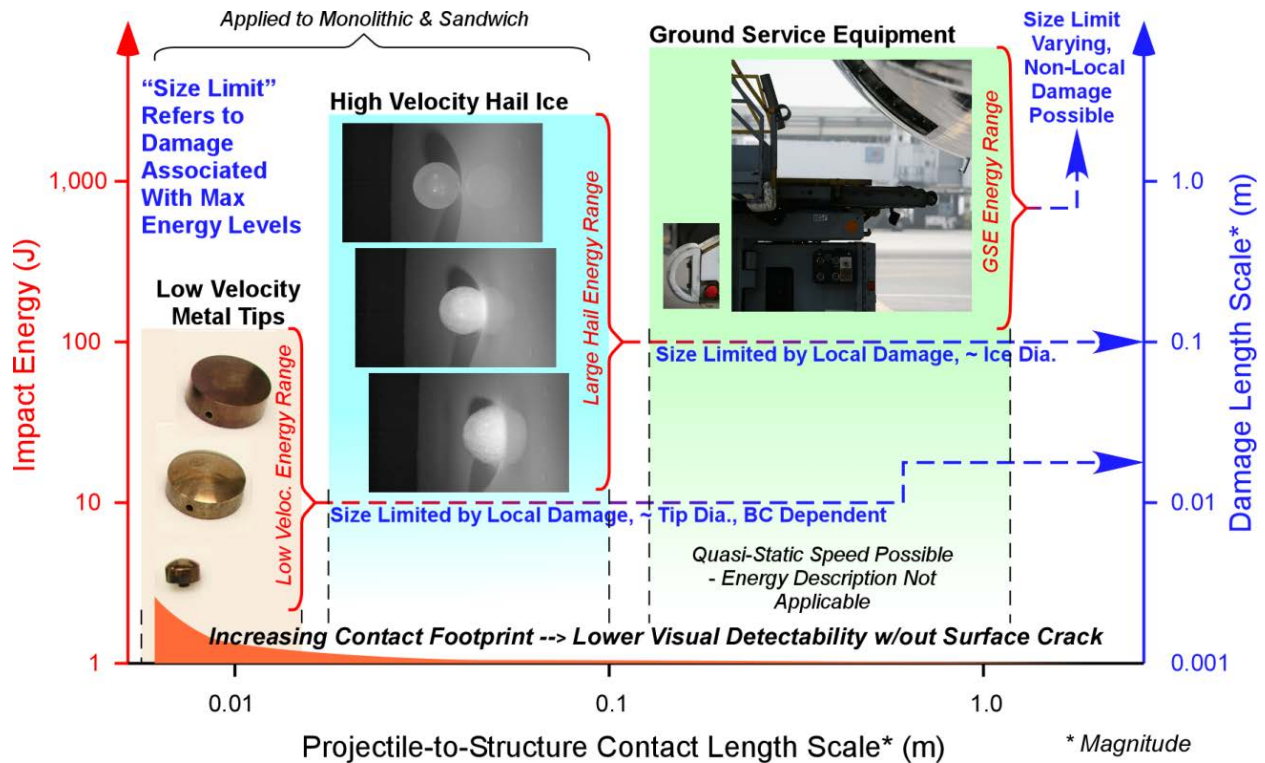
Figure 60. Blunt impact energy-damage spectrum

Among the three impact sources being studied at UC-San Diego (see figure 60), both the low-velocity metal tips and high-velocity ice impact can usually be associated with a damage size limit (see right-hand axis in figure 60). This damage limit reflects the ability for these impact sources to induce localized failure at the point of impact/contact. Therefore, maximum-level cases of velocity and energy will typically produce penetration damage because of this localized response. Penetration damage has a size limit roughly equivalent in dimension to the impacting projectile (see figure 60). For this reason, the worst-case scenario might not always produce the most critical mode(s) of damage.

For the GSE impact, a non-local response has been observed to be possible. Specifically, internal damage can occur at locations away from the point of impact/contact (e.g., at joints or stress concentrations along the internal load path to the surrounding structure). Therefore, the damage size limit is not clearly known and, depending on the severity (energy level) of the impact event, can possibly be larger than the length scale of the contact between the projectile and structure. Furthermore, the GSE contact speed can be quite varied, even a very slow (quasi-static) level, as indicated in figure 60, so the energy-based description might not fully describe GSE-aircraft interactions.
