**DOT/FAA/TC-19/10**

# **Large Engine Uncontained Debris Analysis—High-Bypass Ratio Engine Update**

April 2019

Final Report

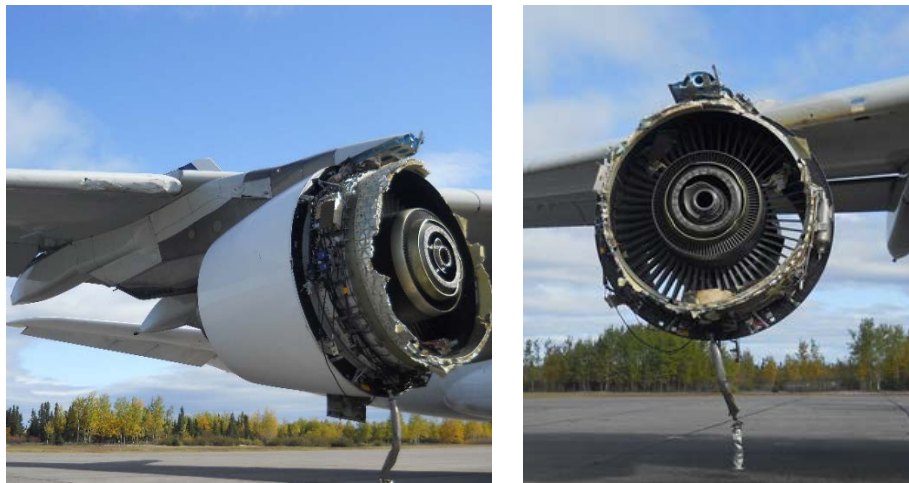
**Figure 25. Fan disk event**

For fan disk damage from a disk failure, figure 25 shows the basic trajectory angles to range from +2 and -3 degrees. A bladed 1/3 disk fragment is used to model fan disk debris. Release velocity and energy levels are estimated at 304 fps and 69,664 ft-lbf, respectively.

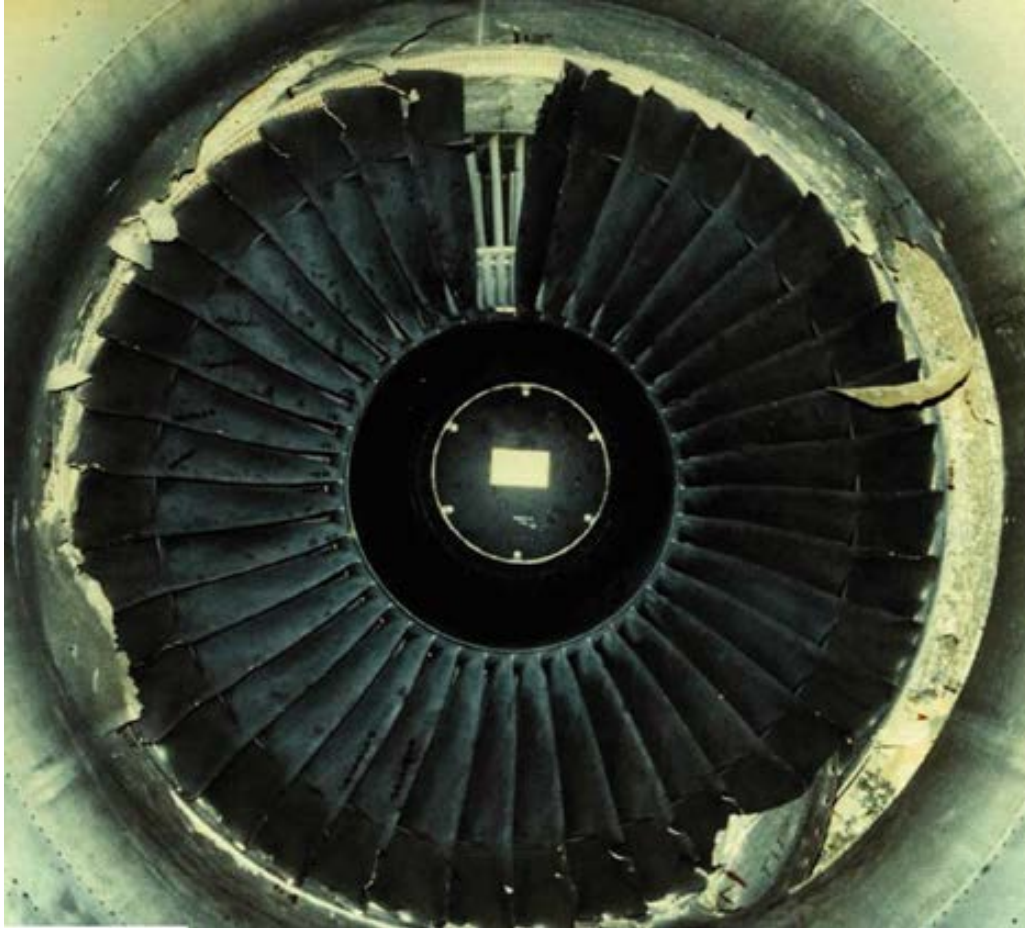
**Figure 29. Fan-blade event**

There are several scenarios that occur, resulting in an uncontained fan-blade event. Two primary failure modes to consider are: 1) helical motion of a blade tip upon fracturing against the containment ring (figure 29), and 2) particles that are re-ingested and then ‘kicked’ forward after impacting the fan rotor. The primary mode addressed in this analysis is the helical-motion model. The re-ingested model is assumed to produce lesser fragment energies than the helical model.

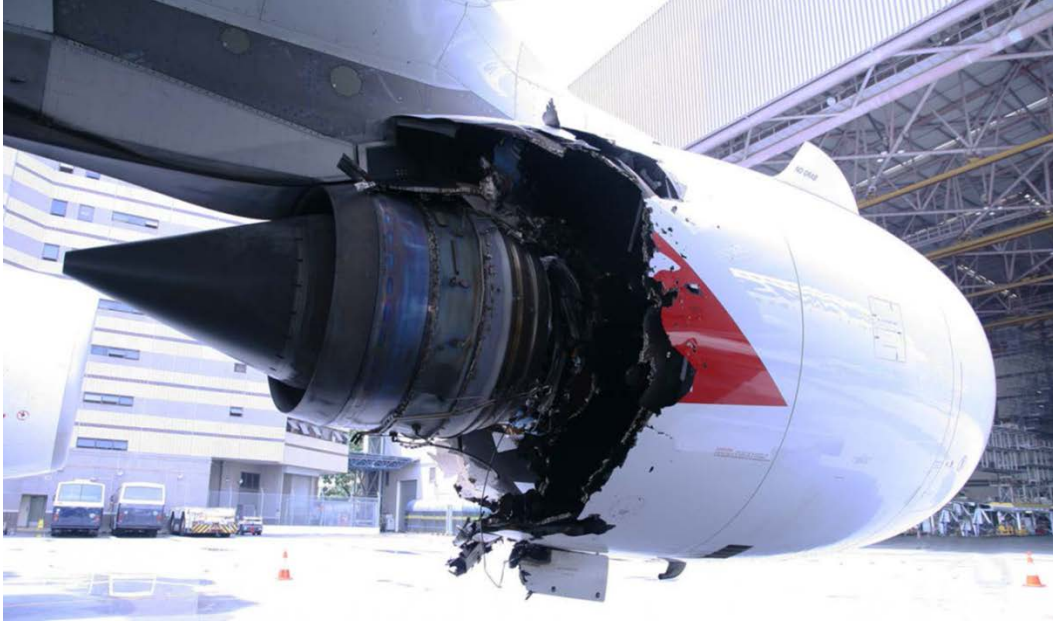
**Figure 55. Turbine disk failure**

Turbine analysis was divided into High-Pressure Turbine (HPT) and Low-Pressure Turbine categories. HPT events are a serious risk to the aircraft because of the high rotational speed, heavy weight, and larger exposure under the wing (figure 55). Representative damage from disk segments penetrating the wing are shown in figure 56. Turbine events were categorized by blade, rim, and disk failure events. There were eight HPT events, five HPT Disk events, three HPT Rim events, and no HPT Blade events (previous characterization was from LBPR engines). Each of these failure modes is characterized in sections 4.3.1.1–4.3.2.2 .

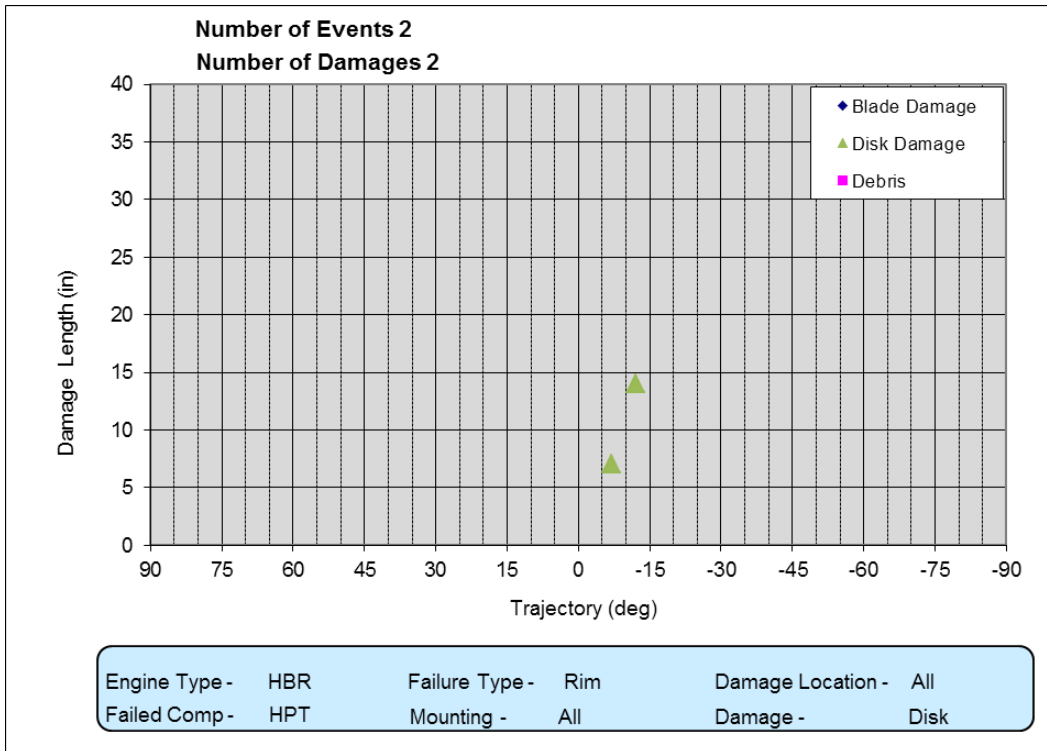
**Figure 71. Spacer-rim damage, HPT spacer-rim event**

Aircraft damage resulting from an HPT spacer-rim impact is shown in figure 71. The damage ratio is shown in figure 72. The representative turbine blade debris size for characterization is 50% disk diameter. There were two HPT spacer-rim events and two damage locations, resulting in an average of one disk fragment per event. The trajectory angles range between -6 degrees and -12 degrees. Peak cowl exit velocity for a 50% blade fragment is 745 feet per second with energy of 71,930 ft-lbf (figure 73).

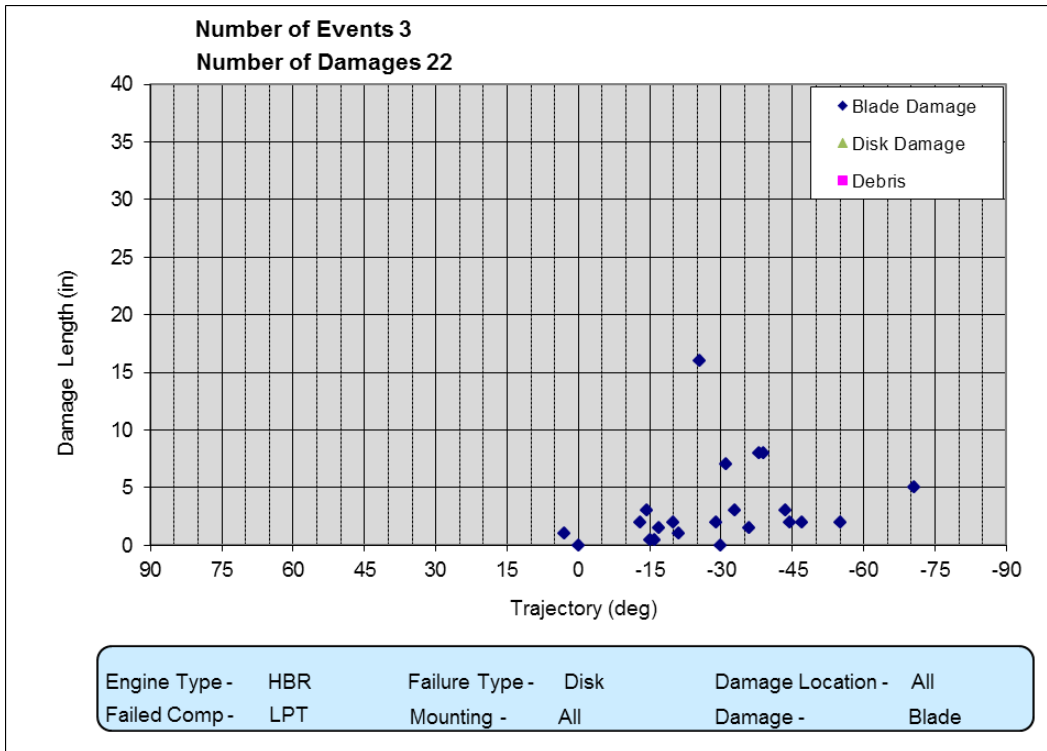
**Figure 75. Blade damage, LPT disk event**

Aircraft damage resulting from an LPT blade impact is shown in figure 75. Damage ratio is shown in figure 76. Representative turbine blade debris size for characterization is 70% blade length. The 3 disk events produced 22 damage locations, resulting in an average of 7.33 (7) blade fragments per event. The trajectory angles range between 5 degrees and -70 degrees. For characterization, the trajectory spread angle is defined as +5 to -45 degrees. Peak cowl exit velocity for a 70% blade fragment is 436 feet per second with energy of 1399 ft-lbf (figure 77). Aerodynamic effects are shown in figure 78. Required skin thickness to defeat the fragment is shown in figure 79. As can be seen, windage for these lower energy blade fragments can be significant and can account for the large aft trajectories.

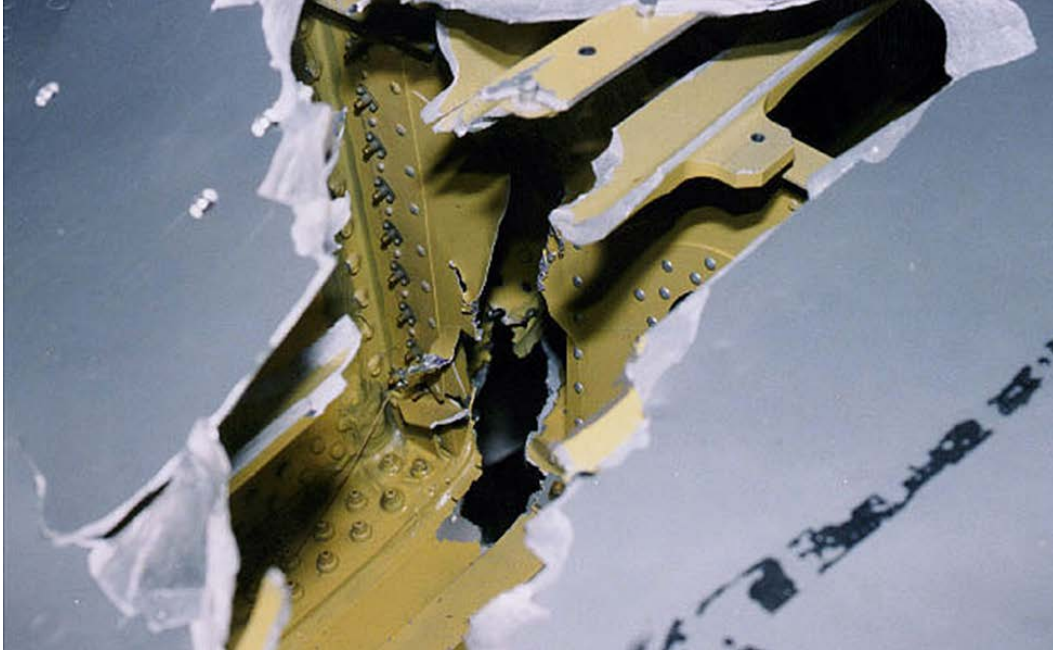
**Figure 80. Wing structure damage, LPT disk event**

An example of aircraft damage resulting from an LPT disk impact is shown in figure 80. Aircraft damage recorded in the database is shown in figure 81. The damage ratio is shown in figure 82. Representative turbine disk debris size for characterization is 90% disk diameter (1/3 disk). Of the three disk events, two produced aircraft damage including two damage locations. The average number of disk fragments per event is one. The trajectory angles range between +3 degrees and -7 degrees. For characterization, the trajectory spread angle is defined as +3 to -5 degrees. The peak cowl exit velocity for a 90% disk fragment is 291 feet per second with energy of 56,466 ft-lbf (figure 83).

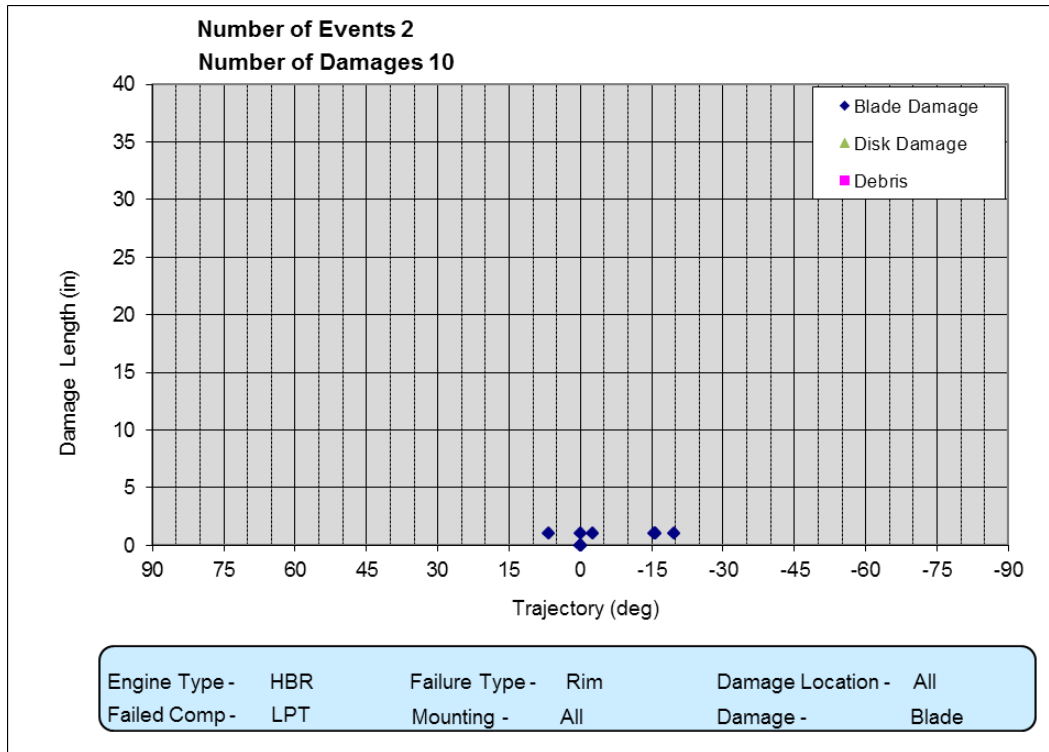
**Figure 84. Blade damage, LPT spacer-rim event**

Aircraft damage recorded in the database is shown in figure 84. The damage ratio is shown in figure 85. Representative turbine blade debris size for characterization is 15% blade length. Of the two spacer-rim events, ten damage locations were recorded. The average number of blade fragments per event is five. The trajectory angles range between +7 degrees and -20 degrees. The peak cowl exit velocity for a 15% blade fragment is 471 feet per second with energy of 350 ft-lbf (figure 86). Aerodynamic effects are shown in figure 87. Required skin thickness to defeat the fragment is shown in figure 88.

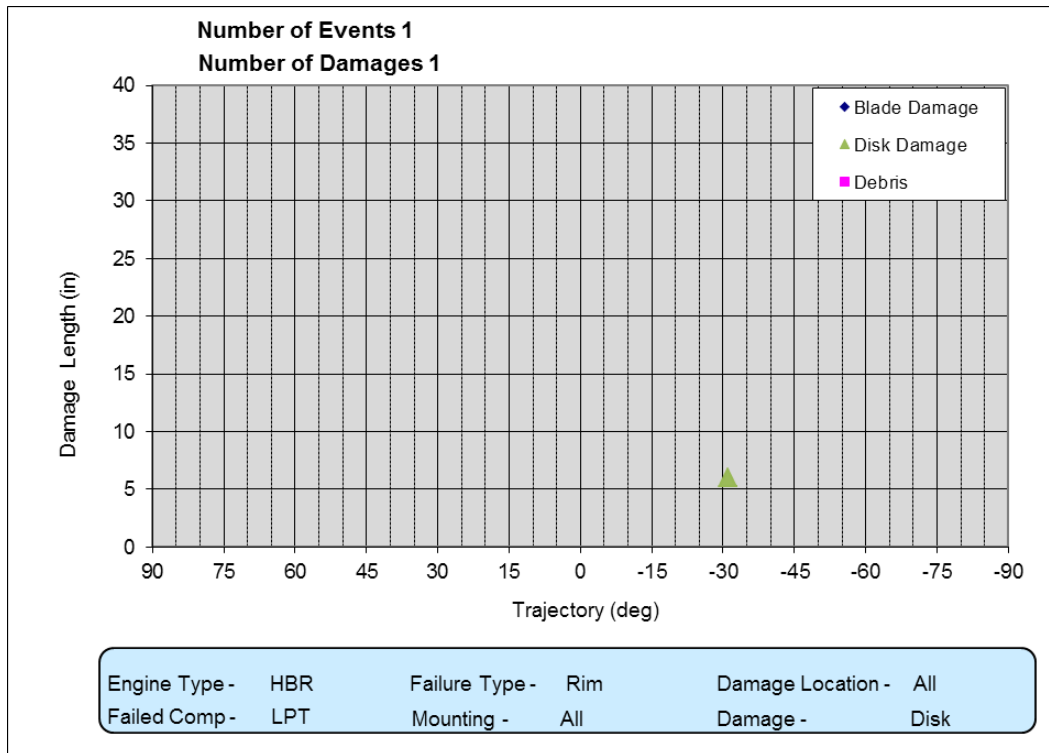
**Figure 89. Spacer-rim damage, LPT spacer-rim event**

Aircraft damage recorded in the database is shown in figure 89. The damage ratio is shown in figure 90. The representative turbine spacer-rim debris size for characterization is 20% disk diameter. Of the one spacer-rim event, one damage location was recorded. The average number of disk fragments per event is one. The trajectory angle for the single recorded event is -31 degrees, which, in this case, was a result of a ground impact. For characterization purposes, the fragment size will be captured; however, the trajectory characterization will default to AC 20-128A [5] guidance for an intermediate fragment. The peak cowl exit velocity for a 20% blade fragment is 325 feet per second with energy of 6323 ft-lbf (figure 91).

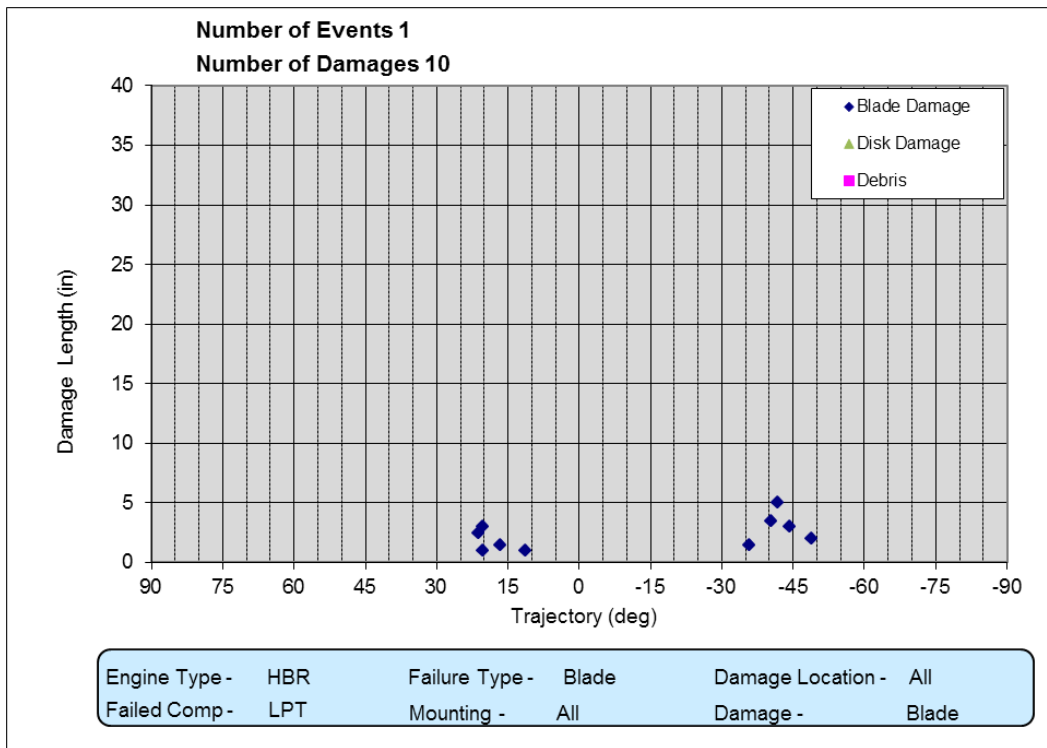
**Figure 92. Blade damage, LPT blade event**

LPT blade event data is an event from turbine stages other than last stage, the last stage is covered in 4.4.4. Aircraft damage recorded in the database is shown in figure 92. The damage ratio is shown in figure 93. Representative turbine blade debris size for characterization is 80% of the blade length. One LPT blade failure event generated ten damage locations. The average number of blade fragments per event is ten. The trajectory angle range for this event is +20 degrees to -45 degrees. The peak cowl exit velocity for an 80% blade fragment is 236 feet per second with energy of 470 ft-lbf (figure 94). The aerodynamic effects are shown in figure 95. Again, windage for these lower energy blade fragments can be significant and can account for the large aft trajectories. Required skin thickness to defeat the fragment is shown in figure 96.

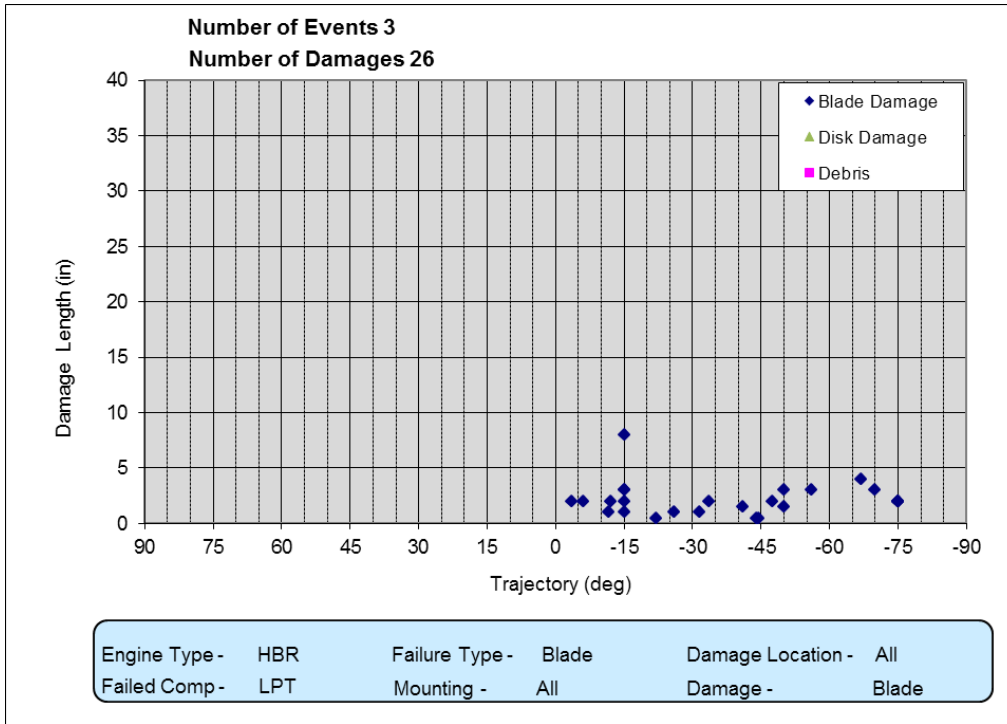
**Figure 98. Blade damage, LPT blade event—last stage**

A subset of the LPT blade event data is the LPT last-stage event. Examples of this type of turbine-blade debris are shown in figure 97. These events have high potential for very large aft trajectories because debris exiting the tailpipe can also be included in the damage data. Aircraft damage recorded in the database is shown in figure 98. The damage ratio is shown in figure 99. Representative turbine blade debris size for characterization is 40% blade length. Three LPT blade failure events generated 26 damage locations. The average number of blade fragments per event is nine. The trajectory angle range for this event is +20 to -75 degrees; for characterization purposes, trajectory spread angle is defined as +20 to -60 degrees. Peak cowl exit velocity for a 40% blade fragment is 147 feet per second with energy of 90 ft-lbf (figure 100).

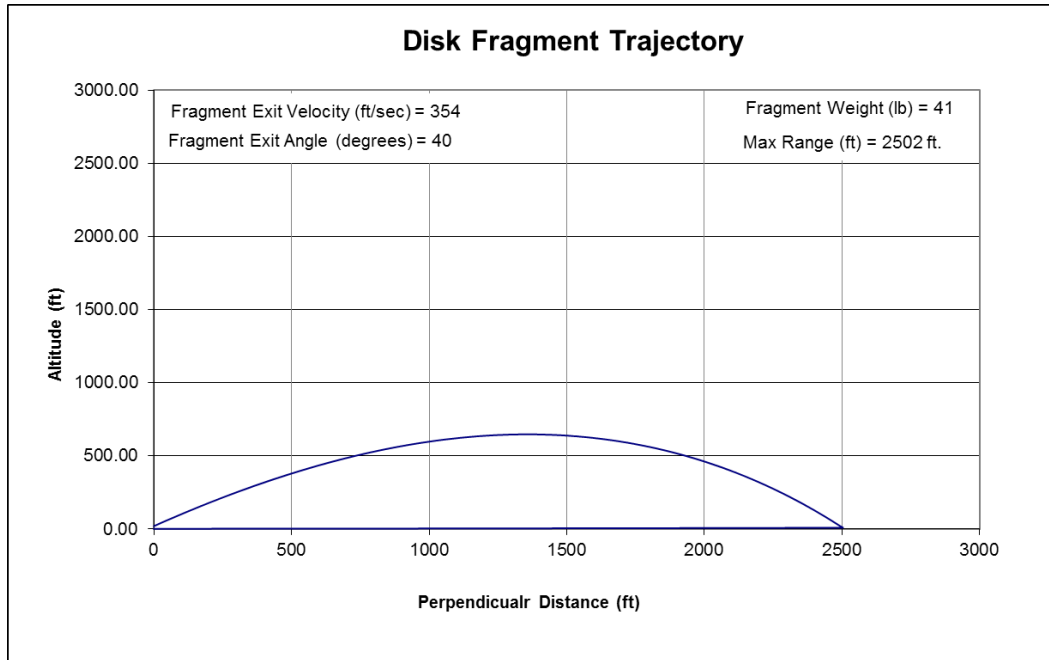
**Figure 103. 1/3 disk fly-out trajectory results**

An uncontained fan disk event resulted in a 1/3 disk section (figure 101) exiting the engine containment case and cowling passing just over the fuselage and landing in a field approximately 2400 ft abeam of the aircraft. The 1/3 disk hub trajectory analysis was conducted to verify the initial fragment exit conditions. This analysis was based on the event data to attain initial velocity, mass, trajectory angle, fragment presented area, and drag coefficient, the analysis was matched the distance traveled, and the trajectory was understood. In this case, it was assessed that the disk segment did not impact the aircraft fuselage but exited the engine case at an angle of approximately

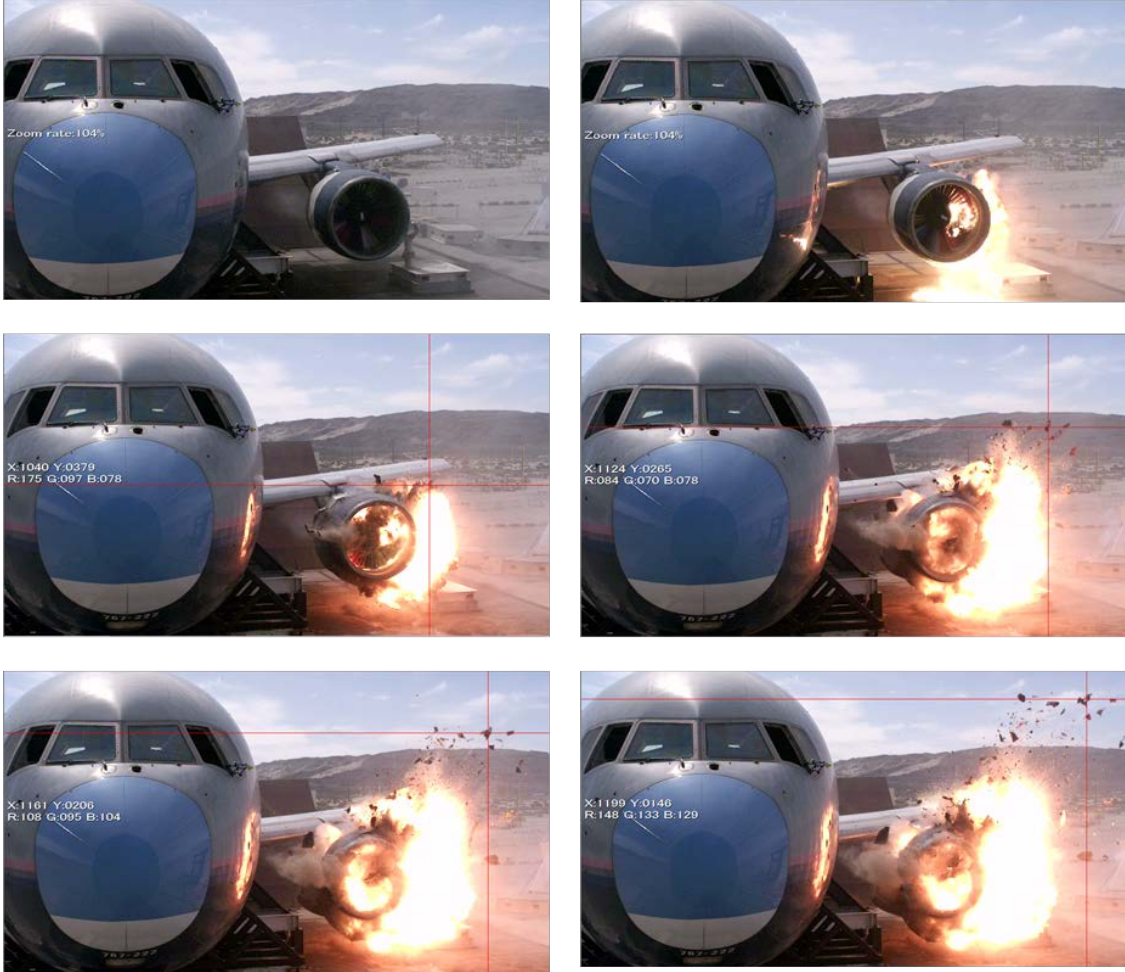
**Figure 104. Event high-speed video images**

A large engine test was conducted at the Naval Air Warfare Center, Weapons Division to address fan uncontainment and the engine fragment threat to aircraft from a high-bypass ratio engine. During this test, several fan blades were severed with the engine operating at takeoff power. High-speed video of the event show released fragments moved forward of the fan containment structure. Blade fragments can be seen penetrating the inlet inner barrel exiting through the inlet and cowl structure 6 msec after the event was initiated. Approximately 20 significant-sized fragments can be seen exiting at a high velocity. Six of these fragments were tracked, and velocity estimates are provided below. It was evident that the fragments exiting at high velocity were a fairly localized tangent of the release point. The circumferential location of the release point resulted in the fragment tangent velocity vectors projecting away from the aircraft so none of these high-velocity fragments impacted aircraft structure.

High-speed video was also used to estimate fragment exit velocities (figure 104). This provides a reasonable estimate of fragment velocities during an uncontained fan-blade event (figure 105).

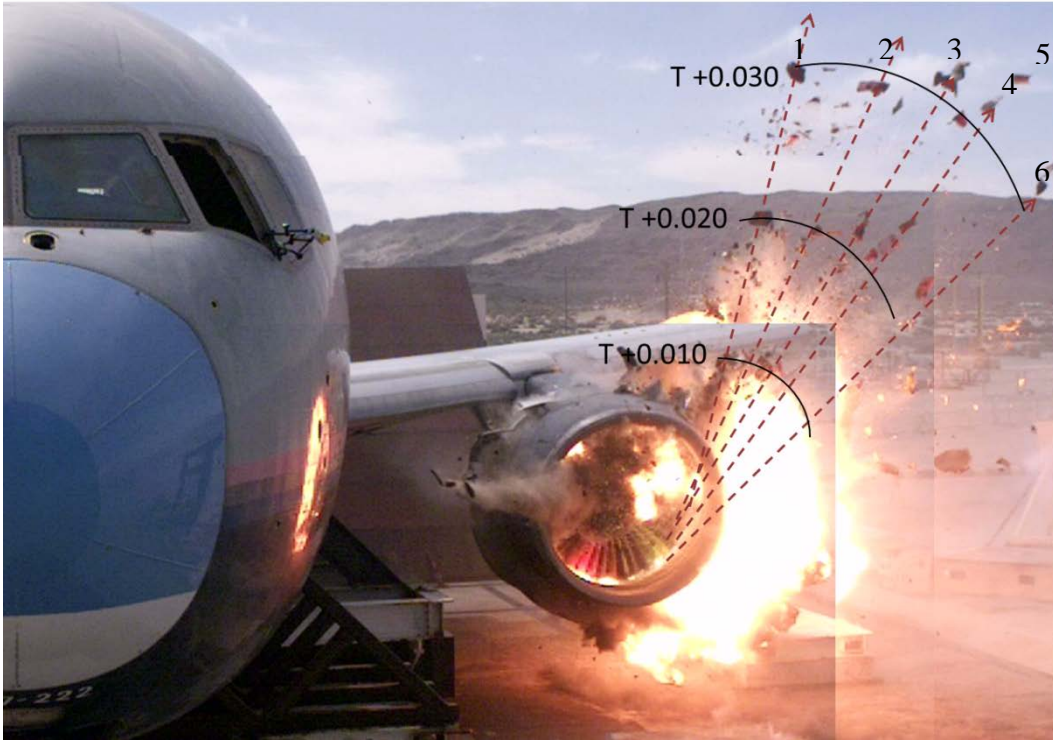
**Figure 105. Event time overlay tracking high velocity fragments  
(Debris ID #, T in seconds)**

Fragment-velocity analysis for six of the fragments is shown in table 29. Estimated velocities range from 717 to 1066 fps. Comparing these velocities to the fan-blade-event fragment velocities in the debris model provides a good correlation supporting the methodology for helical fan blade failure events as discussed in section 3.1.2 of this report. Fan-blade failure characterization estimated exit velocities between 827 to 954 fps depending on the fragment size. The size of the high-velocity fragments appears consistent with the fan blade fragment model provided in this report, ranging 10% to 50% in blade length. It can also be noted that in the last image of figure 104, there are a number of additional blade fragments traveling at a slightly slower velocity than the six identified and tracked.

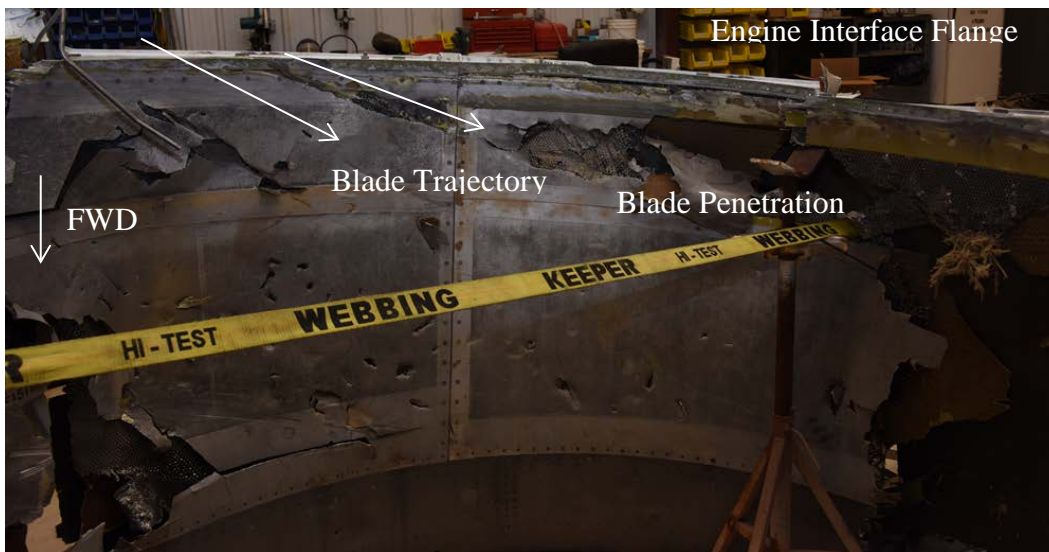
**Figure 106. Helical failure trajectory, inlet inner barrel**

The fan containment structure was completely intact. Post-test inspection indicated that the fan blade fragments exited the inlet cowling in a helical trajectory (figure 106). Figure 107 provides a sample of the fragment size.

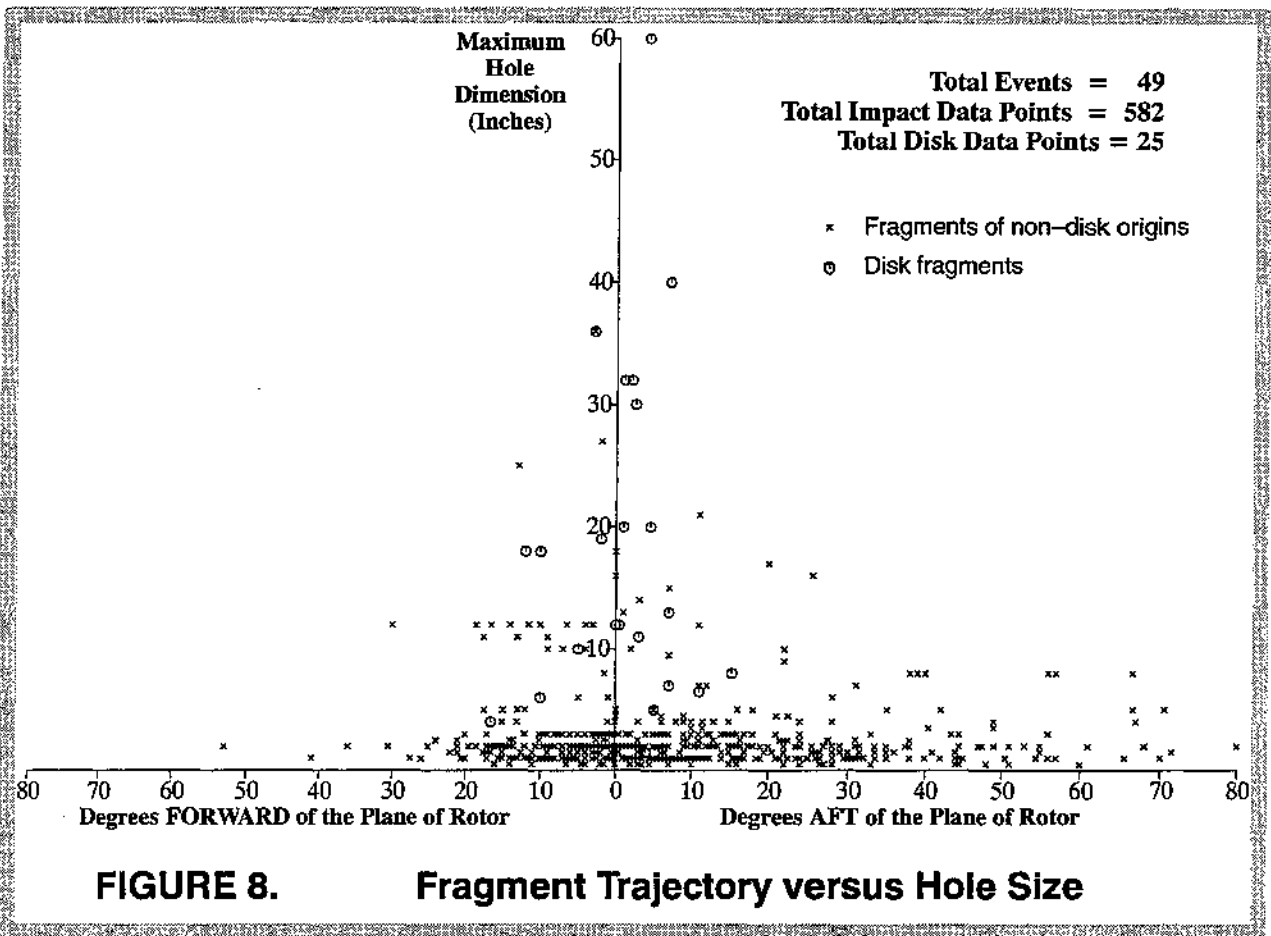
The trajectories from the plane of engine disintegration to the penetration location have been calculated for 582 holes in the 49 events. Figure 8 is a "splatter" plot of this data, showing the trajectory and size of all fragments which have been documented for this study.

The trajectories of fragments ejected by uncontained turbine engine disintegrations varies from the largest forward angle of 53.5° to the largest aft angle of 80°. The penetration at 53.5° forward angle (event 22, hole 3) was relatively small. The hole left by the fragment was in the lower cargo section of the fuselage, measuring 2 inches by 2 inches. The fragment which caused this was a part of the fan section. The penetration at 80° aft (event 9, hole 2) was also small,

measuring 2 inches by 1 inch. The fragment which caused this hole was from the first stage of the low pressure turbine (LPT). It impacted the aircraft on the horizontal stabilizer lower skin.

The trajectory of the fragment which caused the largest hole (event 4, hole 5) was calculated to be 4° aft of the plane of disintegration, and resulted in a lengthy slice (60 inches by 5 inches) in the vertical tail fin of a rear-engine-mounted aircraft.

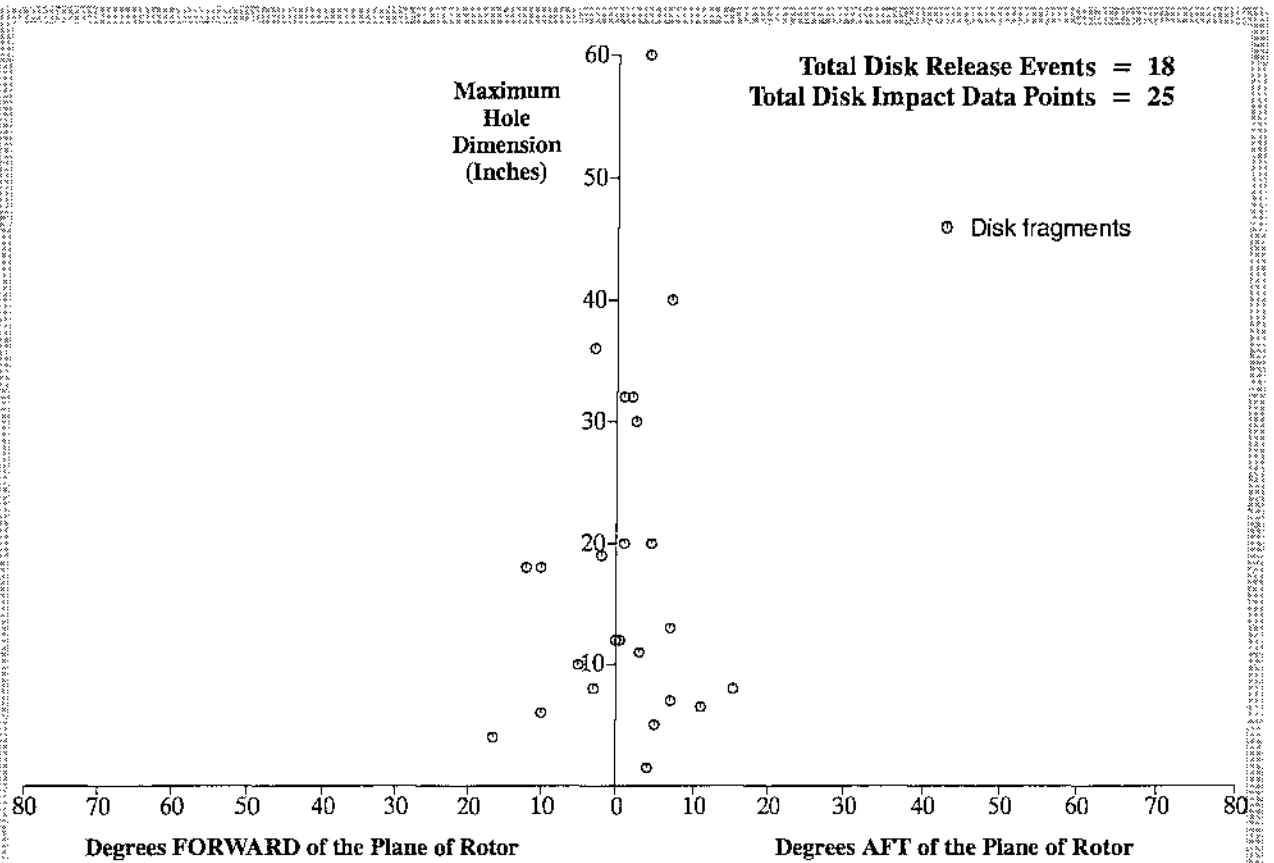
**FIGURE 9. Disk Fragment Trajectory versus Hole Size**

The trajectories of disk fragments ejected in these events varies from 16.5° forward to 15.0° aft (figure 9).

The forward-most disk penetration at 16.5° forward (event 18, hole 14) measured approximately 4 inches by 4 inches, in the vertical stabilizer of the aircraft (tail-mounted engine). The disk fragment was released from the compressor section of the engine. It is not described in detail.

The furthest aft penetration by a disk fragment, at 15.0° aft (event 16, hole 3), measured 8 inches by 5 inches. The disk rim segment which caused this hole was approximately 20 inches by 2 inches in size, weighing close to 5 pounds. It was released from the high pressure turbine (HPT) section of the engine. The engine manufacturer has estimated the velocity of this fragment to be in the range of 700 feet per second.

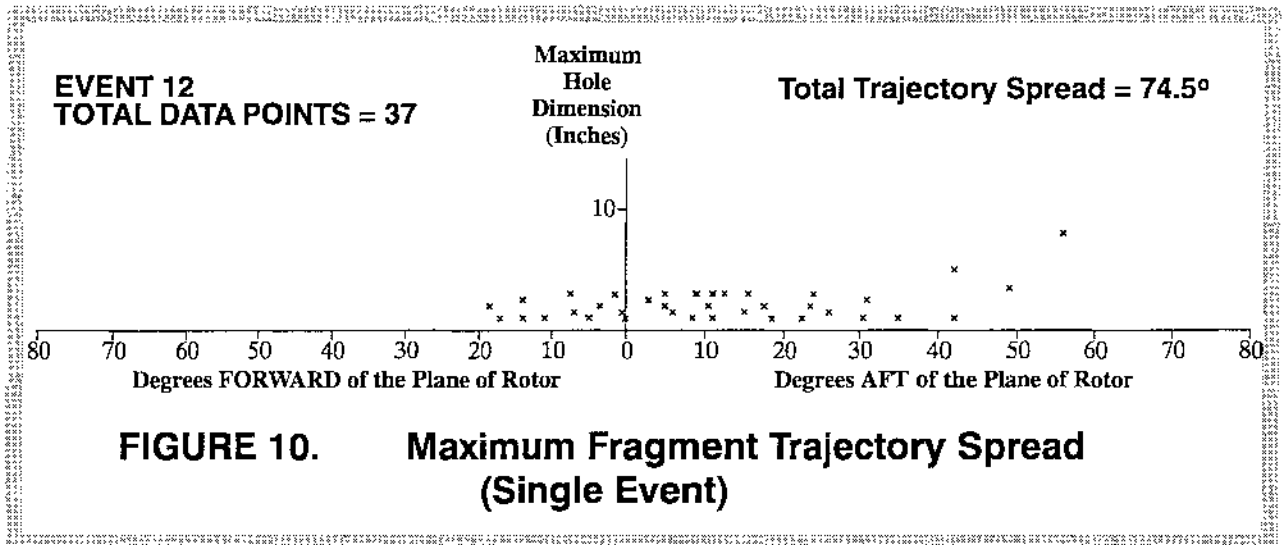
The largest trajectory spread of fragments in one event occurred in event 12, where fragments ejected were spread from 18.5° forward (hole 13) to 56.0° aft (hole 7) (a total debris trajectory spread of 74.5°). Figure 10 contains a graphical summary of this event data. All aircraft penetrations in this event had maximum dimensions of 4 inches or less. There were no disk fragments ejected in this event.

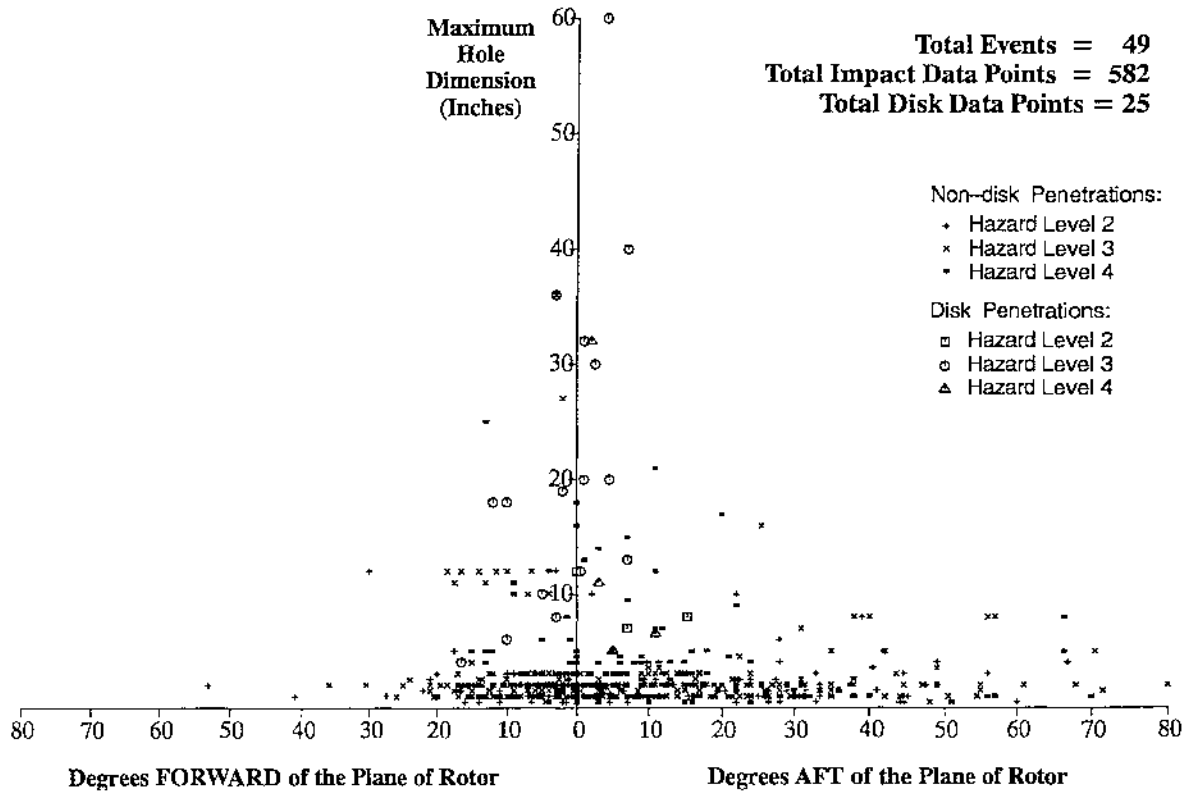
**FIGURE 15. Uncontained Trajectories by CAAM Hazard Level**

Further analysis shows the fragment trajectories and impact locations for events which are classified by CAAM hazard levels. Figure 15 (following page) repeats the data contained in the database as presented earlier in Figure 8, separated to show the trajectories and hole sizes by

CAAM hazard level. The data shown in Figure 15 is contained in the Propulsion Research Uncontained Engine Disintegration Database, and can also be plotted separately to show clearly the trajectories and hole sizes for events of each specific hazard level.

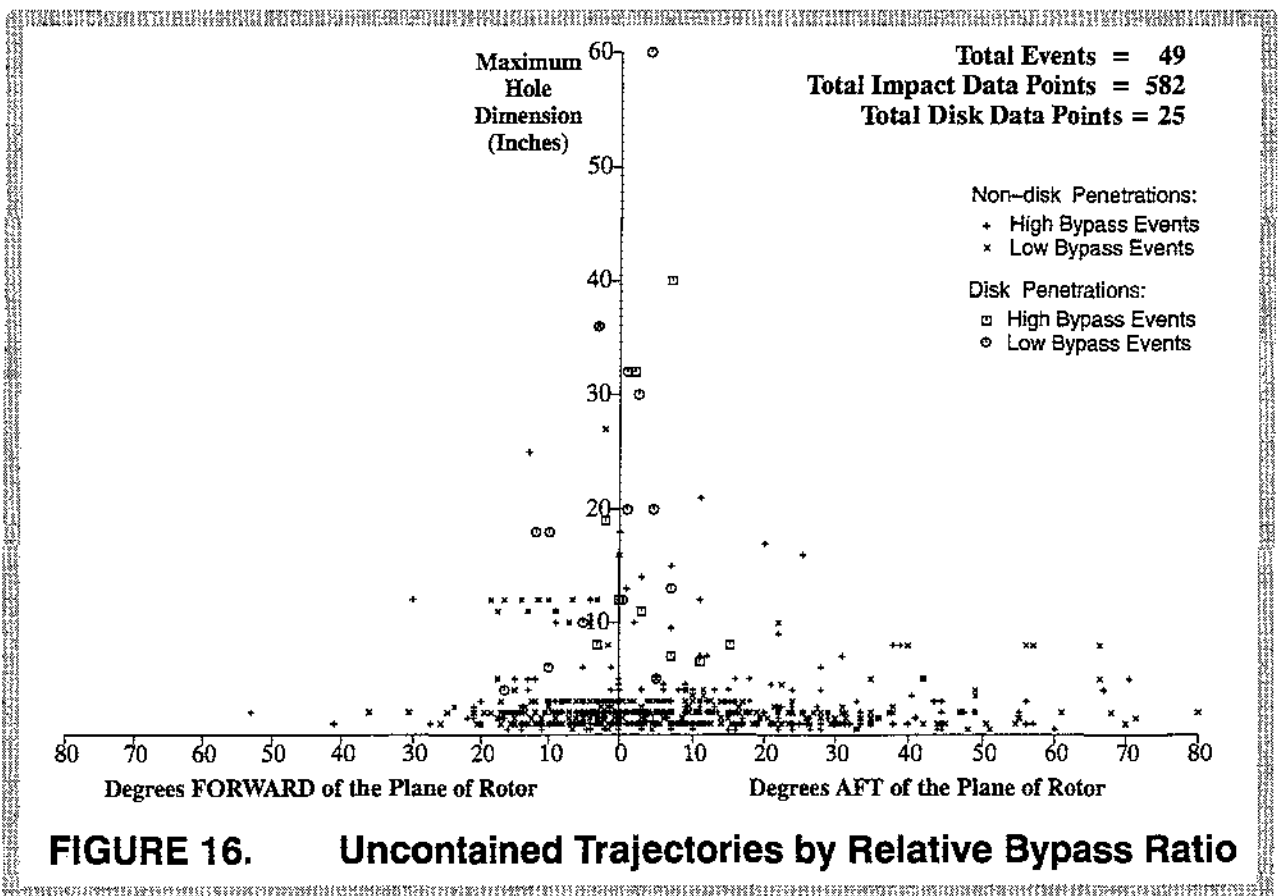
Figure 16 was extracted from the Uncontained Engine Disintegration Database, once again containing the same data as Figure 8. However, in this instance the data is separated to show a comparison of the fragment trajectories along with respective hole sizes in the aircraft structure due to high bypass ratio engine events and due to low bypass ratio engine events.

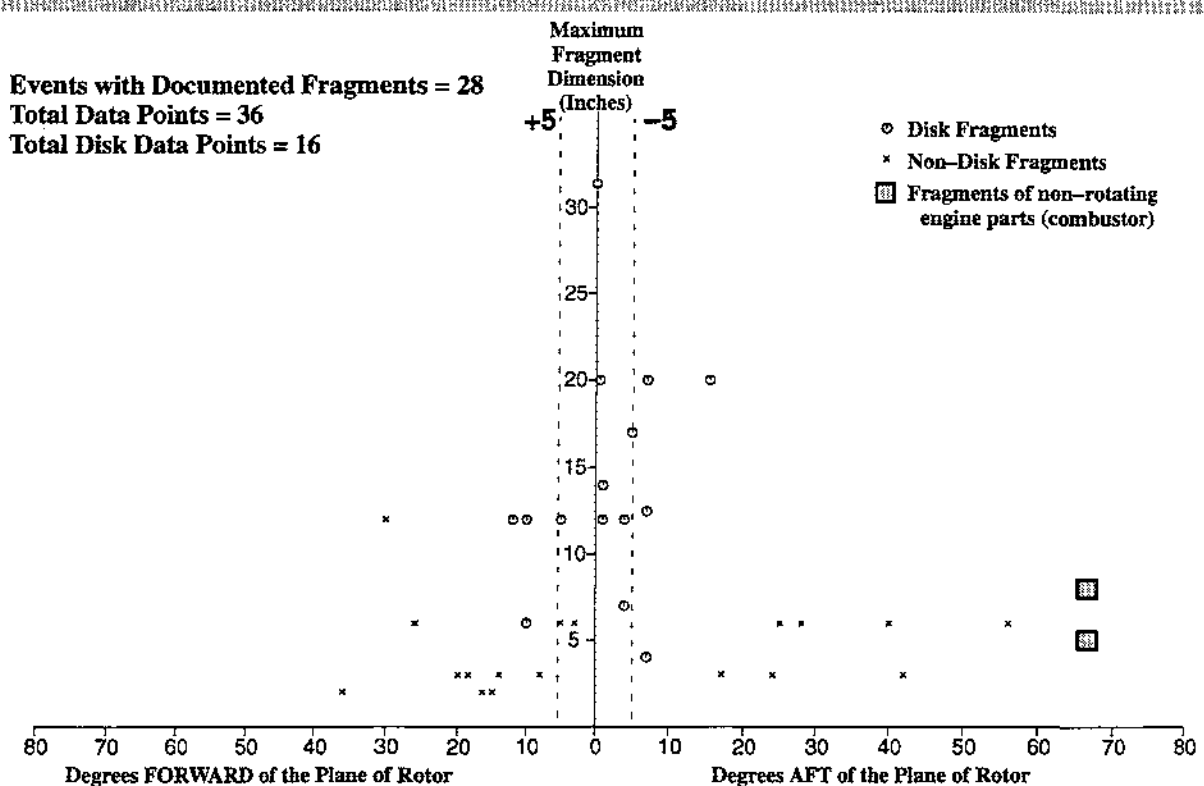
**FIGURE 17.      Fragment Trajectories of Known Fragments**

There were a total of 36 fragments documented in these 28 events. 20 fragments were of non-disk origins, while the remaining 16 were of disk origins. Figure 17 (following page) shows the trajectories of these fragments by the actual fragment size.

The trajectories of these pieces ranged from 36° forward of the plane of rotor disintegration (event 7, fragment 6) to 56° aft of the plane of rotor disintegration (event 12, fragment 1). The two fragments shown at 66.5° aft of the plane of rotation were the result of a combustor can explosion which caused an aircraft hull loss. Because these fragments were not from a rotating part of the engine, it was decided to show these as separate data points. These data points are represented by the shaded squares in figure 17.

The largest documented fragment ejected in all events was a disk section measuring approximately 60% of the entire disk in event 39. This large fragment did not impact the aircraft, but was recovered from the area where the incident occurred. Because there is no aircraft impact location, the trajectory of this fragment is unknown. The diameter of the disk (and therefore the maximum dimension of the fragment) was 31.4 inches. Figure 17 shows this data point at 0° trajectory, 31.4 inches.

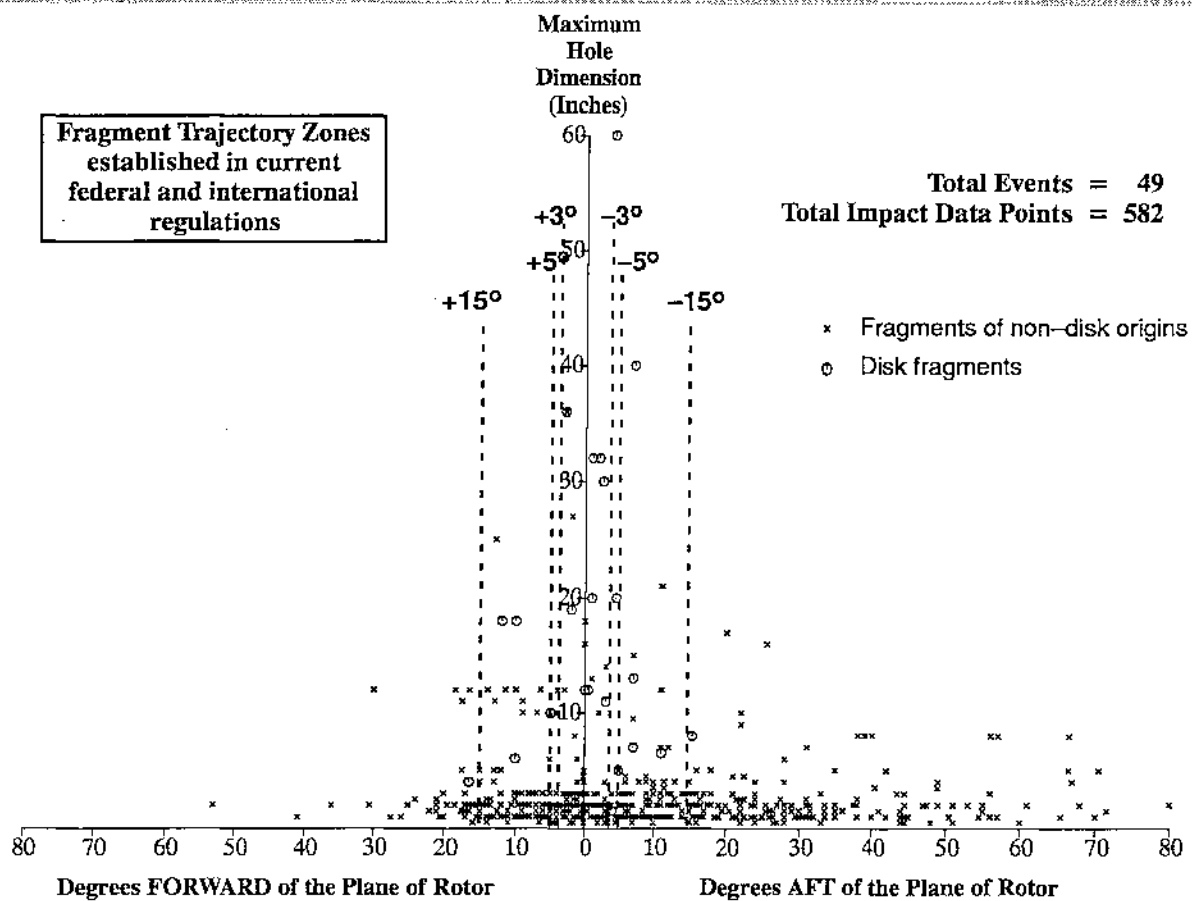
**FIGURE 18. Current Trajectory Limits overlaid on Historical Trajectory Data**

Figure 18 (following page) contains a plot showing the data points which have been collected and documented in this study (duplicated from Figure 8), overlaid by dashed lines showing the current regulatory limits. A significant number of trajectory data points, both disk and non-disk, are observed in Figure 18 to lie outside the limits imposed by current regulations. This observation is

valid both for penetration trajectory data points *forward* of the plane of the rotor and penetration trajectory data points *aft* of the plane of the rotor.
