DOT/FAA/TC-20/2

A Summary of Results from Two Full-Scale Fokker F28 Fuselage Section Drop Tests

May 2020

Final Report

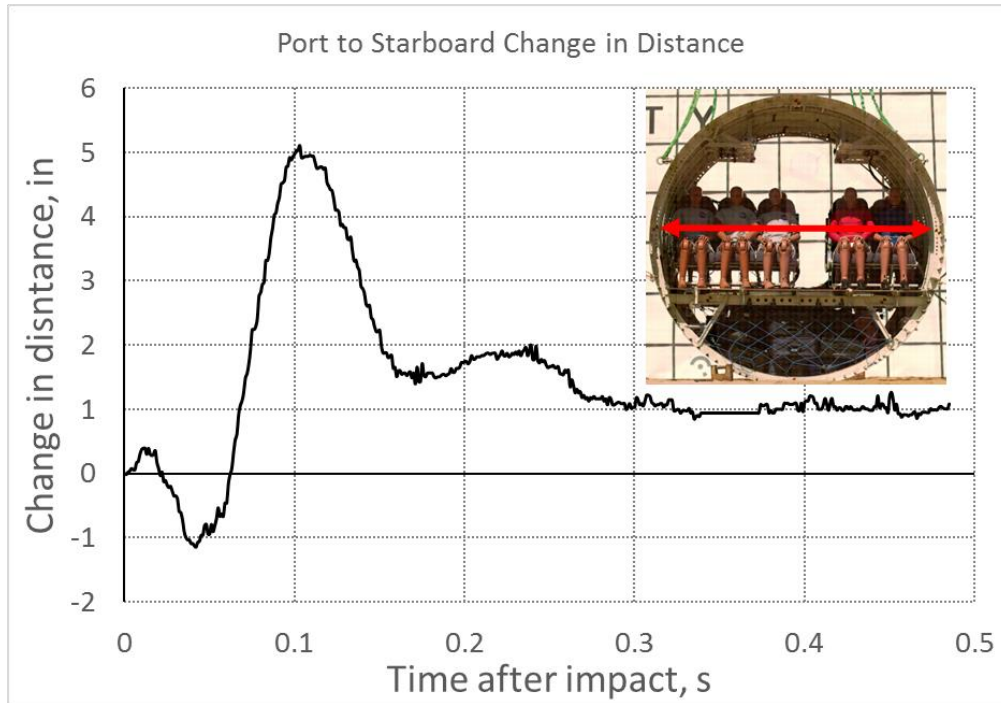
Figure 3.1. Forward section ovalization

The negative values shown before 0.06 s were caused by inward motion of the port and starboard targets, which indicated an initial vertical ovalization of the fuselage at impact. This vertical ovalization was caused by floor bending, which pulled the sidewalls of the fuselage inward. After the initial vertical ovalization, the sides of the fuselage deformed outward to a maximum value of 5.1 in at 0.103 s after impact. The late time history in Figure 3.1 showed that the fuselage sustained a permanent deformation of approximately 1 in. post-test. The test sequence as captured from the forward viewing high-speed camera is shown in Figure 3.2 with highlighted notable events. Note the initial floor bending in the upper right image.

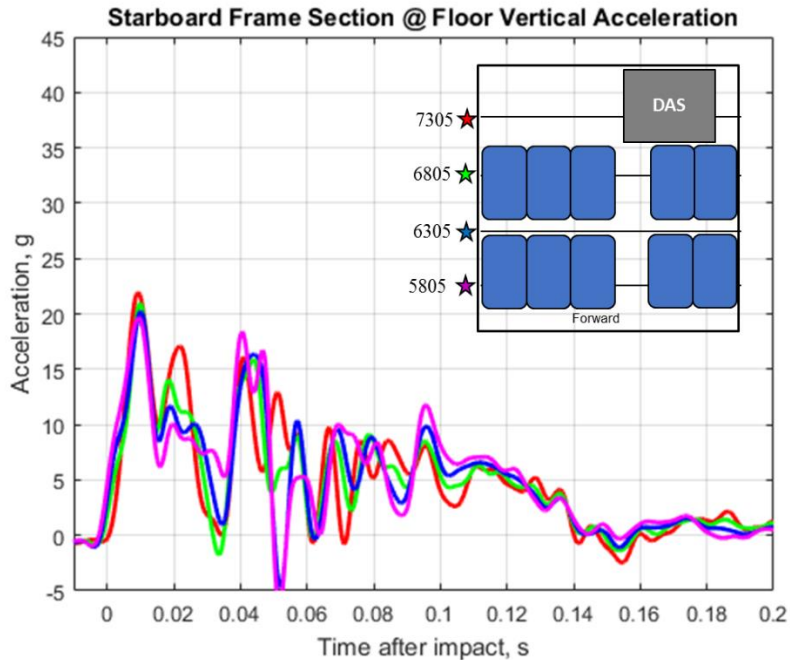
Figure 3.8. Starboard floor/frame accelerations from forward section test

The acceleration data at the starboard floor/frame junction locations were examined to determine airframe response, see Figure 3.8. The data showed the fuselage section exhibited a nearly uniform response, which was the first indication that the test was a (nearly) pure vertical drop. In addition, the fuselage, at least for the starboard side at the floor/frame junctions, reacted uniformly during the impact event. The different colored data series show the response at different FS locations on the section, which are defined by starred locations in the legend in Figure 3.8.

The accelerations reached initial peak values ranging between 19.7 g to 21.9 g, depending on location. This occurred approximately 0.010 s after initial ground contact. A large valley occurred at 0.033 s after impact, which was close to when the change in the fuselage ovalization measurement shown in Figure 3.1. This was also the same approximate time there was maximum luggage compression, shown in Figure 3.2. The acceleration had oscillatory motion through the major portion of the impact event. The overall shape of the acceleration data can be approximated as an acute trapezoid with a rise time of 0.015 s, a plateau until 0.120 s, and a fall time of 0.031 s. Average accelerations were computed using the plateau region starting at 0.015 s and ending at 0.120 s. The average values of 7.2 g, 6.8 g, 6.8 g, and 6.9 g were obtained for FS 5805, FS 6305, FS 6805, and FS 7305, respectively.

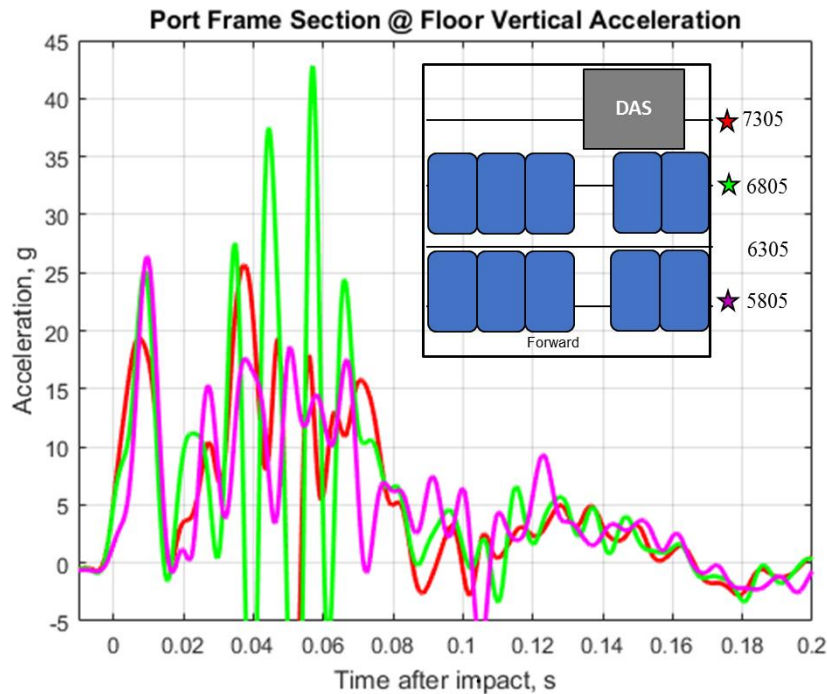
Figure 3.9. Port floor/frame accelerations from forward section test

Acceleration results for the port side of the airframe are shown in Figure 3.9. Although there was a large amount of noise in the accelerometer located at FS 6805, the general shape in the data matched the starboard side results. The cause of the noise is currently unknown and was only seen at this location. Thus, the large oscillations produced between 0.035 s and 0.070 s were based on a type of localized motion and did not represent the test article. Additionally, the sensor at FS 6305 failed and did not record data, which might have been due to the localized phenomena recorded in the sensor at FS 6805. If local oscillations are neglected, the acceleration time histories for all three locations resemble a trapezoid in shape with a duration of approximately 0.086 s for FS 7305 and

FS 6805, and a duration of 0.103 s for FS 5805. The end points of the plateau were measured between the times in which the acceleration response crossed the zero-g mark after impact. The initial peak accelerations were 19.4 g, 25.3 g, and 26.4 g when examining the response from FS 7335, FS 6805 and FS 5805 respectively. The peak increased going from aft to forward in the test article, primarily due to the slight pitch down impact condition from the photogrammetric results. When averaging the acceleration values between the end points in the plateau, values of 9.8 g, 9.7 g, and 9.6 g were obtained for FS 5805, FS 6805, and FS 7305, respectively. These numbers are slightly higher than the starboard side accelerations and might be caused by the small amount of starboard roll at impact.

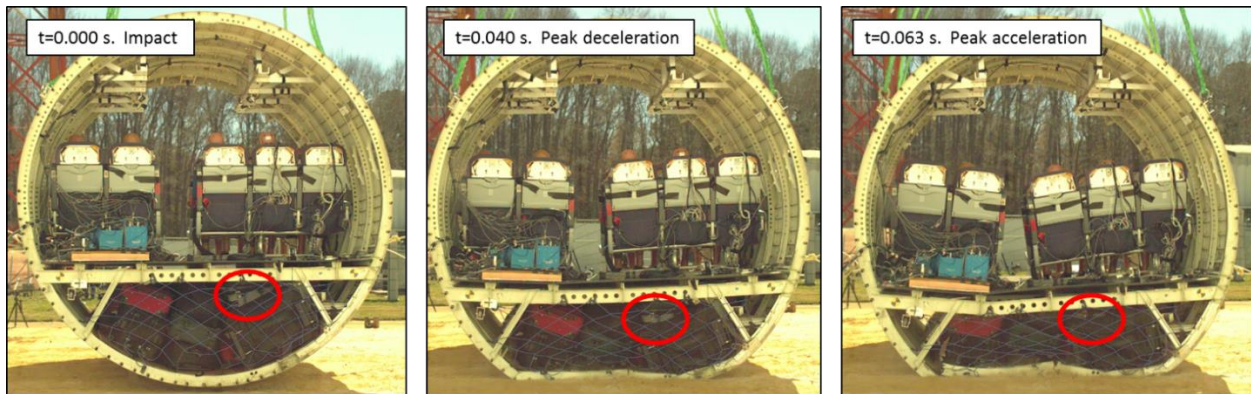
Figure 3.16. Luggage response image series

The CDR measured two distinct peaks in the luggage response: the first at 0.040 s after impact and the second (in the negative direction) at 0.063 s after impact. These two events were the result of the luggage interaction with the soil (event #1) and the luggage rebound into the floor support lateral stiffeners (event #2). Three images were taken from the camera focused on the rear portion of the forward section. This camera viewed the bag containing the CDR, so correlation of the event data and video was possible. Figure 3.16 shows the image series of the luggage response using the two peak times identified from Figure 3.15. The bag containing the CDR is circled.

The first positive acceleration peak of 98 g shown in the data was the maximum deceleration due to the compression of the luggage, including the bag containing the CDR at impact. The high spike at 0.040 s resembles a compaction portion of a response curve from typical materials that exhibit compaction such as foams or honeycombs. This timing also agreed within a few milliseconds to

the image series obtained from of the forward view of the section, as shown the top right image in Figure 3.2. The second acceleration, shown as a negative 96.6 g value in Figure 3.15, was caused by the luggage rebound after maximum compression. This acted as a bearing surface for the floor support lateral stiffeners to react against as they continued downward through the impact event. This was also likely around when the failures occurred in the floor support lateral stiffeners.

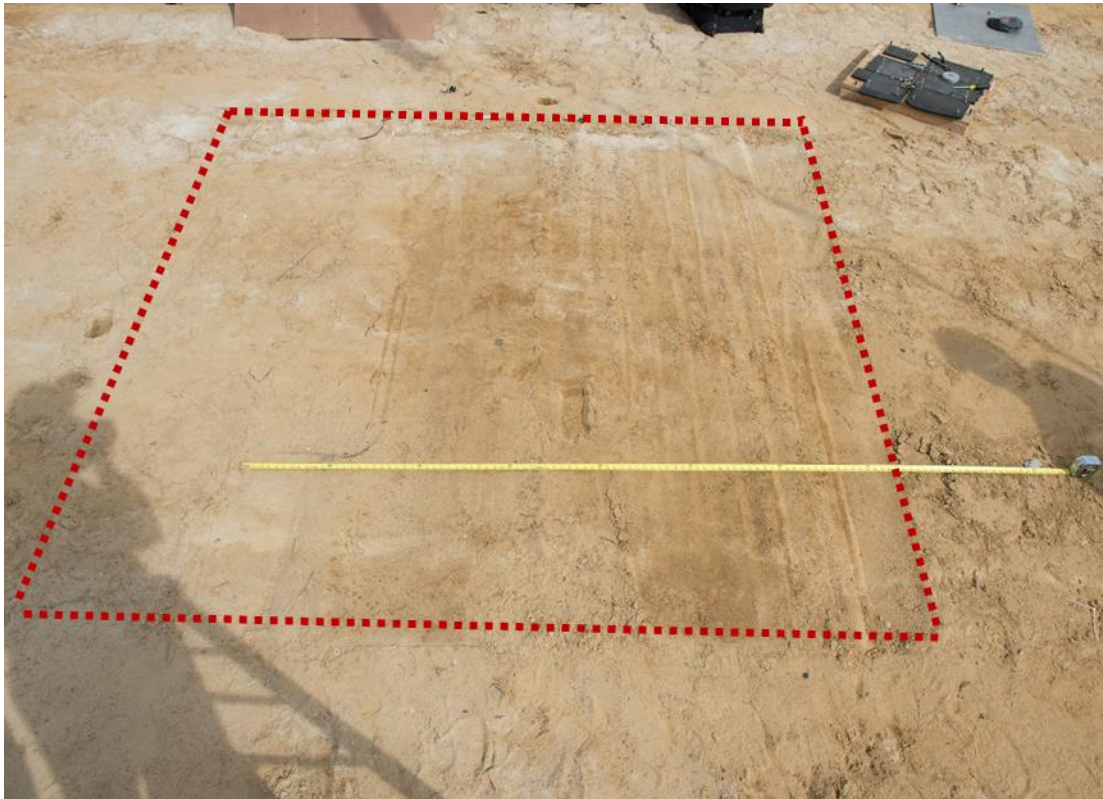
Figure 3.18. Forward section soil indentation results with test article outline

The soil indentation was measured once the test article was removed from the test area. Because most of the deformation was in the fuselage itself, a large indentation was not made in the soil.

Only ripples in the soil were created from the stringers located on the bottom skin. Indentations ranging from 0.25 in. to approximately 1.5 in. were measured at locations around the impact site. As shown in the CBR measurements, at this depth the soil showed a jump in stiffness. Consequently, the deformations were primarily contained to the outermost layer of loose soil. Figure 3.18 shows the impact area with the outline of the fuselage footprint highlighted.

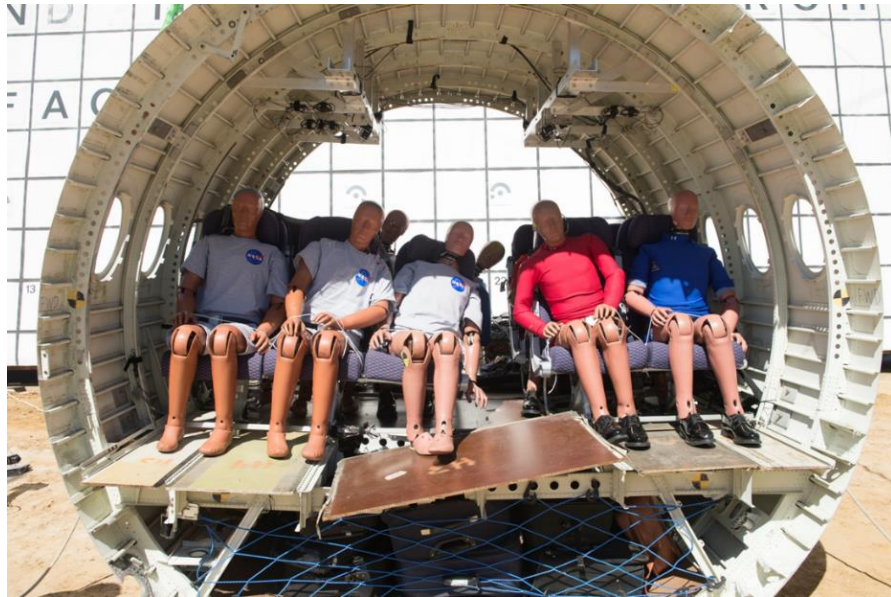
Figure 3.19. Forward section front row ATDs (Seats 6 through 10)

After examining the airframe deformation and responses, responses of the occupants were evaluated to determine the magnitude of loads and likelihood of injury. Figure 3.19 shows the front row of occupants post-test. The ATD seated in seat 8 was leaning into the aisle, restricting any potential egress. The ATDs seated in seats 7 and 9 were also leaning toward the aisle. The outboard ATDs seated in seats 6 and 10 were upright. The inward lean in most ATDs was due to the fuselage floor supports failing, primarily inboard of the lower stanchions. This caused the weight of the ATDs and seats to sag onto the underfloor luggage.

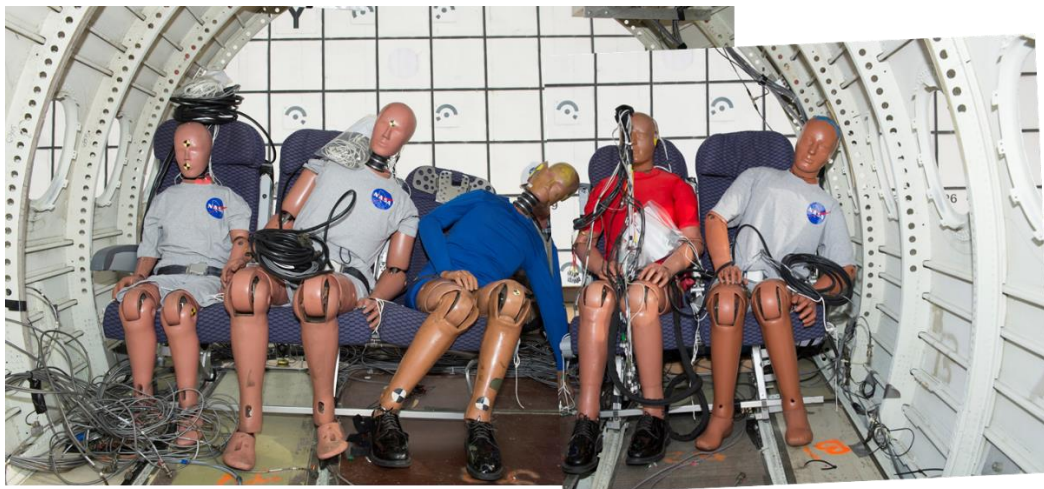
Figure 3.20. Forward section rear row ATDs (Seats 1 through 5)

A view of the rear row ATDs appears in a pieced together composite view in Figure 3.20. A composite view was only available for the rear row ATDs because the section needed to be partially disassembled to examine the rear row in detail. In the rear row, the post-test ATD positions were similar to the front row. ATD 3 was leaning into the aisle, almost contacting ATD 4. The large amount of deformation in seat 3 was also noticeable, which included the headrest separating from the seat frame. The 95th percentile ATD 2 also showed a lean toward the center. However, ATDs 1 and 4 remained upright and ATD 5 showed an outward lean toward the outside of the test article.

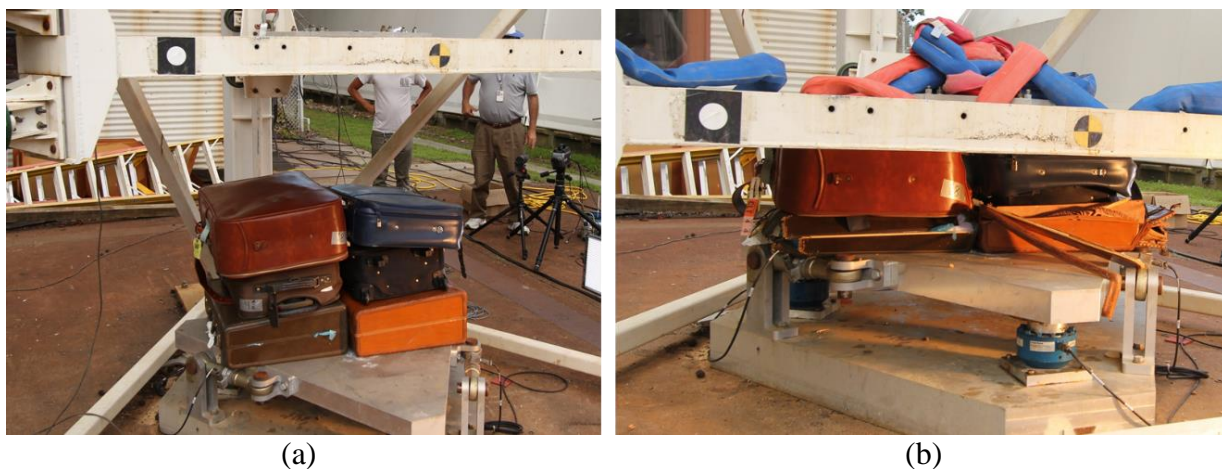
Figure 4.5. Luggage test 2 pre-test (a) and post-test (b)

Test 2 was conducted like test 1. Six different bags were used, but the methodology in developing the crush curve was identical. In test 2, the impact velocity was 24.5 ft/s, which was 85% more of the initial kinetic energy at impact. The total luggage weight for test 2 was 147.4 lb. Figure 4.5 shows a pre- and post-test picture of test 2.

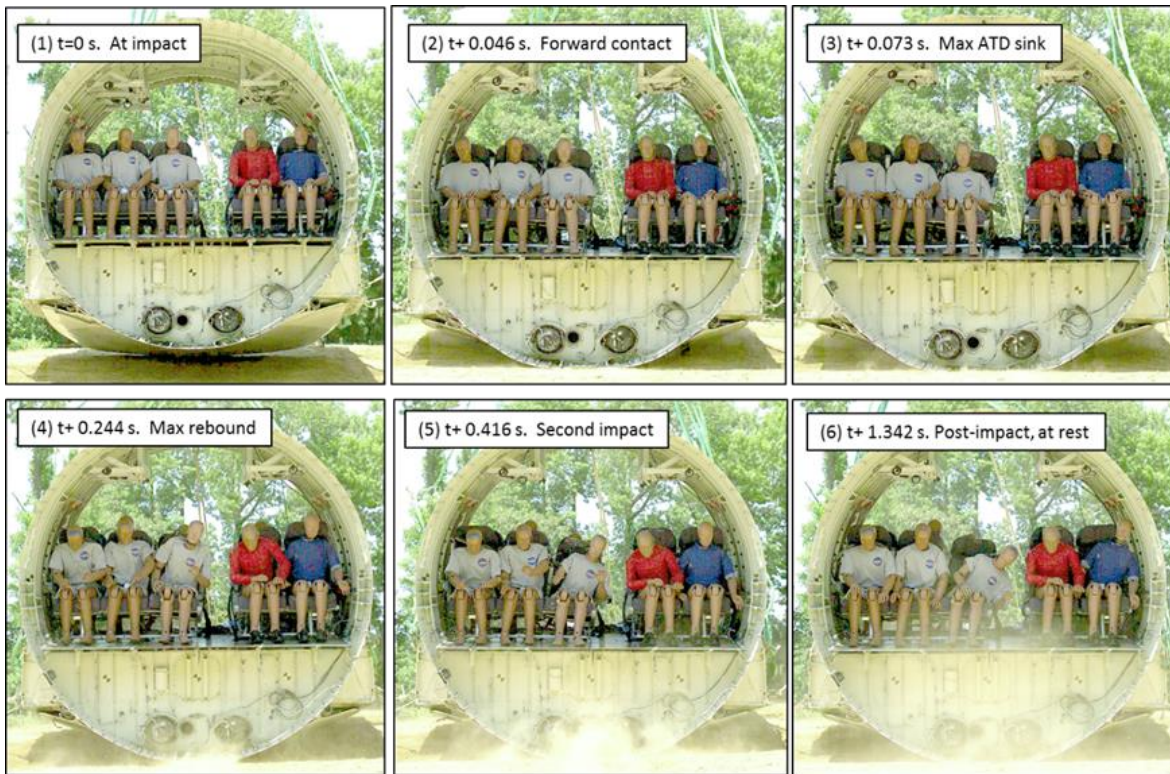
Figure 5.1. Sequence of test events for the wingbox section test, forward view

The initial contact of the aft portion of the test article onto the sloped soil surface was considered the initial impact, depicted in the top left image of Figure 5.1. Between impact and $t+0.046$ s, the test article rotated about the rear impact point, terminating with the forward portion of the test article initiating ground contact at $t+0.046$ s, which is depicted in the top-middle image. No sliding between impact at $t+0.046$ s was evident from the videos, so the horizontal acceleration between these two times was presumed to be from the test article rotation. The next notable time occurred when the onboard ATDs experienced their maximum downward vertical motion, also known as maximum sink position, occurring at $t+0.073$ s. The test article and ATDs appeared to exhibit uniform motion between $t+0.073$ s and $t+0.244$ s, until both test article and ATDs rebounded to their maximum unloaded positions. There was a second impact of the test article at $t+0.416$ s. During the second impact, the test article uniformly contacted the soil surface without rotational motion. The test article came to rest shortly thereafter. A final position of the test article is depicted in the lower right portion of Figure 5.1. This shows the test article at rest at a time well beyond the final motion during the test. An additional side view image sequence illustrates the fuselage motion, especially the fuselage rotation during the impact event. See Figure 5.2.

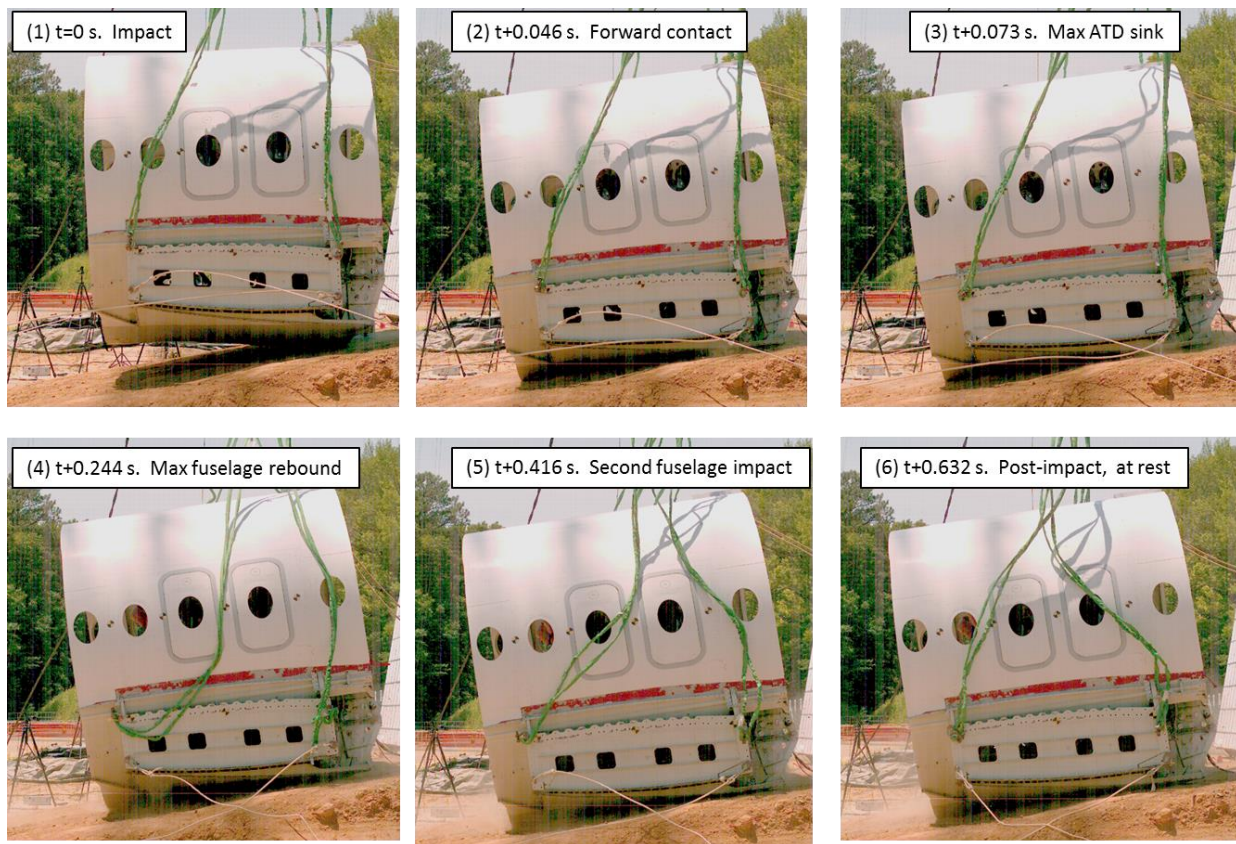
Figure 5.2. Sequence of test events for the wingbox section test, port side view

The image sequence in Figure 5.2 depicts the motion of the wingbox section from the port side and corresponds to discrete times highlighted in Figure 5.1. The initial contact with the rear portion of the fuselage is shown in the upper left image. A gap underneath the forward portion of the section is also shown. In the top middle image, the gap closed due to the rotation about the rear portion of the fuselage. The top right image shows the section at ATD maximum sink. This image

is included for reference because the ATDs were not visible in the port side camera. At $t+0.244$ s, maximum upward rebound occurred in the test article. The bottom middle image shows the second contact, which occurred at $t+0.416$ s. The bottom right image shows the final frame of captured video from the camera after all the major impact events.

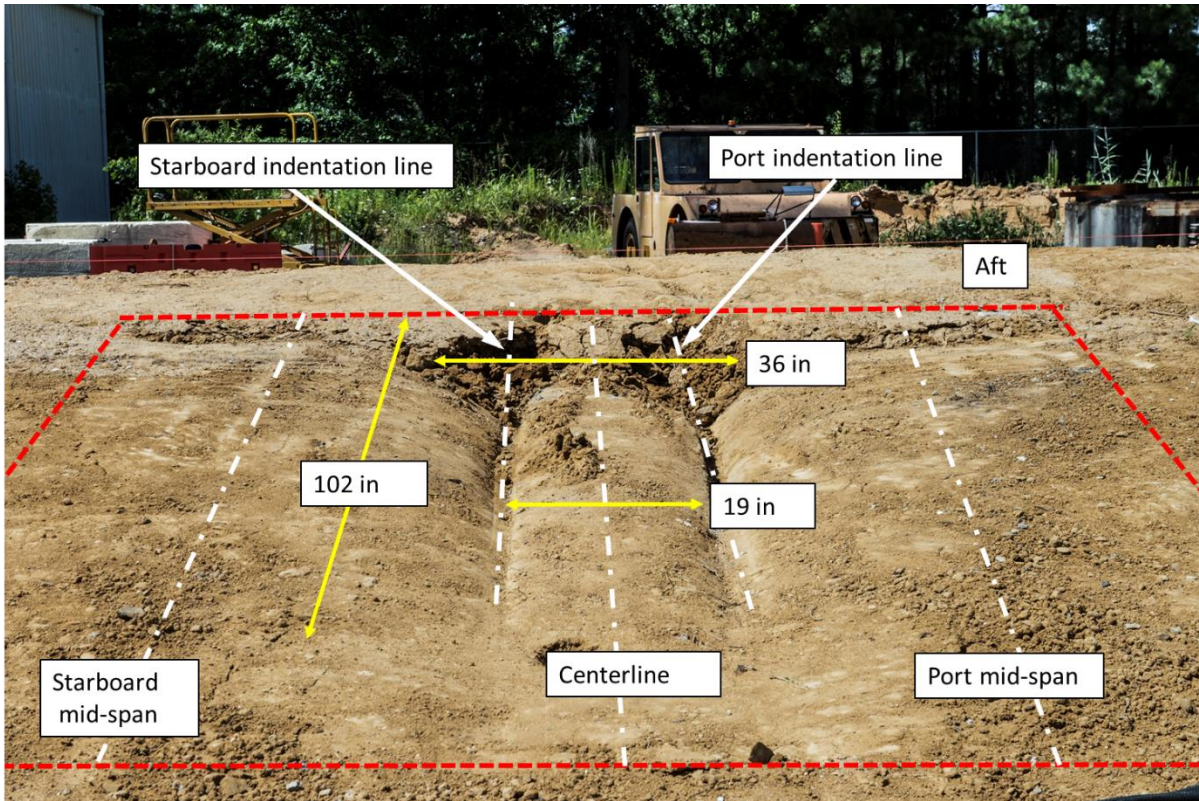
Figure 5.10. Wingbox section soil indentation results with test article outline

The impact caused a distinct impression in the soil. Specifically, the impression exhibited two distinct parallel vertical lines with the deepest penetration near the aft of the test article and gradually becoming shallower when moving toward the front. The parallel lines were created by vertical stiffeners located at the bottom of the test article, approximately 9 in. outboard from the test article's geometric centerline. Because the aft portion of the test article impacted first, the rear features, including the vertical stiffeners, made the deepest impression in the soil surface. Generally, the rest of the soil mound was undeformed due to the impact. Figure 5.10 shows the indentation of the soil surface from the test. The two vertical indentations are noted, and the top of the image is toward the aft end of the section.

Penetration measurements were taken at three locations in the crater, depicted in Figure 5.10. Measurements for the starboard indentation line, which is the vertical line on the left in Figure 5.10, the middle between the indentation lines, and the port indentation line, which is shown to the right in Figure 5.10, were taken. The results are shown in Table 5.1.

The soil crater measurement data marked differences between the vertical stiffener and bottom span locations. In the aft impact location, vertical stiffener penetration was 7 in. deep on the starboard side and 7.25 in. deep on the port side. The location of the mid-spans corresponding to

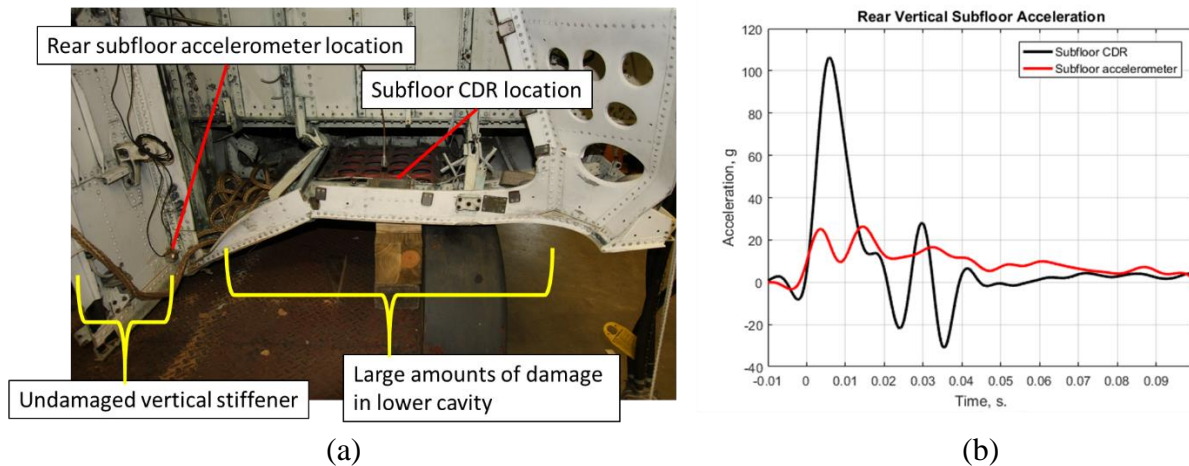
Figure 5.11. Wingbox section aft lower sensor locations (a) and acceleration results (b)

the lower cavity locations of the test article lightly penetrated the soil. The differences were notable because accelerations obtained at the different measured locations provided a local loading profile. The acceleration data was compared between the aft subfloor accelerometer for the vertical stiffener accelerations and the CDR for the lower cavity accelerations. Figure 5.9, left, shows the locations of both accelerometers in the post-test damaged view to contrast the difference in their locations. The data are shown in Figure 5.11, right. The data were not time synchronized, so manual shifting was implemented on the CDR data to give a more direct comparison. The data in Figure 5.11 are filtered using a Channel Frequency Class 60 low-pass filter for visualization.

The filtered CDR data showed a triangular shaped pulse with a peak acceleration of approximately 106 g and duration of approximately 0.021 s. This is using the first data point for which the acceleration trace crossed the zero-g mark after maximum. In contrast, the subfloor accelerometer located on the vertical stiffener produced accelerations that more closely matched the results from the airframe floor accelerometers. The vertical stiffener remained undamaged during the impact but produced the deepest soil crater where penetration occurred (shown in Figure 5.10) in a controlled manner throughout the initial rotation, front impact, and ATD max sink. The soil penetration, along with the rotation, limited the peak magnitude of 26.0 g with a duration of 0.100 s.
