DOT/FAA/TC-21/25

Assessment of Emerging Metallic Structures Technologies through Test and Analysis of Fuselage Structure: Panel 1

Feb 05, 2021

Final report

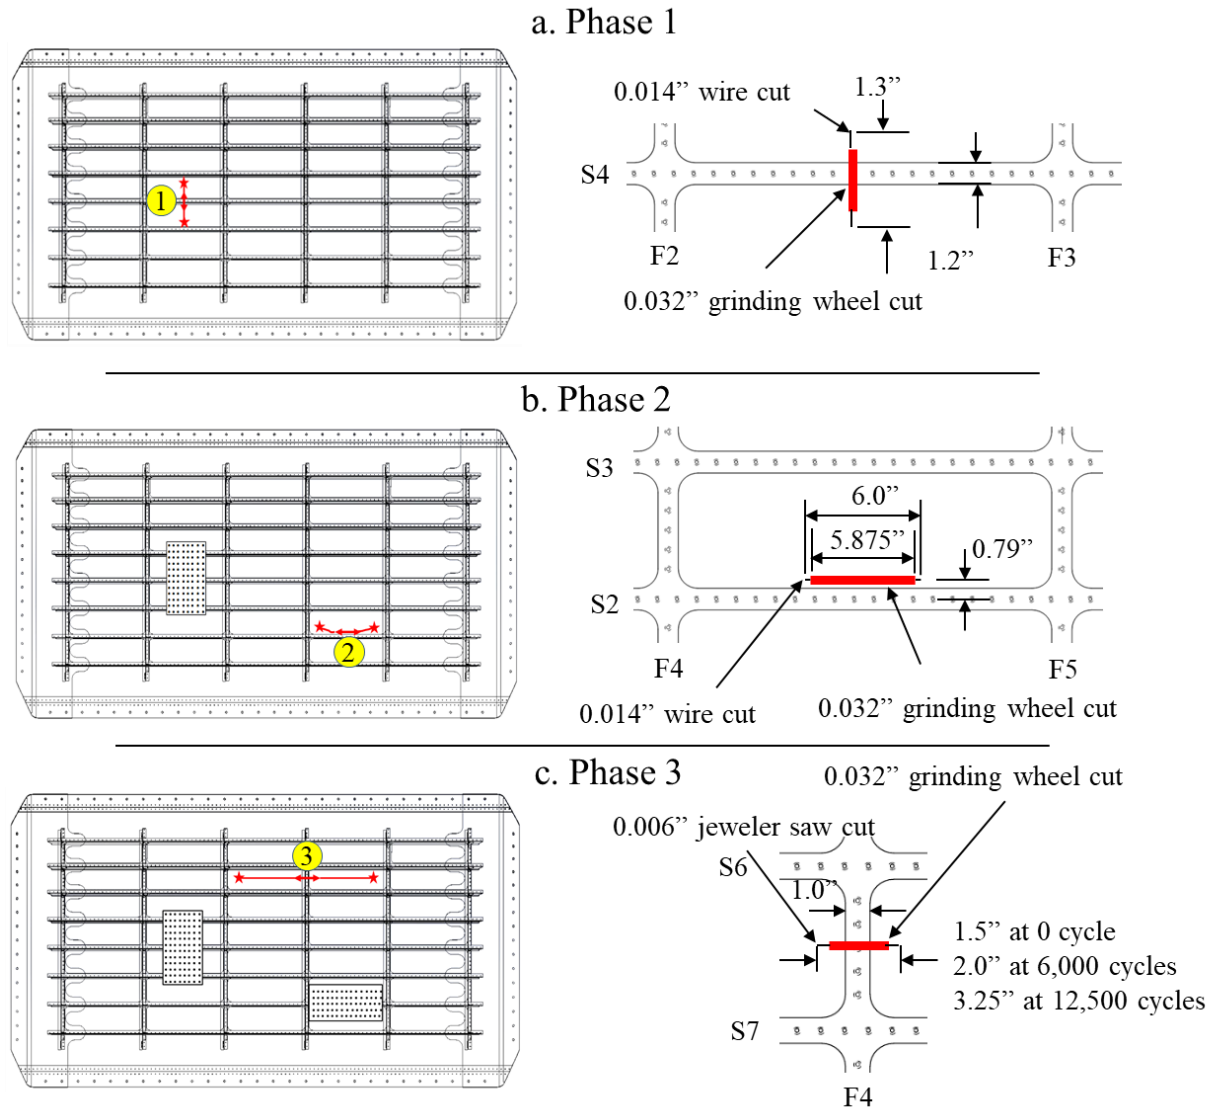
Figure 4. Initial damage scenarios used in the three test phases

Phase 1: Initial damage consisted of a crack-like notch having a length of 1.3 in. in the circumferential direction spanning two skin bays between frames F2 and F3, with the central stringer S4 severed (see Figure 4a). Strain surveys were conducted to ensure proper load introduction. The panel was then fatigue tested under loads representing pressure, flight maneuver and gust accelerations, and landing loads in the forward crown section of a single-aisle aircraft. Fatigue testing was conducted until the crack extended to a final total length of 11.3 in. Afterwards, a limit load test was conducted, during which the panel was subjected to approximately 2.5 g axial load while holding the pressure constant under operational conditions. The panel was then repaired for follow-on phases (Appendix B).

Phase 2: To study crack turning phenomena, the initial damage consisted of a crack-like notch along a mill-line having a total length of 6.0 in. in the skin parallel to stringer S2 midway between frames F4 and F5, as shown in Figure 4b. Strain surveys were conducted to ensure proper load introduction and to verify no effects from the repair made in Phase 1. The panel was then fatigue tested, simulating pressure-only flight-load conditions to monitor the direction and rate of crack growth. Afterwards, the panel was repaired for follow-on phases (Appendix B).

Phase 3: Initial damage consisted of a two-bay longitudinal crack-like notch between stringers S6 and S7, with the central frame/shear tie F4 severed, as shown in Figure 4c. Three notch lengths at the same location were used, having lengths of 1.5, 2.0 and 3.25 in. and inserted at 0, 6000, and 12,500 fatigue cycles, respectively, due to crack binding issues as discussed in section 4.3. Initial strain surveys were conducted to ensure proper load introduction and to verify no effects from the repairs made in Phases 1 and 2. The panel was then fatigue tested, simulating pressure-only operational conditions, until the crack extended to a final length of approximately 16 in. A residual strength test was finally conducted to failure, measuring the load-carrying capacity of the panel.

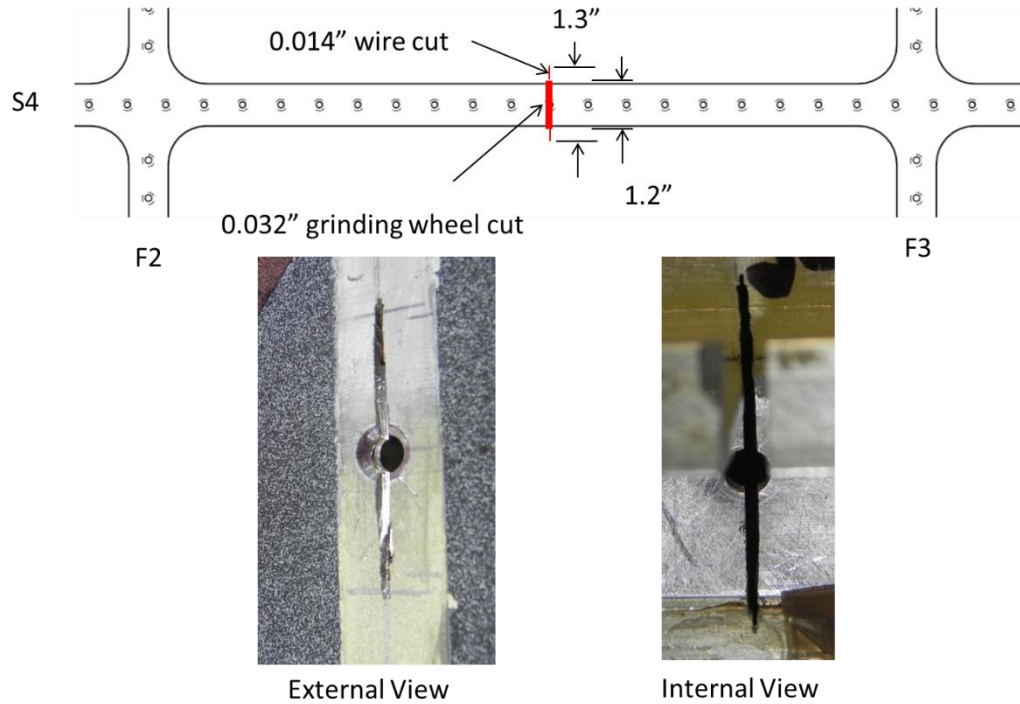
Figure 10. Configure of Phase 1 damage scenario

A central crack-like notch was machined in the skin above the severed stringer S4, which is 1.30 in. total length and 0.032 in. wide. The notch was centered about the removed fastener, having the geometry shown in Figure 10. Initial strain surveys were conducted to verify proper load introduction to the baseline panel and validate the FEA model. Representative results shown in Figure 11 reveal that axial strains measured at gages near the original notch-tip were in agreement with FEA results.

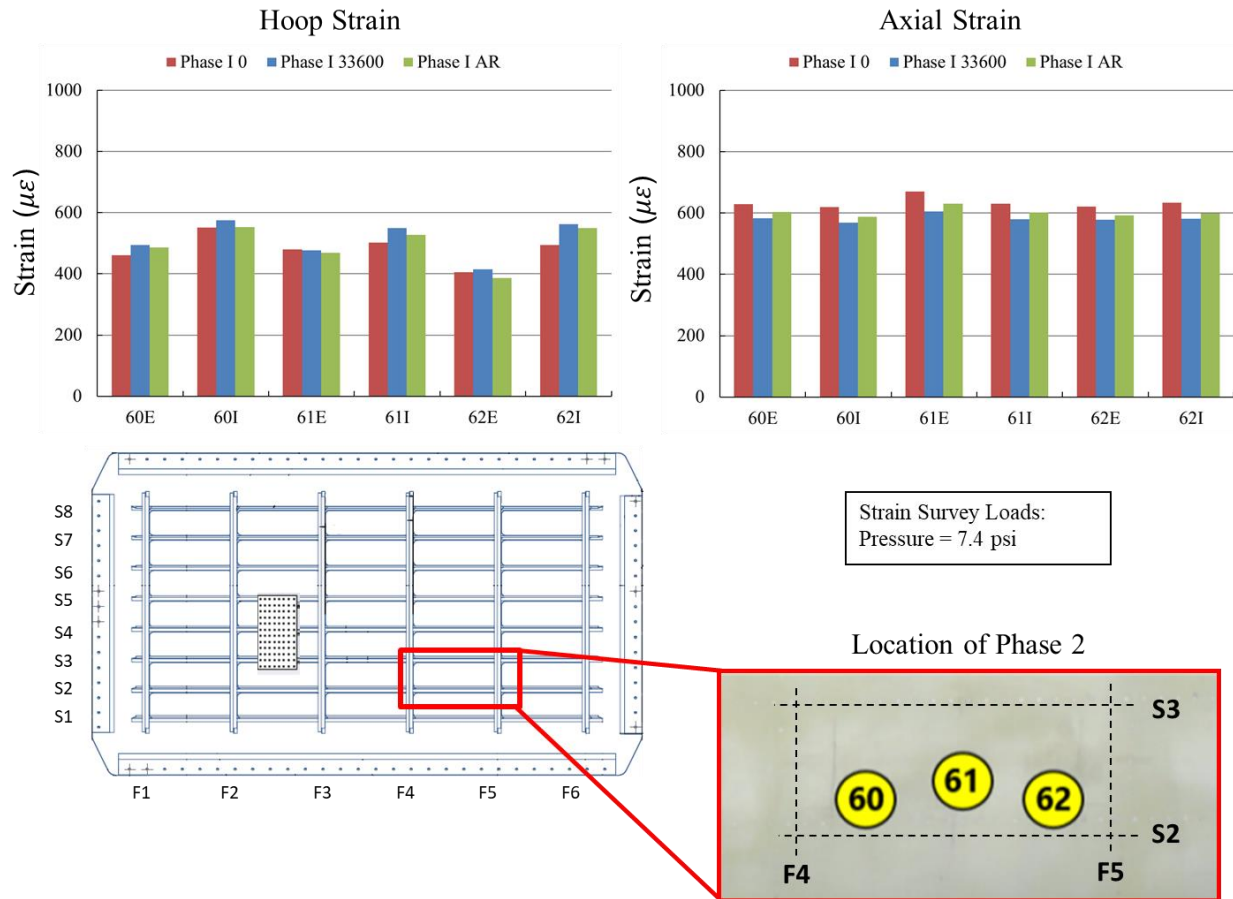
Figure 22. Strain survey after Phase 1 crack repair

The panel was then repaired for follow-on phases, as shown in Appendix B. The strain survey was conducted to ensure there is no effect of repair on Phase 2 test bay, as shown in Figure 22.

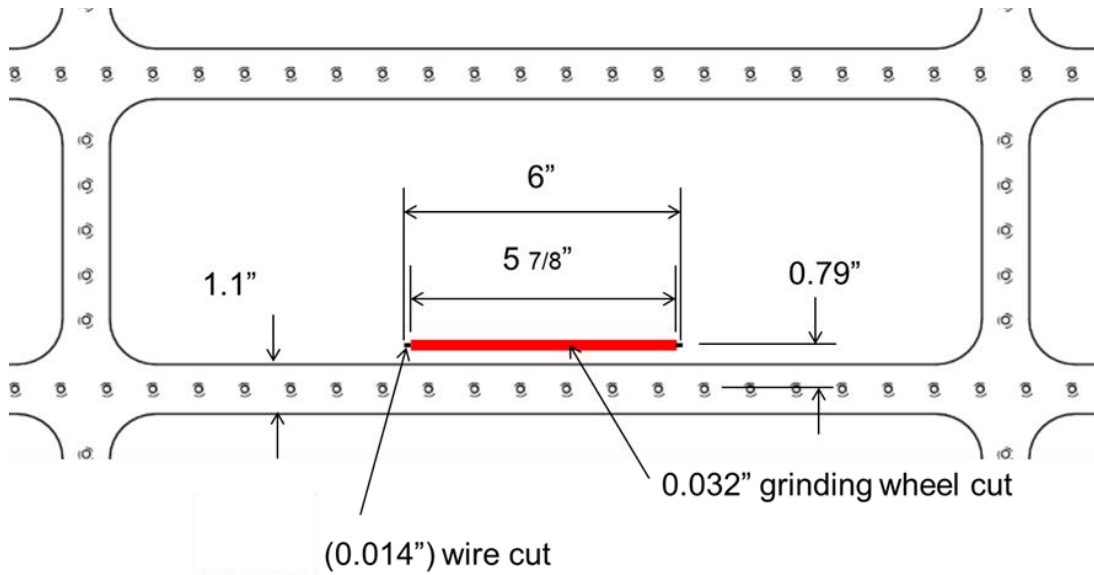
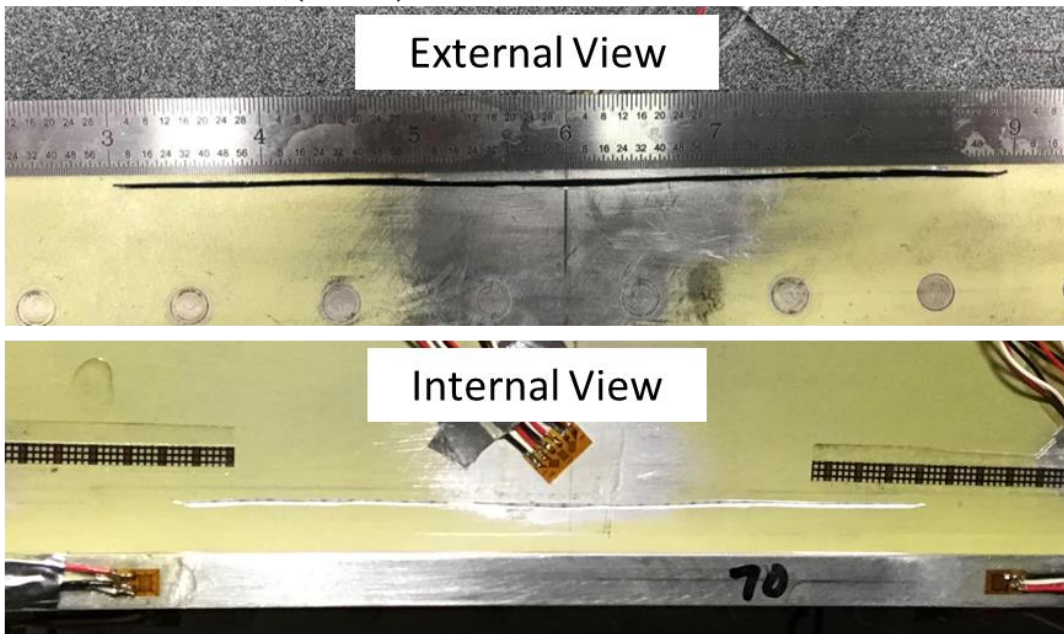
Figure 23. Configuration of Phase 2 damage scenario

The crack scenario for Phase 2 is shown in Figure 23. A crack-like notch, located in mid-bay between frame F4 and F5, was machined in the skin parallel to stringer S2. The notch along the longitudinal direction was 6.0 in. long and 0.032 in. wide.

In this phase, the panel was fatigue tested under pressure load conditions for 7,500 cycles, in which the crack extended approximately 1.97 in. from each notch-tip. Representative results are shown in Figure 24. In general, natural cracks developed at 18° and 15° angles from the left and right notch-tips, respectively, which agreed with FEA predictions, as shown in Figure 24a. The initial crack growth increased steadily and correlated with analysis up to approximately 1,000 cycles, where crack extension reduced precipitously, as shown in Figure 24b. Subsequently, the fatigue behavior displayed additional slow/no growth intervals at 4,500 and 6,000 cycles, at which the crack wake surfaces were notched with 0.014 in. diamond wire, leaving the natural

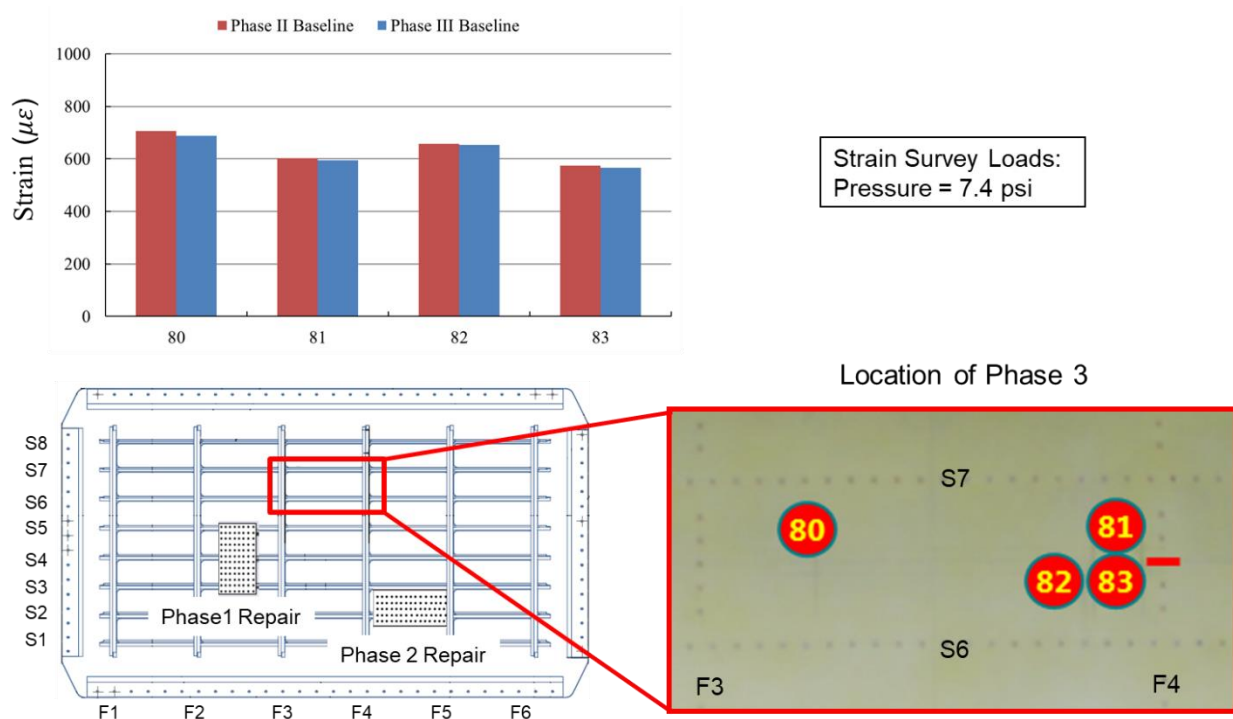
Figure 26. Strain survey conducted after Phase 2 crack repair

Upon completing the fatigue test, the panel was repaired for the final phase of testing, as shown in Appendix B. A strain survey conducted revealed that there was no effect of the repair on Phase 3 test bay, as shown in Figure 26.

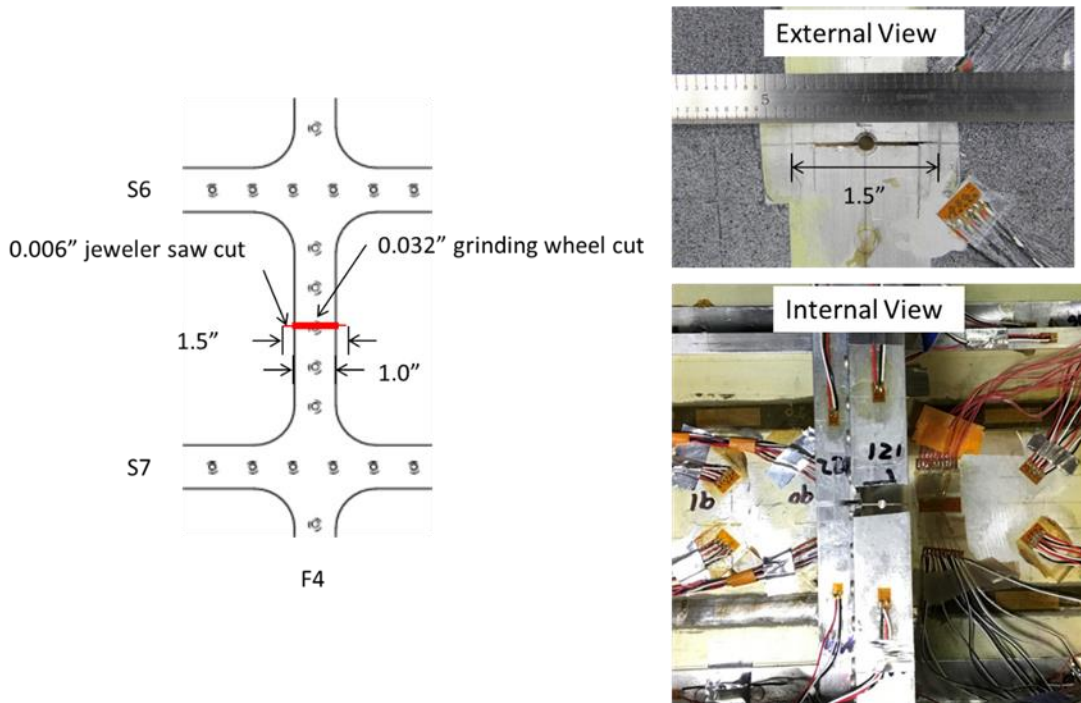
Figure 27. Configuration of Phase 3 damage scenario

The longitudinal damage scenario for Phase 3 is shown in Figure 27. The frame F4 rivet at the mid-frame location between stringers S6 and S7 was removed, and frame F4 was severed at this location. Damage was simulated by machining a 1.5-in.-long notch in the skin above the severed F4 frame.

For this final phase, the panel was fatigue tested under pressure load conditions for 43,600 cycles, during which the skin crack extended across two frame bays to a final total length of approximately 16 in. Representative results are shown in Figure 28. The crack growth was quite slow in the initial stages of fatigue testing from the initial total notch length of 1.5 in. Consequently, the notch was extended twice to lengths of 2.0 in. and 3.25 in. after 6,000 cycles and 12,500 cycles, respectively. Local effects from the severed frame-end suppressed crack growth and caused binding for the shorter notch lengths (less than 3.25 in.).

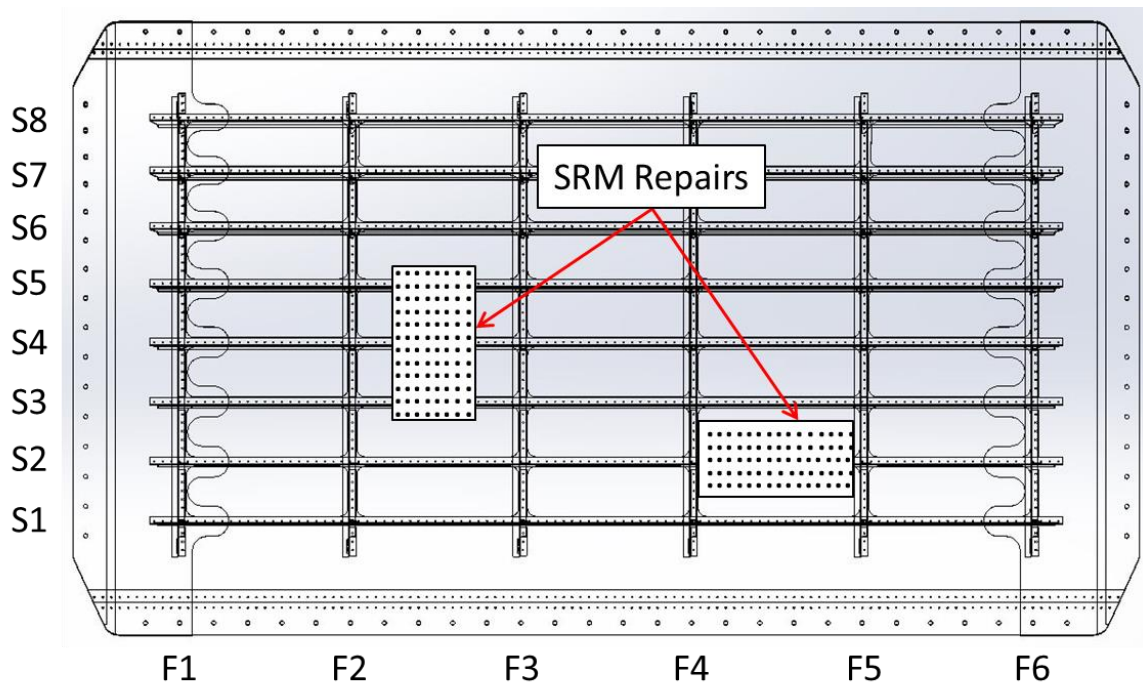
Figure 39. Location of Phase 1 and Phase 2 SRM repairs

Figure 39 shows the location of the two SRM repairs on Panel 1. Before the installation of the SRM repair, the surface of the skin was cleaned with acetone and dry air to remove any contaminants. Next, the eddy current system was used to mark the crack tips for both crack locations.

At the end of Phase 1 and Phase 2, a repair needed to be installed on each crack to continue to the next phase of testing. Both cracks were repaired using Boeing 727 structural repair manual 53-30-3 as guideline. This appendix provides some details of the procedure and material used for the installation of Structural Repair Manual (SRM) repairs.

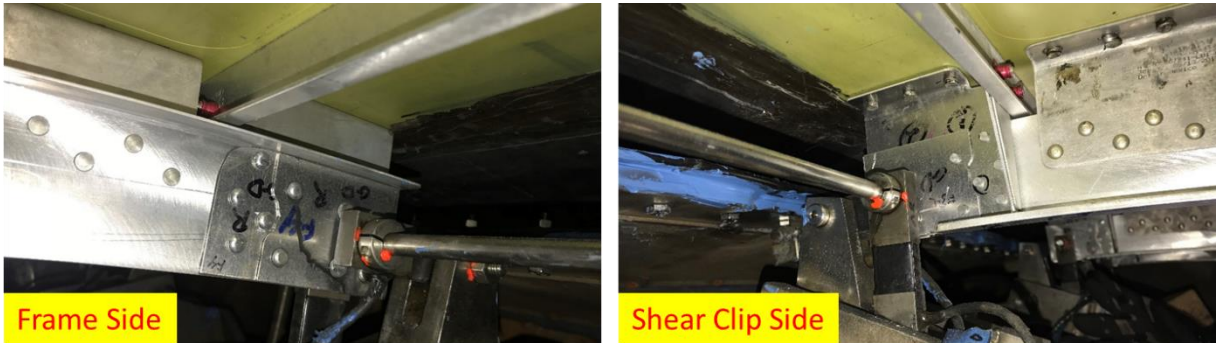
Figure 61. Configuration of frame repair from both ends

During the Phase 1 fatigue testing, the frame end of F5 was unexpectedly broken at 19,800 cycles due to the lack of a reinforcement doubler on frame ends, as shown in Figure 59. The frame end broke again during the Phase 2 fatigue test—at around 4,500 cycles—due to the use of general aluminum rivets and the absence of structural adhesive bonding. A thorough inspection was conducted, which found cracks in the majority of frame ends. The test panel was removed from the FASTER fixture due to the limitation of working space inside of the pressure box and the intensity of the repair work. The frame ends were reinforced on both ends as shown in Figure 60, Figure 61, and Figure 62. The extra frame end pieces from the previous 727 test panel were used to reinforce the frame ends. The new end stringer clips were fabricated based on the drawings in Appendix A. The panel was installed back on the FASTER fixture after the repair, and the strain survey was conducted to ensure the frame repair and reinforcements did not change load introduction, as shown in Figure 63.
