# Evaluation of Premature Cracking in Urban Concrete Pavement

Research Report No. FHWA-ICT-21-001

A report of the findings of  
**ICT PROJECT R27-193-4**  
**Premature Cracking Mechanism for**  
**Jointed Plain Concrete Pavement**

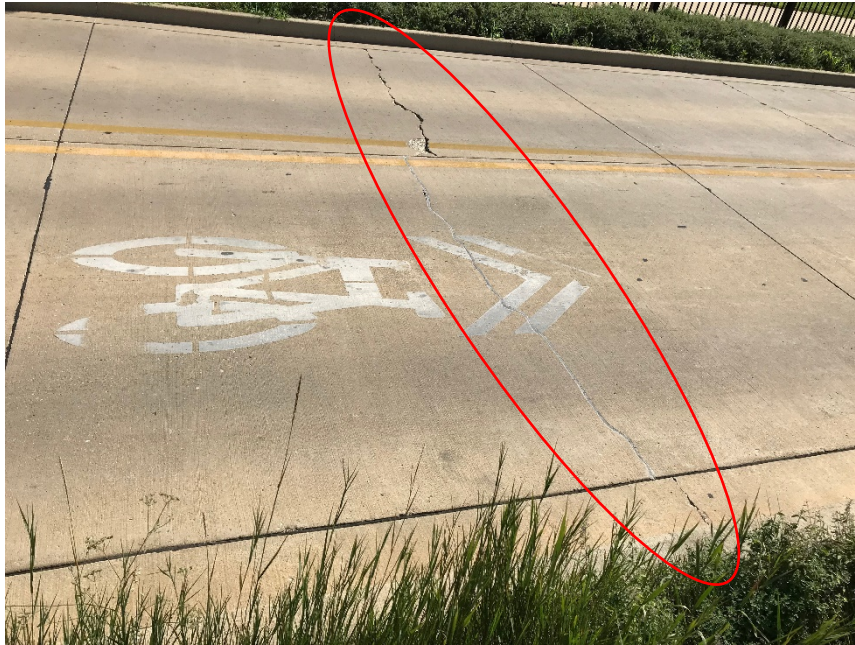
The University of Illinois at Urbana-Champaign conducted a research investigation on the potential mechanisms causing premature cracking distresses in urban jointed plain concrete pavements (JPCP) in the state of Illinois. Premature transverse cracking has been periodically observed in relatively new urban concrete pavements. Figure S1 illustrates an example of a premature transverse crack in Champaign, Illinois.

**Figure S1. Photo. Urban concrete pavement section with a transverse crack.**

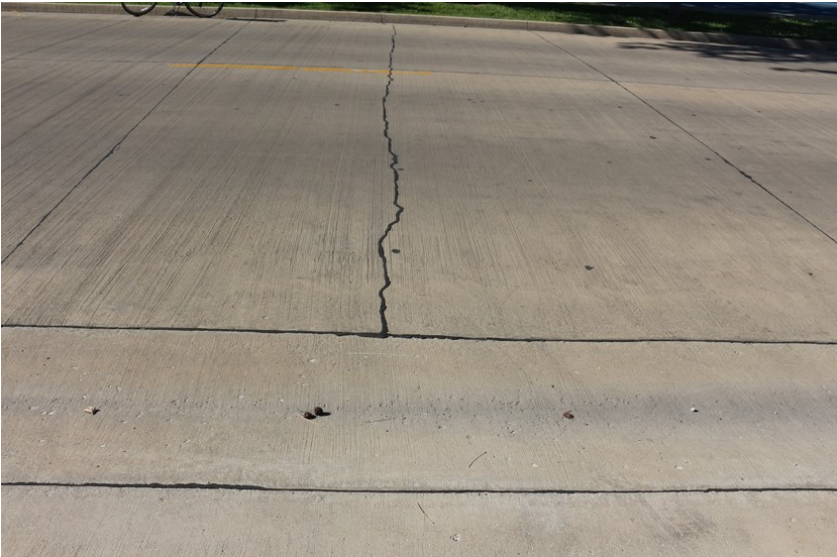
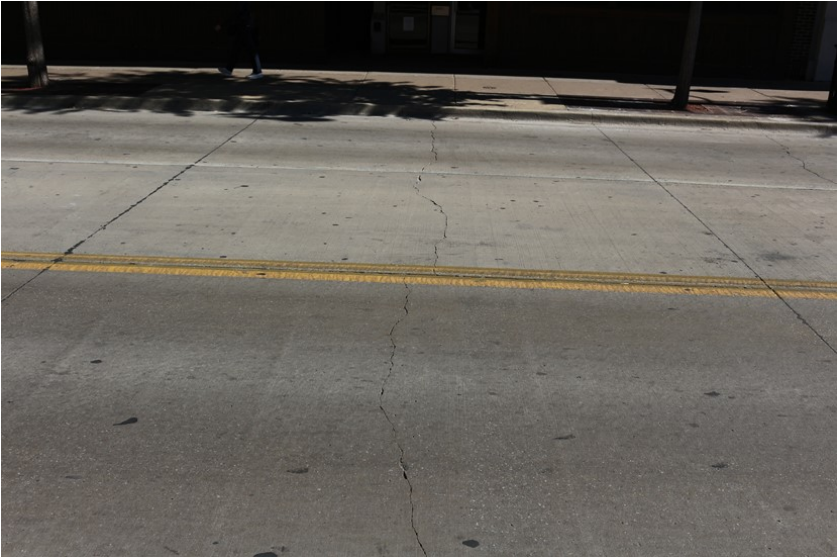
Over the past 15 years, premature cracks have been occasionally observed on jointed plain concrete pavements (JPCP) in Illinois. Premature cracking was first observed in Champaign-Urbana on urban JPCP sections designed with a curb and gutter (C&G). The design life for a JPCP section in Illinois is 20 years, with an even longer expected service life. Some of these observed sections had developed mid-panel transverse cracks within the first few years after construction. Figure 1 shows several urban streets in Champaign, Illinois, that exhibited mid-panel transverse cracking within several years after construction (Figure 1).

**Figure 1. Photo. Premature transverse cracking on (a) East Armory Avenue and (b) Green Street in Champaign, Illinois.**

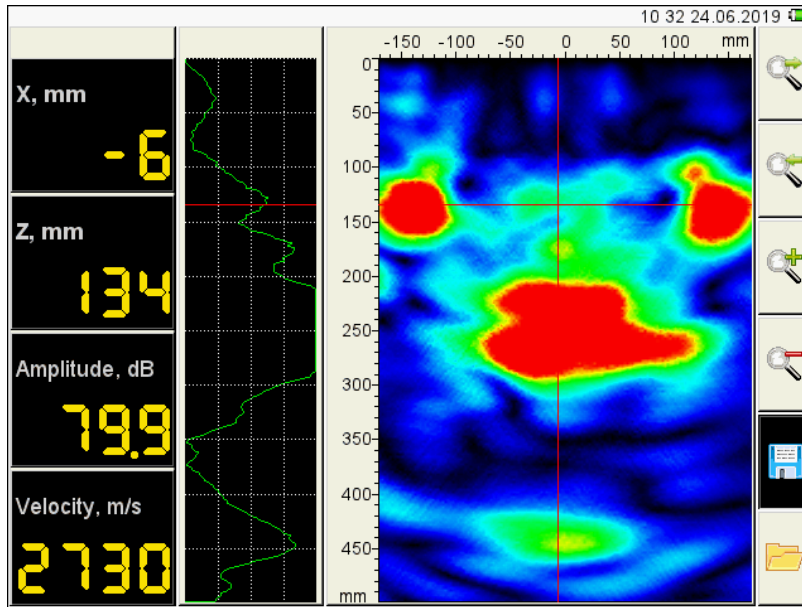
Figure 10. Photo. Ultrasonic MIRA example image for IL 59.

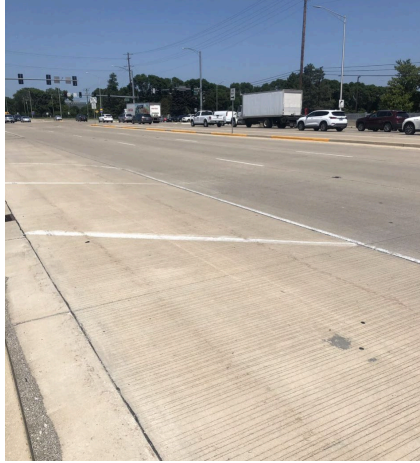
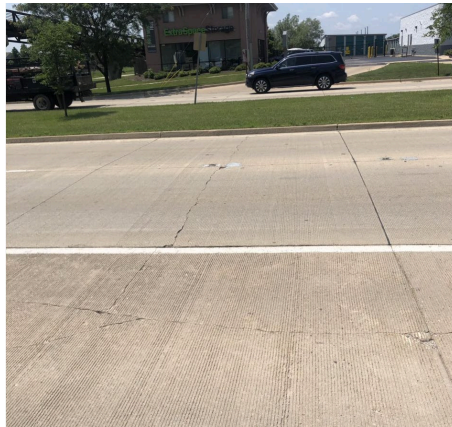
The most recent sections constructed on IL 59 (see Figure 11) were well constructed JPCP and do not exhibit any distress. Figure 12-A presents a picture of another section constructed around 2002. This section was 17 years old at the time of the survey and has some mid-panel transverse cracks. Figure 12-B illustrates the 1998 section, which has a significant amount of cracking distress. It is unknown when the distress initiated and developed.

(A) IL 59 section constructed in 2002 (some cracking).

(B) IL 59 section constructed in 1998 (significant cracking).

**Figure 12. Photo. IL 59 with cracking present.**

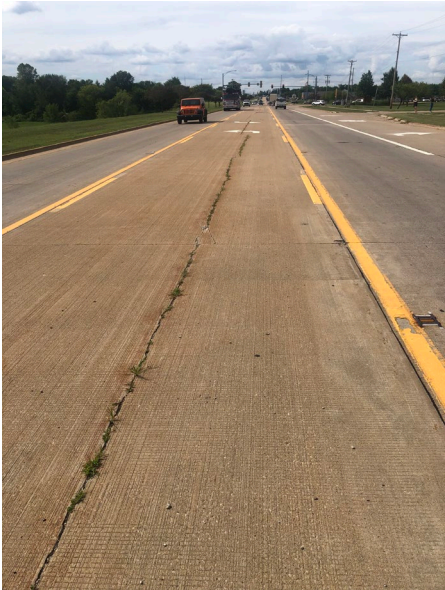
US 20 is a principal arterial highway that connects cities and towns across the United States. In 2002, a section of the highway near Galena underwent a full reconstruction. The constructed pavement consists of a JPCP with curb and gutter. The surveyed pavement section had one lane in each direction along with a two-way left turn lane. This section shows significant distress and deterioration. Figures 13 and 14 show longitudinal cracking and joint deterioration within the section.

**Figure 13. Photo. US 20 longitudinal cracking in a two-way left turn lane.**

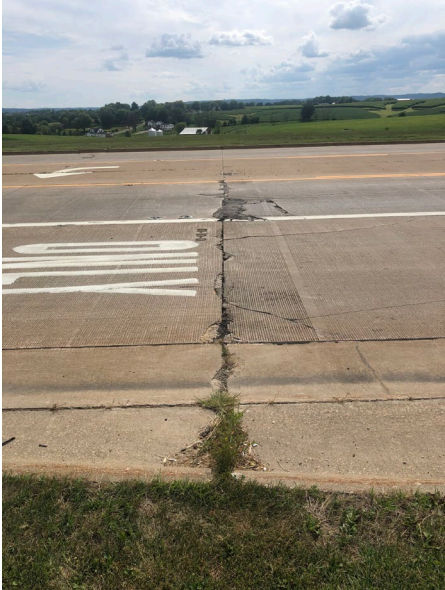
**Figure 14. Photo. Transverse construction joint deterioration on US 20.**

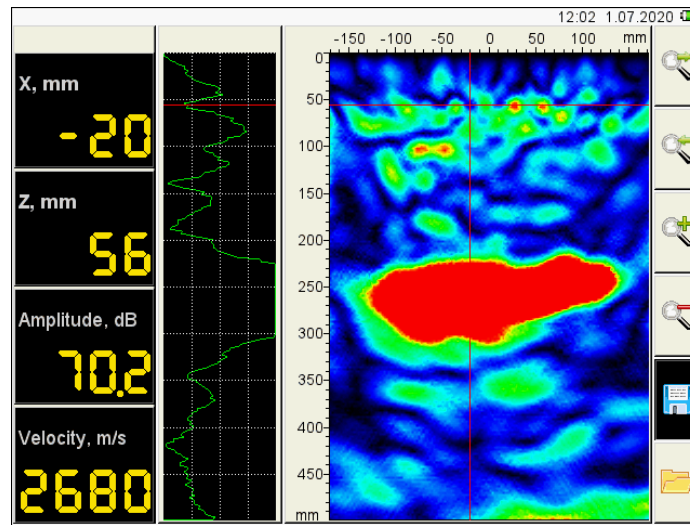
Table 7 presents the ultrasonic evaluation results for slab thickness and joint reinforcement. The evaluation also showed near-surface reflections at about 50 mm (2 in.) below the surface (see Figure 15). These reflections could represent potential voids or poor consolidation within the top portion of the concrete, but coring would need to be taken to verify the image results.

**Figure 15. Photo. Ultrasonic MIRA example image for US 20.**

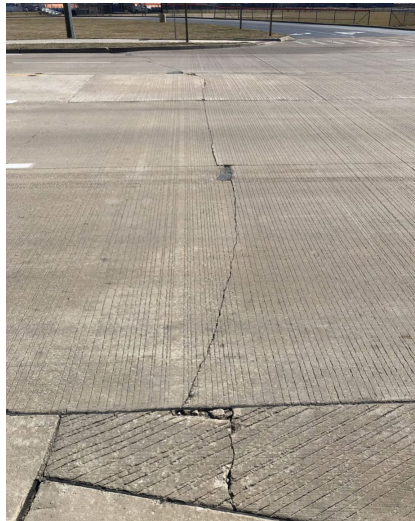
IL 71 showed a mid-panel transverse crack, as seen in Figure 16, spanning the entire width of the pavement cross-section near the entrance to Oswego High School. The results of the ultrasonic evaluation are presented in Figure 17 and Table 9. The ultrasonic evaluation did not show anomalies in the dowel or tie bar construction and design. A plausible deterioration mechanism is an over-restriction caused by the intersection panels.

Figure 16. Photo. IL 71 transverse cracking distress.

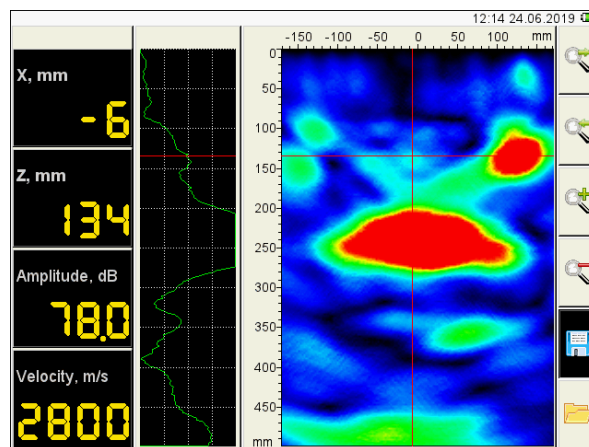
Figure 17. Photo. IL 71 MIRA ultrasound evaluation.

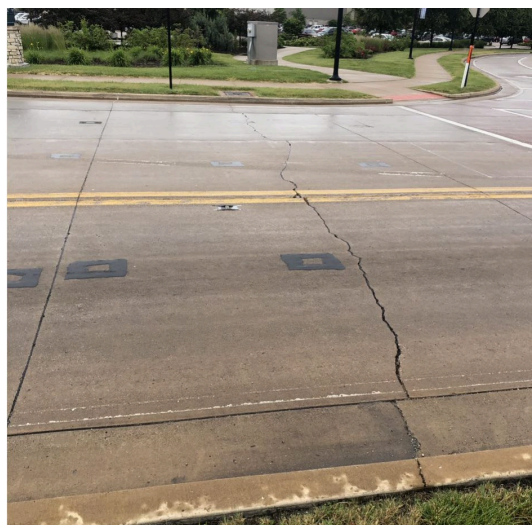
The distress in MacArthur Highway consisted of a transverse crack spanning the entire width of the pavement section (Figure 18). The crack is extremely wide and is located by a utility manhole (seen in Figure 18 on the opposite side of the road). This is likely the cause of the premature distress.

**Figure 18. Photo. MacArthur Highway transverse distress near utility duct.**

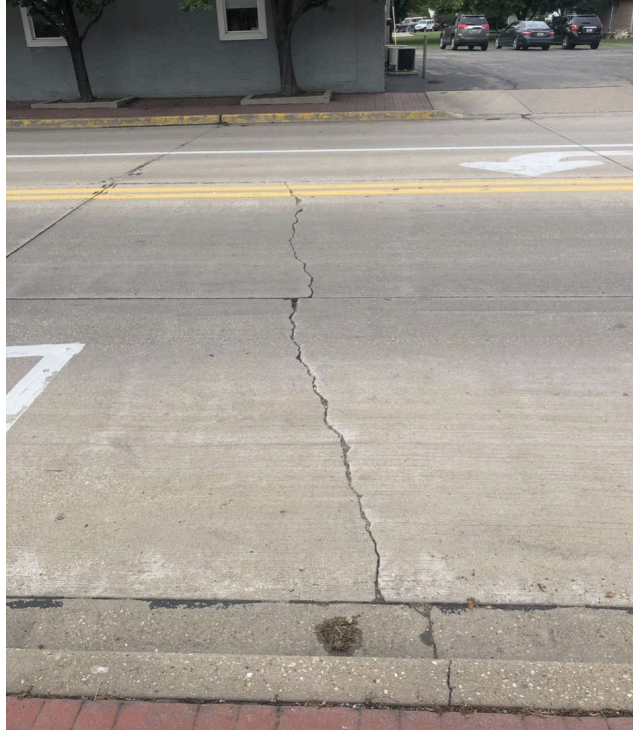
The distresses observed in Jefferson Avenue consisted of mid-panel transverse cracks (Figure 19). Table 11 presents the results of the ultrasonic evaluation. The observed transverse cracks are likely related to the excessive slab length of 20 ft for the given slab thickness of 9 in.

**Figure 19. Photo. Transverse crack on Jefferson Avenue near Jackson Street.**

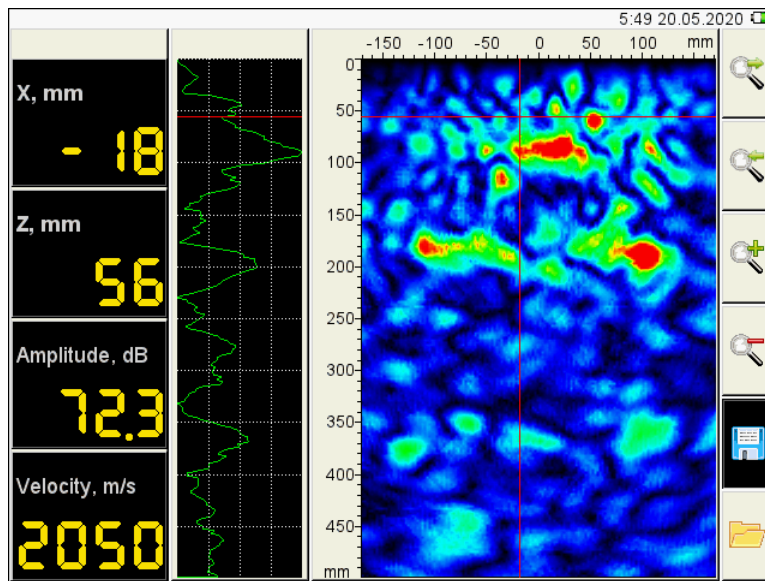
Healey Street is a road that runs parallel to Green Street but is located one block north. Healey Street is a local street and has only car traffic. This recently reconstructed urban JPCP section is showing premature transverse cracks in about 30% of the slab panels (see Figure 21). The images from the ultrasonic evaluation showed significant distortion near the surface of the concrete (Figure 22). This may be related to poor consolidation of the concrete and may have contributed to premature cracking with another mechanism.

**Figure 22. Photo. Healey Street ultrasonic image.**

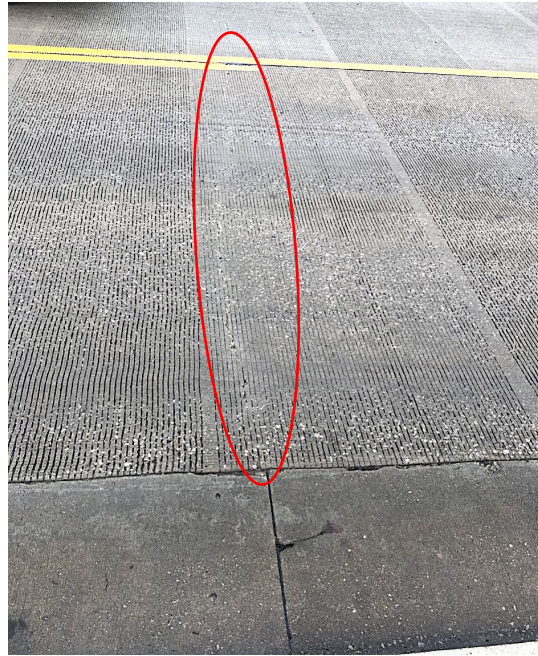
Harrison Street is composed of long JPCP panels (up to ~45 ft) that are showing significant premature cracking distress and deterioration. Almost all the panels (98%) are showing a type of distress in the form of either a transverse crack (Figure 23) or joint deterioration (Figure 24). Excessive panel length with an 8 in. thickness is the main factor contributing to the transverse cracks. In addition, large joint spacing can cause large changes in magnitude of joint width and can lead to joint damage and deterioration.

**Figure 23. Photo. Harrison Street transverse crack.**

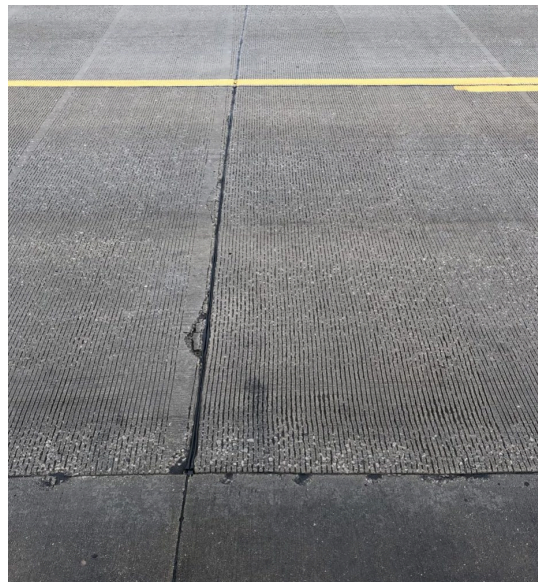
**Figure 24. Photo. Harrison Street transverse joint deterioration.**

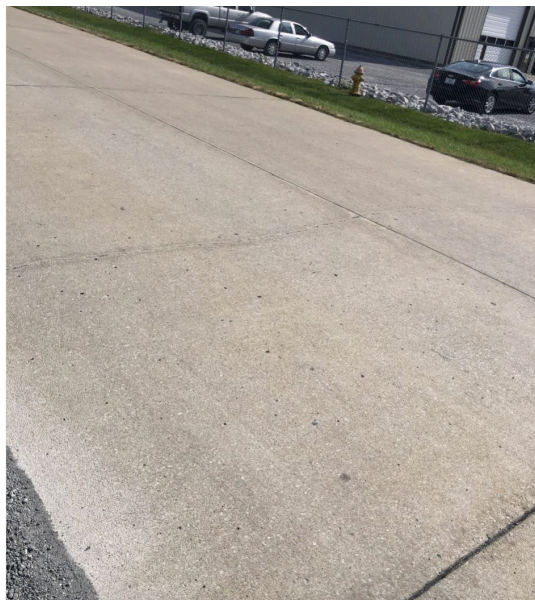
Similar to Harrison Street, Central Street is composed of very long JPCP slab panels (~30 ft) that are exhibiting premature transverse cracks. These mid-panel cracks are likely due to excessive panel length relative to this slab's thickness (see Figure 25).

**Figure 25. Photo. Mid-panel transverse crack on Central Street (East St. Louis, IL).**

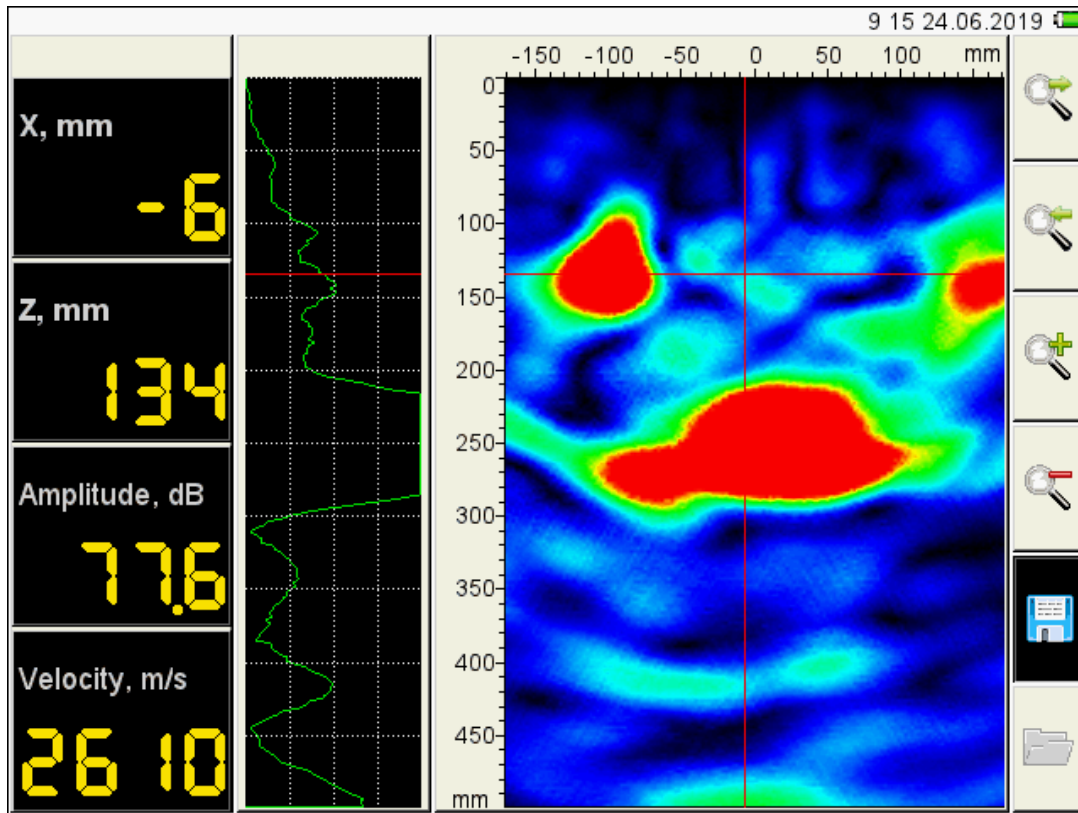
**Figure 33. Photo. Ultrasound image of IL 30 with SS 55.**

Thickness (in.)	Panel Length (ft)	Panel Width (ft)	Dowel Bar Spacing (in.)	Tie Bar Spacing (in.)	Lane Configuration	Visual Distress	Additional Observations
10	15	11	12	27	Two lanes per direction + central lane	No distress observed	Construction date ~2015

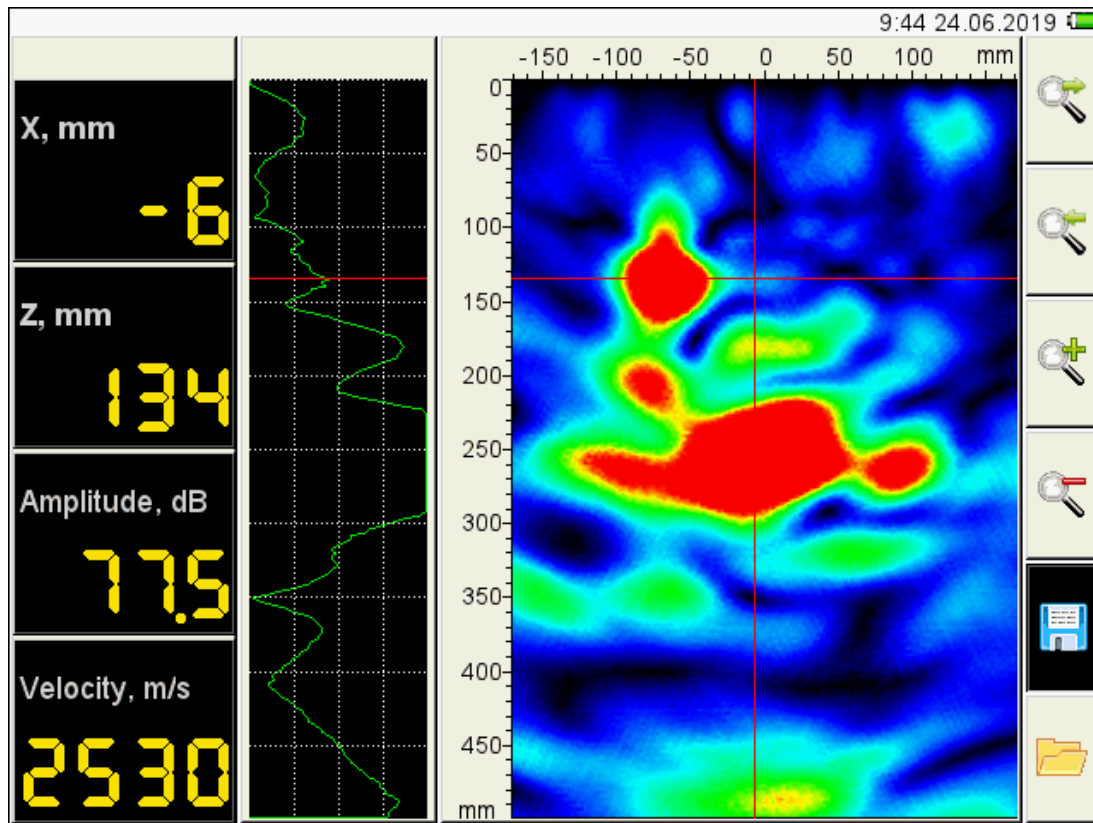
**Figure 35. Photo. Ultrasound image of IL 59 from IL 30 to IL 80.**

Thickness (in.)	Panel Length (ft)	Panel Width (ft)	Dowel Bar Spacing (in.)	Tie Bar Spacing (in.)	Lane Configuration	Visual Distress	Additional Observations
10	15	11	12	27	Two lanes per direction + central lane	About 3% of the panels showed deterioration in the form of cracks and joint spalling.	Construction date ~2002

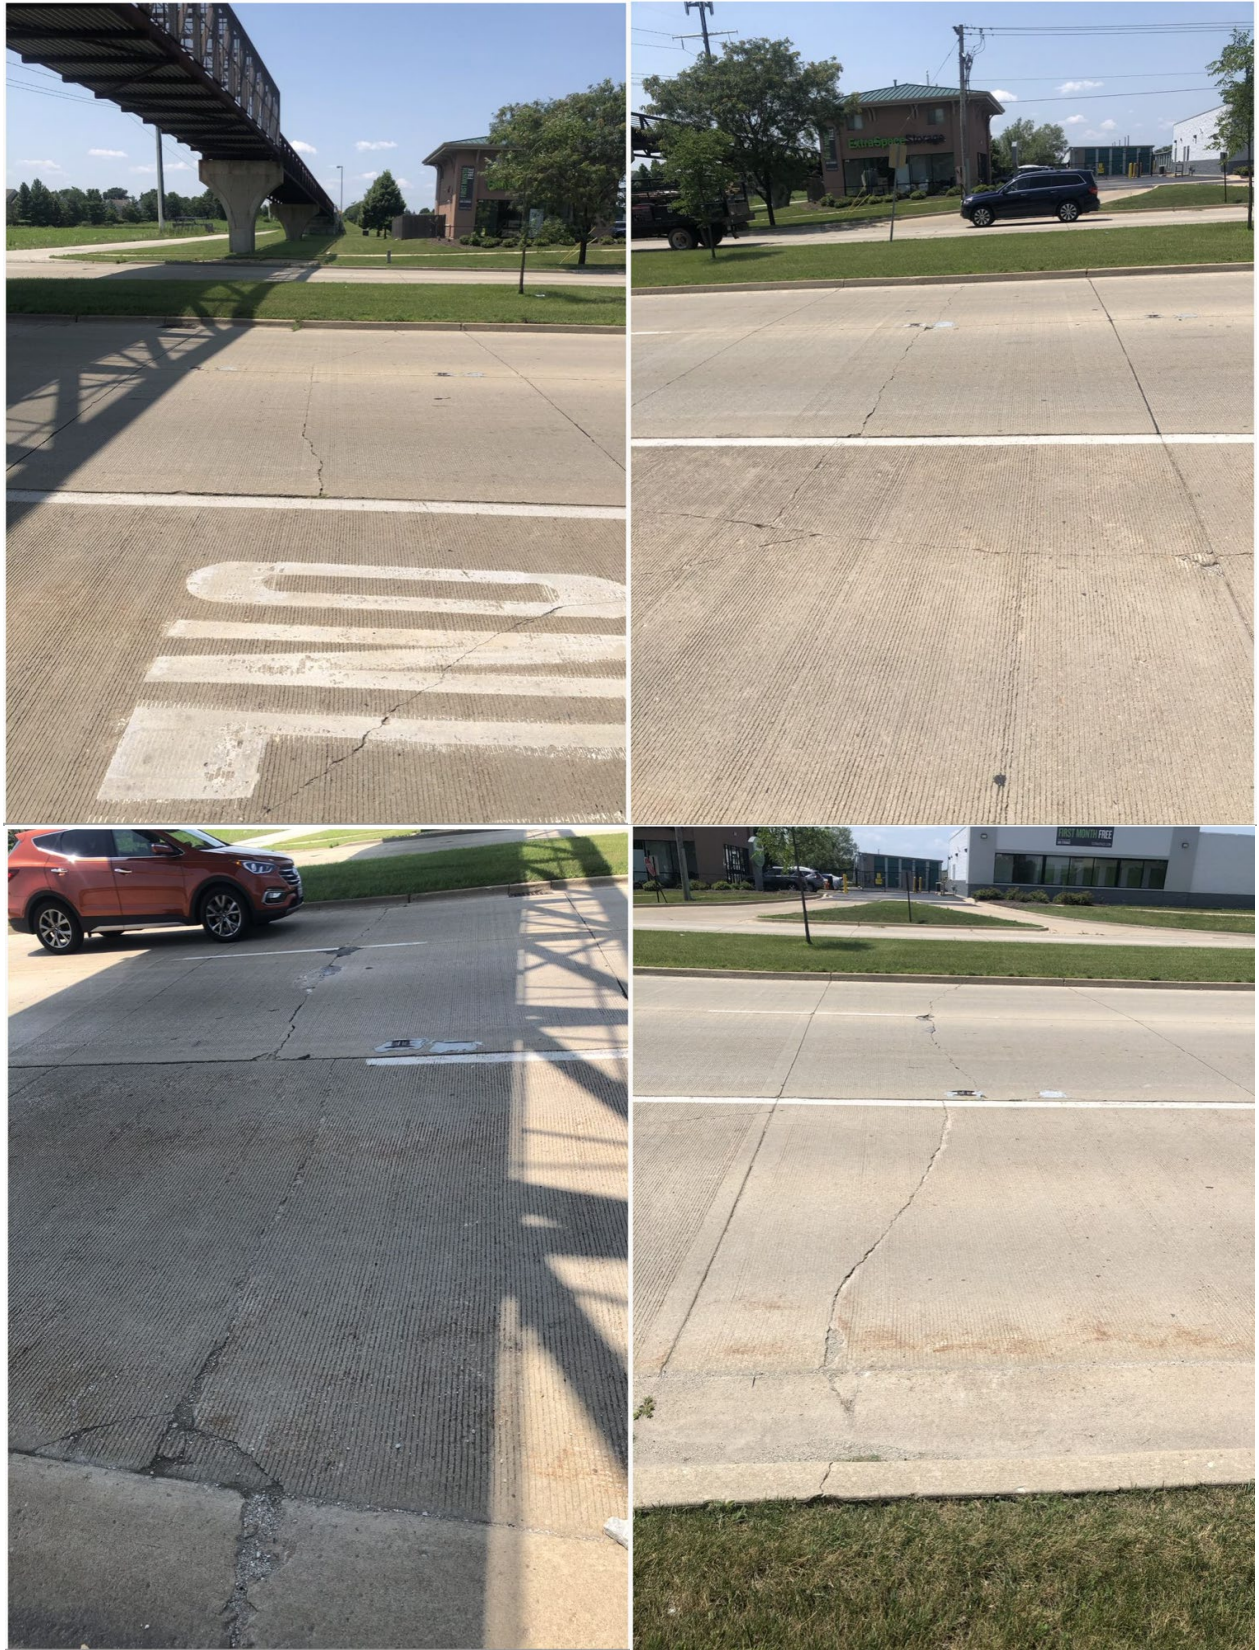
Figure 37. Photos. IL 59 from 103rd to 95th Streets.

Thickness (in.)	Panel Length (ft)	Panel Width (ft)	Dowel Bar Spacing (in.)	Tie Bar Spacing (in.)	Lane Configuration	Visual Distress	Additional Observations
10	15	11	12	27	Two lanes per direction + central lane	More than 50% of the panels showed deterioration in the form of cracks and joint spalling.	Construction date ~1998

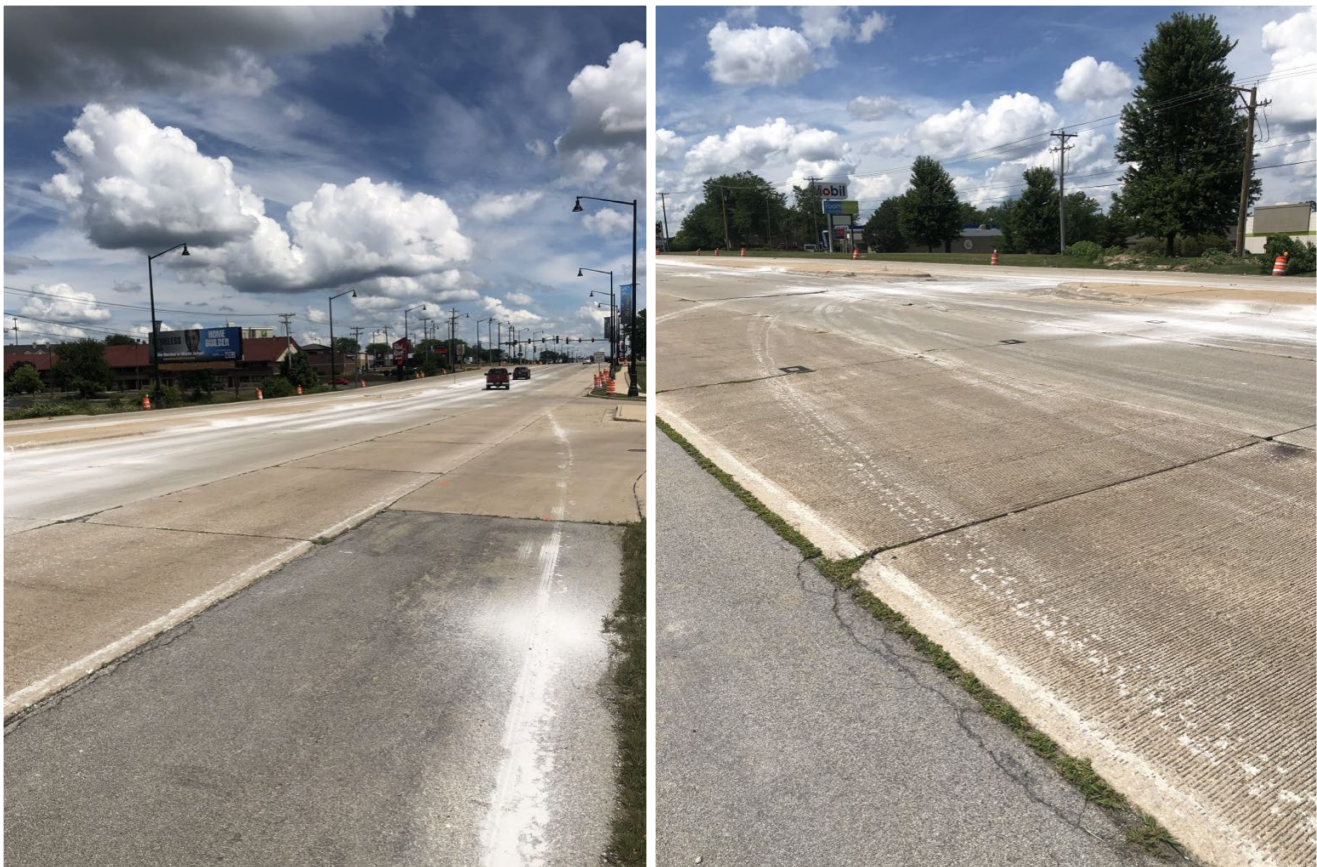
**Figure 45. Photos. State Street with Bell School Road.**

Thickness (in.)	Panel Length (ft)	Panel Width (ft)	Dowel Bar Spacing (in.)	Tie Bar Spacing (in.)	Lane Configuration	Visual Distress	Additional Observations
Not evaluated due to heavy traffic	42	15	Not evaluated due to heavy traffic	Not evaluated due to heavy traffic	3 lanes per direction	Severe longitudinal and transverse cracks. (>50%)	Construction date ~2000s Some panels were renewed.

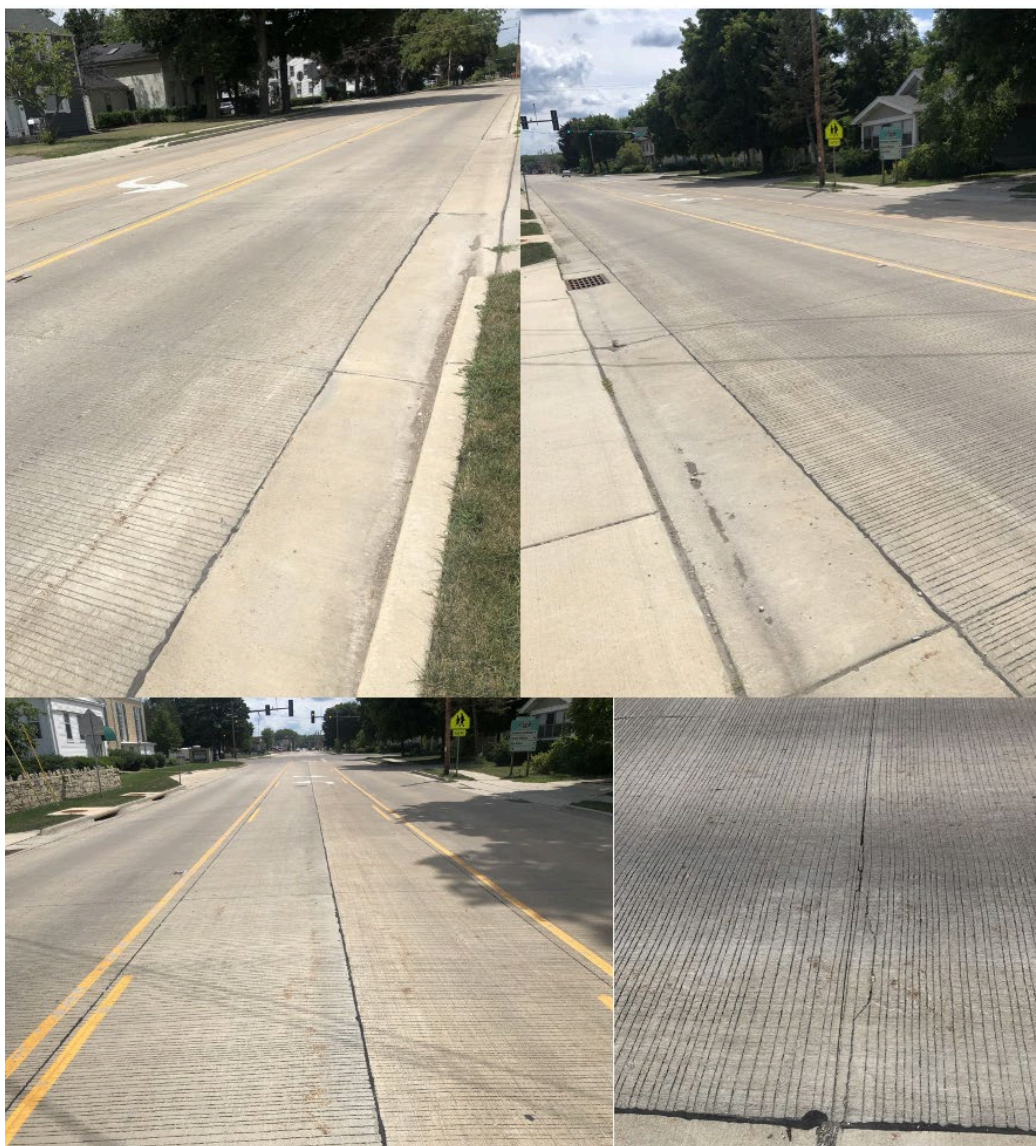
**Figure 46. Photos. Union Street with Blackhawk Boulevard.**

Thickness (in.)	Panel Length (ft)	Panel Width (ft)	Dowel Bar Spacing (in.)	Tie Bar Spacing (in.)	Lane Configuration	Visual Distress	Additional Observations
10	15	13	12	24	One lane per direction + center turning lane	Minimal joint deterioration (<2%)	Construction date ~2010s

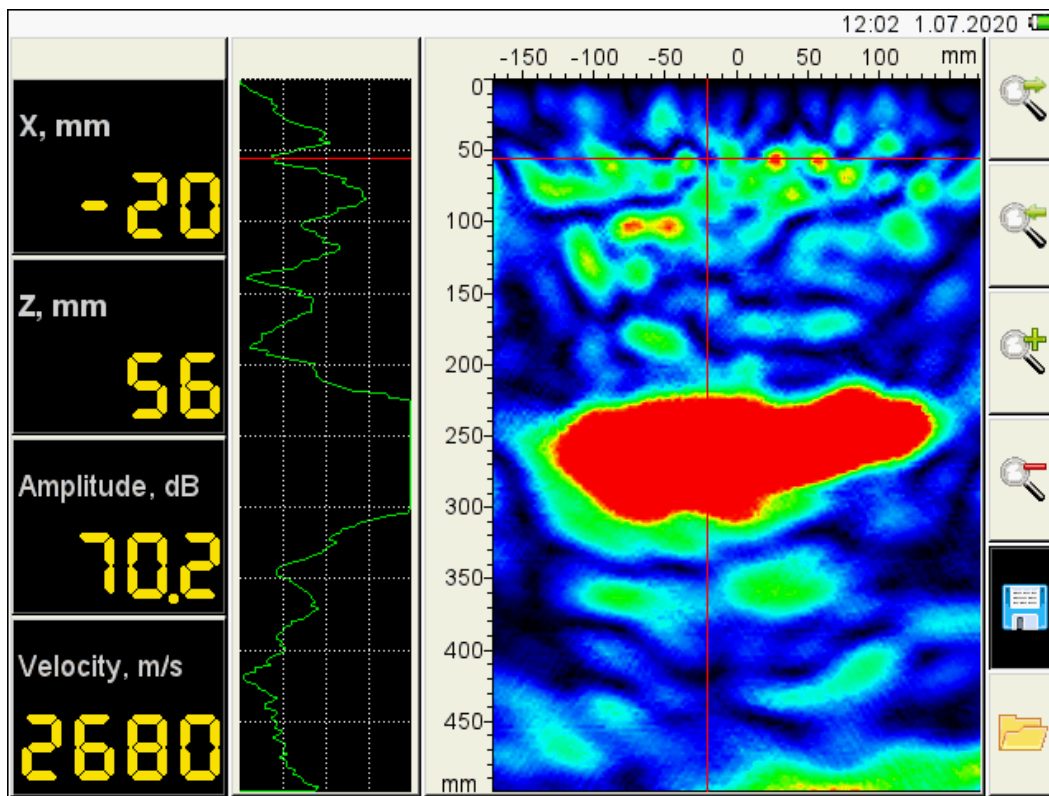
**Figure 47. Photo. Ultrasound image of US 20 at Galena, IL.**

Thickness (in.)	Panel Length (ft)	Panel Width (ft)	Dowel Bar Spacing (in.)	Tie Bar Spacing (in.)	Lane Configuration	Visual Distress	Additional Observations
10	15	13	12	36	One lane per direction + center turning lane	Severe longitudinal and transverse cracks. (>50%)	Construction date ~2002 The ultrasonic evaluation showed a potential delamination.

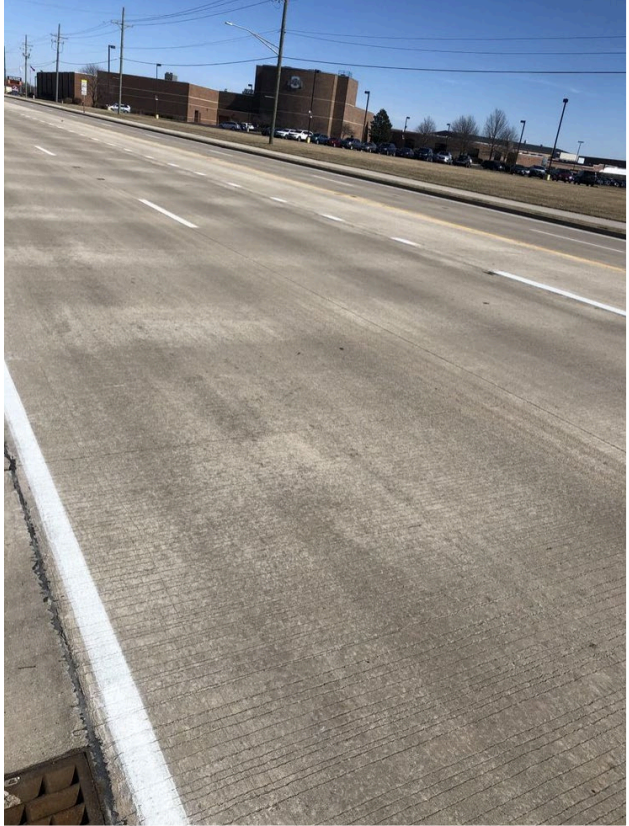
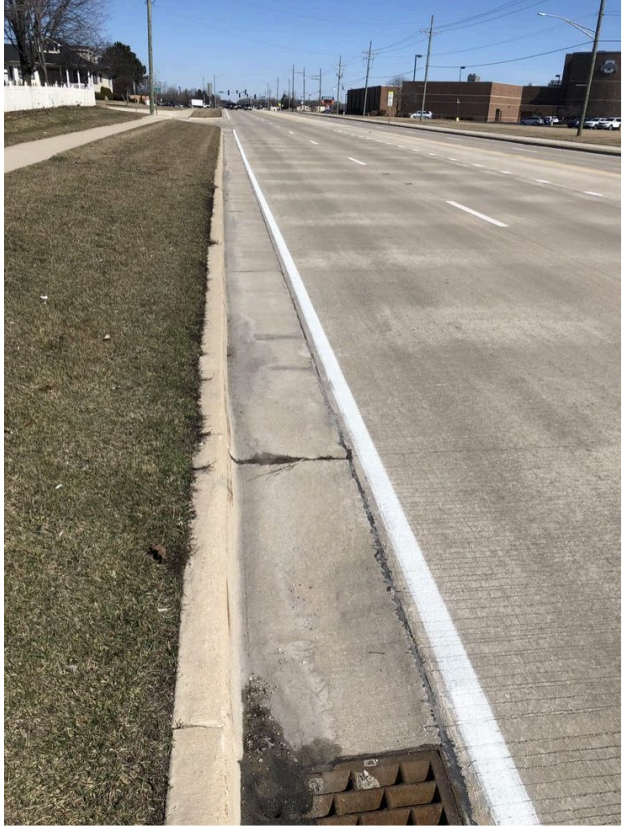
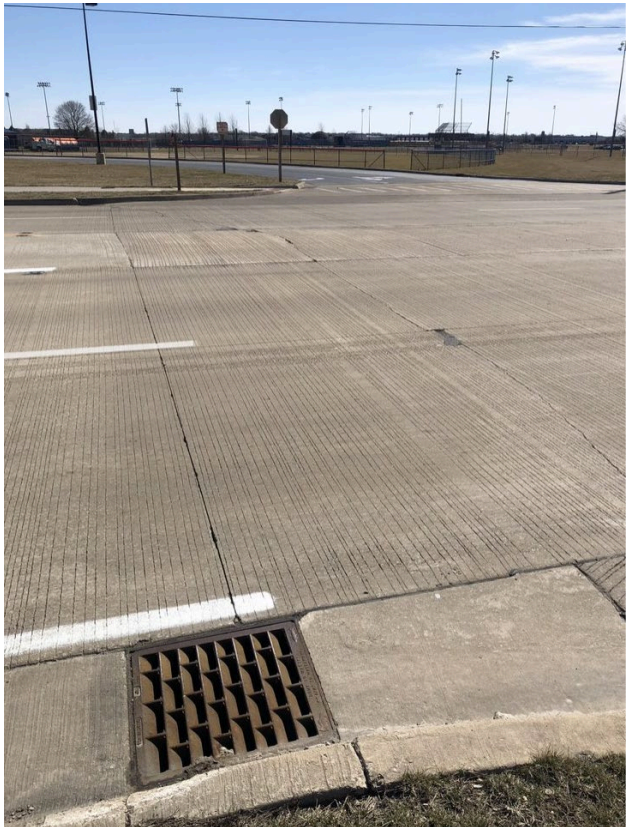
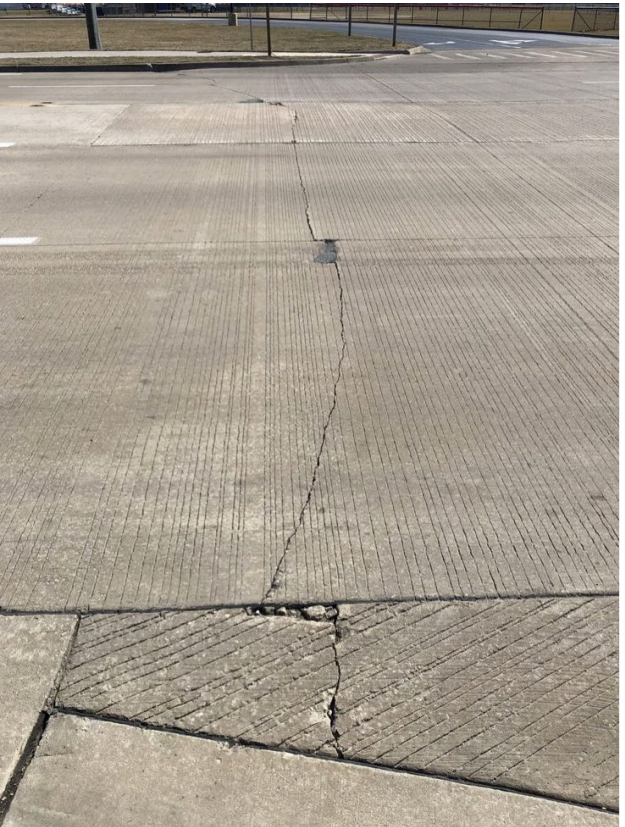
**Figure 52. Photos. IL 71 with Franklin Street.**

Thickness (in.)	Panel Length (ft)	Panel Width (ft)	Dowel Bar Spacing (in.)	Tie Bar Spacing (in.)	Lane Configuration	Visual Distress	Additional Observations
10	15	12	12	24	2 lanes per direction + central turning lane	One full lane width transverse crack located at the intersection with a school entrance.	Construction date ~2010s

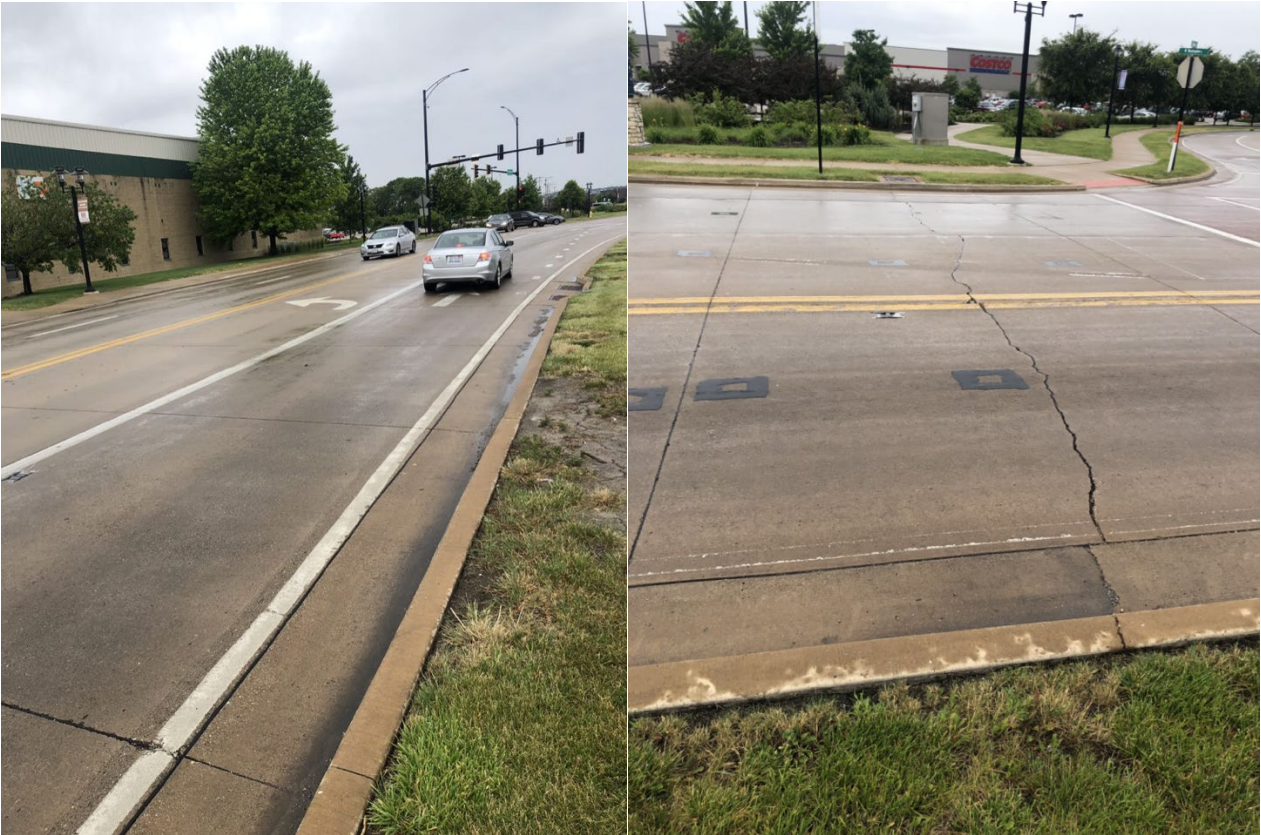
**Figure 57. Photos. MacArthur Highway with Richland Street.**

Thickness (in.)	Panel Length (ft)	Panel Width (ft)	Dowel Bar Spacing (in.)	Tie Bar Spacing (in.)	Lane Configuration	Visual Distress	Additional Observations
Not evaluated due to heavy traffic	12	12	Not evaluated due to heavy traffic	Not evaluated due to heavy traffic	2 lanes per direction + central lane	Minimum transverse cracking around drainage area (<2%)	Construction date ~2011

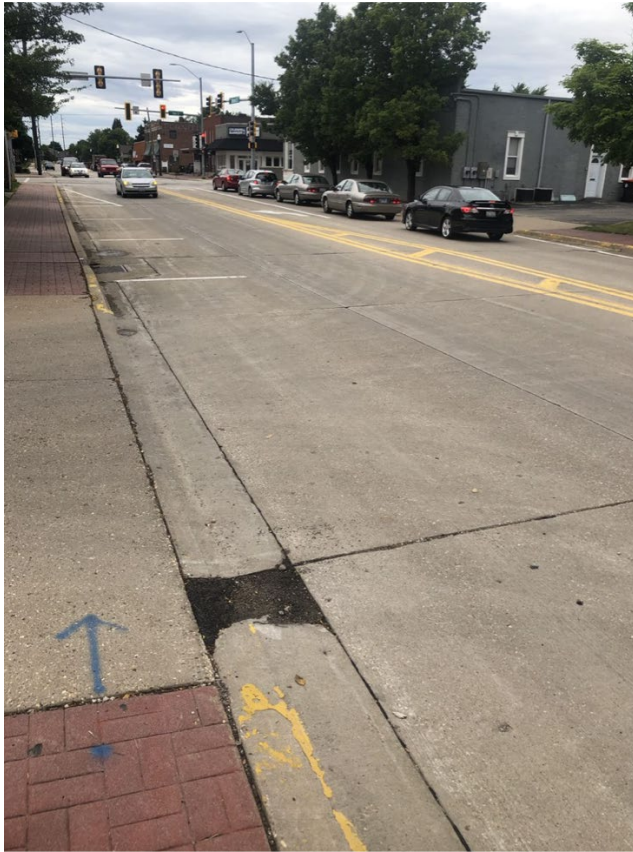
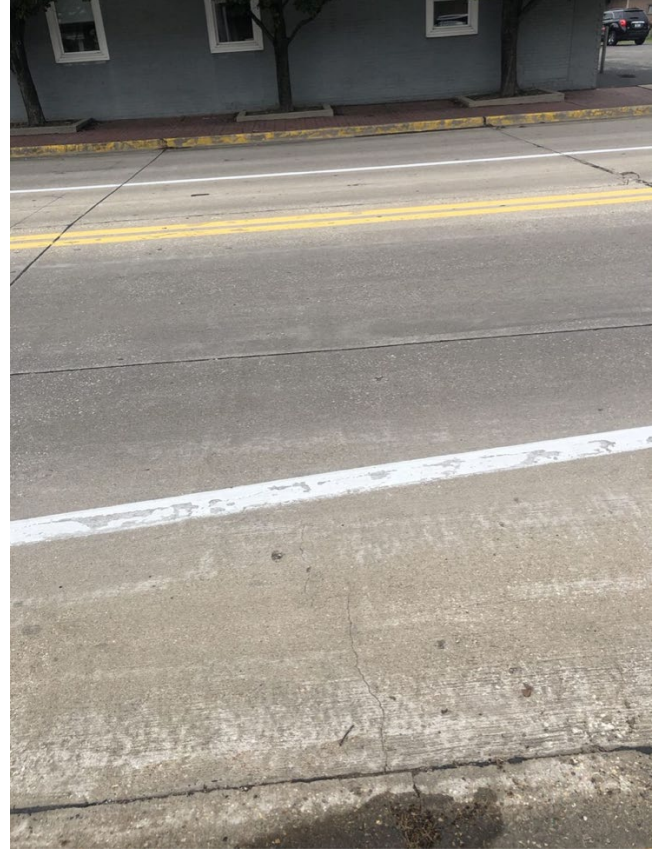
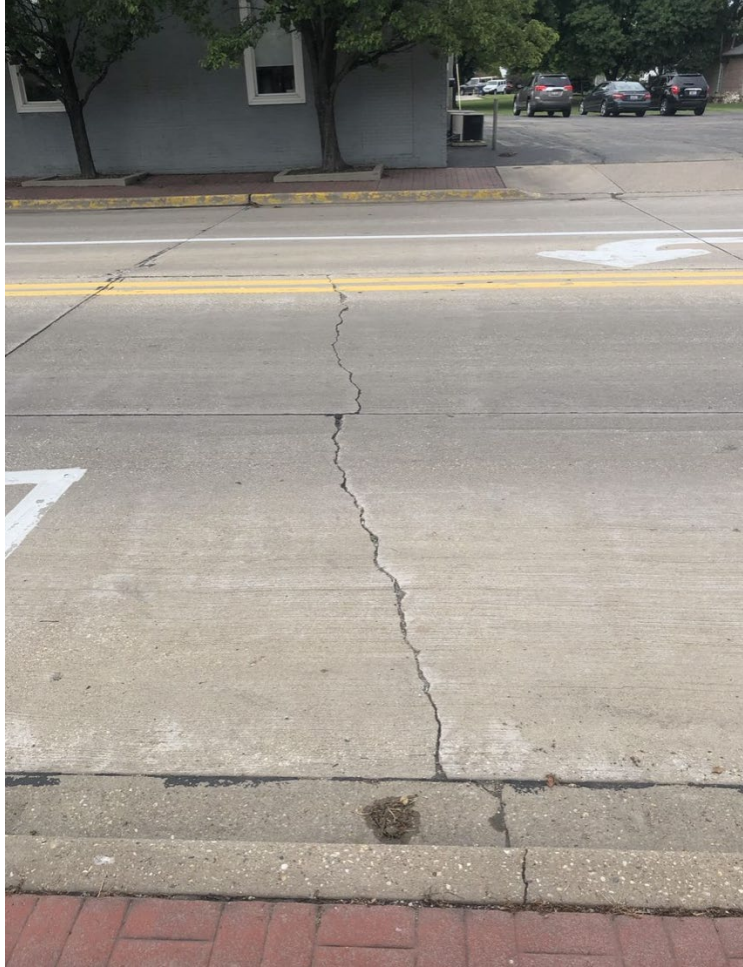
Figure 60. Photos. Jefferson Street with Jackson Street.

Thickness (in.)	Panel Length (ft)	Panel Width (ft)	Dowel Bar Spacing (in.)	Tie Bar Spacing (in.)	Lane Configuration	Visual Distress	Additional Observations
9	20	9	Dowels present*	45	2 lanes per direction	Minimum transverse cracks (<30%)	Construction date ~2016 * It has dowel bars, but no measurements due to heavy traffic.

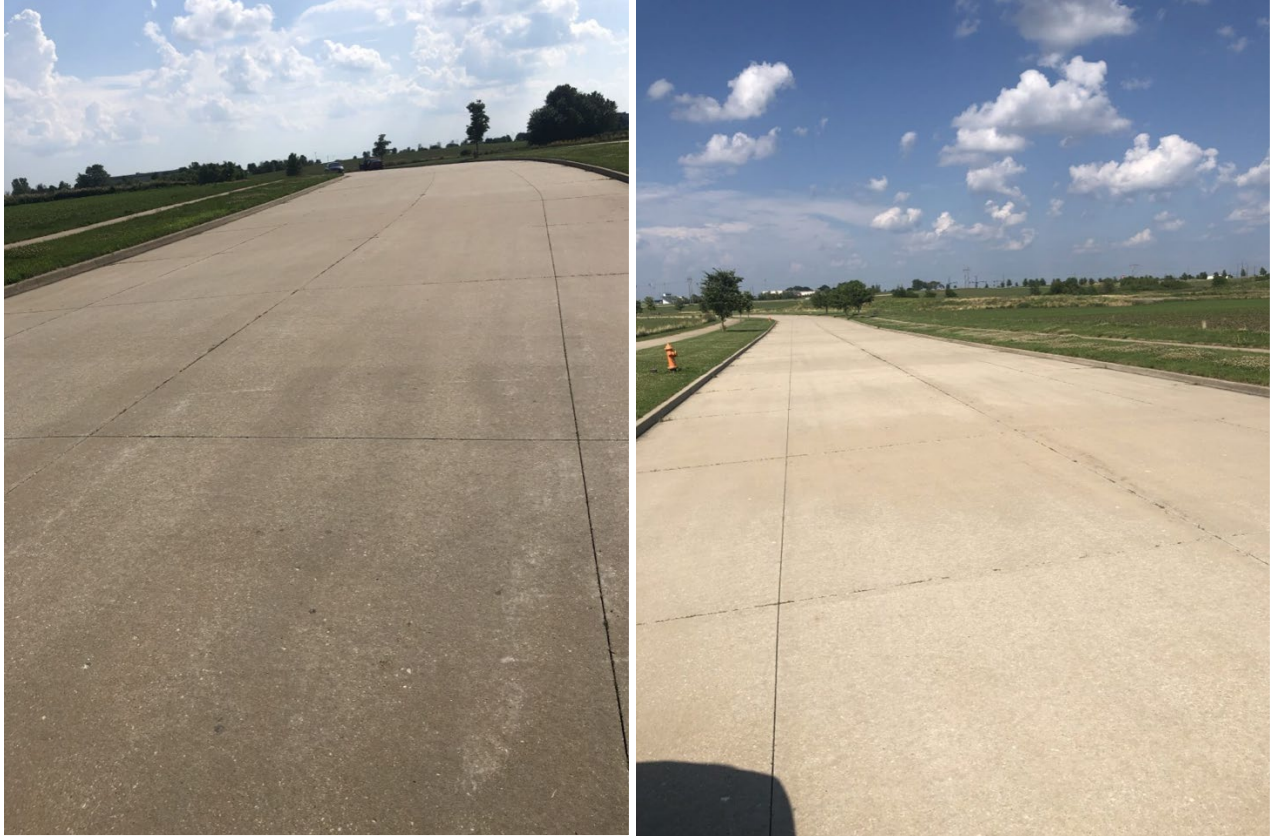
Figure 61. Photos. Legacy Avenue.

Thickness (in.)	Panel Length (ft)	Panel Width (ft)	Dowel Bar Spacing (in.)	Tie Bar Spacing (in.)	Lane Configuration	Visual Distress	Additional Observations
8	15	10	Not observed	Not observed	2 lanes total	No distress observed	Construction date ~2007 <i>Very low traffic (new neighborhood)</i>

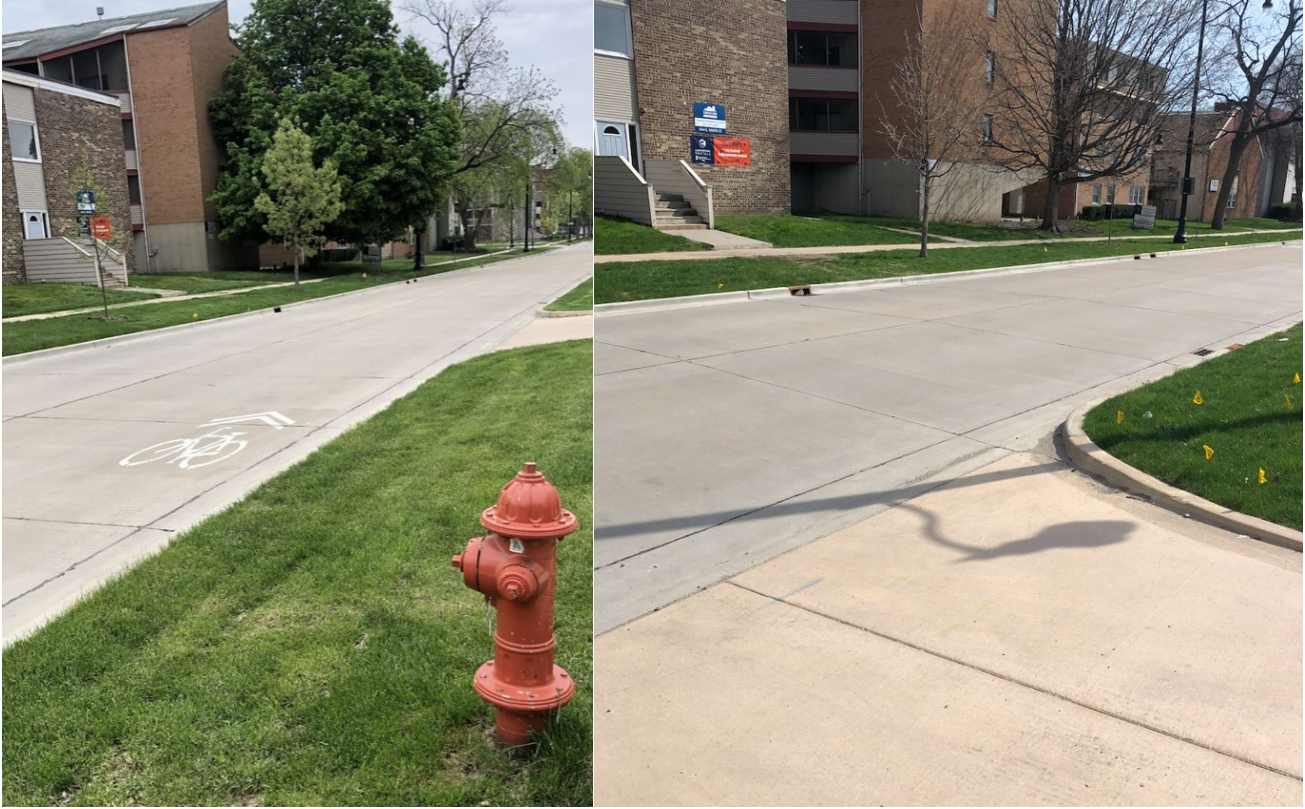
Figure 63. Photos. White Street.

Thickness (in.)	Panel Length (ft)	Panel Width (ft)	Dowel Bar Spacing (in.)	Tie Bar Spacing (in.)	Lane Configuration	Visual Distress	Additional Observations
10	15	10	25	25	One lane per direction	No distress observed.	Construction date 2019. High volume of buses.
