# Evaluation of Premature Cracking in Urban Concrete Pavement

Research Report No. FHWA-ICT-21-001

A report of the findings of  
**ICT PROJECT R27-193-4**  
**Premature Cracking Mechanism for**  
**Jointed Plain Concrete Pavement**

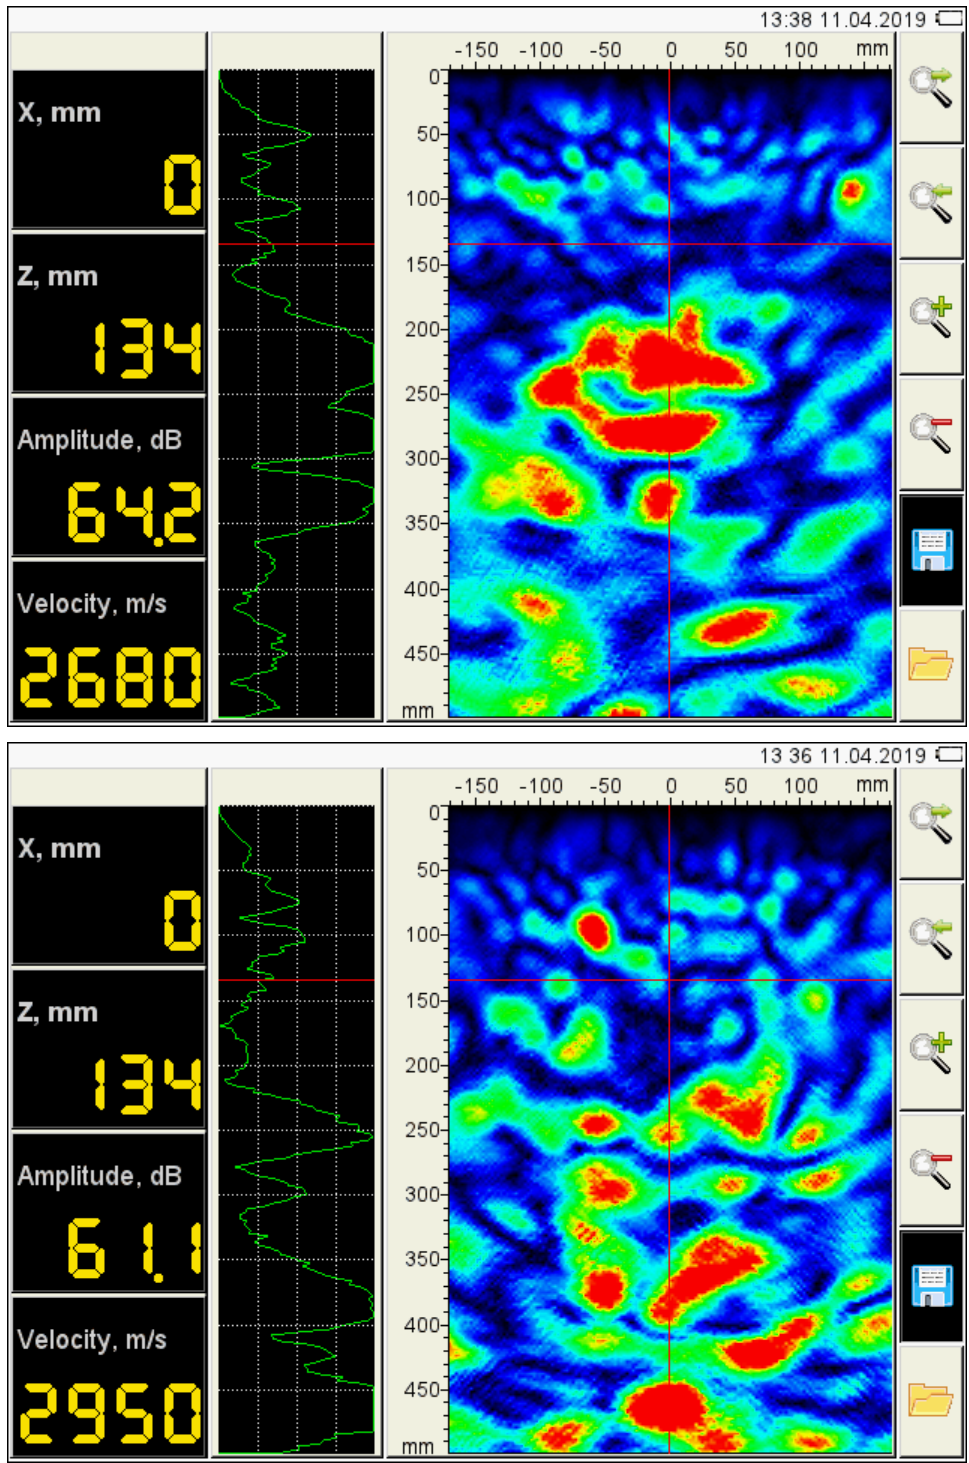
Figure 64. Photo. Ultrasound images of Healey Street from Fourth Street to Fifth Street.

Thickness (in.)	Panel Length (ft)	Panel Width (ft)	Dowel Bar Spacing (in.)	Tie Bar Spacing (in.)	Lane Configuration	Visual Distress	Additional Observations
8	12.5	12	24	26	1 lane per direction	mid-panel transverse cracks (>50%)	<i>Construction date ~2015</i>

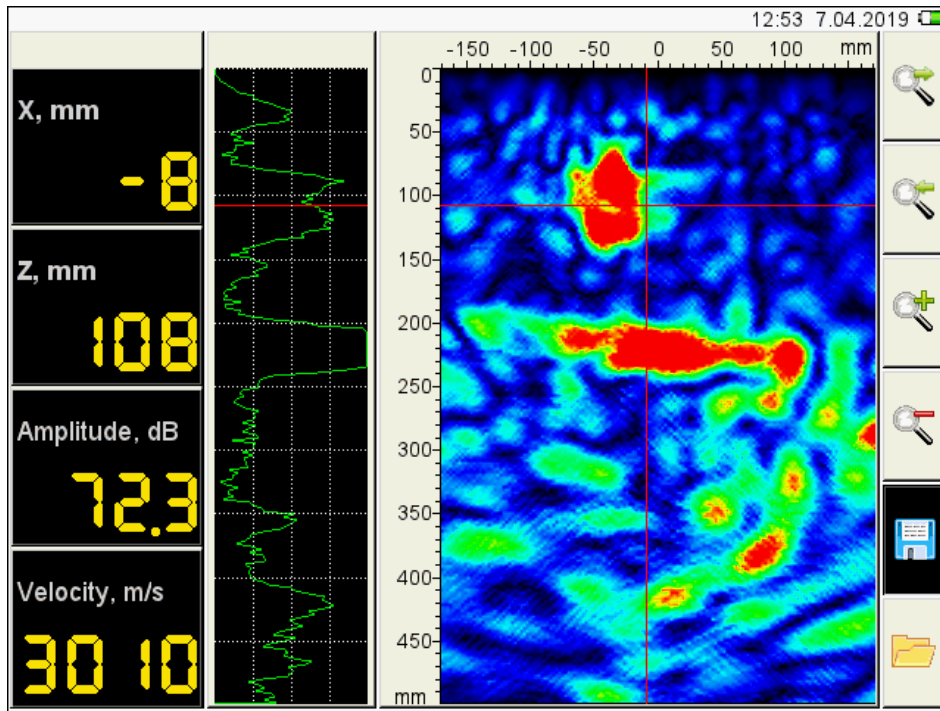
Figure 66. Photo. Ultrasound images of Healey Street from Fifth Street to Sixth Street.

Thickness (in.)	Panel Length (ft)	Panel Width (ft)	Dowel Bar Spacing (in.)	Tie Bar Spacing (in.)	Lane Configuration	Visual Distress	Additional Observations
8	12.5	12	16	26	1 lane per direction	mid-panel transverse cracks (>30%)	<i>Construction date ~2015</i>

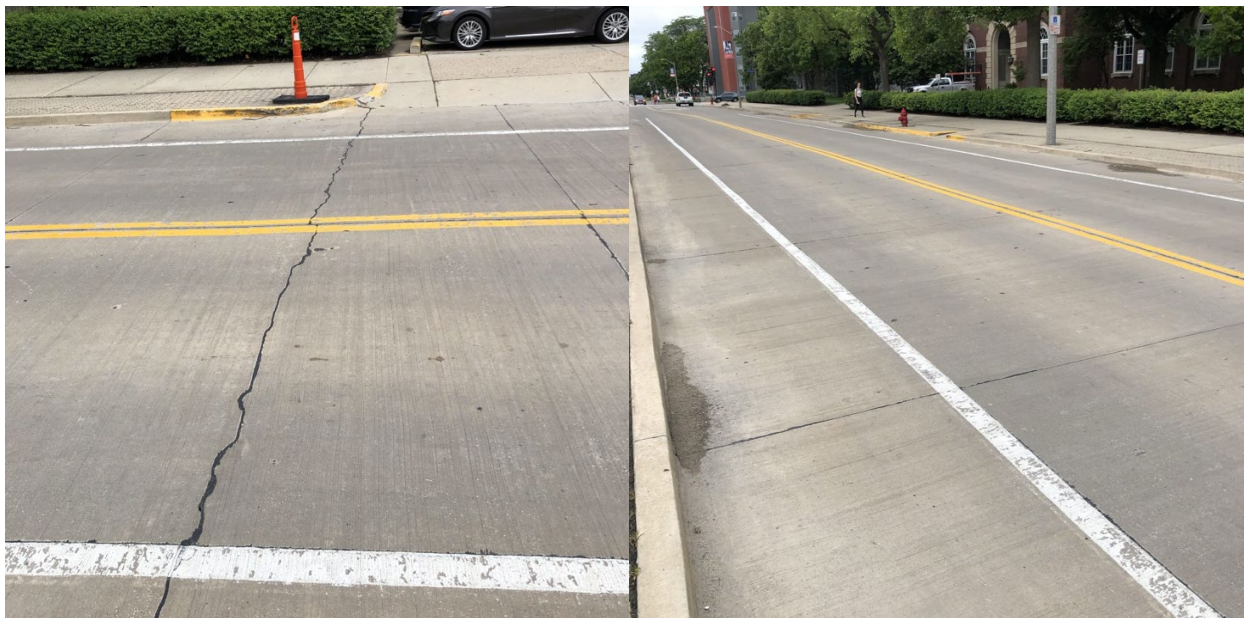
**Figure 68. Photos. Gregory Drive from Fourth Street to Sixth Street.**

Thickness (in.)	Panel Length (ft)	Panel Width (ft)	Dowel Bar Spacing (in.)	Tie Bar Spacing (in.)	Lane Configuration	Visual Distress	Additional Observations
8	15	10.5	23	39	1 lane per direction + 1 bicycle lane per side	mid-panel transverse cracks (>50%)	<i>Construction date ~2013</i>

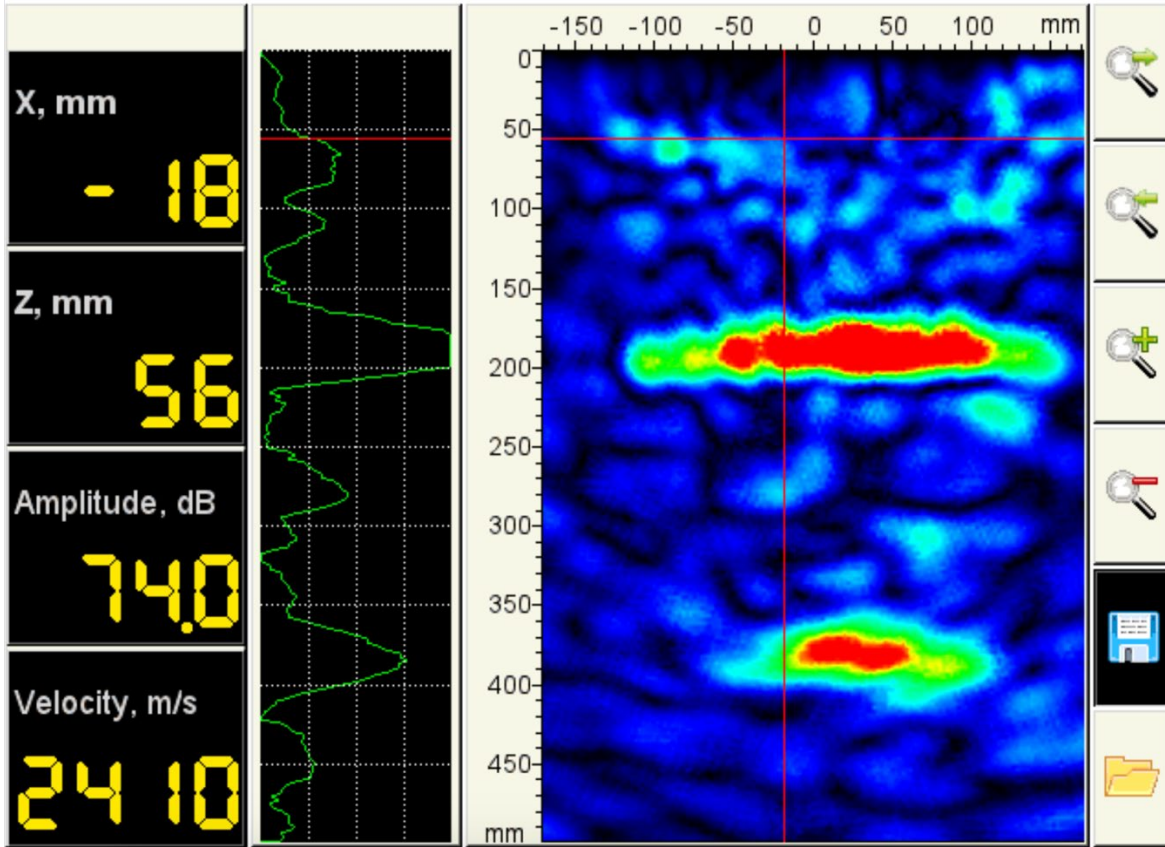
Figure 69. Photos. Ultrasound images of Gregory Drive from First Street to Fourth Street.

Thickness (in.)	Panel Length (ft)	Panel Width (ft)	Dowel Bar Spacing (in.)	Tie Bar Spacing (in.)	Lane Configuration	Visual Distress	Additional Observations
7-8*	15	10.5	Not observed	36	1 lane per direction + 1 bicycle lane per side	Mid-panel transverse cracks (>50%)	Construction date ~2013 <i>*Thickness was variable between slabs</i>

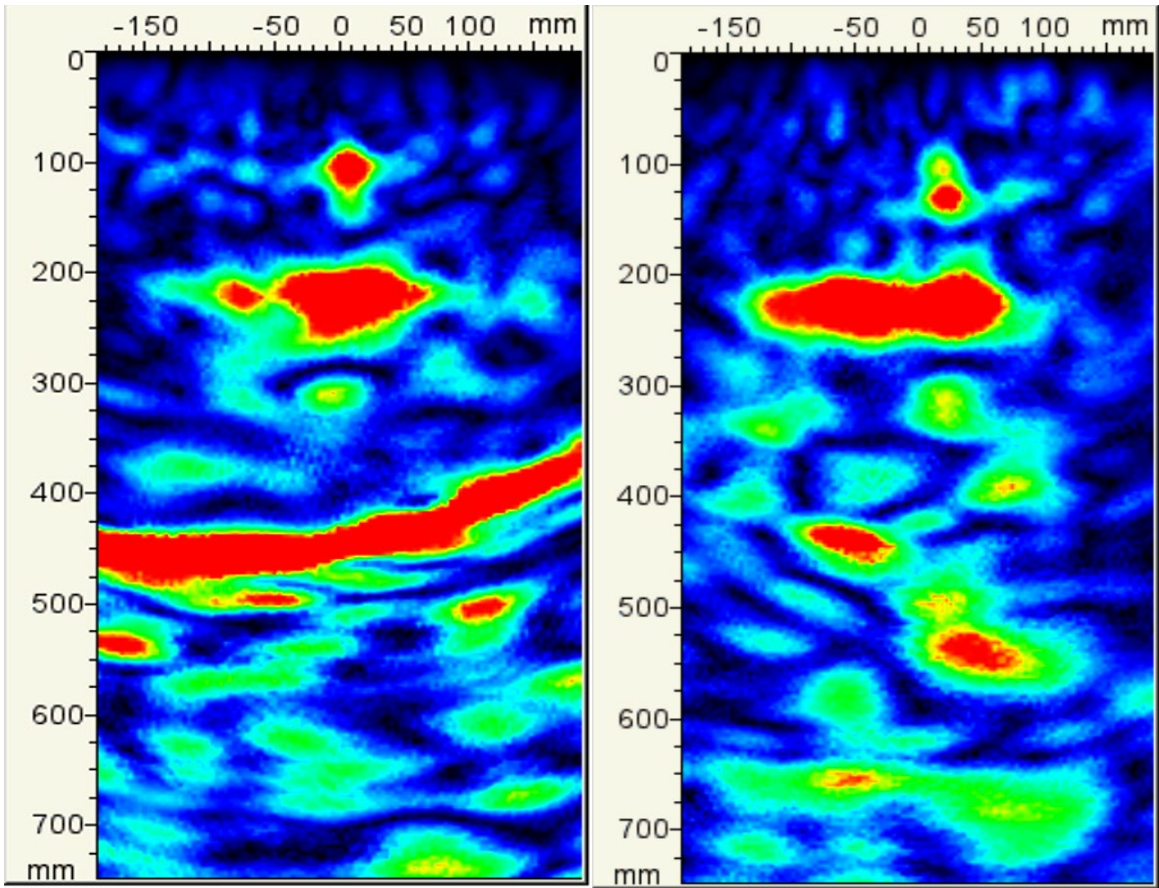
**Figure 71. Photos. Ultrasound images of Gregory Drive from Oak Street to First Street.**

Thickness (in.)	Panel Length (ft)	Panel Width (ft)	Dowel Bar Spacing (in.)	Tie Bar Spacing (in.)	Lane Configuration	Visual Distress	Additional Observations
8	18	15	12	24	2 lane per side +	Mid-panel transverse cracks (>50%)	<i>Construction date ~2013</i>

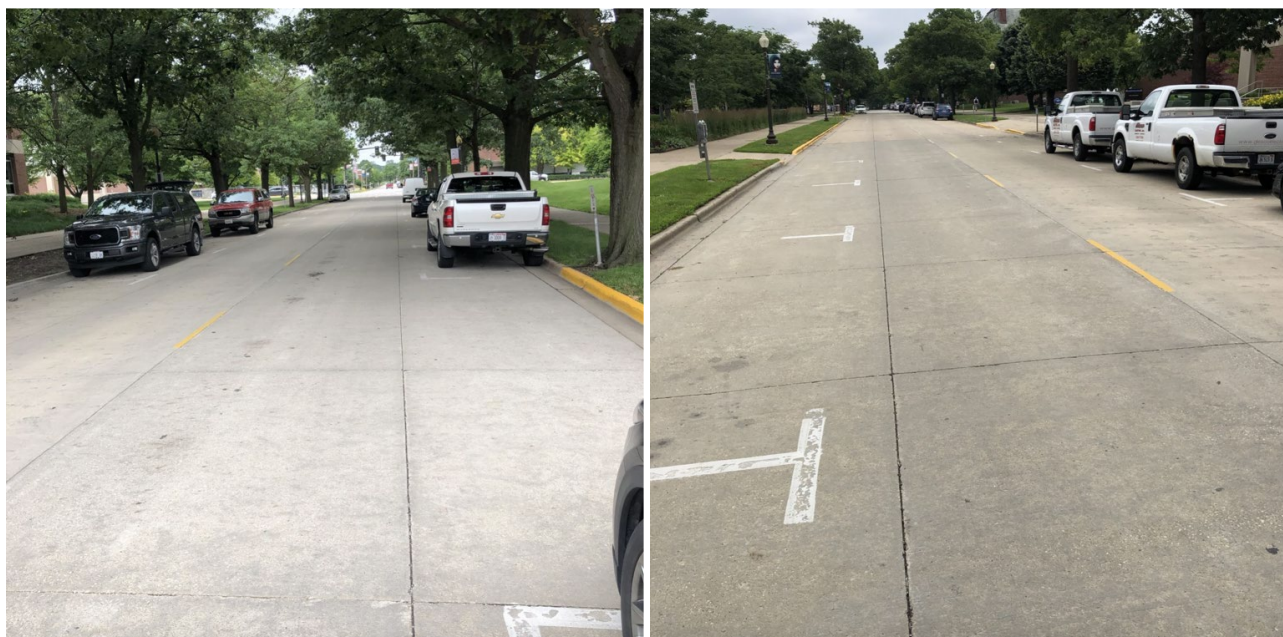
**Figure 73. Photos. Peabody Drive.**

Thickness (in.)	Panel Length (ft)	Panel Width (ft)	Dowel Bar Spacing (in.)	Tie Bar Spacing (in.)	Lane Configuration	Visual Distress	Additional Observations
8	10.5	8	Not observed	47	1 lane per direction with parking on both sides	No distress observed.	Construction date ~2010

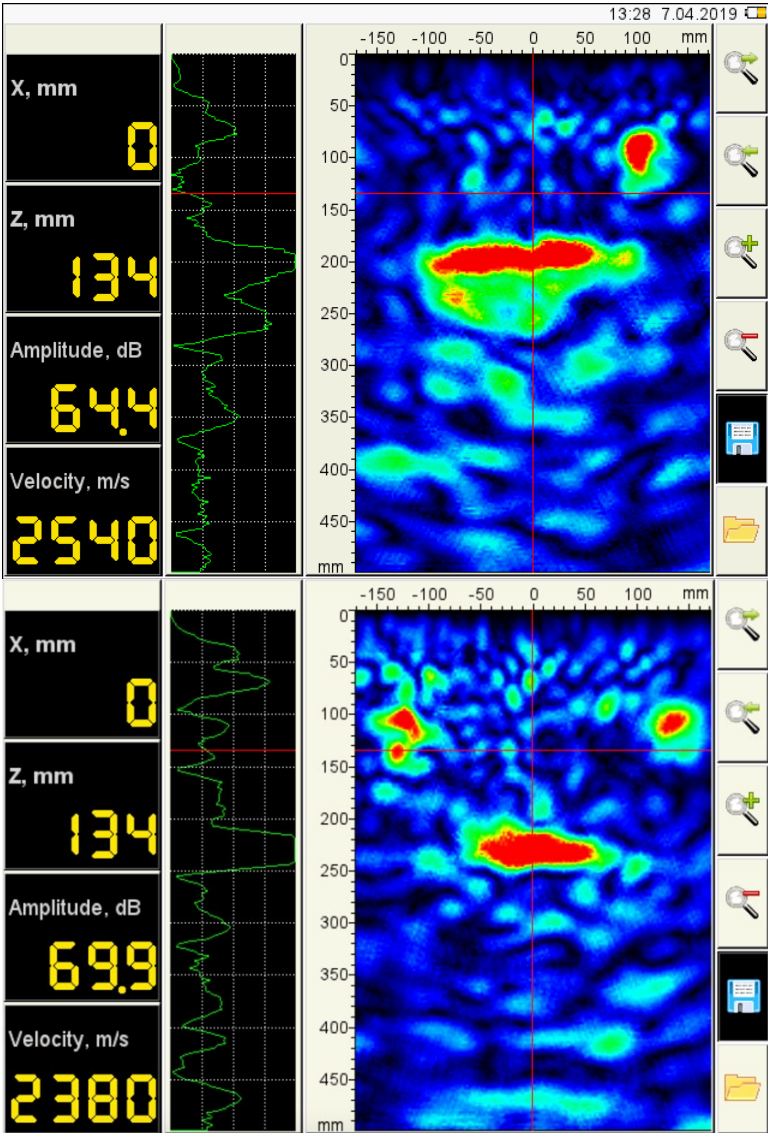
**Figure 74. Photos. Ultrasound images of John Street from Prospect Avenue to New Street.**

Thickness (in.)	Panel Length (ft)	Panel Width (ft)	Dowel Bar Spacing (in.)	Tie Bar Spacing (in.)	Lane Configuration	Visual Distress	Additional Observations
8	13*	13	12	24	1 lane per direction.	Transverse Cracking (>30%)	<i>*The section showed variability in the panel length, long panels (20 ft) showed premature distress.</i>

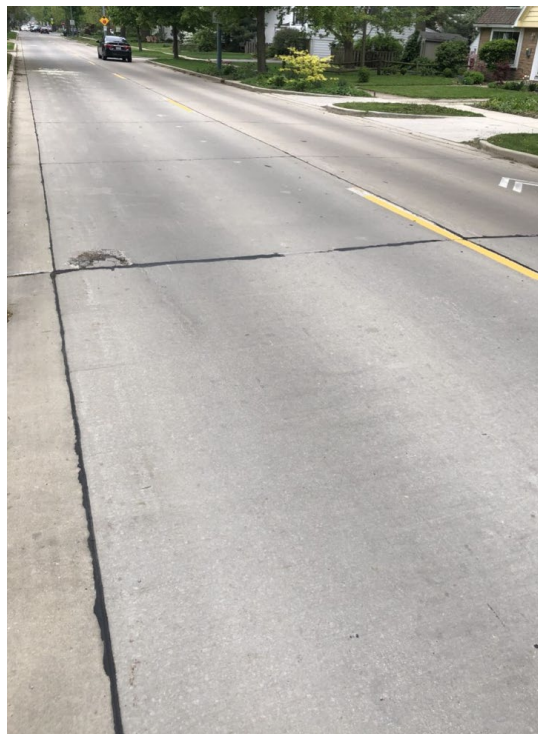
**Figure 76. Photo. John Street from Neil Street to Elm Street.**

Thickness (in.)	Panel Length (ft)	Panel Width (ft)	Dowel Bar Spacing (in.)	Tie Bar Spacing (in.)	Lane Configuration	Visual Distress	Additional Observations
8.5	Variable (10–15)	7.5	12	24	1 lane per direction	Transverse cracking (>30%) and minimum joint deterioration	Construction date ~2008

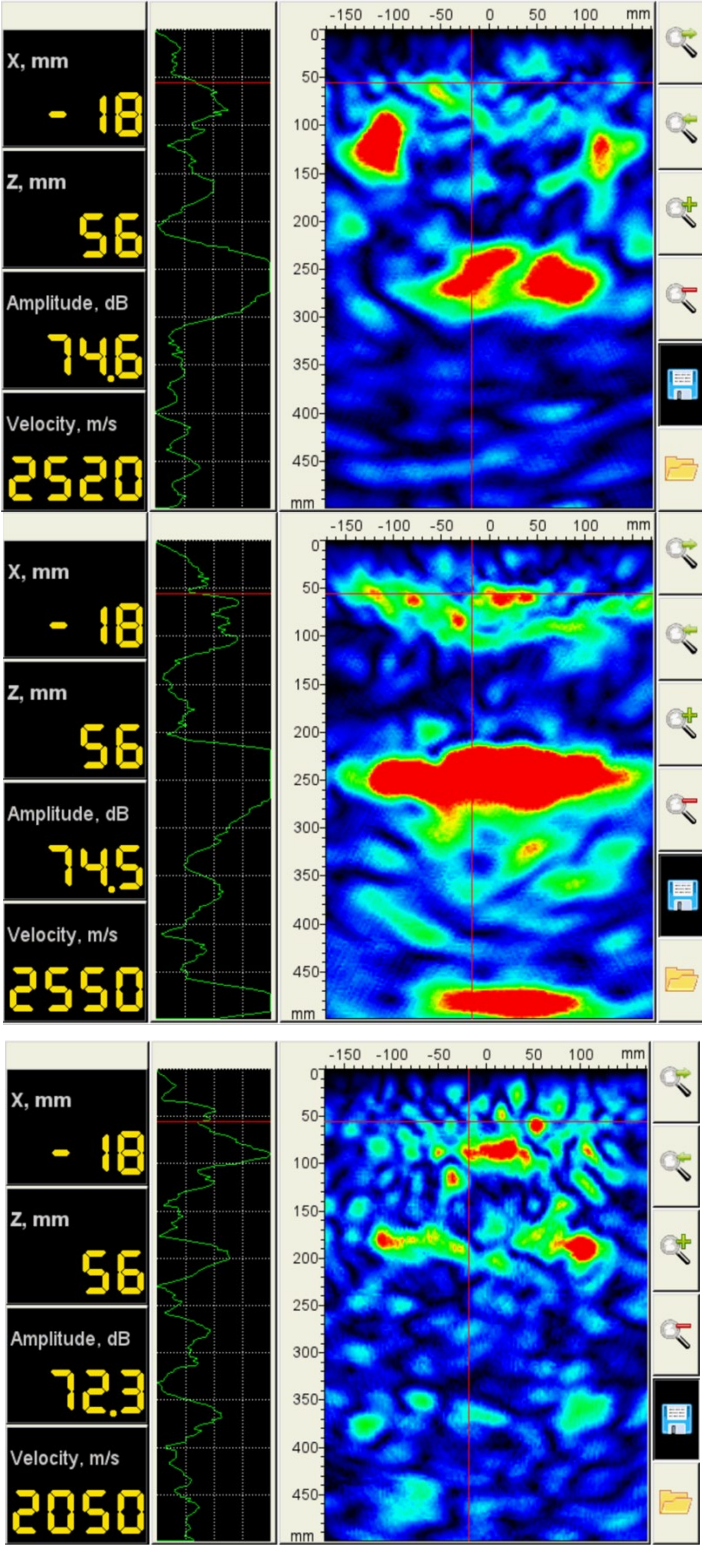
Figure 77. Photos. Ultrasound images of Green Street from First Street to Wright Street.

Thickness (in.)	Panel Length (ft)	Panel Width (ft)	Dowel Bar Spacing (in.)	Tie Bar Spacing (in.)	Lane Configuration	Visual Distress	Additional Observations
8-10*	15	11	12	24	1 lane per direction + central lane	Transverse Cracking (>50%)	Construction date ~2011 *Slab thickness varies from 8" to 10".

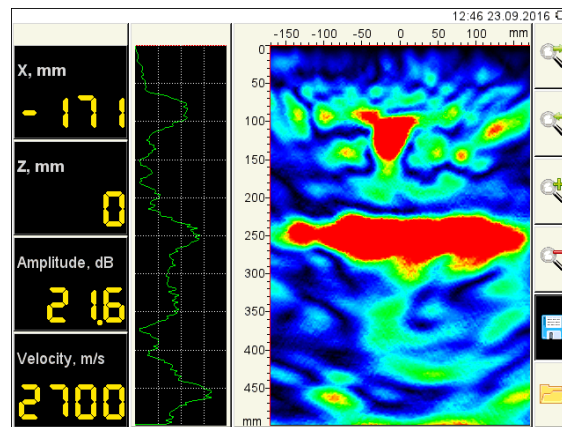
Figure 79. Photo. Ultrasound image of Stadium Drive.

Thickness (in.)	Panel Length (ft)	Panel Width (ft)	Dowel Bar Spacing (in.)	Tie Bar Spacing (in.)	Lane Configuration	Visual Distress	Additional Observations
10	15	9	Not observed	24	2 lanes per direction + 1 bicycle lane	Transverse Cracking (>50%)	Construction date ~2016

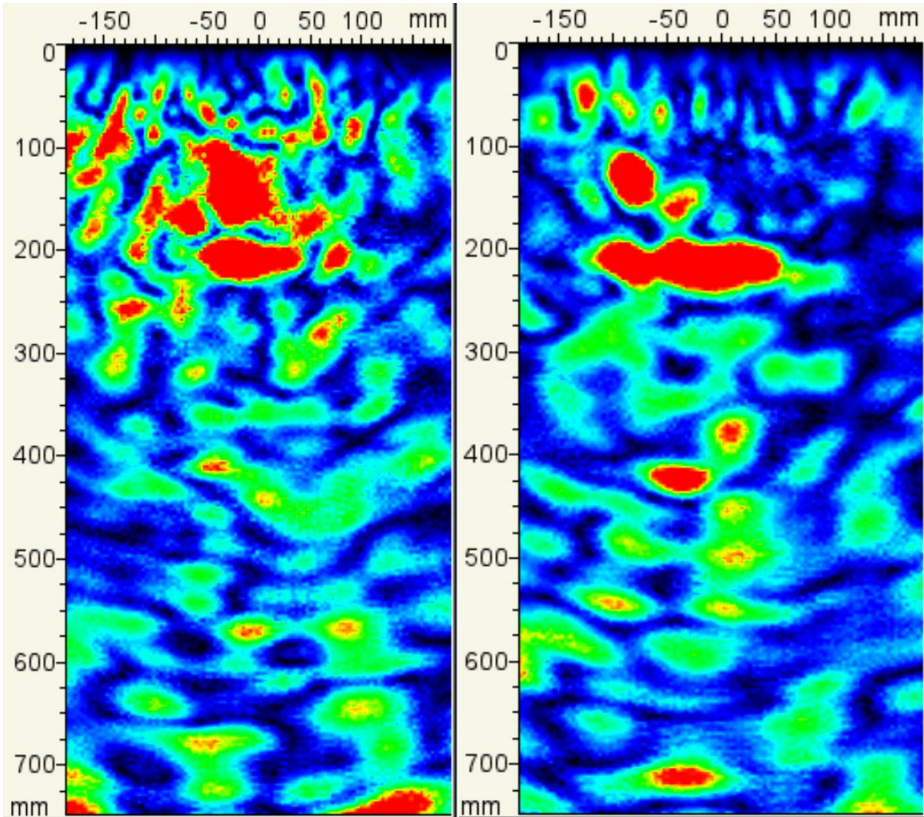
**Figure 83. Photos. Ultrasound images of Fourth Street from West Kirby to St. Mary’s Road.**

Thickness (in.)	Panel Length (ft)	Panel Width (ft)	Dowel Bar Spacing (in.)	Tie Bar Spacing (in.)	Lane Configuration	Visual Distress	Additional Observations
10	14	11	12	26	2 lanes per direction	No distress observed.	Construction date ~2016. <i>Scattering</i> on ultrasound.

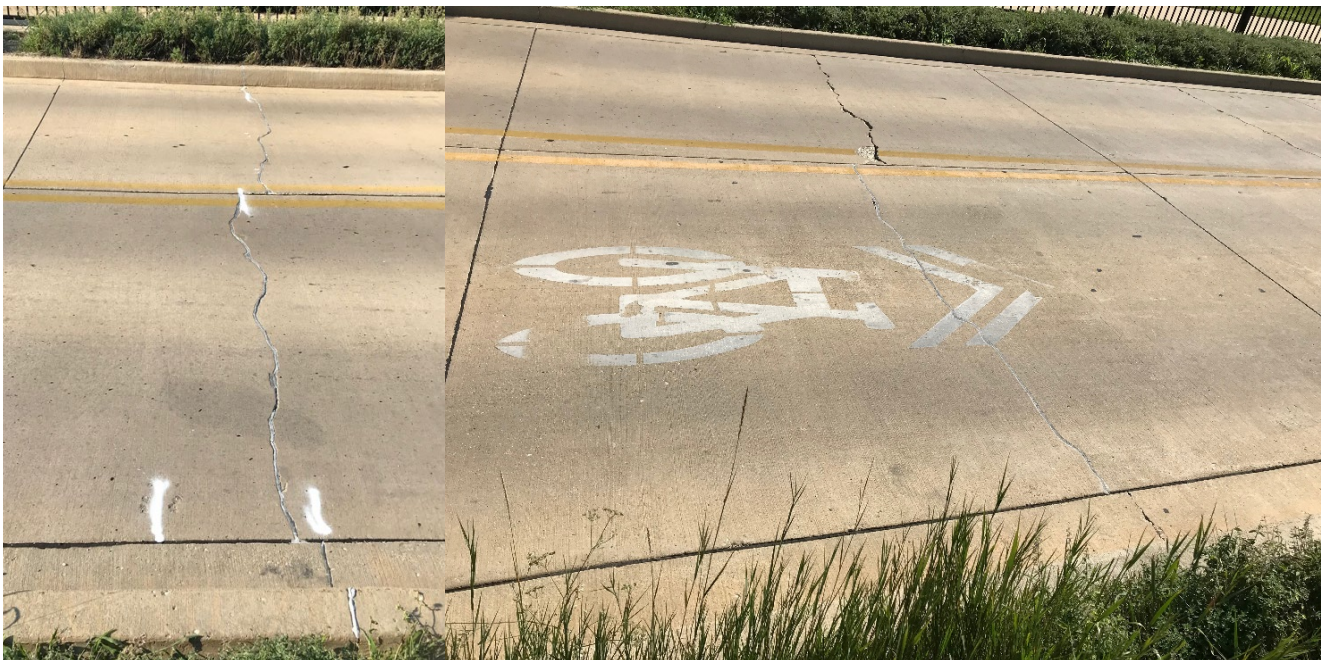
**Figure 84. Photos. Logan Street.**

Thickness (in.)	Panel Length (ft)	Panel Width (ft)	Dowel Bar Spacing (in.)	Tie Bar Spacing (in.)	Lane Configuration	Visual Distress	Additional Observations
8	15	11	12	23	1 lane per direction	Transverse Cracking (>50%)	<i>Construction date ~2010</i>

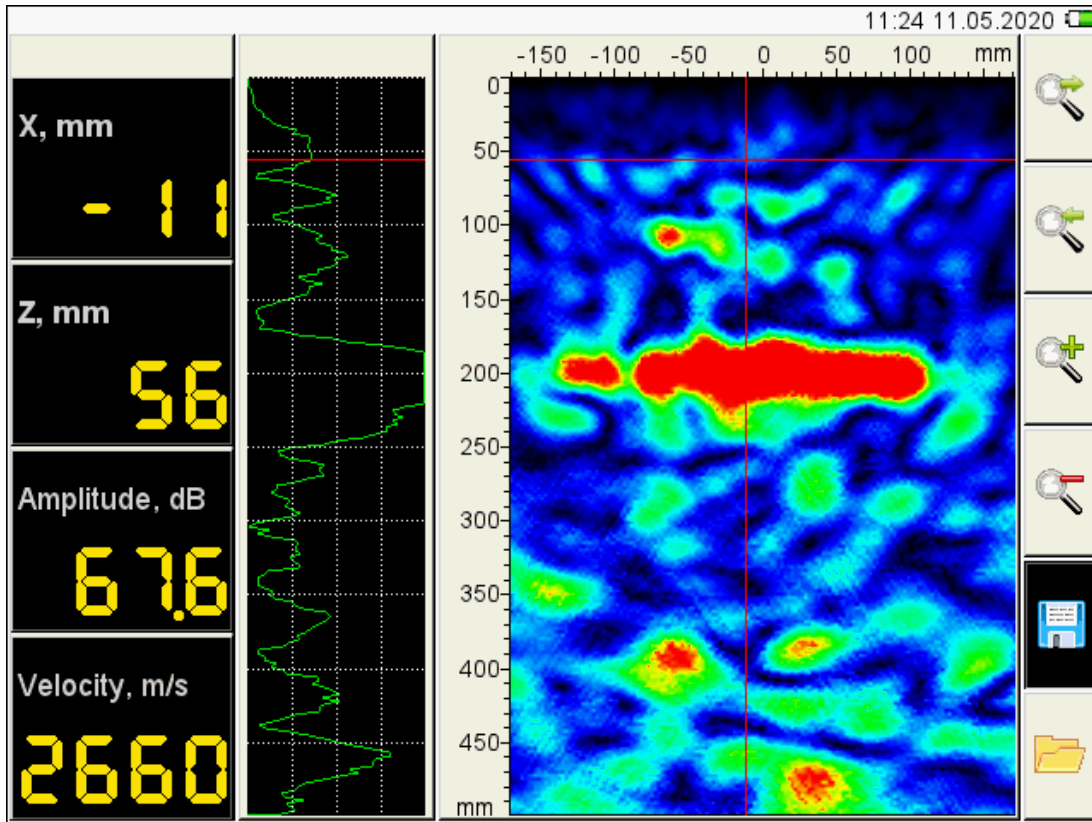
Figure 85. Photos. Ultrasound images of Curtis Road from Prospect Avenue to Duncan Road.

Thickness (in.)	Panel Length (ft)	Panel Width (ft)	Dowel Bar Spacing (in.)	Tie Bar Spacing (in.)	Lane Configuration	Visual Distress	Additional Observations
8	15	12	12	36	2 lanes per direction	Transverse cracking (>30%)	<i>Construction date ~2010</i>

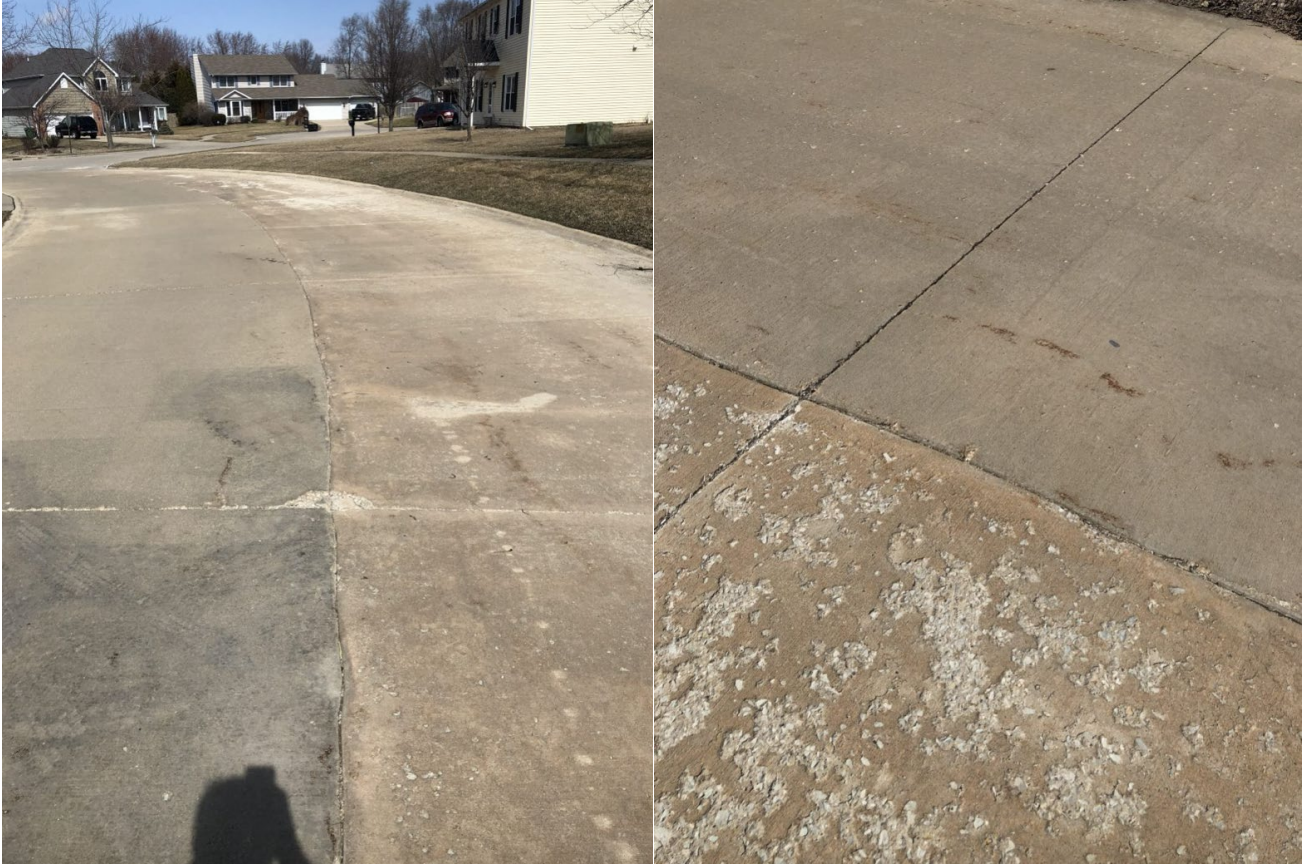
Figure 92. Photos. Sprucer Drive.

Thickness (in.)	Panel Length (ft)	Panel Width (ft)	Dowel Bar Spacing (in.)	Tie Bar Spacing (in.)	Lane Configuration	Visual Distress	Additional Observations
7	15	13	24	Not observed	1 lane per direction	Joint spalling and slab scaling	<i>Construction date not available.</i>

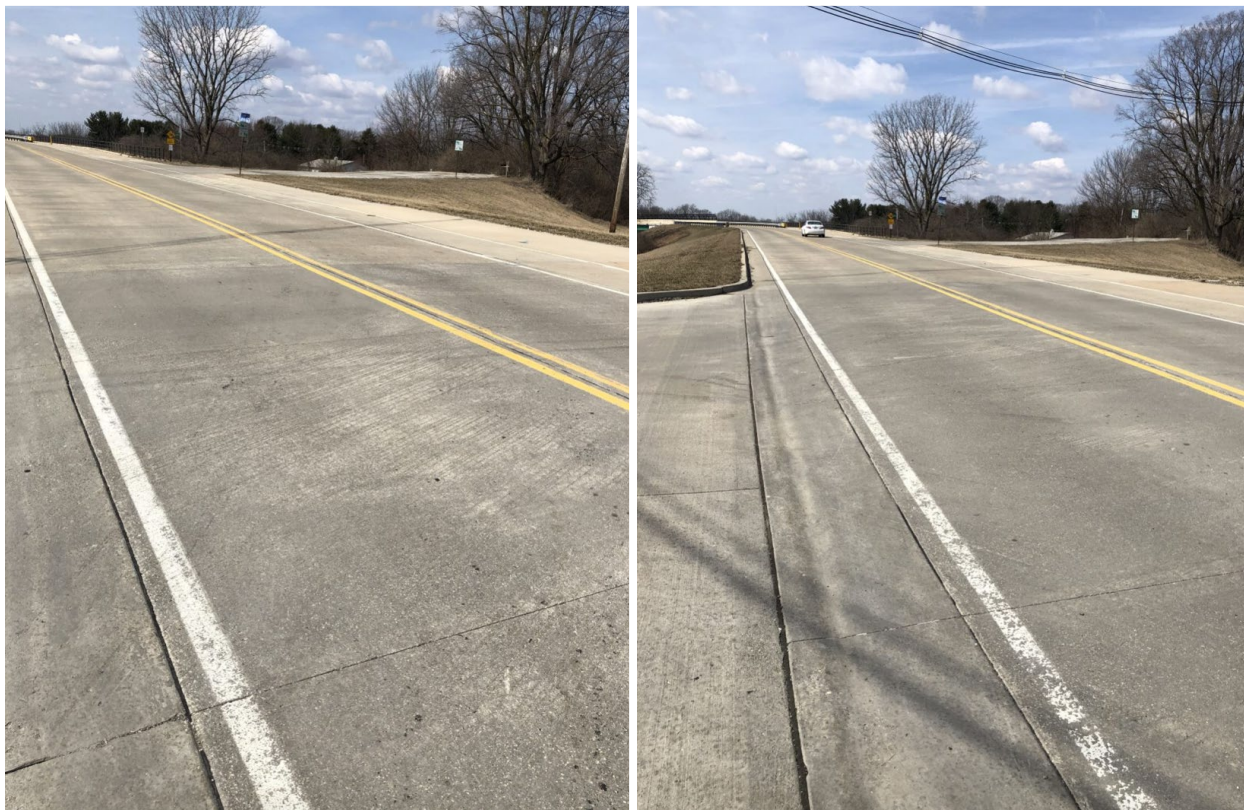
Figure 94. Photos. Lake of the Woods Road.

Thickness (in.)	Panel Length (ft)	Panel Width (ft)	Dowel Bar Spacing (in.)	Tie Bar Spacing (in.)	Lane Configuration	Visual Distress	Additional Observations
9	12	13	30	22	1 lane per direction + central lane	Transverse cracking (<30%)	<i>Construction date ~ 2014.</i>

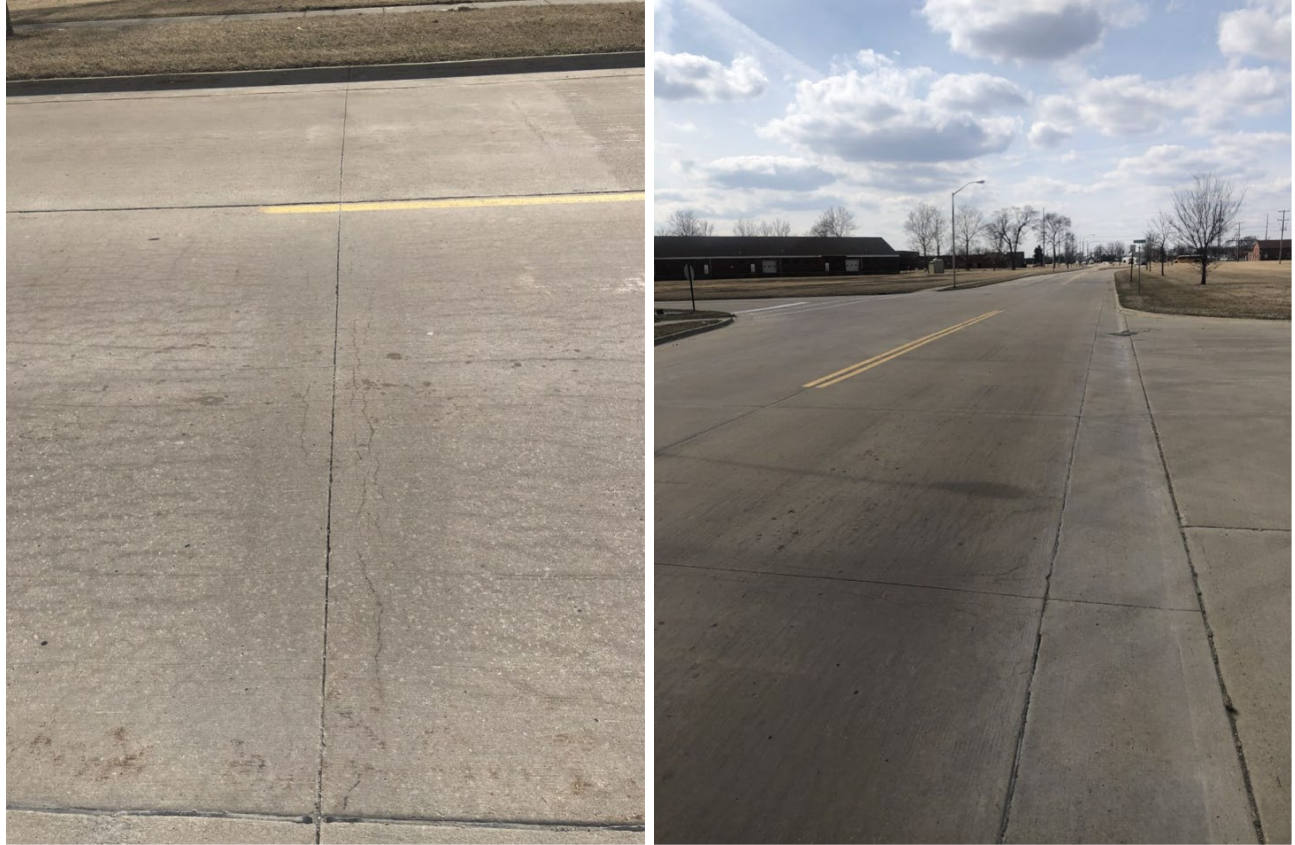
Figure 96. Photos. Veterans Parkway.

Thickness (in.)	Panel Length (ft)	Panel Width (ft)	Dowel Bar Spacing (in.)	Tie Bar Spacing (in.)	Lane Configuration	Visual Distress	Additional Observations
8	15	13	26	Not observed	1 lane per direction + central lane	Minimum surface cracks parallel to joint	<i>Construction date ~2014</i>

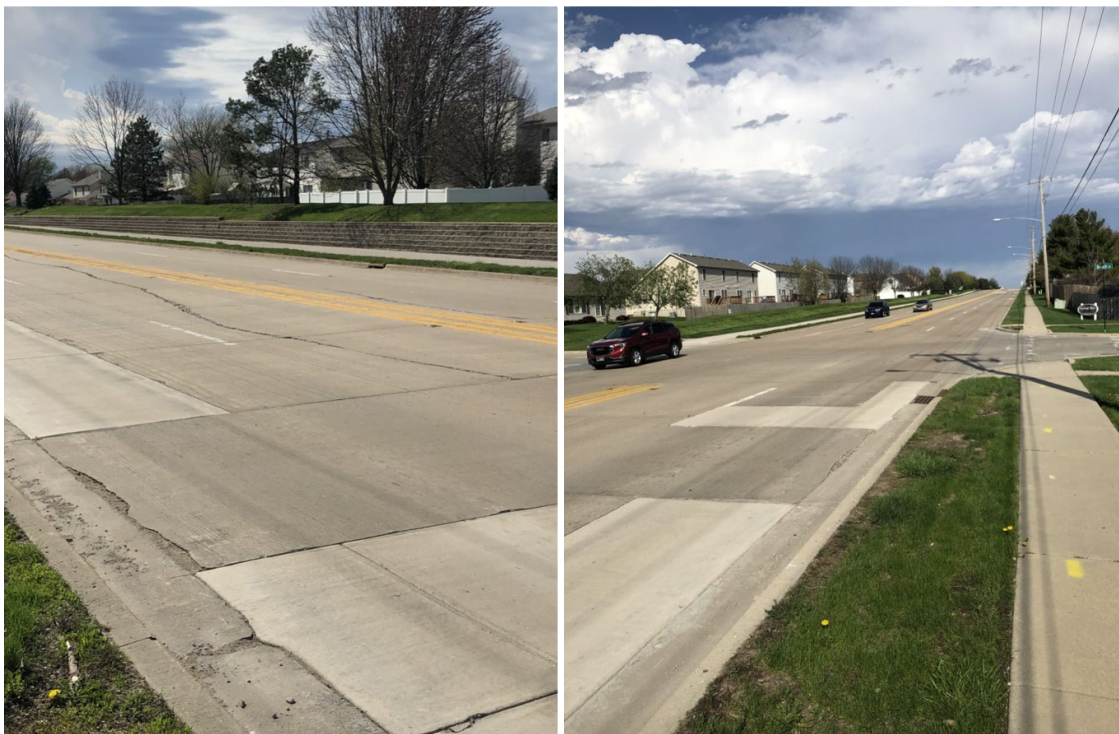
**Figure 99. Photos. Raab Street.**

Thickness (in.)	Panel Length (ft)	Panel Width (ft)	Dowel Bar Spacing (in.)	Tie Bar Spacing (in.)	Lane Configuration	Visual Distress	Additional Observations
Not evaluated.	17	12	Not evaluated.	Not evaluated.	2 lanes per direction	Continuous longitudinal cracking. (>50%)	Construction date ~ 2000s

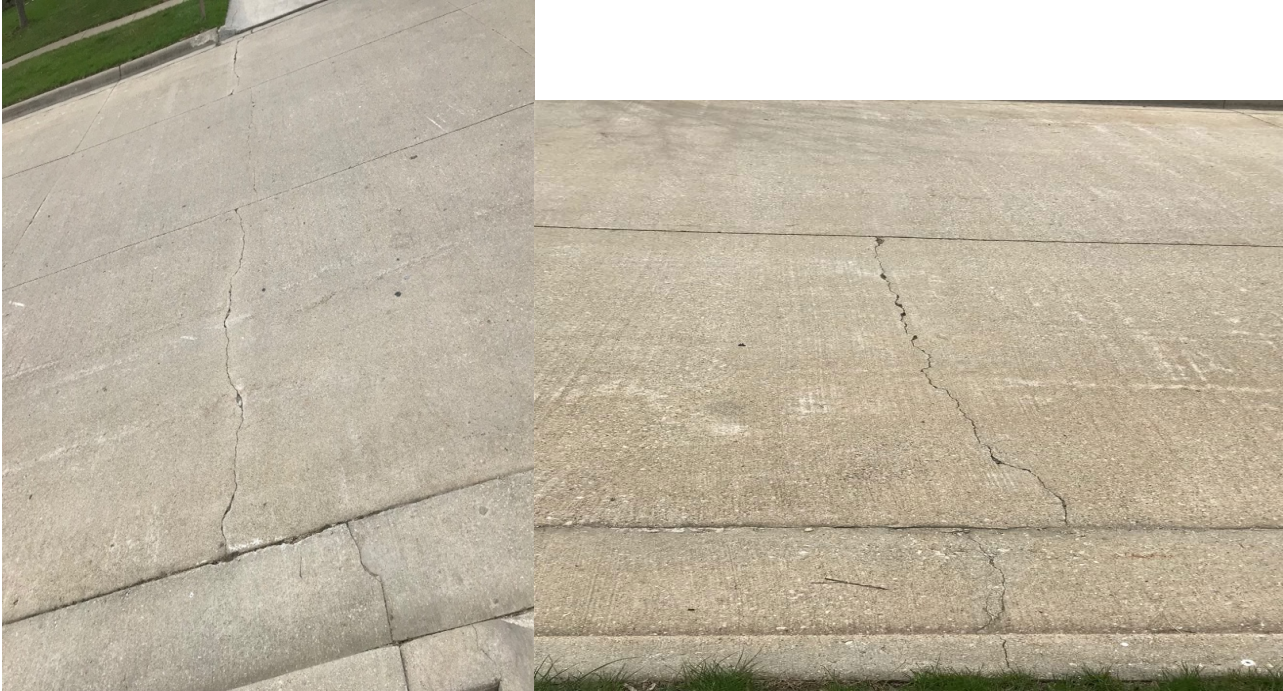
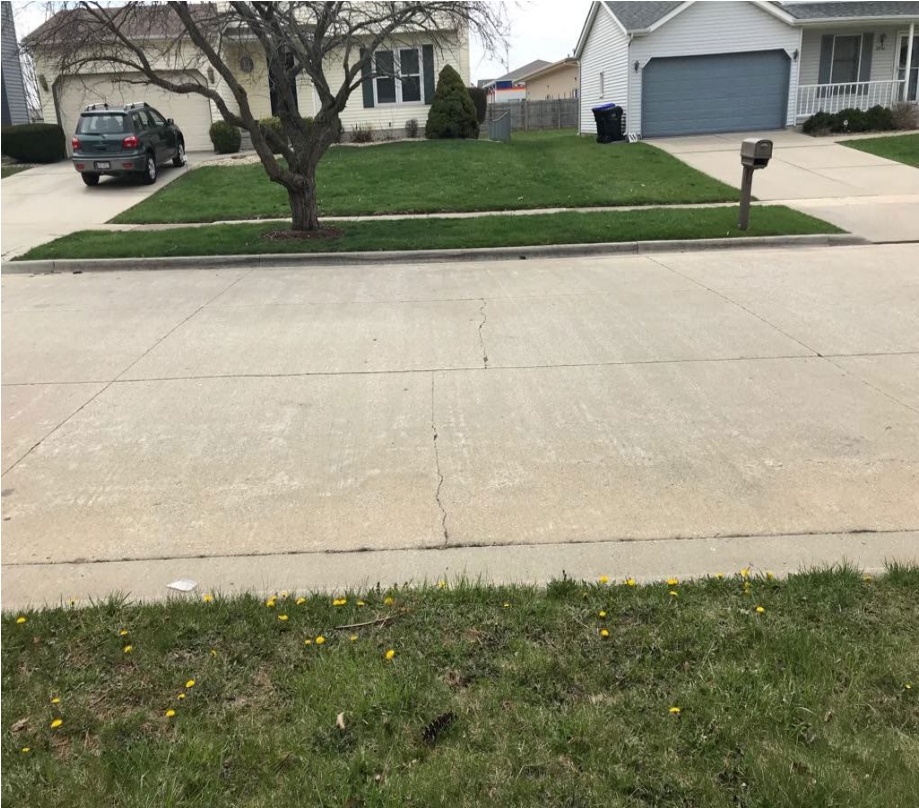
**Figure 100. Photos. Providence Drive.**

Thickness (in.)	Panel Length (ft)	Panel Width (ft)	Dowel Bar Spacing (in.)	Tie Bar Spacing (in.)	Lane Configuration	Visual Distress	Additional Observations
Not evaluated	20	9	Not evaluated	Not evaluated	1 lane per direction + central lane	Medium transverse cracking (>30%)	Construction date ~ 2000s

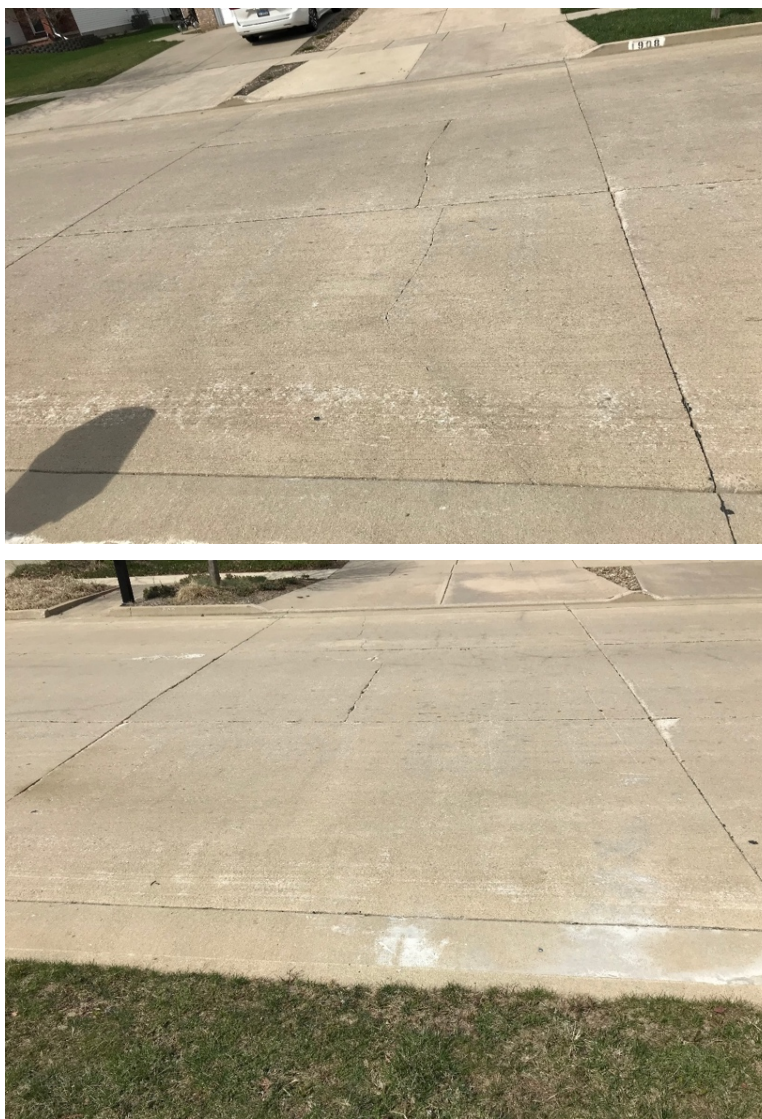
**Figure 101. Photos. Vladimir Drive.**

Thickness (in.)	Panel Length (ft)	Panel Width (ft)	Dowel Bar Spacing (in.)	Tie Bar Spacing (in.)	Lane Configuration	Visual Distress	Additional Observations
Not evaluated	15	9	Not evaluated	Not evaluated	1 lane per direction + central lane	Transverse cracking (>30%)	<i>Construction date ~2000s</i>

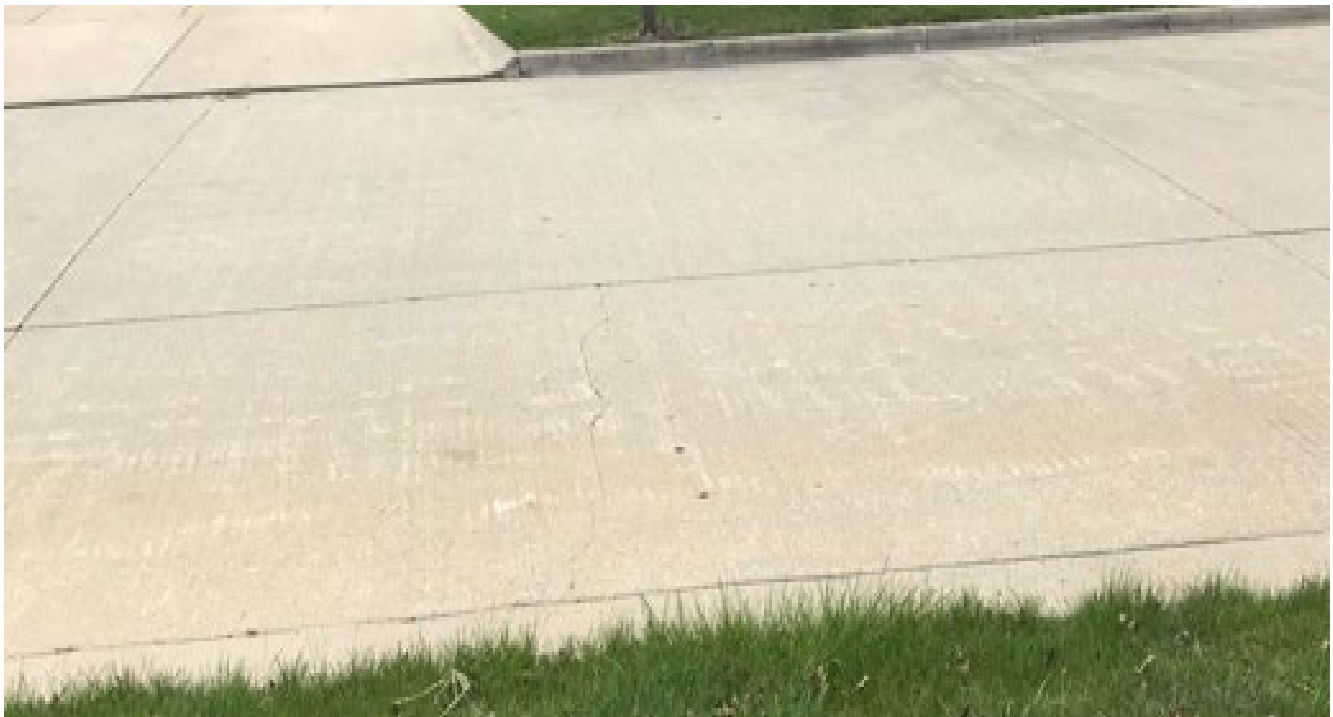
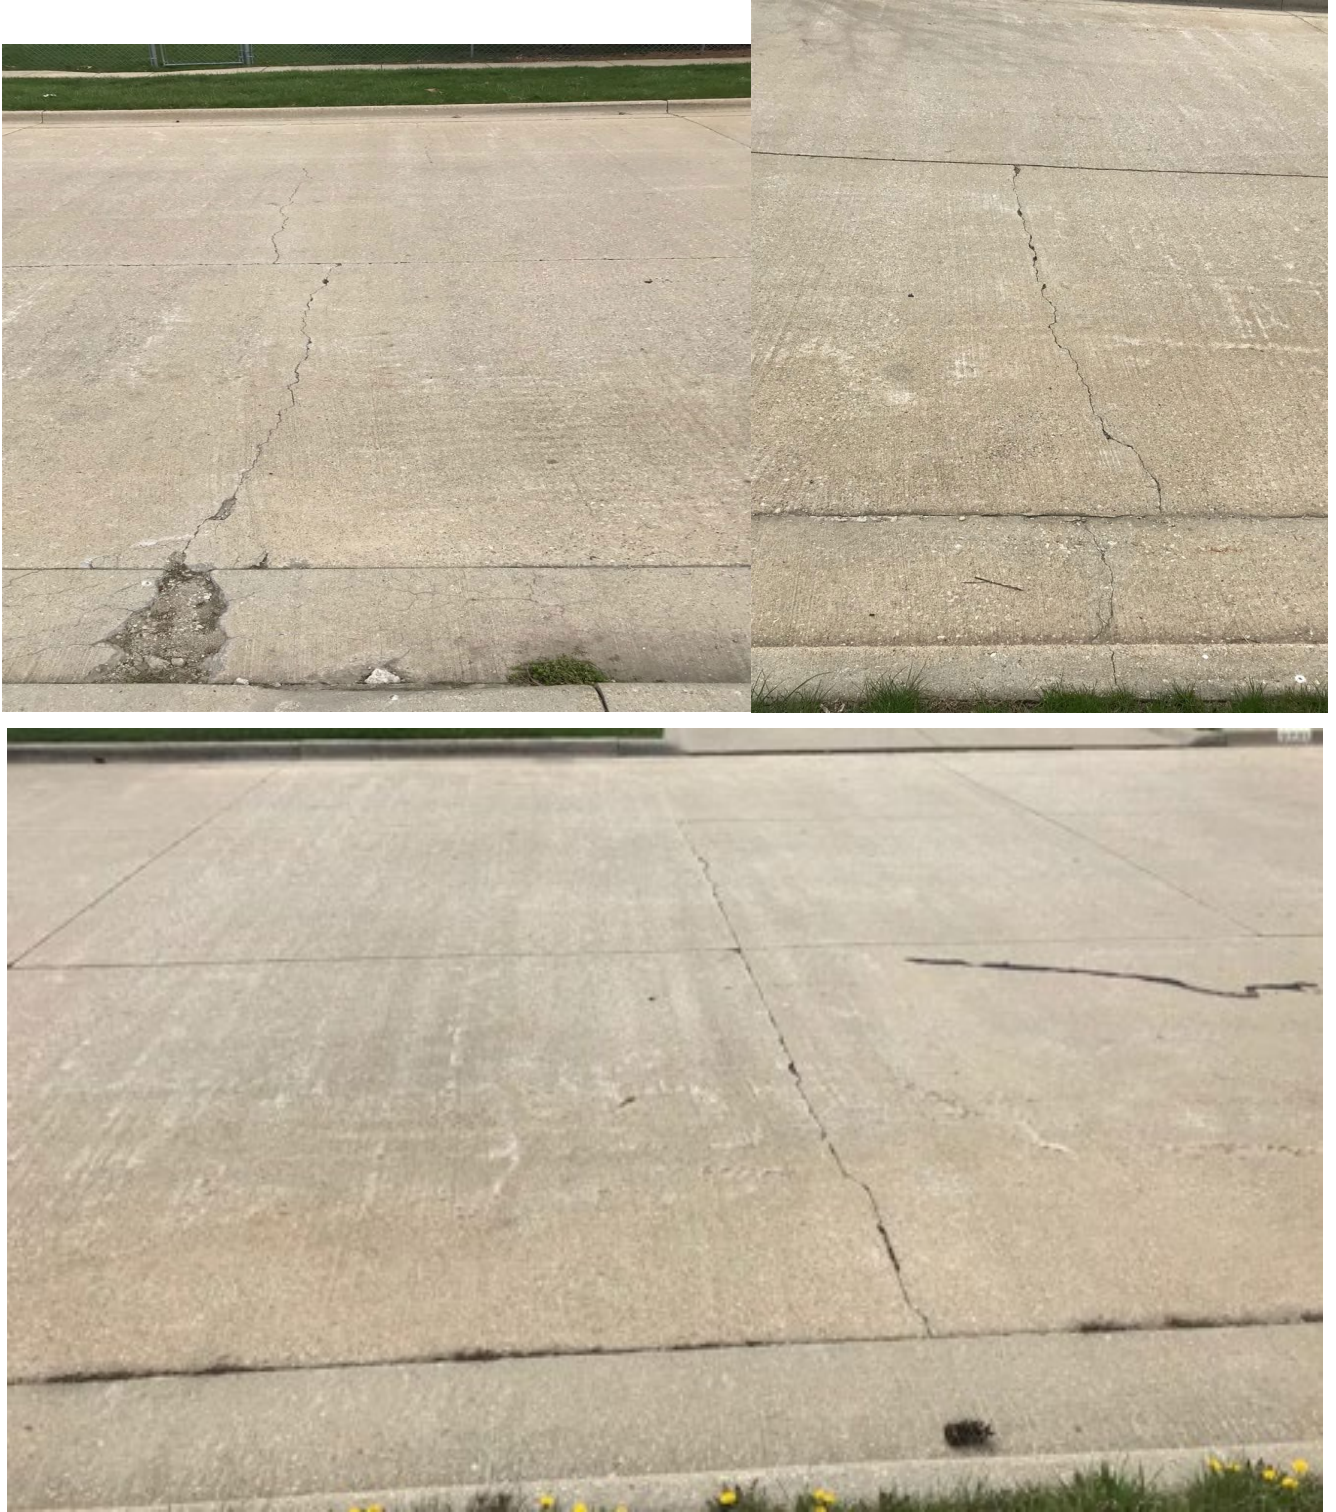
**Figure 102. Photos. Slaydon Drive.**

Thickness (in.)	Panel Length (ft)	Panel Width (ft)	Dowel Bar Spacing (in.)	Tie Bar Spacing (in.)	Lane Configuration	Visual Distress	Additional Observations
Not evaluated	20	9	Not evaluated	Not evaluated	1 lane per direction + central lane	Transverse cracking (>50%)	<i>Construction date ~2000s</i>
