# Evaluation of Premature Cracking in Urban Concrete Pavement

Research Report No. FHWA-ICT-21-001

A report of the findings of  
**ICT PROJECT R27-193-4**  
**Premature Cracking Mechanism for**  
**Jointed Plain Concrete Pavement**

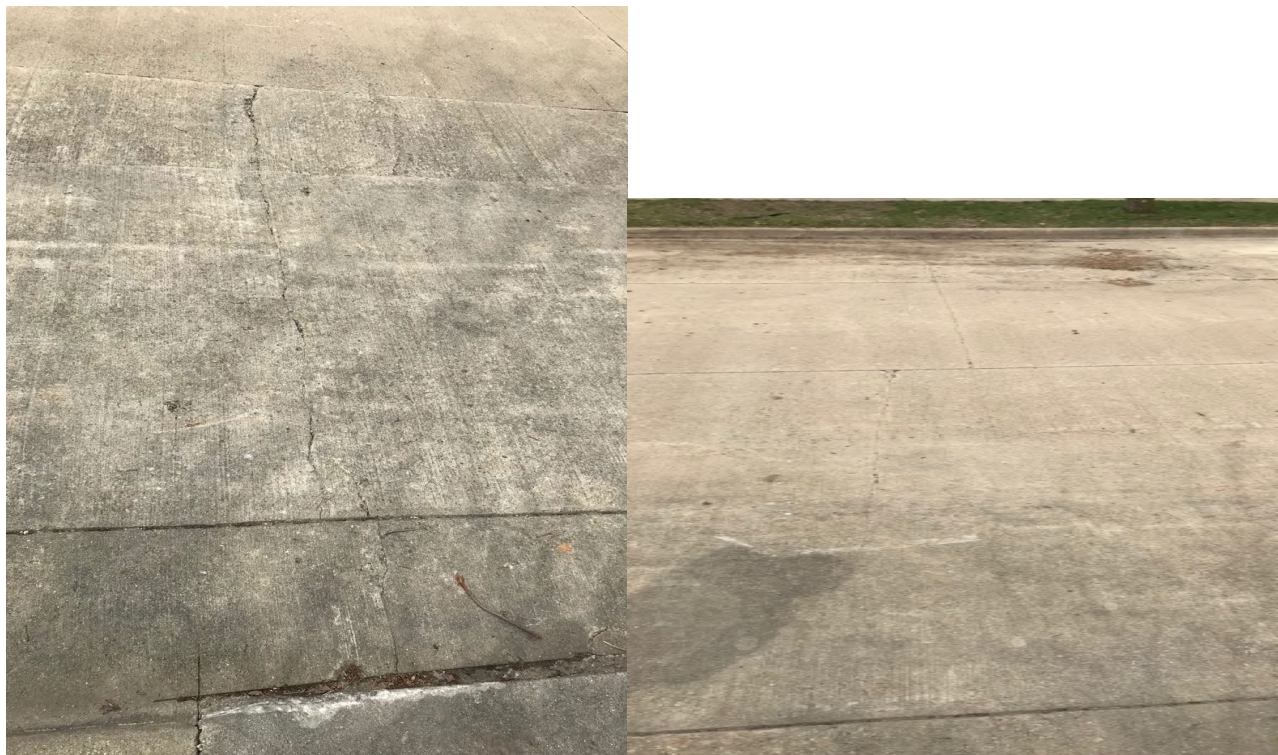
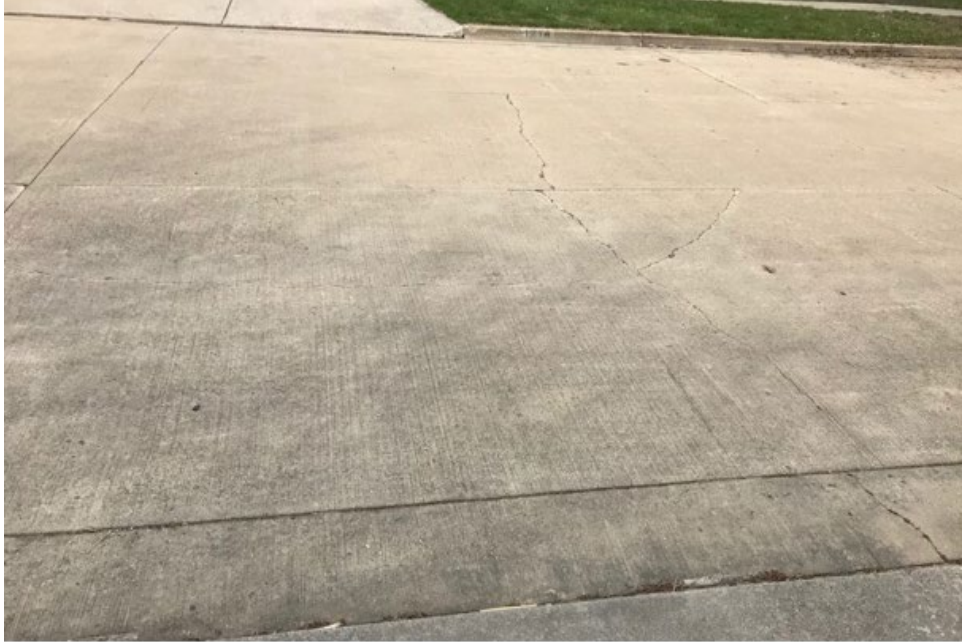
Figure 103. Photos. Challis Drive.

Thickness (in.)	Panel Length (ft)	Panel Width (ft)	Dowel Bar Spacing (in.)	Tie Bar Spacing (in.)	Lane Configuration	Visual Distress	Additional Observations
Not evaluated	20	9	Not evaluated	Not evaluated	1 lane per direction + central lane	Transverse cracking (>30%)	<i>Construction date ~2000s</i>

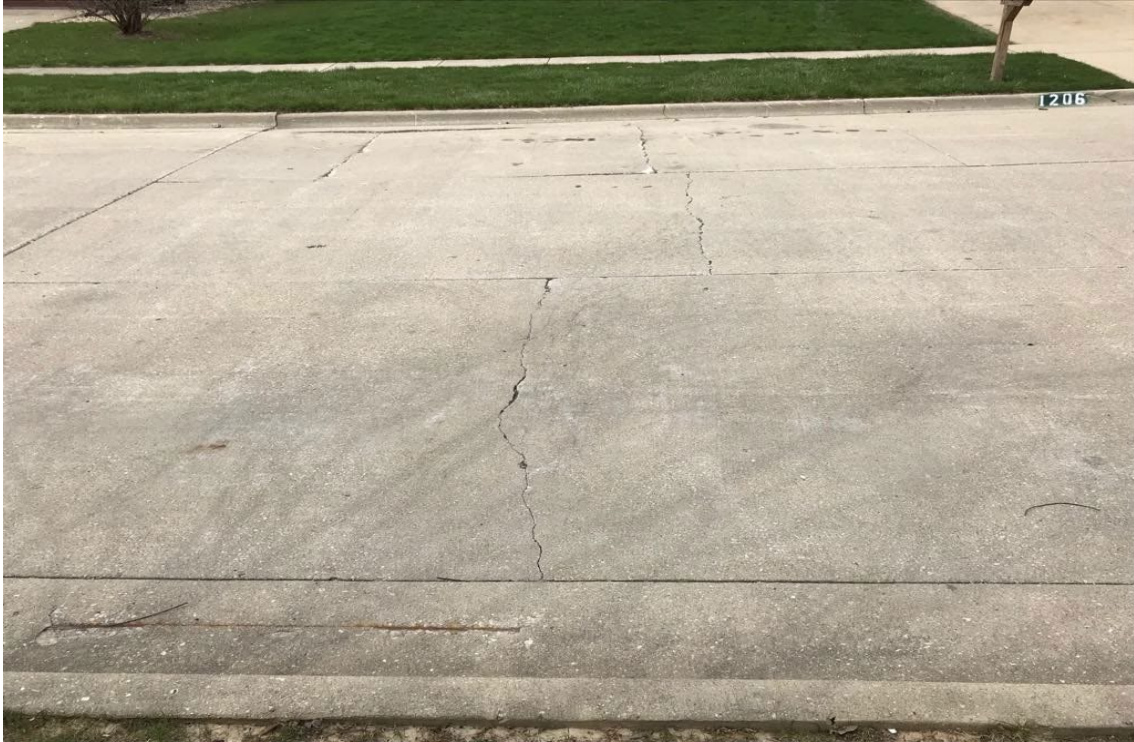
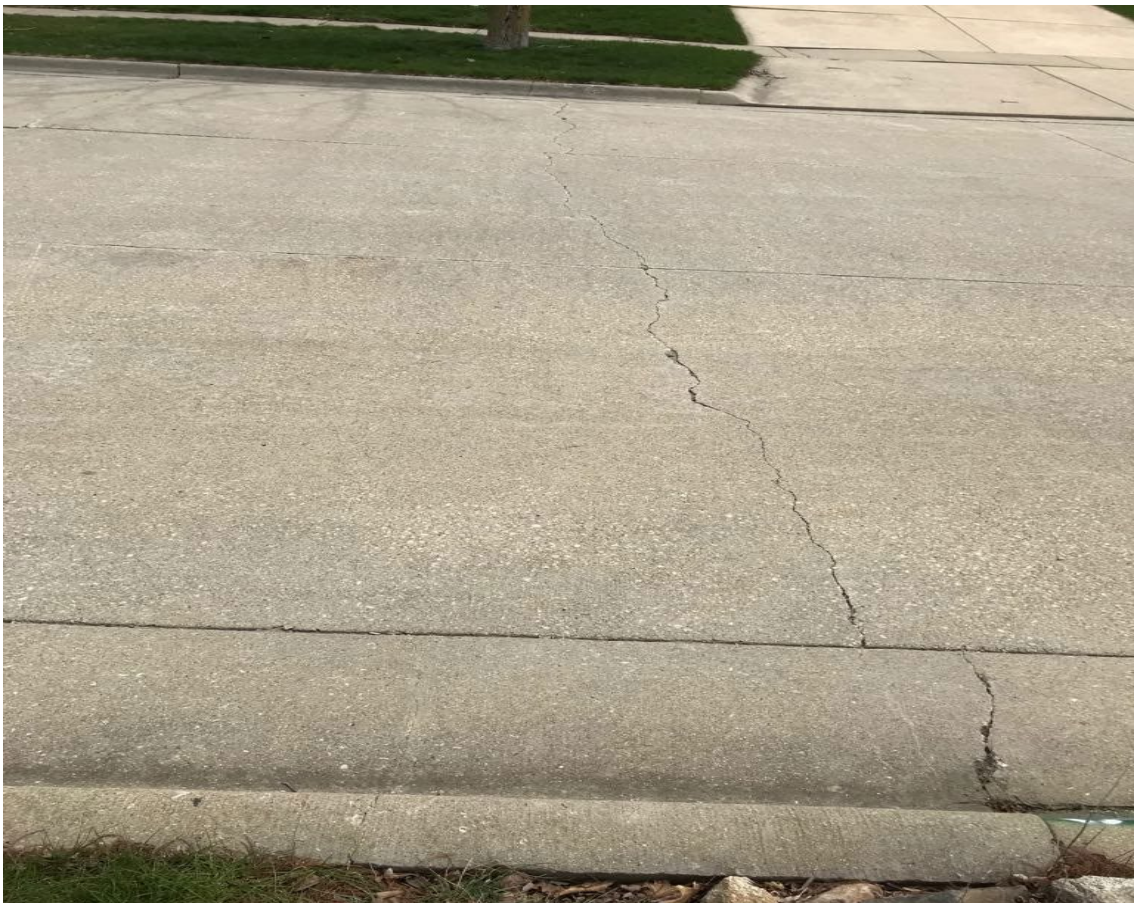
**Figure 104. Photos. Bancoft Drive.**

Thickness (in.)	Panel Length (ft)	Panel Width (ft)	Dowel Bar Spacing (in.)	Tie Bar Spacing (in.)	Lane Configuration	Visual Distress	Additional Observations
Not evaluated	20	9	Not evaluated	Not evaluated	1 lane per direction + central lane	Medium transverse cracking (>50%)	<i>Construction date ~2000s</i>

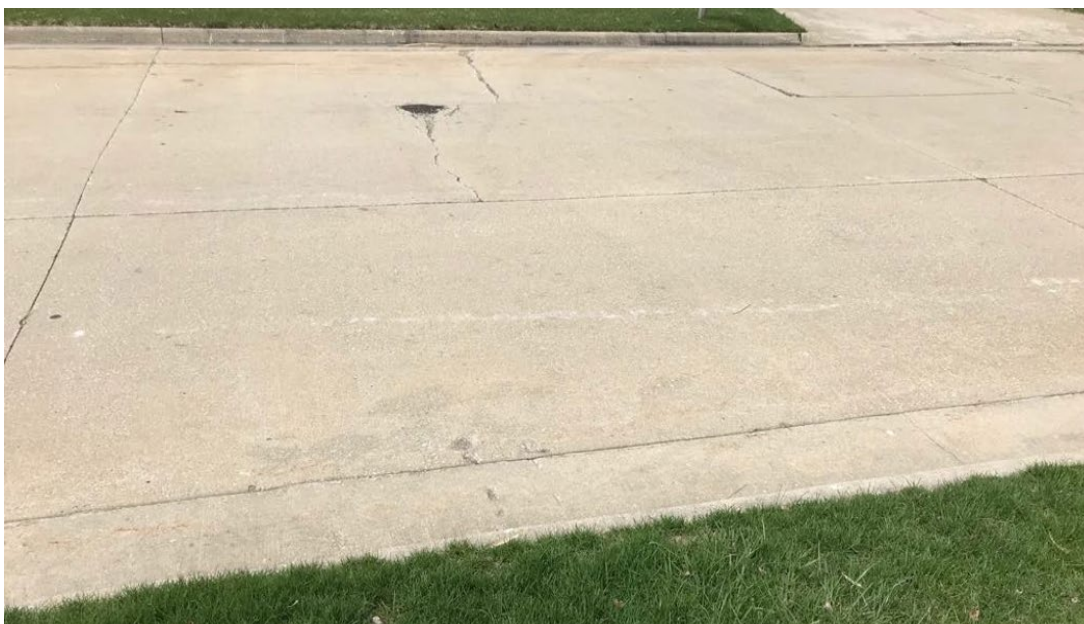
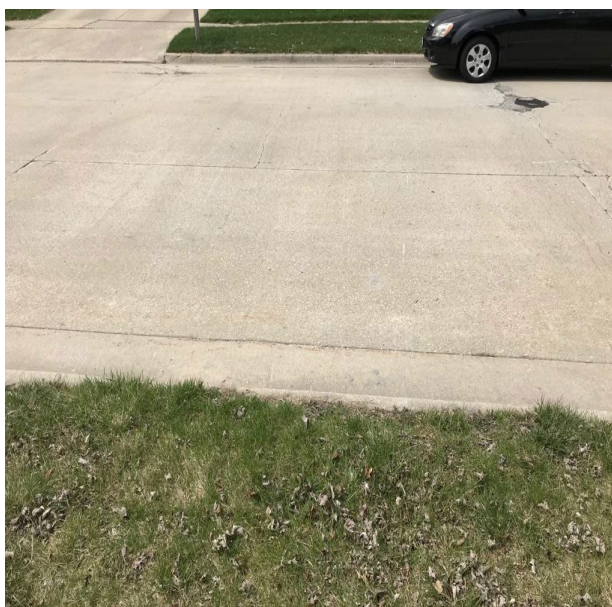
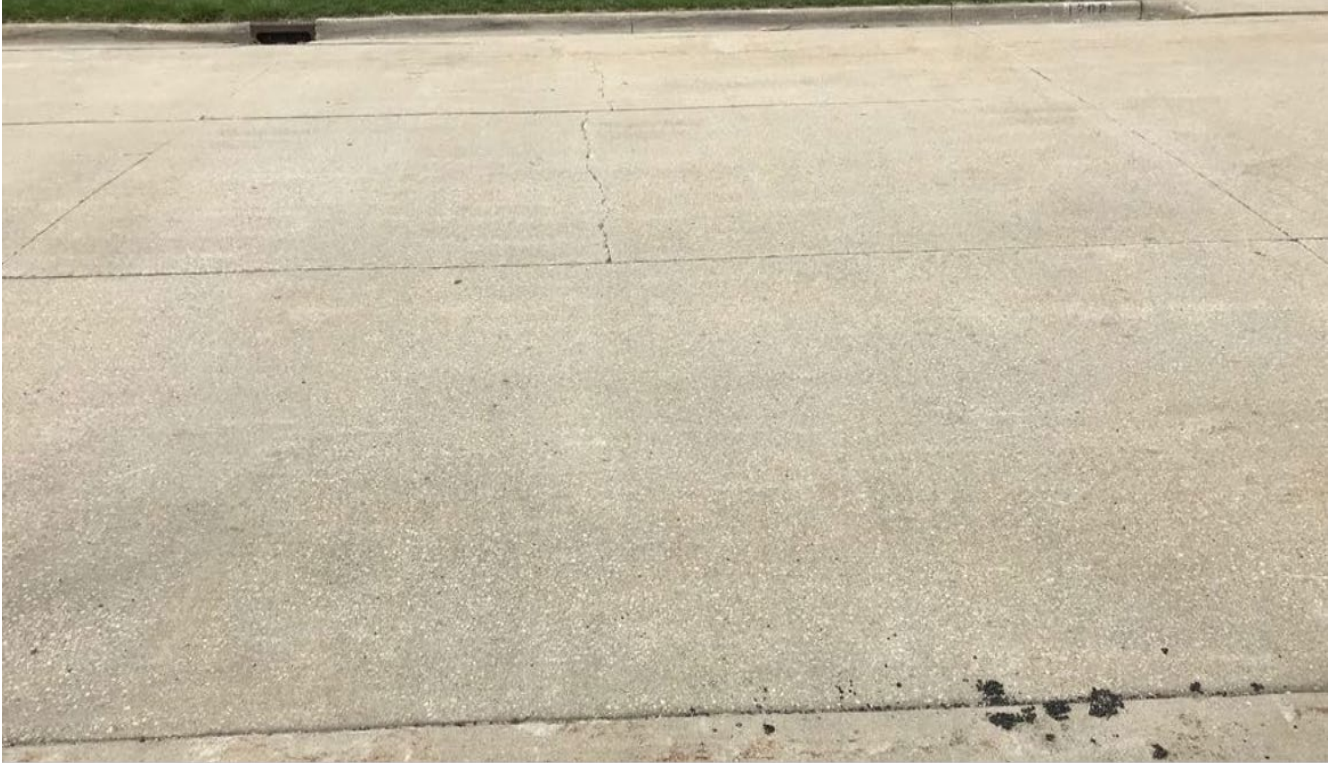
Figure 105. Photos. Cadwell Drive.

Thickness (in.)	Panel Length (ft)	Panel Width (ft)	Dowel Bar Spacing (in.)	Tie Bar Spacing (in.)	Lane Configuration	Visual Distress	Additional Observations
Not evaluated	20	9	Not evaluated	Not evaluated	1 lane per direction + central lane	Transverse cracking (>30%)	<i>Construction date ~2000s</i>

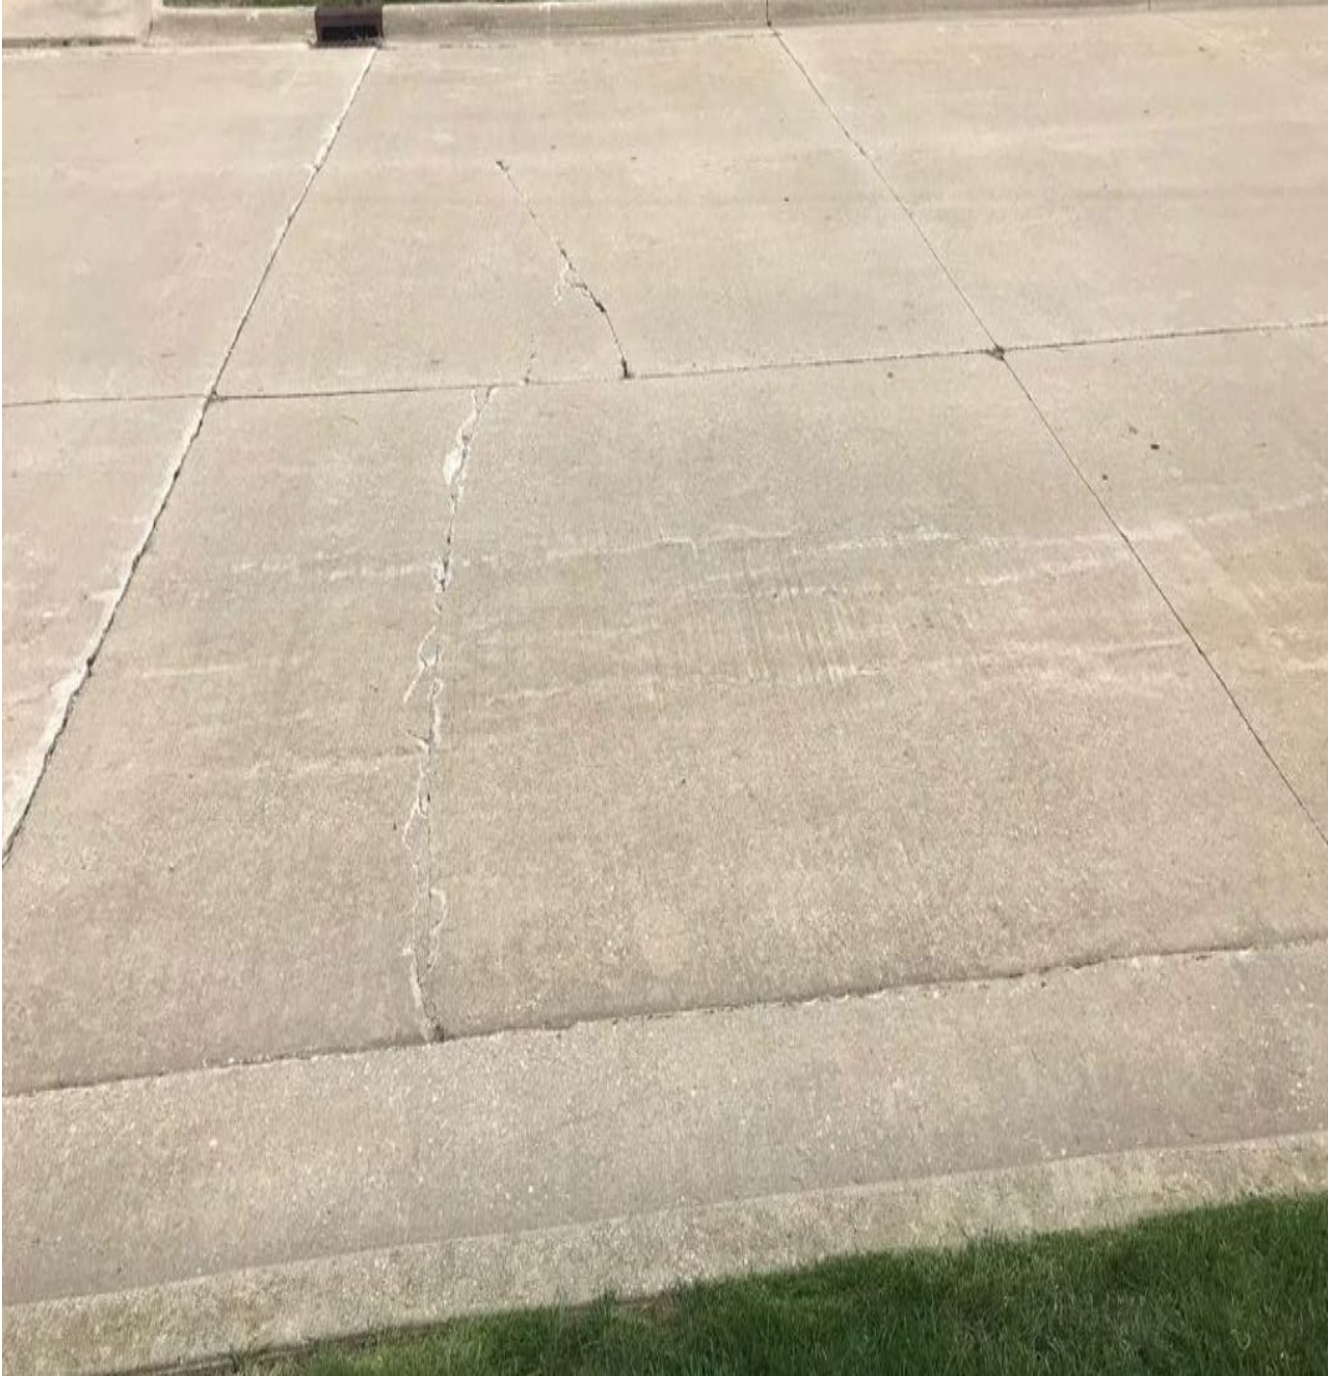
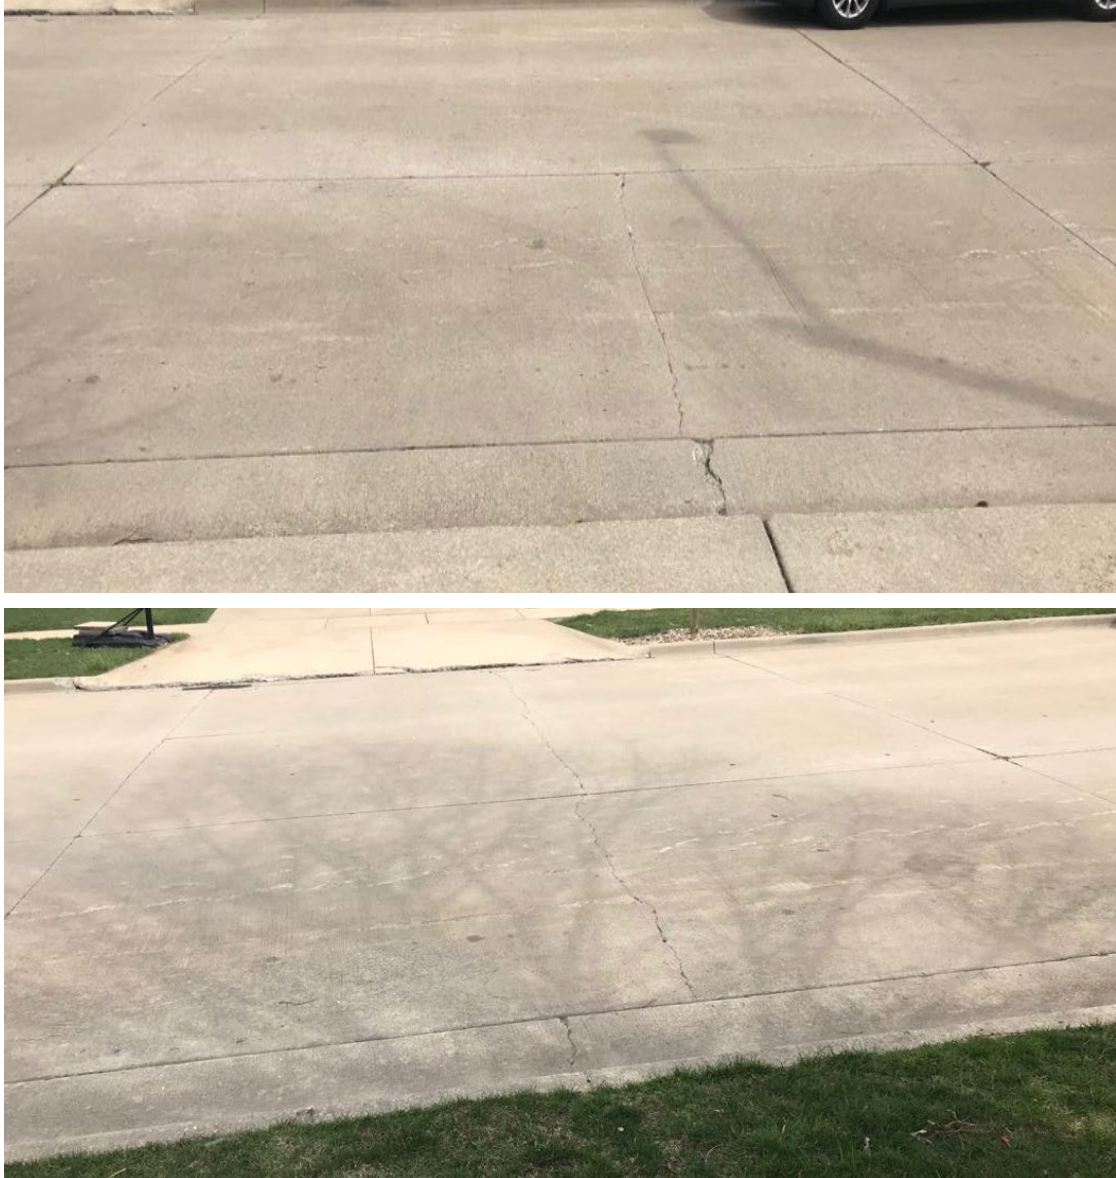
Figure 106. Photos. Newcastle Drive.

Thickness (in.)	Panel Length (ft)	Panel Width (ft)	Dowel Bar Spacing (in.)	Tie Bar Spacing (in.)	Lane Configuration	Visual Distress	Additional Observations
Not evaluated	20	9	Not evaluated	Not evaluated	1 lane per side + central lane	Transverse cracking (>30%)	<i>Construction date ~2000s</i>

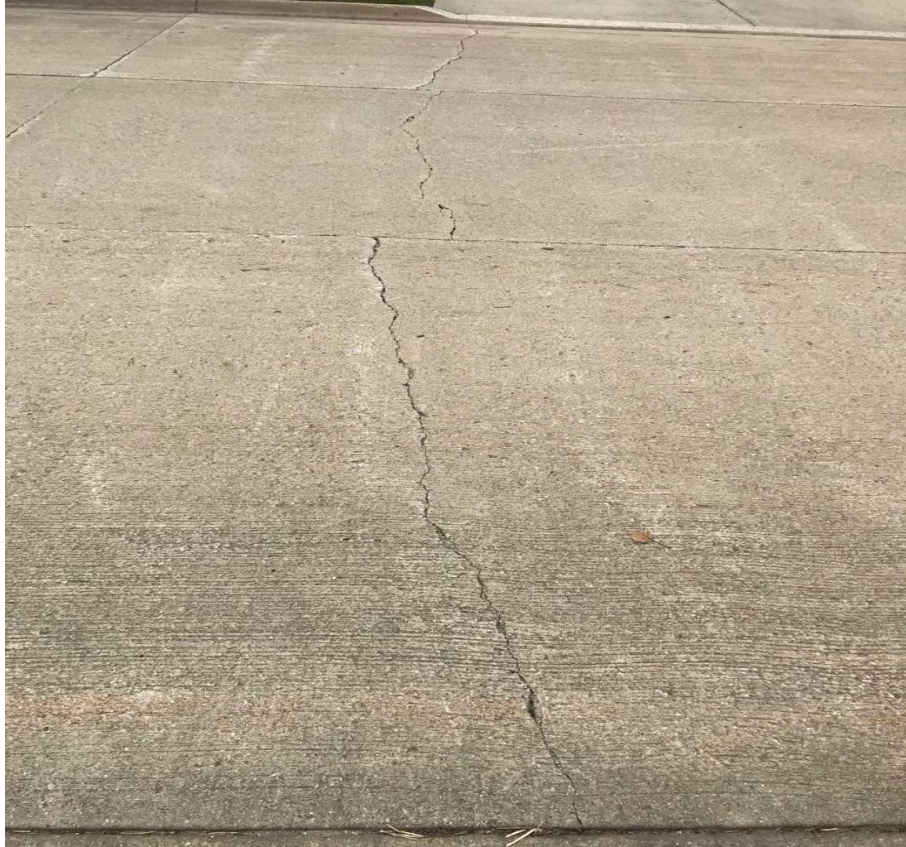
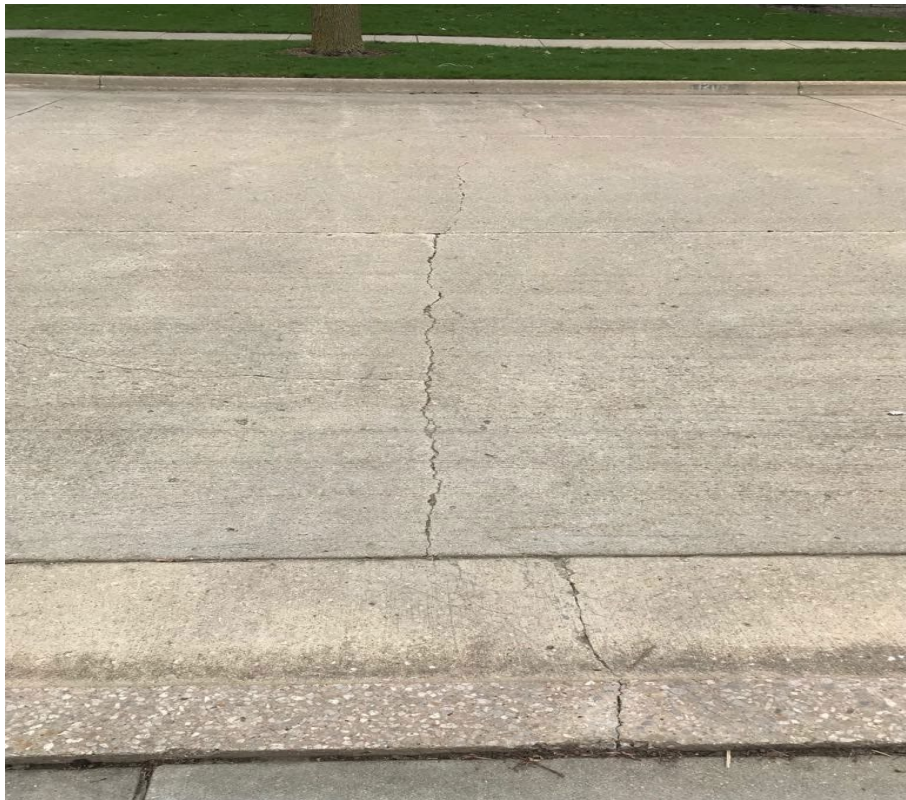
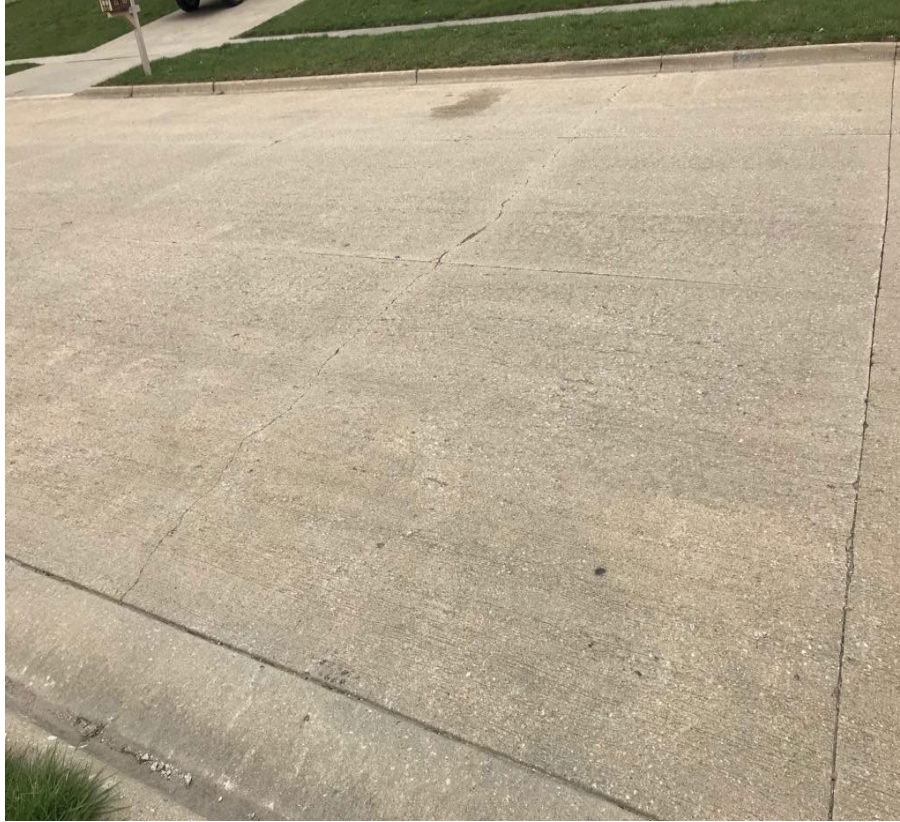
Figure 107. Photos. Chantal Lane.

Thickness (in.)	Panel Length (ft)	Panel Width (ft)	Dowel Bar Spacing (in.)	Tie Bar Spacing (in.)	Lane Configuration	Visual Distress	Additional Observations
Not evaluated	20	9	Not evaluated	Not evaluated	1 lane per direction + central lane	Transverse cracking (>30%)	Construction date ~2000s

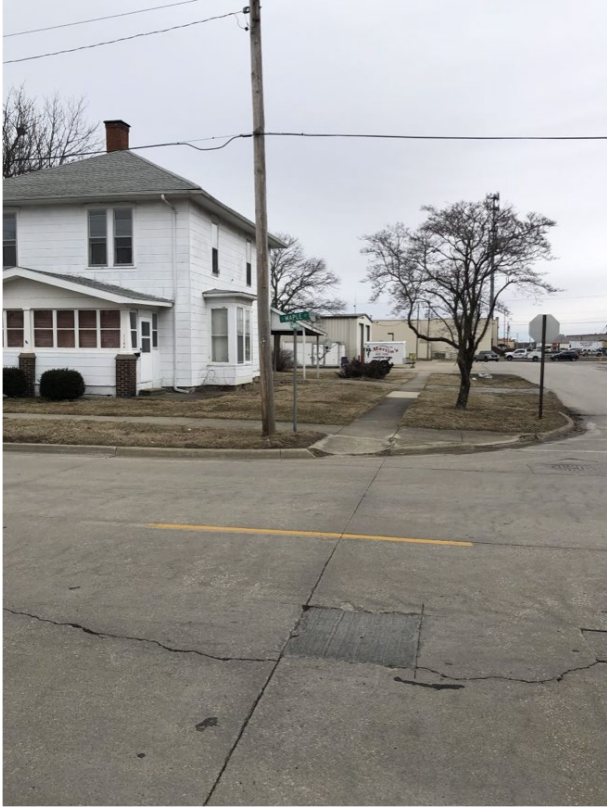
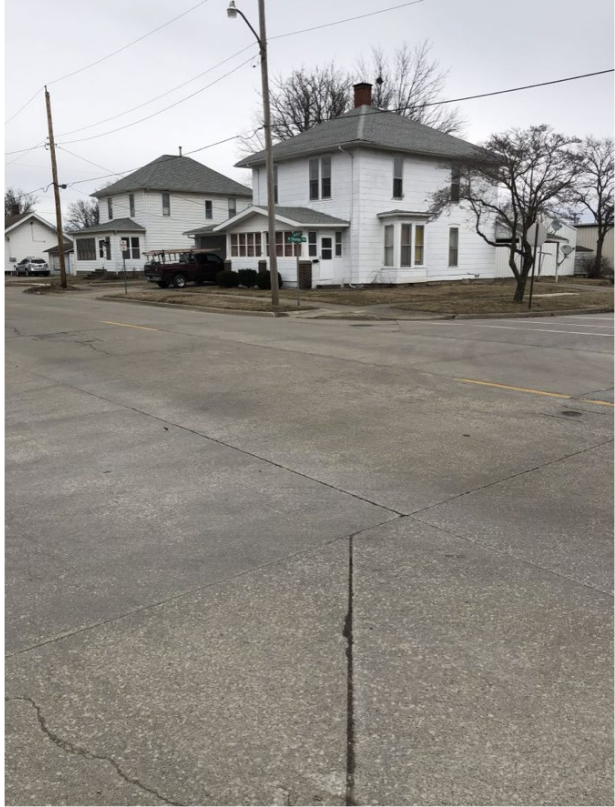
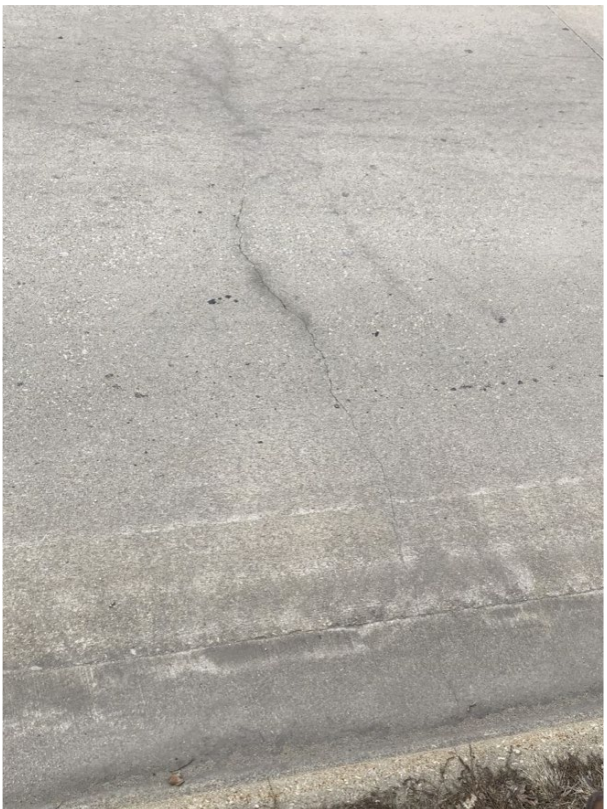
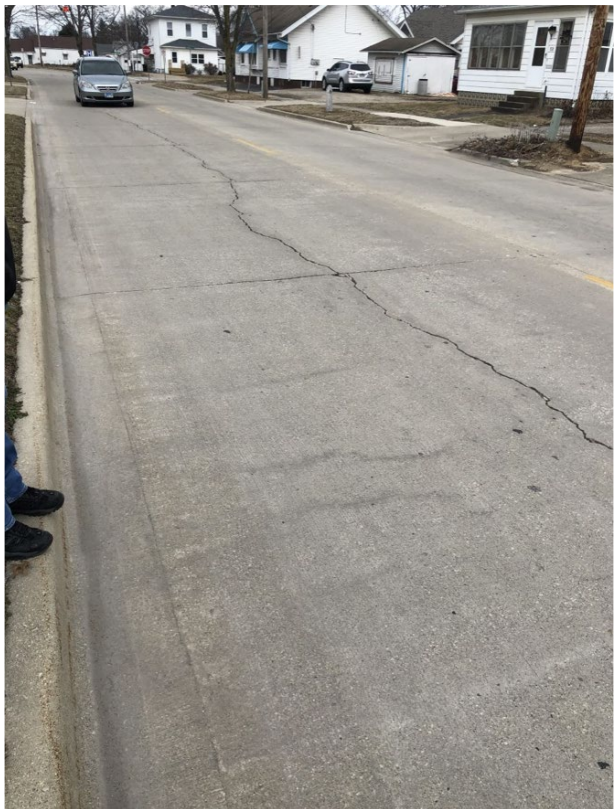
**Figure 109. Photos. Maple Street (downtown).**

Thickness (in.)	Panel Length (ft)	Panel Width (ft)	Dowel Bar Spacing (in.)	Tie Bar Spacing (in.)	Lane Configuration	Visual Distress	Additional Observations
8	15	12	Not observed	Not observed	1 lane per direction	Longitudinal cracking. (>50%)	<i>Construction date ~2000s</i>

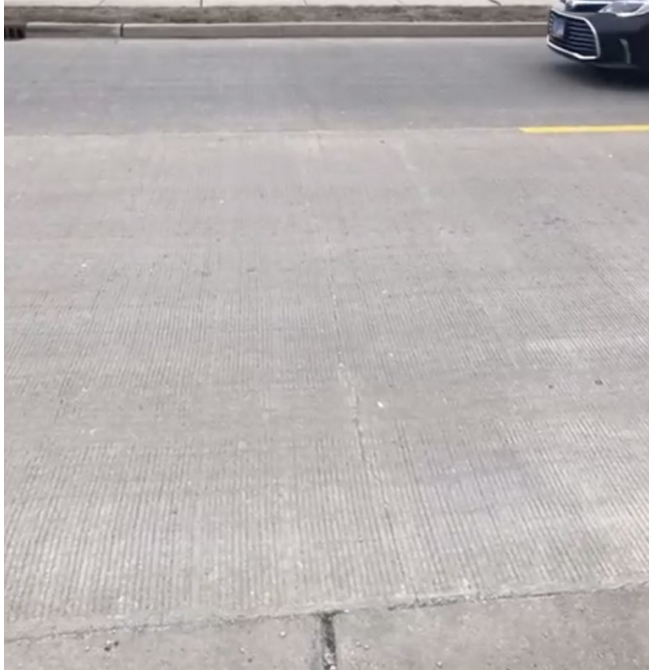
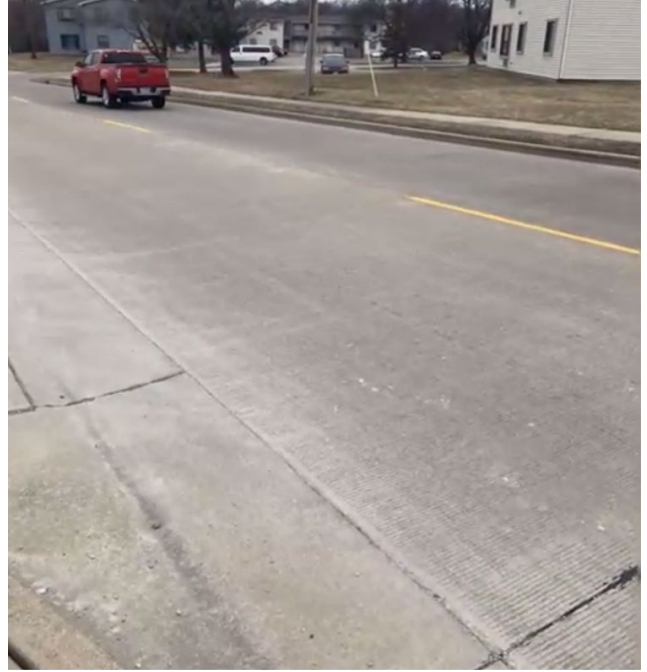
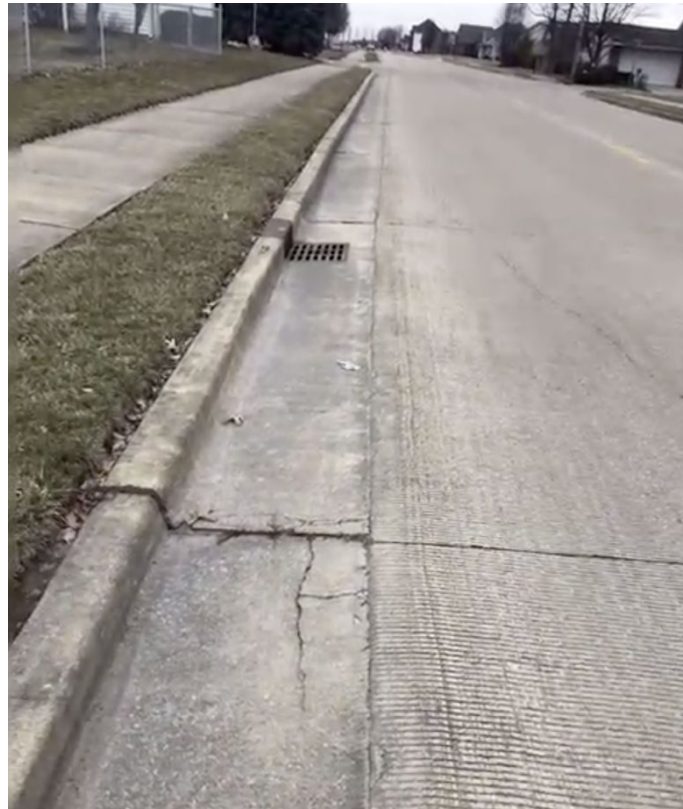
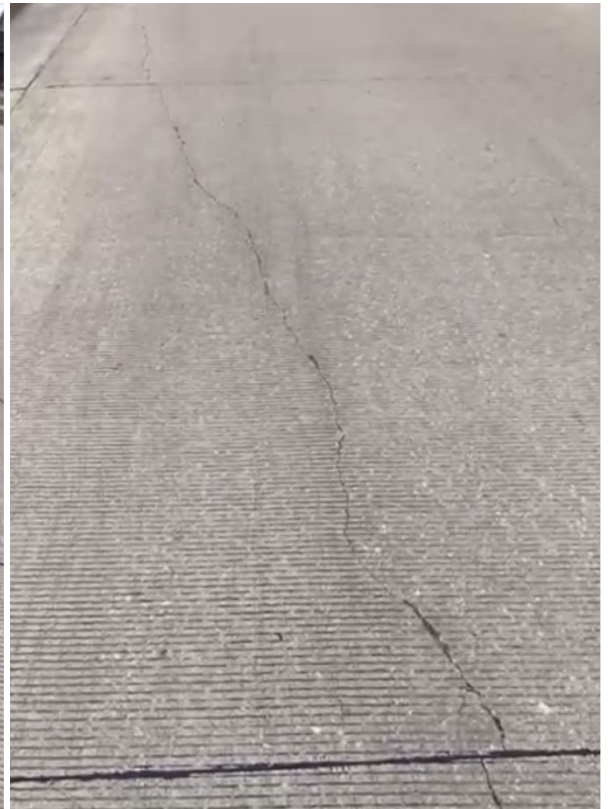
**Figure 111. Photos. Maple Street (North).**

Thickness (in.)	Panel Length (ft)	Panel Width (ft)	Dowel Bar Spacing (in.)	Tie Bar Spacing (in.)	Lane Configuration	Visual Distress	Additional Observations
8	15	12	Variable	Variable	1 lane per direction	Mid-panel cracking and longitudinal cracks (<30%)	<i>Construction date ~2000s</i>

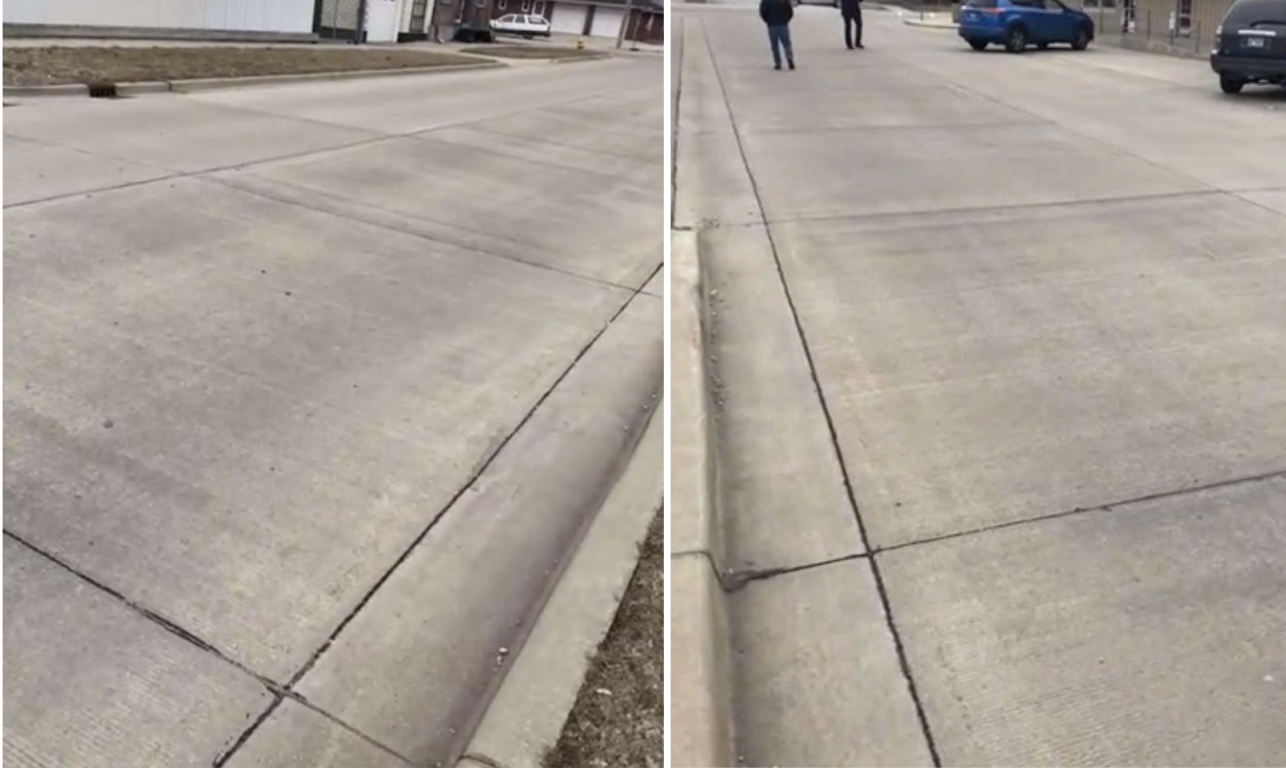
Figure 113. Photos. Ford Street.

Thickness (in.)	Panel Length (ft)	Panel Width (ft)	Dowel Bar Spacing (in.)	Tie Bar Spacing (in.)	Lane Configuration	Visual Distress	Additional Observations
9	13	20	Not observed	Variable	1 lane per direction	Transverse cracking (>30%)	Construction date ~2000s

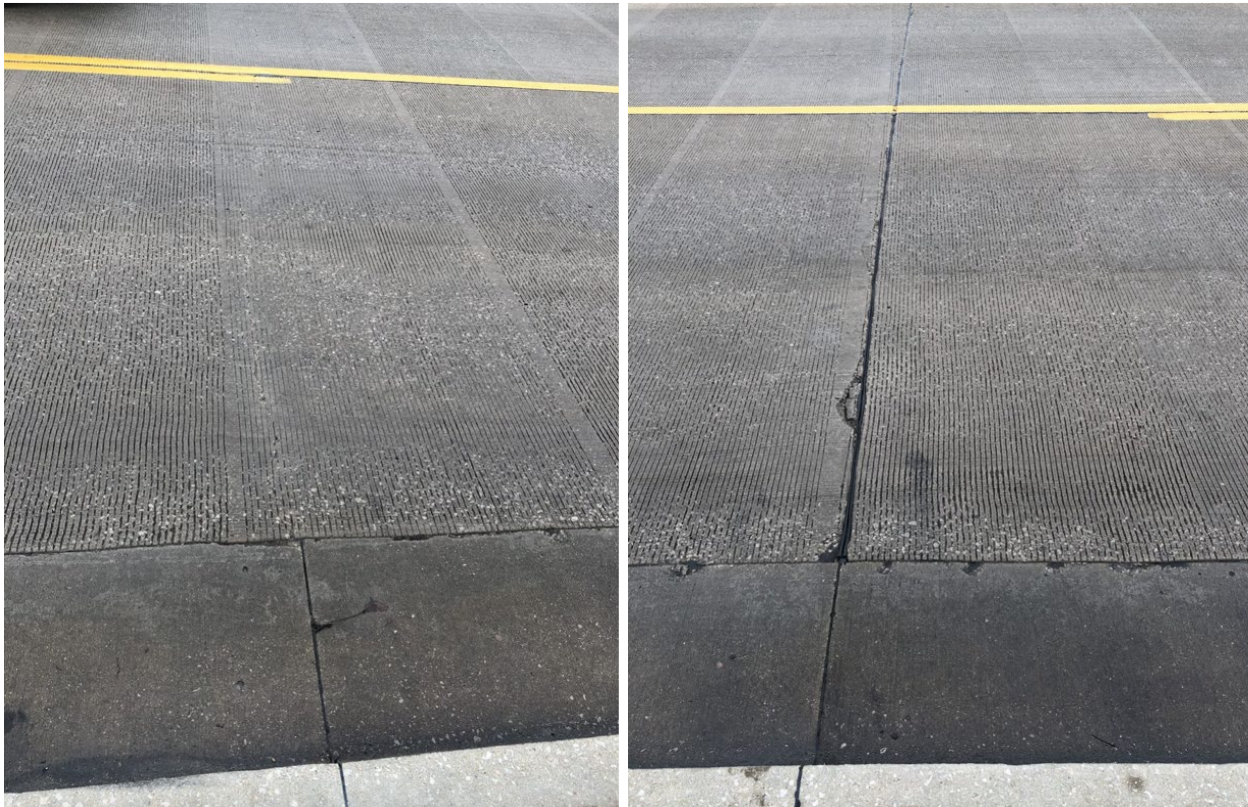
Figure 116. Photos. Harrison Street with Wesley Drive.

Thickness (in.)	Panel Length (ft)	Panel Width (ft)	Dowel Bar Spacing (in.)	Tie Bar Spacing (in.)	Lane Configuration	Visual Distress	Additional Observations
8	45	12	24	Not observed	2 lanes per direction	Transverse cracking and joint deterioration (~98%)	<i>Construction date ~2010s</i>

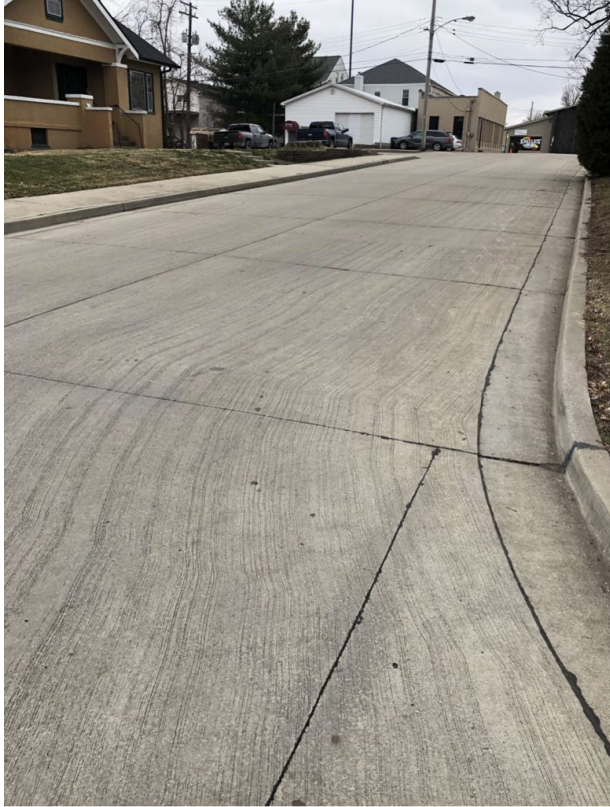
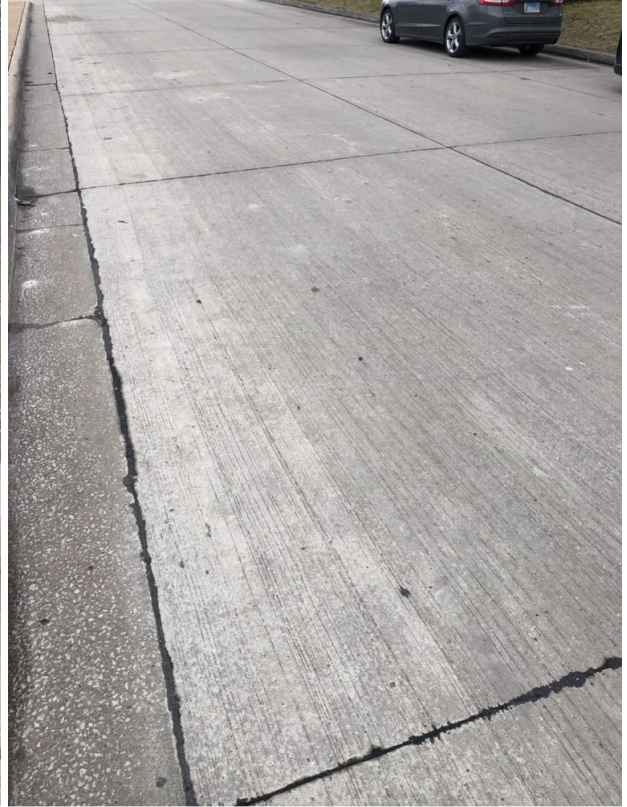
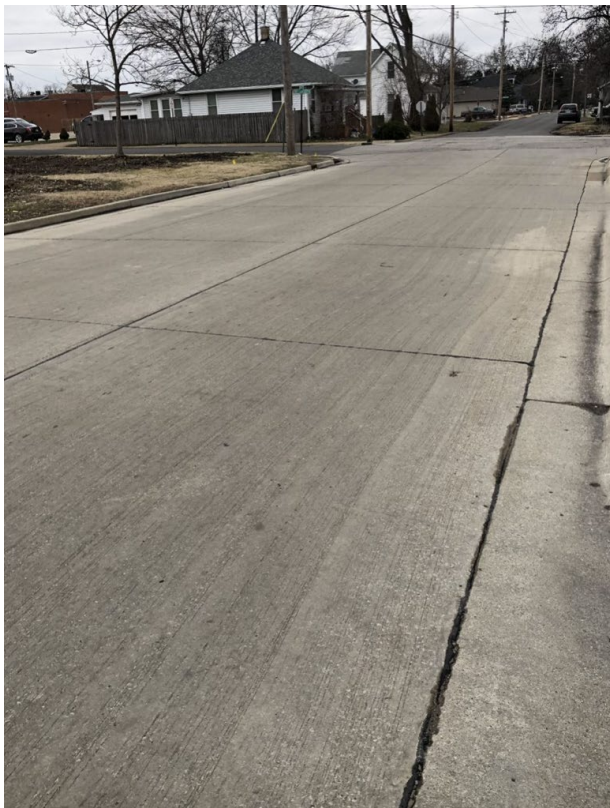
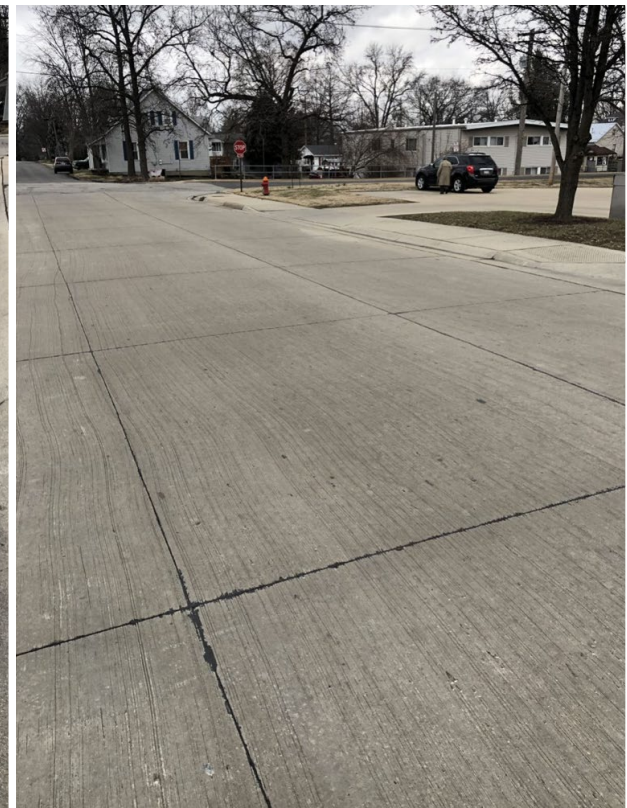
**Figure 117. Photos. Matter Avenue.**

Thickness (in.)	Panel Length (ft)	Panel Width (ft)	Dowel Bar Spacing (in.)	Tie Bar Spacing (in.)	Lane Configuration	Visual Distress	Additional Observations
8	15	11	Not detected	36	1 lane per direction	None	Construction date ~ 2010s

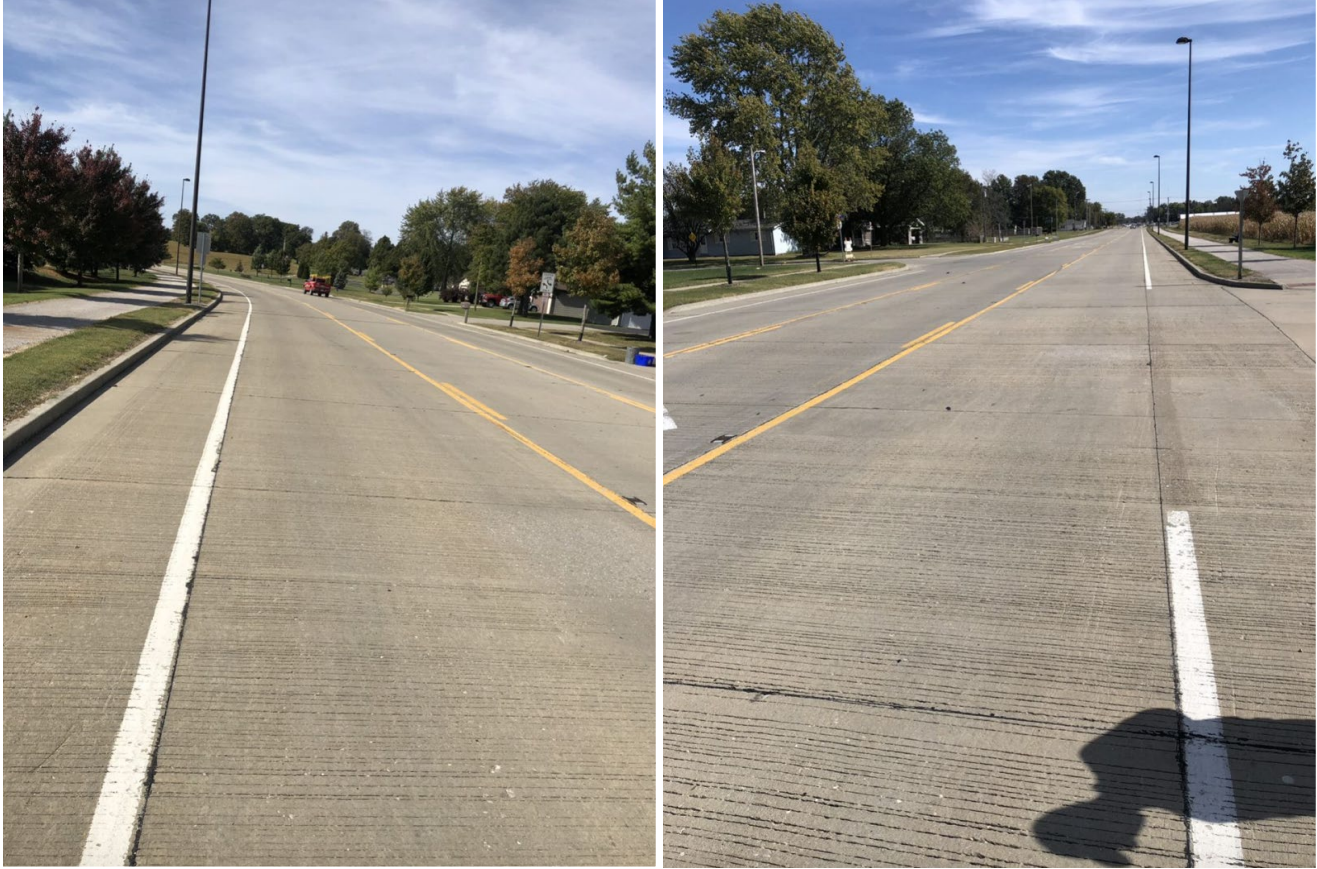
Figure 119. Photos. Koefil Lane.

Thickness (in.)	Panel Length (ft)	Panel Width (ft)	Dowel Bar Spacing (in.)	Tie Bar Spacing (in.)	Lane Configuration	Visual Distress	Additional Observations
8	15	12	12	36	2 lanes per direction + bicycle lane	No distress observed	Construction date ~2010s

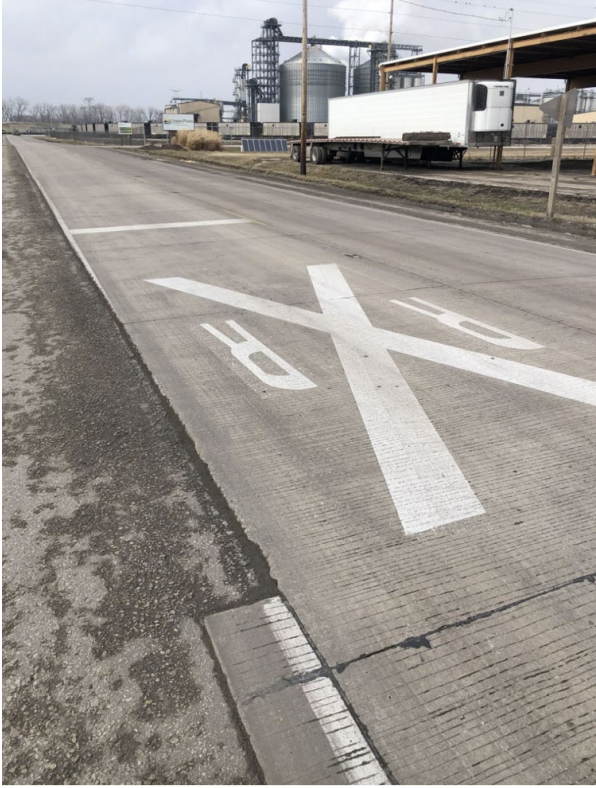
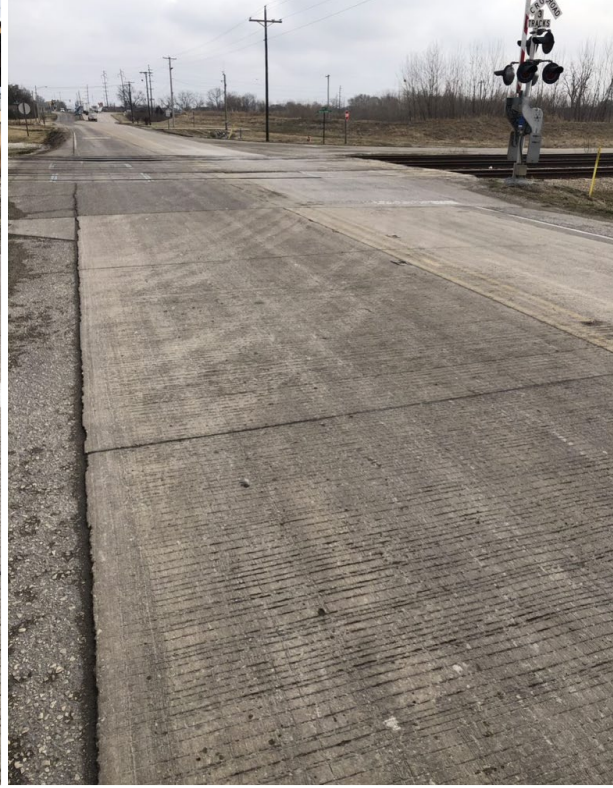
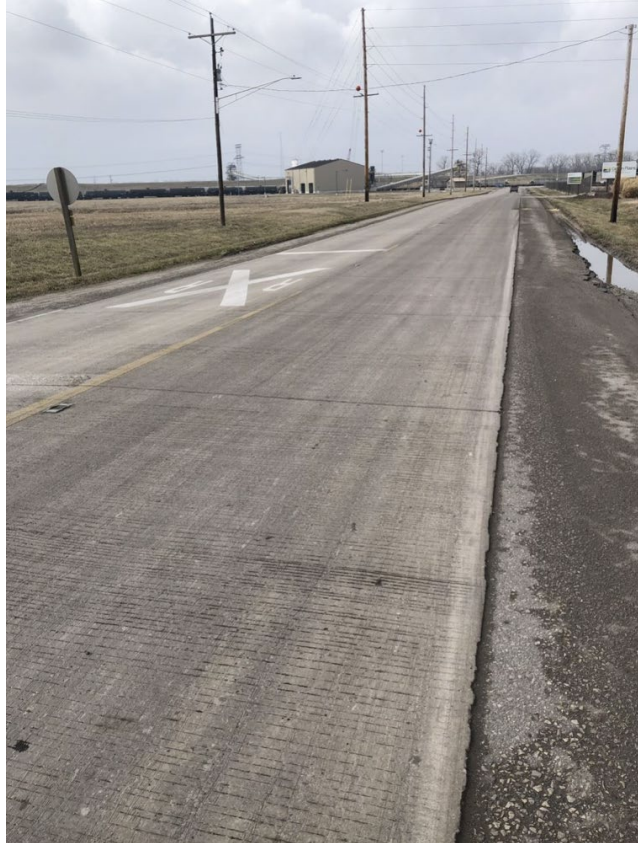
**Figure 121. Photos. Bissel Road.**

Thickness (in.)	Panel Length (ft)	Panel Width (ft)	Dowel Bar Spacing (in.)	Tie Bar Spacing (in.)	Lane Configuration	Visual Distress	Additional Observations
Variable within 10-12	15	12	24	36	2 lanes per direction	No distress observed	Construction date ~ 2010s
