# Evaluation of Premature Cracking in Urban Concrete Pavement

Research Report No. FHWA-ICT-21-001

A report of the findings of  
**ICT PROJECT R27-193-4**  
**Premature Cracking Mechanism for**  
**Jointed Plain Concrete Pavement**

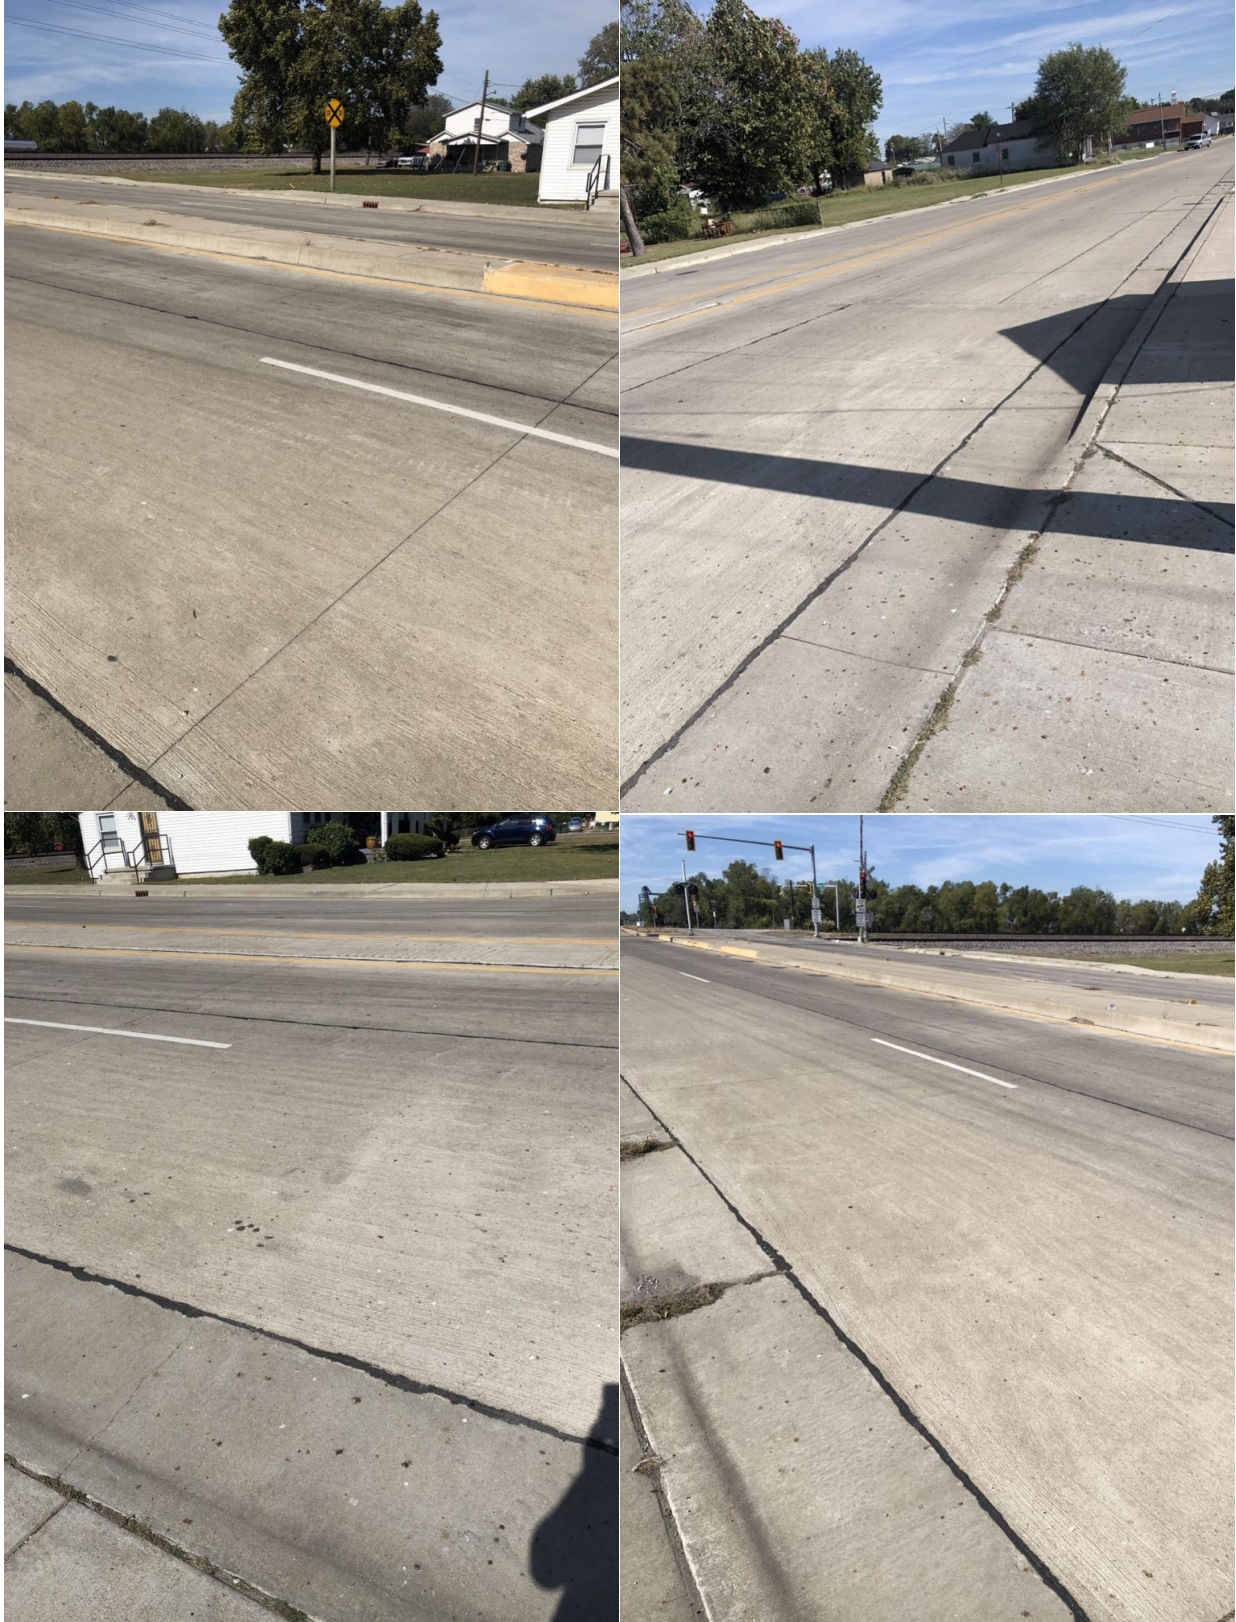
**Figure 123. Photos. Bissel Road section 2.**

Thickness (in.)	Panel Length (ft)	Panel Width (ft)	Dowel Bar Spacing (in.)	Tie Bar Spacing (in.)	Lane Configuration	Visual Distress	Additional Observations
7	18	12	12	72	1 lane per direction	Transverse cracking (>50%)	Construction date ~2010s

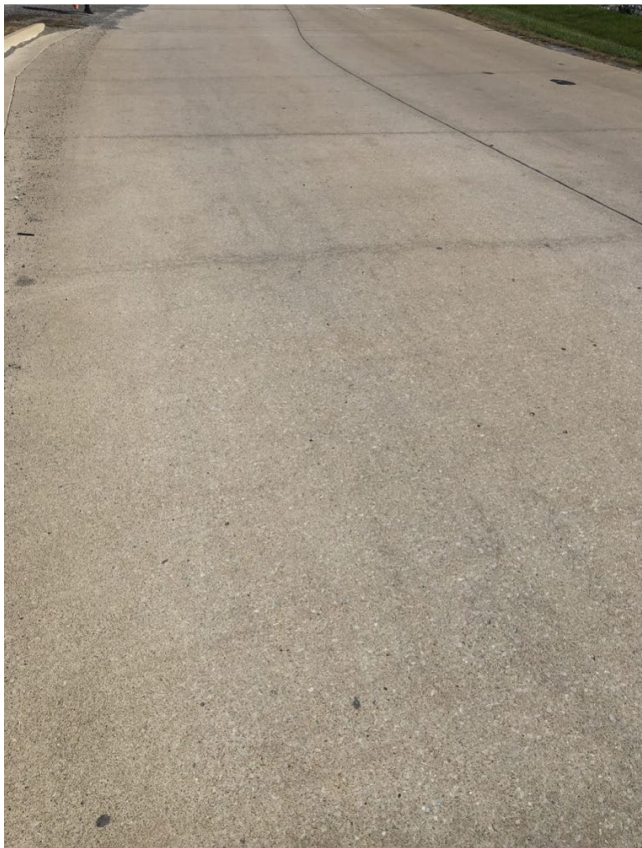
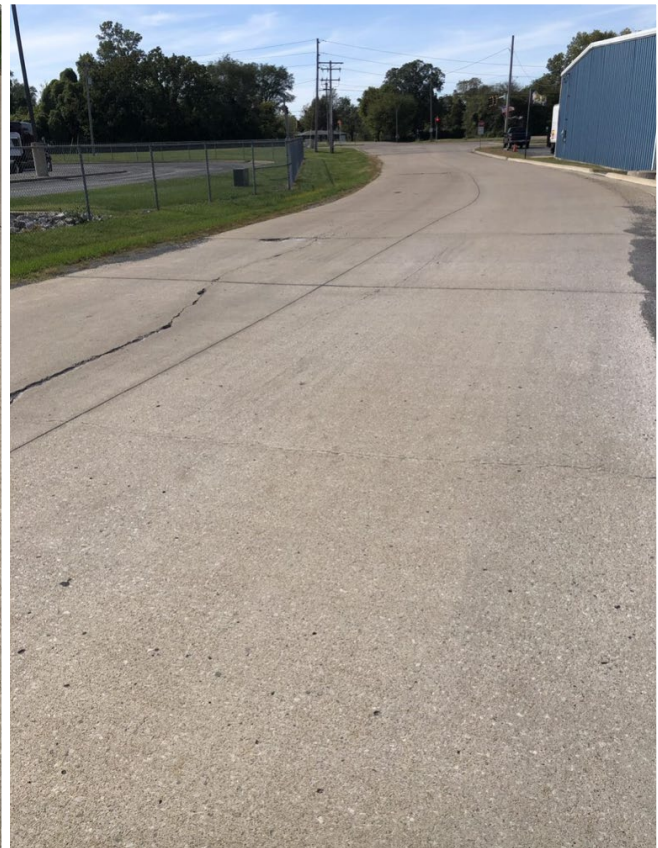
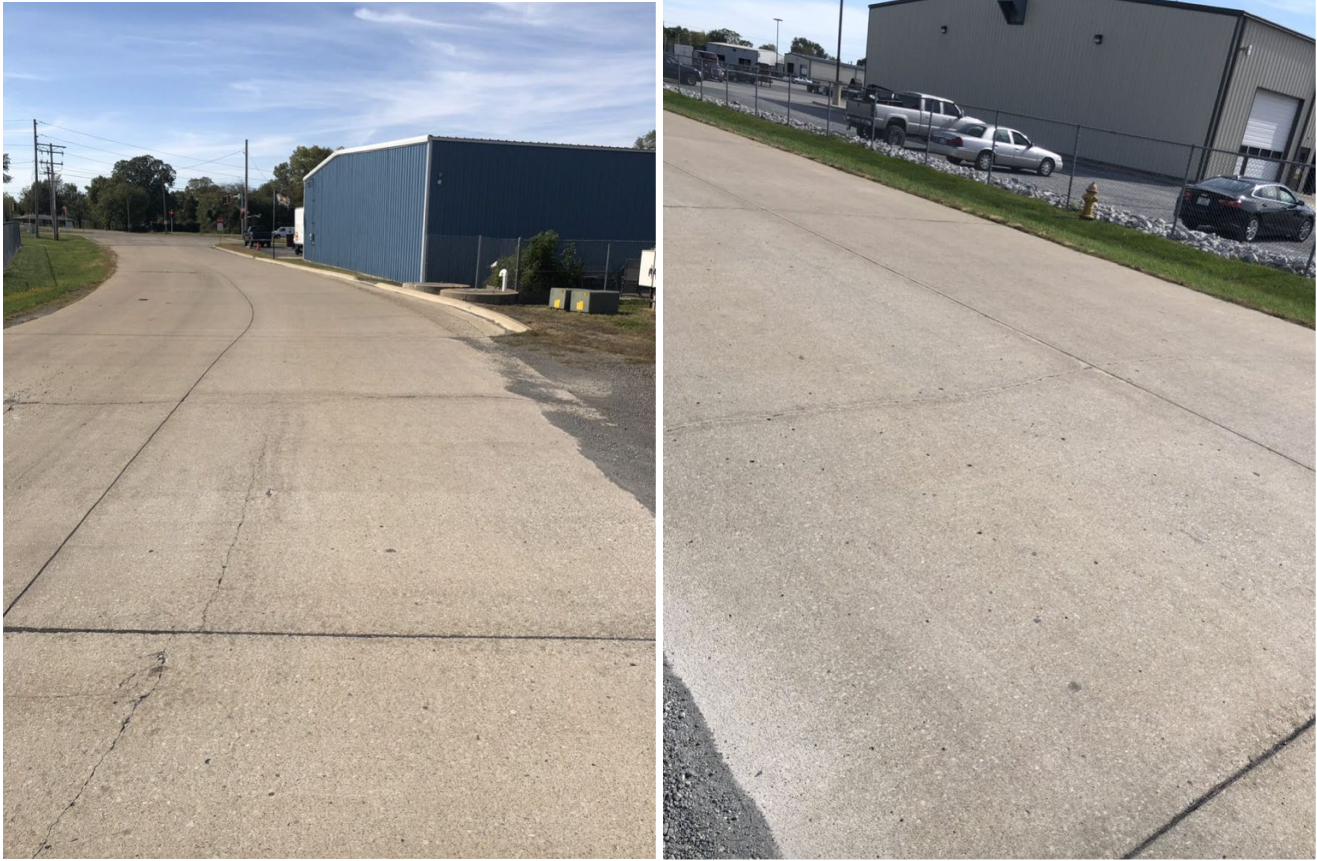
**Figure 124. Photos. Central Street.**

Thickness (in.)	Panel Length (ft)	Panel Width (ft)	Dowel Bar Spacing (in.)	Tie Bar Spacing (in.)	Lane Configuration	Visual Distress	Additional Observations
8	30	14	12	36	1 lane per direction	Transverse cracking (>50%)	Construction date ~2010s

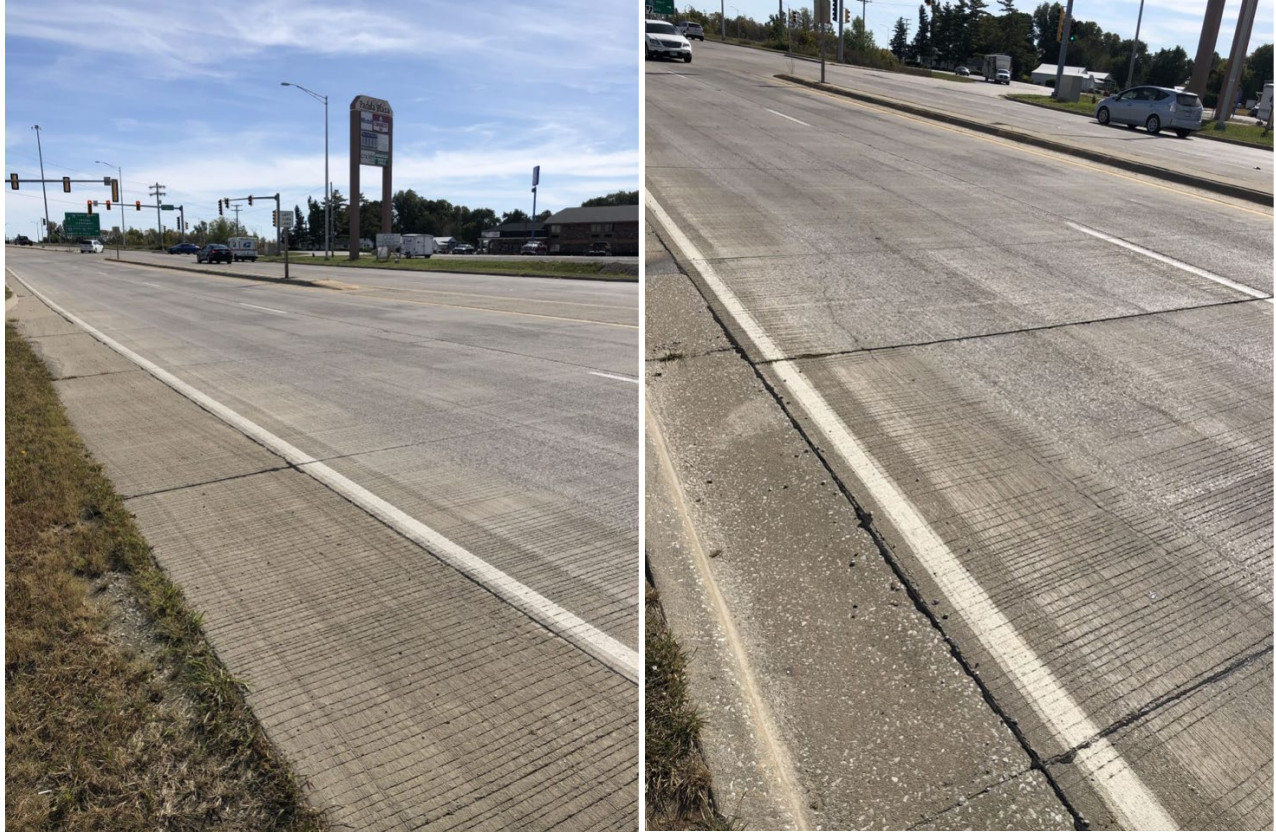
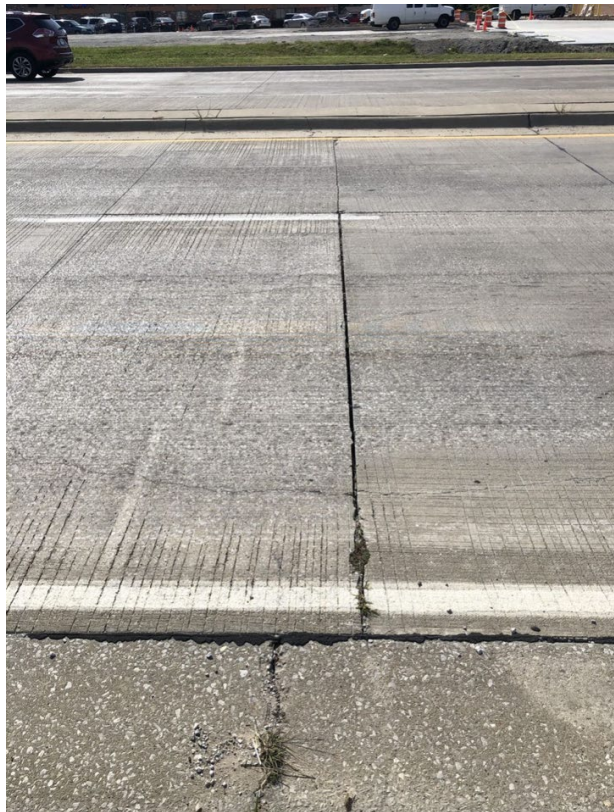
**Figure 125. Photos. Troy Avenue.**

Thickness (in.)	Panel Length (ft)	Panel Width (ft)	Dowel Bar Spacing (in.)	Tie Bar Spacing (in.)	Lane Configuration	Visual Distress	Additional Observations
10	15	13	12	36	2 lanes per direction + central lane	Longitudinal cracking (>50%)	Construction date ~2000s

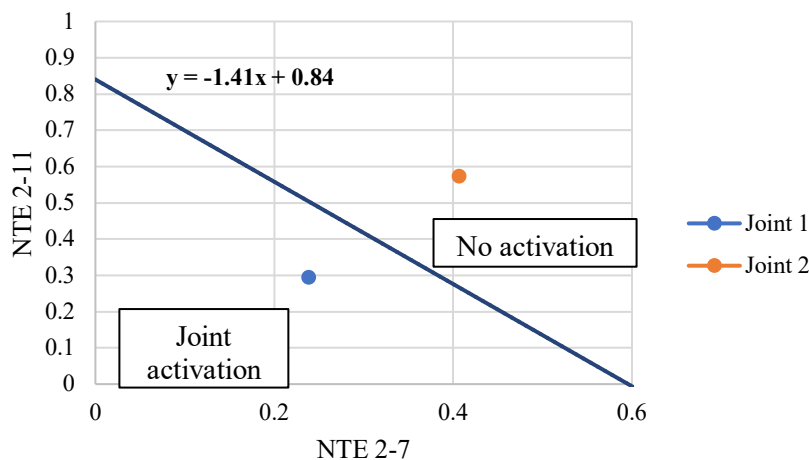
An investigation was performed on six streets in Champaign, Illinois—Green Street, Healey Street, Gregory Avenue, Armory Drive, Curtis Road, and Logan Street—to check the existing algorithm developed by Tran and Roesler (2020b) and determine the percentage of transverse contraction joints that may not be activated on urban concrete pavements. An initial analysis was performed in 2019 along Healey Street for two adjacent joints that spanned a transverse crack. Figure 126 shows the results of the joint activation analysis between the two adjacent joints from Healey Street. Joint 1 is below the hyperplane, and Joint 2 is above the hyperplane. This can be interpreted as Joint 1 is an activated working joint and Joint 2 is an uncracked contraction joint. This initial analysis shows that some joints may not be activated and could be contributing to premature cracking in urban JPCP sections, which could indicate late sawing, inadequate saw-cut depth, or another reason.

Figure 126. Graph. Healey Street joint activation NTE results—2019.

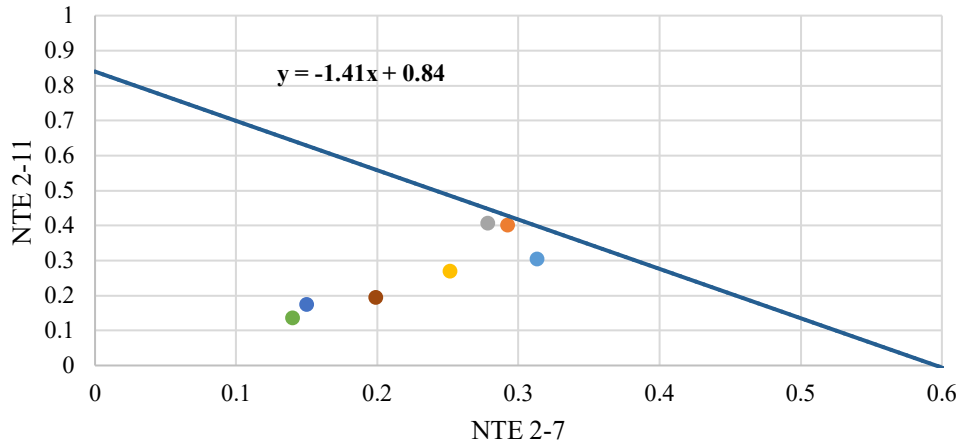
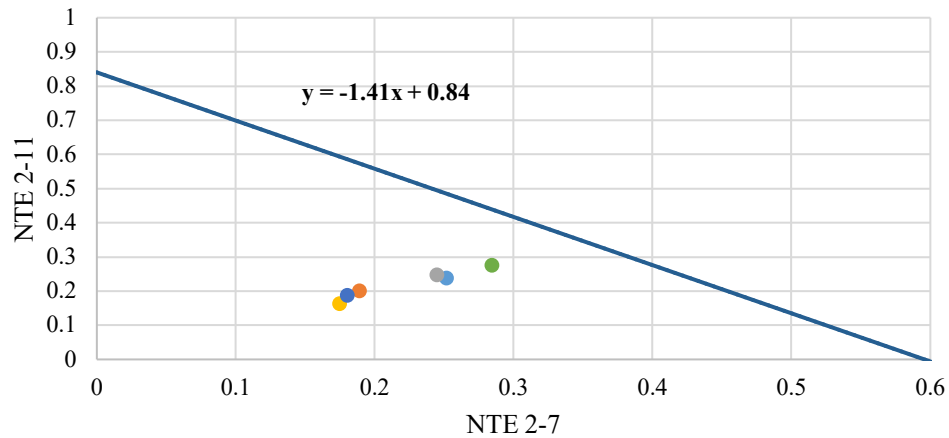
Table 91 presents the results obtained from Healey Street. This data includes two different dates of testing: April 7, 2019, and October 21, 2020. Three separate segments of Healey Street were tested, as seen in Figure 127. These segments were separated based on the observed cracking in each segment. The first segment (Healey Street between Second and Third Streets) was used in the initial analysis to assess if joint activation is a potential contributor in premature transverse crack development. The second segment (Healey Street between Fourth and Fifth Streets) appeared to have a transverse crack on every other slab, which is approximately 50% slab cracking. The joint activation analysis resulted in three joints that fall very close to the hyperplane and are reported as

inconclusive, whereas the remaining joints were evaluated as being activated. These joints had widths approximately 0.25 in. with joint sealant (all sealed very well with some joints over-sealed). From visual inspection during testing, Joints 5 and 7 were wider than the other joints, implying active joints. In addition, the transverse crack between Joints 5 and 6 was very tight and low severity.

The third segment (Healey Street between Fifth and Sixth Streets) had very minimal cracking. Only one transverse crack was observed in this segment, between Joints 2 and 3. From the joint activation ultrasonic evaluation, all joints appear to be active and working joints. The transverse crack between Joints 2 and 3 potentially developed directly over the tie bars between the longitudinal construction joint with the curb and gutter shoulder.

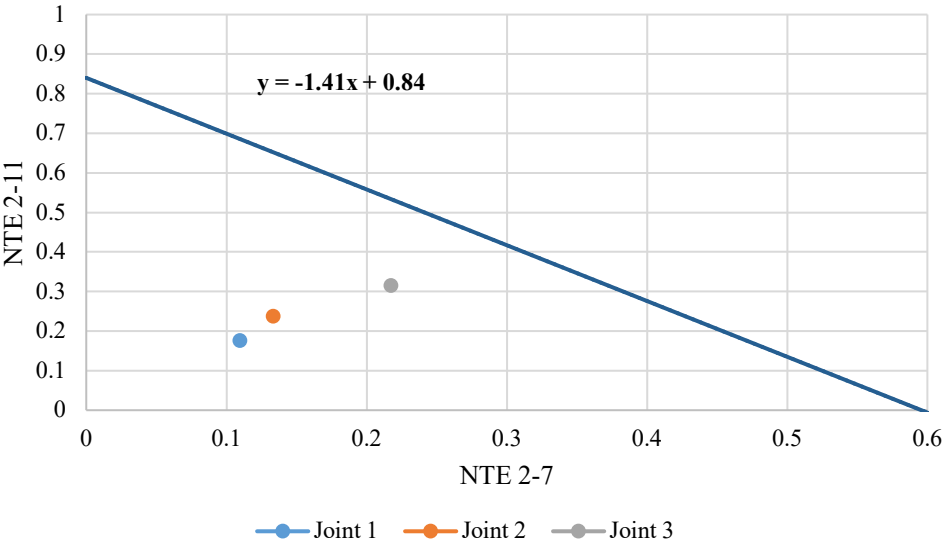
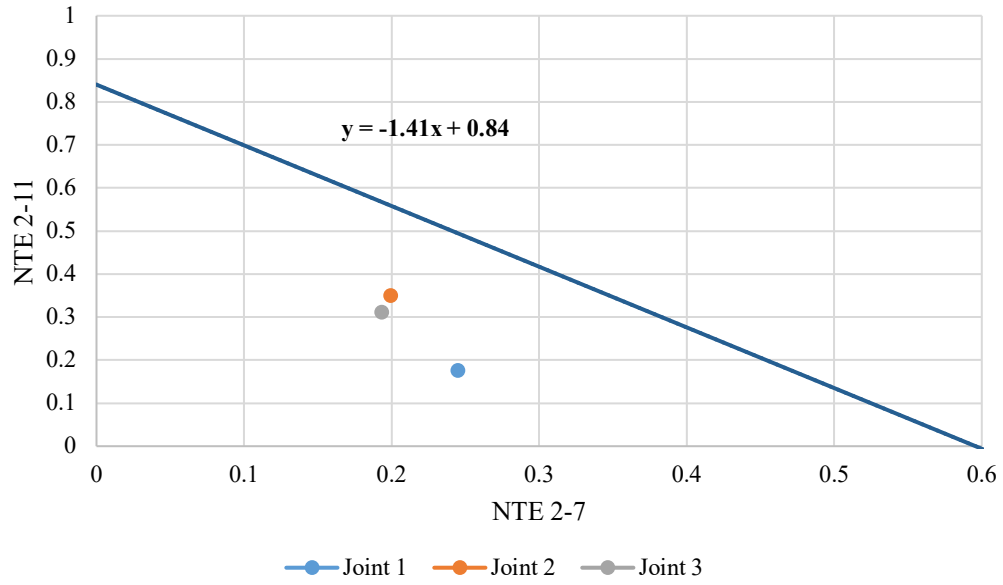
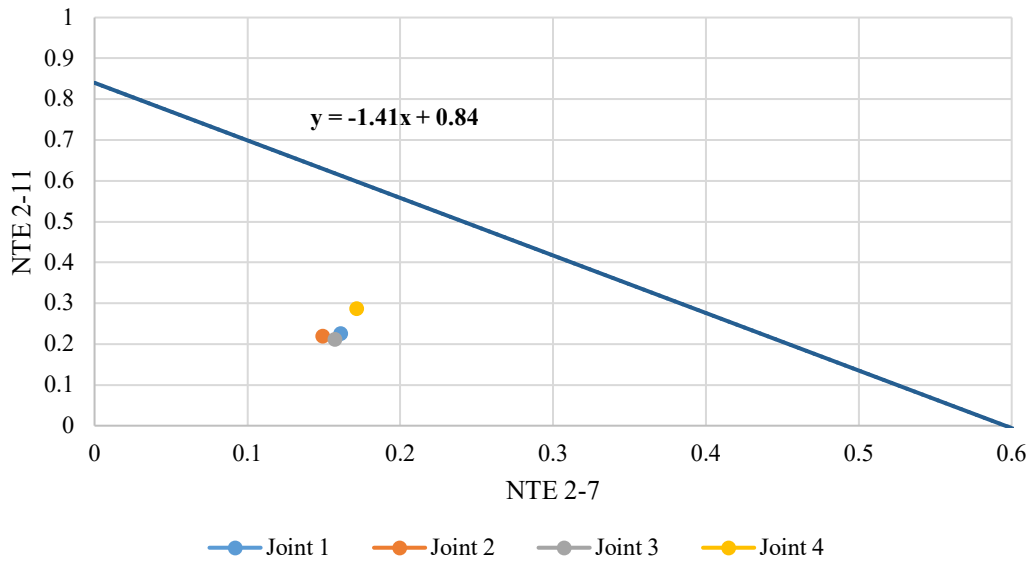
**Figure 129. Graphs. Green Street between Wright Street and Fourth Street joint activation analysis NTE results.**

Street is a very busy street in Champaign, Illinois, which made testing more challenging than other sections. Therefore, only three to four adjacent joints were able to be evaluated per location. Table 92 summarizes the results of the joint evaluation conducted on the three testing locations on Green Street between Wright Street and Fourth Street in Champaign, Illinois. From this ultrasonic joint analysis, all joints tested along Green Street are activated and are not likely the main contribution to the transverse cracking (see Figure 129).

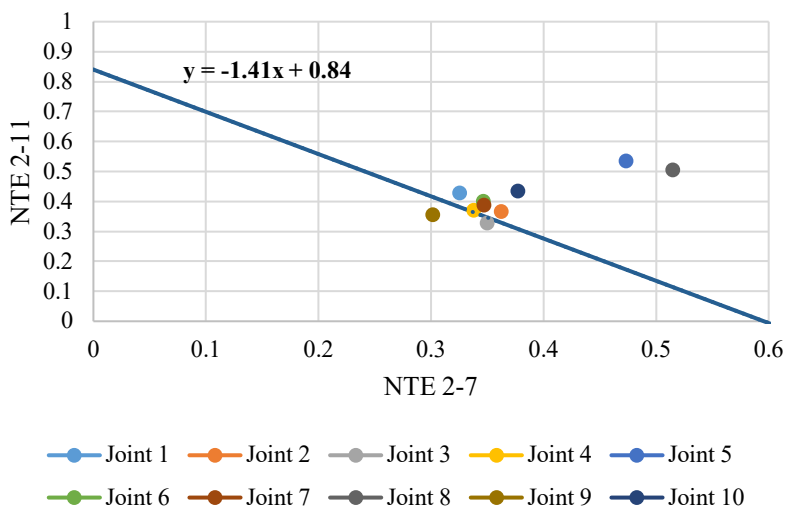
Green Street between the intersection of First Street and Fourth Street was constructed at a different date and with a different design than Green Street between Fourth Street and Wright Street. Table 93 summarizes the results of the joint evaluation conducted on Green Street between First Street and Fourth Street in Champaign, Illinois. This section consisted of 15 ft x 9 ft panels (L x W), with a curb and gutter shoulder. This section did not have any cracking present and was performing well. From the ultrasonic joint analysis, all joints tested along Green Street resulted inconclusive or not activated, as seen in Figure 130. Additionally, Joint 8 was concluded as not activated based on the NTE analysis results, but this joint appears to be a construction joint.

<sup>2</sup> Not activated—Joint 8: This is a construction joint. It is unclear why the NTE results indicate not activated.

**Figure 130. Graph. Green Street near Second Street joint activation analysis NTE results.**

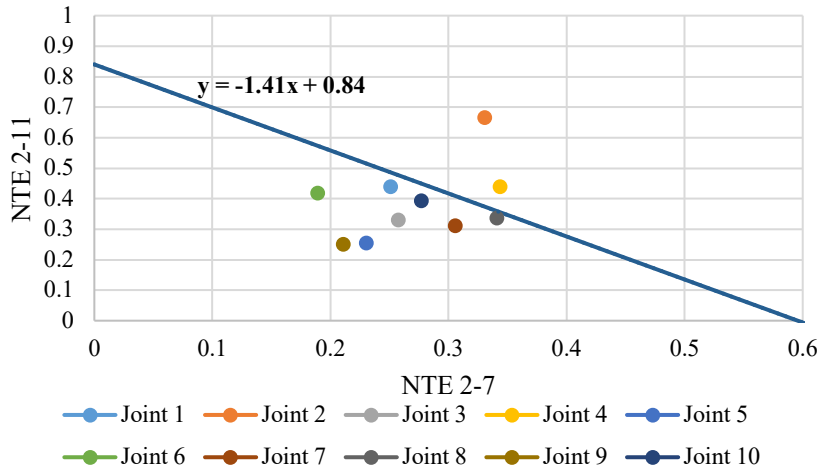
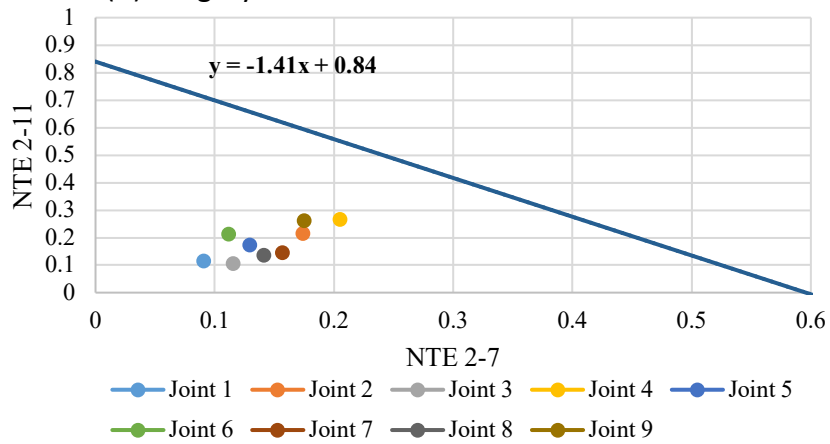
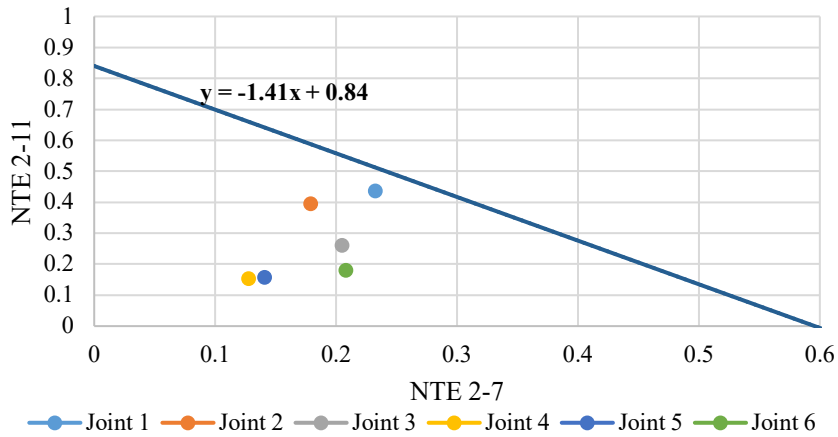
Figure 131. Graphs. Gregory Drive joint activation analysis NTE results.

the results of the joint evaluation conducted along Gregory Drive between Oak Street and First Street in Champaign, Illinois, along with Figure 131-A. The joint spacing was not conventional in this section with 15 ft × 18 ft (L × W) panels. The eastbound lane was tested, and the first panel had a longitudinal crack spanning the slab and intersecting Joint 1. There were no anomalies observed based on dowel bar and tie bar spacing and depths. However, dowels were observed at a depth of 3.15 in. (80 mm) instead of 4 in. (100 mm).

Table 95 summarizes the results of the joint evaluation conducted along Gregory Drive between First Street and Fourth Street in Champaign, Illinois. The joint spacing was nonconventional in this section with 17 ft × 13 ft (L × W) panels and also contained a bike lane in the westbound direction (17 ft by 5 ft) with a curb and gutter shoulder. The westbound lane was tested and included nine consecutive joints. There were several anomalies observed based on the dowel bar and tie bar spacing and depths. Dowels were observed in every other joint (Joint 2, 4, 6, and 8) and spaced at 36 in. on center (100 mm depth). These joints with the dowels had longitudinal cracking developing over the dowels. Joint 2 included dowels; however, they were observed to be at a depth of 2 in. (50 mm); there is a mid-panel transverse crack and a corner break (Approach Joint 3) on the same slab between Joints 2 and 3. For the joints without reinforcement (Joints 1, 3, 5, and 7), transverse joint faulting was observed. These anomalies observed within this section are most likely contributing significantly to the observed distress because all joints observed within the ultrasonic analysis appear to be activated and working joints (See Figure 131-B and Table 95).

section with 15 ft × 11 ft (L × W) panels and also contained a bike lane in the westbound direction (15 ft by 5 ft) with a curb and gutter shoulder. There were no anomalies observed when performing the ultrasonic investigation in this section. All joints observed within this section are believed to be activated, except for Joint 1, which falls near the hyperplane (inconclusive). Figure 131-C presents the NTE results for the joints in this section and show they fall below the hyperplane.

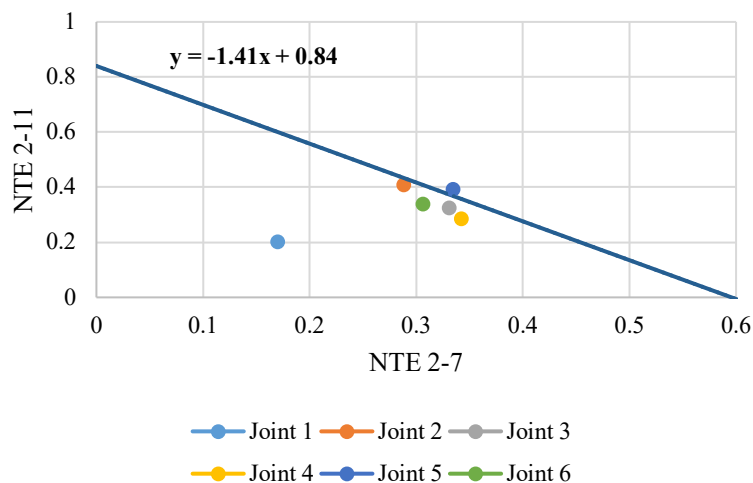
The analysis performed along Logan Street was conducted between First Street and Neil Street. This section is along a bus route but has minimal traffic volume. Table 97 summarizes the results of the joint evaluation conducted along Logan Street near the intersection of Water Street heading westbound towards the underpass in Champaign, Illinois. The joint spacing in this section was 12.5 ft × 10.5 ft (L × W) panels with a curb and gutter shoulder. There were no anomalies observed based on dowel bar and tie bar spacing and depths. Figure 132 presents the NTE results. It can be observed that Joint 1 is activated; however, the remaining joints were inconclusive as they fall very close to the hyperplane. The three transverse cracks observed were all wide with spalling and were sealed. Based on these widths and apparent age of the joint sealant in the cracks, these cracks developed a number of years ago and, likely, shortly after construction. Inconclusive joints can mean activated joints or nonactivated joints with the transverse cracks are acting as the transverse joints.

**Figure 132. Graph. Logan Street joint activation analysis NTE results.**

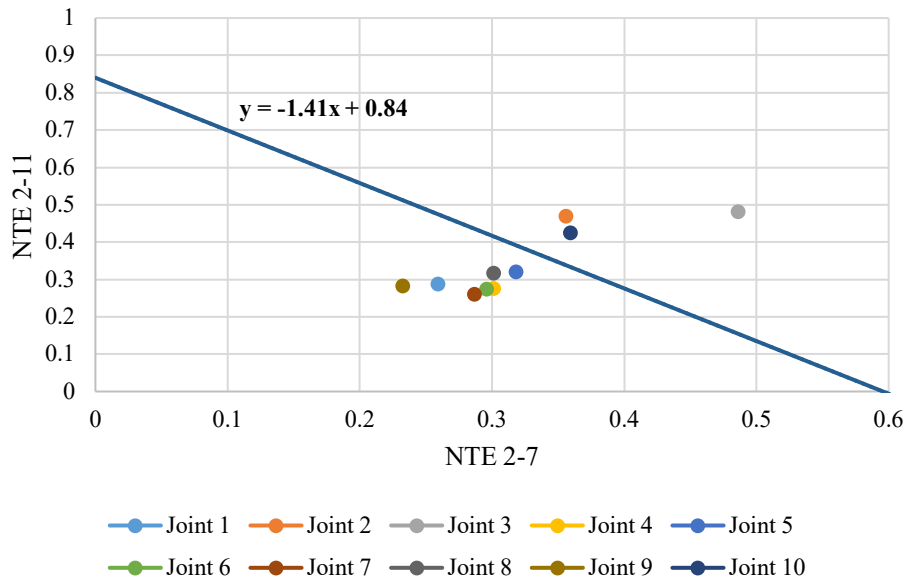
The MIRA measurements were performed along East Armory Drive between Wright Street and Sixth Street. This section is primarily trafficked by buses and delivery trucks. The thickness recorded from ultrasonic testing was between 12 to 13 in. (300–325 mm). Testing was performed heading east in the eastbound lane (one-way street). The joint spacing was 12 ft × 12 ft on average, as the panels were tapered from Sixth Street toward Wright Street. There were no anomalies observed based on dowel bar and tie bar spacing and depths. Table 99 summarizes the results of the joint evaluation conducted along East Armory Drive near Sixth Street in Champaign, Illinois. There were no observed transverse cracks in this newly constructed section. Figure 134 presents the NTE results from the analysis. The results indicate three joints are not activated and the remaining seven are activated. The three joints that were identified as not activated (Joints 2, 3, and 10) spanned a drain. Additionally, Joint 9 was a construction joint. It is possible a transverse crack may develop between Joints 2 and 3.

**Figure 134. Graph. East Armory Drive joint activation analysis NTE results.**
