# Crash Test Between a 6-KG/M U-Channel Sign Support and a 1997 Geo Metro: FOIL Test Number 99F010

PUBLICATION NO. FHWA-RD-01-046

MARCH 2001

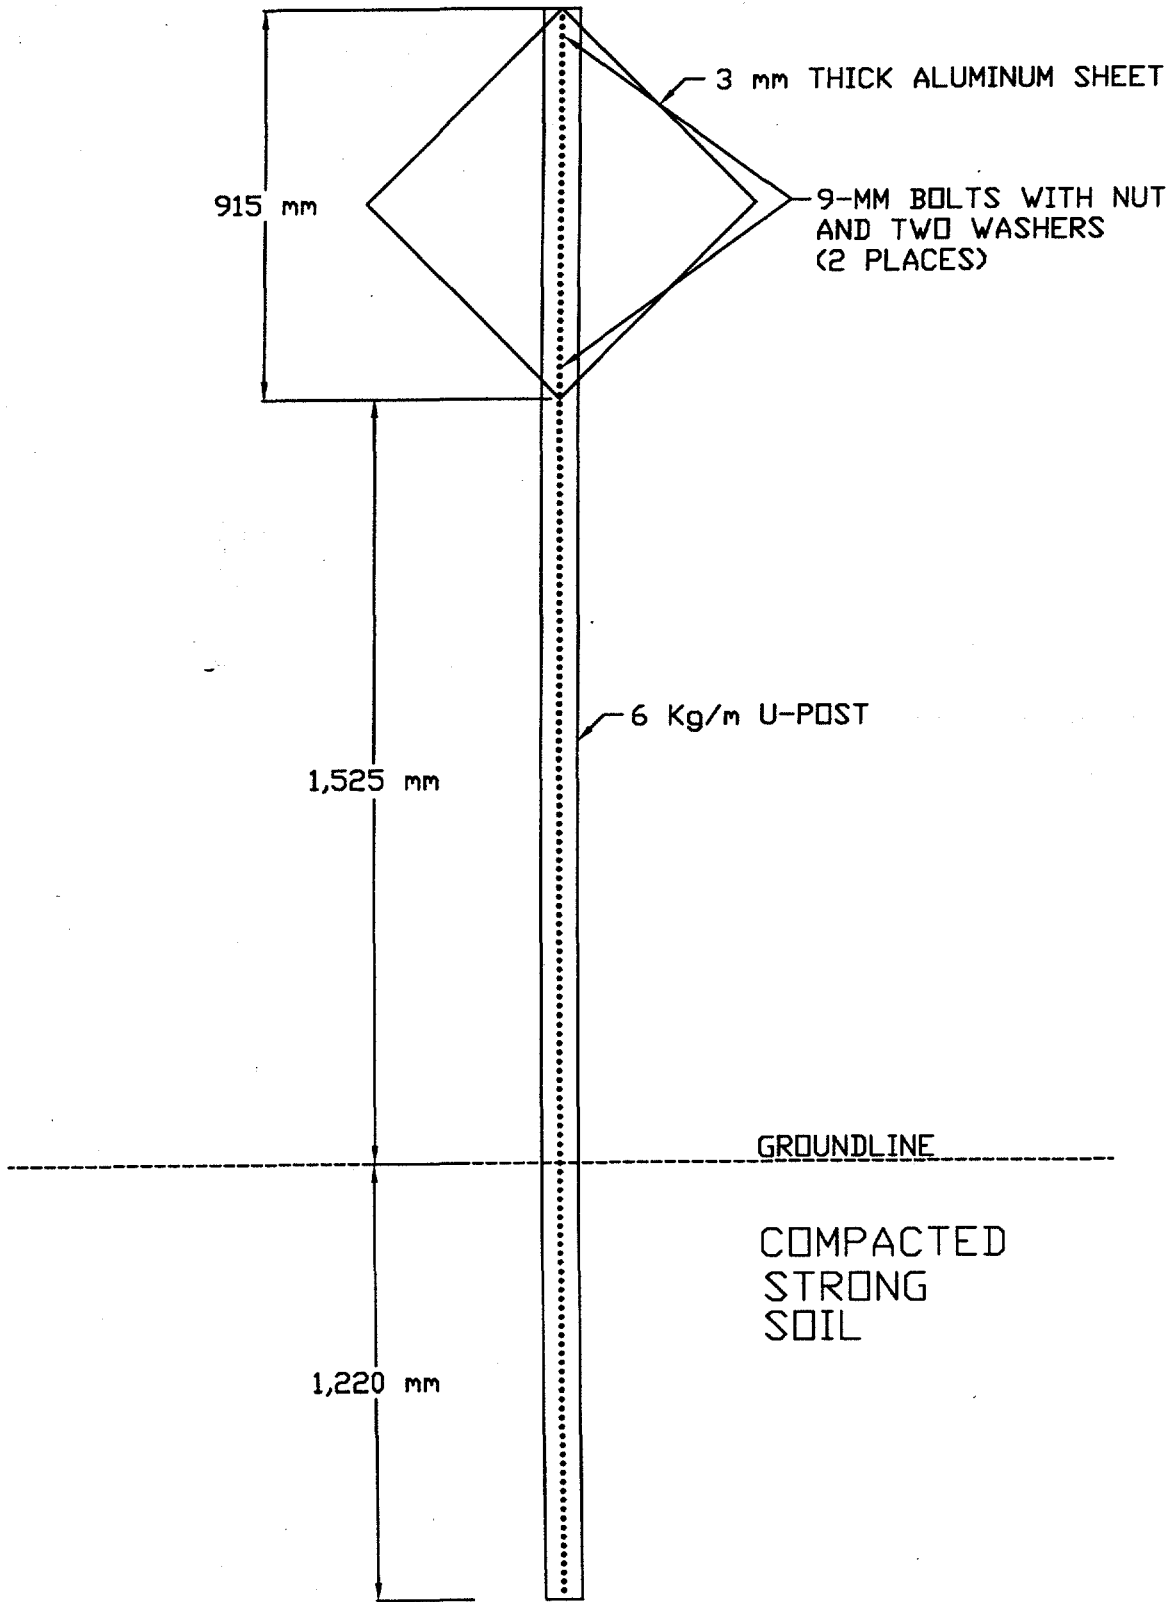
Figure 2. Sketch of small sign support.

The device tested at the FOIL was a single-leg small sign support buried in *NCHRP Report 350 S1* strong soil. The sign support was constructed from one 6-kg/m u-channel hat-section and a 650-mm square aluminum sheet. The u-channel was cut to length (3,660 mm) and the sign panel was attached 1,525 mm above the ground line. The assembled sign support was placed in a 1,220-mm hole within the FOIL strong soil (crush-and-run) pit. The hole was back filled and compacted in 305-mm increments until ground level was reached. The sign panel was attached to the sign post using two 9-mm hardware quality bolts. A flat round washer was placed under the bolt head and nut.

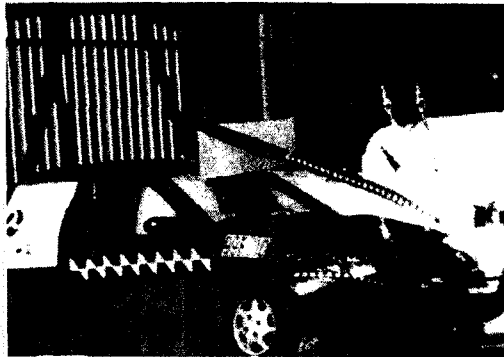
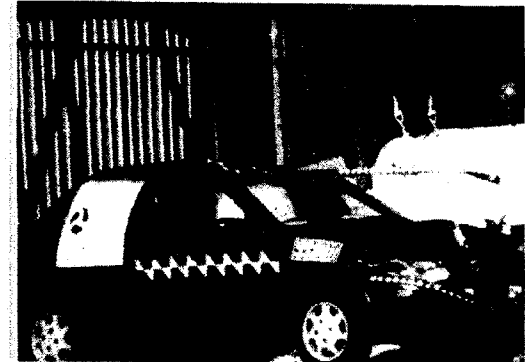
Figure 6. Additional photographs during the test, test 99F010.

roof boundry. The vehicle passed over the sign stub and continued out into the FOIL runout area where the brakes were applied. The vehicle's bumper was torn from the vehicle prior to sign post fracture. The vehicle remained stable and upright. The vehicle came to rest after contact with the FOIL catch fence 101 m downstream from the impact location. Figure 4 summarizes the results from the small sign support test. Appendix A contains photographs of the test during the collision and the pre and post test environments. Table 5 lists the maximum and minimum peak values obtained from the vehicle accelerometers. The values listed are Class 180 data (digital filter cut-off frequency of 300 Hz). Appendix B contains data plots of the data collected from each vehicle sensor and velocity and displacement data plots created from the longitudinal cg acceleration trace. All acceleration data plots are from Class 180 data.
