Crash Test Between a 6-KG/M U-Channel Sign Support and a 1997 Geo Metro: FOIL Test Number 99F007

PUBLICATION NO. FHWA-RD-01-049

MARCH 2001

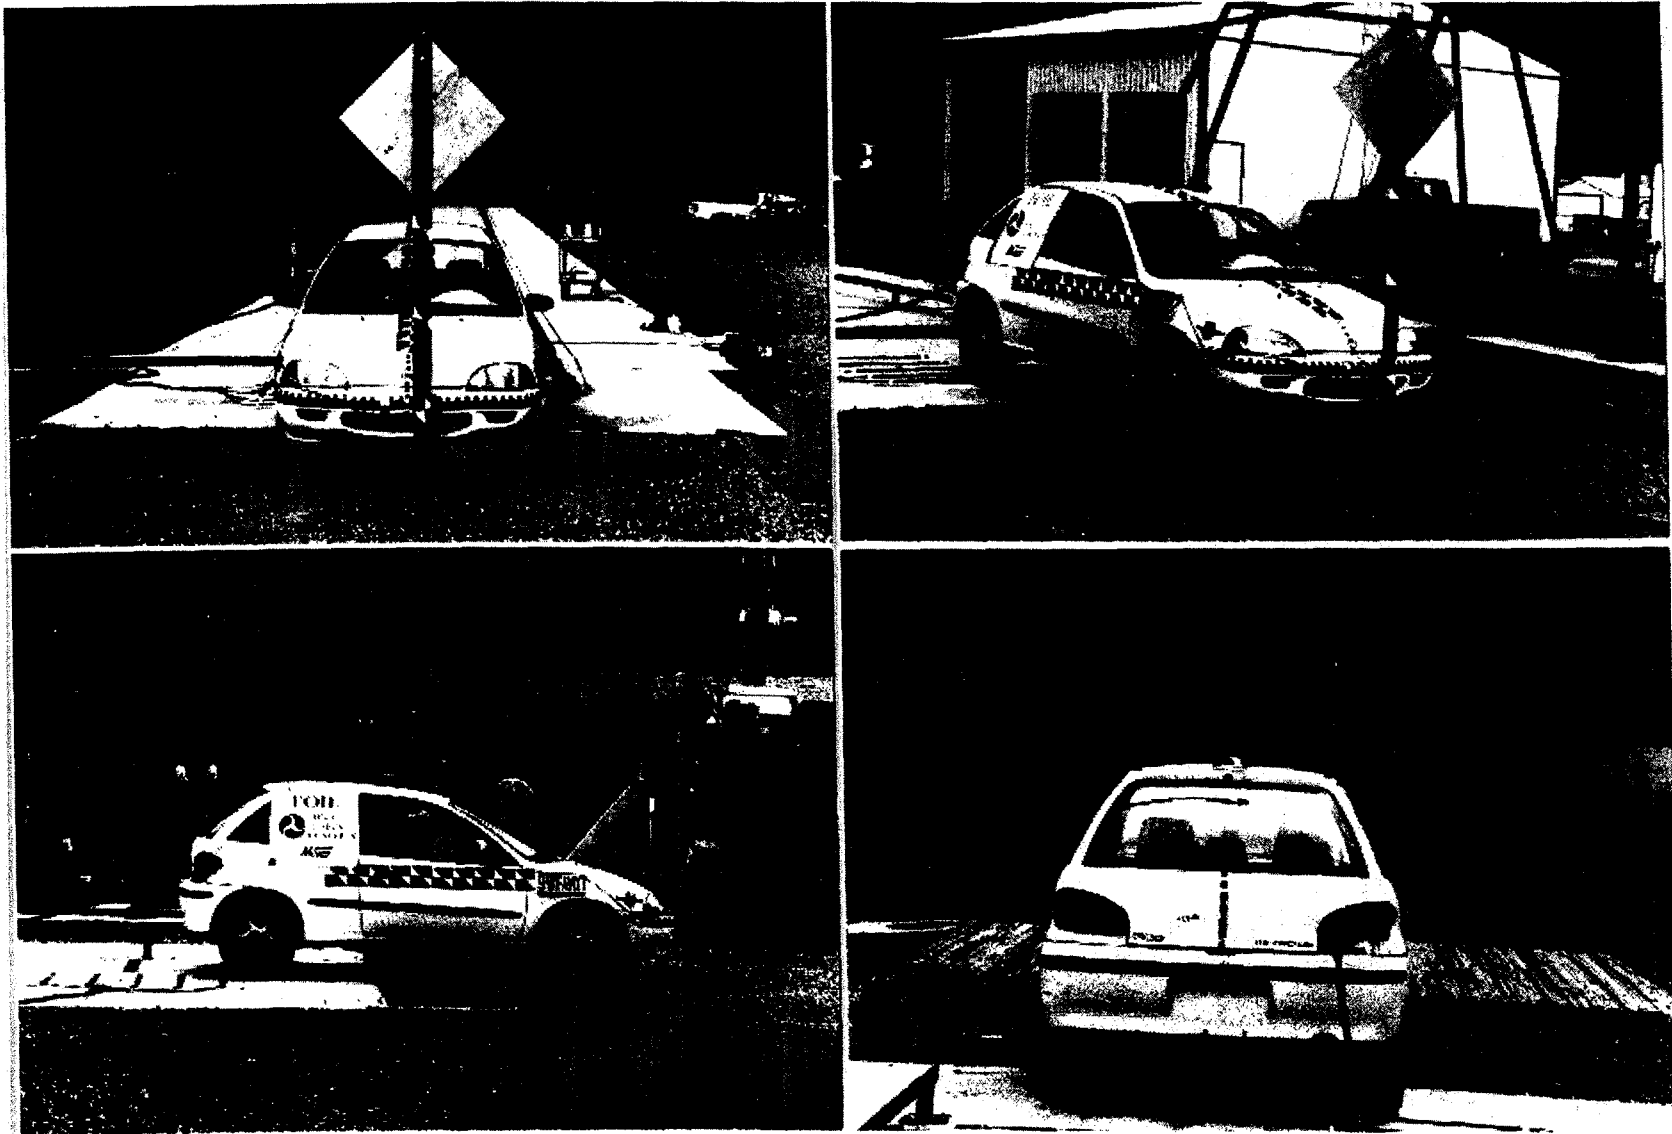
Figure 7. Pre-test photographs, test 99F007.

Sign damage. The sign support was bent and twisted and laid flat. The post did pull out of the soil. The u-channel web was torn vertically (approximately 460 mm). The sign post did not fracture or shear. The sign post could not be reused.
