DYNAMIC TESTING AND EVALUATION OF CULVERT-MOUNTED, STRONG-POST MGS TO TL-3 GUIDELINES OF MASH 2016

WISCONSIN DEPARTMENT OF TRANSPORTATION

MwRSF Research Report No. TRP-03-383-20-R1

November 2, 2020

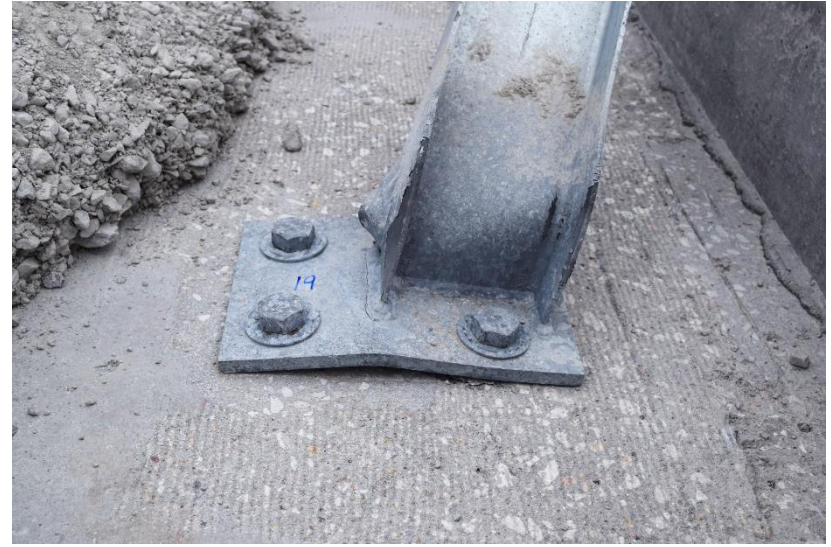
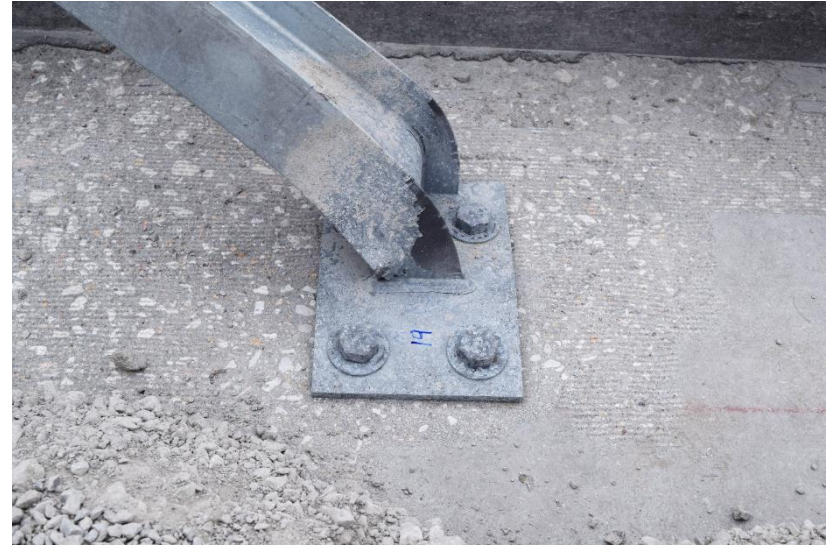
Figure 63. Damage to Post and Base Plate Nos. 18 and 19, Test No. CMGS-1

Post no. 17 slightly deflected backward. Post nos. 18 and 19 were bent longitudinally toward the ground in the downstream direction. Post no. 20 was bent slightly longitudinally downstream. Contact marks were found on the front face of post nos. 18 and 19. No significant post damage occurred to post nos. 1 through 16 nor 21 through 41. The upstream and downstream anchorage systems remained unmoved and the posts in both anchorage systems were not damaged. The wooden blockout at post nos. 18, 19, and 21 disengaged from the system. The blockout at post no. 20 rotated but did not disengage. The blockouts at post nos. 3 through 17 and 22 through 39 were undamaged.

Following the test, the soil on top of the culvert headwall was removed for inspection of the damage to the posts and base plates as well as to review any potential damage to the culvert. Deformation of the post base plates was observed on post nos. 17 through 21. Minor cracking was observed on the weld at the front flange of the base plate of post no. 17. The upstream side of the front flange of post no. 18 was torn up to the web near the base plate weld. All anchorage bolts and epoxied threaded rods were intact and remained secure, although some minor deformation of the bolts and rods was observed. No damage was observed to the concrete culvert slab or the headwall.

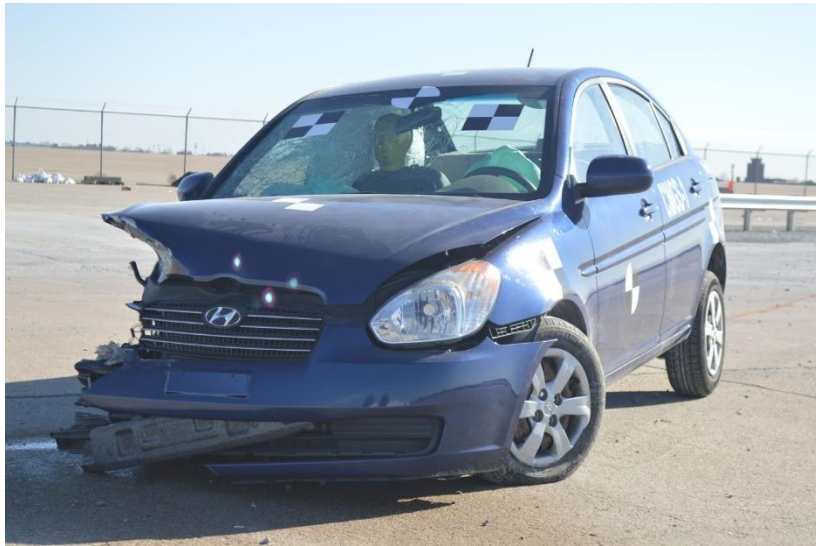
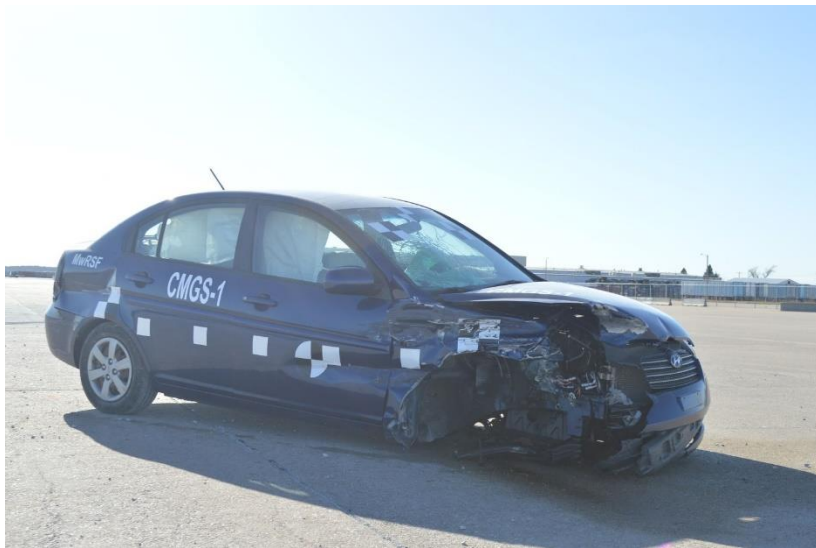
Figure 68. Vehicle Damage, Test No. CMGS-1

Majority of the vehicle damage was concentrated on the right-front corner, where primary impact occurred. The right-front wheel contacted post nos. 18 and 19 and was disengaged, and the left-front tire was deflated. The right corner of the hood buckled. The side and front airbags on both the passenger and driver side deployed, which caused the windshield on the passenger side to shatter but remain intact. The right-rear quarter panel was crushed inward.

The roof, the left side, and the rear of the vehicle remained undamaged. The left-side and rear window glass also remained undamaged. The front right strut broke at the weld point on the top of the gas cylinder, and only the top portion of the shock absorber was still intact. The right-side wheel hub attachment point detached from the steering rack, and the tie rod was bent. The right-front brake assembly disengaged from the car. There was no damage to the vehicle's frame, rear suspension, or rear shocks and springs.

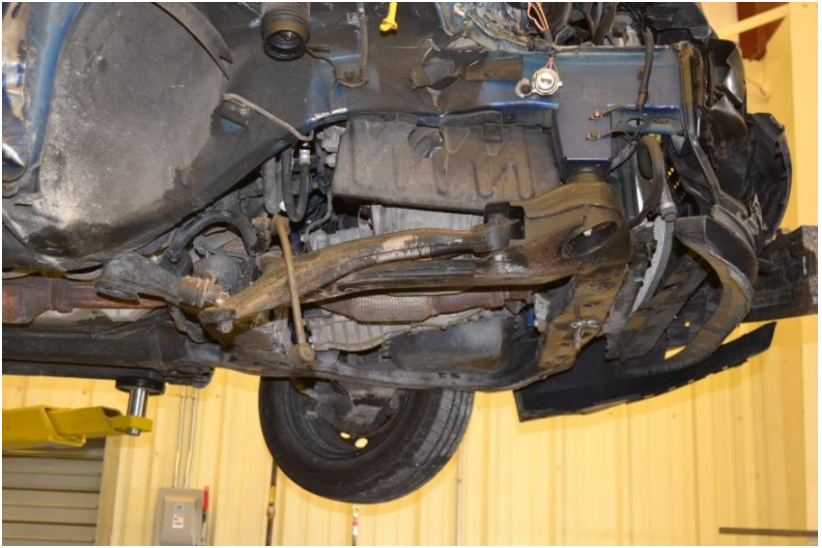
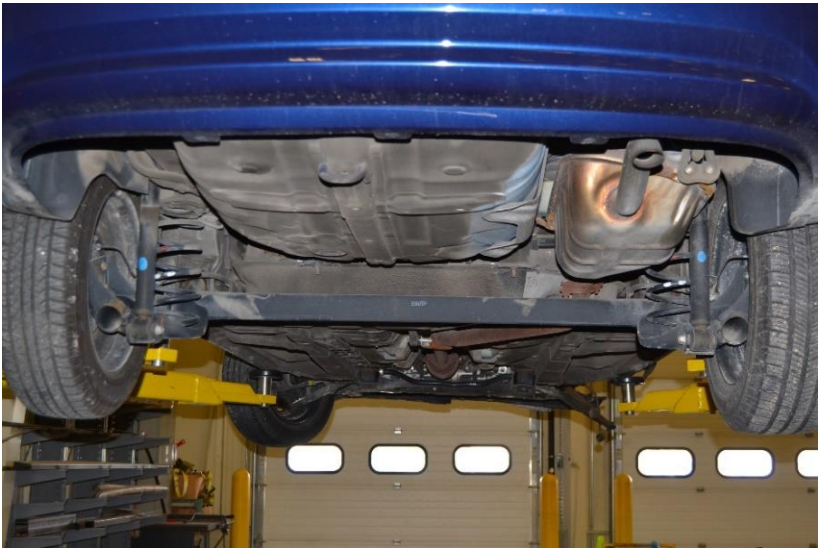
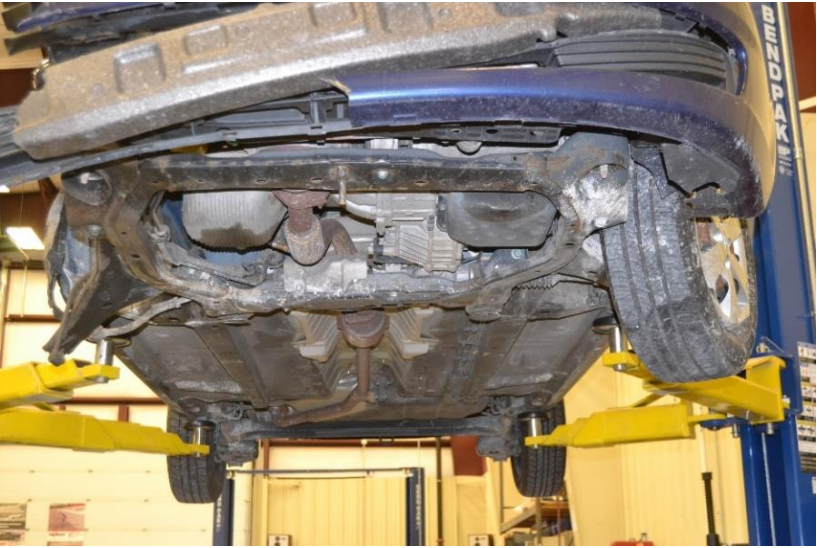
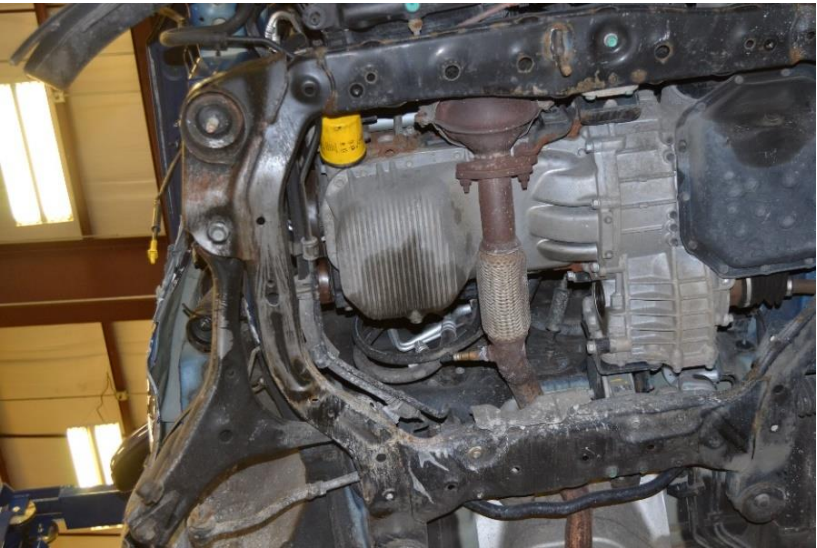
The damage to the vehicle was moderate, as shown in Figures 68 through 72. The maximum occupant compartment deformations are listed in Table 6 along with the intrusion limits established in MASH 2016 for various areas of the occupant compartment. MASH 2016 defines intrusion or deformation as the occupant compartment being deformed and reduced in size with no observed penetration. The maximum deformation of the windshield was measured to be $3\frac{3}{8}$ in. (86 mm) which was not observed on the test day, as shown in Figure 70. Prior to the vehicle deformation measurements, the snow and ice on the windshield caused an additional caving in deformation. Therefore, this deformation exceeding the MASH deformation criteria was not due to the impact event and is not critical to the test evaluation. All other occupant compartment deformations were within MASH limits. Complete occupant compartment and vehicle deformations as well as the corresponding locations are provided in Appendix D.

Figure 71. Occupant Compartment Damage, Test No. CMGS-1

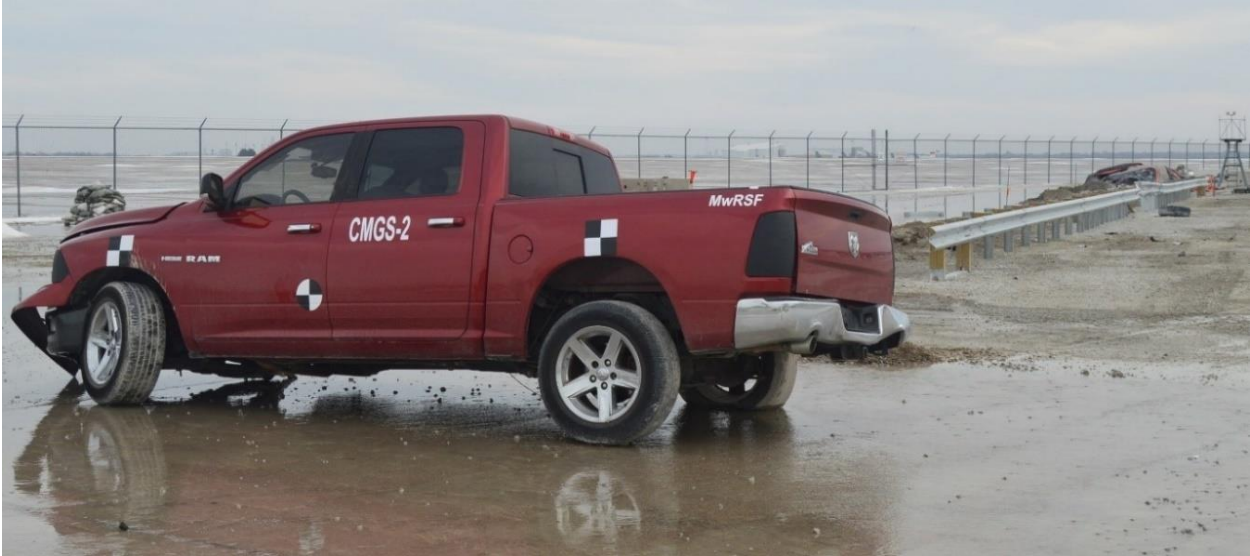
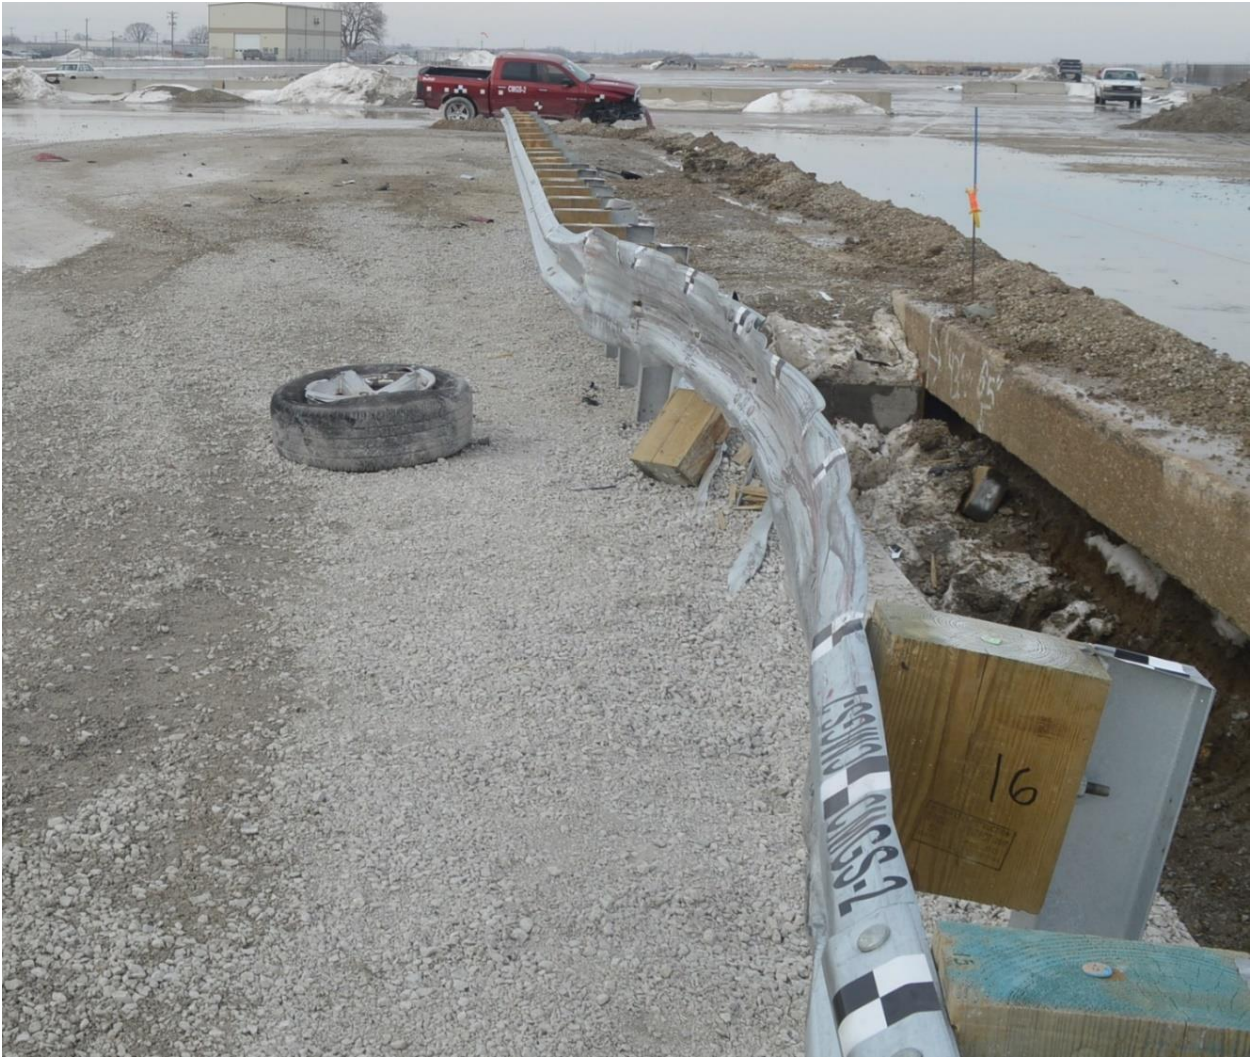
Figure 79. Vehicle Trajectory and Final Position, Test No. CMGS-2

A detailed sequential description of the impact events is shown in Table 9. Sequential photographs are shown in Figures 75 and 76. Documentary photographs of the crash test are shown in Figure 78. The vehicle trajectory and final position are shown in Figure 79.

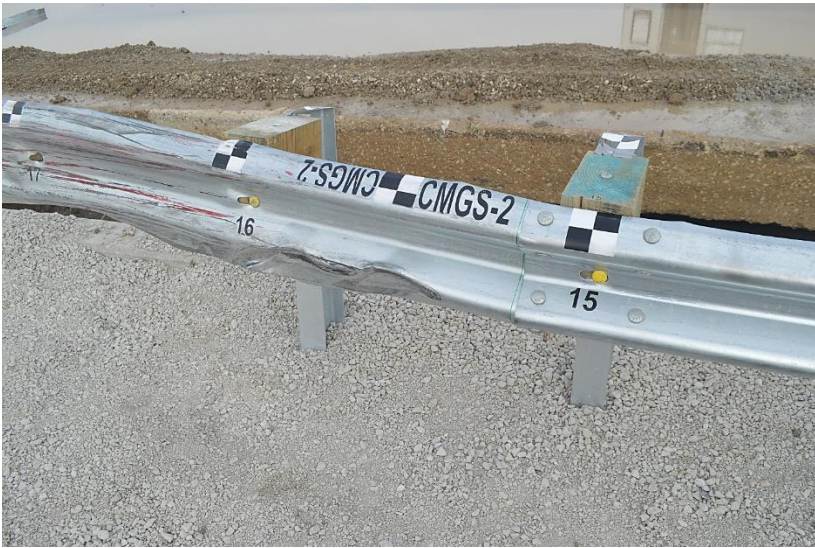
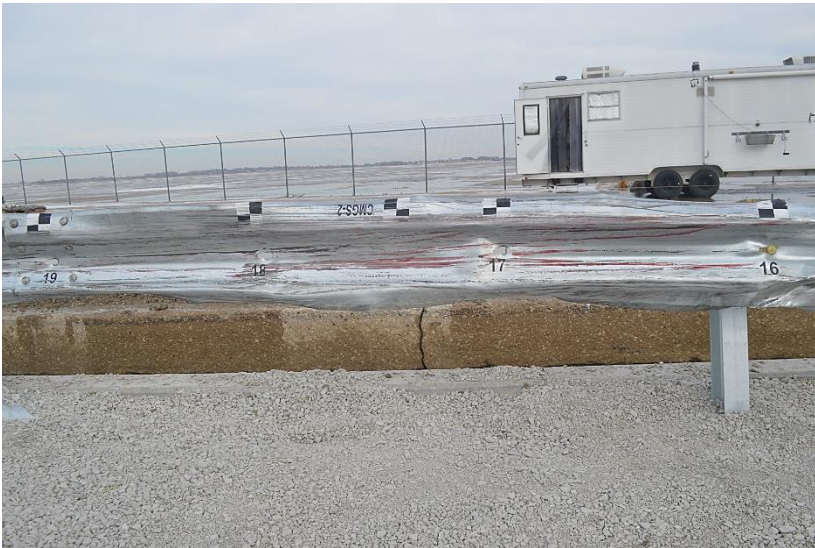
Figure 81. Damage to Post Nos. 15 through 21, Test No. CMGS-2

Post nos. 15 and 16 slightly deflected backward. Post nos. 17 and 18 broke away from the base plate and were pulled out of the soil. However, this did not adversely affect the system's performance, and the disengaged posts did not pose secondary hazard to traffic. Post nos. 19 through 21 also deflected longitudinally toward the ground in the downstream direction but remained attached to the culvert. Contact marks were found on the front face of post nos. 18 and 19. No significant post damage occurred to post nos. 1 through 15 or 24 through 41. The upstream anchorage system was displaced nearly 1 in. (25 mm) and the downstream anchorage system remained unmoved. The posts in both the upstream and downstream anchorage systems were not damaged. The wooden blockouts at post nos. 17 through 20 disengaged from the system. The blockout at post no. 21 rotated but did not disengage from the rail. The blockouts at post nos. 3 through 16 and 22 through 39 remained undamaged.

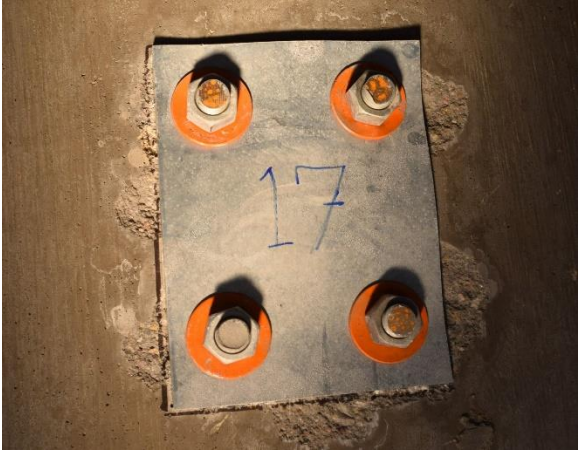
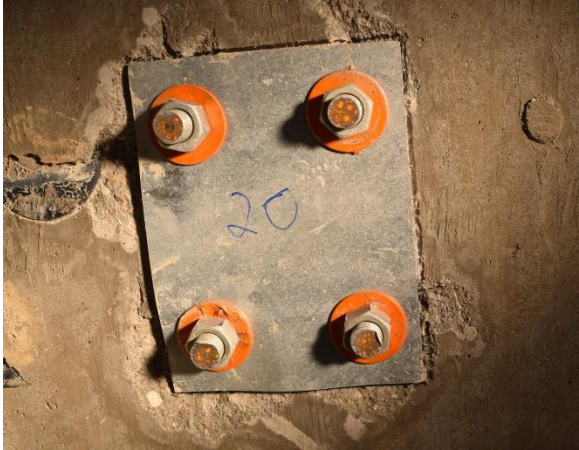
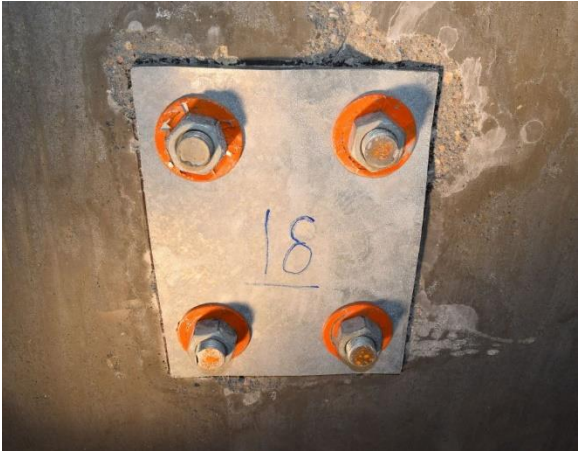
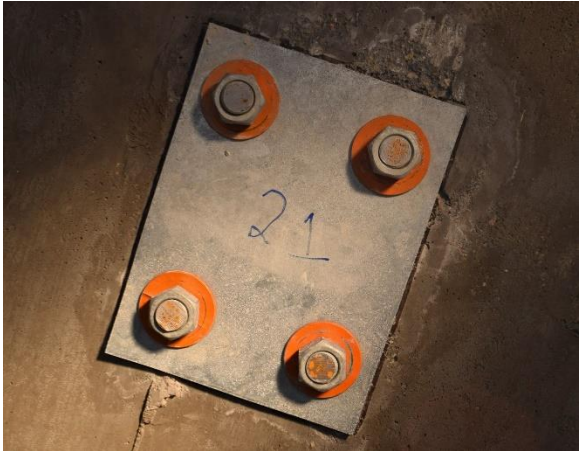
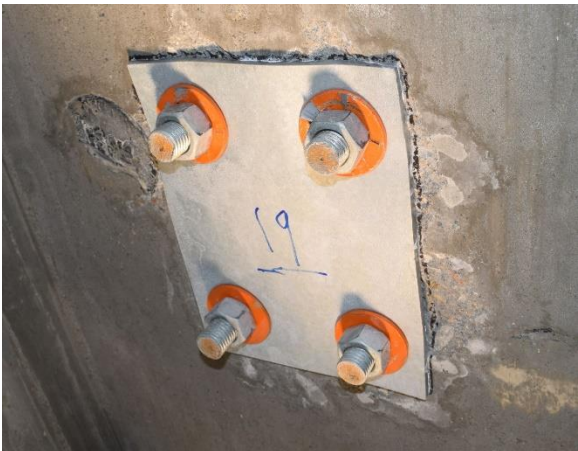
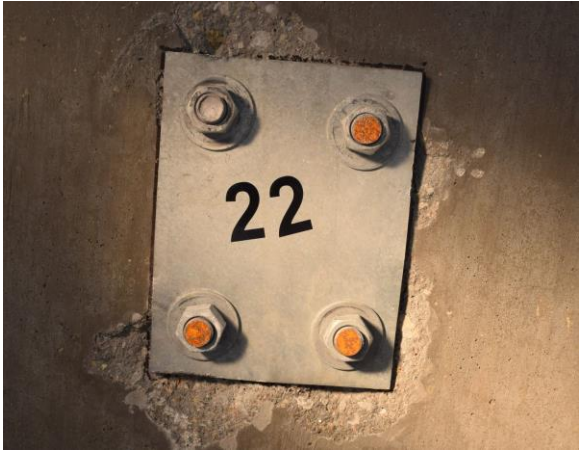
Figure 85. Damage to Base Plates of Post Nos. 17 through 22, Test No. CMGS-2

Following the test, the soil on top of the culvert headwall was removed for inspection of the damage to the posts and base plates as well as to review any potential damage to the culvert. Deformation of the post base plates was observed on post nos. 16 through 22. Post nos. 17 and 18 fractured at the base of the post above the weld line at the front flange and web of the post and through the weld at the back flange of the post. The upstream side of the front flange of post nos. 20 and 21 was torn up to the web near the base plate weld. All anchorage bolts and epoxied threaded rods were intact and remained secure, although some minor deformation of the bolts and rods was observed. No damage was observed to the concrete culvert slab or the headwall.

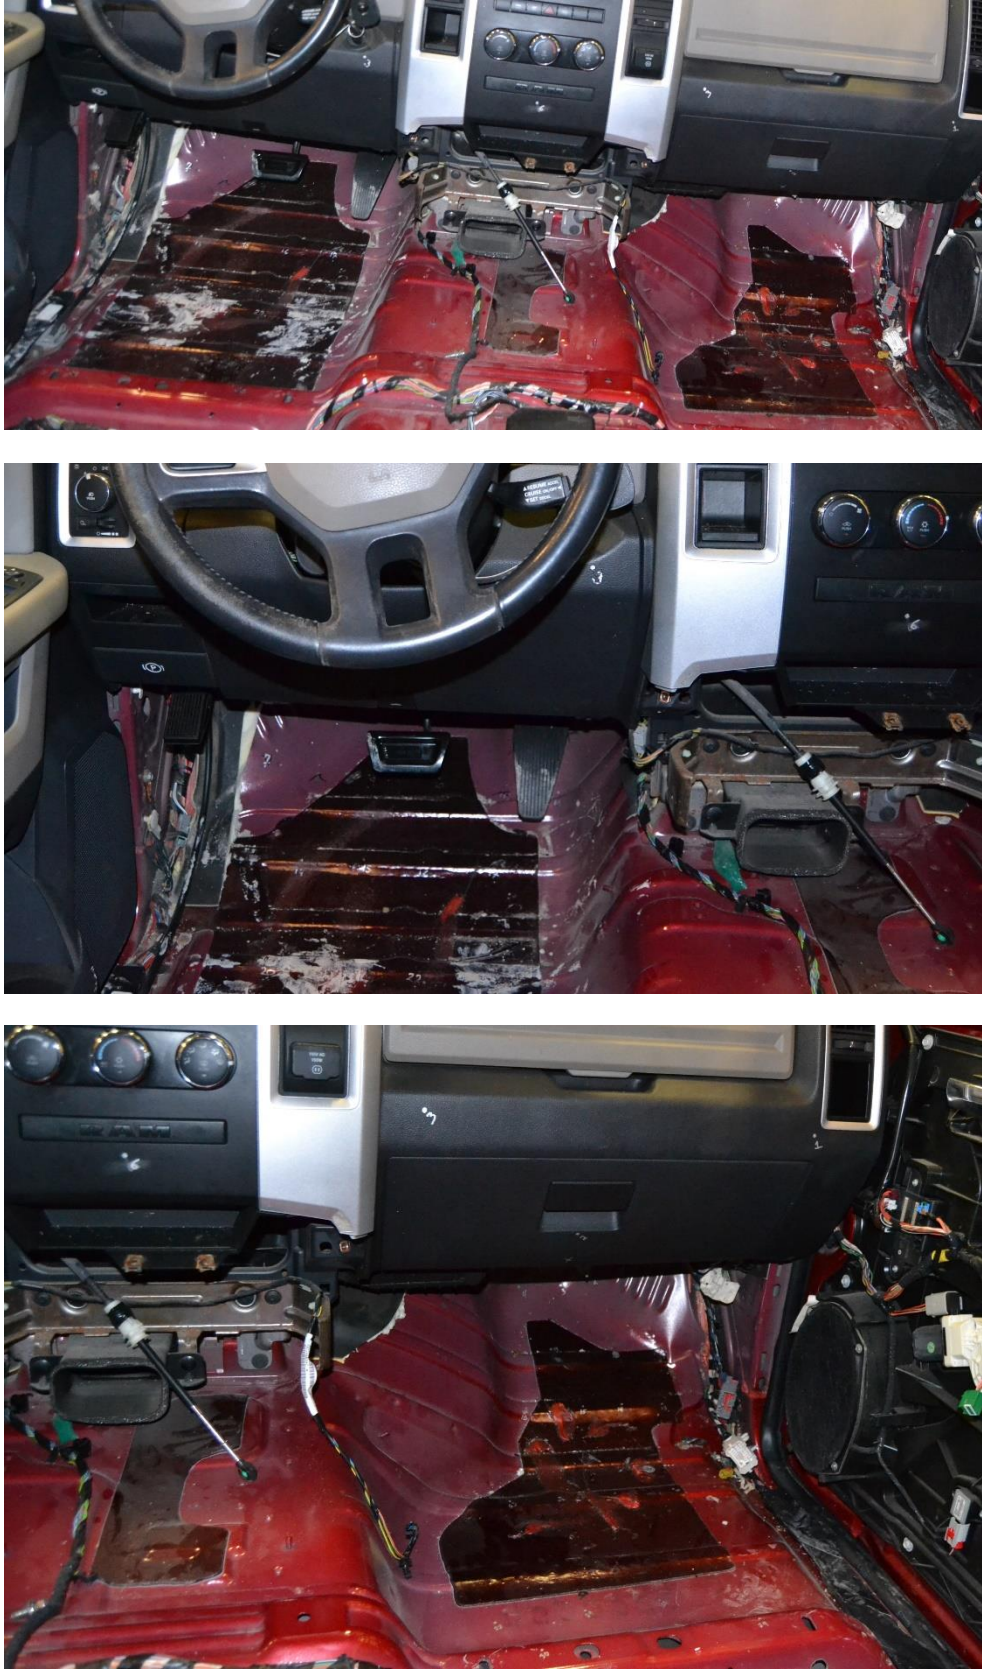
Figure 94. Vehicle Occupant Compartment Damage, Test No. CMGS-2

The damage to the vehicle was moderate, as shown in Figures 91 through 95. The maximum occupant compartment deformations are listed in Table 11 along with the intrusion limits established in MASH 2016 for various areas of the occupant compartment. MASH 2016 defines intrusion or deformation as the occupant compartment being deformed and reduced in size with no observed penetration. Complete occupant compartment and vehicle deformations as well as the corresponding locations are provided in Appendix D.

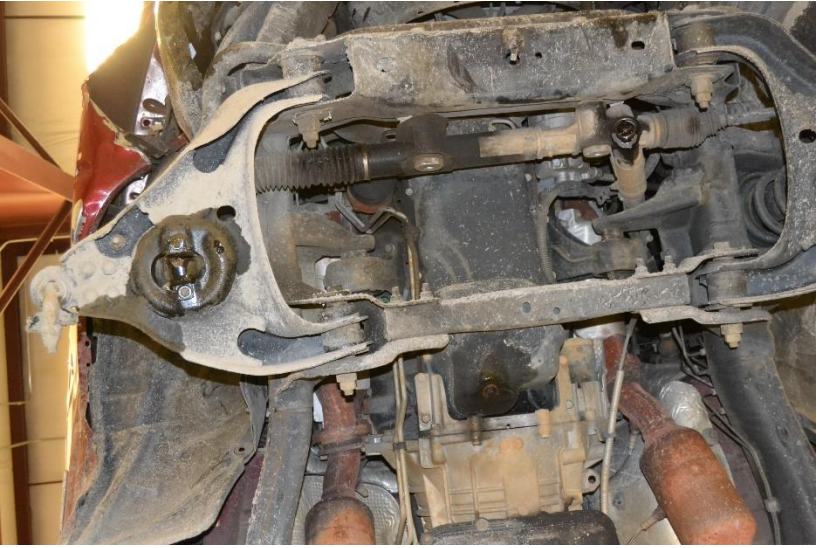
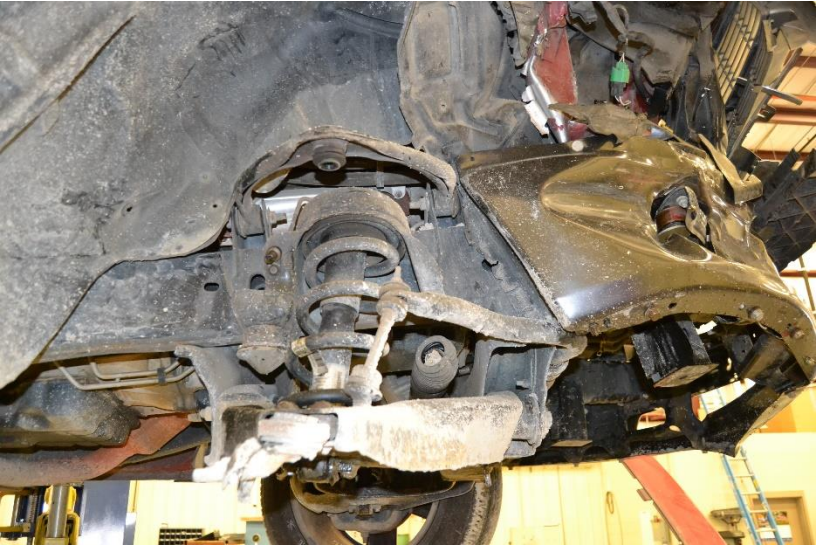
Figure 95. Vehicle Undercarriage Damage, Test No. CMGS-2

The roof, the hood, and the left side remained undamaged. The left-side and rear window glass also remained undamaged. The airbags did not deploy during the impact. The overall undercarriage damage included a 2-in. (51 mm) bend in the lower control arm, and the steering knuckle broke along with the steering arm on the passenger side. The front passenger-side brake line was disconnected. Interior occupant compartment deformations were moderate with a maximum of 1 1/8 in. (29 mm), which did not violate the limits established in MASH 2016.
