# Determination of Fatigue Resistance of Coupler Connections in Aluminum Overhead Truss Structures

Final Report

THE KANSAS DEPARTMENT OF TRANSFORMATION  
TOPEKA, KANSAS

October 2021

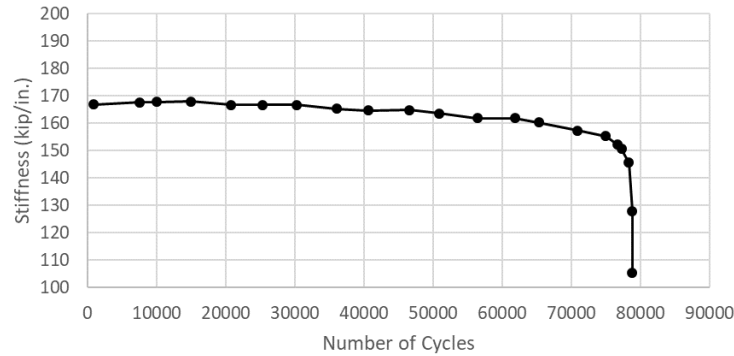
**Figure 4.9: Stiffness vs. Number of Cycles for FAT-TENS13 Tested at 15.1 ksi**

The graph of the assembly stiffness versus the number of applied cycles is presented in Figure 4.9. The stiffness started to reduce at approximately 30,000 cycles and then began to rapidly decrease at approximately 750,000 cycles. However, despite regular inspections, cracks were not observed until complete failure of the coupler.

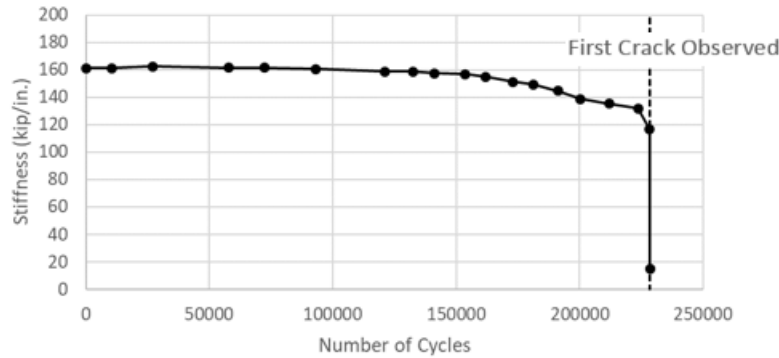
**Figure 4.11: Stiffness vs. Number of Cycles for FAT-TENS11 Tested at 10.5 ksi**

Figure 4.11 presents assembly stiffness with respect to the number of applied cycles. Stiffness started to decrease at approximately 150,000 cycles. However, when the researcher observed the crack, it was only 55 cycles away from failure.

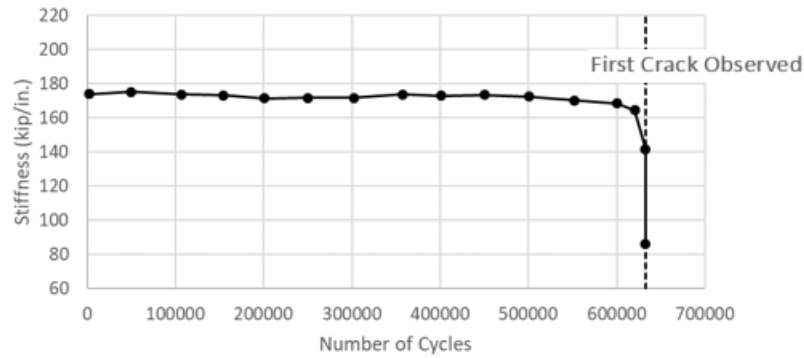
**Figure 4.13: Stiffness vs. Number of Cycles for FAT-TENS12 Tested at 10.5 ksi**

The record of assembly stiffness during testing is shown in Figure 4.13. The stiffness started to reduce slightly at approximately 450,000 cycles, but did not change much before it started to decrease rapidly at approximately 600,000 cycles. When the first crack was observed, it was still thin, but the coupler was only 323 cycles away from failure.

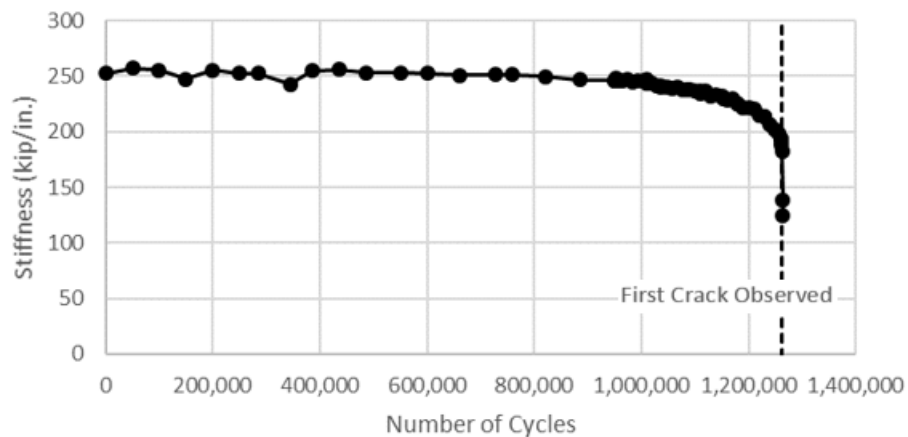
**Figure 4.16: Stiffness vs. Number of cycles for FAT-TENS3 Tested at 8.3 ksi**

The load and displacement are shown in Figure 4.16. The stiffness of the coupler assembly started to decrease at approximately 950,000 cycles, but no visible fatigue damage was observed until half of the 8-inch coupler cracked at 1,263,000 cycles. An additional 600 cycles led to complete failure of the coupler.

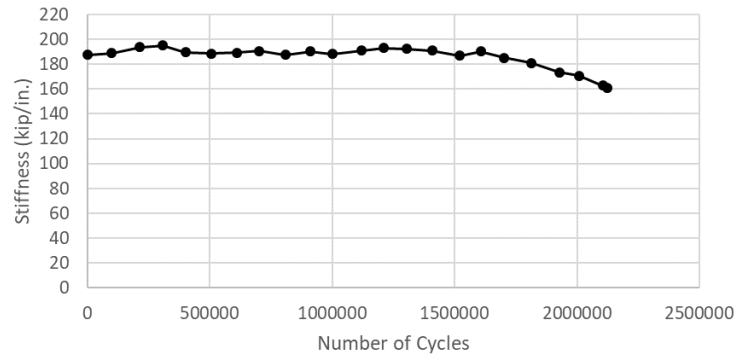
**Figure 4.18: Stiffness vs. Number of Cycles for FAT-TENS9 Tested at 8.3 ksi**

The record of coupler assembly stiffness during the test is presented in Figure 4.18. The last inspection performed before failure was at approximately 1.9 million cycles. Although the stiffness of the assembly started to decrease at approximately 1.6 million cycles, no visible cracks were observed in the last inspection.

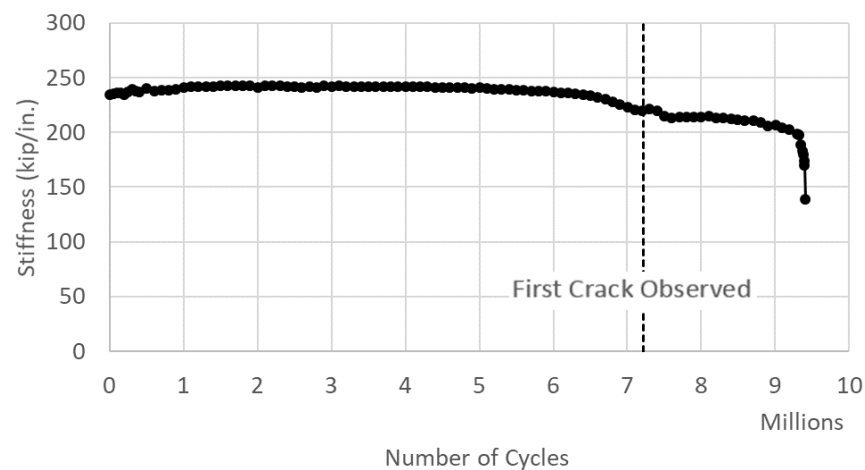
**Figure 4.21: Stiffness vs. Number of Applied Cycles for FAT-TENS5 Tested at 5.8 ksi**

The stiffness record for FAT-TENS4 is presented in Figure 4.21. In this test, the first crack was detected at about 7.2 million cycles, and it took an additional 2 million cycles to reach complete failure. This was different than other tests, since in most of the tests, cracks were not visually-observable until complete failure was imminent.

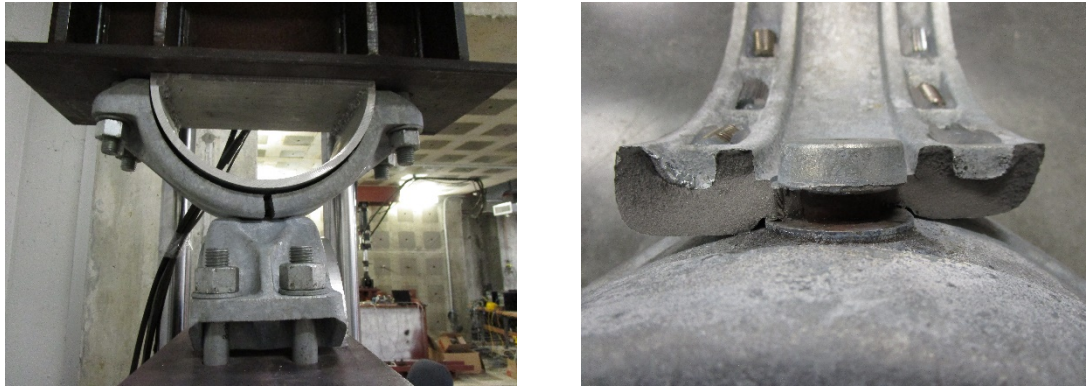
**Figure 4.22: Failure of FAT-TENS5 Tested at 5.8 ksi**

FAT-TENS5 was a new “off-the-shelf” coupler, tested at a stress range of 5.8 ksi. Failure occurred at 4,453,581 cycles, characterized by the 10-inch coupler cracking in half. In the last inspection performed at 4,432,960 cycles, a decrease of stiffness was observed but no visible crack was identified. Photographs of the specimen after failure are presented in Figure 4.22.

(a) Failure of FAT-TENS5

(b) Failure Surface of FAT-TENS5

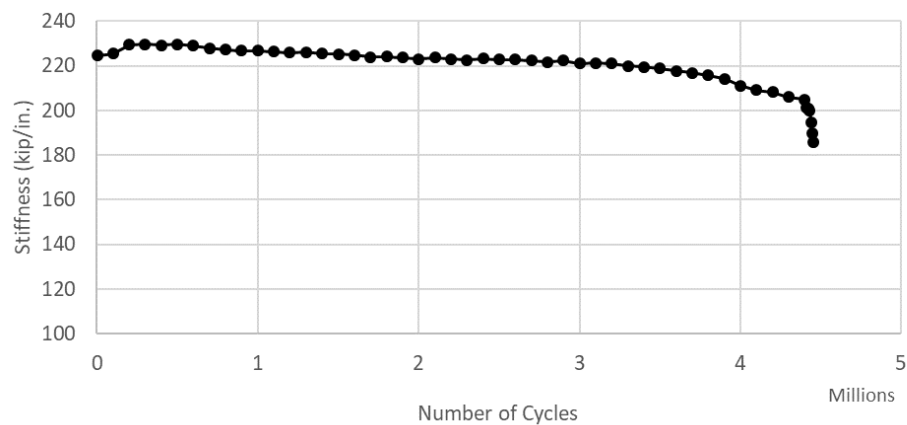
**Figure 4.23: Stiffness vs. Number of Cycles for FAT-TENS5 Tested at 5.8 ksi**

The stiffness record for FAT-TENS5 is presented in Figure 4.23. Although stiffness of the assembly started to decrease at approximately 3.2 million cycles, no cracking was observed until complete failure occurred.

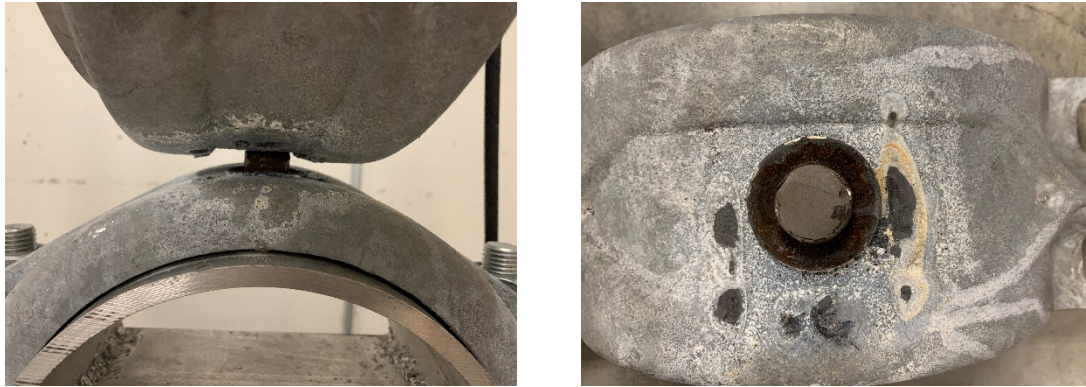
**Figure 4.24: Failure of FAT-TENS7 Tested at 5.8 ksi**

FAT-TENS7 was a new “off-the-shelf” coupler, tested at a stress range of 5.8 ksi. The specimen failed by cracking of rivet, with failure occurring at 2,961,381 cycles. Although inspection was performed regularly, no visible damage was observed until failure. Photographs of the specimen after failure are shown in Figure 4.24.

(a) Failure of FAT-TENS7

(b) Failure Surface of FAT-TENS7

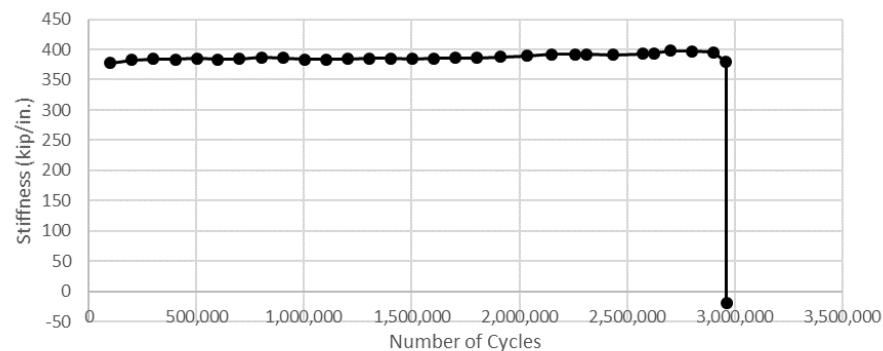
**Figure 4.25: Stiffness vs. Number of Cycles for FAT-TENS7 Tested at 5.8 ksi**

The stiffness record for FAT-TENS7 is shown in Figure 4.25. No gradual decrease in stiffness was observed as occurring in this test.

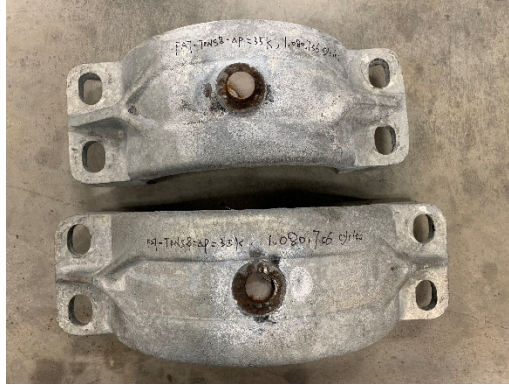
**Figure 4.26: Failure of FAT-TENS8 Tested at 5.8 ksi**

FAT-TENS8 was a new “off-the-shelf” coupler, tested at a stress range of 5.8 ksi. The specimen failed by cracking of rivet at 1,080,756 cycles. No visible damage was observed before failure. Photographs of the specimen after failure are shown in Figure 4.26.

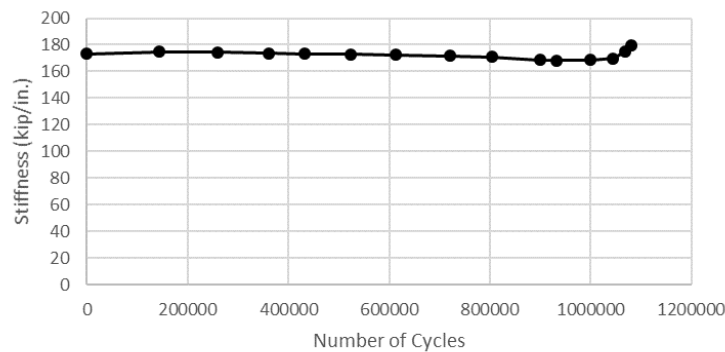
**Figure 4.27: Stiffness vs. Number of Cycles for FAT-TENS8 Tested at 5.8 ksi**

The stiffness record for FAT-TENS8 is shown in Figure 4.27. Similar to the behavior observed for FAT-TENS7, reductions in stiffness were not observed as occurring before failure.

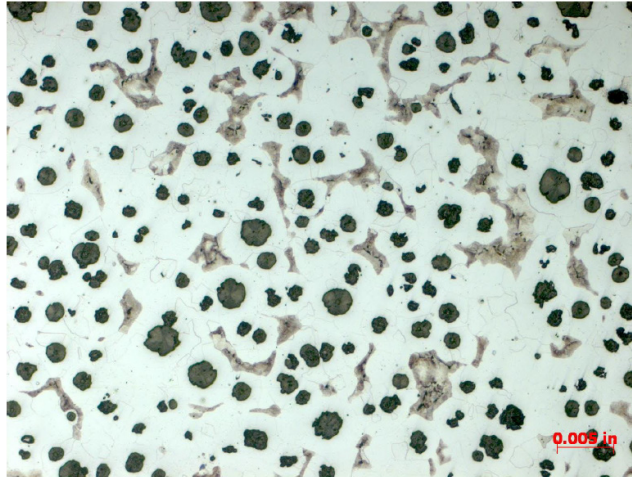
**Figure 4.30: Photomicrograph of Coupler Material Sample**

To determine the material composition of the coupler connections, a sample was cut from one of the couplers taken from an out-of-service OHTSS and sent to a materials testing laboratory. The material test was performed by Pacific Testing Laboratories, Inc., Valencia, CA. Figure 4.30 shows a photomicrograph showing the microstructure of the material sample. Graphite nodules in a matrix of  $\alpha$ -ferrite (with some pearlite) were observed. The microstructure is characteristic of ductile cast irons.
