Federal Railroad  
Administration

RR 21-24 | November 2021

## HIGHWAY-RAIL GRADE CROSSING COLLISION TEST OF A FUEL TENDER

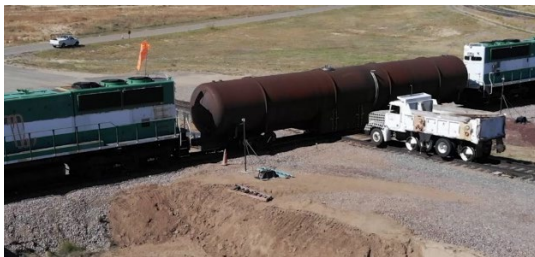
This fuel tender was a double-walled tank (i.e., tank-within-a-tank) designed to carry a cryogenic liquid (i.e., liquefied natural gas), as a locomotive fuel. The tested tender was purpose-built for this test with the structural features of a fuel tender, including all piping and valves found in normal service. The tested tender did not feature all the equipment required of a functional fuel tender (e.g., trucks, heat exchanger). The tender was coupled between two six-axle freight locomotives, as defined in the standard. The protective housing around the external piping and valves was struck by an 80,000-pound dump truck that had been modified to travel on railroad tracks. [Figure 1](#) shows the tank car in its pre-test position at the TTC.

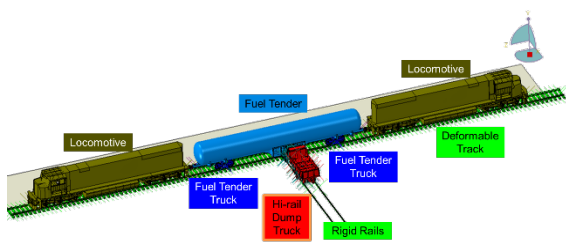
**Figure 3. Grade Crossing Impact Scenario FE Model**

Researchers performed a finite element analysis (FEA) in conjunction with the test. A schematic of the finite element (FE) model is shown in [Figure 3](#). In addition to a deformable model of the fuel tender, the FE model also included a deformable dump truck (i.e., based on a publicly available tractor model) and two deformable locomotives (i.e., based on a model provided by AAR as per M-1004). The model also required development of a deformable representation of the three-piece freight trucks under the tender and a deformable track structure beneath the test consist.
